Contract No. DC/2008/03
Design, Build and Operate Pillar
Point Sewage Treatment Works:
Fifty-first Monthly EM&A Report

February 2015

MONTHLY EM&A REPORT

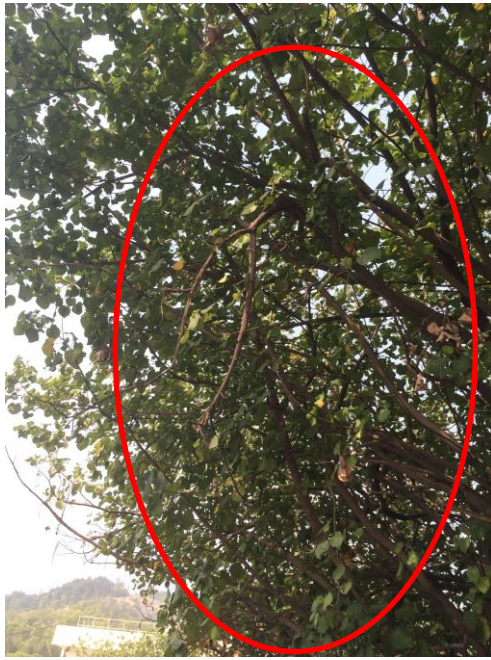
- Retained trees T01 were observed some branches were damaged by others (see attached photos – Fig. 001 and Fig. 002). The Contractor was reminded to protect the retain trees every time and arrange tree specialist to check the health condition of the tree accordingly.
