# Contract No. HY/2012/07 Tuen Mun - Chek Lap Kok Link Southern Connection Viaduct Section

Fifth Quarterly Environmental Monitoring & Audit (EM&A) Report

13 July 2015

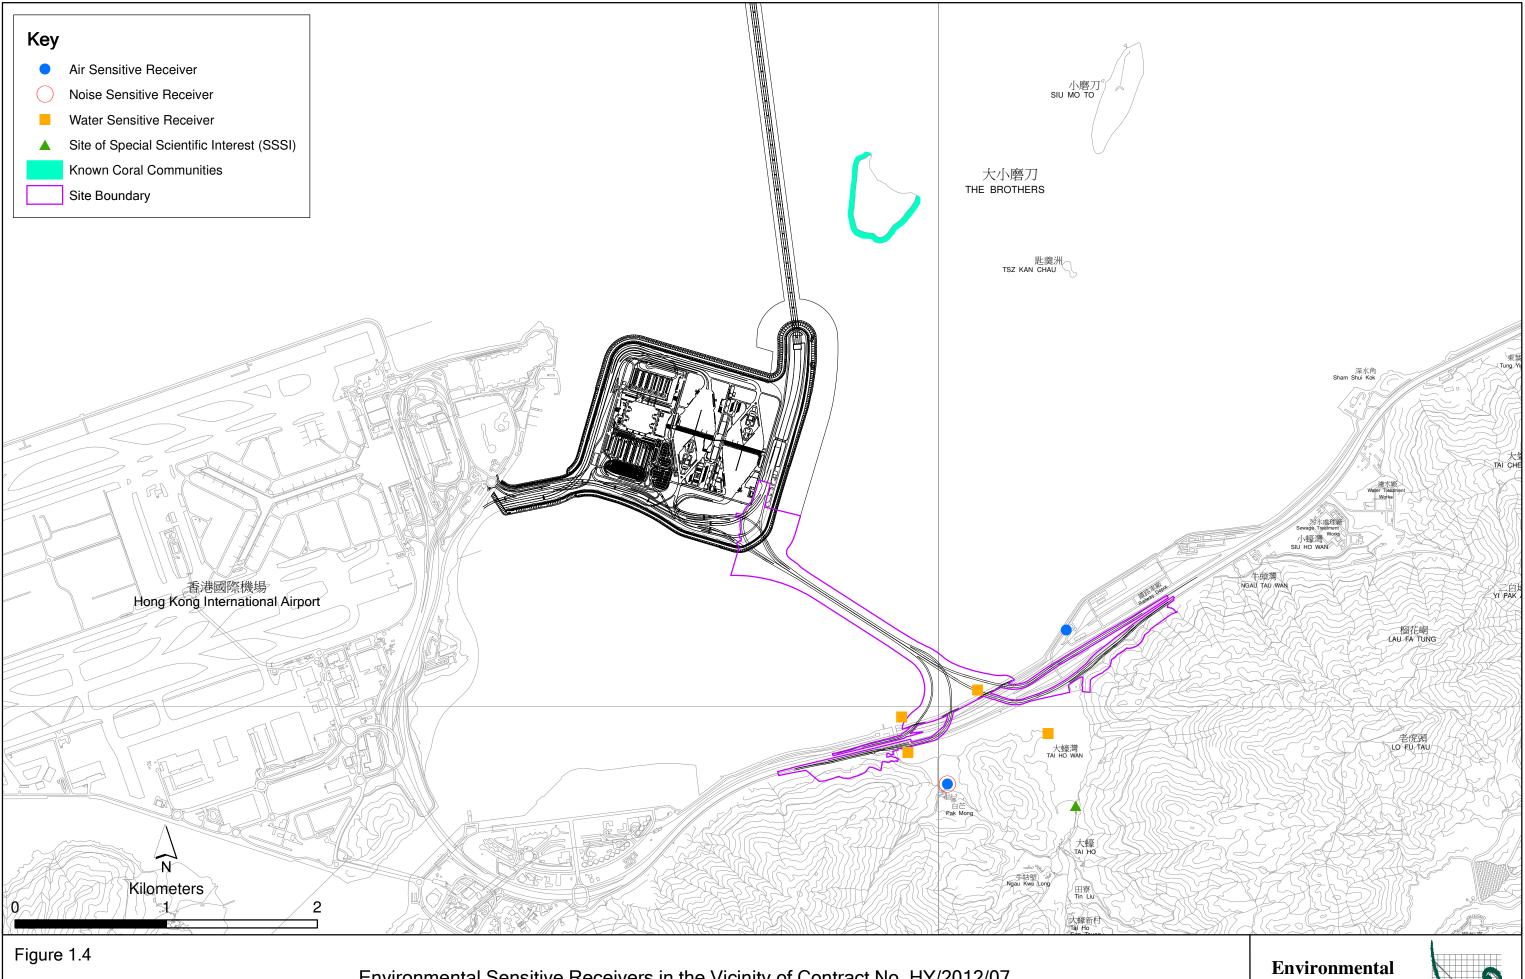
Environmental Sensitive Receivers in the Vicinity of Contract No. HY/2012/07 Tuen Mun - Chek Lap Kok Link - Southern Connection Viaduct Section

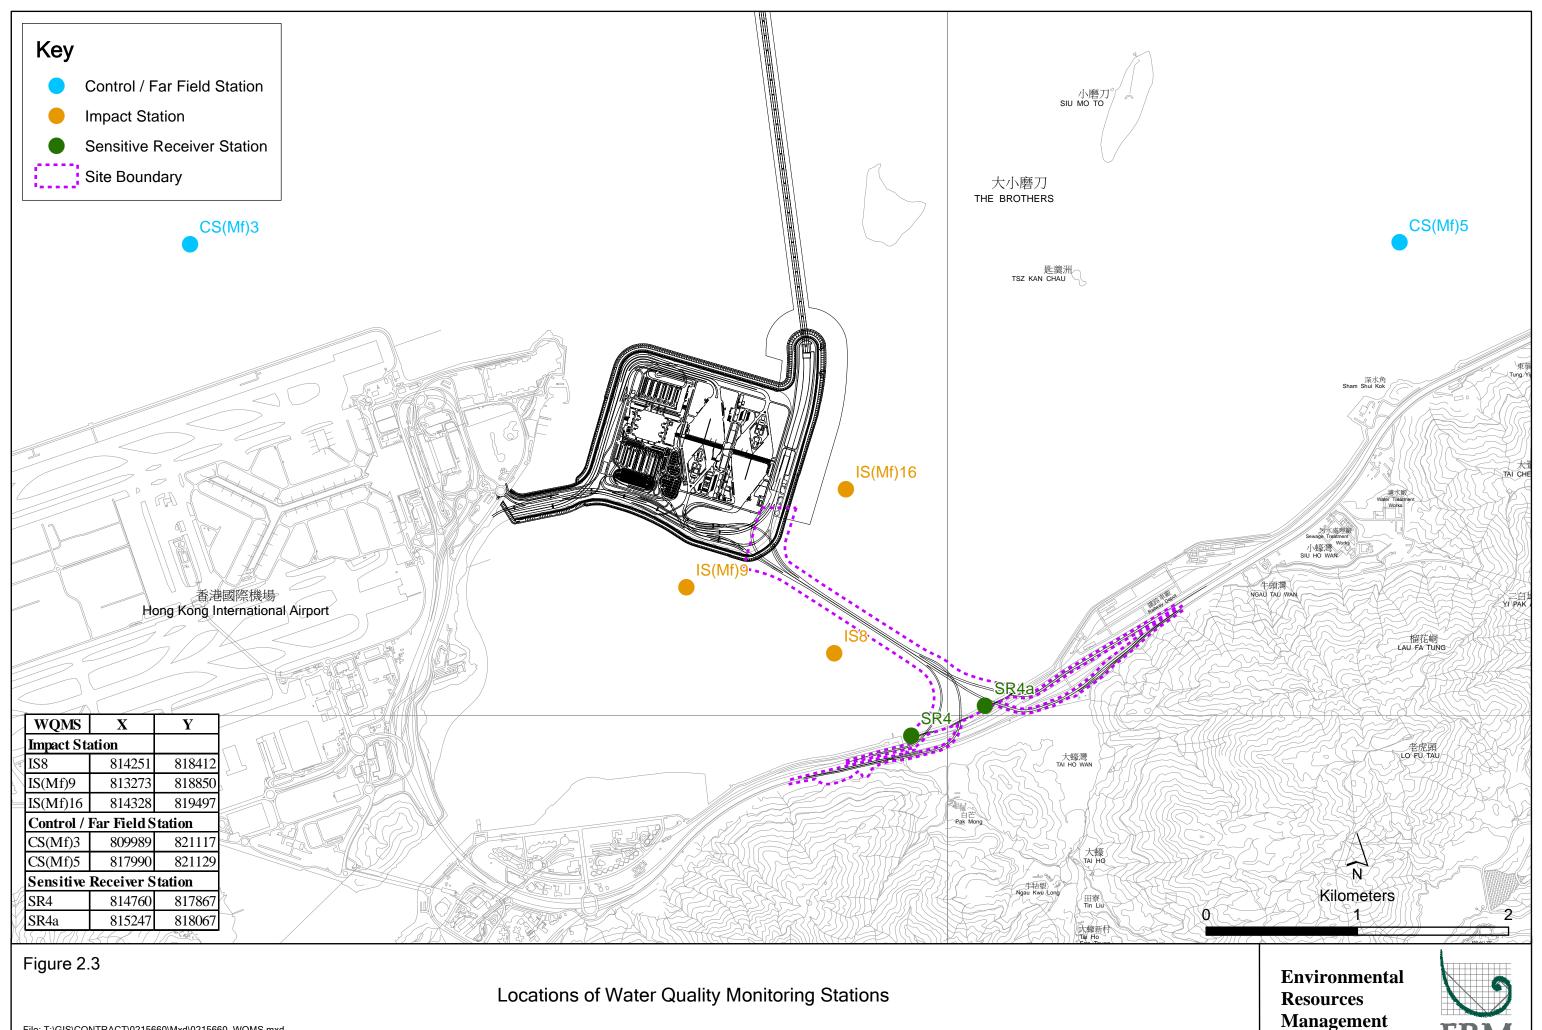
Impact water quality monitoring was carried out to ensure that any deterioration of water quality was detected, and that timely action was taken to rectify the situation. Impact water quality monitoring was undertaken three days per week during the construction period at seven water quality monitoring stations in accordance with the Updated EM&A Manual (*Figure* 2.3; *Table* 2.8).

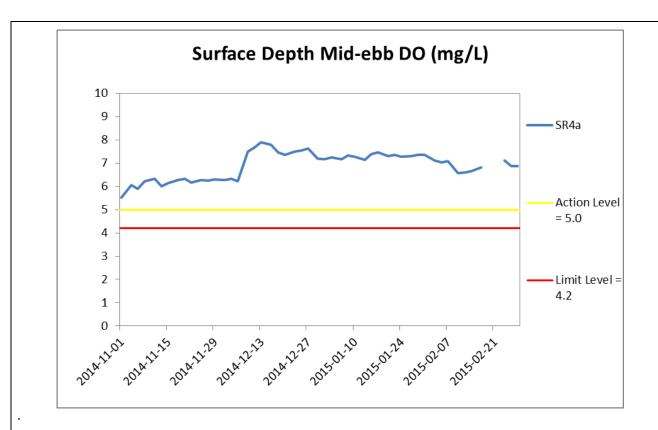
Figure H4 Impact Monitoring – Mean Level of Dissolved Oxygen (mg/L) in surface waters during mid-ebb tide between 1 November 2014 and 28 February 2015 at SR4a.

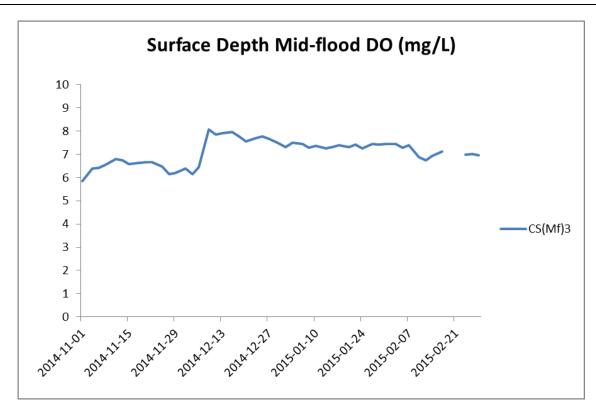
Figure H5 Impact Monitoring – Mean Level of Dissolved Oxygen (mg/L) in surface waters during mid-flood tide between 1 November 2014 and 28 February 2015 at CS(Mf)3 and CS(Mf)5.

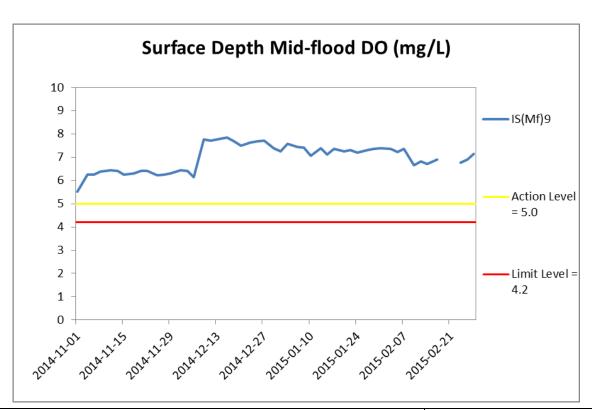
Figure H6 Impact Monitoring – Mean Level of Dissolved Oxygen (mg/L) in surface waters during mid-flood tide between 1 November 2014 and 28 February 2015 at IS(Mf)16 and IS(Mf)9.

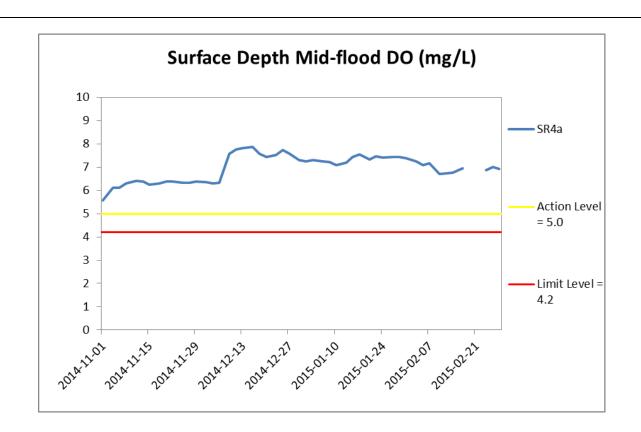
Figure H8 Impact Monitoring – Mean Level of Dissolved Oxygen (mg/L) in surface waters during mid-flood tide between 1 November 2014 and 28 February 2015 at SR4a.

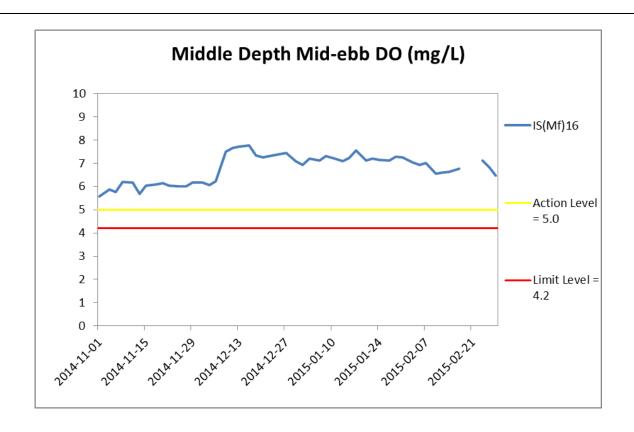
Figure H10 Impact Monitoring - Mean Level of Dissolved Oxygen (mg/L) in mid-depth waters during mid-ebb tide between 1 November 2014 and 28 February 2015 at IS(Mf)16.

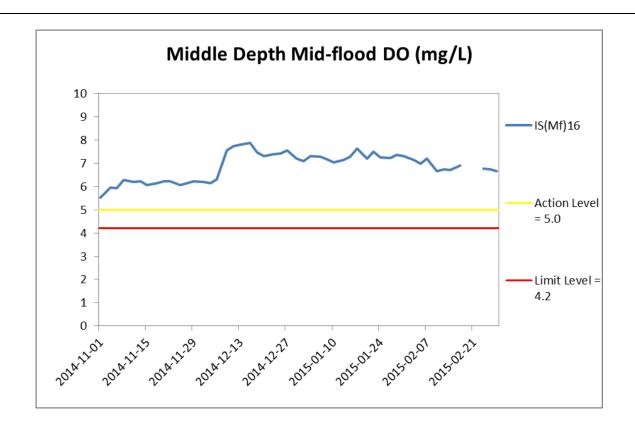
Figure H12 Impact Monitoring - Mean Level of Dissolved Oxygen (mg/L) in mid-depth waters during mid-flood tide between 1 November 2014 and 28 February 2015 at IS(Mf)16.

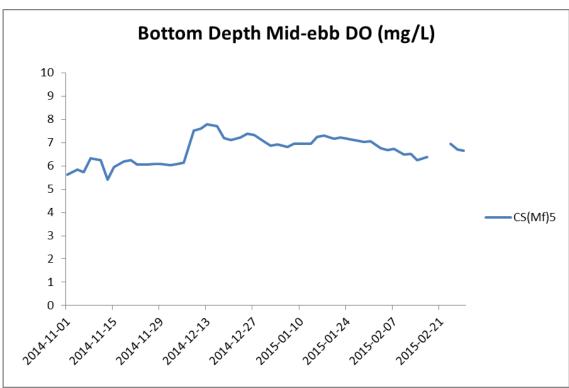
Figure H13 Impact Monitoring – Mean Level of Dissolved Oxygen (mg/L) in bottom waters during mid-ebb tide between 1 November 2014 and 28 February 2015 at CS(Mf)3 and CS(Mf)5.

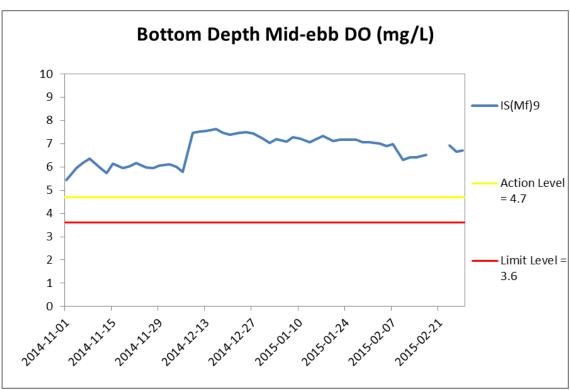
Figure H14 Impact Monitoring - Mean Level of Dissolved Oxygen (mg/L) in bottom waters during mid-ebb tide between 1 November 2014 and 28 February 2015 at IS(Mf)16 and IS(Mf)9.

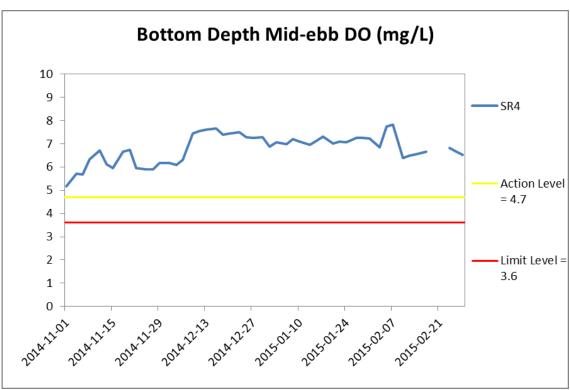
Figure H15 Impact Monitoring – Mean Level of Dissolved Oxygen (mg/L) in bottom waters during mid-ebb tide between 1 November 2014 and 28 February 2015 at IS8 and SR4.

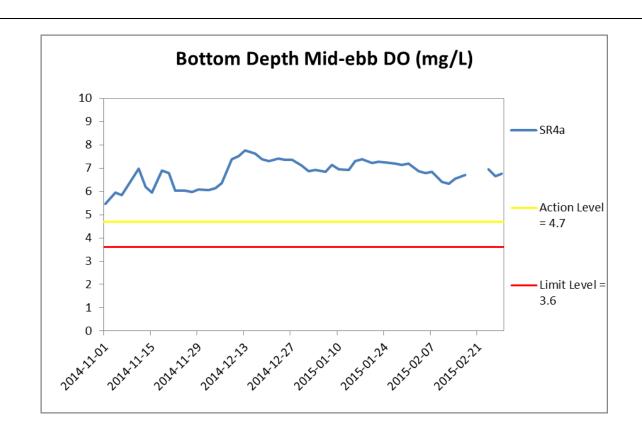
Figure H16 Impact Monitoring – Mean Level of Dissolved Oxygen (mg/L) in bottom waters during mid-ebb tide between 1 November 2014 and 28 February 2015 at SR4a.

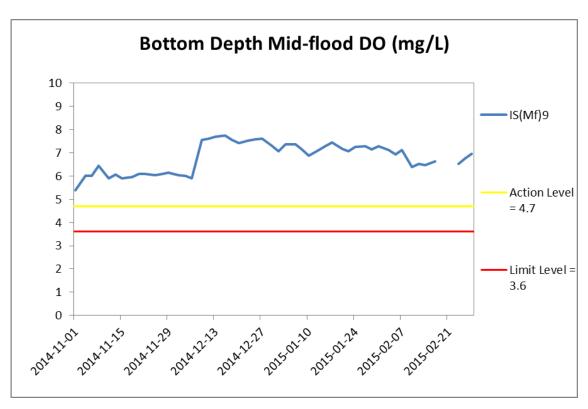
Figure H18 Impact Monitoring – Mean Level of Dissolved Oxygen (mg/L) in bottom waters during mid-flood tide between 1 November 2014 and 28 February 2015 at IS(Mf)16 and IS(Mf)9.

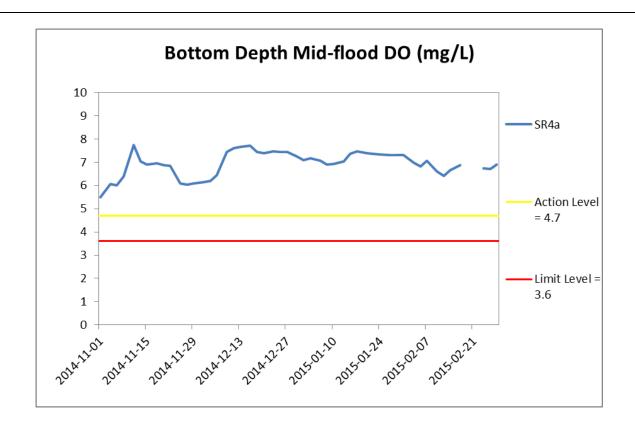
Figure H20 Impact Monitoring – Mean Level of Dissolved Oxygen (mg/L) in bottom waters during mid-flood tide between 1 November 2014 and 28 February 2015 at SR4a.

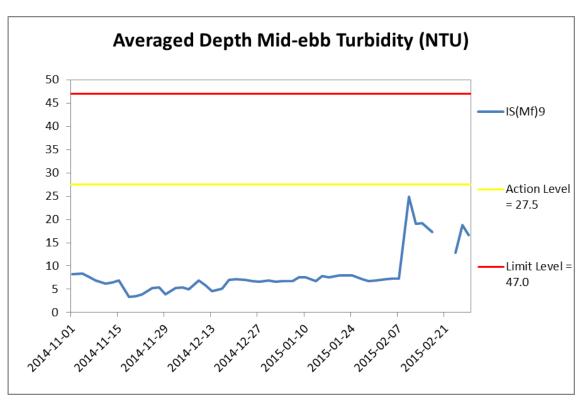
Figure H22 Impact Monitoring – Mean Level of depth-averaged Turbidity (NTU) during mid-ebb tide between 1 November 2014 and 28 February 2015 at IS(Mf)16 and IS(Mf)9.

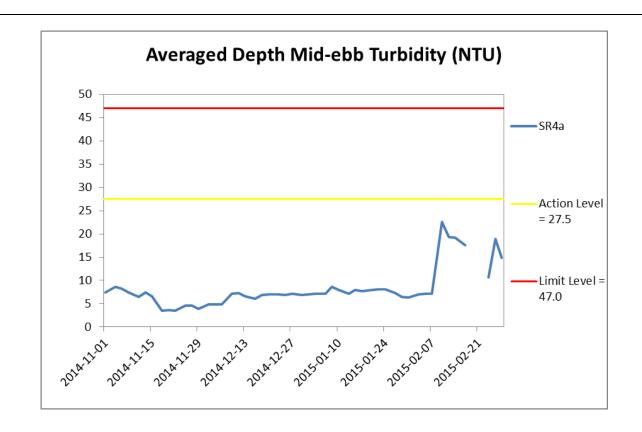
Figure H24 Impact Monitoring – Mean Level of depth-averaged Turbidity (NTU) during mid-ebb tide between 1 November 2014 and 28 February 2015 at SR4a.

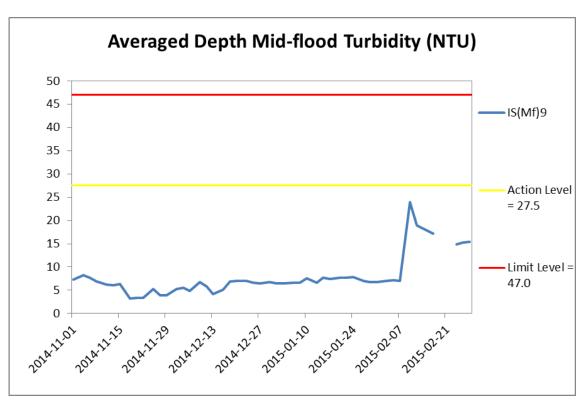
Figure H26 Impact Monitoring – Mean Level of depth-averaged Turbidity (NTU) during mid-flood tide between 1 November 2014 and 28 February 2015 at IS(Mf)16 and IS(Mf)9.

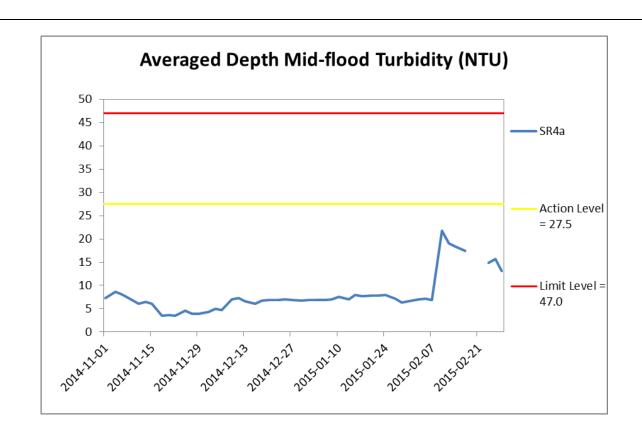
Figure H28 Impact Monitoring – Mean Level of depth-averaged Turbidity (NTU) during mid-flood tide between 1 November 2014 and 28 February 2015 at SR4a.

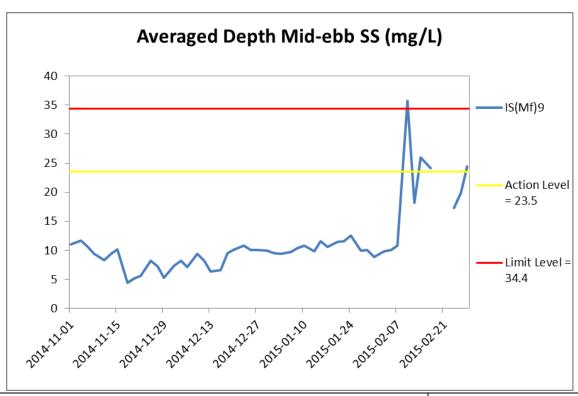
Figure H30 Impact Monitoring – Mean depth-averaged level of Suspended Solids (mg/L) during mid-ebb tide between 1 November 2014 and 28 February 2015 at IS(Mf)16 and IS(Mf)9.

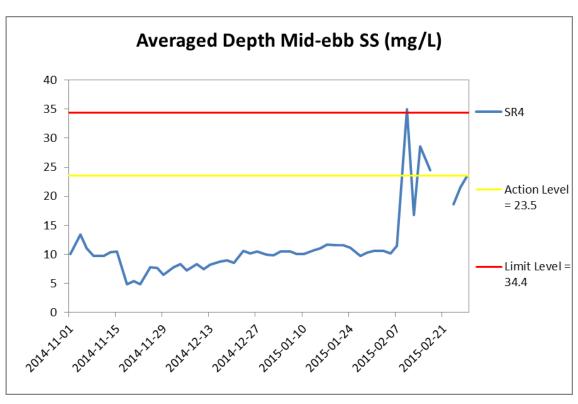
Figure H31 Impact Monitoring – Mean depth-averaged level of Suspended Solids (mg/L) during mid-ebb tide between 1 November 2014 and 28 February 2015 at IS8 and SR4.

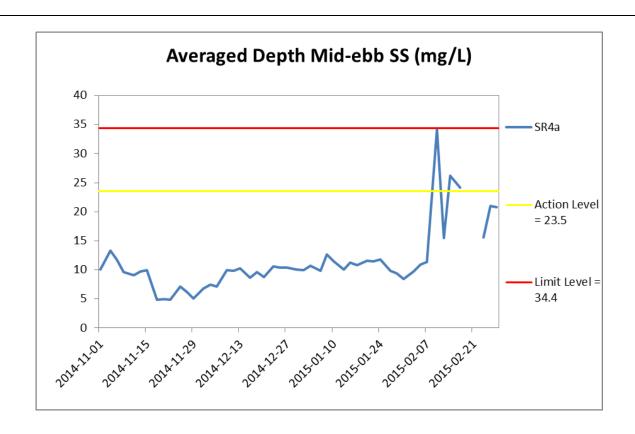
Figure H32 Impact Monitoring – Mean depth-averaged level of Suspended Solids (mg/L) during mid-ebb tide between 1 November 2014 and 28 February 2015 at SR4a.

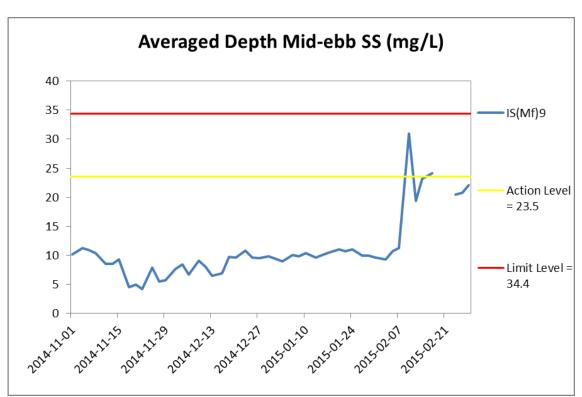
Figure H34 Impact Monitoring – Mean depth-averaged level of Suspended Solids (mg/L) during mid-flood tide between 1 November 2014 and 28 February 2015 at IS(Mf)16 and IS(Mf)9.

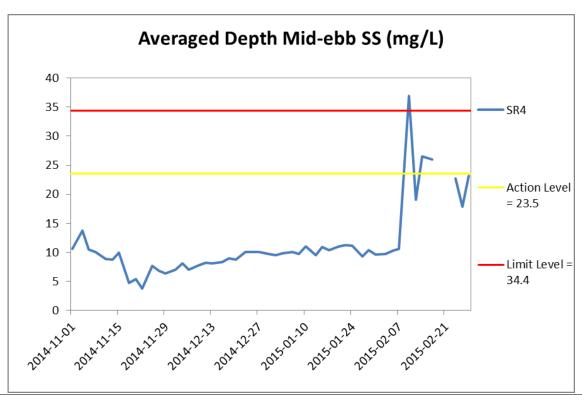
Figure H35 Impact Monitoring – Mean depth-averaged level of Suspended Solids (mg/L) during mid-flood tide between 1 November 2014 and 28 February 2015 at IS8 and SR4.

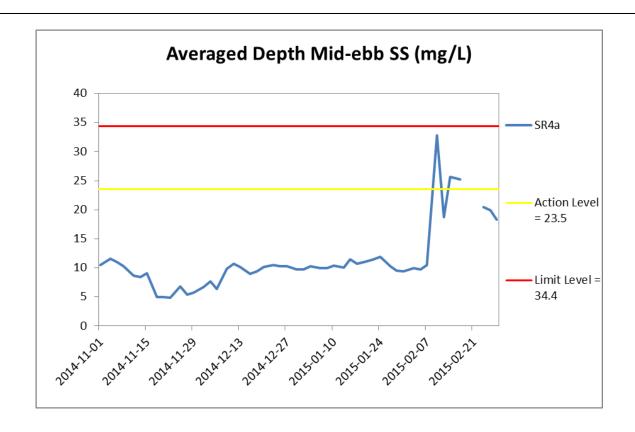
Figure H36 Impact Monitoring – Mean depth-averaged level of Suspended Solids (mg/L) during mid-flood tide between 1 November 2014 and 28 February 2015 at SR4a.

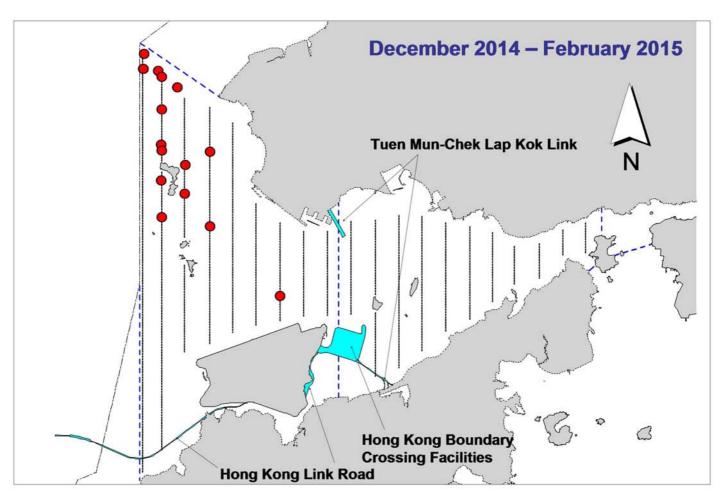
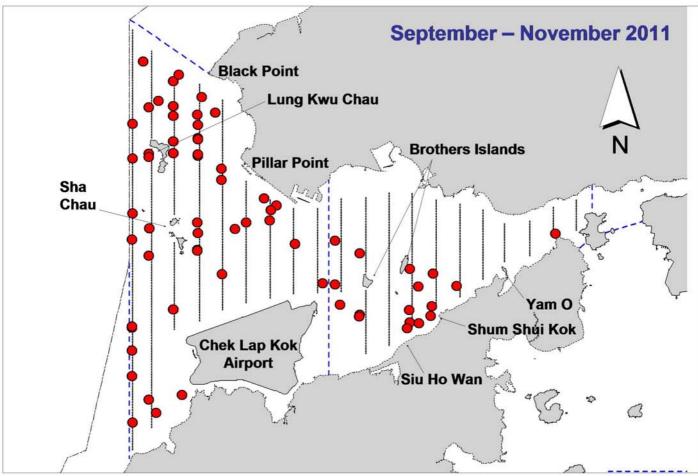
Figure 1. Distribution of Chinese white dolphin sighting in Northwest and Northeast Lantau during HKLR03 impact phase (top) and baseline monitoring surveys (bottom)

Whilst one (1) Limit Level exceedance was observed for the quarterly dolphin monitoring data between December 2014 and February 2015, no unacceptable impact from the activities of this Contract on Chinese White Dolphins was noticeable from the general observations in this quarter.
