Contract No. CV/2013/08
Liantang / Heung Yuen Wai Boundary Control Point
Site Formation and Infrastructure Works – Contract 6

Environmental Permit No. EP-404/2011/C
Condition 2.14 – Archaeological Surveys
Submission of Archaeological Survey Report

Archaeological Survey Areas

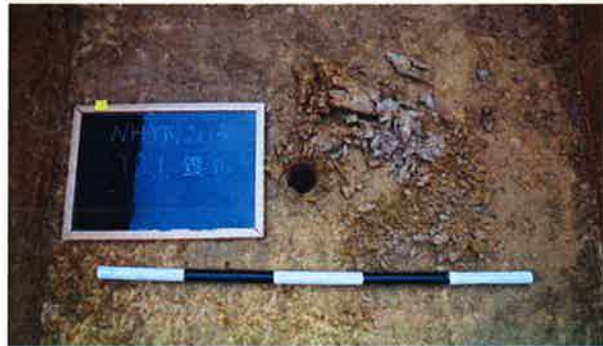
Zoom in view of auger result in TP1

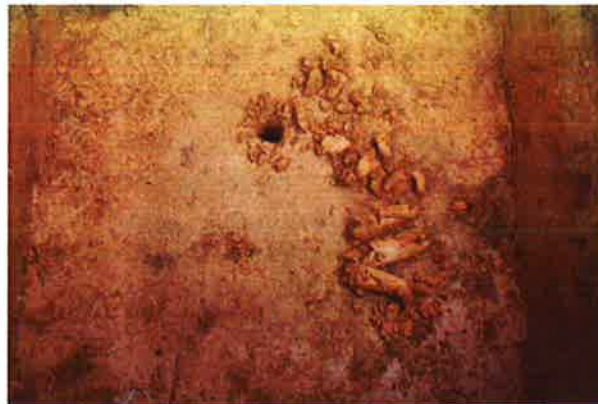
Zoom in view of auger result in TP2

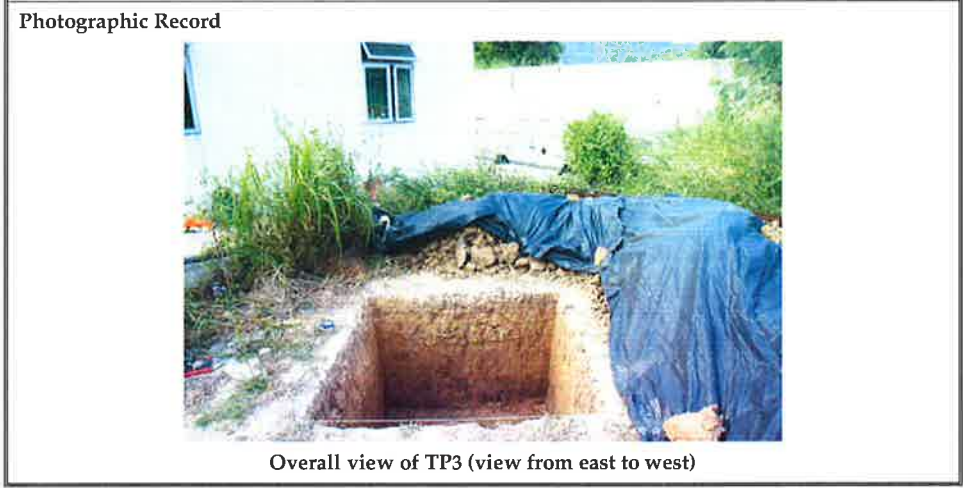
Site Code	NHYW2015		Test Pit No.	TP3	
Test Pit SE corner Coordinate (E,N)	835444.183	843757.583	Test Pit Measurement (LxW) (m)	1.5x1.5	
Digging Method	Hand digging		Ground Level (mPD)	23.214	
Stratigraphy (Reference to North Wall)					
Layer	Description	Cultural Remains	Archaeological Dating	Depth from Ground Level (cm)	Thickness (cm)
1	Greyish brown sandy soil, with lots of stones, loose and hard	None	Early 20th Century ⁽³⁾	0	12-26
2	Yellowish brown sandy soil, with large amount of yellow and red lumps, loose and hard, contains large amount of stones	None	Earlier than early 20th Century ⁽⁴⁾	12-26	13-29
3	Upper part is yellowish brown and gradually turns brown at the bottom, sandy soil, firm and soft, contains small amount of stones (sterile layer)	N/A	N/A	29-42	56-70
4 (auger hole)	Yellowish sandy soil, firm and hard (sterile layer)	N/A	N/A	106	24
5 (auger hole)	Yellowish brown sandy soil with large amount of red spots and fine sand, firm (sterile layer)	N/A	N/A	130	16

North wall of TP3

East wall of TP3

TP3 and TP4 are close to existing buildings. Beneath the top soil, L2 of both TP3 and TP4 are both yellowish brown sandy soil with large amount of yellow and red lumps, loose and hard. These layers should be regarded as the fill soil for site flattening for building construction.

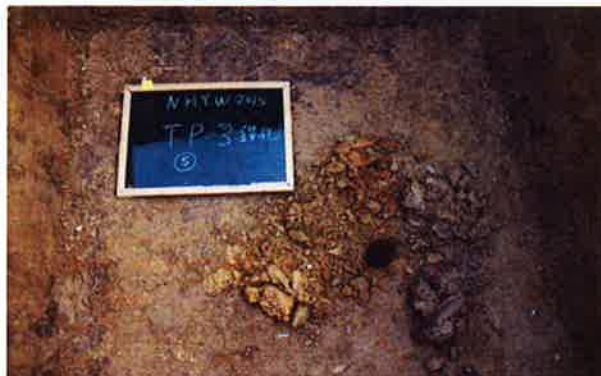
Zoom in view of auger result in TP3

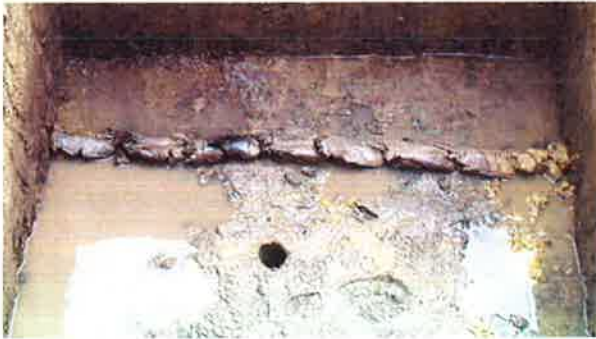
Zoom in view of auger result in TP4

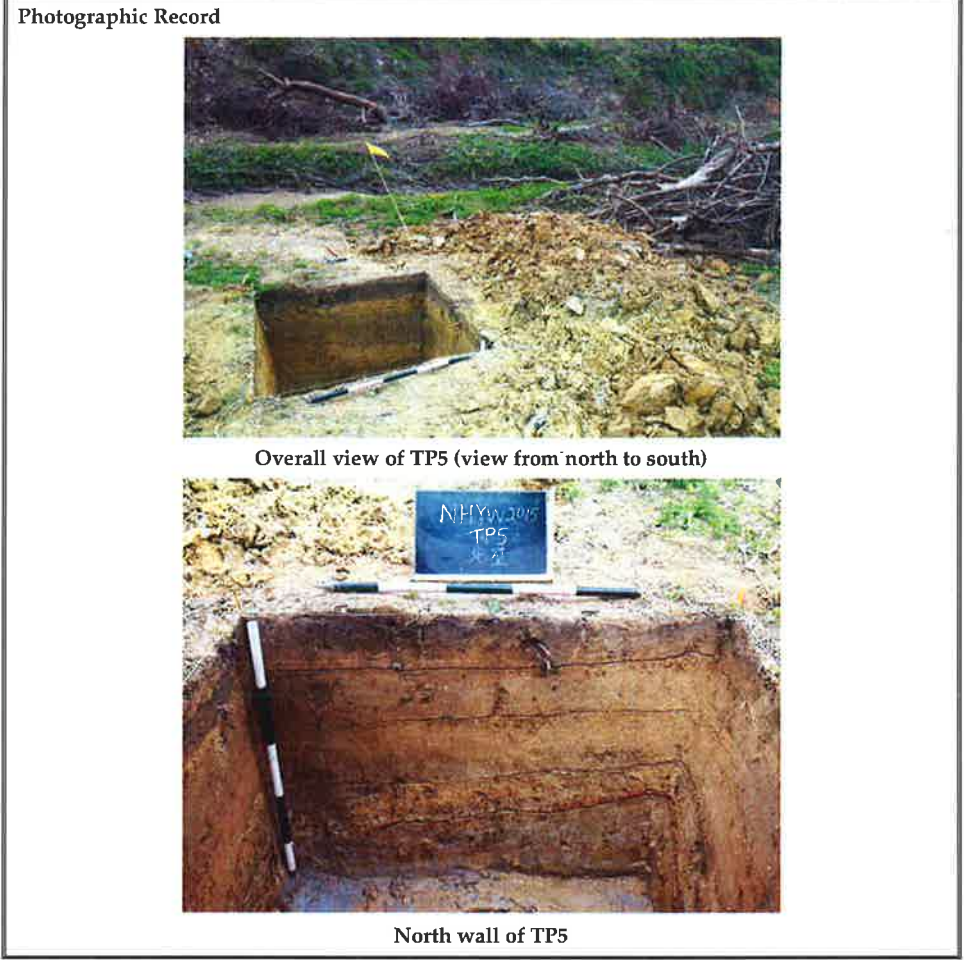
Site Code	NHYW2015		Test Pit No.	TP5	
Test Pit SE corner Coordinate (E,N)	835114.252	844211.538	Test Pit Measurement (LxW) (m)	1.5x1.5	
Digging Method	Hand digging		Ground Level (mPD)	18.182	
Stratigraphy (Reference to North Wall)					
Layer	Description	Cultural Remains	Archaeological Dating	Depth from Ground Level (cm)	Thickness (cm)
1	Topsoil. The upper sub-layer is dark grey sandy soil, contains large amount of humus (smelly) and with modern rubbish (i.e. plastics). The lower sub-layer is yellow sandy soil as fill soil, not distributed evenly. Both sublayers are loose.	Modern rubbish (i.e. plastics)	Modern	0	14-20
2	Brownish grey sandy soil, firm and hard, pure. It has large amount of rusted iron spots. (sterile layer)	N/A	N/A	14-20	18-21
3	Yellow sandy, loose and soft, contains small amount of stones. (sterile layer)	N/A	N/A	34-38	19-24
4	Yellow sandy soil with small amount of grey sand (fine and soft), very loose and soft. It has large amount of dark brown spots. (sterile layer)	N/A	N/A	51-60	12-24

5	Grey sand, loose and soft, pure (sterile layer, river bed sediment)	N/A	N/A	65-85 (water table was reached at 100)	>34

East wall of TP5

Sterile layers were found immediately beneath L1 of TP5 to TP8. TP5 and TP7 are located at the bottom of valley which the water table was reached at 1m bgl at TP5 and 95cm bgl at TP7. L2 to L5 of TP5 are sandy layers which are likely the sediments of river beds. Although L2 and L3 of TP7 are silty, bottom strata L4 and L5 of TP7 are also sandy. L4 and L5 of TP7 should also be regarded as the sediments of river beds. TP6 is located on a higher ground under trees. L2 and L3 are yellow sandy soil and yellow sandy soil

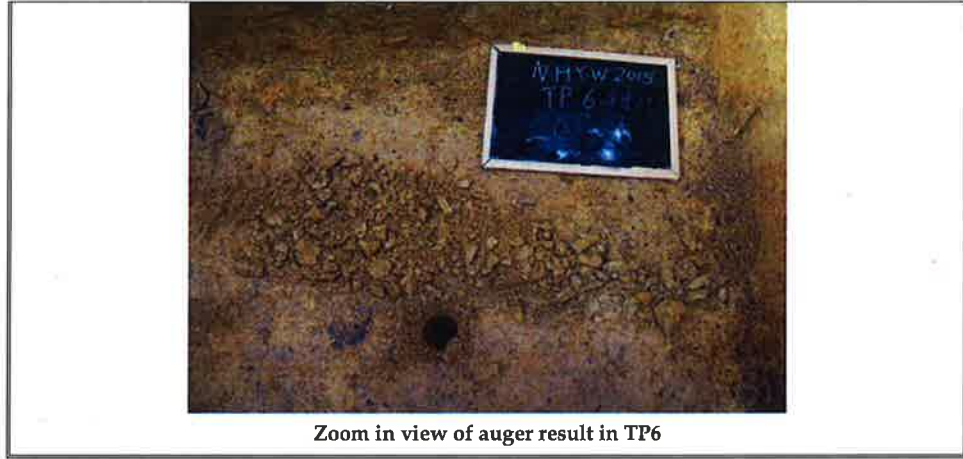
Zoom in view of auger result in TP6

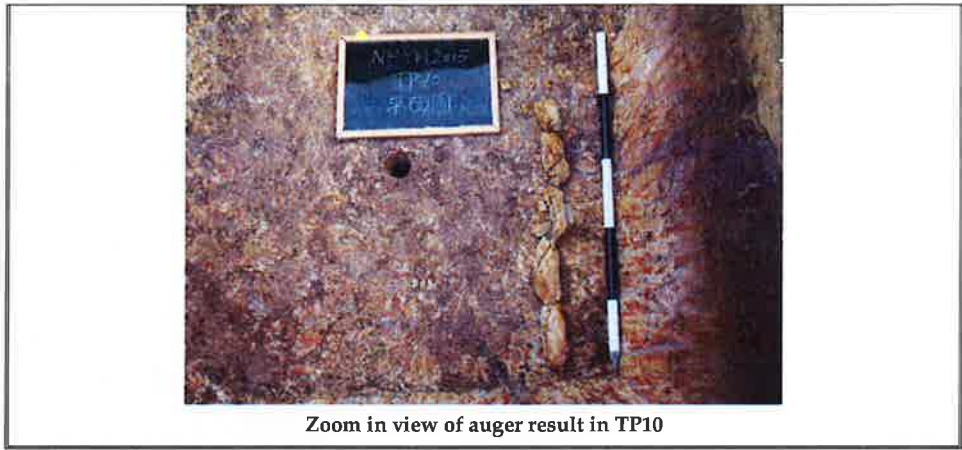
Zoom in view of auger result in TP10

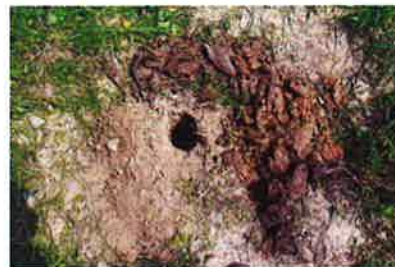
Auger Hole No.	Strata	Depth (cm)	Thickness (cm)	Description
AH3	1	0	30	Yellowish brown sand, loose (road side fill layer)
	2	30	20	Dark grey sandy soil (fine sand), loose and soft, contains lots of humus
	3	50	20	Light grey sandy soil (fine sand), firm and soft
	4	70	30	Grey sandy soil (fine sand), firm and a bit hard, contains reddish brown lumps
	5	100	>100	Black silty soil, firm and soft *Reached the maximum depth of auger

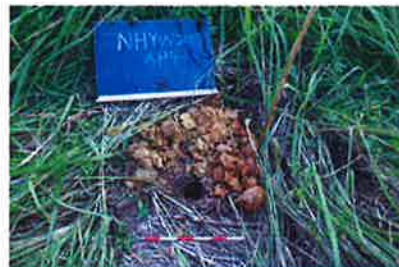
Auger Hole No.	Strata	Depth (cm)	Thickness (cm)	Description
AH5	1	0	35	Reddish brown silty soil
	2	35	85	Brown silty soil with red spots
	3	120	55	Greyish brown silty soil with red spots (very silty)
	4	175	>25	Greyish brown sand

Sterile layers were also found immediately beneath L1 of AH4 to AH8. Some similarity of the strata between the auger holes are worth to note. For example, L3 of AH5 and L2 of AH7 are greyish brown silty soil with red spots. L4 of AH5 and AH6 are greyish brown sand.

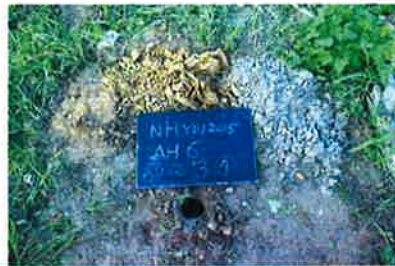
AH7	1	0	50	Greyish brown silty soil
	2	50	20	Greyish brown silty soil with red spots
	3	70	90	Greyish white silty soil
	4	160	>40	Greyish white sandy soil with deteriorated rock

In addition, deteriorated rocks were reached in AH7 and AH8. Greyish brown sandy layer which should be the river bed was also revealed as L4 of AH6.

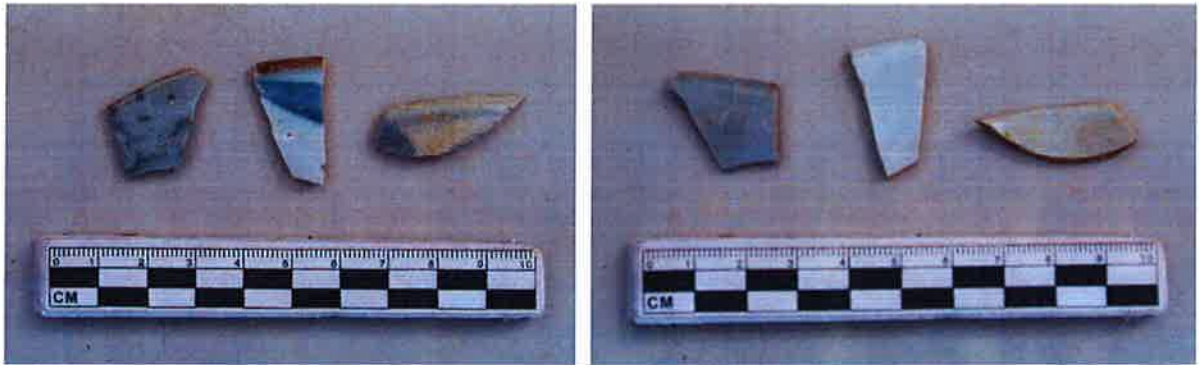
Rim Shards of Blue and White Porcelain Bowl Dated to Early 20th Century Found in H1 of TP2
[NHYW2015 Area B TP2 H1 GF1]

A feature H1 is found in TP2 of Area B. It is a garbage pit containing three pieces of blue and white porcelain shards and 13 pieces of pottery shards, which the artefacts are village wares that have very low archaeological significance. H1 should be dated to early 20th Century based on the dating of the artefacts revealed.

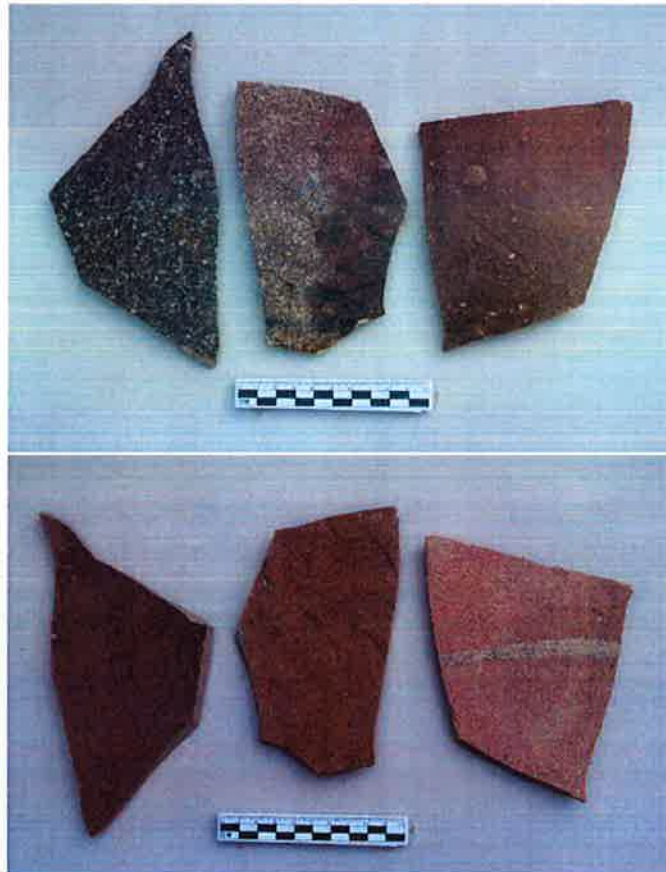
Brownish Glazed Pottery Jar Shards Dated to Early 20th Century Found in H1 of TP2
[NHYW2015 Area B TP2 H1 GF2]

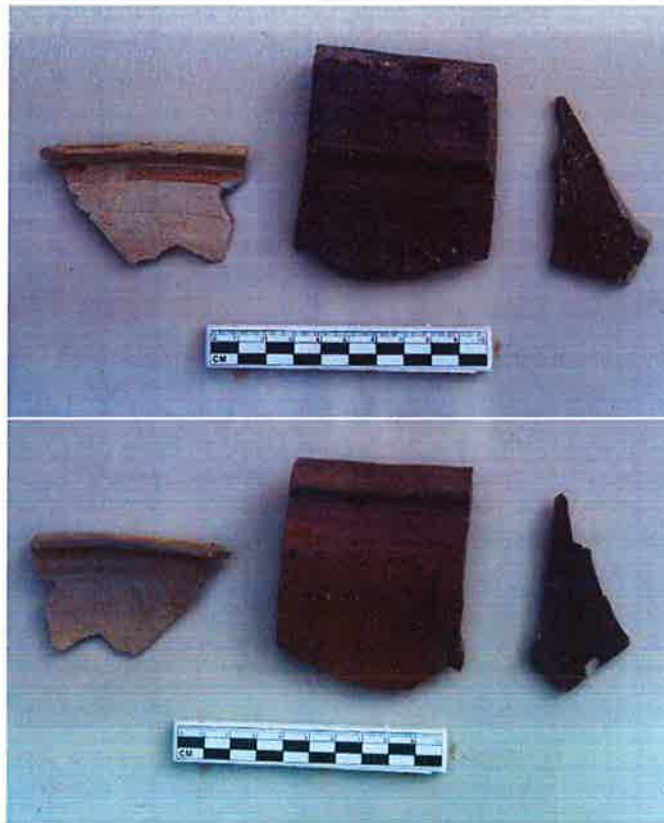
Rim Shards of Brownish Glazed Pottery Basin and Vat Dated to Early 20th Century Found in H1 of TP2
[NHYW2015 Area B TP2 H1 GF3]

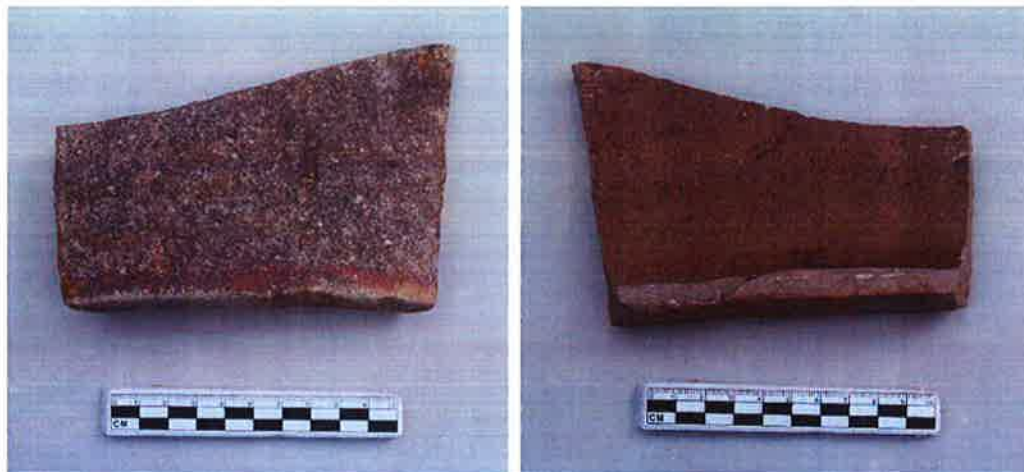
Bottom shard of Brownish Glazed Pottery Jar Dated to Early 20th Century Found in H1 of TP2
[NHYW2015 Area B TP2 H1 GF4]

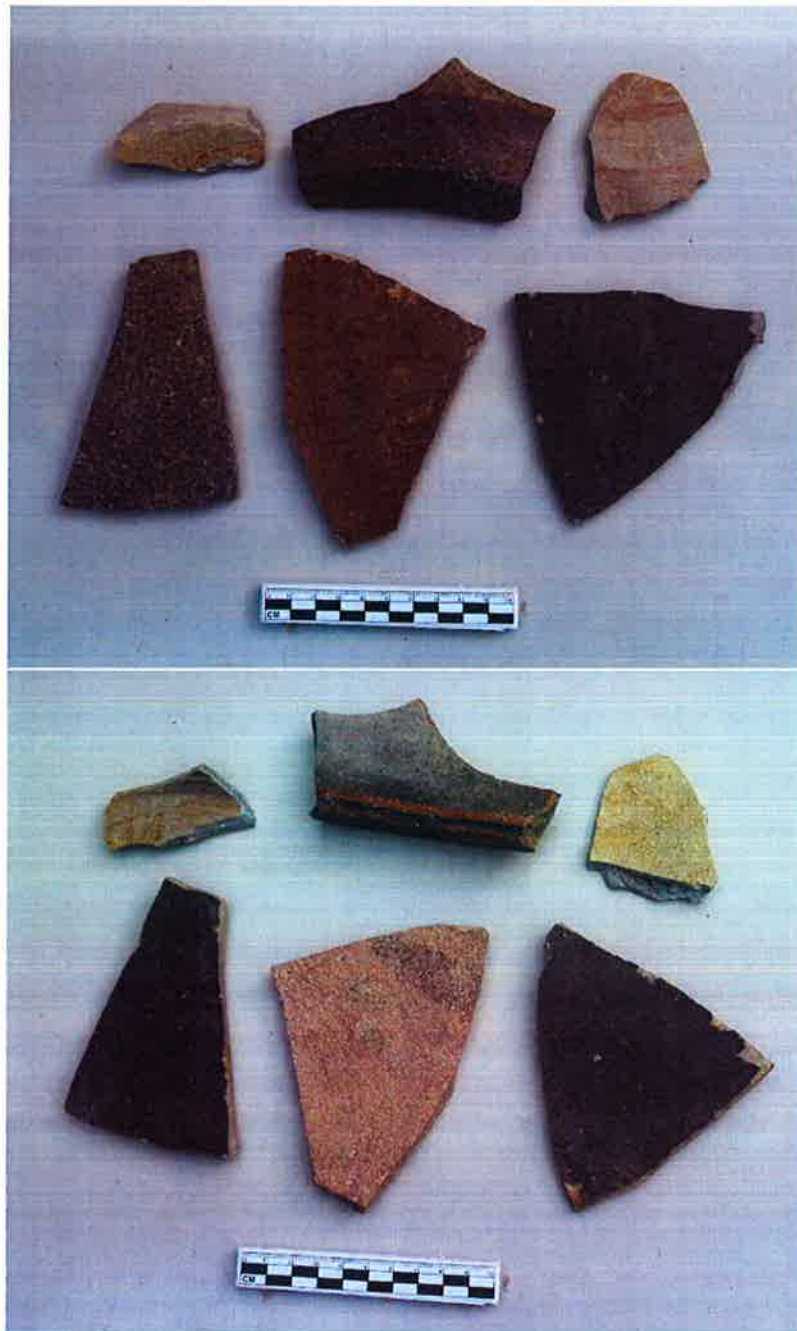
Brownish Glazed Pottery Shards Dated to Early 20th Century Found in H1 of TP2
[NHYW2015 Area B TP2 H1 GF5]
