**CONSTRUCTION OF AN ADDITIONAL SEWAGE RISING MAIN
BETWEEN TUNG CHUNG AND SIU HO WAN AND
ASSOCIATED WORKS**

**ENTRUSTED LANDSCAPE WORKS FROM CONTRACT NO.
HY/2012/07 TO CONTRACT NO. DC/2016/01
UNDER ENVIRONMENTAL PERMIT NO. EP-354/2009/D**

MONTHLY ENVIRONMENTAL MONITORING & AUDIT REPORT

AUGUST 2023

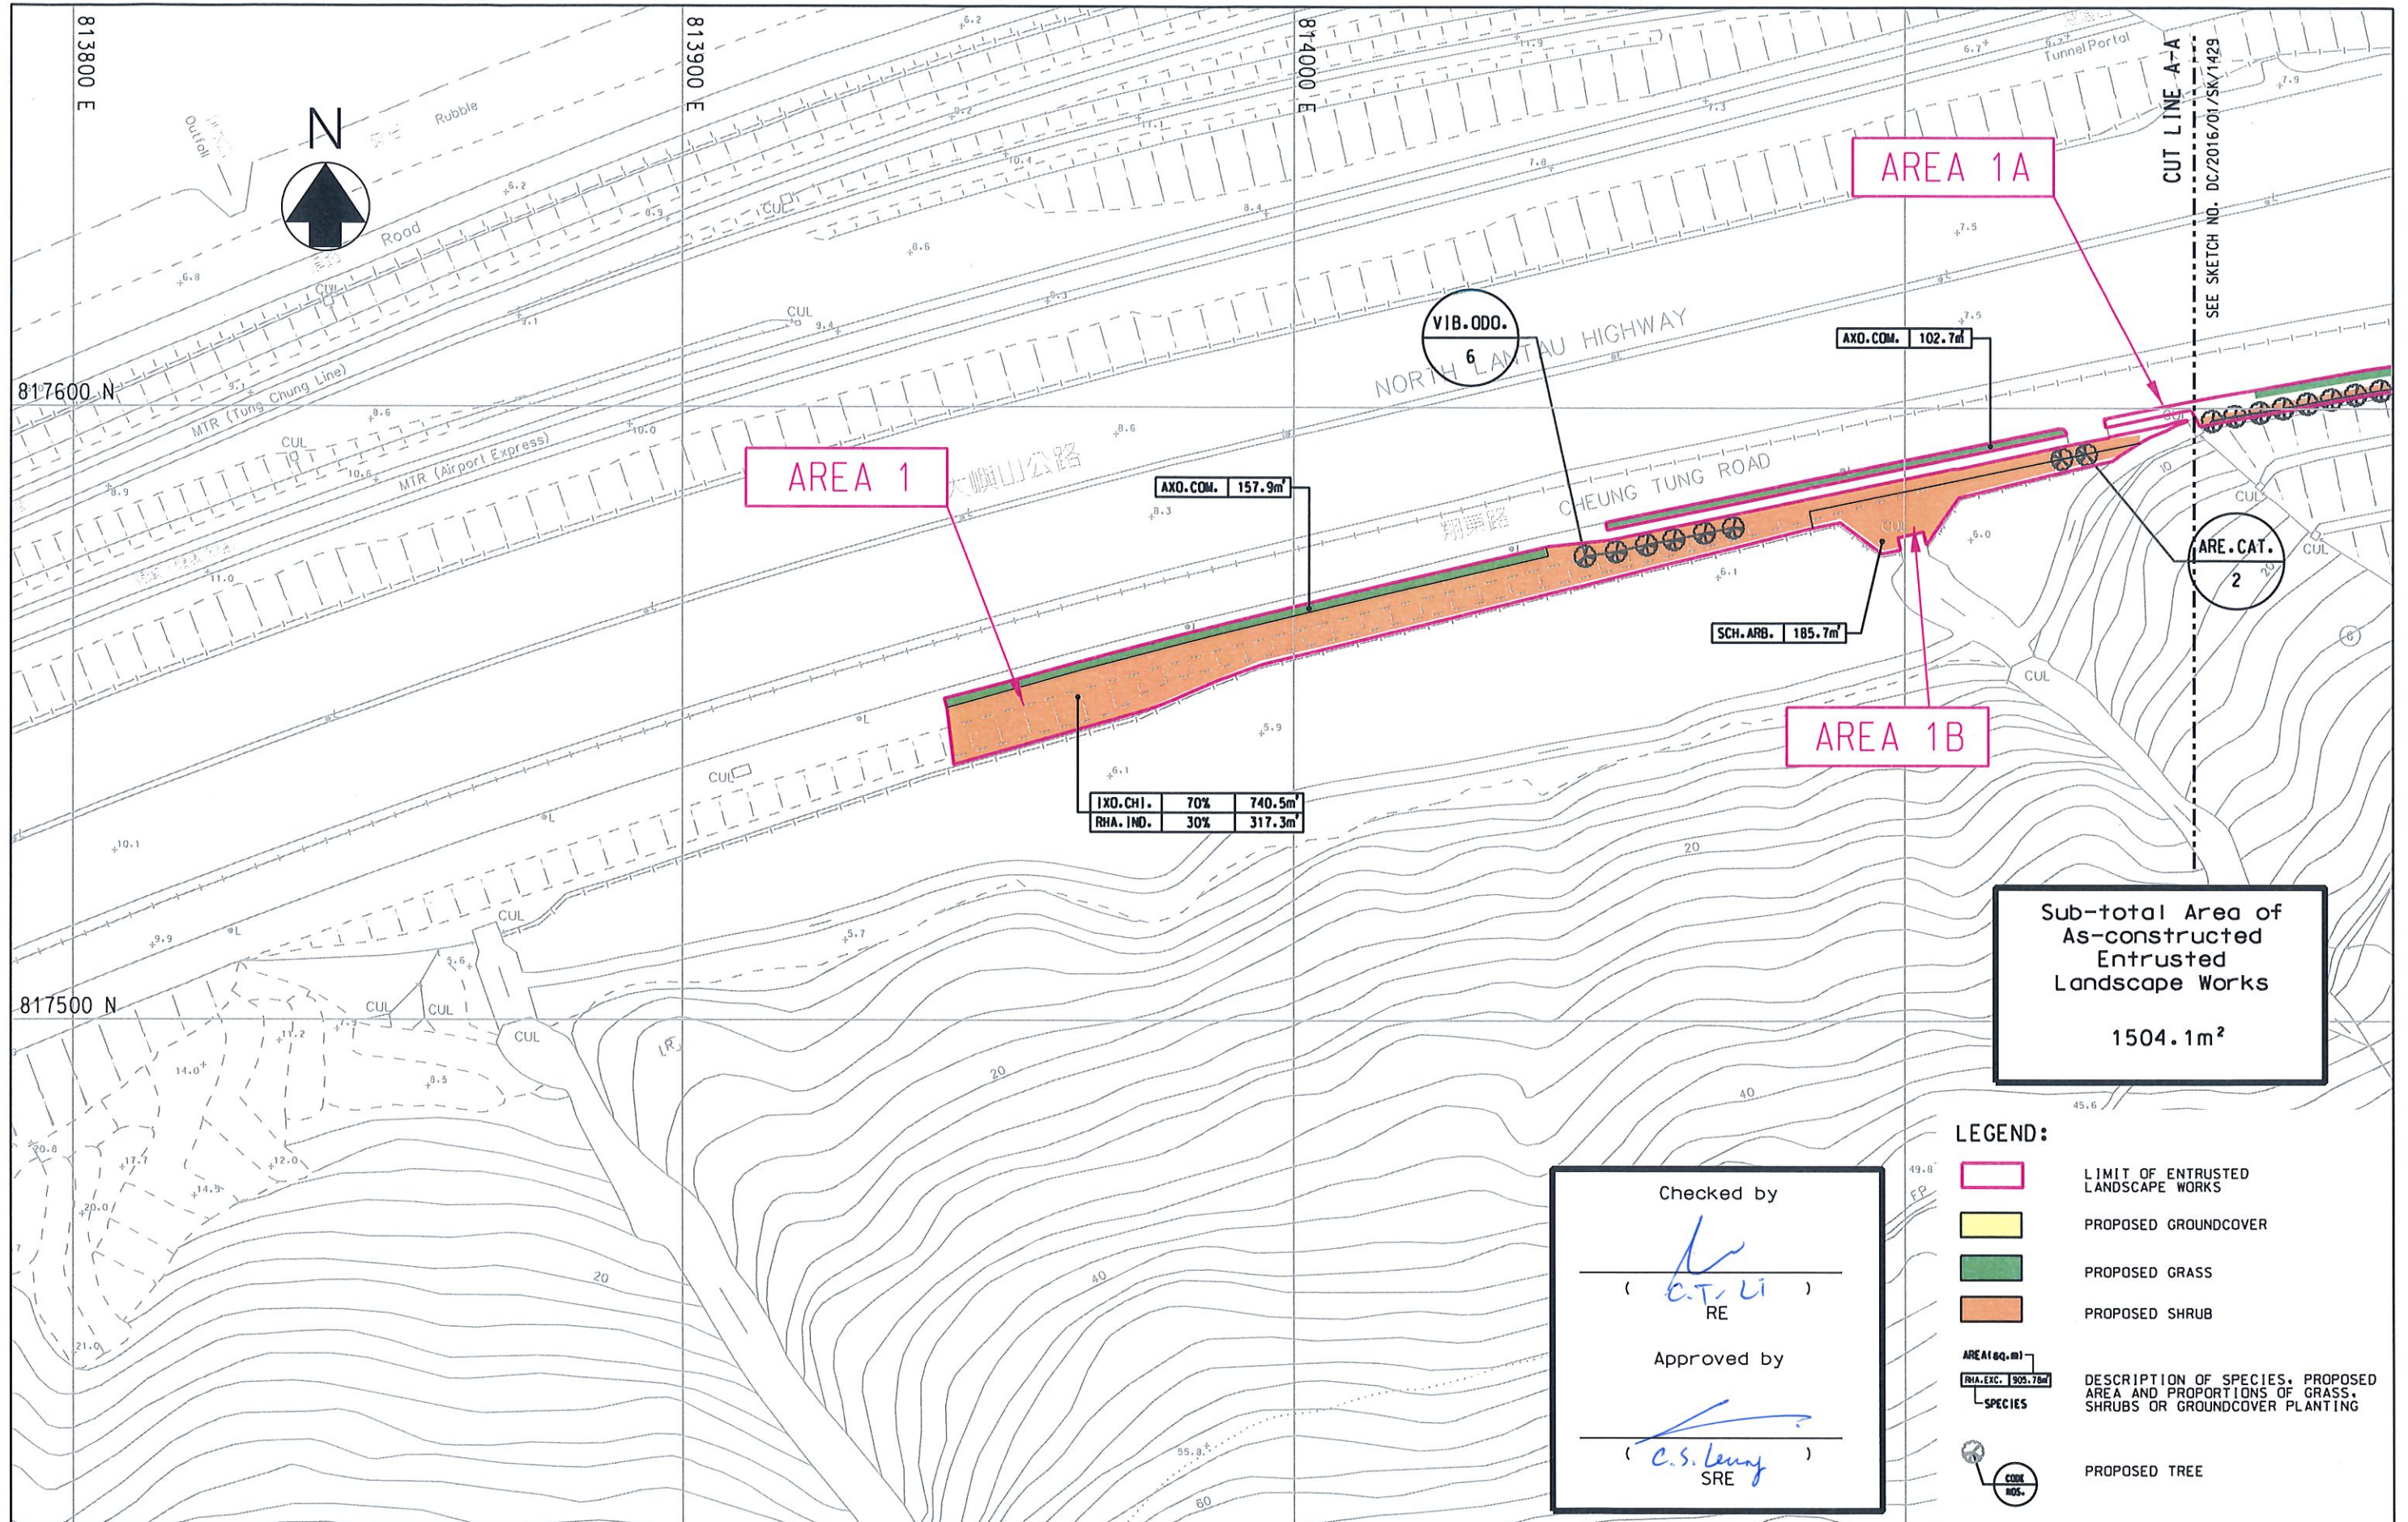
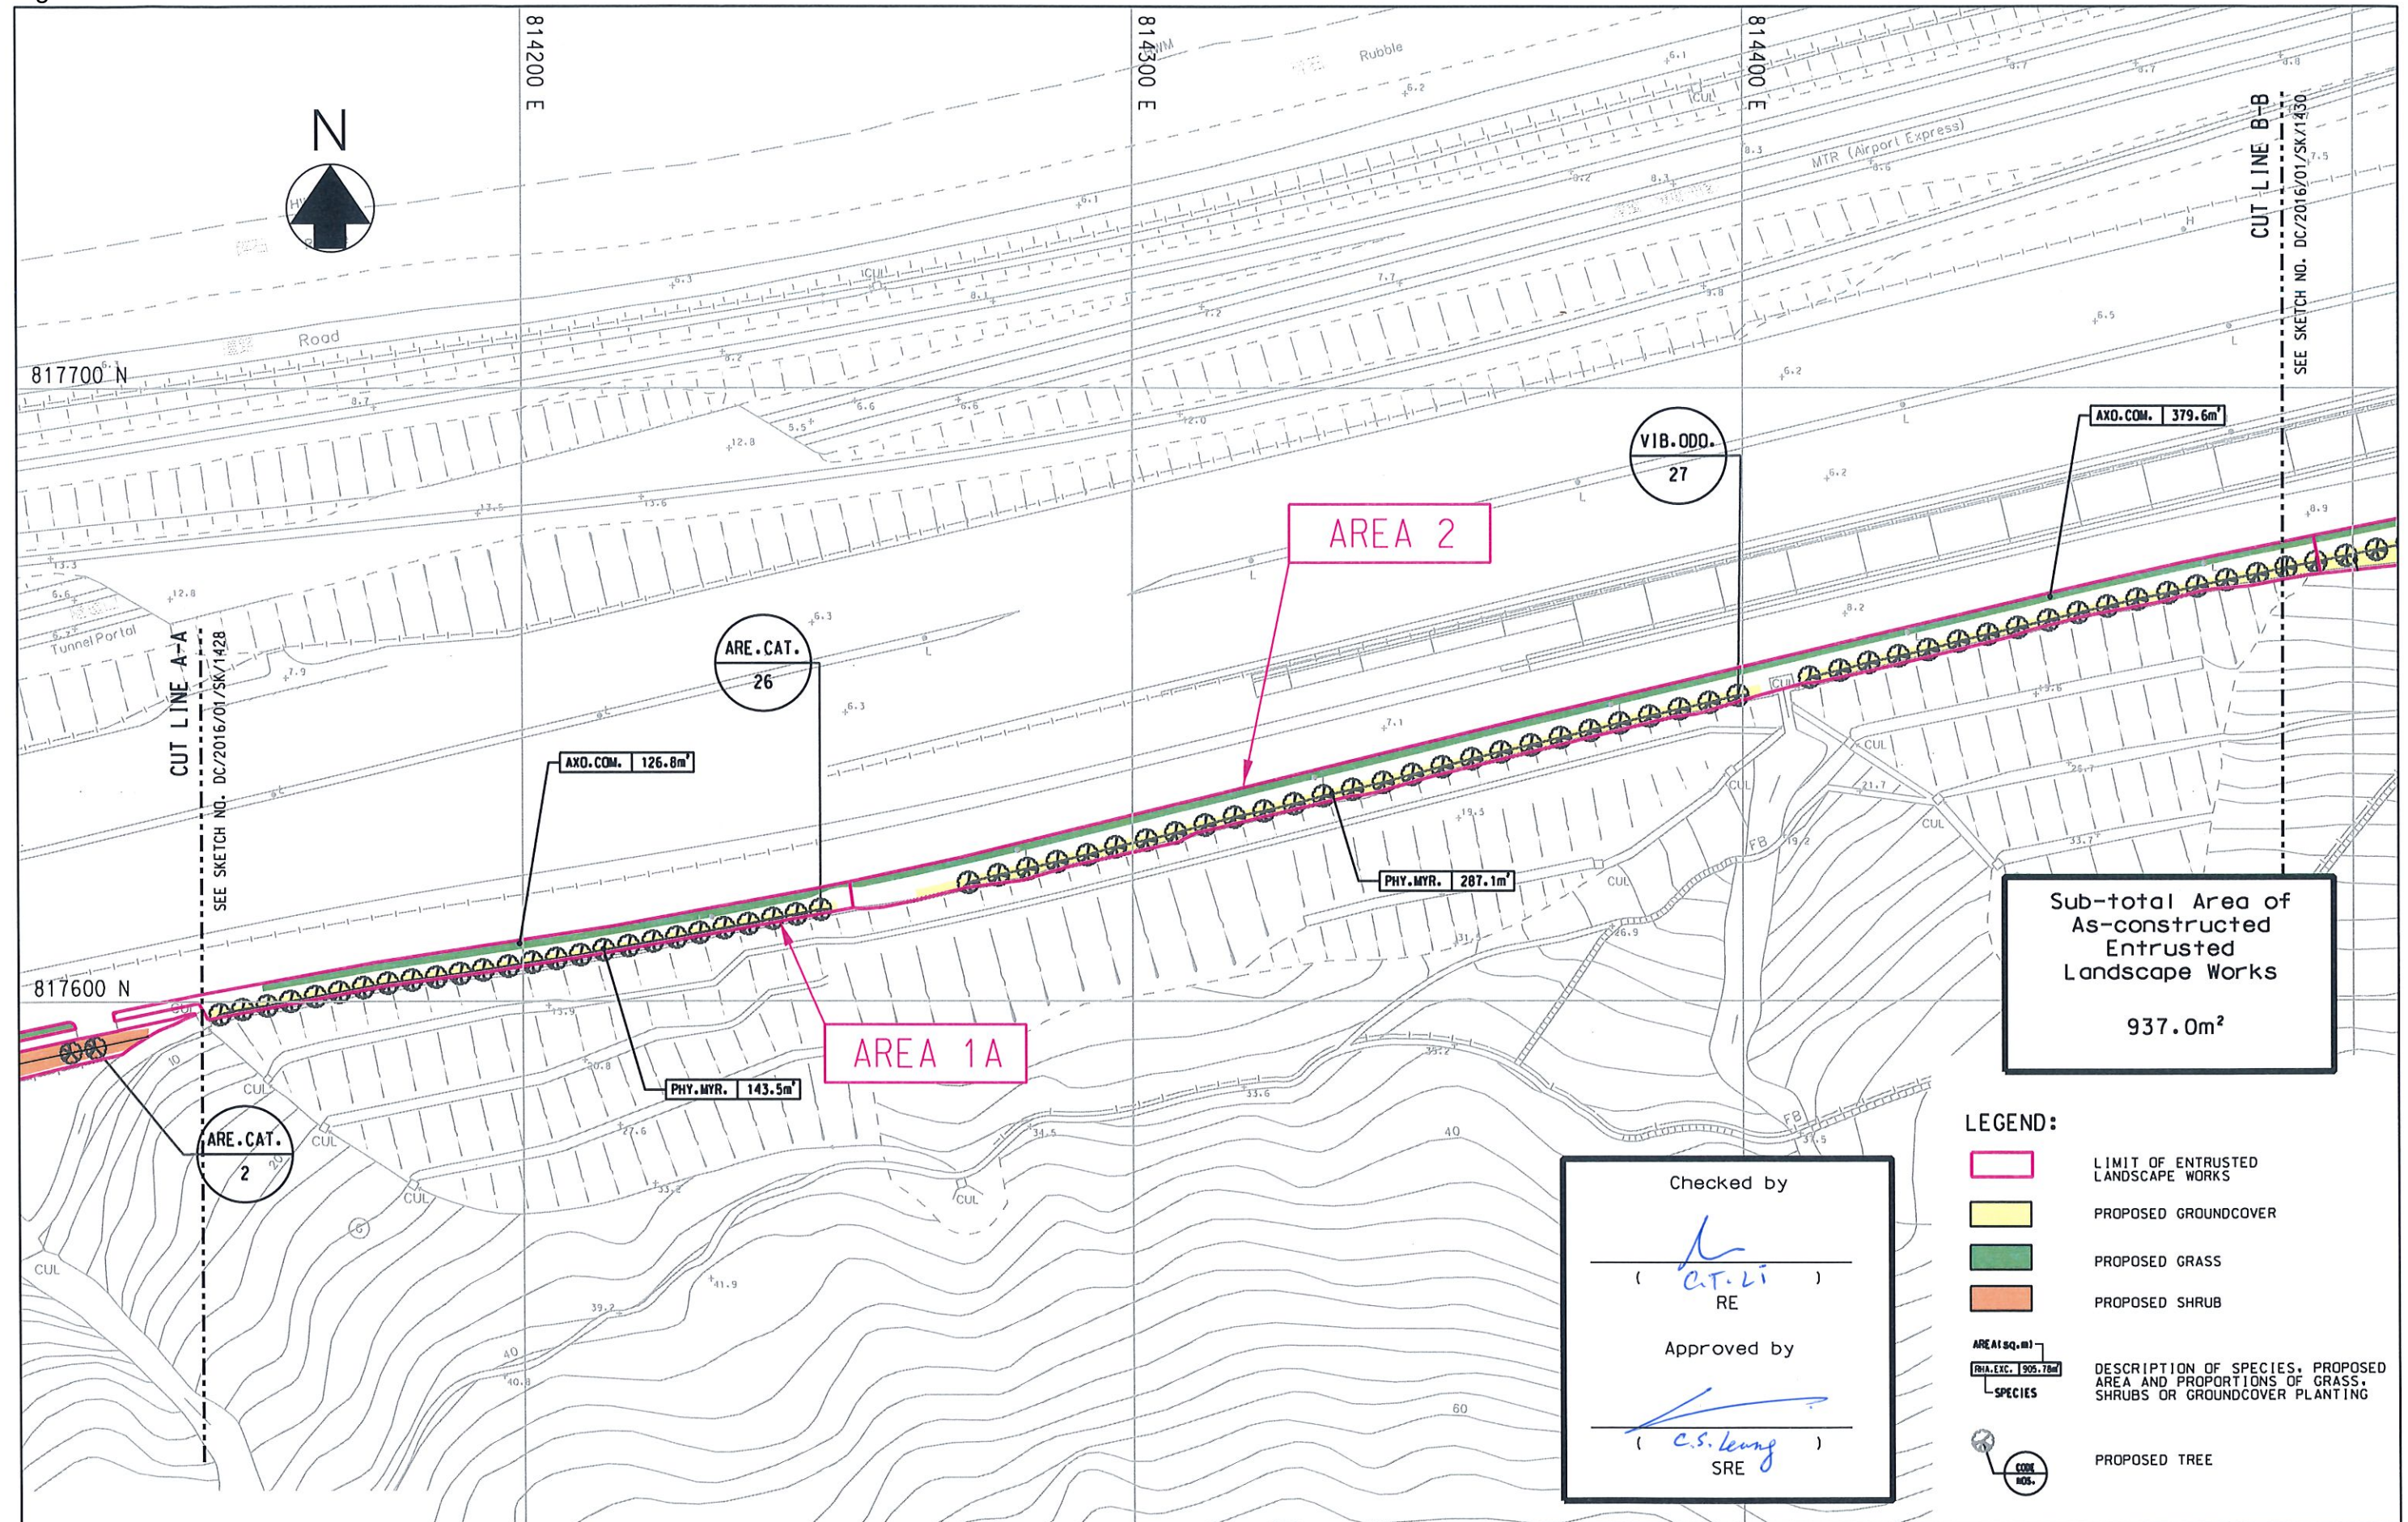
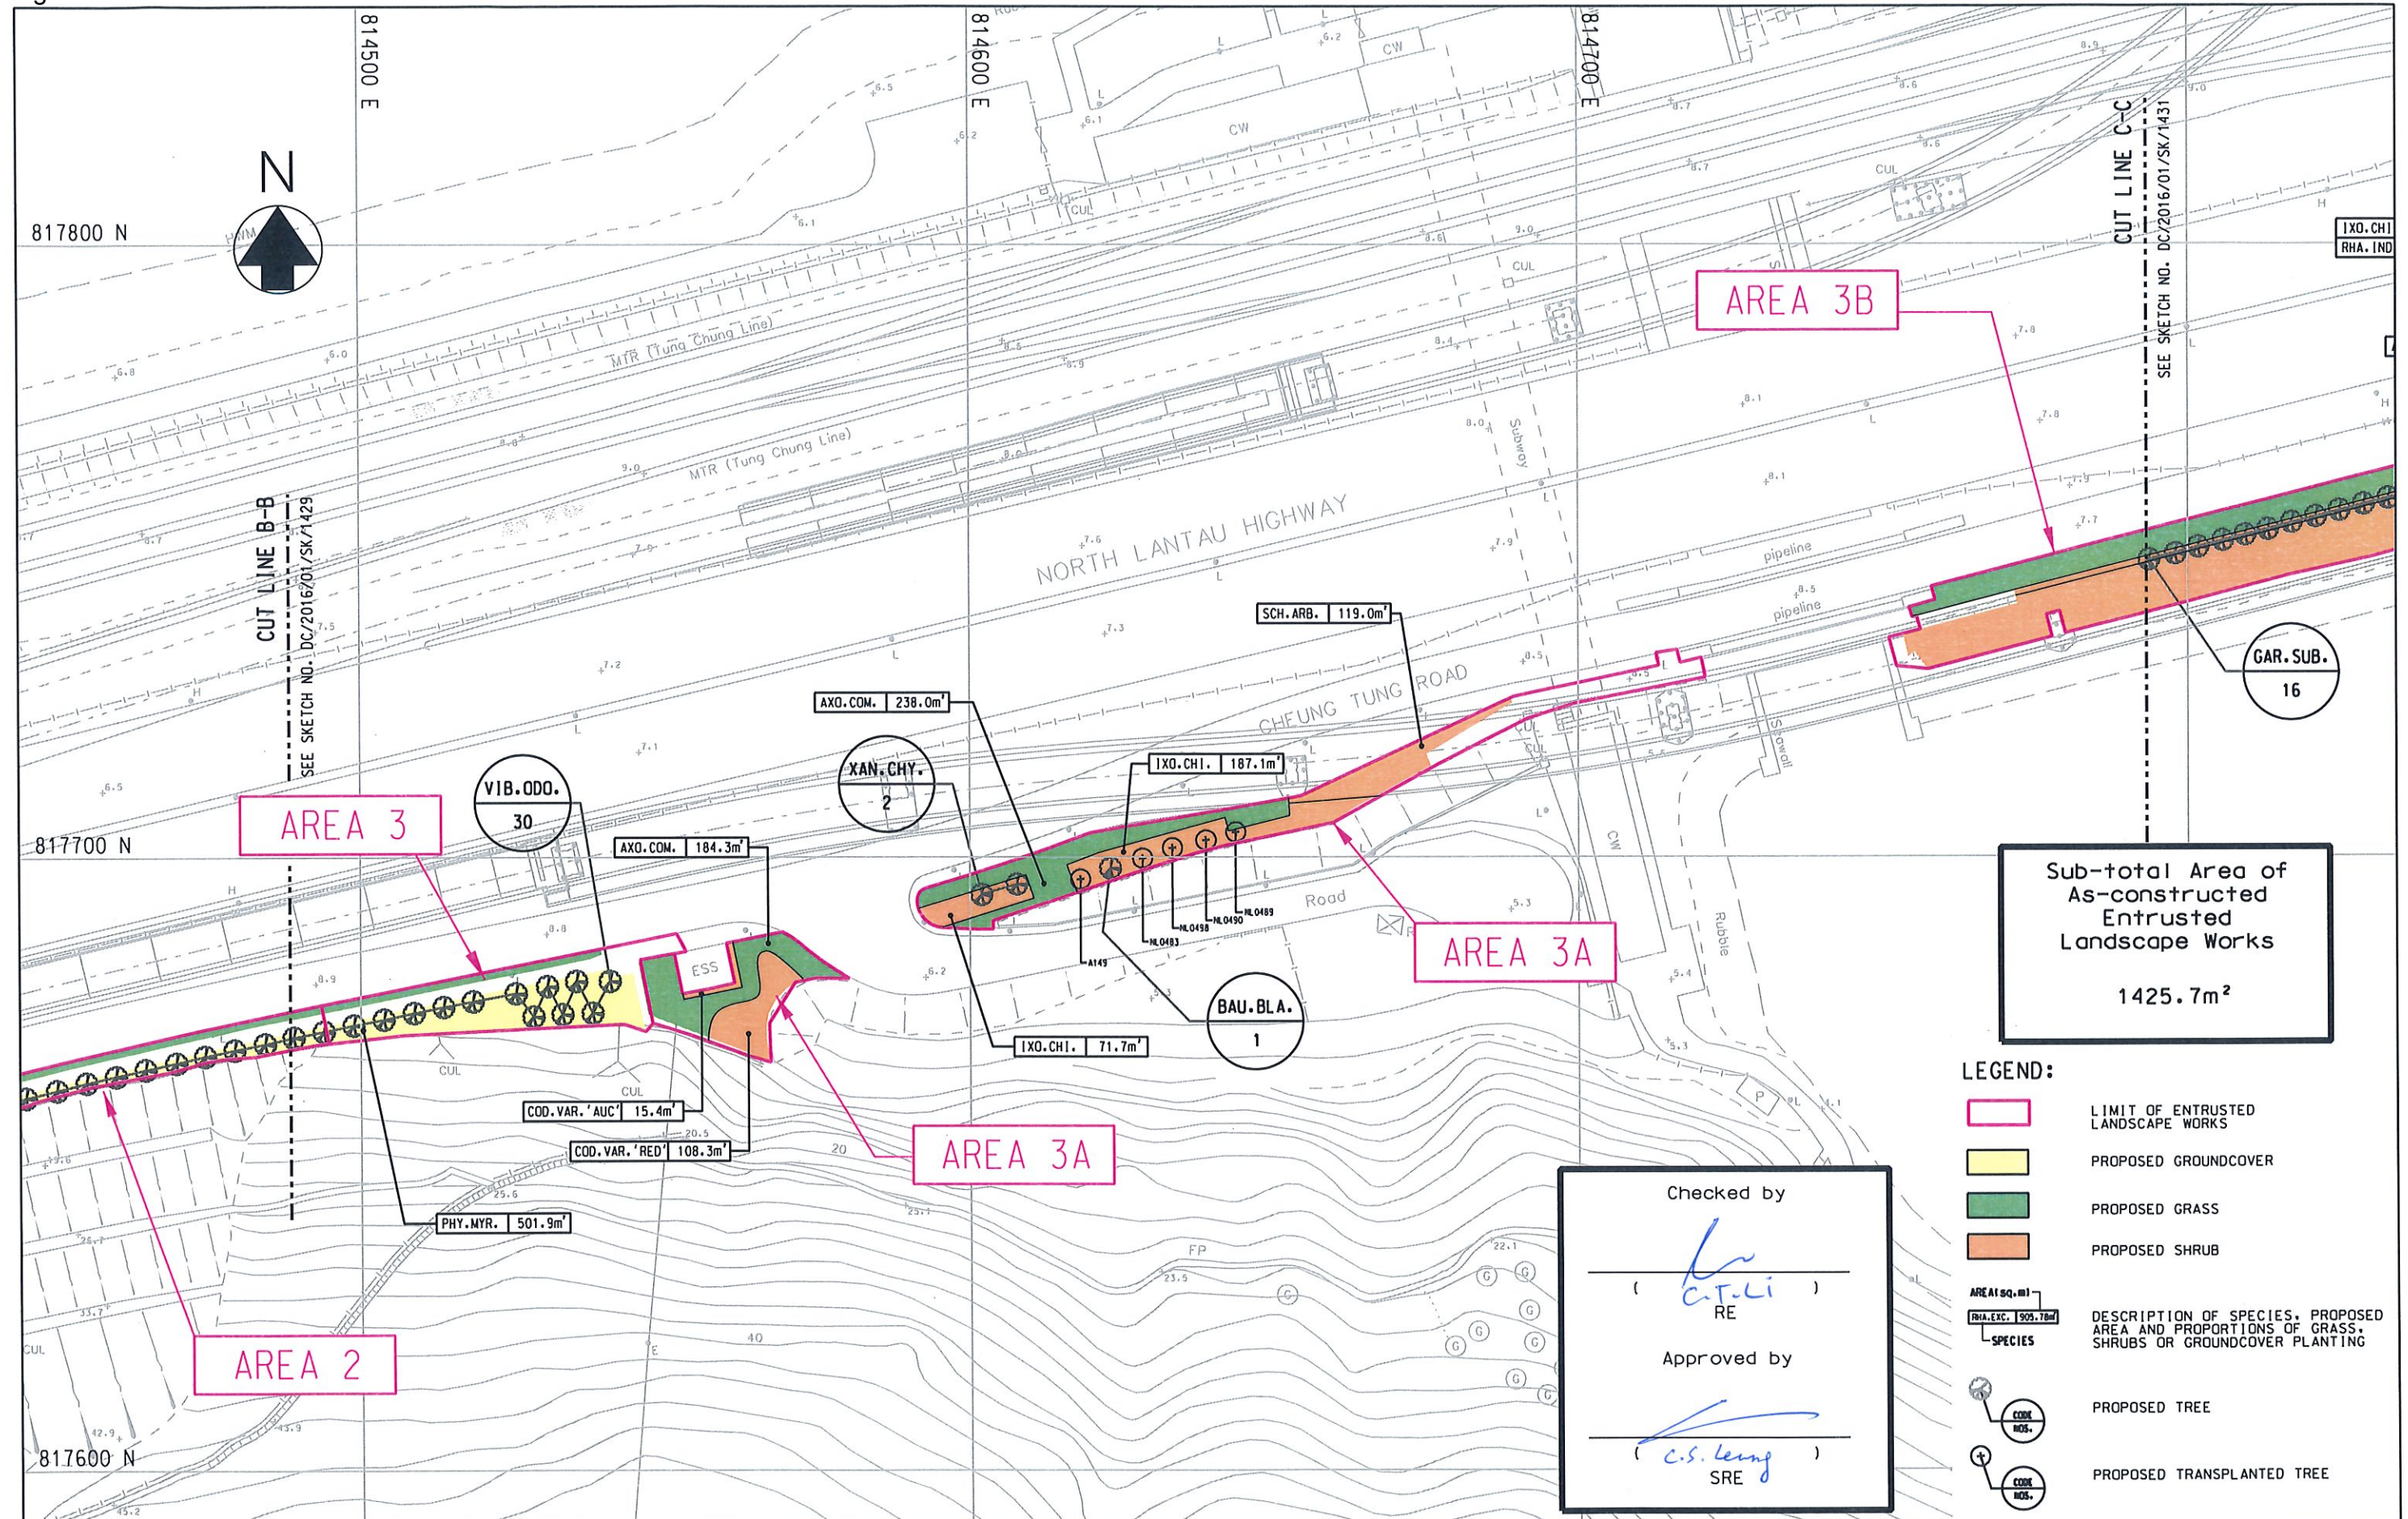
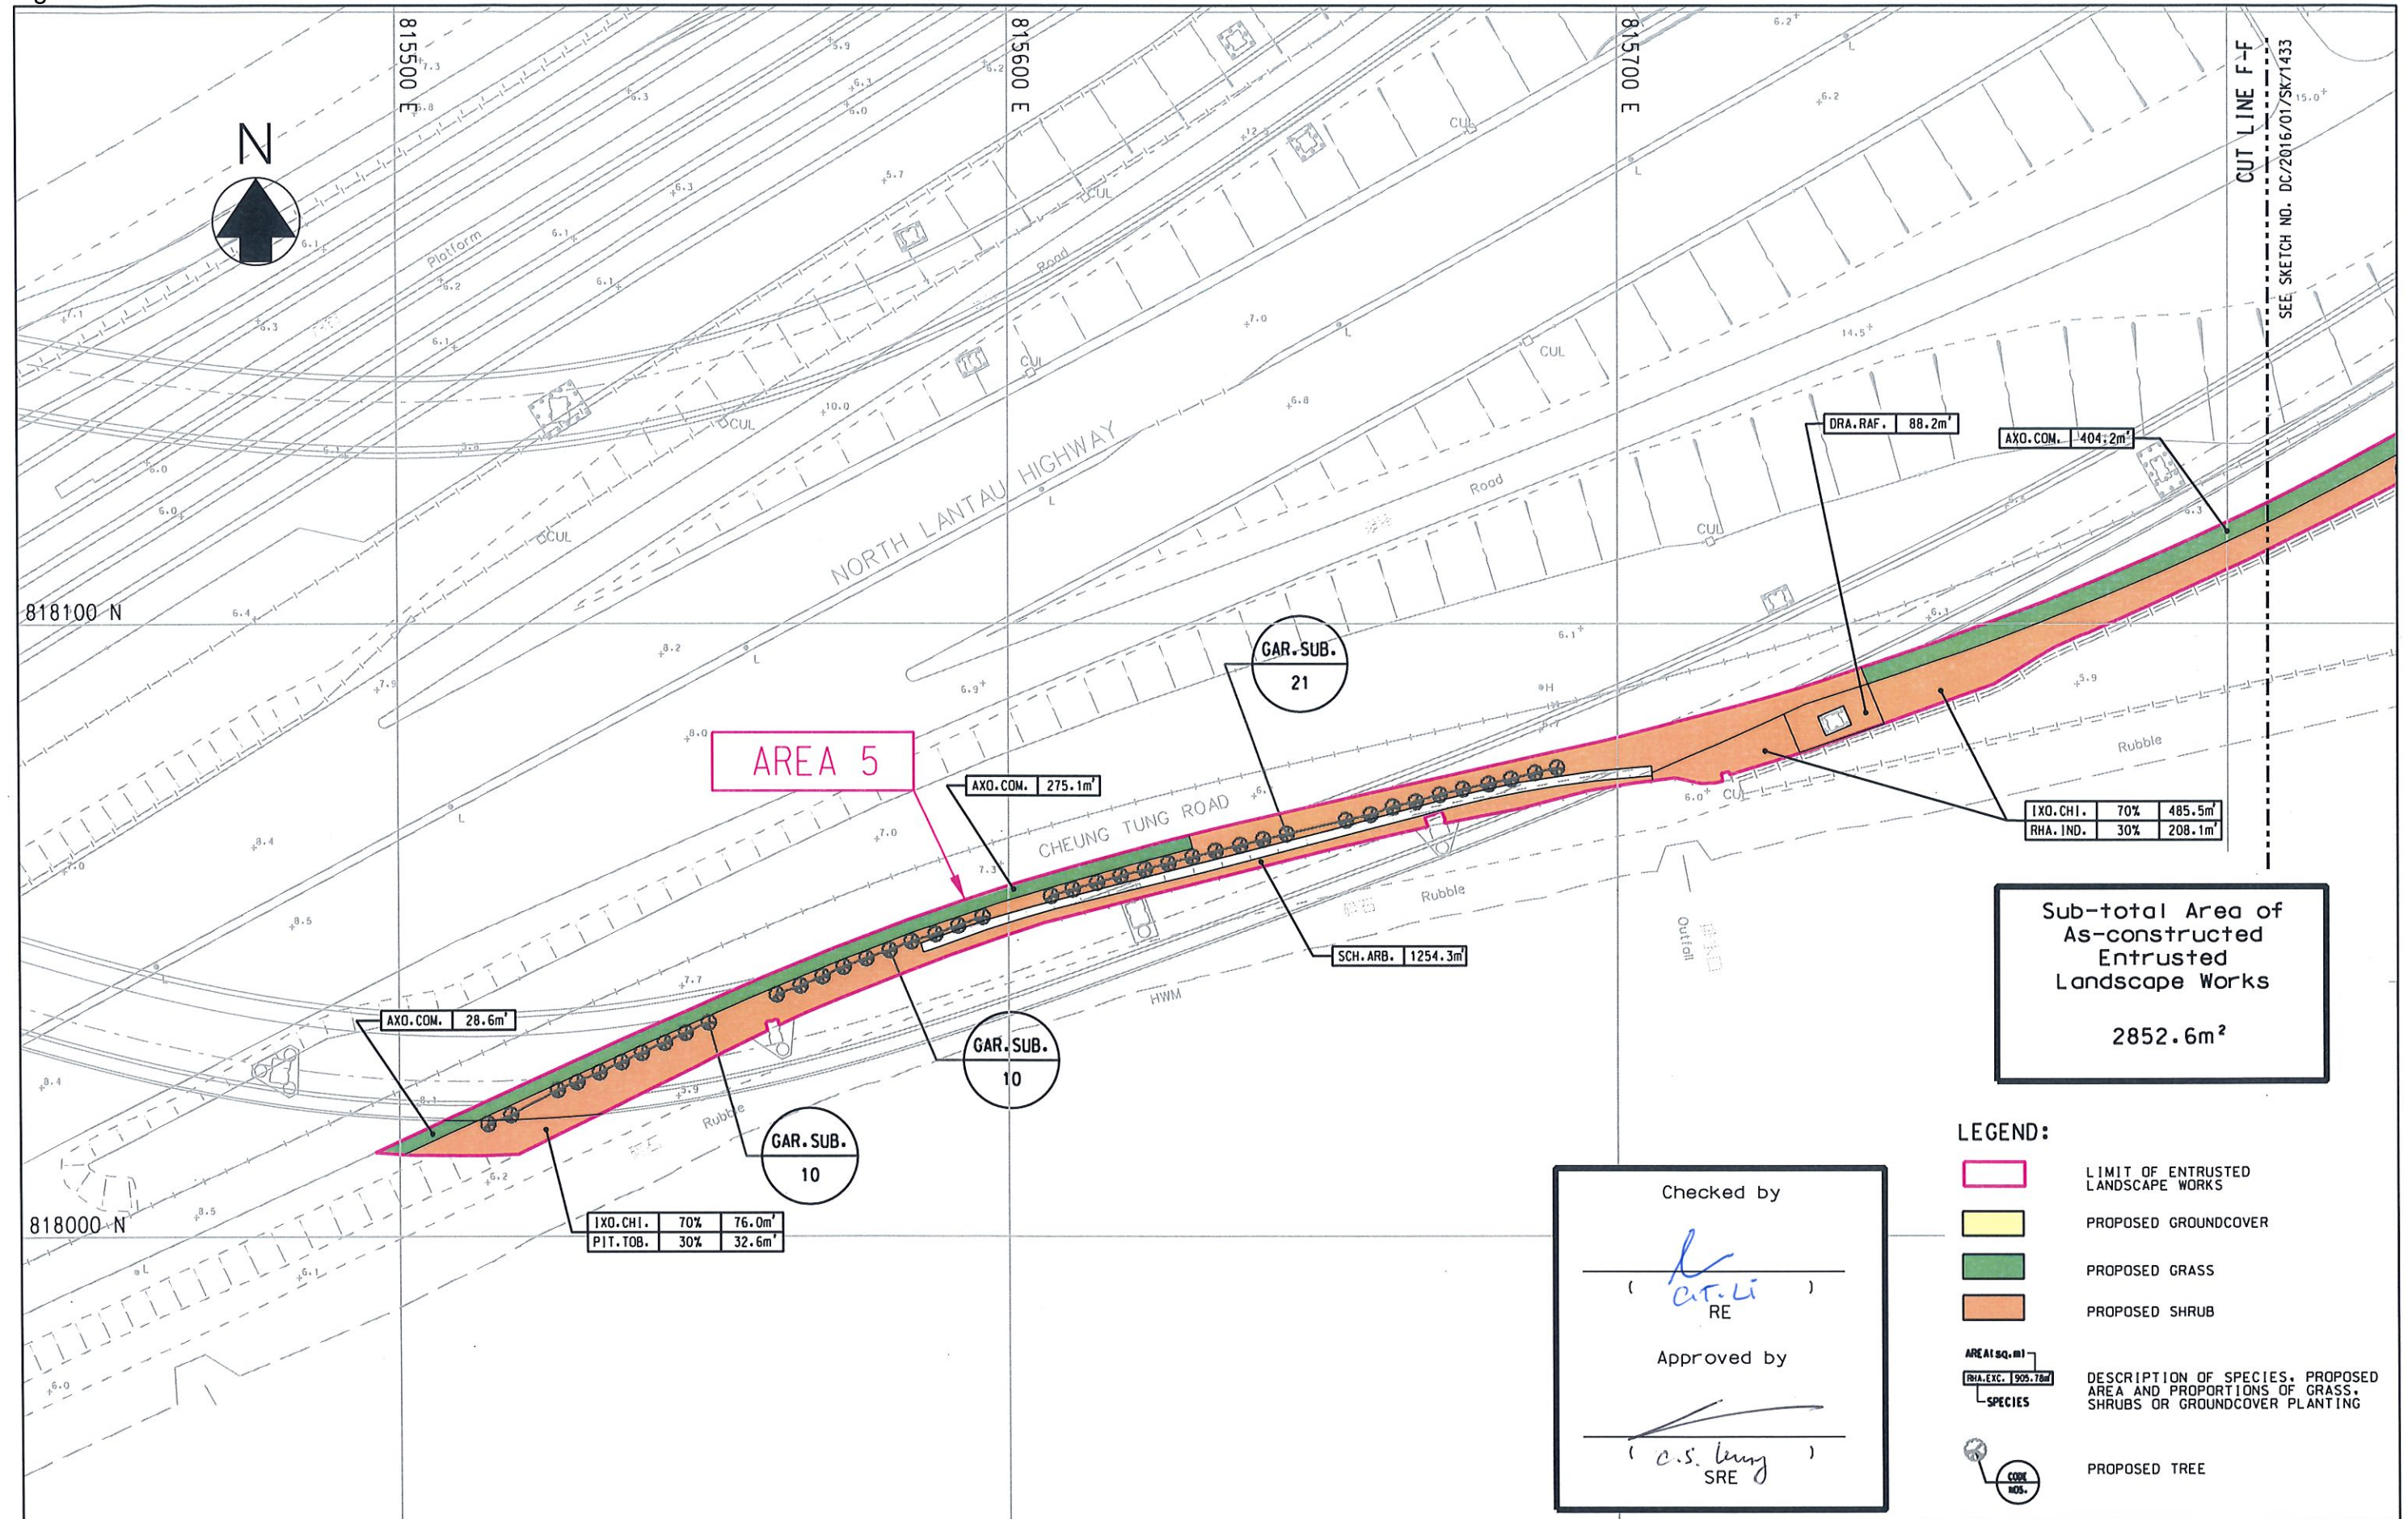
Figure 2.2

Layout Plan of Entrusted Landscape Works from HY/2012/07 to DC/2016/01 (Sheet 1 to Sheet 7)

2.1.2. Locations and planting schedule of entrusted landscape works are showed in [Figure 2.1](#), [Figure 2.2](#) and [Figure 2.3](#) respectively.

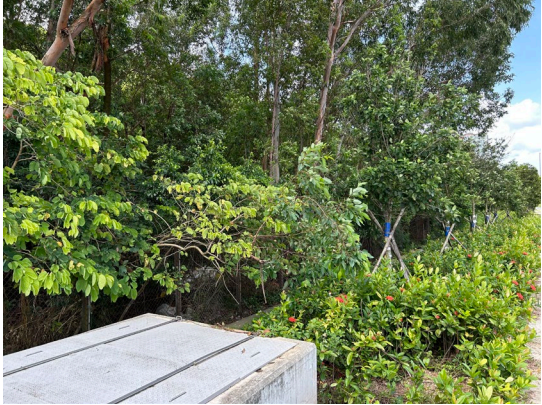
<p>Over-hanging branch above plantation posed threat to potential damage was observed, interface liaison maintenance party for removal shall be arranged. (Obs.1)</p>
Zone 1 (Area 1A)

Zone 1 (Area 1B) – Over-hanging branch above plantation posed threat to potential damage was observed, interface liaison maintenance party for removal shall be arranged. (Obs.1)

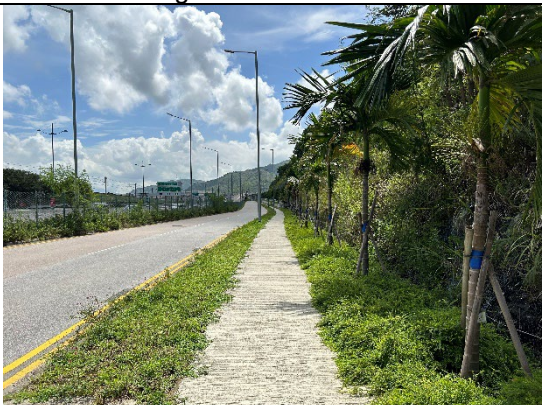
<p>Weeds along grass verge were observed, regular weeding is required. (Obs.2)</p>

Zone 1 (Area 1A, 2, 3A, 4, 6) – Weed observed at various area require regular weeding. (Obs.2, 3, 4, 6, 11)

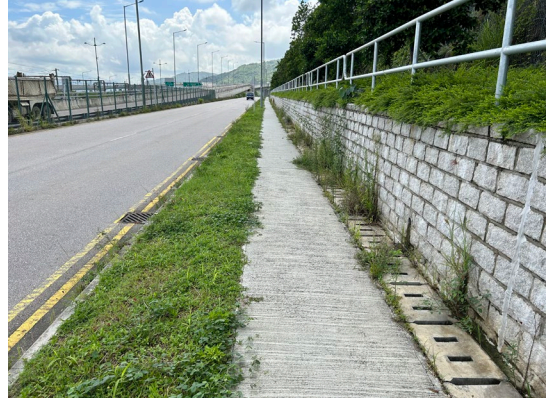
Weeds along grass verge were observed, regular weeding is required. (Obs.3)
Zone 1 (Area 3)

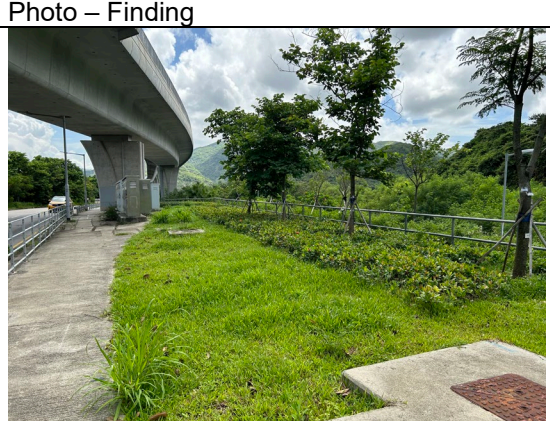
Weeds along the grass verge were observed, regular weeding is required. (Obs.4)

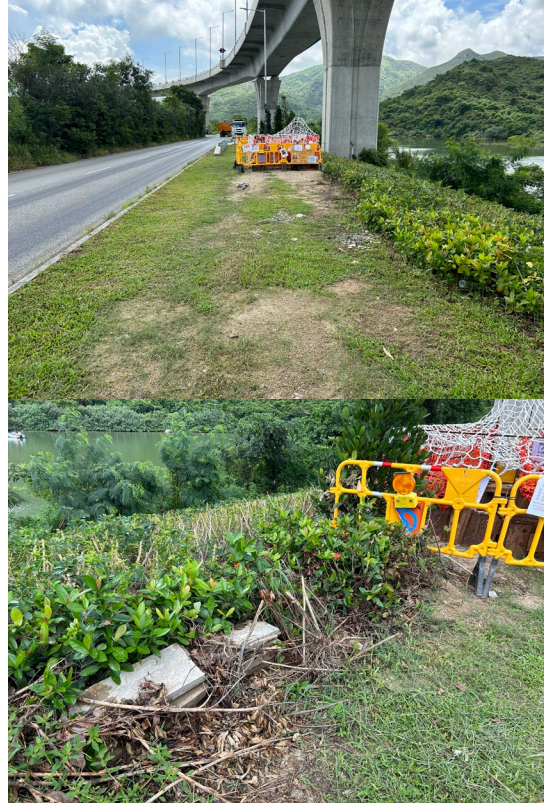
<p>Grass verge damage and temporary stored materials affecting shrubs were observed, reinstatement is required. (Obs.5)</p>
<p>Zone 1 (Area 4)</p>

Zone 1 (Area 3B, 5) – Grass verge damage and temporary stored materials affecting shrubs require reinstatement. (Obs.5, 9)

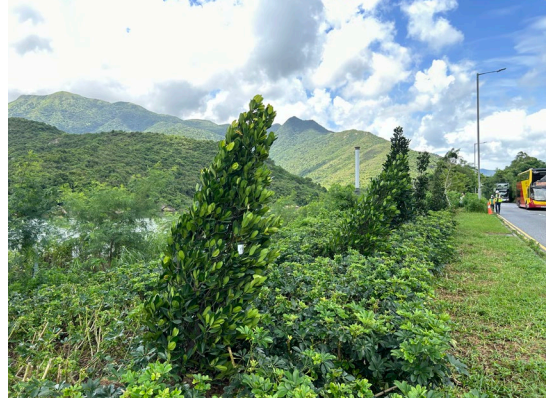
<p>Tilted <i>Garcinia subelliptica</i> shall be reinstated. (Obs.7)</p>

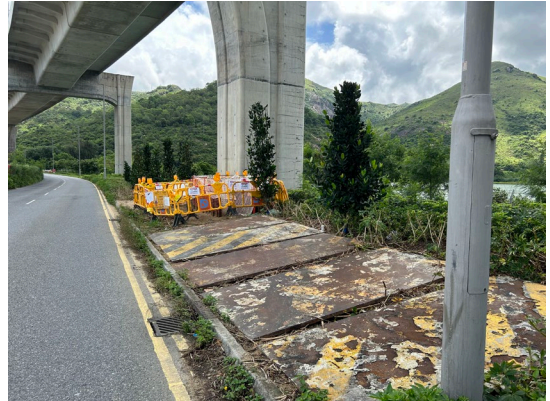
<p>Fencing for tree protection shall be provided for <i>Garcinia subelliptica</i> next to remedial works area to protect plant damage from machinery and vehicle movement. (Obs.8)</p>

Zone 1 (Area 5) – Fencing for tree protection shall be provided for *Garcinia subelliptica* next to remedial works area to protect plant damage from machinery and vehicle movement. (Obs.8)

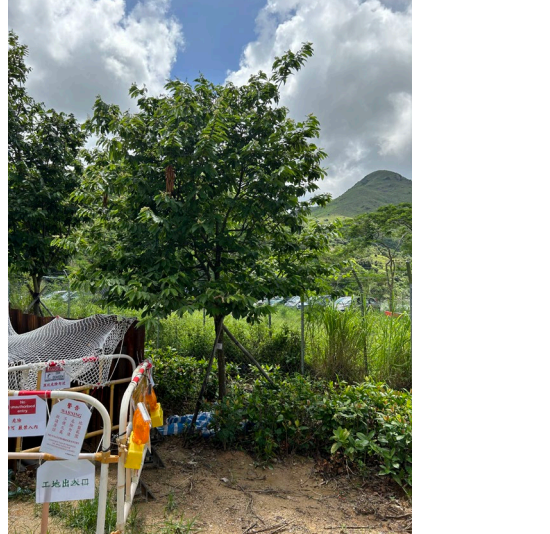
<p>Grass verge temporary removed for remedial works shall be reinstated. (Obs.9)</p> <p>Ant colonies were observed, proper treatment is required. (Obs.10)</p>
--	--	--

Zone 1 (Area 5) – Ant colonies were observed, proper treatment is required. (Obs.10)

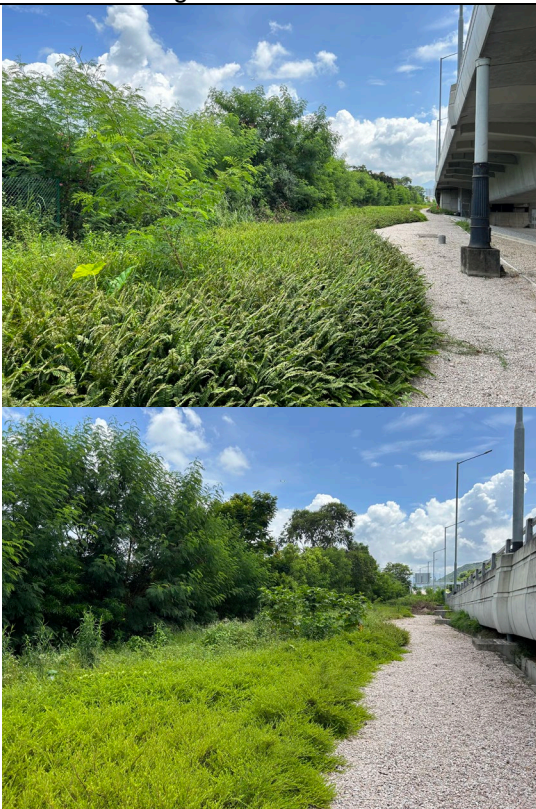
<p data-bbox="963 1986 1501 2047">Weeds on planted shrub were observed, regular weeding is required. (Obs.11)</p>
