**TUEN MUN - CHEK LAP KOK LINK
CONTRACT NO. HMWSD 2/2020 (HY) –
ESTABLISHMENT OF LANDSCAPE SOFTWORKS FOR
THE TUEN MUN - CHEK LAP KOK LINK**

**19TH MONTHLY ENVIRONMENTAL MONITORING AND
AUDIT (EM&A) REPORT – OCTOBER 2022**

Contract No. HMWSD 2/2020 (HY)
Establishment of Landscape Softworks for Tuen Mun-Chek Lap Kok Link
Monthly Environmental Monitoring and Audit Report – October 2022

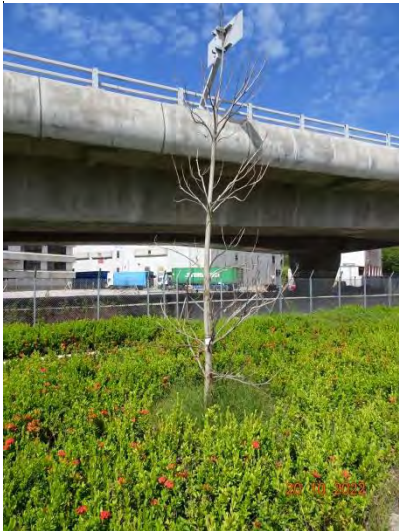
Location	Photo	Information
Zone 1

Observation 1: The tree (L-TN42: <i>Elaeocarpus apiculatus</i>) in Zone 1 became wilted; the tree health condition in terms of irrigation should be closely monitored and reviewed.
Zone 1

1. The tree (L-TN42: *Elaeocarpus apiculatus*) in Zone 1 became wilted; the tree health condition in terms of irrigation should be closely monitored and reviewed.
2. Two trees (L-TN303 & L-TN308: *Elaeocarpus hainanensis*) in Zone 1 became wilted; the tree health condition in terms of irrigation should be closely monitored and reviewed.
3. Two trees (L-TN160 & L-TN171: *Sterculia lanceolata*) in Zone 4 became wilted; the tree health condition in terms of irrigation should be closely monitored and reviewed.

1. Tree health condition, irrigation in particular, should be closely monitored and reviewed.

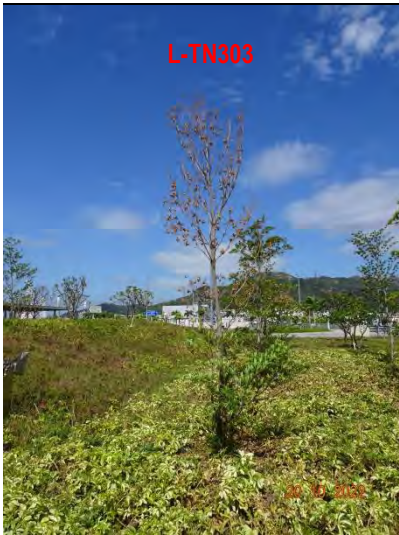
Observation 2: Two trees (L-TN303 & L-TN308: <i>Elaeocarpus hainanensis</i>) in Zone 1 became wilted; the tree health condition in terms of irrigation should be closely monitored and reviewed.

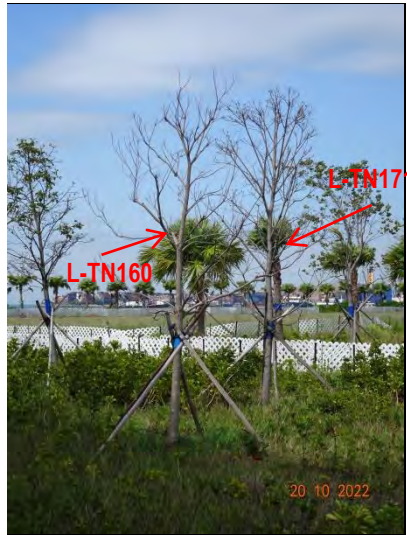
Observation 3: Two trees (L-TN160 & L-TN171: *Sterculia lanceolata*) in Zone 4 became wilted; the tree health condition in terms of irrigation should be closely monitored and reviewed.

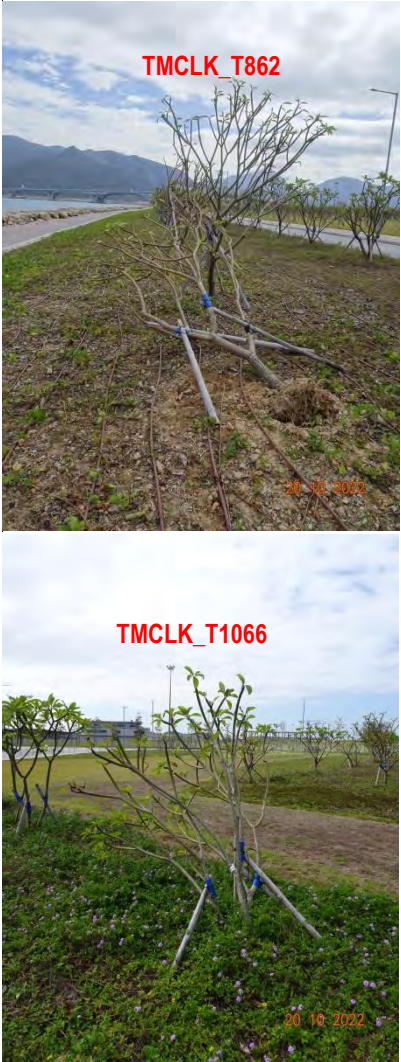
Location	Photo	Information
Zone 6

Observation 1: Two trees (TMCLK_T862 & TMCLK_T1066: <i>Plumeria rubra</i>) in Zone 6 was fallen down after typhoon had been supported in upright position.

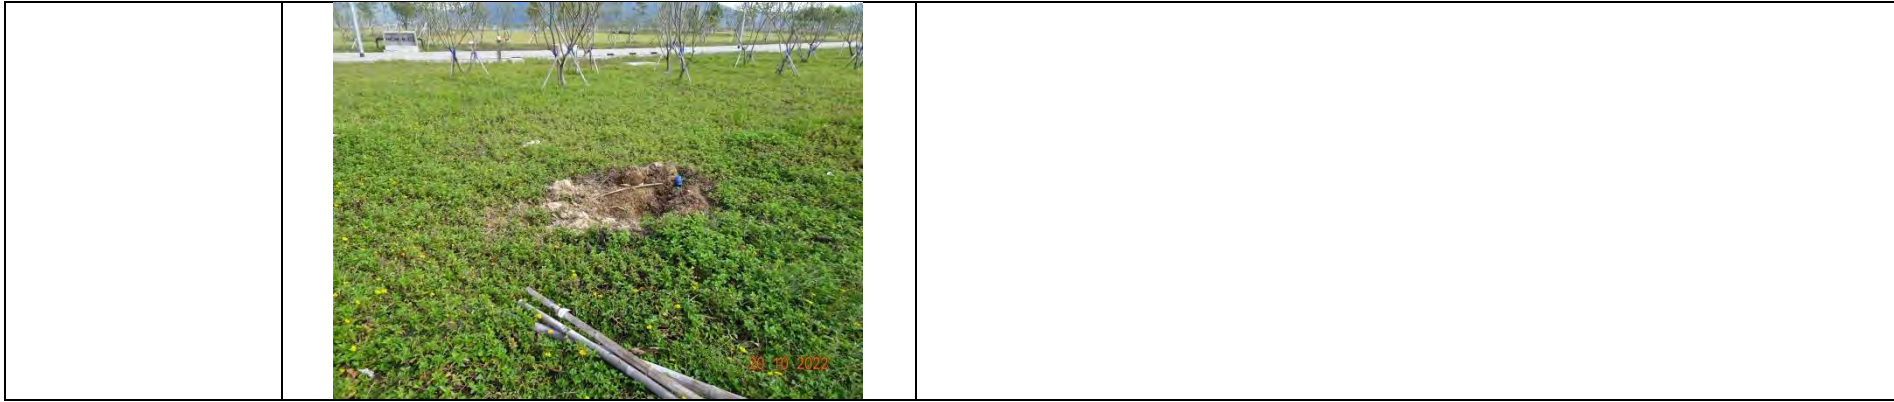
<p>Zone 6</p>	   	<p>Observation 2: Two trees (TMCLK_T346 & TMCLK_T350: <i>Grevillea robusta</i>) in Zone 6 was fallen down and removed after typhoon should be replanted.</p>
<p>Zone 6</p>	 	<p>Observation 3: The tree (TMCLK_T393: <i>Plumeria rubra</i>) in Zone 6 was fallen down and removed after typhoon should be replanted.</p>

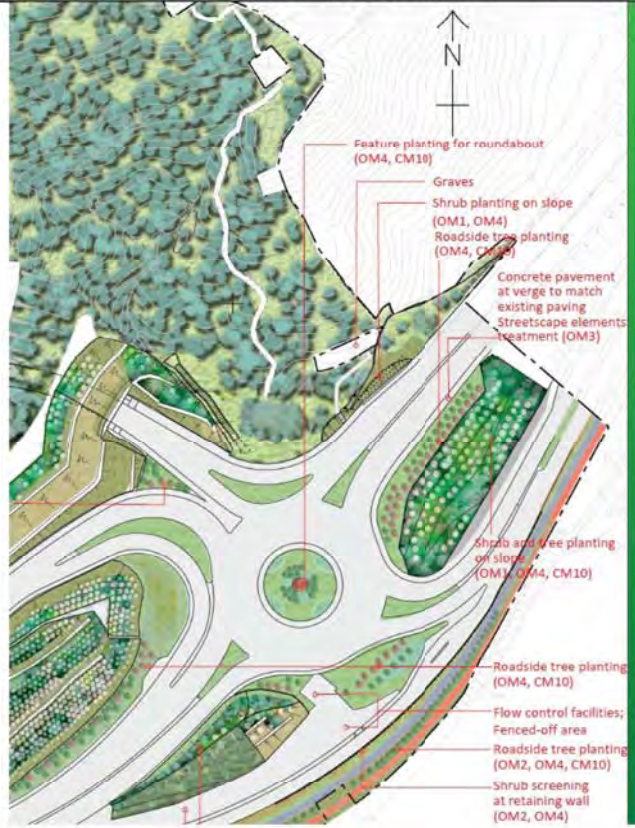
Lung Fu Road Roundabout arrangement in the approved Landscape and Visual Plan

(i) The surrounding planters of the Lung Fu Road Roundabout would be modified, resulting in minor rearrangement of trees within the planters.

Extracted from the approved Landscape and Visual Plan, Drawing no. C3/LM/030.

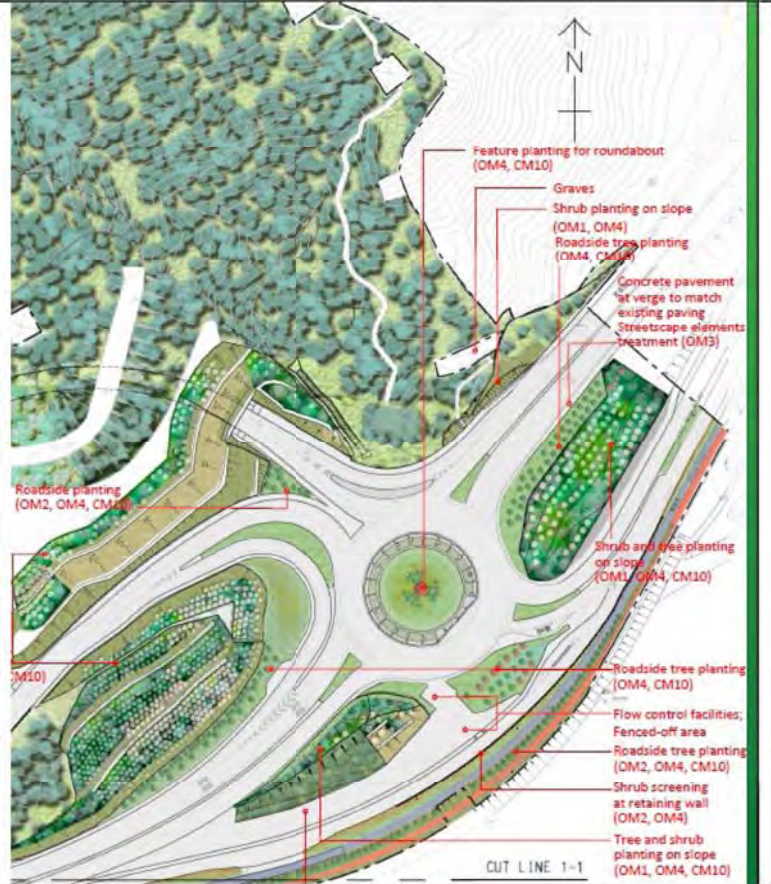
Proposed road enhancement arrangement at the Lung Fu Road Roundabout

The proposed road enhancement arrangement at the Lung Fu Road Roundabout would result in a slightly different outlook and tree arrangement at the planters in the vicinity.

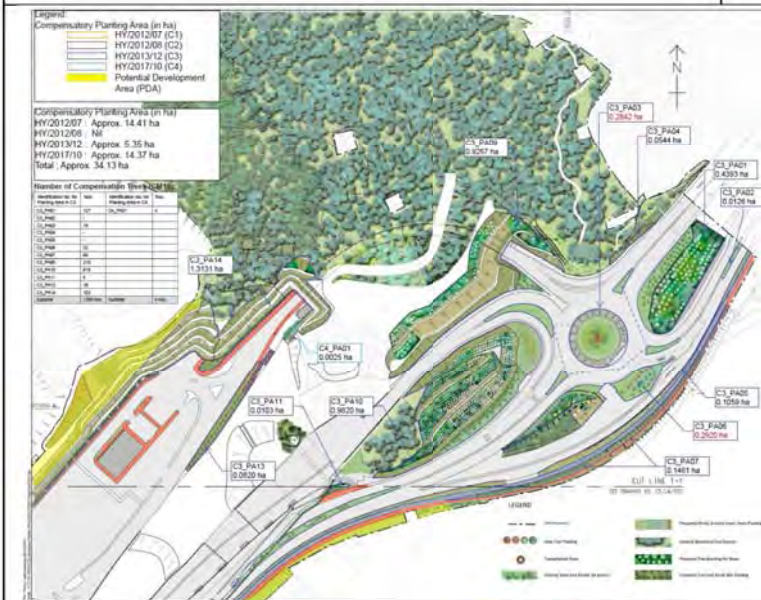
The species of tree planting within the surrounding roadside planters are proposed to be changed to smaller species. The quantity of tree planting remains unchanged.

Planter Area C3_PA01 (roadside of Lung Fu Road): 21 nos. *Tabebuia impetiginosa* 風鈴木 proposed to be changed to *Phoenix roebelenii* 日本葵.

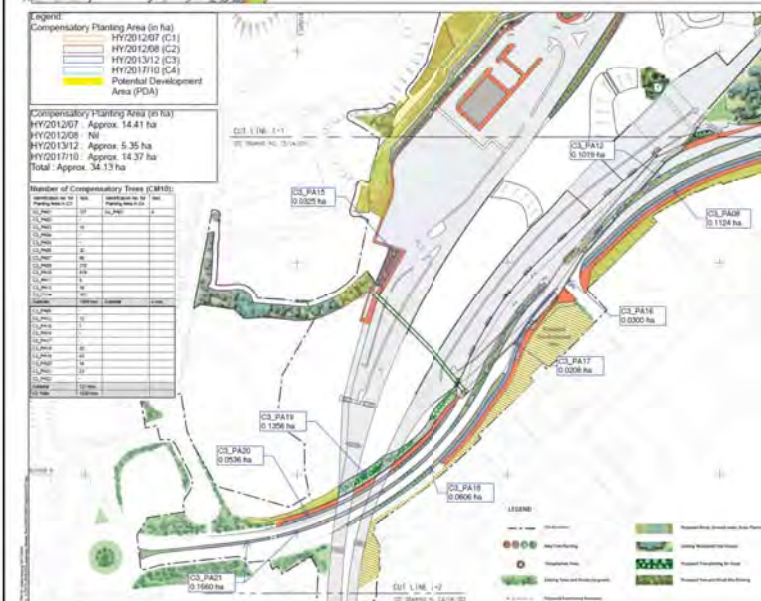
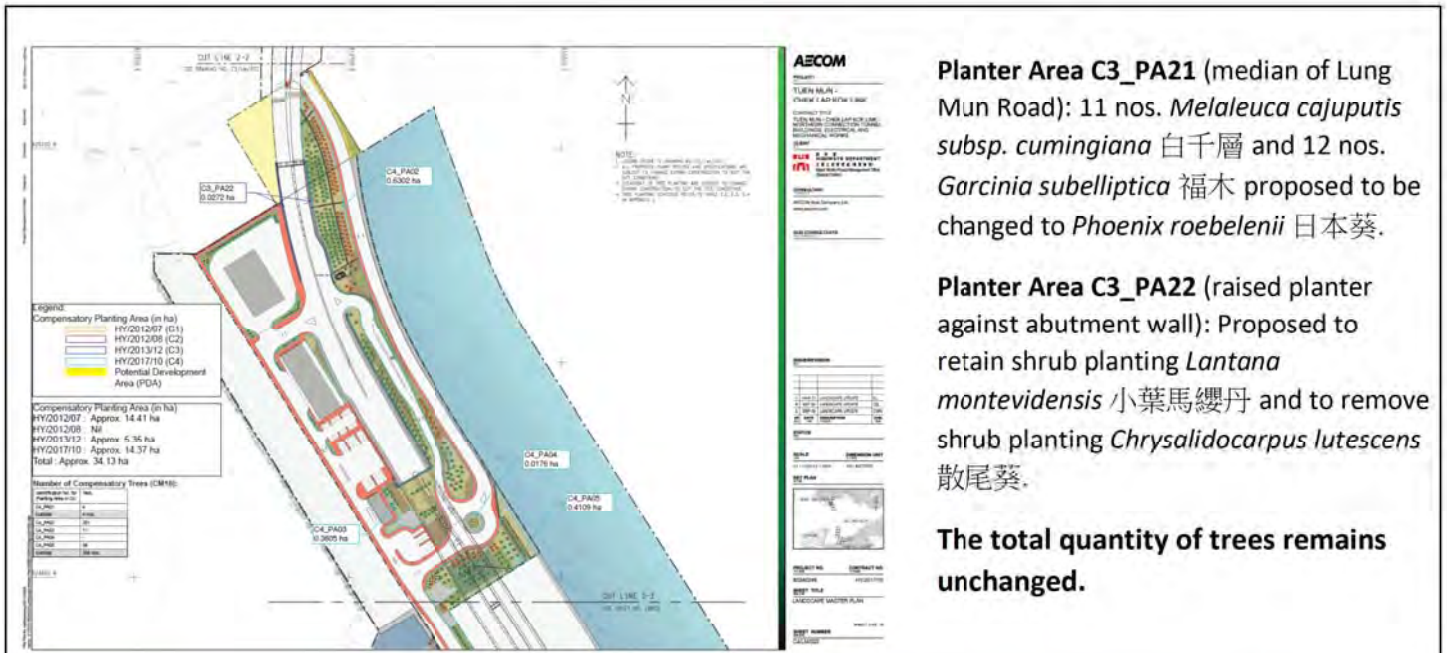
Planter Area C3_PA21 (median of Lung Mun Road): 11 nos. *Melaleuca cajuputi* subsp. *cumingiana* 白千層 and 12 nos. *Garcinia subelliptica* 福木 proposed to be changed to *Phoenix roebelenii* 日本葵.

Planter Area C3_PA22 (raised planter against abutment wall): Proposed to retain shrub planting *Lantana montevidensis* 小葉馬纓丹 and to remove shrub planting *Chrysalidocarpus lutescens* 散尾葵.

The total quantity of trees remains unchanged.

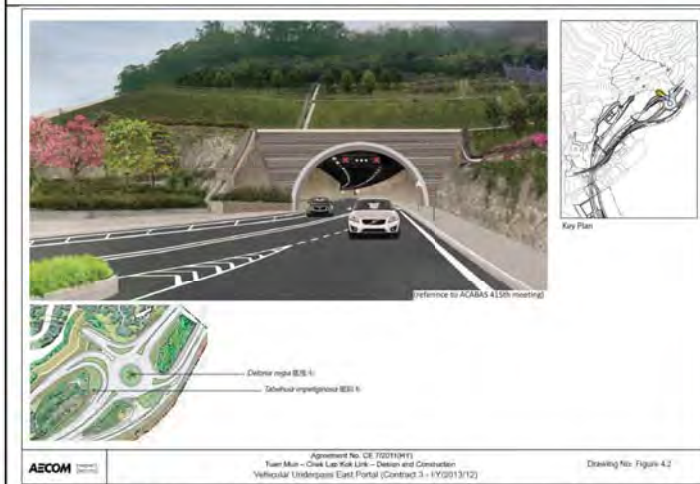
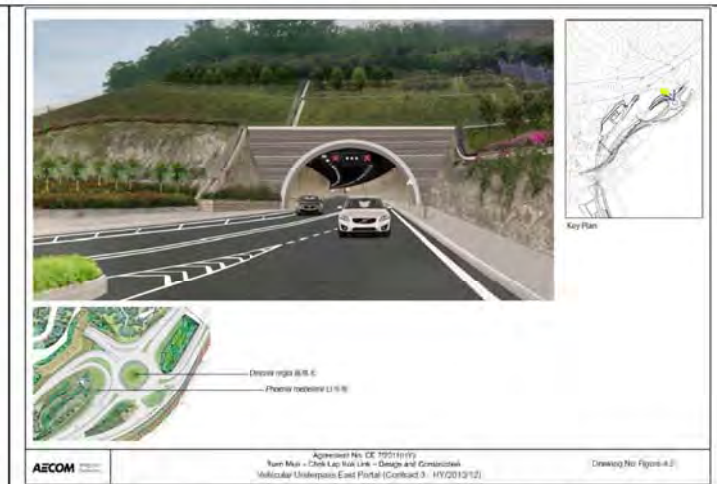
Extracted from the approved Landscape and Visual Plan, Drawing no. Figure 4.2.

The species of tree planting within the surrounding planters are proposed to be changed to smaller size species. The quantity of tree planting remains unchanged.

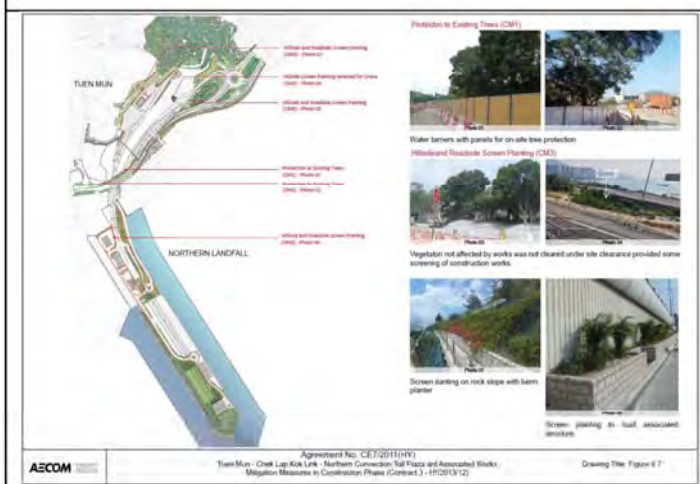
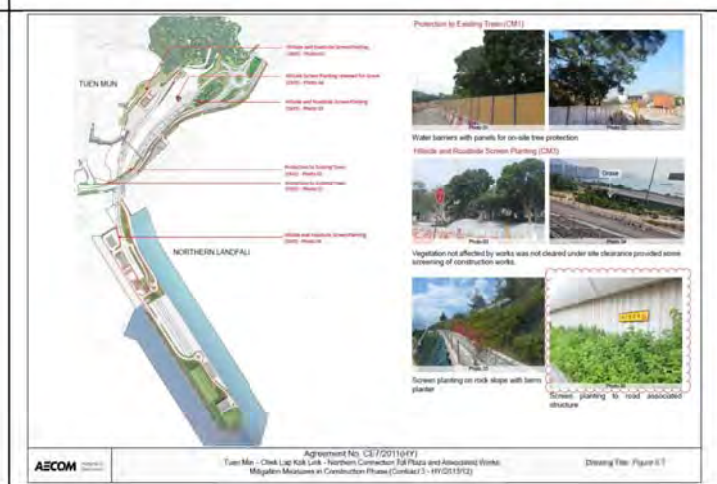
<p>Extracted from the approved Landscape and Visual Plan, Drawing no. Figure 8.7.</p>	<p>Planter Area C3_PA22 (raised planter against abutment wall in Photo 06): Proposed to retain shrub planting <i>Lantana montevidensis</i> 小葉馬纓丹 and to remove shrub planting <i>Chrysalidocarpus lutescens</i> 散尾葵.</p>
---	---
