**Contract No. HY/2012/08
Tuen Mun – Chek Lap Kok Link –
Northern Connection Sub-sea Tunnel
Section**

*Twentieth Quarterly Environmental Monitoring
& Audit (EM&A) Report*

26 March 2019

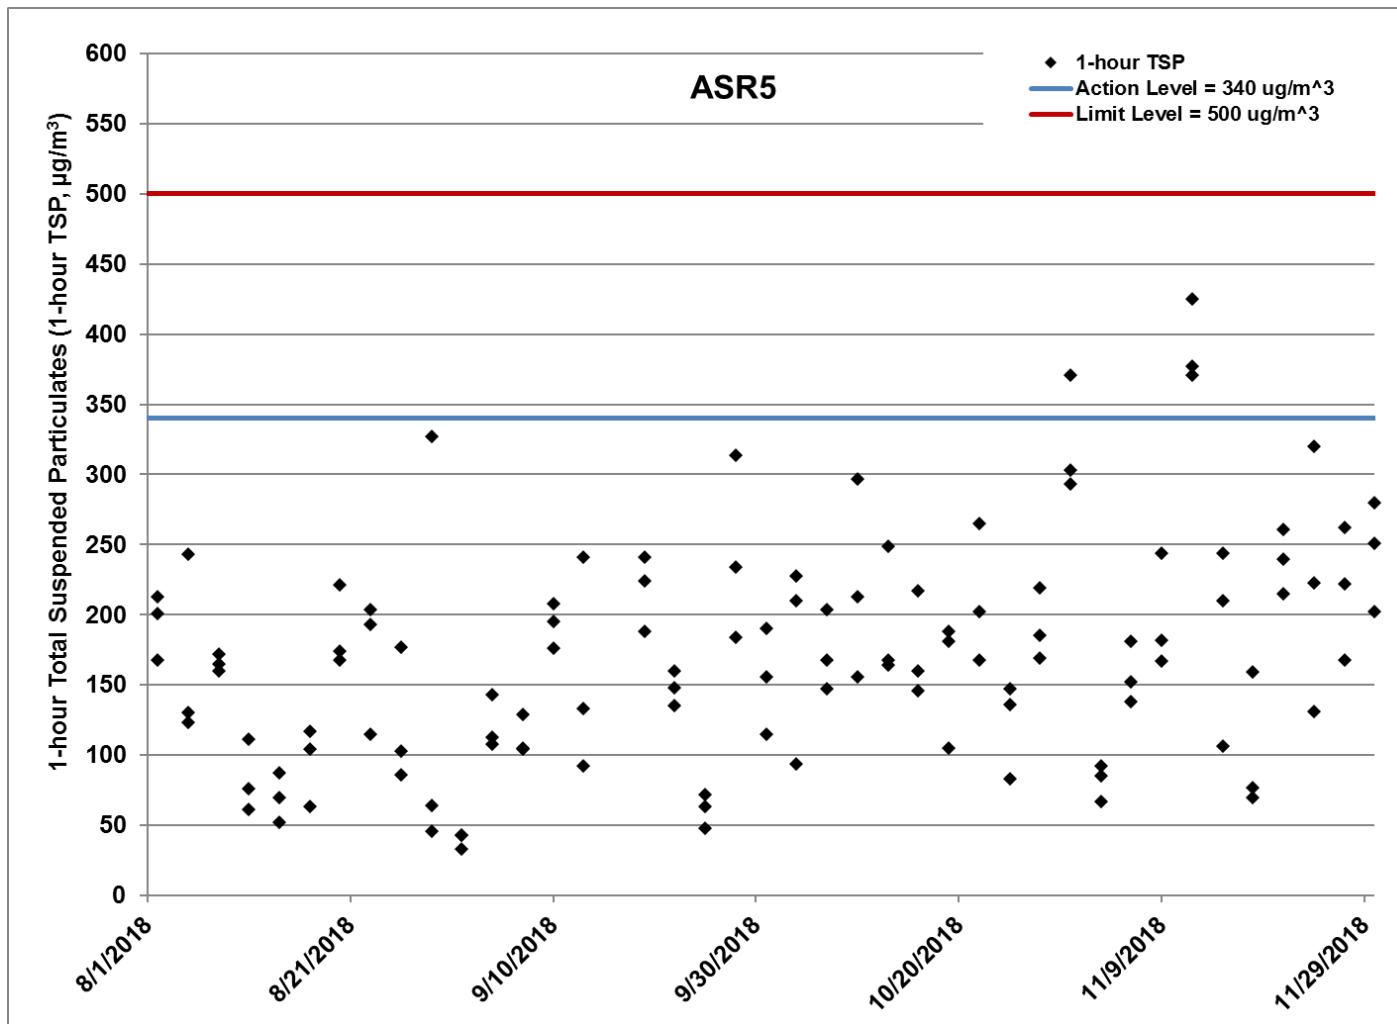
Figure F.4 Impact Monitoring - 1-hour Total Suspended Particulates ($\mu\text{g}/\text{m}^3$) at ASR5 between 1 August 2018 and 30 November 2018 during impact monitoring period. The weather conditions during the monitoring period varied from sunny to cloudy. Major land-based construction activities included: Bulk Excavation, TBM Tunnel Works (1/8/2018 - 30/11/2018)

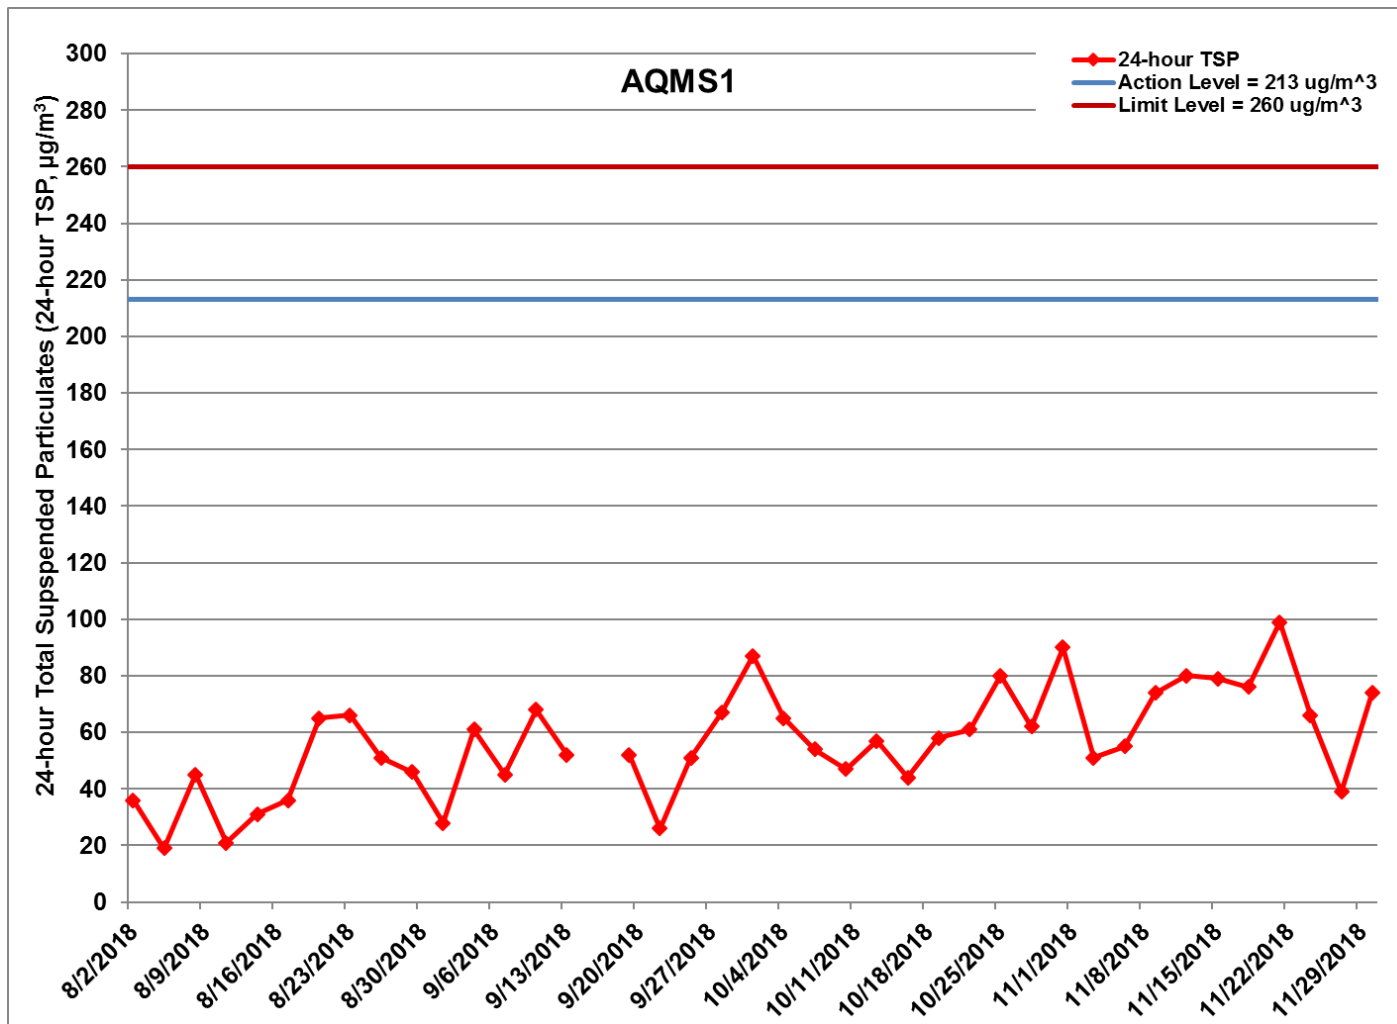
Figure F.8 Impact Monitoring - 24-hour Total Suspended Particulates ($\mu\text{g}/\text{m}^3$) at AQMS1 between 1 August 2018 and 30 November 2018 during impact monitoring period. The weather conditions during the monitoring period varied from sunny to cloudy. Major land-based construction activities included: Bulk Excavation, TBM Tunnel Works (1/8/2018 - 30/11/2018)

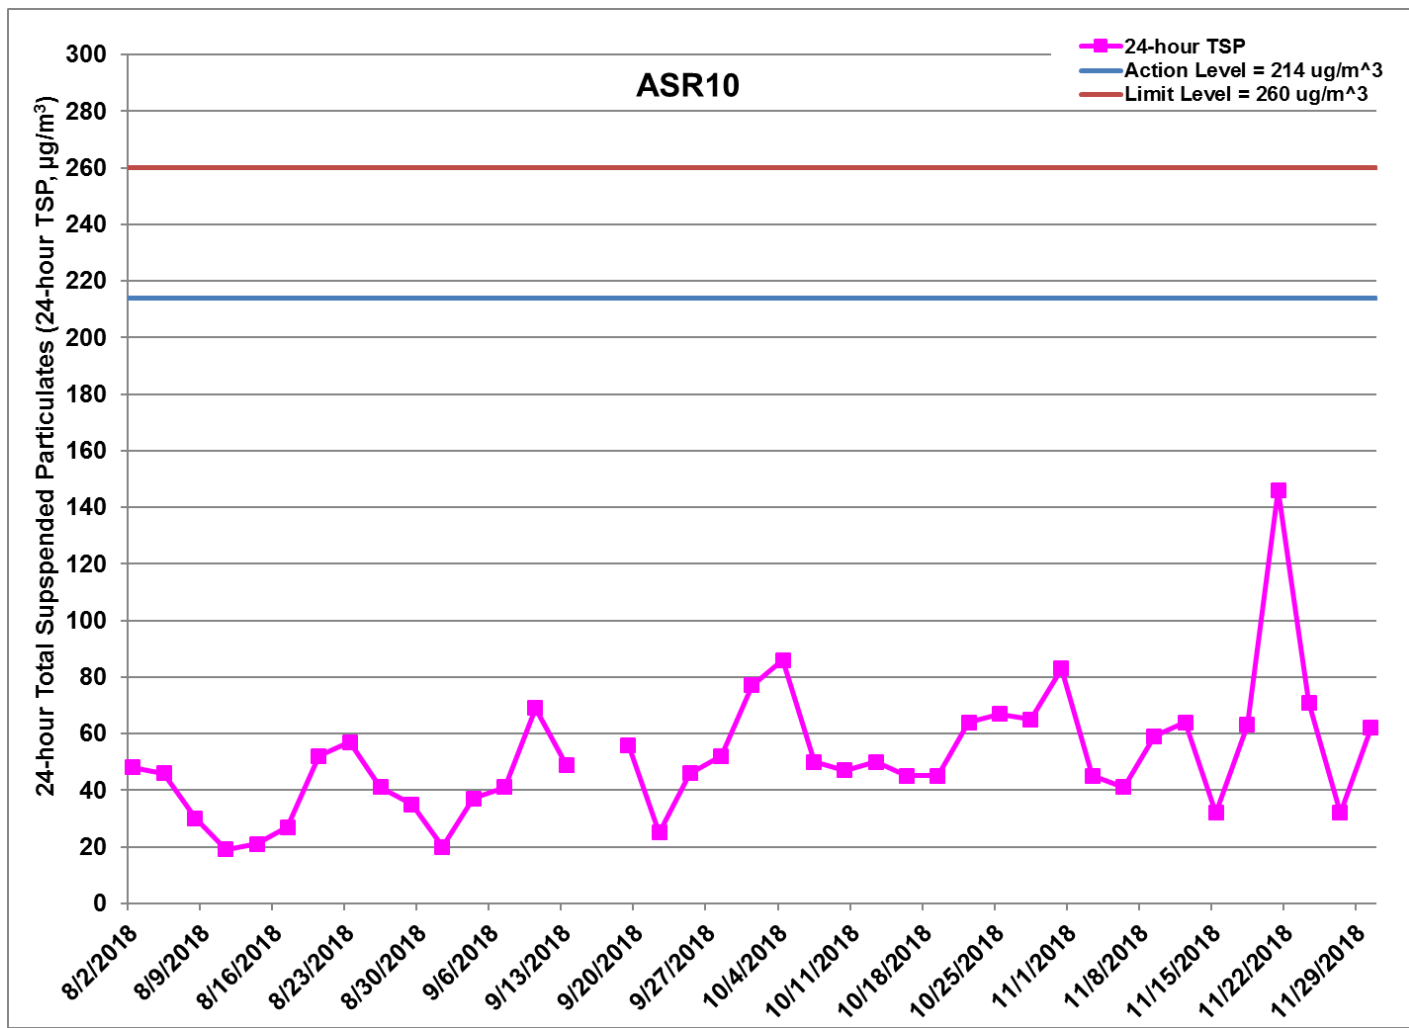
Figure F.10 Impact Monitoring - 24-hour Total Suspended Particulates ($\mu\text{g}/\text{m}^3$) at ASR10 between 1 August 2018 and 30 November 2018 during impact monitoring period. The weather conditions during the monitoring period varied from sunny to cloudy. Major land-based construction activities included: Bulk Excavation, TBM Tunnel Works (1/8/2018 - 30/11/2018)

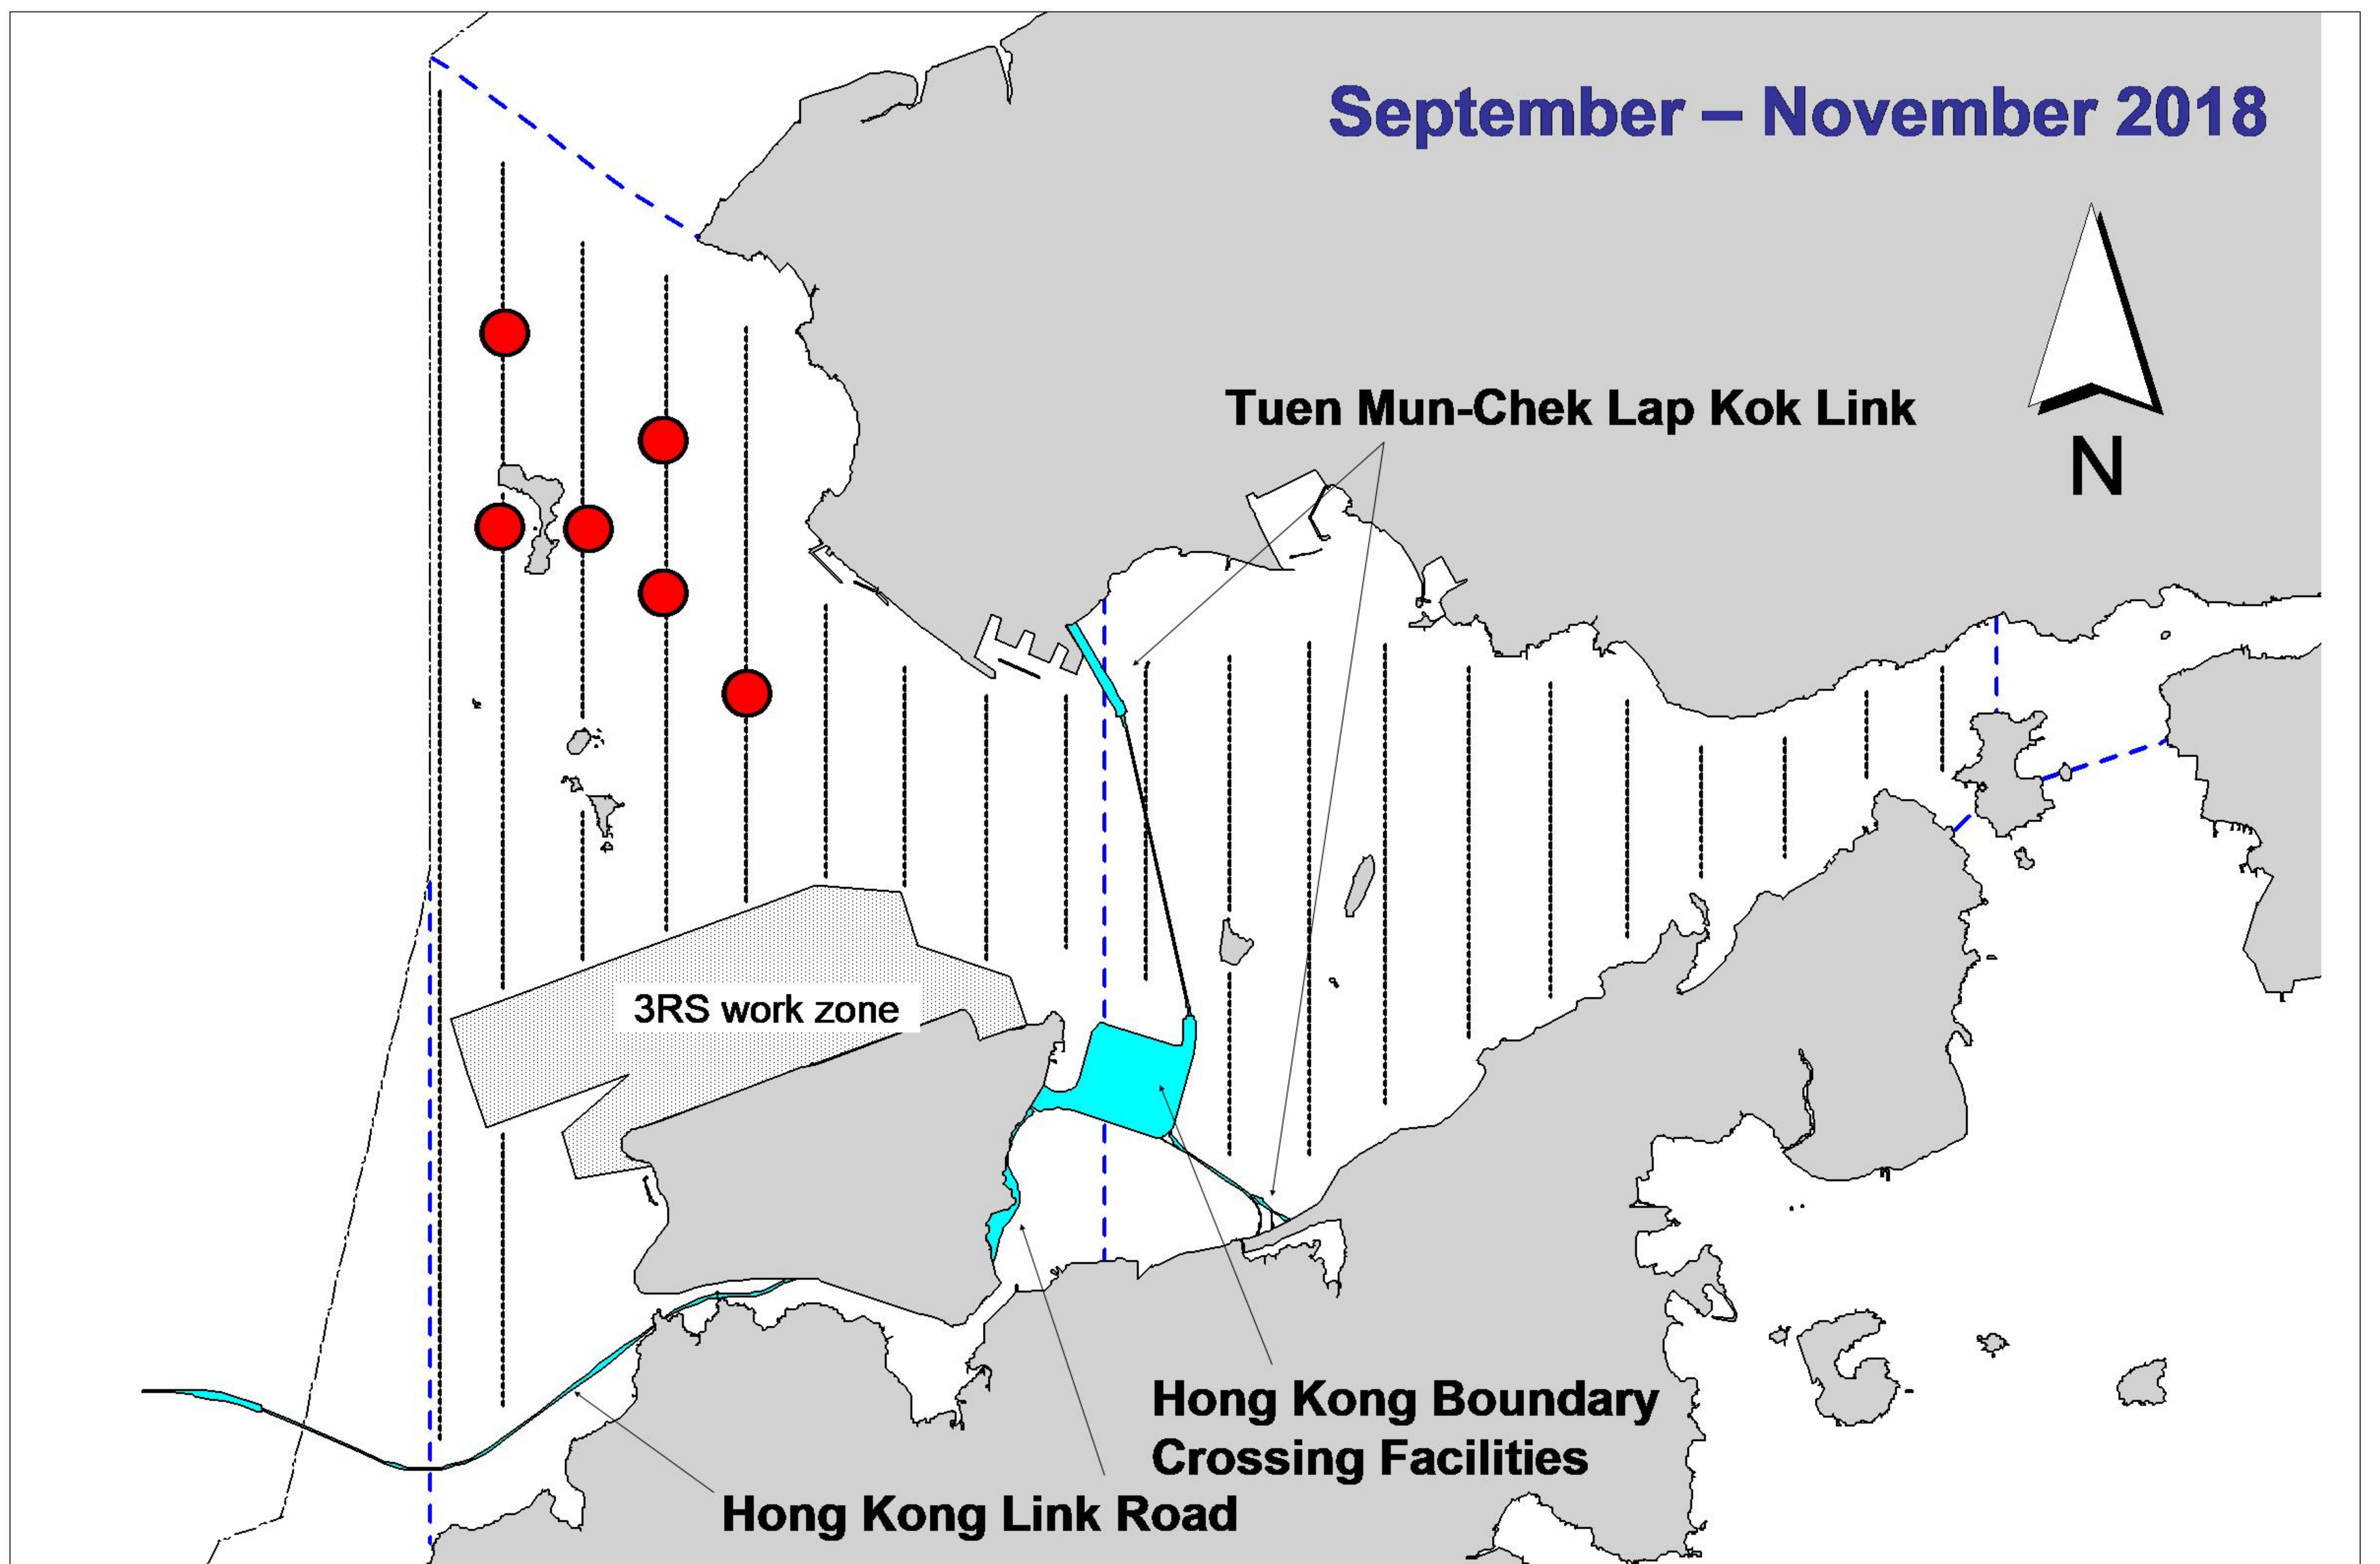
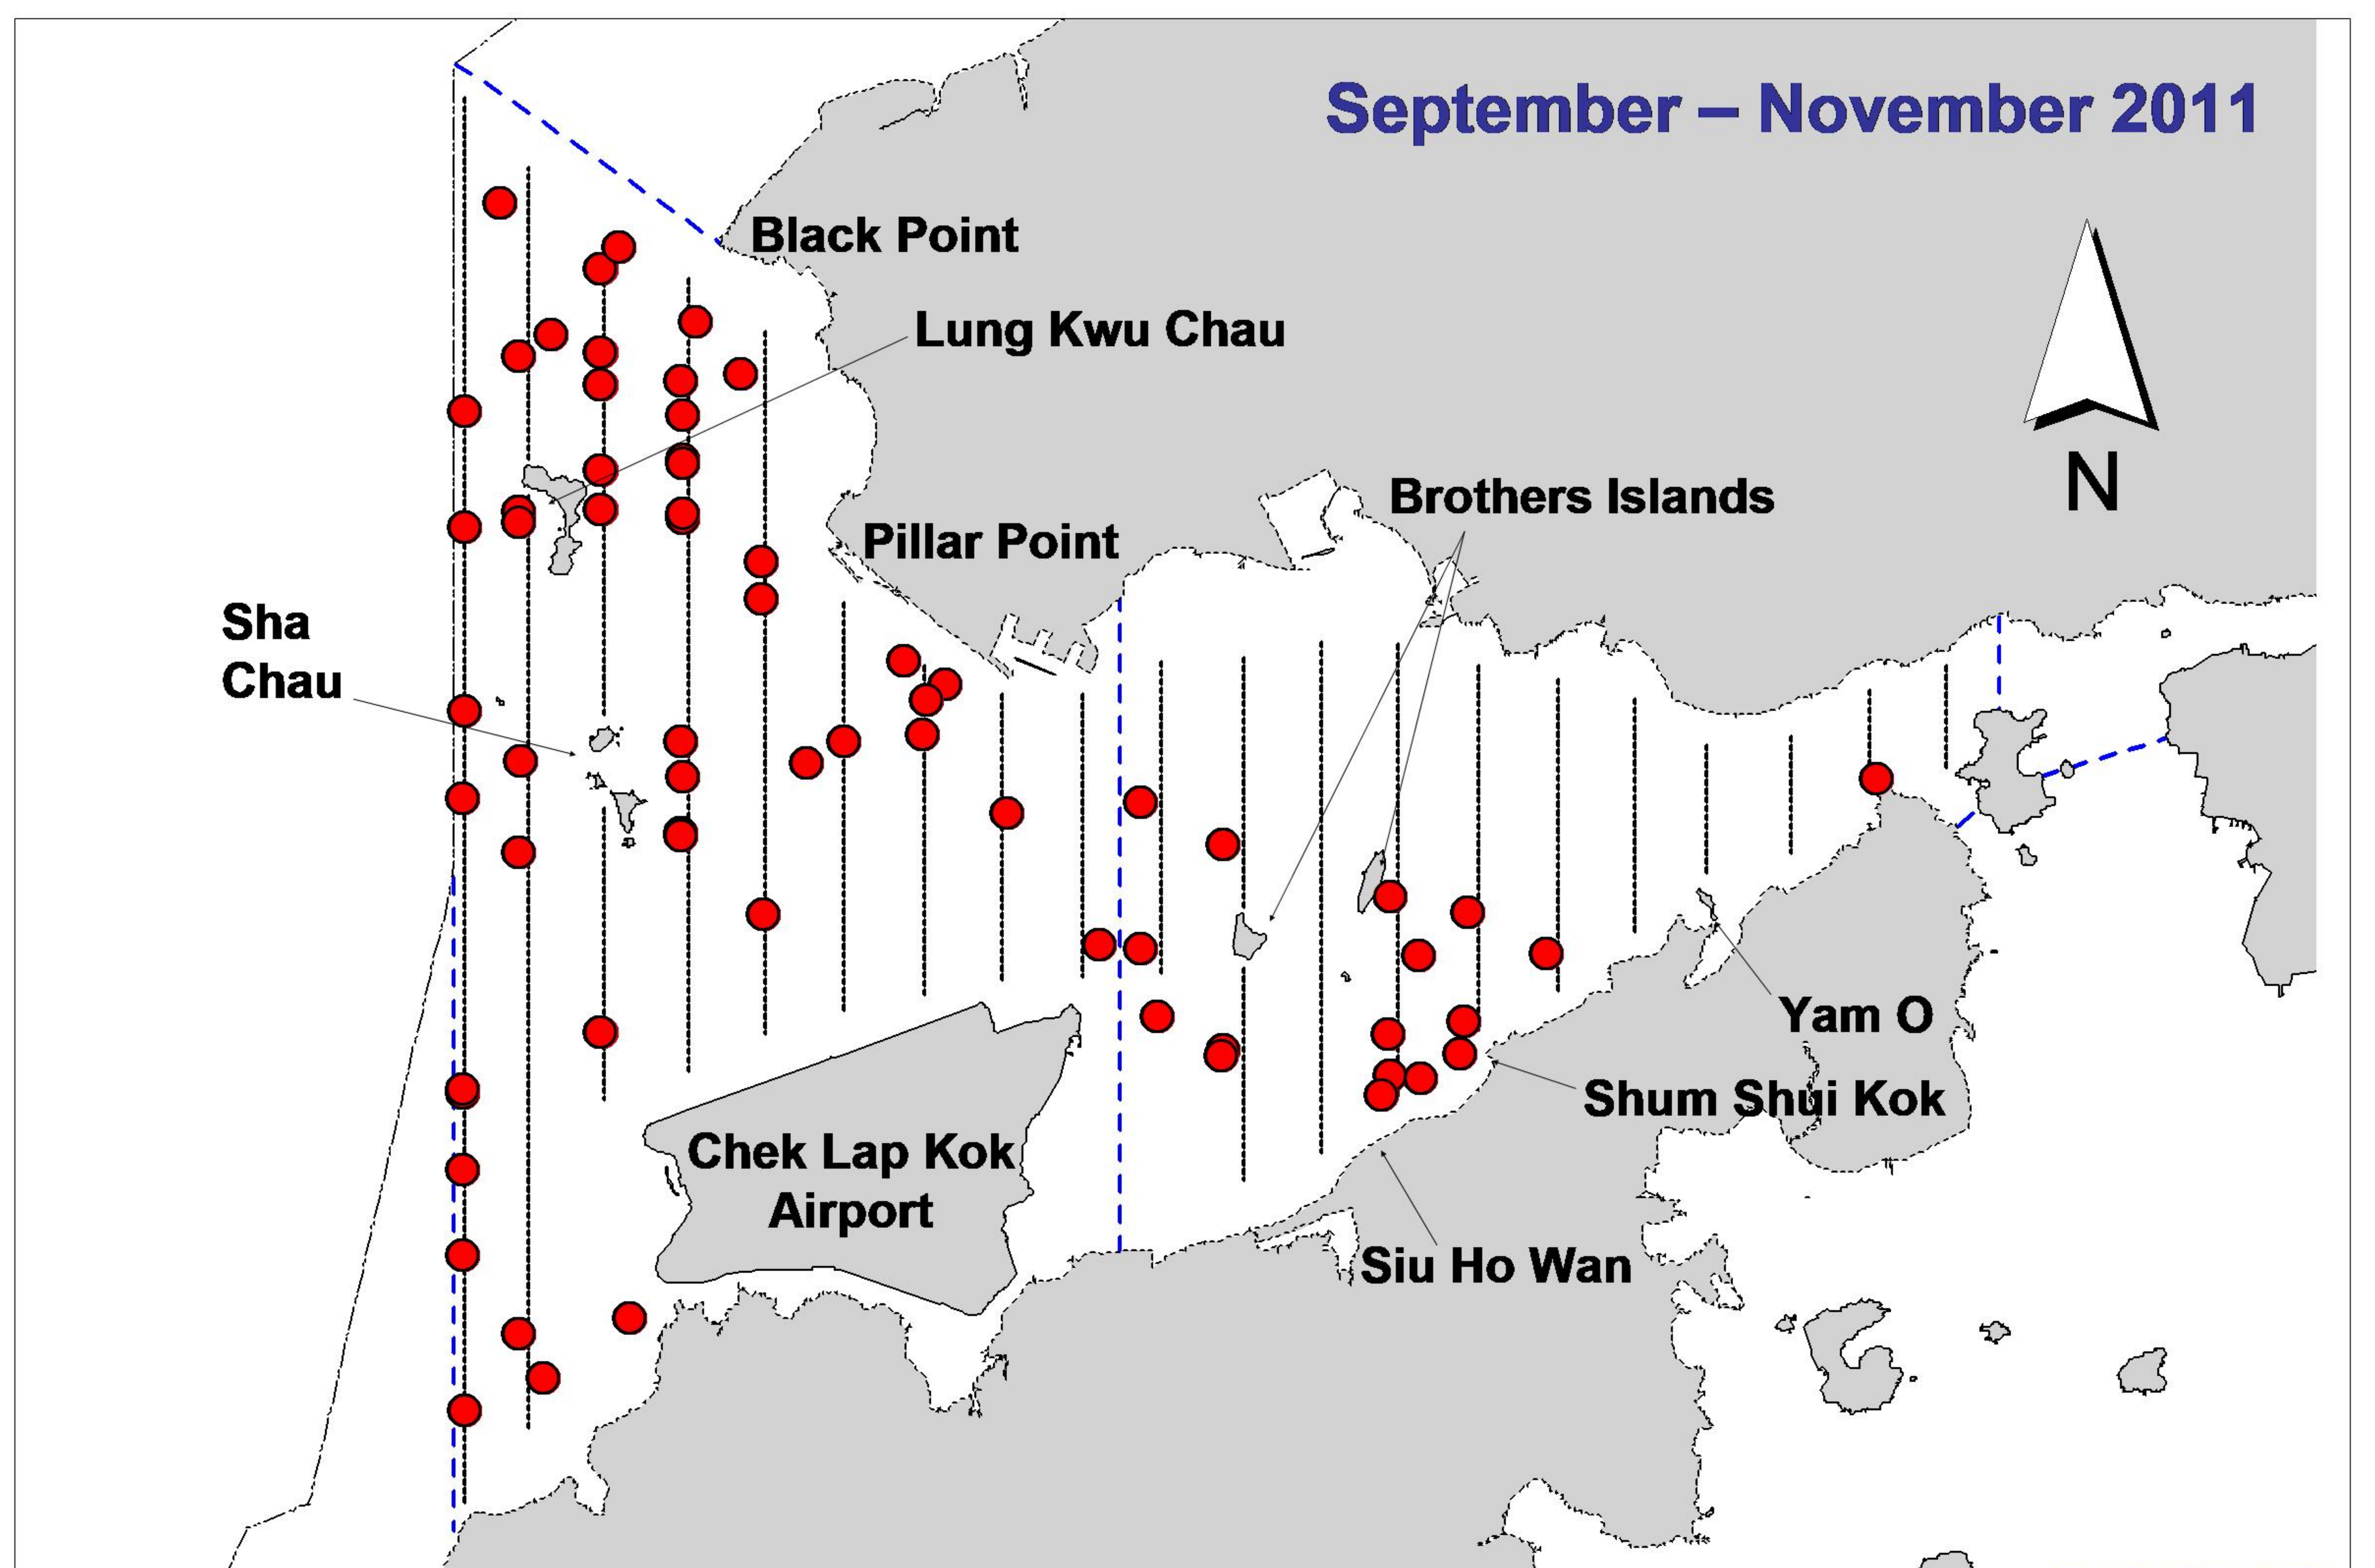
Figure 1. Distribution of Chinese white dolphin sighting in Northwest and Northeast Lantau during HKLR03 impact phase (top) and baseline monitoring surveys (bottom)
