Contract No. HY/2012/07 Tuen Mun – Chek Lap Kok Link – Southern Connection Viaduct Section

Twenty-first Quarterly Environmental Monitoring & Audit (EM&A) Report

28 May 2019

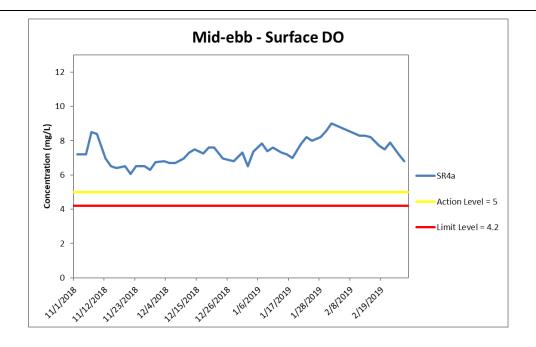
Figure H4 Impact Monitoring - Mean Level of Dissolved Oxygen (mg/L) in surface waters during mid-ebb tide between 1 November 2018 and 28 February 2019 at SR4a.

(Weather condition varied between sunny to rainy within the reporting period.) WQM on 4, 6, 8 February 2019 was cancelled due to suspension of marine works. In-situ monitoring is taken according to the requirement specified in the EM&A Manual, i.e. 3 water depth namely 1m below sea surface, mid-depth and 1m above sea bed. If the water depth is less than 3m, mid-depth sampling only. If water depth less than 6m, mid-depth may be omitted.

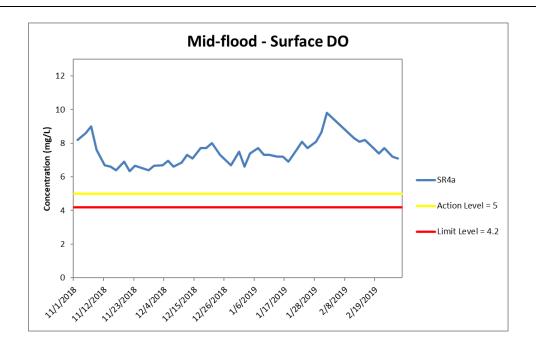
Figure H8 Impact Monitoring - Mean Level of Dissolved Oxygen (mg/L) in surface waters during mid-flood tide between 1 November 2018 and 28 February 2019 at SR4a.

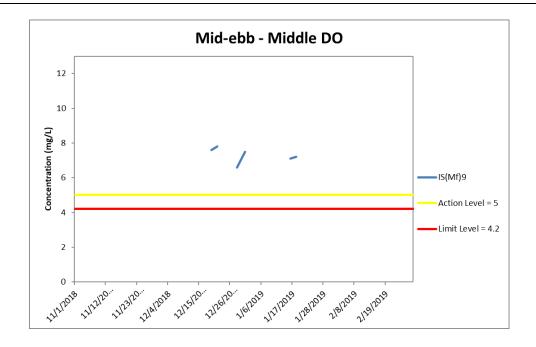
Figure H10 Impact Monitoring – Mean Level of Dissolved Oxygen (mg/L) in mid-depth waters during mid-ebb tide between 1 November 2018 and 28 February 2019 at IS(Mf)9.

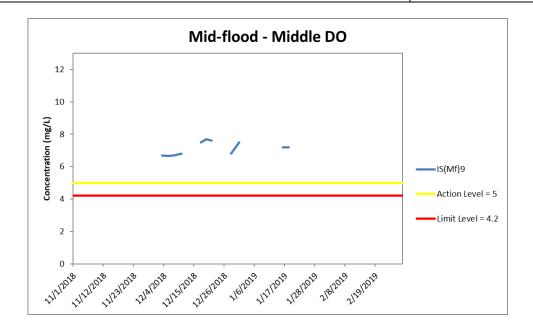
Figure H12 Impact Monitoring – Mean Level of Dissolved Oxygen (mg/L) in mid-depth waters during mid-flood tide between 1 November 2018 and 28 February 2019 at IS(Mf)9.

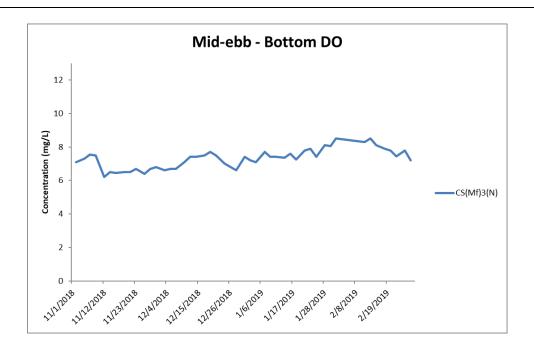
Figure H13 Impact Monitoring – Mean Level of Dissolved Oxygen (mg/L) in bottom waters during mid-ebb tide between 1 November 2018 and 28 February 2019 at CS(Mf)3(N) and CS(Mf)5.

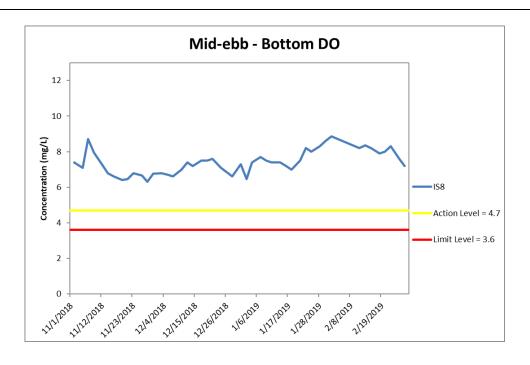
Figure H15 Impact Monitoring – Mean Level of Dissolved Oxygen (mg/L) in bottom waters during mid-ebb tide between 1 November 2018 and 28 February 2019 at IS8 and SR4(N).

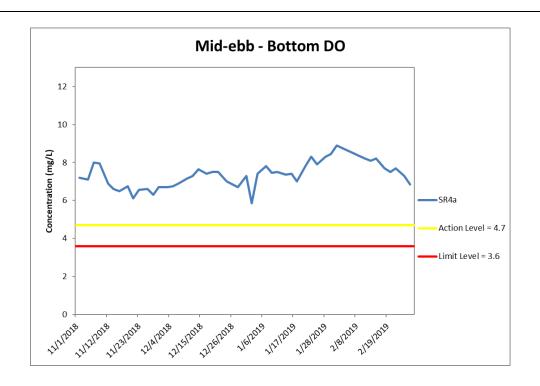
Figure H16 Impact Monitoring – Mean Level of Dissolved Oxygen (mg/L) in bottom waters during mid-ebb tide between 1 November 2018 and 28 February 2019 at SR4a.

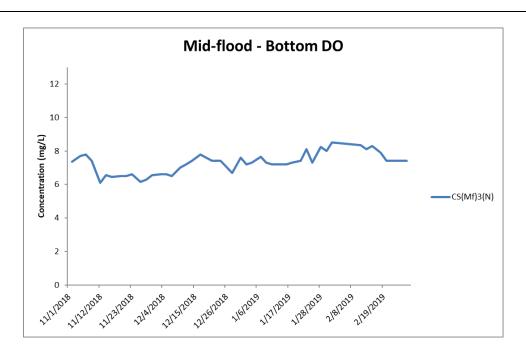
Figure H17 Impact Monitoring - Mean Level of Dissolved Oxygen (mg/L) in bottom waters during mid-flood tide between 1 November 2018 and 28 February 2019 at CS(Mf)3(N) and CS(Mf)5.

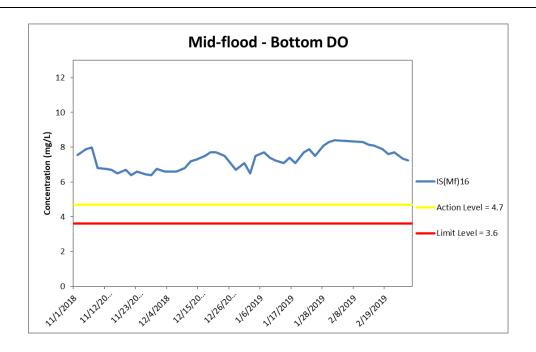
Figure H18 Impact Monitoring - Mean Level of Dissolved Oxygen (mg/L) in bottom waters during mid-flood tide between 1 November 2018 and 28 February 2019 at IS(Mf)16 and IS(Mf)9.

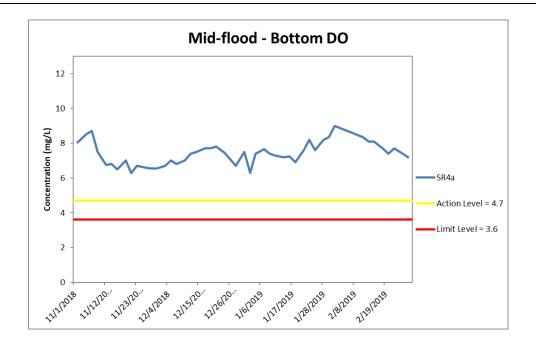
Figure H20 Impact Monitoring - Mean Level of Dissolved Oxygen (mg/L) in bottom waters during mid-flood tide between 1 November 2018 and 28 February 2019 at SR4a.

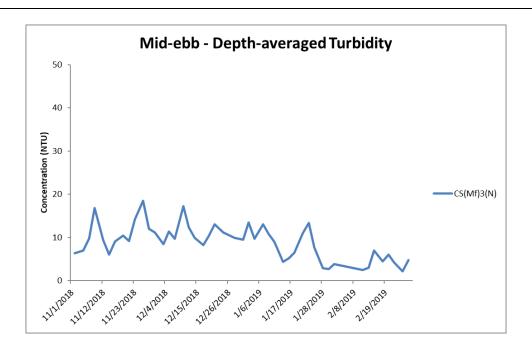
Figure H21 Impact Monitoring – Mean Level of depth-averaged Turbidity (NTU) during mid-ebb tide between 1 November 2018 and 28 February 2019 at CS(Mf)3(N) and CS(Mf)5.

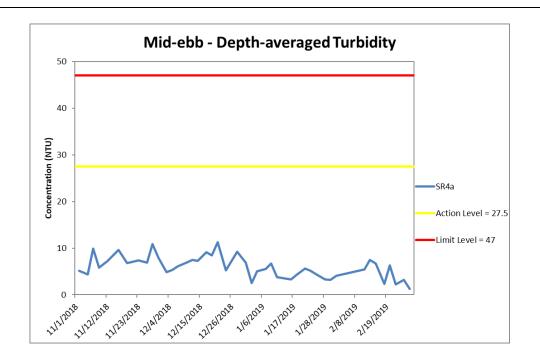
Figure H24 Impact Monitoring – Mean Level of depth-averaged Turbidity (NTU) during mid-ebb tide between 1 November 2018 and 28 February 2019 at SR4a.

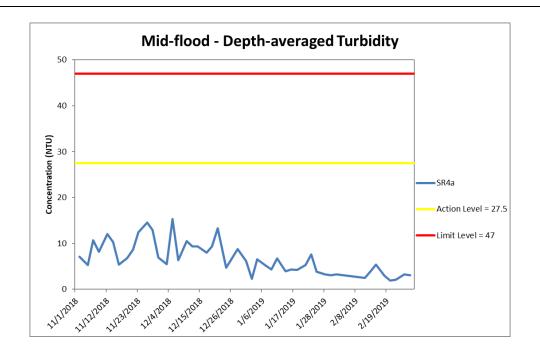
Figure H28 Impact Monitoring – Mean Level of depth-averaged Turbidity (NTU) during mid-flood tide between 1 November 2018 and 28 February 2019 at SR4a.

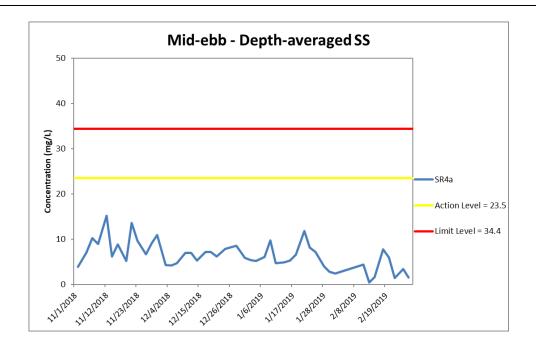
Figure H32 Impact Monitoring – Mean depth-averaged level of Suspended Solids (mg/L) during mid-ebb tide between 1 November 2018 and 28 February 2019 at SR4a.

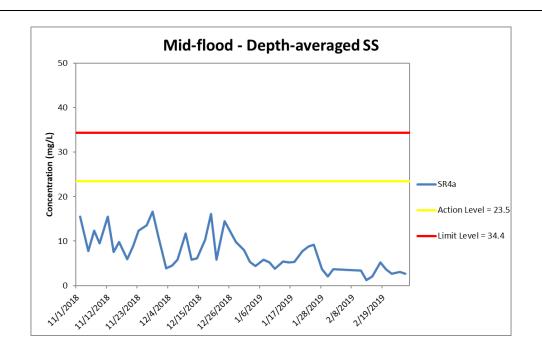
Figure H36 Impact Monitoring – Mean depth-averaged level of Suspended Solids (mg/L) during mid-flood tide between 1 November 2018 and 28 February 2019 at SR4a.

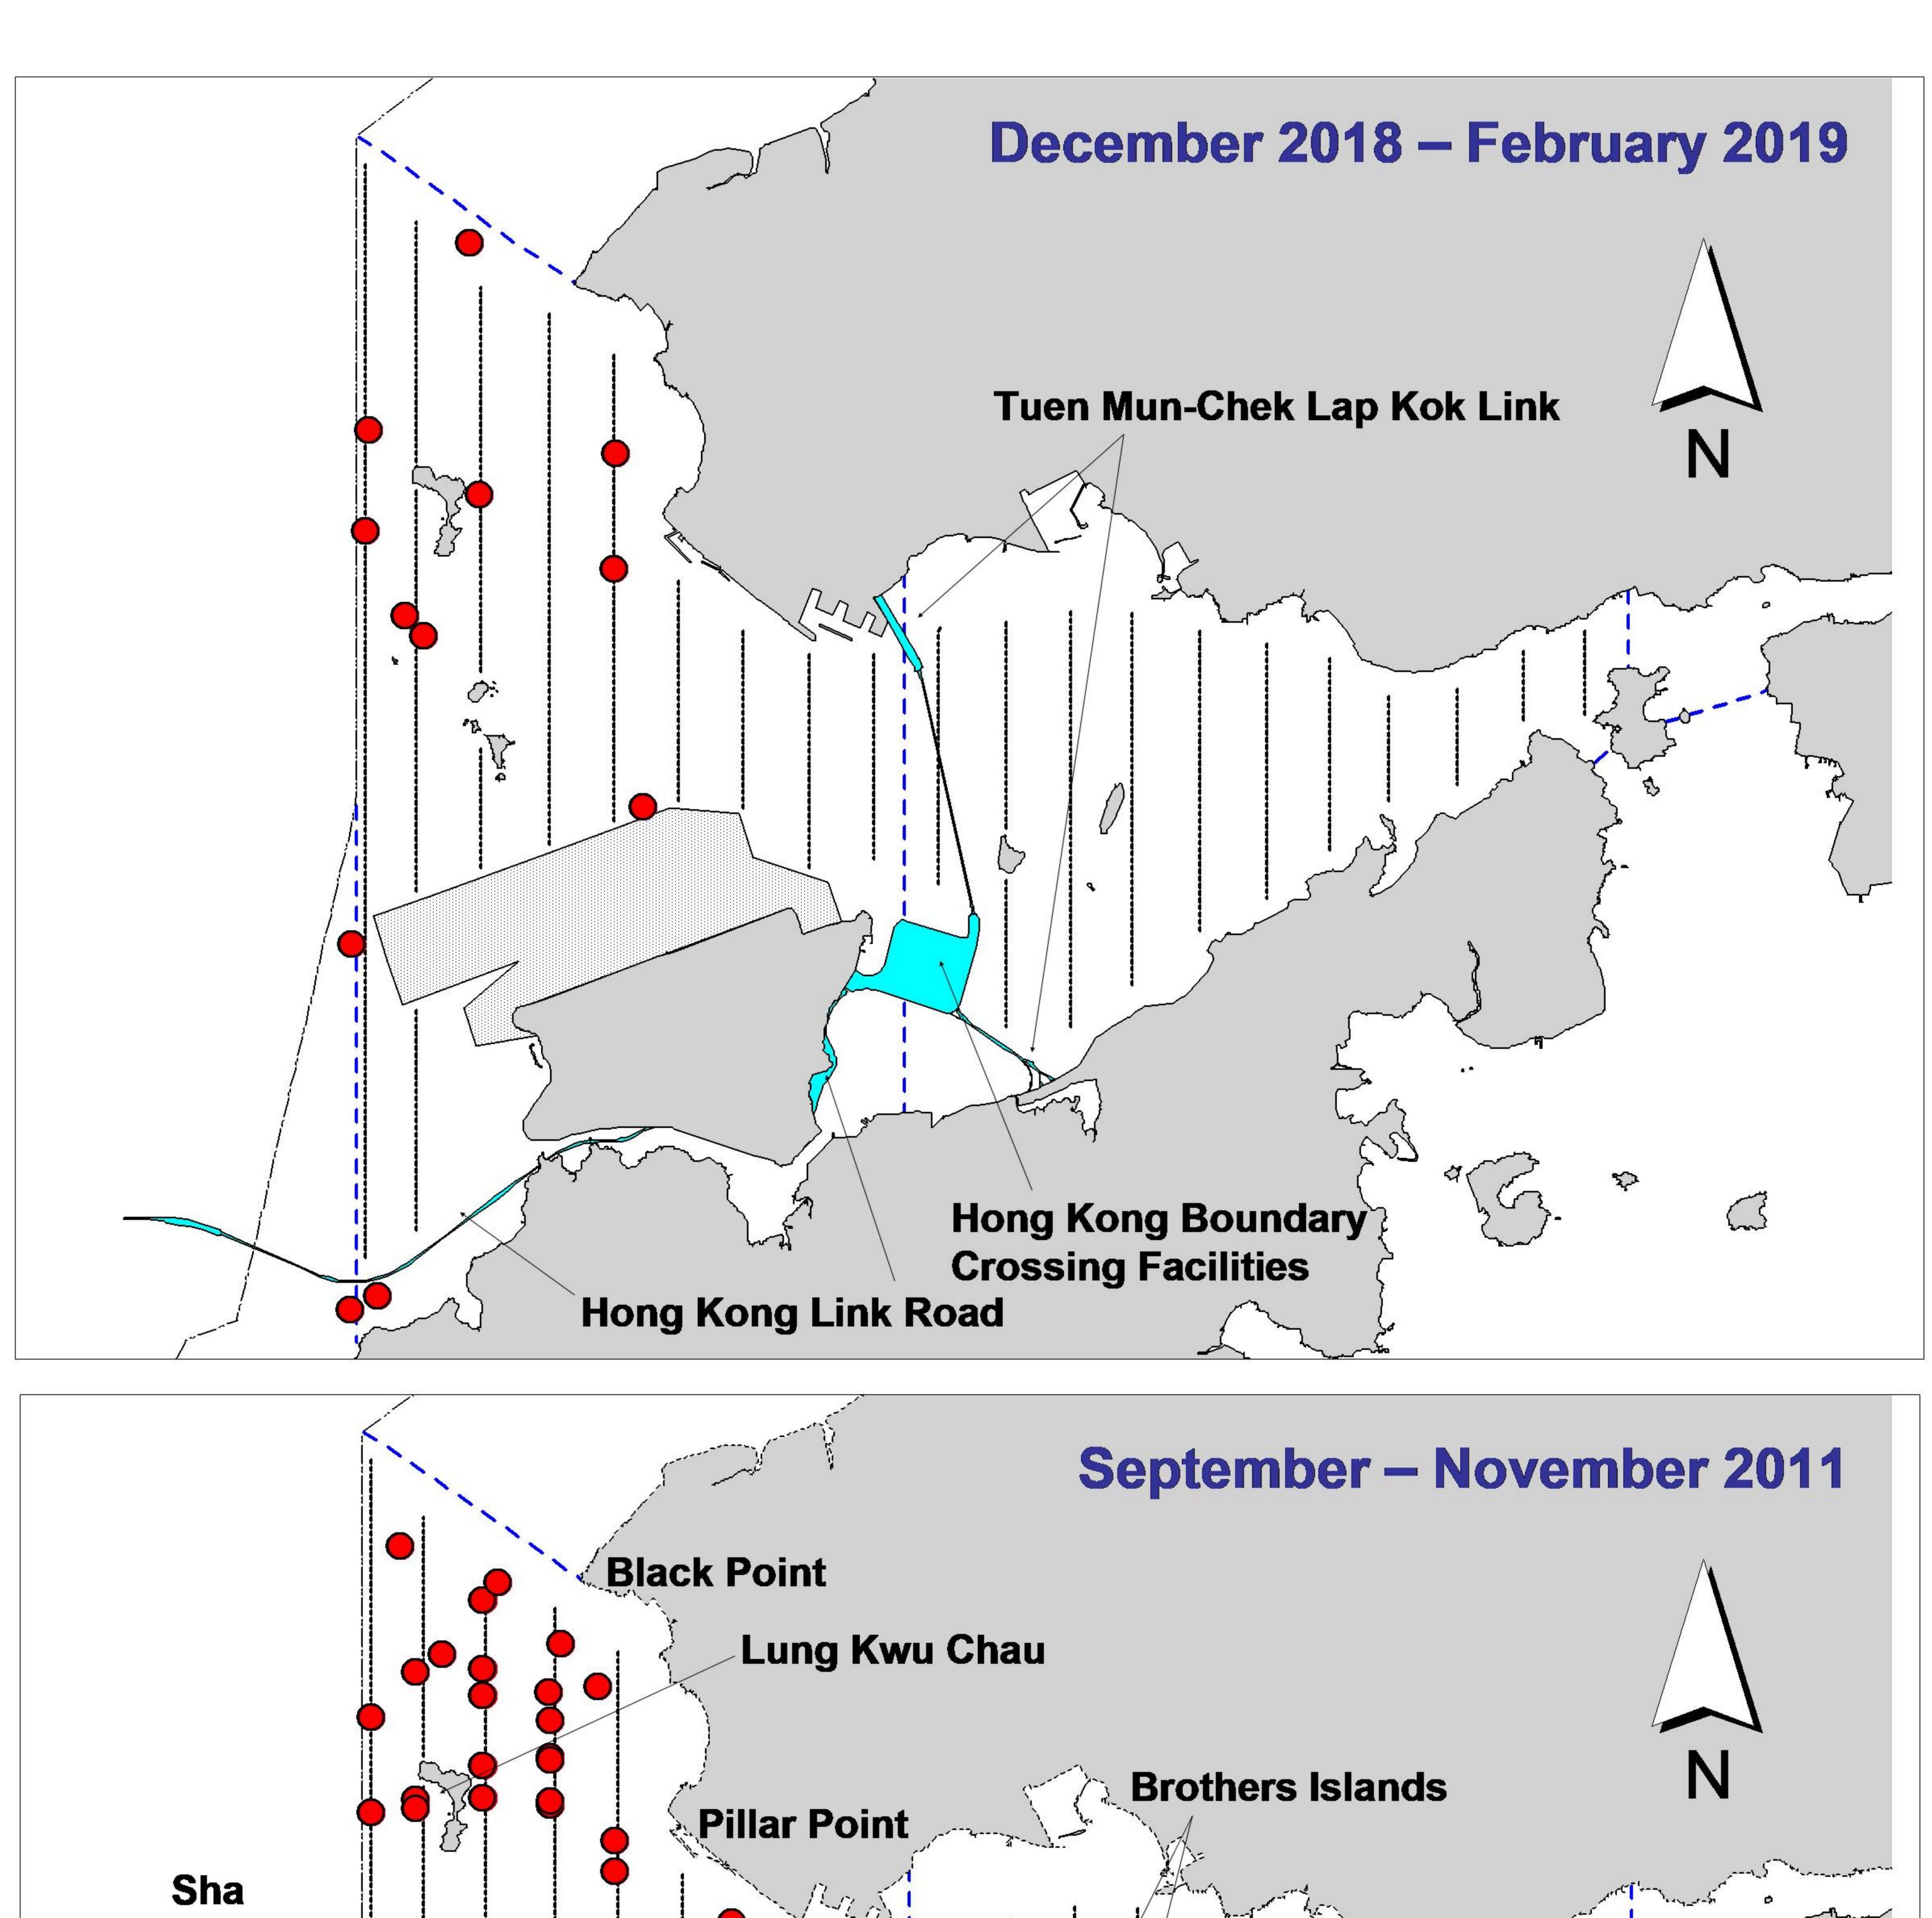
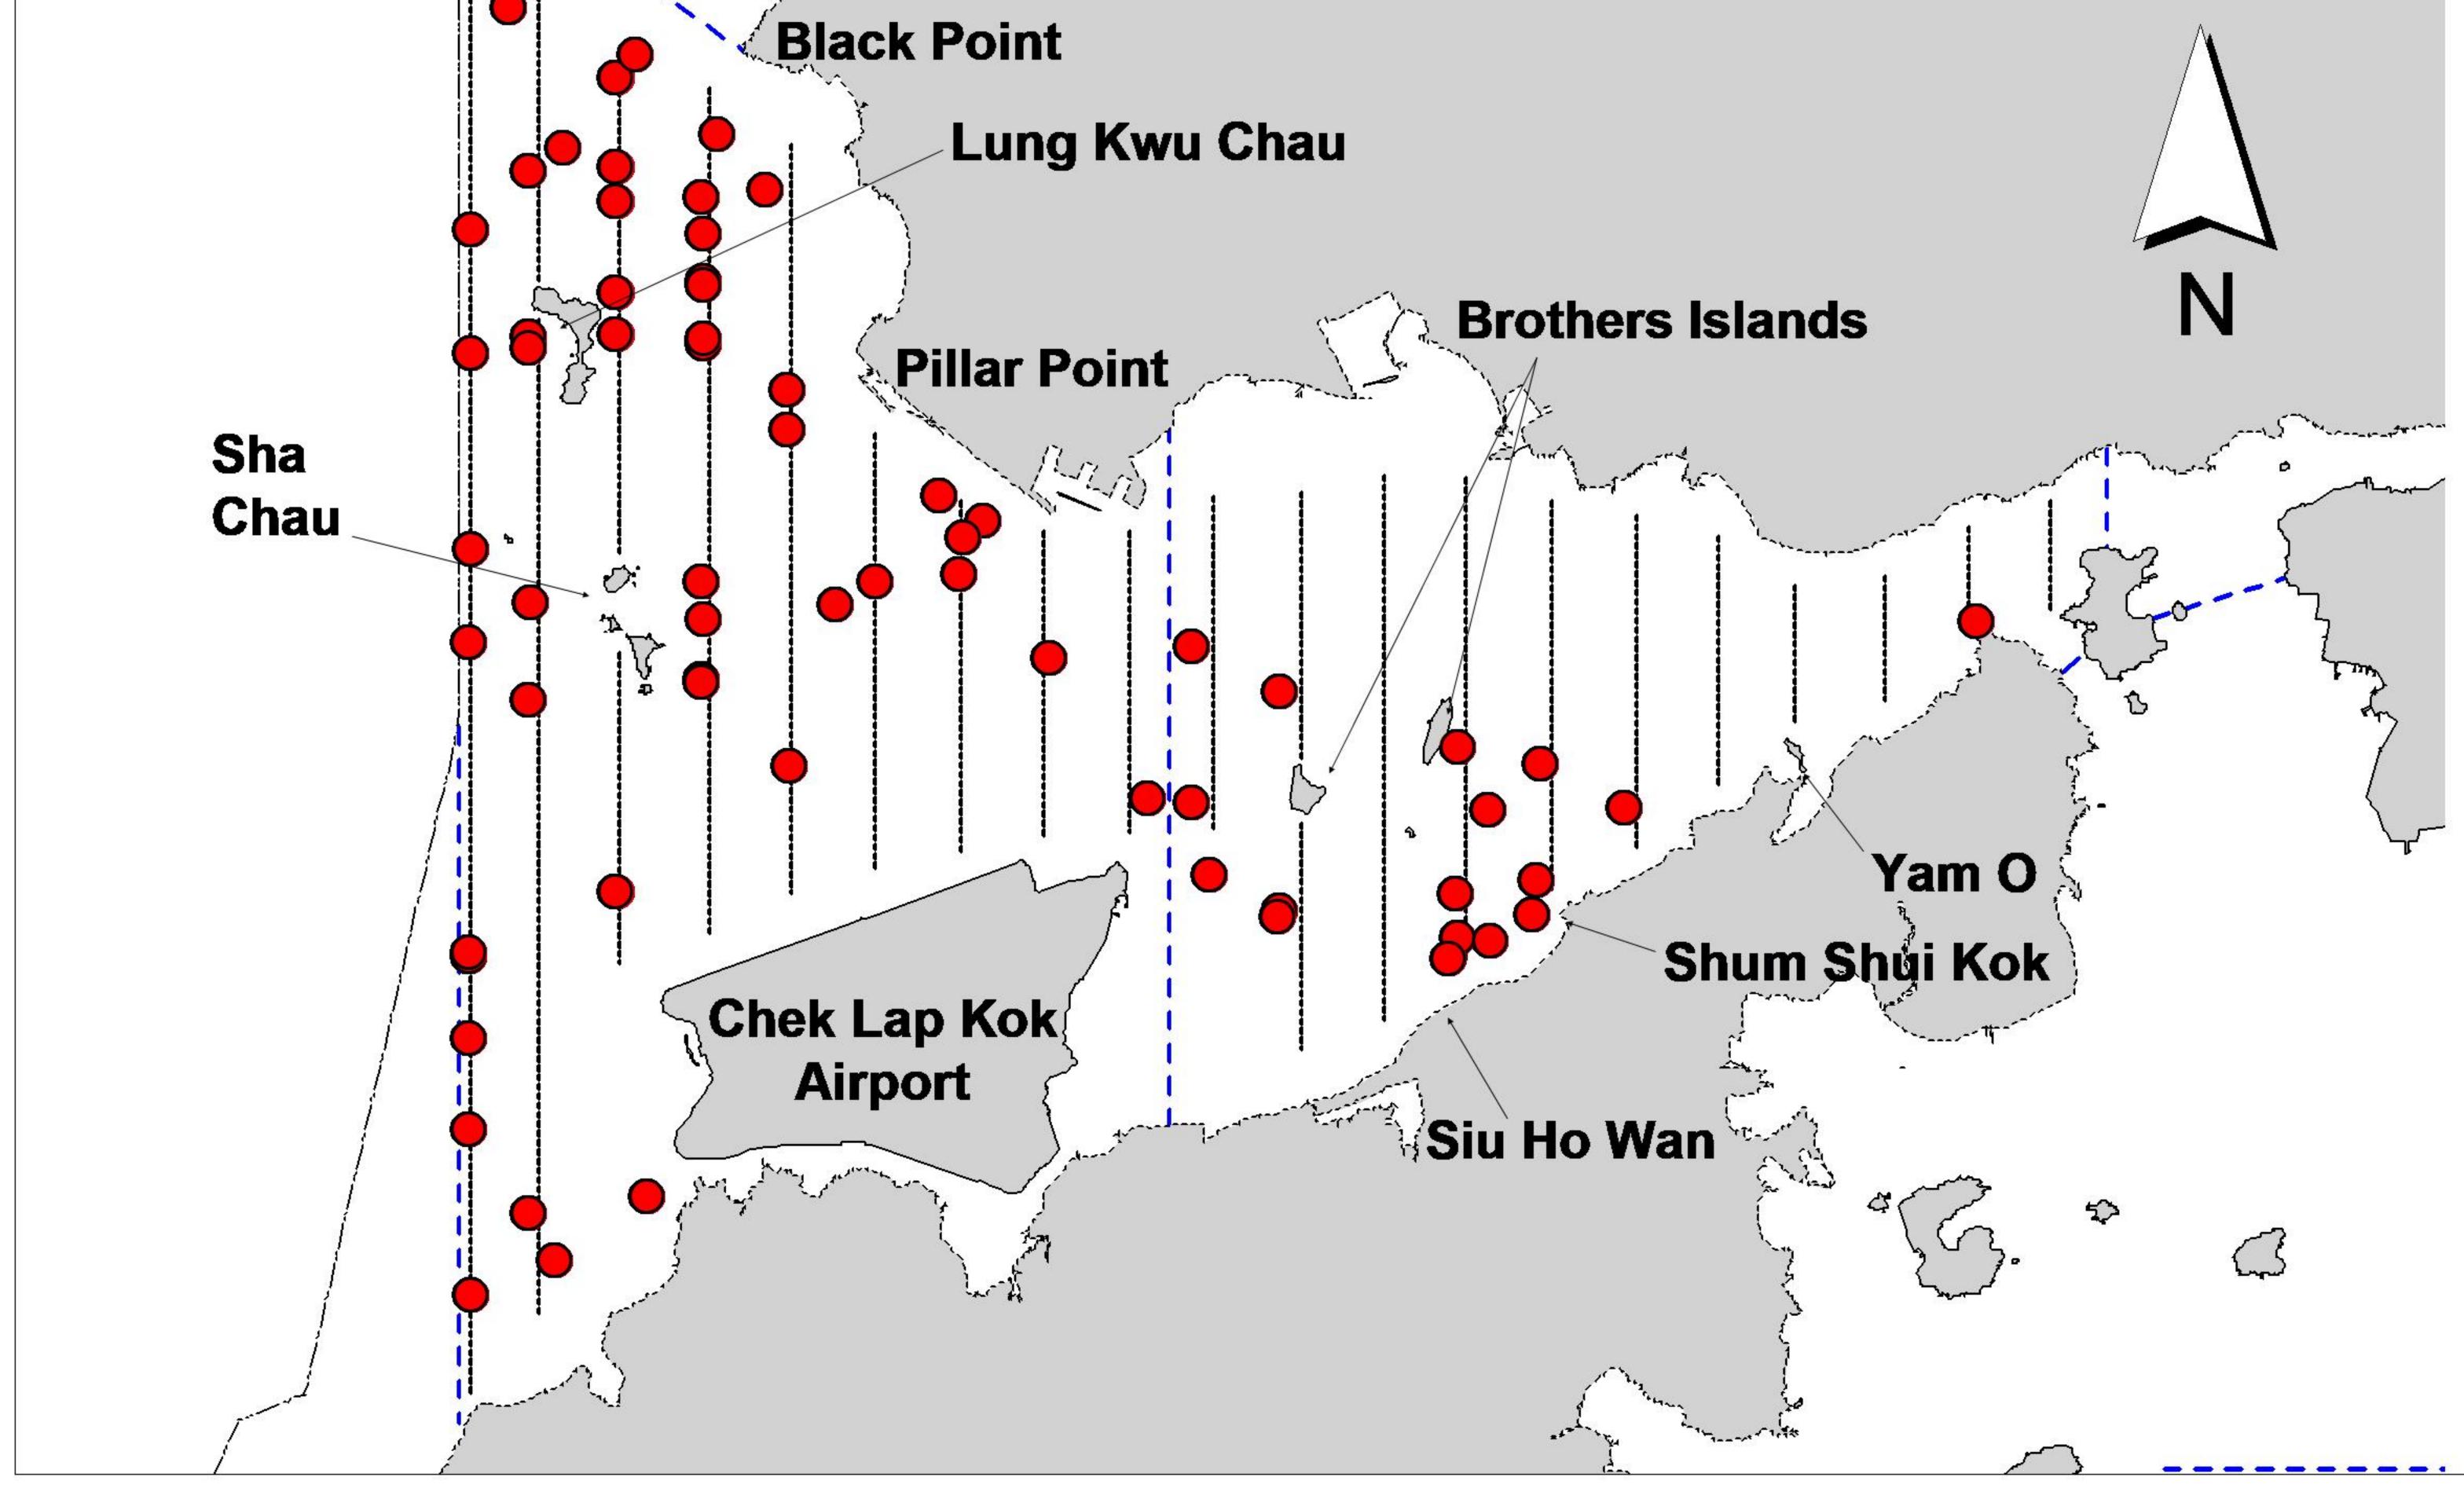
Figure 1. Distribution of Chinese white dolphin sighting in Northwest and Northeast Lantau during HKLR03 impact phase (top) and baseline monitoring surveys (bottom)

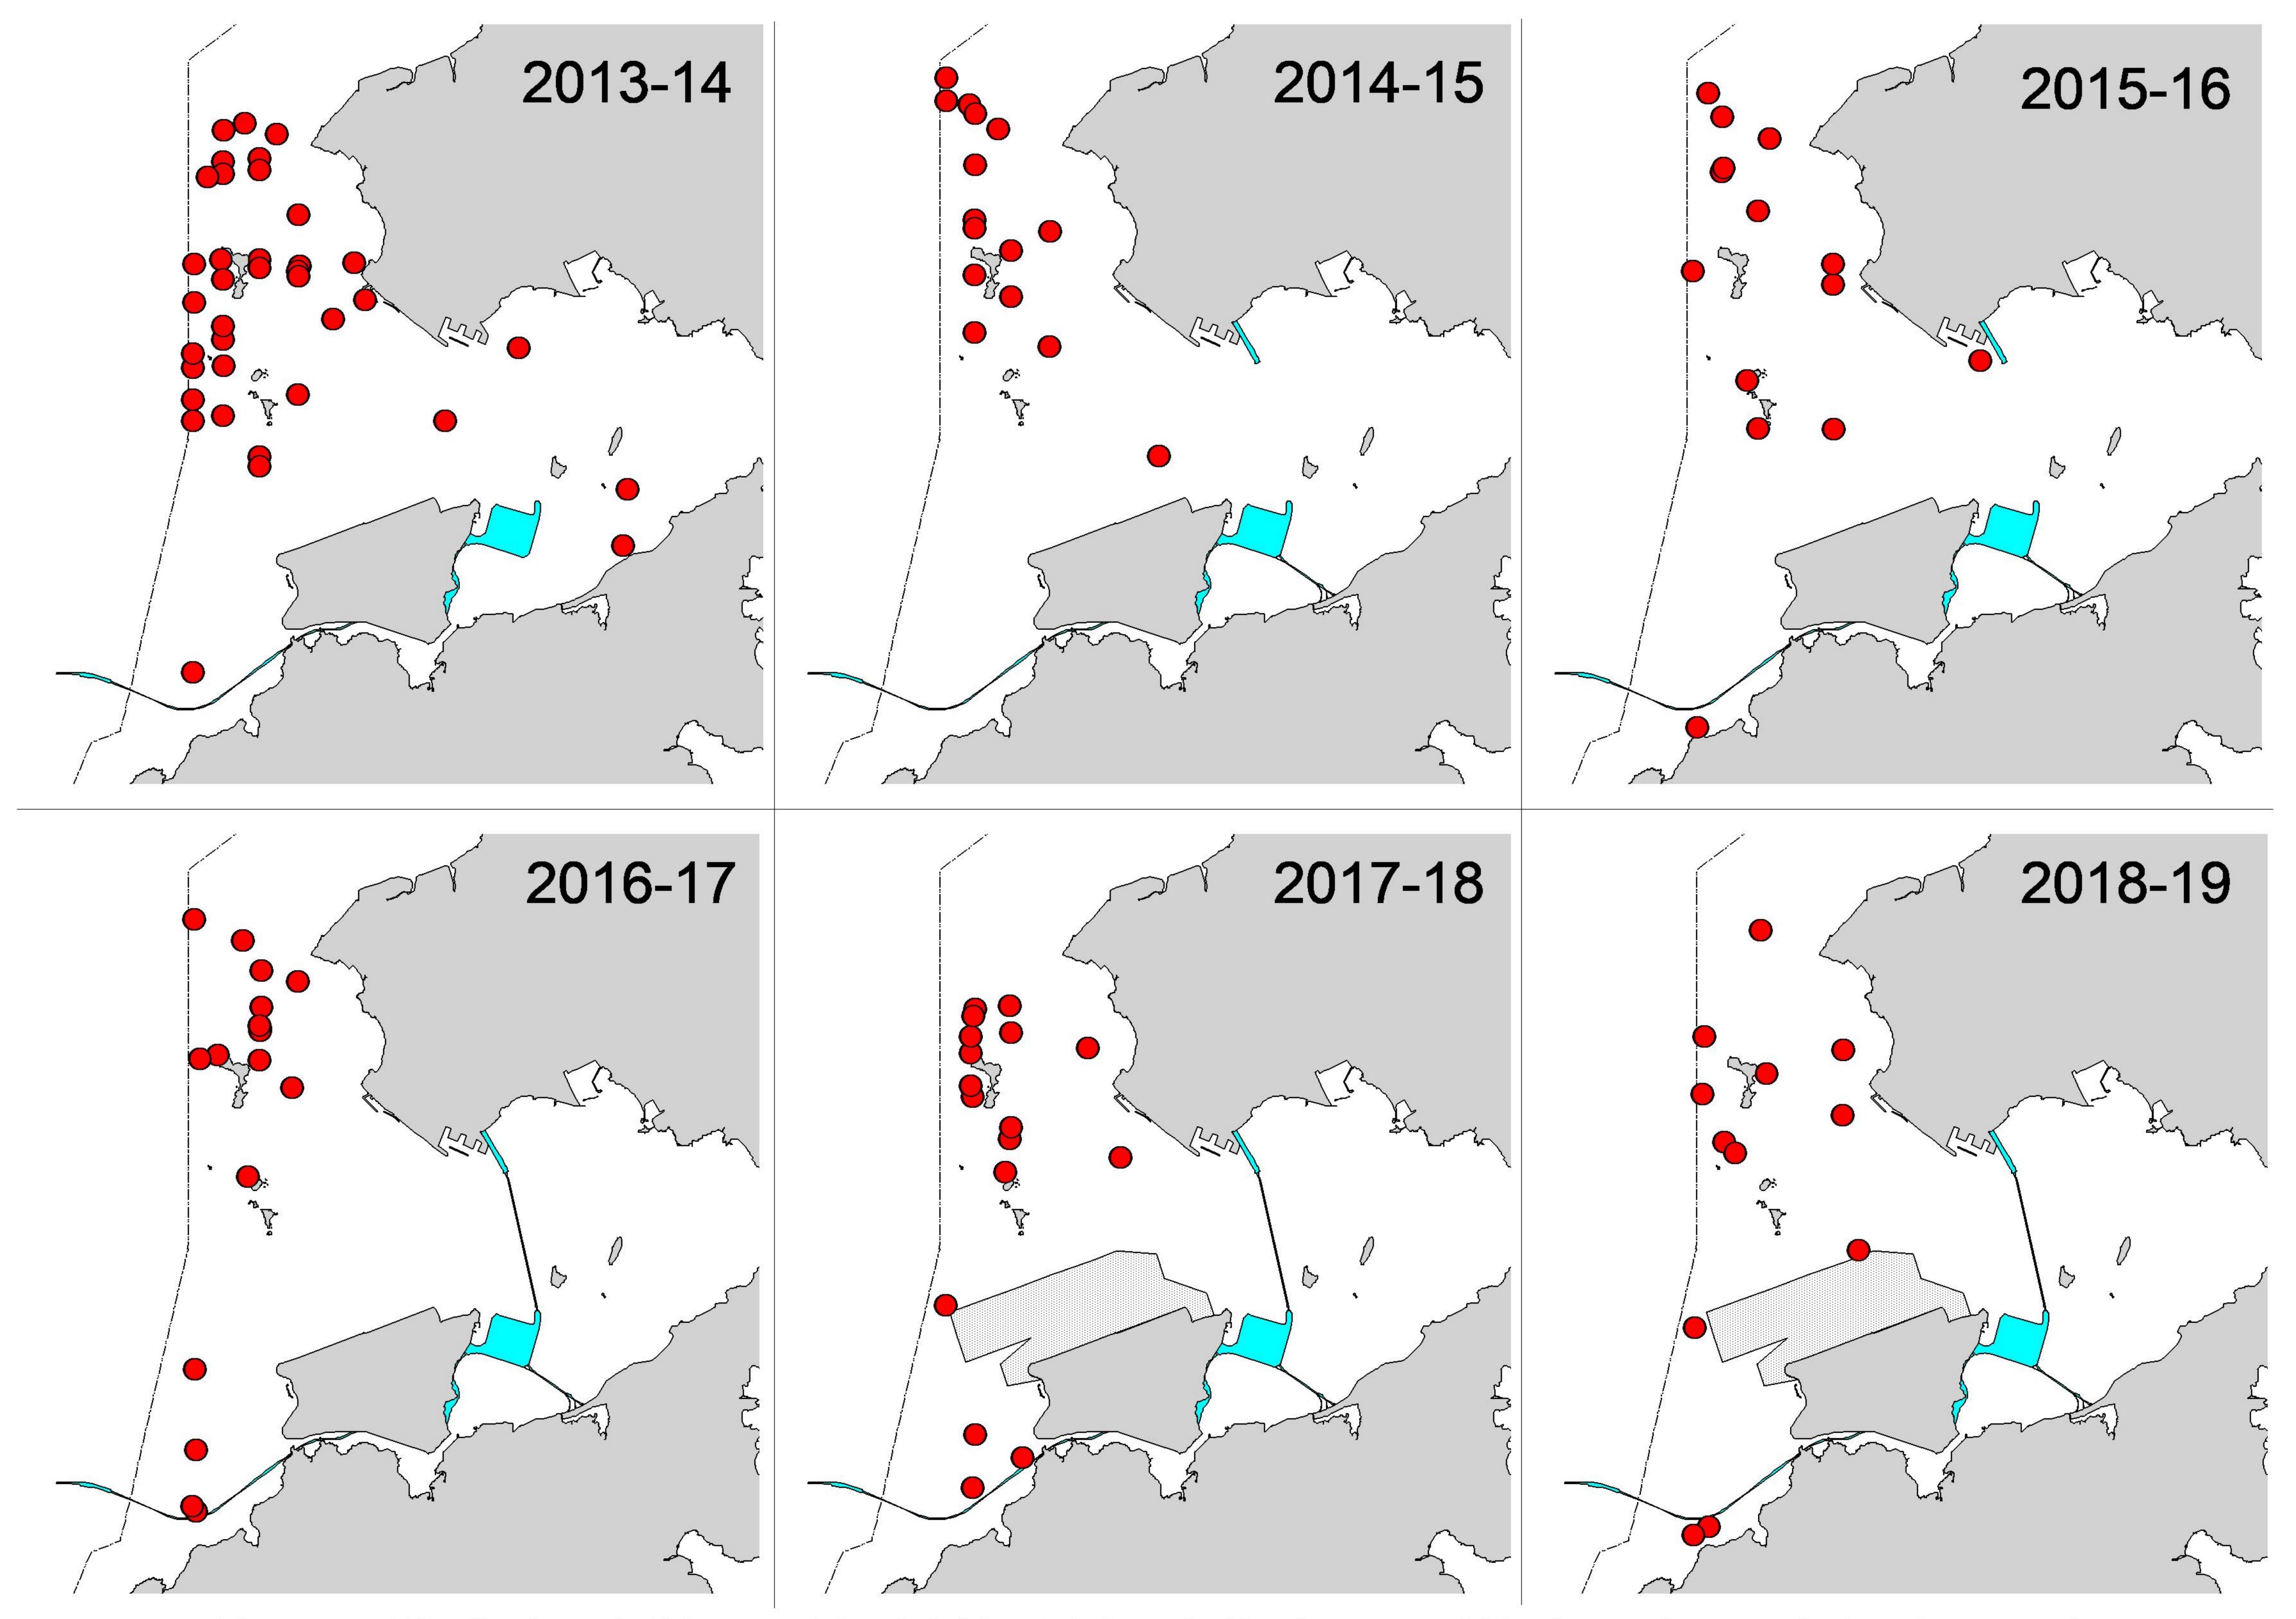
Figure 2. Distribution of Chinese white dolphin sightings in Northwest and Northeast Lantau during the past six winter quarters (December-February) of HKLR03 impact phase in 2013-19

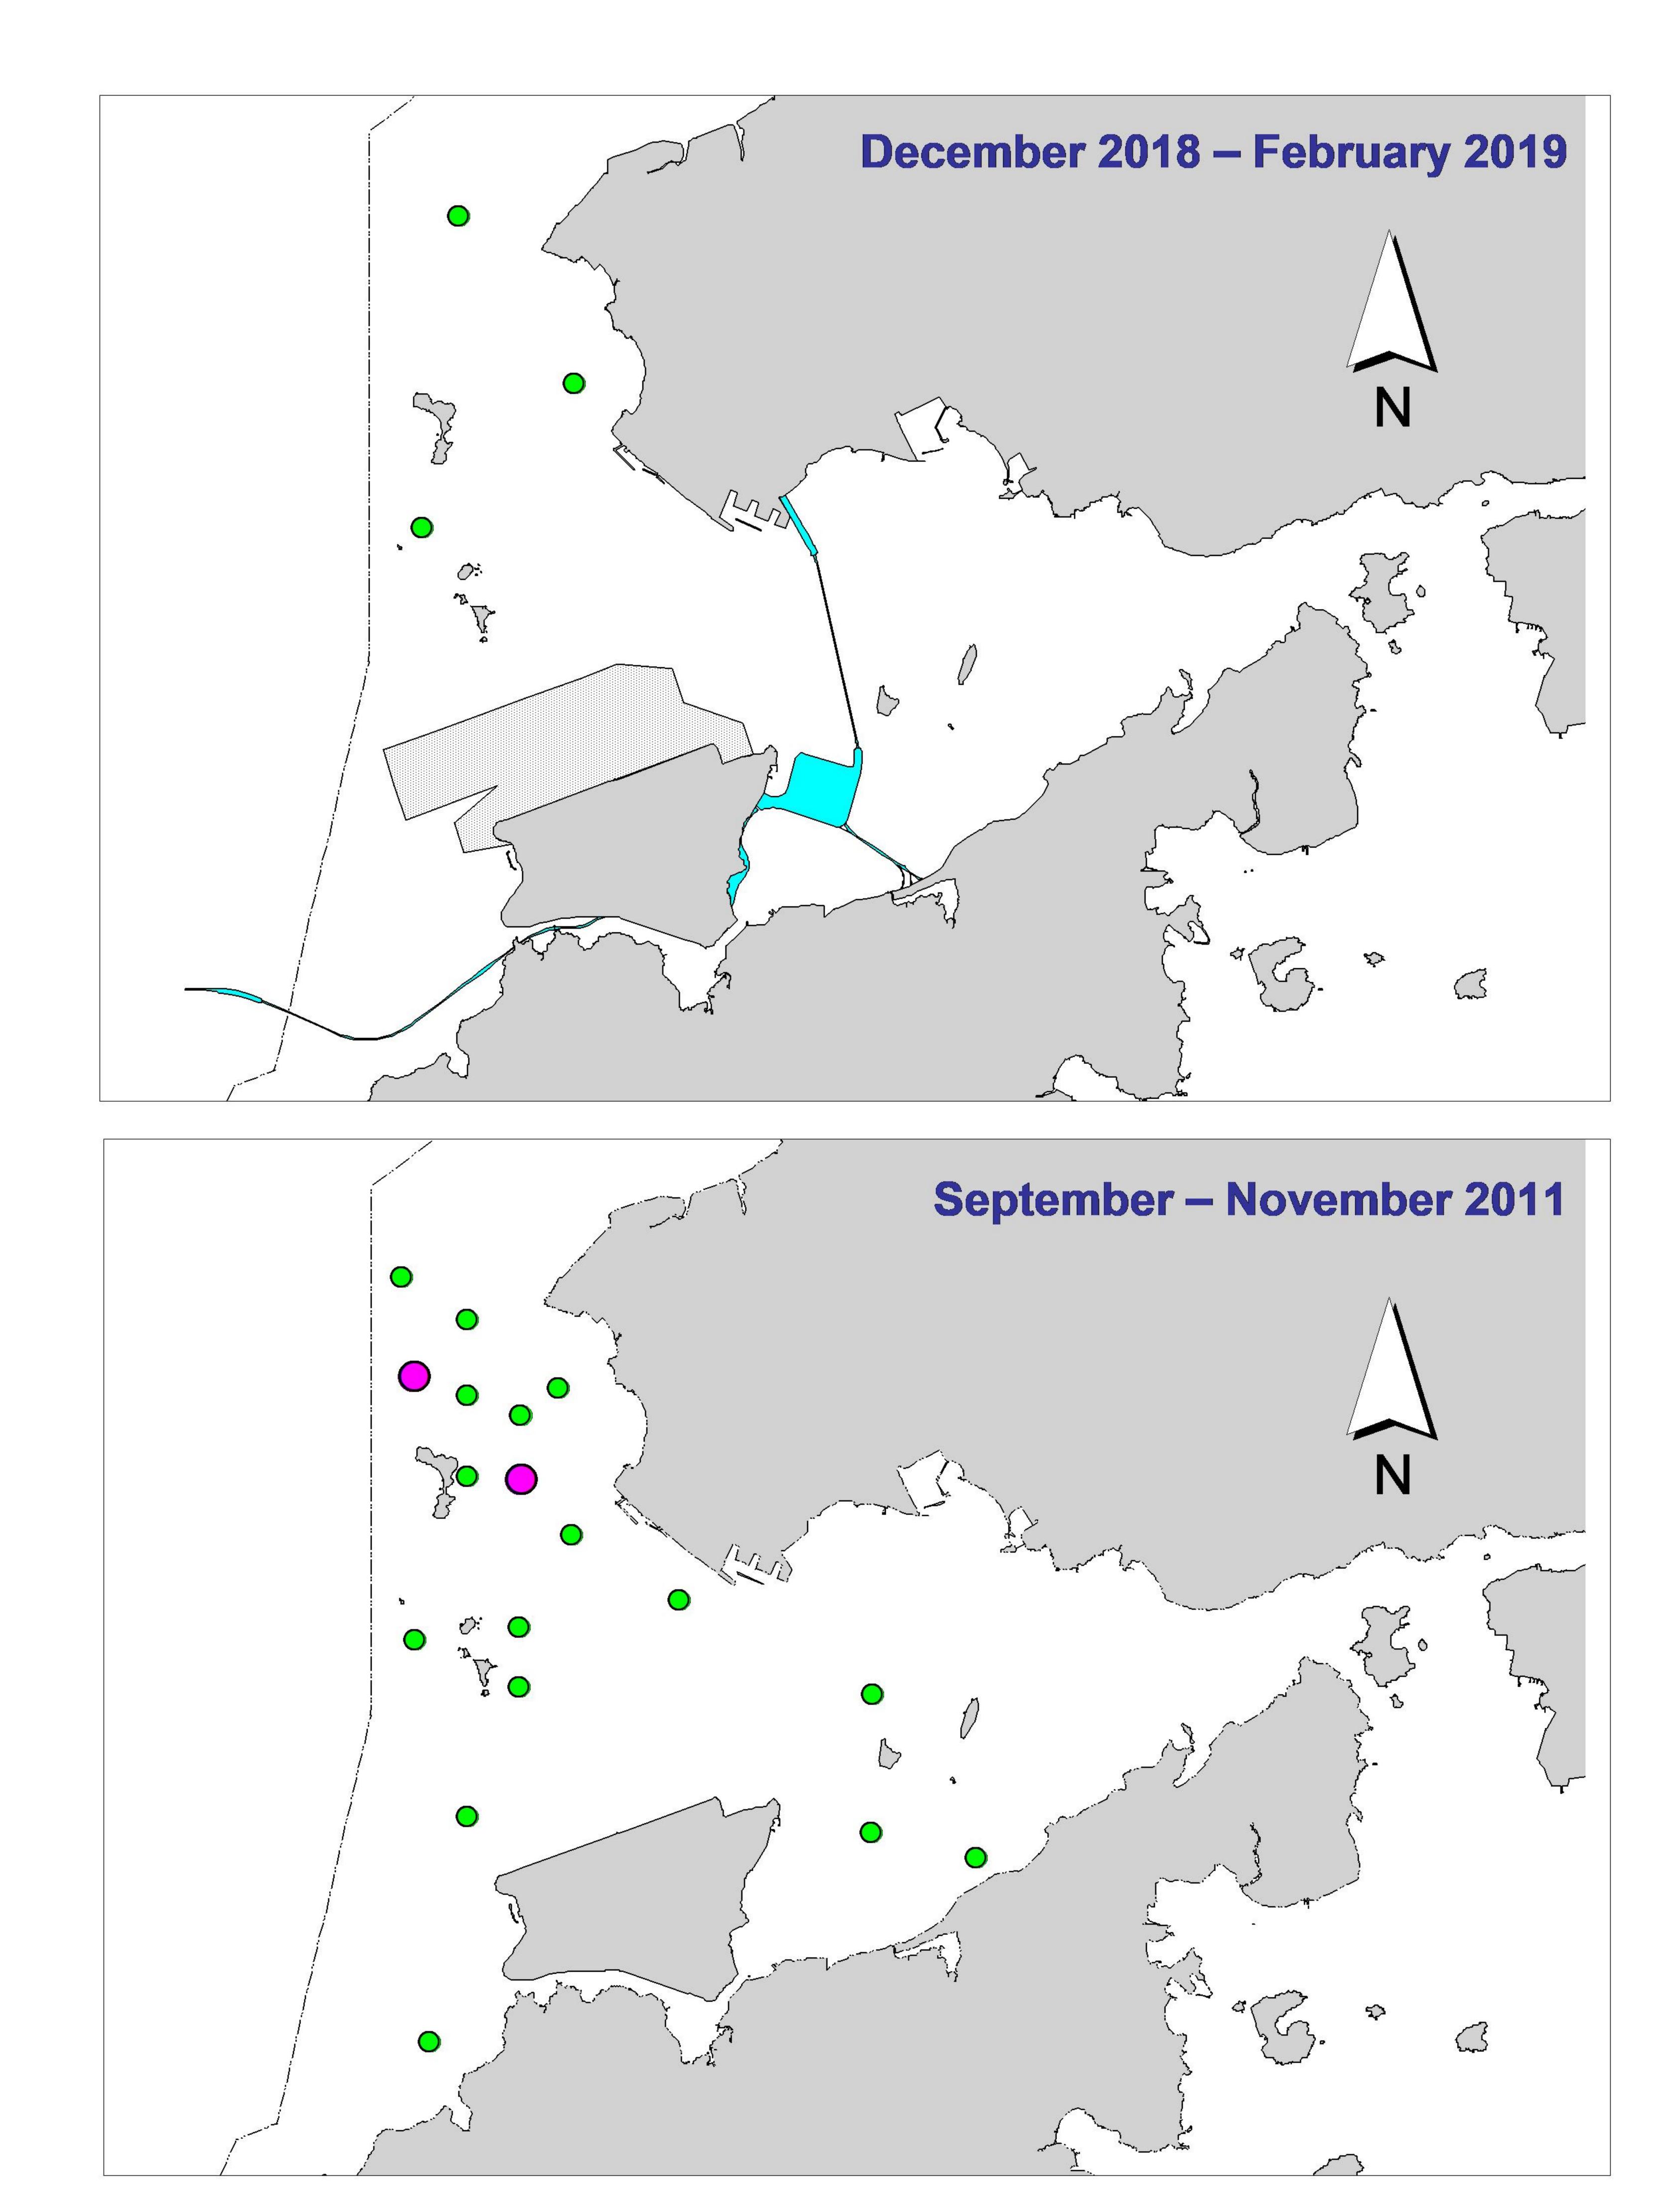
Figure 3. Distribution of Chinese white dolphins with larger group sizes during HKLR03 impact phase (top) and baseline monitoring surveys (bottom) (green dots: group sizes of 5 or more; purple dots: group sizes of 10 or more)

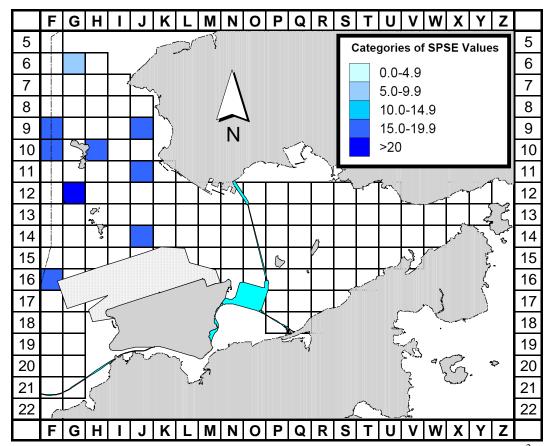
Figure 4a. Sighting density of Chinese white dolphins with corrected survey effort per km² in Northeast and Northwest Lantau survey areas, using data collected during HKLR03 impact monitoring period monitoring period (Dec 18-Feb 19) (SPSE = no. of on-effort sightings per 100 units of survey effort)

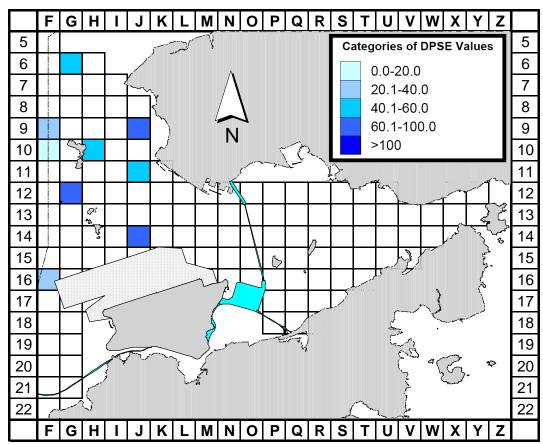
Figure 4b. Density of Chinese white dolphins with corrected survey effort per km² in Northeast and Northwest Lantau survey areas, using data collected during HKLR03 impact monitoring period (Dec 18-Feb 19) (DPSE = no. of dolphins per 100 units of survey effort)

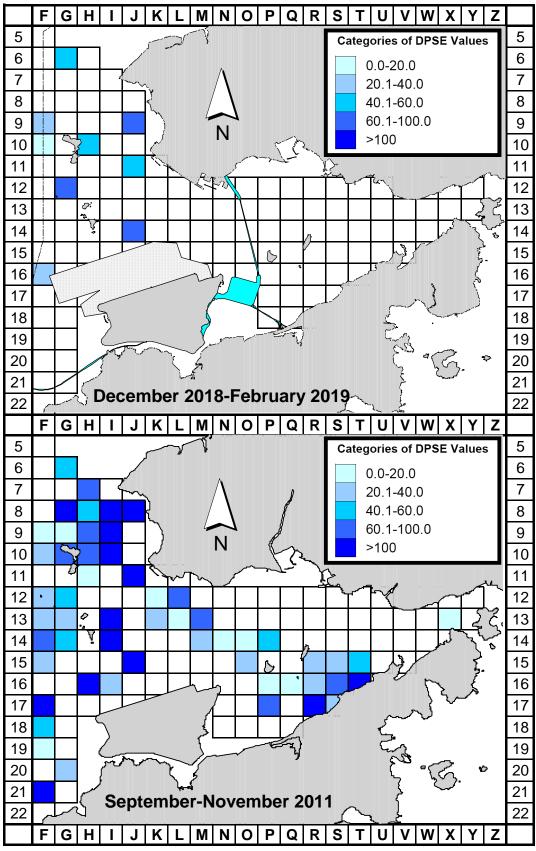
Figure 5. Comparison of density of Chinese white dolphins with corrected survey effort per km² in Northwest and Northeast Lantau survey area between the impact monitoring period (December 2018-February 2019) and baseline monitoring period (September-November 2011) (DPSE = no. of dolphins per 100 units of survey effort)
