Contract No. HY/2012/07 Tuen Mun – Chek Lap Kok Link – Southern Connection Viaduct Section

Twenty-first Quarterly Environmental Monitoring & Audit (EM&A) Report

28 May 2019

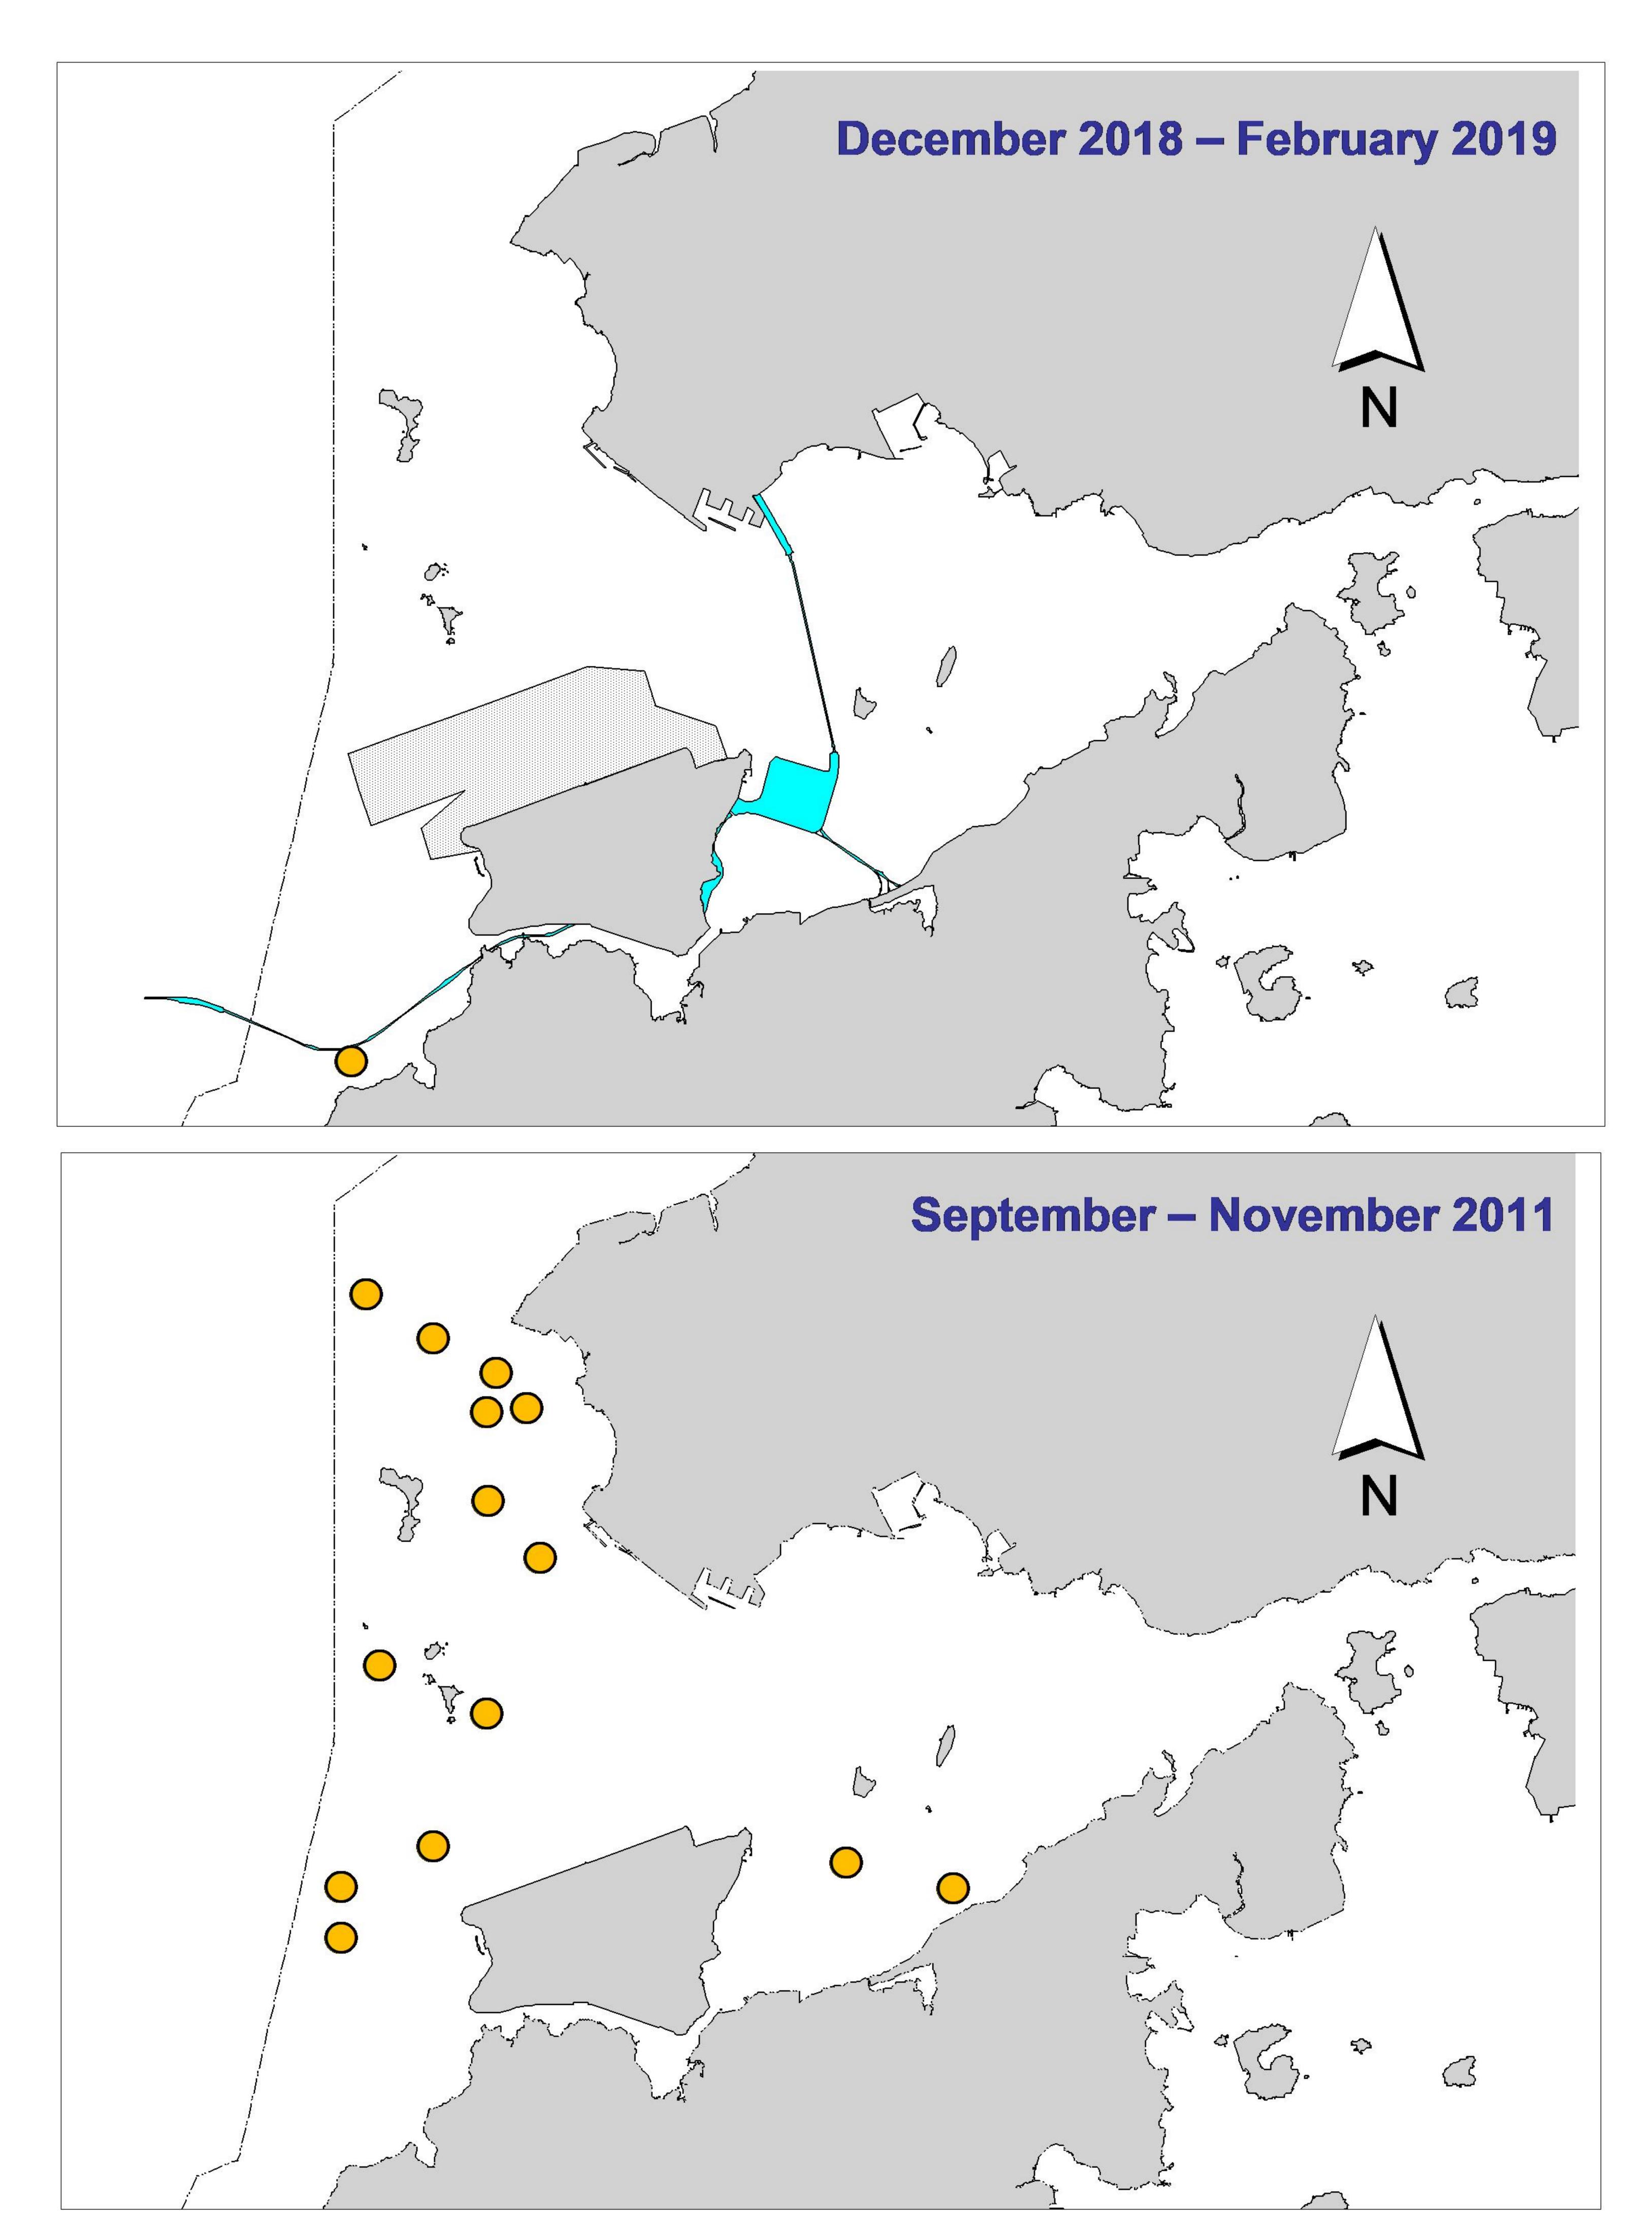
Figure 6. Distribution of young calves of Chinese white dolphins during HKLR03 impact phase (top) and baseline monitoring surveys (bottom)

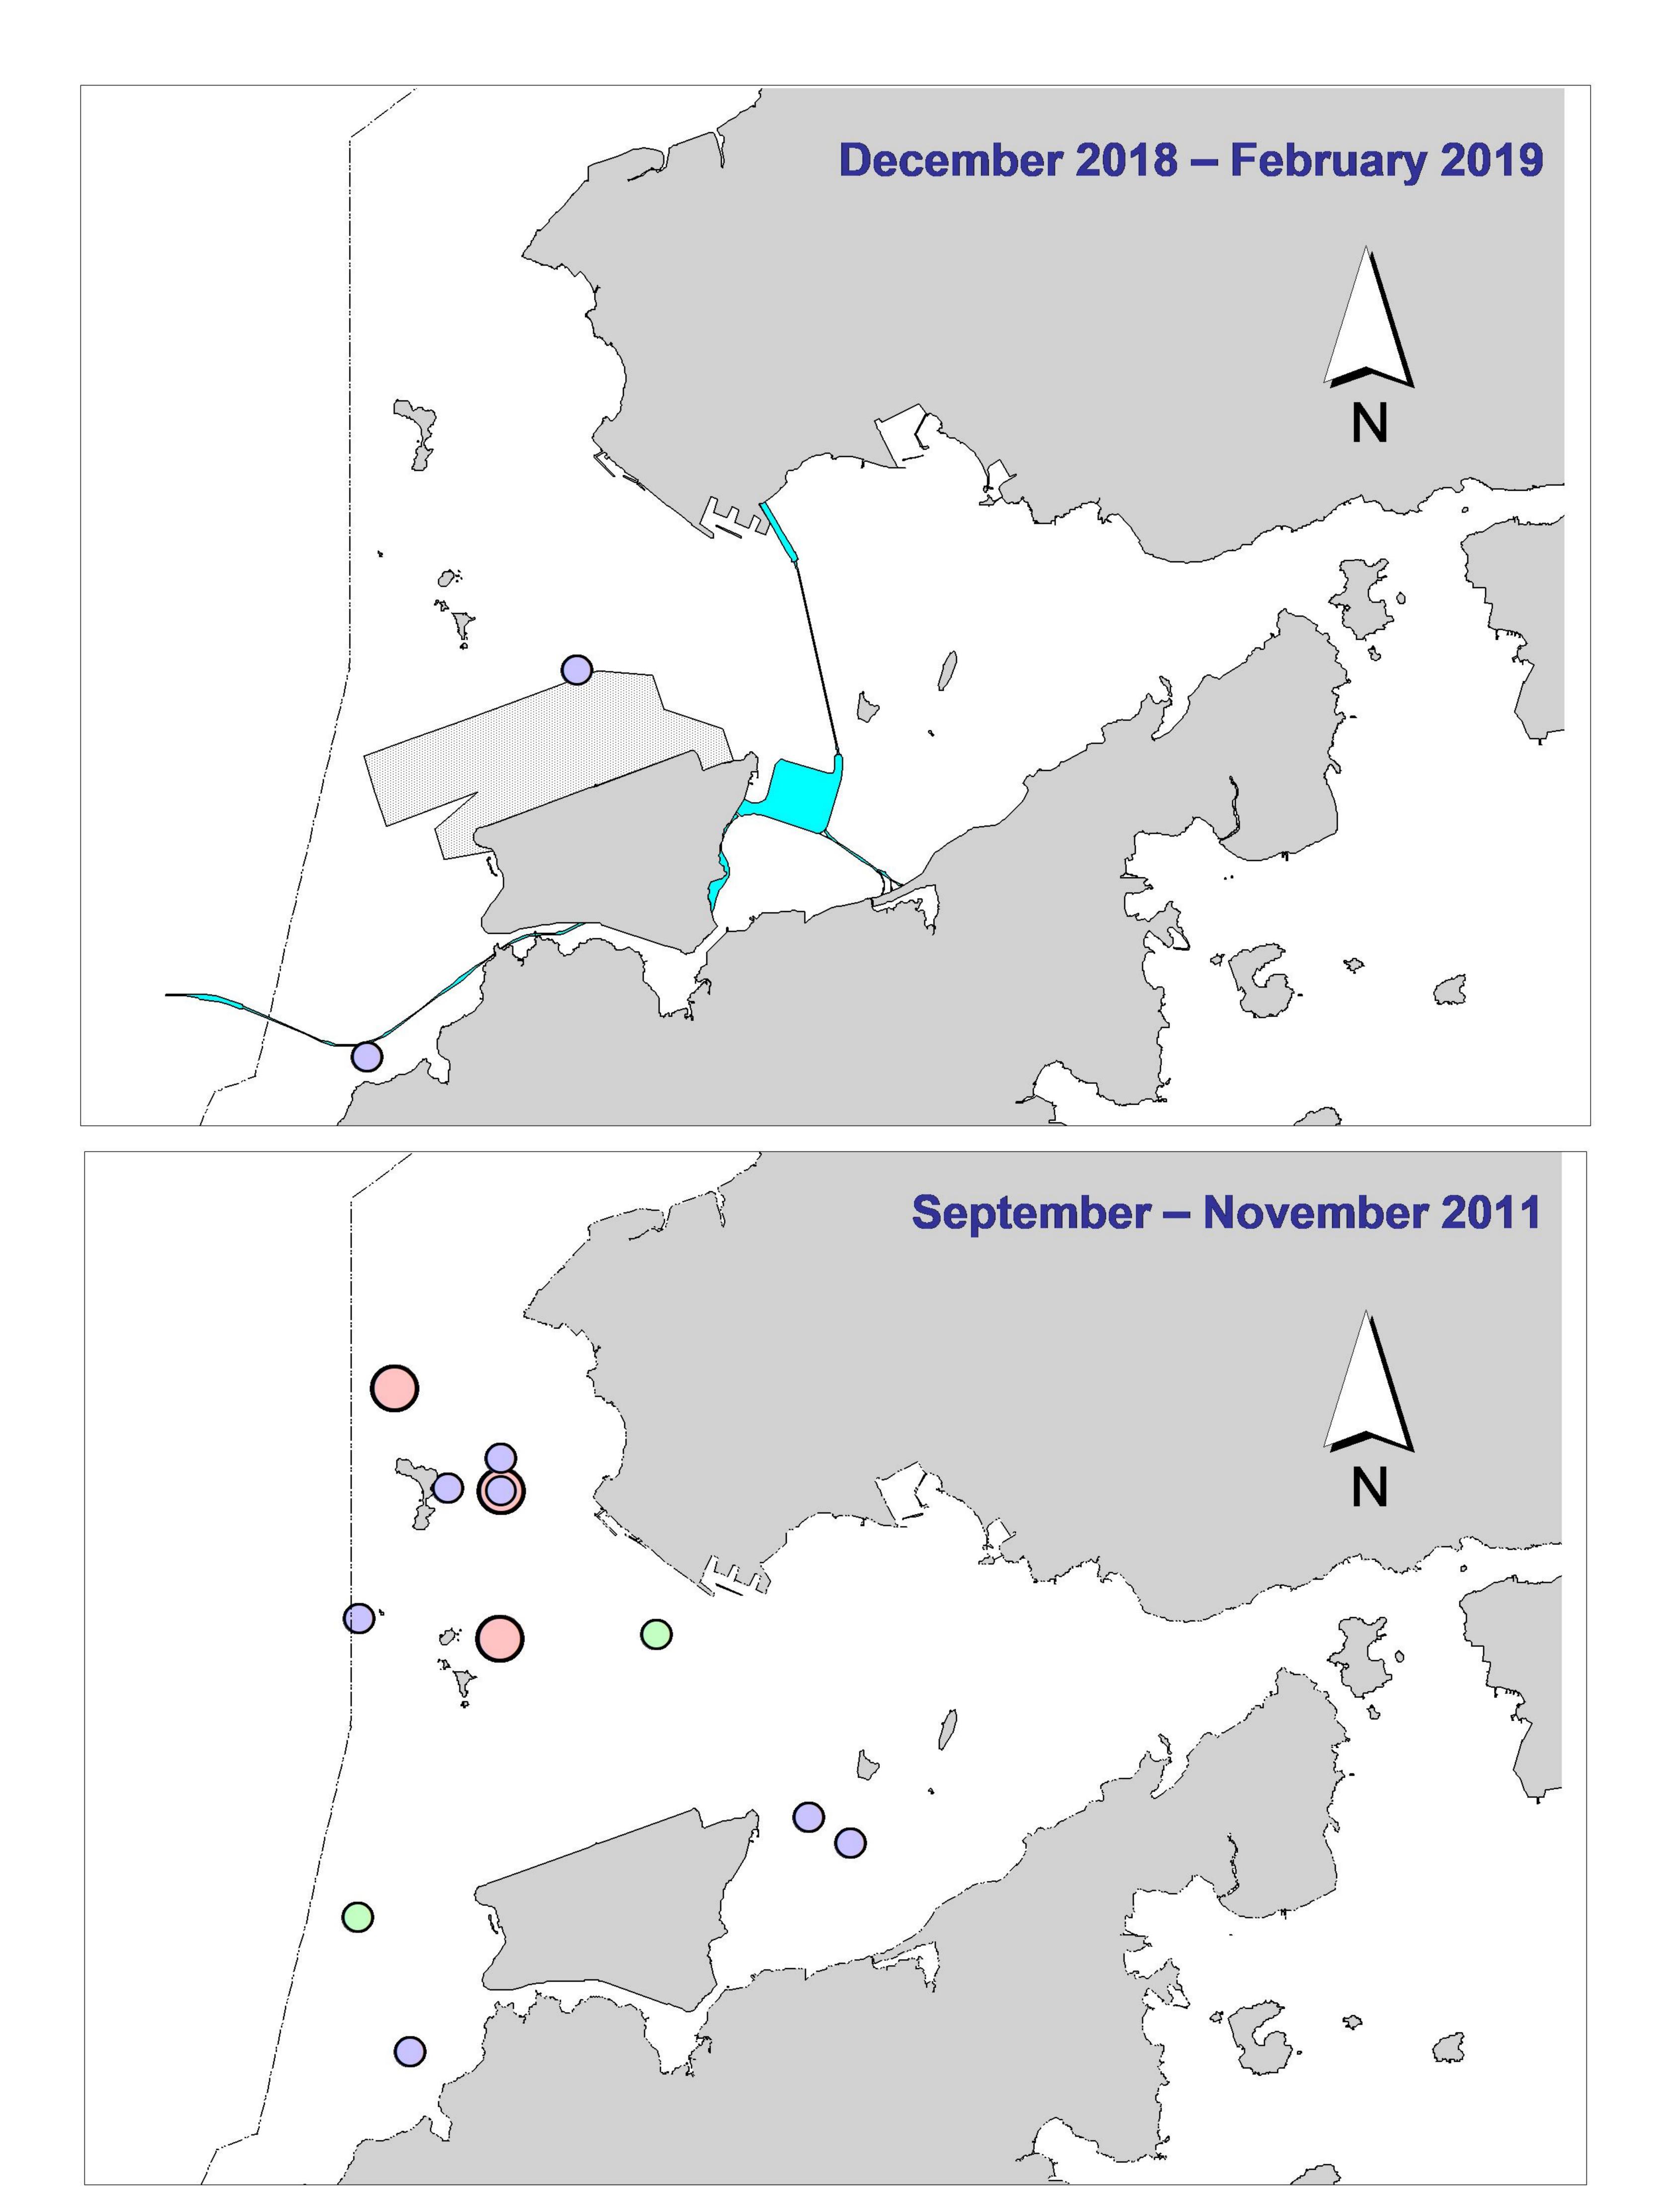
Figure 7. Distribution of Chinese white dolphins engaged in feeding (purple dots), socializing (pink dots) and traveling (green dots) activities during HKLR03 impact phase (top) and baseline monitoring surveys (bottom)

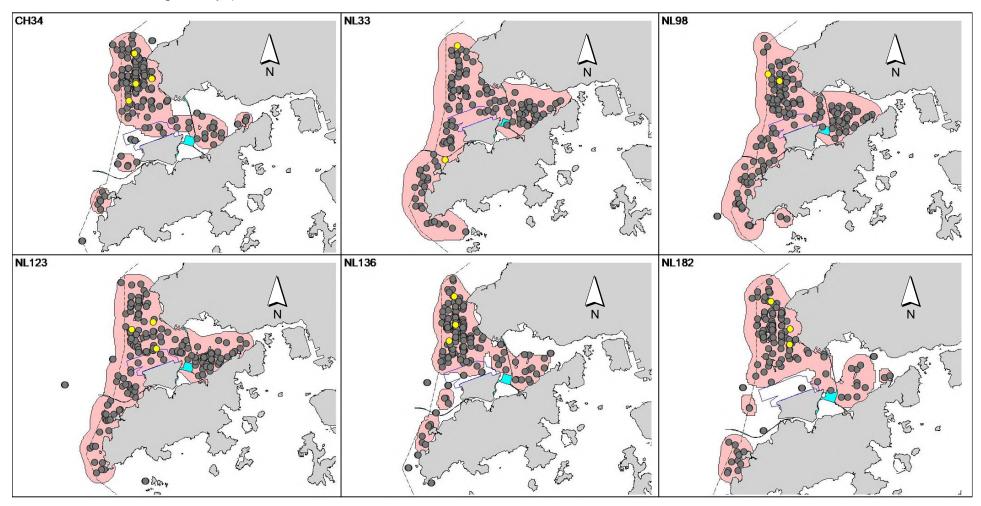
Appendix V. Ranging patterns (95% kernel ranges) of 16 individual dolphins that were sighted during HKLR03 impact phase monitoring period (note: yellow dots indicate sightings made in Dec 2018 – Feb 2019 during HKLR03 and HKLR09 monitoring surveys)
