**Contract No. HY/2012/07
Tuen Mun – Chek Lap Kok Link –
Southern Connection Viaduct Section**

***Twenty-second Quarterly Environmental
Monitoring & Audit (EM&A) Report***

30 September 2019

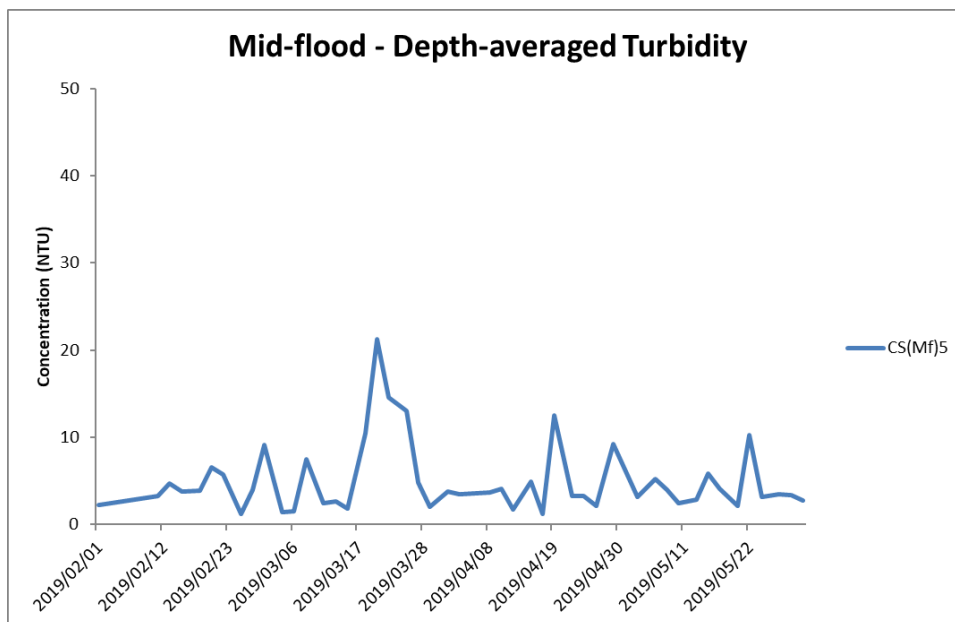
Figure H25 Impact Monitoring – Mean Level of depth-averaged Turbidity (NTU) during mid-flood tide between 1 February and 31 May 2019 at CS(Mf)3(N) and CS(MF)5.
