**Contract No. HY/2012/07
Tuen Mun - Chek Lap Kok Link -
Southern Connection Viaduct Section**

***Twenty-fourth Quarterly Environmental
Monitoring & Audit (EM&A) Report***

21 April 2020

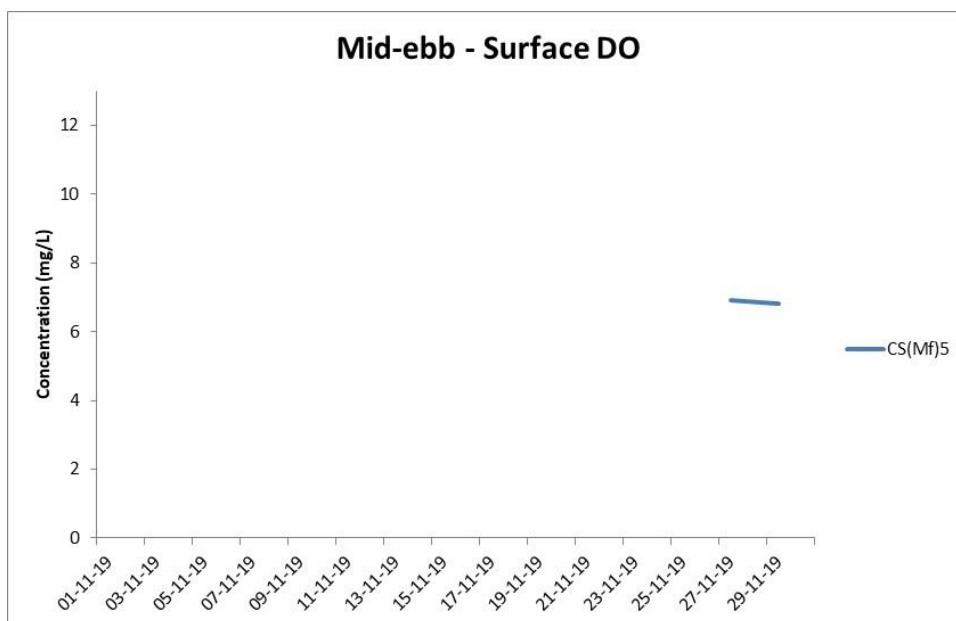
Figure G1 Post-Construction Monitoring - Mean Level of Dissolved Oxygen (mg/L) in surface waters during mid-ebb tide between 1 November 2019 and 30 November 2019 at CS(Mf)3(N) and CS(Mf)5.

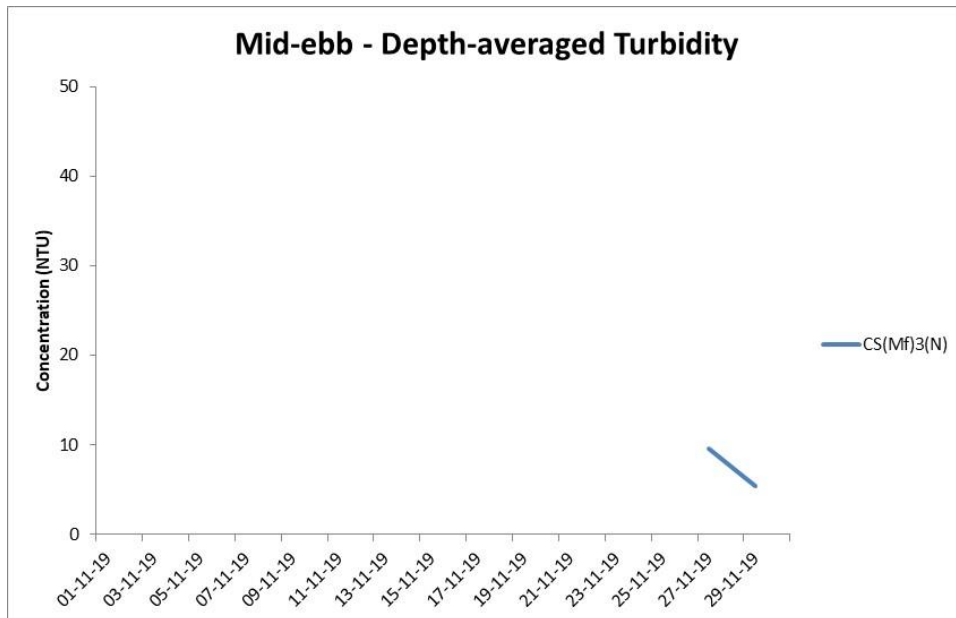
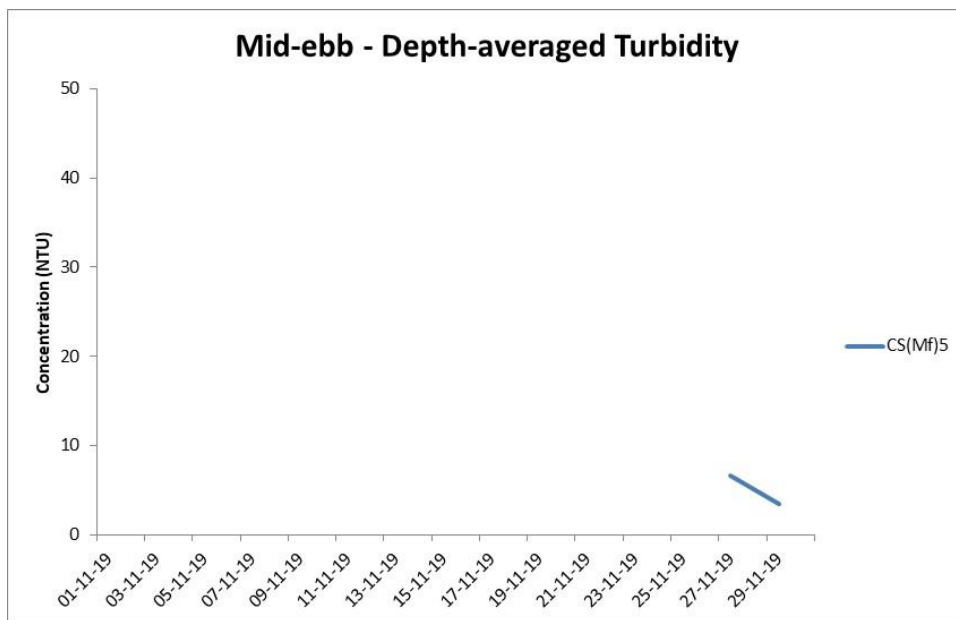
Figure G19 Post-Construction Monitoring - Mean Level of depth-averaged Turbidity (NTU) during mid-ebb tide between 1 November 2019 and 30 November 2019 at CS(Mf)3(N) and CS(Mf)5.

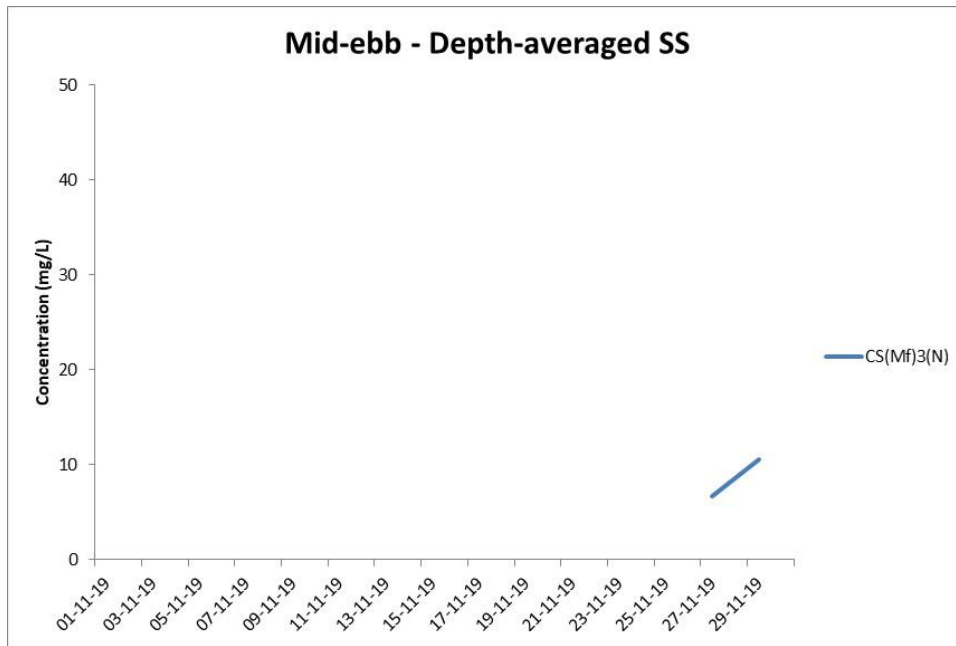
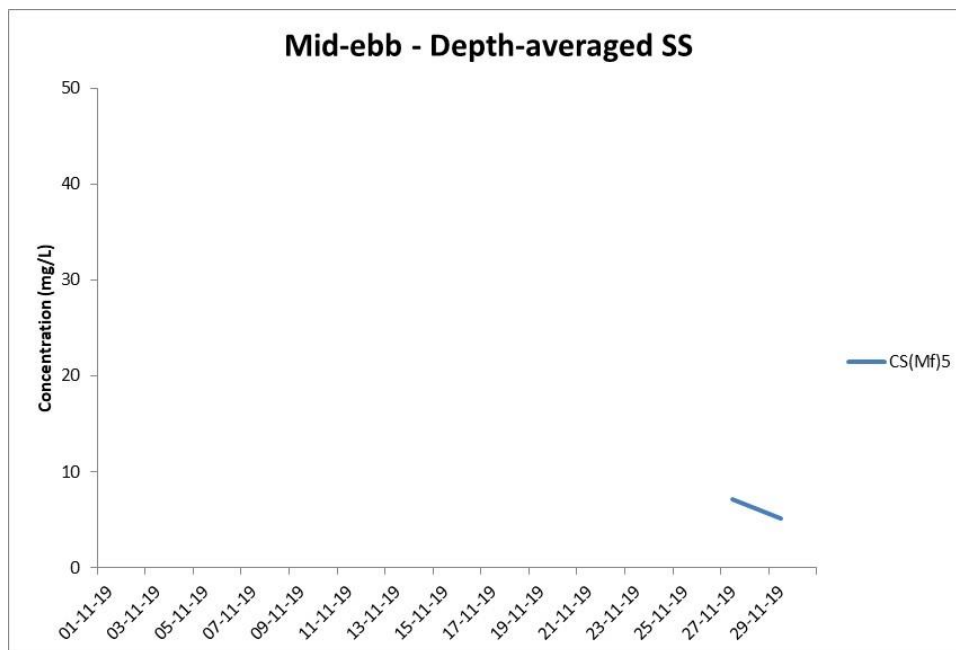
Figure G27 Post-Construction Monitoring - Mean depth-averaged level of Suspended Solids (mg/L) during mid-ebb tide between 1 November 2019 and 30 November 2019 at CS(Mf)3(N) and CS(Mf)5.

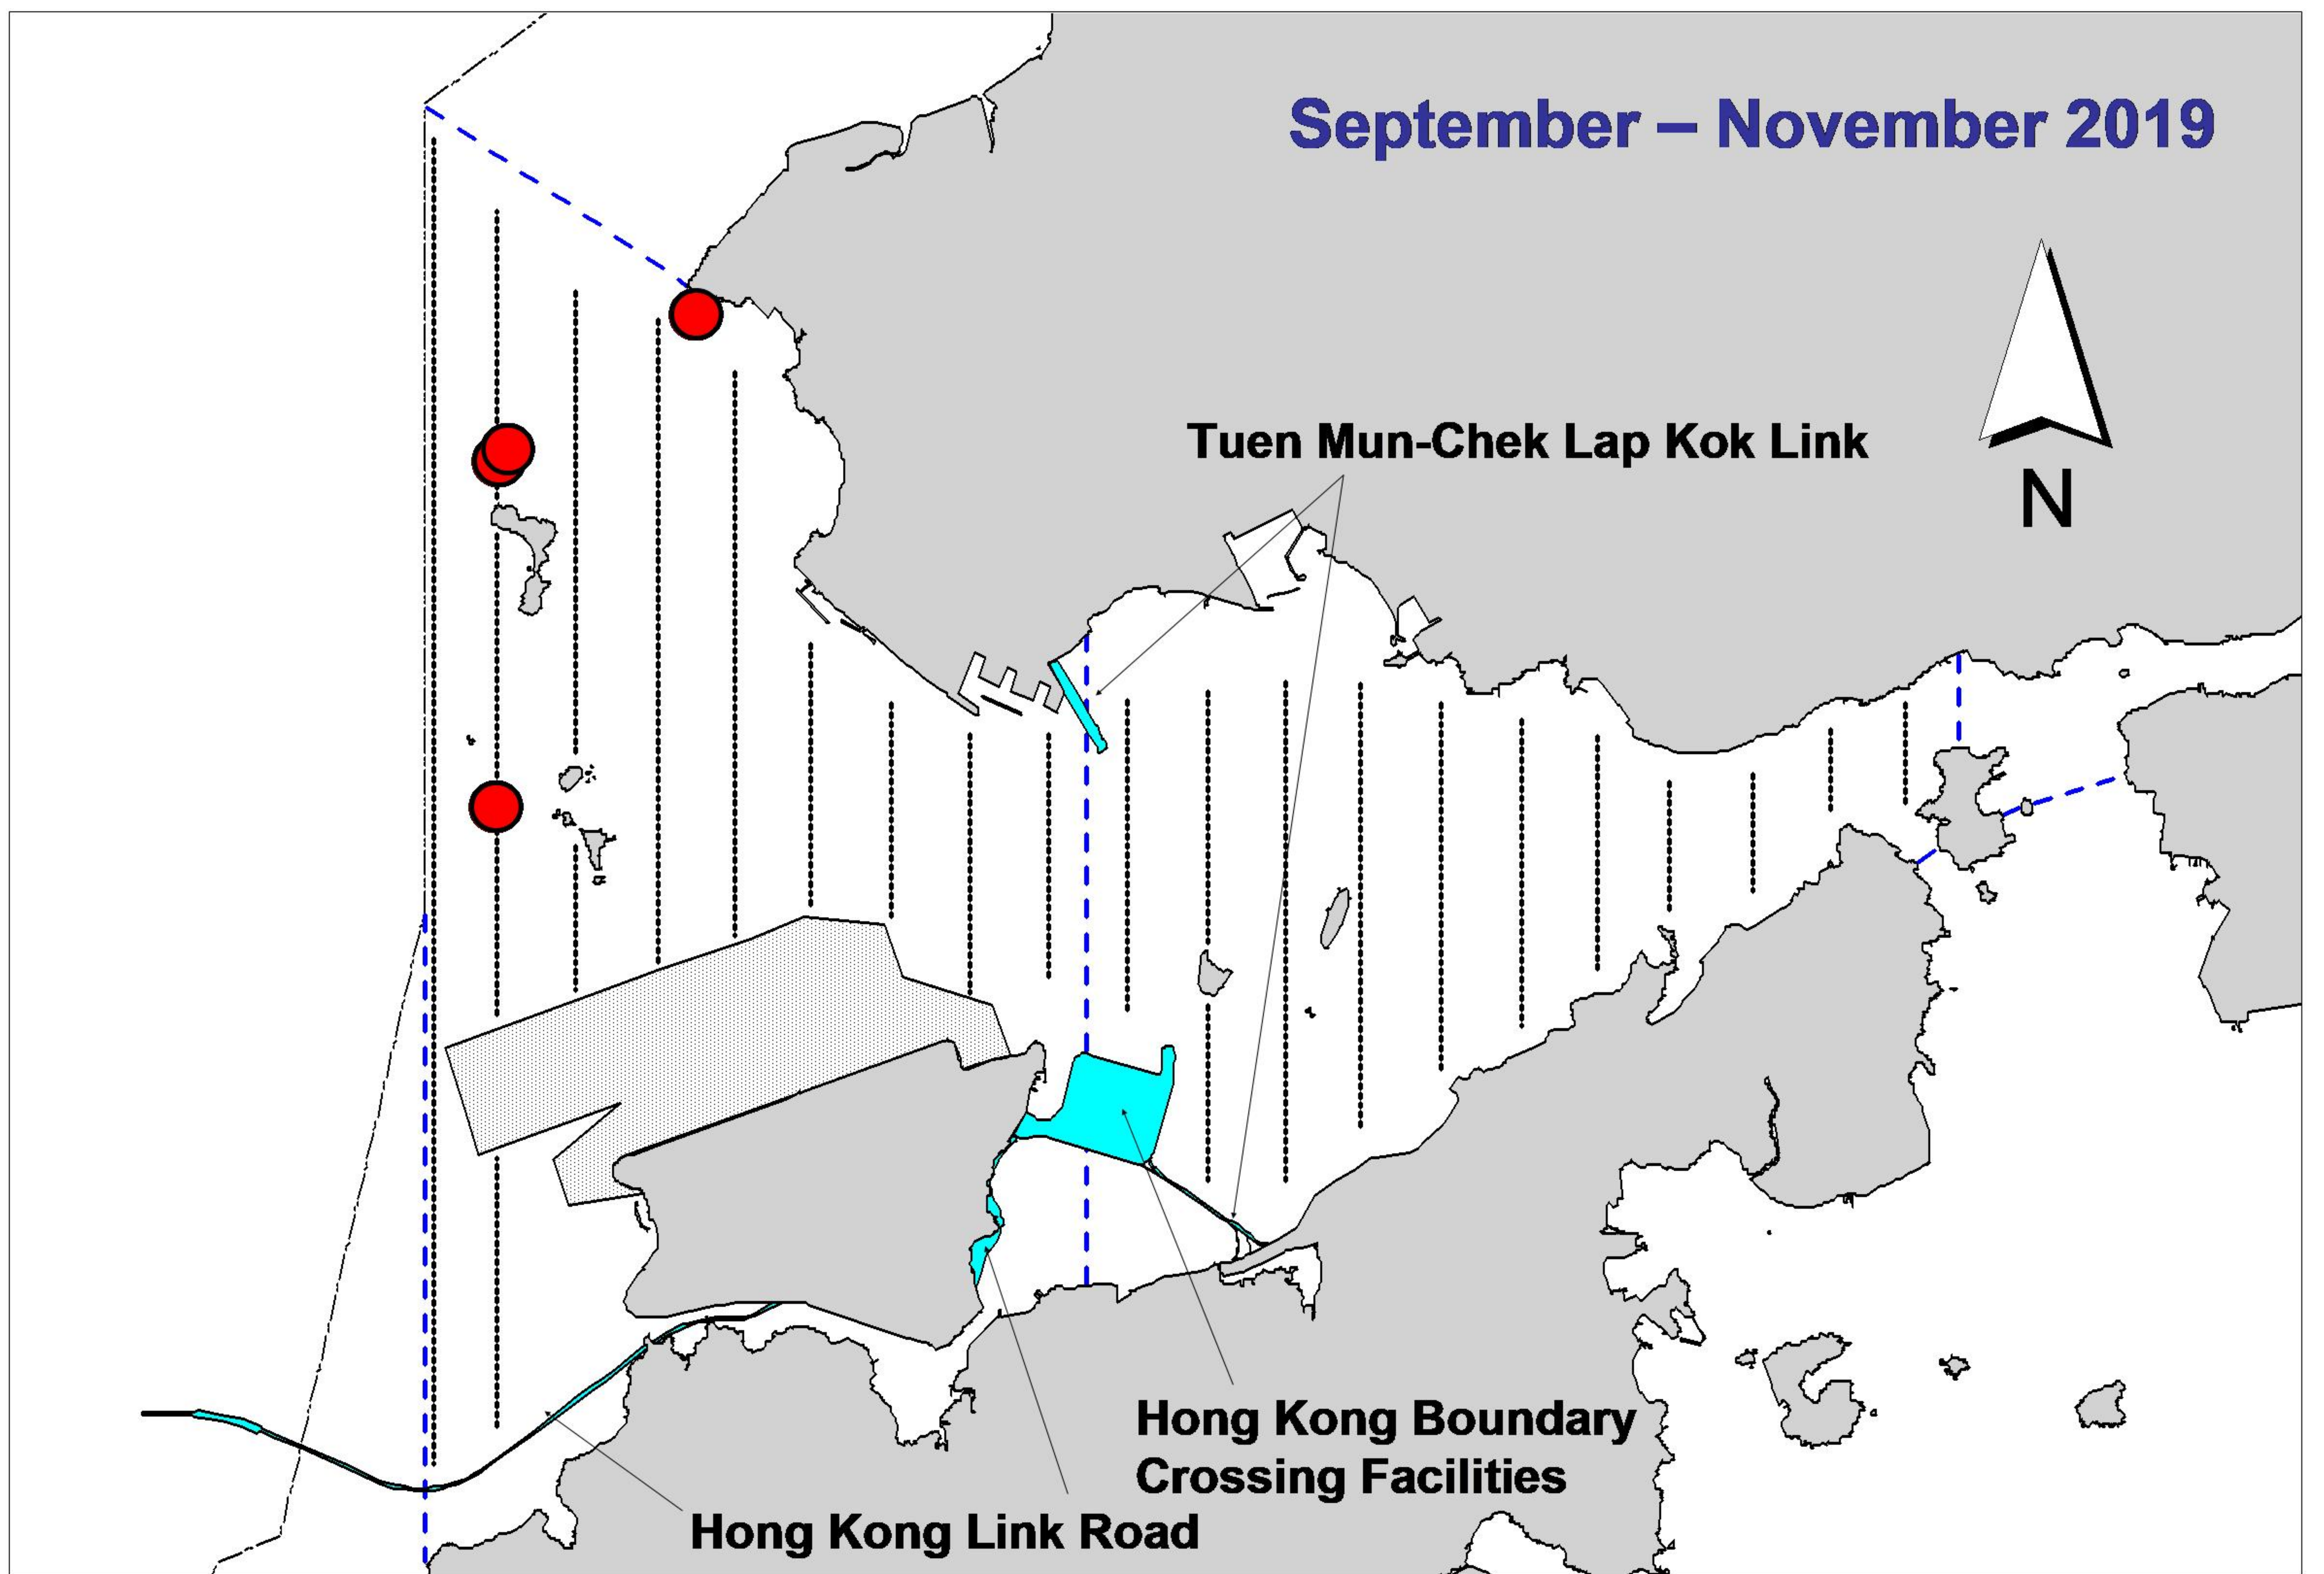
Figure 1. Distribution of Chinese white dolphin sighting in Northwest and Northeast Lantau during HKLR03/TMCLKL08 impact phase (top) and baseline monitoring surveys (bottom)

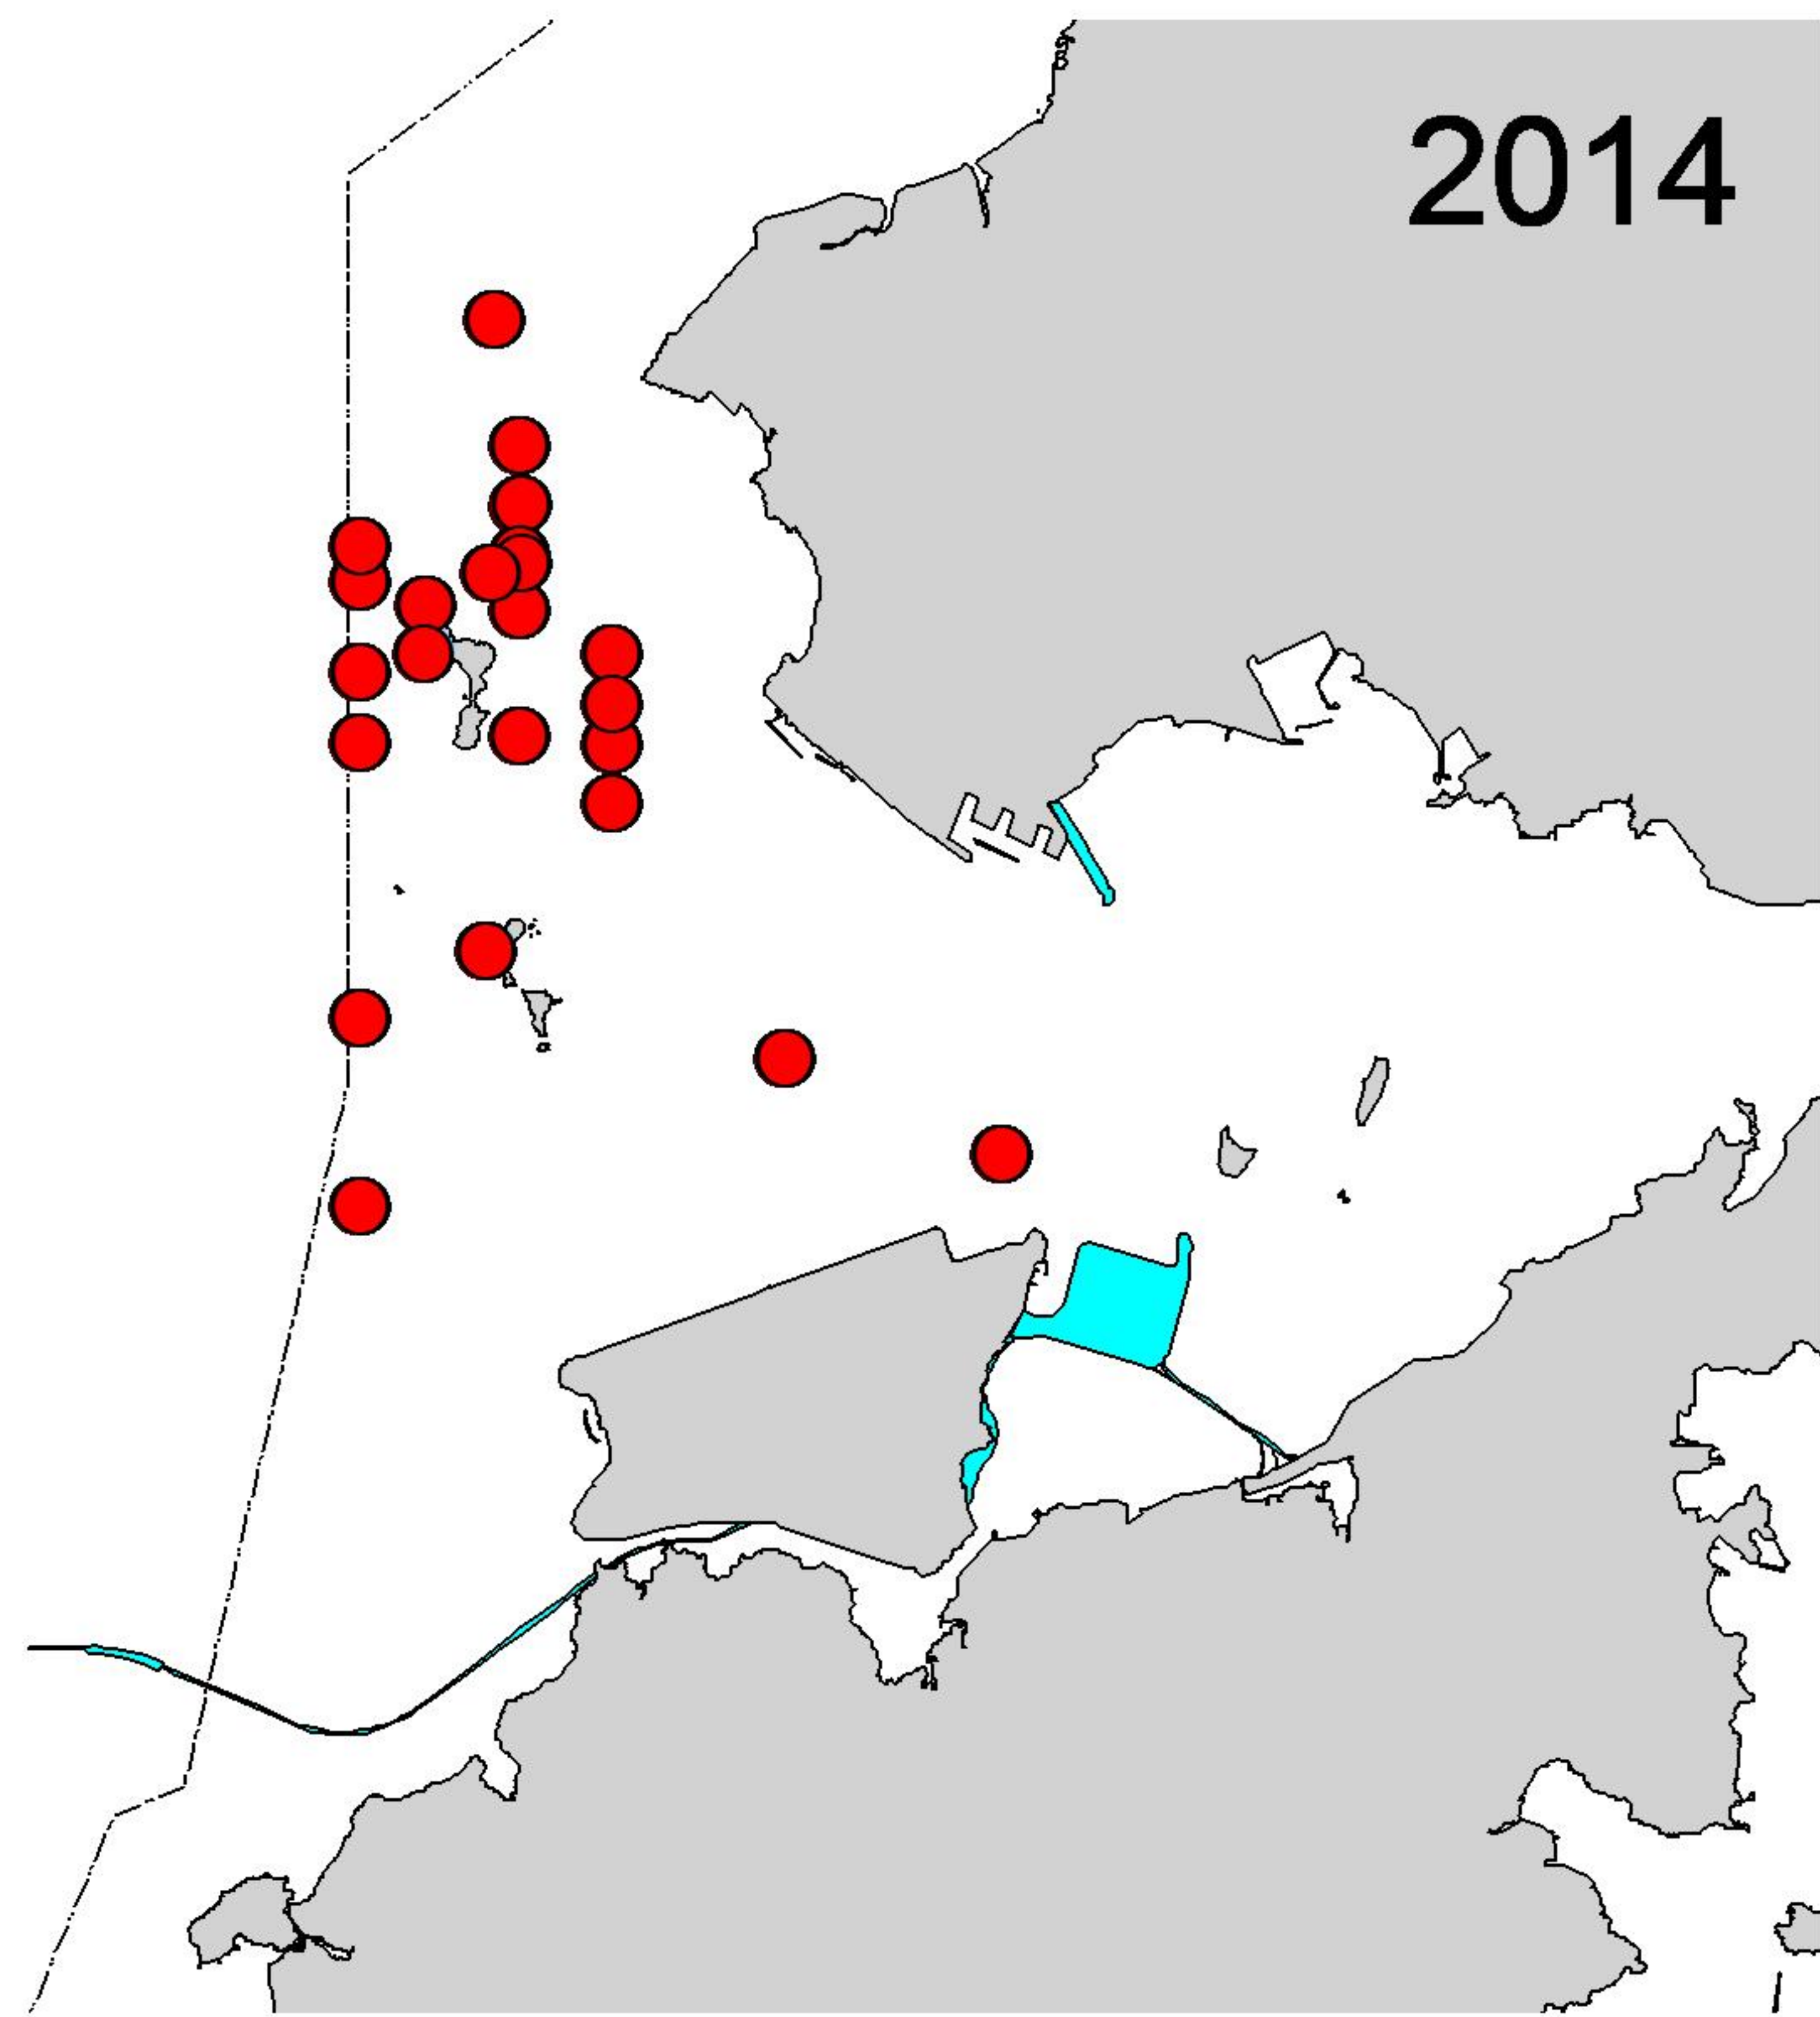
Figure 2. Distribution of Chinese white dolphin sightings in Northwest and Northeast Lantau during the past six autumn quarters (September-November) of HKLR03/TMCLKL08 impact phase in 2014-19

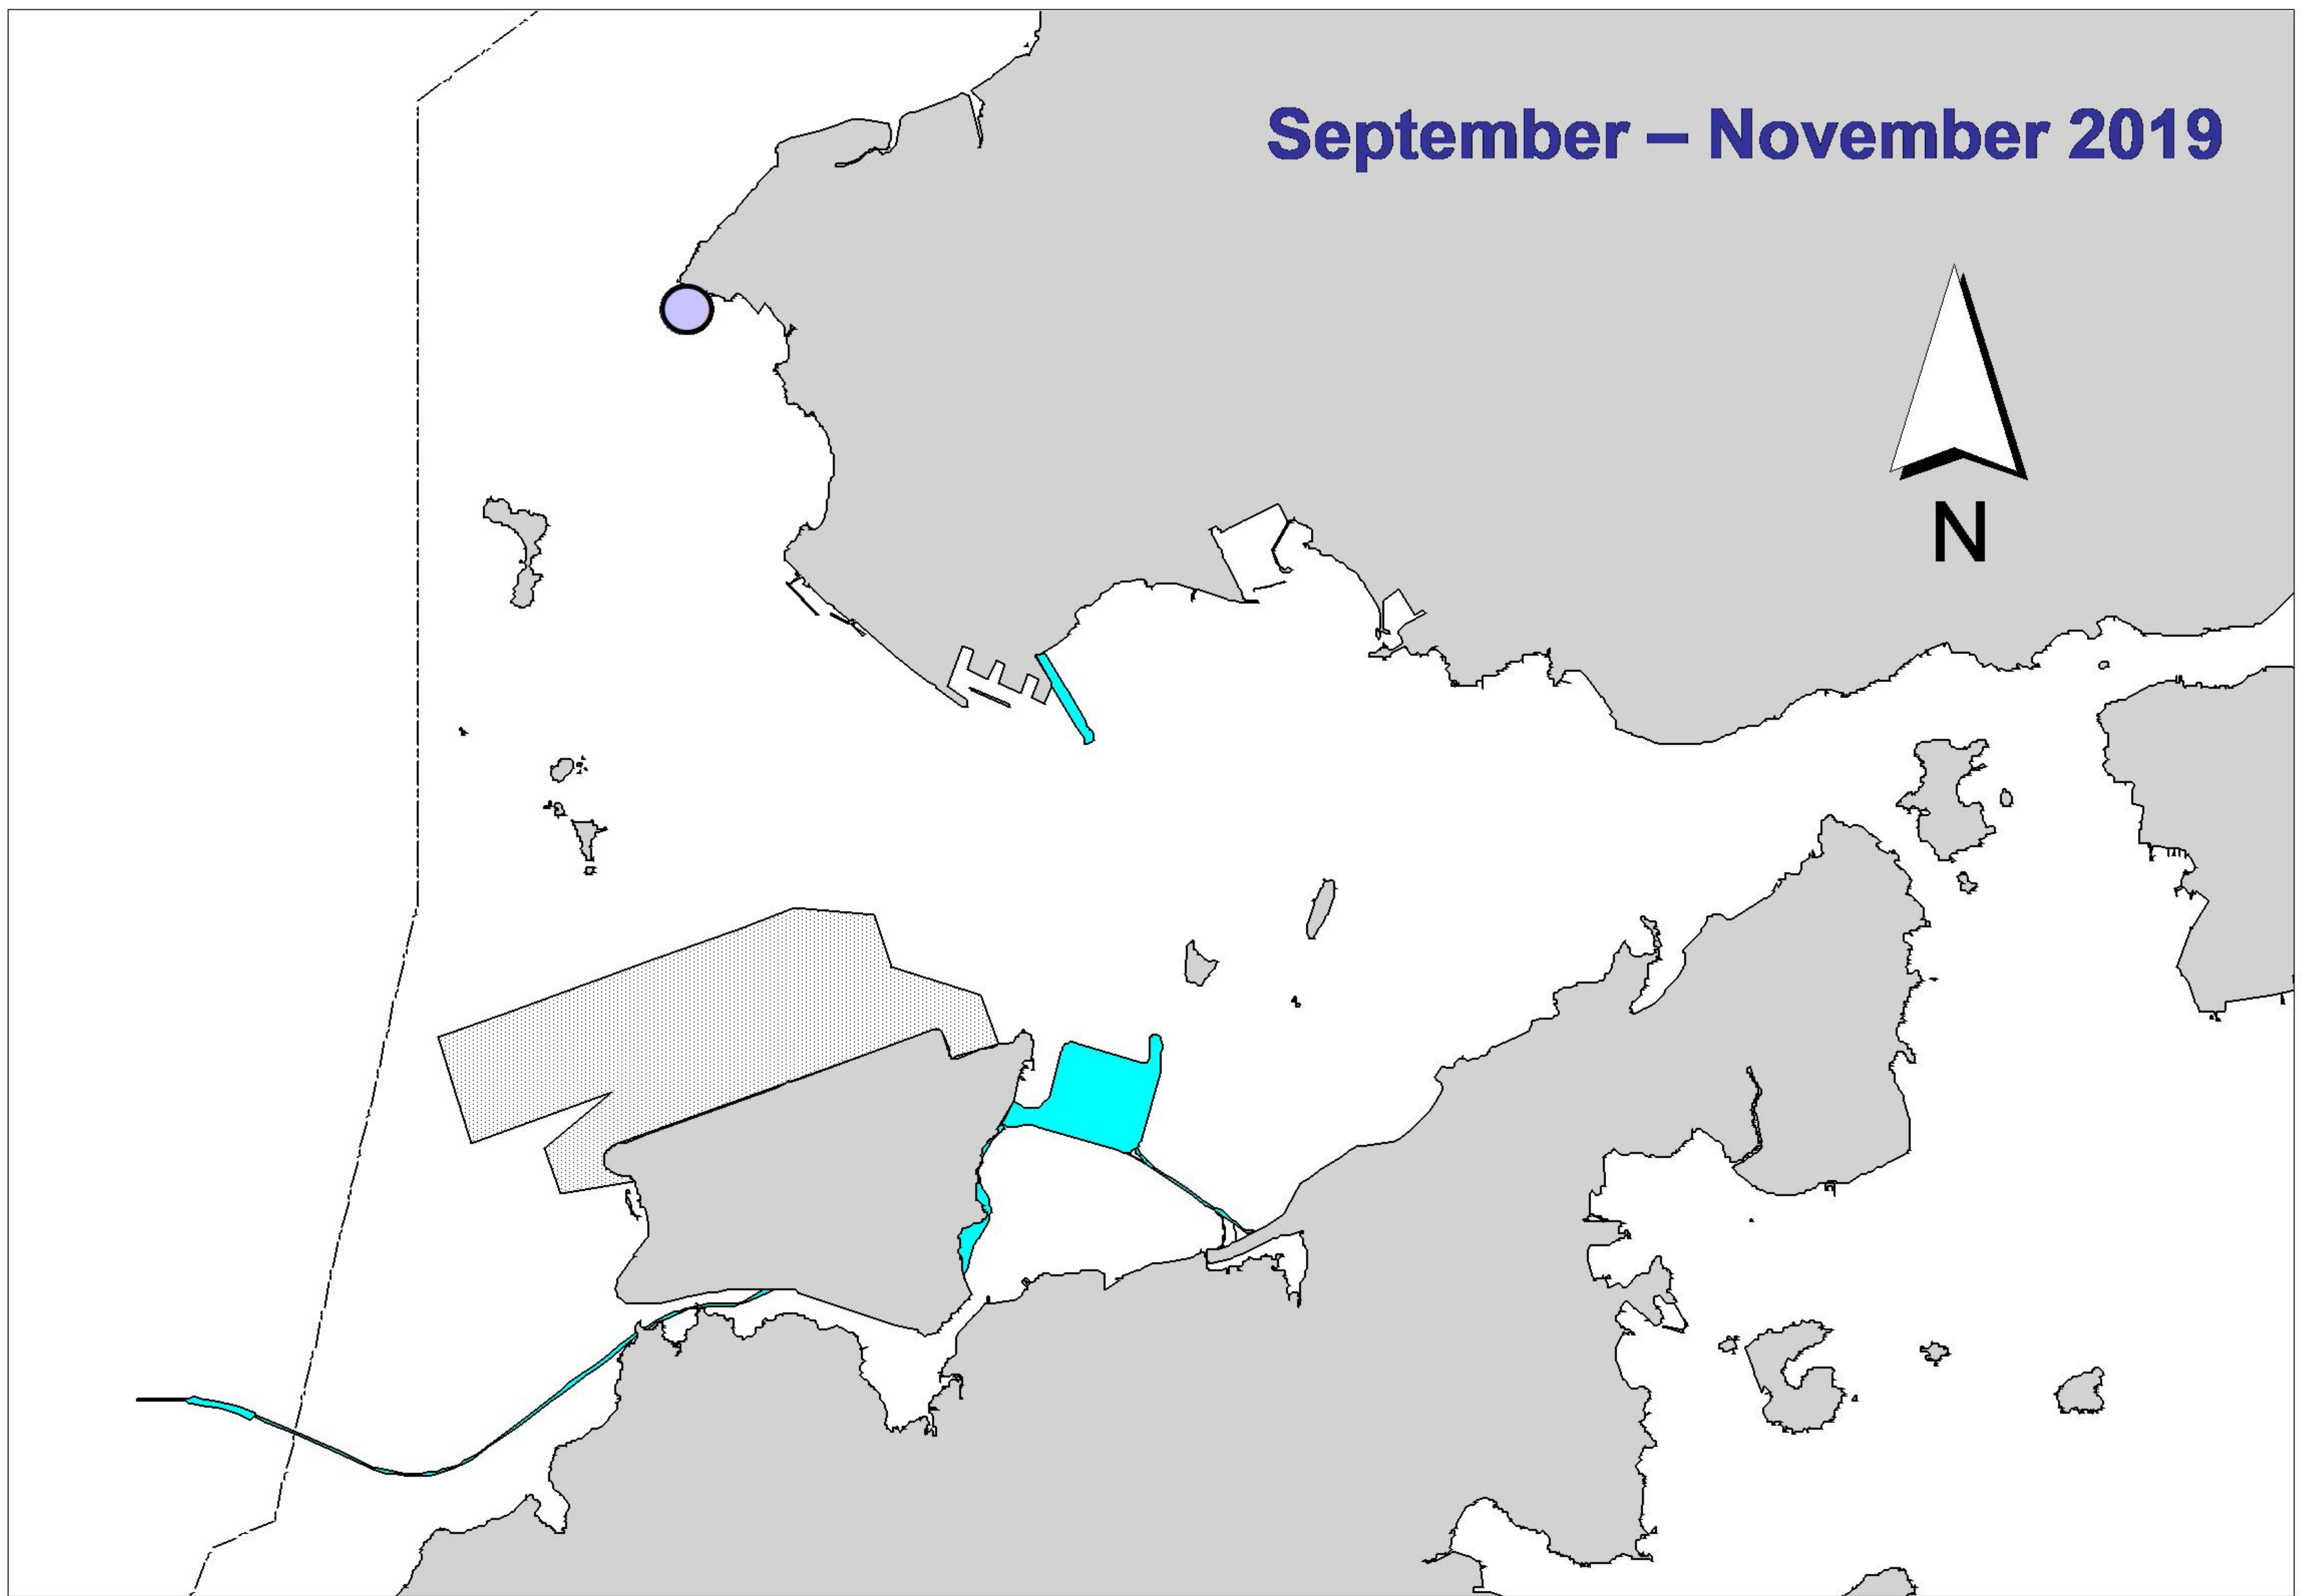
Figure 5. Distribution of Chinese white dolphins engaged in feeding (purple dots), socializing (pink dots) and traveling (green dots) activities during HKLR03/TMCLKL08 impact phase (top) and baseline monitoring surveys (bottom)

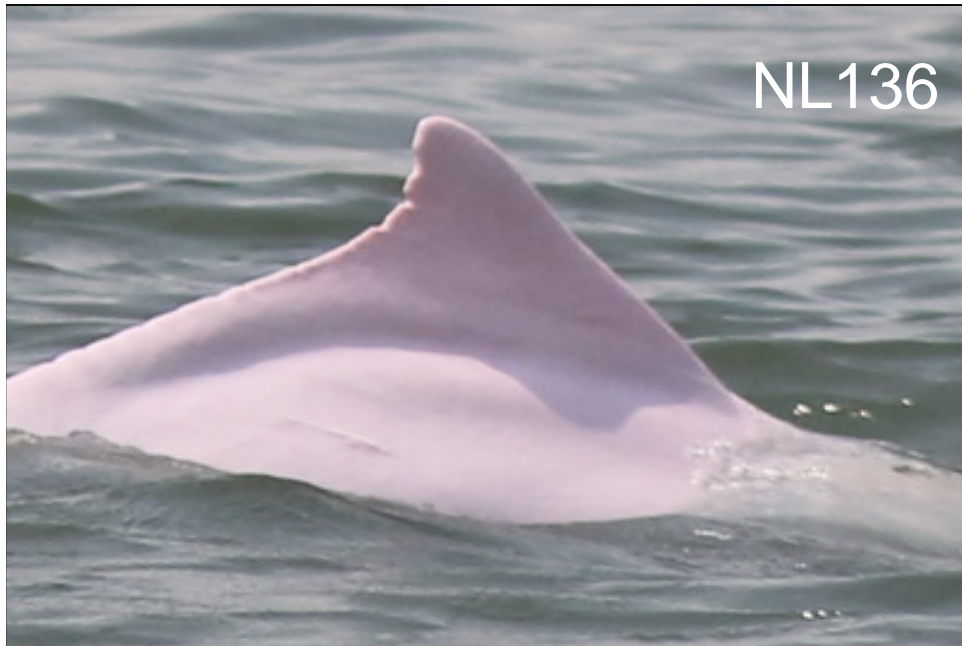
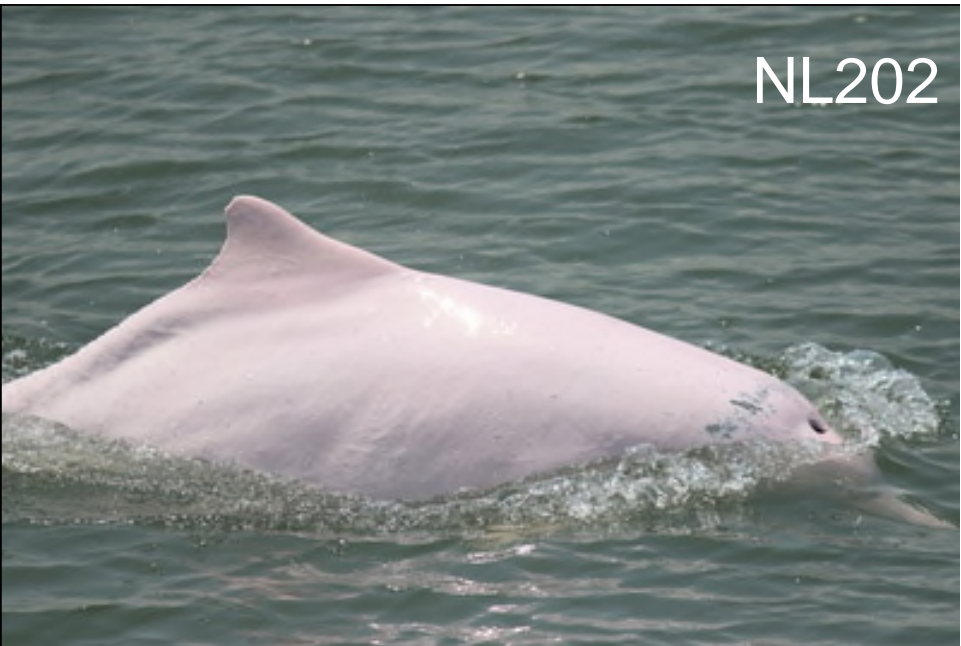
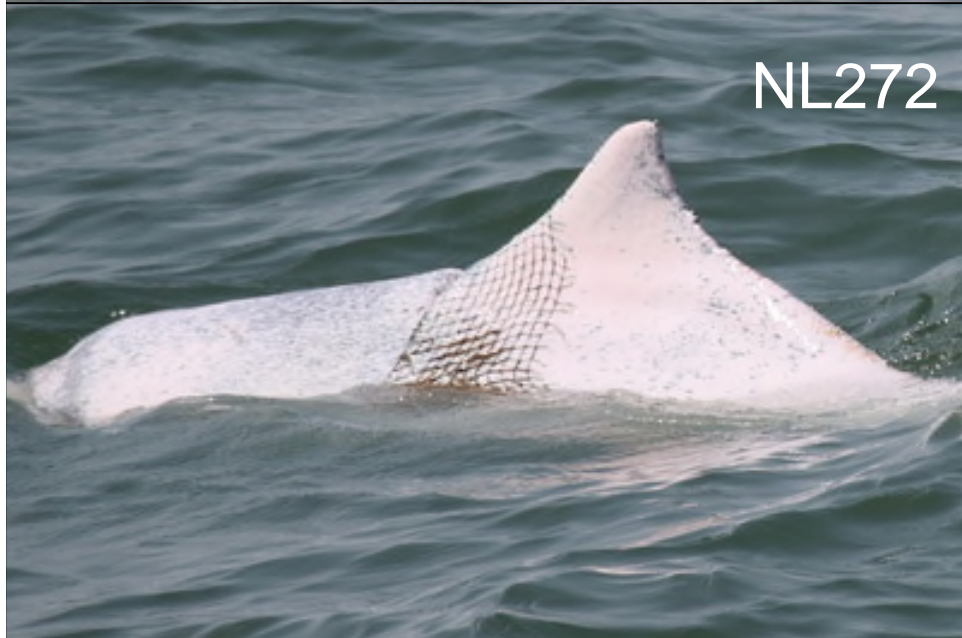
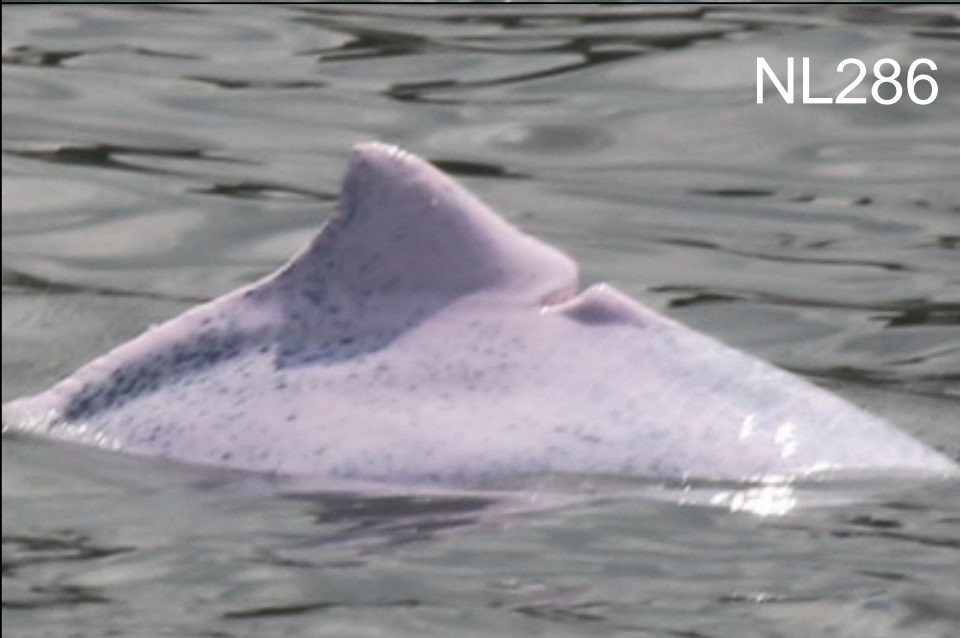
Appendix V. Ranging patterns (95% kernel ranges) of four individual dolphins that were sighted during TMCLKL08/HKLR03 impact phase monitoring period (note: yellow dots indicate sightings made in September-November 2019 during TMCLKL08/HKLR03 monitoring surveys)
