**Contract No. HY/2012/08
Tuen Mun – Chek Lap Kok Link –
Northern Connection Sub-sea Tunnel
Section**

*Second Annual Environmental Monitoring &
Audit (EM&A) Report*

18 May 2017

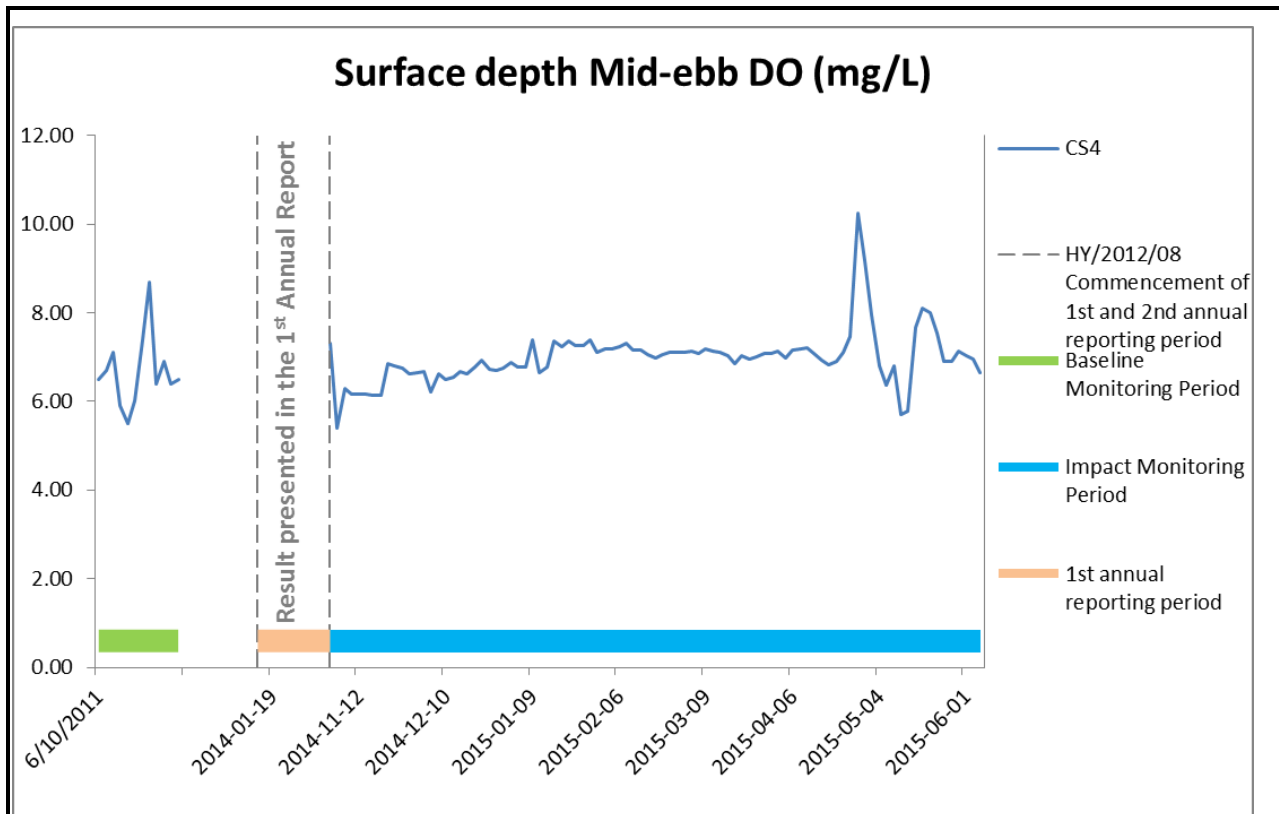
Figure E1 Baseline & Impact Monitoring - Mean Level of Dissolved Oxygen (mg/L) in surface waters between Baseline monitoring period: 6/10/2011 to 31/10/2011 and Impact monitoring period: 1/11/2014 to 5/6/2015 at CS4. Weather condition within the reporting period varied between sunny to rainy. The overall monitoring results were not affected by weather conditions. Major marine construction activities included: Vertical and Sloping Seawall construction; Marine Sheet Piling for box culvert extension; Reclamation filling; and Box Culvert extension. Water Quality Monitoring was suspended from 6 June 2015 effectively. Ref: 0212330_Impact-WQM_2nd annual.xlsx

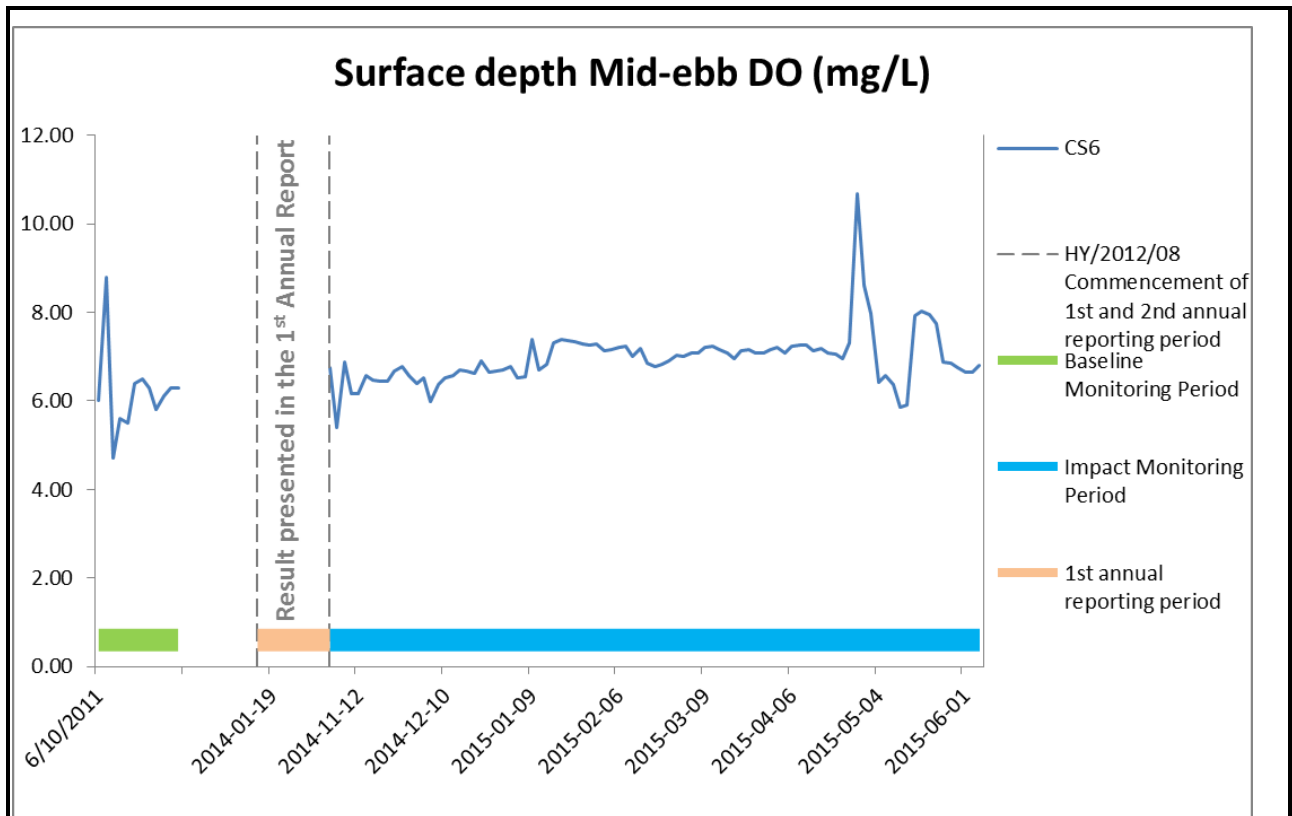
Figure E2 Baseline & Impact Monitoring - Mean Level of Dissolved Oxygen (mg/L) in surface waters between Baseline monitoring period: 6/10/2011 to 31/10/2011 and Impact monitoring period: 1/11/2014 to 5/6/2015 at CS6. Weather condition within the reporting period varied between sunny to rainy. The overall monitoring results were not affected by weather conditions. Major marine construction activities included: Vertical and Sloping Seawall construction; Marine Sheet Piling for box culvert extension; Reclamation filling; and Box Culvert extension. Water Quality Monitoring was suspended from 6 June 2015 effectively. *Ref:0212330_Impact-WQM_2nd annual.xlsx*

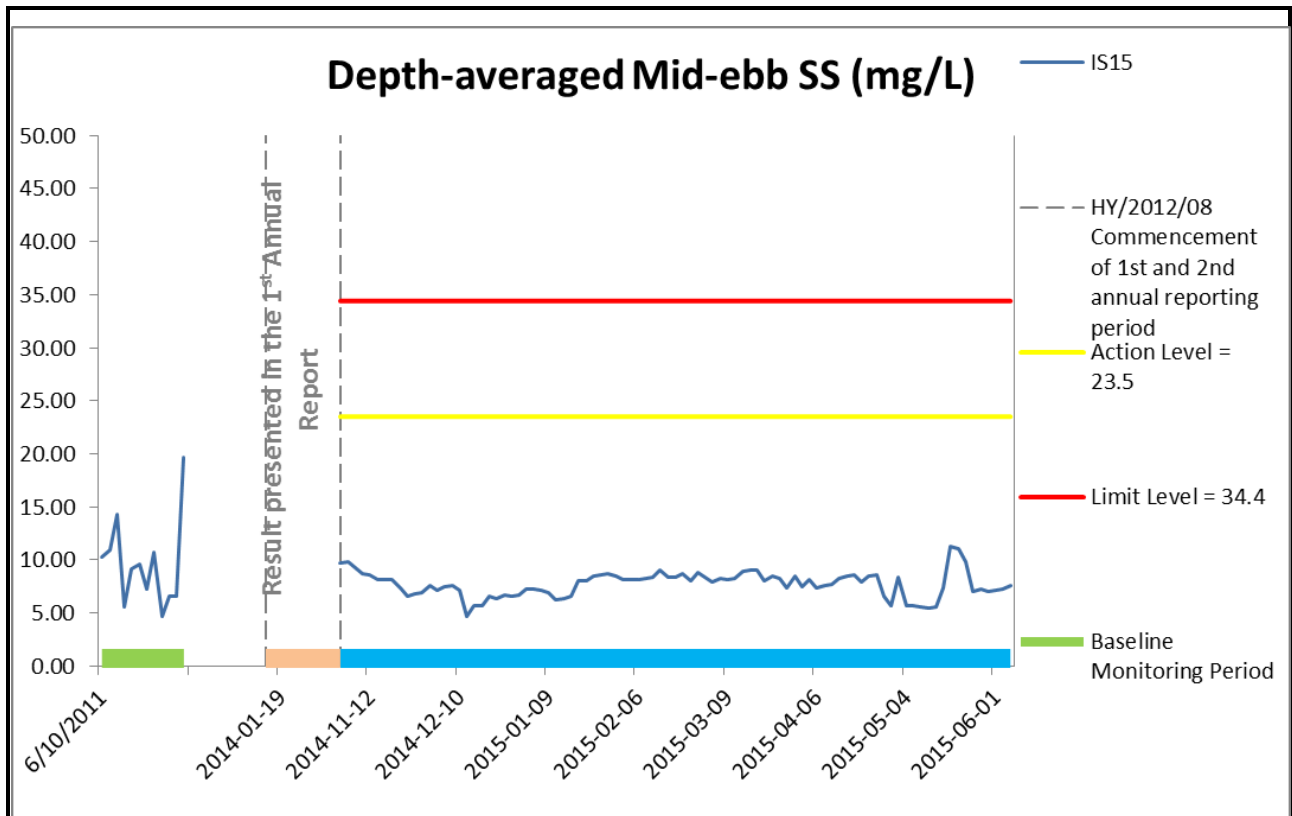
Figure E40 Baseline & Impact Monitoring - Mean Depth-averaged Level of Suspended Solids (mg/L) between Baseline monitoring period: 6/10/2011 to 31/10/2011 and Impact monitoring period: 1/11/2014 to 5/6/2015 at IS15. Weather condition within the reporting period varied between sunny to rainy. The overall monitoring results were not affected by weather conditions. Major marine construction activities included: Vertical and Sloping Seawall construction; Marine Sheet Piling for box culvert extension; Reclamation filling; and Box Culvert extension. Water Quality Monitoring was suspended from 6 June 2015 effectively.
