**AUES JOB No.: TCS01137/20**

**TUEN MUN - CHEK LAP KOK LINK  
CONTRACT NO. HMWSD 2/2020 (HY) –  
ESTABLISHMENT OF LANDSCAPE SOFTWORKS FOR  
THE TUEN MUN - CHEK LAP KOK LINK**

**4<sup>TH</sup> MONTHLY ENVIRONMENTAL MONITORING AND  
AUDIT (EM&A) REPORT – JULY 2021**

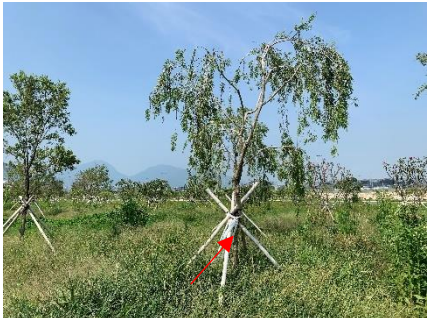
Location	Photo	Information
Zone 6	 	<p>Date: 27 July 2021</p> <p>Follow-up action 1: Tree re-planting works for tree no. TS446 within Zone 6 was completed in accordance with the latest planting plan.</p> <p>Species: <i>Grevillea robusta</i></p>
Zone 6

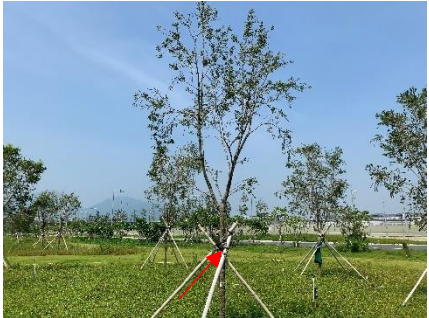
<p>Date: 27 July 2021</p> <p>Follow-up action 1: Tree re-planting works for tree no. TS1162 within Zone 6 was completed in accordance with the latest planting plan.</p> <p>Species: <i>Callistemon viminalis</i></p>
Zone 6

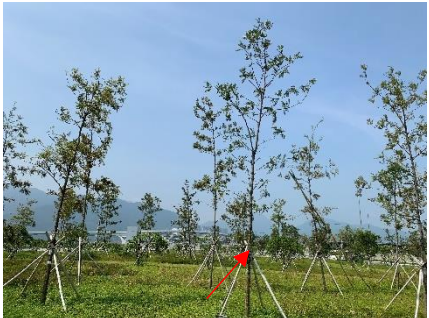
<p>Date: 27 July 2021</p> <p>Follow-up action 1: Tree re-planting works for tree no. TS1349 within Zone 6 was completed in accordance with the latest planting plan.</p> <p>Species: <i>Grevillea robusta</i></p>

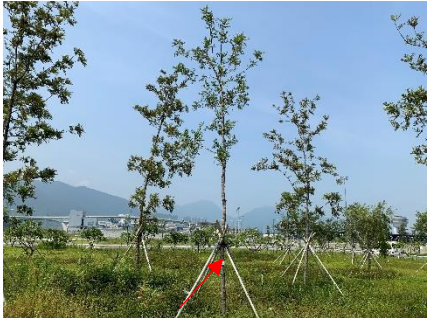
<p>Date: 27 July 2021</p> <p>Follow-up action 1: Tree re-planting works for tree no. TS1380 within Zone 6 was completed in accordance with the latest planting plan.</p> <p>Species: <i>Grevillea robusta</i></p>
Zone 6

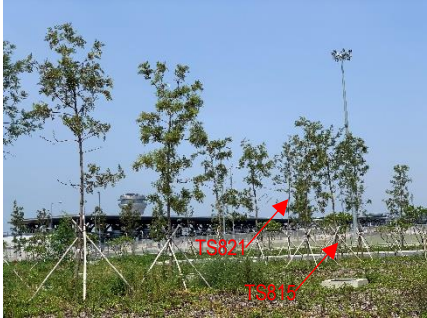
<p>Date: 27 July 2021</p> <p>Follow-up action 1: Tree re-planting works for tree nos. TS815 and TS821 within Zone 6 was completed in accordance with the latest planting plan.</p> <p>Species: <i>Grevillea robusta</i></p>

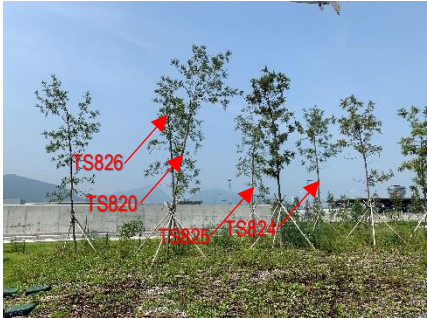
<p>Date: 27 July 2021</p> <p>Follow-up action 1: Tree re-planting works for tree nos. TS820, TS824, TS825 and TS826 within Zone 6 was completed in accordance with the latest planting plan.</p> <p>Species: <i>Grevillea robusta</i></p>
Zone 4

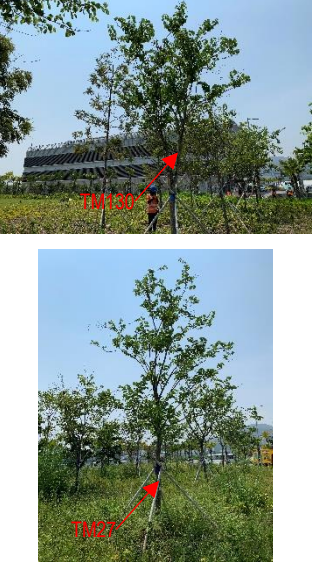
<p>Date: 27 July 2021</p> <p>Follow-up action 2: Correct tree species, <i>Bauhinia variegata</i>, for tree nos. TM27 and TM130 within Zone 4 were re-planted in accordance with the latest planting plan.</p> <p>Species: <i>Bauhinia variegata</i></p>

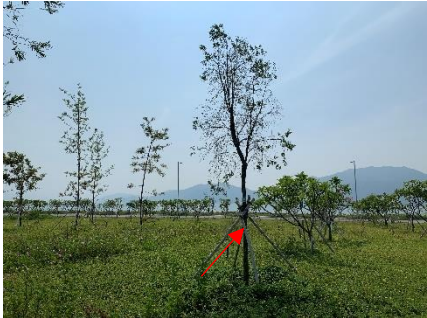
**Obs. 1:** Tree re-planting works for tree no. TS1177 (*Callistemon viminalis*) within Zone 6 was completed in accordance with the latest planting plan with sparse foliage observed. The health of the tree should be closely monitored and reviewed.

<p>Date: 27 July 2021</p> <p>Follow-up action 1 (Observation 1): Tree re-planting works for tree no. TS1177 within Zone 6 was completed in accordance with the latest planting plan with sparse foliage observed. The health of the tree should be closely monitored and reviewed.</p> <p>Species: <i>Callistemon viminalis</i></p>
Zone 4

- Tree health should be closely monitored and reviewed, with remedial actions taken for pest control, as appropriate.
- Tree re-planting works for the trees requiring replacement should be completed in accordance with the latest planting plan.

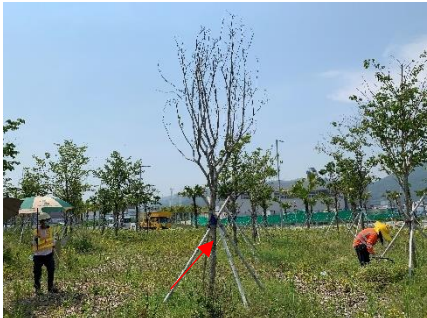
<p>Date: 27 July 2021</p> <p>Observation 2: The tree (tree no. TM42) within Zone 4 was in wilting. The health of the tree should be closely monitored and reviewed, and tree re-planting works should also be carried out in accordance with the latest planting plan if the tree is unavoidably removed from site.</p> <p>Species: <i>Bauhinia variegata</i></p>

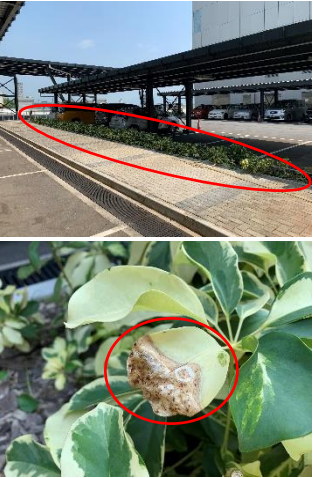
<p>Date: 27 July 2021</p> <p>Observation 3: Suspected pest infestation was noticed from the leaves of shrub species, <i>Schefflera arboricola</i> “variegata”, planted in the vicinity of car park area within Zone 5. The health of shrub should be closely monitored and reviewed, and take remedial actions in terms of pest control as appropriate.</p> <p>Species: <i>Schefflera arboricola</i> “variegata”</p>
Zone 4

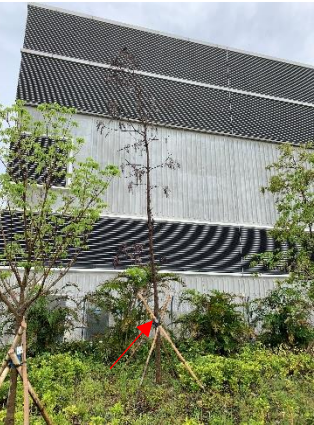
<p>Date: 30 July 2021</p> <p>Observation 4: The tree (tree no. TM149) within Zone 4 was dead. Tree re-planting works should be carried out in accordance with the latest planting plan.</p> <p>Species: <i>Grevillea robusta</i></p>

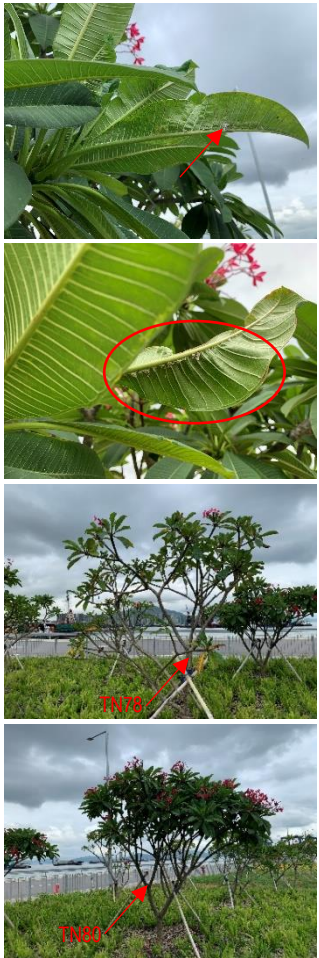
<p>Date: 30 July 2021</p> <p>Observation 7: The leaves of trees (tree nos. TN78 &amp; TN80) within Zone 1 were invaded by scale insects belonging to the family Coccidae. The health of the trees should be closely monitored and reviewed, and take remedial actions in terms of pest control as appropriate.</p> <p>Species: <i>Plumeria rubra</i></p>

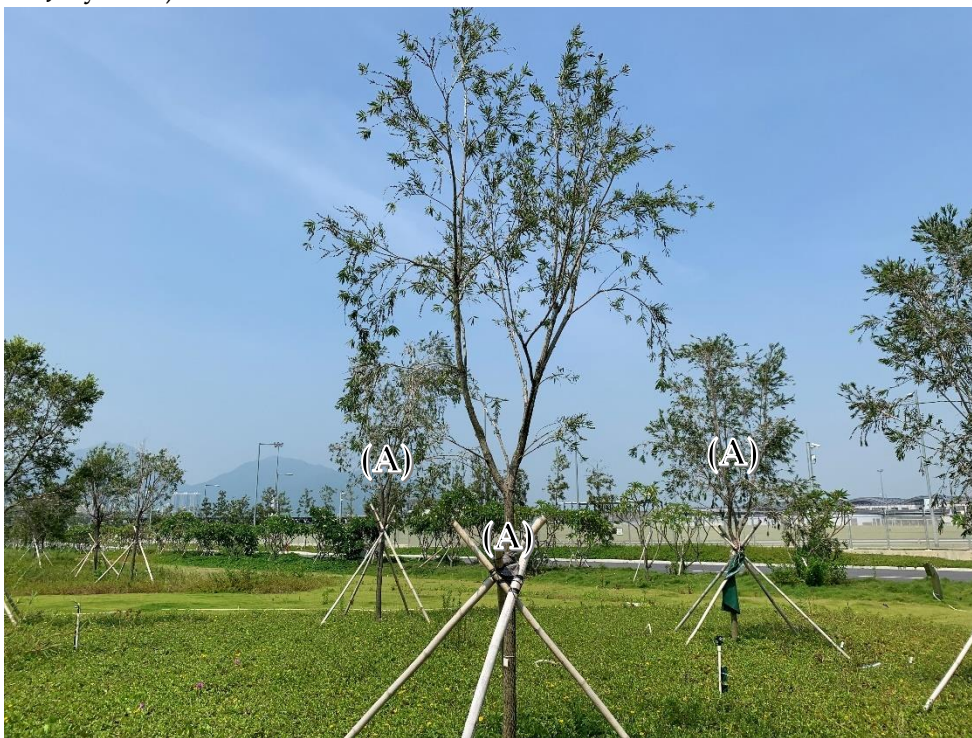
Photo 30: (A): *Callistemon viminalis* within Zone 6  
 (Taken on: 27 July 2021)
