**Contract No. HY/2012/08  
Tuen Mun – Chek Lap Kok Link –  
Northern Connection Sub-sea Tunnel  
Section**

*Fourth Annual Environmental Monitoring &  
Audit (EM&A) Report*

26 November 2018

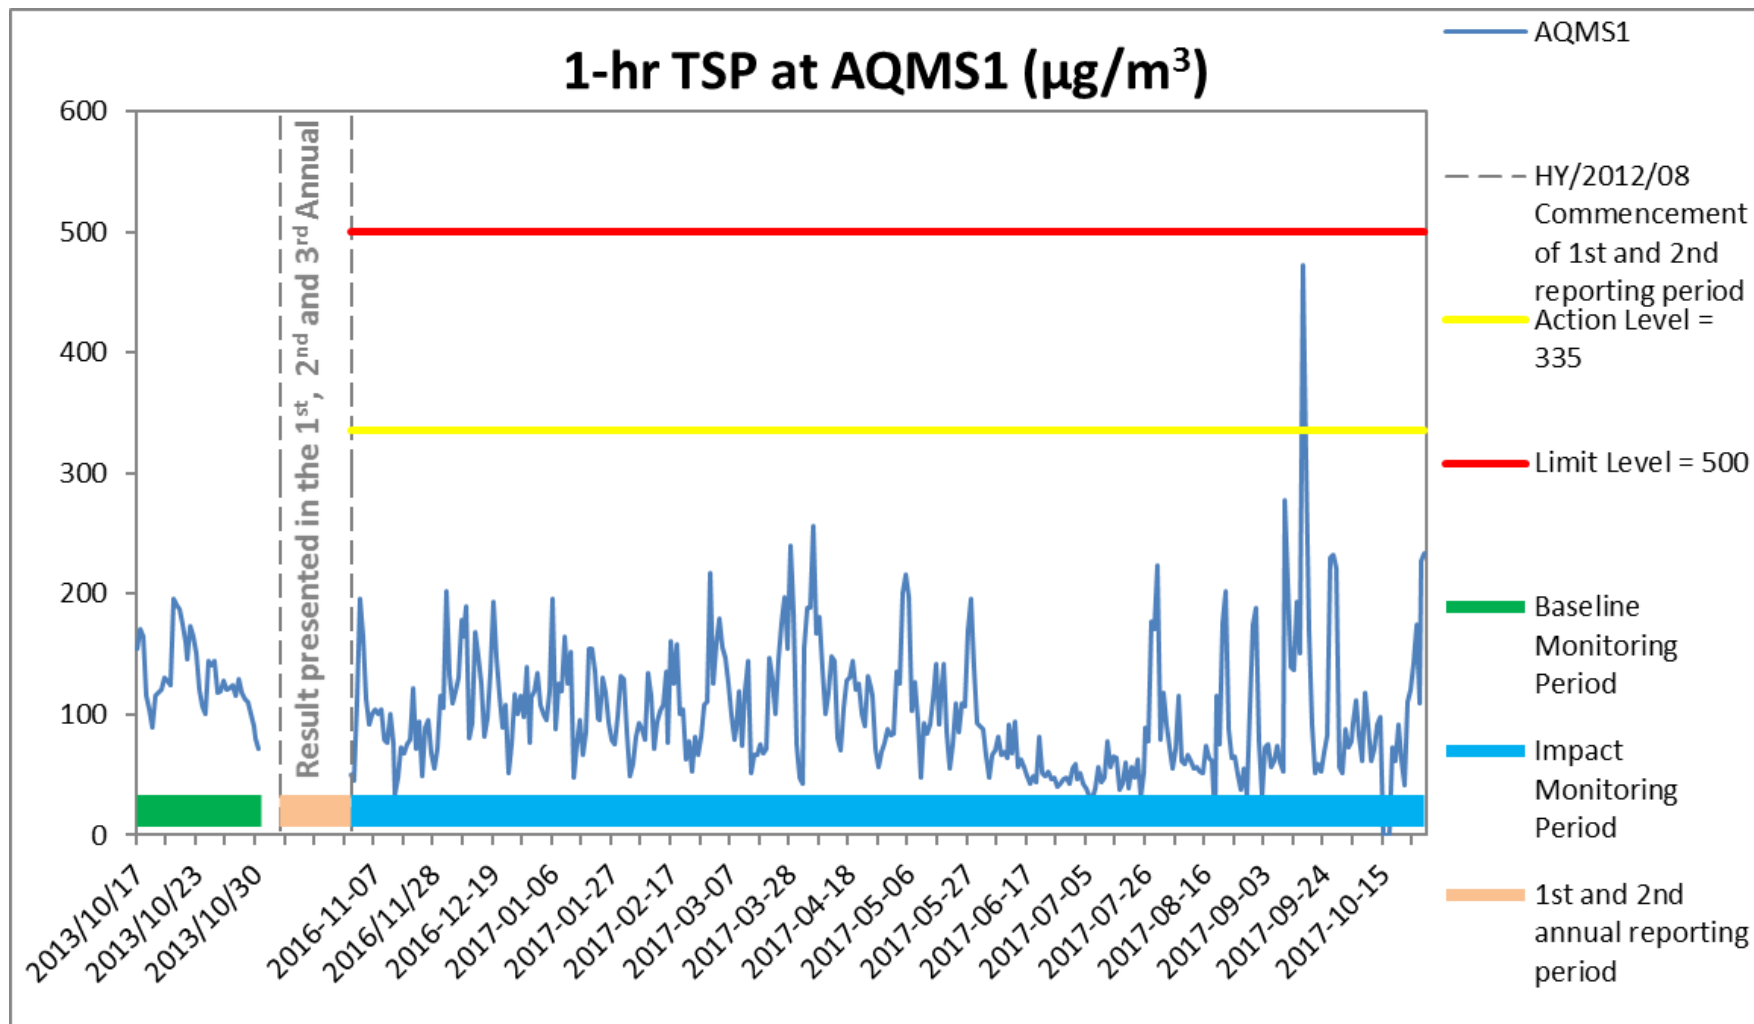
Figure D.1 Baseline & Impact Monitoring - 1-hour Total Suspended Particulates ( $\mu\text{g}/\text{m}^3$ ) at AQMS1 between 17 October 2013 and 31 October 2017 during Baseline & Impact Monitoring period. Weather condition within the reporting period varied between sunny to rainy. The overall monitoring results were not affected by weather conditions. Major land-based construction activities included: Construction of Cross Passage Tympanum, Box Culvert Extension, CSM Ground Treatment, TBM Tunnel Works & Excavation of sub-sea tunnel. Ref: 0212330\_Impact AQM graphs\_4thAnnual\_REV a.xlsx

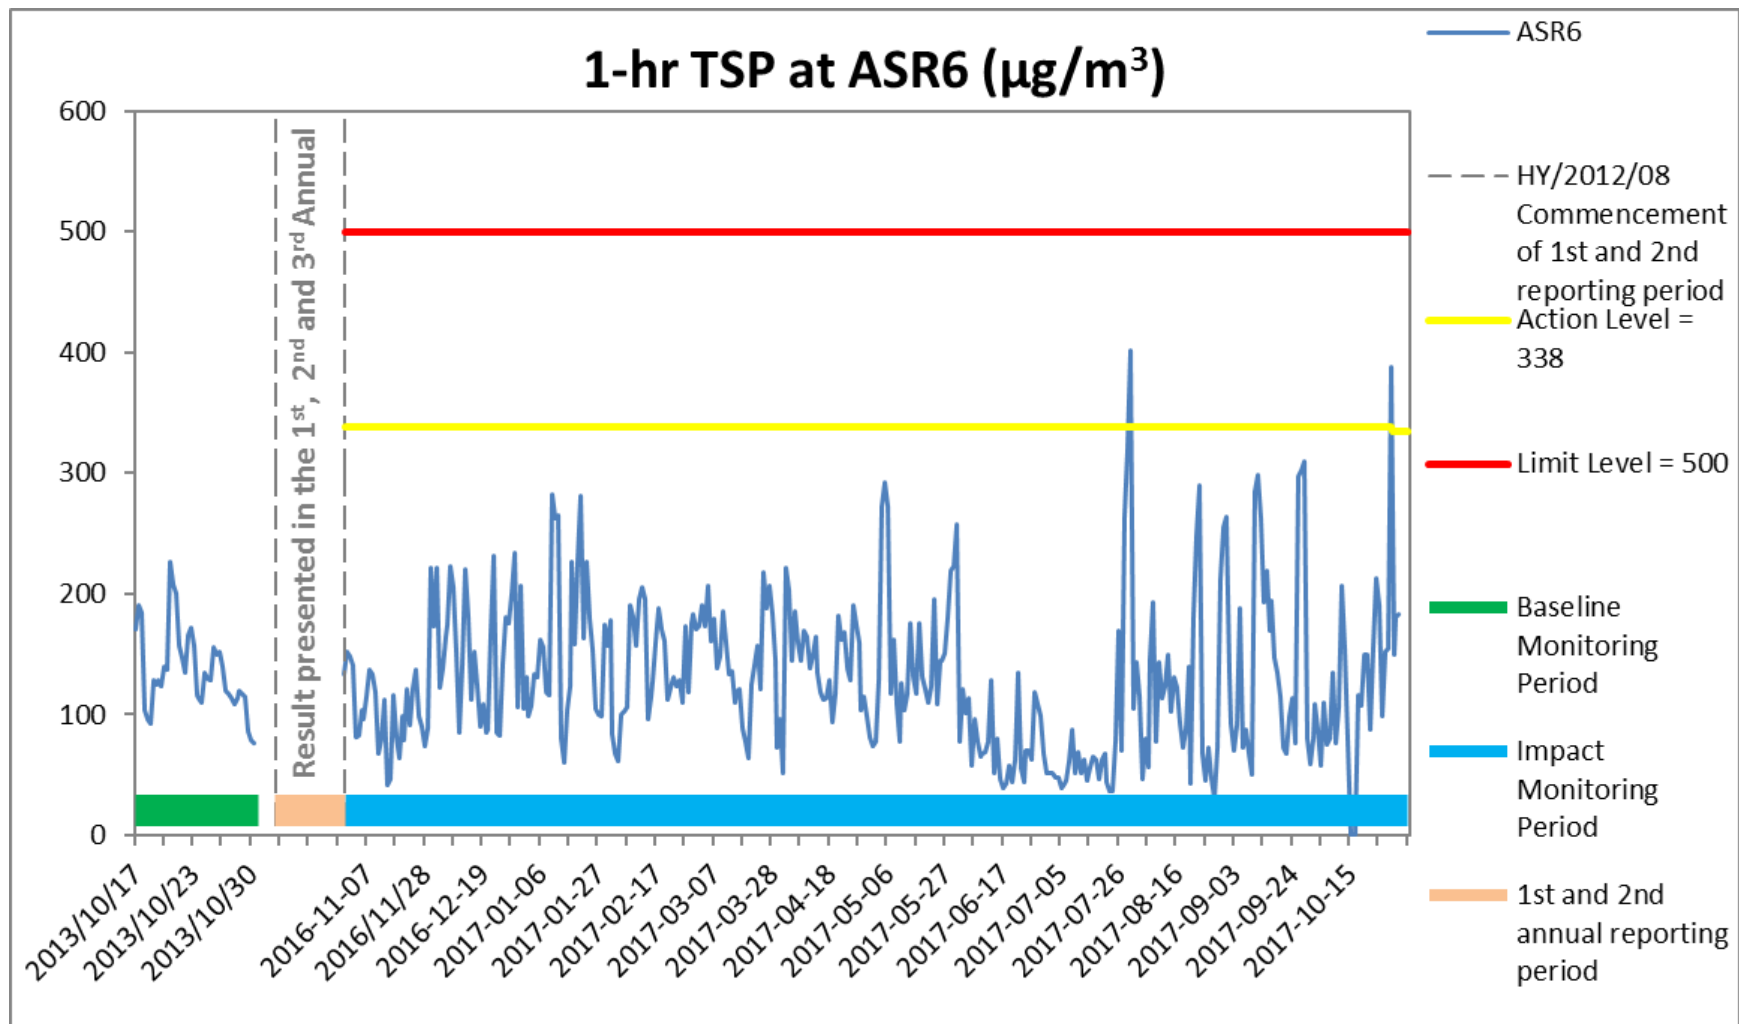
Figure D.2 Baseline & Impact Monitoring - 1-hour Total Suspended Particulates ( $\mu\text{g}/\text{m}^3$ ) at AQMS2/ASR6 between 17 October 2013 and 31 October 2017 during Baseline & Impact Monitoring period. Weather condition within the reporting period varied between sunny to rainy. The overall monitoring results were not affected by weather conditions. Major land-based construction activities included: Construction of Cross Passage Tympanum, Box Culvert Extension, CSM Ground Treatment, TBM Tunnel Works & Excavation of sub-sea tunnel. Ref: 0212330\_Impact AQM graphs\_4thAnnual\_REV a.xlsx

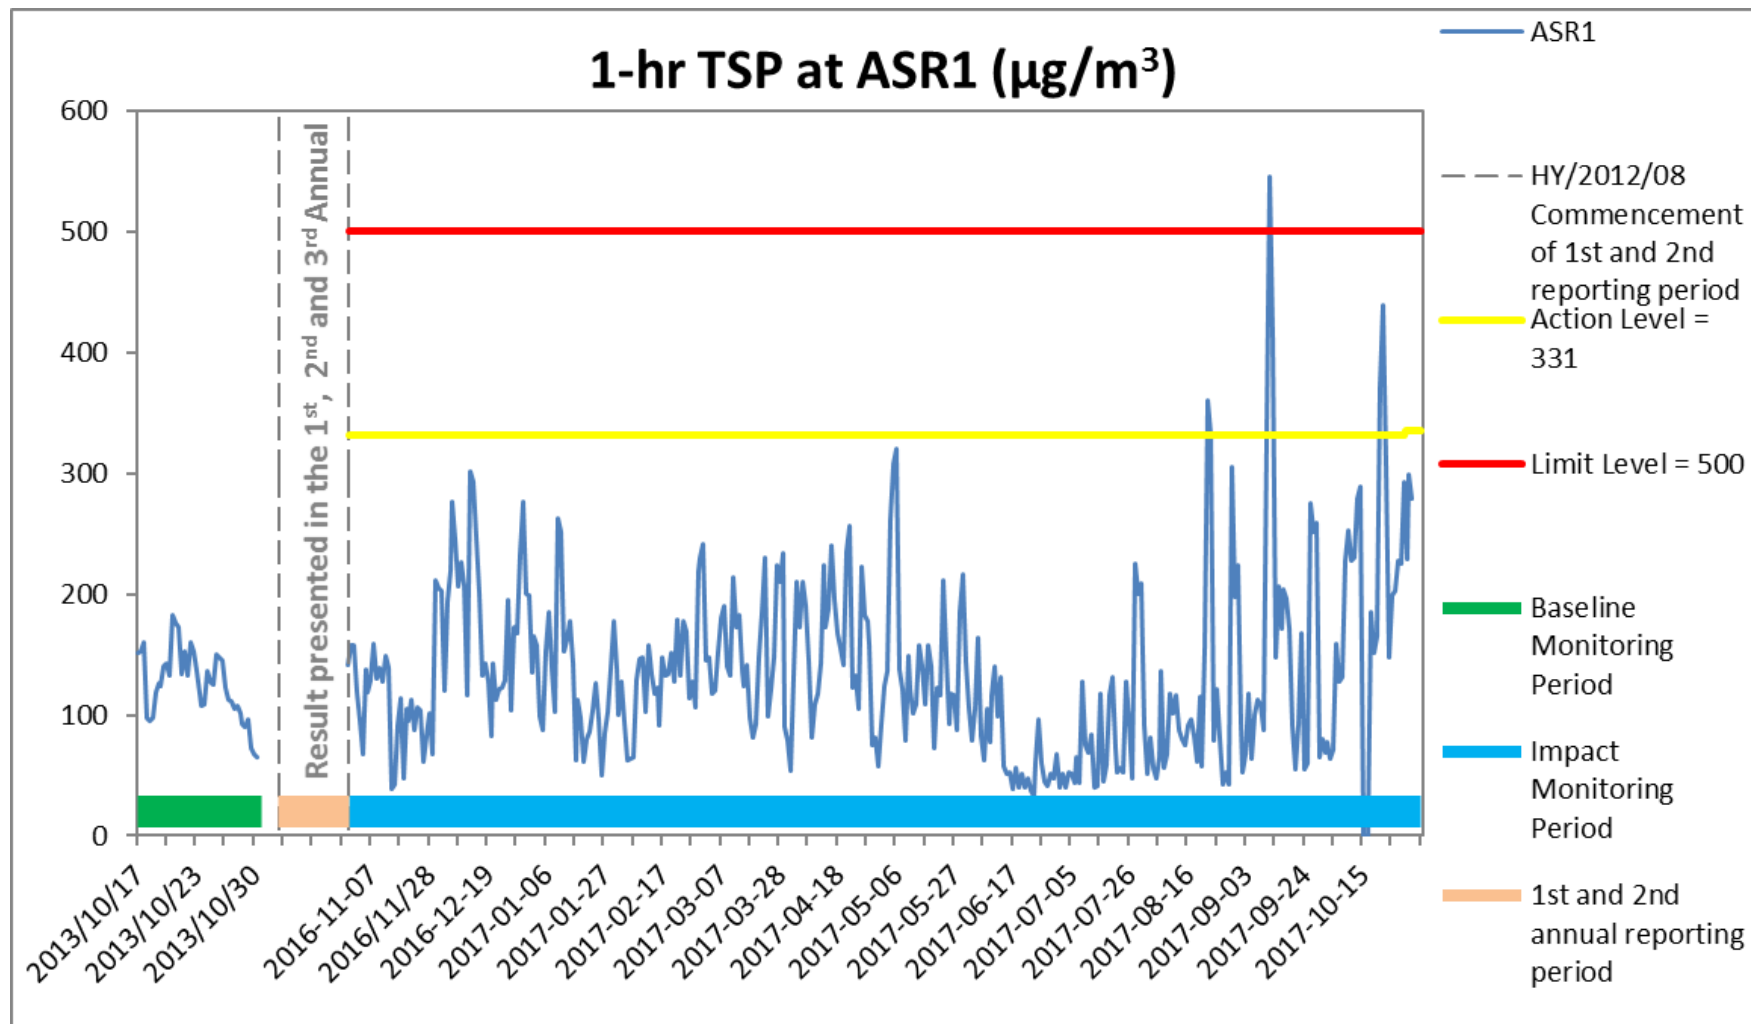
Figure D.3 Baseline & Impact Monitoring - 1-hour Total Suspended Particulates ( $\mu\text{g}/\text{m}^3$ ) at ASR1 between 17 October 2013 and 31 October 2017 during Baseline & Impact Monitoring period. Weather condition within the reporting period varied between sunny to rainy. The overall monitoring results were not affected by weather conditions. Major land-based construction activities included: Construction of Cross Passage Tympanum, Box Culvert Extension, CSM Ground Treatment, TBM Tunnel Works & Excavation of sub-sea tunnel. Ref: 0212330\_Impact AQM graphs\_4thAnnual\_REV a.xlsx

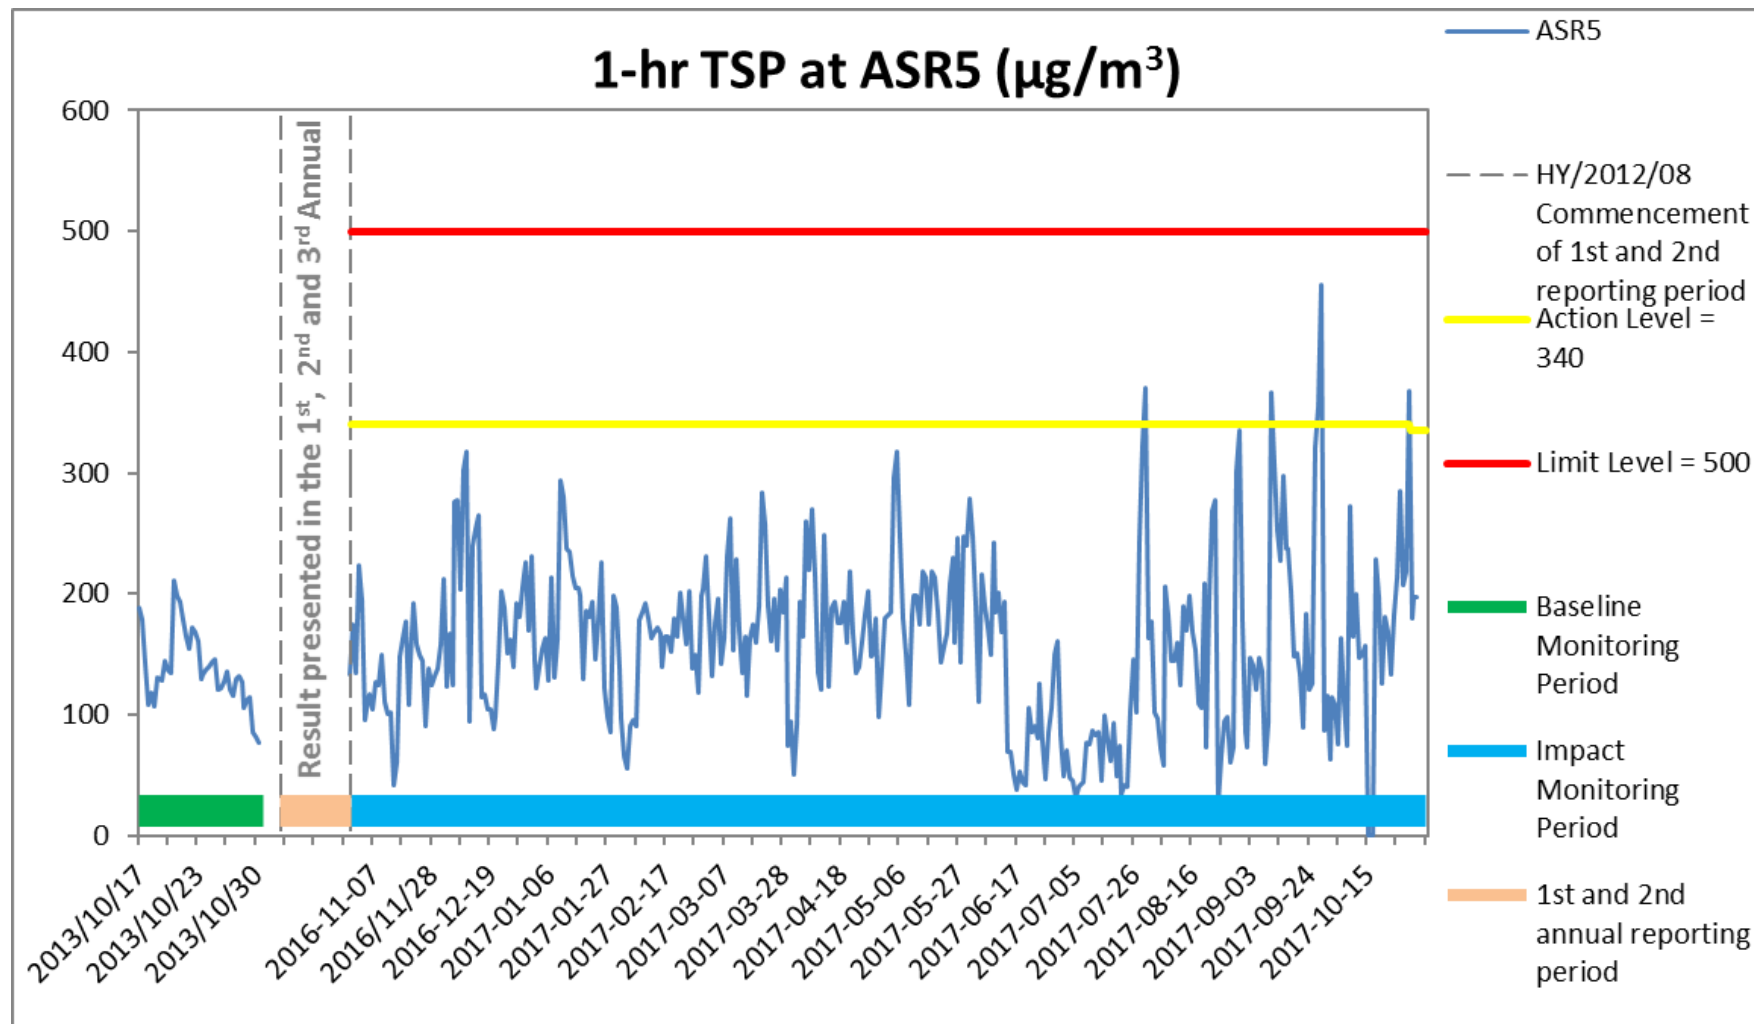
Figure D.4 Baseline & Impact Monitoring - 1-hour Total Suspended Particulates ( $\mu\text{g}/\text{m}^3$ ) at ASR5 between 17 October 2013 and 31 October 2017 during Baseline & Impact Monitoring period. Weather condition within the reporting period varied between sunny to rainy. The overall monitoring results were not affected by weather conditions. Major land-based construction activities included: Construction of Cross Passage Tympanum, Box Culvert Extension, CSM Ground Treatment, TBM Tunnel Works & Excavation of sub-sea tunnel. Ref: 0212330\_Impact AQM graphs\_4thAnnual\_REV a.xlsx

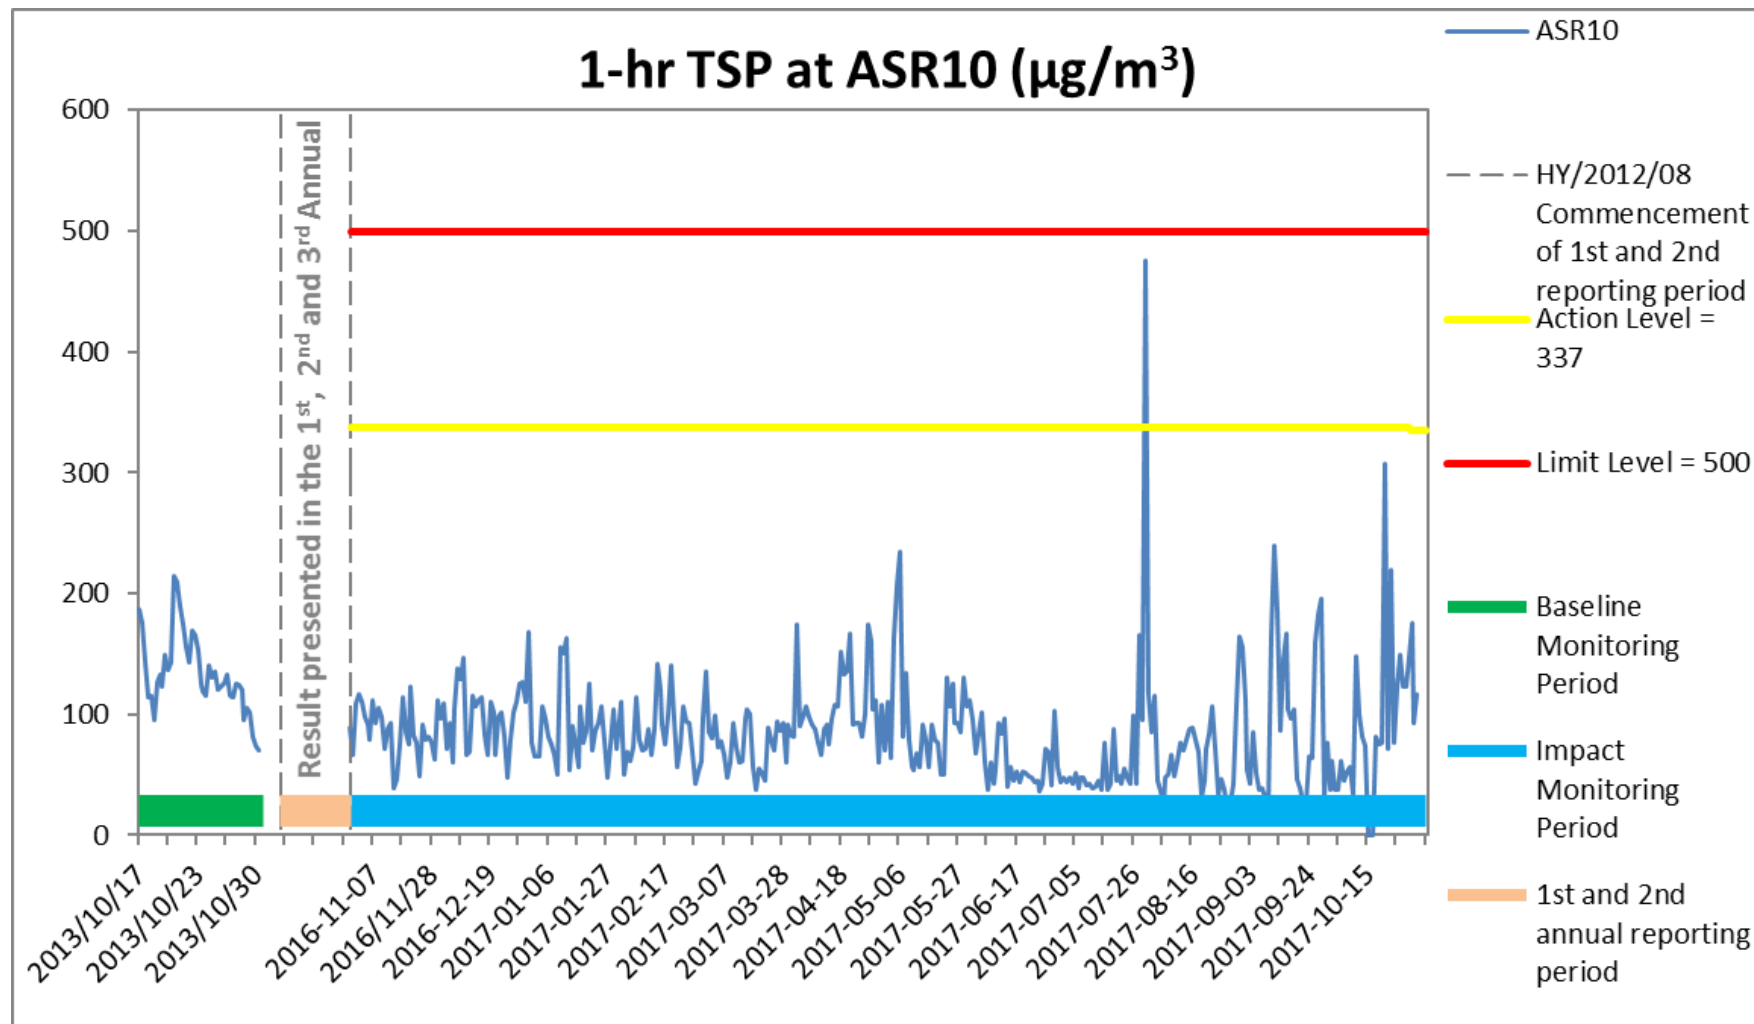
Figure D.5 Baseline & Impact Monitoring - 1-hour Total Suspended Particulates ( $\mu\text{g}/\text{m}^3$ ) at ASR10 between 17 October 2013 and 31 October 2017 during Baseline & Impact Monitoring period. Weather condition within the reporting period varied between sunny to rainy. The overall monitoring results were not affected by weather conditions. Major land-based construction activities included: Construction of Cross Passage Tympanum, Box Culvert Extension, CSM Ground Treatment, TBM Tunnel Works & Excavation of sub-sea tunnel. Ref: 0212330\_Impact AQM graphs\_4thAnnual\_REV a.xlsx

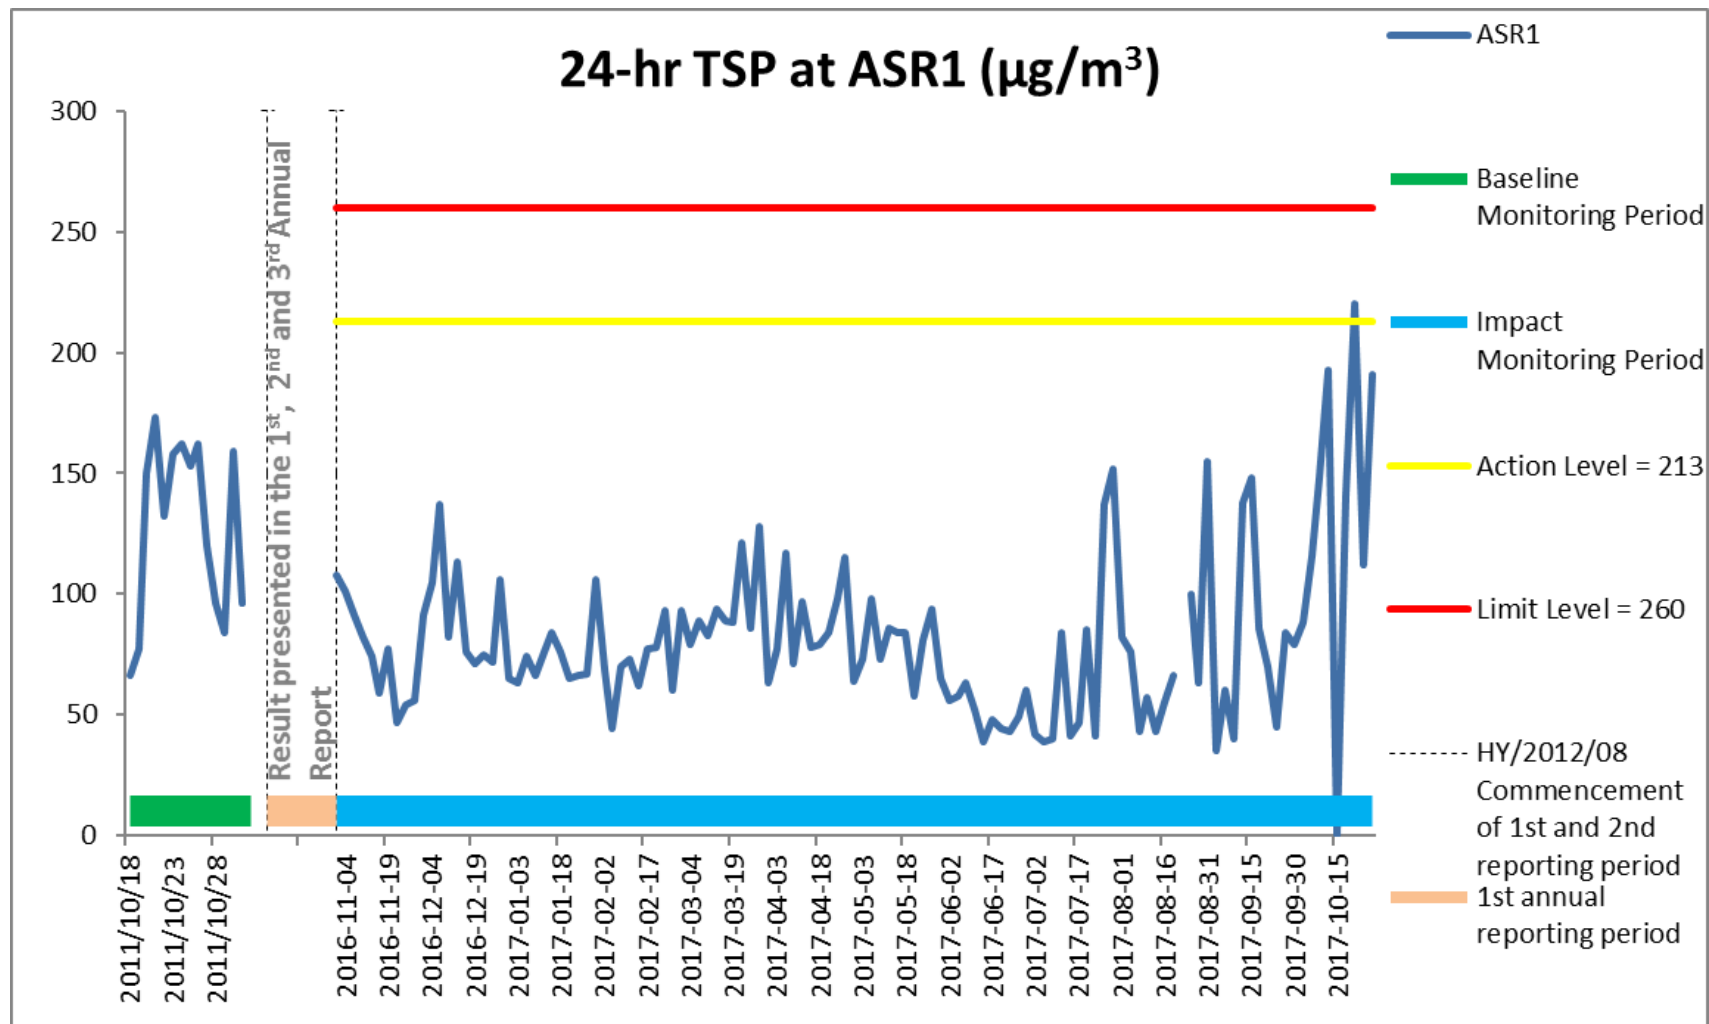
Figure D.6 Baseline & Impact Monitoring - 24-hour Total Suspended Particulates ( $\mu\text{g}/\text{m}^3$ ) at ASR1 between 17 October 2013 and 31 October 2017 during Baseline & Impact Monitoring period. Weather condition within the reporting period varied between sunny to rainy. The overall monitoring results were not affected by weather conditions. Major land-based construction activities included: Construction of Cross Passage Tympanum, Box Culvert Extension, CSM Ground Treatment, TBM Tunnel Works & Excavation of sub-sea tunnel. Ref: 0212330\_Impact AQM graphs\_4thAnnual\_REV a.xlsx

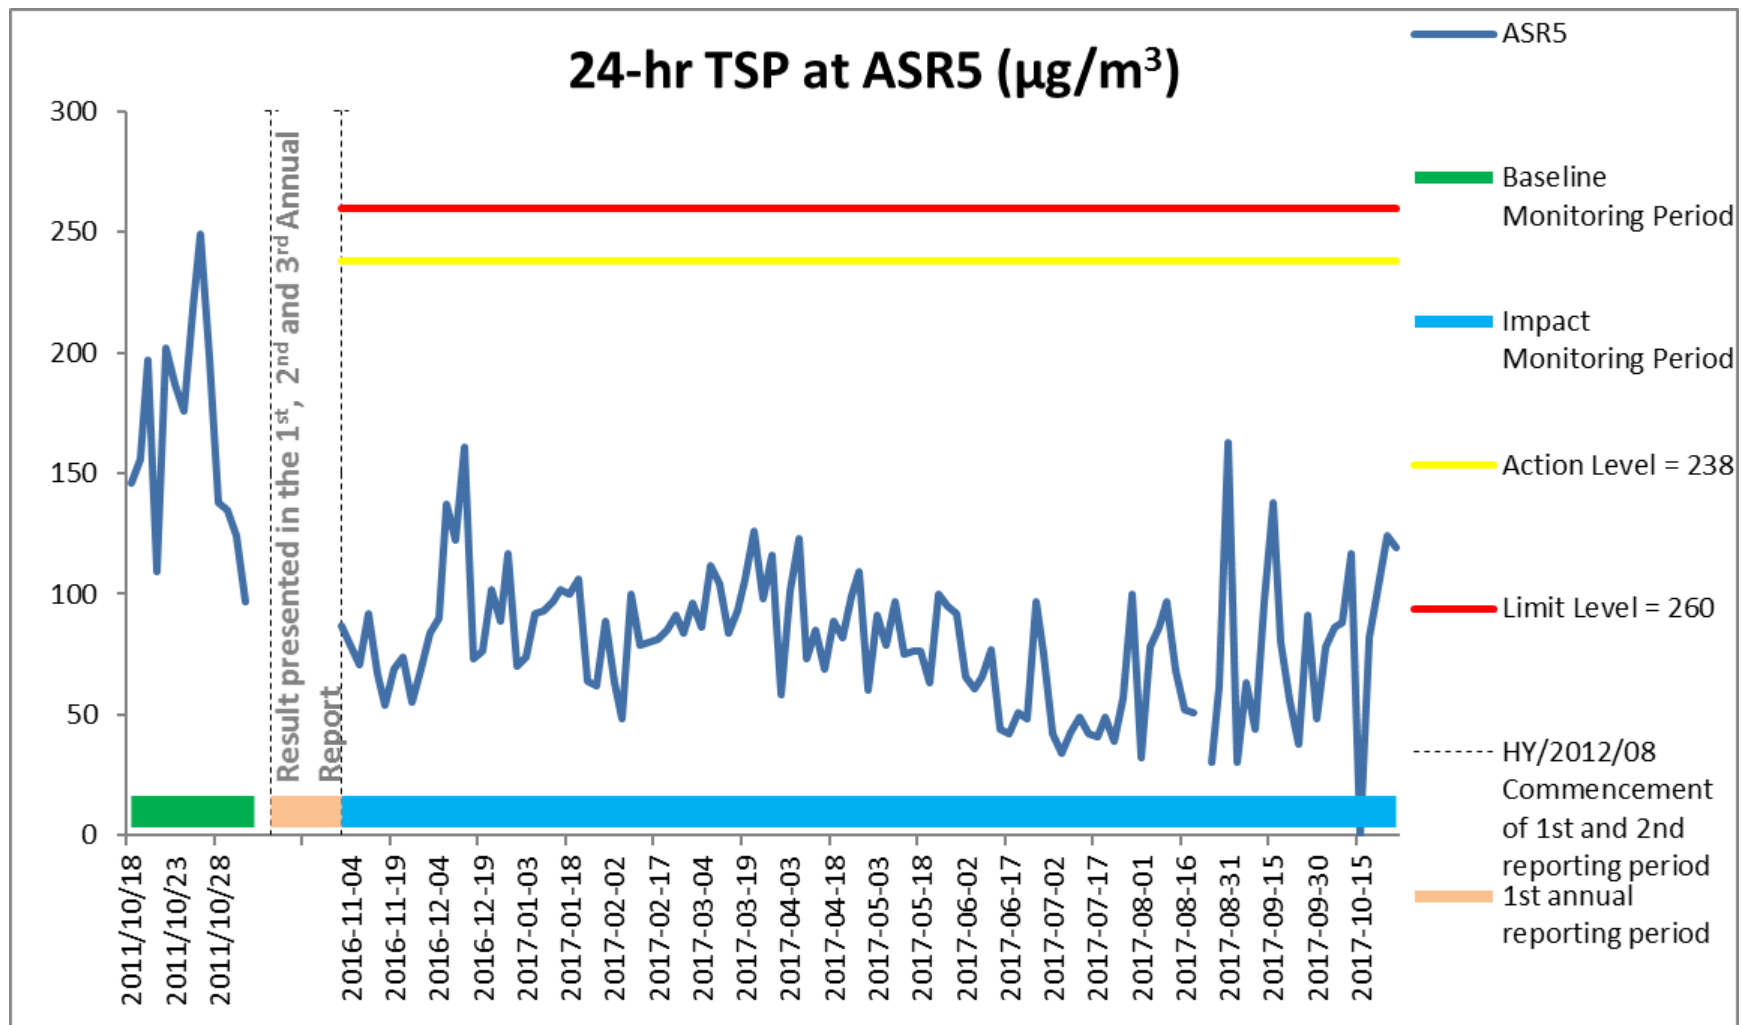
Figure D.7 Baseline & Impact Monitoring - 24-hour Total Suspended Particulates ( $\mu\text{g}/\text{m}^3$ ) at ASR5 between 17 October 2013 and 31 October 2017 during Baseline & Impact Monitoring period. Weather condition within the reporting period varied between sunny to rainy. The overall monitoring results were not affected by weather conditions. Major land-based construction activities included: Construction of Cross Passage Tympanum, Box Culvert Extension, CSM Ground Treatment, TBM Tunnel Works & Excavation of sub-sea tunnel. Ref: 0212330\_Impact AQM graphs\_4thAnnual\_REV a.xlsx

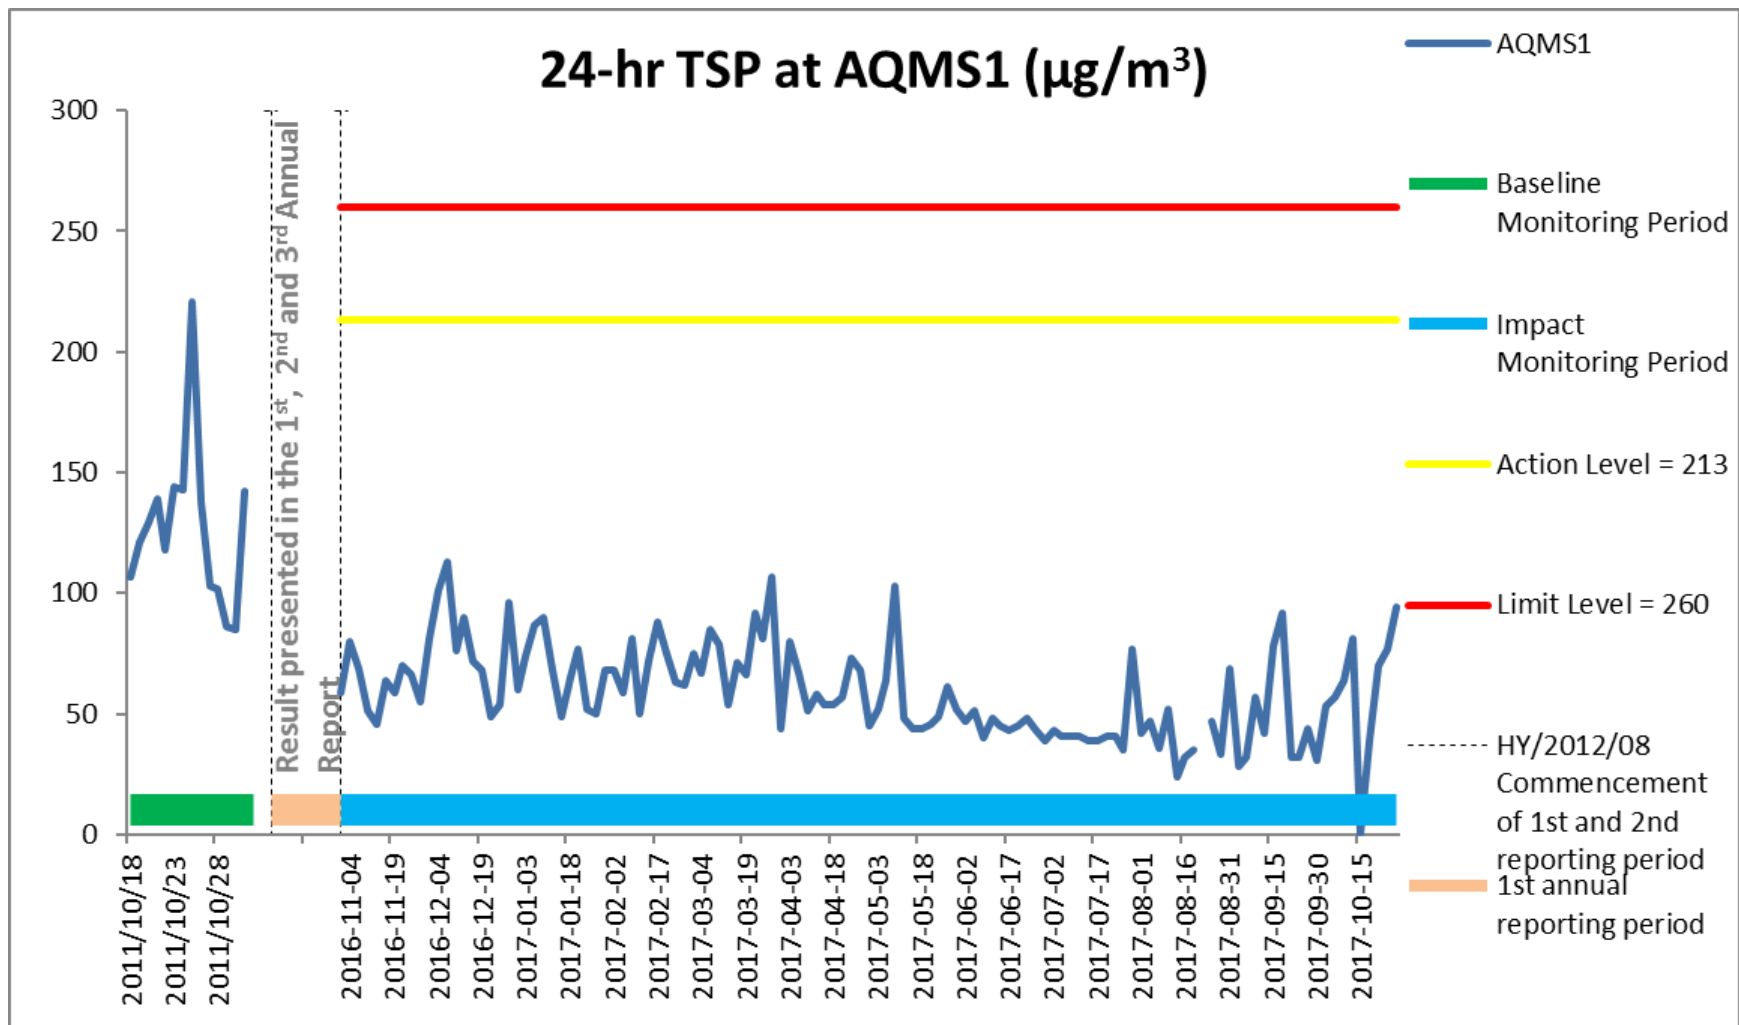
Figure D.8 Baseline & Impact Monitoring - 24-hour Total Suspended Particulates ( $\mu\text{g}/\text{m}^3$ ) at AQMS1 between 17 October 2013 and 31 October 2017 during Baseline & Impact Monitoring period. Weather condition within the reporting period varied between sunny to rainy. The overall monitoring results were not affected by weather conditions. Major land-based construction activities included: Construction of Cross Passage Tympanum, Box Culvert Extension, CSM Ground Treatment, TBM Tunnel Works & Excavation of sub-sea tunnel. Ref: 0212330\_Impact AQM graphs\_4thAnnual\_REV a.xlsx

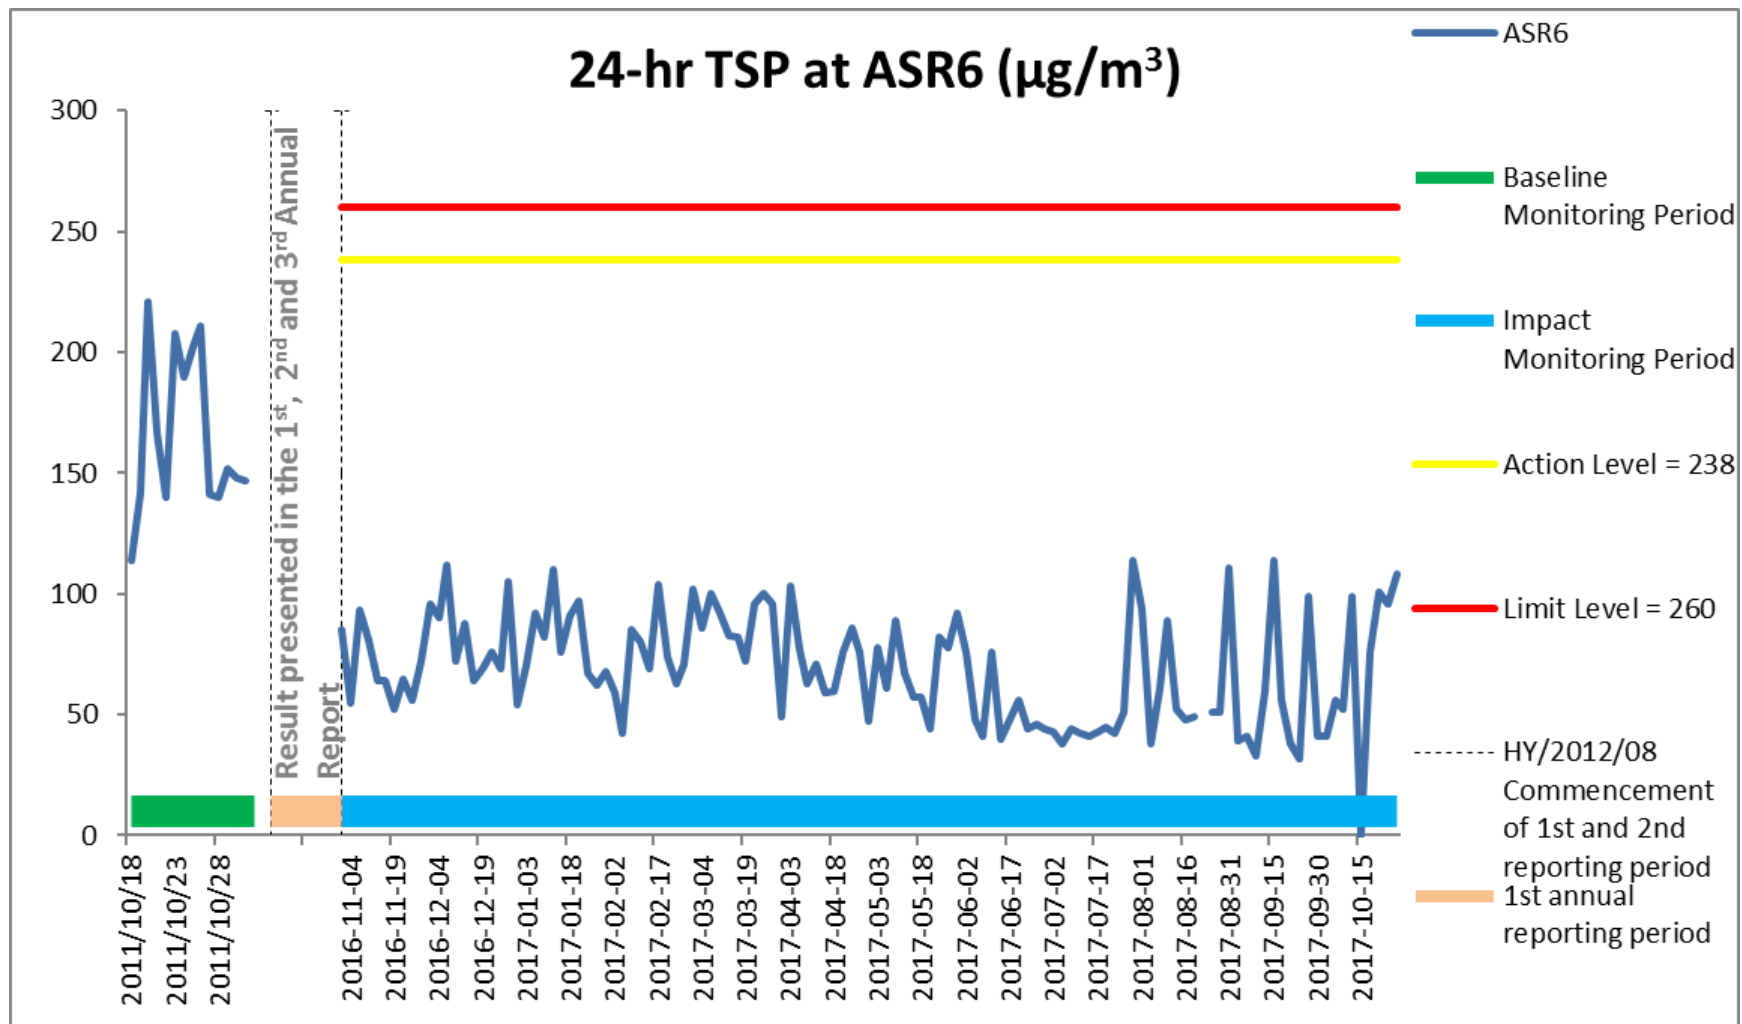
Figure D.9 Baseline & Impact Monitoring - 24-hour Total Suspended Particulates ( $\mu\text{g}/\text{m}^3$ ) at AQMS2/ASR6 between 17 October 2013 and 31 October 2017 during Baseline & Impact Monitoring period. Weather condition within the reporting period varied between sunny to rainy. The overall monitoring results were not affected by weather conditions. Major land-based construction activities included: Construction of Cross Passage Tympanum, Box Culvert Extension, CSM Ground Treatment, TBM Tunnel Works & Excavation of sub-sea tunnel. Ref: 0212330\_Impact AQM graphs\_4thAnnual\_REV a.xlsx

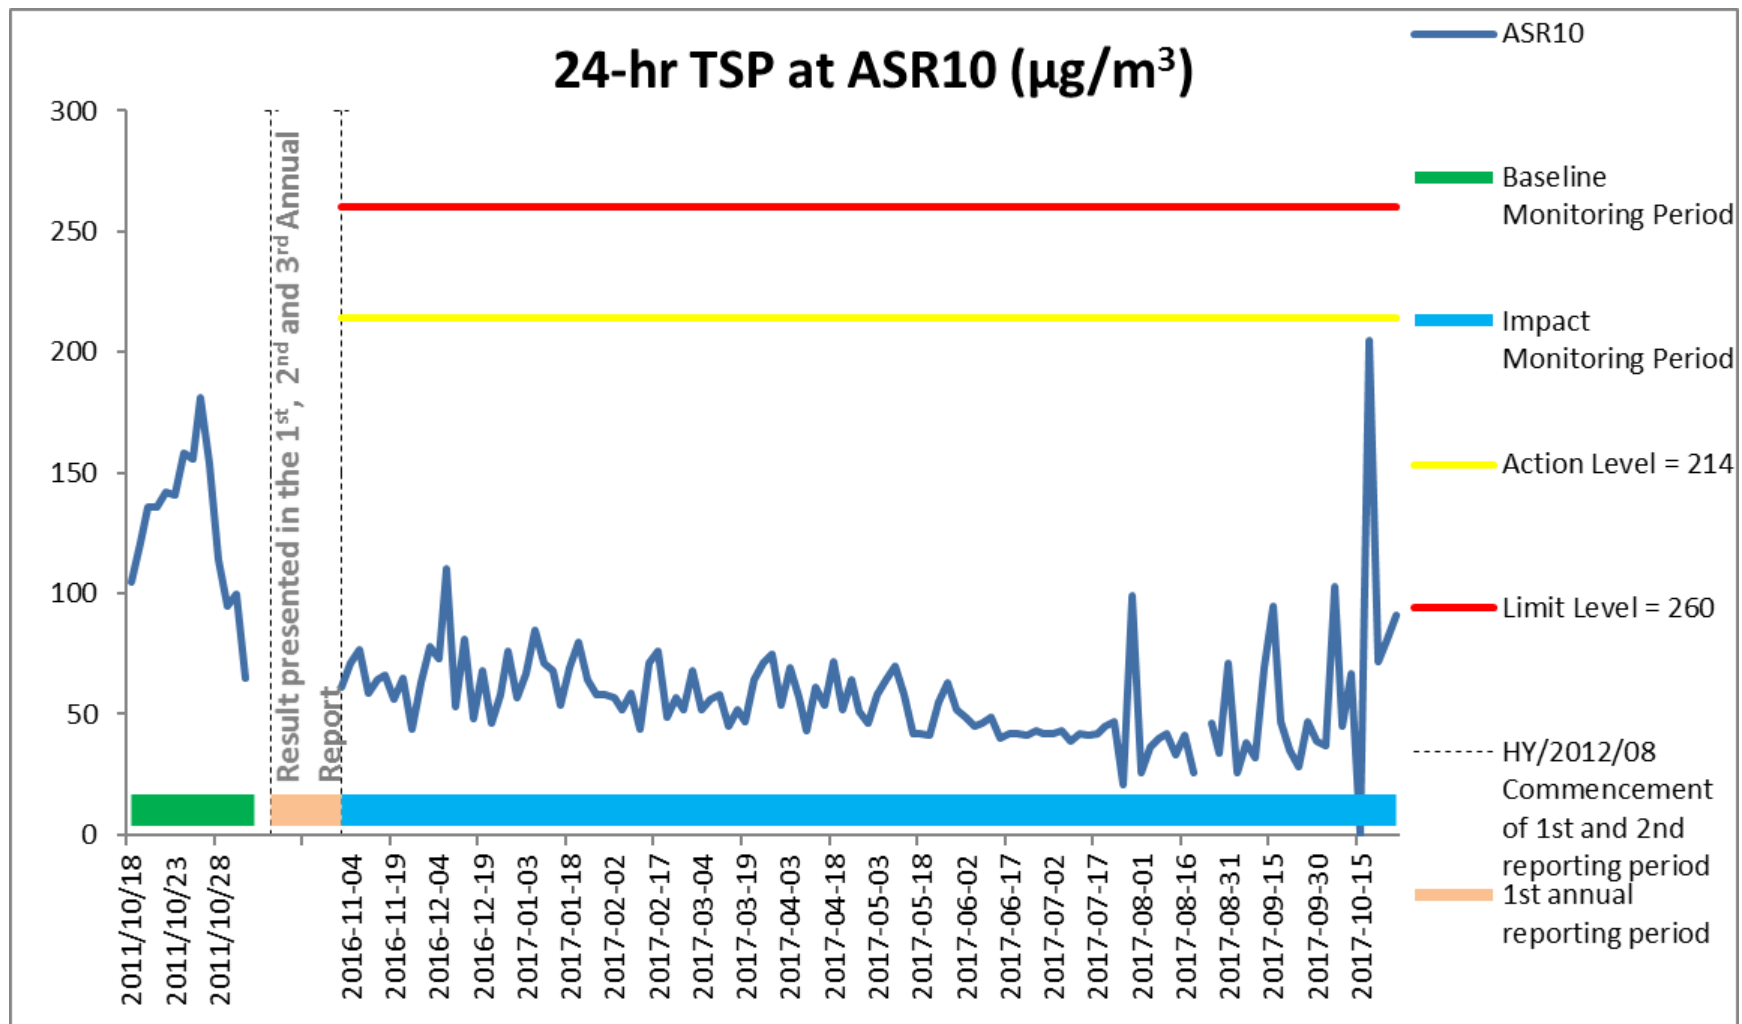
Figure D.10 Baseline & Impact Monitoring - 24-hour Total Suspended Particulates ( $\mu\text{g}/\text{m}^3$ ) at ASR10 between 17 October 2013 and 31 October 2017 during Baseline & Impact Monitoring period. Weather condition within the reporting period varied between sunny to rainy. The overall monitoring results were not affected by weather conditions. Major land-based construction activities included: Construction of Cross Passage Tympanum, Box Culvert Extension, CSM Ground Treatment, TBM Tunnel Works & Excavation of sub-sea tunnel. Ref: 0212330\_Impact AQM graphs\_4thAnnual\_REV a.xlsx

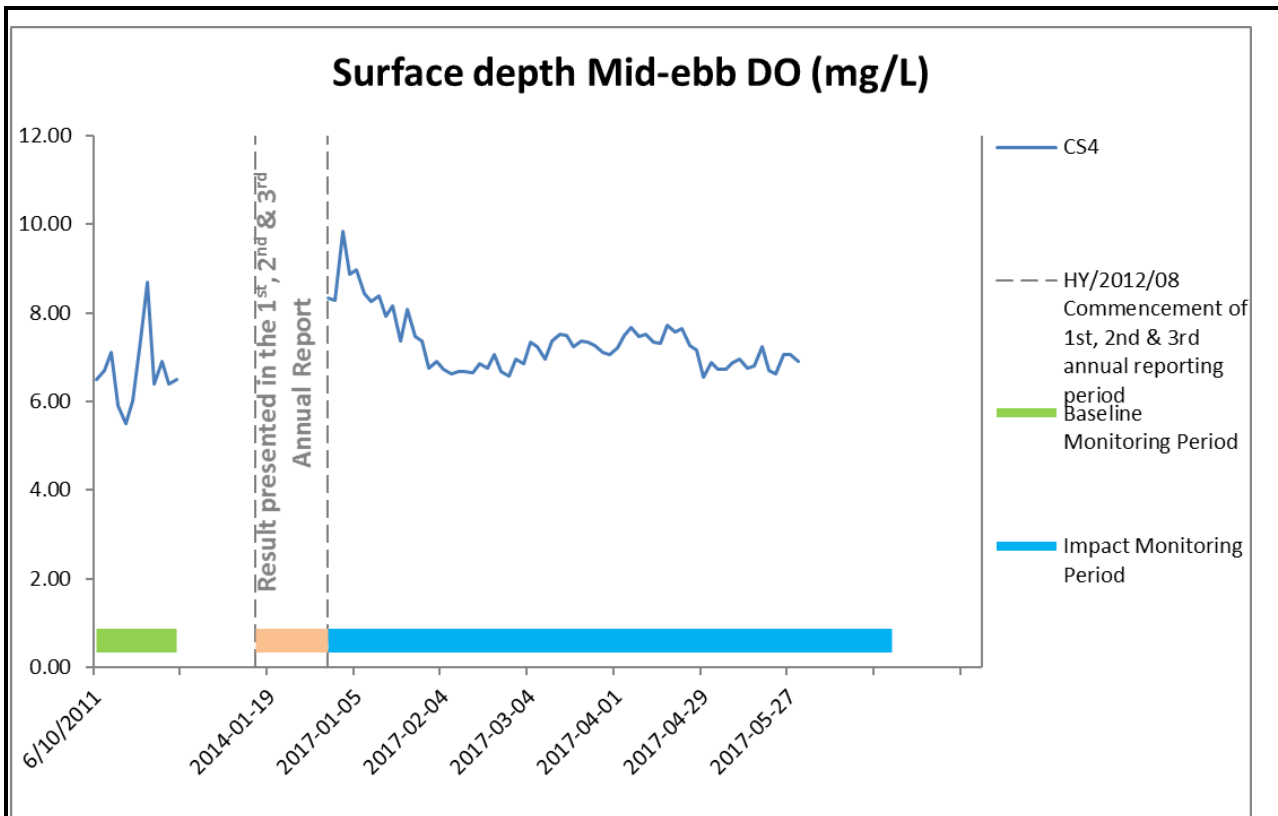
**Figure E1 Baseline & Impact Monitoring - Mean Level of Dissolved Oxygen (mg/L) in surface waters between Baseline monitoring period: 6/10/2011 to 31/10/2011 and Impact monitoring period: 3/1/2017 to 30/5/2017 at CS4. Weather condition within the reporting period varied between sunny to rainy. The overall monitoring results were not affected by weather conditions. Major marine construction activities included: Dredging, Reclamation filling and Construction of Vertical Seawall**

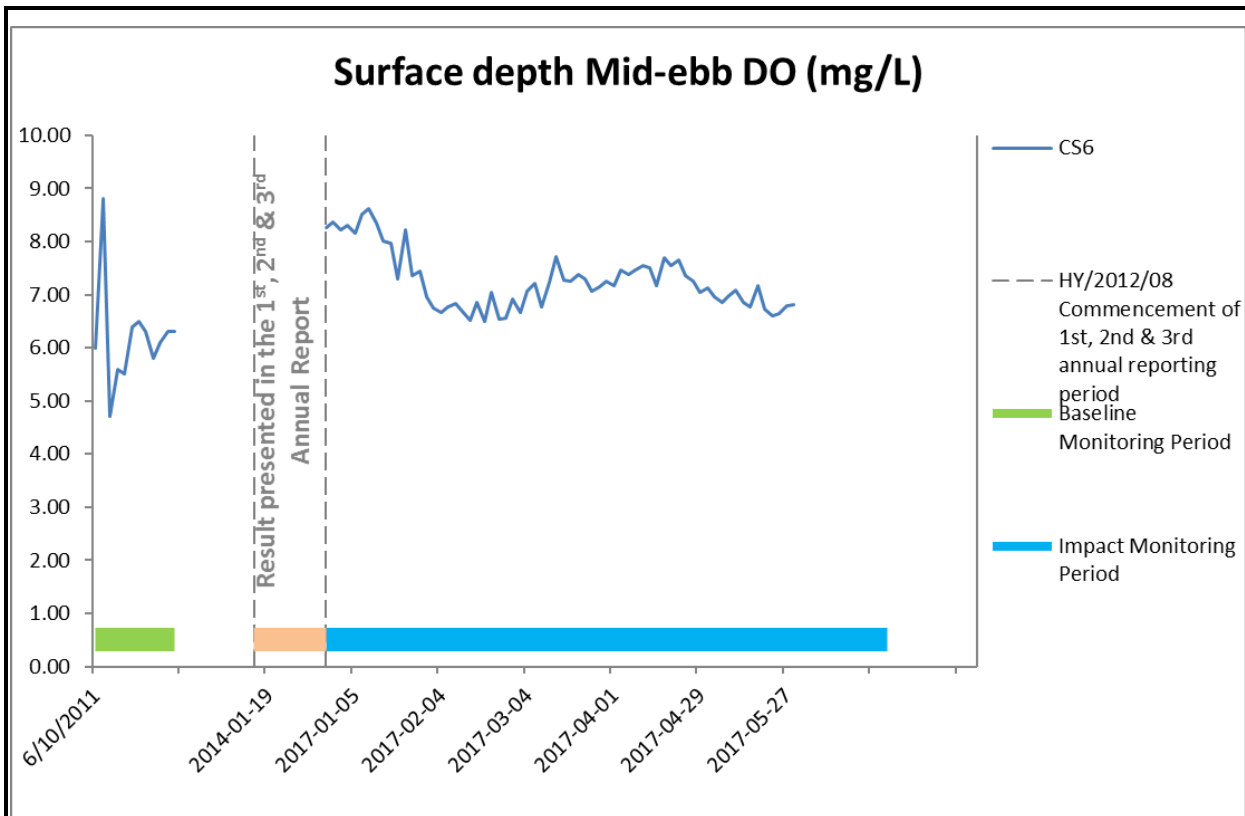
**Figure E2 Baseline & Impact Monitoring - Mean Level of Dissolved Oxygen (mg/L) in surface waters between Baseline monitoring period: 6/10/2011 to 31/10/2011 and Impact monitoring period: 3/1/2017 to 30/5/2017 at CS6. Weather condition within the reporting period varied between sunny to rainy. The overall monitoring results were not affected by weather conditions. Major marine construction activities included: Dredging, Reclamation filling and Construction of Vertical Seawall**

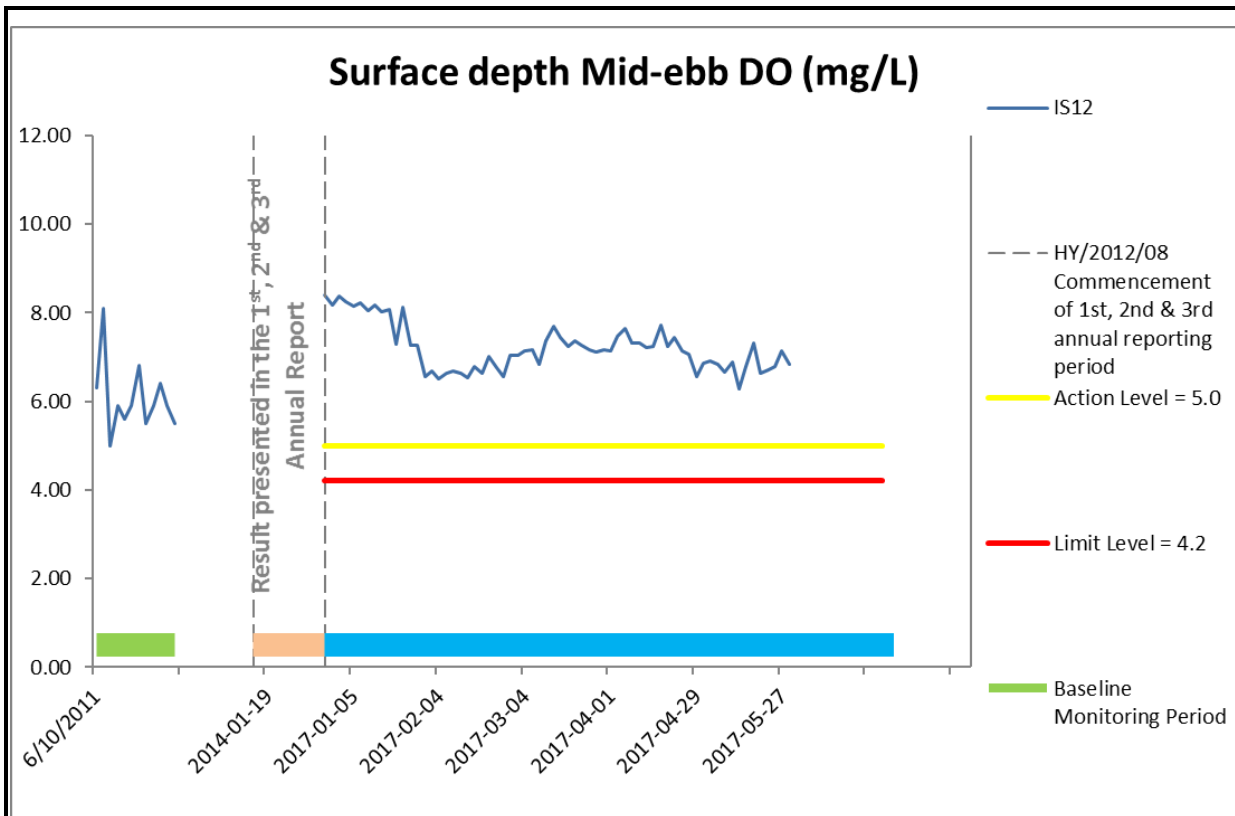
Figure E3 Baseline & Impact Monitoring - Mean Level of Dissolved Oxygen (mg/L) in surface waters between Baseline monitoring period: 6/10/2011 to 31/10/2011 and Impact monitoring period: 3/1/2017 to 30/5/2017 at IS12. Weather condition within the reporting period varied between sunny to rainy. The overall monitoring results were not affected by weather conditions. Major marine construction activities included: Dredging, Reclamation filling and Construction of Vertical Seawall
