**Contract No. HY/2012/08  
Tuen Mun – Chek Lap Kok Link –  
Northern Connection Sub-sea Tunnel  
Section**

*Fourth Annual Environmental Monitoring &  
Audit (EM&A) Report*

26 November 2018

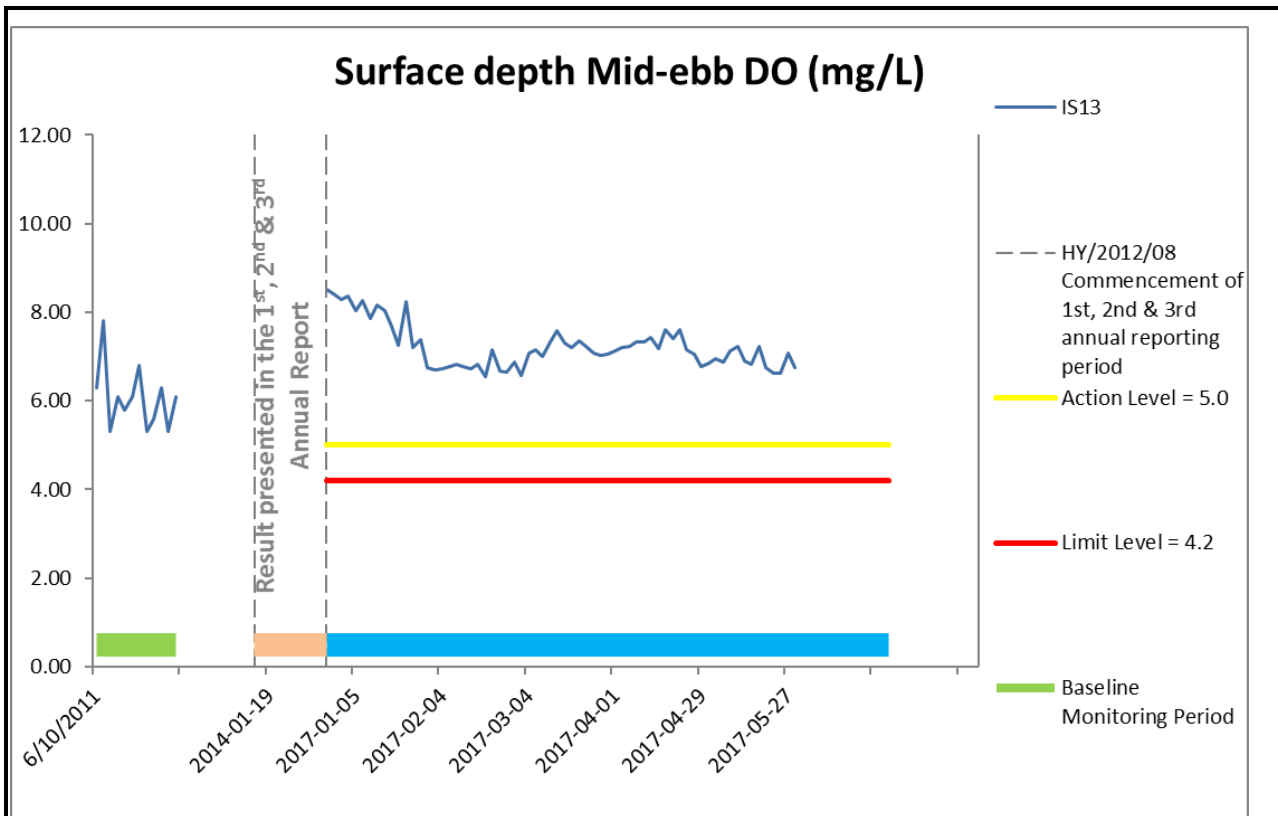
Figure E4 Baseline & Impact Monitoring - Mean Level of Dissolved Oxygen (mg/L) in surface waters between Baseline monitoring period: 6/10/2011 to 31/10/2011 and Impact monitoring period: 3/1/2017 to 30/5/2017 at IS13. Weather condition within the reporting period varied between sunny to rainy. The overall monitoring results were not affected by weather conditions. Major marine construction activities included: Dredging, Reclamation filling and Construction of Vertical Seawall

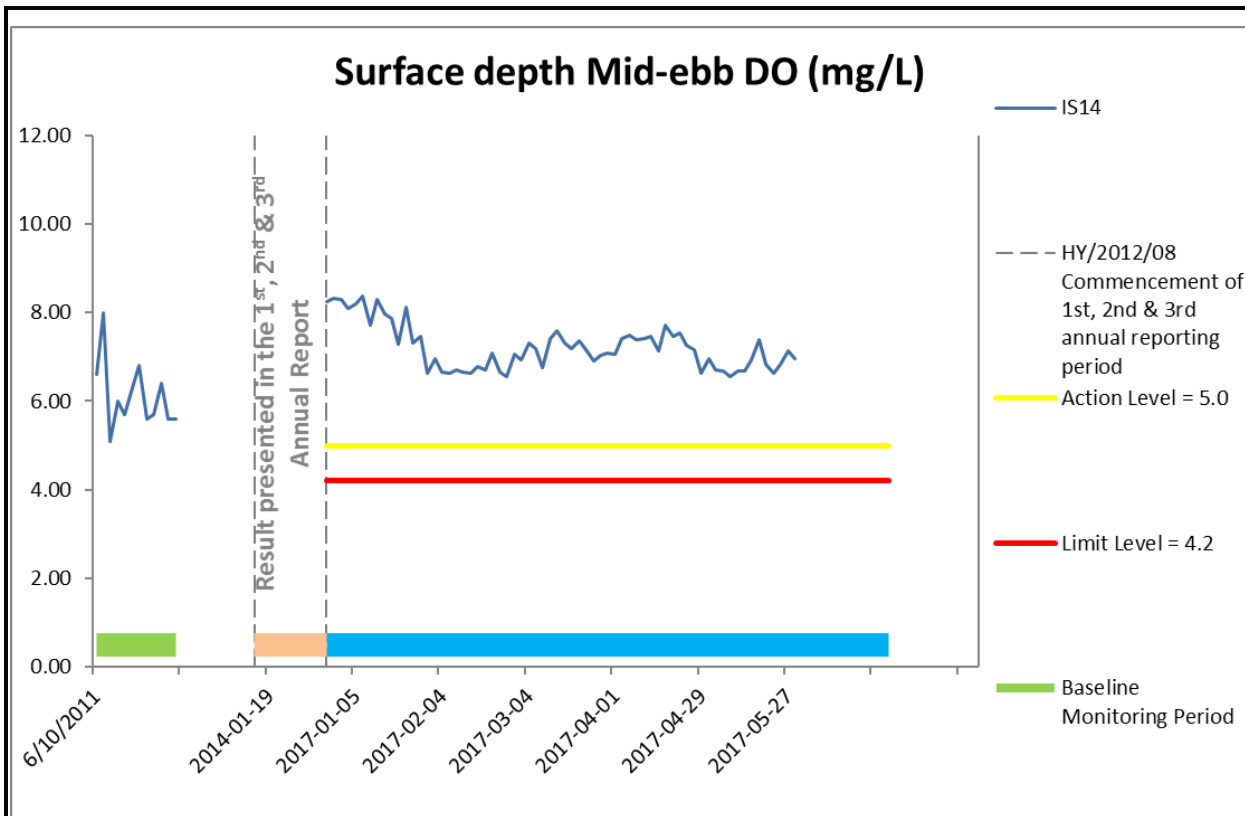
**Figure E5 Baseline & Impact Monitoring - Mean Level of Dissolved Oxygen (mg/L) in surface waters between Baseline monitoring period: 6/10/2011 to 31/10/2011 and Impact monitoring period: 3/1/2017 to 30/5/2017 at IS14. Weather condition within the reporting period varied between sunny to rainy. The overall monitoring results were not affected by weather conditions. Major marine construction activities included: Dredging, Reclamation filling and Construction of Vertical Seawall**

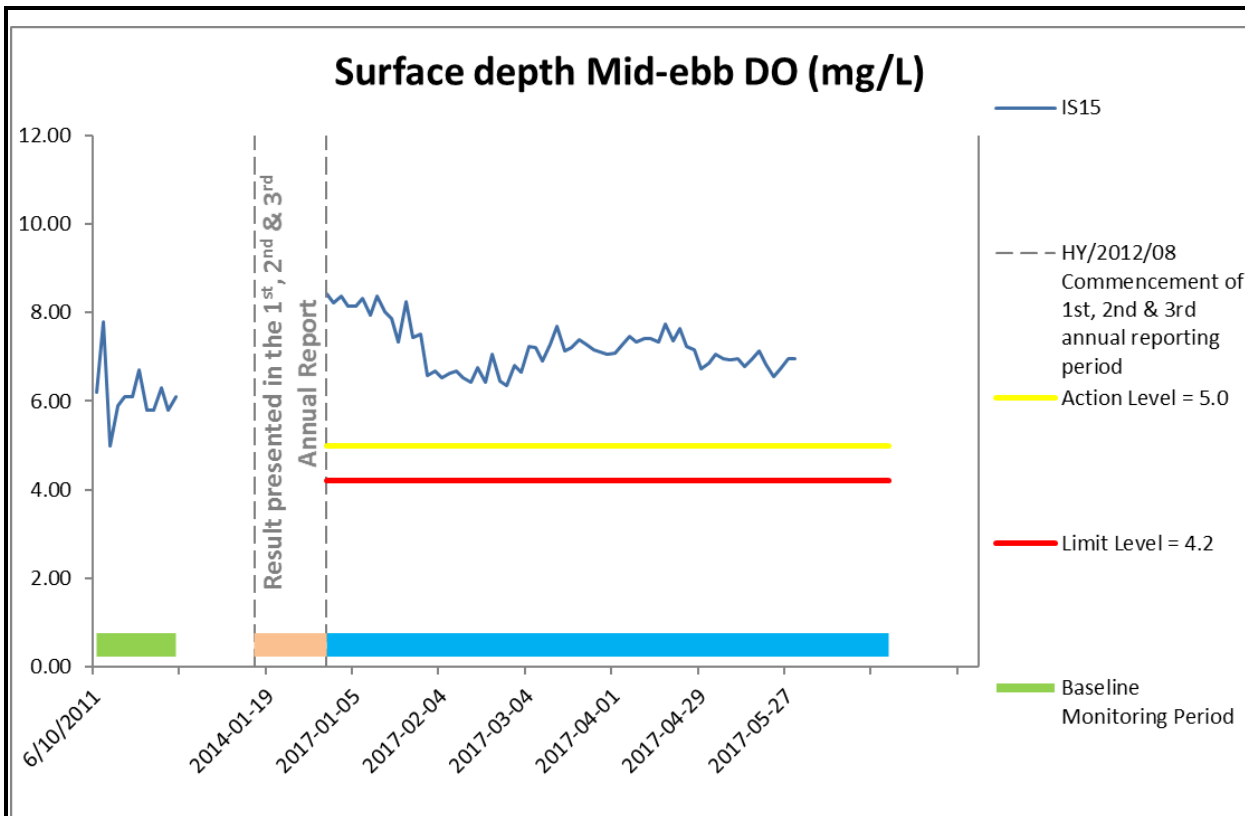
**Figure E6 Baseline & Impact Monitoring - Mean Level of Dissolved Oxygen (mg/L) in surface waters between Baseline monitoring period: 6/10/2011 to 31/10/2011 and Impact monitoring period: 3/1/2017 to 30/5/2017 at IS15. Weather condition within the reporting period varied between sunny to rainy. The overall monitoring results were not affected by weather conditions. Major marine construction activities included: Dredging, Reclamation filling and Construction of Vertical Seawall**

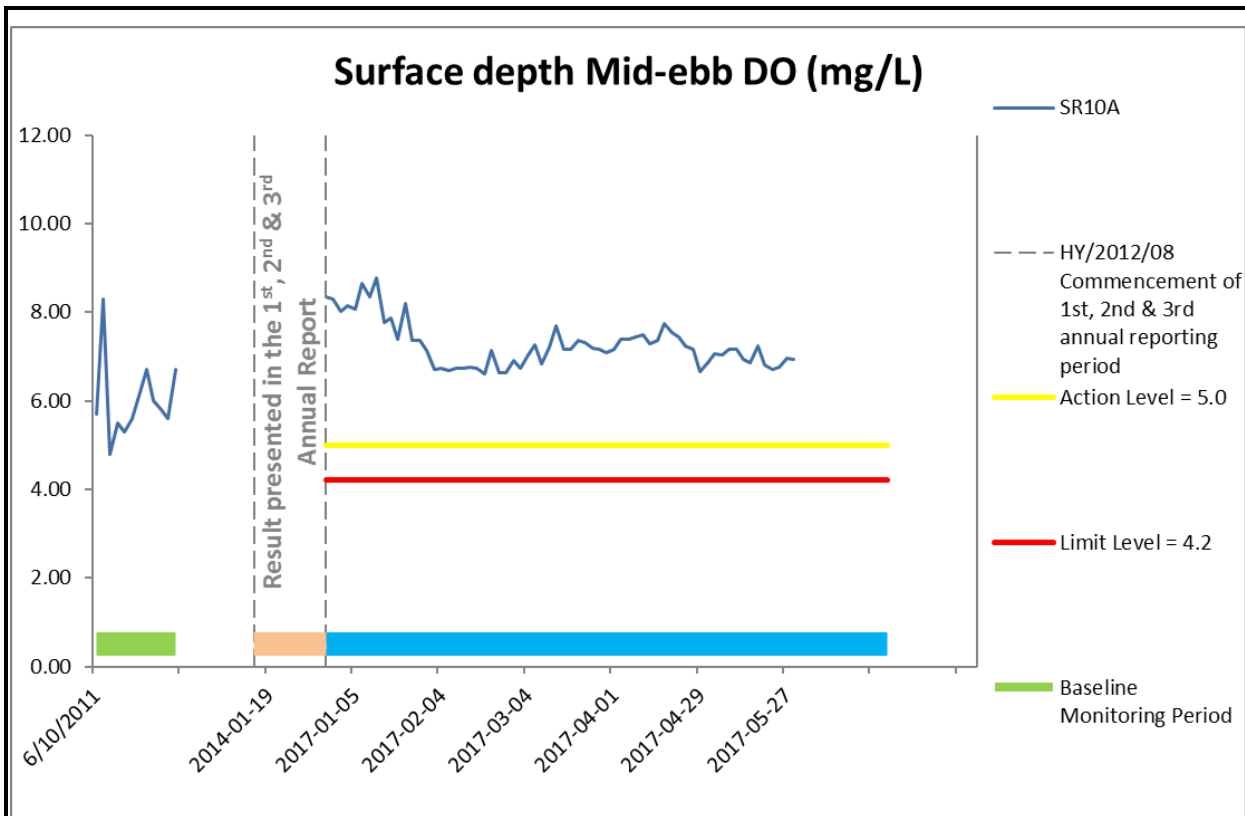
**Figure E7 Baseline & Impact Monitoring - Mean Level of Dissolved Oxygen (mg/L) in surface waters between Baseline monitoring period: 6/10/2011 to 31/10/2011 and Impact monitoring period: 3/1/2017 to 30/5/2017 at SR10A. Weather condition within the reporting period varied between sunny to rainy. The overall monitoring results were not affected by weather conditions. Major marine construction activities included: Dredging, Reclamation filling and Construction of Vertical Seawall**

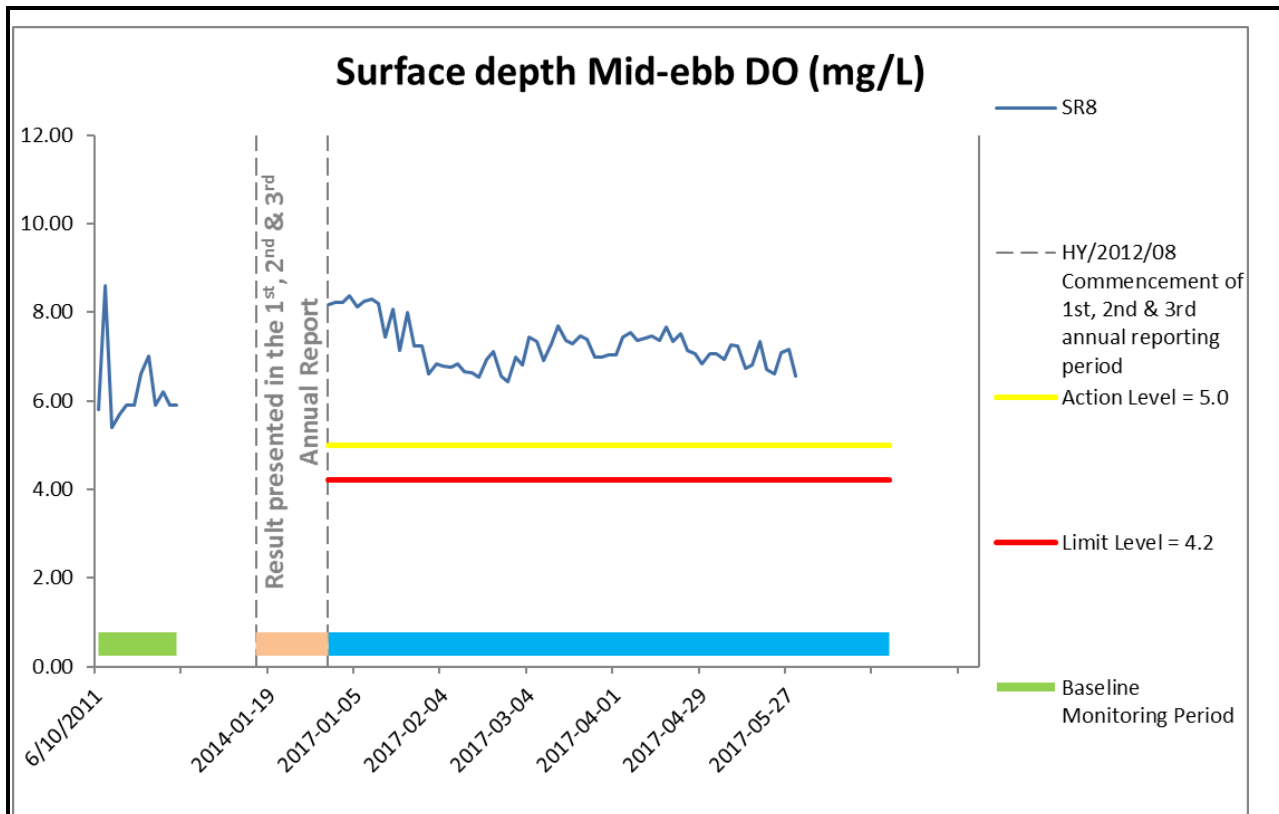
**Figure E8 Baseline & Impact Monitoring - Mean Level of Dissolved Oxygen (mg/L) in surface waters between Baseline monitoring period: 6/10/2011 to 31/10/2011 and Impact monitoring period: 3/1/2017 to 30/5/2017 at SR8. Weather condition within the reporting period varied between sunny to rainy. The overall monitoring results were not affected by weather conditions. Major marine construction activities included: Dredging, Reclamation filling and Construction of Vertical Seawall**

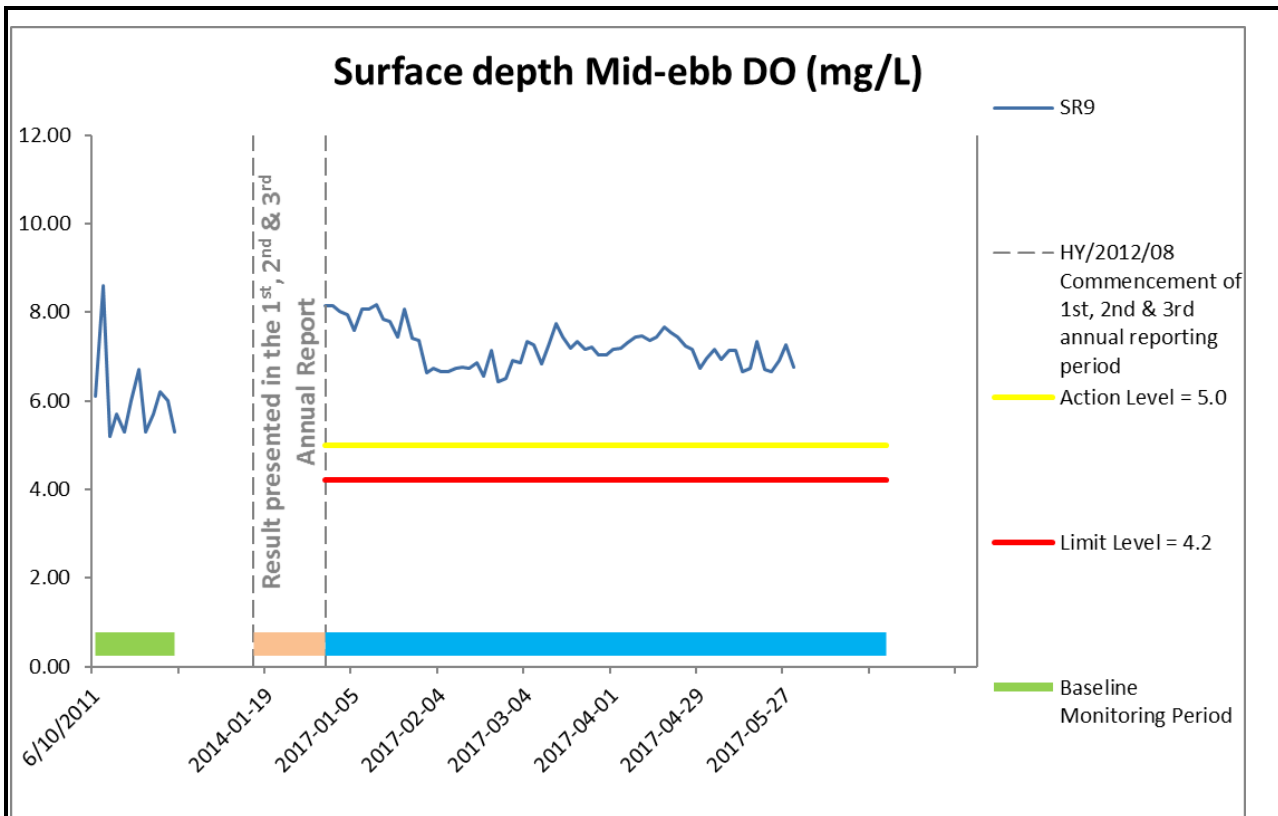
**Figure E9 Baseline & Impact Monitoring - Mean Level of Dissolved Oxygen (mg/L) in surface waters between Baseline monitoring period: 6/10/2011 to 31/10/2011 and Impact monitoring period: 3/1/2017 to 30/5/2017 at SR9. Weather condition within the reporting period varied between sunny to rainy. The overall monitoring results were not affected by weather conditions. Major marine construction activities included: Dredging, Reclamation filling and Construction of Vertical Seawall**

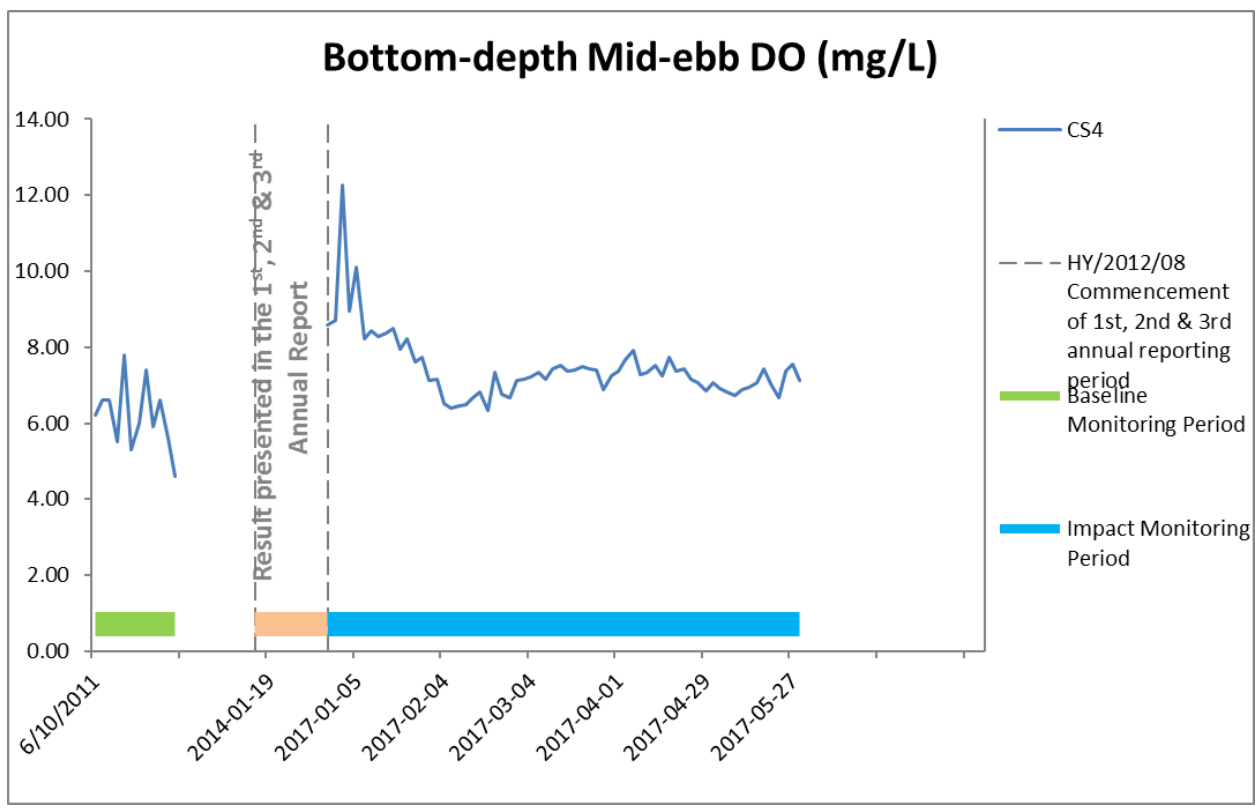
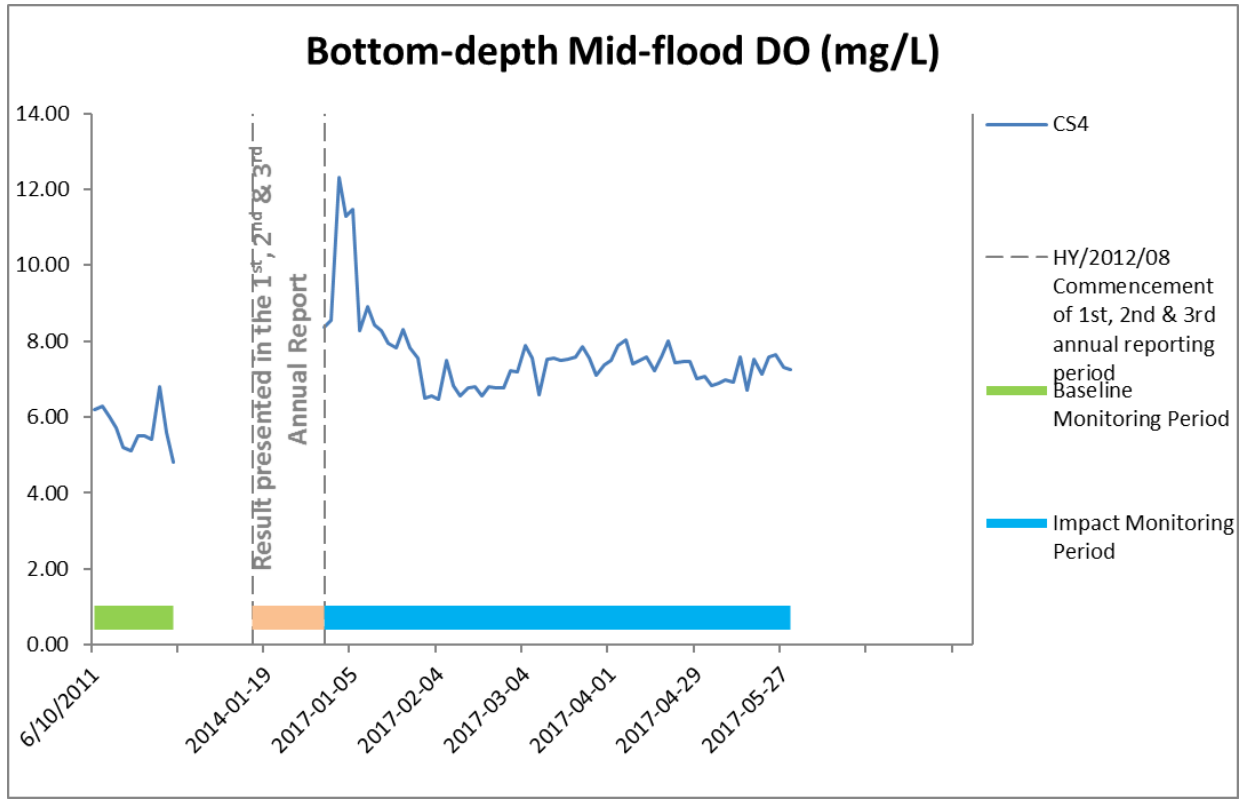
**Figure E17 Baseline & Impact Monitoring - Mean Level of Dissolved Oxygen (mg/L) in bottom water between Baseline monitoring period: 6/10/2011 to 31/10/2011 and Impact monitoring period: 3/1/2017 to 30/5/2017 at CS4. Weather condition within the reporting period varied between sunny to rainy. The overall monitoring results were not affected by weather conditions. Major marine construction activities included: Dredging, Reclamation filling and Construction of Vertical Seawall**

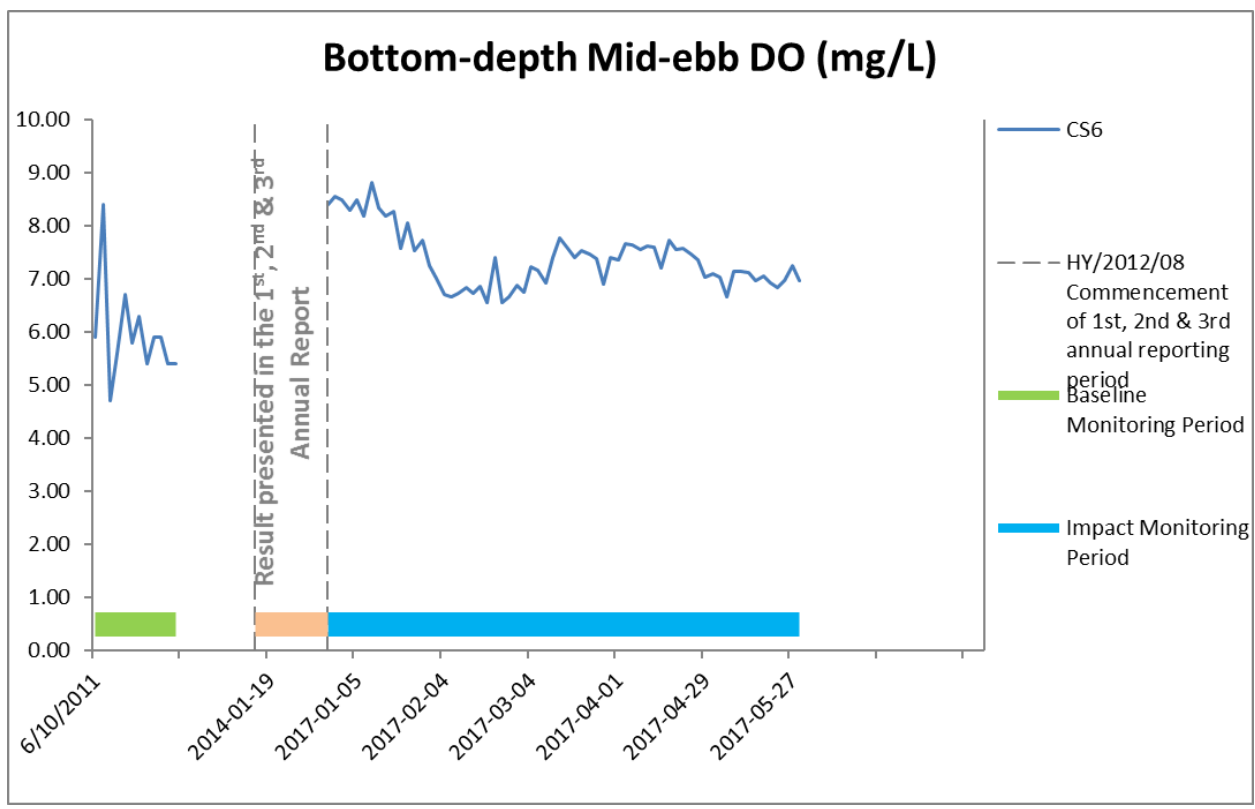
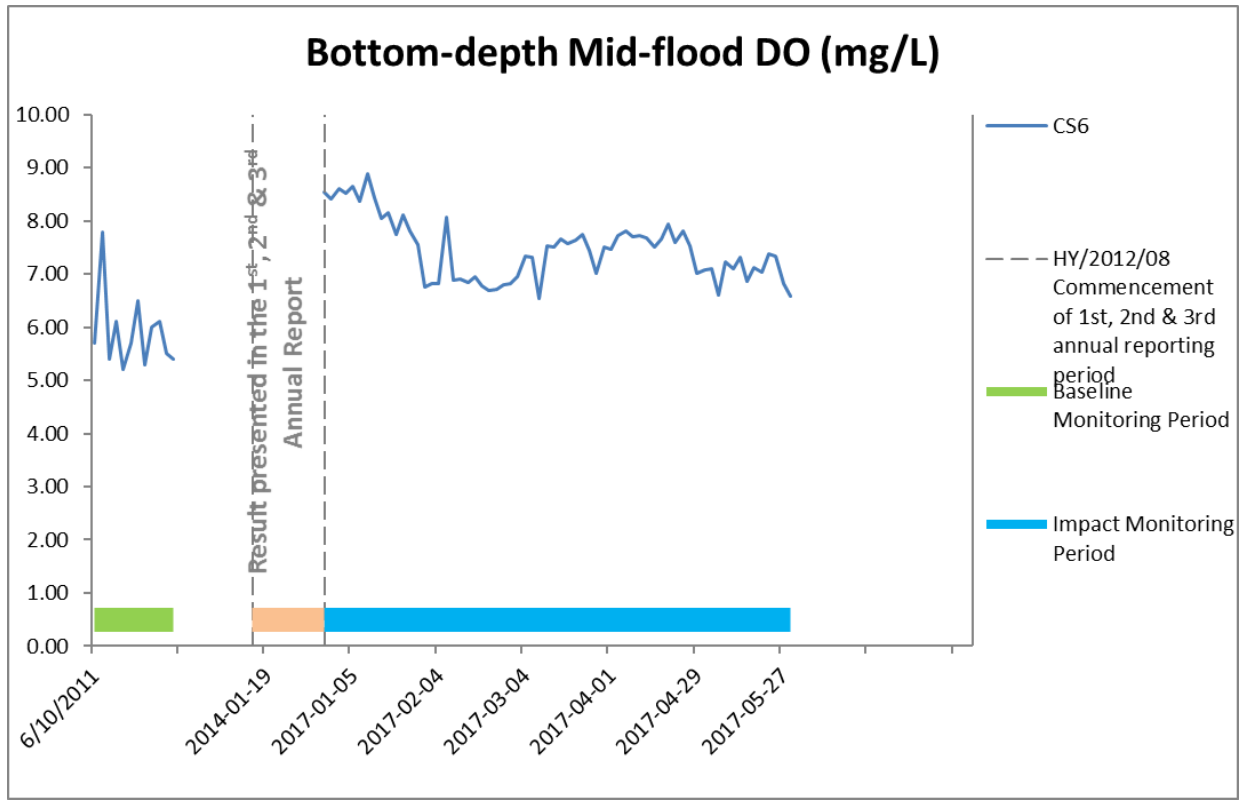
**Figure E18 Baseline & Impact Monitoring - Mean Level of Dissolved Oxygen (mg/L) in bottom water between Baseline monitoring period: 6/10/2011 to 31/10/2011 and Impact monitoring period: 3/1/2017 to 30/5/2017 at CS6. Weather condition within the reporting period varied between sunny to rainy. The overall monitoring results were not affected by weather conditions. Major marine construction activities included: Dredging, Reclamation filling and Construction of Vertical Seawall**

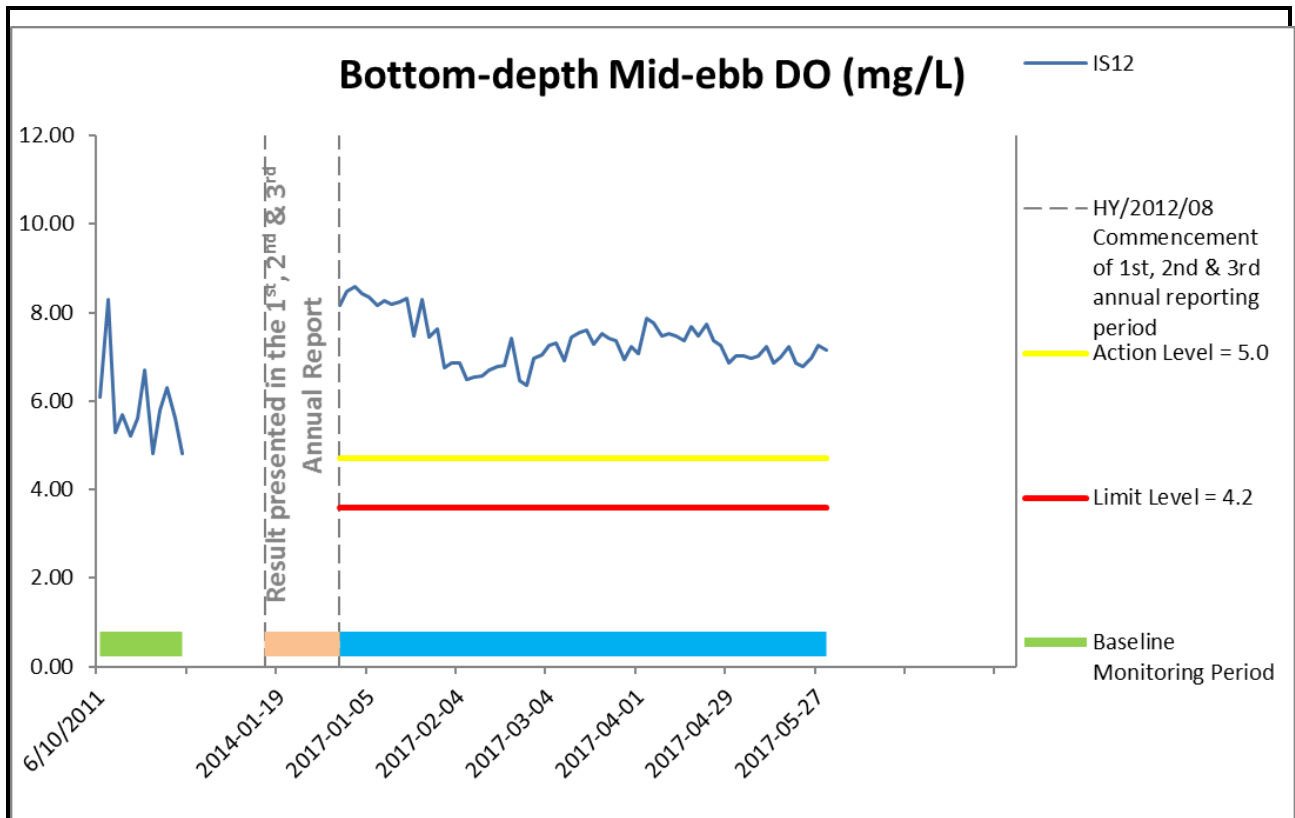
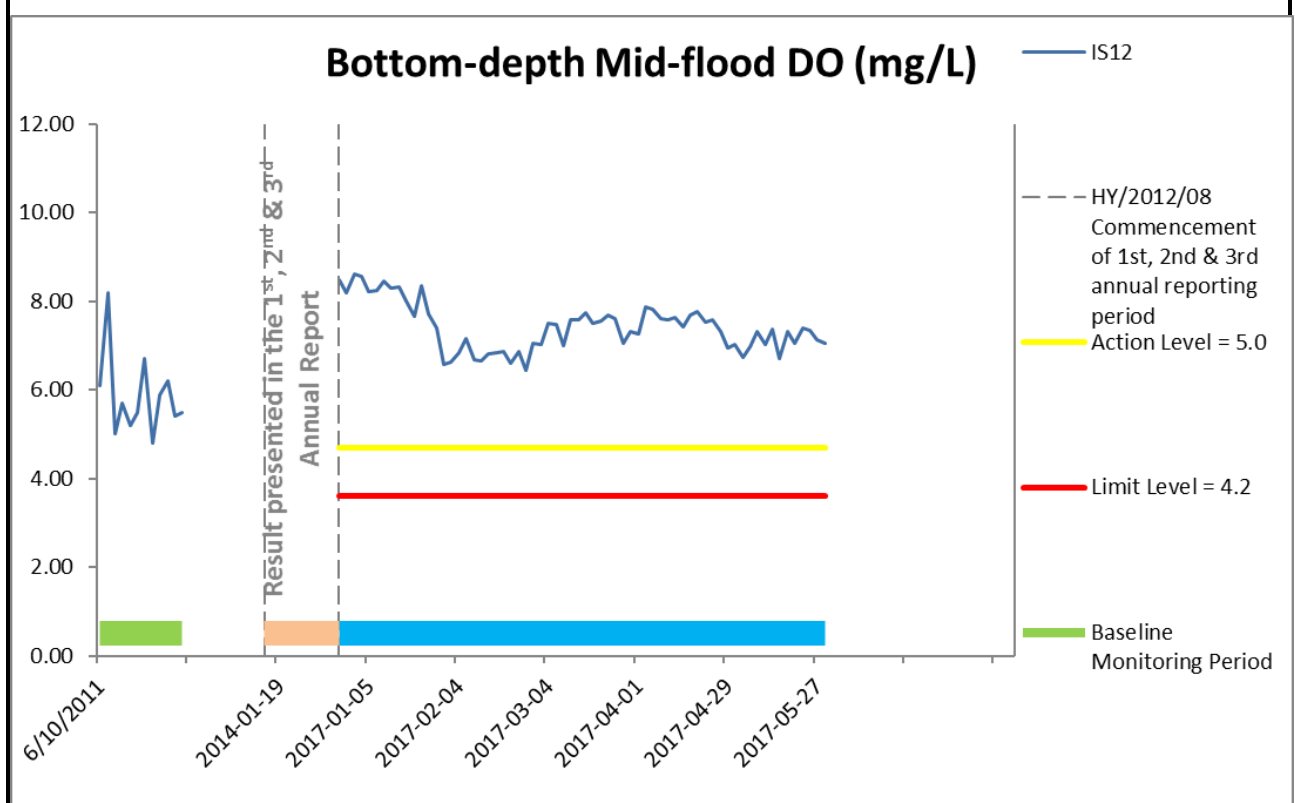
**Figure E19 Baseline & Impact Monitoring - Mean Level of Dissolved Oxygen (mg/L) in bottom water between Baseline monitoring period: 6/10/2011 to 31/10/2011 and Impact monitoring period: 3/1/2017 to 30/5/2017 at IS12. Weather condition within the reporting period varied between sunny to rainy. The overall monitoring results were not affected by weather conditions. Major marine construction activities included: Dredging, Reclamation filling and Construction of Vertical Seawall**

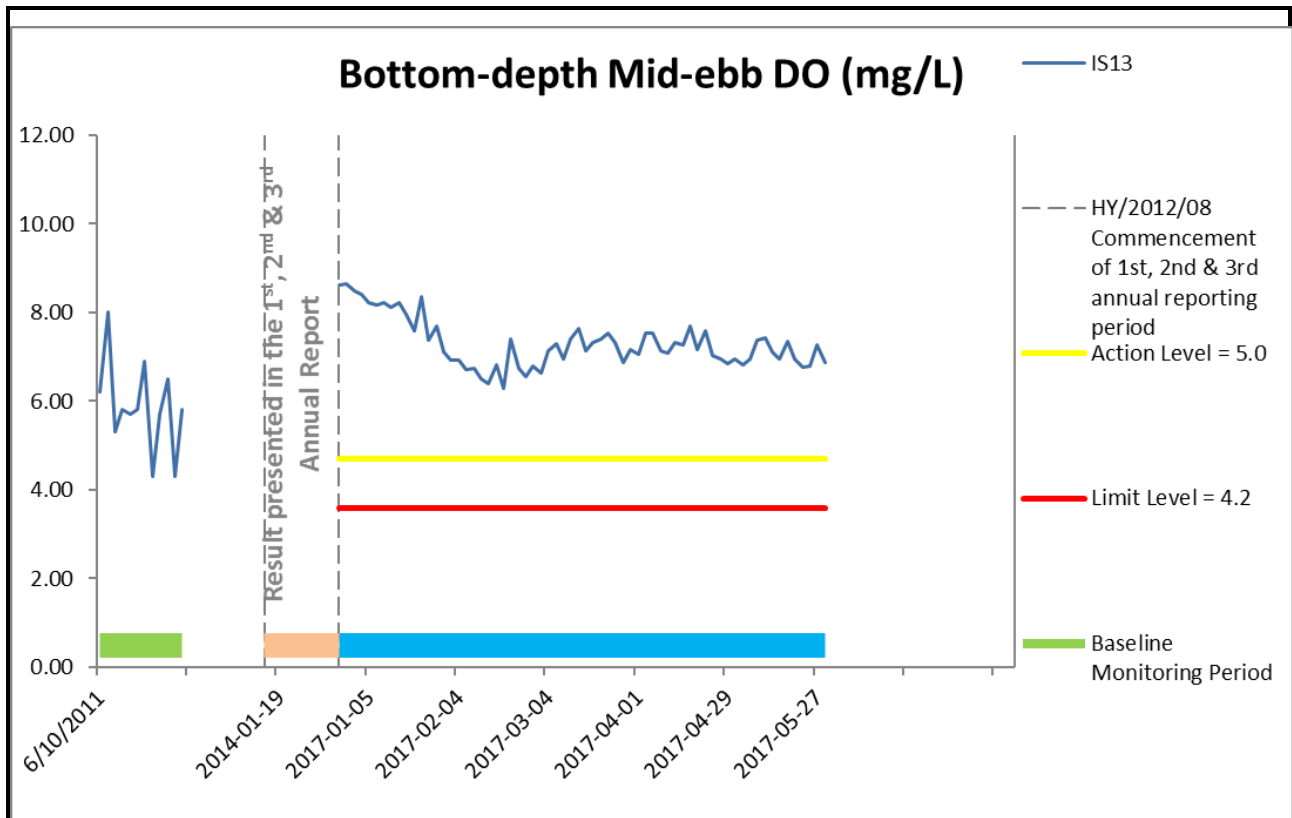
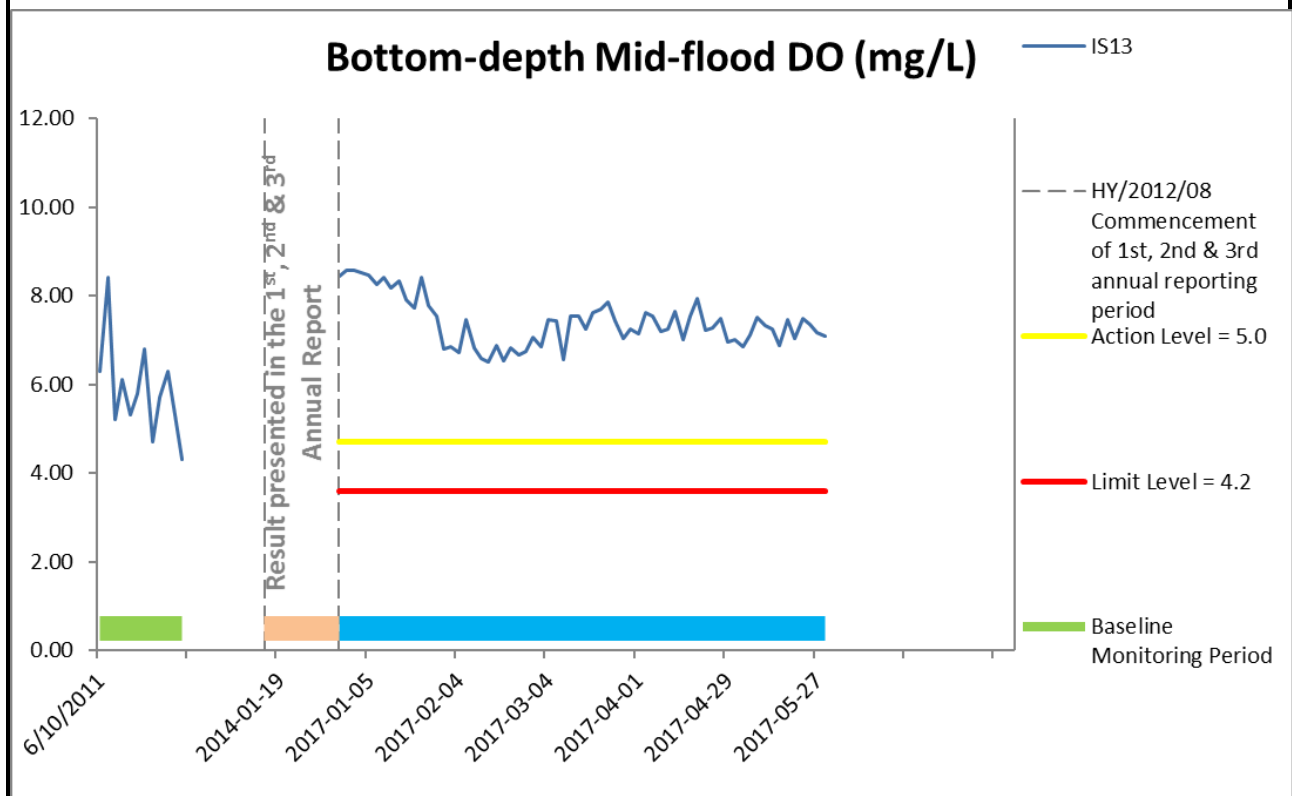
Figure E20 Baseline & Impact Monitoring - Mean Level of Dissolved Oxygen (mg/L) in bottom water between Baseline monitoring period: 6/10/2011 to 31/10/2011 and Impact monitoring period: 3/1/2017 to 30/5/2017 at IS13. Weather condition within the reporting period varied between sunny to rainy. The overall monitoring results were not affected by weather conditions. Major marine construction activities included: Dredging, Reclamation filling and Construction of Vertical Seawall

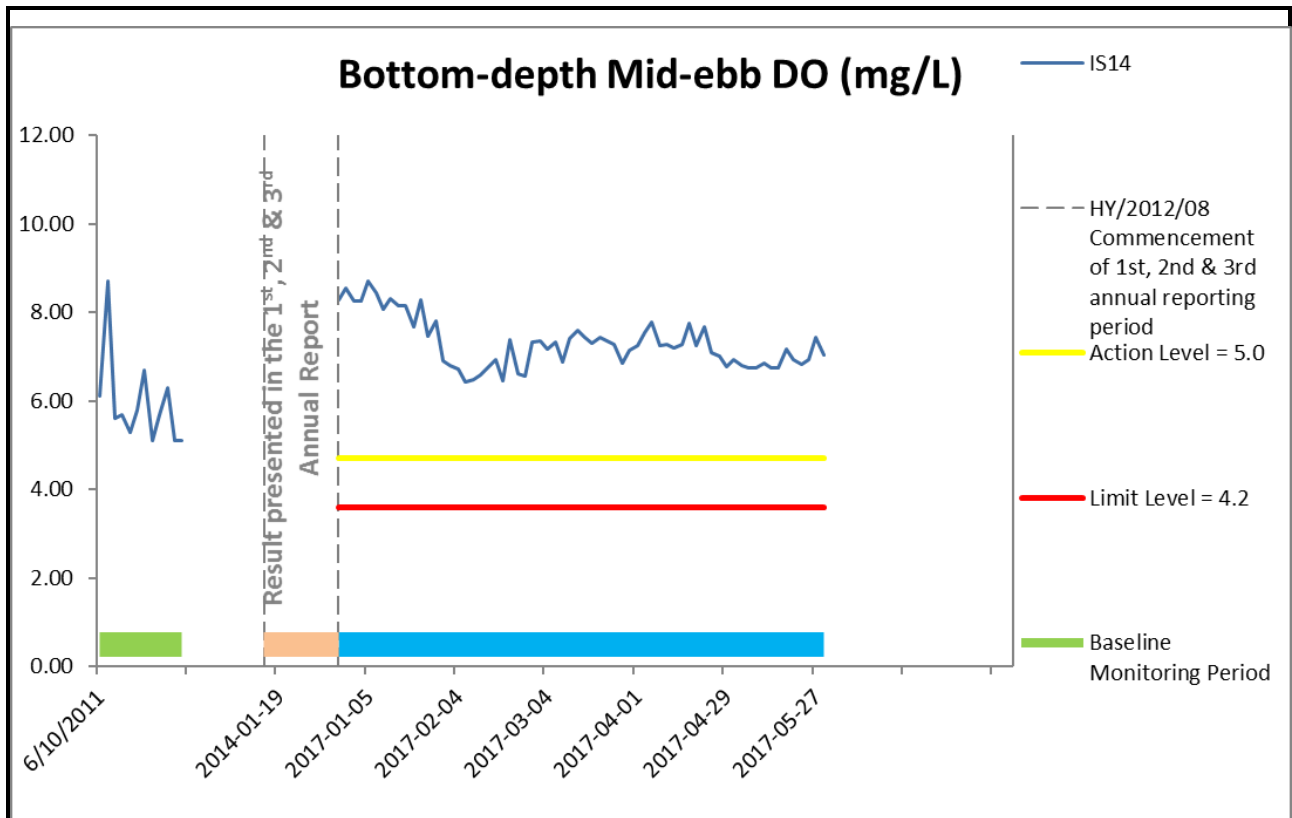
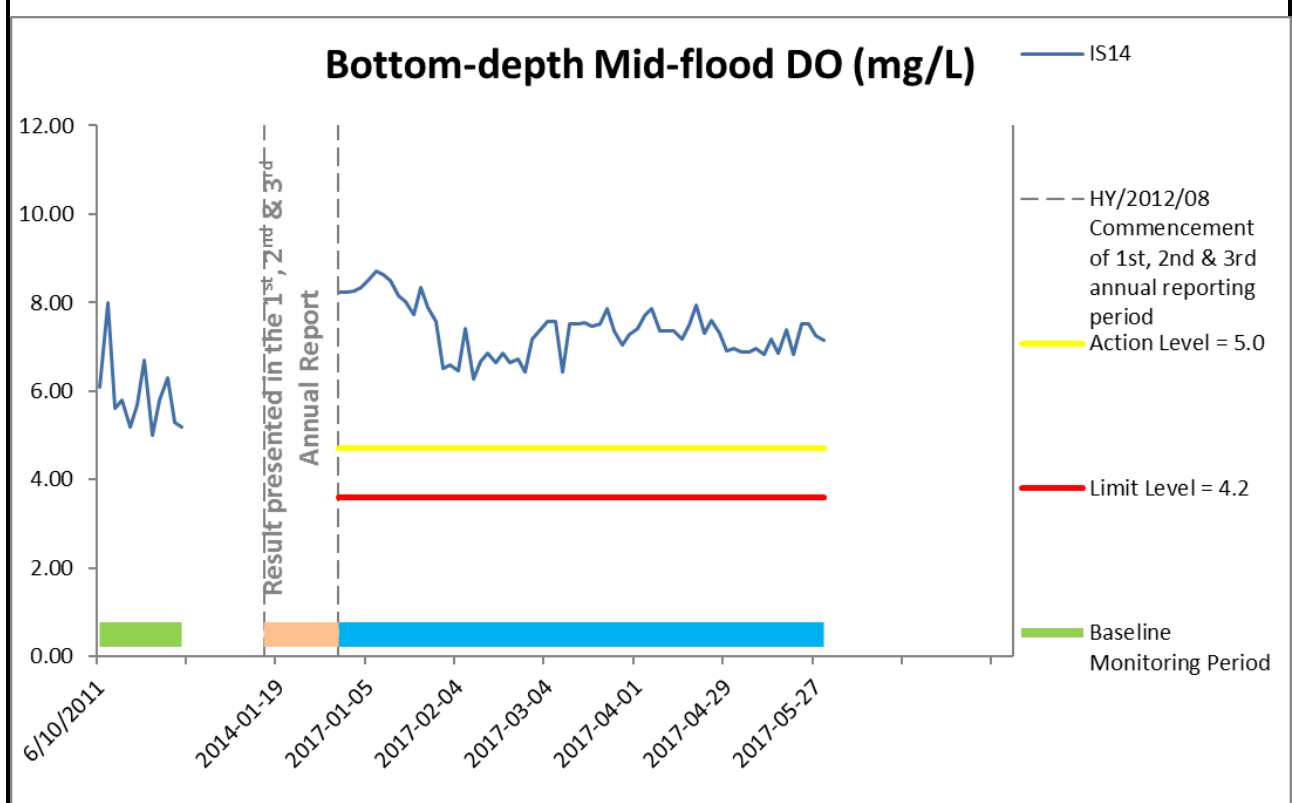
Figure E21 Baseline & Impact Monitoring - Mean Level of Dissolved Oxygen (mg/L) in bottom water between Baseline monitoring period: 6/10/2011 to 31/10/2011 and Impact monitoring period: 3/1/2017 to 30/5/2017 at IS14. Weather condition within the reporting period varied between sunny to rainy. The overall monitoring results were not affected by weather conditions. Major marine construction activities included: Dredging, Reclamation filling and Construction of Vertical Seawall

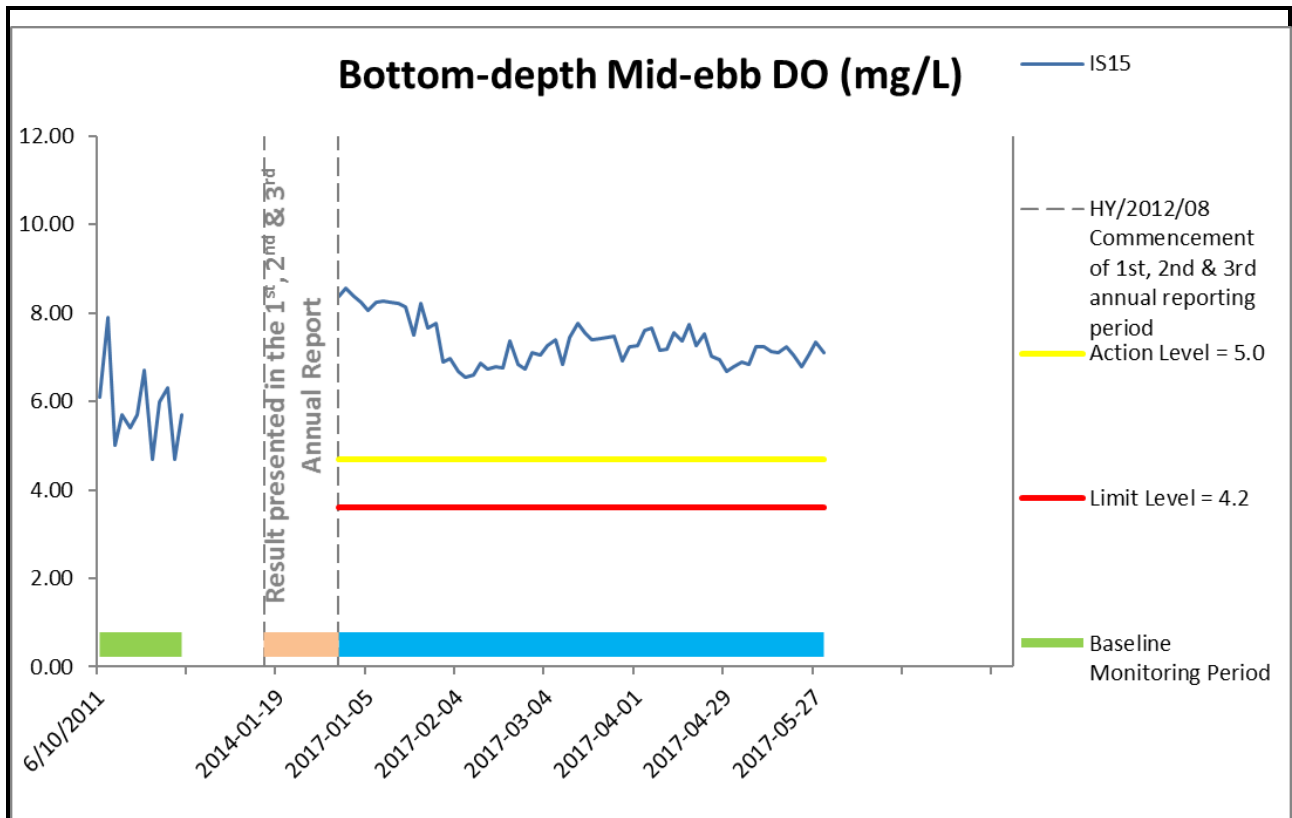
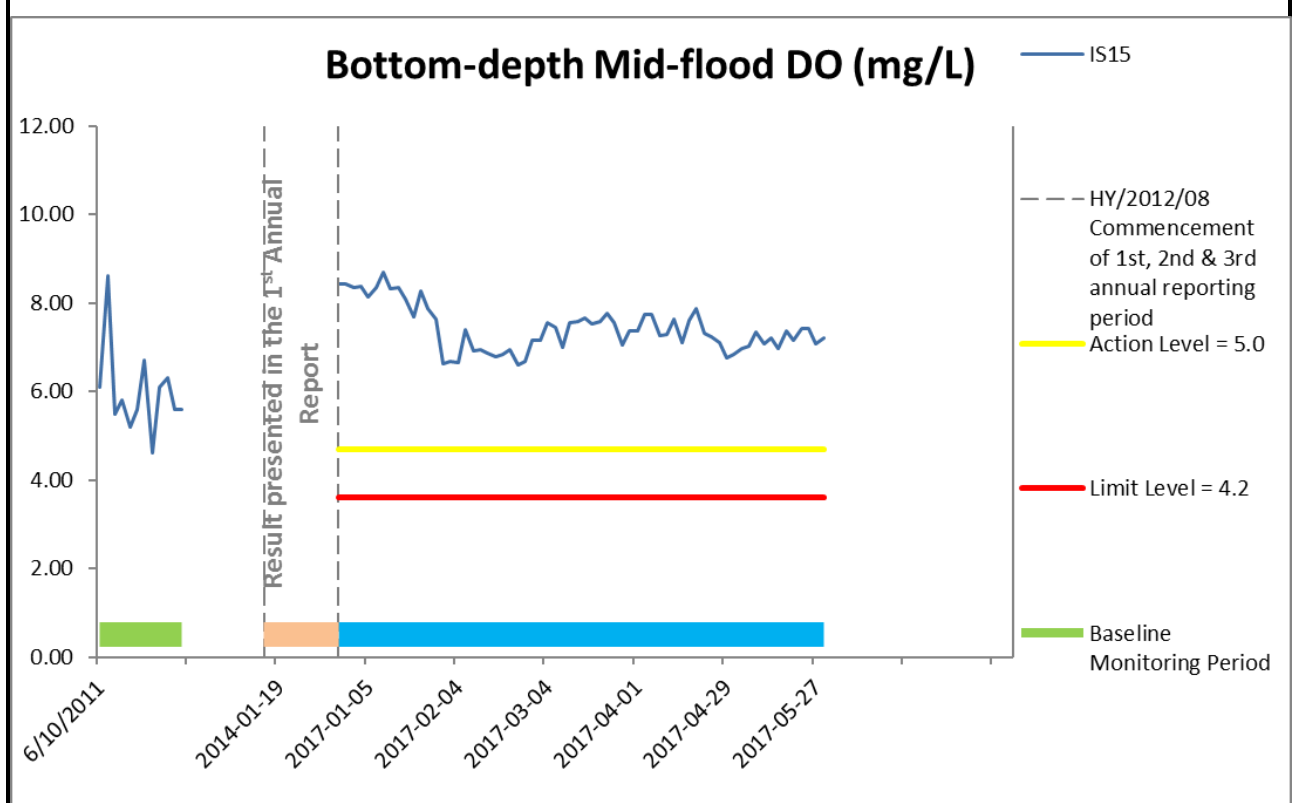
Figure E22 Baseline & Impact Monitoring - Mean Level of Dissolved Oxygen (mg/L) in bottom water between Baseline monitoring period: 6/10/2011 to 31/10/2011 and Impact monitoring period: 3/1/2017 to 30/5/2017 at IS15. Weather condition within the reporting period varied between sunny to rainy. The overall monitoring results were not affected by weather conditions. Major marine construction activities included: Dredging, Reclamation filling and Construction of Vertical Seawall

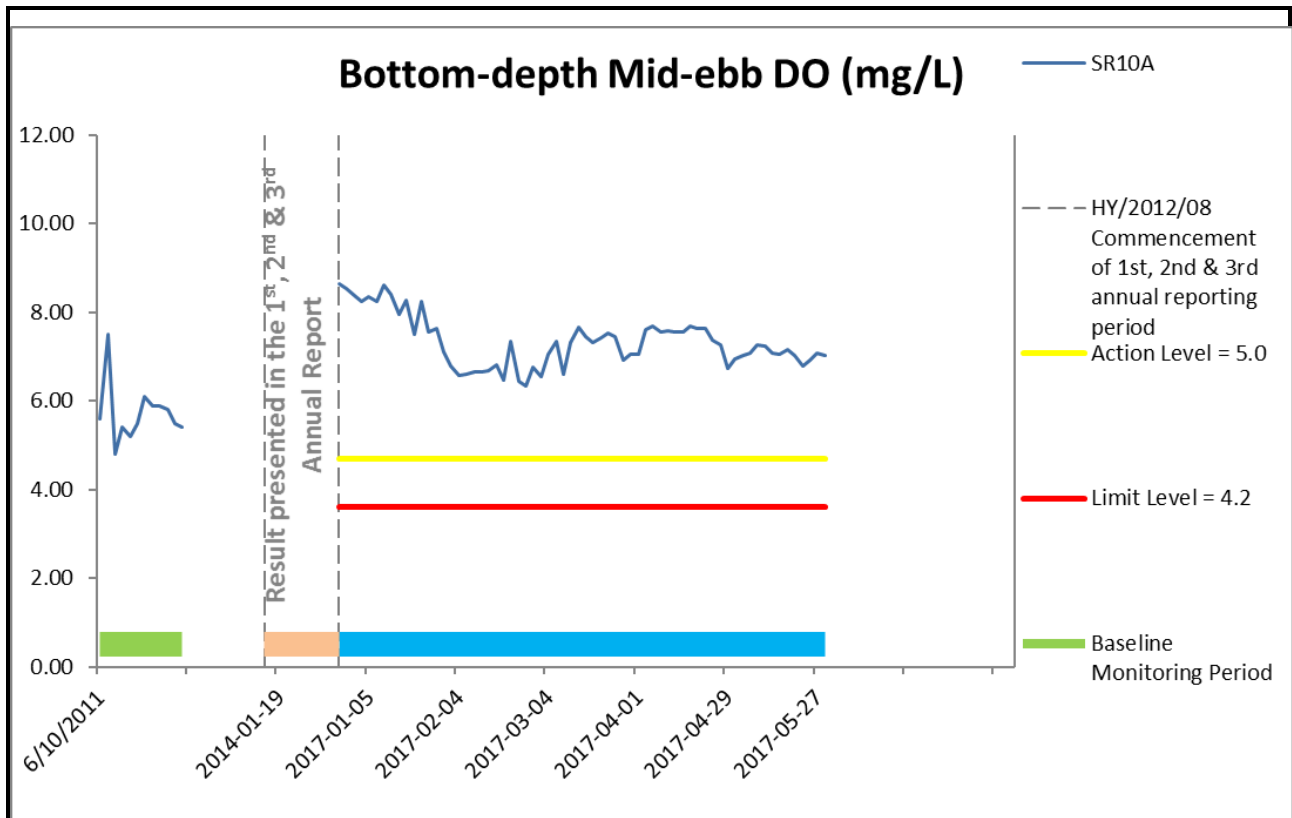
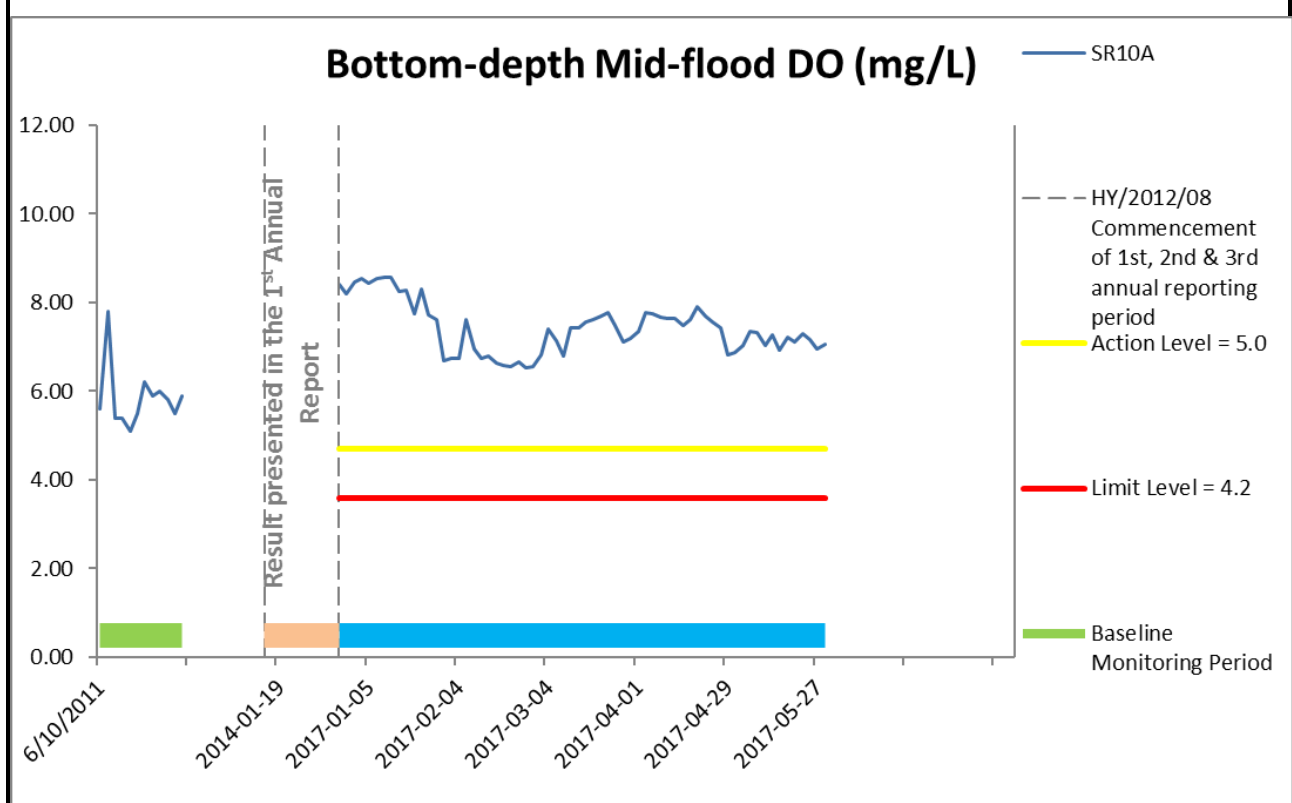
Figure E23 Baseline & Impact Monitoring - Mean Level of Dissolved Oxygen (mg/L) in bottom water between Baseline monitoring period: 6/10/2011 to 31/10/2011 and Impact monitoring period: 3/1/2017 to 30/5/2017 at SR10A. Weather condition within the reporting period varied between sunny to rainy. The overall monitoring results were not affected by weather conditions. Major marine construction activities included: Dredging, Reclamation filling and Construction of Vertical Seawall
