**Contract No. HY/2012/08  
Tuen Mun – Chek Lap Kok Link –  
Northern Connection Sub-sea Tunnel  
Section**

*Fourth Annual Environmental Monitoring &  
Audit (EM&A) Report*

26 November 2018

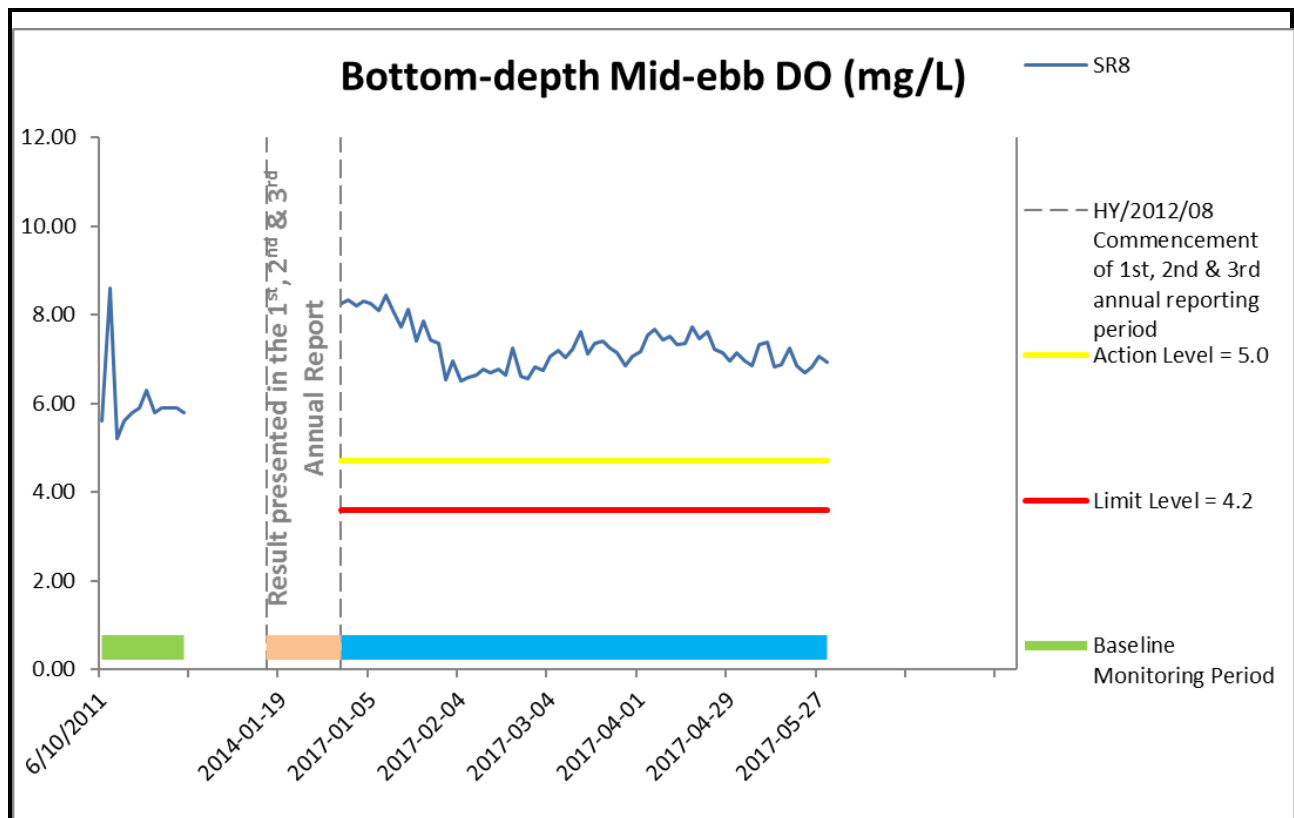
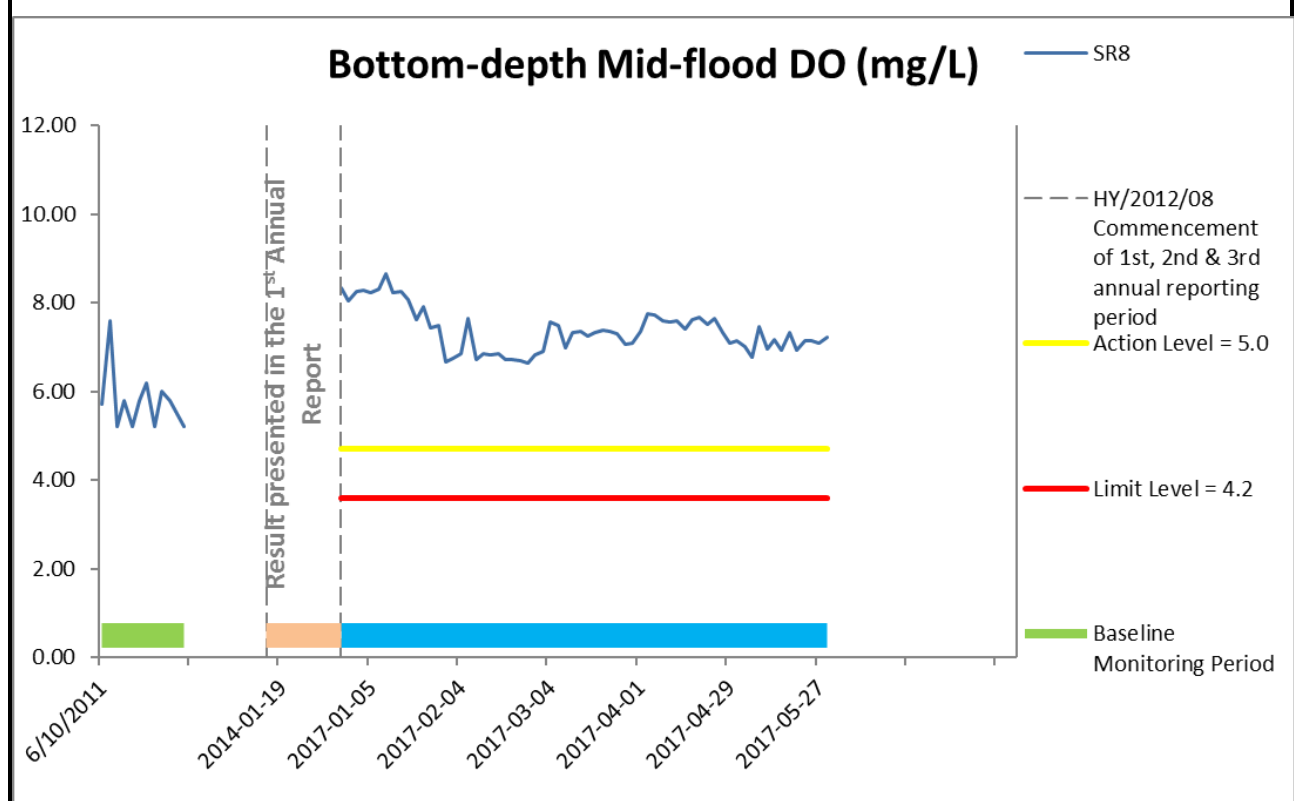
Figure E24 Baseline & Impact Monitoring - Mean Level of Dissolved Oxygen (mg/L) in bottom water between Baseline monitoring period: 6/10/2011 to 31/10/2011 and Impact monitoring period: 3/1/2017 to 30/5/2017 at SR8. Weather condition within the reporting period varied between sunny to rainy. The overall monitoring results were not affected by weather conditions. Major marine construction activities included: Dredging, Reclamation filling and Construction of Vertical Seawall

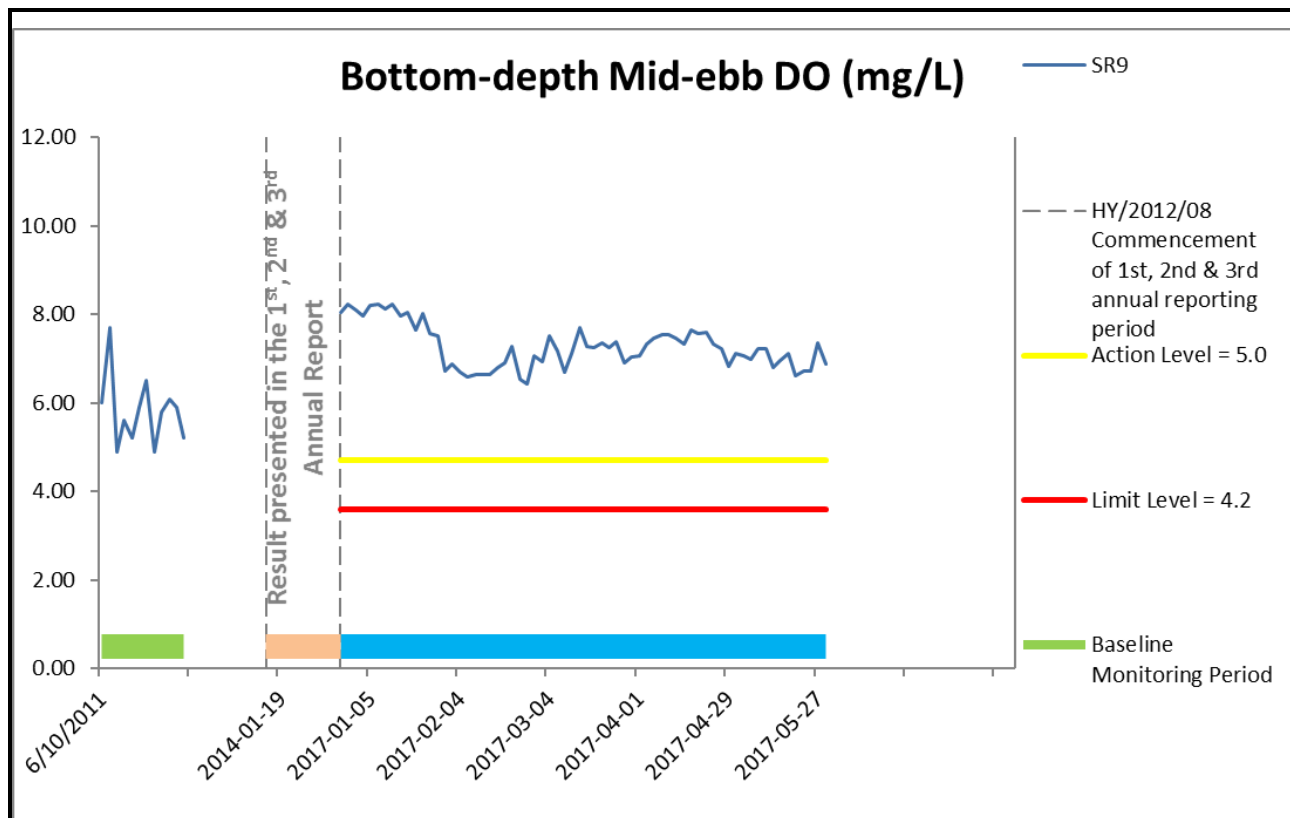
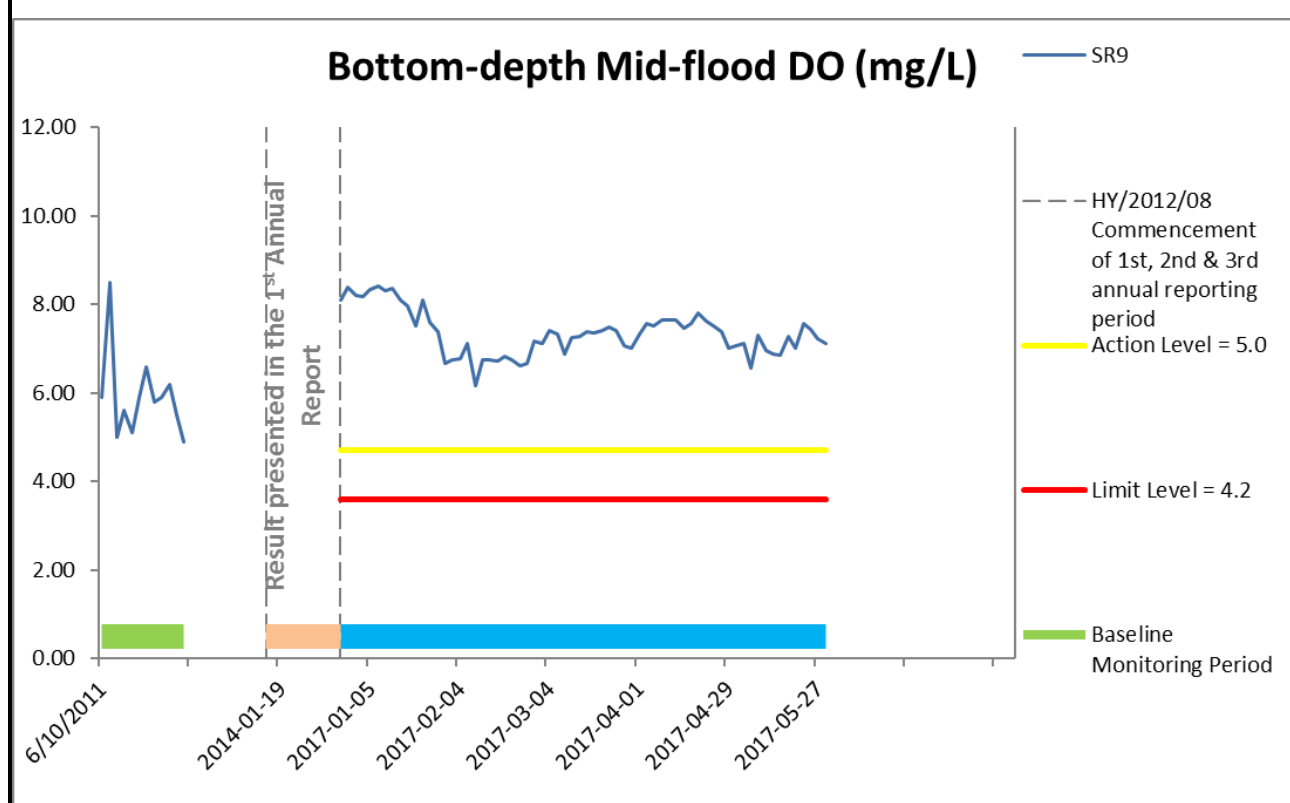
Figure E25 Baseline & Impact Monitoring - Mean Level of Dissolved Oxygen (mg/L) in bottom water between Baseline monitoring period: 6/10/2011 to 31/10/2011 and Impact monitoring period: 3/1/2017 to 30/5/2017 at SR9. Weather condition within the reporting period varied between sunny to rainy. The overall monitoring results were not affected by weather conditions. Major marine construction activities included: Dredging, Reclamation filling and Construction of Vertical Seawall

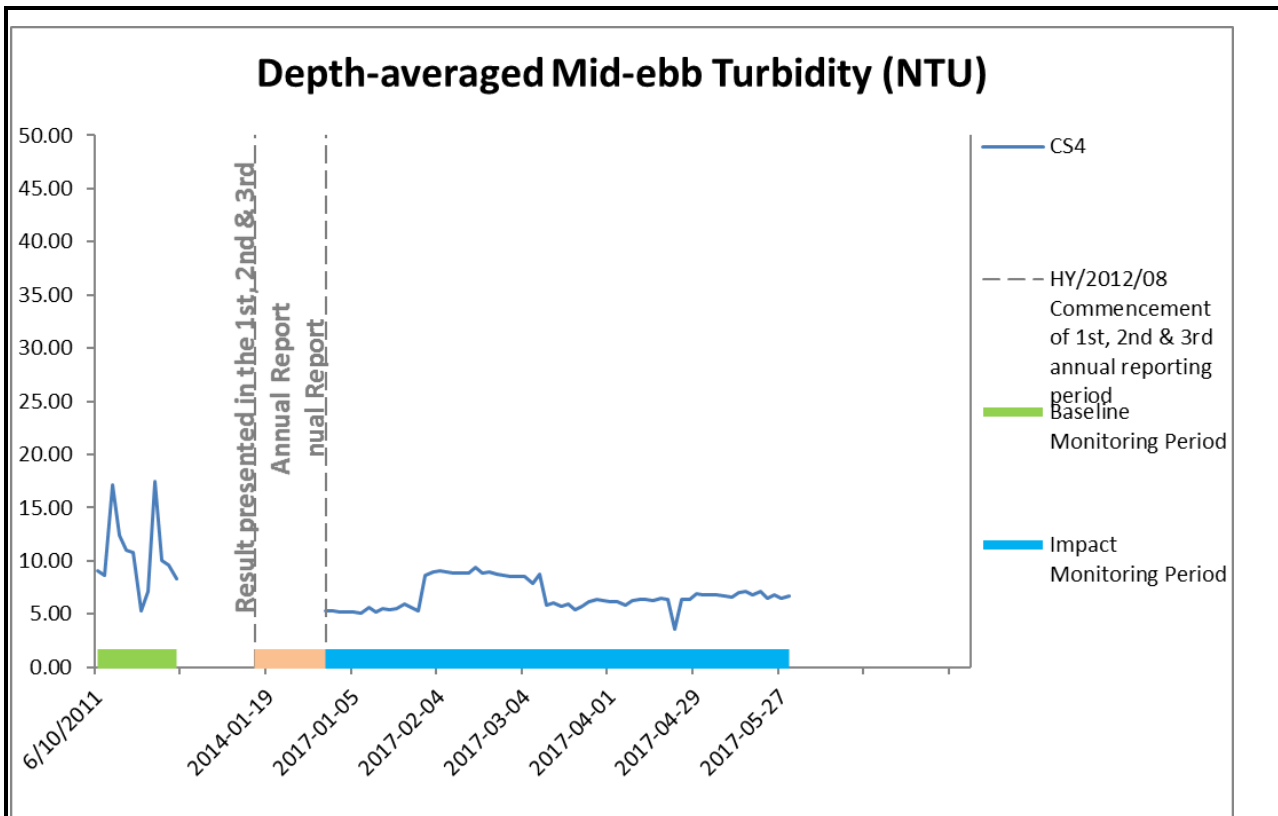
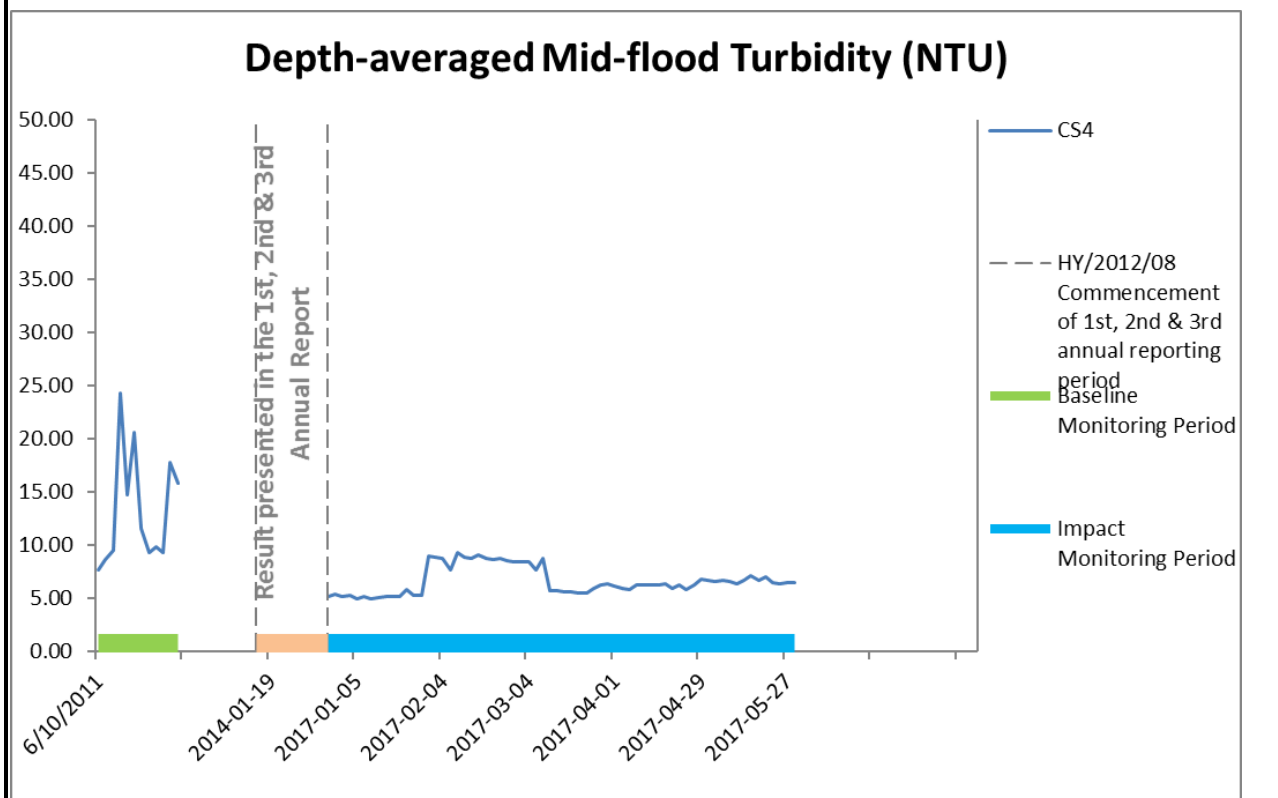
**Figure E26 Baseline & Impact Monitoring – Mean Depth-averaged Level of Turbidity (NTU) between Baseline monitoring period: 6/10/2011 to 31/10/2011 and Impact monitoring period: 3/1/2017 to 30/5/2017 at CS4. Weather condition within the reporting period varied between sunny to rainy. The overall monitoring results were not affected by weather conditions. Major marine construction activities included: Dredging, Reclamation filling and Construction of Vertical Seawall**

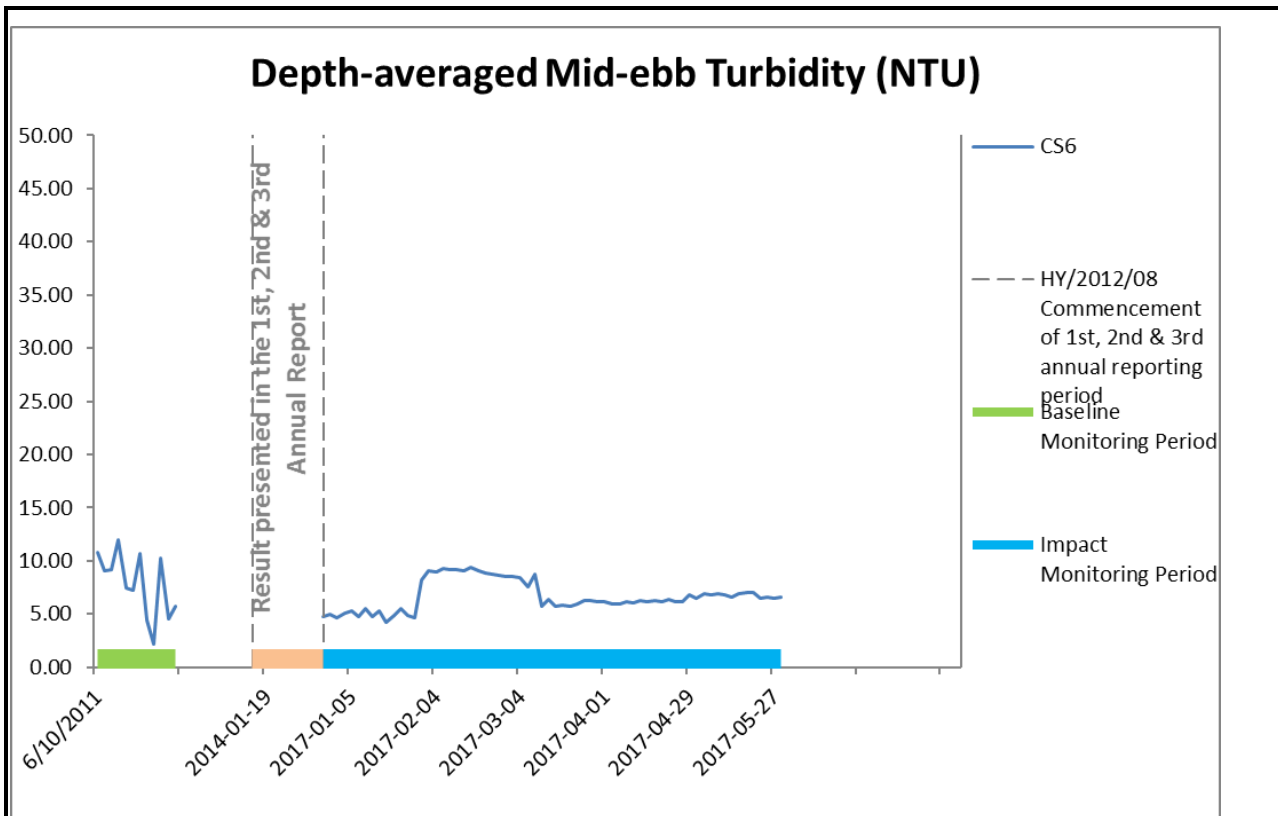
**Figure E27 Baseline & Impact Monitoring - Mean Depth-averaged Level of Turbidity (NTU) between Baseline monitoring period: 6/10/2011 to 31/10/2011 and Impact monitoring period: 3/1/2017 to 30/5/2017 at CS6. Weather condition within the reporting period varied between sunny to rainy. The overall monitoring results were not affected by weather conditions. Major marine construction activities included: Dredging, Reclamation filling and Construction of Vertical Seawall**

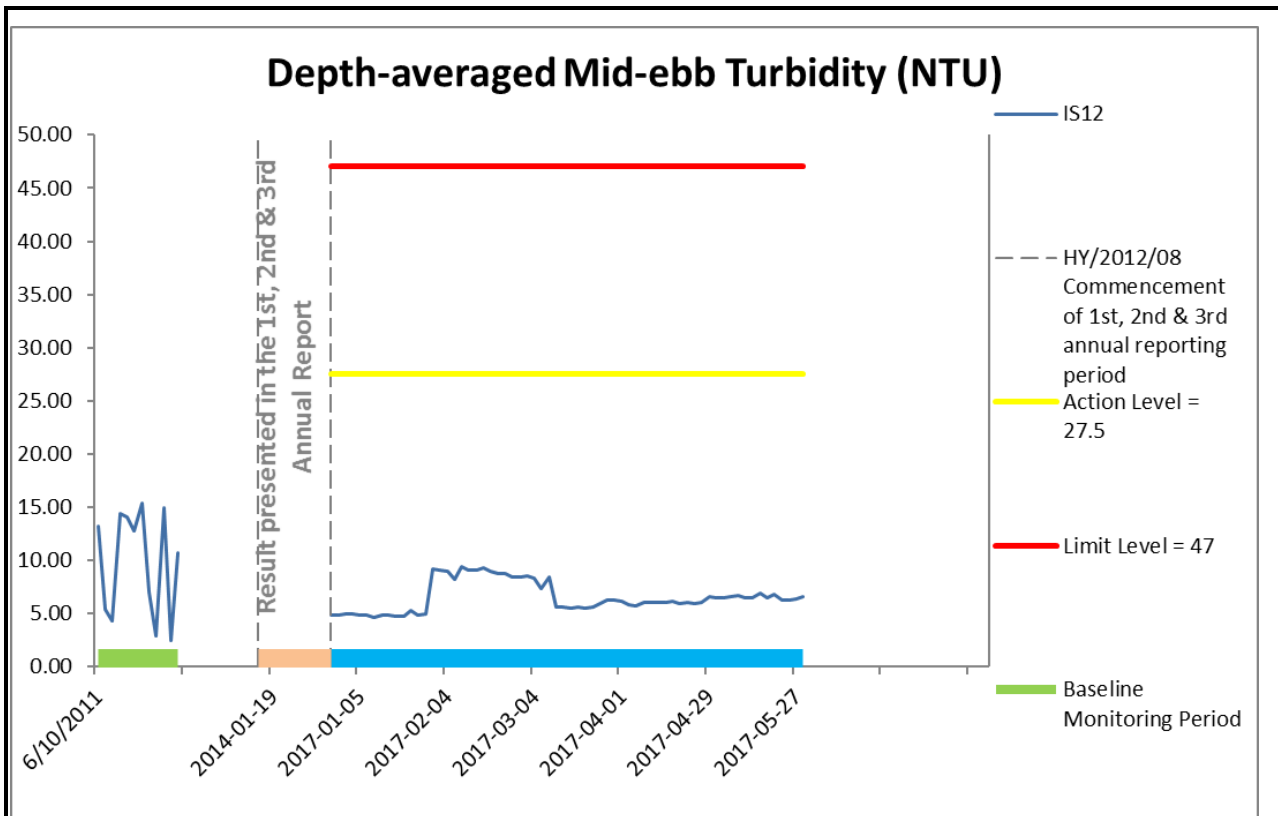
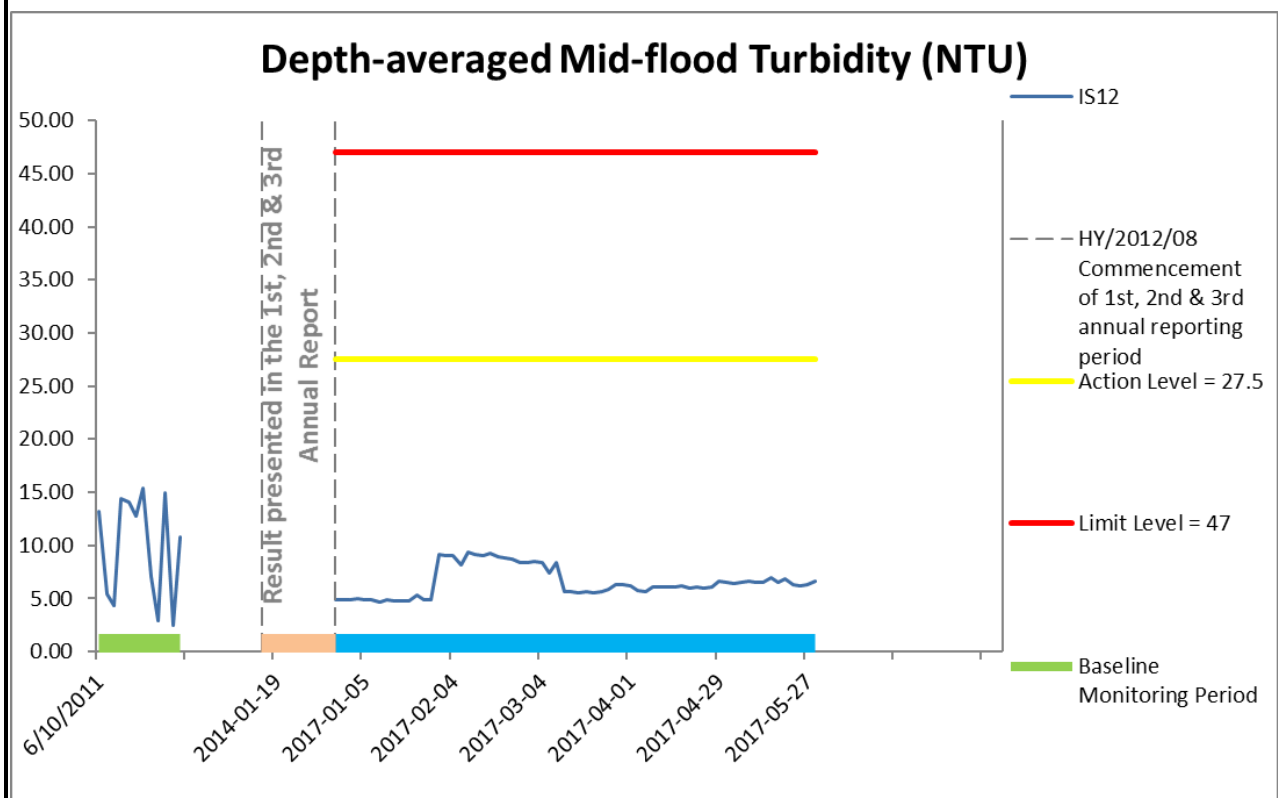
**Figure E28 Baseline & Impact Monitoring - Mean Depth-averaged Level of Turbidity (NTU) between Baseline monitoring period: 6/10/2011 to 31/10/2011 and Impact monitoring period: 3/1/2017 to 30/5/2017 at IS12. Weather condition within the reporting period varied between sunny to rainy. The overall monitoring results were not affected by weather conditions. Major marine construction activities included: Dredging, Reclamation filling and Construction of Vertical Seawall**

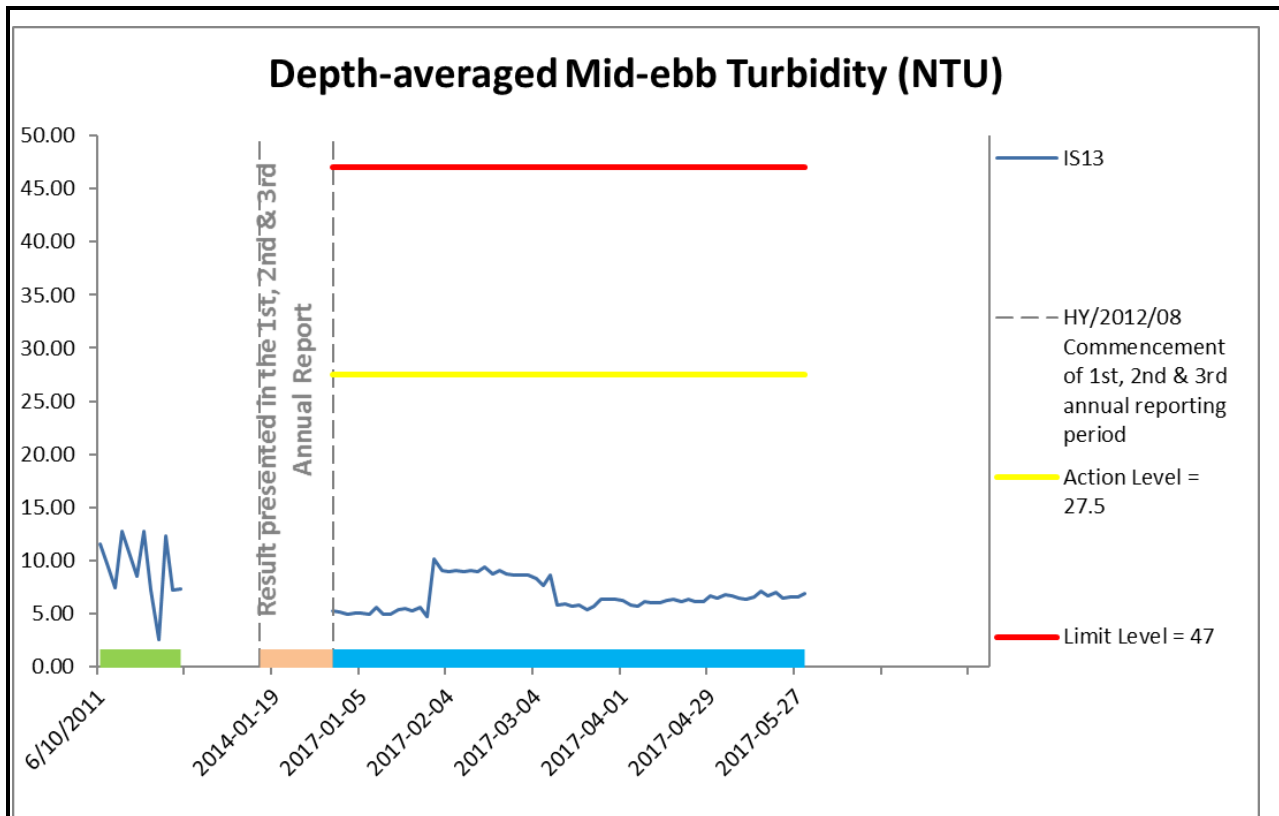
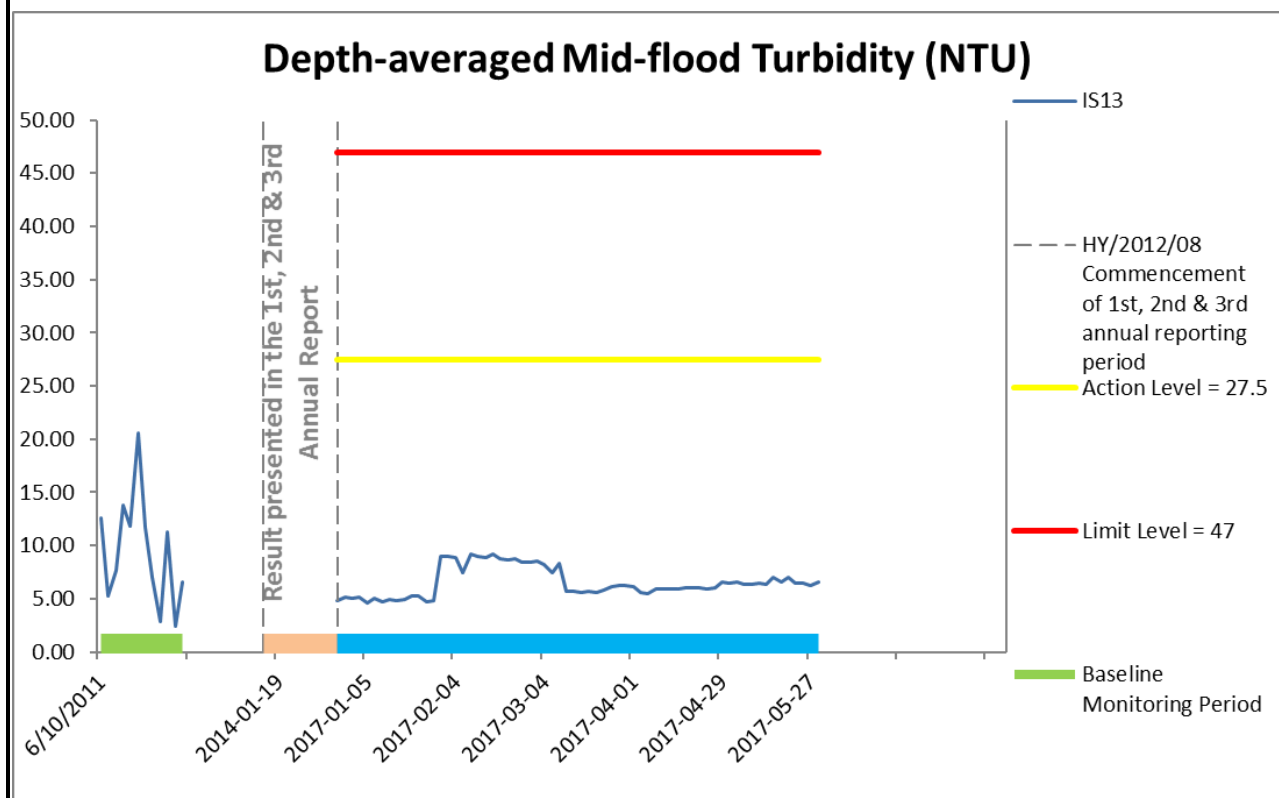
**Figure E29 Baseline & Impact Monitoring - Mean Depth-averaged Level of Turbidity (NTU) between Baseline monitoring period: 6/10/2011 to 31/10/2011 and Impact monitoring period: 3/1/2017 to 30/5/2017 at IS13. Weather condition within the reporting period varied between sunny to rainy. The overall monitoring results were not affected by weather conditions. Major marine construction activities included: Dredging, Reclamation filling and Construction of Vertical Seawall**

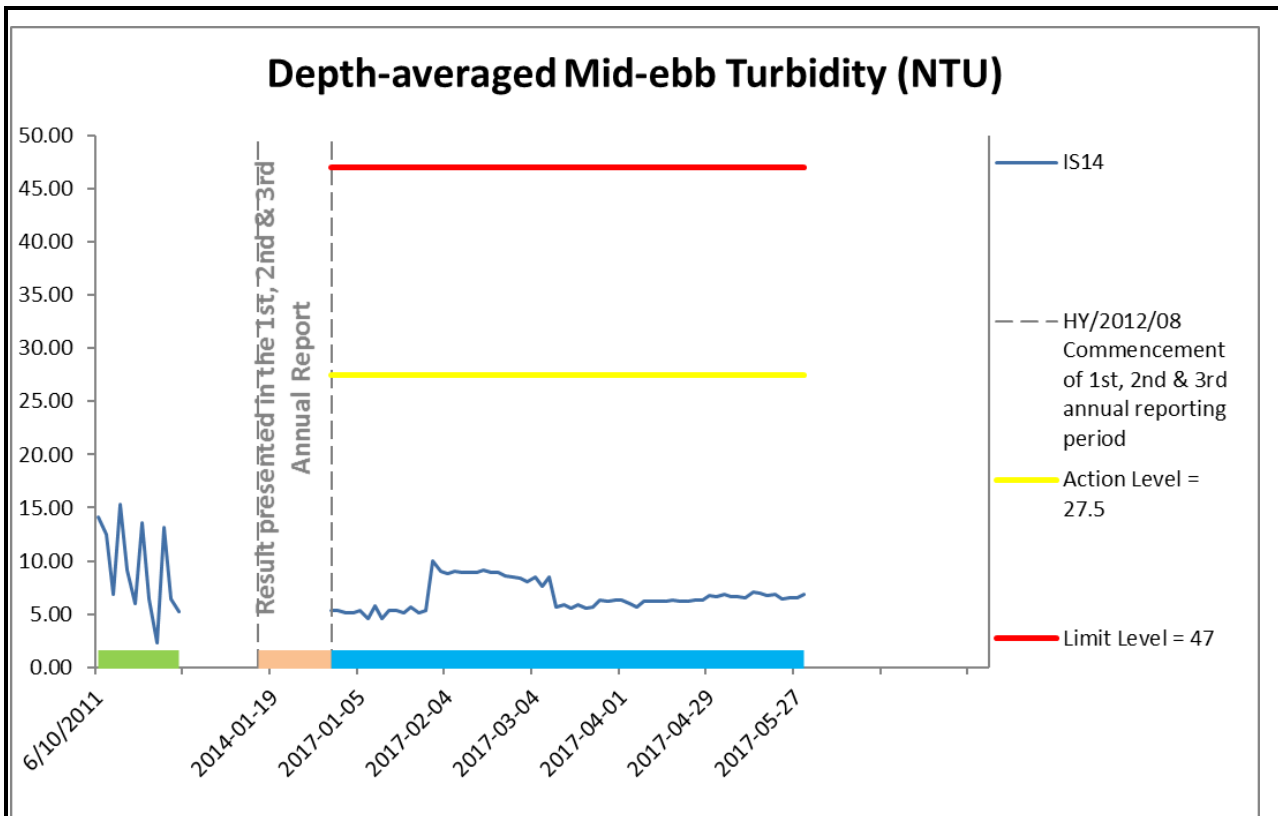
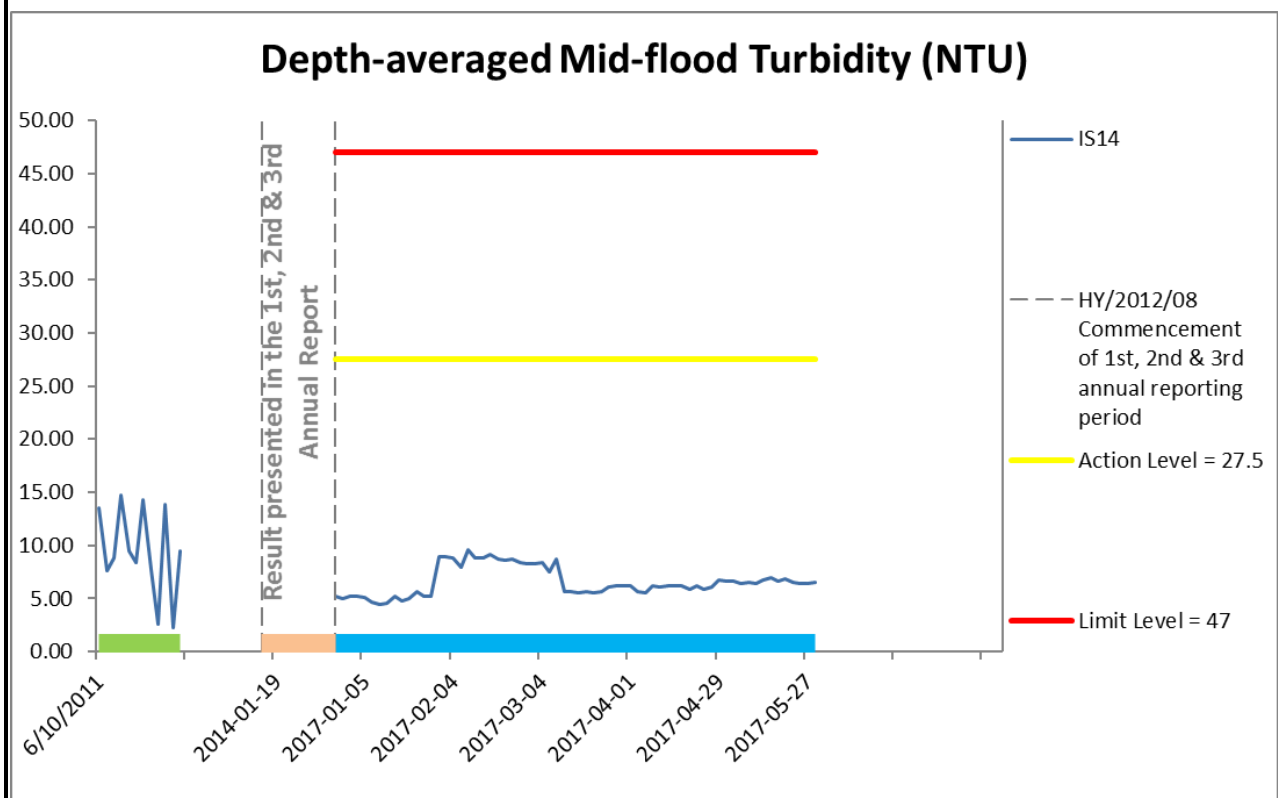
**Figure E30 Baseline & Impact Monitoring - Mean Depth-averaged Level of Turbidity (NTU) between Baseline monitoring period: 6/10/2011 to 31/10/2011 and Impact monitoring period: 3/1/2017 to 30/5/2017 at IS14. Weather condition within the reporting period varied between sunny to rainy. The overall monitoring results were not affected by weather conditions. Major marine construction activities included: Dredging, Reclamation filling and Construction of Vertical Seawall**

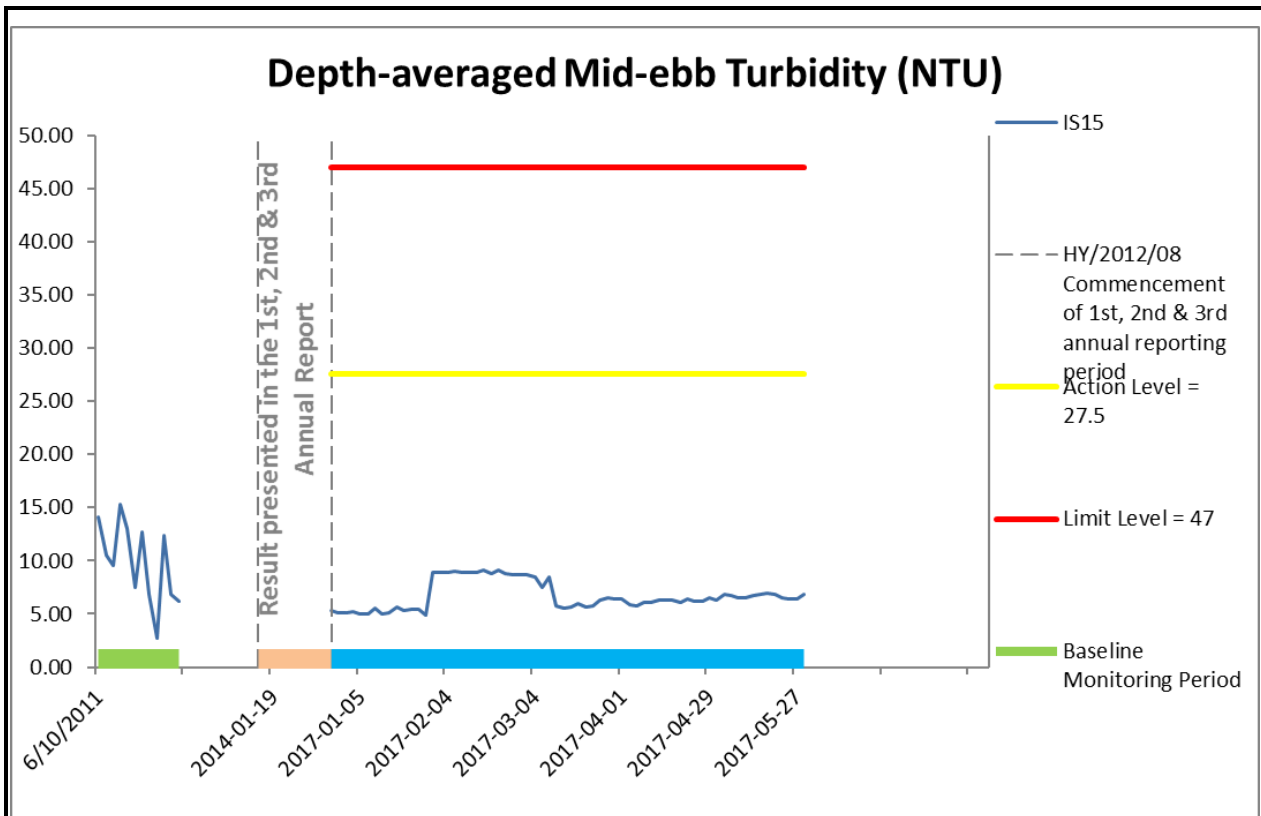
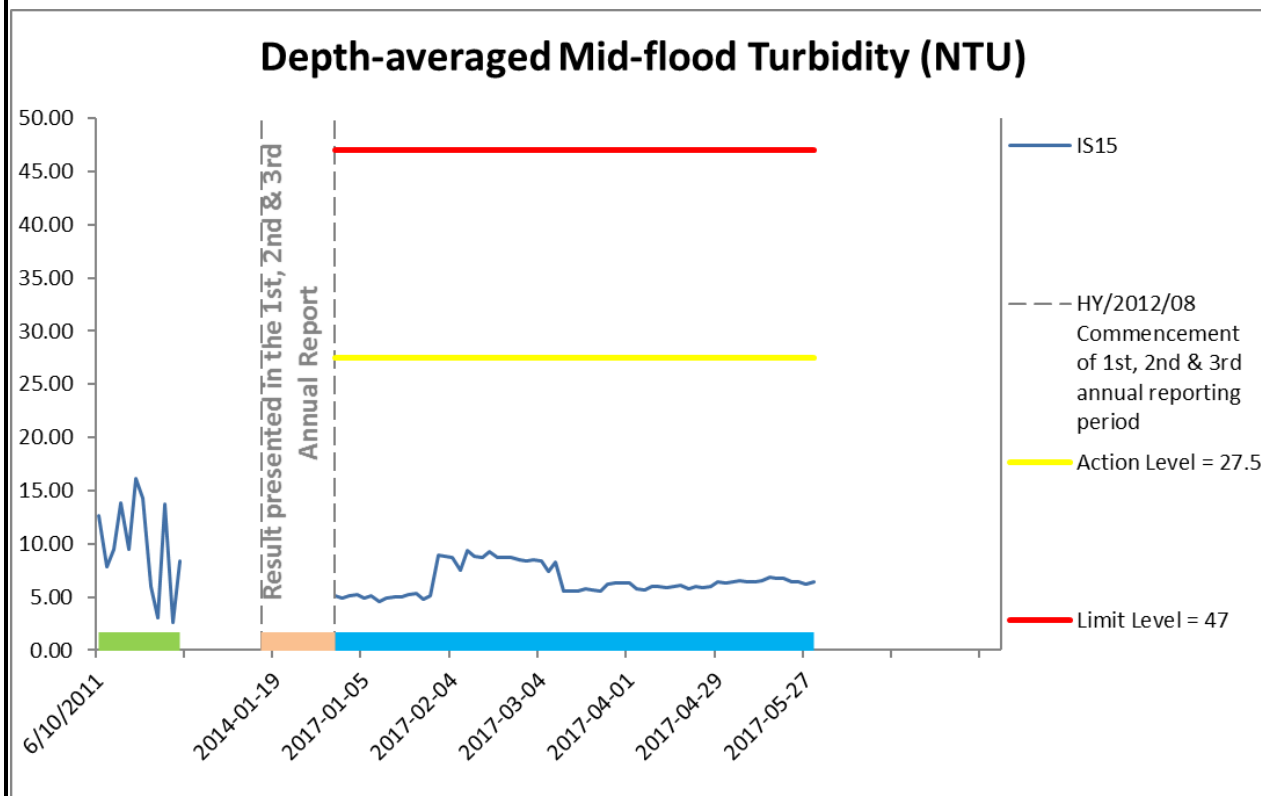
**Figure E31 Baseline & Impact Monitoring - Mean Depth-averaged Level of Turbidity (NTU) between Baseline monitoring period: 6/10/2011 to 31/10/2011 and Impact monitoring period: 3/1/2017 to 30/5/2017 at IS15. Weather condition within the reporting period varied between sunny to rainy. The overall monitoring results were not affected by weather conditions. Major marine construction activities included: Dredging, Reclamation filling and Construction of Vertical Seawall**

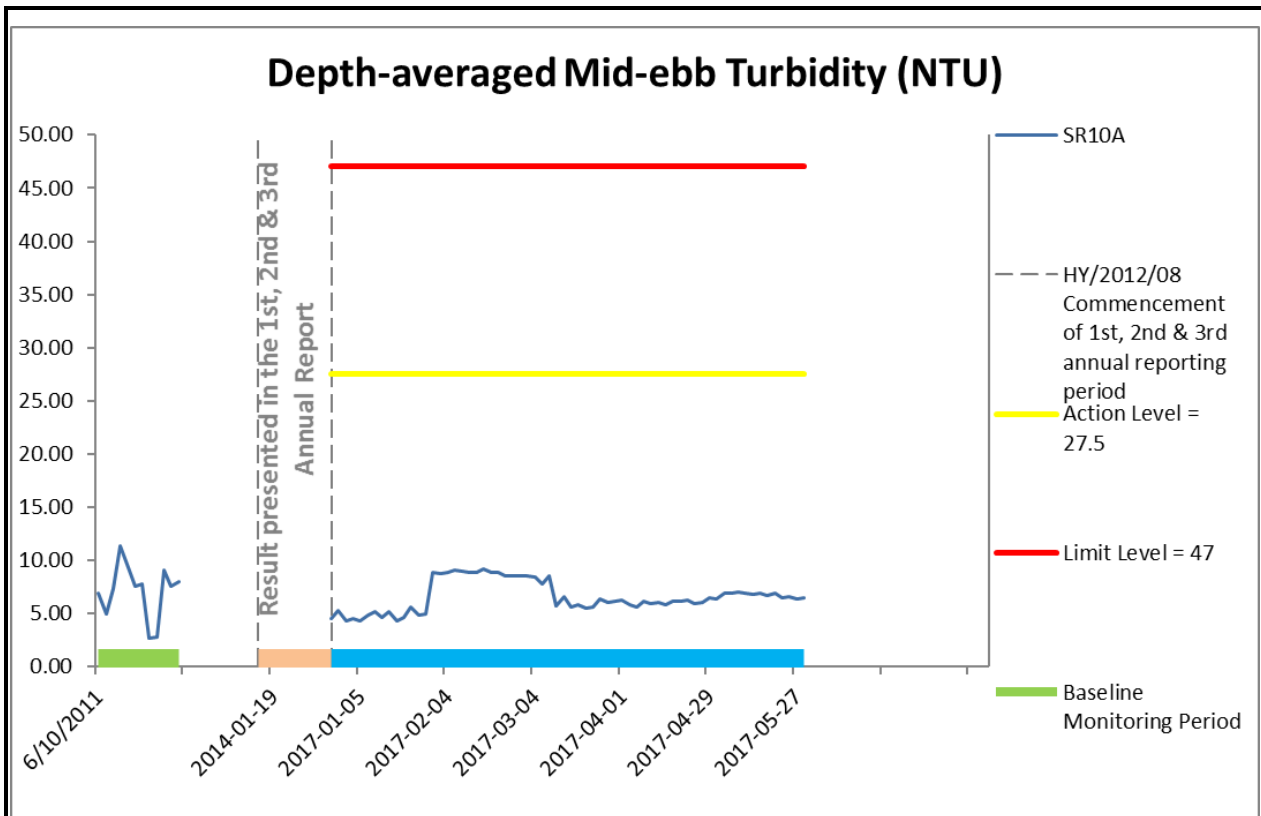
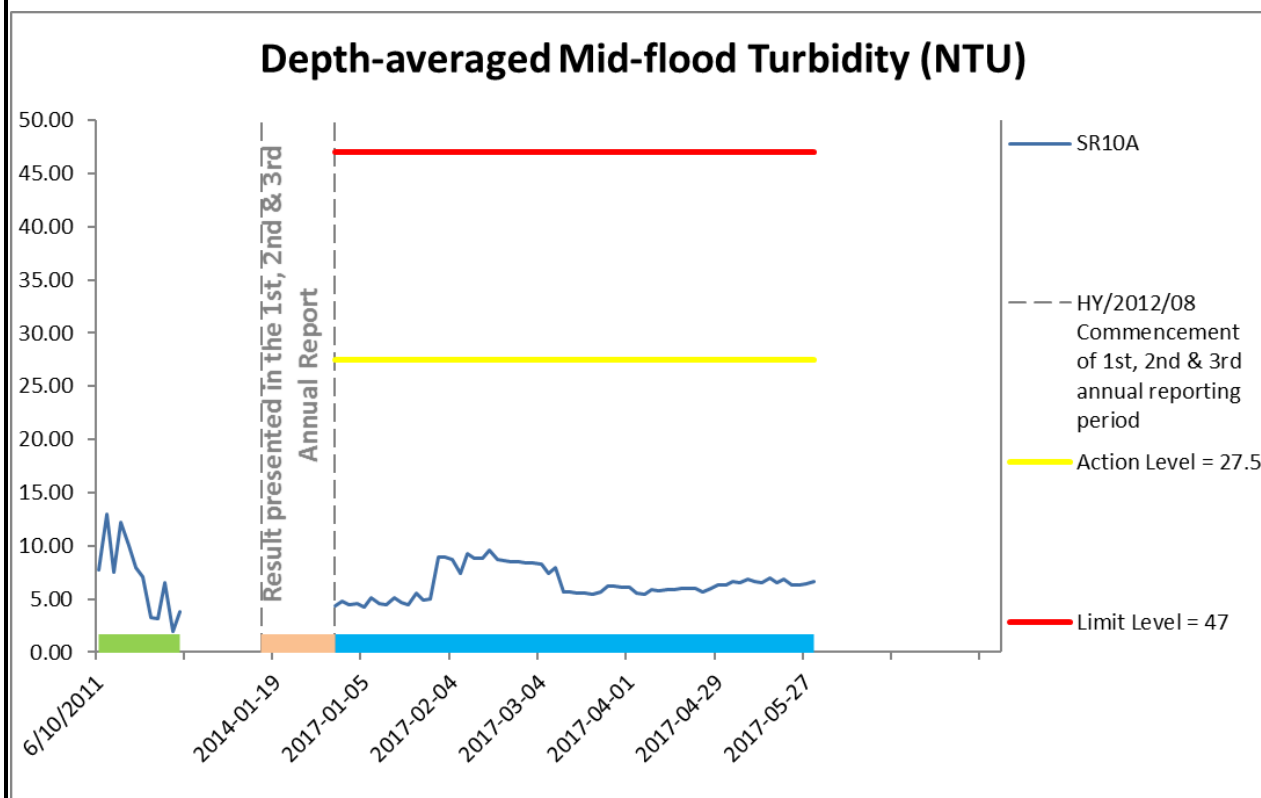
Figure E32 Baseline & Impact Monitoring - Mean Depth-averaged Level of Turbidity (NTU) between Baseline monitoring period: 6/10/2011 to 31/10/2011 and Impact monitoring period: 3/1/2017 to 30/5/2017 at SR10A. Weather condition within the reporting period varied between sunny to rainy. The overall monitoring results were not affected by weather conditions. Major marine construction activities included: Dredging, Reclamation filling and Construction of Vertical Seawall

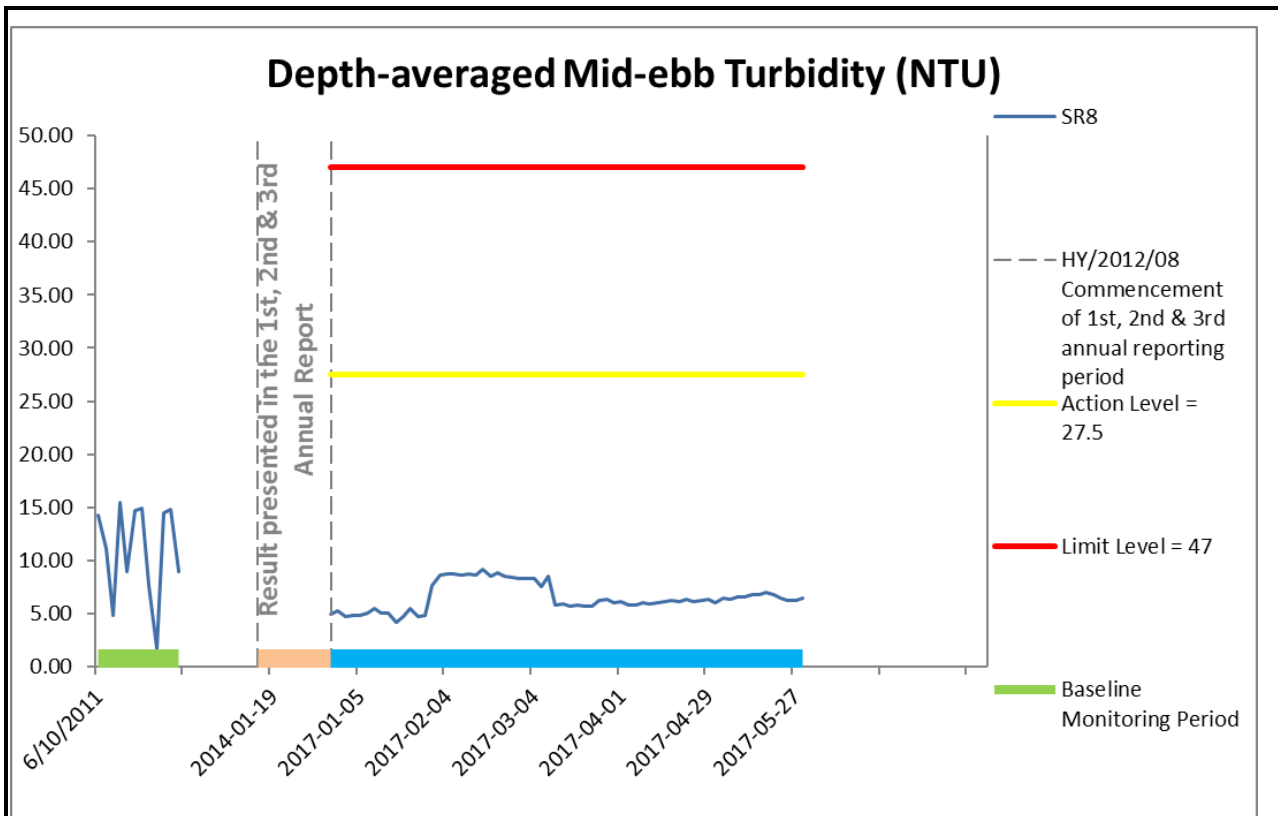
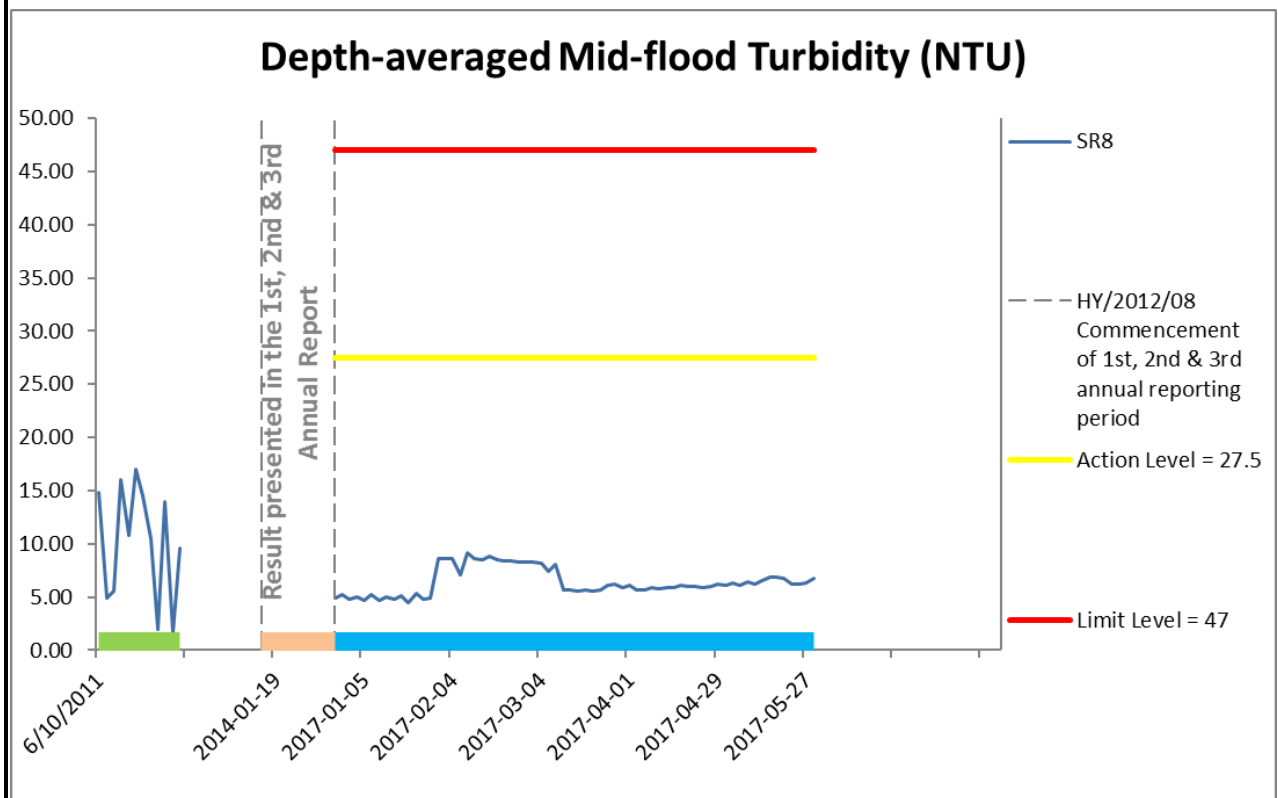
**Figure E33 Baseline & Impact Monitoring - Mean Depth-averaged Level of Turbidity (NTU) between Baseline monitoring period: 6/10/2011 to 31/10/2011 and Impact monitoring period: 3/1/2017 to 30/5/2017 at SR8. Weather condition within the reporting period varied between sunny to rainy. The overall monitoring results were not affected by weather conditions. Major marine construction activities included: Dredging, Reclamation filling and Construction of Vertical Seawall**

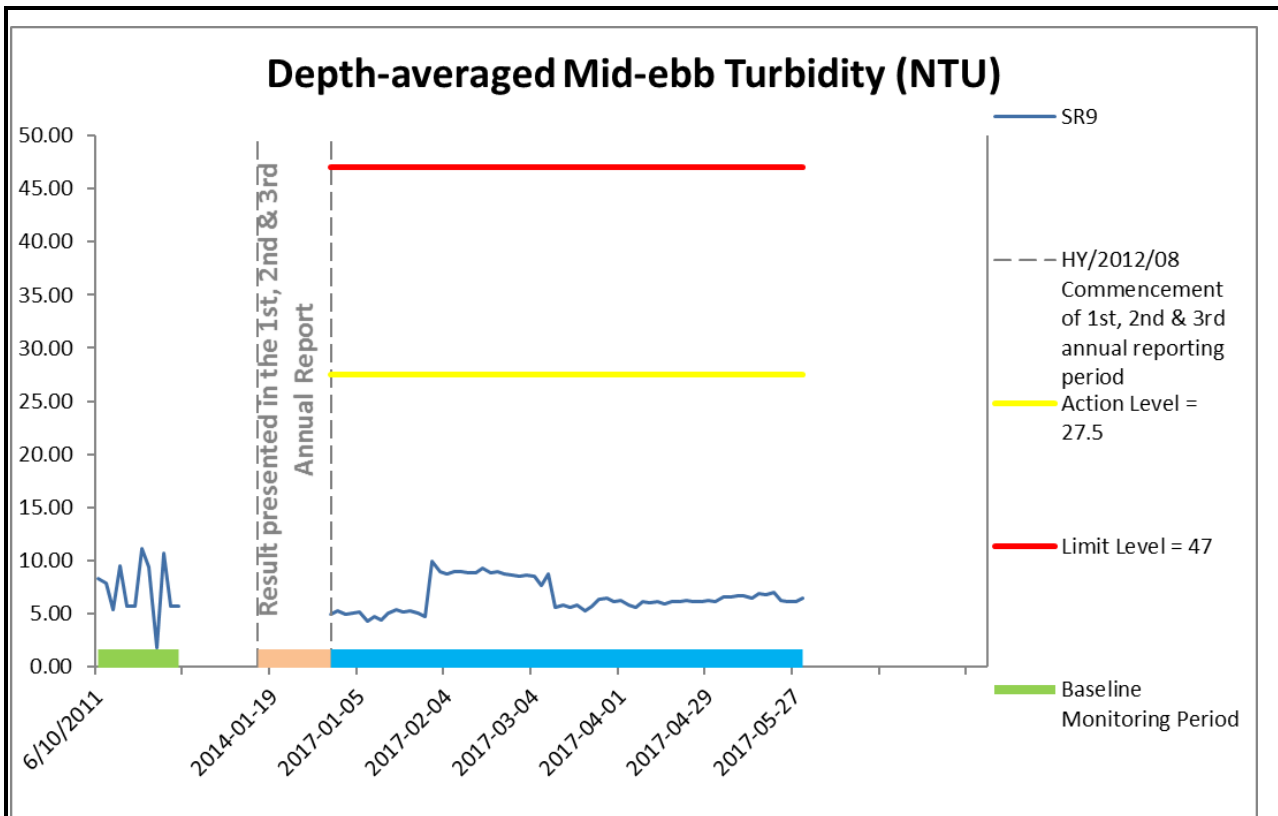
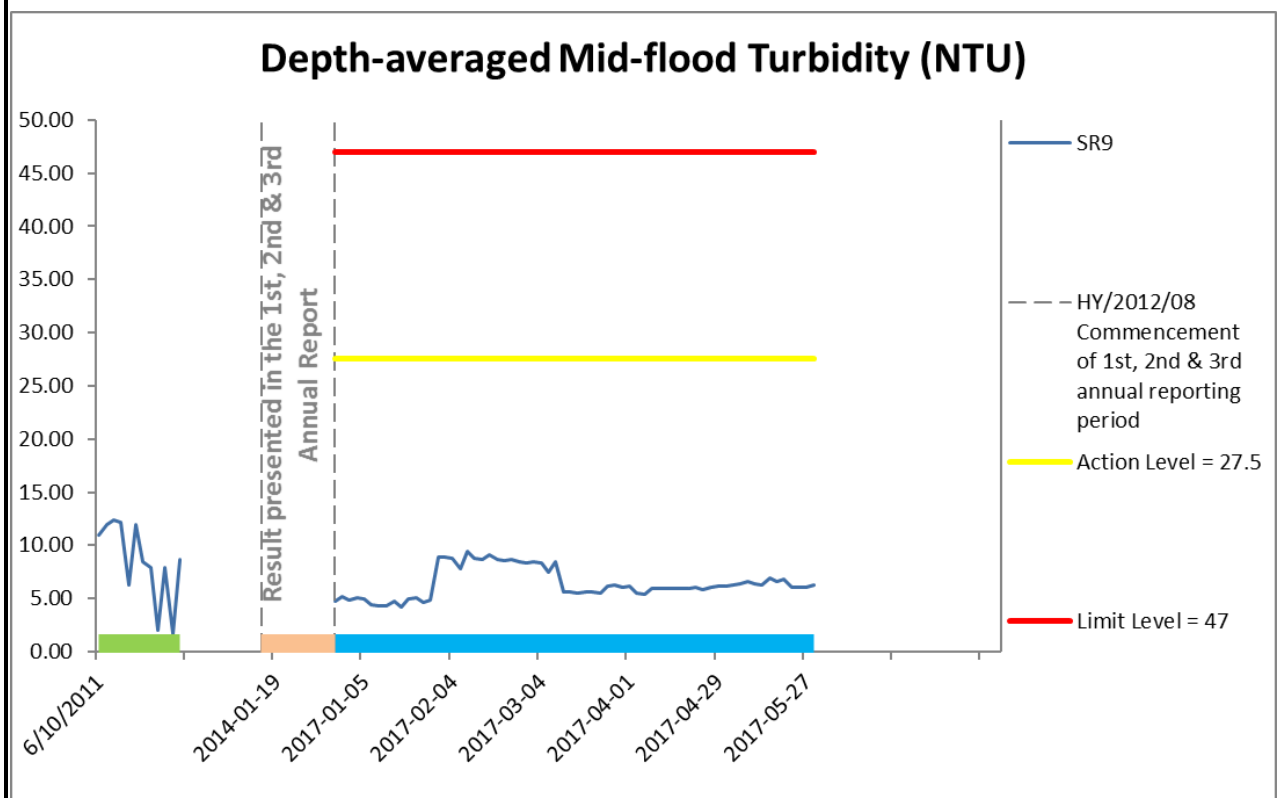
**Figure E34 Baseline & Impact Monitoring - Mean Depth-averaged Level of Turbidity (NTU) between Baseline monitoring period: 6/10/2011 to 31/10/2011 and Impact monitoring period: 3/1/2017 to 30/5/2017 at SR9. Weather condition within the reporting period varied between sunny to rainy. The overall monitoring results were not affected by weather conditions. Major marine construction activities included: Dredging, Reclamation filling and Construction of Vertical Seawall**
