**Contract No. HY/2012/08  
Tuen Mun – Chek Lap Kok Link –  
Northern Connection Sub-sea Tunnel  
Section**

*Fourth Annual Environmental Monitoring &  
Audit (EM&A) Report*

26 November 2018

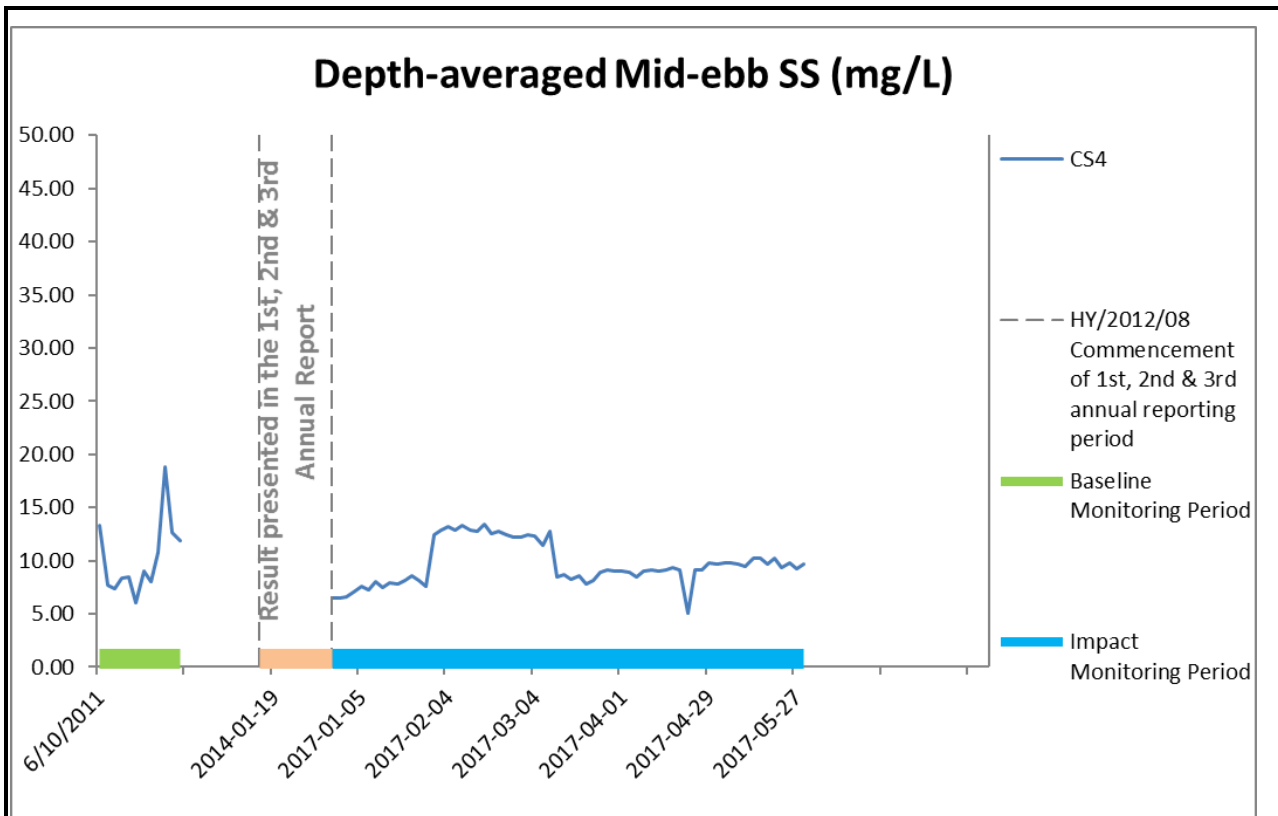
**Figure E35 Baseline & Impact Monitoring – Mean Depth-averaged Level of Suspended Solids (mg/L) between Baseline monitoring period: 6/10/2011 to 31/10/2011 and Impact monitoring period: 3/1/2017 to 30/5/2017 at CS4. Weather condition within the reporting period varied between sunny to rainy. The overall monitoring results were not affected by weather conditions. Major marine construction activities included: Dredging, Reclamation filling and Construction of Vertical Seawall**

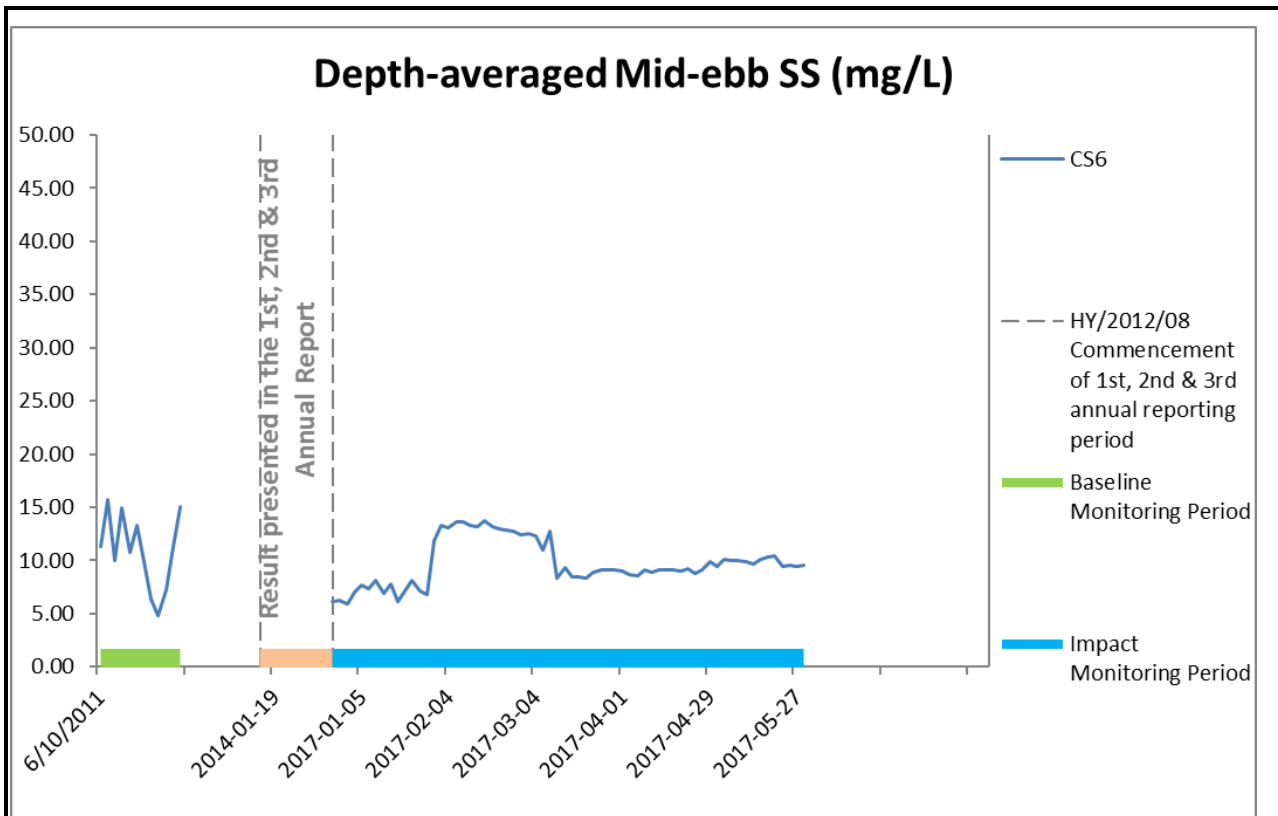
**Figure E36 Baseline & Impact Monitoring - Mean Depth-averaged Level of Suspended Solids (mg/L) between Baseline monitoring period: 6/10/2011 to 31/10/2011 and Impact monitoring period: 3/1/2017 to 30/5/2017 at CS6. Weather condition within the reporting period varied between sunny to rainy. The overall monitoring results were not affected by weather conditions. Major marine construction activities included: Dredging, Reclamation filling and Construction of Vertical Seawall**

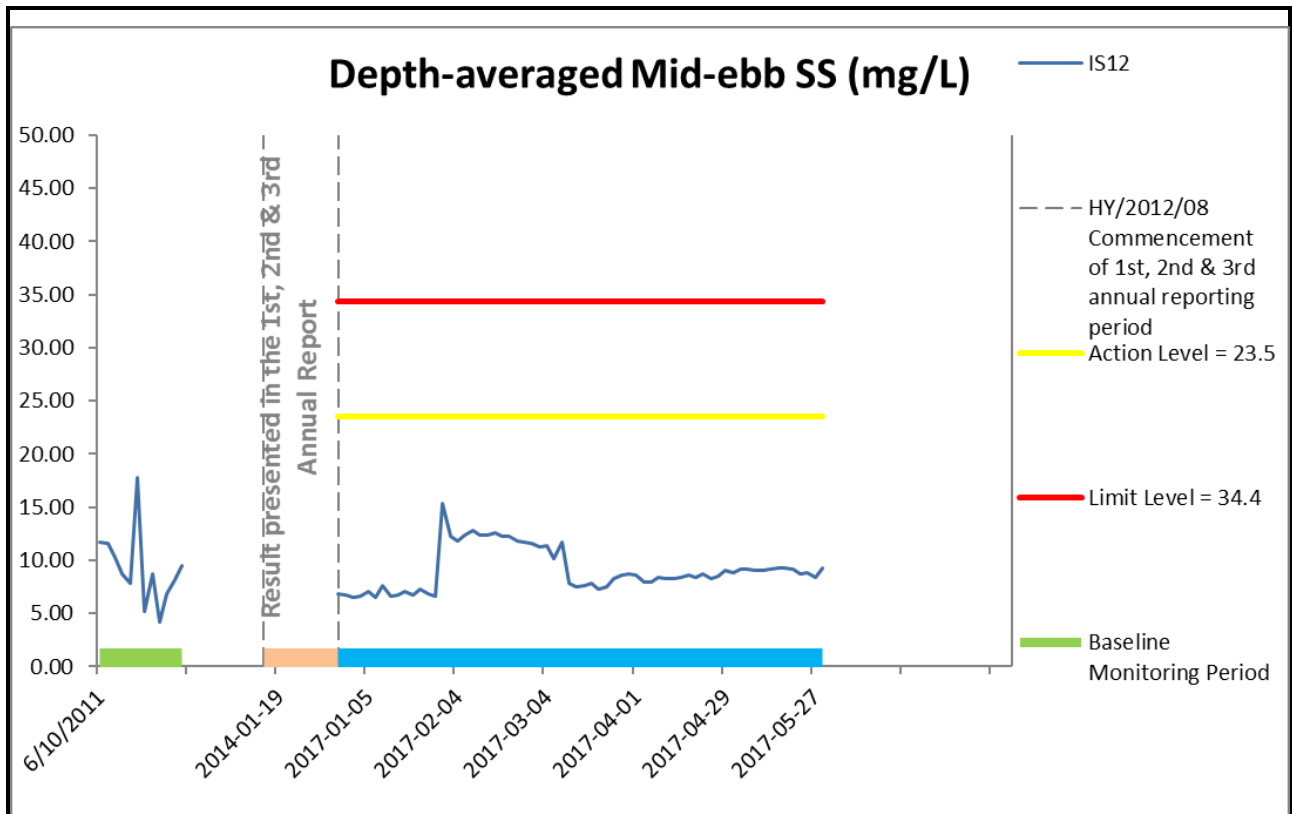
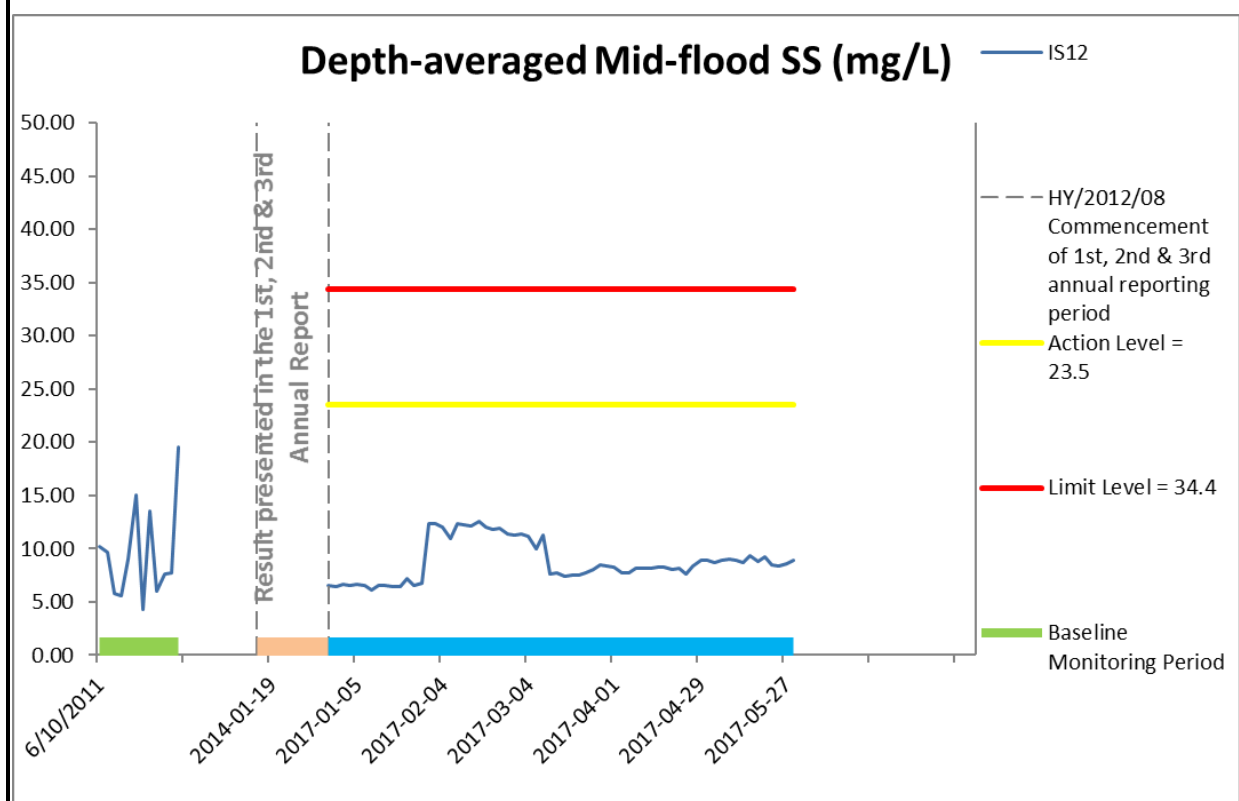
**Figure E37 Baseline & Impact Monitoring - Mean Depth-averaged Level of Suspended Solids (mg/L) between Baseline monitoring period: 6/10/2011 to 31/10/2011 and Impact monitoring period: 3/1/2017 to 30/5/2017 at IS12. Weather condition within the reporting period varied between sunny to rainy. The overall monitoring results were not affected by weather conditions. Major marine construction activities included: Dredging, Reclamation filling and Construction of Vertical Seawall**

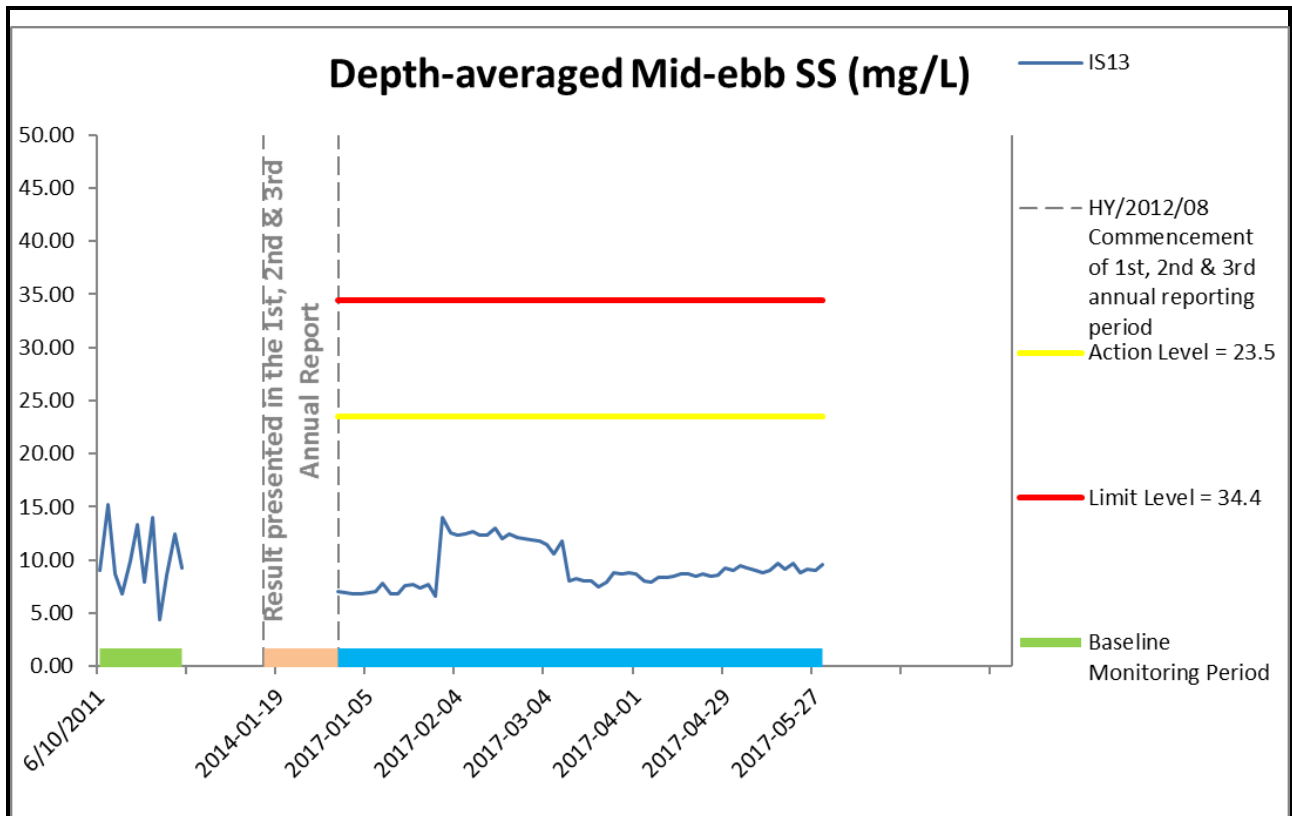
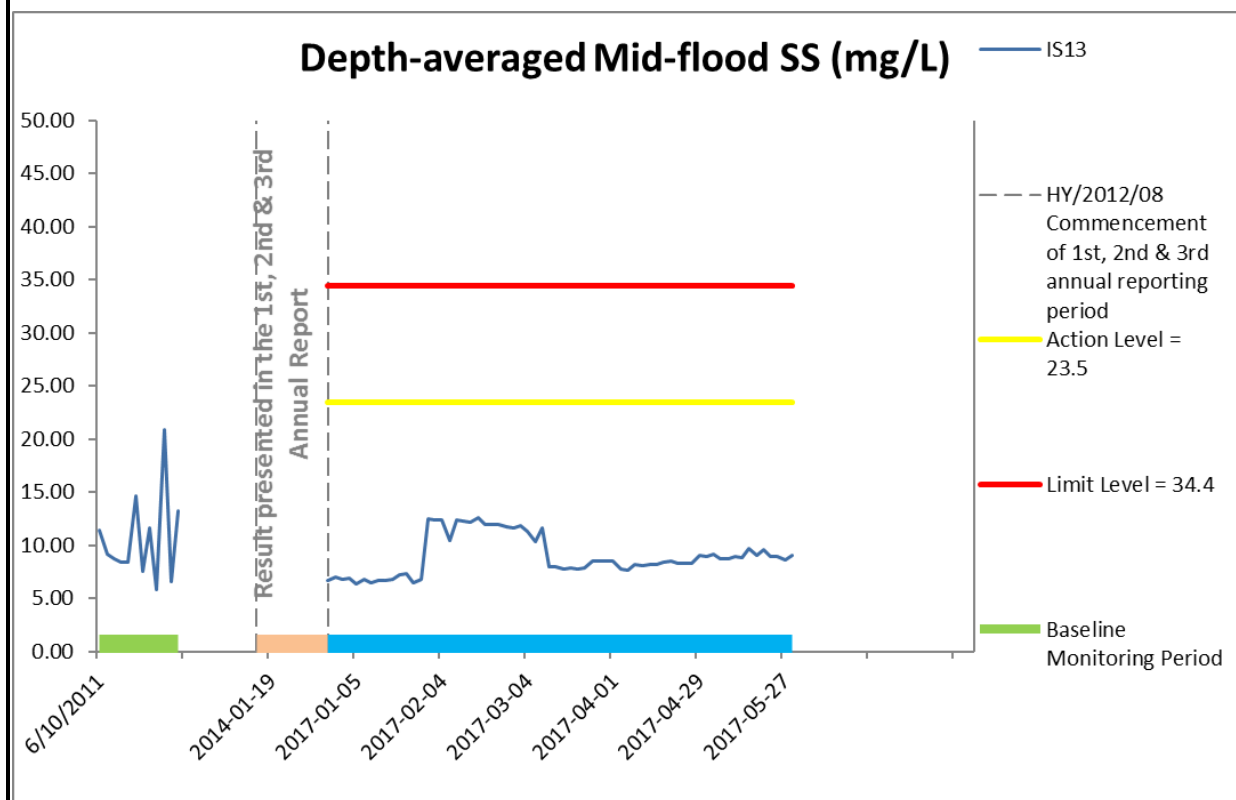
**Figure E38 Baseline & Impact Monitoring - Mean Depth-averaged Level of Suspended Solids (mg/L) between Baseline monitoring period: 6/10/2011 to 31/10/2011 and Impact monitoring period: 3/1/2017 to 30/5/2017 at IS13. Weather condition within the reporting period varied between sunny to rainy. The overall monitoring results were not affected by weather conditions. Major marine construction activities included: Dredging, Reclamation filling and Construction of Vertical Seawall**

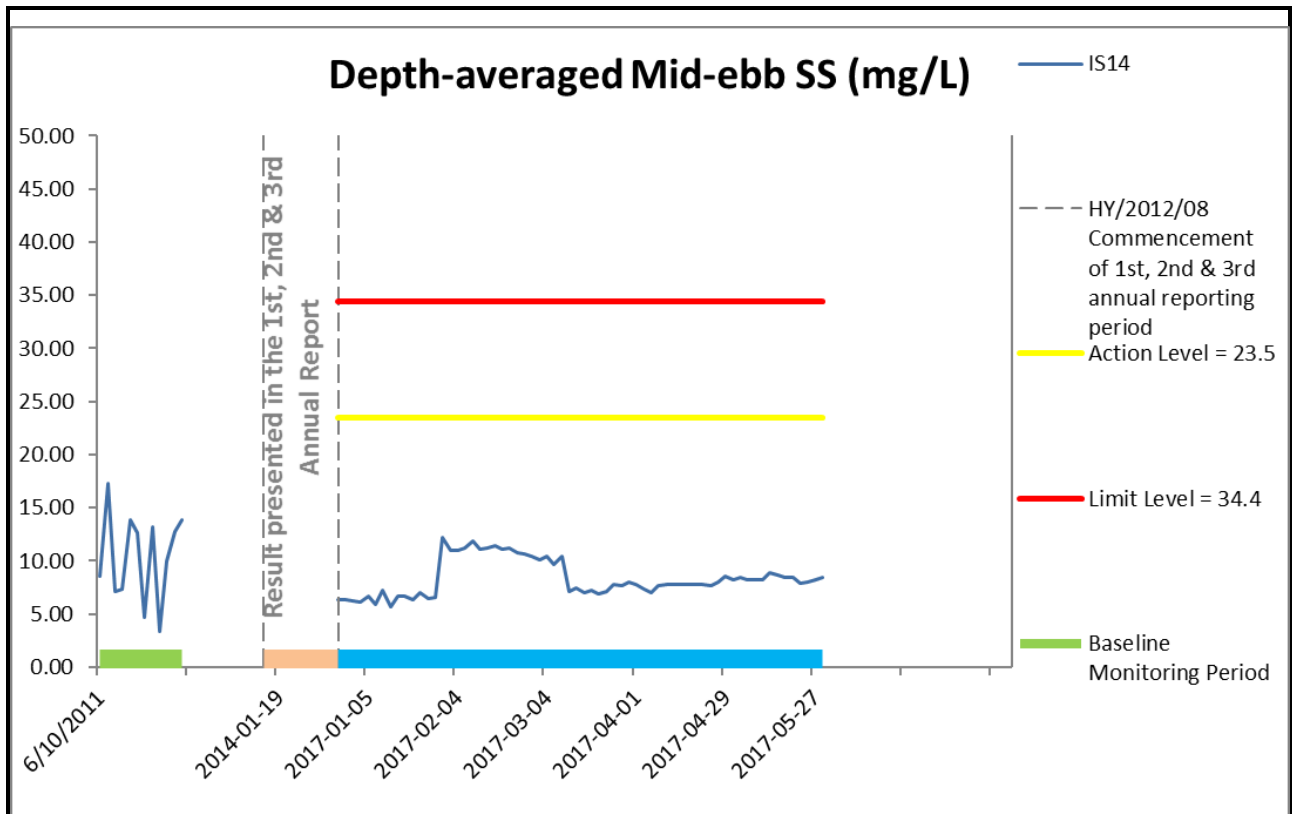
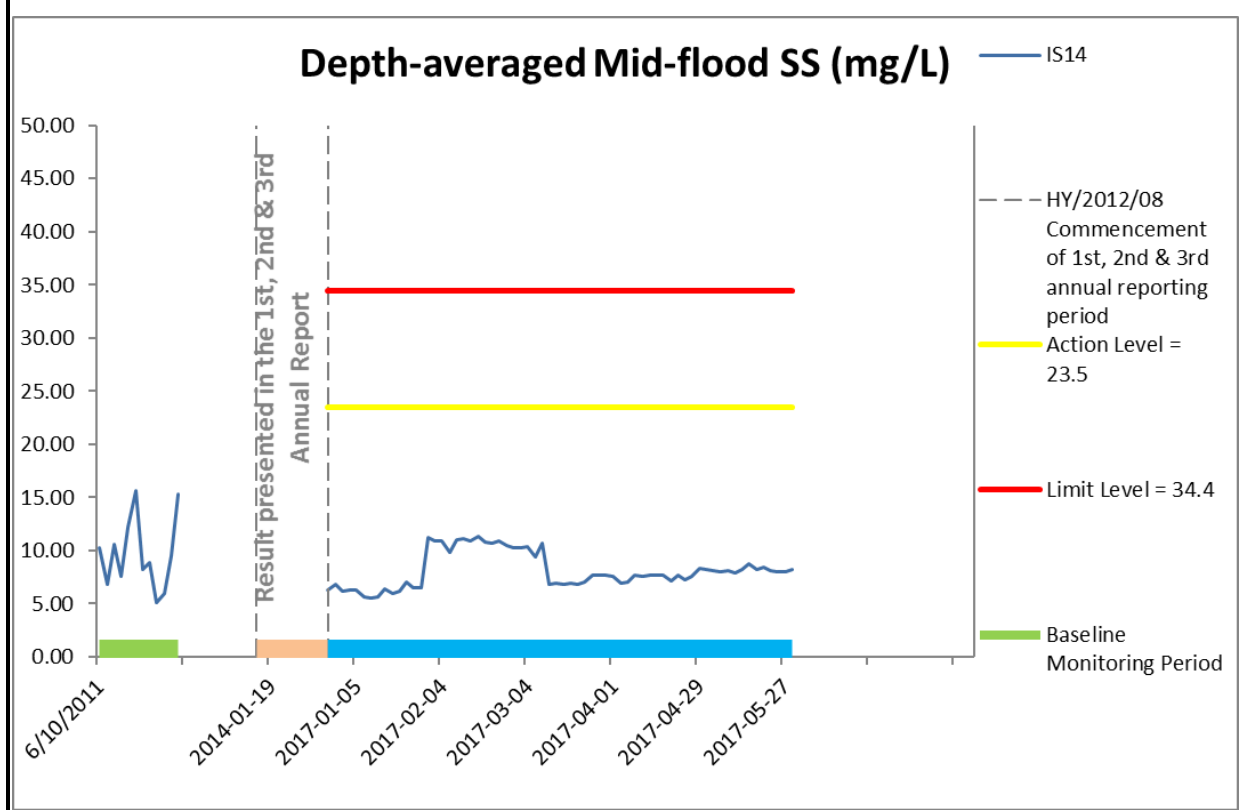
**Figure E39 Baseline & Impact Monitoring - Mean Depth-averaged Level of Suspended Solids (mg/L) between Baseline monitoring period: 6/10/2011 to 31/10/2011 and Impact monitoring period: 3/1/2017 to 30/5/2017 at IS14. Weather condition within the reporting period varied between sunny to rainy. The overall monitoring results were not affected by weather conditions. Major marine construction activities included: Dredging, Reclamation filling and Construction of Vertical Seawall**

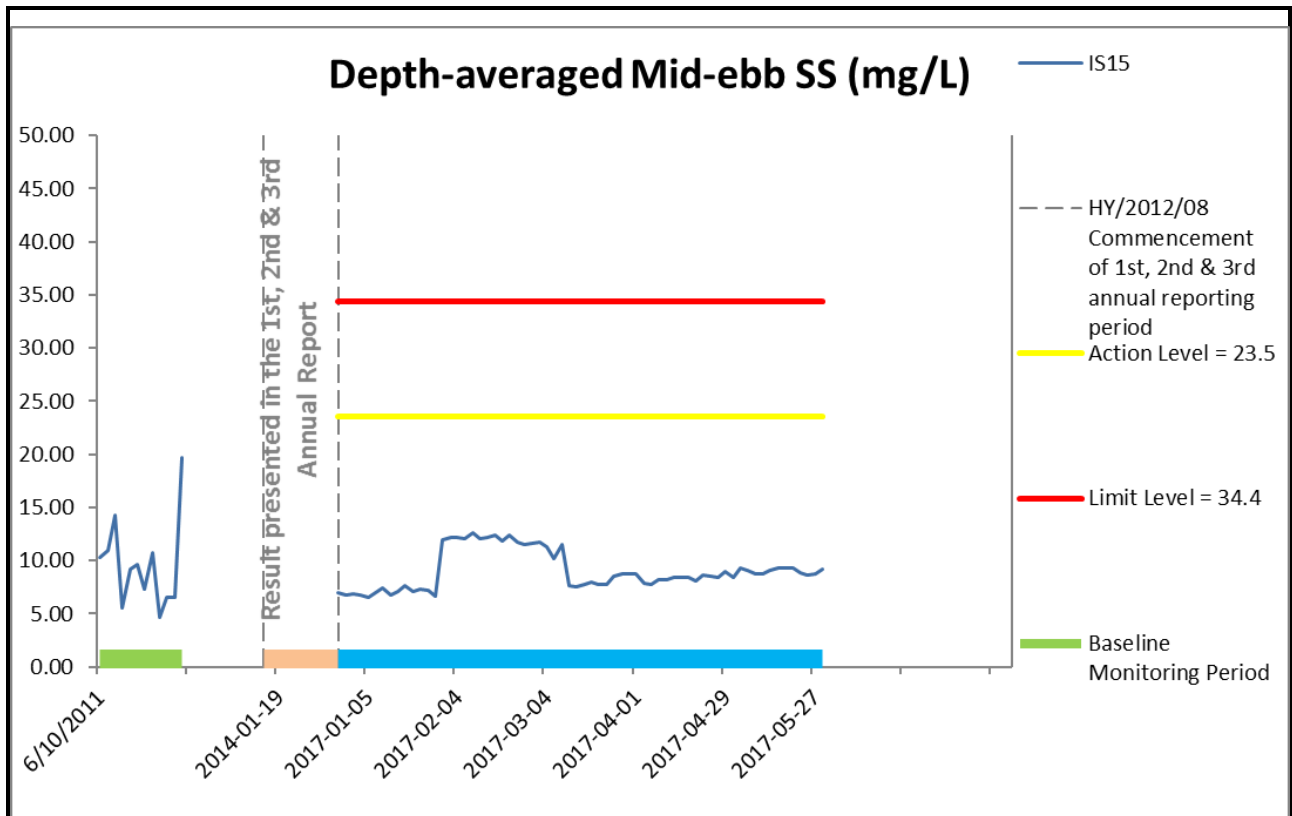
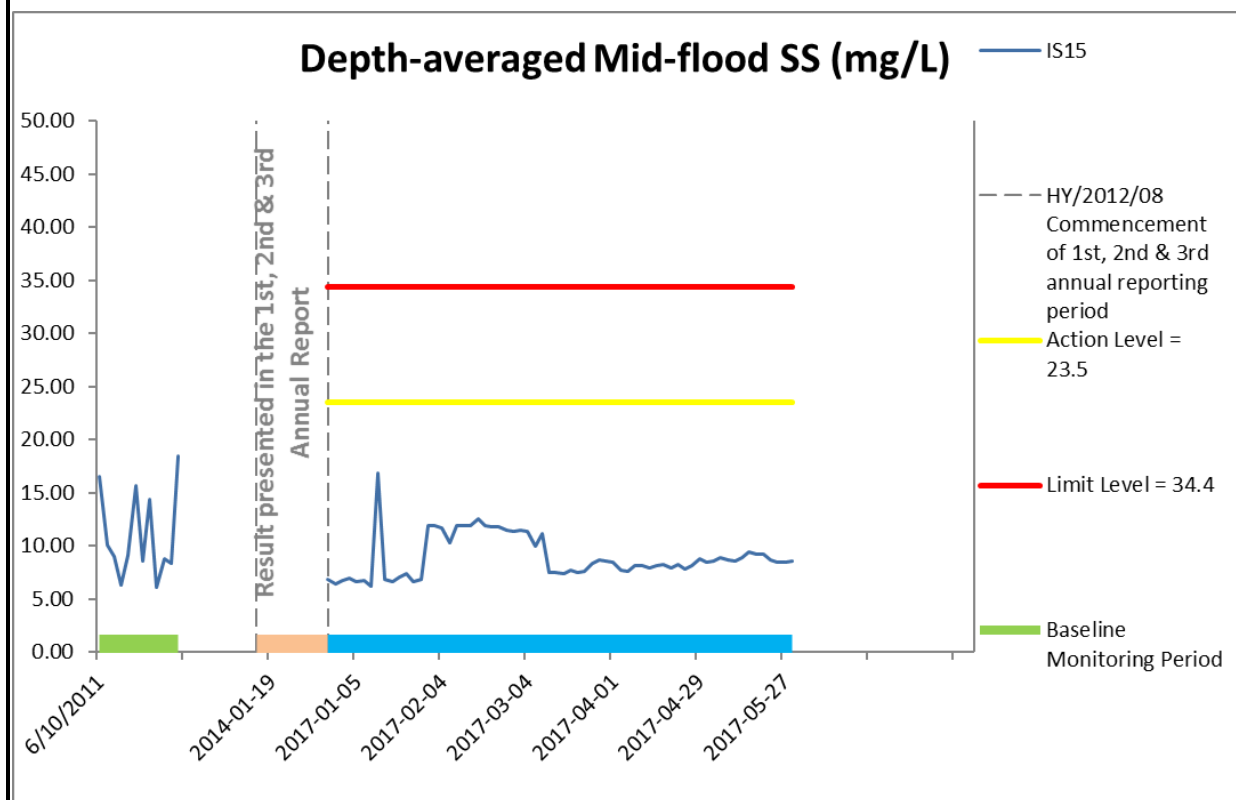
**Figure E40 Baseline & Impact Monitoring – Mean Depth-averaged Level of Suspended Solids (mg/L) between Baseline monitoring period: 6/10/2011 to 31/10/2011 and Impact monitoring period: 3/1/2017 to 30/5/2017 at IS15. Weather condition within the reporting period varied between sunny to rainy. The overall monitoring results were not affected by weather conditions. Major marine construction activities included: Dredging, Reclamation filling and Construction of Vertical Seawall**

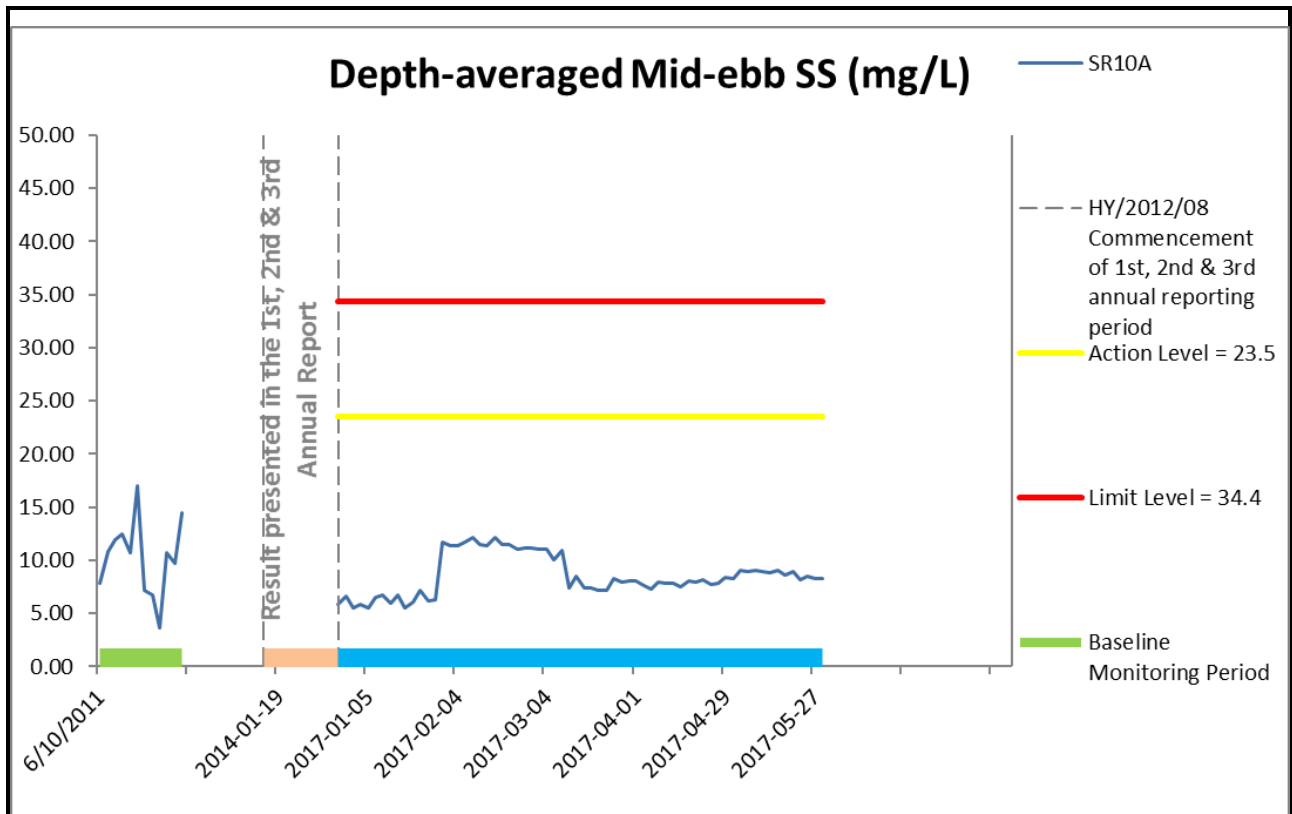
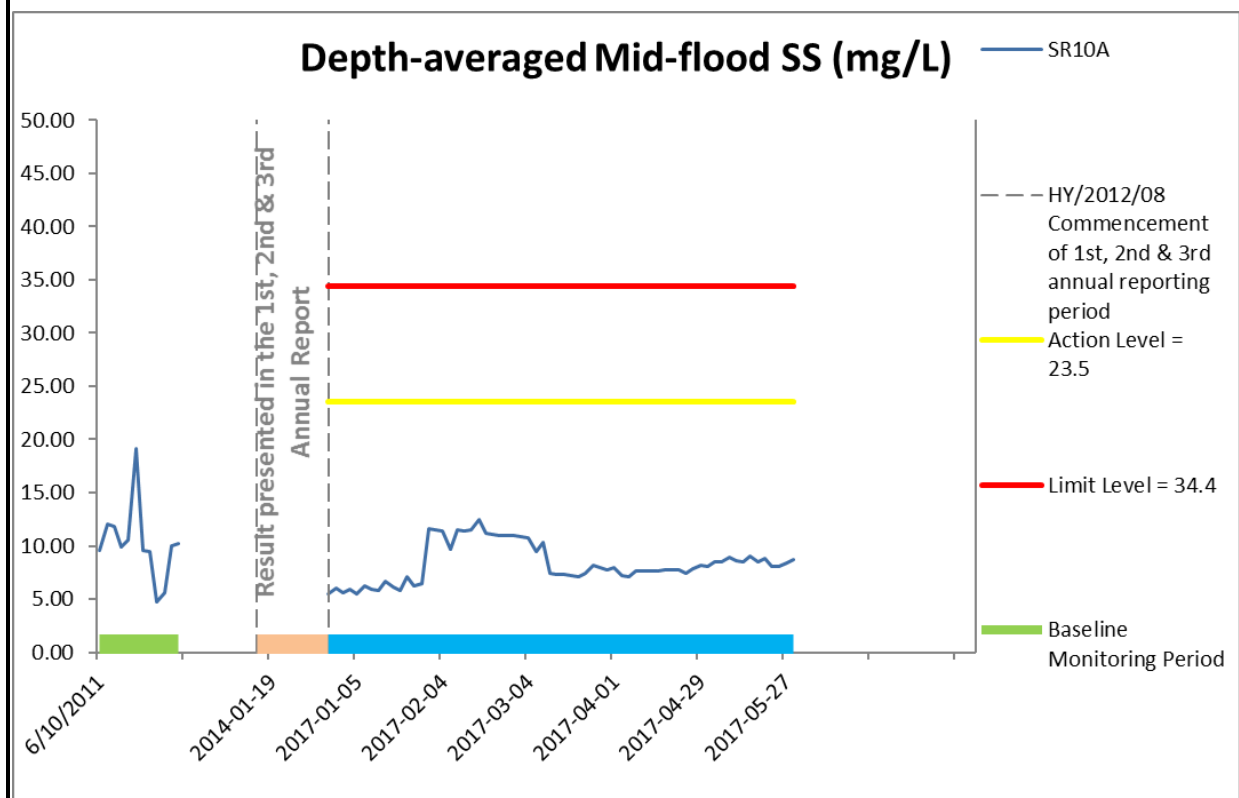
**Figure E41 Baseline & Impact Monitoring - Mean Depth-averaged Level of Suspended Solids (mg/L) between Baseline monitoring period: 6/10/2011 to 31/10/2011 and Impact monitoring period: 3/1/2017 to 30/5/2017 at SR10A. Weather condition within the reporting period varied between sunny to rainy. The overall monitoring results were not affected by weather conditions. Major marine construction activities included: Dredging, Reclamation filling and Construction of Vertical Seawall**

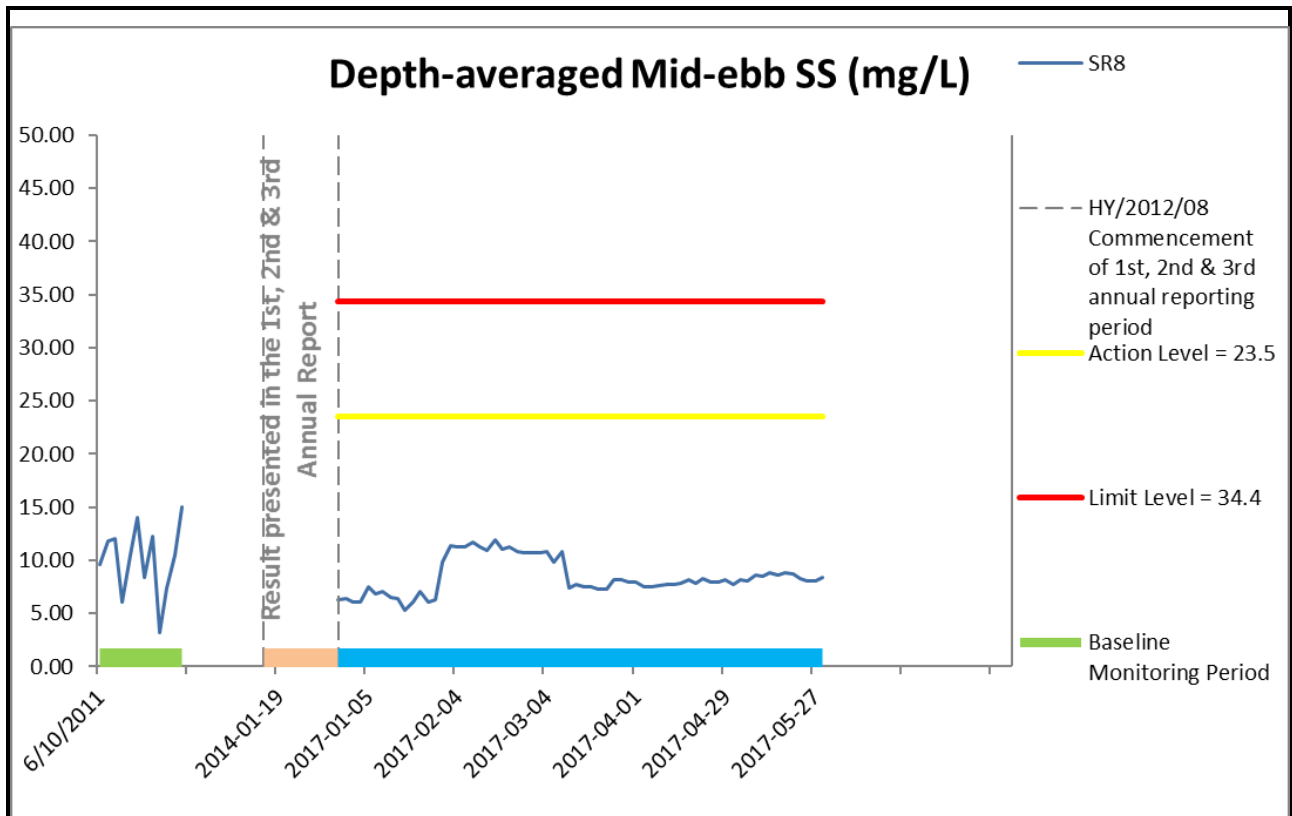
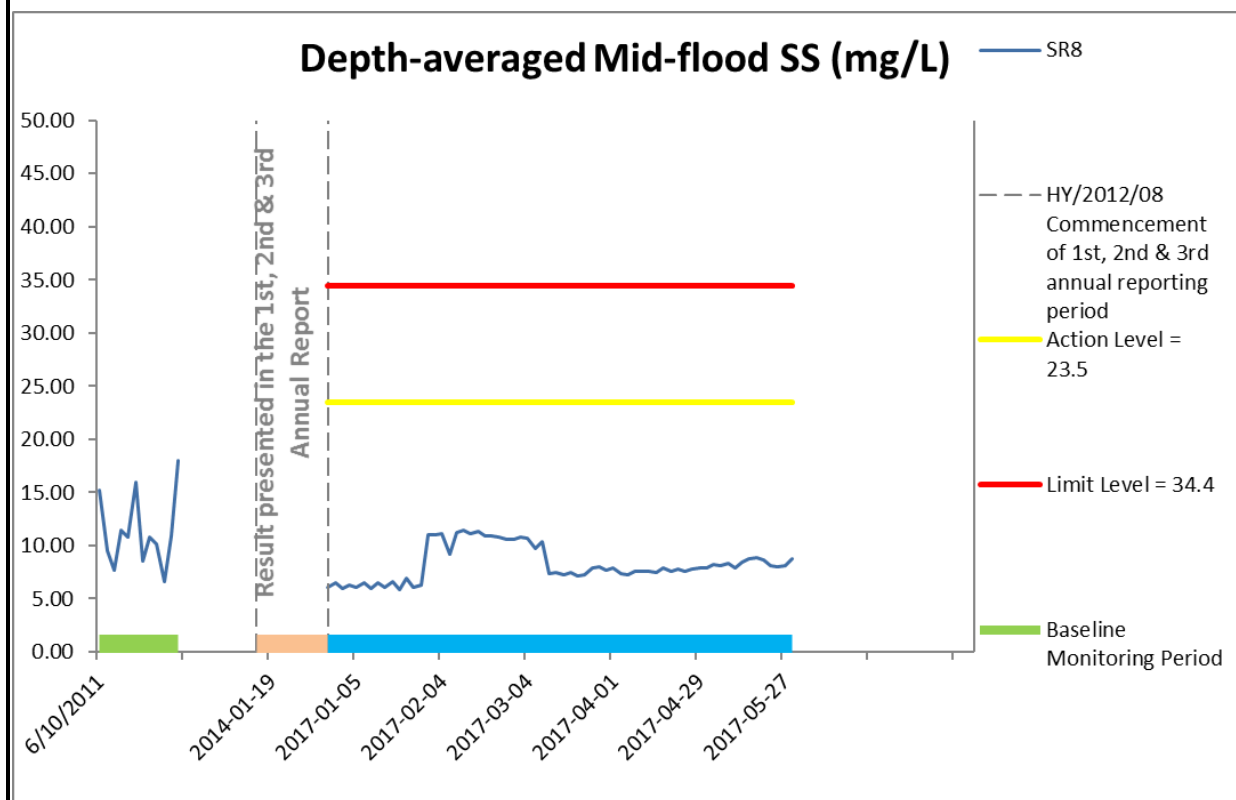
**Figure E42 Baseline & Impact Monitoring - Mean Depth-averaged Level of Suspended Solids (mg/L) between Baseline monitoring period: 6/10/2011 to 31/10/2011 and Impact monitoring period: 3/1/2017 to 30/5/2017 at SR8. Weather condition within the reporting period varied between sunny to rainy. The overall monitoring results were not affected by weather conditions. Major marine construction activities included: Dredging, Reclamation filling and Construction of Vertical Seawall**

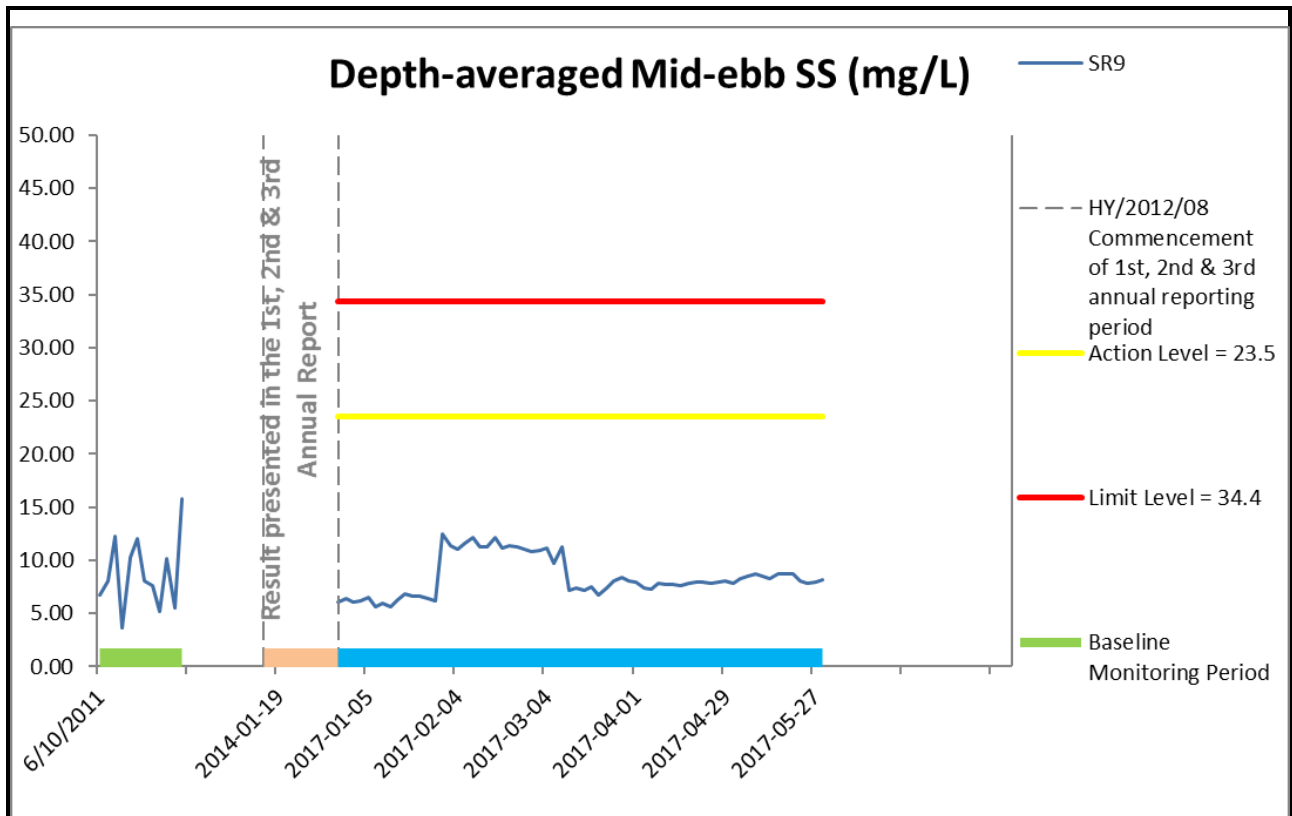
Figure E43 Baseline & Impact Monitoring - Mean Depth-averaged Level of Suspended Solids (mg/L) between Baseline monitoring period: 6/10/2011 to 31/10/2011 and Impact monitoring period: 3/1/2017 to 30/5/2017 at SR9. Weather condition within the reporting period varied between sunny to rainy. The overall monitoring results were not affected by weather conditions. Major marine construction activities included: Dredging, Reclamation filling and Construction of Vertical Seawall
