**Contract No. HY/2012/08
Tuen Mun – Chek Lap Kok Link –
Northern Connection Sub-sea Tunnel
Section**

*Fifth Annual Environmental Monitoring & Audit
(EM&A) Report*

30 July 2019

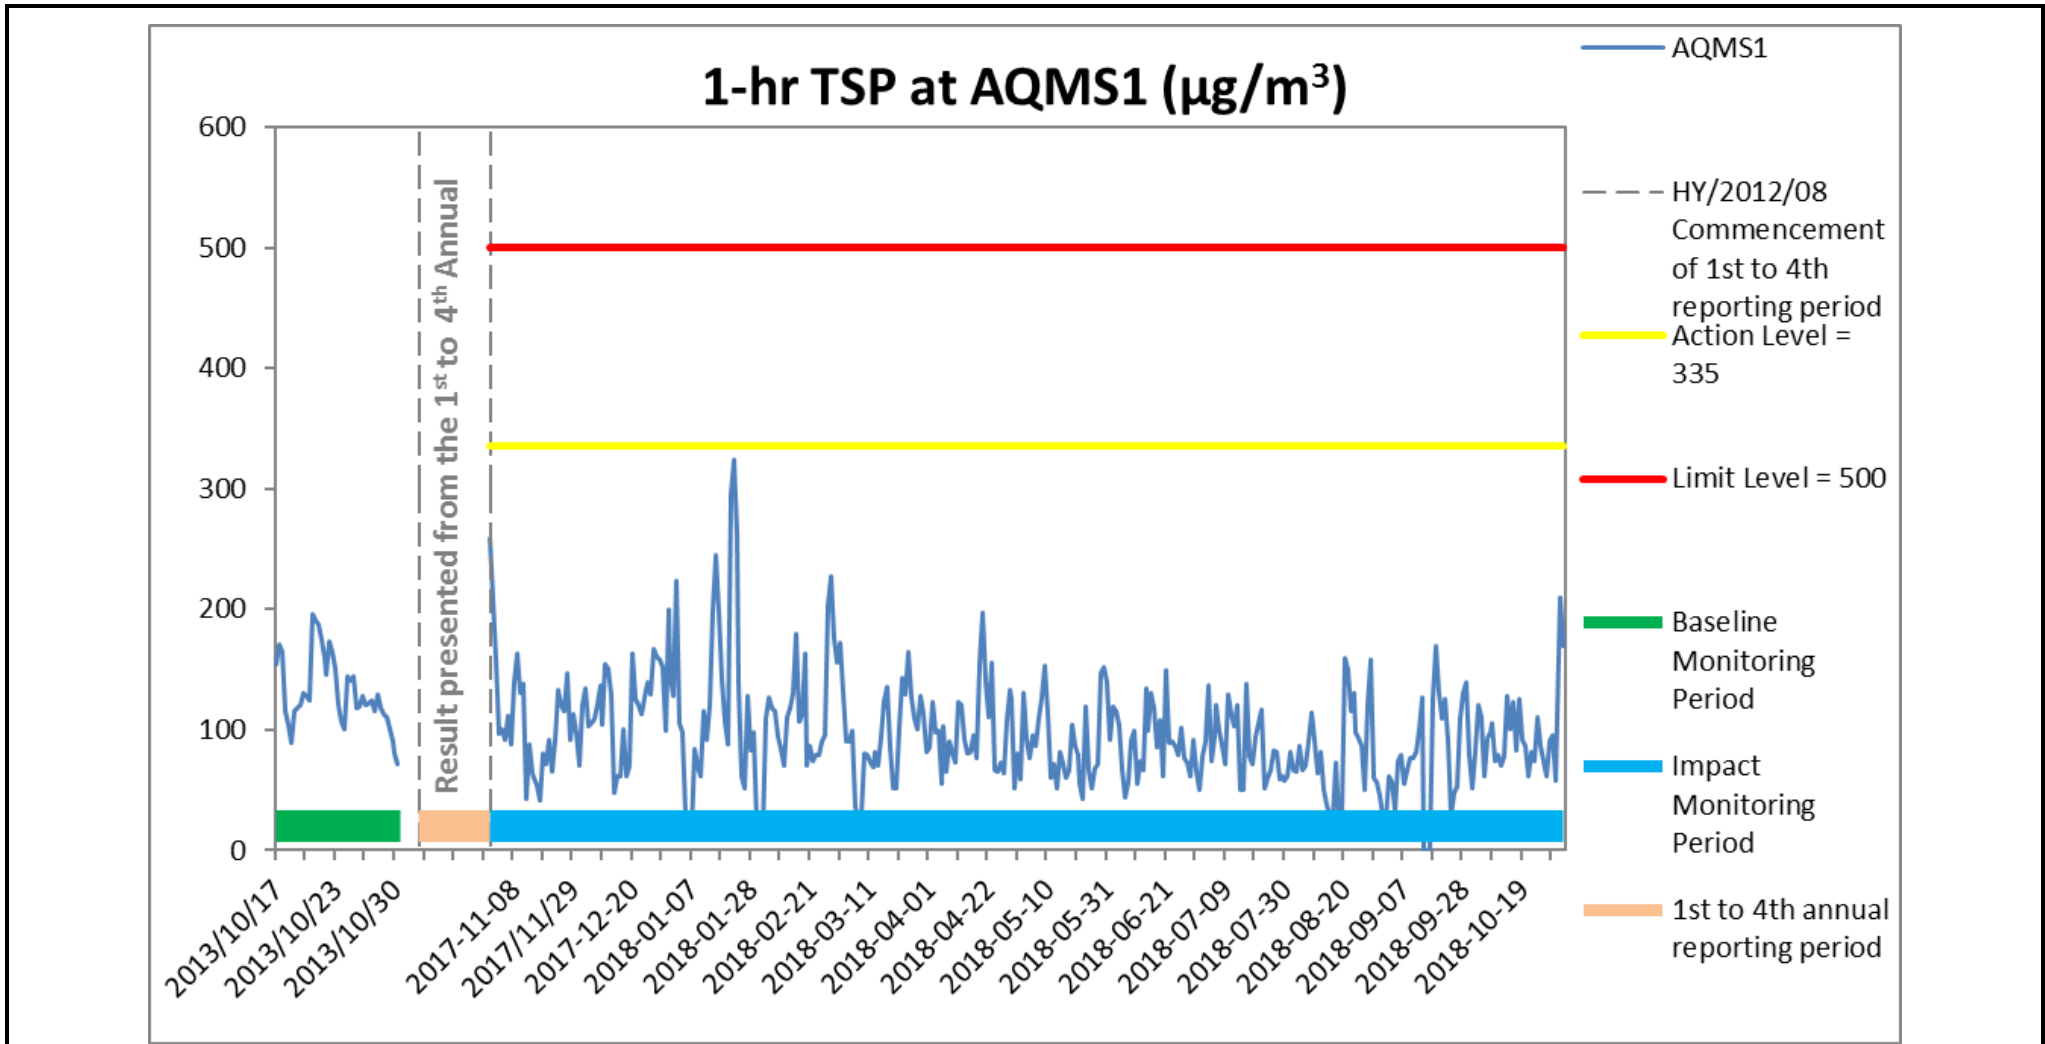
Figure D.1 Baseline & Impact Monitoring - 1-hour Total Suspended Particulates ($\mu\text{g}/\text{m}^3$) at AQMS1 between 17 October 2013 and 31 October 2018 during Baseline & Impact Monitoring period. Weather condition within the reporting period varied between sunny to rainy. The overall monitoring results were not affected by weather conditions. Major land-based construction activities included: Construction of Cross Passage Tympanum, Bulk Excavation, CSM Ground Treatment, TBM Tunnel Works & Excavation of sub-sea tunnel. Ref: 0212330_Impact AQM graphs_5thAnnual_REV a.xlsx

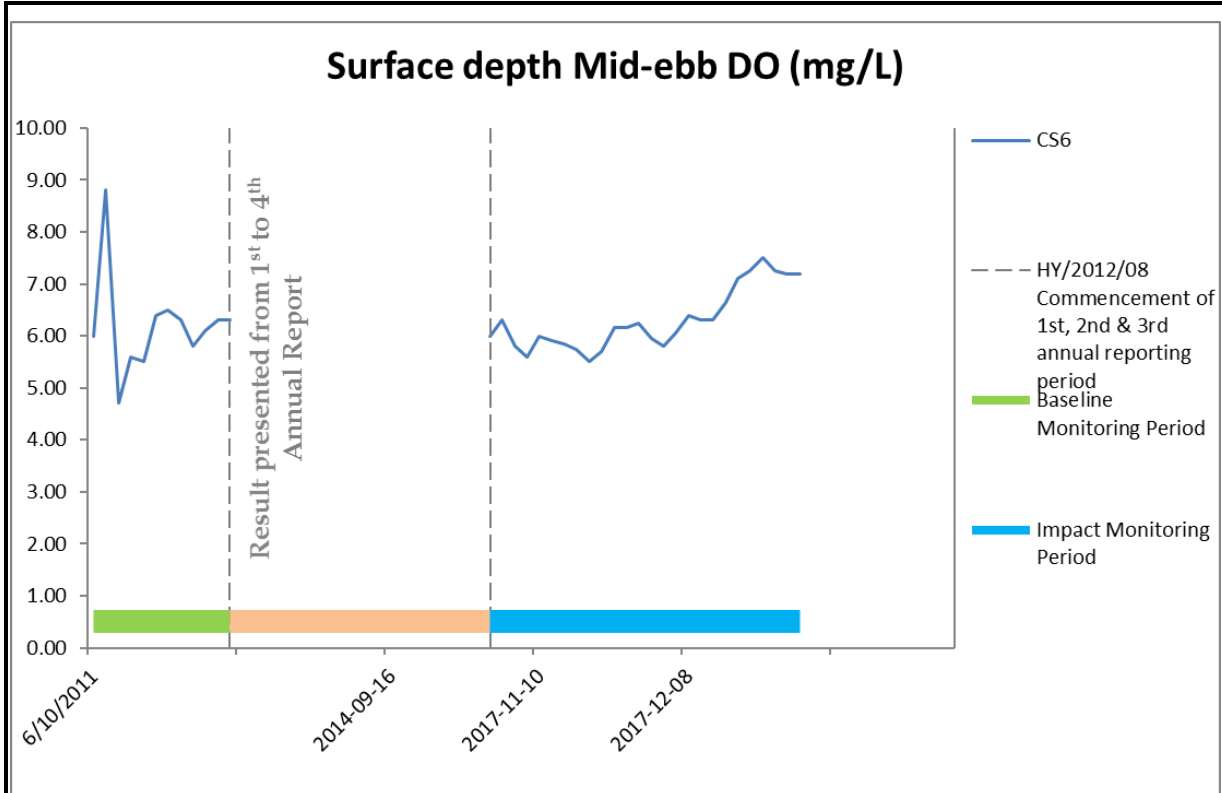
Figure E2 Baseline & Impact Monitoring - Mean Level of Dissolved Oxygen (mg/L) in surface waters between Baseline monitoring period: 6/10/2011 to 31/10/2011 and Impact monitoring period: 1/11/2017 to 31/12/2017 at CS6. Weather condition within the reporting period varied between sunny to rainy. The overall monitoring results were not affected by weather conditions. Major marine construction activities included: Seawall Construction and Filling works at Portion N-A, Seawall Enhancement Works at Portion N-C

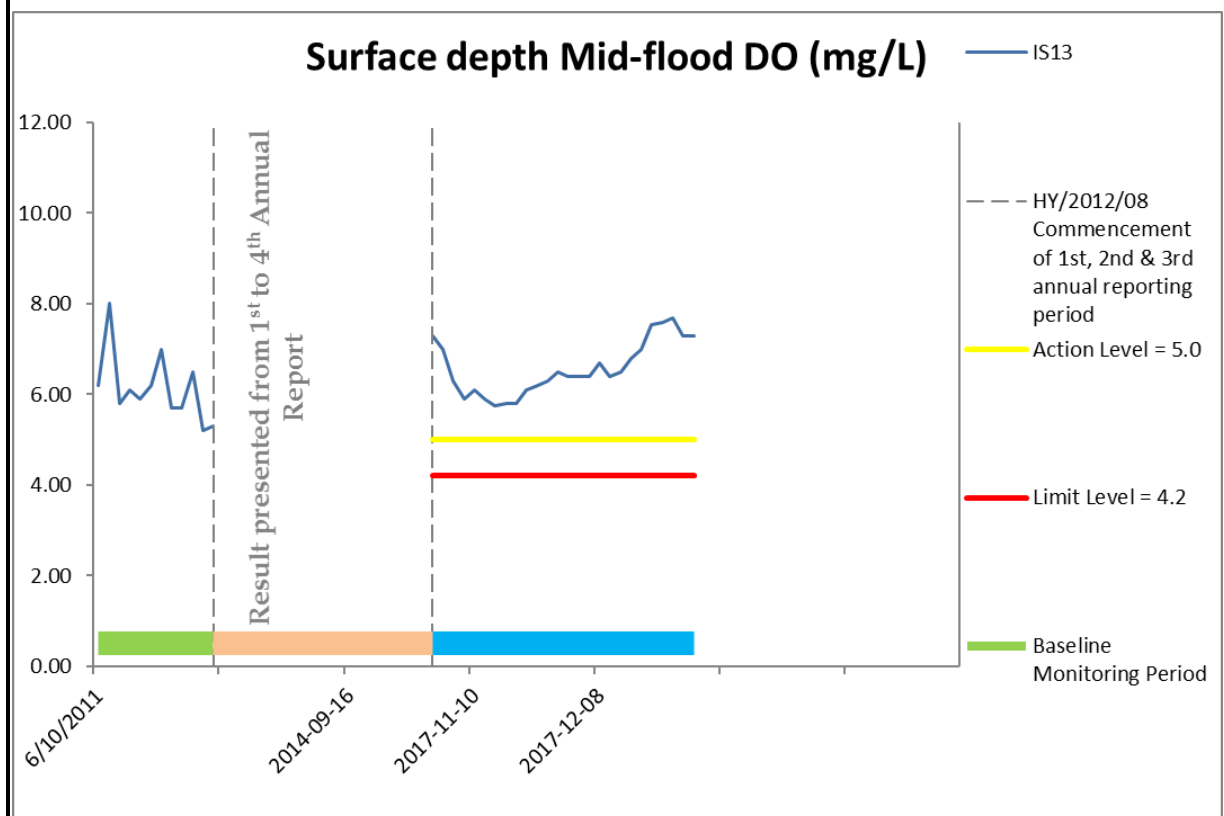
Figure E4 Baseline & Impact Monitoring - Mean Level of Dissolved Oxygen (mg/L) in surface waters between Baseline monitoring period: 6/10/2011 to 31/10/2011 and Impact monitoring period: 1/11/2017 to 31/12/2017 at IS13. Weather condition within the reporting period varied between sunny to rainy. The overall monitoring results were not affected by weather conditions. Major marine construction activities included: Seawall Construction and Filling works at Portion N-A, Seawall Enhancement Works at Portion N-C

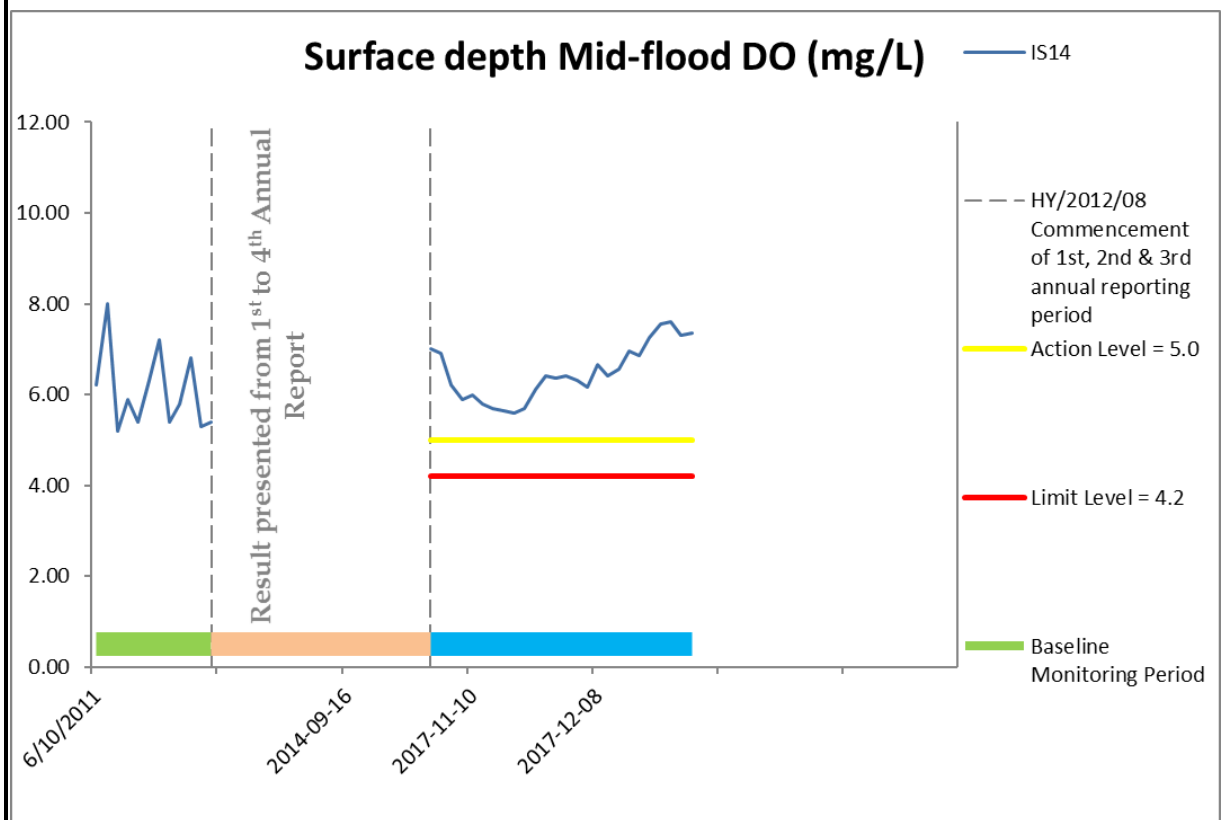
Figure E5 Baseline & Impact Monitoring - Mean Level of Dissolved Oxygen (mg/L) in surface waters between Baseline monitoring period: 6/10/2011 to 31/10/2011 and Impact monitoring period: 1/11/2017 to 31/12/2017 at IS14. Weather condition within the reporting period varied between sunny to rainy. The overall monitoring results were not affected by weather conditions. Major marine construction activities included: Seawall Construction and Filling works at Portion N-A, Seawall Enhancement Works at Portion N-C

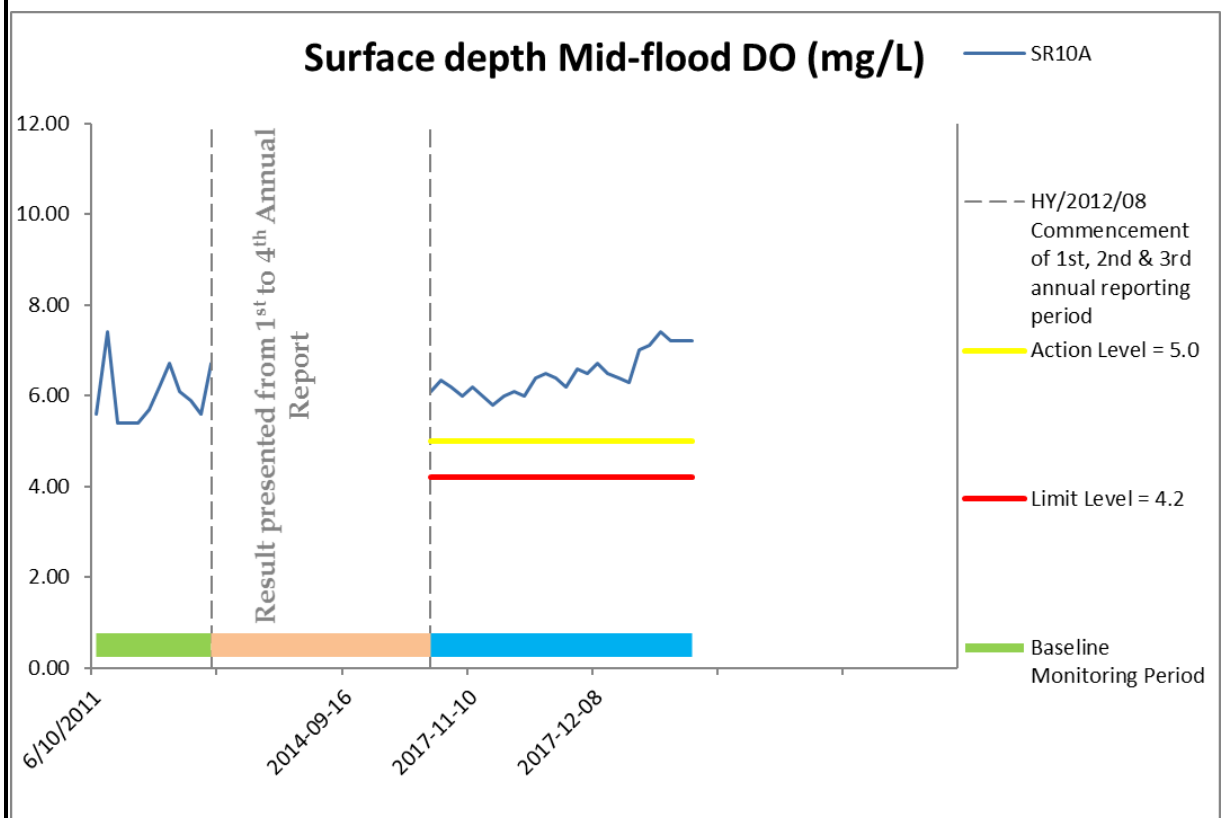
Figure E7 Baseline & Impact Monitoring - Mean Level of Dissolved Oxygen (mg/L) in surface waters between Baseline monitoring period: 6/10/2011 to 31/10/2011 and Impact monitoring period: 1/11/2017 to 31/12/2017 at SR10A. Weather condition within the reporting period varied between sunny to rainy. The overall monitoring results were not affected by weather conditions. Major marine construction activities included: Seawall Construction and Filling works at Portion N-A, Seawall Enhancement Works at Portion N-C
