**Contract No. HY/2012/07  
Tuen Mun - Chek Lap Kok Link -  
Southern Connection Viaduct Section**

***Sixth Annual Environmental Monitoring & Audit  
(EM&A) Report***

14 July 2020

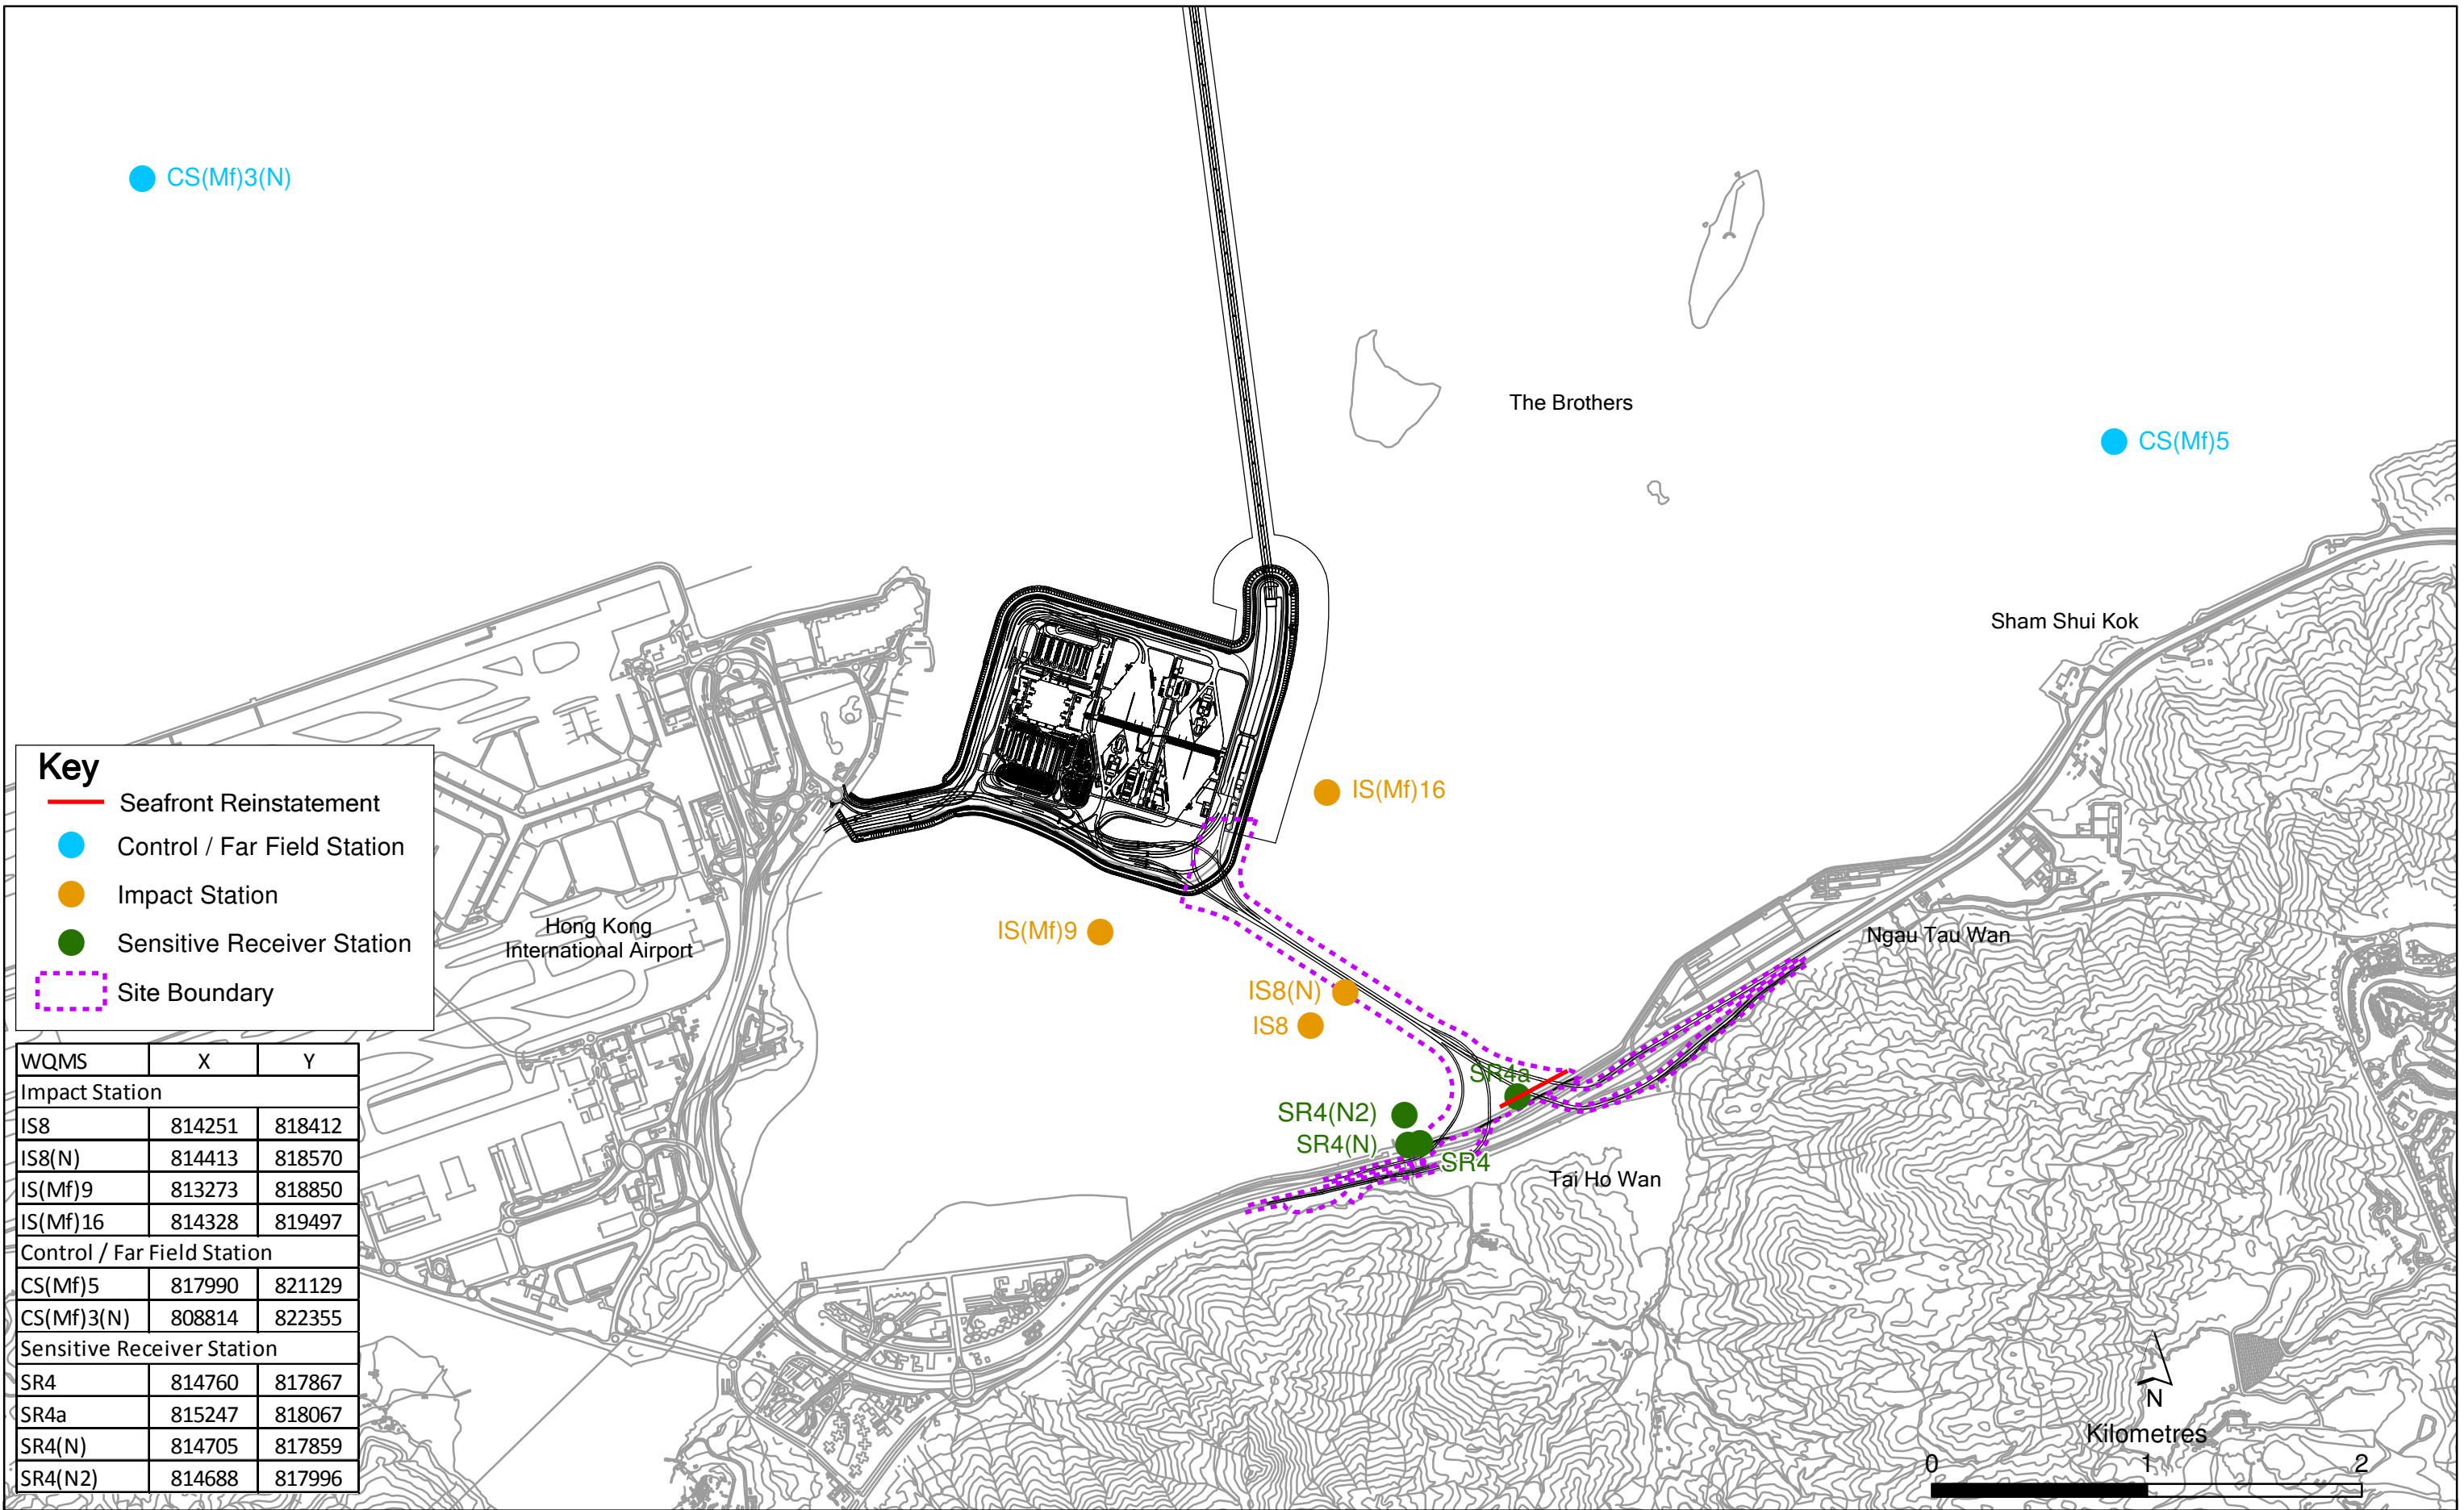
Figure 2.3

Locations of Water Quality Monitoring Stations

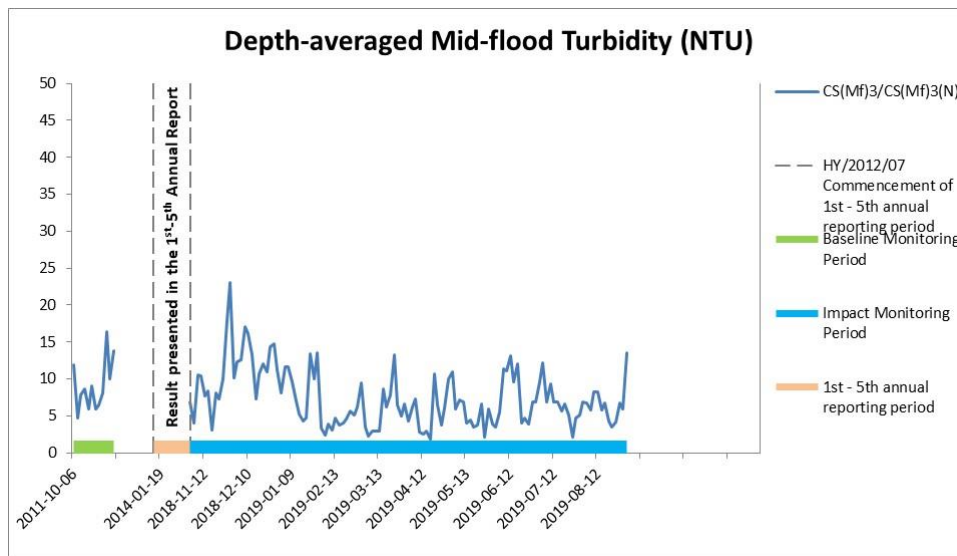
**Figure F24 Impact Monitoring - Mean Level of depth-averaged Turbidity (NTU) during mid-flood tide between 1 November 2018 and 30 August 2019 at CS(Mf)3/CS(Mf)3(N) and CS(Mf)5.**
