Contract No. HY/2012/08
Tuen Mun – Chek Lap Kok Link –
Northern Connection Sub-sea Tunnel
Section

Seventh Annual Environmental Monitoring & Audit (EM&A) Report

07 October 2021

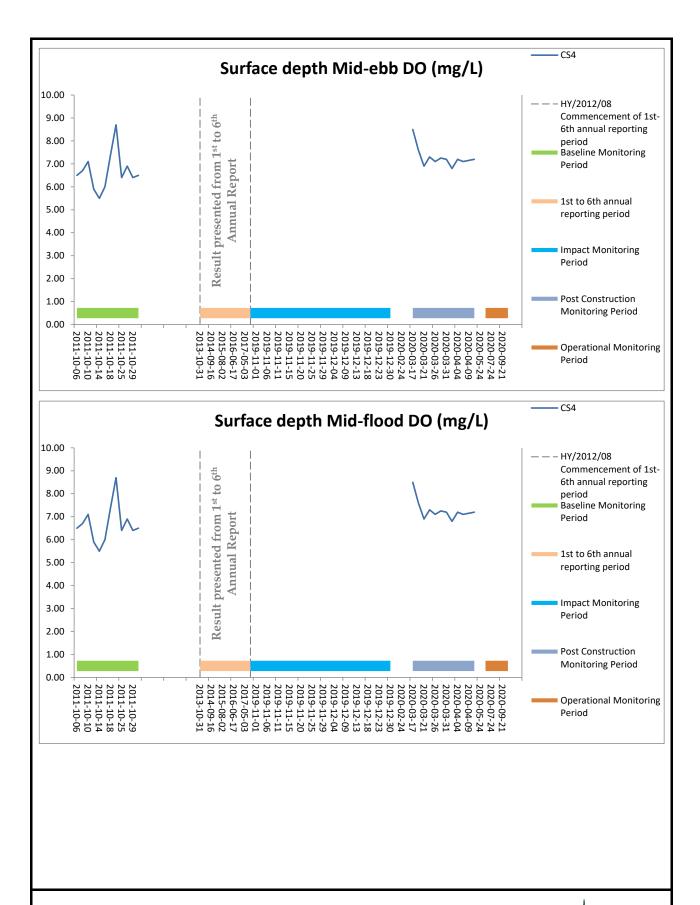
Figure E1 Baseline, Impact, Post-construction & Operational Monitoring – Mean Level of Dissolved Oxygen (mg/L) in surface waters between Baseline, Impact, Post-construction & Operational Monitoring (1/11/2019 to 31/10/2020) at CS4. Weather condition within the reporting period varied between sunny to rainy. The overall monitoring results were not affected by weather conditions. Major marine construction activities included: Seawall Modification Works at Portion S-B

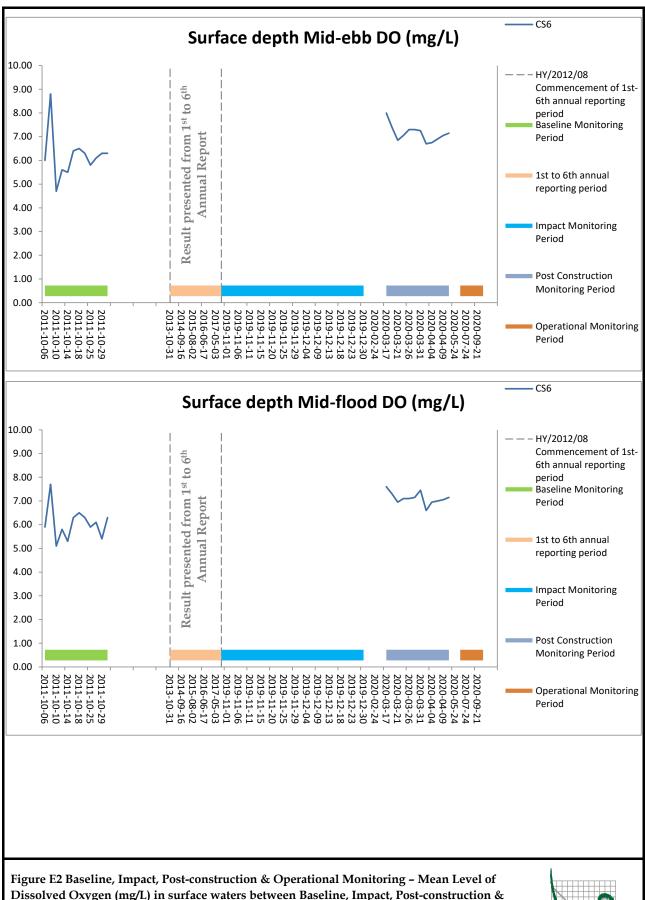
Figure E2 Baseline, Impact, Post-construction & Operational Monitoring – Mean Level of Dissolved Oxygen (mg/L) in surface waters between Baseline, Impact, Post-construction & Operational Monitoring (1/11/2019 to 31/10/2020) at CS6. Weather condition within the reporting period varied between sunny to rainy. The overall monitoring results were not affected by weather conditions. Major marine construction activities included: Seawall Modification Works at Portion S-B

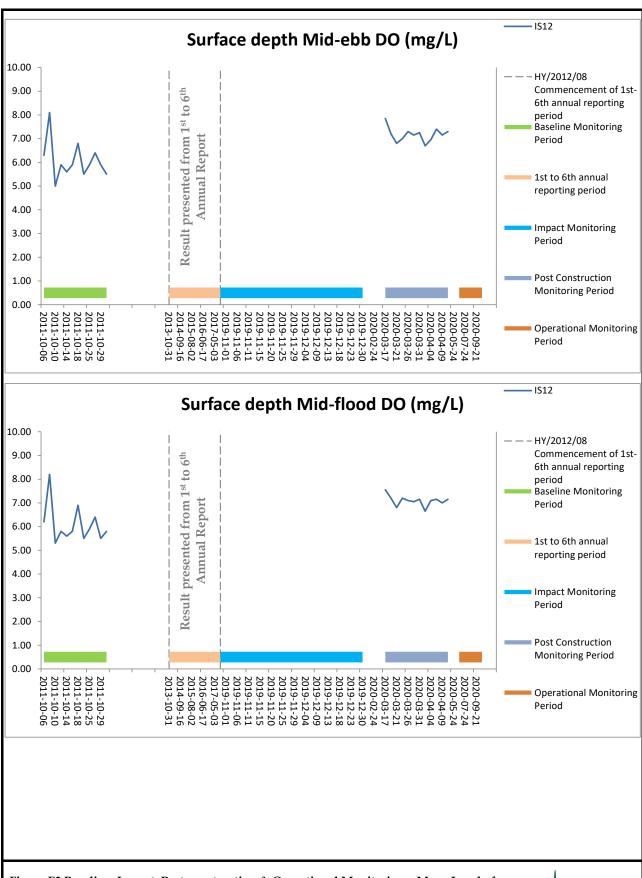
Figure E3 Baseline, Impact, Post-construction & Operational Monitoring – Mean Level of Dissolved Oxygen (mg/L) in surface waters between Baseline, Impact, Post-construction & Operational Monitoring (1/11/2019 to 31/10/2020) at IS12. Weather condition within the reporting period varied between sunny to rainy. The overall monitoring results were not affected by weather conditions. Major marine construction activities included: Seawall Modification Works at Portion S-B

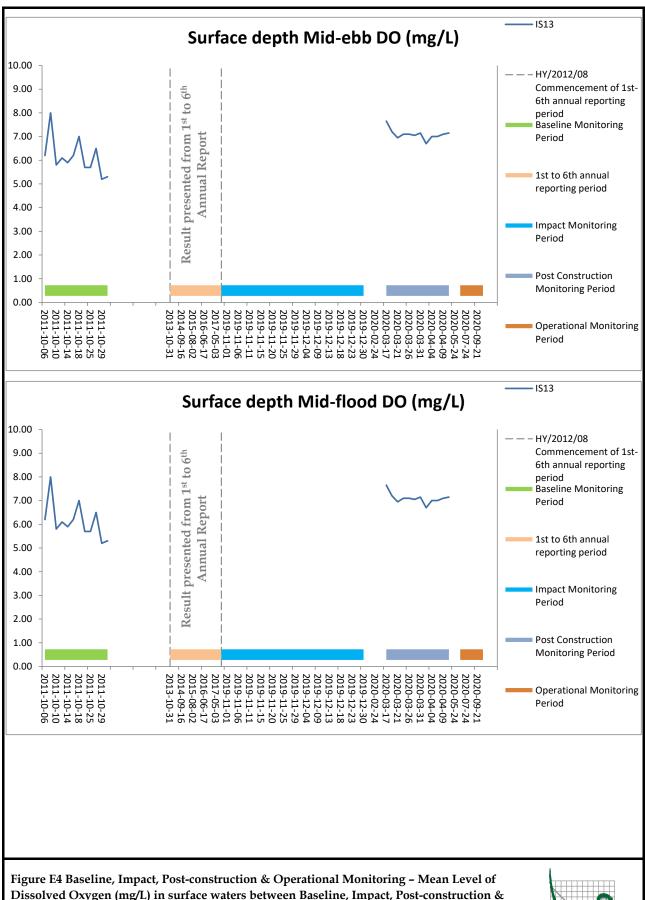
Figure E4 Baseline, Impact, Post-construction & Operational Monitoring – Mean Level of Dissolved Oxygen (mg/L) in surface waters between Baseline, Impact, Post-construction & Operational Monitoring (1/11/2019 to 31/10/2020) at IS13. Weather condition within the reporting period varied between sunny to rainy. The overall monitoring results were not affected by weather conditions. Major marine construction activities included: Seawall Modification Works at Portion S-B

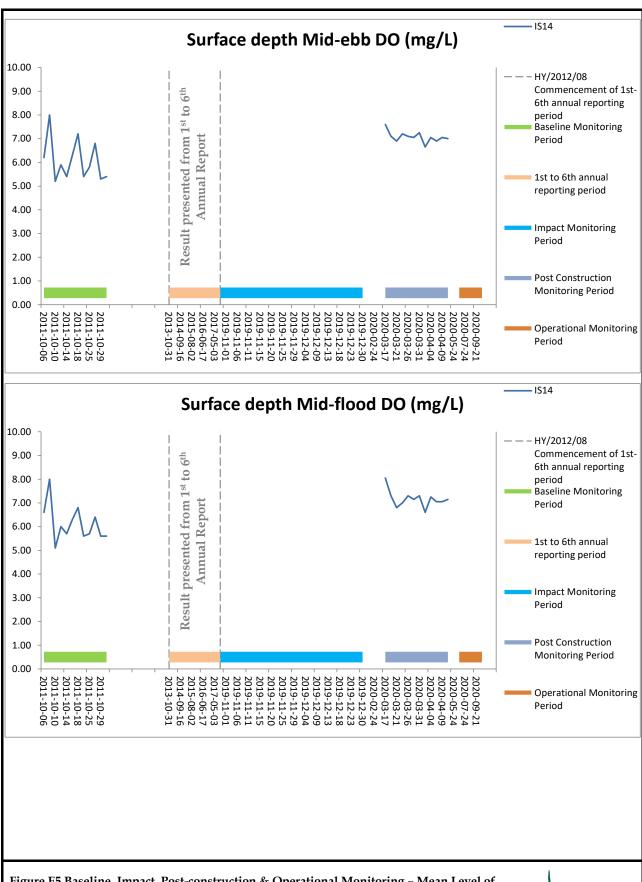
Figure E5 Baseline, Impact, Post-construction & Operational Monitoring - Mean Level of Dissolved Oxygen (mg/L) in surface waters between Baseline, Impact, Post-construction & Operational Monitoring (1/11/2019 to 31/10/2020) at IS14. Weather condition within the reporting period varied between sunny to rainy. The overall monitoring results were not affected by weather conditions. Major marine construction activities included: Seawall Modification Works at Portion S-B

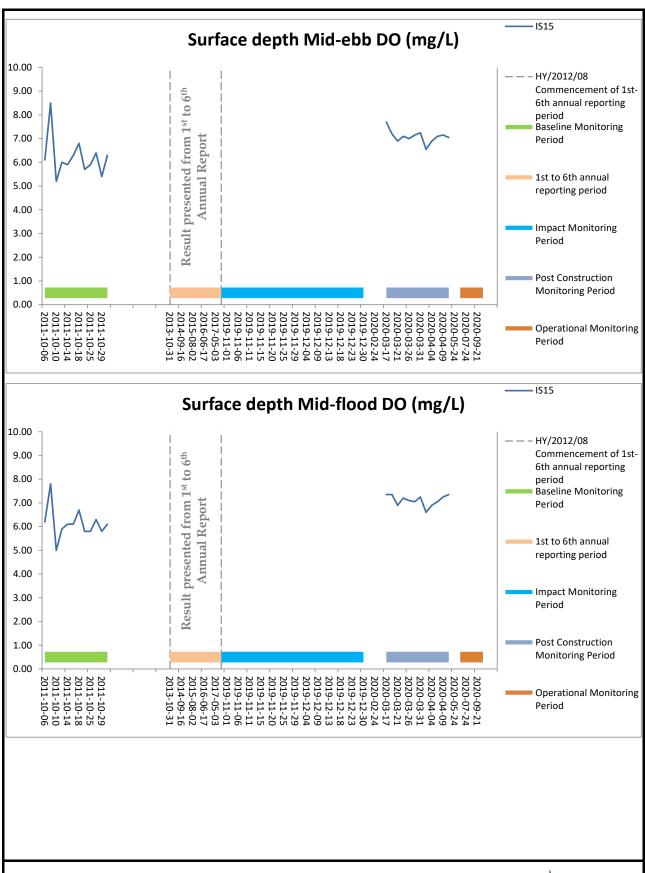
Figure E6 Baseline, Impact, Post-construction & Operational Monitoring – Mean Level of Dissolved Oxygen (mg/L) in surface waters between Baseline, Impact, Post-construction & Operational Monitoring (1/11/2019 to 31/10/2020) at IS15. Weather condition within the reporting period varied between sunny to rainy. The overall monitoring results were not affected by weather conditions. Major marine construction activities included: Seawall Modification Works at Portion S-B

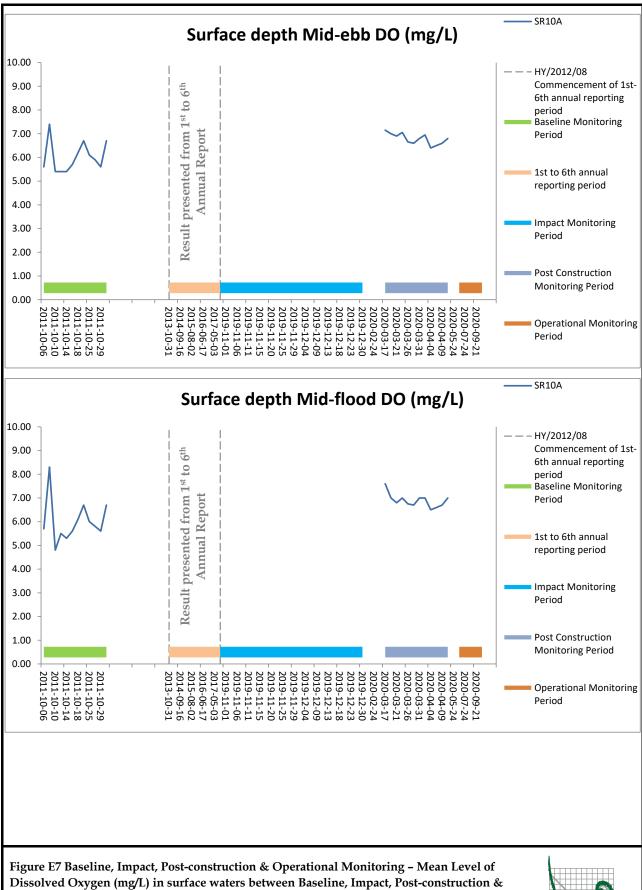
Figure E7 Baseline, Impact, Post-construction & Operational Monitoring – Mean Level of Dissolved Oxygen (mg/L) in surface waters between Baseline, Impact, Post-construction & Operational Monitoring (1/11/2019 to 31/10/2020) at SR10A. Weather condition within the reporting period varied between sunny to rainy. The overall monitoring results were not affected by weather conditions. Major marine construction activities included: Seawall Modification Works at Portion S-B

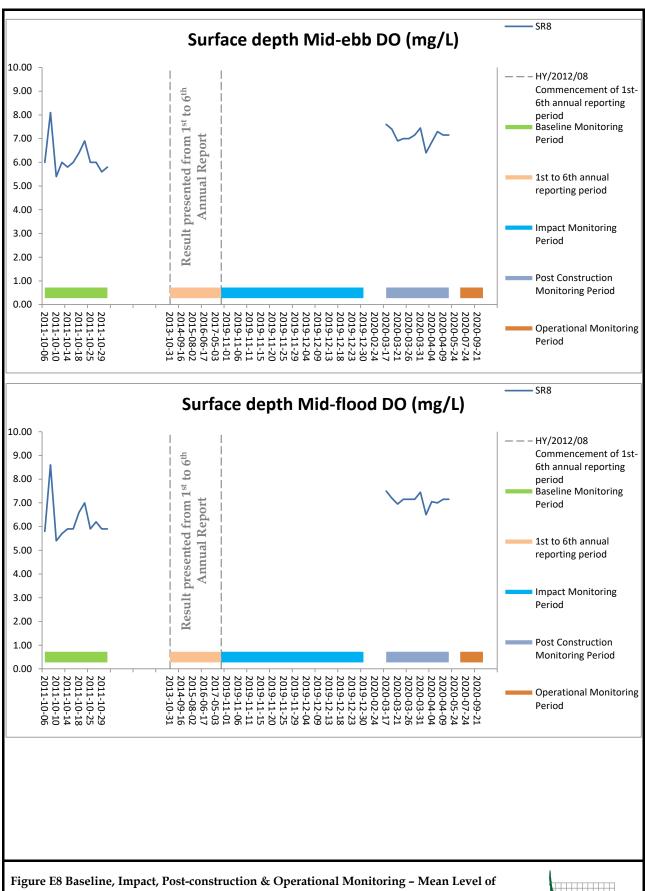
Figure E8 Baseline, Impact, Post-construction & Operational Monitoring – Mean Level of Dissolved Oxygen (mg/L) in surface waters between Baseline, Impact, Post-construction & Operational Monitoring (1/11/2019 to 31/10/2020) at SR8. Weather condition within the reporting period varied between sunny to rainy. The overall monitoring results were not affected by weather conditions. Major marine construction activities included: Seawall Modification Works at Portion S-B

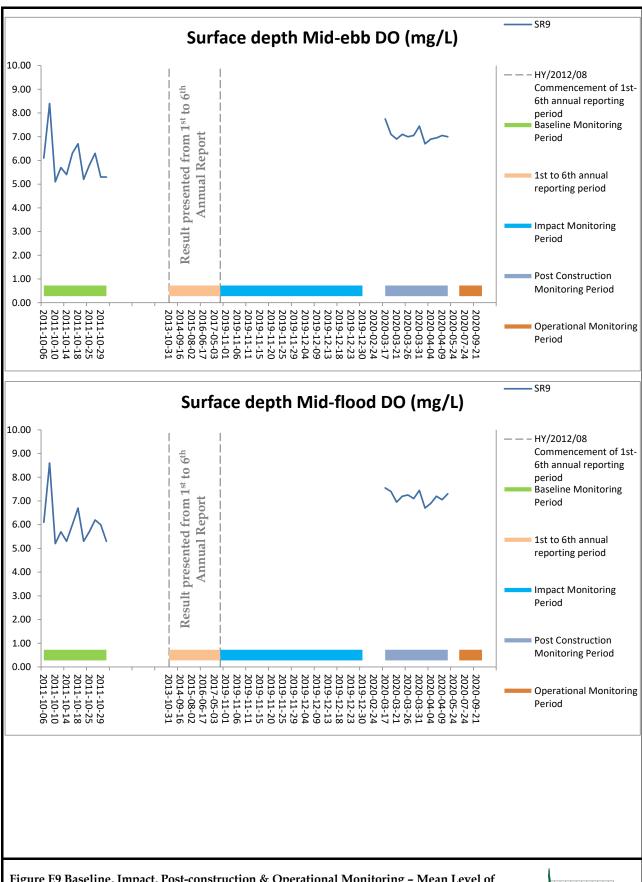
Figure E9 Baseline, Impact, Post-construction & Operational Monitoring – Mean Level of Dissolved Oxygen (mg/L) in surface waters between Baseline, Impact, Post-construction & Operational Monitoring (1/11/2019 to 31/10/2020) at SR9. Weather condition within the reporting period varied between sunny to rainy. The overall monitoring results were not affected by weather conditions. Major marine construction activities included: Seawall Modification Works at Portion S-B

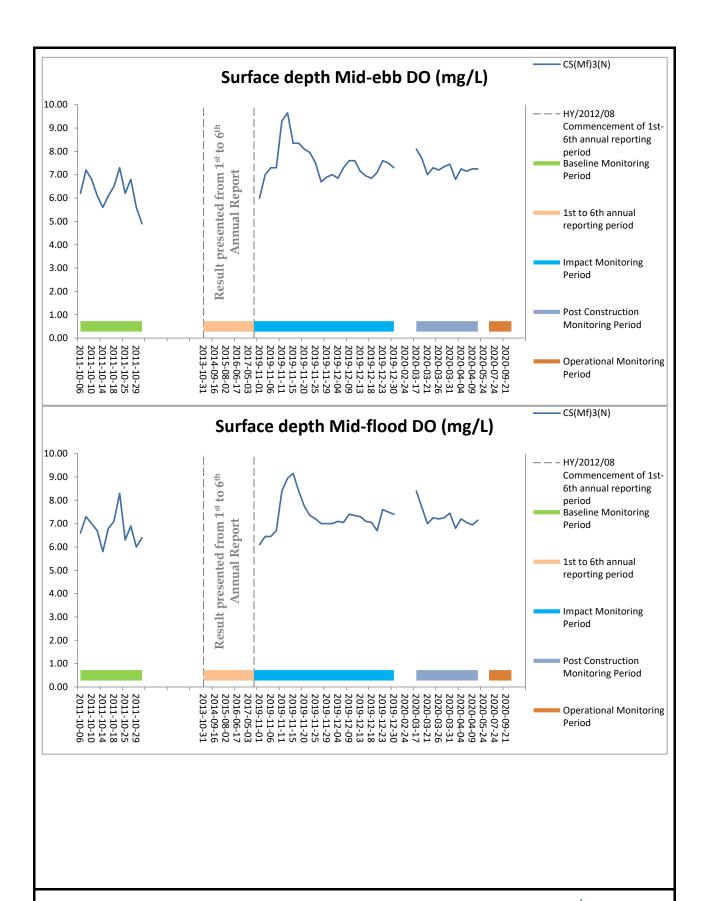
Figure E13 Baseline, Impact, Post-construction & Operational Monitoring – Mean Level of Dissolved Oxygen (mg/L) in surface waters between Baseline, Impact, Post-construction & Operational Monitoring (1/11/2019 to 31/10/2020) at CS(Mf)3(N). Weather condition within the reporting period varied between sunny to rainy. The overall monitoring results were not affected by weather conditions. Major marine construction activities included: Seawall Modification Works at Portion S-B

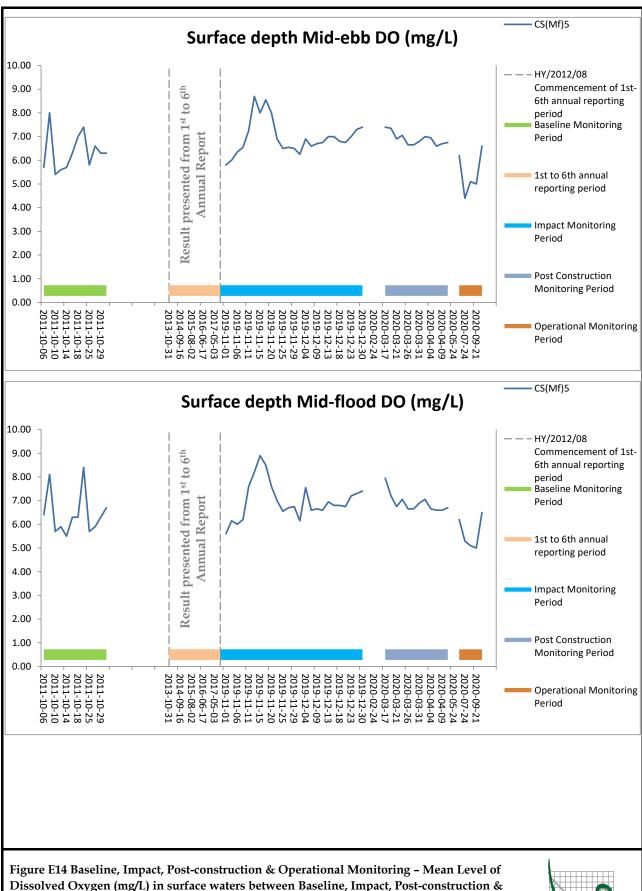
Figure E14 Baseline, Impact, Post-construction & Operational Monitoring – Mean Level of Dissolved Oxygen (mg/L) in surface waters between Baseline, Impact, Post-construction & Operational Monitoring (1/11/2019 to 31/10/2020) at CS(Mf)5. Weather condition within the reporting period varied between sunny to rainy. The overall monitoring results were not affected by weather conditions. Major marine construction activities included: Seawall Modification Works at Portion S-B

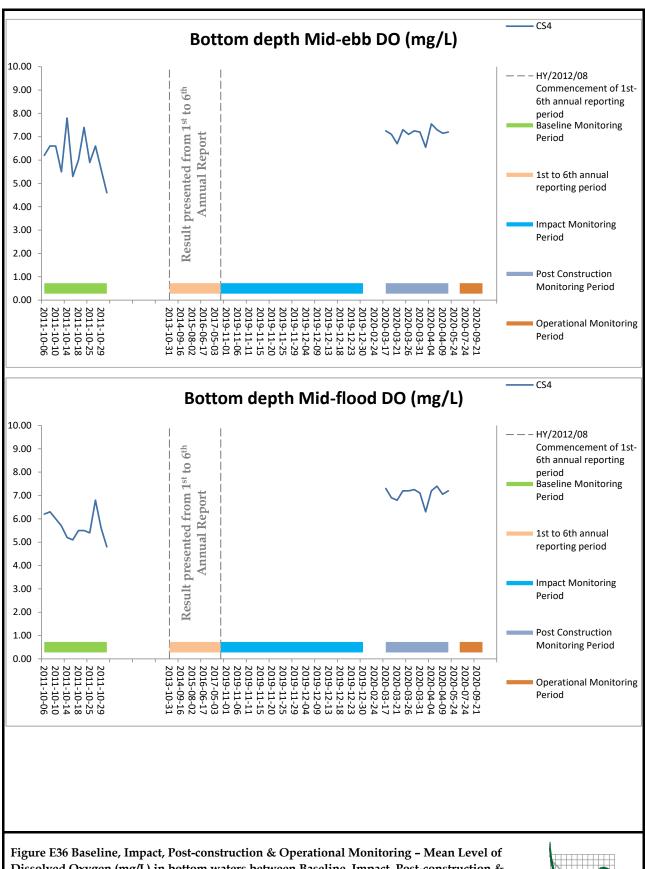
Figure E36 Baseline, Impact, Post-construction & Operational Monitoring – Mean Level of Dissolved Oxygen (mg/L) in bottom waters between Baseline, Impact, Post-construction & Operational Monitoring (1/11/2019 to 31/10/2020) at CS4. Weather condition within the reporting period varied between sunny to rainy. The overall monitoring results were not affected by weather conditions. Major marine construction activities included: Seawall Modification Works at Portion S-B

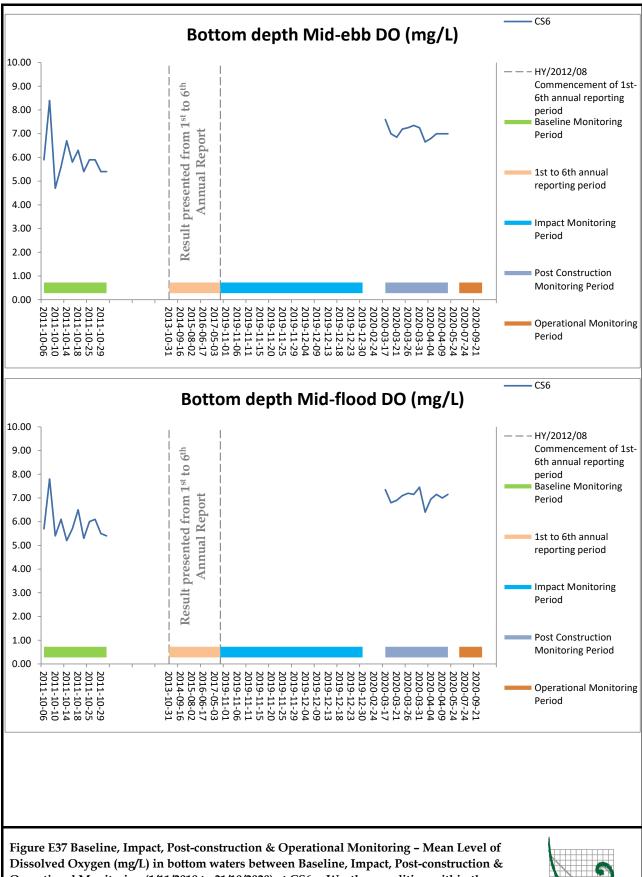
Figure E37 Baseline, Impact, Post-construction & Operational Monitoring - Mean Level of Dissolved Oxygen (mg/L) in bottom waters between Baseline, Impact, Post-construction & Operational Monitoring (1/11/2019 to 31/10/2020) at CS6. Weather condition within the reporting period varied between sunny to rainy. The overall monitoring results were not affected by weather conditions. Major marine construction activities included: Seawall Modification Works at Portion S-B

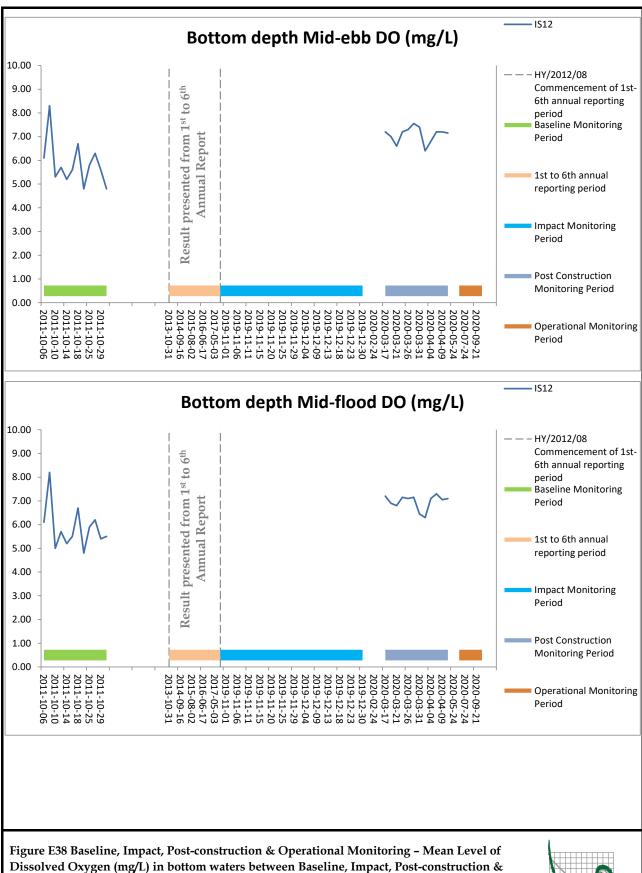
Figure E38 Baseline, Impact, Post-construction & Operational Monitoring – Mean Level of Dissolved Oxygen (mg/L) in bottom waters between Baseline, Impact, Post-construction & Operational Monitoring (1/11/2019 to 31/10/2020) at IS12. Weather condition within the reporting period varied between sunny to rainy. The overall monitoring results were not affected by weather conditions. Major marine construction activities included: Seawall Modification Works at Portion S-B

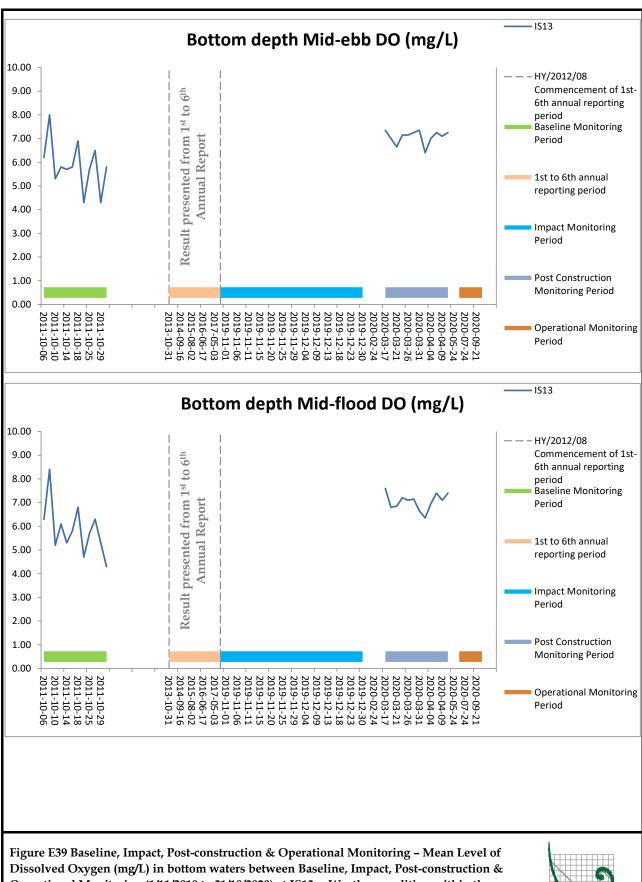
Figure E39 Baseline, Impact, Post-construction & Operational Monitoring - Mean Level of Dissolved Oxygen (mg/L) in bottom waters between Baseline, Impact, Post-construction & Operational Monitoring (1/11/2019 to 31/10/2020) at IS13. Weather condition within the reporting period varied between sunny to rainy. The overall monitoring results were not affected by weather conditions. Major marine construction activities included: Seawall Modification Works at Portion S-B

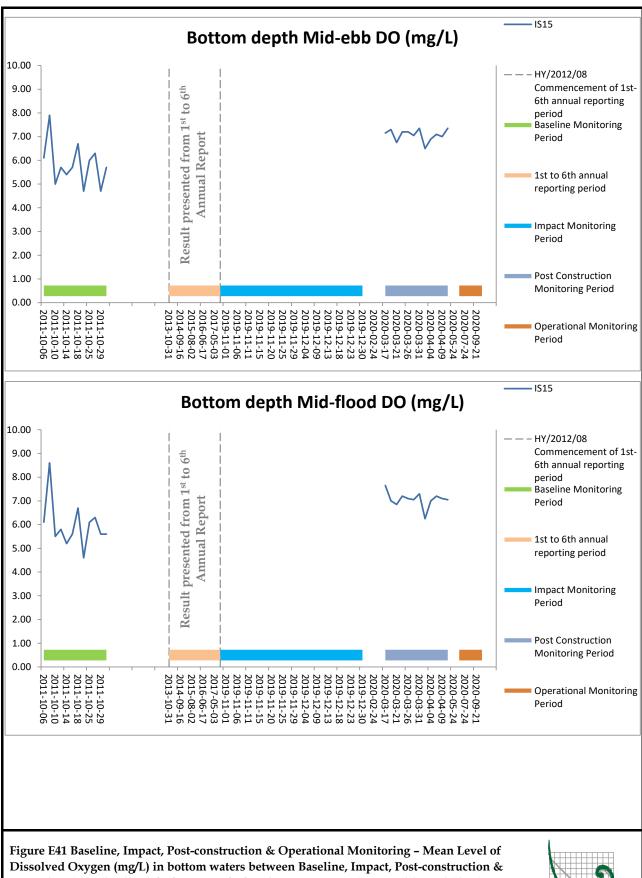
Figure E41 Baseline, Impact, Post-construction & Operational Monitoring – Mean Level of Dissolved Oxygen (mg/L) in bottom waters between Baseline, Impact, Post-construction & Operational Monitoring (1/11/2019 to 31/10/2020) at IS15. Weather condition within the reporting period varied between sunny to rainy. The overall monitoring results were not affected by weather conditions. Major marine construction activities included: Seawall Modification Works at Portion S-B

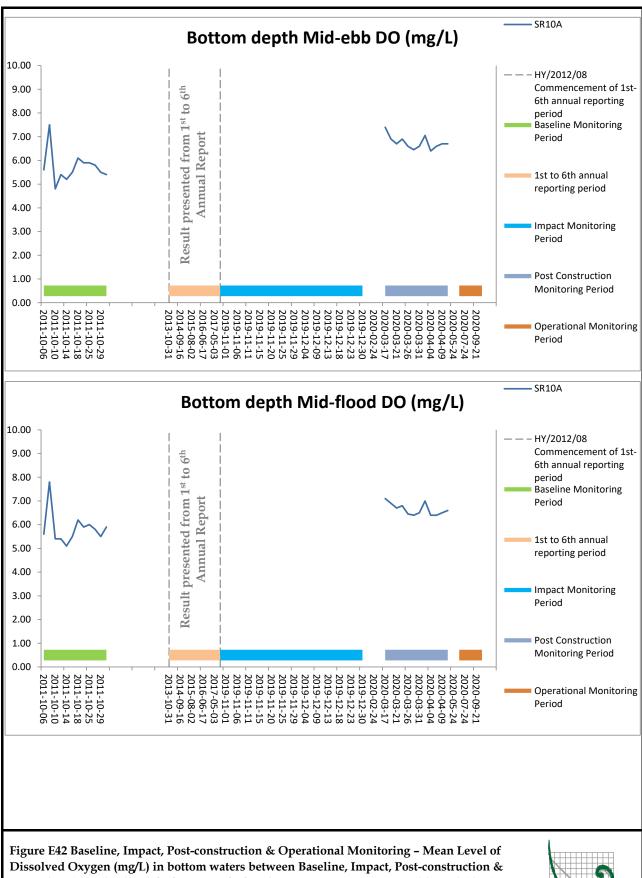
Figure E42 Baseline, Impact, Post-construction & Operational Monitoring – Mean Level of Dissolved Oxygen (mg/L) in bottom waters between Baseline, Impact, Post-construction & Operational Monitoring (1/11/2019 to 31/10/2020) at SR10A. Weather condition within the reporting period varied between sunny to rainy. The overall monitoring results were not affected by weather conditions. Major marine construction activities included: Seawall Modification Works at Portion S-B

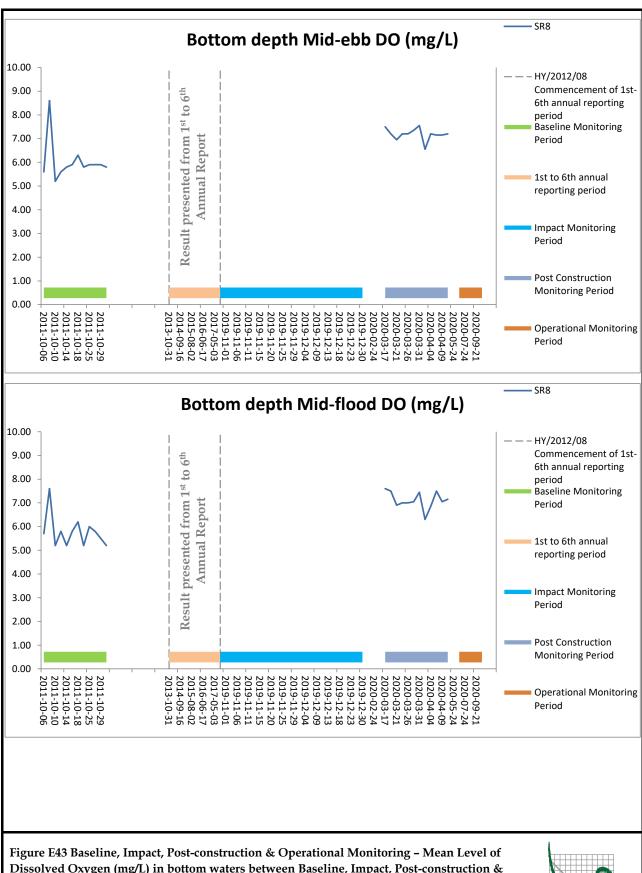
Figure E43 Baseline, Impact, Post-construction & Operational Monitoring - Mean Level of Dissolved Oxygen (mg/L) in bottom waters between Baseline, Impact, Post-construction & Operational Monitoring (1/11/2019 to 31/10/2020) at SR8. Weather condition within the reporting period varied between sunny to rainy. The overall monitoring results were not affected by weather conditions. Major marine construction activities included: Seawall Modification Works at Portion S-B

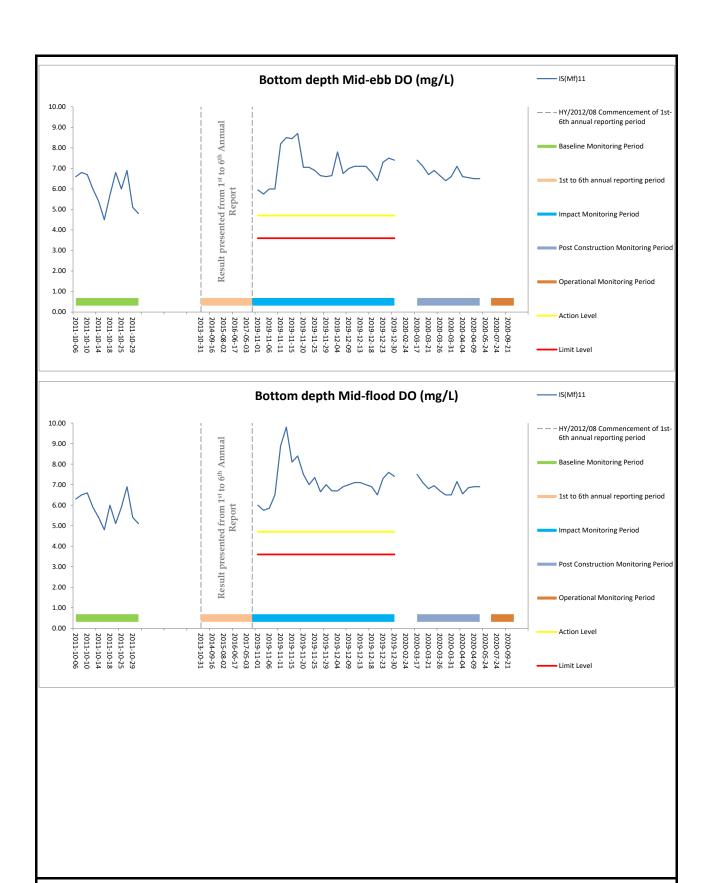
Figure E45 Baseline, Impact, Post-construction & Operational Monitoring - Mean Level of Dissolved Oxygen (mg/L) in bottom waters between Baseline, Impact, Post-construction & Operational Monitoring (1/11/2019 to 31/10/2020) at IS(Mf)11. Weather condition within the reporting period varied between sunny to rainy. The overall monitoring results were not affected by weather conditions. Major marine construction activities included: Seawall Modification Works at Portion S-B

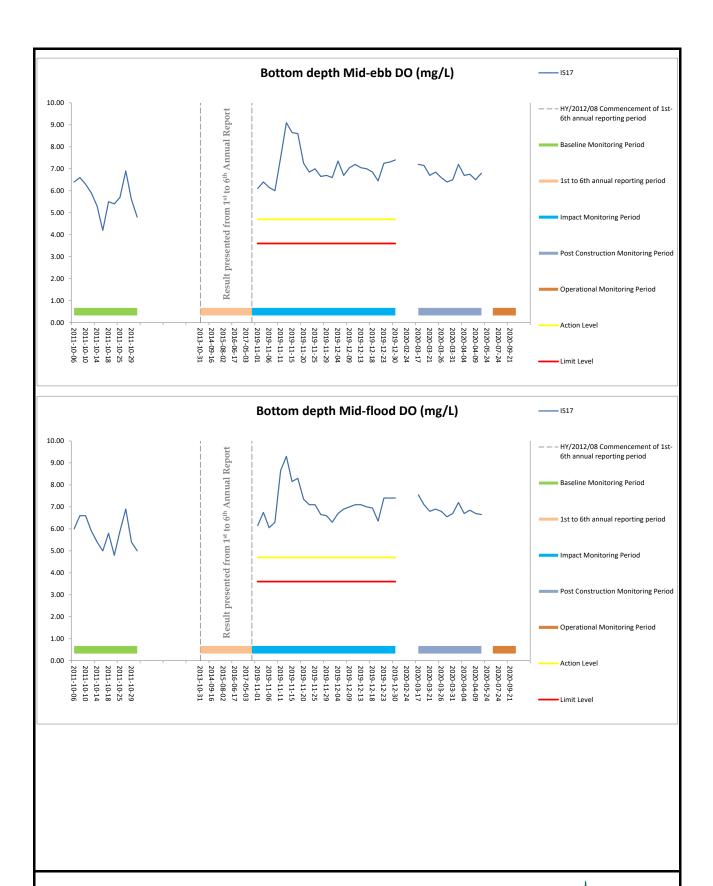
Figure E47 Baseline, Impact, Post-construction & Operational Monitoring – Mean Level of Dissolved Oxygen (mg/L) in bottom waters between Baseline, Impact, Post-construction & Operational Monitoring (1/11/2019 to 31/10/2020) at IS17. Weather condition within the reporting period varied between sunny to rainy. The overall monitoring results were not affected by weather conditions. Major marine construction activities included: Seawall Modification Works at Portion S-B

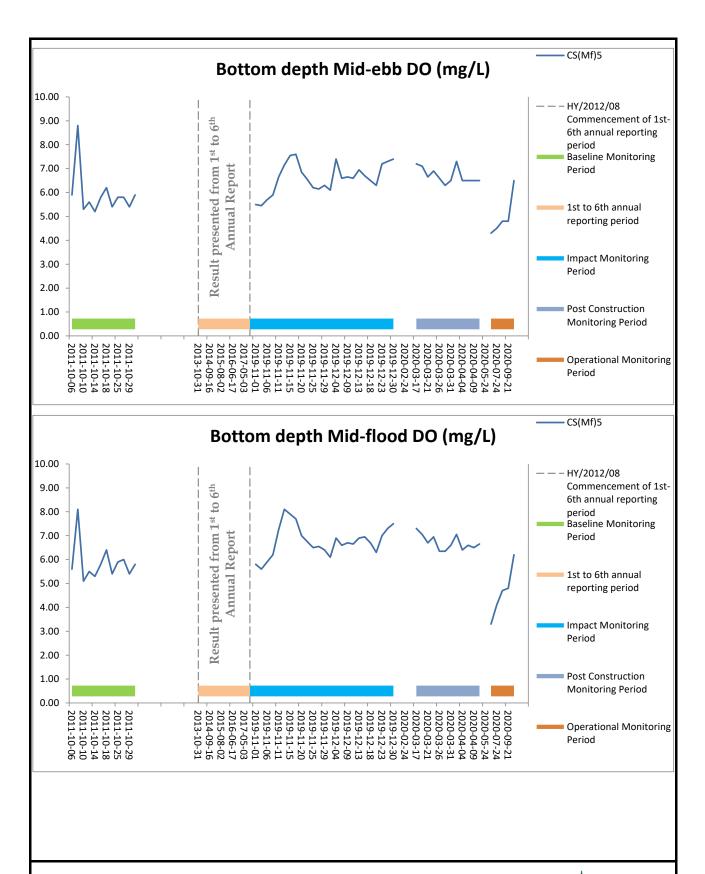
Figure E49 Baseline, Impact, Post-construction & Operational Monitoring – Mean Level of Dissolved Oxygen (mg/L) in bottom waters between Baseline, Impact, Post-construction & Operational Monitoring (1/11/2019 to 31/10/2020) at CS(Mf)5. Weather condition within the reporting period varied between sunny to rainy. The overall monitoring results were not affected by weather conditions. Major marine construction activities included: Seawall Modification Works at Portion S-B

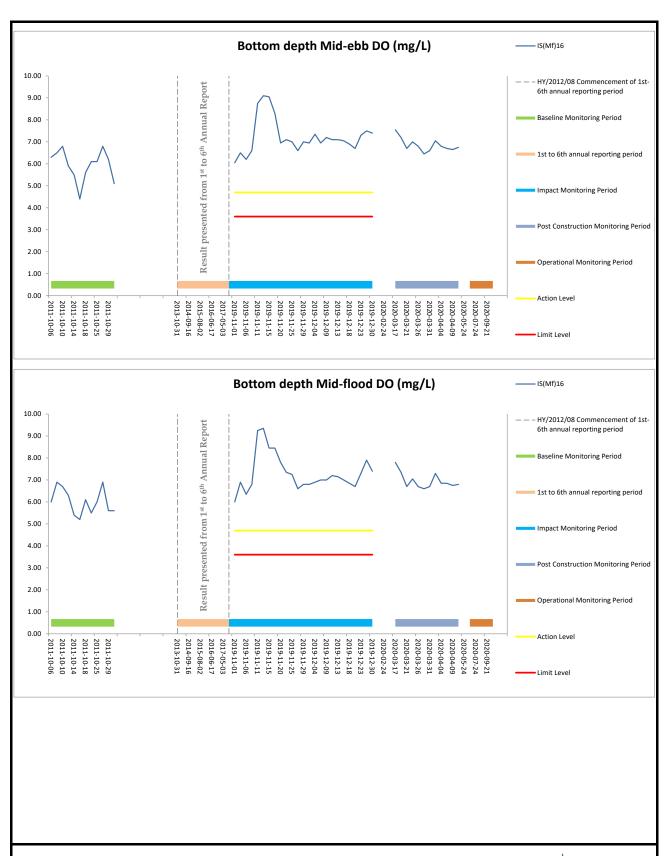
Figure E50 Baseline, Impact, Post-construction & Operational Monitoring – Mean Level of Dissolved Oxygen (mg/L) in bottom waters between Baseline, Impact, Post-construction & Operational Monitoring (1/11/2019 to 31/10/2020) at IS(Mf)16. Weather condition within the reporting period varied between sunny to rainy. The overall monitoring results were not affected by weather conditions. Major marine construction activities included: Seawall Modification Works at Portion S-B

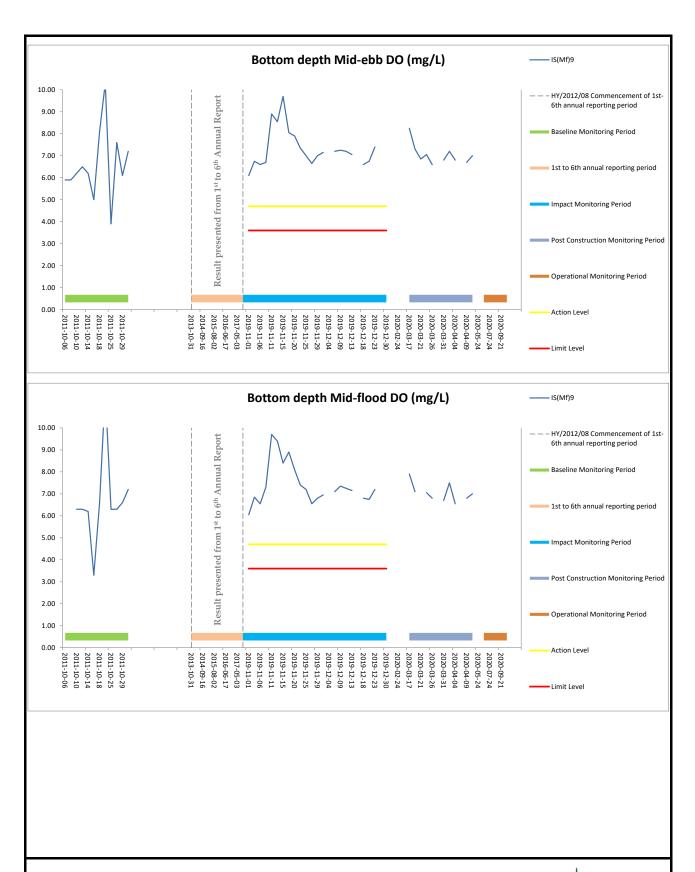
Figure E51 Baseline, Impact, Post-construction & Operational Monitoring - Mean Level of Dissolved Oxygen (mg/L) in bottom waters between Baseline, Impact, Post-construction & Operational Monitoring (1/11/2019 to 31/10/2020) at IS(Mf)9. Weather condition within the reporting period varied between sunny to rainy. The overall monitoring results were not affected by weather conditions. Major marine construction activities included: Seawall Modification Works at Portion S-B

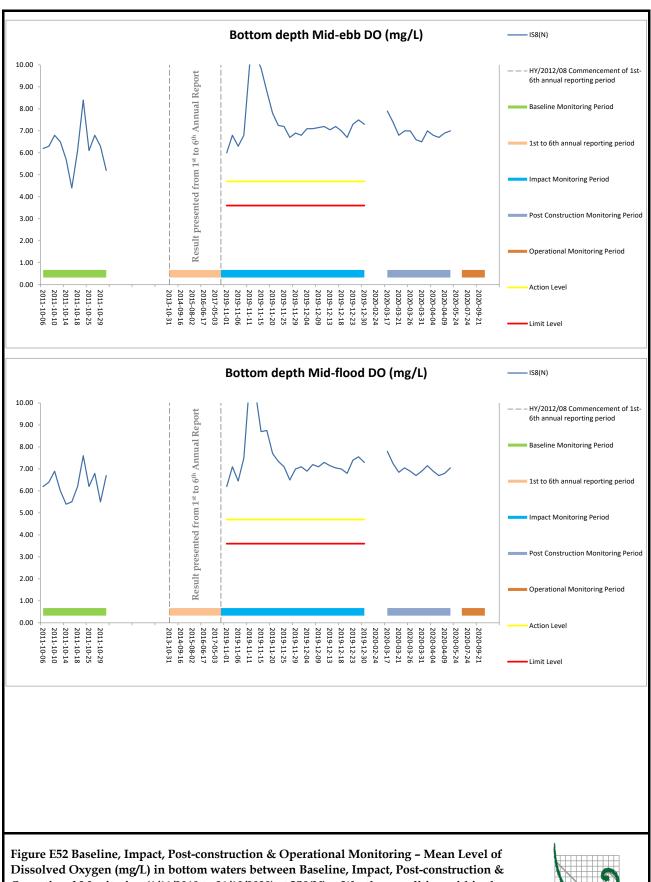
Figure E52 Baseline, Impact, Post-construction & Operational Monitoring – Mean Level of Dissolved Oxygen (mg/L) in bottom waters between Baseline, Impact, Post-construction & Operational Monitoring (1/11/2019 to 31/10/2020) at IS8(N). Weather condition within the reporting period varied between sunny to rainy. The overall monitoring results were not affected by weather conditions. Major marine construction activities included: Seawall Modification Works at Portion S-B

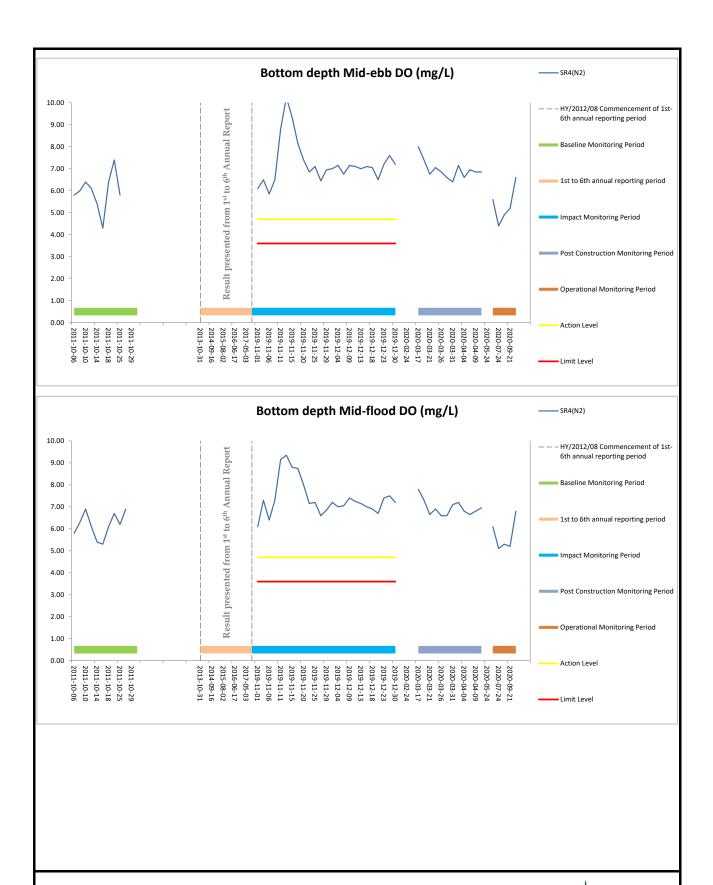
Figure E53 Baseline, Impact, Post-construction & Operational Monitoring – Mean Level of Dissolved Oxygen (mg/L) in bottom waters between Baseline, Impact, Post-construction & Operational Monitoring (1/11/2019 to 31/10/2020) at SR4(N2). Weather condition within the reporting period varied between sunny to rainy. The overall monitoring results were not affected by weather conditions. Major marine construction activities included: Seawall Modification Works at Portion S-B

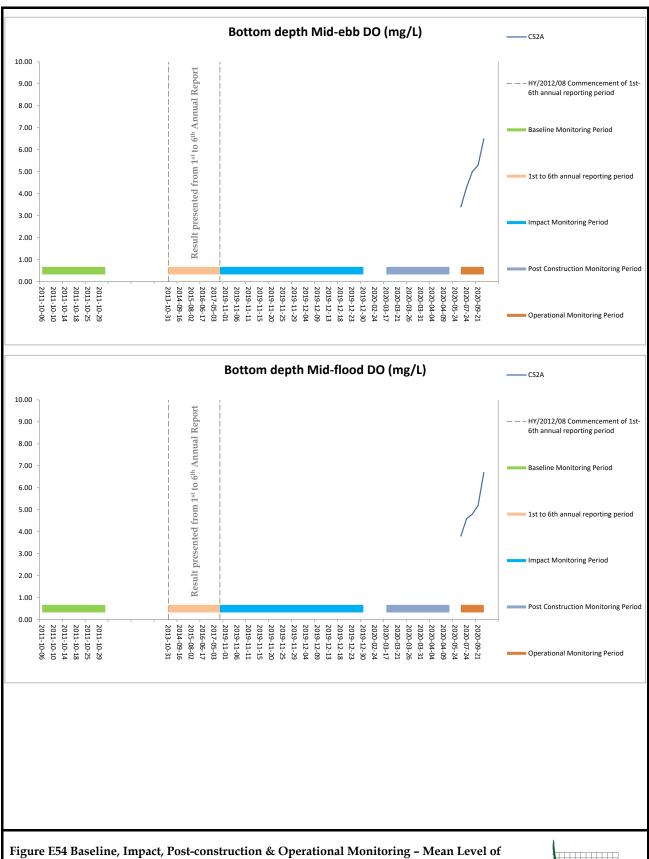
Figure E54 Baseline, Impact, Post-construction & Operational Monitoring – Mean Level of Dissolved Oxygen (mg/L) in bottom waters between Baseline, Impact, Post-construction & Operational Monitoring (1/11/2019 to 31/10/2020) at CS2A. Weather condition within the reporting period varied between sunny to rainy. The overall monitoring results were not affected by weather conditions. Major marine construction activities included: Seawall Modification Works at Portion S-B

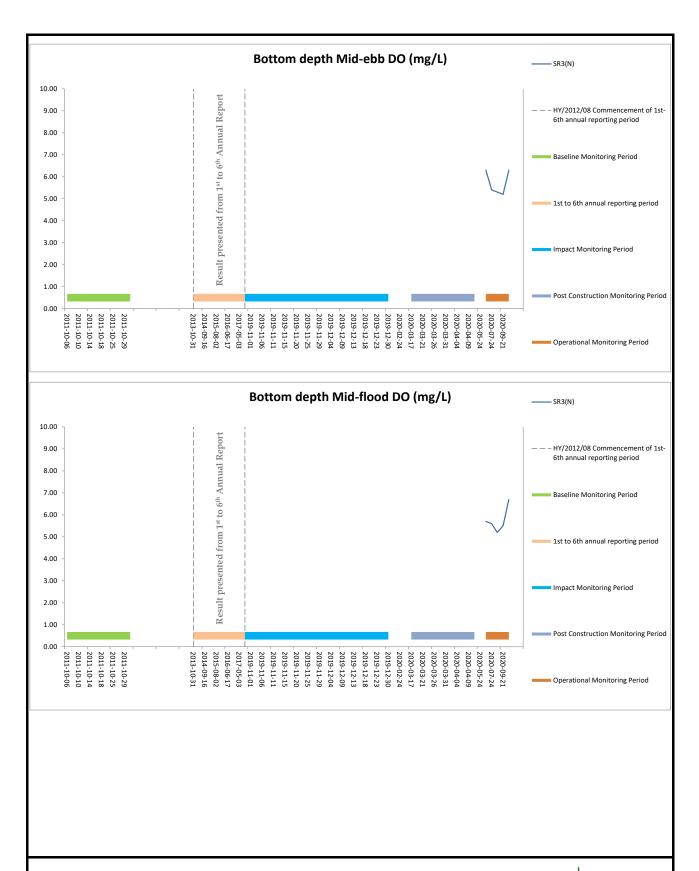
Figure E55 Baseline, Impact, Post-construction & Operational Monitoring – Mean Level of Dissolved Oxygen (mg/L) in bottom waters between Baseline, Impact, Post-construction & Operational Monitoring (1/11/2019 to 31/10/2020) at SR3(N). Weather condition within the reporting period varied between sunny to rainy. The overall monitoring results were not affected by weather conditions. Major marine construction activities included: Seawall Modification Works at Portion S-B

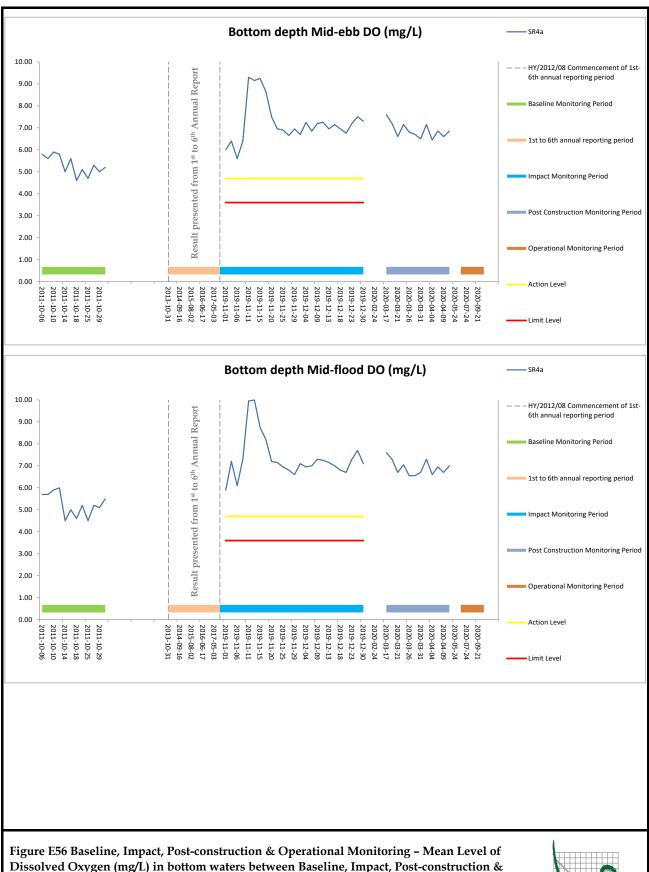
Figure E56 Baseline, Impact, Post-construction & Operational Monitoring – Mean Level of Dissolved Oxygen (mg/L) in bottom waters between Baseline, Impact, Post-construction & Operational Monitoring (1/11/2019 to 31/10/2020) at SR4a. Weather condition within the reporting period varied between sunny to rainy. The overall monitoring results were not affected by weather conditions. Major marine construction activities included: Seawall Modification Works at Portion S-B

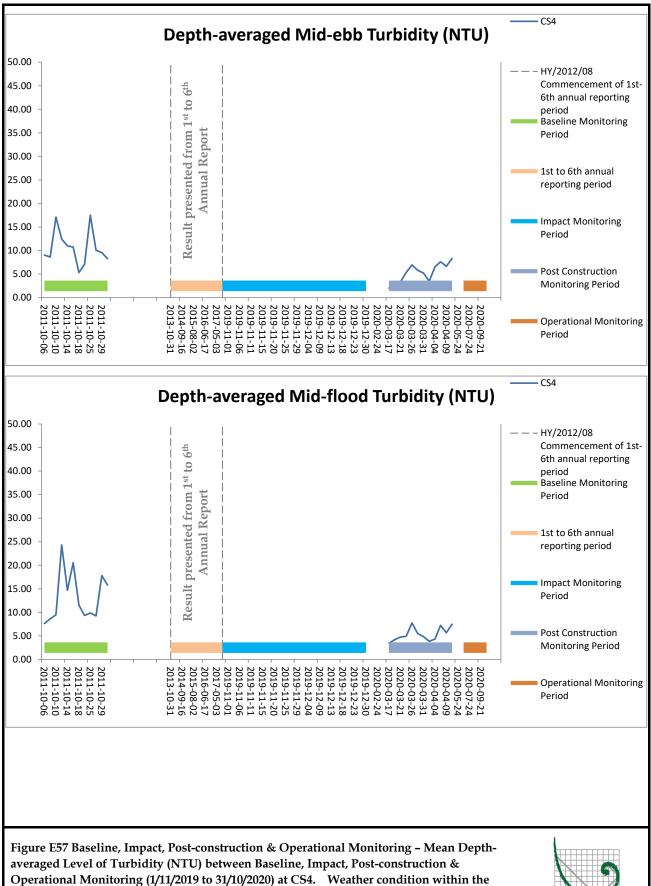
Figure E57 Baseline, Impact, Post-construction & Operational Monitoring – Mean Depthaveraged Level of Turbidity (NTU) between Baseline, Impact, Post-construction & Operational Monitoring (1/11/2019 to 31/10/2020) at CS4. Weather condition within the reporting period varied between sunny to rainy. The overall monitoring results were not affected by weather conditions. Major marine construction activities included: Seawall Modification Works at Portion S-B

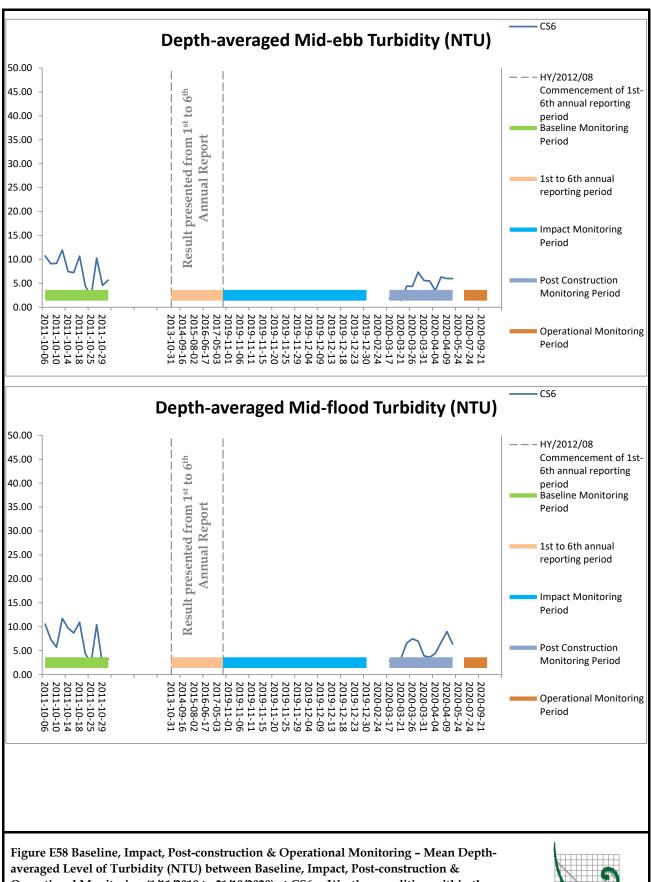
Figure E58 Baseline, Impact, Post-construction & Operational Monitoring - Mean Depth-averaged Level of Turbidity (NTU) between Baseline, Impact, Post-construction & Operational Monitoring (1/11/2019 to 31/10/2020) at CS6. Weather condition within the reporting period varied between sunny to rainy. The overall monitoring results were not affected by weather conditions. Major marine construction activities included: Seawall Modification Works at Portion S-B

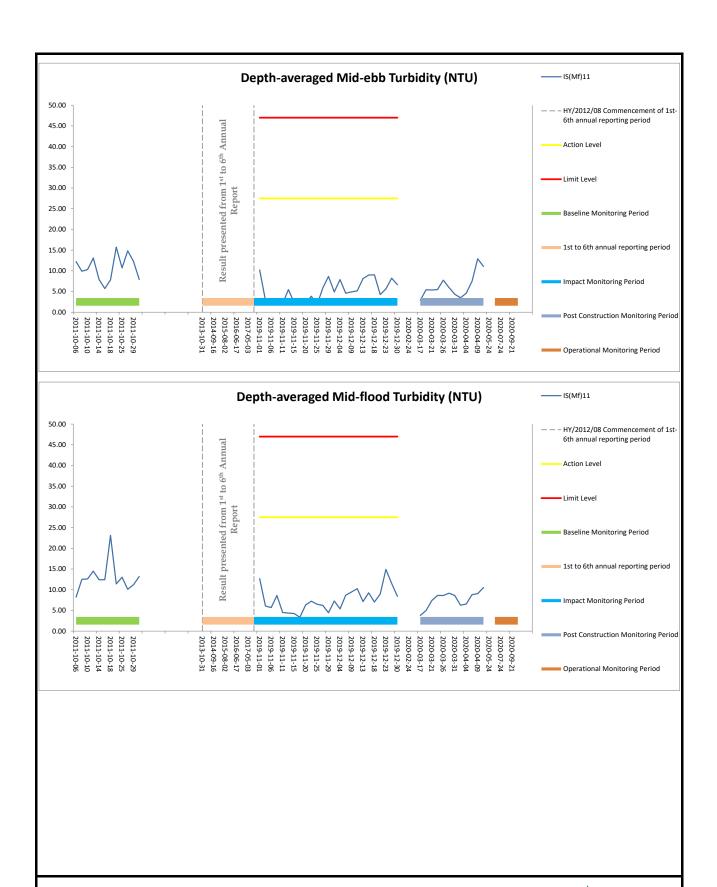
Figure E66 Baseline, Impact, Post-construction & Operational Monitoring – Mean Depthaveraged Level of Turbidity (NTU) between Baseline, Impact, Post-construction & Operational Monitoring (1/11/2019 to 31/10/2020) at IS(Mf)11. Weather condition within the reporting period varied between sunny to rainy. The overall monitoring results were not affected by weather conditions. Major marine construction activities included: Seawall Modification Works at Portion S-B
