Contract No. HY/2012/08
Tuen Mun – Chek Lap Kok Link –
Northern Connection Sub-sea Tunnel
Section

Seventh Annual Environmental Monitoring & Audit (EM&A) Report

07 October 2021

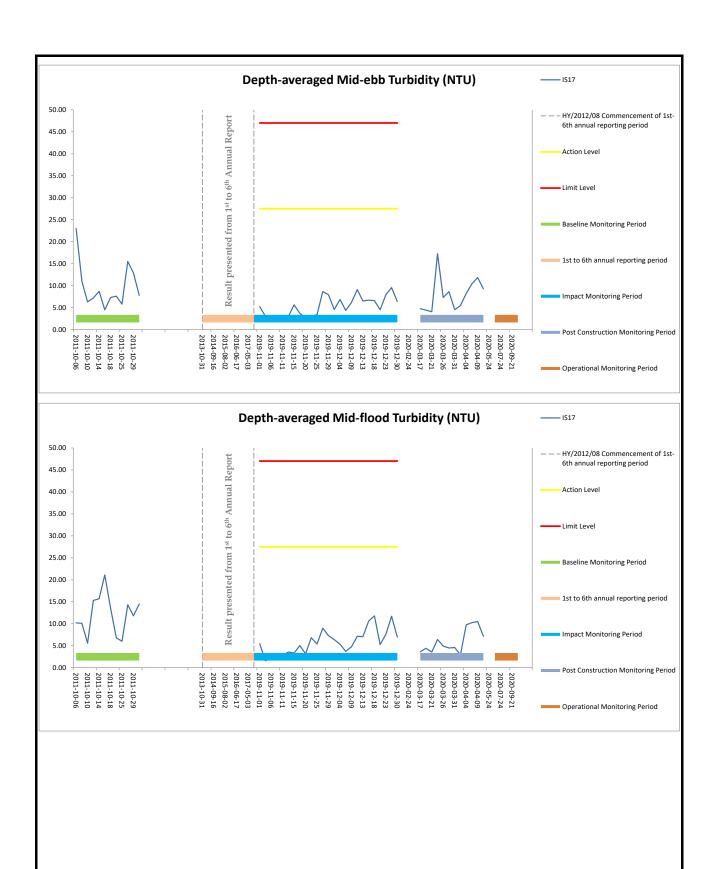
Figure E68 Baseline, Impact, Post-construction & Operational Monitoring – Mean Depthaveraged Level of Turbidity (NTU) between Baseline, Impact, Post-construction & Operational Monitoring (1/11/2019 to 31/10/2020) at IS17. Weather condition within the reporting period varied between sunny to rainy. The overall monitoring results were not affected by weather conditions. Major marine construction activities included: Seawall Modification Works at Portion S-B

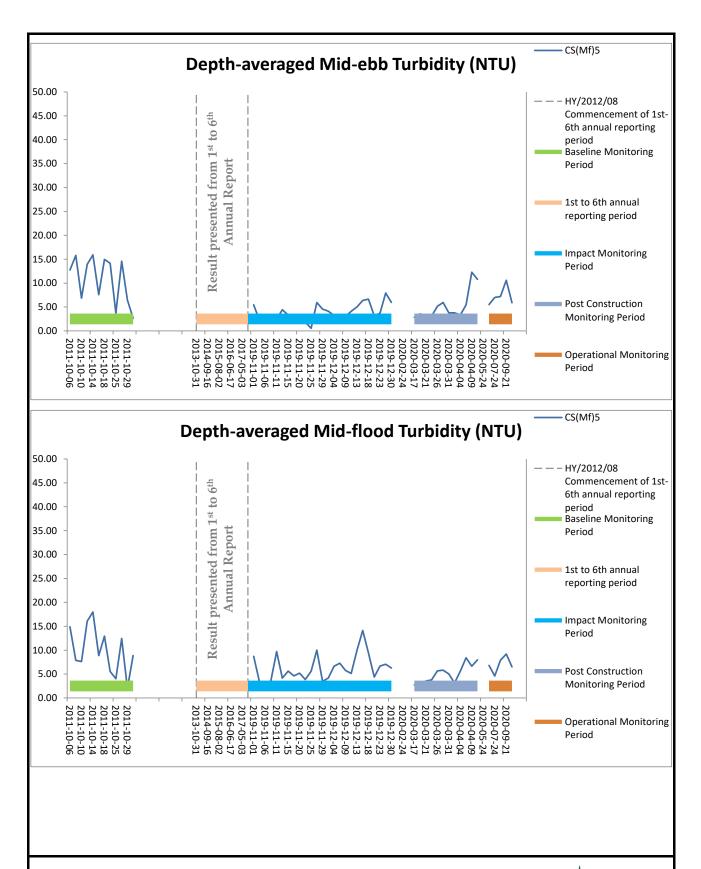
Figure E70 Baseline, Impact, Post-construction & Operational Monitoring – Mean Depthaveraged Level of Turbidity (NTU) between Baseline, Impact, Post-construction & Operational Monitoring (1/11/2019 to 31/10/2020) at CS(Mf)5. Weather condition within the reporting period varied between sunny to rainy. The overall monitoring results were not affected by weather conditions. Major marine construction activities included: Seawall Modification Works at Portion S-B

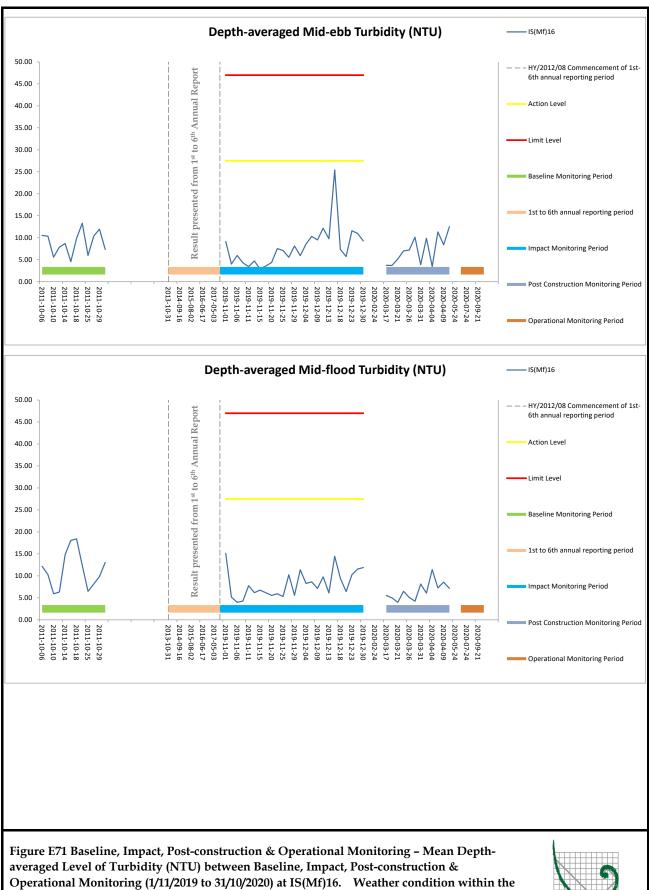
Figure E71 Baseline, Impact, Post-construction & Operational Monitoring – Mean Depthaveraged Level of Turbidity (NTU) between Baseline, Impact, Post-construction & Operational Monitoring (1/11/2019 to 31/10/2020) at IS(Mf)16. Weather condition within the reporting period varied between sunny to rainy. The overall monitoring results were not affected by weather conditions. Major marine construction activities included: Seawall Modification Works at Portion S-B

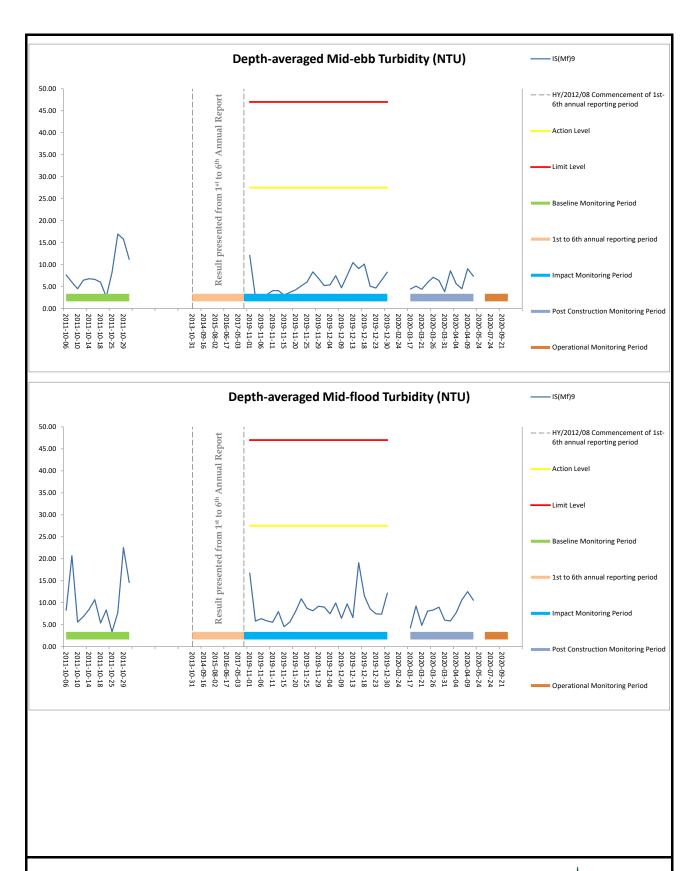
Figure E72 Baseline, Impact, Post-construction & Operational Monitoring - Mean Depth-averaged Level of Turbidity (NTU) between Baseline, Impact, Post-construction & Operational Monitoring (1/11/2019 to 31/10/2020) at IS(Mf)9. Weather condition within the reporting period varied between sunny to rainy. The overall monitoring results were not affected by weather conditions. Major marine construction activities included: Seawall Modification Works at Portion S-B

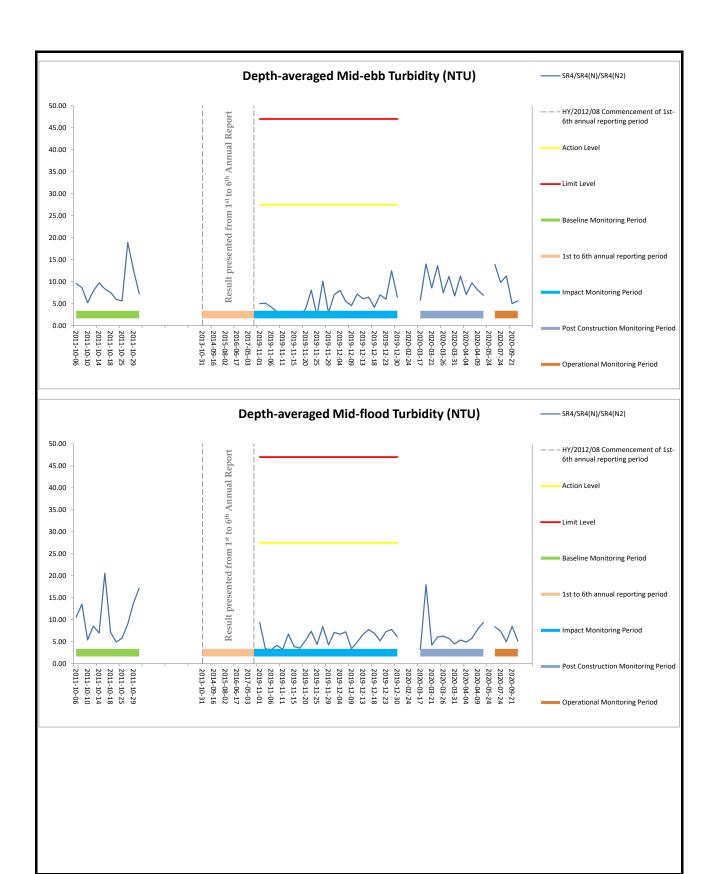
Figure E74 Baseline, Impact, Post-construction & Operational Monitoring – Mean Depthaveraged Level of Turbidity (NTU) between Baseline, Impact, Post-construction & Operational Monitoring (1/11/2019 to 31/10/2020) at SR4/SR4(N)/SR4(N2). Weather condition within the reporting period varied between sunny to rainy. The overall monitoring results were not affected by weather conditions. Major marine construction activities included: Seawall Modification Works at Portion S-B

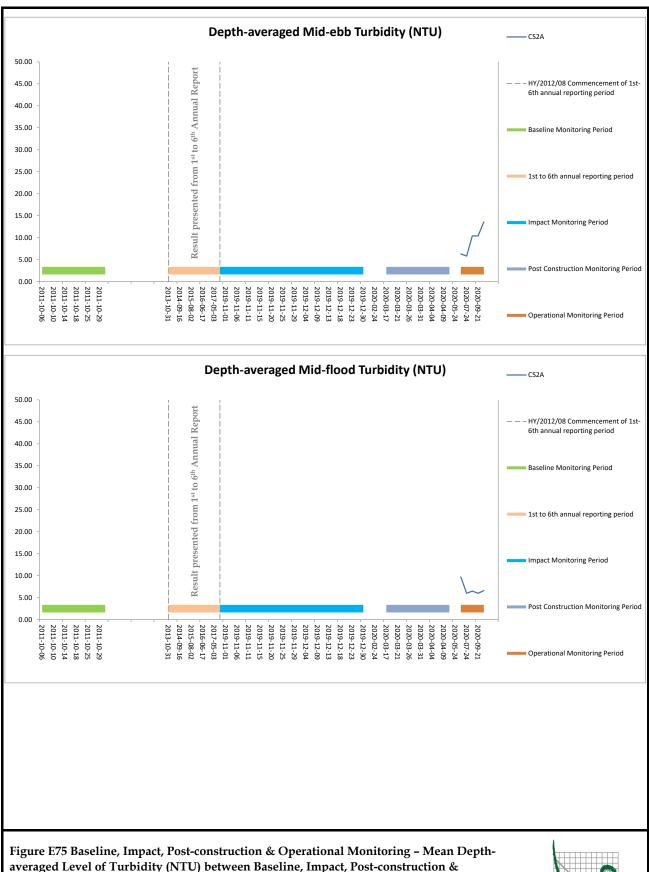
Figure E75 Baseline, Impact, Post-construction & Operational Monitoring – Mean Depthaveraged Level of Turbidity (NTU) between Baseline, Impact, Post-construction & Operational Monitoring (1/11/2019 to 31/10/2020) at CS2A. Weather condition within the reporting period varied between sunny to rainy. The overall monitoring results were not affected by weather conditions. Major marine construction activities included: Seawall Modification Works at Portion S-B

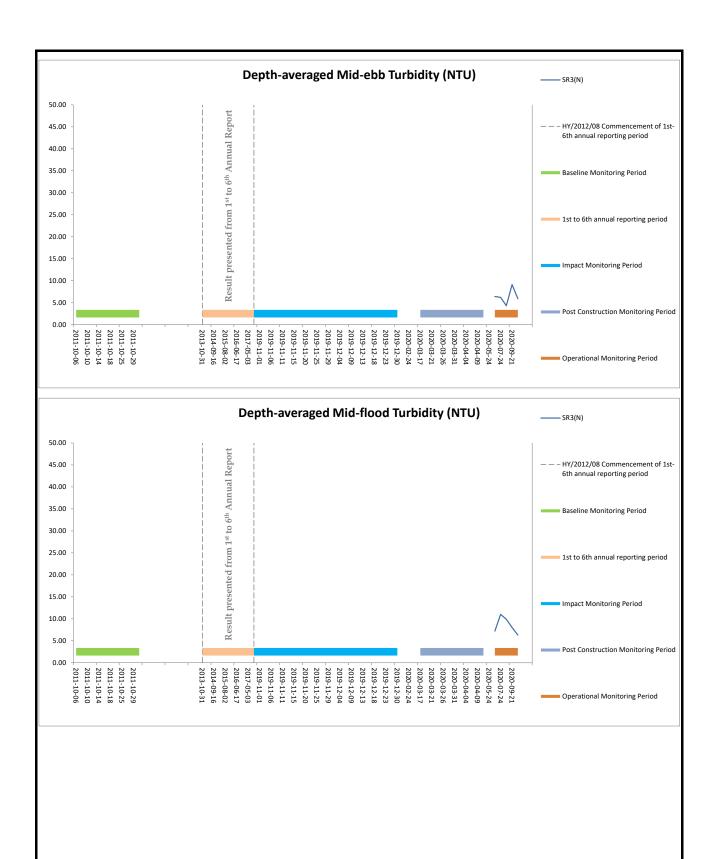
Figure E76 Baseline, Impact, Post-construction & Operational Monitoring – Mean Depth-averaged Level of Turbidity (NTU) between Baseline, Impact, Post-construction & Operational Monitoring (1/11/2019 to 31/10/2020) at SR3(N). Weather condition within the reporting period varied between sunny to rainy. The overall monitoring results were not affected by weather conditions. Major marine construction activities included: Seawall Modification Works at Portion S-B

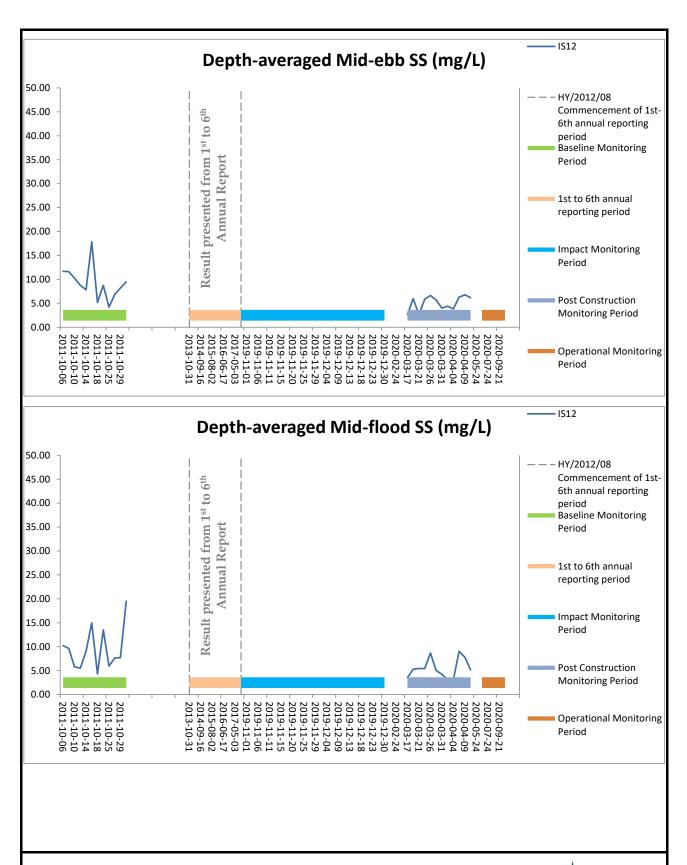
Figure E80 Baseline, Impact, Post-construction & Operational Monitoring – Mean Depth-averaged Level of Suspended Solids (mg/L) between Baseline, Impact, Post-construction & Operational Monitoring (1/11/2019 to 31/10/2020) at IS12. Weather condition within the reporting period varied between sunny to rainy. The overall monitoring results were not affected by weather conditions. Major marine construction activities included: Seawall Modification Works at Portion S-B

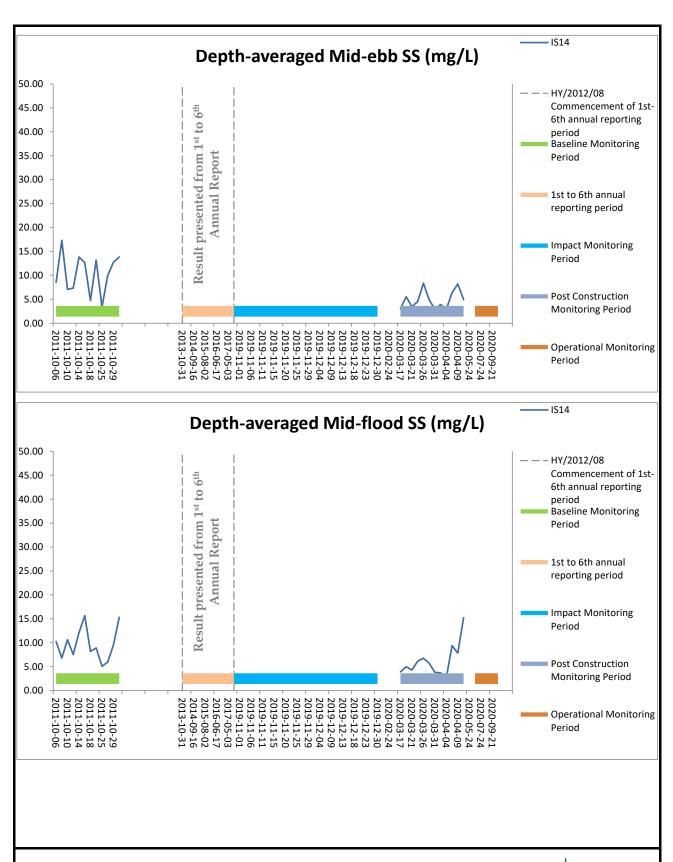
Figure E82 Baseline, Impact, Post-construction & Operational Monitoring – Mean Depth-averaged Level of Suspended Solids (mg/L) between Baseline, Impact, Post-construction & Operational Monitoring (1/11/2019 to 31/10/2020) at IS14. Weather condition within the reporting period varied between sunny to rainy. The overall monitoring results were not affected by weather conditions. Major marine construction activities included: Seawall Modification Works at Portion S-B

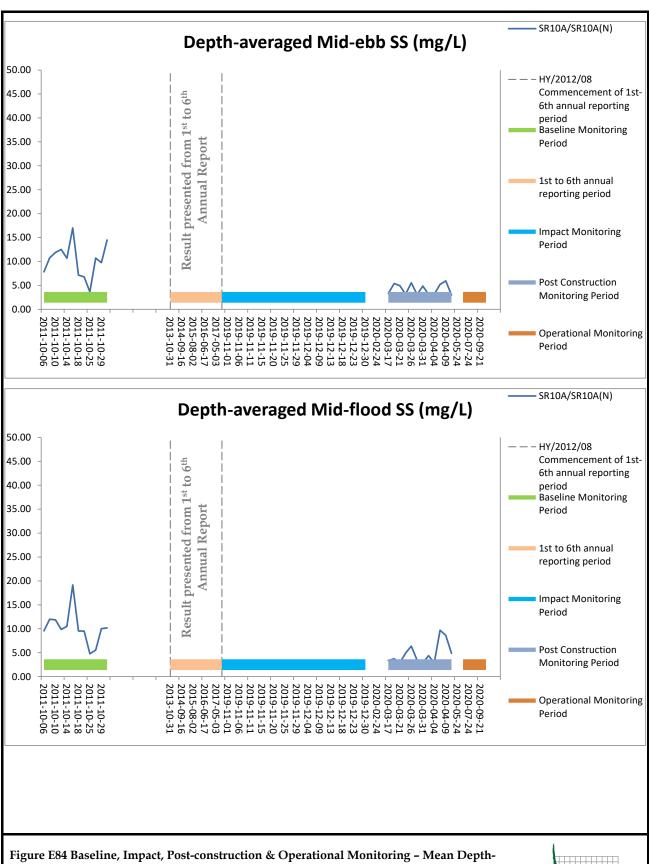
Figure E84 Baseline, Impact, Post-construction & Operational Monitoring – Mean Depth-averaged Level of Suspended Solids (mg/L) between Baseline, Impact, Post-construction & Operational Monitoring (1/11/2019 to 31/10/2020) at SR10A/SR10A(N). Weather condition within the reporting period varied between sunny to rainy. The overall monitoring results were not affected by weather conditions. Major marine construction activities included: Seawall Modification Works at Portion S-B

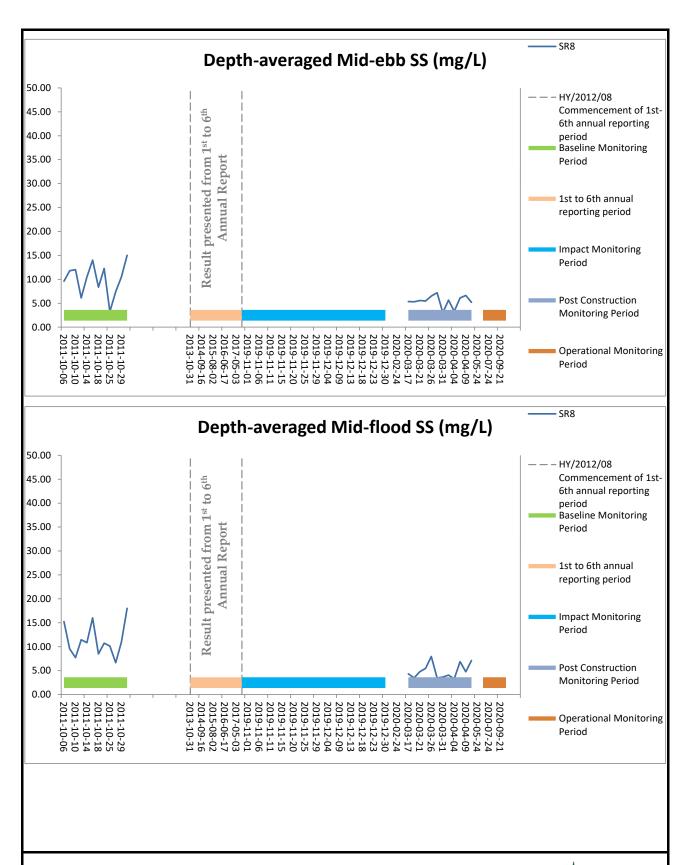
Figure E85 Baseline, Impact, Post-construction & Operational Monitoring – Mean Depthaveraged Level of Suspended Solids (mg/L) between Baseline, Impact, Post-construction & Operational Monitoring (1/11/2019 to 31/10/2020) at SR8. Weather condition within the reporting period varied between sunny to rainy. The overall monitoring results were not affected by weather conditions. Major marine construction activities included: Seawall Modification Works at Portion S-B

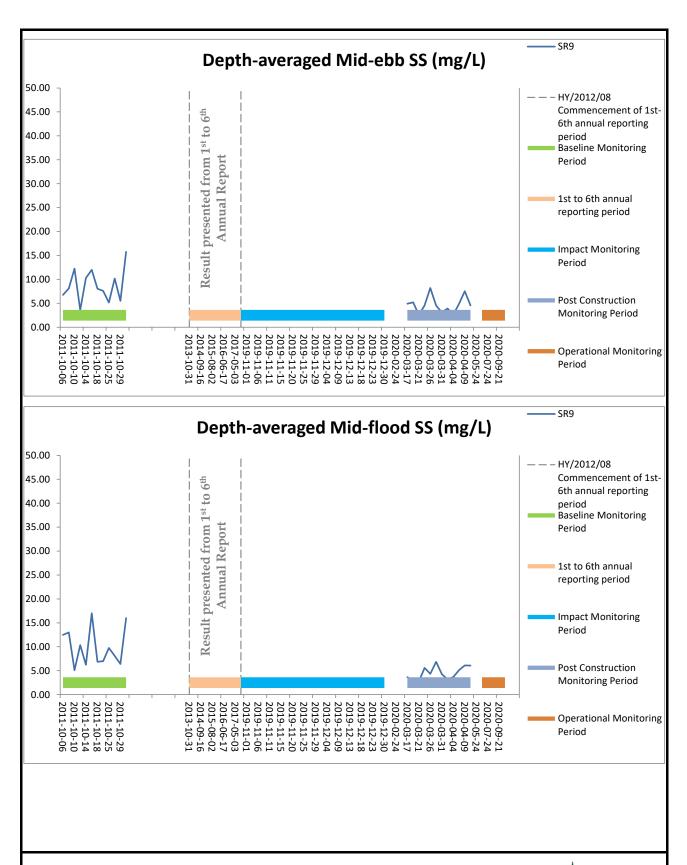
Figure E86 Baseline, Impact, Post-construction & Operational Monitoring – Mean Depth-averaged Level of Suspended Solids (mg/L) between Baseline, Impact, Post-construction & Operational Monitoring (1/11/2019 to 31/10/2020) at SR9. Weather condition within the reporting period varied between sunny to rainy. The overall monitoring results were not affected by weather conditions. Major marine construction activities included: Seawall Modification Works at Portion S-B

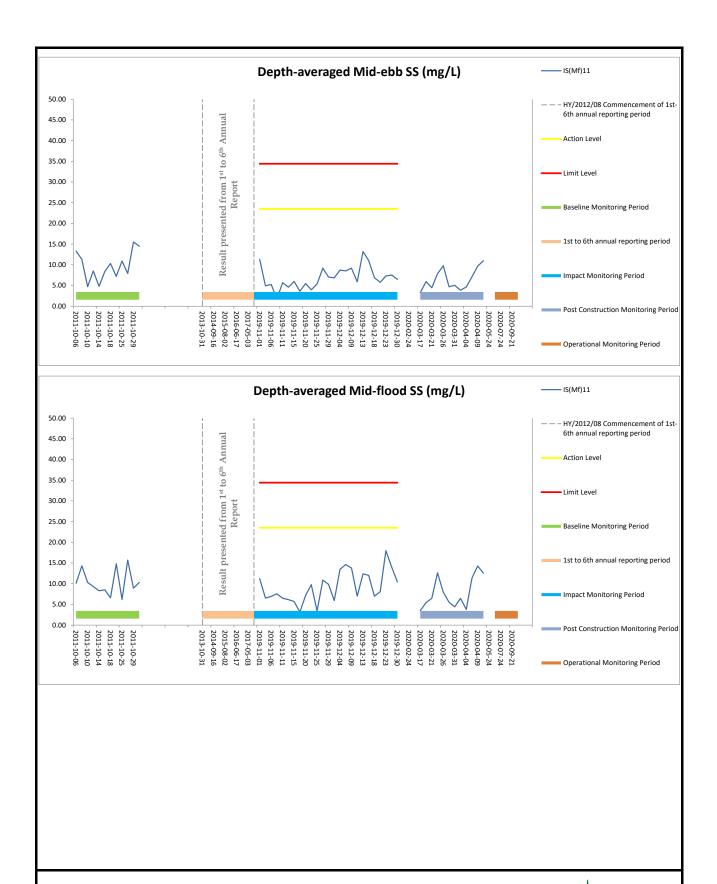
Figure E87 Baseline, Impact, Post-construction & Operational Monitoring – Mean Depthaveraged Level of Suspended Solids (mg/L) between Baseline, Impact, Post-construction & Operational Monitoring (1/11/2019 to 31/10/2020) at IS(Mf)11. Weather condition within the reporting period varied between sunny to rainy. The overall monitoring results were not affected by weather conditions. Major marine construction activities included: Seawall Modification Works at Portion S-B

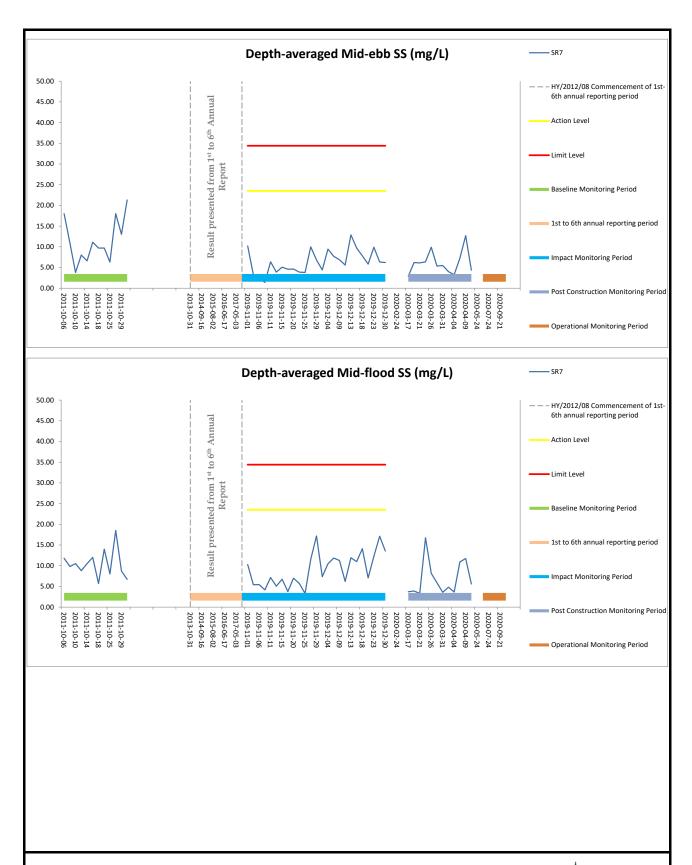
Figure E88 Baseline, Impact, Post-construction & Operational Monitoring – Mean Depth-averaged Level of Suspended Solids (mg/L) between Baseline, Impact, Post-construction & Operational Monitoring (1/11/2019 to 31/10/2020) at SR7. Weather condition within the reporting period varied between sunny to rainy. The overall monitoring results were not affected by weather conditions. Major marine construction activities included: Seawall Modification Works at Portion S-B
