**Contract No. HY/2012/08  
Tuen Mun – Chek Lap Kok Link –  
Northern Connection Sub-sea Tunnel  
Section**

*Seventh Quarterly Environmental Monitoring &  
Audit (EM&A) Report*

**Contract No. HY/2012/08 TM-CLKL Northern Connection Sub-sea  
Tunnel Section  
Seventh Quarterly EM&A Report**

**Document Code: 0212330\_7th Quarterly EM&A\_20151221.doc**

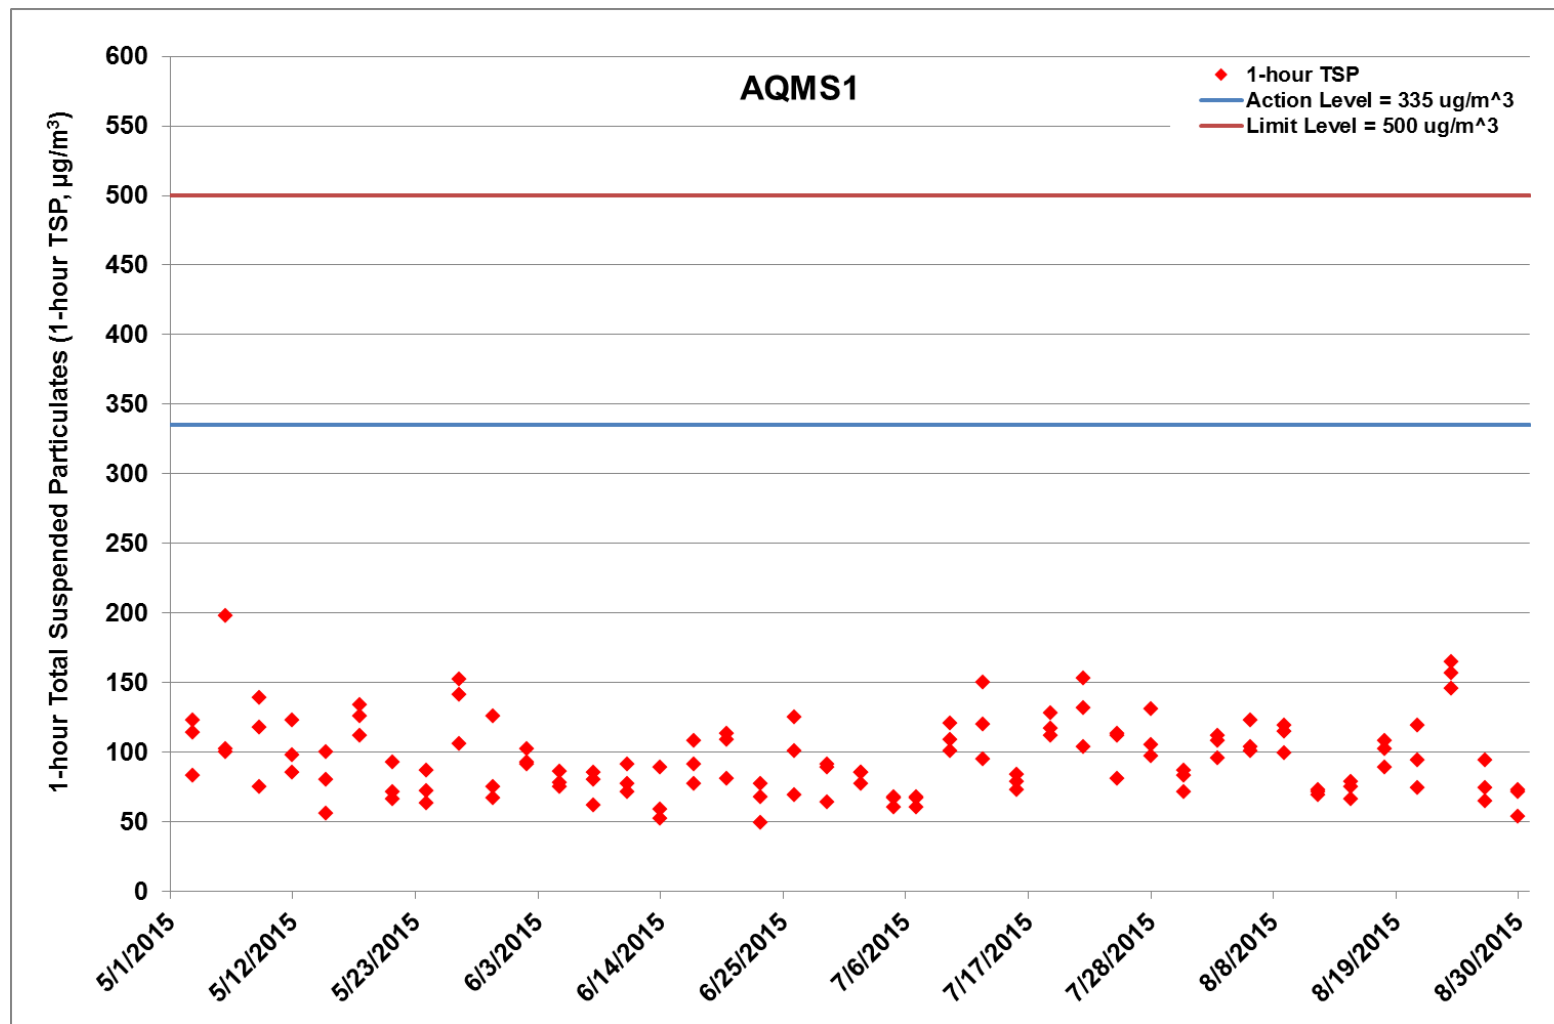
Figure F.1 Impact Monitoring - 1-hour Total Suspended Particulates ( $\mu\text{g}/\text{m}^3$ ) at AQMS1 between 1 May 2015 and 31 August 2015 during impact monitoring period. The weather conditions during the monitoring period varied from sunny to cloudy. Major land-based construction activities included: Construction of capping beam and base slab for Ventilation Shaft at Works Area - Portion N-C (1/8/2015 - 31/8/2015), Excavation for Ventilation Shaft at Works Area - Portion N-C (1/5/2015 - 31/7/2015) and Setting up of Slurry Treatment Plant (1/5/2015 - 31/7/2015). Ref: 0212330\_Impact AQM graphs\_August 2015\_REV a.xlsx

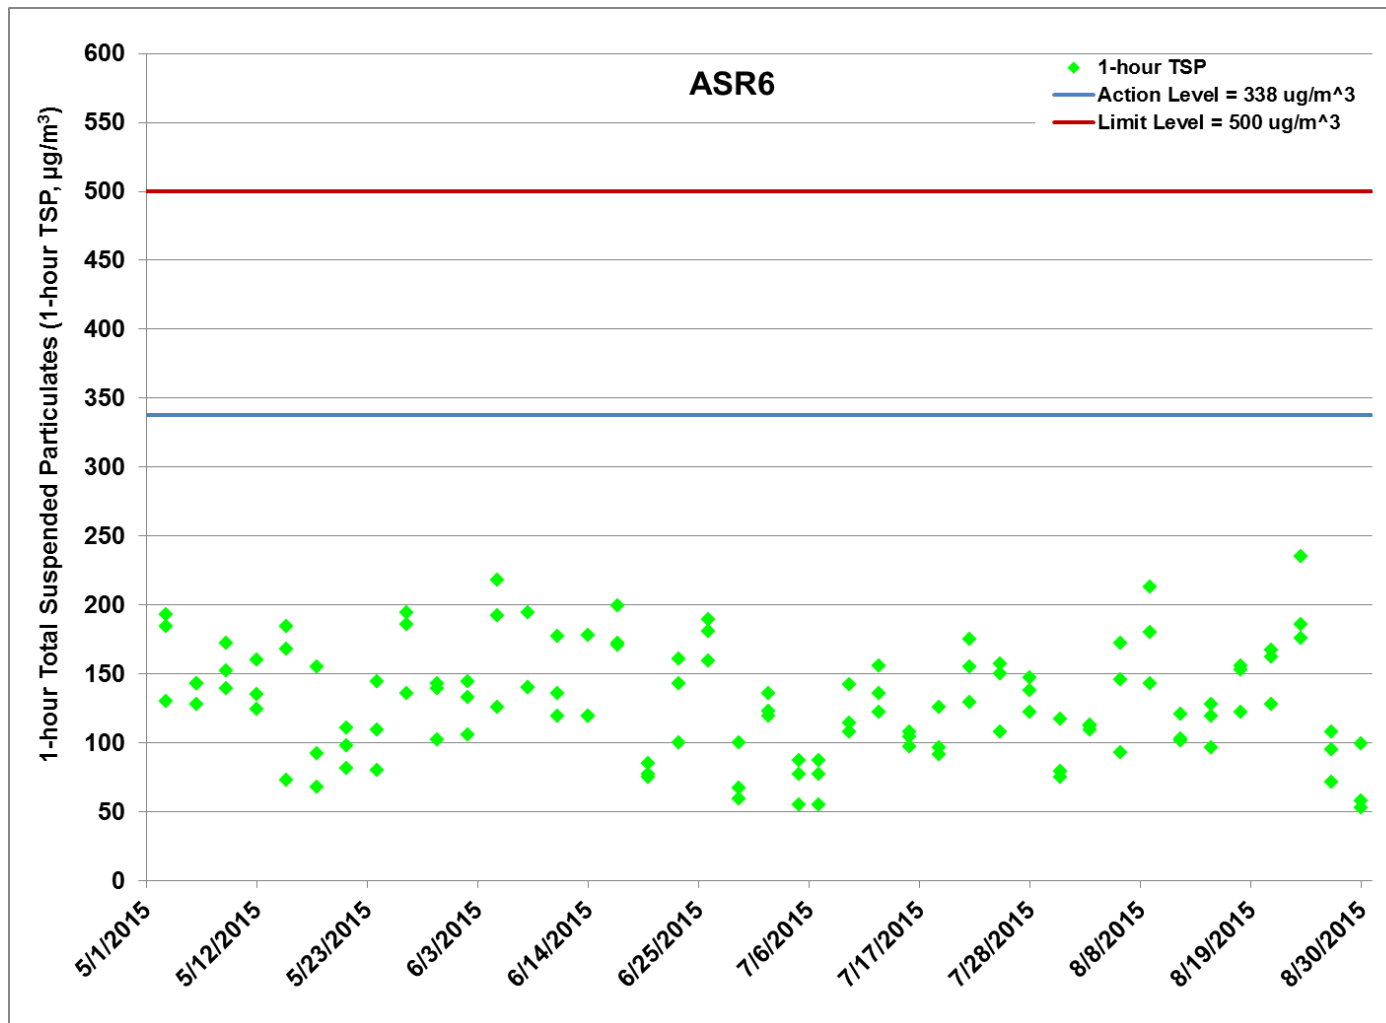
Figure F.2 Impact Monitoring - 1-hour Total Suspended Particulates ( $\mu\text{g}/\text{m}^3$ ) at ASR6 between 1 May 2015 and 31 August 2015 during impact monitoring period. The weather conditions during the monitoring period varied from sunny to cloudy. Major land-based construction activities included: Construction of capping beam and base slab for Ventilation Shaft at Works Area - Portion N-C (1/8/2015 - 31/8/2015), Excavation for Ventilation Shaft at Works Area - Portion N-C (1/5/2015 - 31/7/2015) and Setting up of Slurry Treatment Plant (1/5/2015 - 31/7/2015). Ref: 0212330\_Impact AQM graphs\_August 2015\_REV a.xlsx

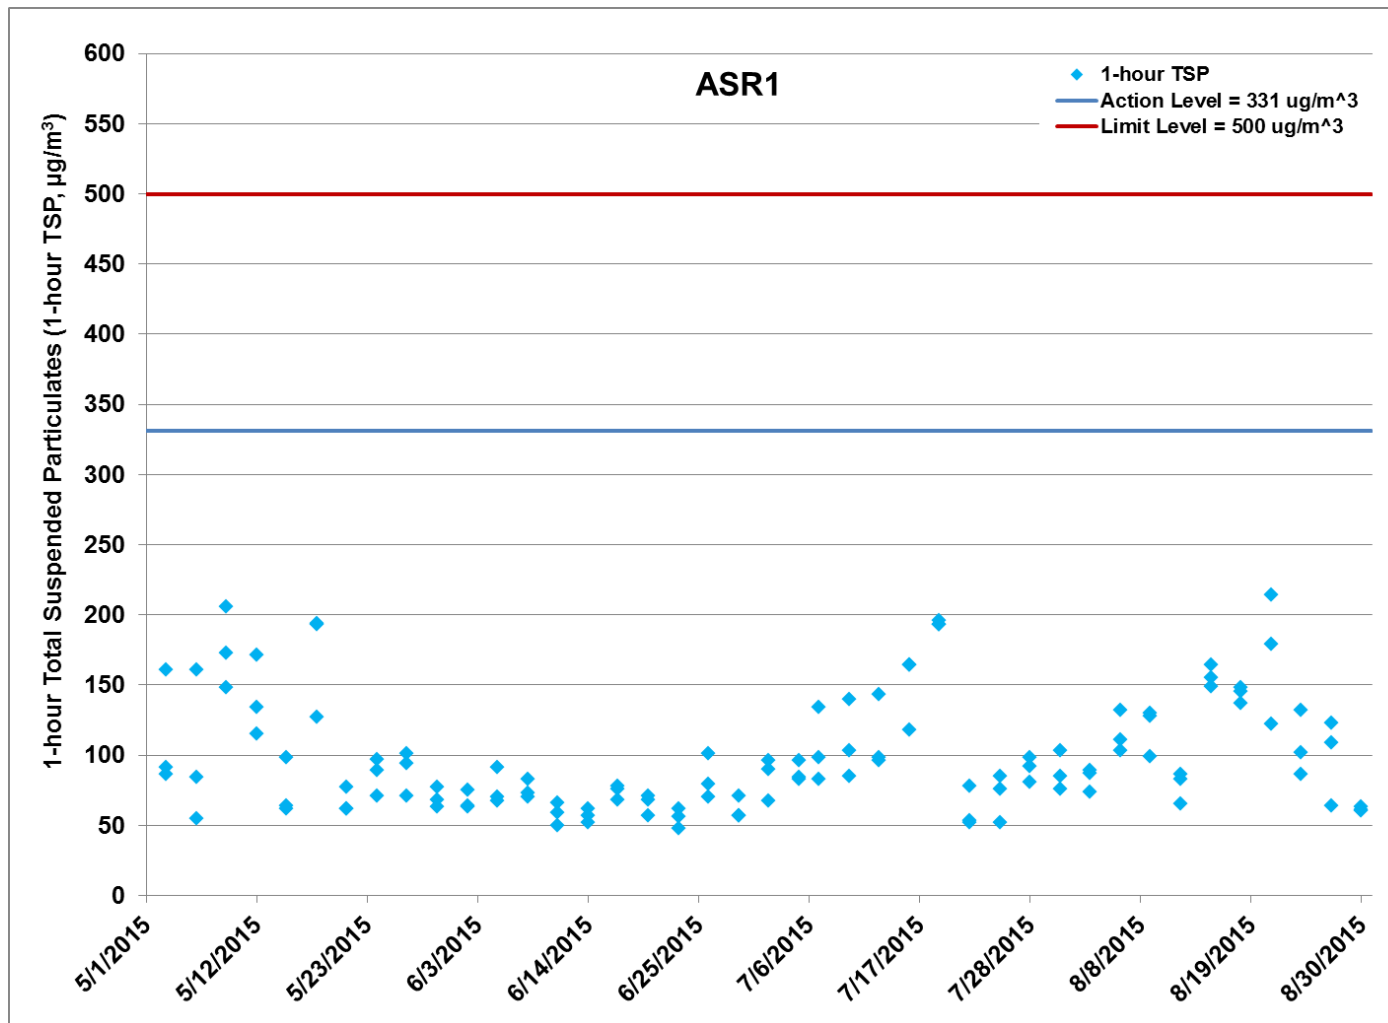
Figure F.3 Impact Monitoring - 1-hour Total Suspended Particulates ( $\mu\text{g}/\text{m}^3$ ) at ASR1 between 1 May 2015 and 31 August 2015 during impact monitoring period. The weather conditions during the monitoring period varied from sunny to cloudy. Major land-based construction activities included: Construction of capping beam and base slab for Ventilation Shaft at Works Area - Portion N-C (1/8/2015 - 31/8/2015), Excavation for Ventilation Shaft at Works Area - Portion N-C (1/5/2015 - 31/7/2015) and Setting up of Slurry Treatment Plant (1/5/2015 - 31/7/2015). Ref: 0212330\_Impact AQM graphs\_August 2015\_REV a.xlsx

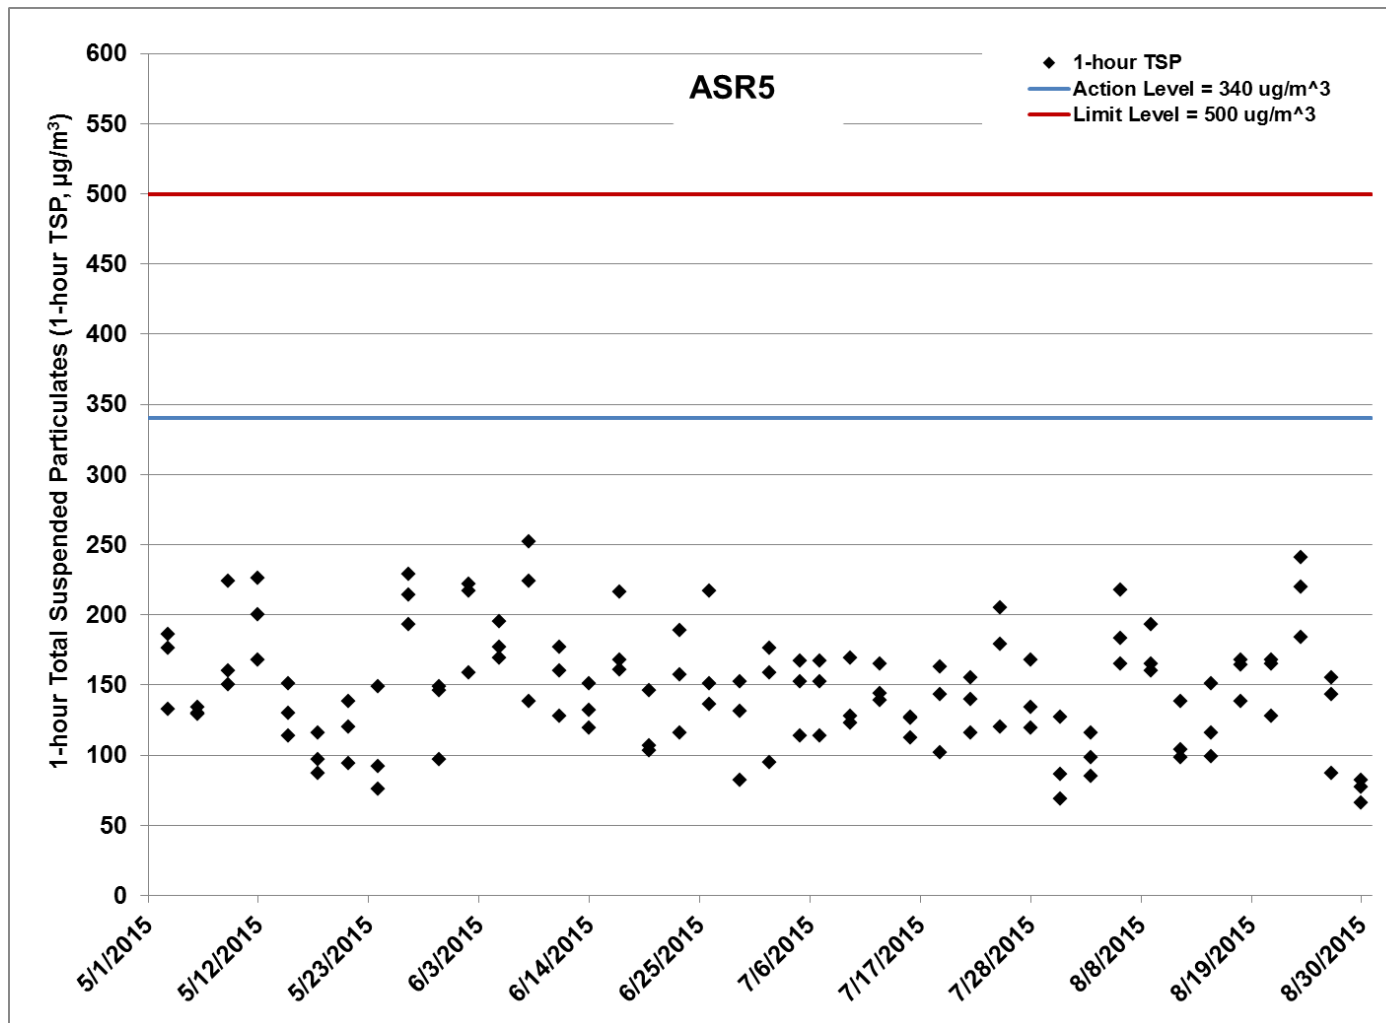
Figure F.4 Impact Monitoring - 1-hour Total Suspended Particulates ( $\mu\text{g}/\text{m}^3$ ) at ASR5 between 1 May 2015 and 31 August 2015 during impact monitoring period. The weather conditions during the monitoring period varied from sunny to cloudy. Major land-based construction activities included: Construction of capping beam and base slab for Ventilation Shaft at Works Area - Portion N-C (1/8/2015 - 31/8/2015), Excavation for Ventilation Shaft at Works Area - Portion N-C (1/5/2015 - 31/7/2015) and Setting up of Slurry Treatment Plant (1/5/2015 - 31/7/2015). Ref: 0212330\_Impact AQM graphs\_August 2015\_REV a.xlsx

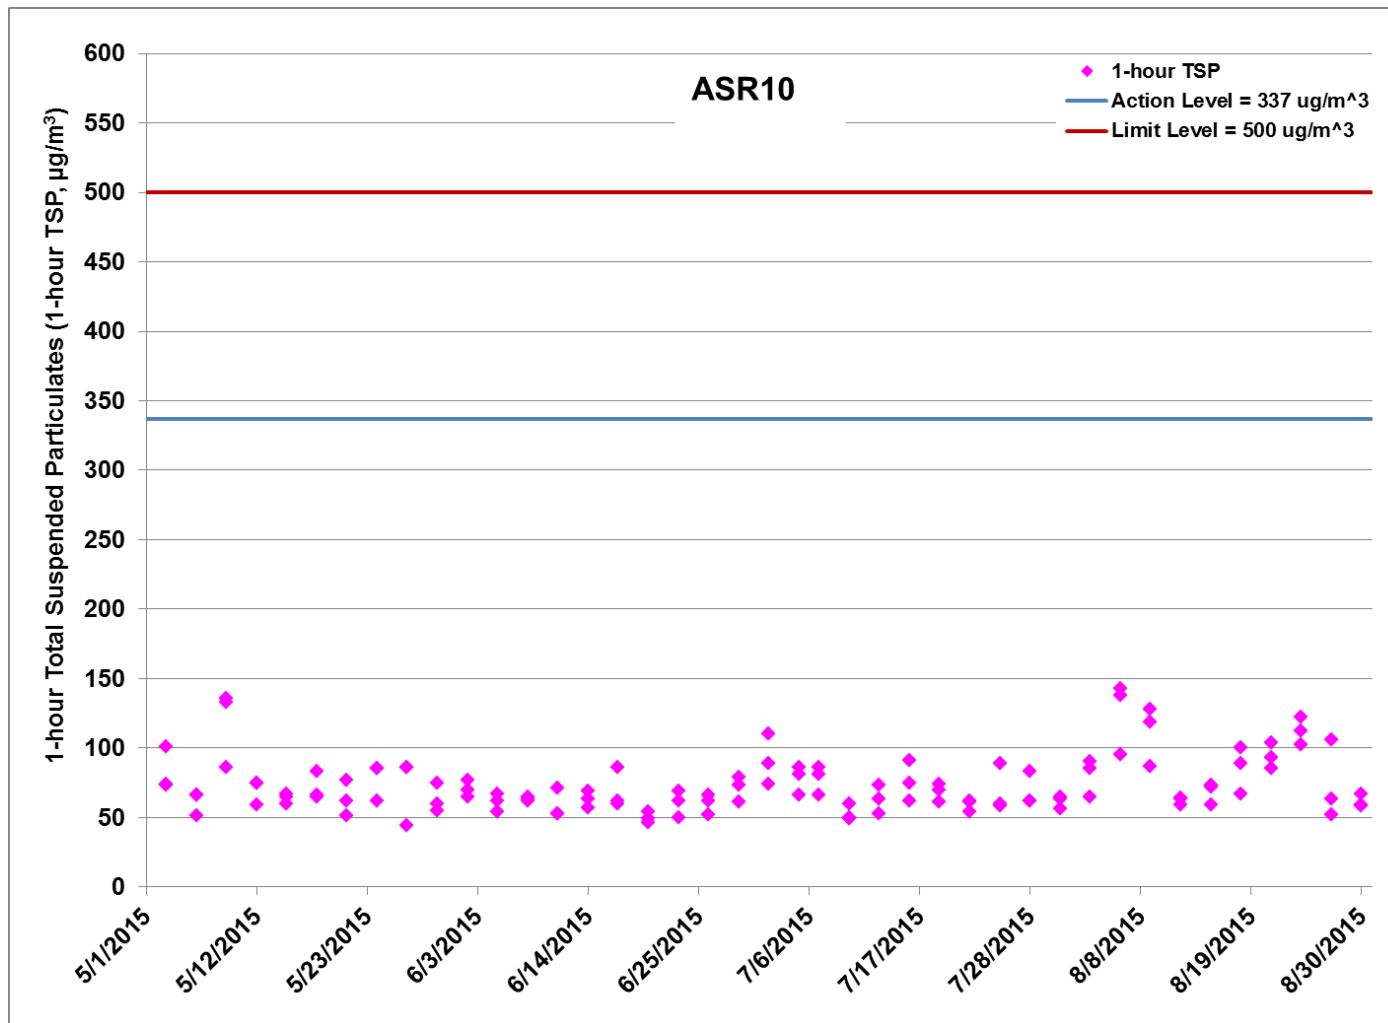
Figure F.5 Impact Monitoring - 1-hour Total Suspended Particulates ( $\mu\text{g}/\text{m}^3$ ) at ASR10 between 1 May 2015 and 31 August 2015 during impact monitoring period. The weather conditions during the monitoring period varied from sunny to cloudy. Major land-based construction activities included: Construction of capping beam and base slab for Ventilation Shaft at Works Area - Portion N-C (1/8/2015 - 31/8/2015), Excavation for Ventilation Shaft at Works Area - Portion N-C (1/5/2015 - 31/7/2015) and Setting up of Slurry Treatment Plant (1/5/2015 - 31/7/2015). Ref: 0212330\_Impact AQM graphs\_August 2015\_REV a.xlsx

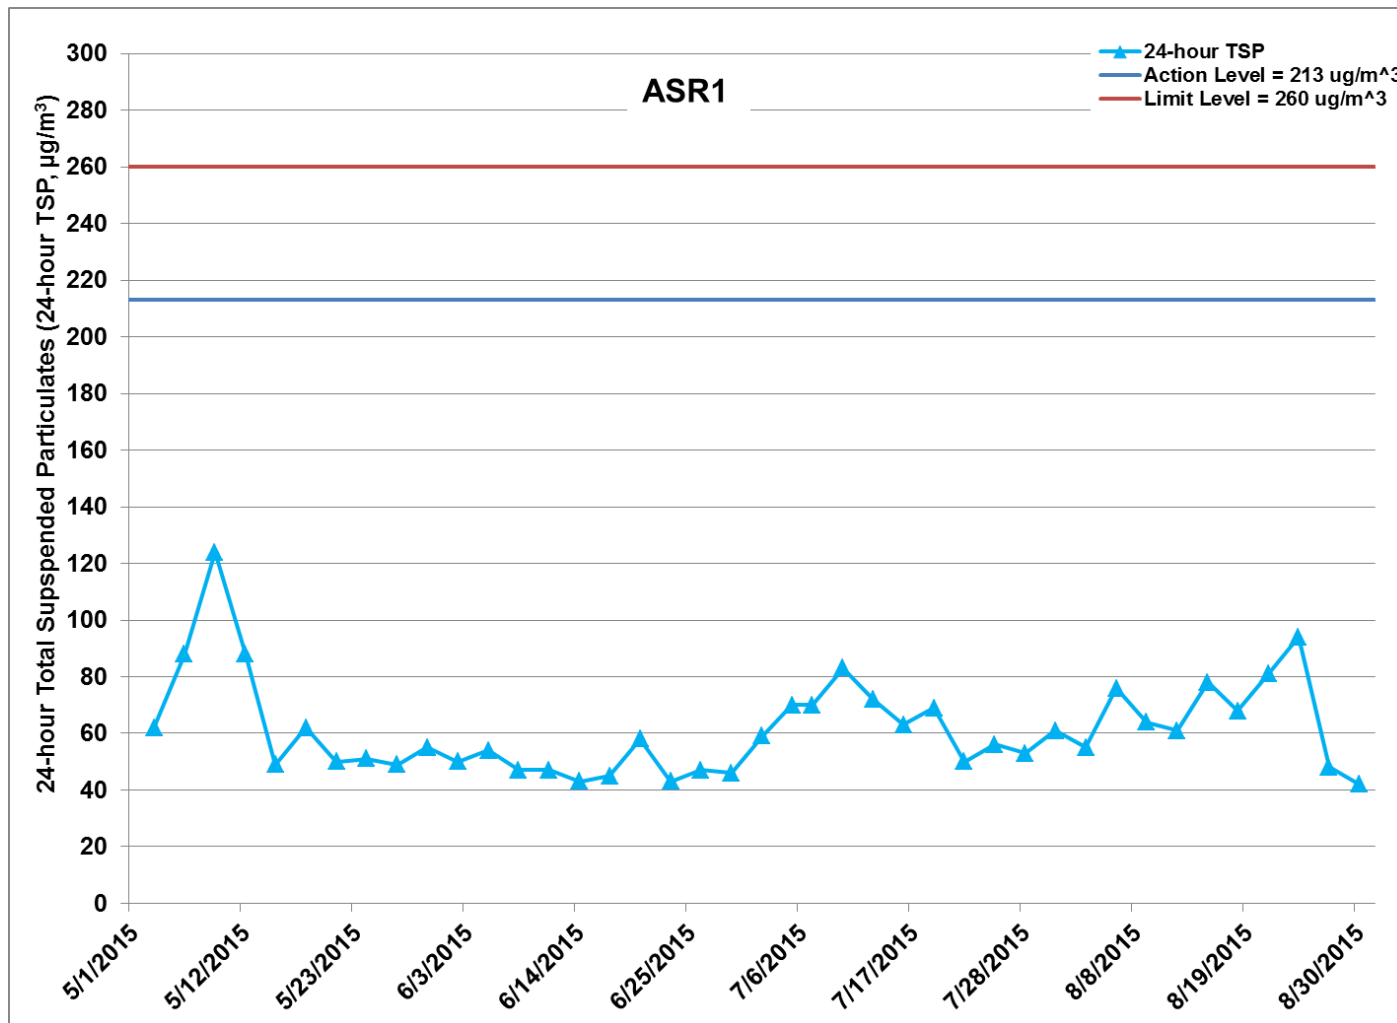
Figure F.6 Impact Monitoring - 24-hour Total Suspended Particulates ( $\mu\text{g}/\text{m}^3$ ) at ASR1 between 1 May 2015 and 31 August 2015 during impact monitoring period. The weather conditions during the monitoring period varied from sunny to cloudy. Major land-based construction activities included: Construction of capping beam and base slab for Ventilation Shaft at Works Area - Portion N-C (1/8/2015 - 31/8/2015), Excavation for Ventilation Shaft at Works Area - Portion N-C (1/5/2015 - 31/7/2015) and Setting up of Slurry Treatment Plant (1/5/2015 - 31/7/2015). Ref: 0212330\_Impact AQM graphs\_August 2015\_REV a.xlsx

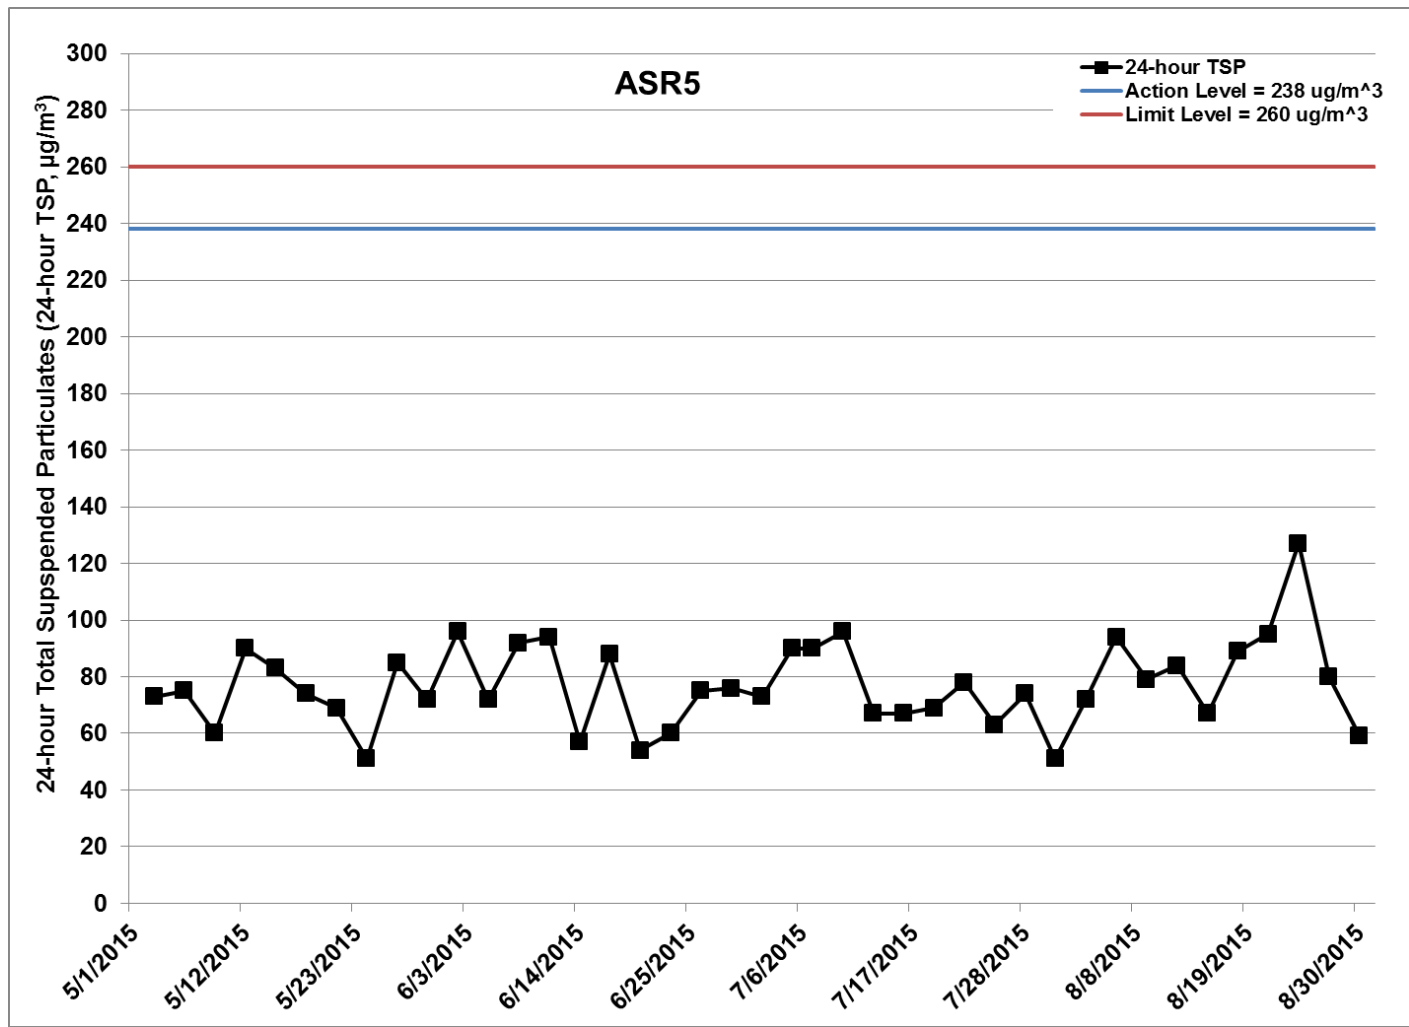
Figure F.7 Impact Monitoring - 24-hour Total Suspended Particulates ( $\mu\text{g}/\text{m}^3$ ) at ASR5 between 1 May 2015 and 31 August 2015 during impact monitoring period. The weather conditions during the monitoring period varied from sunny to cloudy. Major land-based construction activities included: Construction of capping beam and base slab for Ventilation Shaft at Works Area - Portion N-C (1/8/2015 - 31/8/2015), Excavation for Ventilation Shaft at Works Area - Portion N-C (1/5/2015 - 31/7/2015) and Setting up of Slurry Treatment Plant (1/5/2015 - 31/7/2015). Ref: 0212330\_Impact AQM graphs\_August 2015\_REV a.xlsx

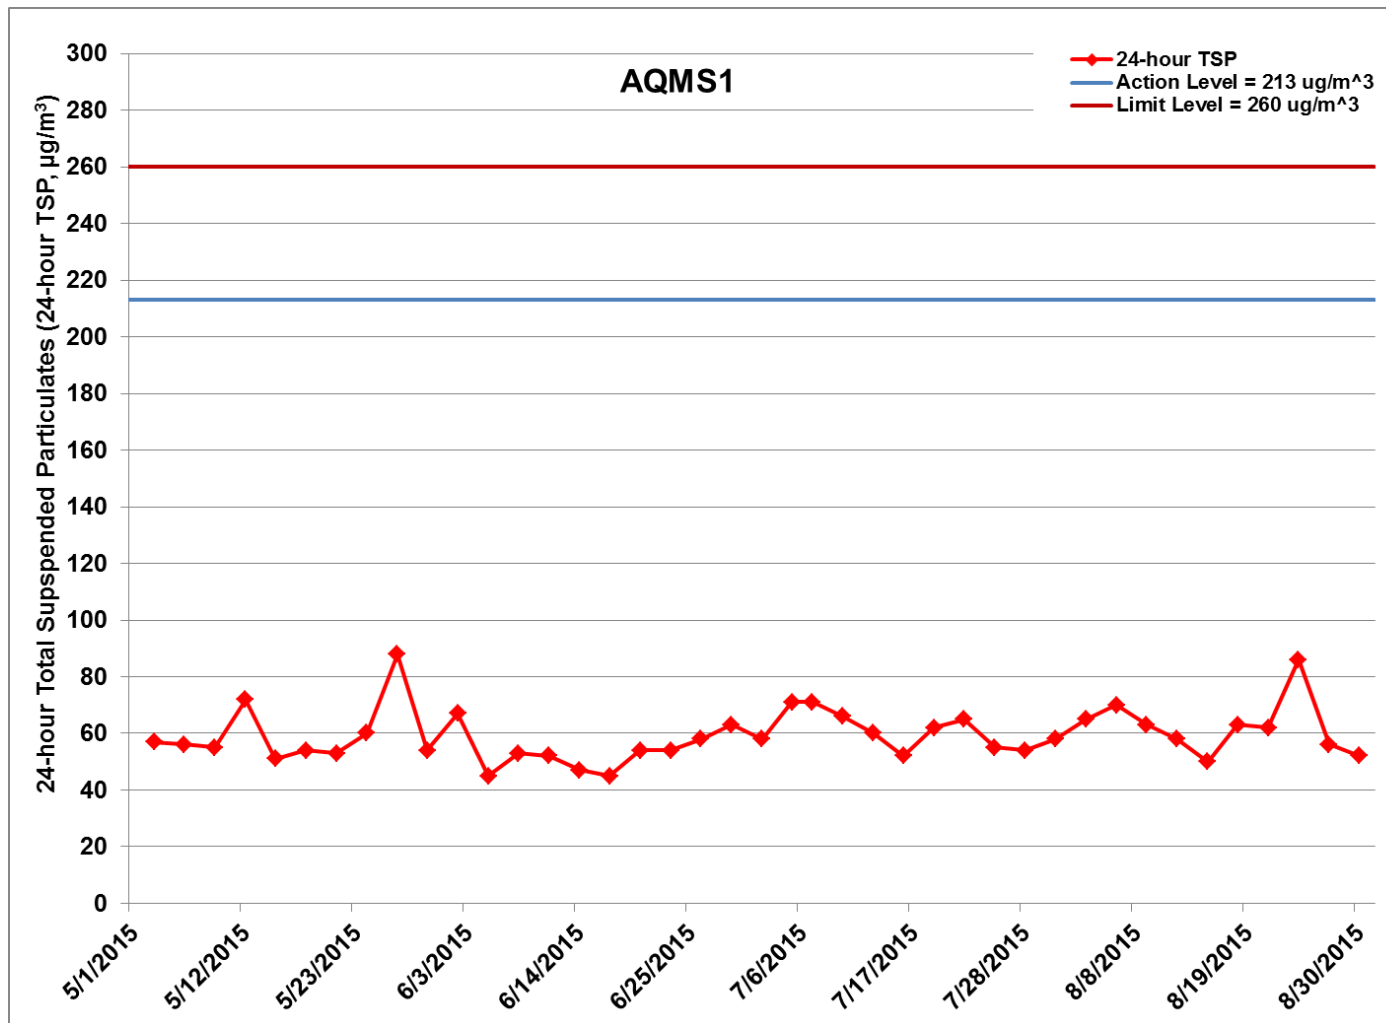
Figure F.8 Impact Monitoring - 24-hour Total Suspended Particulates ( $\mu\text{g}/\text{m}^3$ ) at AQMS1 between 1 May 2015 and 31 August 2015 during impact monitoring period. The weather conditions during the monitoring period varied from sunny to cloudy. Major land-based construction activities included: Construction of capping beam and base slab for Ventilation Shaft at Works Area - Portion N-C (1/8/2015 - 31/8/2015), Excavation for Ventilation Shaft at Works Area - Portion N-C (1/5/2015 - 31/7/2015) and Setting up of Slurry Treatment Plant (1/5/2015 - 31/7/2015). Ref: 0212330\_Impact AQM graphs\_August 2015\_REV a.xlsx

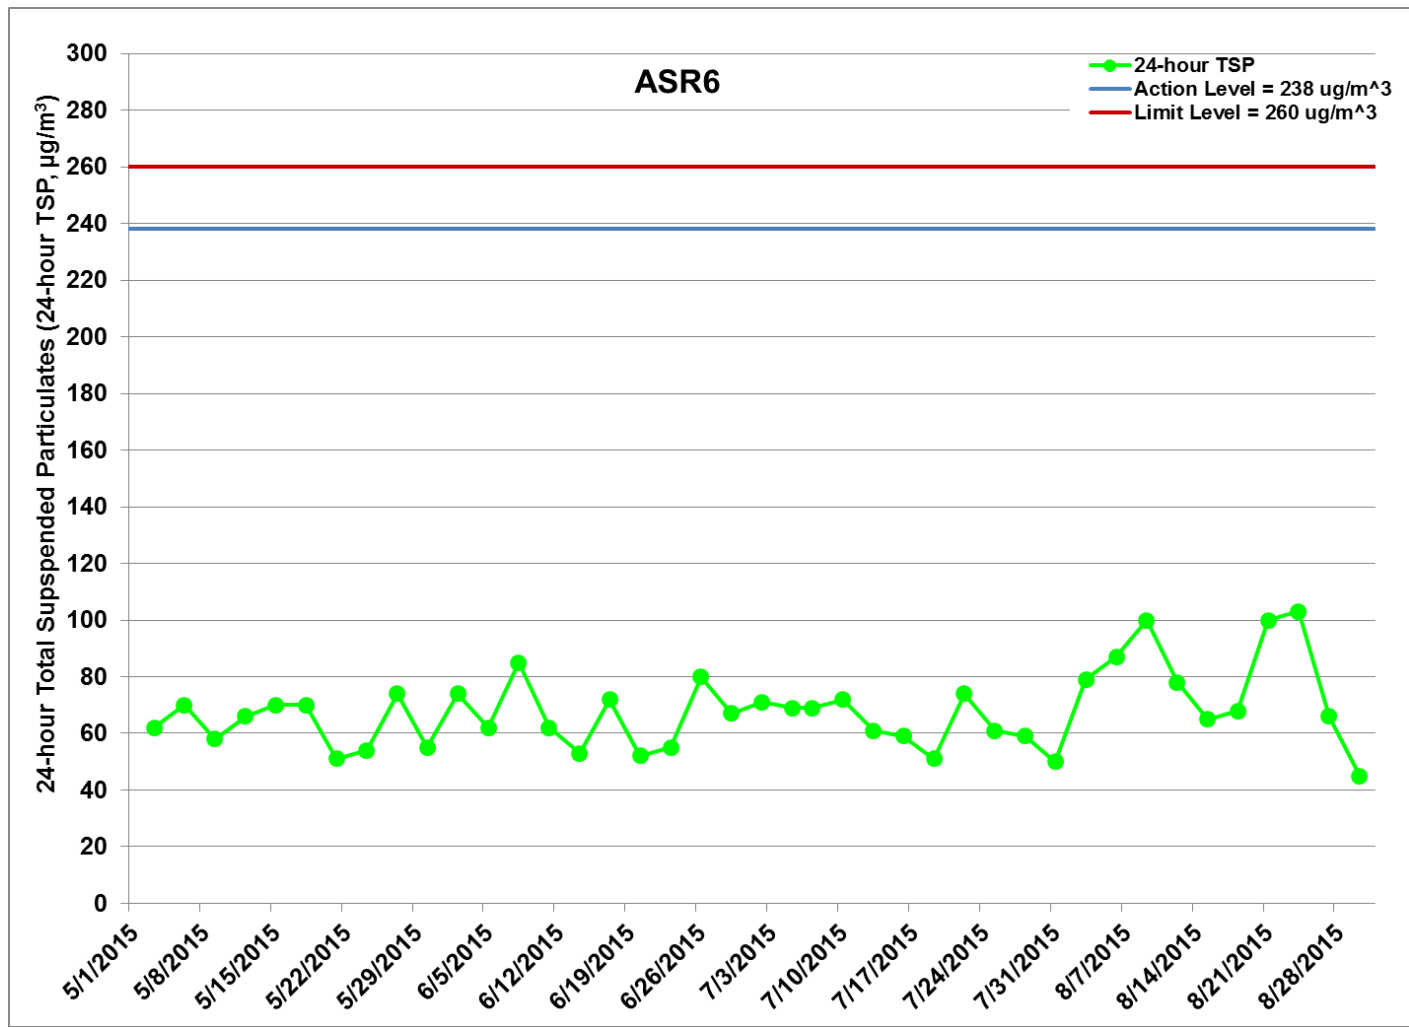
Figure F.9 Impact Monitoring - 24-hour Total Suspended Particulates ( $\mu\text{g}/\text{m}^3$ ) at ASR6 between 1 May 2015 and 31 August 2015 during impact monitoring period. The weather conditions during the monitoring period varied from sunny to cloudy. Major land-based construction activities included: Construction of capping beam and base slab for Ventilation Shaft at Works Area - Portion N-C (1/8/2015 - 31/8/2015), Excavation for Ventilation Shaft at Works Area - Portion N-C (1/5/2015 - 31/7/2015) and Setting up of Slurry Treatment Plant (1/5/2015 - 31/7/2015). *Ref: 0212330\_Impact AQM graphs\_August 2015\_REV a.xlsx*

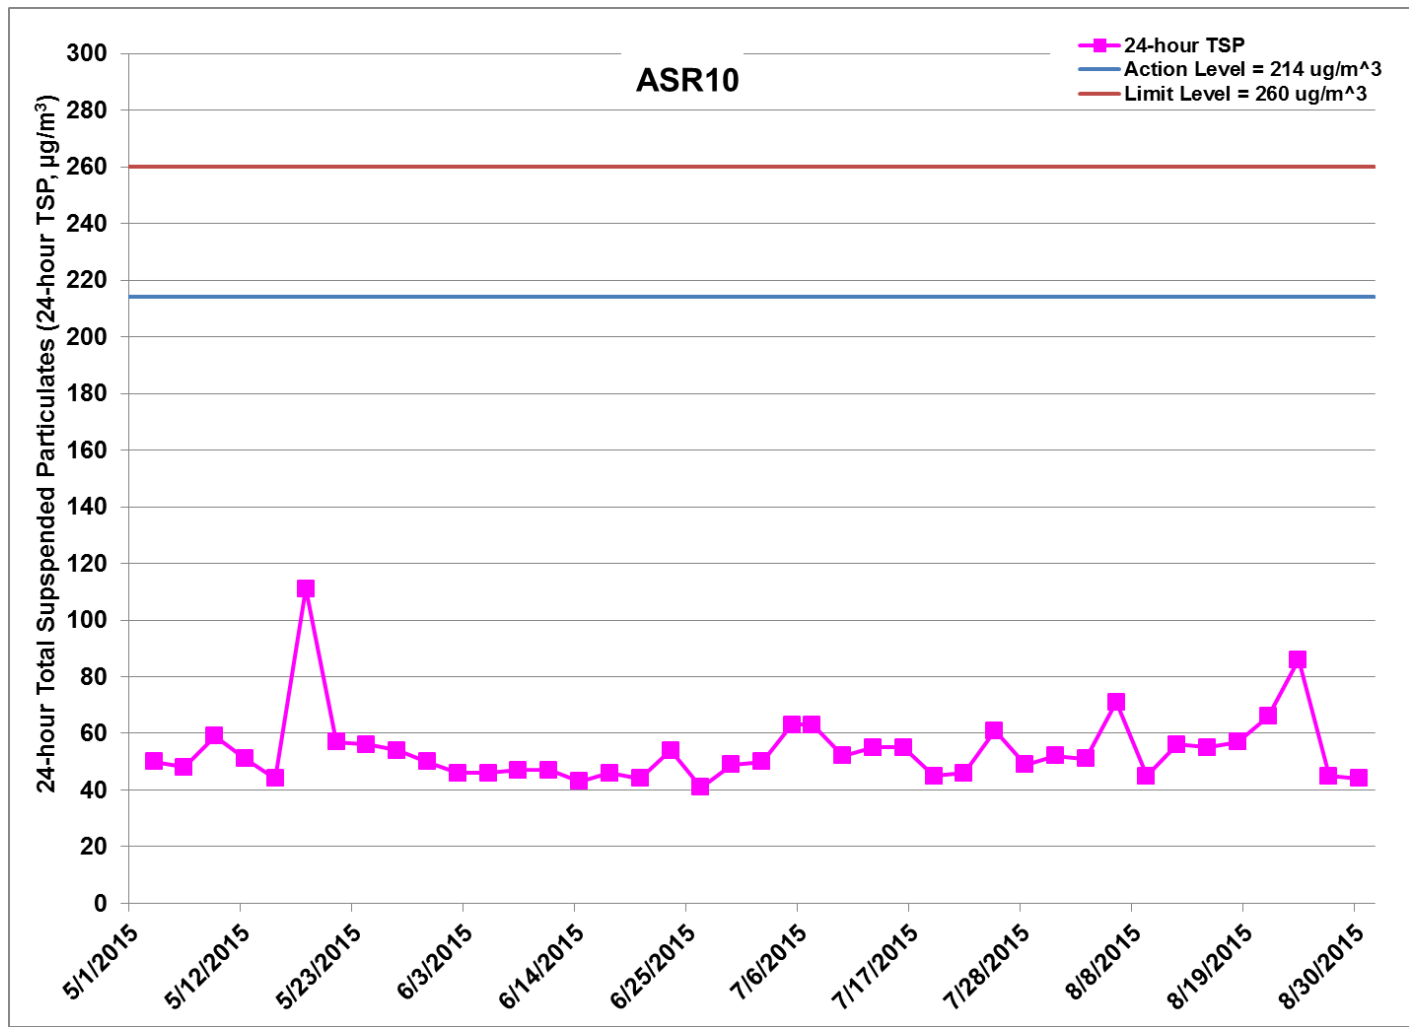
Figure F.10 Impact Monitoring - 24-hour Total Suspended Particulates ( $\mu\text{g}/\text{m}^3$ ) at ASR10 between 1 May 2015 and 31 August 2015 during impact monitoring period. The weather conditions during the monitoring period varied from sunny to cloudy. Major land-based construction activities included: Construction of capping beam and base slab for Ventilation Shaft at Works Area - Portion N-C (1/8/2015 - 31/8/2015), Excavation for Ventilation Shaft at Works Area - Portion N-C (1/5/2015 - 31/7/2015) and Setting up of Slurry Treatment Plant (1/5/2015 - 31/7/2015). Ref: 0212330\_Impact AQM graphs\_August 2015\_REV a.xlsx

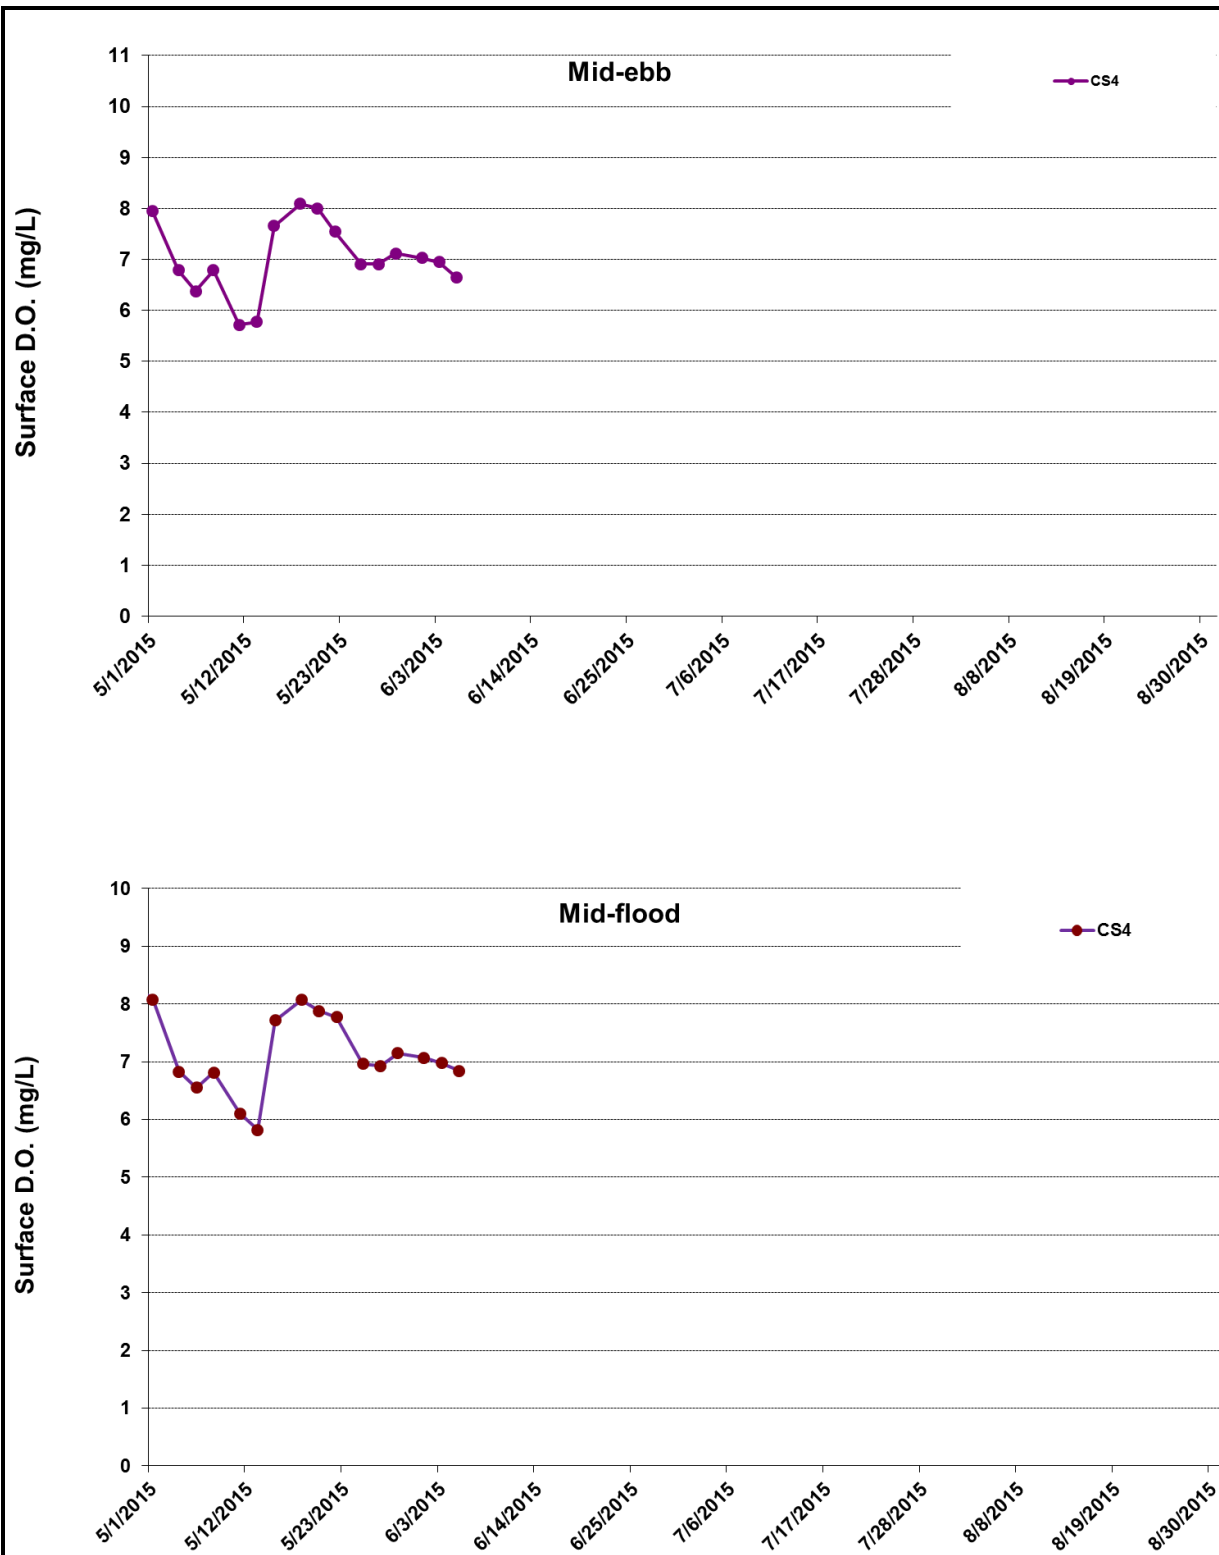
Figure G1 Impact Monitoring - Mean Level of Dissolved Oxygen (mg/L) in surface waters between 1 May 2015 and 5 June 2015 at CS4. The weather conditions during the monitoring period varied mostly from sunny to cloudy. No marine works was undertaken during the reporting period.

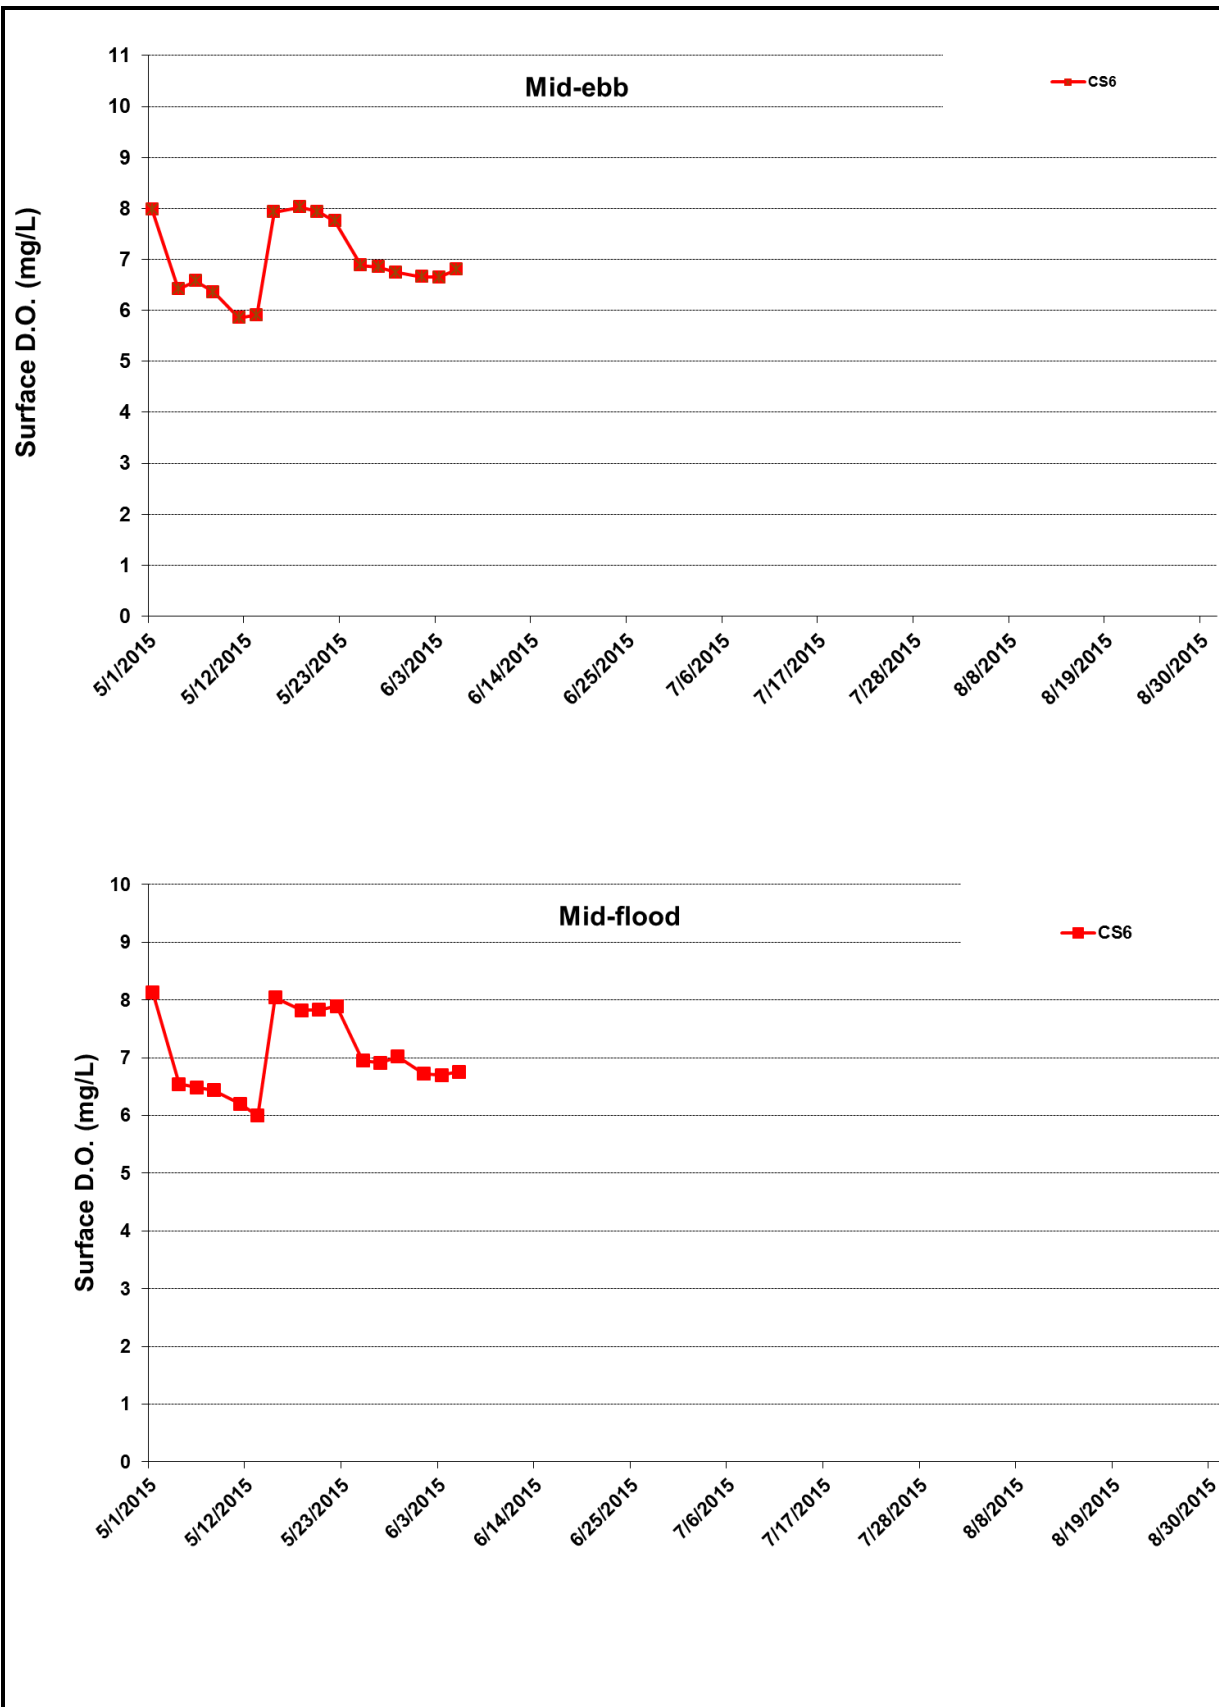
Figure G2 Impact Monitoring - Mean Level of Dissolved Oxygen (mg/L) in surface waters between 1 May 2015 and 5 June 2015 at CS6. The weather conditions during the monitoring period varied mostly from sunny to cloudy. No marine works was undertaken during the reporting period.

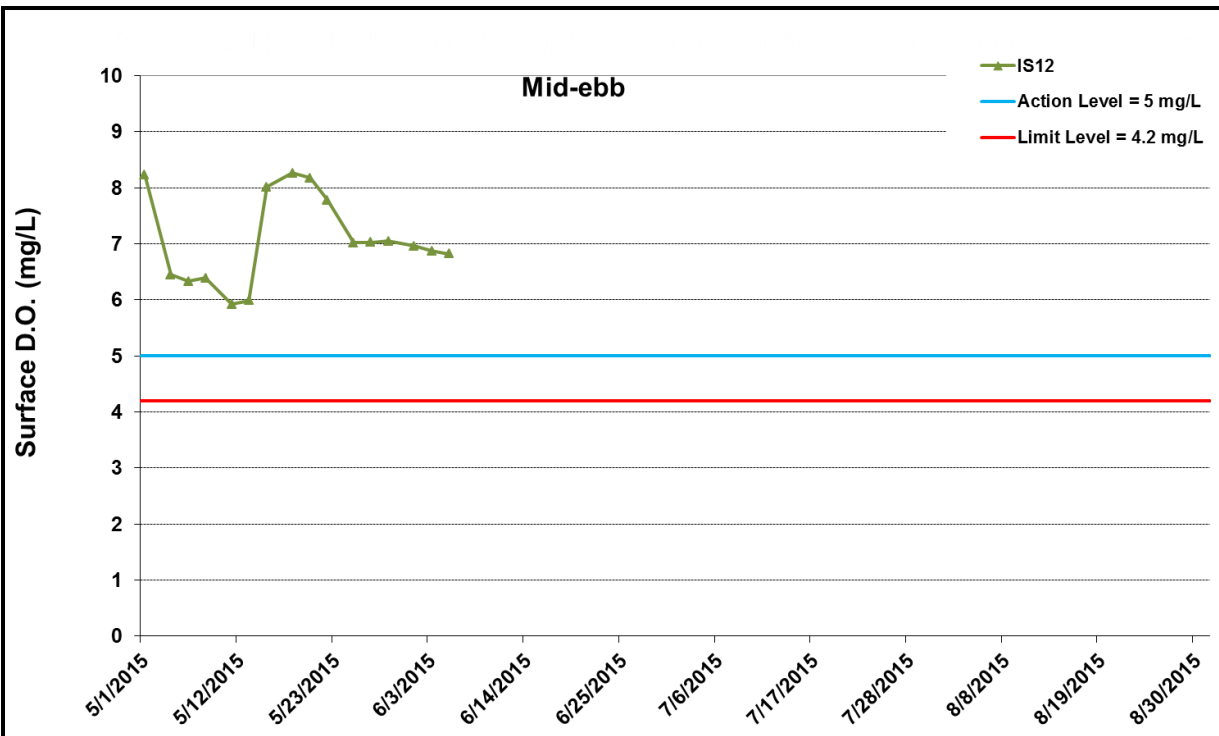
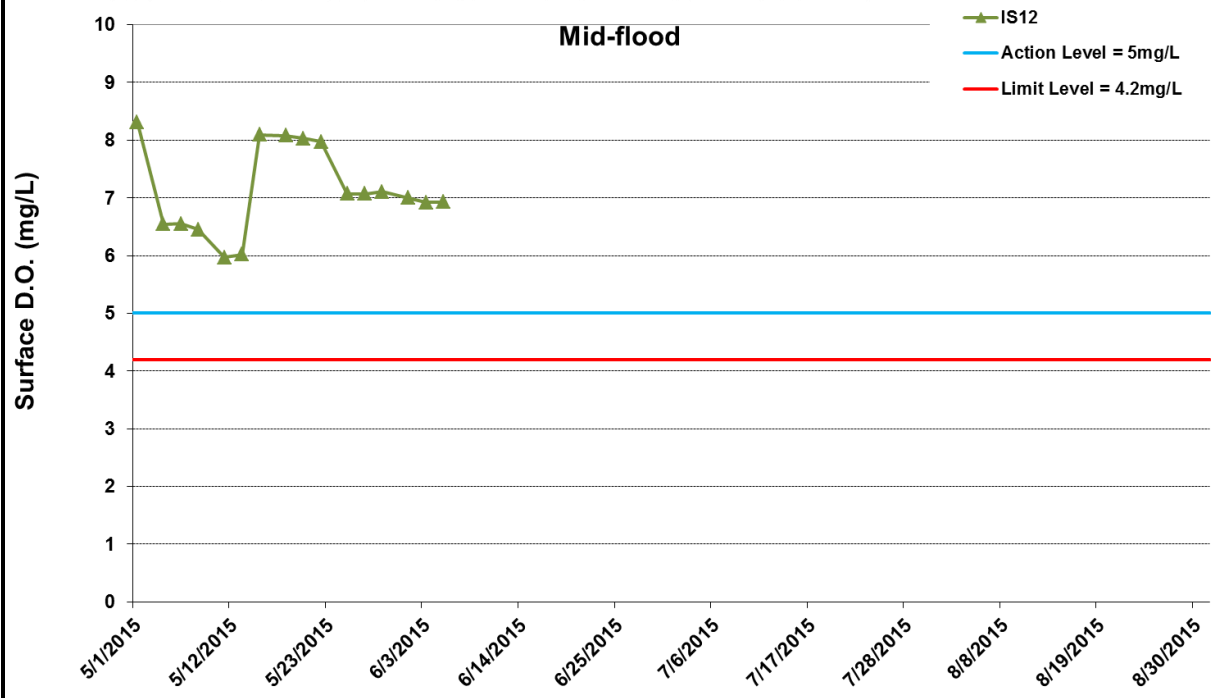
Figure G3 Impact Monitoring - Mean Level of Dissolved Oxygen (mg/L) in surface waters between 1 May 2015 and 5 June 2015 at IS12. The weather conditions during the monitoring period varied mostly from sunny to cloudy. No marine works was undertaken during the reporting period.
