**Contract No. HY/2012/08  
Tuen Mun – Chek Lap Kok Link –  
Northern Connection Sub-sea Tunnel  
Section**

*Seventh Quarterly Environmental Monitoring &  
Audit (EM&A) Report*

**Contract No. HY/2012/08 TM-CLKL Northern Connection Sub-sea  
Tunnel Section  
Seventh Quarterly EM&A Report**

**Document Code: 0212330\_7th Quarterly EM&A\_20151221.doc**

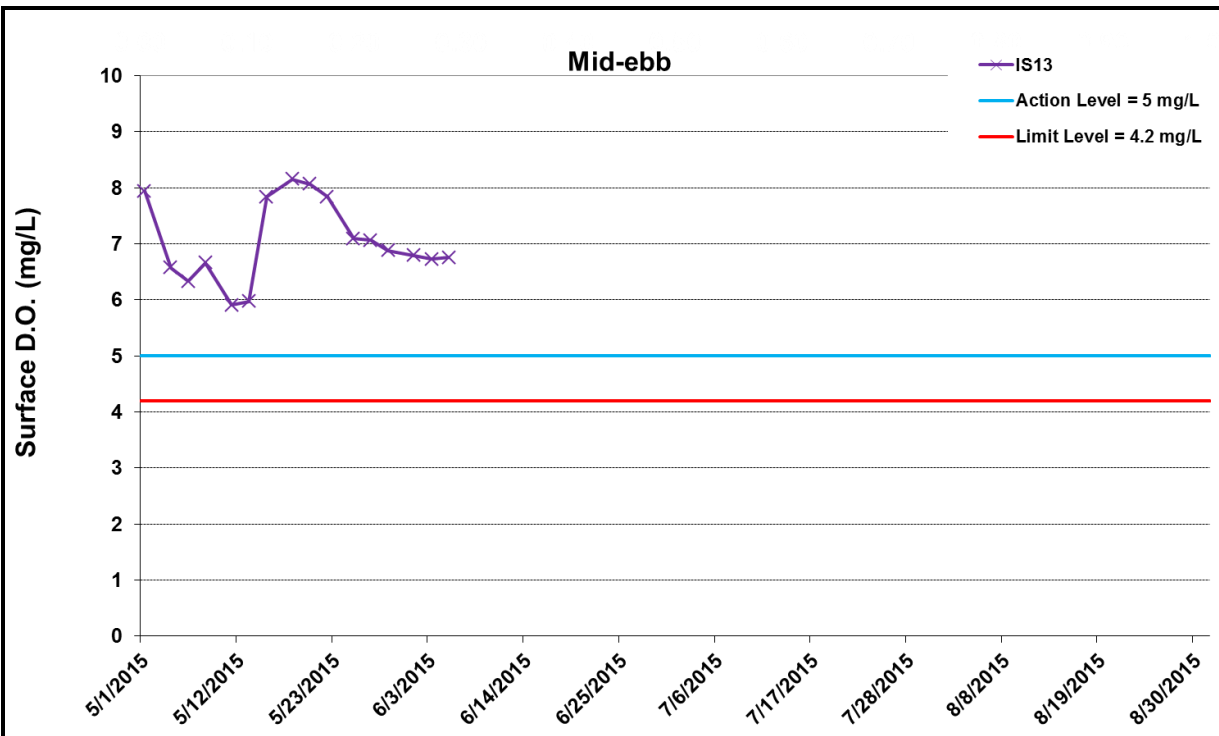
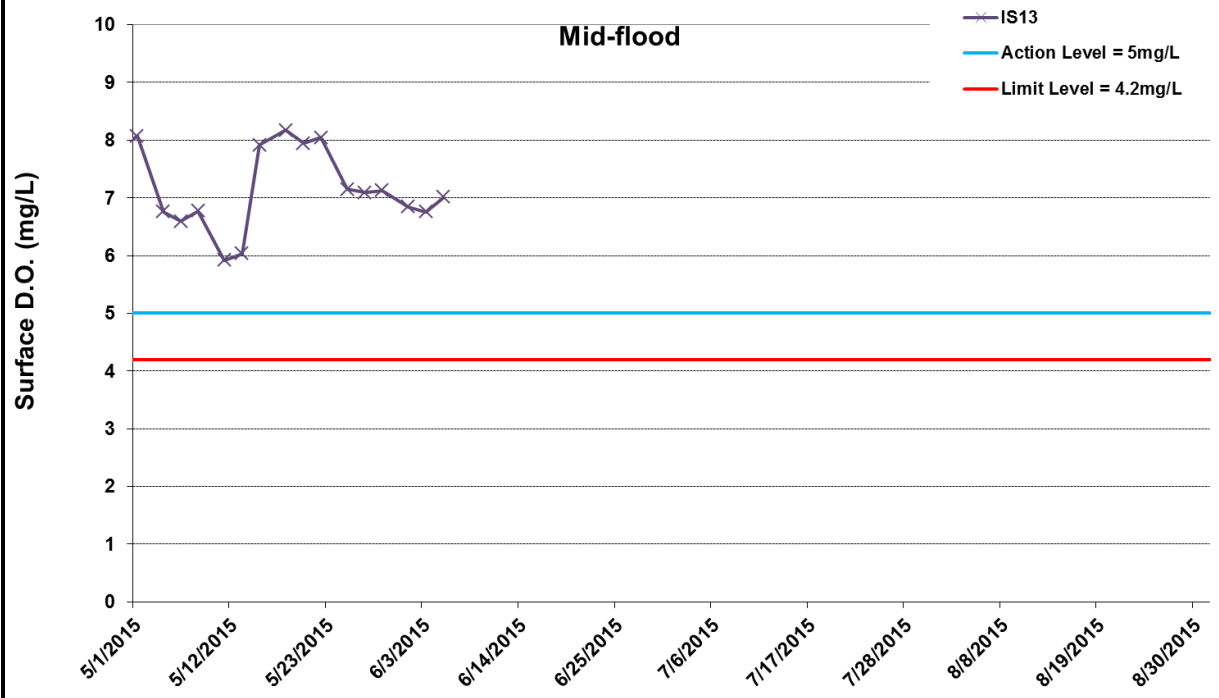
Figure G4 Impact Monitoring - Mean Level of Dissolved Oxygen (mg/L) in surface waters between 1 May 2015 and 5 June 2015 at IS13. The weather conditions during the monitoring period varied mostly from sunny to cloudy. No marine works was undertaken during the reporting period.

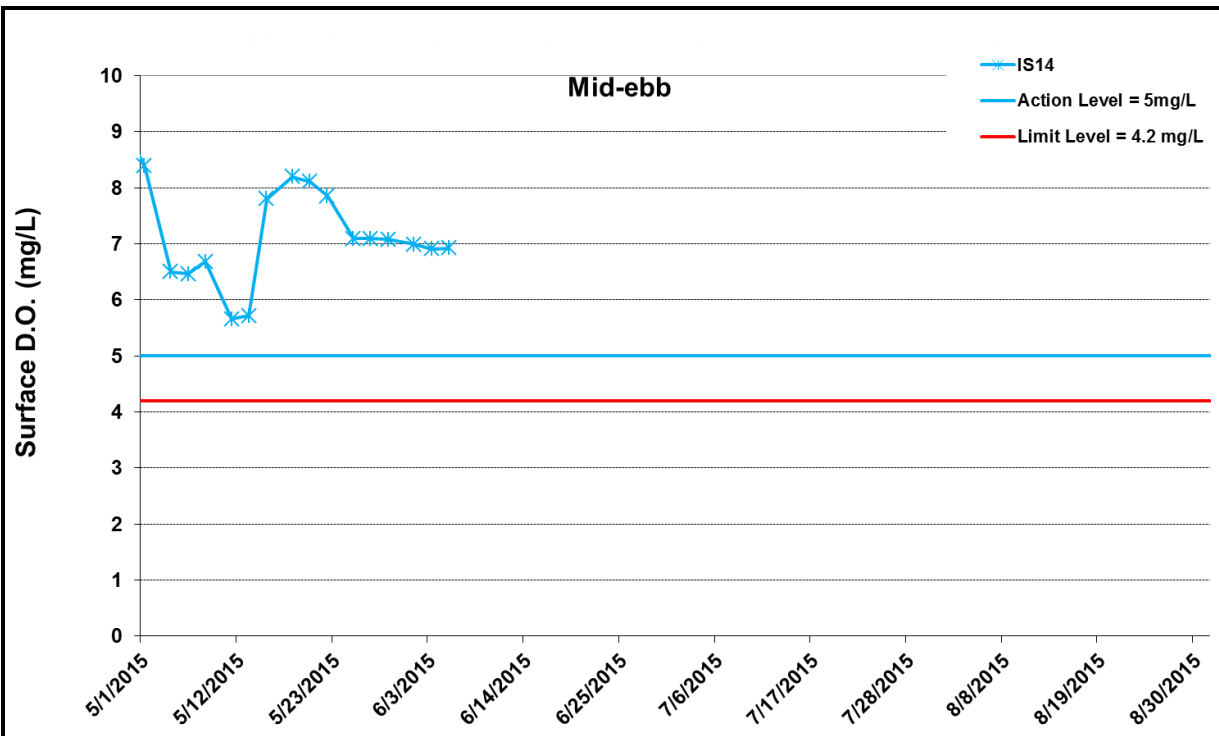
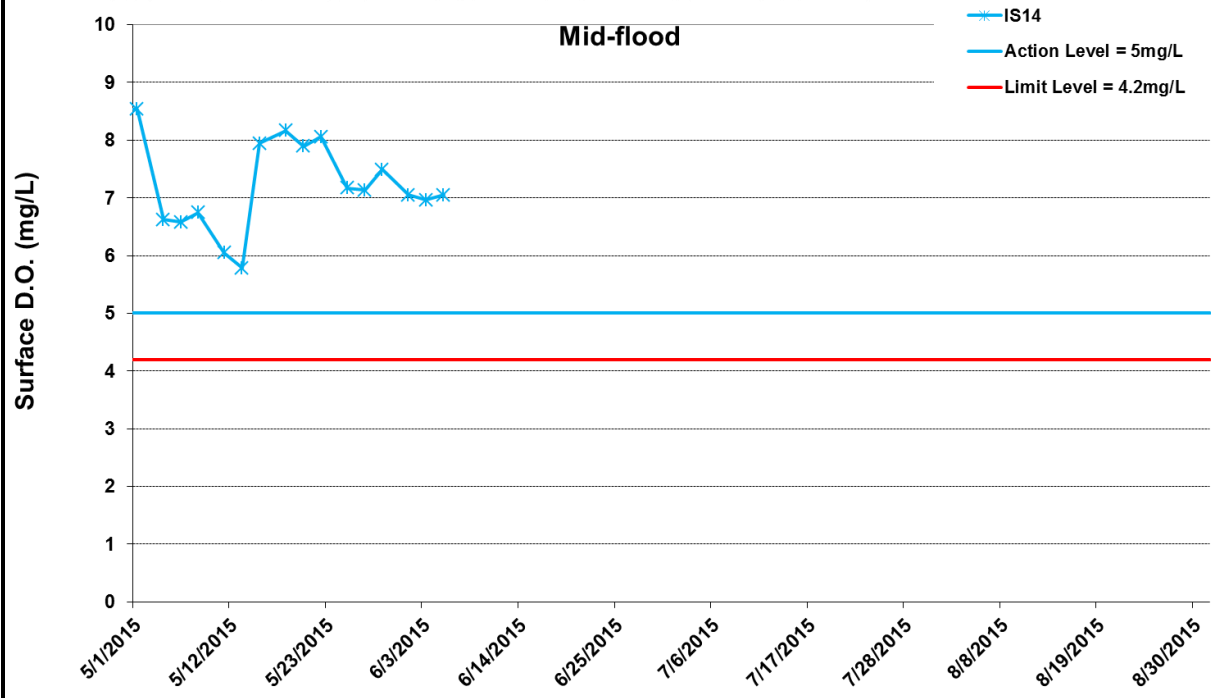
Figure G5 Impact Monitoring - Mean Level of Dissolved Oxygen (mg/L) in surface waters between 1 May 2015 and 5 June 2015 at IS14. The weather conditions during the monitoring period varied mostly from sunny to cloudy. No marine works was undertaken during the reporting period.

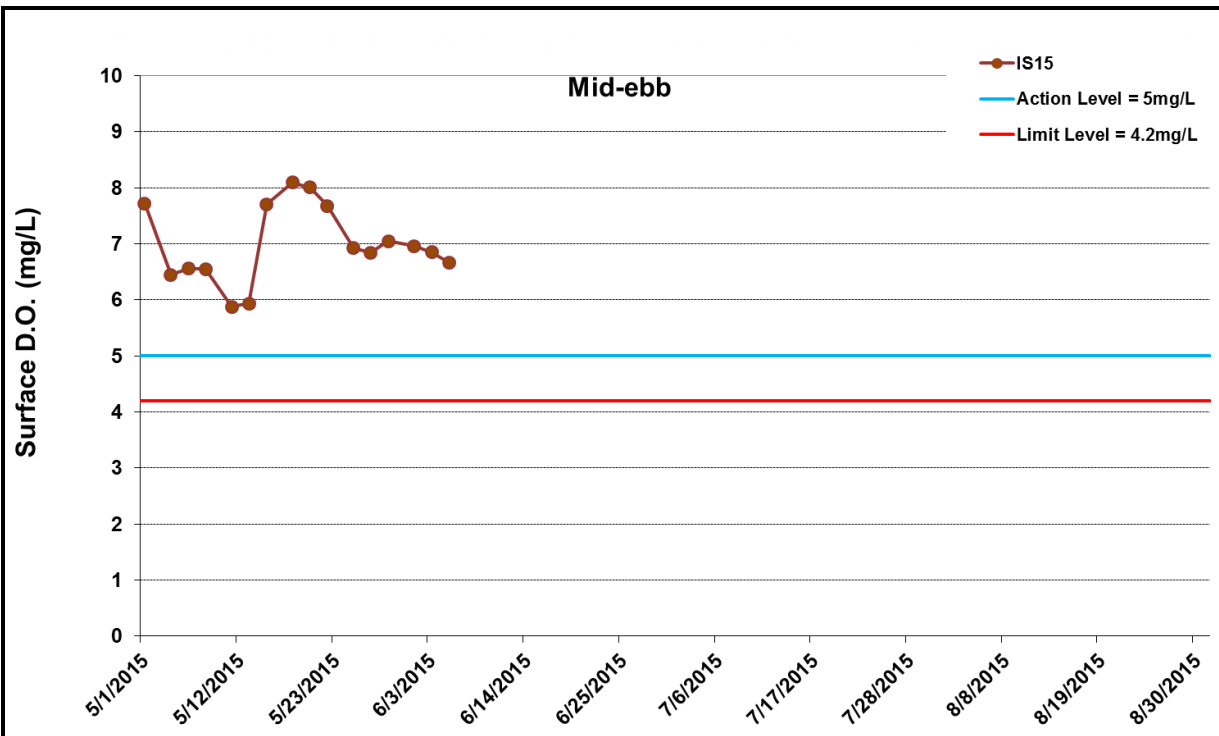
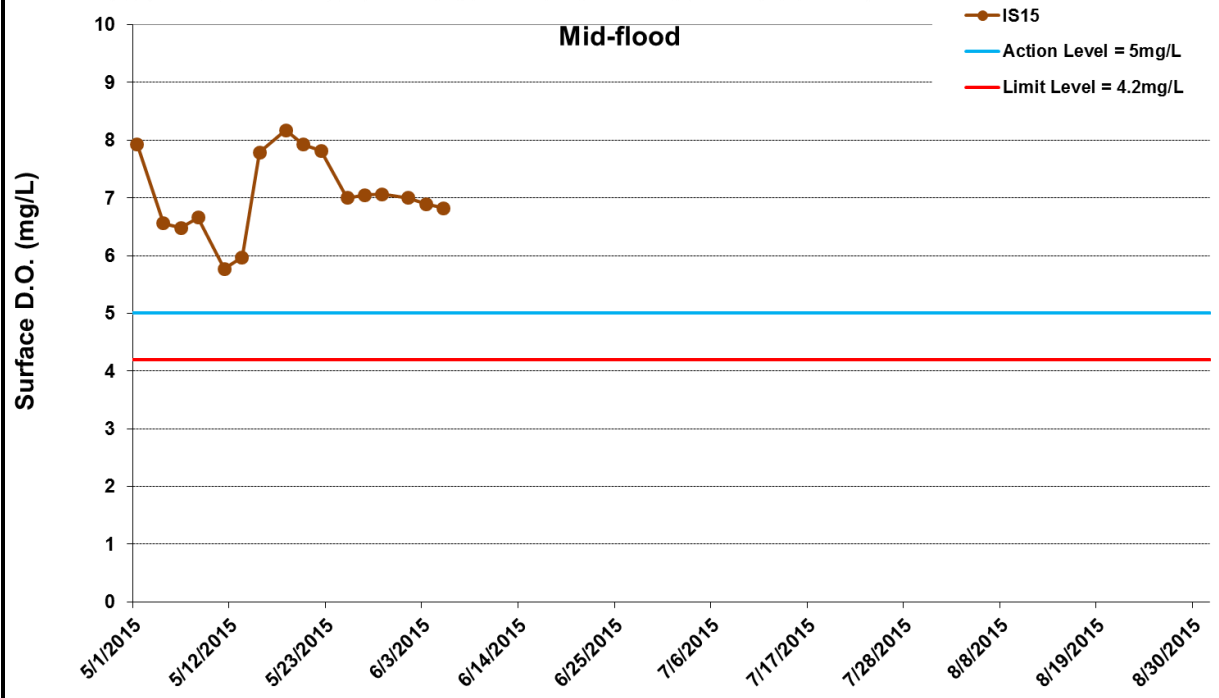
Figure G6 Impact Monitoring - Mean Level of Dissolved Oxygen (mg/L) in surface waters between 1 May 2015 and 5 June 2015 at IS15. The weather conditions during the monitoring period varied mostly from sunny to cloudy. No marine works was undertaken during the reporting period.

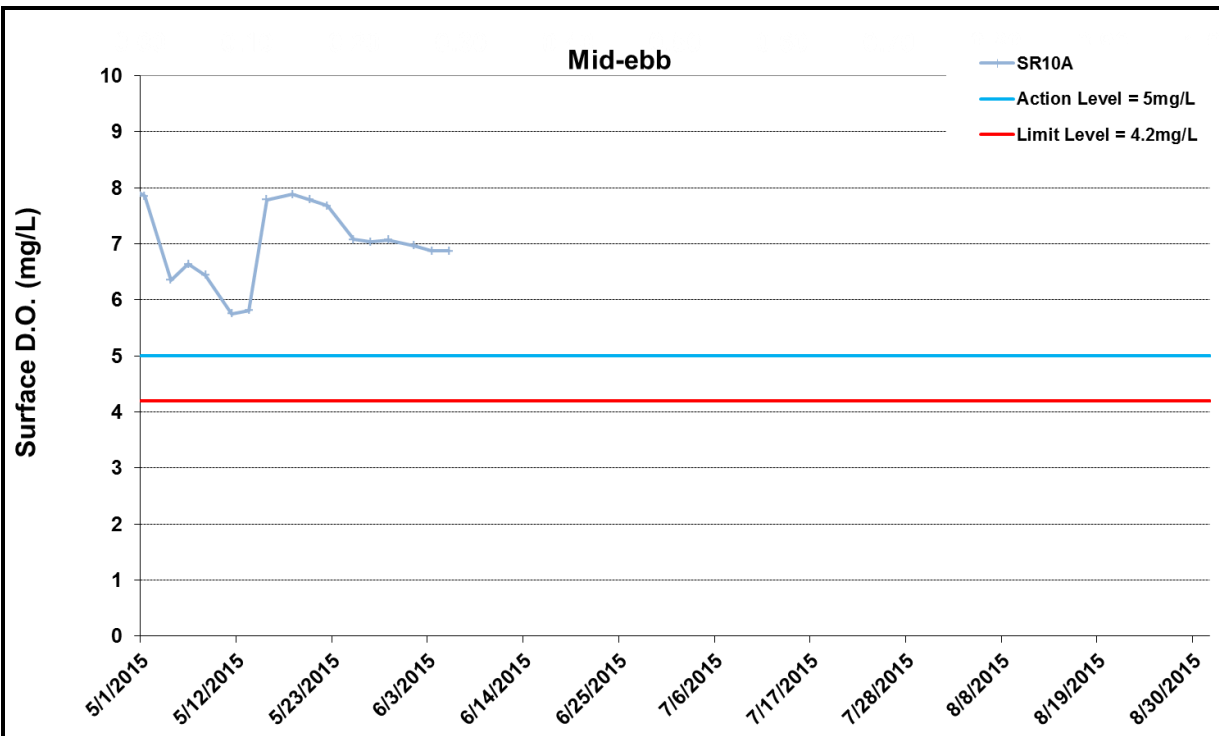
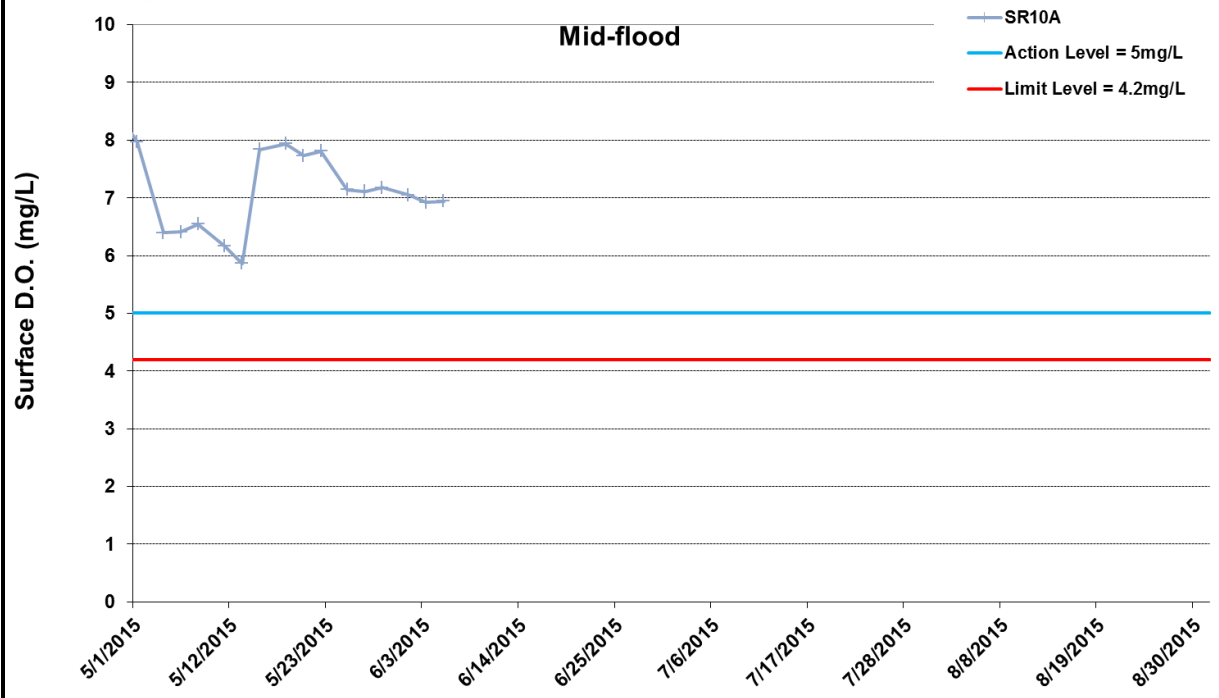
Figure G7 Impact Monitoring - Mean Level of Dissolved Oxygen (mg/L) in surface waters between 1 May 2015 and 5 June 2015 at SR10A. The weather conditions during the monitoring period varied mostly from sunny to cloudy. No marine works was undertaken during the reporting period.

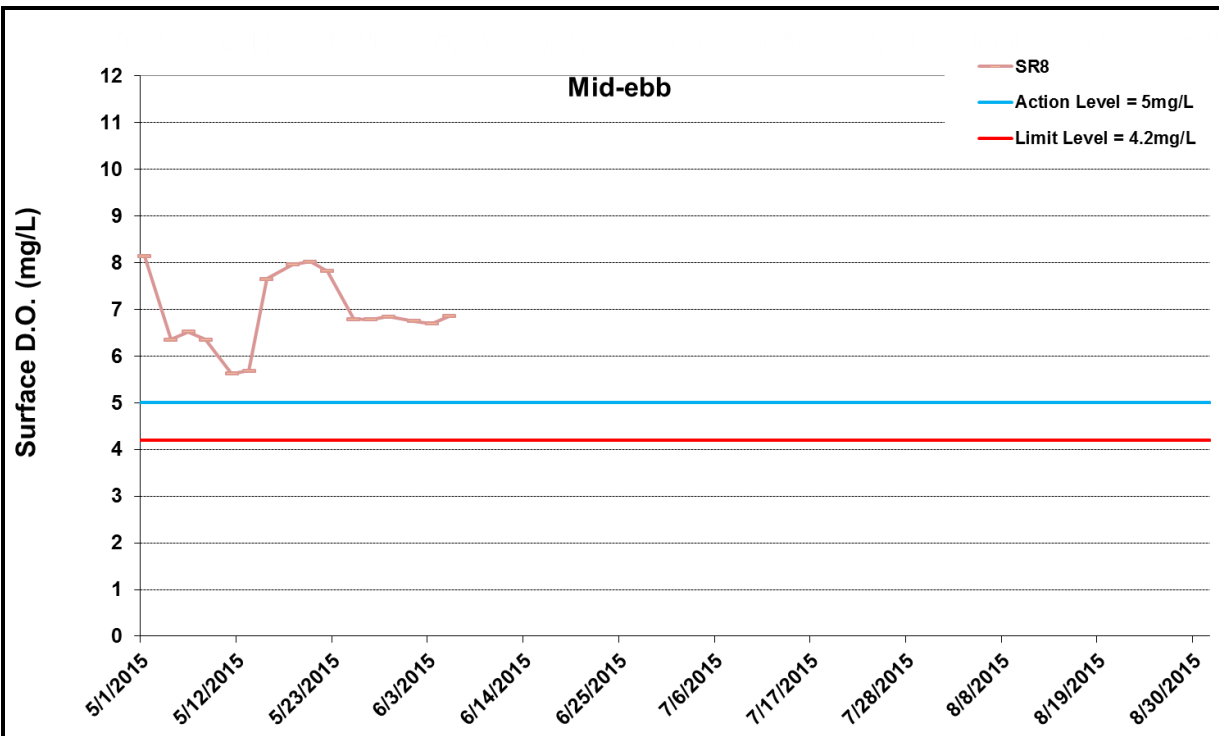
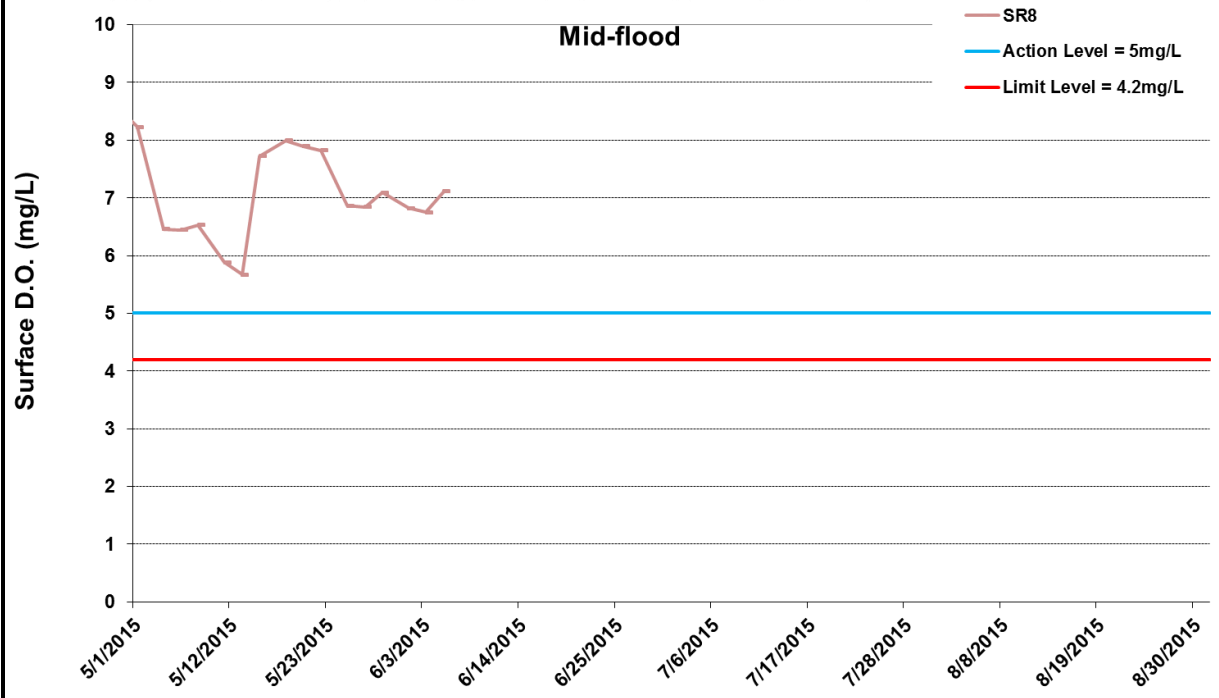
Figure G8 Impact Monitoring - Mean Level of Dissolved Oxygen (mg/L) in surface waters between 1 May 2015 and 5 June 2015 at SR8. The weather conditions during the monitoring period varied mostly from sunny to cloudy. No marine works was undertaken during the reporting period.

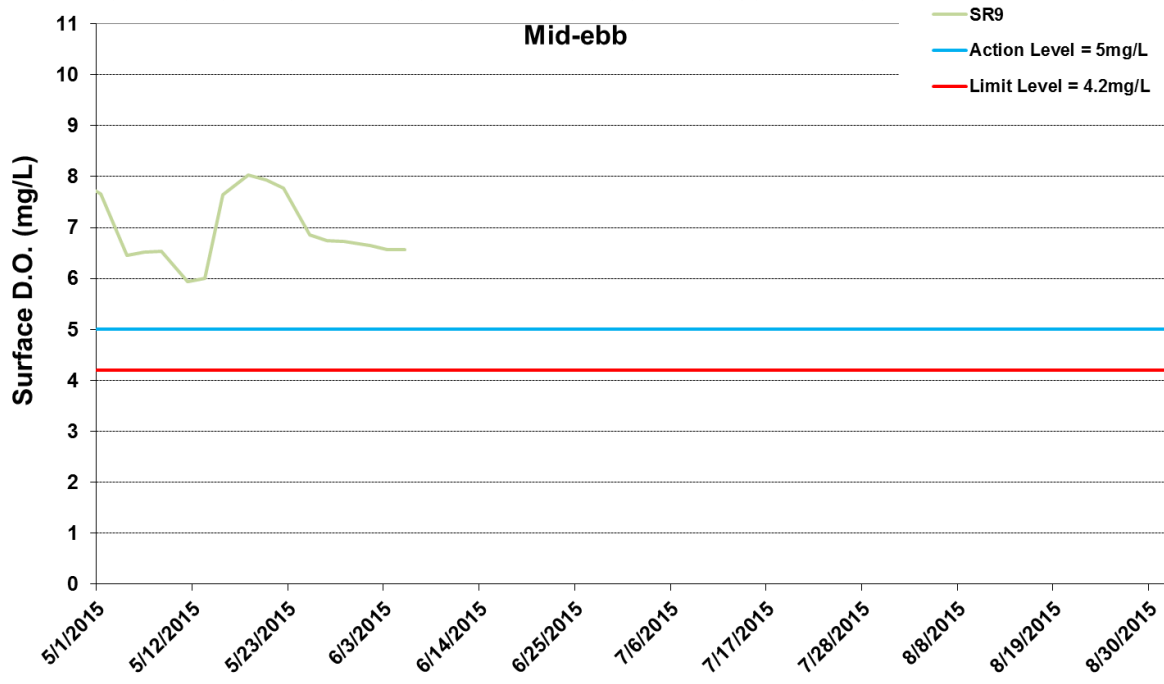
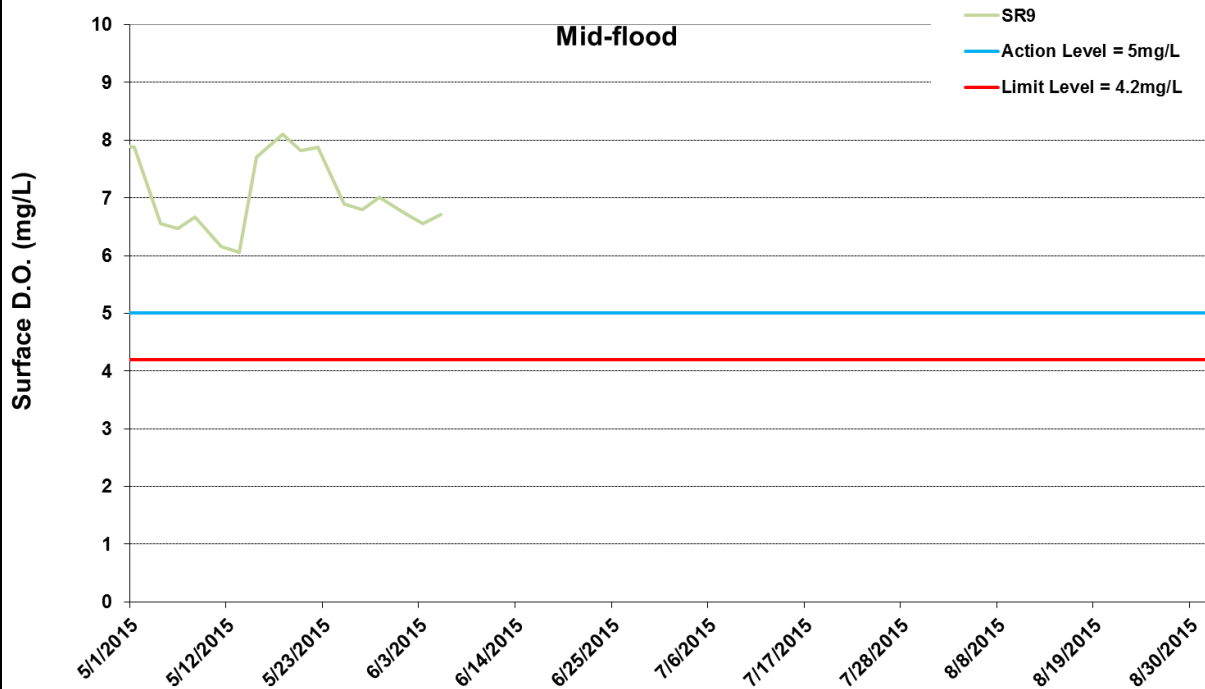
Figure G9 Impact Monitoring - Mean Level of Dissolved Oxygen (mg/L) in surface waters between 1 May 2015 and 5 June 2015 at SR9. The weather conditions during the monitoring period varied mostly from sunny to cloudy. No marine works was undertaken during the reporting period.

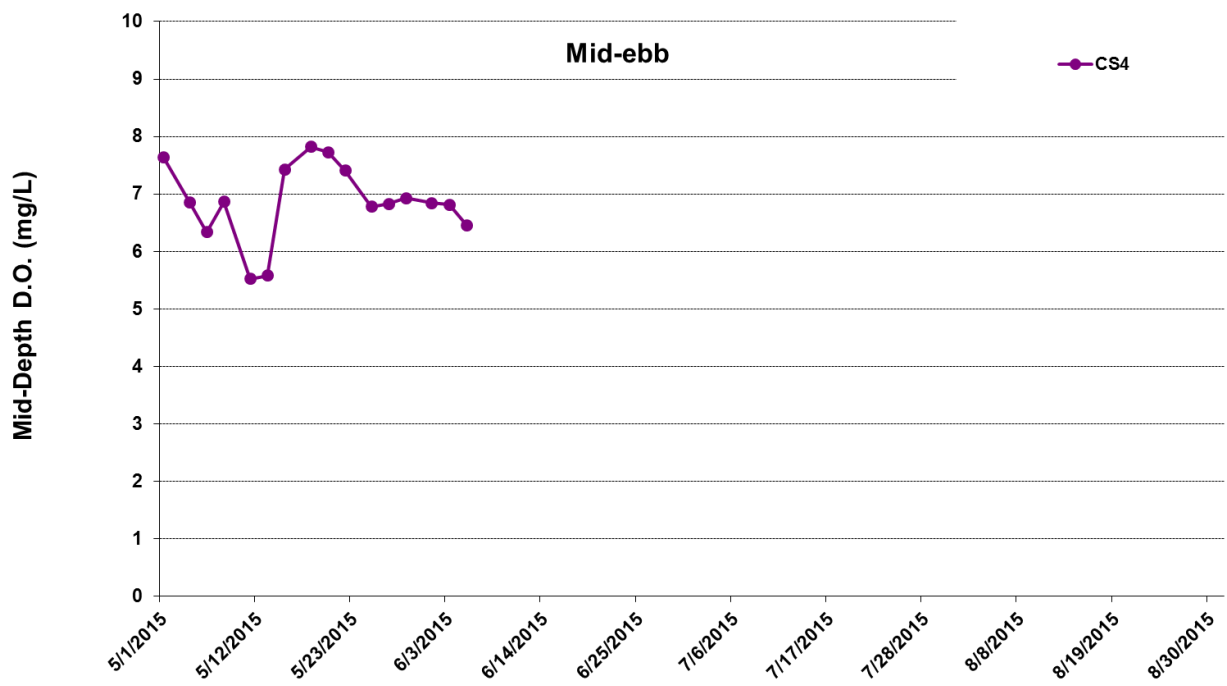
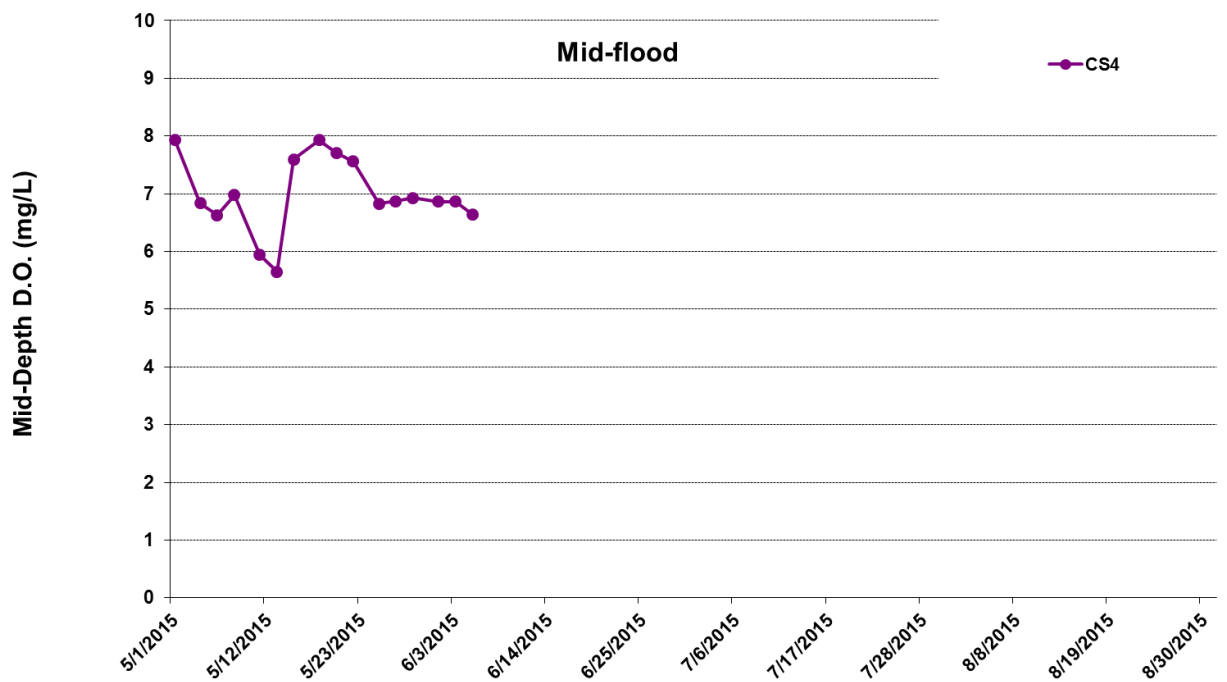
\*No data for Stations SR8 and SR9 due to shallow water depth (< 6m).

Figure G10 Impact Monitoring - Mean Level of Dissolved Oxygen (mg/L) in mid-depth waters between 1 May 2015 and 5 June 2015 at CS4. The weather conditions during the monitoring period varied mostly from sunny to cloudy. No marine works was undertaken during the reporting period.

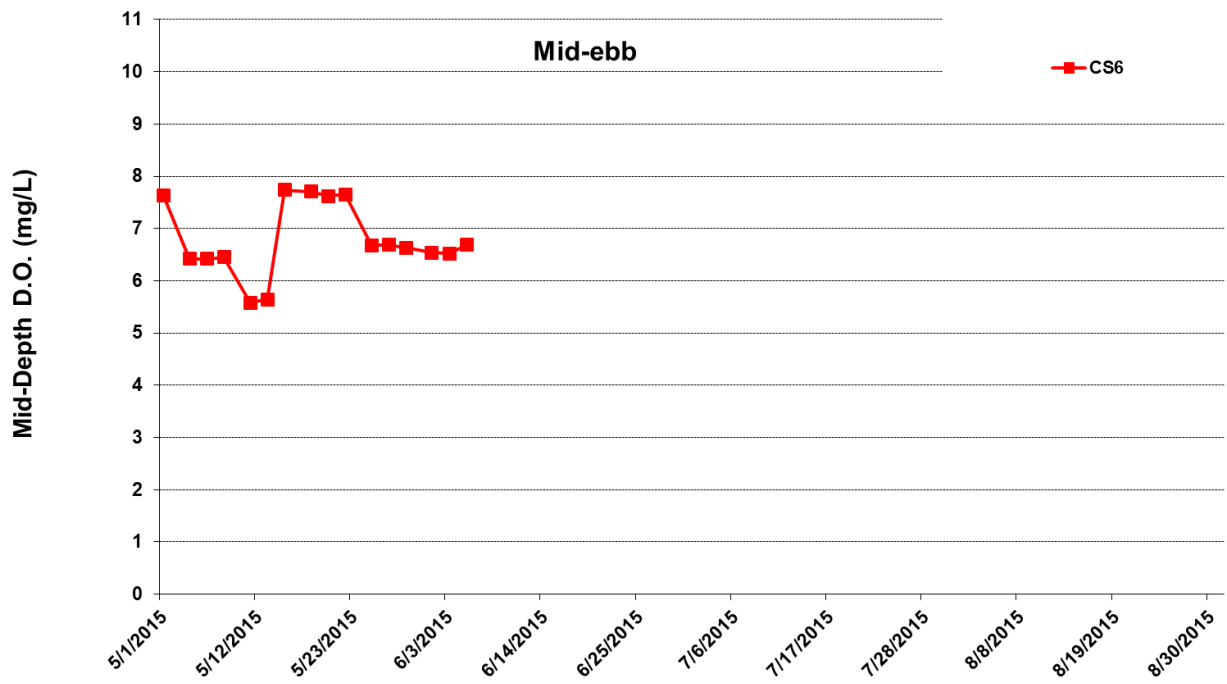
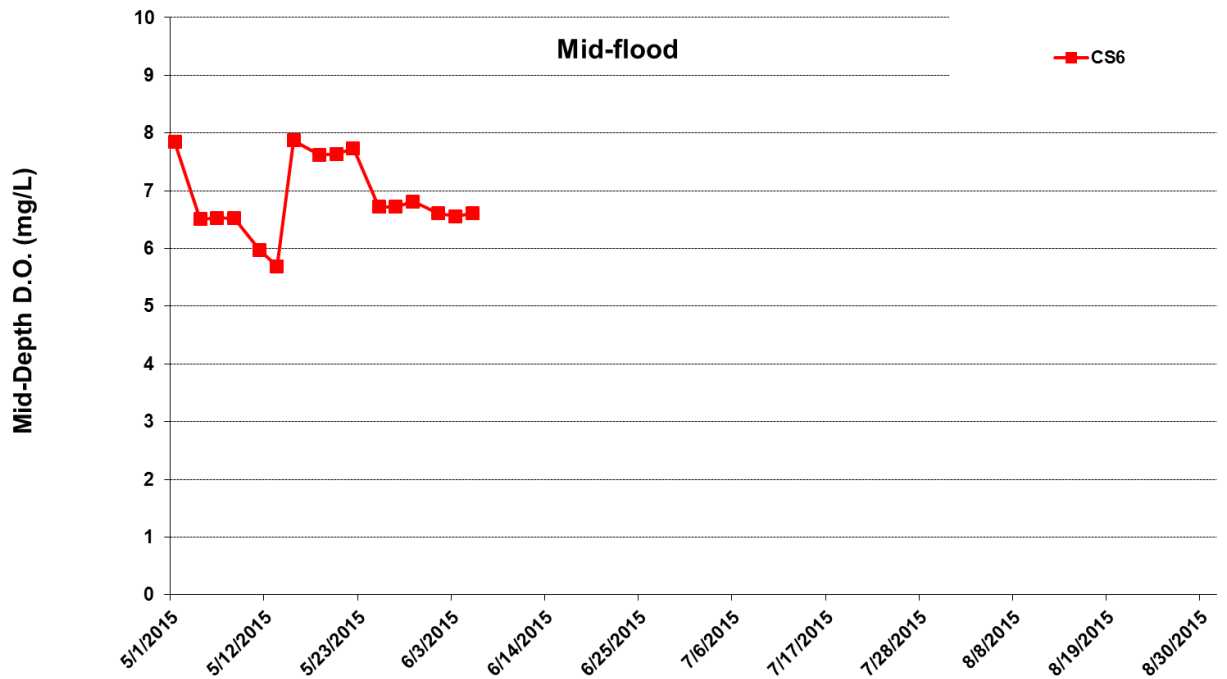
\*No data for Stations SR8 and SR9 due to shallow water depth (< 6m).

Figure G11 Impact Monitoring - Mean Level of Dissolved Oxygen (mg/L) in mid-depth waters between 1 May 2015 and 5 June 2015 at CS6. The weather conditions during the monitoring period varied mostly from sunny to cloudy. No marine works was undertaken during the reporting period.

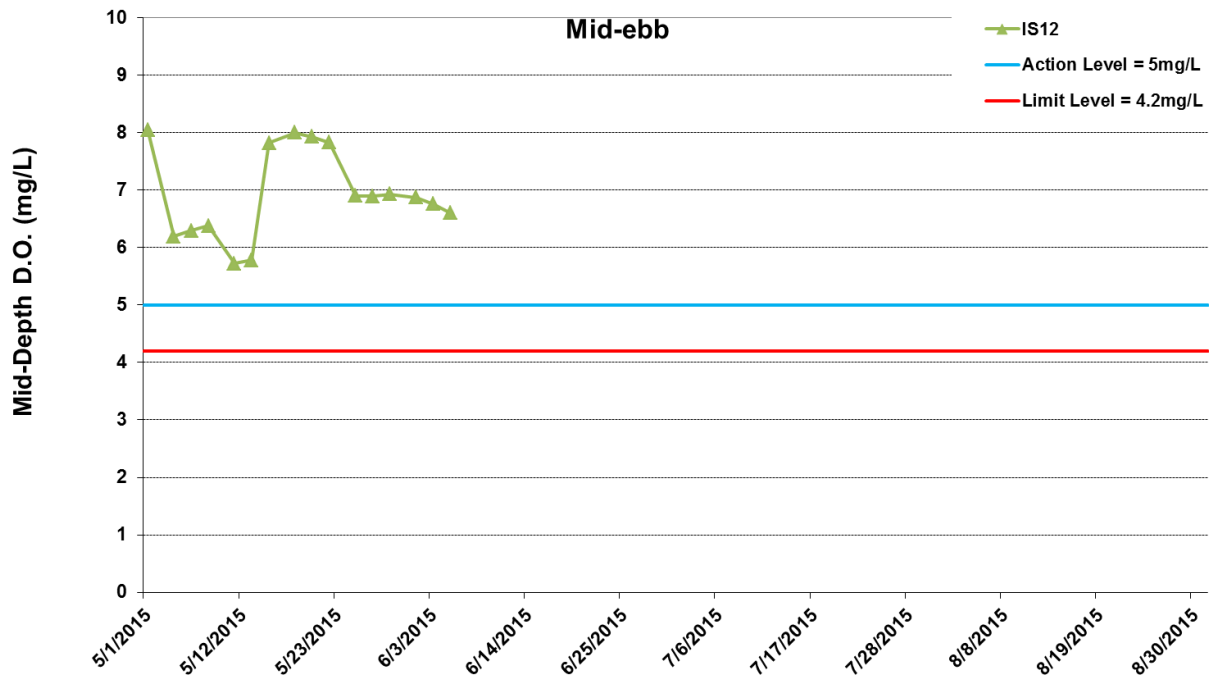
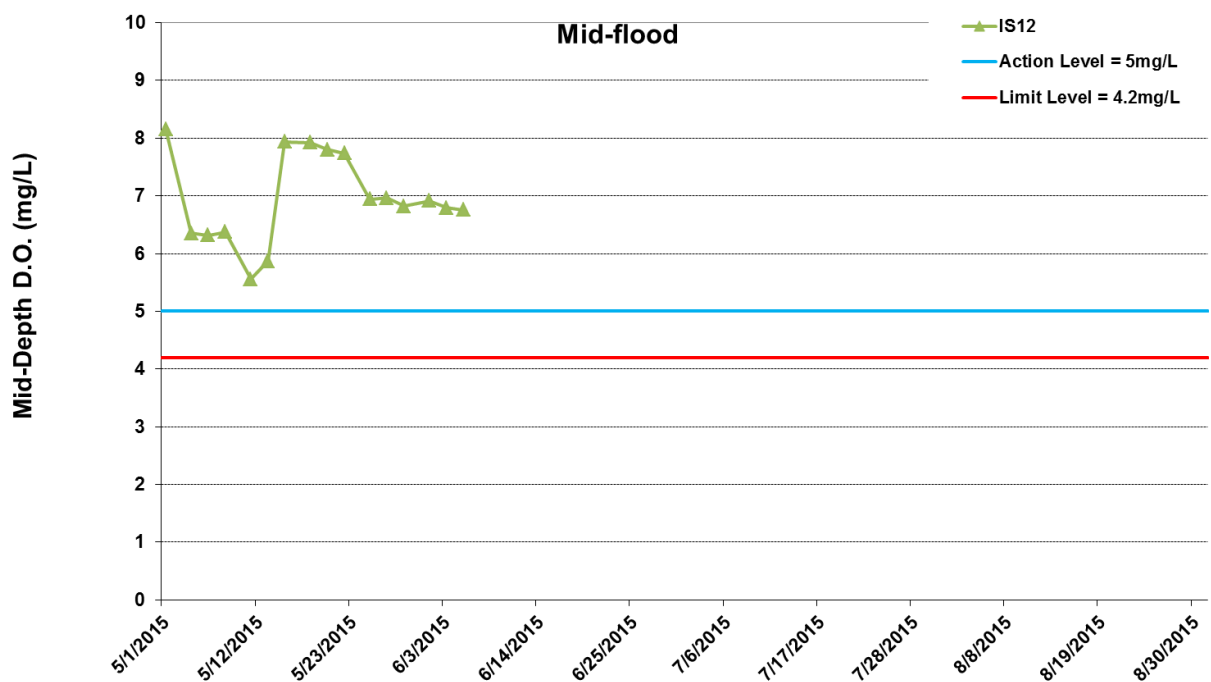
\*No data for Stations SR8 and SR9 due to shallow water depth (< 6m).

Figure G12 Impact Monitoring - Mean Level of Dissolved Oxygen (mg/L) in mid-depth waters between 1 May 2015 and 5 June 2015 at IS12. The weather conditions during the monitoring period varied mostly from sunny to cloudy. No marine works was undertaken during the reporting period.

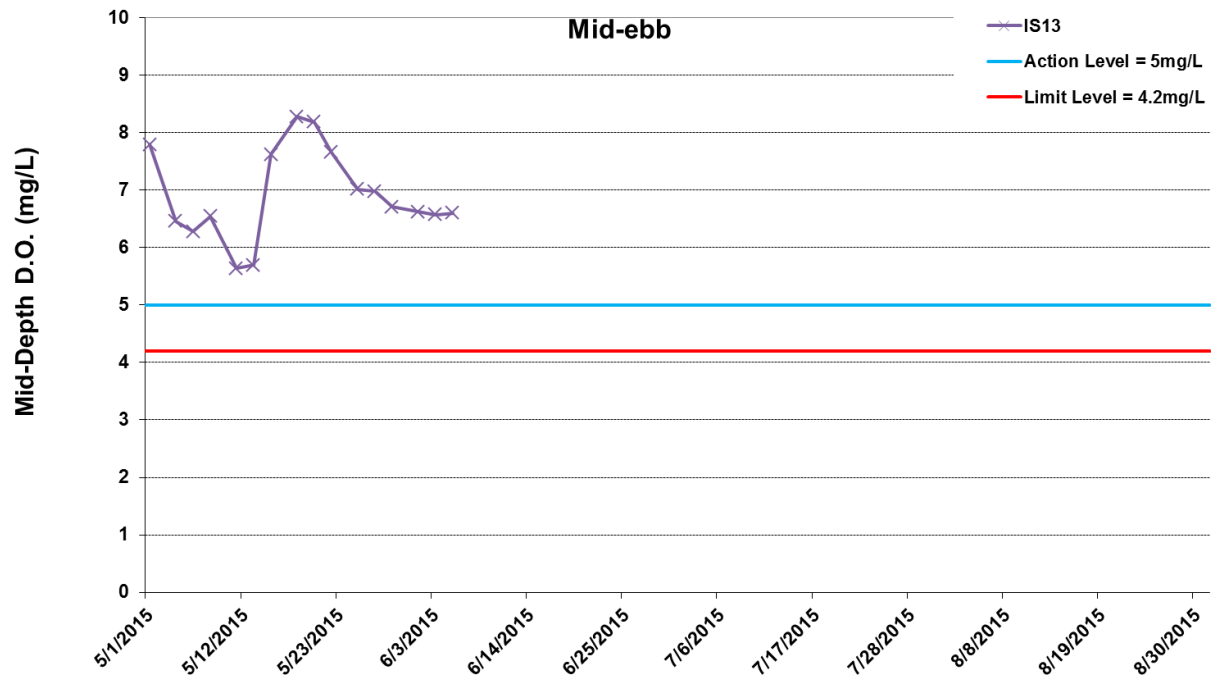
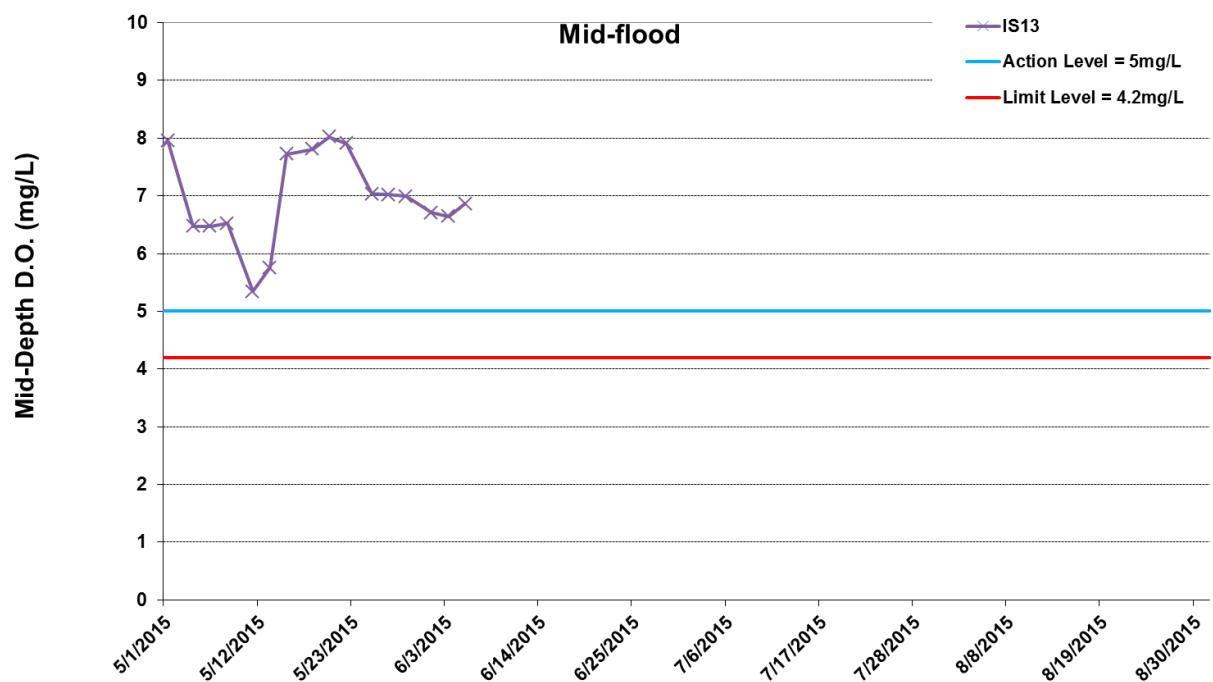
\*No data for Stations SR8 and SR9 due to shallow water depth (< 6m).

Figure G13 Impact Monitoring - Mean Level of Dissolved Oxygen (mg/L) in mid-depth waters between 1 May 2015 and 5 June 2015 at IS13. The weather conditions during the monitoring period varied mostly from sunny to cloudy. No marine works was undertaken during the reporting period.

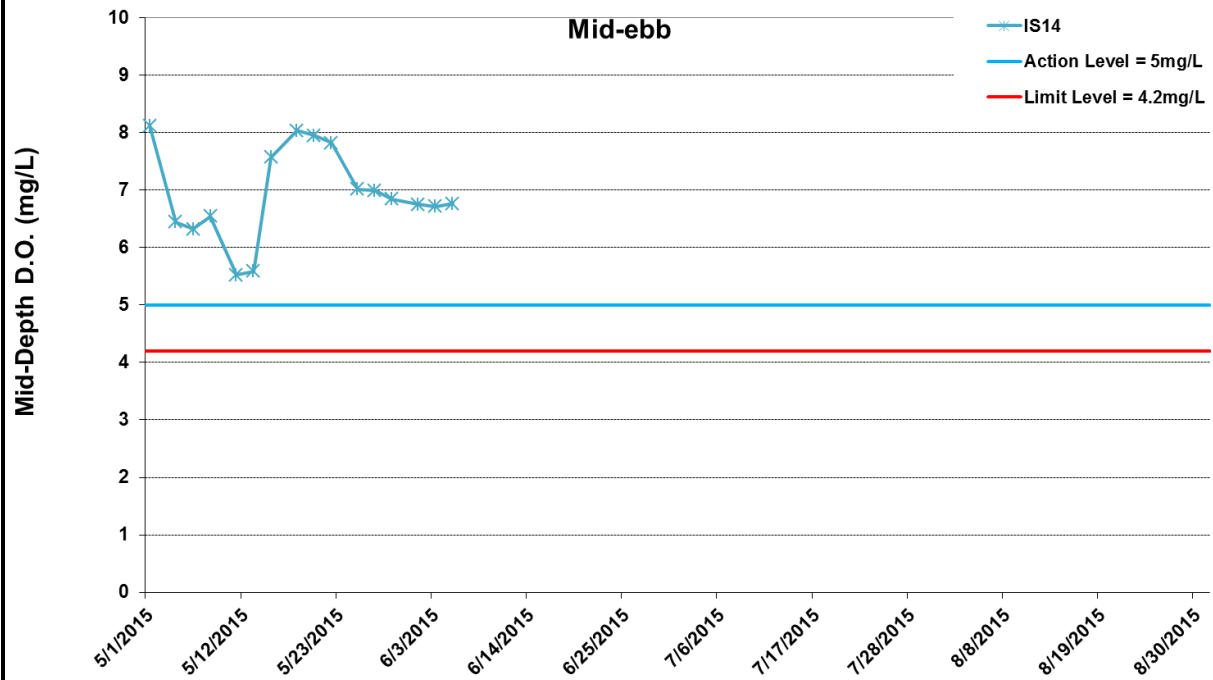
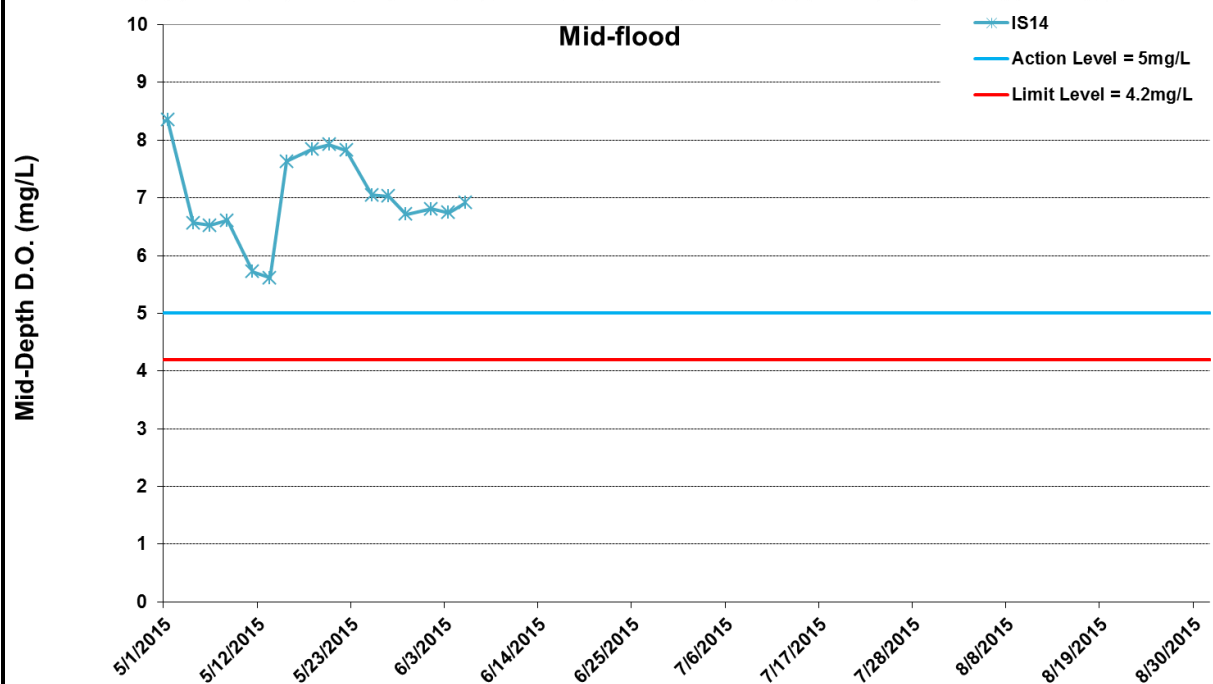
\*No data for Stations SR8 and SR9 due to shallow water depth (< 6m).

Figure G14 Impact Monitoring - Mean Level of Dissolved Oxygen (mg/L) in mid-depth waters between 1 May 2015 and 5 June 2015 at IS14. The weather conditions during the monitoring period varied mostly from sunny to cloudy. No marine works was undertaken during the reporting period.

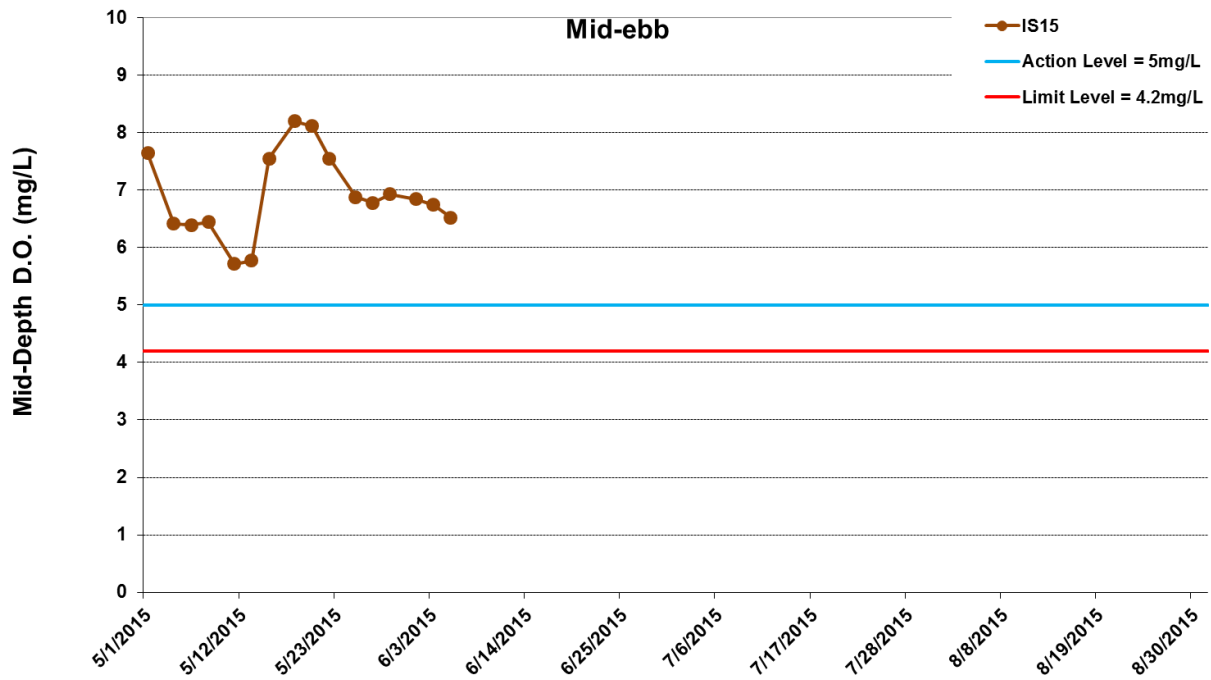
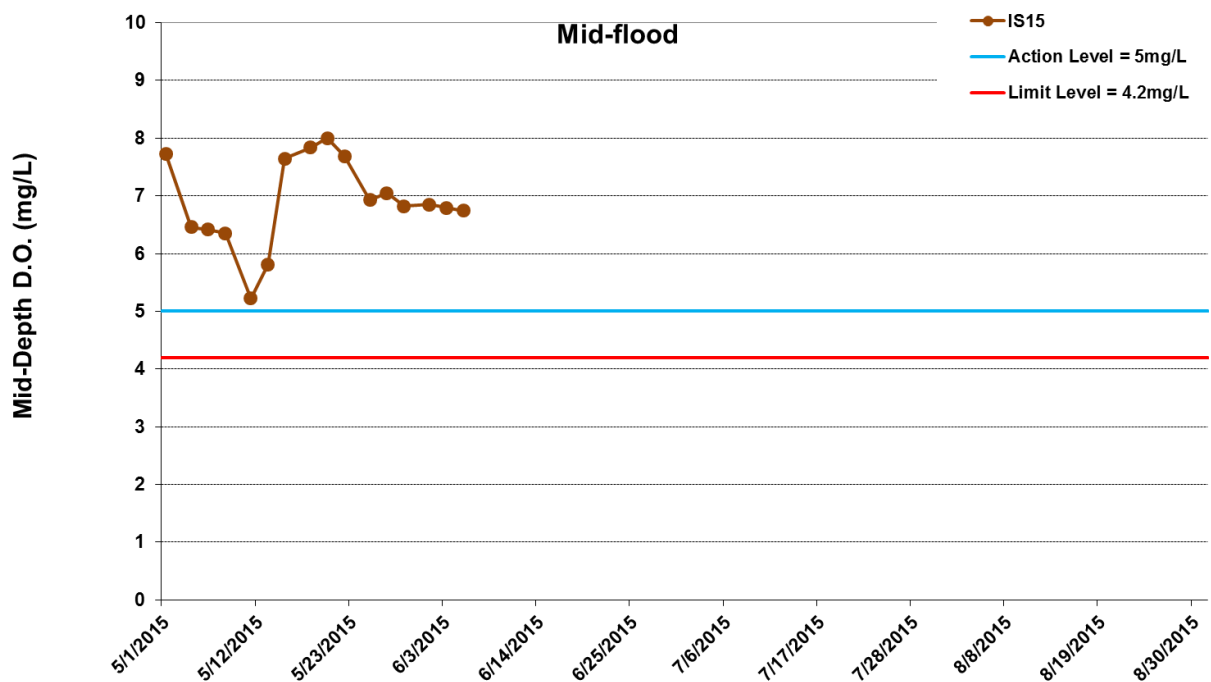
\*No data for Stations SR8 and SR9 due to shallow water depth (< 6m).

Figure G15 Impact Monitoring - Mean Level of Dissolved Oxygen (mg/L) in mid-depth waters between 1 May 2015 and 5 June 2015 at IS15. The weather conditions during the monitoring period varied mostly from sunny to cloudy. No marine works was undertaken during the reporting period.

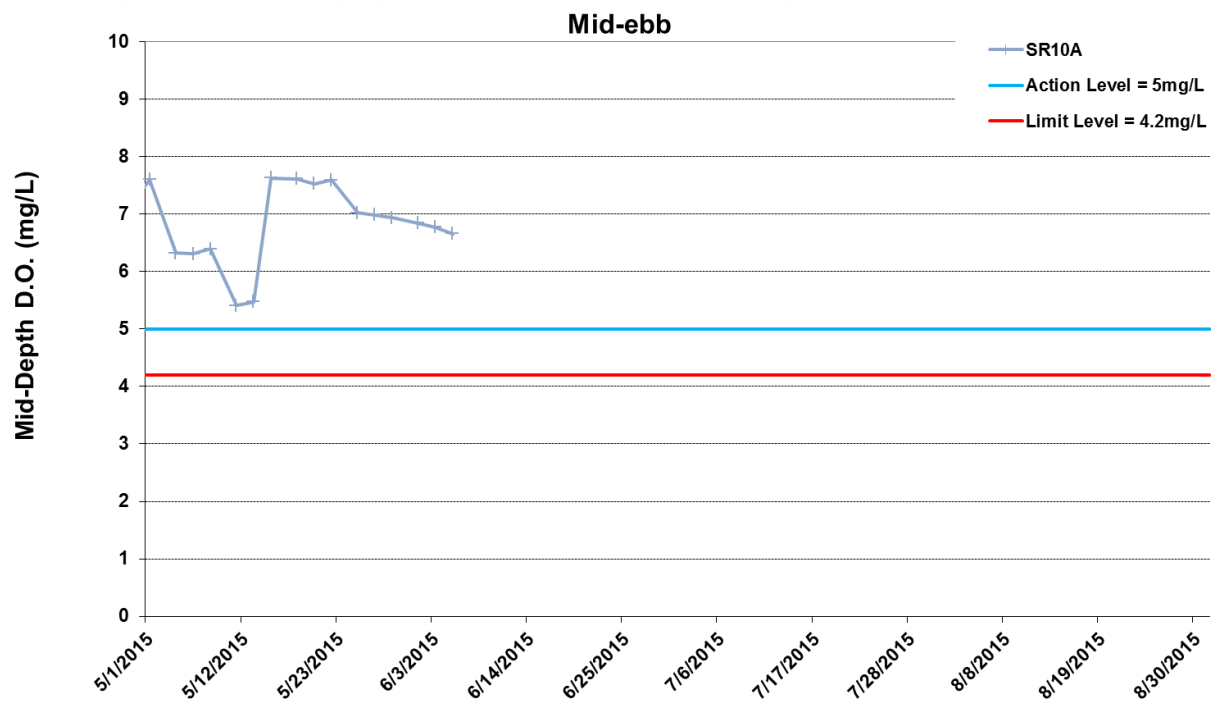
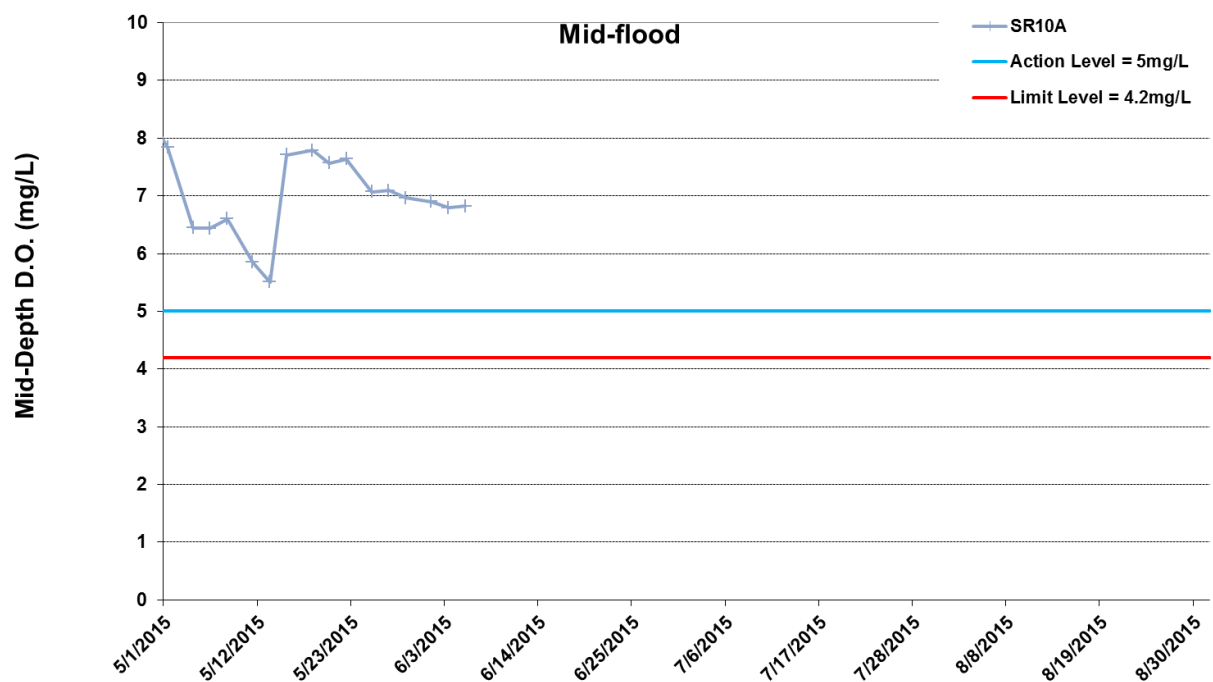
\*No data for Stations SR8 and SR9 due to shallow water depth (< 6m).

**Figure G16 Impact Monitoring - Mean Level of Dissolved Oxygen (mg/L) in mid-depth waters between 1 May 2015 and 5 June 2015 at SR10A. The weather conditions during the monitoring period varied mostly from sunny to cloudy. No marine works was undertaken during the reporting period.**
