**Contract No. HY/2012/08  
Tuen Mun – Chek Lap Kok Link –  
Northern Connection Sub-sea Tunnel  
Section**

*Seventh Quarterly Environmental Monitoring &  
Audit (EM&A) Report*

**Contract No. HY/2012/08 TM-CLKL Northern Connection Sub-sea  
Tunnel Section  
Seventh Quarterly EM&A Report**

**Document Code: 0212330\_7th Quarterly EM&A\_20151221.doc**

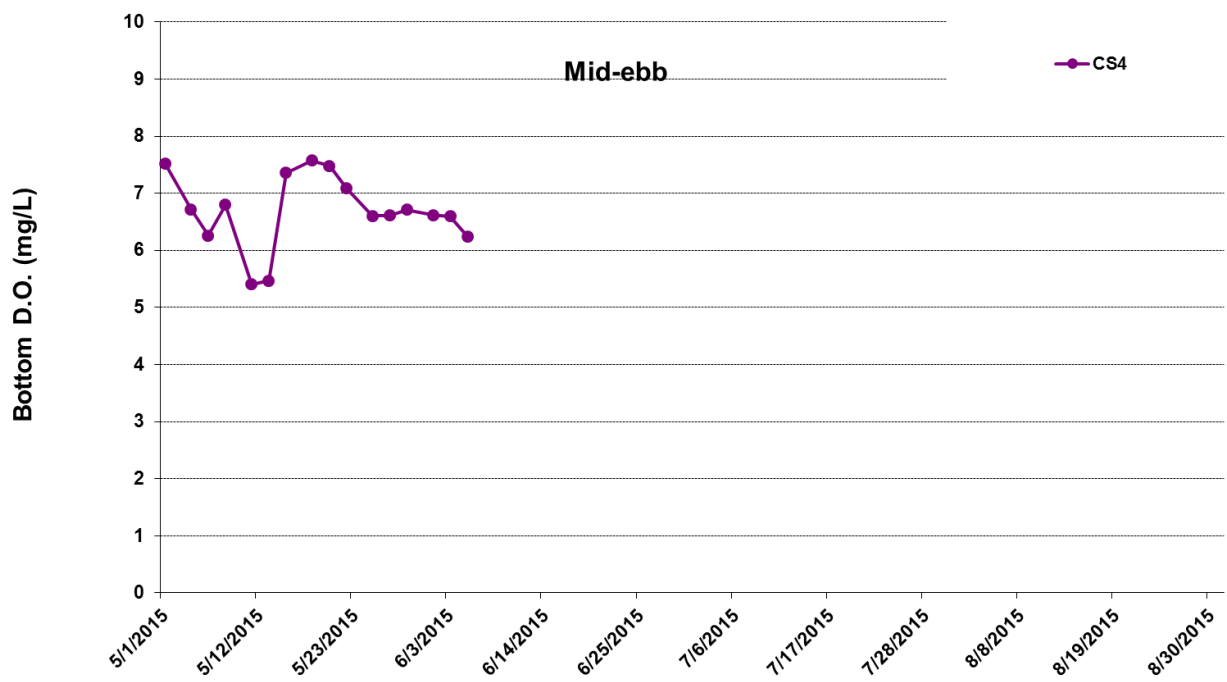
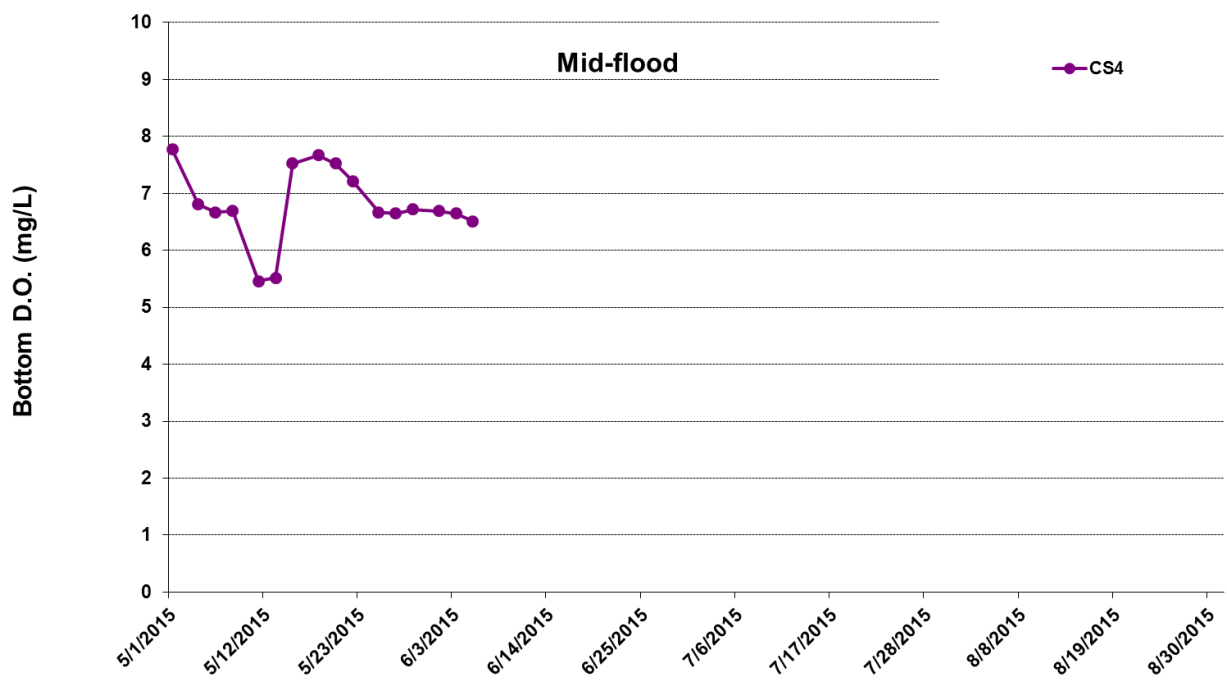
Figure G17 Impact Monitoring - Mean Level of Dissolved Oxygen (mg/L) in bottom water between 1 May 2015 and 5 June 2015 at CS4. The weather conditions during the monitoring period varied mostly from sunny to cloudy. No marine works was undertaken during the reporting period.

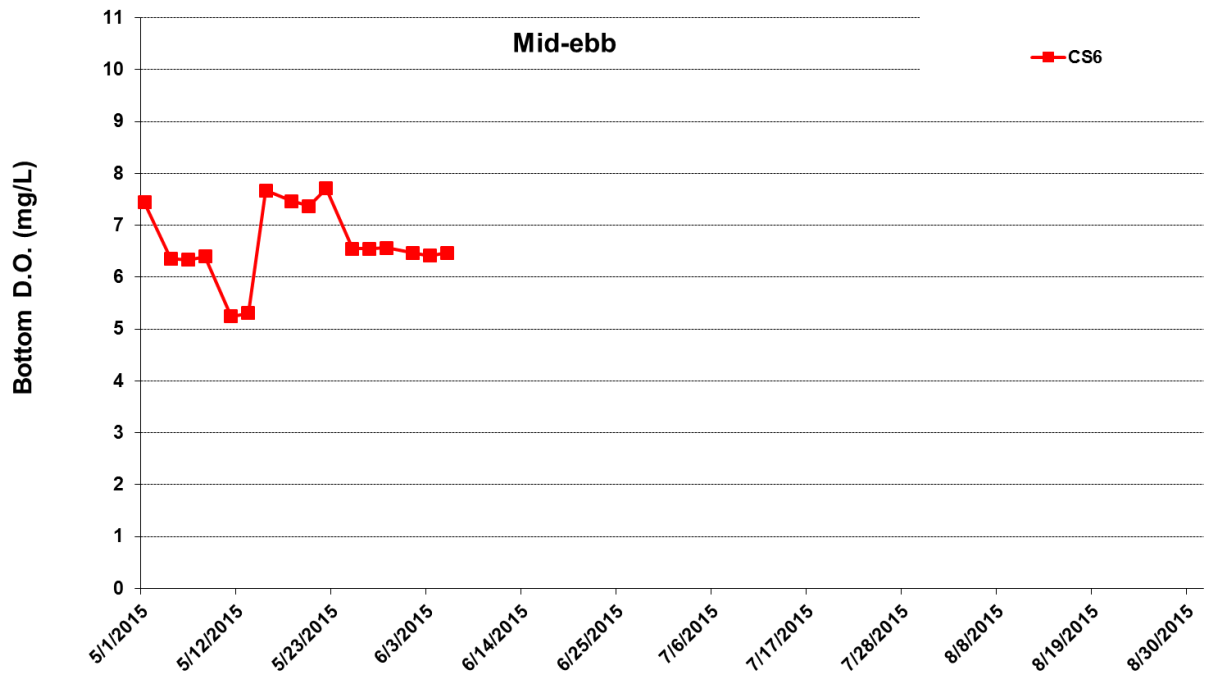
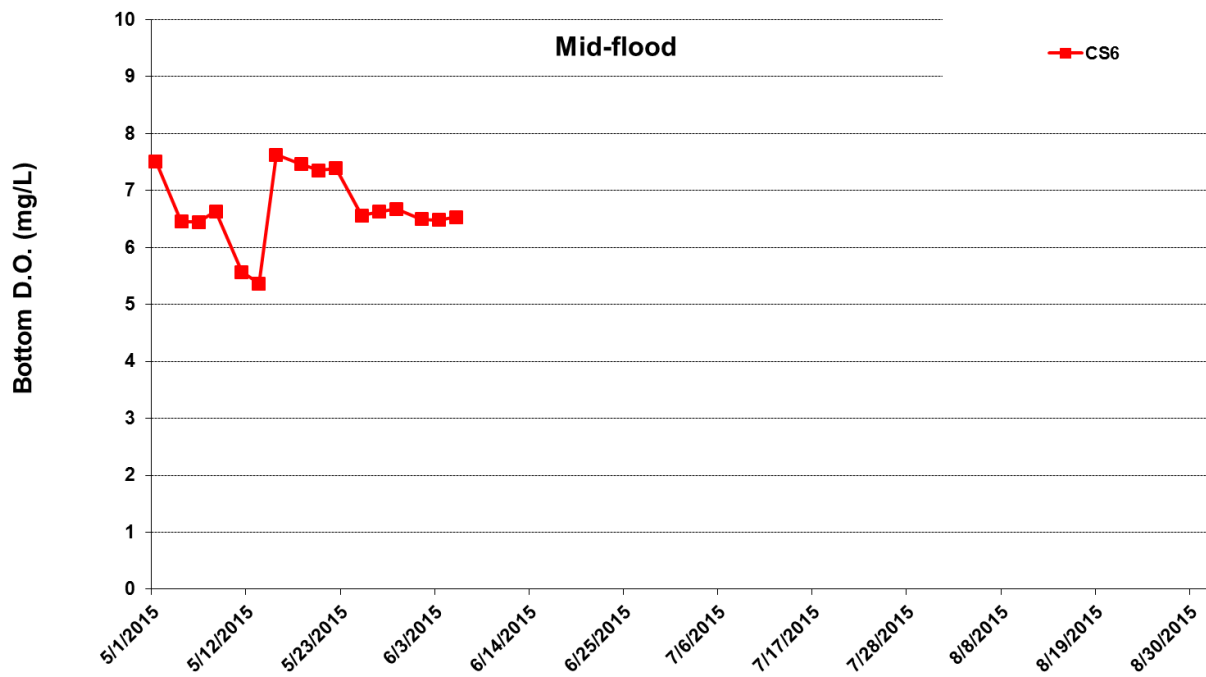
Figure G18 Impact Monitoring - Mean Level of Dissolved Oxygen (mg/L) in bottom water between 1 May 2015 and 5 June 2015 at CS6. The weather conditions during the monitoring period varied mostly from sunny to cloudy. No marine works was undertaken during the reporting period.

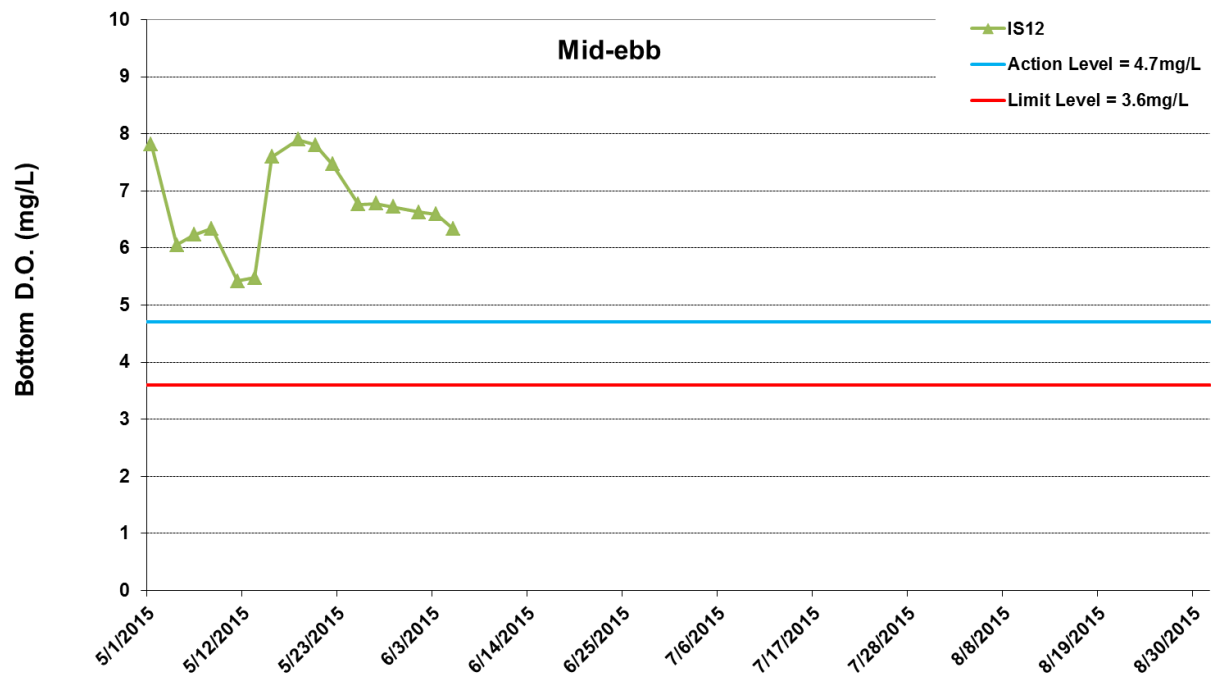
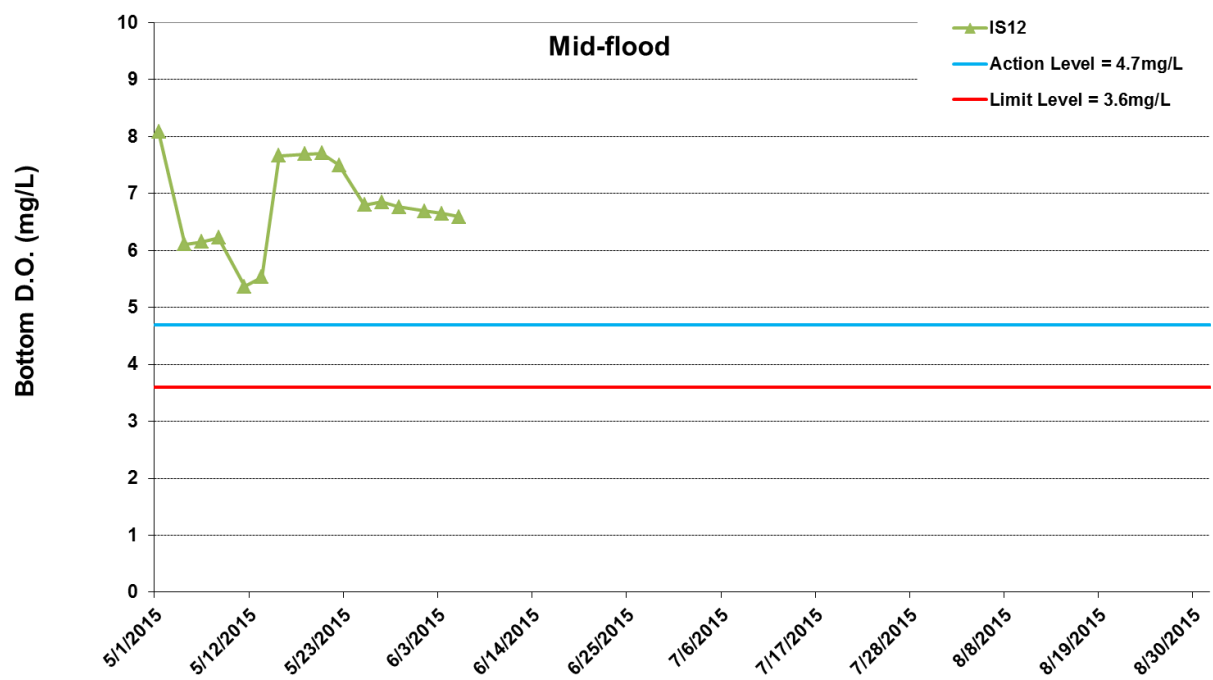
Figure G19 Impact Monitoring - Mean Level of Dissolved Oxygen (mg/L) in bottom water between 1 May 2015 and 5 June 2015 at IS12. The weather conditions during the monitoring period varied mostly from sunny to cloudy. No marine works was undertaken during the reporting period.

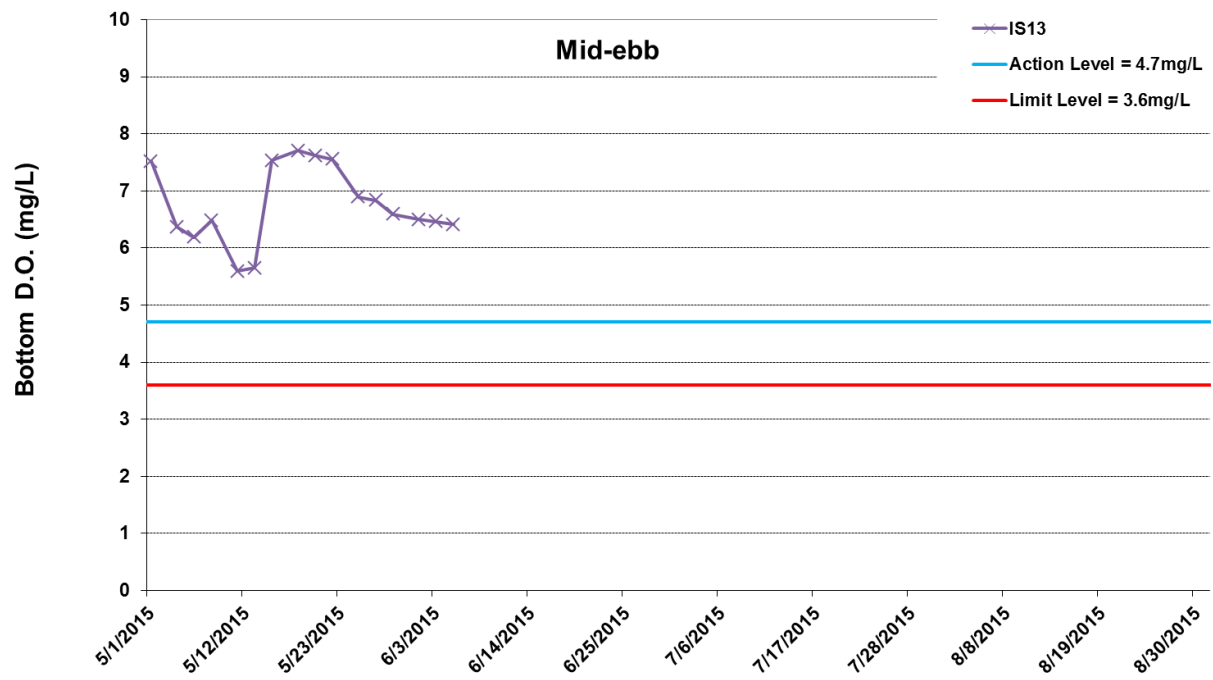
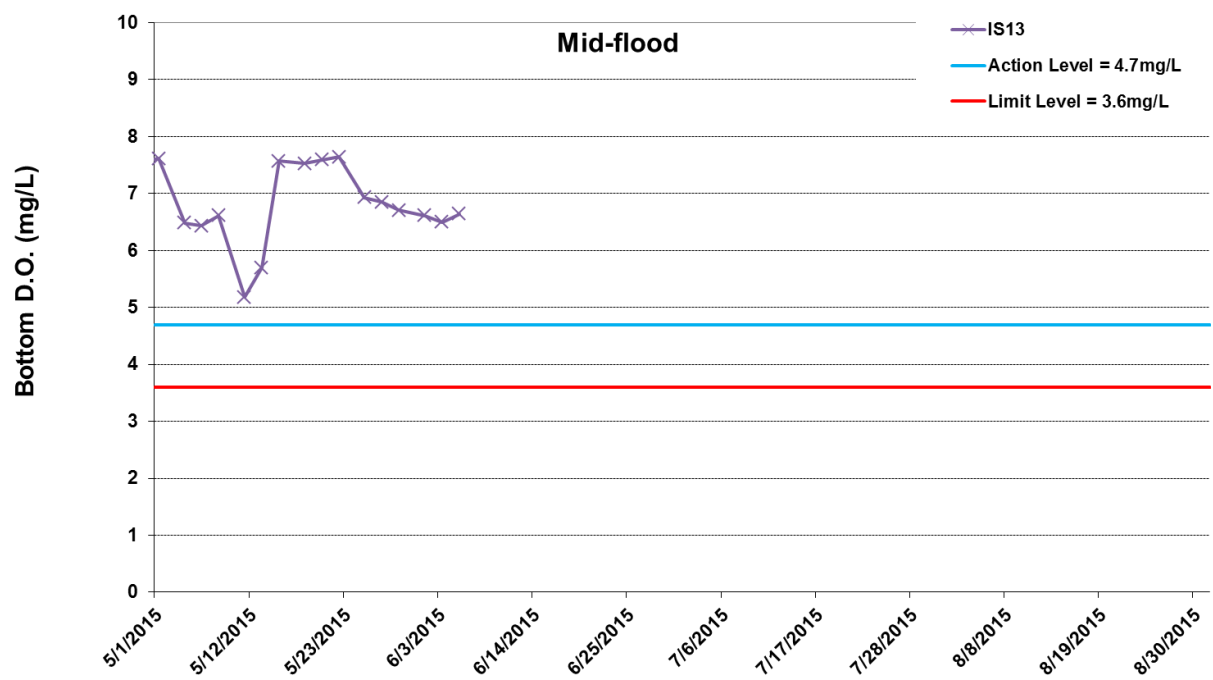
Figure G20 Impact Monitoring - Mean Level of Dissolved Oxygen (mg/L) in bottom water between 1 May 2015 and 5 June 2015 at IS13. The weather conditions during the monitoring period varied mostly from sunny to cloudy. No marine works was undertaken during the reporting period.

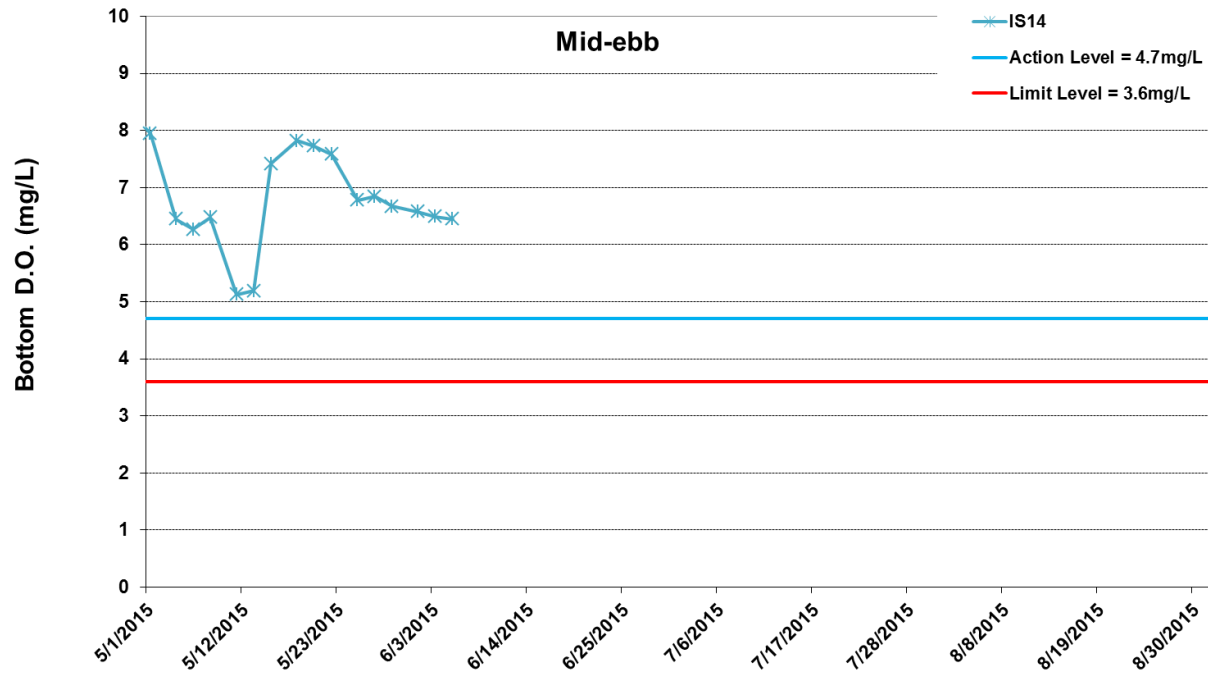
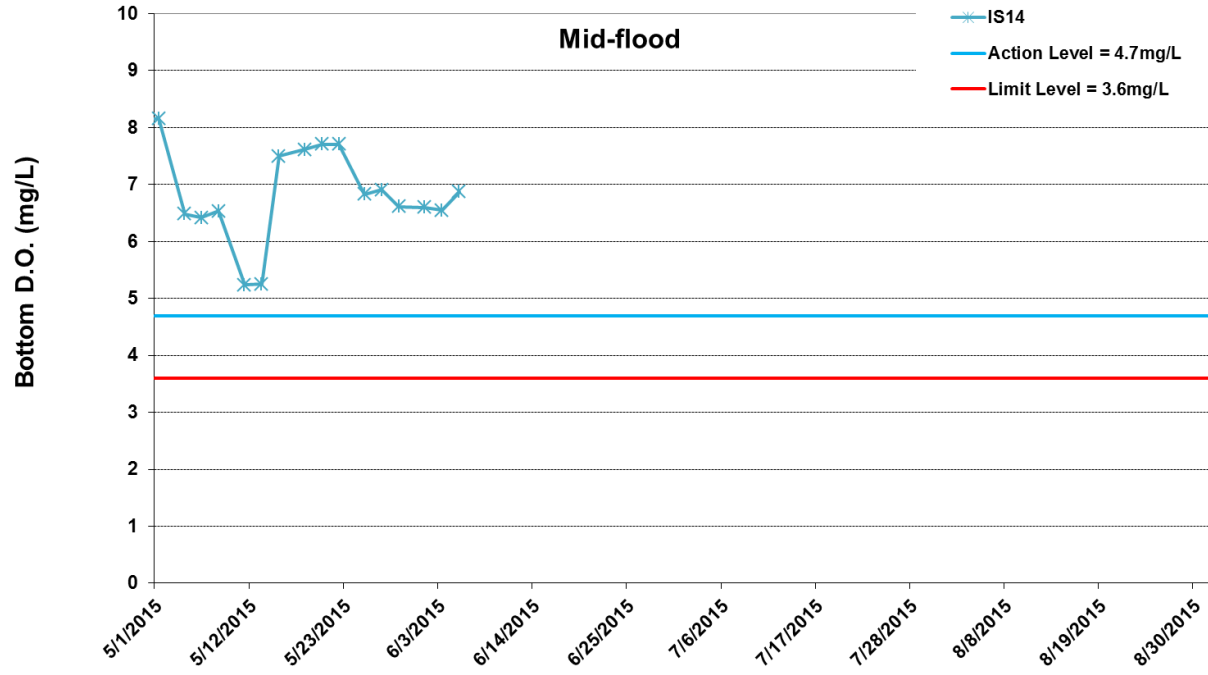
Figure G21 Impact Monitoring - Mean Level of Dissolved Oxygen (mg/L) in bottom water between 1 May 2015 and 5 June 2015 at IS14. The weather conditions during the monitoring period varied mostly from sunny to cloudy. No marine works was undertaken during the reporting period.

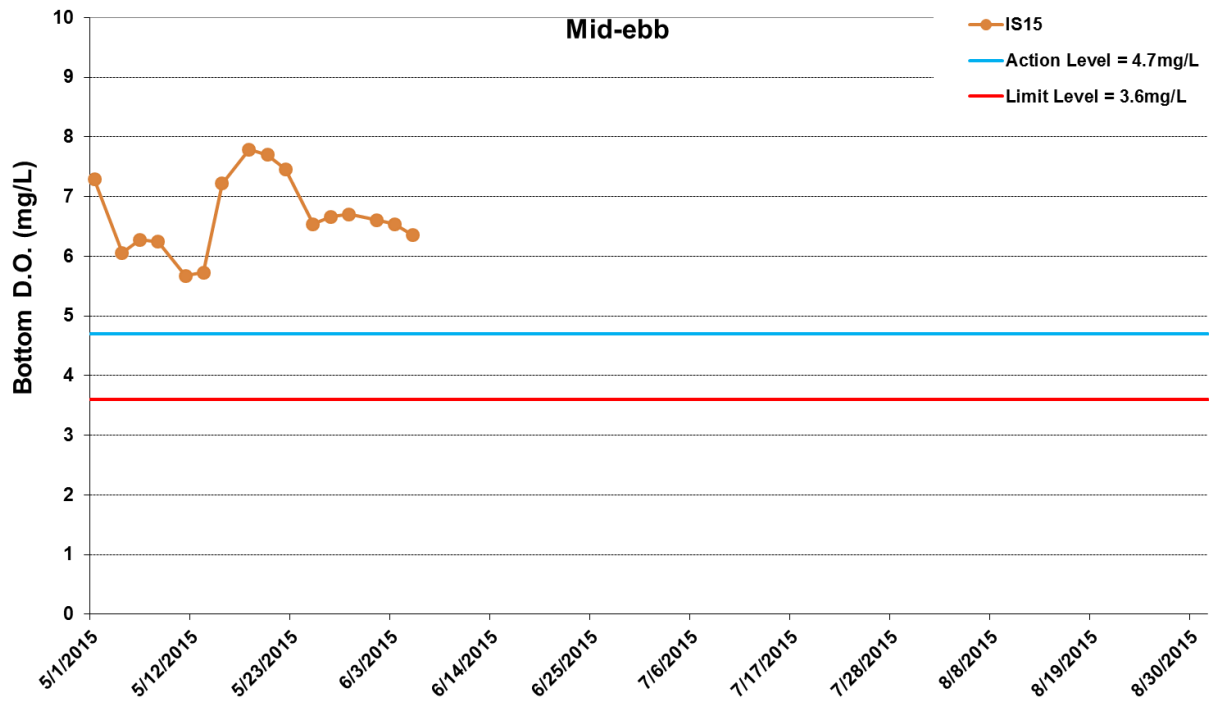
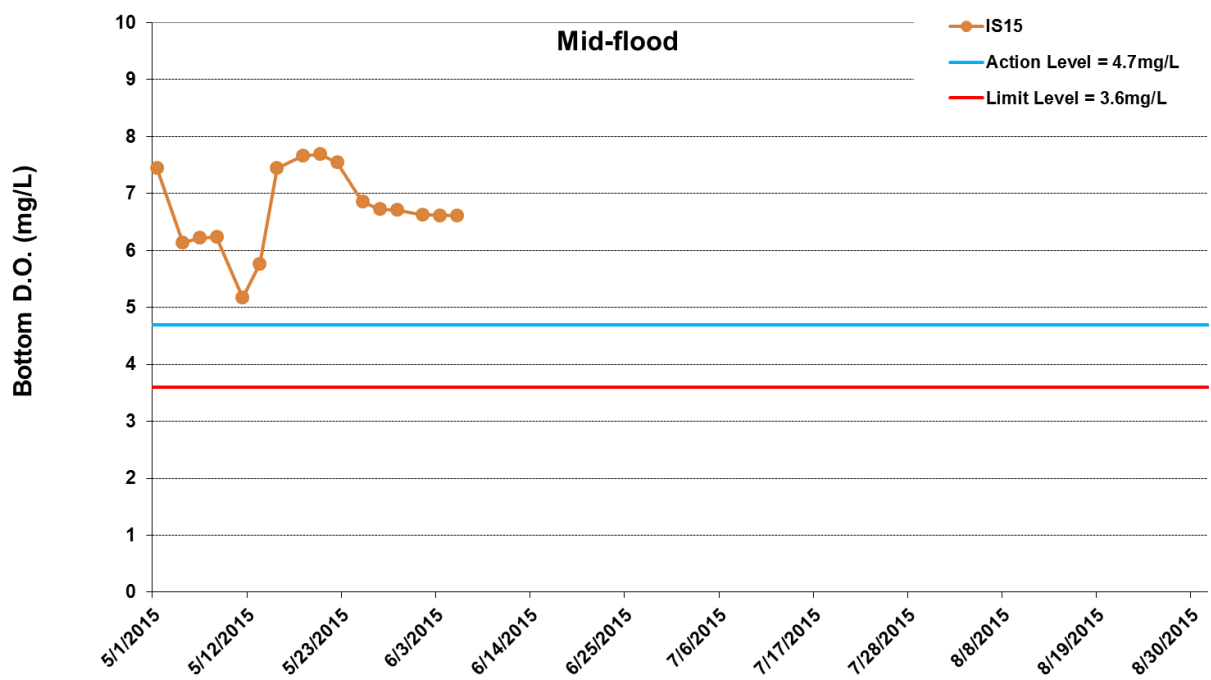
Figure G22 Impact Monitoring - Mean Level of Dissolved Oxygen (mg/L) in bottom water between 1 May 2015 and 5 June 2015 at IS15. The weather conditions during the monitoring period varied mostly from sunny to cloudy. No marine works was undertaken during the reporting period.

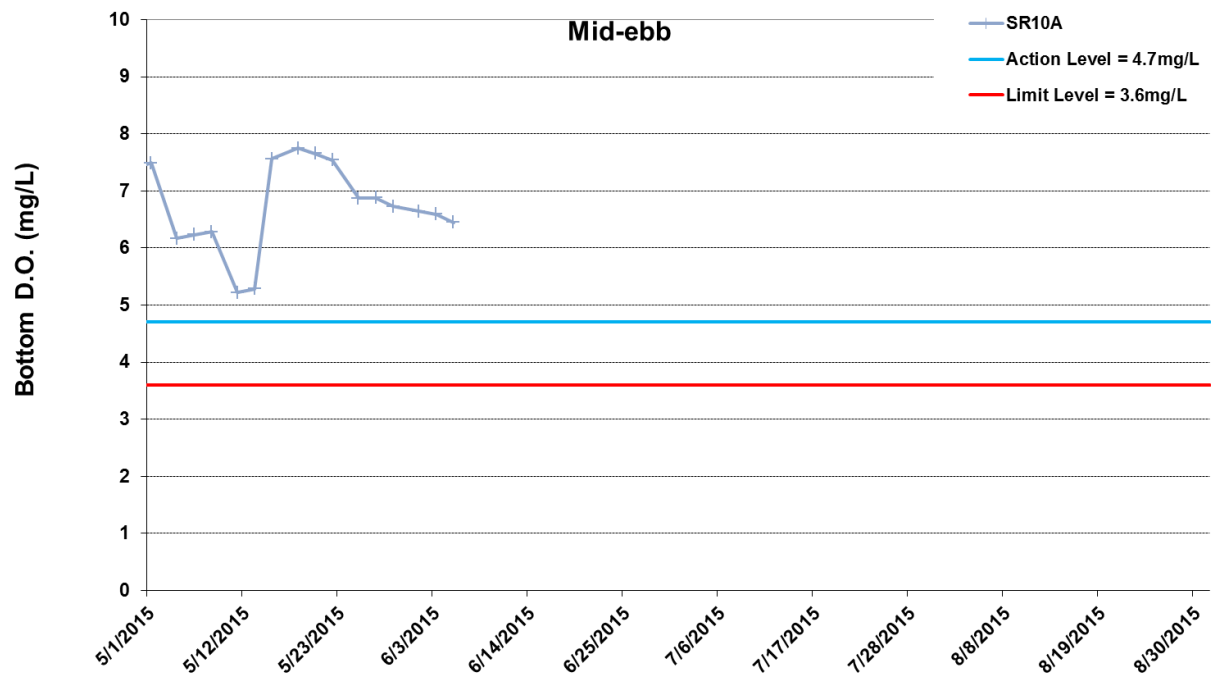
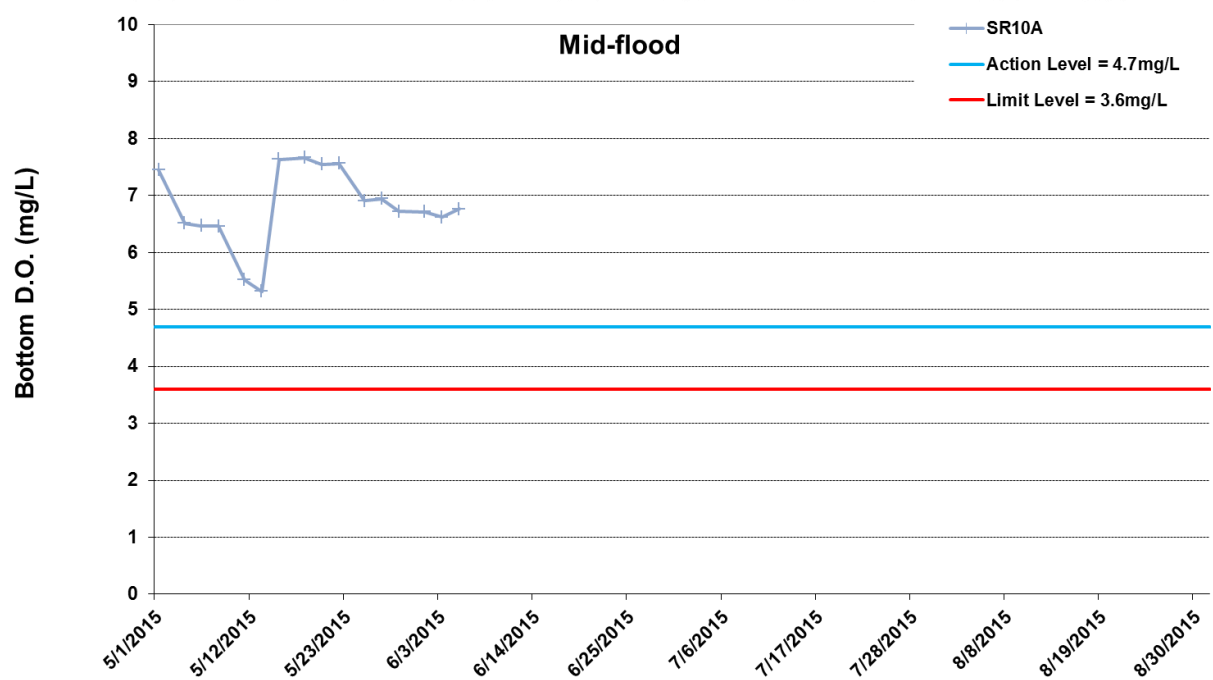
Figure G23 Impact Monitoring - Mean Level of Dissolved Oxygen (mg/L) in bottom water between 1 May 2015 and 5 June 2015 at SR10A. The weather conditions during the monitoring period varied mostly from sunny to cloudy. No marine works was undertaken during the reporting period.

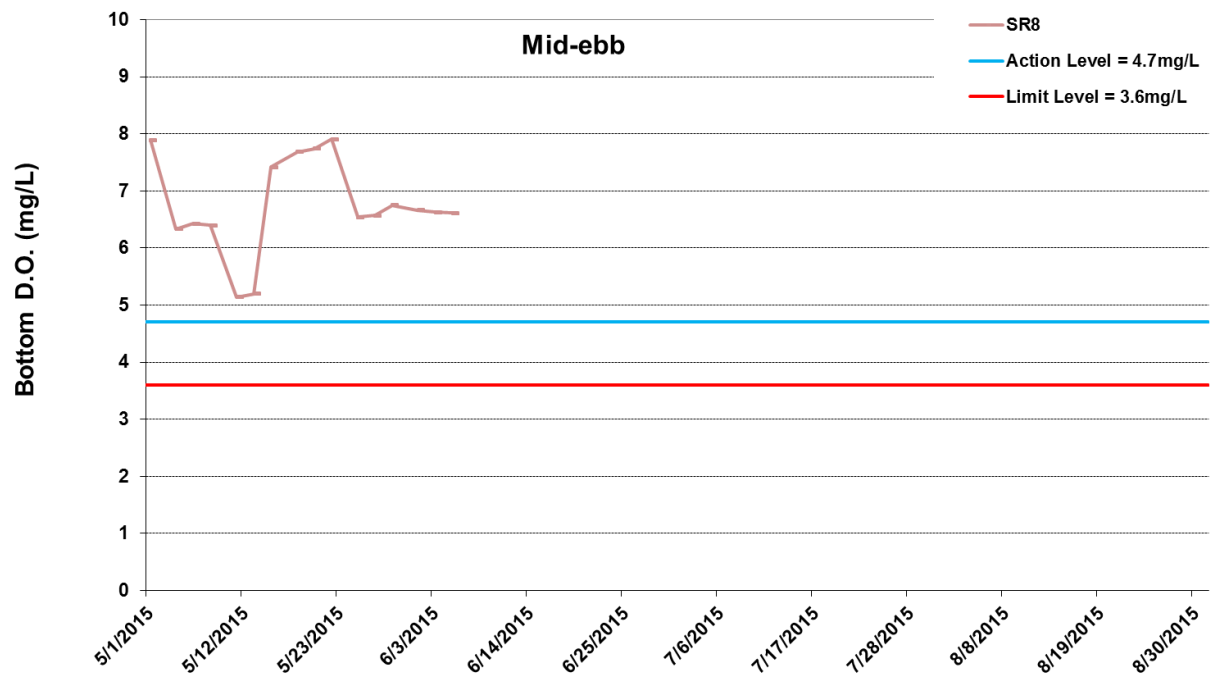
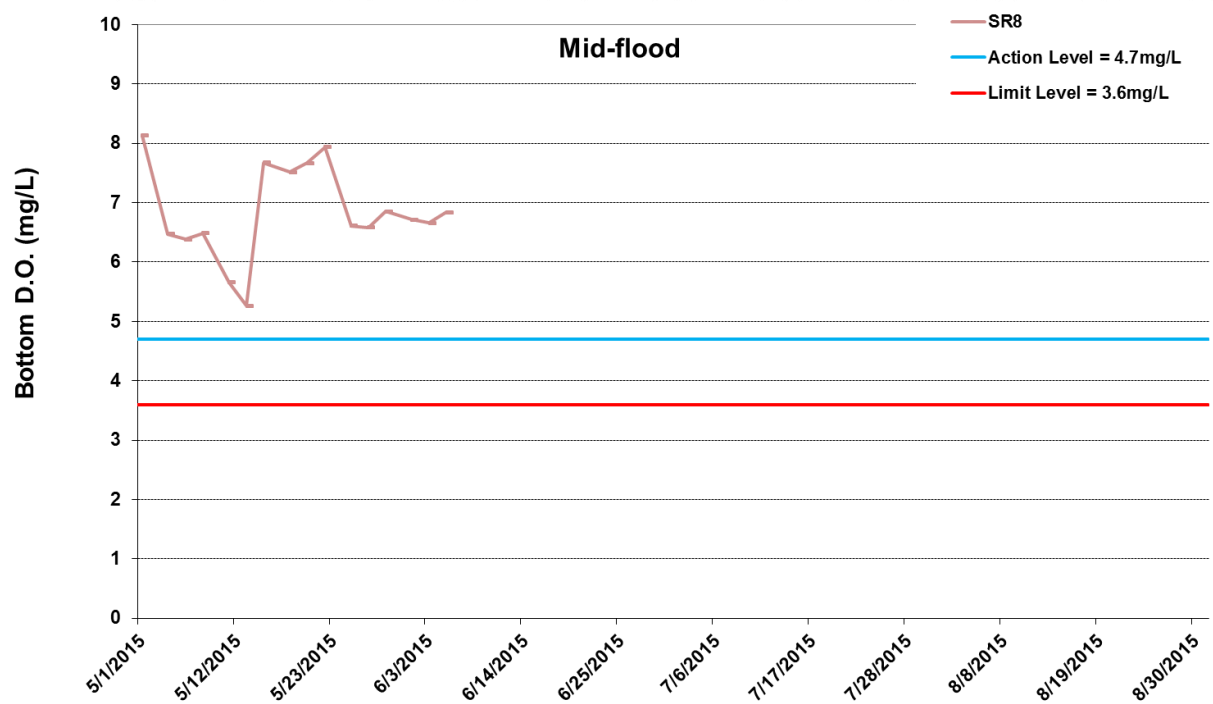
Figure G24 Impact Monitoring - Mean Level of Dissolved Oxygen (mg/L) in bottom water between 1 May 2015 and 5 June 2015 at SR8. The weather conditions during the monitoring period varied mostly from sunny to cloudy. No marine works was undertaken during the reporting period.

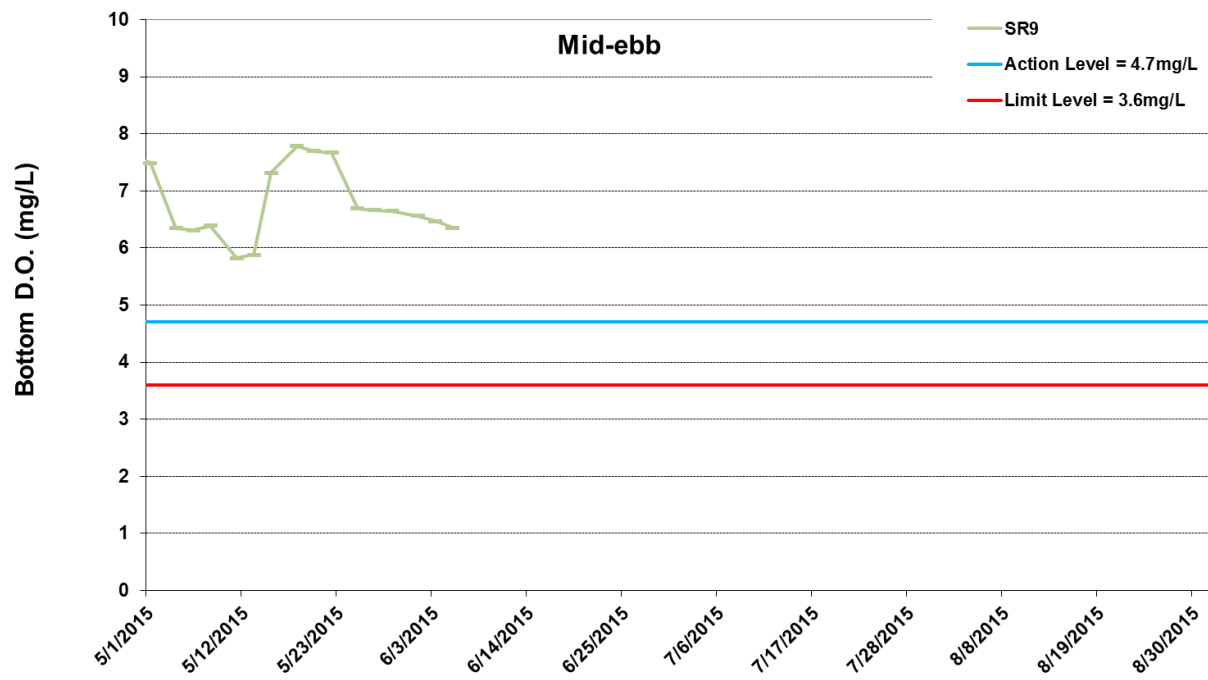
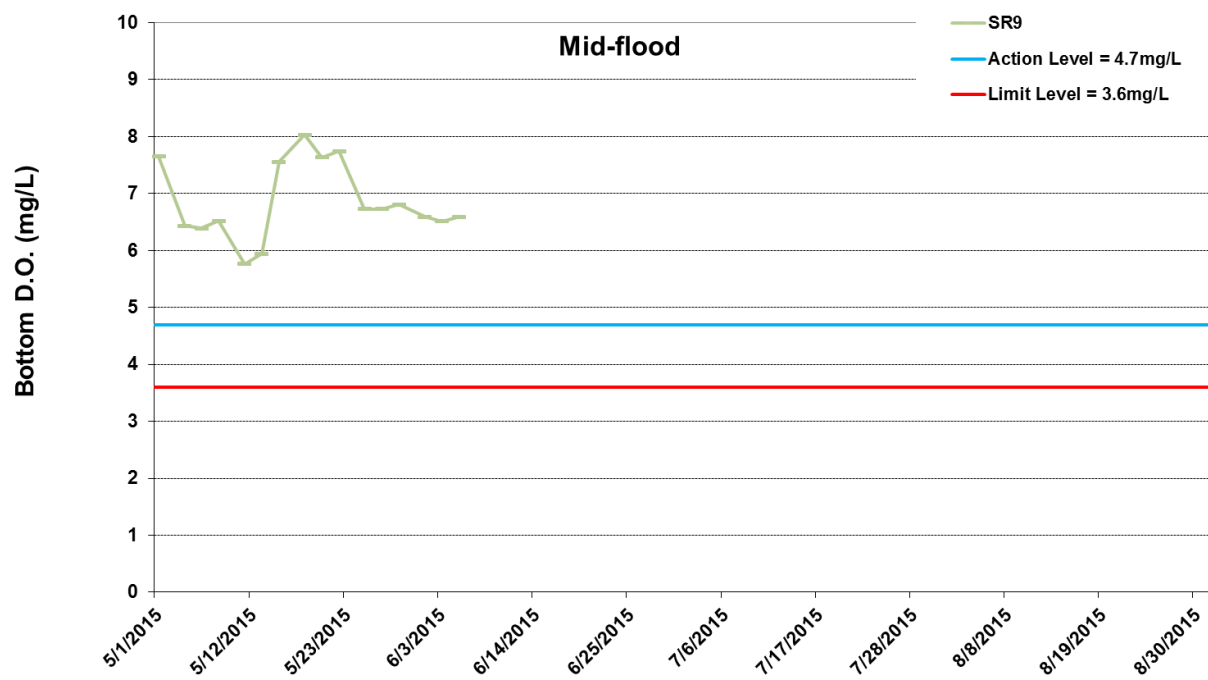
Figure G25 Impact Monitoring - Mean Level of Dissolved Oxygen (mg/L) in bottom water between 1 May 2015 and 5 June 2015 at SR9. The weather conditions during the monitoring period varied mostly from sunny to cloudy. No marine works was undertaken during the reporting period.

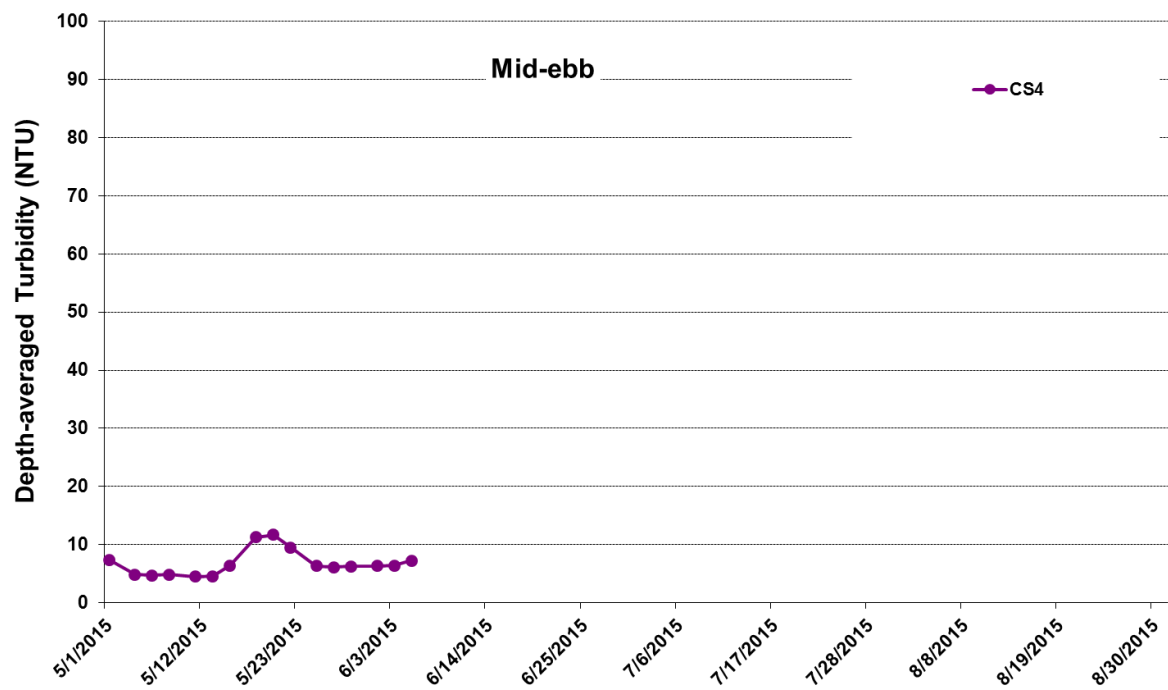
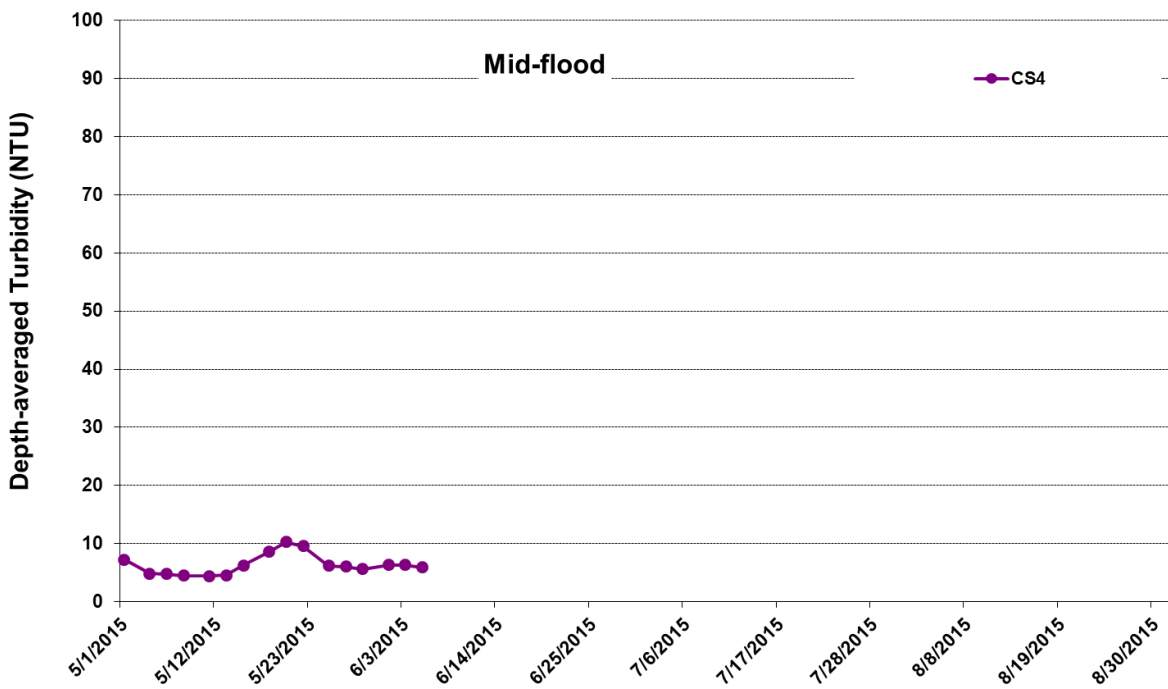
Figure G26 Impact Monitoring - Mean Depth-averaged Level of Turbidity (NTU) between 1 May 2015 and 5 June 2015 at CS4. The weather conditions during the monitoring period varied mostly from sunny to cloudy. No marine works was undertaken during the reporting period.

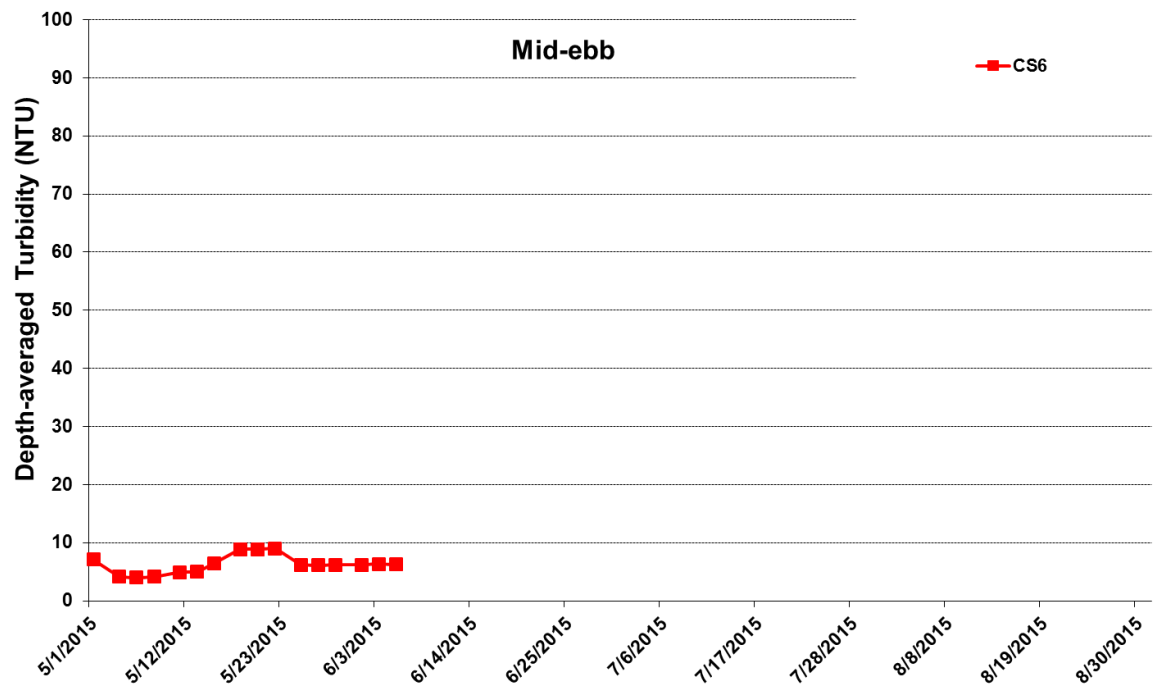
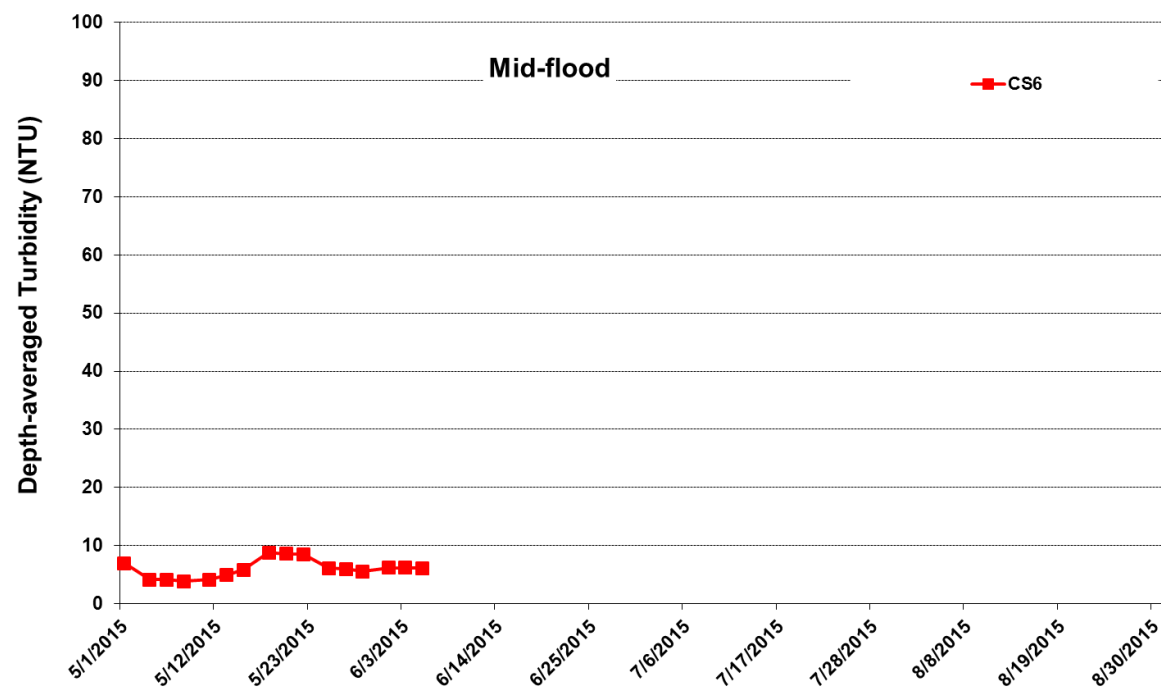
Figure G27 Impact Monitoring - Mean Depth-averaged Level of Turbidity (NTU) between 1 May 2015 and 5 June 2015 at CS6. The weather conditions during the monitoring period varied mostly from sunny to cloudy. No marine works was undertaken during the reporting period.

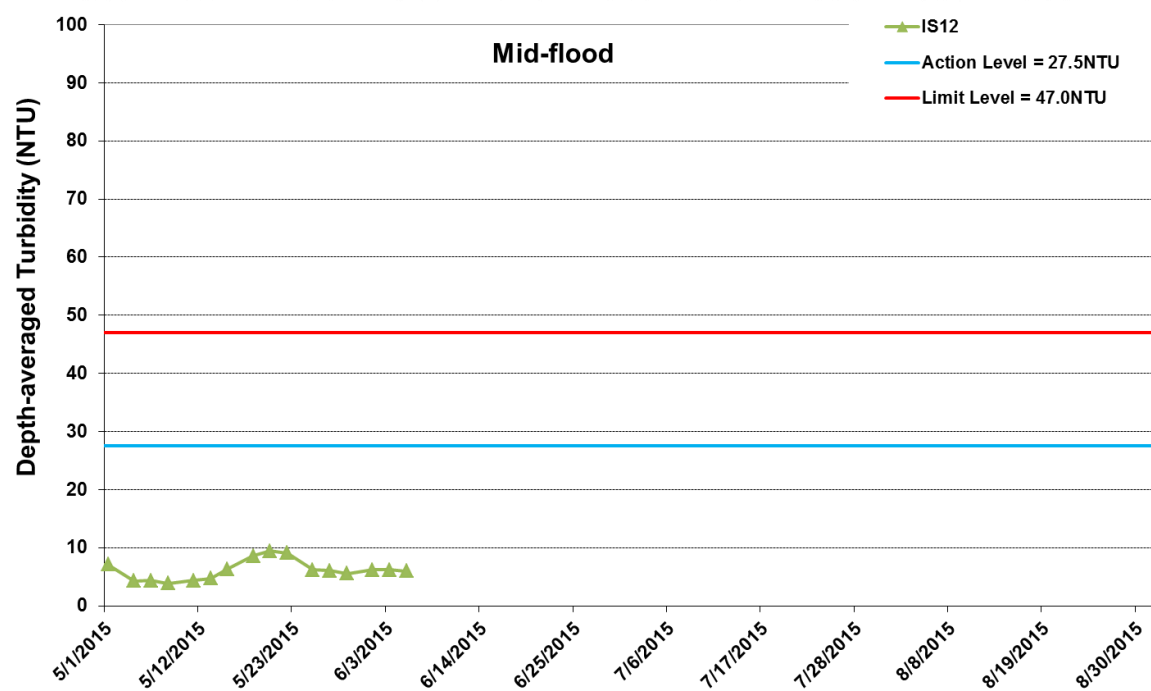
Figure G28 Impact Monitoring - Mean Depth-averaged Level of Turbidity (NTU) between 1 May 2015 and 5 June 2015 at IS12. The weather conditions during the monitoring period varied mostly from sunny to cloudy. No marine works was undertaken during the reporting period.

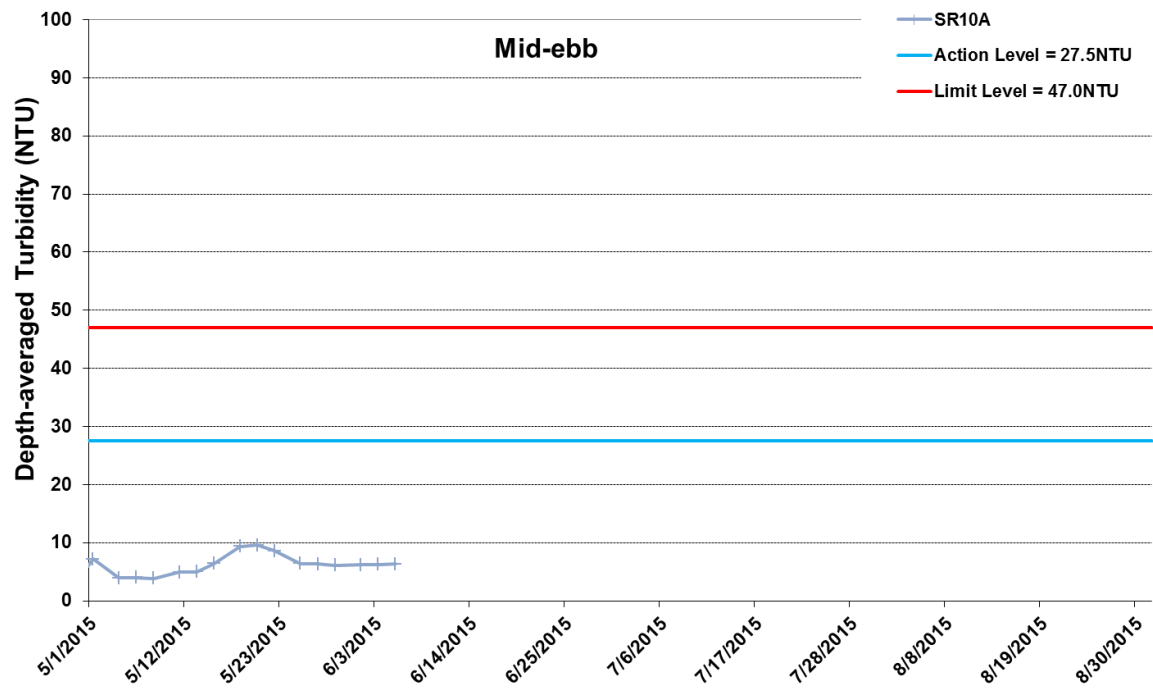
Figure G32 Impact Monitoring - Mean Depth-averaged Level of Turbidity (NTU) between 1 May 2015 and 5 June 2015 at SR10A. The weather conditions during the monitoring period varied mostly from sunny to cloudy. No marine works was undertaken during the reporting period.

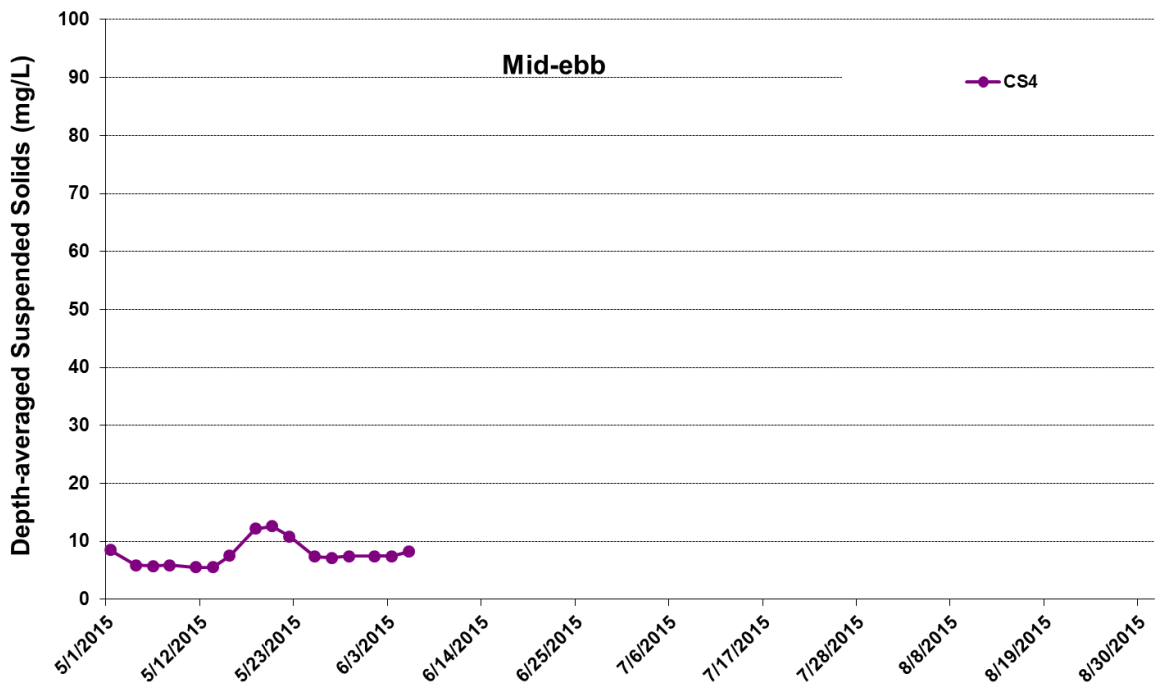
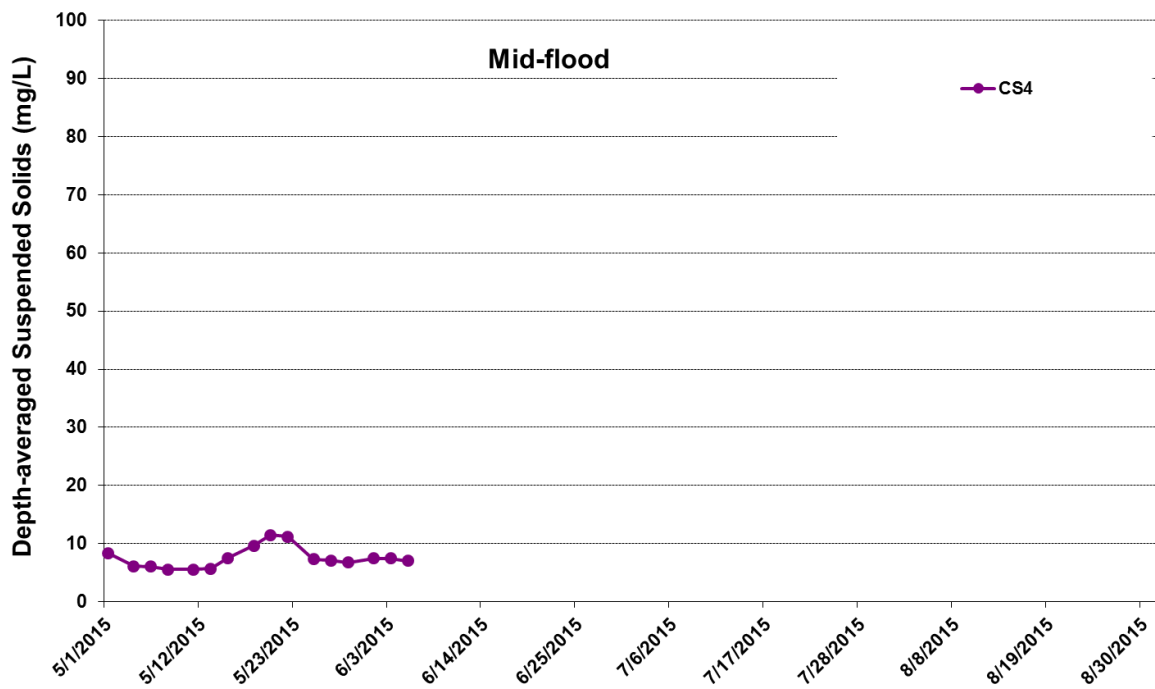
Figure G35 Impact Monitoring – Mean Depth-averaged Level of Suspended Solids (mg/L) between 1 May 2015 and 5 June 2015 at CS4. The weather conditions during the monitoring period varied mostly from sunny to cloudy. No marine works was undertaken during the reporting period.
