**Contract No. HY/2012/08  
Tuen Mun – Chek Lap Kok Link –  
Northern Connection Sub-sea Tunnel  
Section**

*Seventh Quarterly Environmental Monitoring &  
Audit (EM&A) Report*

**Contract No. HY/2012/08 TM-CLKL Northern Connection Sub-sea  
Tunnel Section  
Seventh Quarterly EM&A Report**

**Document Code: 0212330\_7th Quarterly EM&A\_20151221.doc**

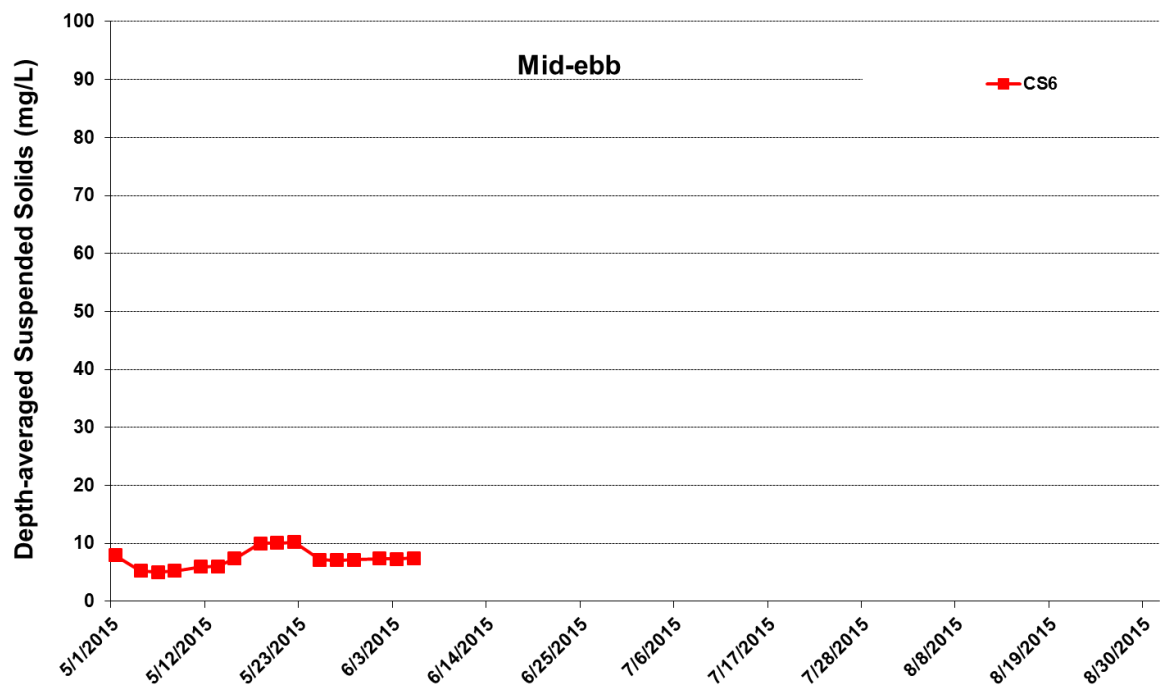
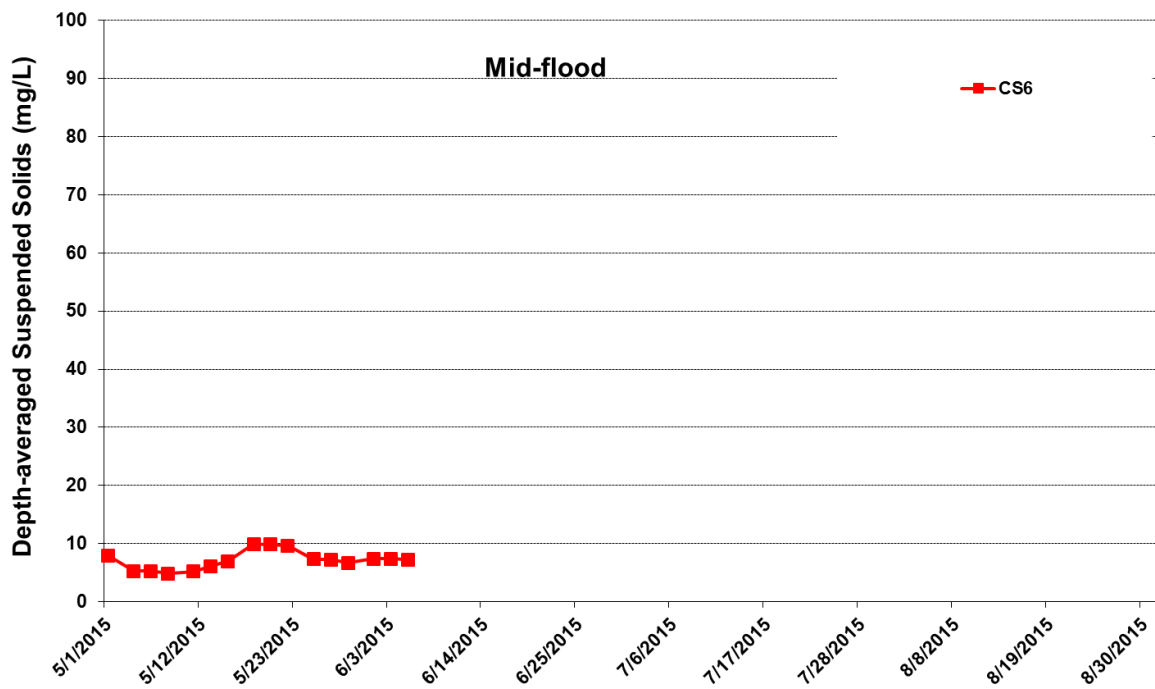
Figure G36 Impact Monitoring – Mean Depth-averaged Level of Suspended Solids (mg/L) between 1 May 2015 and 5 June 2015 at CS6. The weather conditions during the monitoring period varied mostly from sunny to cloudy. No marine works was undertaken during the reporting period.

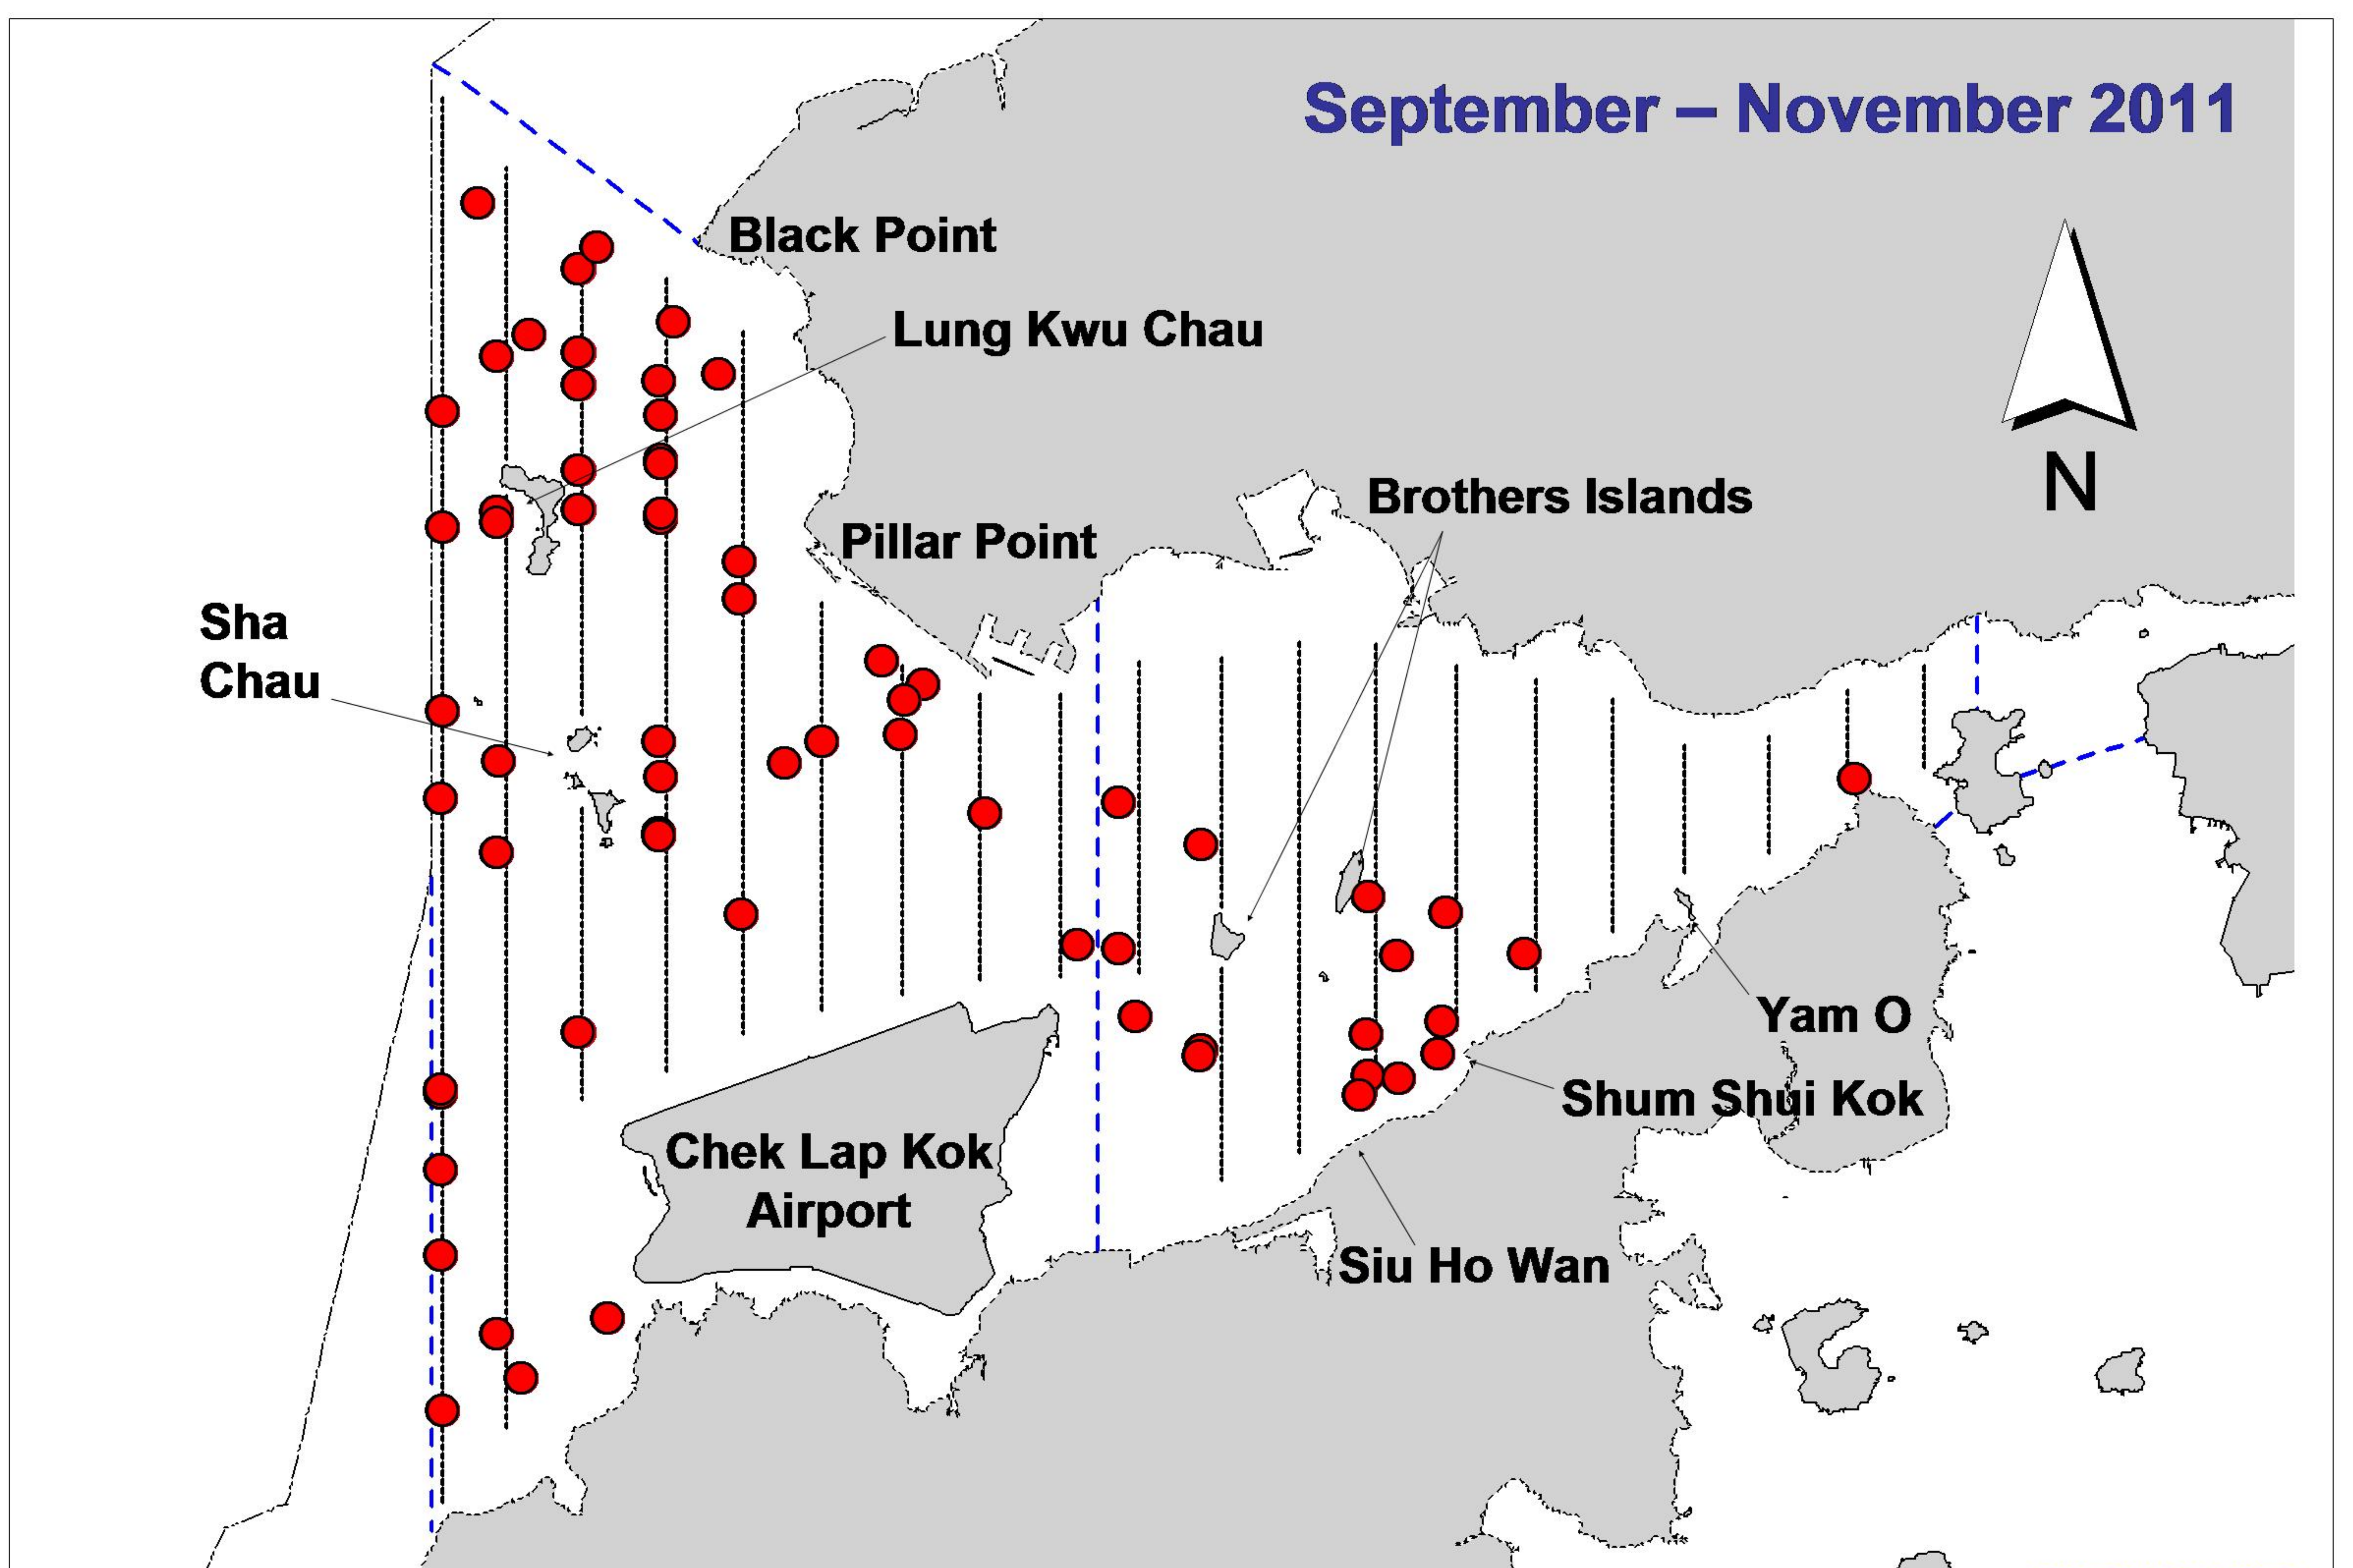
Figure 1. Distribution of Chinese white dolphin sighting in Northwest and Northeast Lantau during HKLR03 impact phase (top) and baseline monitoring surveys (bottom)
