**Contract No. HY/2012/07  
Tuen Mun – Chek Lap Kok Link –  
Southern Connection Viaduct Section**

*Fourth Annual Environmental Monitoring &  
Audit (EM&A) Report*

10 May 2018

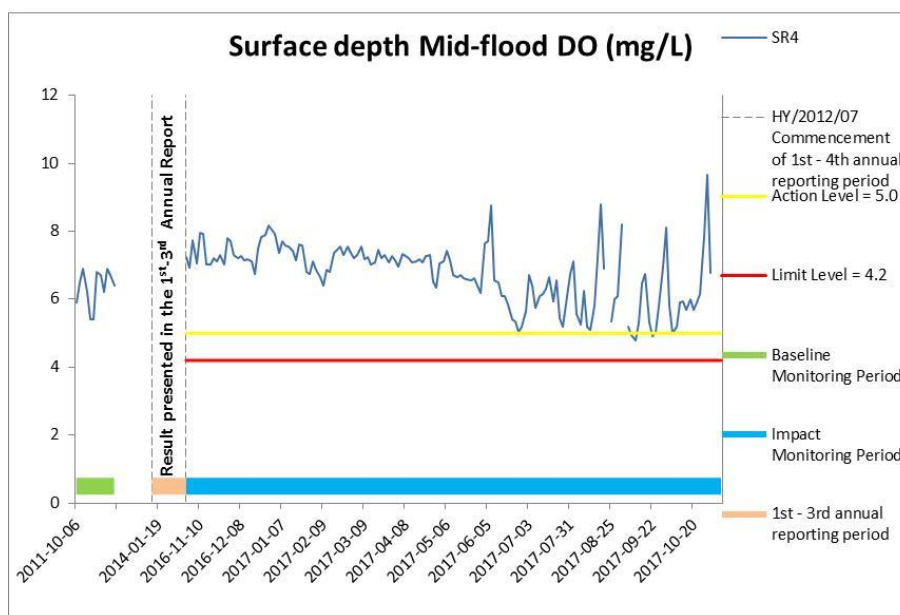
**Figure F7 Impact Monitoring – Mean Level of Dissolved Oxygen (mg/L) in surface waters during mid-flood tide between 1 November 2016 and 31 October 2017 at IS8 and SR4/SR4(N).**

*(Weather condition varied between sunny to rainy within the reporting period.) Overall monitoring results were not affected by weather conditions. Marine works in the reporting period include Uninstallation of marine piling platform; Pier construction; Launching gantry operation; Installation of deck segment and pier head segment; and Construction of underslung truss scheme (no additional seabed will be occupied other than those assumed in the approved EIA Report). Results of WQM between 1 June 2017 and 31 July 2017 are sourced from the published EM&A data and published EM&A reports of Contract No. HY/2010/02 Hong Kong-Zhuhai-Macao Bridge Hong Kong Boundary Crossing Facilities – Reclamation Works. In-situ monitoring is taken according to the requirement specified in the EM&A Manual, i.e. 3 water depth namely 1m below sea surface, mid-depth and 1m above sea bed. If the water depth is less than 3m, mid-depth sampling only. If water depth less than 6m, mid-depth may be omitted. WQM on 28 January 2017, 31 January 2017 and 4 April 2017 were cancelled due to suspension of marine works during holiday, as well as WQM on 23 August 2017 and 4 September 2017 were cancelled due to adverse weather.)*

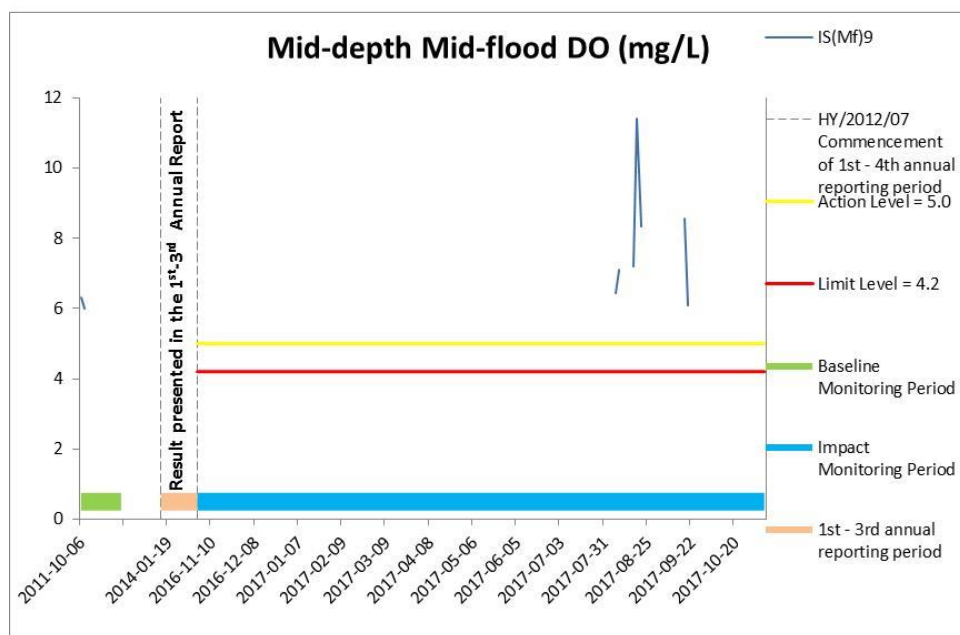
**Figure F12 Impact Monitoring – Mean Level of Dissolved Oxygen (mg/L) in mid-depth waters during mid-flood tide between 1 November 2016 and 31 October 2017 at IS(Mf)16 and IS(Mf)9.**

*(Weather condition varied between sunny to rainy within the reporting period.) Overall monitoring results were not affected by weather conditions. Marine works in the reporting period include Uninstallation of marine piling platform; Pier construction; Launching gantry operation; Installation of deck segment and pier head segment; and Construction of underslung truss scheme (no additional seabed will be occupied other than those assumed in the approved EIA Report). Results of WQM between 1 June 2017 and 31 July 2017 are sourced from the published EM&A data and published EM&A reports of Contract No. HY/2010/02 Hong Kong-Zhuhai-Macao Bridge Hong Kong Boundary Crossing Facilities – Reclamation Works. In-situ monitoring is taken according to the requirement specified in the EM&A Manual, i.e. 3 water depth namely 1m below sea surface, mid-depth and 1m above sea bed. If the water depth is less than 3m, mid-depth sampling only. If water depth less than 6m, mid-depth may be omitted. WQM on 28 January 2017, 31 January 2017 and 4 April 2017 were cancelled due to suspension of marine works during holiday, as well as WQM on 23 August 2017 and 4 September 2017 were cancelled due to adverse weather.)*
