**Contract No. HY/2012/08
Tuen Mun – Chek Lap Kok Link –
Northern Connection Sub-sea Tunnel
Section**

***Eighth Annual Environmental Monitoring & Audit
(EM&A) Report***

14 December 2021

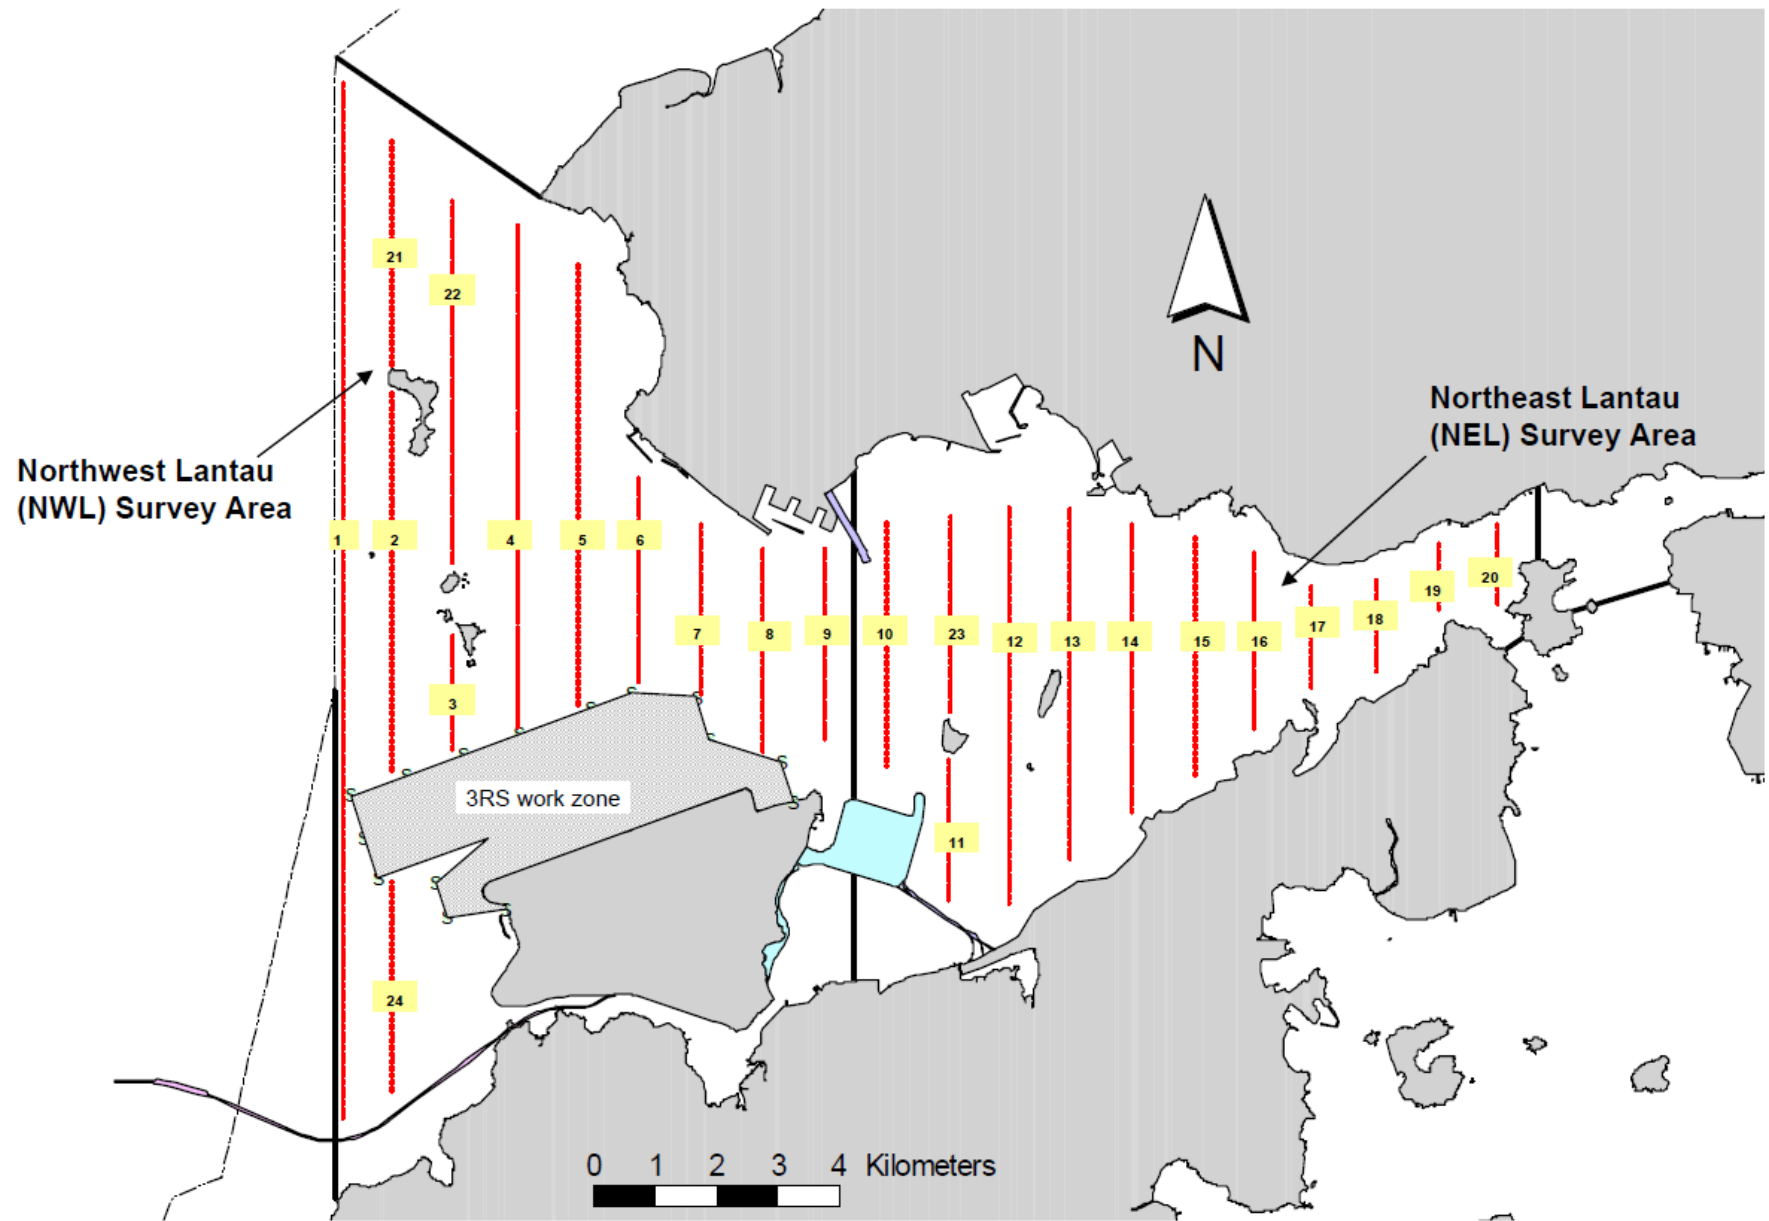
Figure 2.3

Layout of Transect Lines of Dolphin Monitoring in Northwest and Northeast Lantau Areas

The impact and operational phase dolphin monitoring were carried out in the NEL and NWL along the line transect as depicted in Figure 2.3. The coordinates of all transect lines are shown in Table 2.10 below.

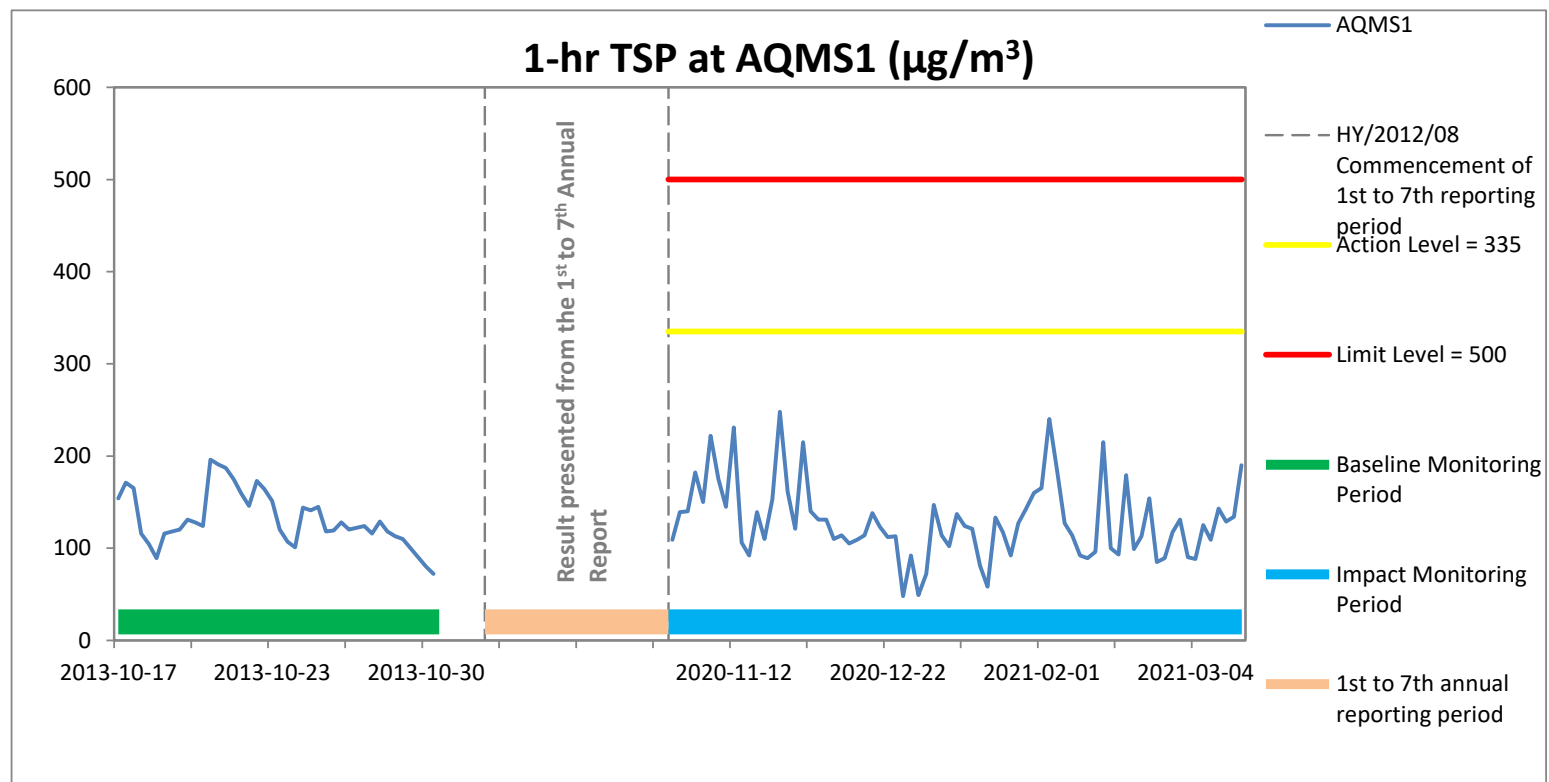
Figure D.1 Baseline & Impact Monitoring - 1-hour Total Suspended Particulates ($\mu\text{g}/\text{m}^3$) at AQMS1 between 17 October 2013 and 19 March 2021 during Baseline & Impact Monitoring period. Weather condition within the reporting period varied between sunny to rainy. The overall monitoring results were not affected by weather conditions. Major land-based construction activities included: Installation of green roof system & chain fence - South Ventilation Building; Defect works for reinstatement at Box culvert - Northern Landfall; and Demolition works and backfilling works of CLP substation.

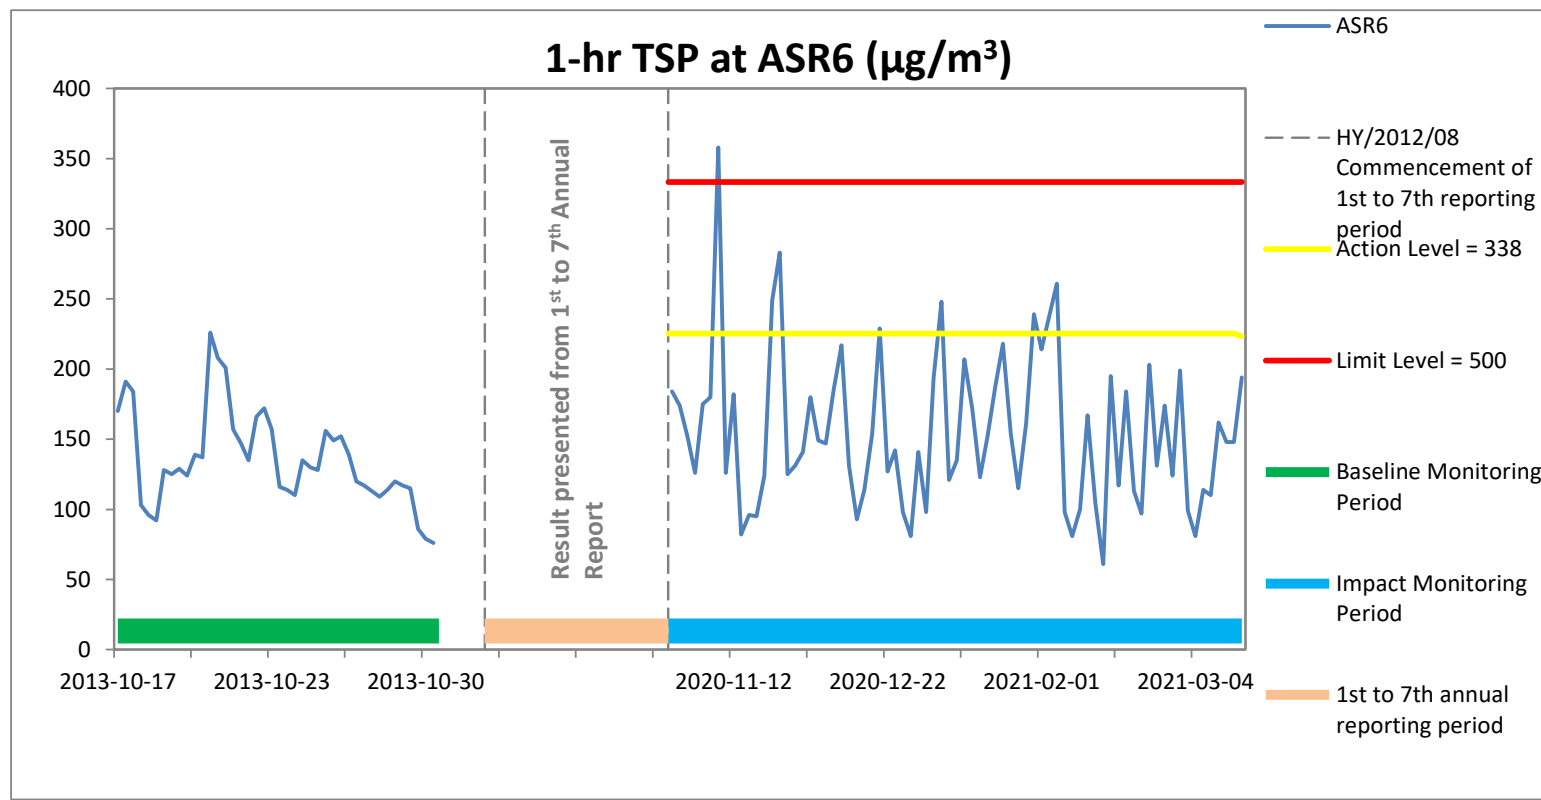
Figure D.2 Baseline & Impact Monitoring - 1-hour Total Suspended Particulates ($\mu\text{g}/\text{m}^3$) at ASR6 between 17 October 2013 and 19 March 2021 during Baseline & Impact Monitoring period. Weather condition within the reporting period varied between sunny to rainy. The overall monitoring results were not affected by weather conditions. Major land-based construction activities included: Installation of green roof system & chain fence - South Ventilation Building; Defect works for reinstatement at Box culvert - Northern Landfall; and Demolition works and backfilling works of CLP substation.

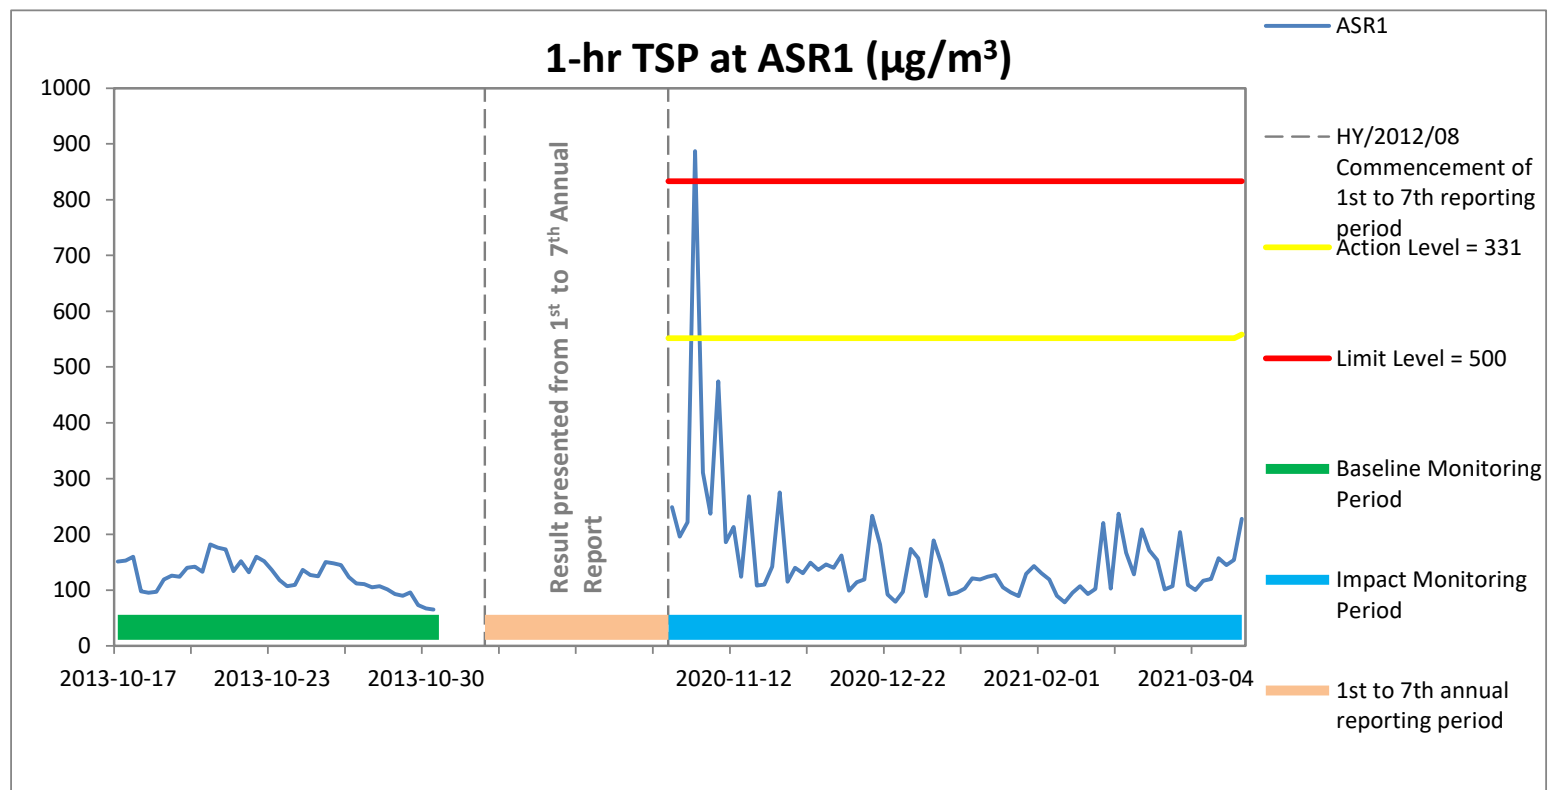
Figure D.3 Baseline & Impact Monitoring - 1-hour Total Suspended Particulates ($\mu\text{g}/\text{m}^3$) at ASR1 between 17 October 2013 and 19 March 2021 during Baseline & Impact Monitoring period. Weather condition within the reporting period varied between sunny to rainy. The overall monitoring results were not affected by weather conditions. Major land-based construction activities included: Installation of green roof system & chain fence - South Ventilation Building; Defect works for reinstatement at Box culvert - Northern Landfall; and Demolition works and backfilling works of CLP substation.

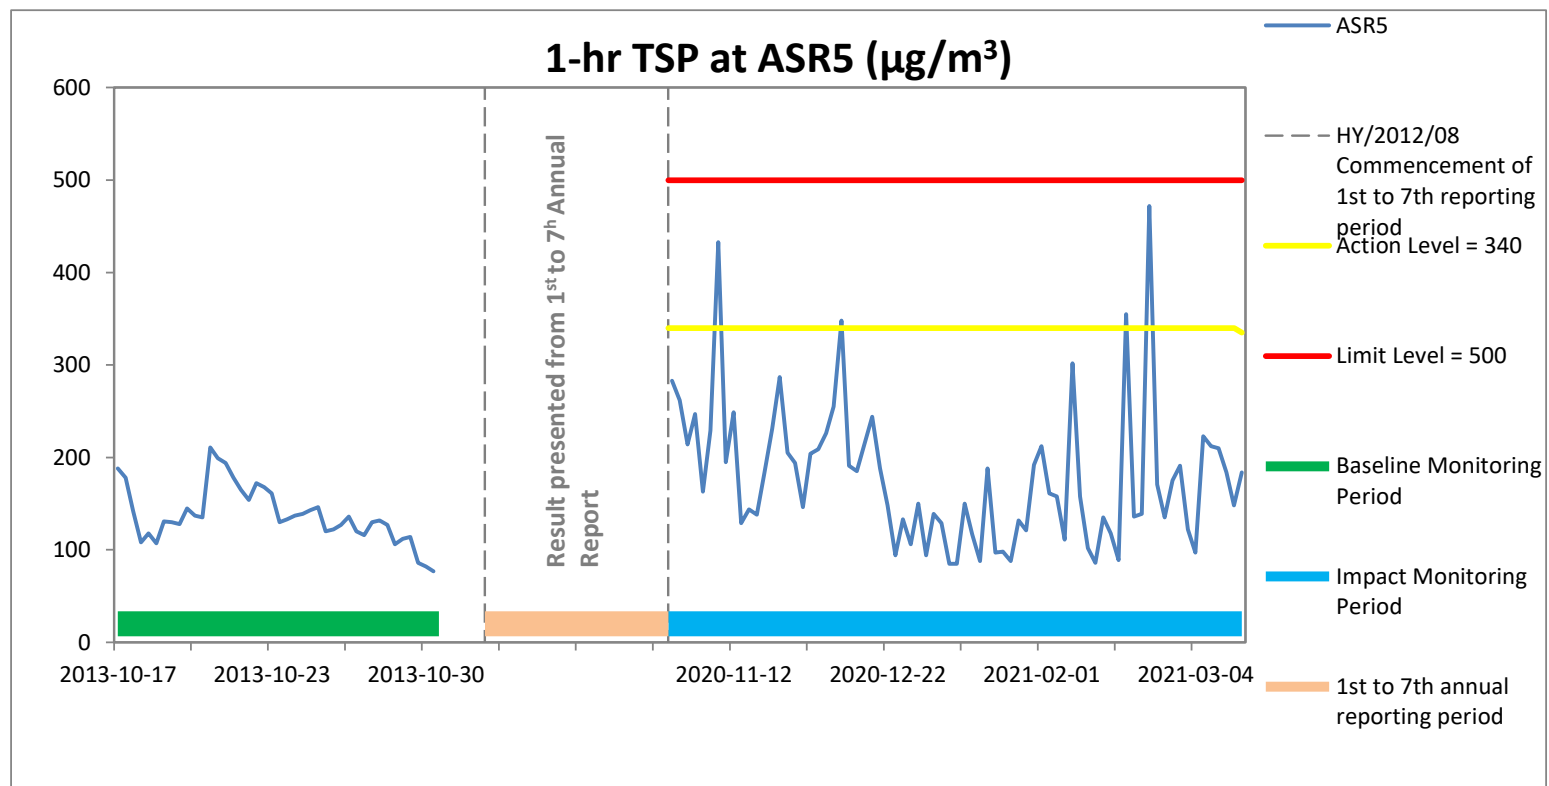
Figure D.4 Baseline & Impact Monitoring - 1-hour Total Suspended Particulates ($\mu\text{g}/\text{m}^3$) at ASR5 between 17 October 2013 and 19 March 2021 during Baseline & Impact Monitoring period. Weather condition within the reporting period varied between sunny to rainy. The overall monitoring results were not affected by weather conditions. Major land-based construction activities included: Installation of green roof system & chain fence - South Ventilation Building; Defect works for reinstatement at Box culvert - Northern Landfall; and Demolition works and backfilling works of CLP substation.

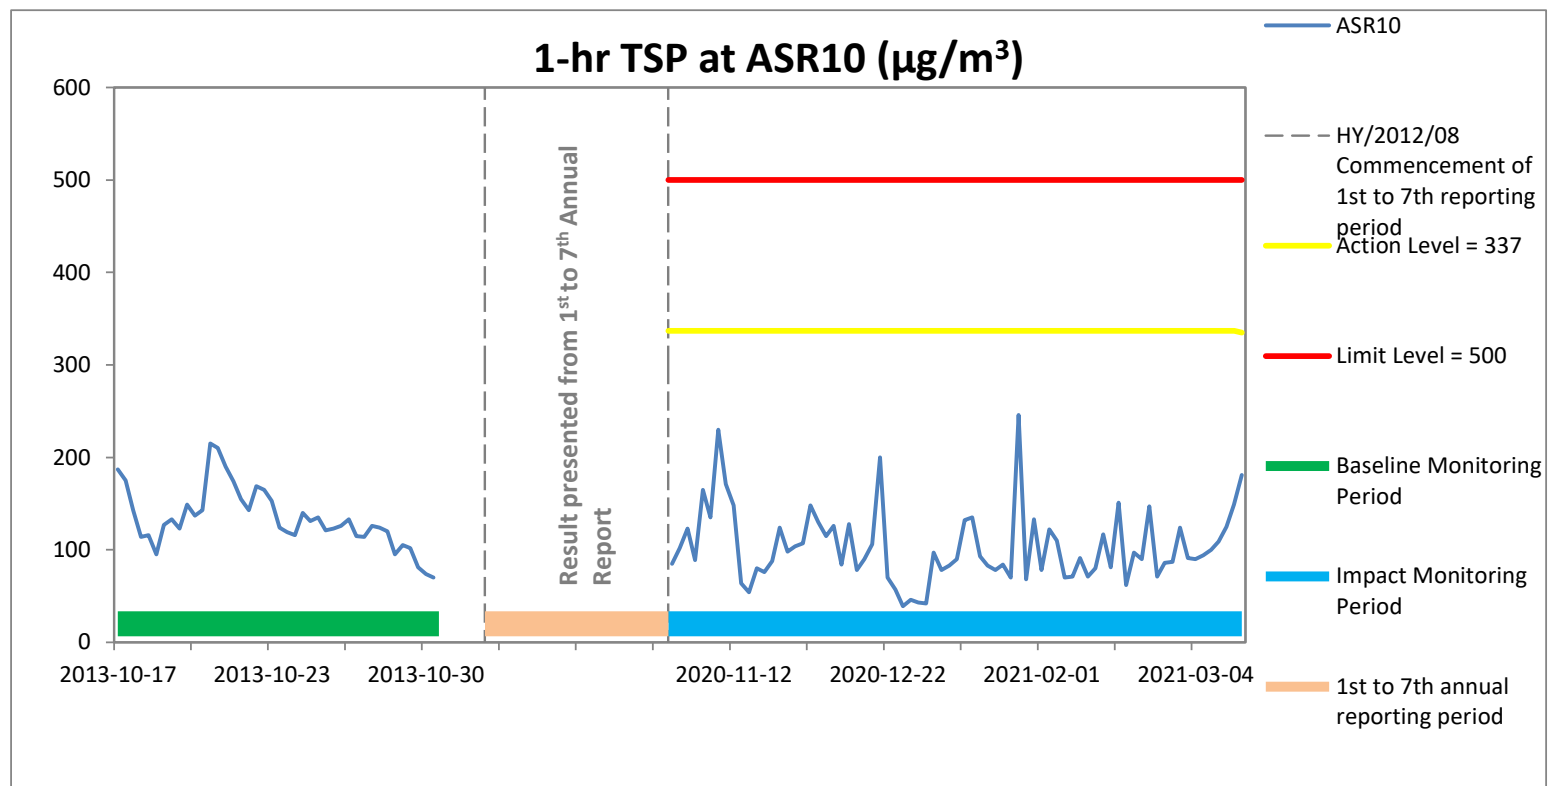
Figure D.5 Baseline & Impact Monitoring - 1-hour Total Suspended Particulates ($\mu\text{g}/\text{m}^3$) at ASR10 between 17 October 2013 and 19 March 2021 during Baseline & Impact Monitoring period. Weather condition within the reporting period varied between sunny to rainy. The overall monitoring results were not affected by weather conditions. Major land-based construction activities included: Installation of green roof system & chain fence - South Ventilation Building; Defect works for reinstatement at Box culvert - Northern Landfall; and Demolition works and backfilling works of CLP substation.

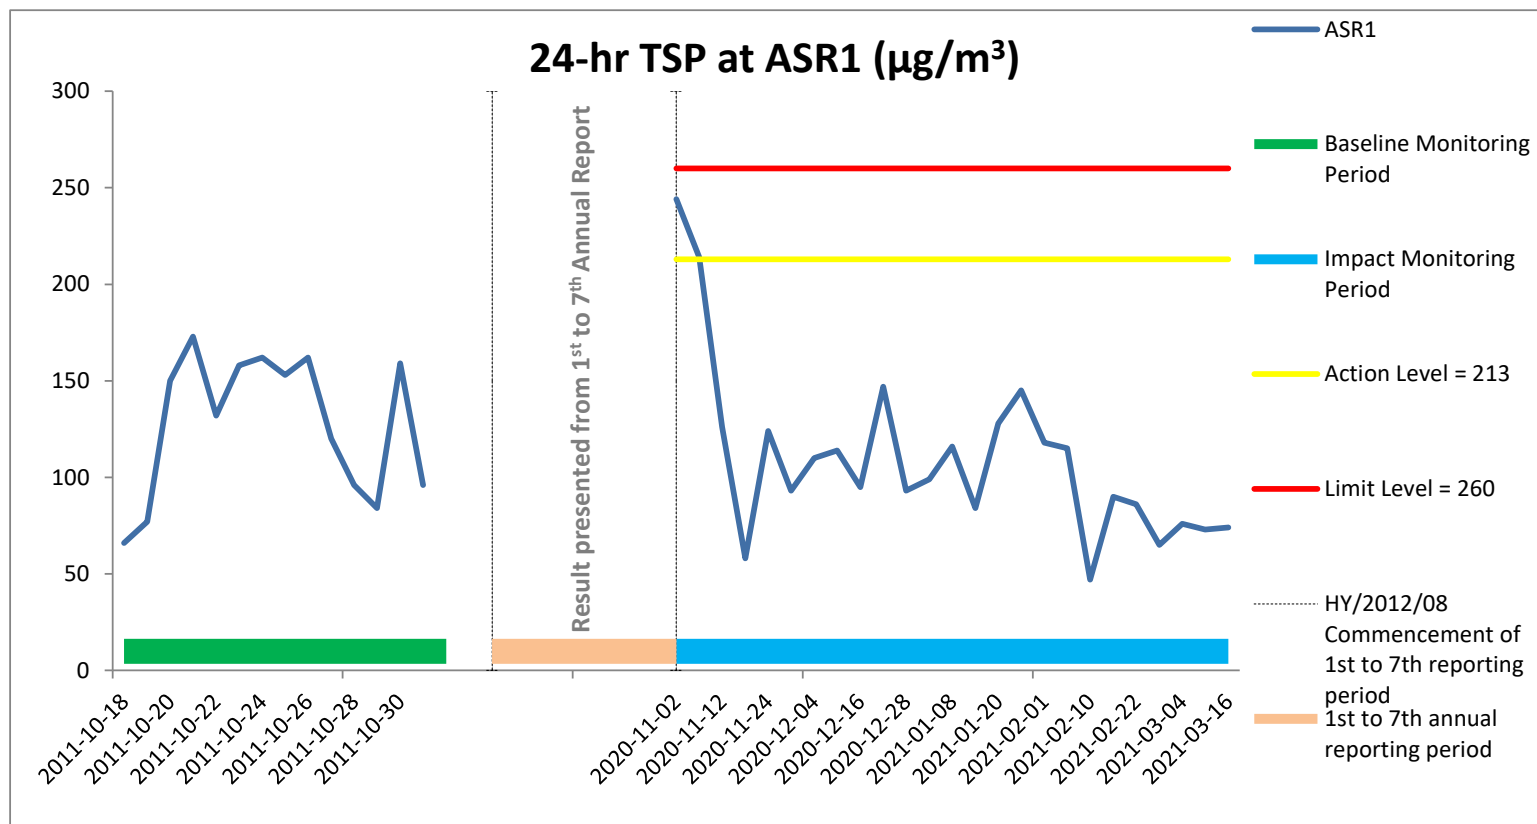
Figure D.6 Baseline & Impact Monitoring - 24-hour Total Suspended Particulates ($\mu\text{g}/\text{m}^3$) at ASR1 between 17 October 2013 and 19 March 2021 during Baseline & Impact Monitoring period. Weather condition within the reporting period varied between sunny to rainy. The overall monitoring results were not affected by weather conditions. Major land-based construction activities included: Installation of green roof system & chain fence - South Ventilation Building; Defect works for reinstatement at Box culvert - Northern Landfall; and Demolition works and backfilling works of CLP substation.

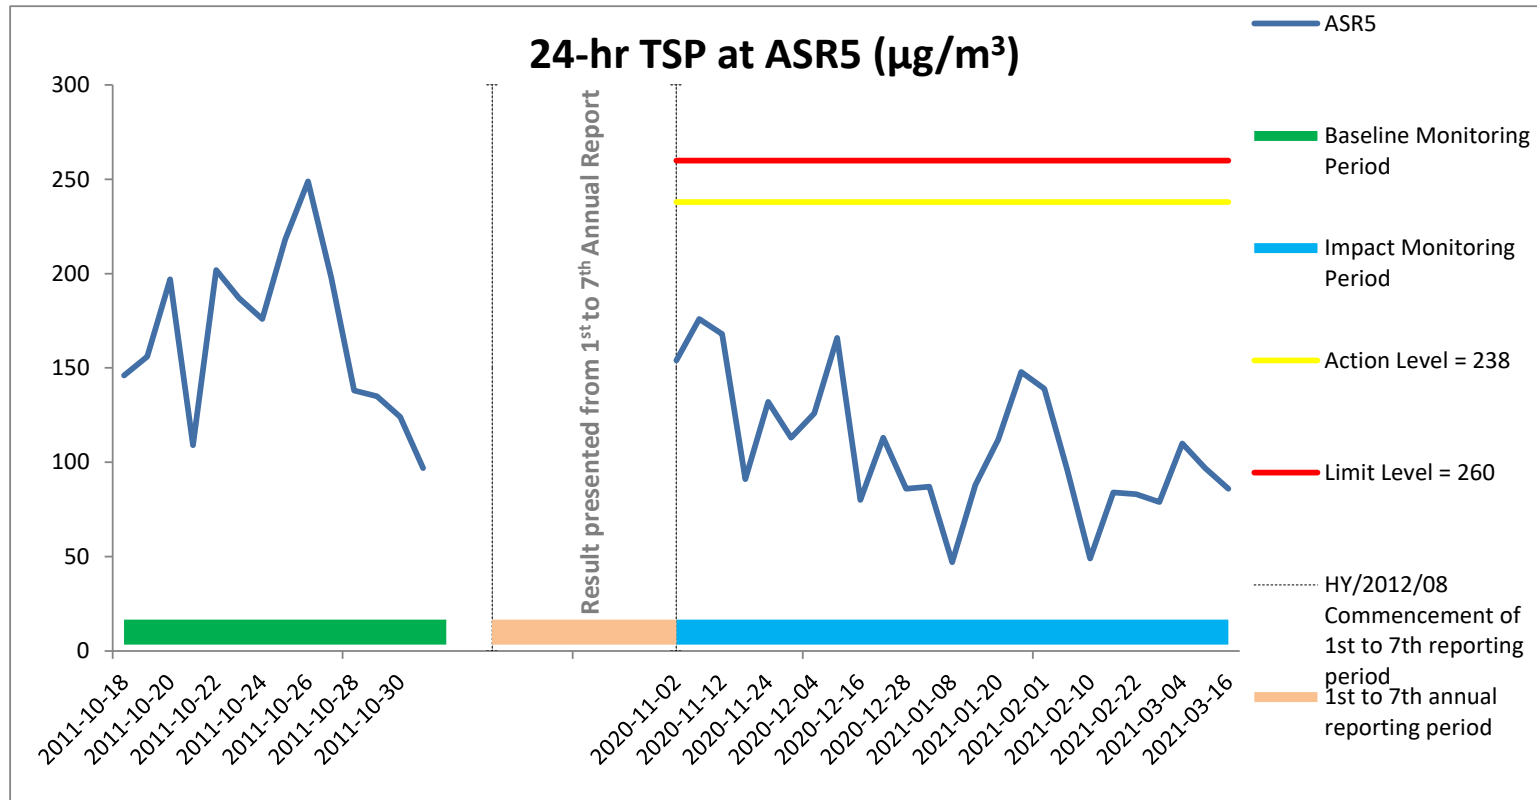
Figure D.7 Baseline & Impact Monitoring - 24-hour Total Suspended Particulates ($\mu\text{g}/\text{m}^3$) at ASR5 between 17 October 2011 and 19 March 2021 during Baseline & Impact Monitoring period. Weather condition within the reporting period varied between sunny to rainy. The overall monitoring results were not affected by weather conditions. Major land-based construction activities included: Installation of green roof system & chain fence - South Ventilation Building; Defect works for reinstatement at Box culvert - Northern Landfall; and Demolition works and backfilling works of CLP substation.

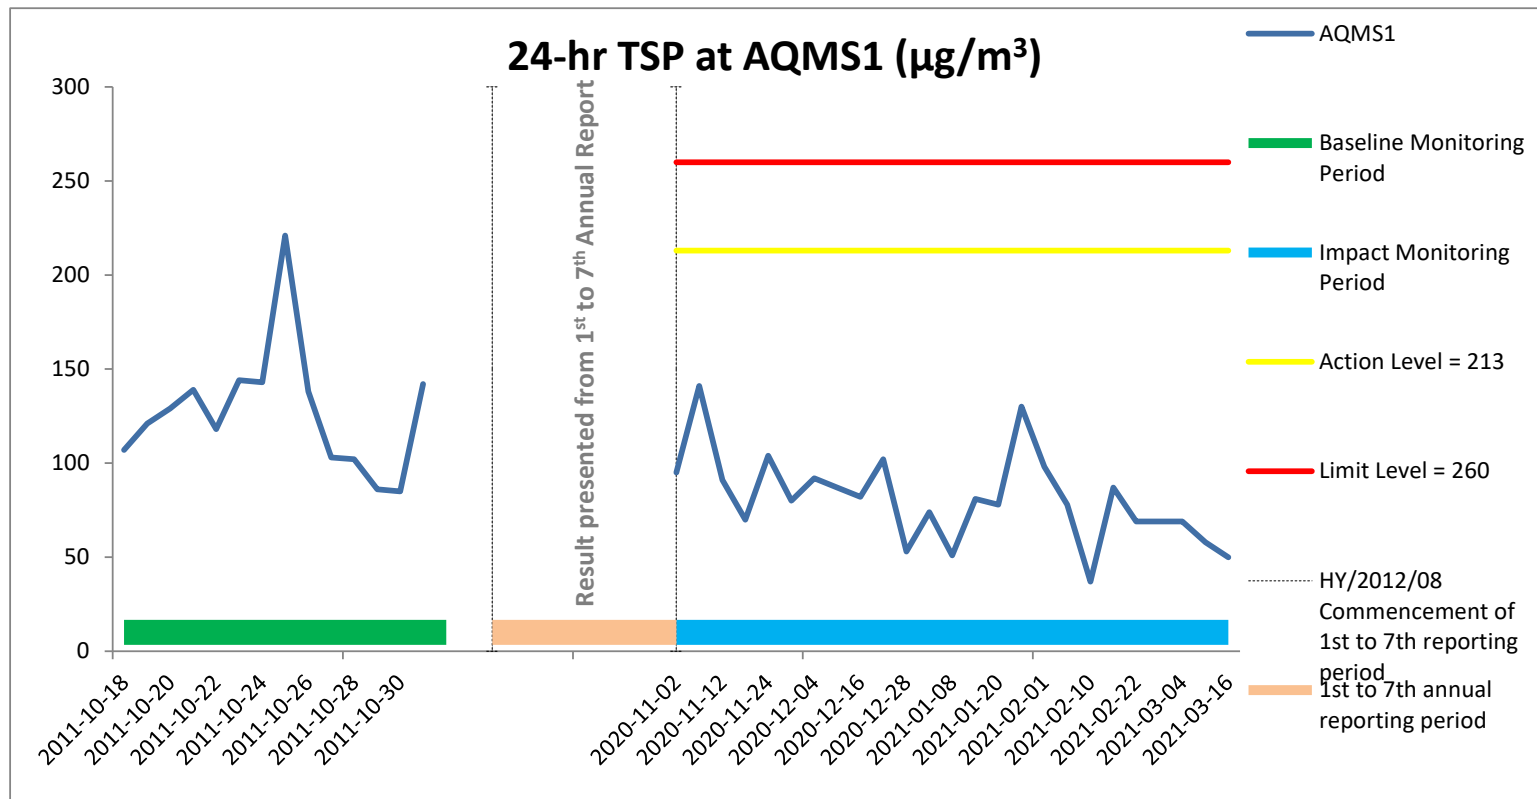
Figure D.8 Baseline & Impact Monitoring - 24-hour Total Suspended Particulates ($\mu\text{g}/\text{m}^3$) at AQMS1 between 17 October 2013 and 19 March 2021 during Baseline & Impact Monitoring period. Weather condition within the reporting period varied between sunny to rainy. The overall monitoring results were not affected by weather conditions. Major land-based construction activities included: Installation of green roof system & chain fence - South Ventilation Building; Defect works for reinstatement at Box culvert - Northern Landfall; and Demolition works and backfilling works of CLP substation.

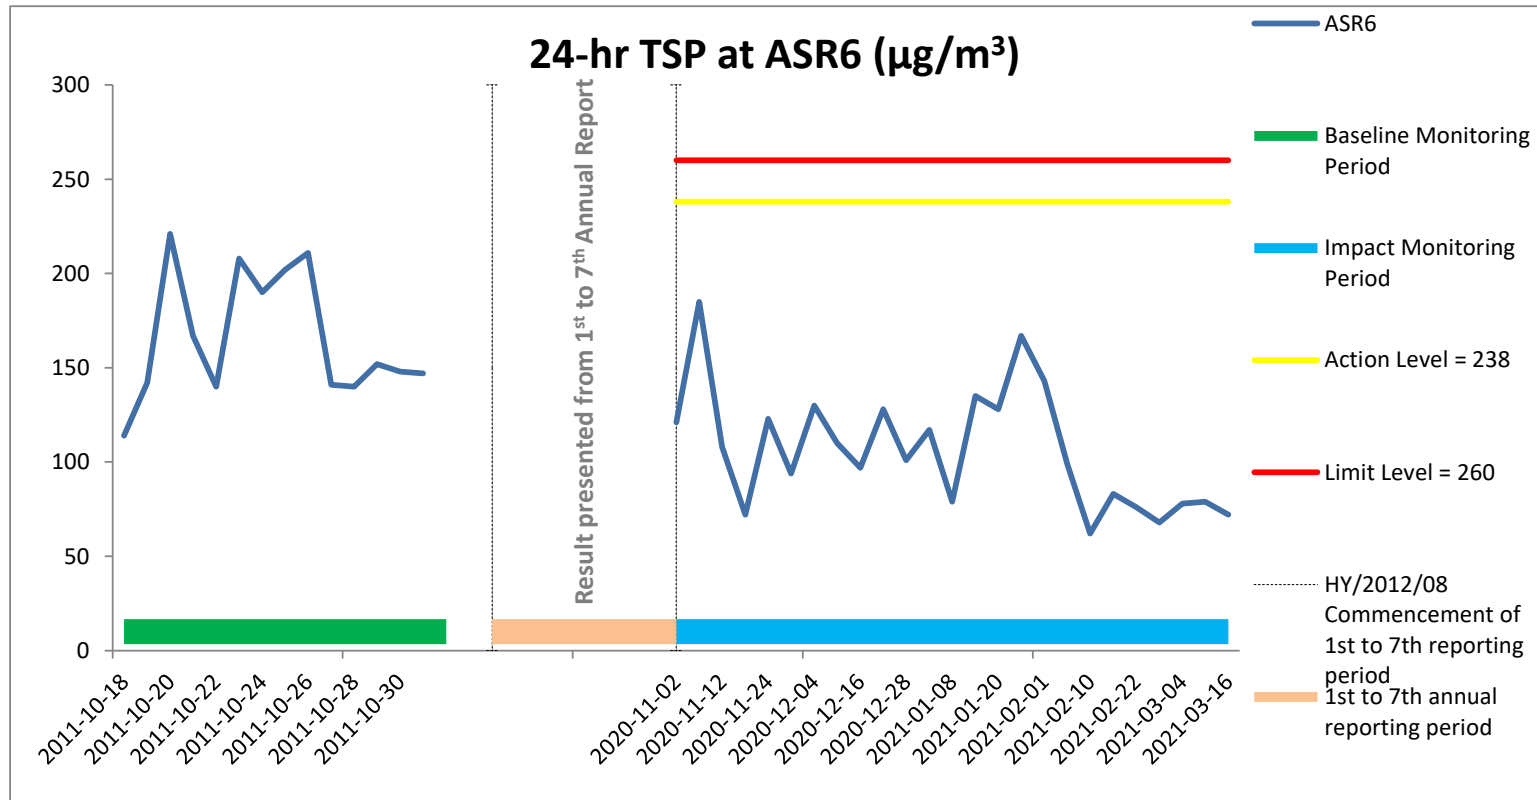
Figure D.9 Baseline & Impact Monitoring - 24-hour Total Suspended Particulates ($\mu\text{g}/\text{m}^3$) at ASR6 between 17 October 2011 and 19 March 2021 during Baseline & Impact Monitoring period. Weather condition within the reporting period varied between sunny to rainy. The overall monitoring results were not affected by weather conditions. Major land-based construction activities included: Installation of green roof system & chain fence - South Ventilation Building; Defect works for reinstatement at Box culvert - Northern Landfall; and Demolition works and backfilling works of CLP substation.

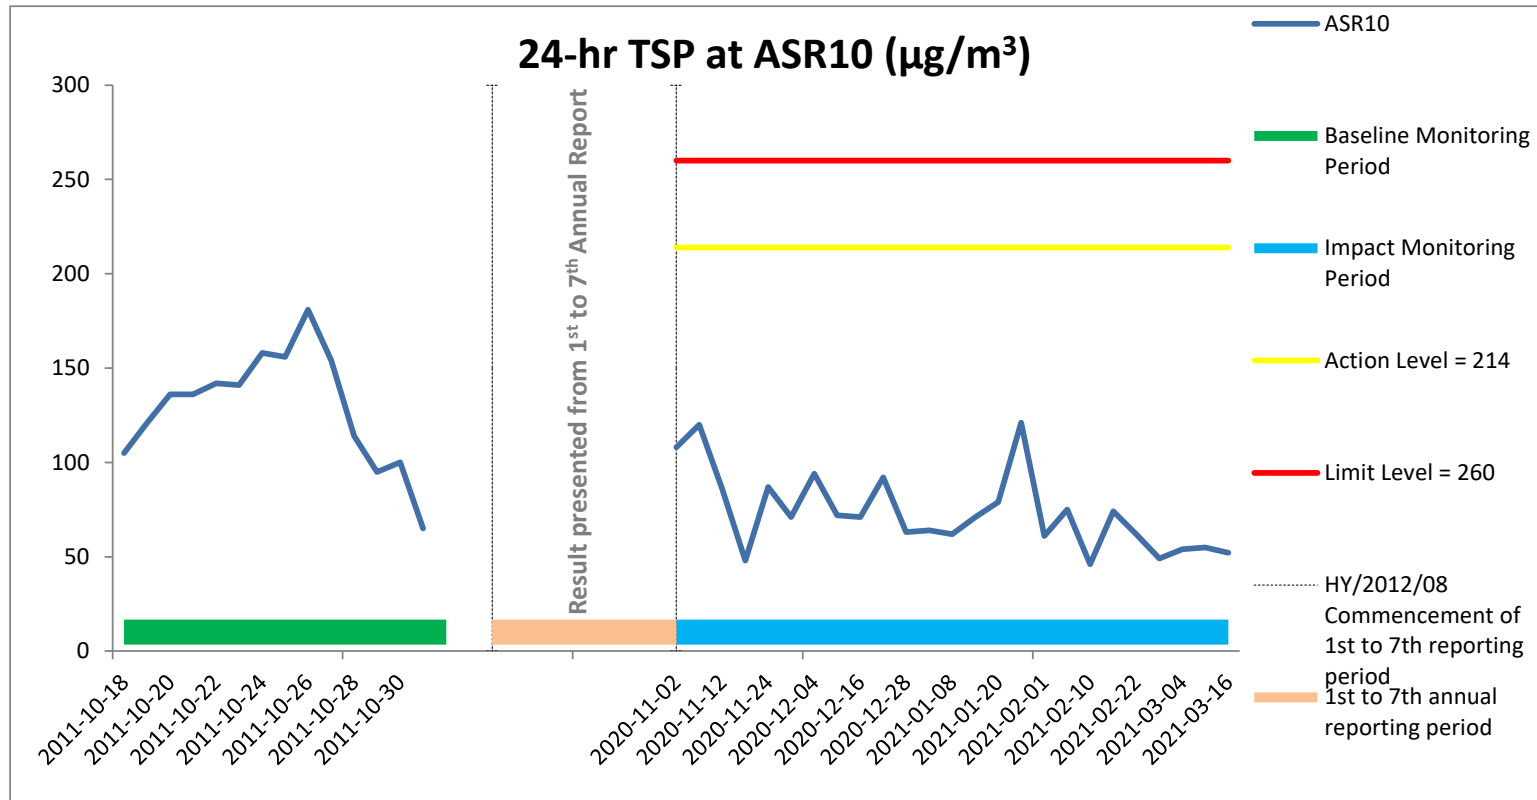
Figure D.10 Baseline & Impact Monitoring – 24-hour Total Suspended Particulates ($\mu\text{g}/\text{m}^3$) at ASR10 between 17 October 2011 and 19 March 2021 during Baseline & Impact Monitoring period. Weather condition within the reporting period varied between sunny to rainy. The overall monitoring results were not affected by weather conditions. Major land-based construction activities included: Installation of green roof system & chain fence - South Ventilation Building; Defect works for reinstatement at Box culvert - Northern Landfall; and Demolition works and backfilling works of CLP substation.

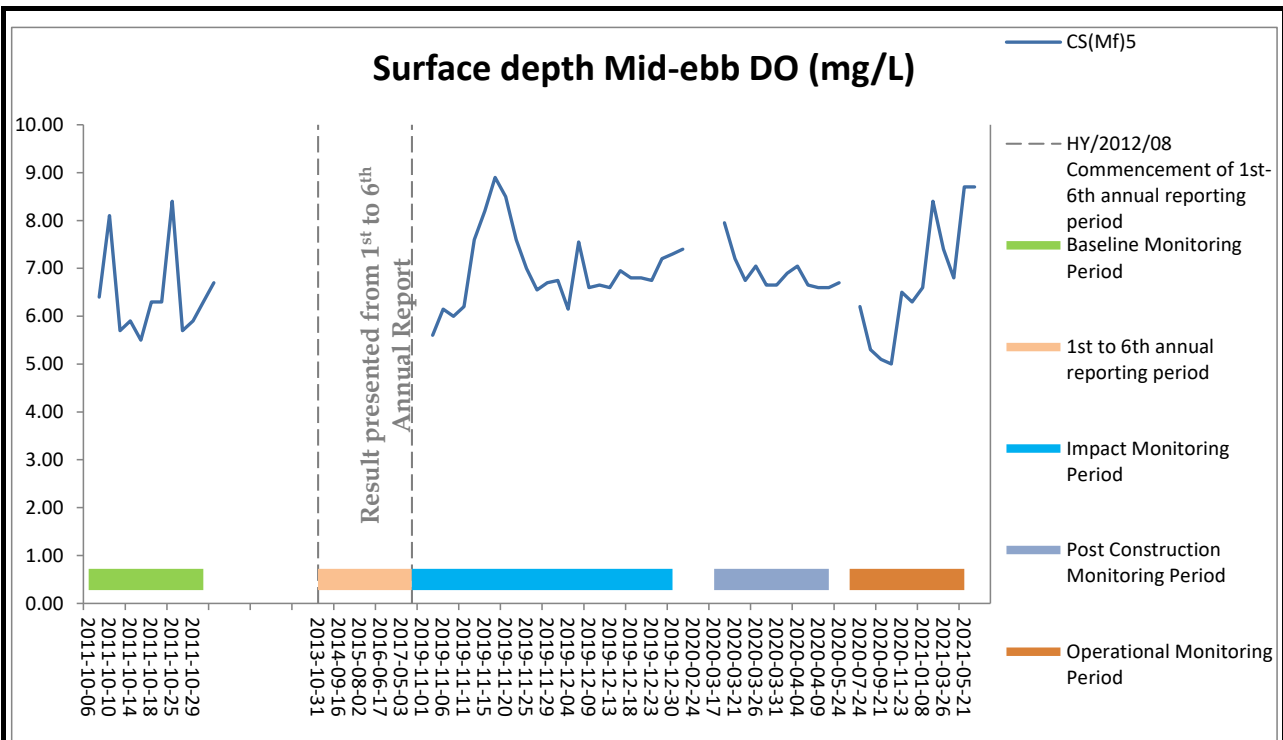
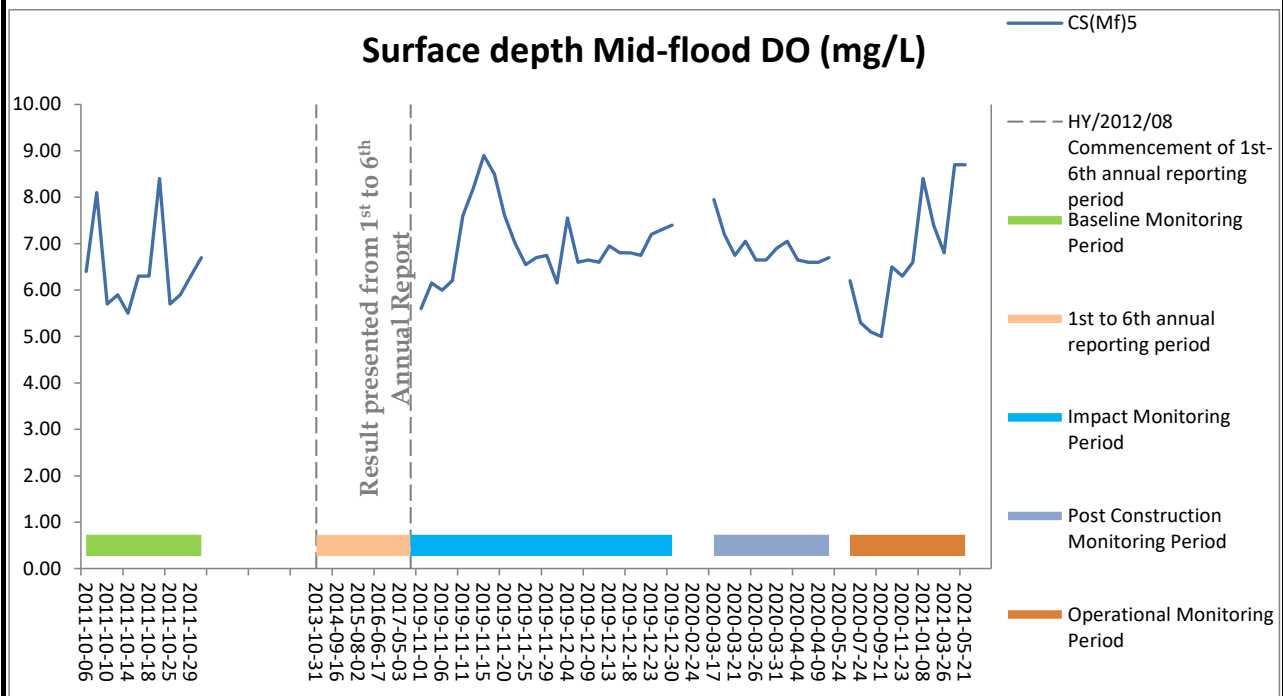
Figure E1 Baseline, Impact, Post-construction & Operational Monitoring - Mean Level of Dissolved Oxygen (mg/L) in surface waters between Baseline, Impact, Post-construction & Operational Monitoring (1/11/2019 to 31/5/2021) at CS(Mf)5. Weather condition within the reporting period varied between sunny to rainy. The overall monitoring results were not affected by weather conditions. Major marine construction activities included: Installation of green roof system & chain fence - South Ventilation Building; Defect works for reinstatement at Box culvert - Northern Landfall; and Demolition works and backfilling works of CLP substation.

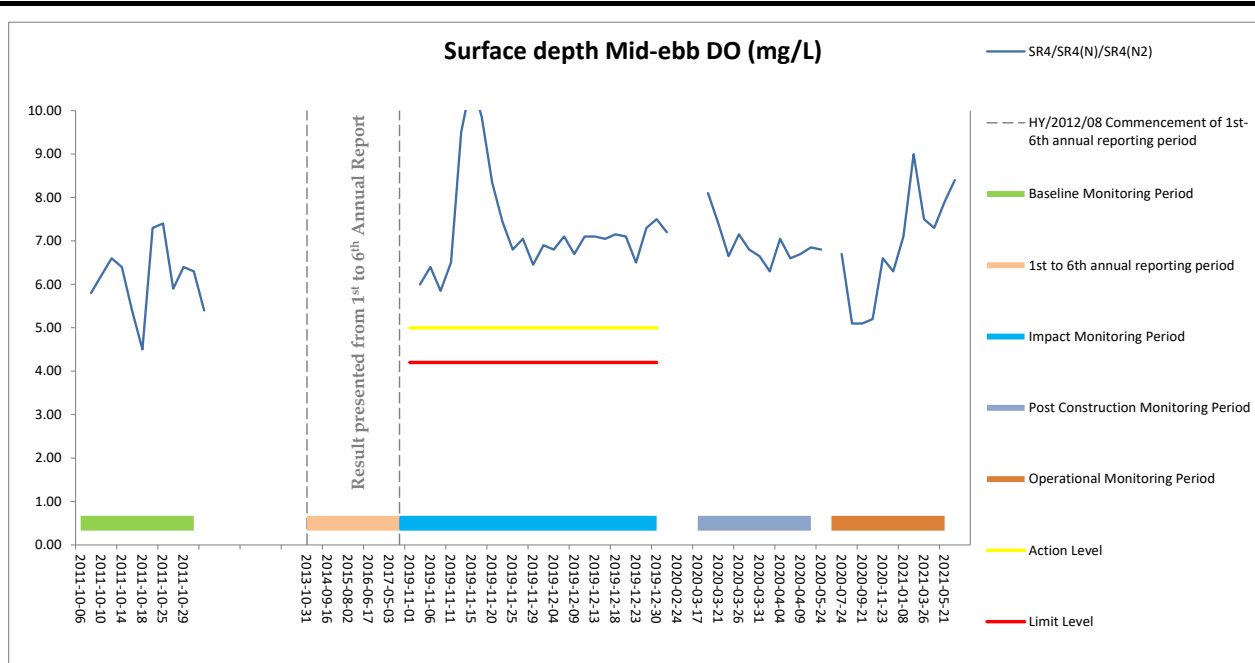
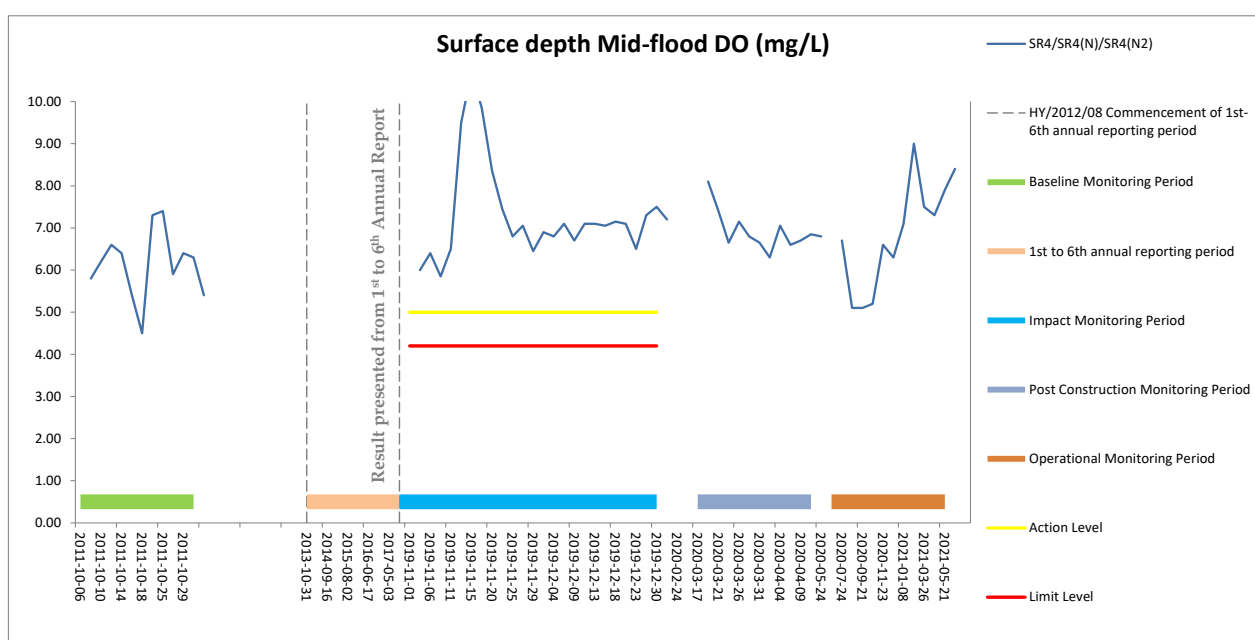
Figure E2 Baseline, Impact, Post-construction & Operational Monitoring - Mean Level of Dissolved Oxygen (mg/L) in surface waters between Baseline, Impact, Post-construction & Operational Monitoring (1/11/2019 to 31/5/2021) at SR4/SR4(N)/SR4(N2). Weather condition within the reporting period varied between sunny to rainy. The overall monitoring results were not affected by weather conditions. Major marine construction activities included: Installation of green roof system & chain fence - South Ventilation Building; Defect works for reinstatement at Box culvert - Northern Landfall; and Demolition works and backfilling works of CLP substation.

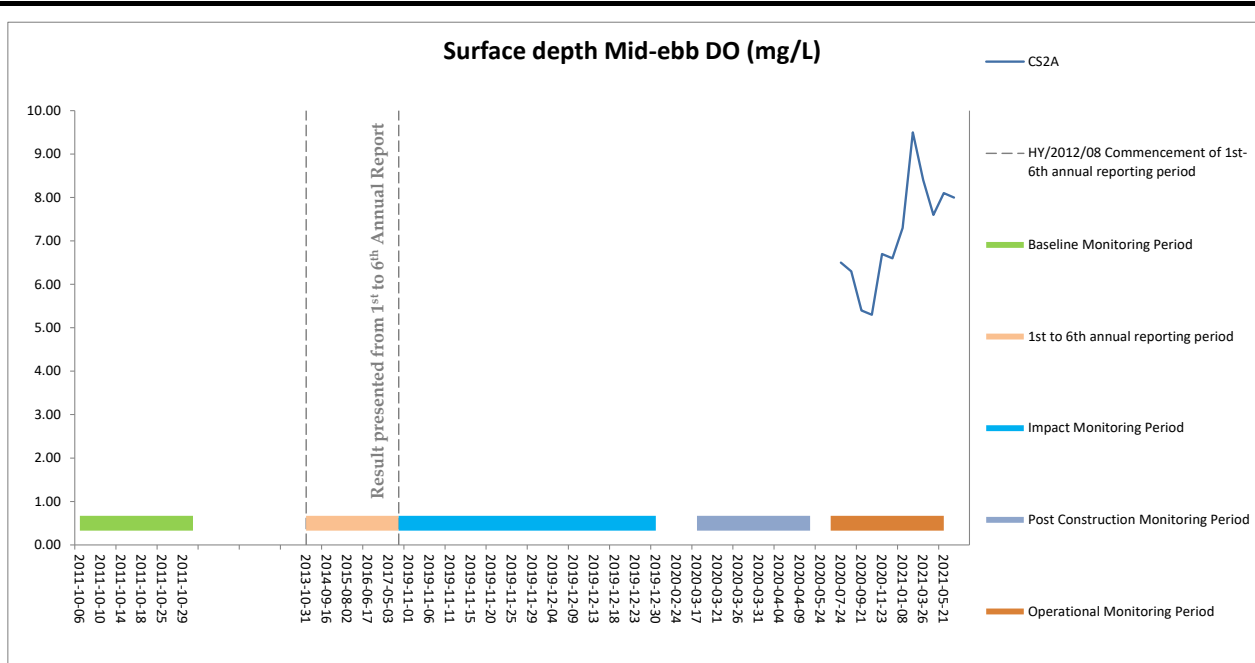
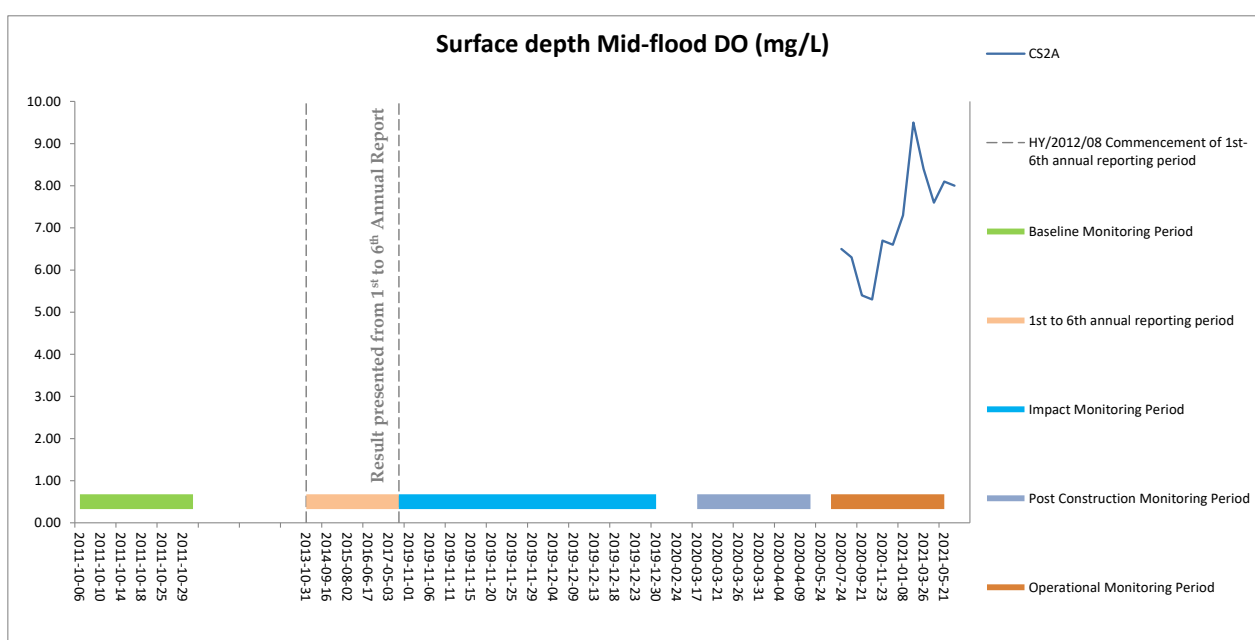
Figure E3 Baseline, Impact, Post-construction & Operational Monitoring – Mean Level of Dissolved Oxygen (mg/L) in surface waters between Baseline, Impact, Post-construction & Operational Monitoring (1/11/2019 to 31/5/2021) at CS2A. Weather condition within the reporting period varied between sunny to rainy. The overall monitoring results were not affected by weather conditions. Major marine construction activities included: Installation of green roof system & chain fence - South Ventilation Building; Defect works for reinstatement at Box culvert - Northern Landfall; and Demolition works and backfilling works of CLP substation.
