**Contract No. HY/2012/08
Tuen Mun – Chek Lap Kok Link –
Northern Connection Sub-sea Tunnel
Section**

***Eighth Annual Environmental Monitoring & Audit
(EM&A) Report***

14 December 2021

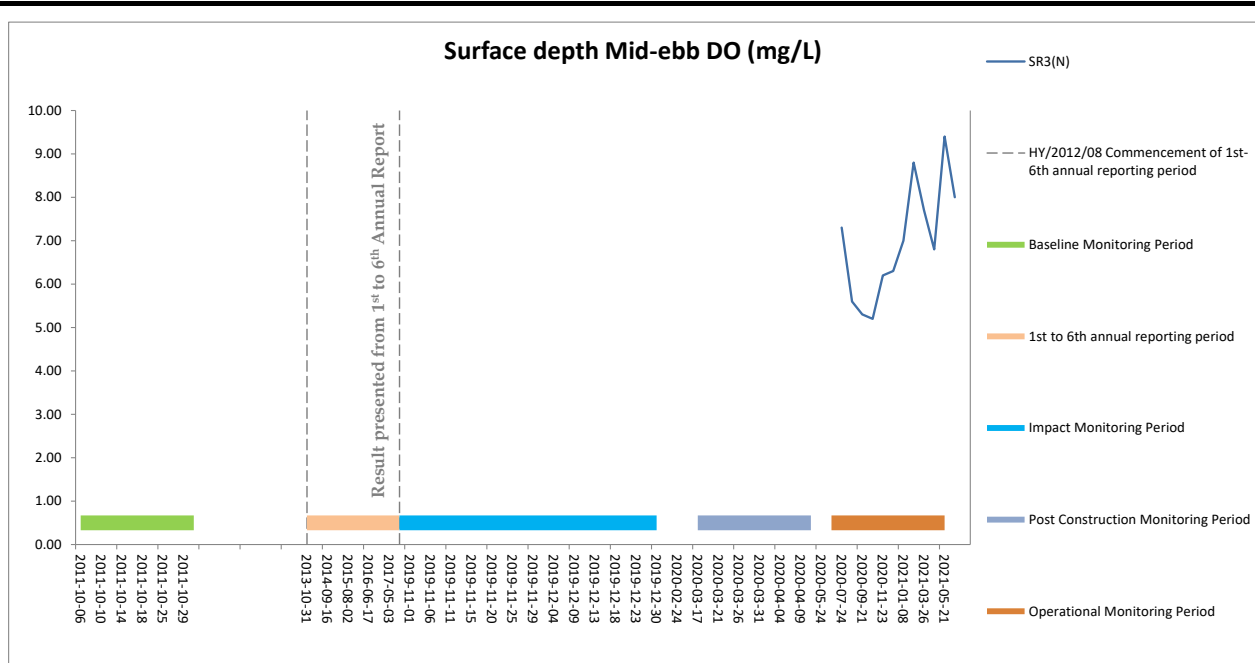
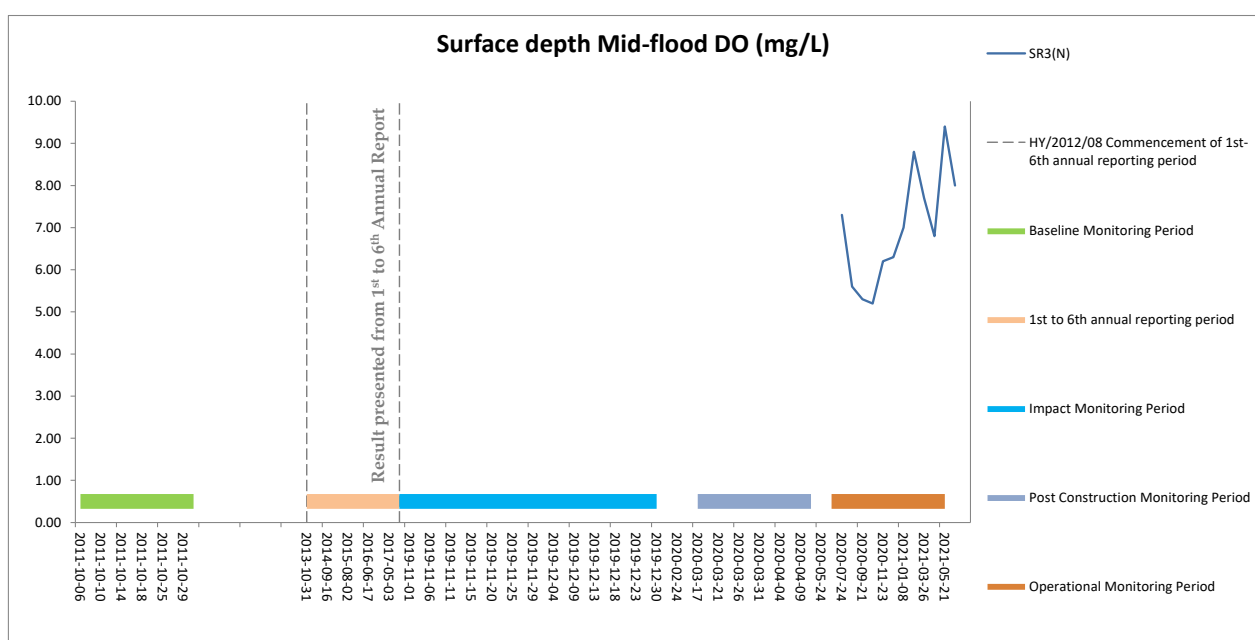
Figure E4 Baseline, Impact, Post-construction & Operational Monitoring – Mean Level of Dissolved Oxygen (mg/L) in surface waters between Baseline, Impact, Post-construction & Operational Monitoring (1/11/2019 to 31/5/2021) at SR3(N). Weather condition within the reporting period varied between sunny to rainy. The overall monitoring results were not affected by weather conditions. Major marine construction activities included: Installation of green roof system & chain fence - South Ventilation Building; Defect works for reinstatement at Box culvert - Northern Landfall; and Demolition works and backfilling works of CLP substation.

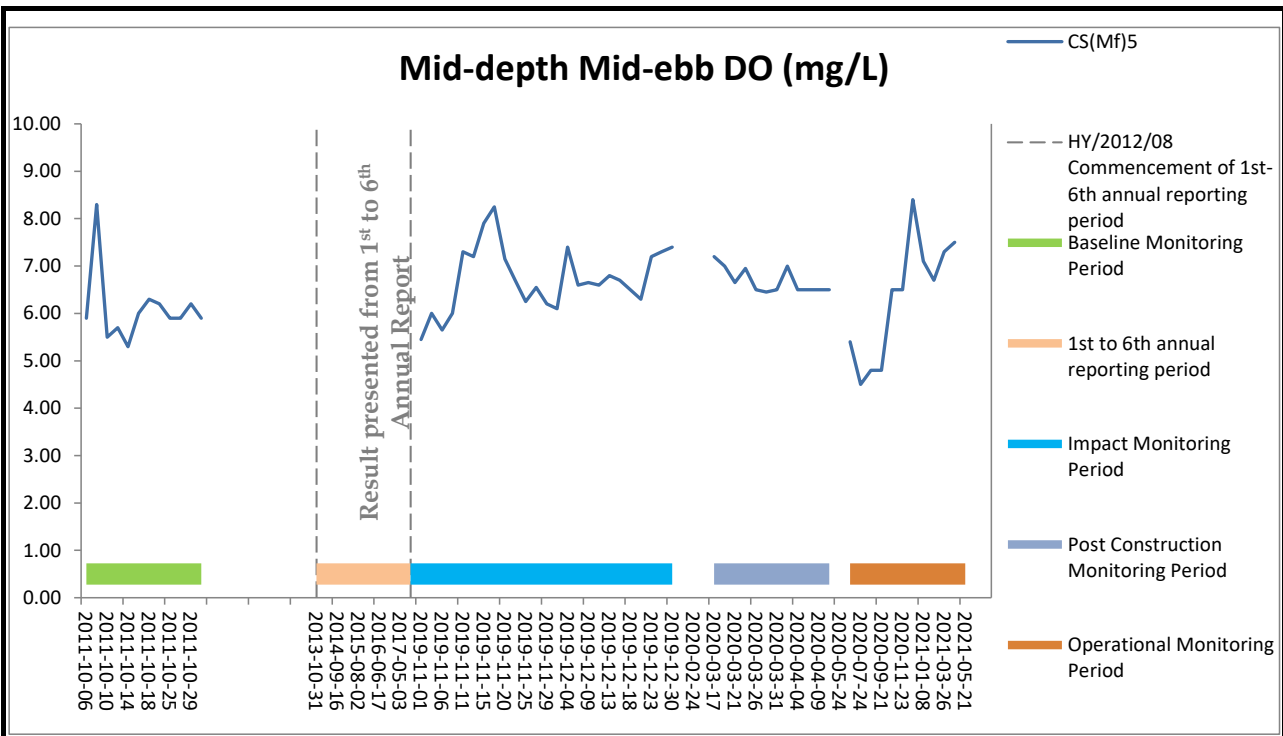
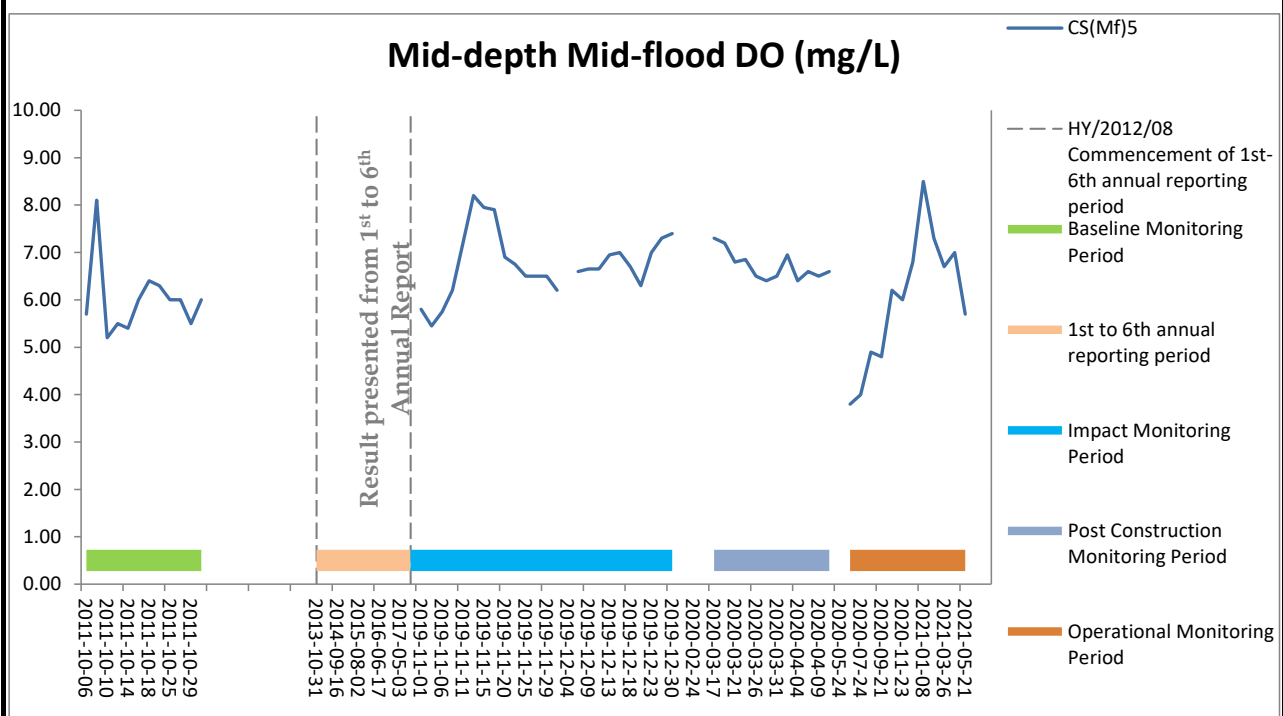
*No data for Stations SR4/SR4(N)/SR4(N2) and SR3(N) during mid-ebb tide due to shallow water depth (< 6m).

Figure E5 Baseline, Impact, Post-construction & Operational Monitoring - Mean Level of Dissolved Oxygen (mg/L) in mid-depth waters between Baseline, Impact, Post-construction & Operational Monitoring (1/11/2019 to 31/5/2021) at CS(Mf)5. Weather condition within the reporting period varied between sunny to rainy. The overall monitoring results were not affected by weather conditions. Major marine construction activities included: Installation of green roof system & chain fence - South Ventilation Building; Defect works for reinstatement at Box culvert - Northern Landfall; and Demolition works and backfilling works of CLP substation.

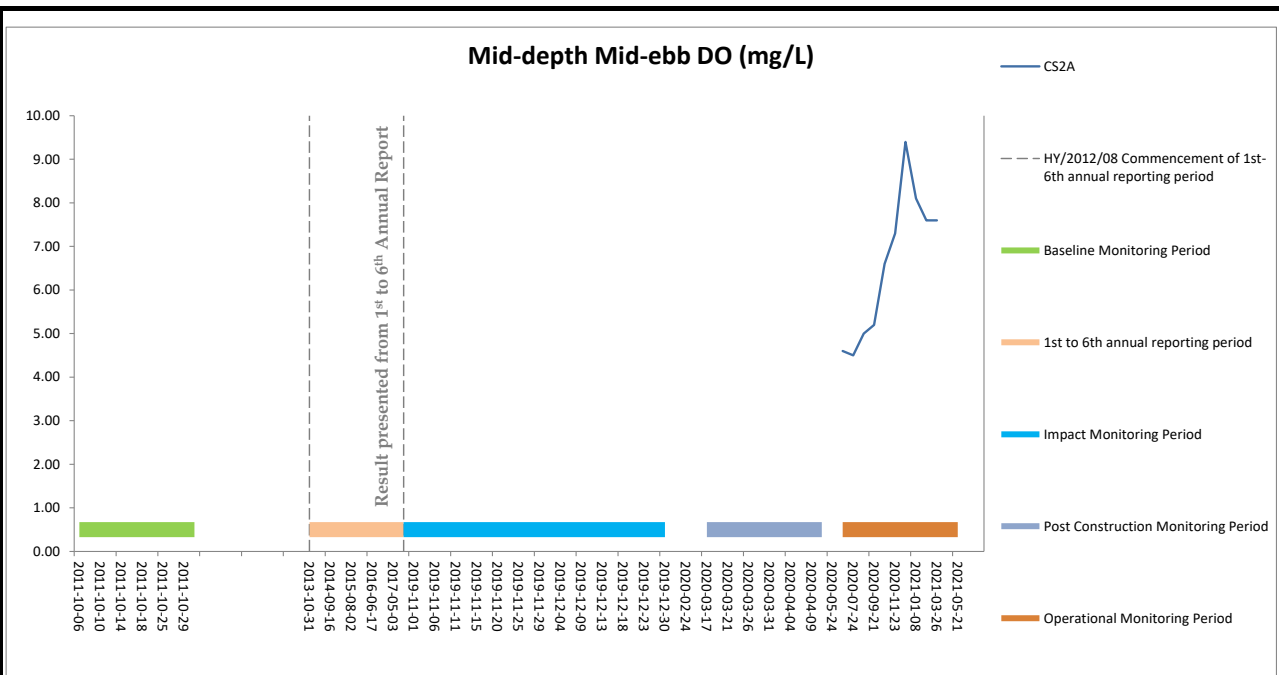
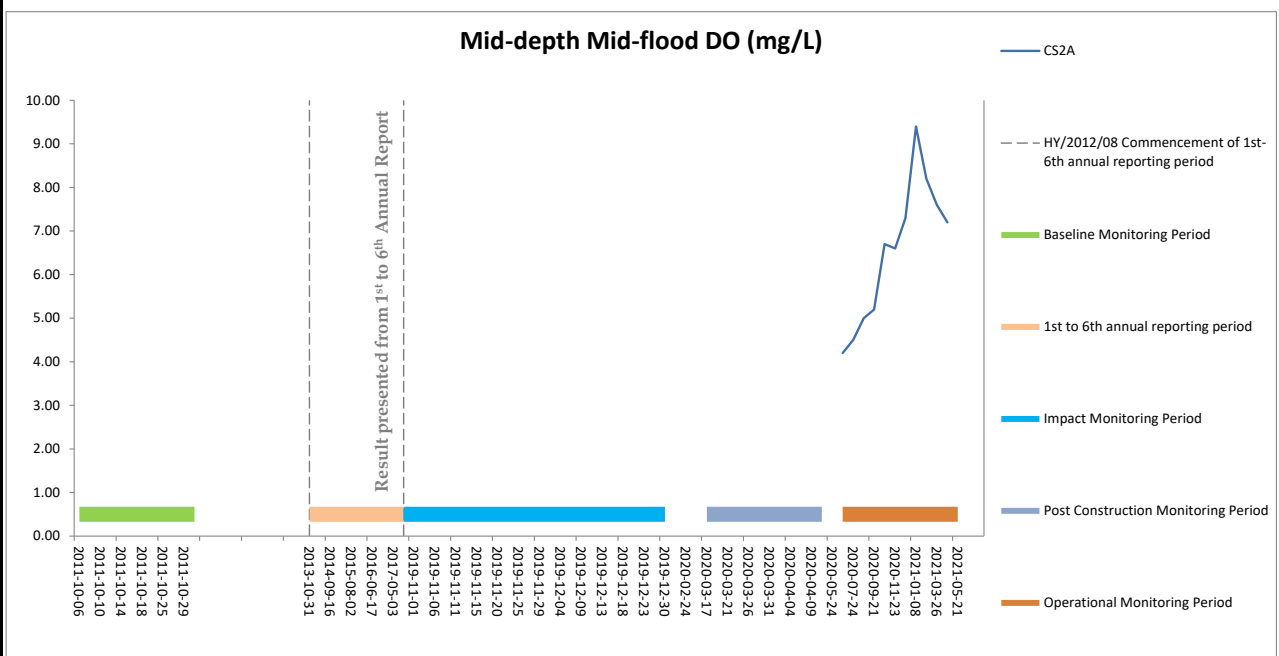
*No data for Stations SR4/SR4(N)/SR4(N2) and SR3(N) during mid-ebb tide due to shallow water depth (< 6m).

Figure E6 Baseline, Impact, Post-construction & Operational Monitoring – Mean Level of Dissolved Oxygen (mg/L) in mid-depth waters between Baseline, Impact, Post-construction & Operational Monitoring (1/11/2019 to 31/5/2021) at CS2(A). Weather condition within the reporting period varied between sunny to rainy. The overall monitoring results were not affected by weather conditions. Major marine construction activities included: Installation of green roof system & chain fence - South Ventilation Building; Defect works for reinstatement at Box culvert - Northern Landfall; and Demolition works and backfilling works of CLP substation.

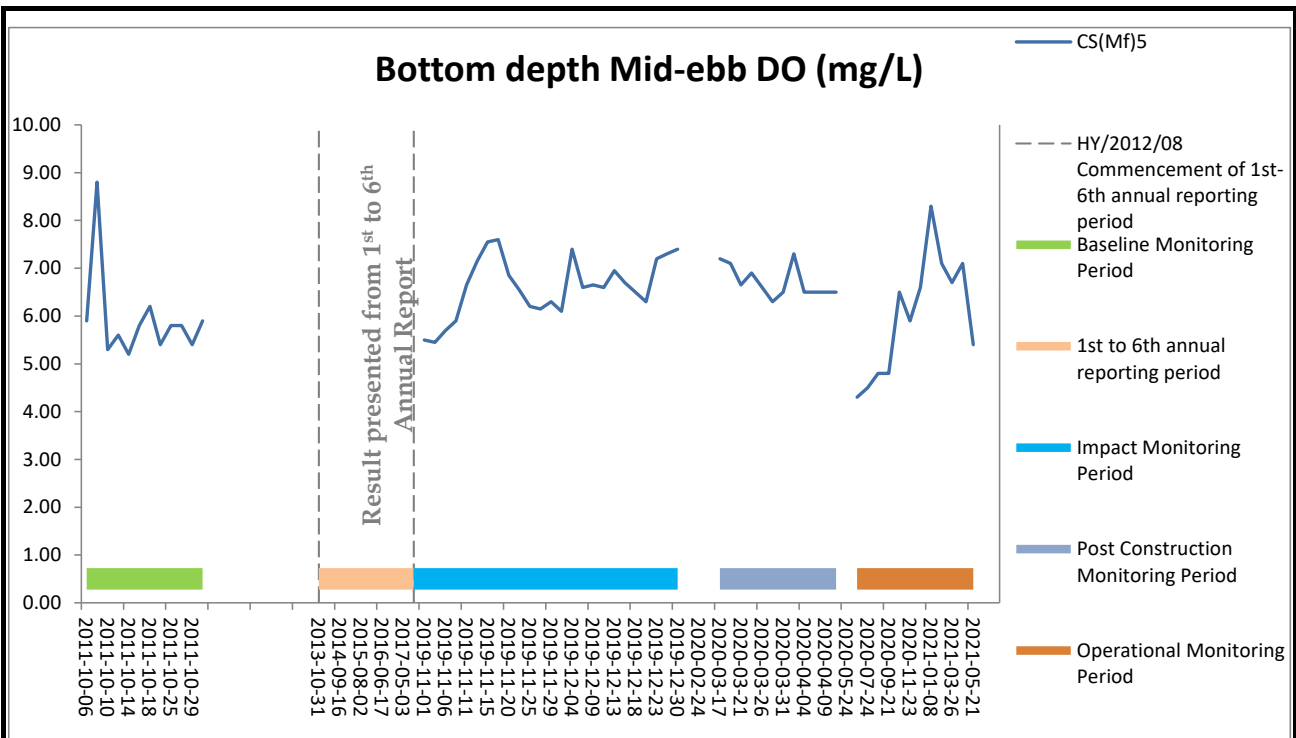
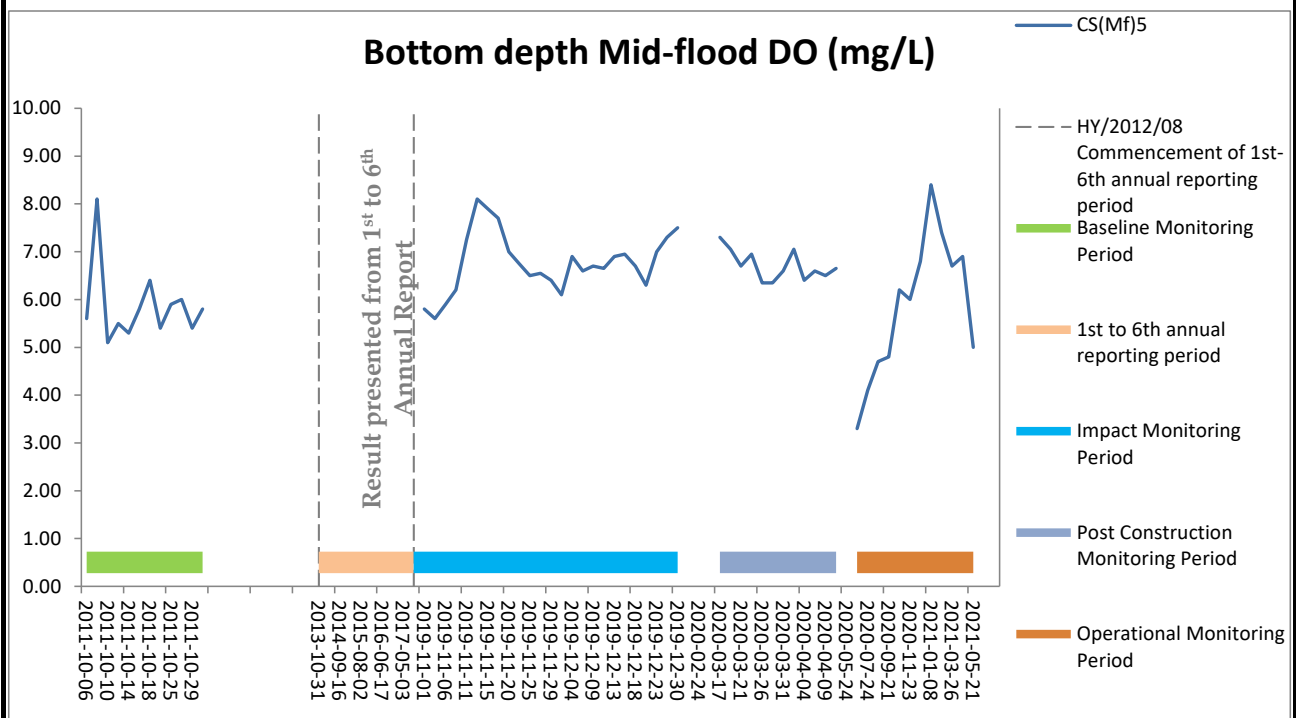
Figure E7 Baseline, Impact, Post-construction & Operational Monitoring – Mean Level of Dissolved Oxygen (mg/L) in bottom waters between Baseline, Impact, Post-construction & Operational Monitoring (1/11/2019 to 31/5/2021) at CS(Mf)5. Weather condition within the reporting period varied between sunny to rainy. The overall monitoring results were not affected by weather conditions. Major marine construction activities included: Installation of green roof system & chain fence - South Ventilation Building; Defect works for reinstatement at Box culvert - Northern Landfall; and Demolition works and backfilling works of CLP substation.

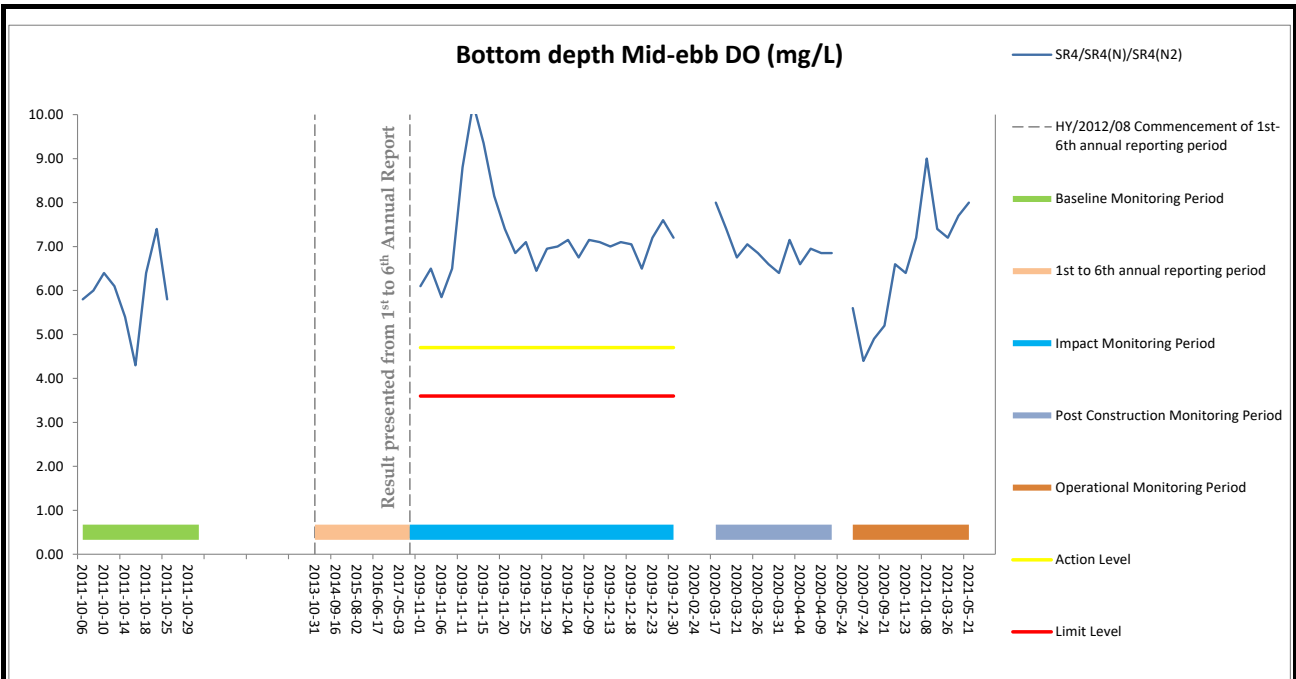
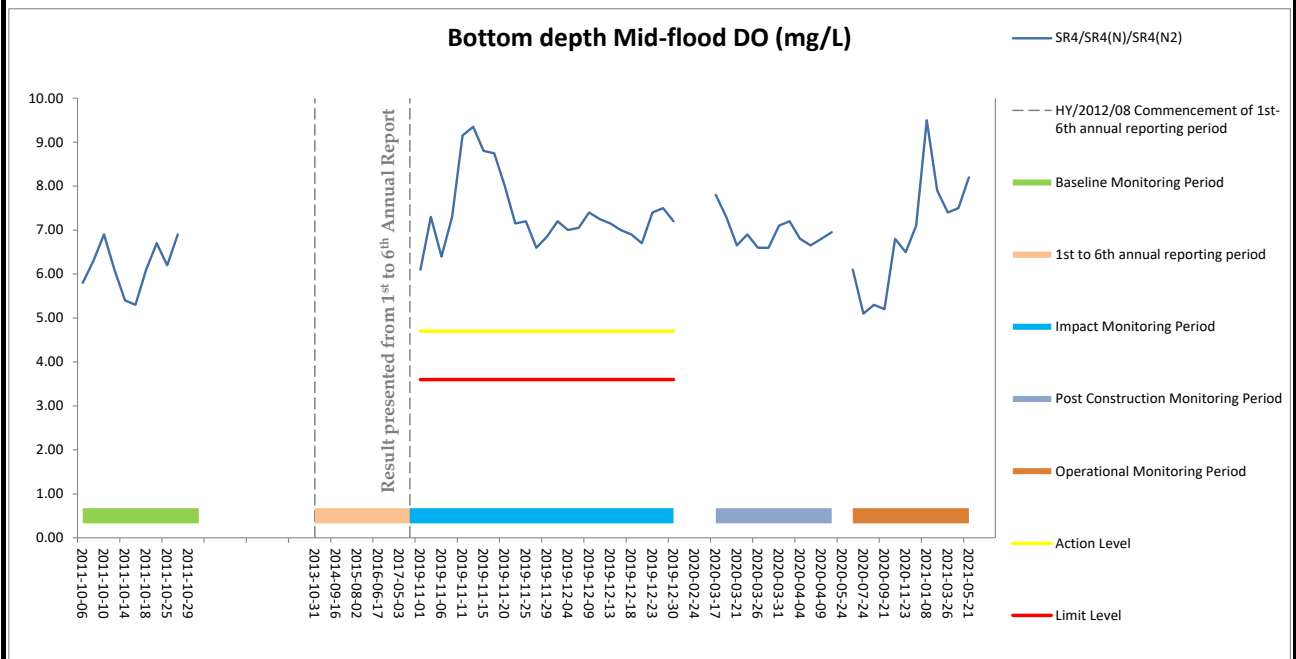
Figure E8 Baseline, Impact, Post-construction & Operational Monitoring - Mean Level of Dissolved Oxygen (mg/L) in bottom waters between Baseline, Impact, Post-construction & Operational Monitoring (1/11/2019 to 31/5/2021) at SR4/SR4(N)/SR4(N2). Weather condition within the reporting period varied between sunny to rainy. The overall monitoring results were not affected by weather conditions. Major marine construction activities included: Installation of green roof system & chain fence - South Ventilation Building; Defect works for reinstatement at Box culvert - Northern Landfall; and Demolition works and backfilling works of CLP substation.

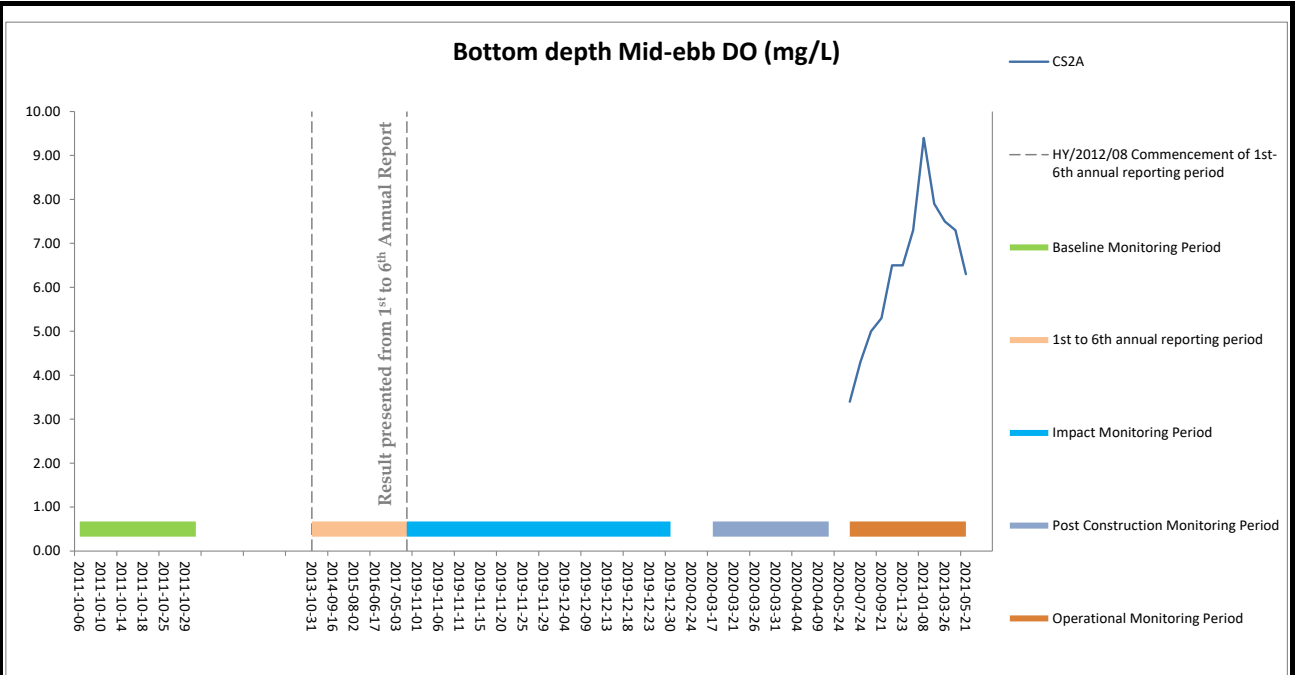
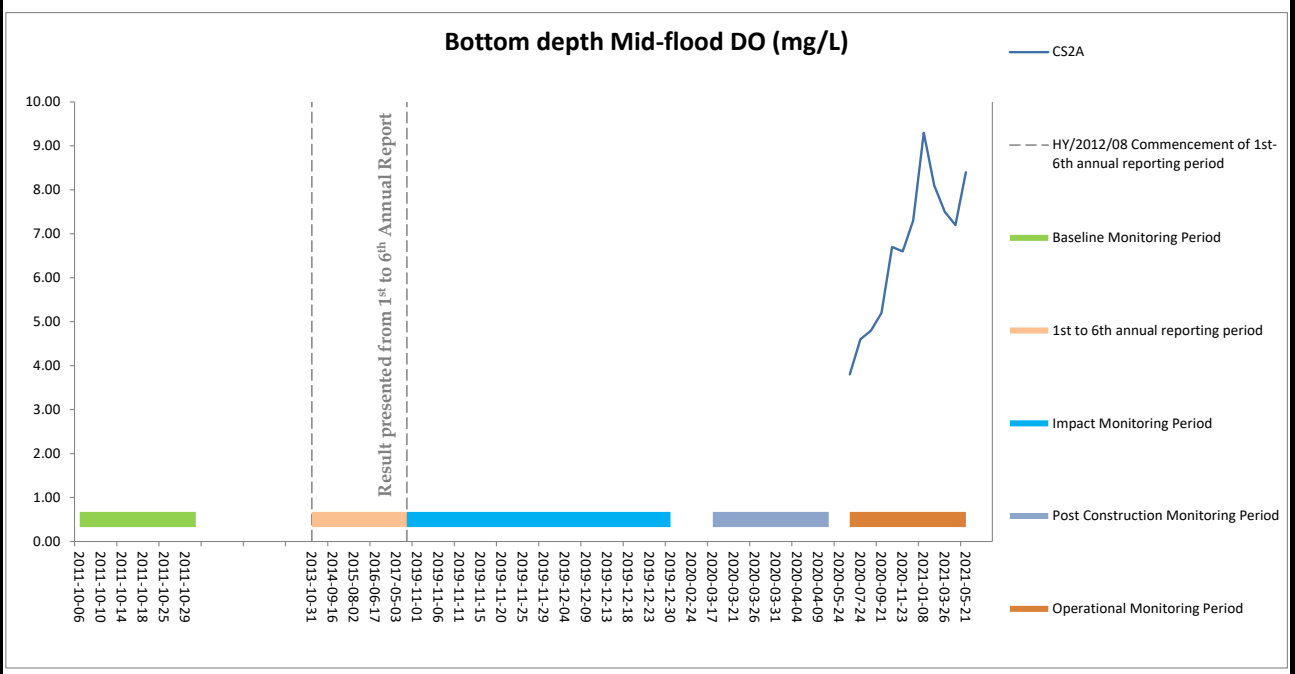
Figure E9 Baseline, Impact, Post-construction & Operational Monitoring – Mean Level of Dissolved Oxygen (mg/L) in bottom waters between Baseline, Impact, Post-construction & Operational Monitoring (1/11/2019 to 31/5/2021) at CS2A. Weather condition within the reporting period varied between sunny to rainy. The overall monitoring results were not affected by weather conditions. Major marine construction activities included: Installation of green roof system & chain fence - South Ventilation Building; Defect works for reinstatement at Box culvert - Northern Landfall; and Demolition works and backfilling works of CLP substation.

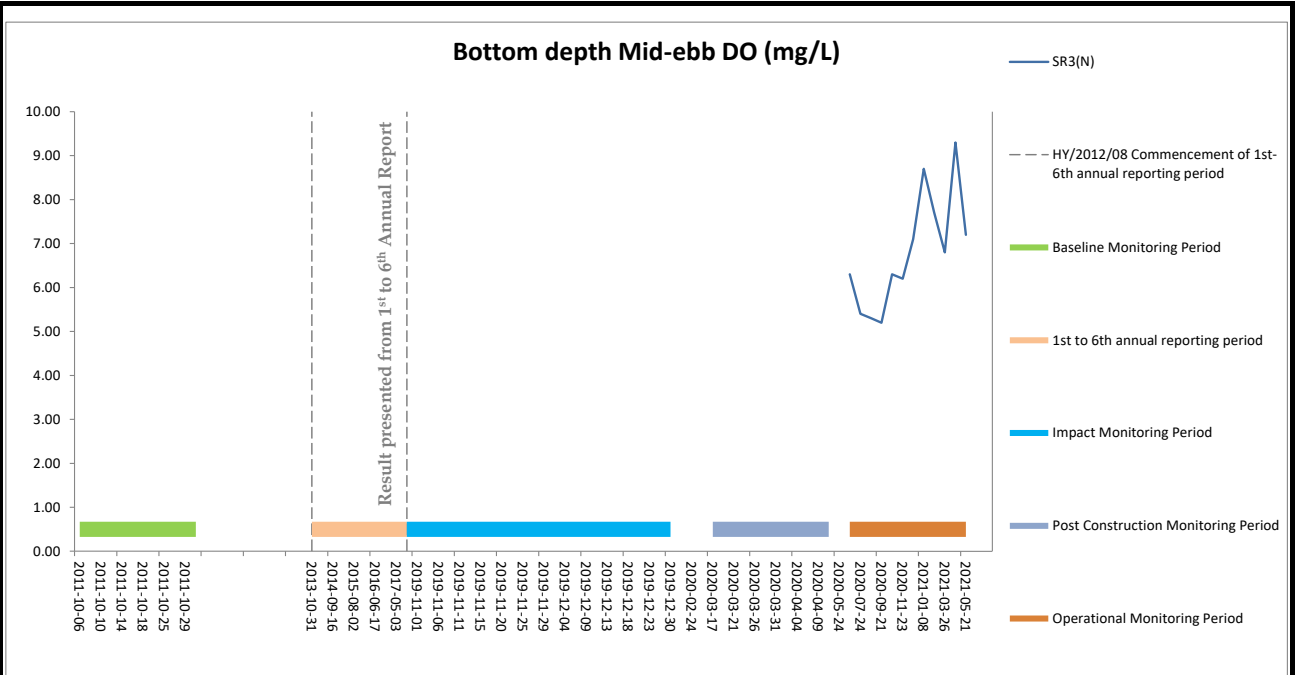
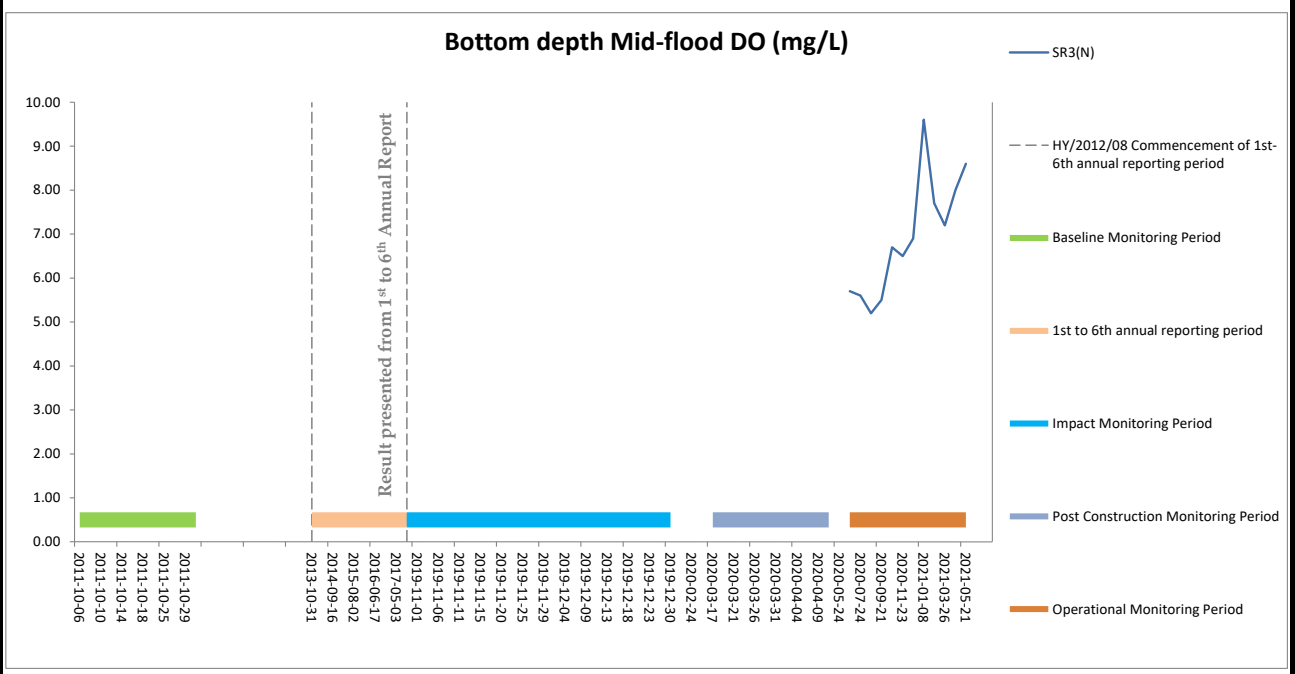
Figure E10 Baseline, Impact, Post-construction & Operational Monitoring - Mean Level of Dissolved Oxygen (mg/L) in bottom waters between Baseline, Impact, Post-construction & Operational Monitoring (1/11/2019 to 31/5/2021) at SR3(N). Weather condition within the reporting period varied between sunny to rainy. The overall monitoring results were not affected by weather conditions. Major marine construction activities included: Installation of green roof system & chain fence - South Ventilation Building; Defect works for reinstatement at Box culvert - Northern Landfall; and Demolition works and backfilling works of CLP substation.

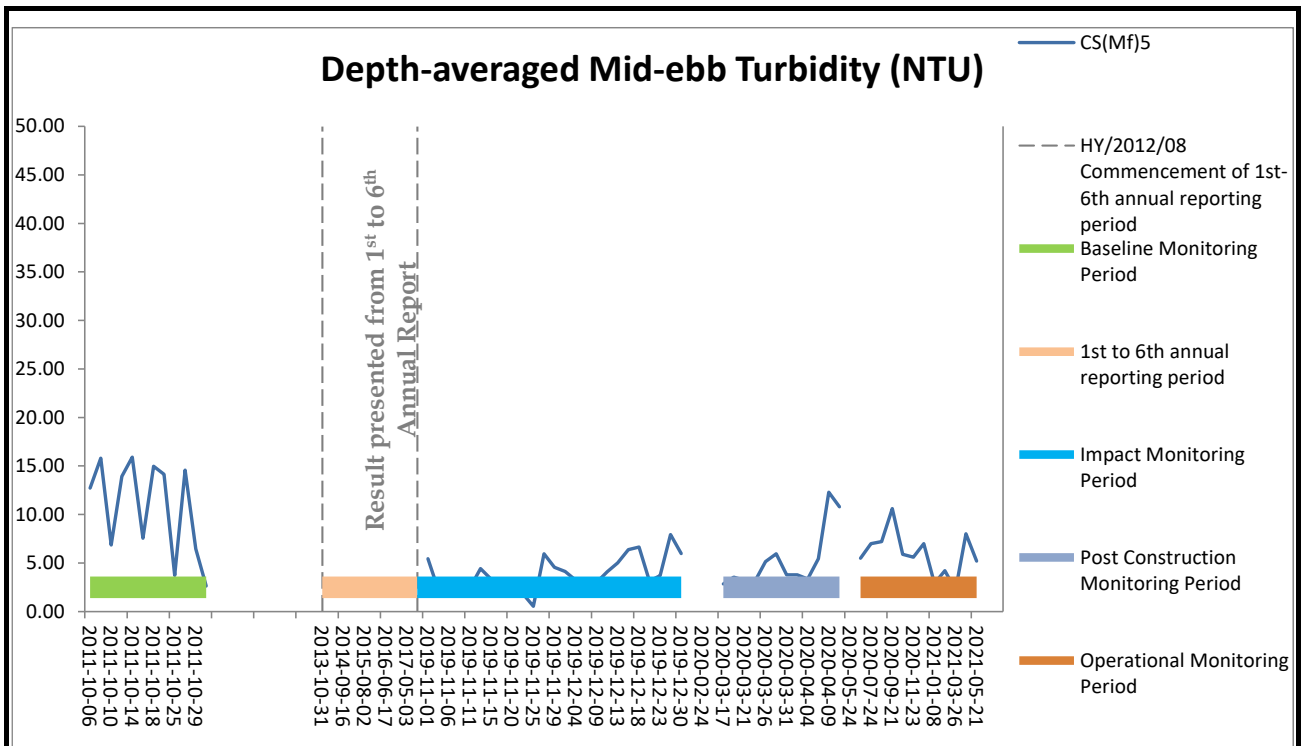
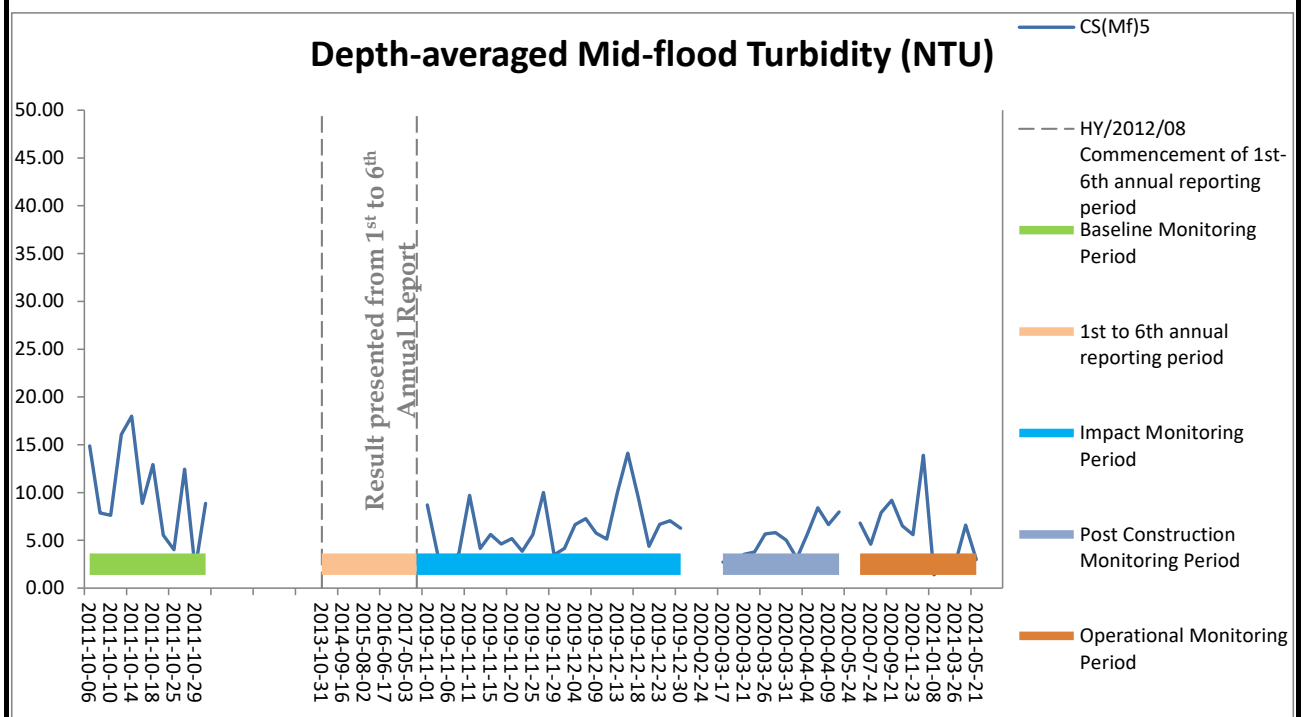
Figure E11 Baseline, Impact, Post-construction & Operational Monitoring - Mean Depth-averaged Level of Turbidity (NTU) between Baseline, Impact, Post-construction & Operational Monitoring (1/11/2019 to 31/5/2021) at CS(Mf)5. Weather condition within the reporting period varied between sunny to rainy. The overall monitoring results were not affected by weather conditions. Major marine construction activities included: Installation of green roof system & chain fence - South Ventilation Building; Defect works for reinstatement at Box culvert - Northern Landfall; and Demolition works and backfilling works of CLP substation.

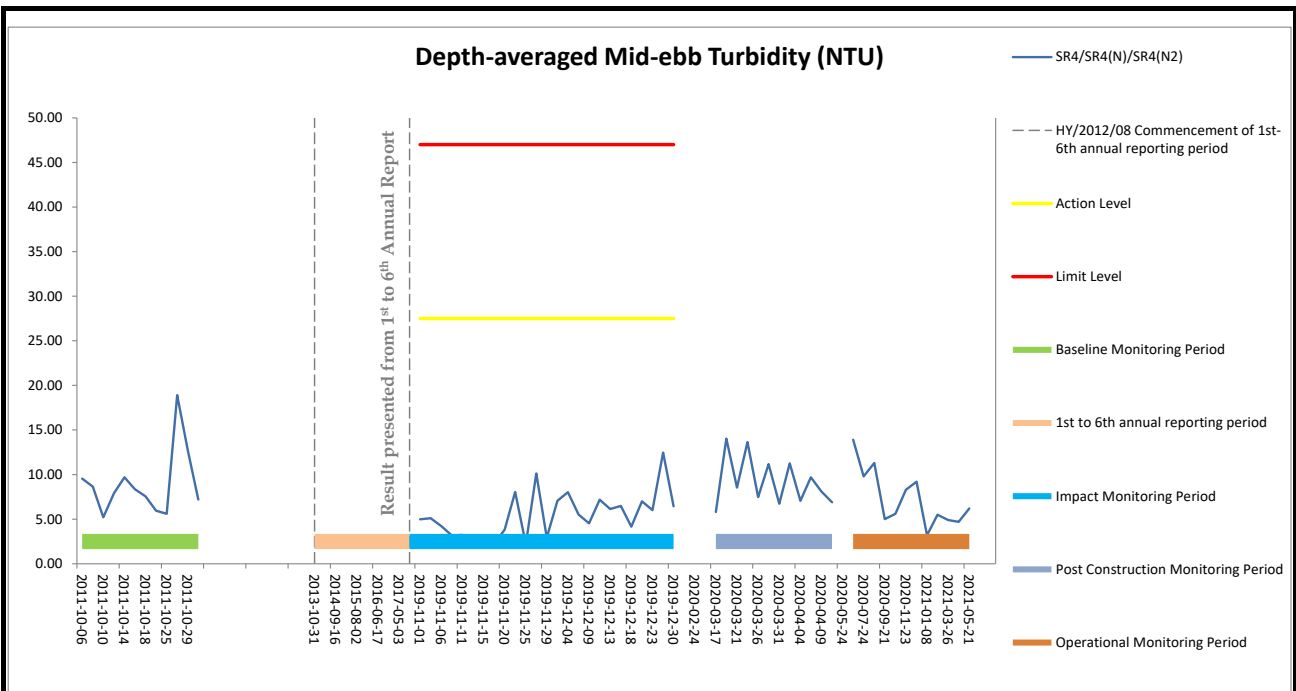
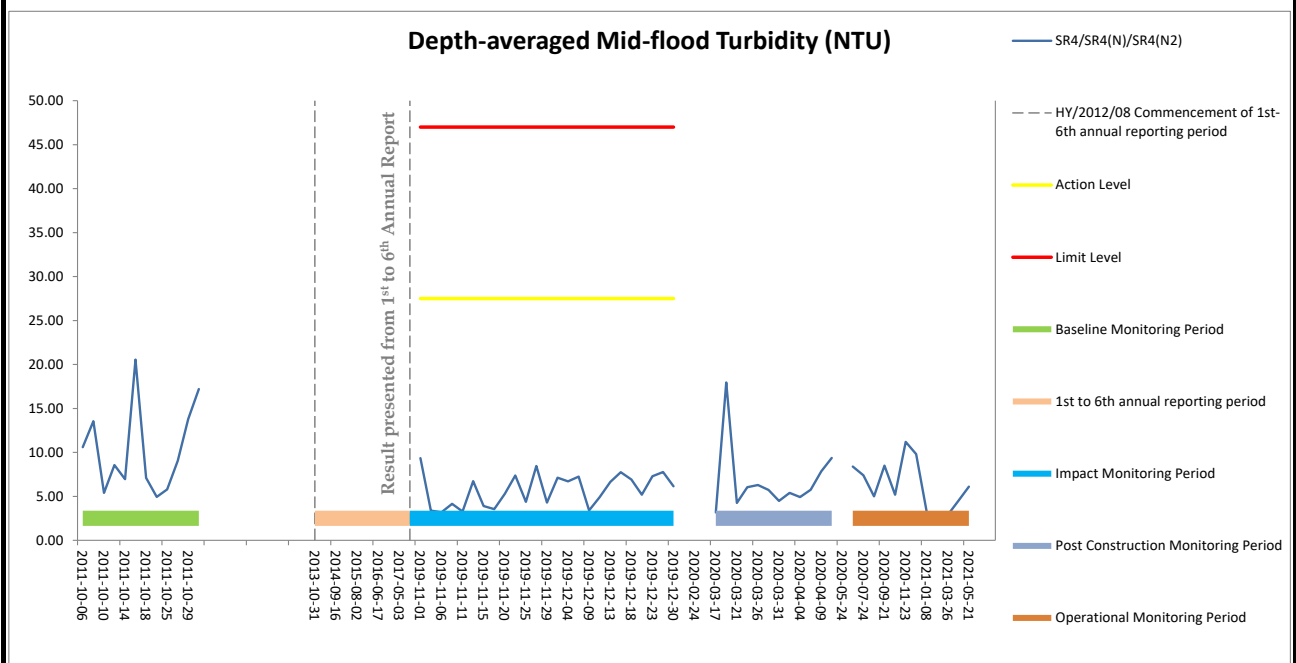
Figure E12 Baseline, Impact, Post-construction & Operational Monitoring - Mean Depth-averaged Level of Turbidity (NTU) between Baseline, Impact, Post-construction & Operational Monitoring (1/11/2019 to 31/5/2021) at SR4/SR4(N)/SR4/SR4(N)/SR4(N2). Weather condition within the reporting period varied between sunny to rainy. The overall monitoring results were not affected by weather conditions. Major marine construction activities included: Installation of green roof system & chain fence - South Ventilation Building; Defect works for reinstatement at Box culvert - Northern Landfall; and Demolition works and backfilling works of CLP substation.

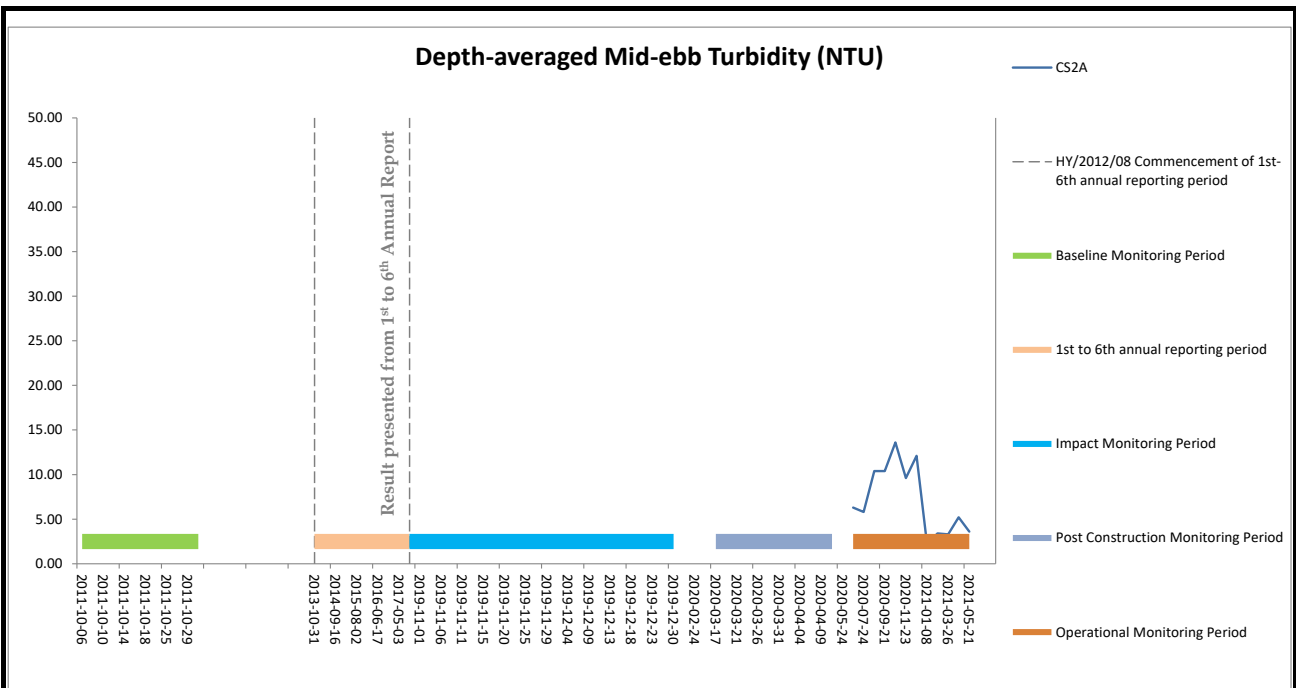
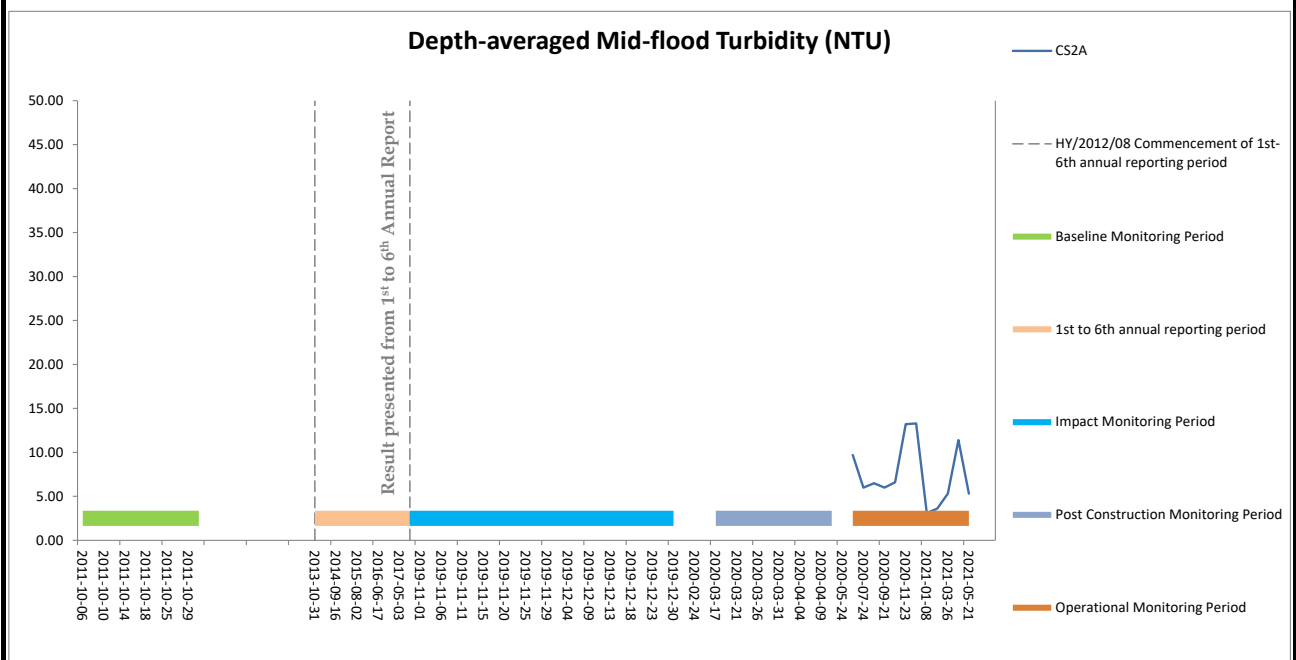
Figure E13 Baseline, Impact, Post-construction & Operational Monitoring - Mean Depth-averaged Level of Turbidity (NTU) between Baseline, Impact, Post-construction & Operational Monitoring (1/11/2019 to 31/5/2021) at CS2A. Weather condition within the reporting period varied between sunny to rainy. The overall monitoring results were not affected by weather conditions. Major marine construction activities included: Installation of green roof system & chain fence - South Ventilation Building; Defect works for reinstatement at Box culvert - Northern Landfall; and Demolition works and backfilling works of CLP substation.

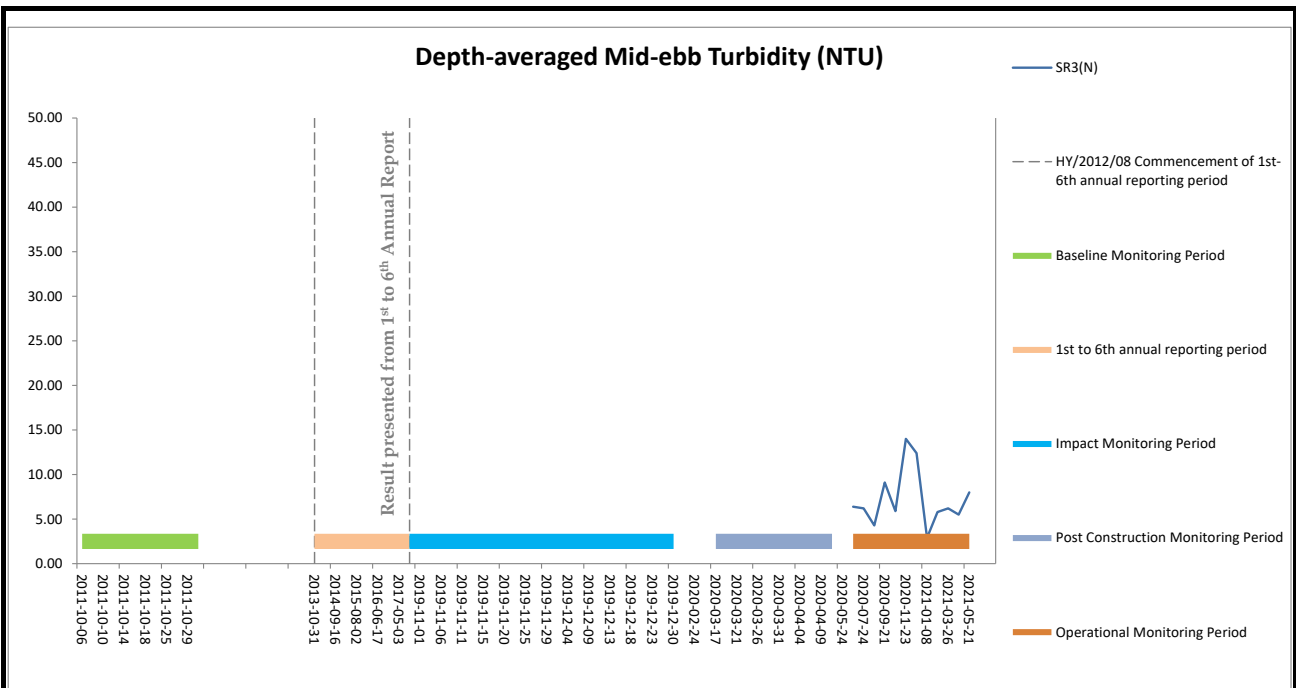
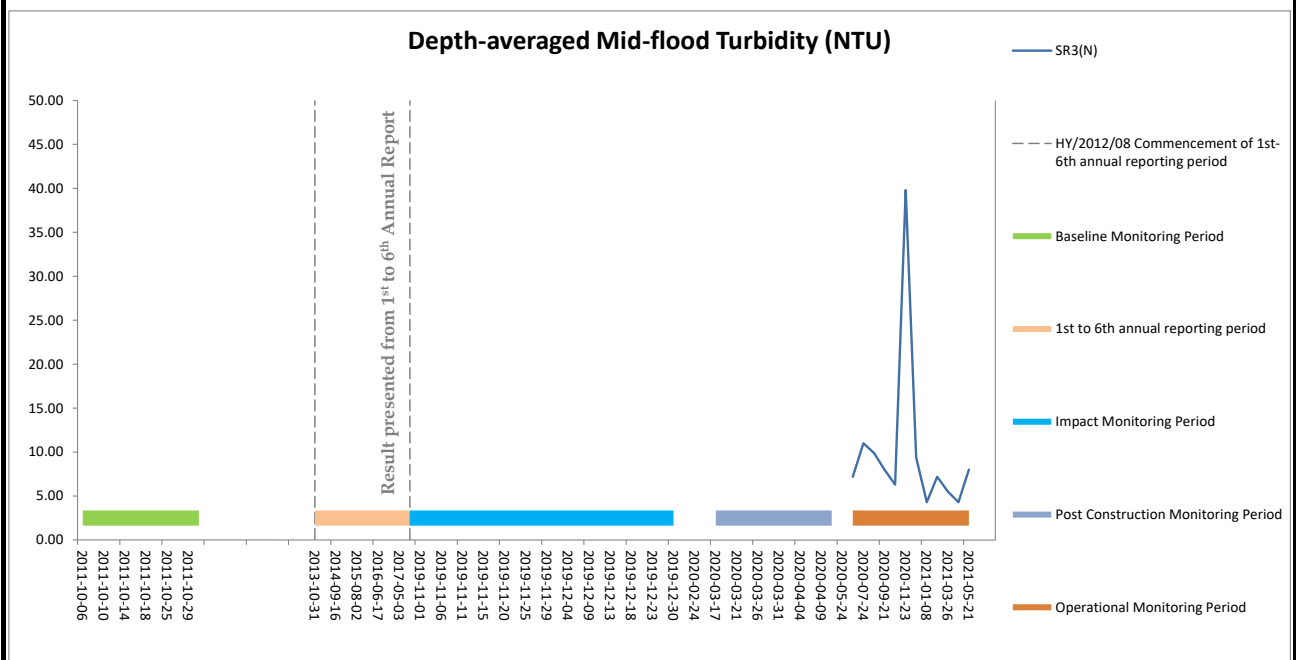
Figure E14 Baseline, Impact, Post-construction & Operational Monitoring - Mean Depth-averaged Level of Turbidity (NTU) between Baseline, Impact, Post-construction & Operational Monitoring (1/11/2019 to 31/5/2021) at SR3(N). Weather condition within the reporting period varied between sunny to rainy. The overall monitoring results were not affected by weather conditions. Major marine construction activities included: Installation of green roof system & chain fence - South Ventilation Building; Defect works for reinstatement at Box culvert - Northern Landfall; and Demolition works and backfilling works of CLP substation.
