**Contract No. HY/2012/08
Tuen Mun – Chek Lap Kok Link –
Northern Connection Sub-sea Tunnel
Section**

***Eighth Annual Environmental Monitoring & Audit
(EM&A) Report***

14 December 2021

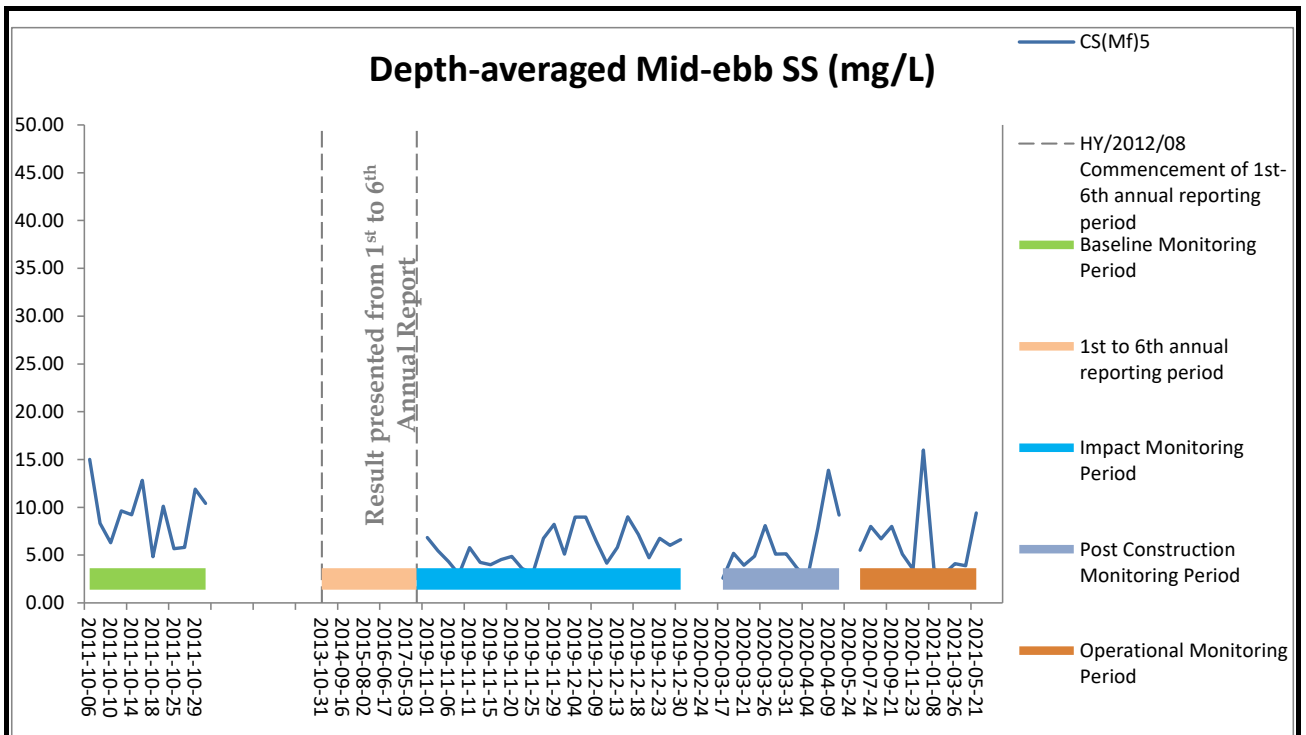
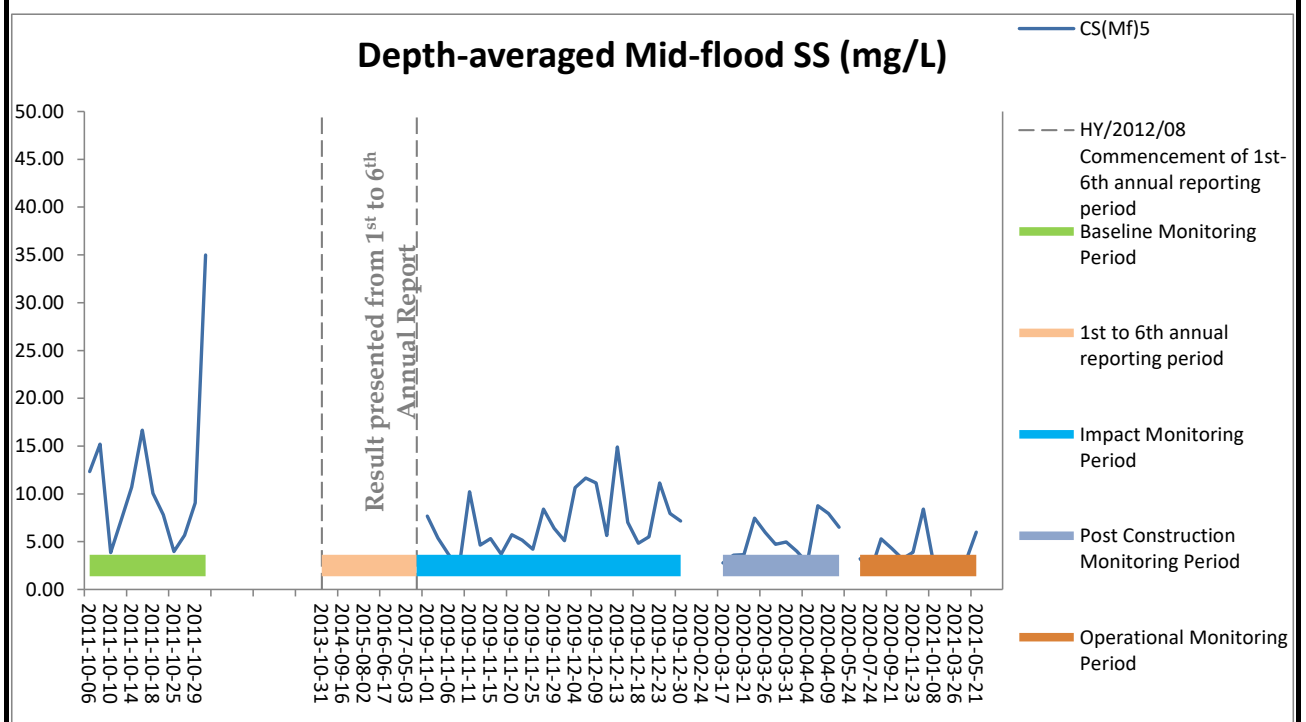
Figure E15 Baseline, Impact, Post-construction & Operational Monitoring - Mean Depth-averaged Level of Suspended Solids (mg/L) between Baseline, Impact, Post-construction & Operational Monitoring (1/11/2019 to 31/5/2021) at CS(Mf)5. Weather condition within the reporting period varied between sunny to rainy. The overall monitoring results were not affected by weather conditions. Major marine construction activities included: Installation of green roof system & chain fence - South Ventilation Building; Defect works for reinstatement at Box culvert - Northern Landfall; and Demolition works and backfilling works of CLP substation.

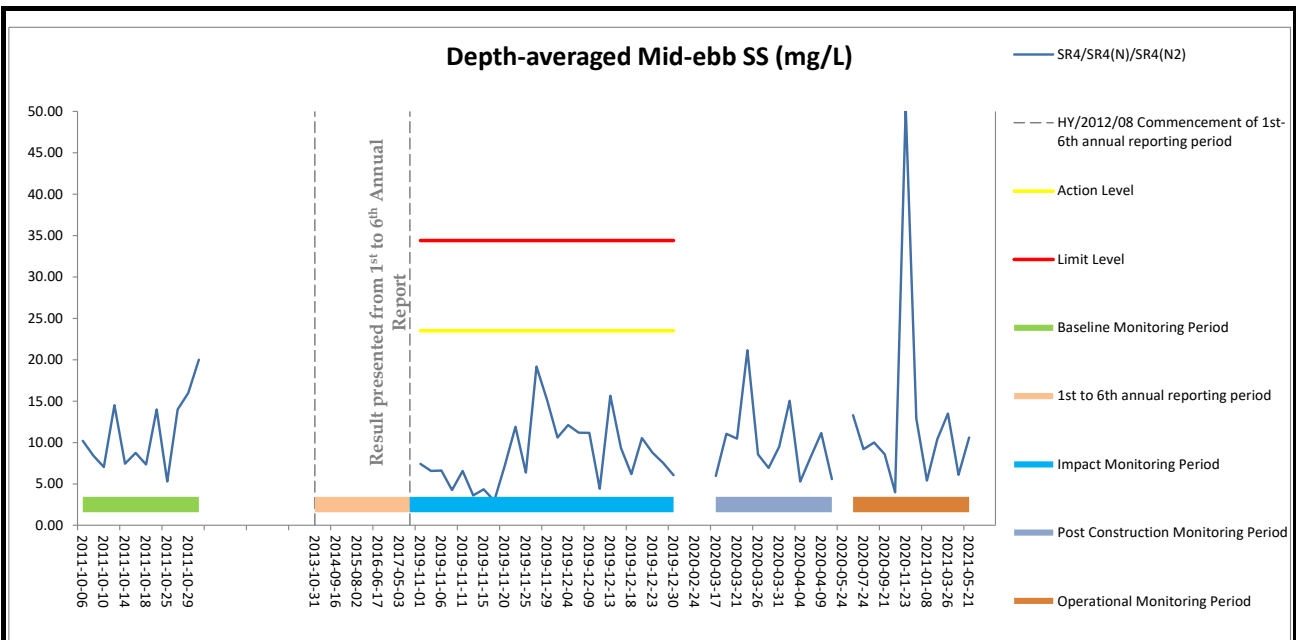
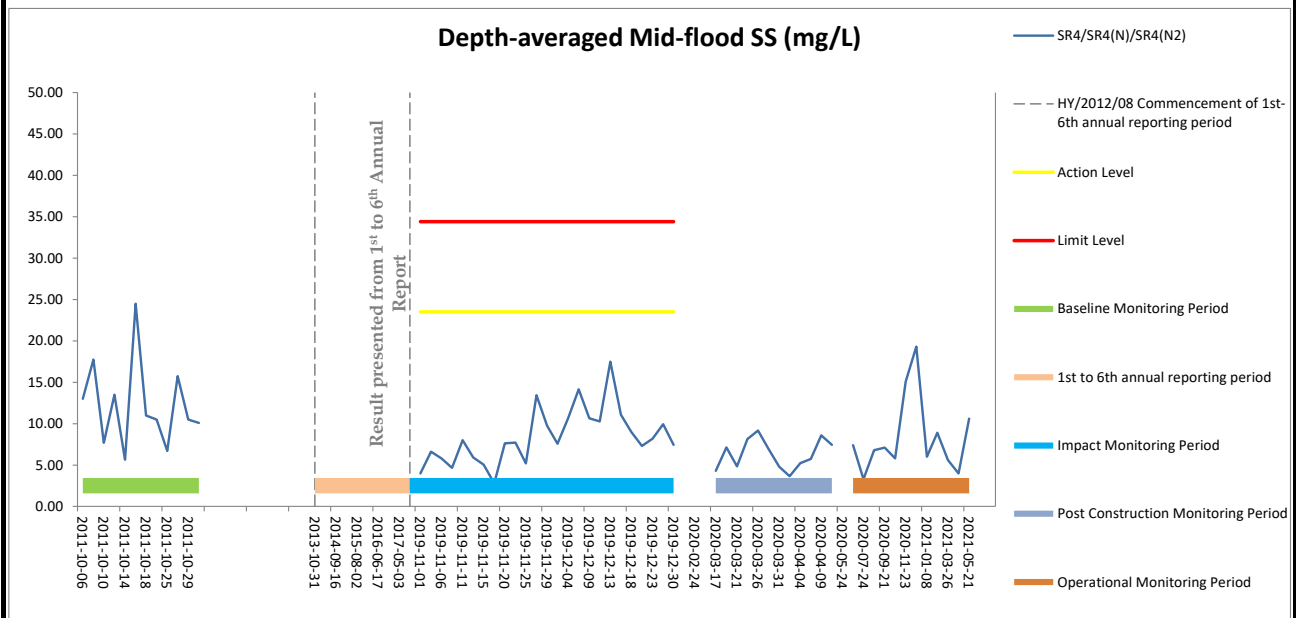
Figure E16 Baseline, Impact, Post-construction & Operational Monitoring - Mean Depth-averaged Level of Suspended Solids (mg/L) between Baseline, Impact, Post-construction & Operational Monitoring (1/11/2019 to 31/5/2021) at SR4/SR4(N)/SR4/SR4(N)/SR4(N2). Weather condition within the reporting period varied between sunny to rainy. The overall monitoring results were not affected by weather conditions. Major marine construction activities included: Installation of green roof system & chain fence - South Ventilation Building; Defect works for reinstatement at Box culvert - Northern Landfall; and Demolition works and backfilling works of CLP substation.

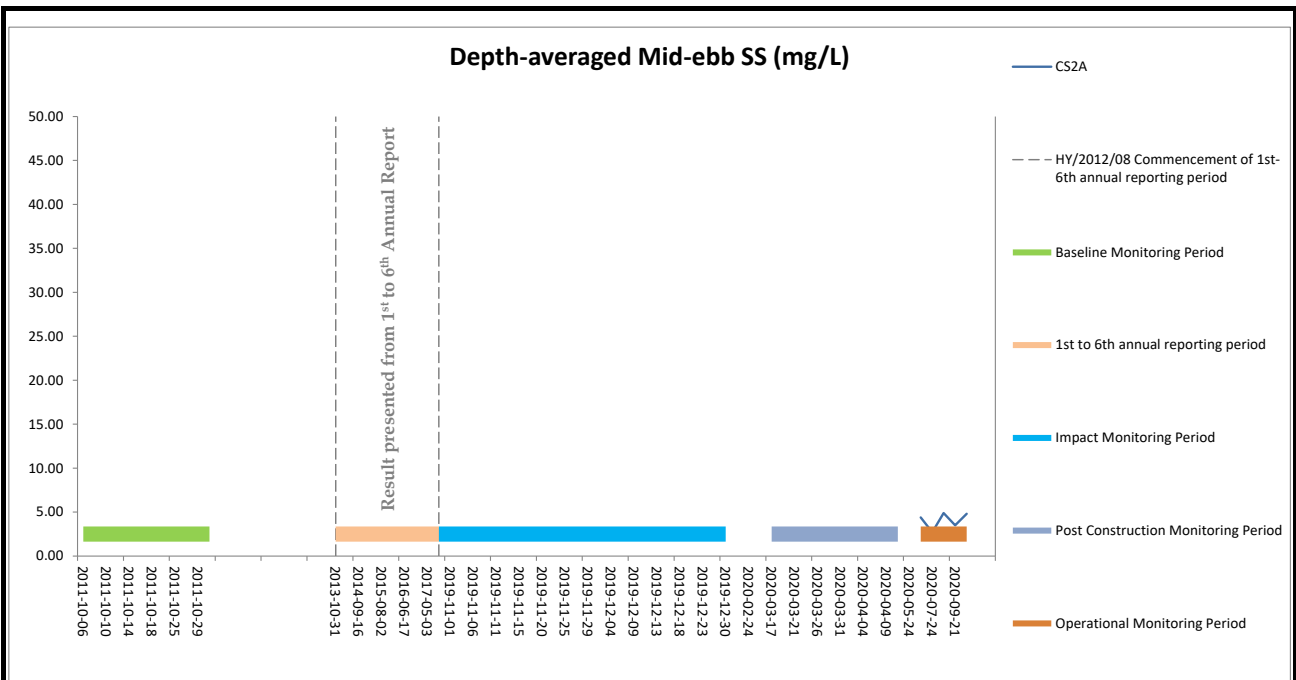
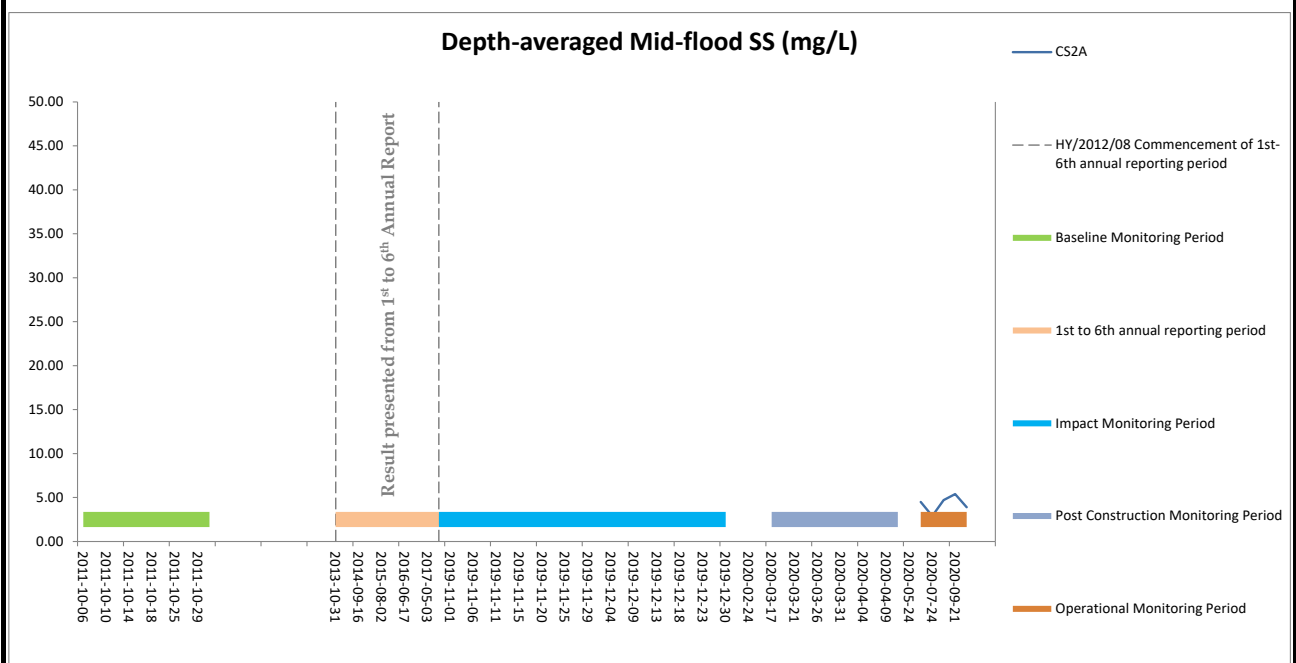
Figure E17 Baseline, Impact, Post-construction & Operational Monitoring - Mean Depth-averaged Level of Suspended Solids (mg/L) between Baseline, Impact, Post-construction & Operational Monitoring (1/11/2019 to 31/5/2021) at CS2A. Weather condition within the reporting period varied between sunny to rainy. The overall monitoring results were not affected by weather conditions. Major marine construction activities included: Installation of green roof system & chain fence - South Ventilation Building; Defect works for reinstatement at Box culvert - Northern Landfall; and Demolition works and backfilling works of CLP substation.

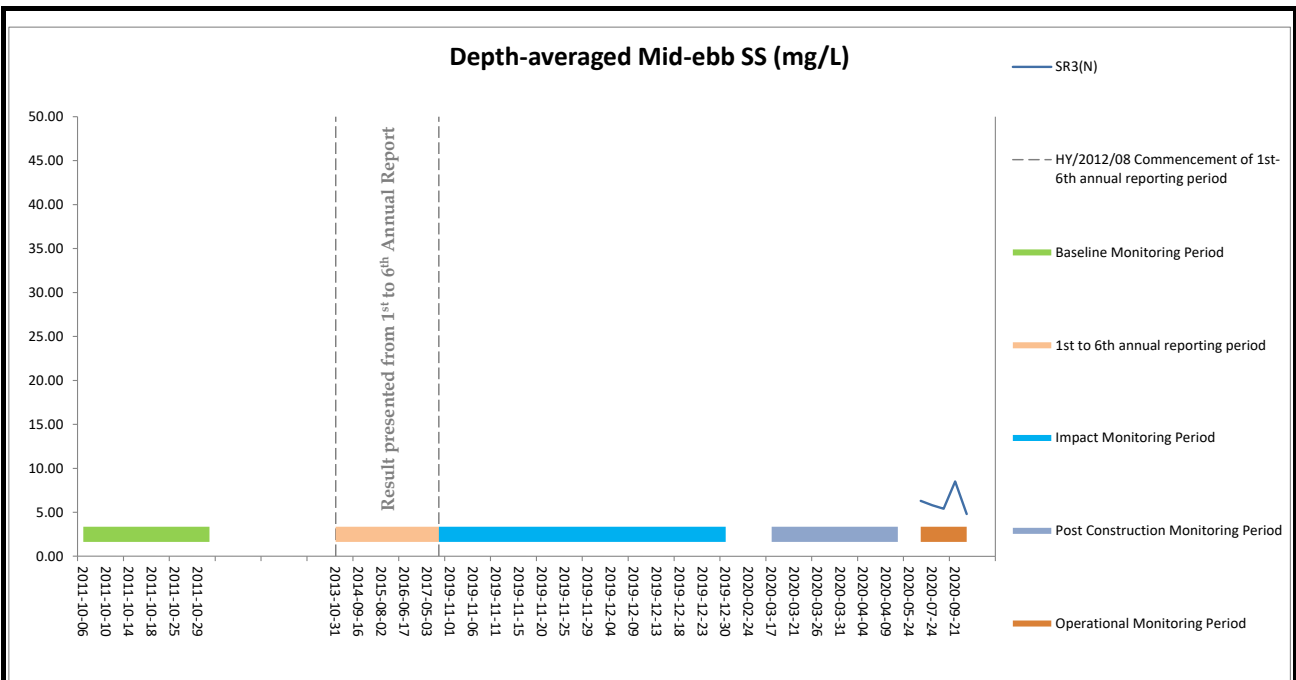
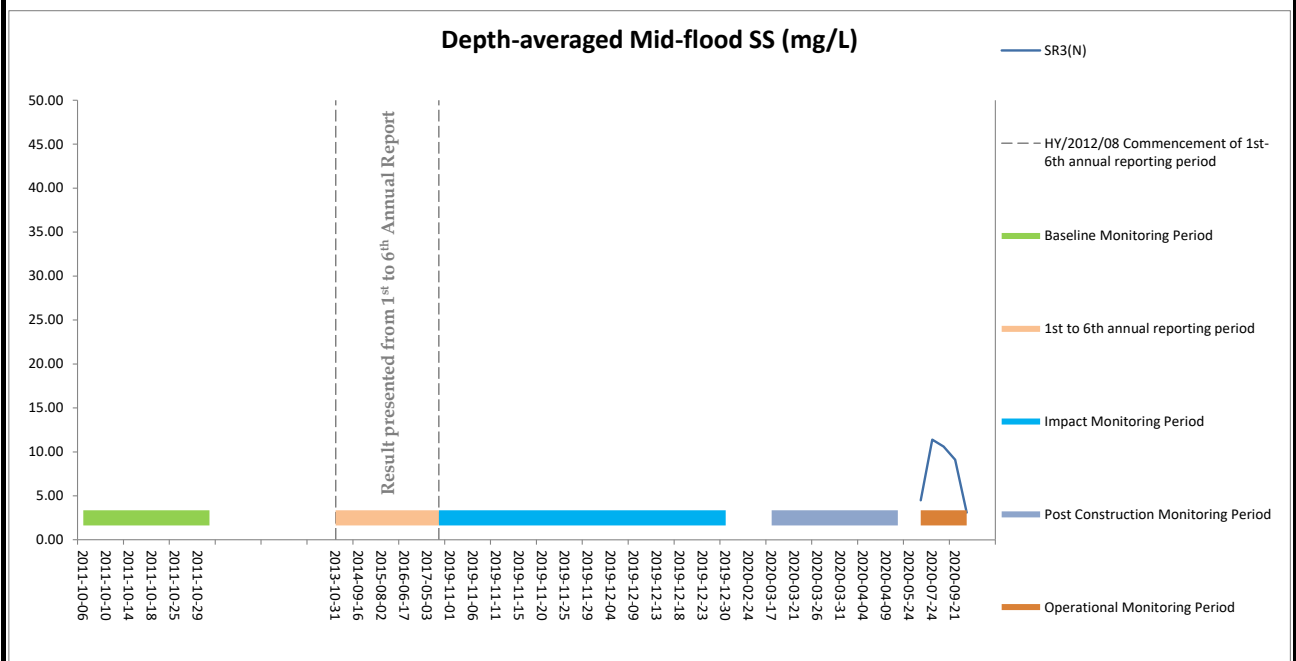
Figure E18 Baseline, Impact, Post-construction & Operational Monitoring - Mean Depth-averaged Level of Suspended Solids (mg/L) between Baseline, Impact, Post-construction & Operational Monitoring (1/11/2019 to 31/5/2021) at SR3(N). Weather condition within the reporting period varied between sunny to rainy. The overall monitoring results were not affected by weather conditions. Major marine construction activities included: Installation of green roof system & chain fence - South Ventilation Building; Defect works for reinstatement at Box culvert - Northern Landfall; and Demolition works and backfilling works of CLP substation.

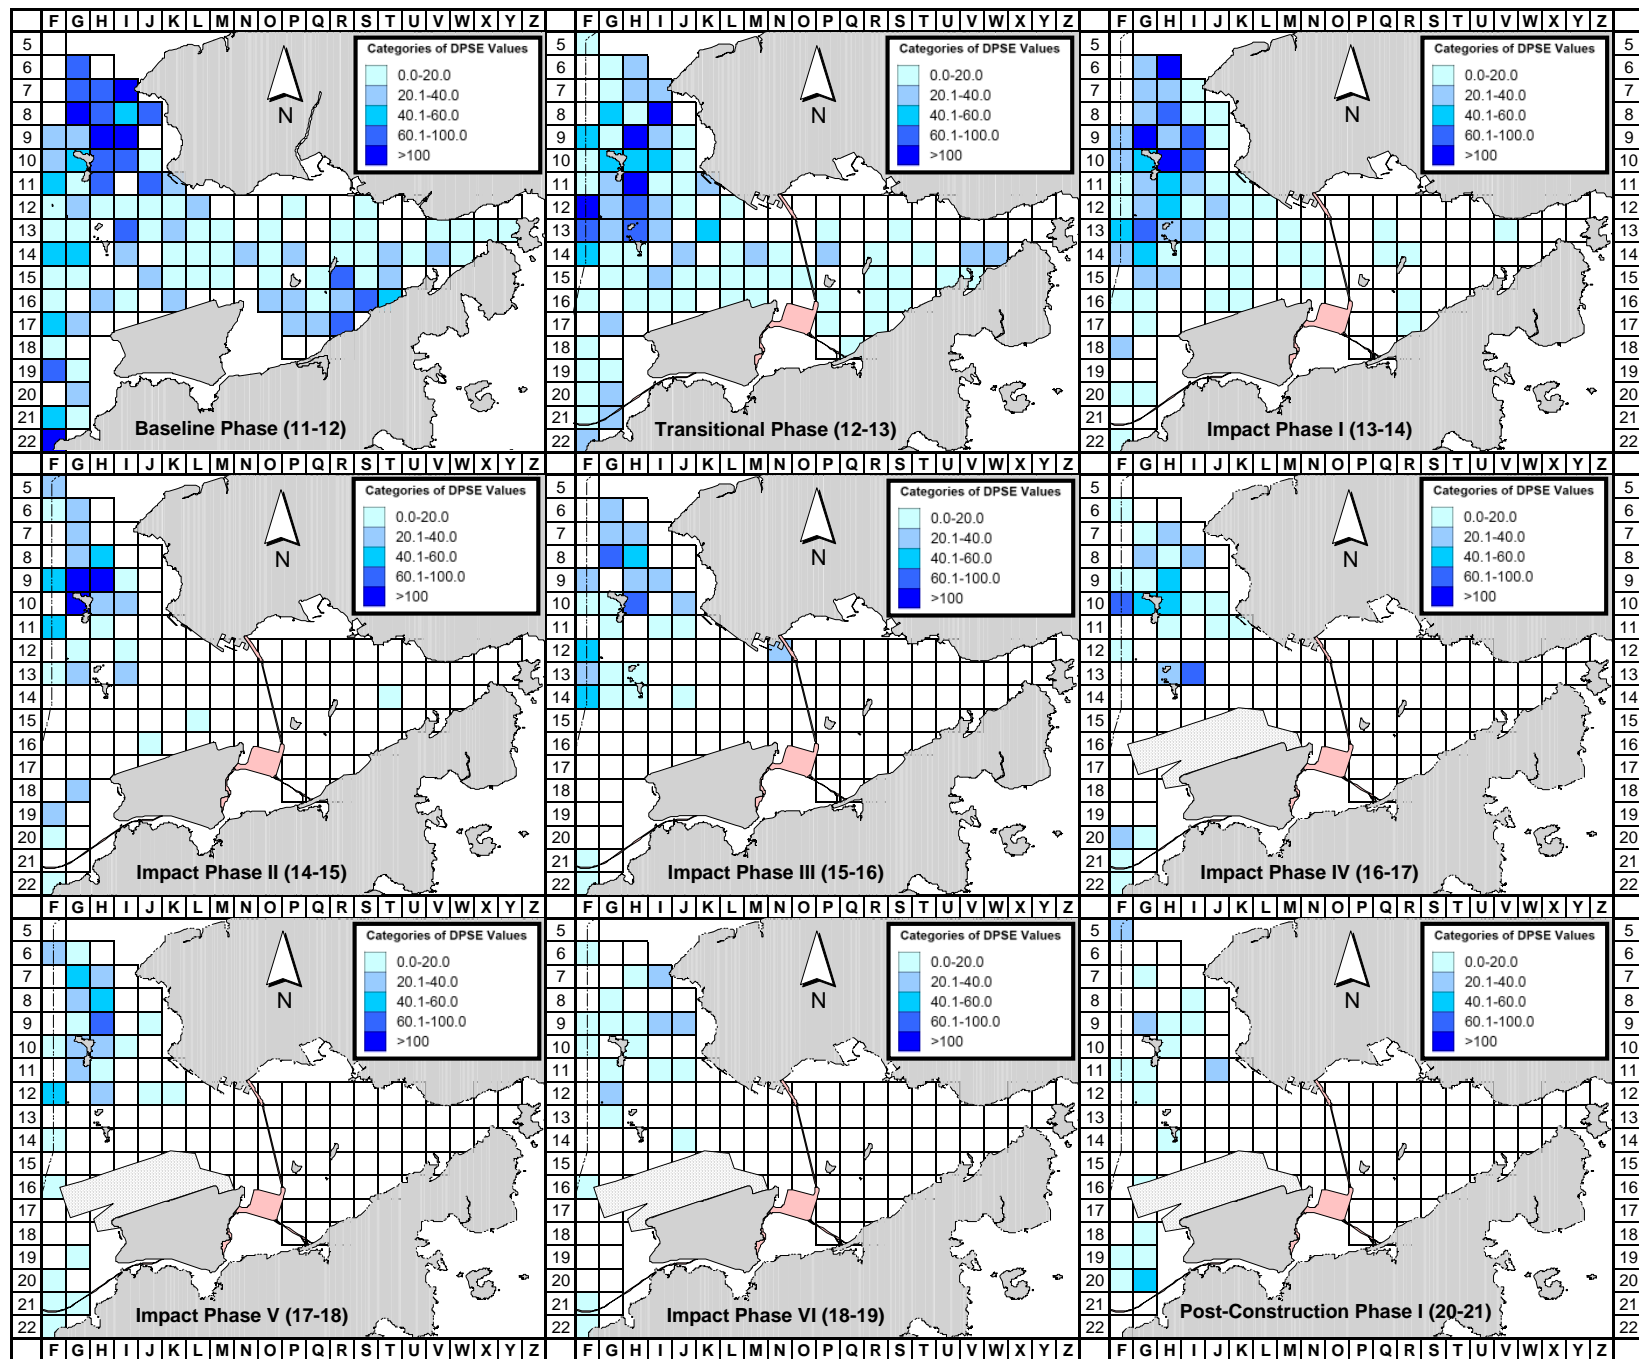
Figure 5. Comparison of density of Chinese white dolphins with corrected survey effort per km² in NWL and NEL survey areas between the first post-construction phase of TMCLKL in 2020-21, the six impact phases of TMCLKL (2013-14, 2014-15, 2015-16, 2016-17, 2017-18 & 2018-19), transitional phase in 2012-13 and baseline phase in 2011-12 (DPSE = no. of dolphins per 100 units of survey effort)
