**Contract No. HY/2012/07  
Tuen Mun - Chek Lap Kok Link -  
Southern Connection Viaduct Section**

*Twenty-fifth Quarterly Environmental  
Monitoring & Audit (EM&A) Report*

12 May 2020

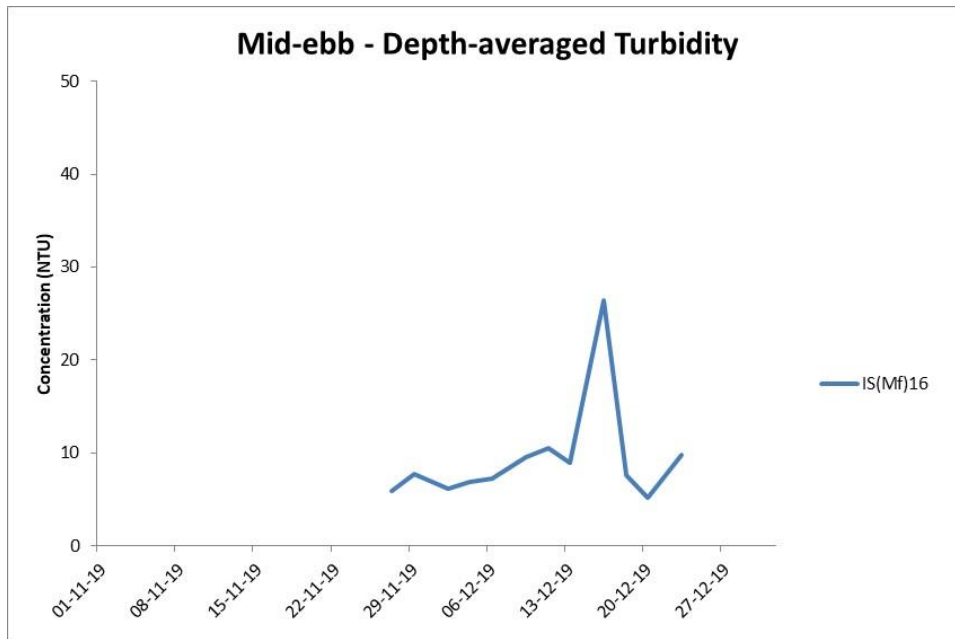
**Figure F20 Post-Construction Monitoring – Mean Level of depth-averaged Turbidity (NTU) during mid-ebb tide between 27 November 2019 and 23 December 2019 at IS(Mf)16 and IS(Mf)9.**

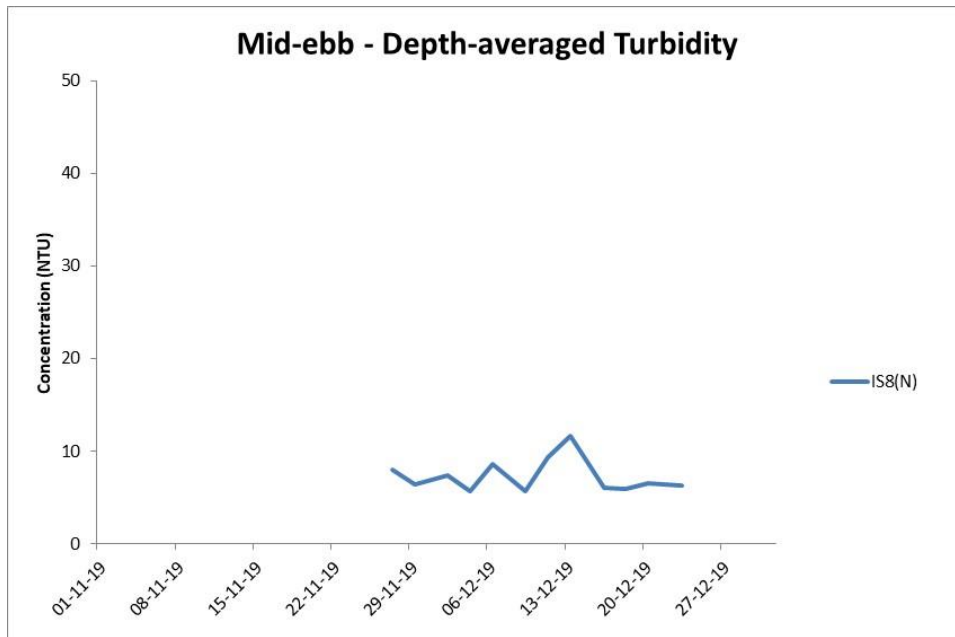
**Figure F21 Post-Construction Monitoring – Mean Level of depth-averaged Turbidity (NTU) during mid-ebb tide between 27 November 2019 and 23 December 2019 at IS8(N) and SR4(N2).**

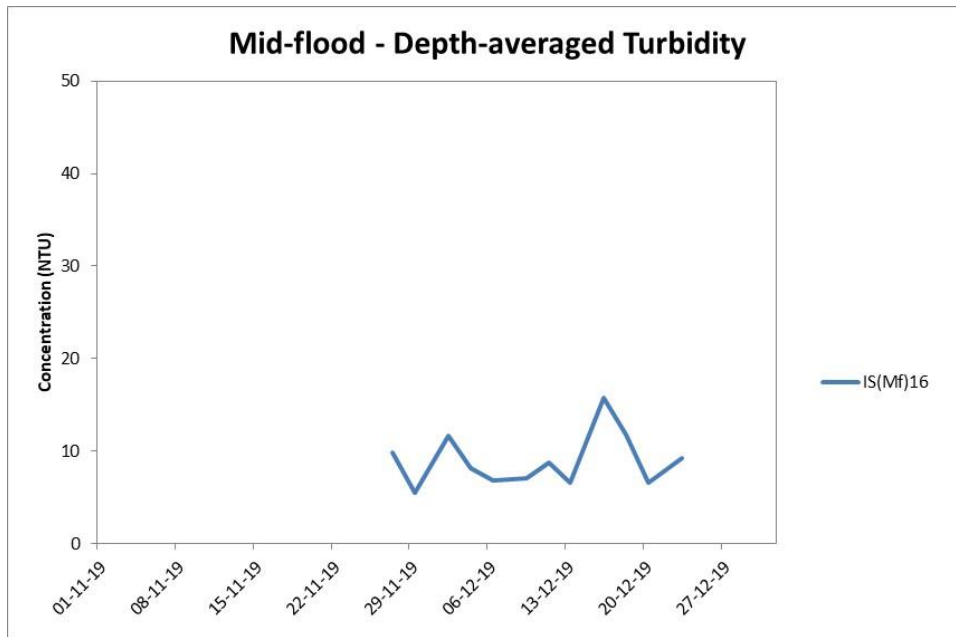
**Figure F24 Post-Construction Monitoring - Mean Level of depth-averaged Turbidity (NTU) during mid-flood tide between 27 November 2019 and 23 December 2019 at IS(Mf)16 and IS(Mf)9.**

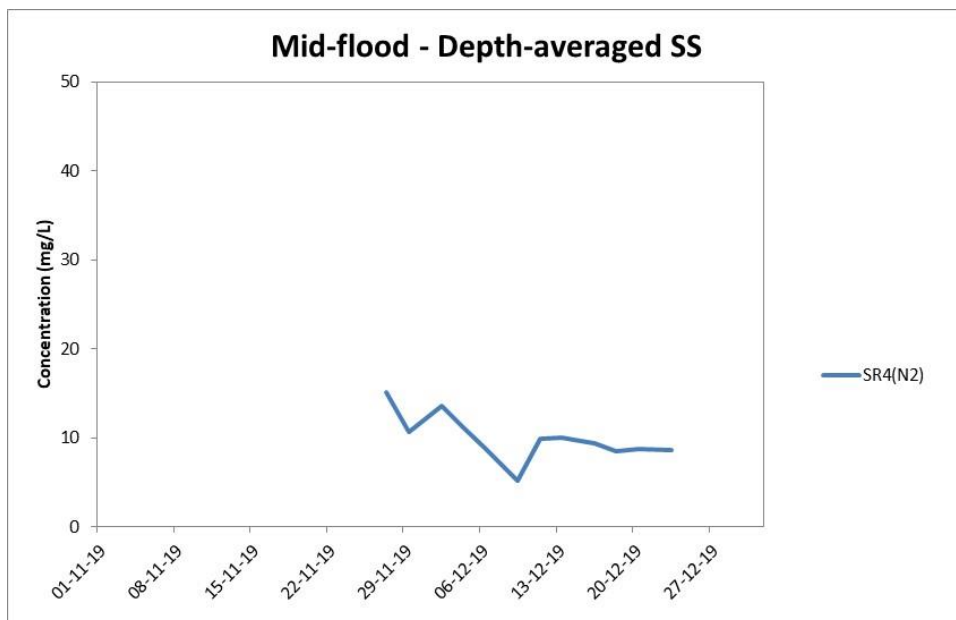
**Figure F33 Post-Construction Monitoring – Mean depth-averaged level of Suspended Solids (mg/L) during mid-flood tide between 27 November 2019 and 23 December 2019 at IS8(N) and SR4(N2).**
