**Contract No. HY/2012/07
Tuen Mun – Chek Lap Kok Link –
Southern Connection Viaduct Section**

***Sixth Quarterly Environmental Monitoring &
Audit (EM&A) Report***

19 October 2015

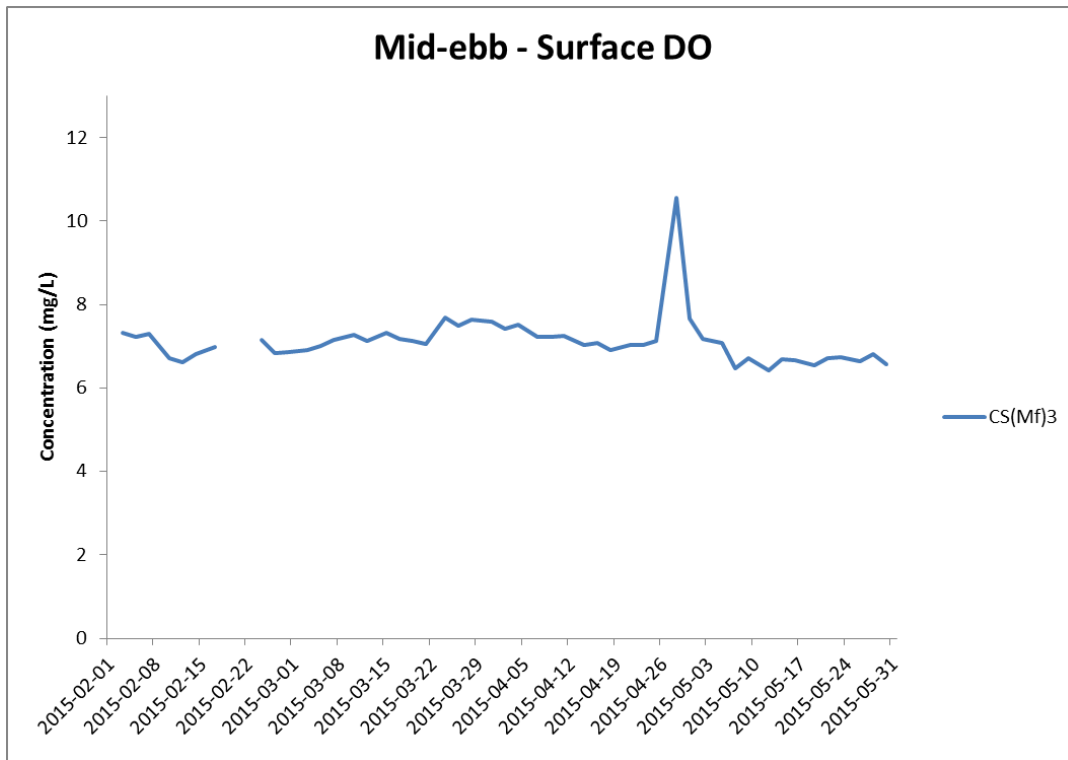
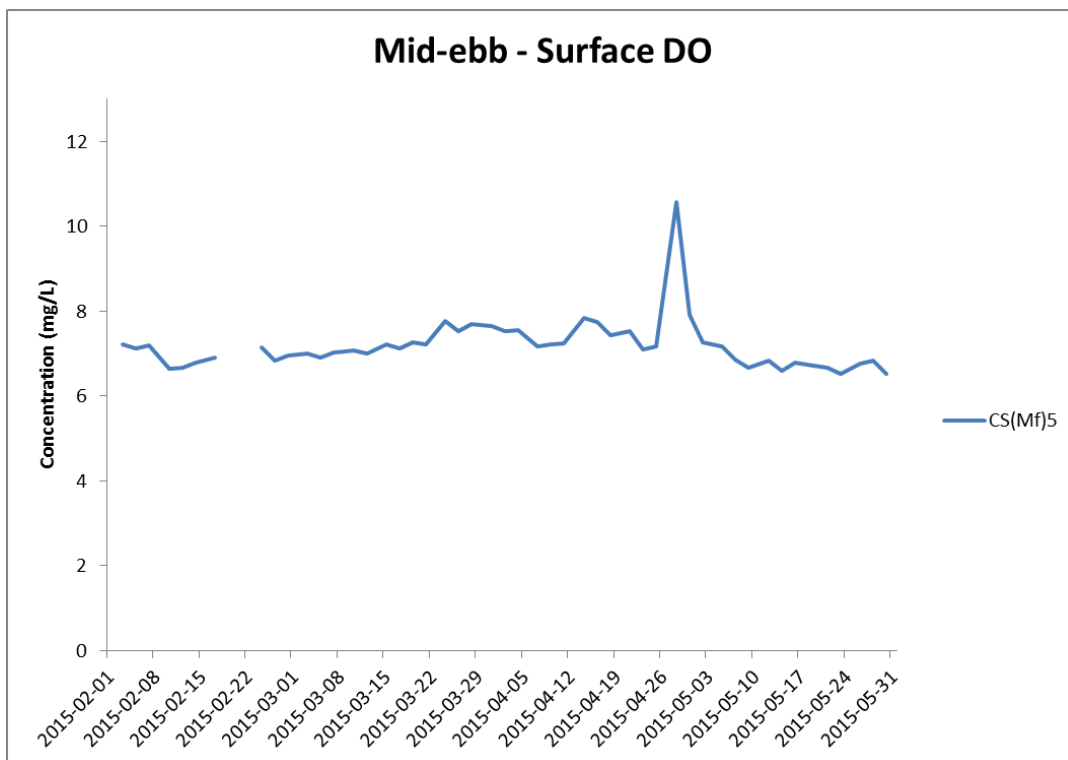
Figure H1 Impact Monitoring - Mean Level of Dissolved Oxygen (mg/L) in surface waters during mid-ebb tide between 1 February and 31 May 2015 at CS(Mf)3 and CS(Mf)5.

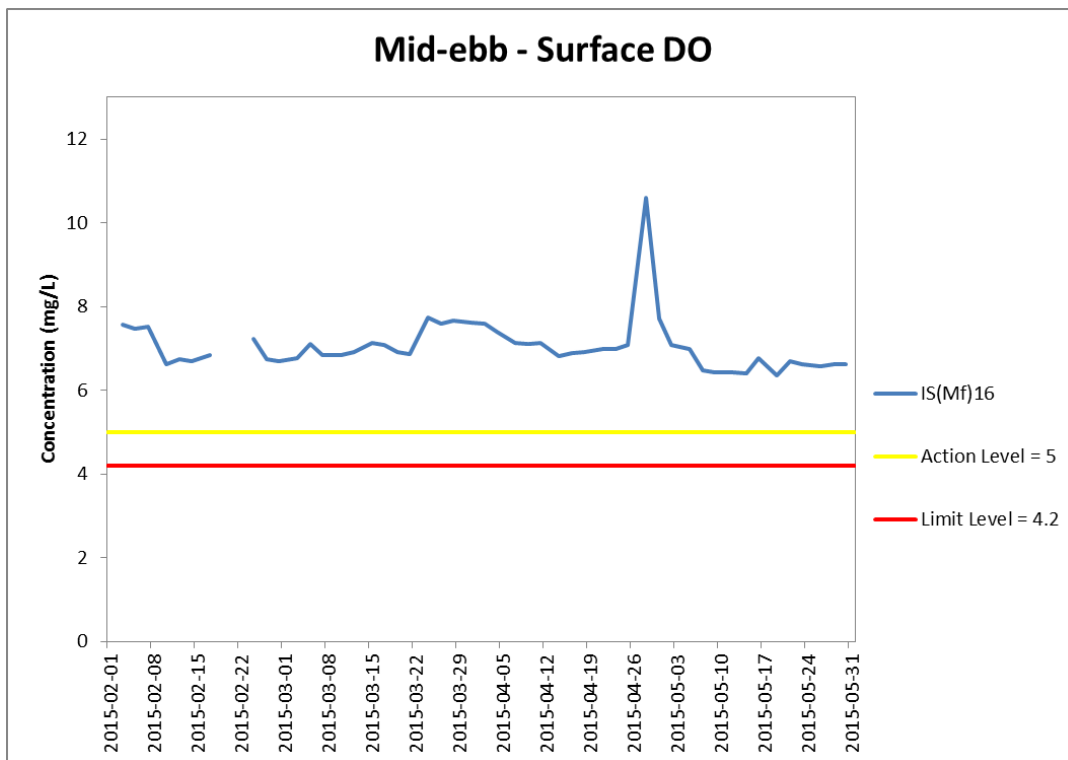
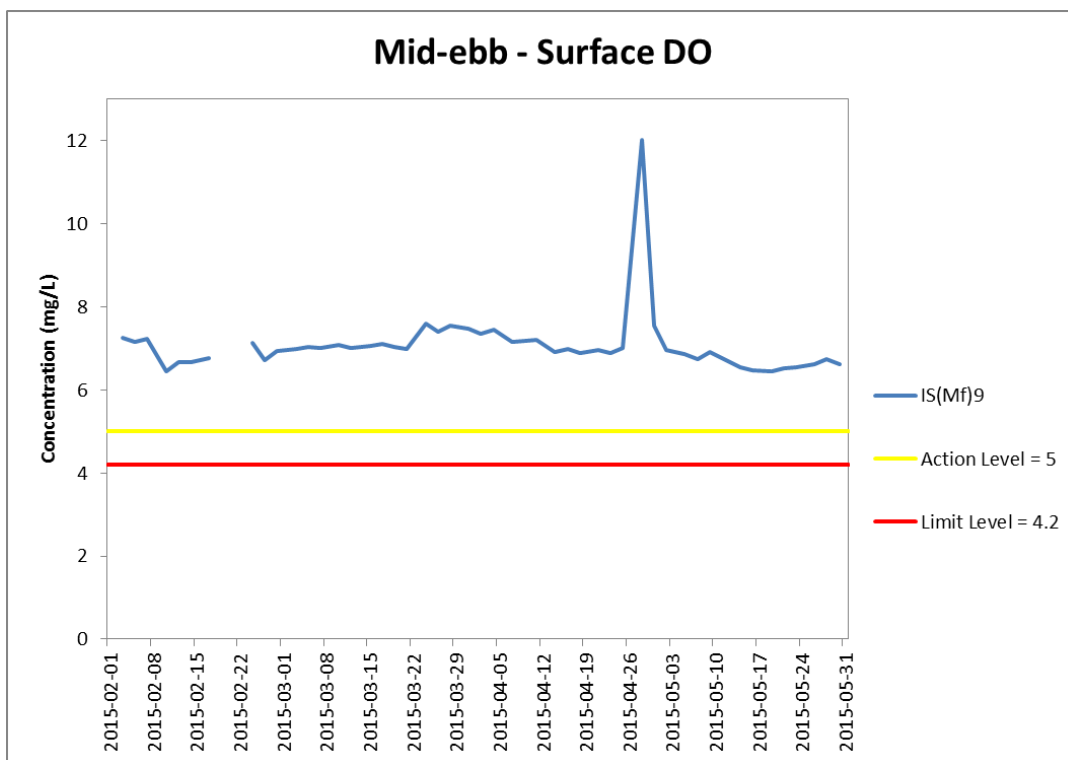
Figure H2 Impact Monitoring - Mean Level of Dissolved Oxygen (mg/L) in surface waters during mid-ebb tide between 1 February and 31 May 2015 at IS(Mf)16 and IS(Mf)9.

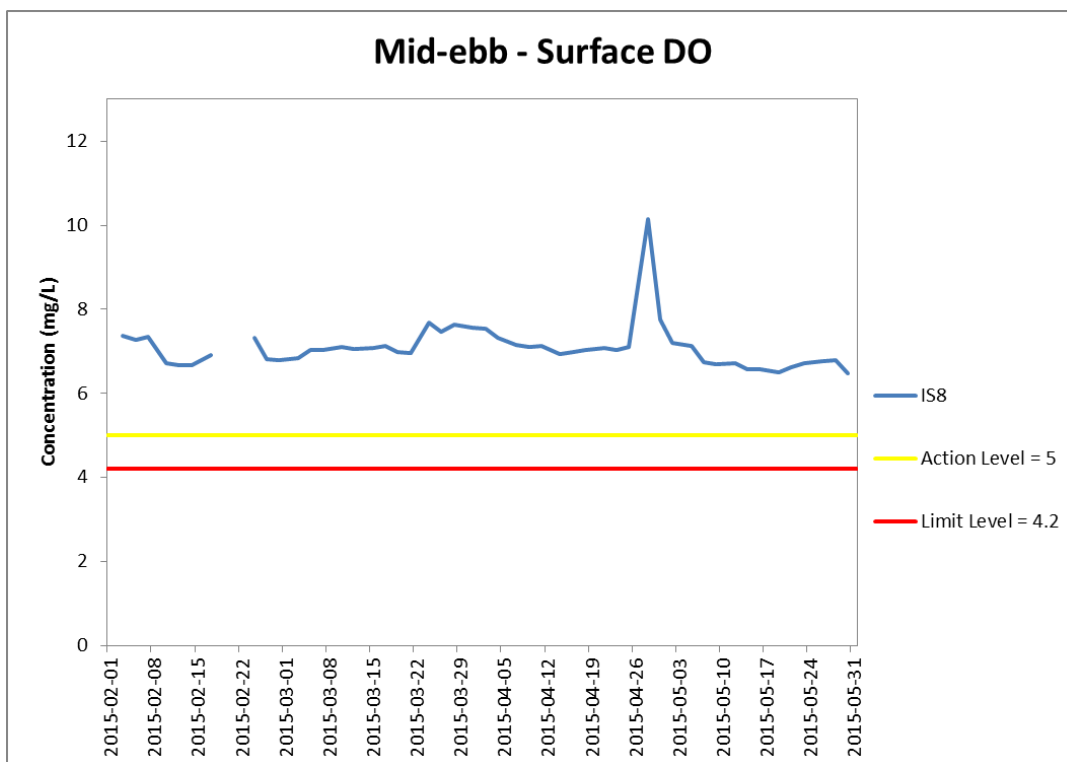
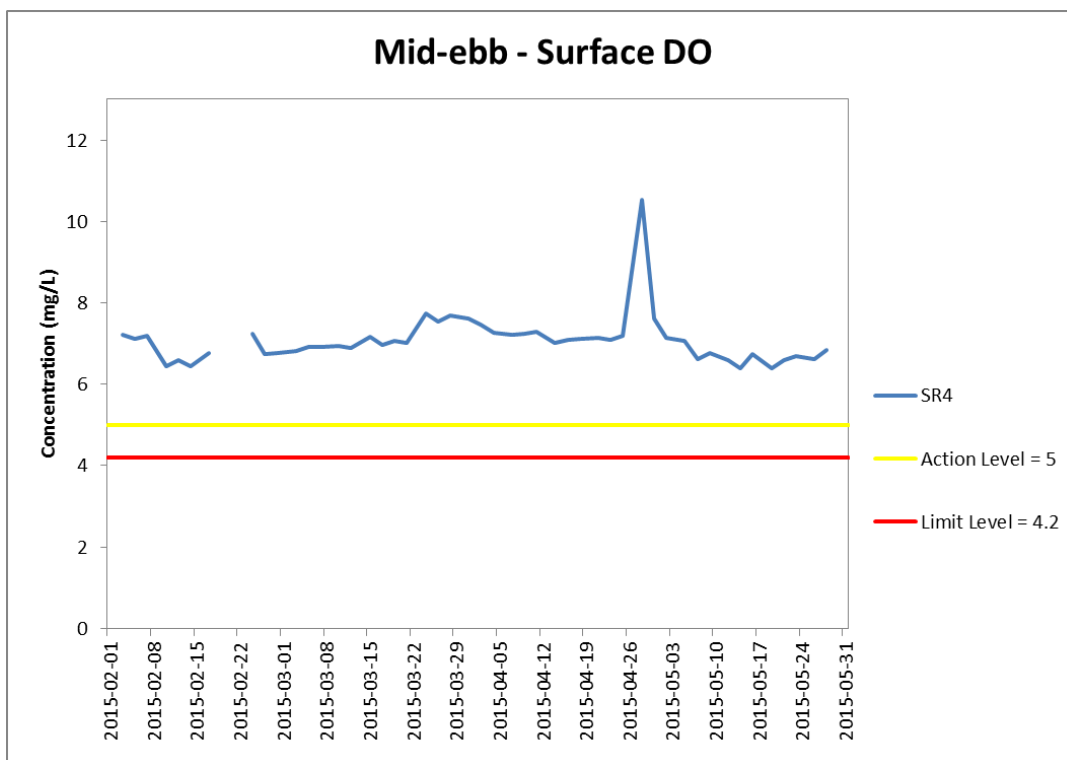
Figure H3 Impact Monitoring – Mean Level of Dissolved Oxygen (mg/L) in surface waters during mid-ebb tide between 1 February and 31 May 2015 at IS8 and SR4.

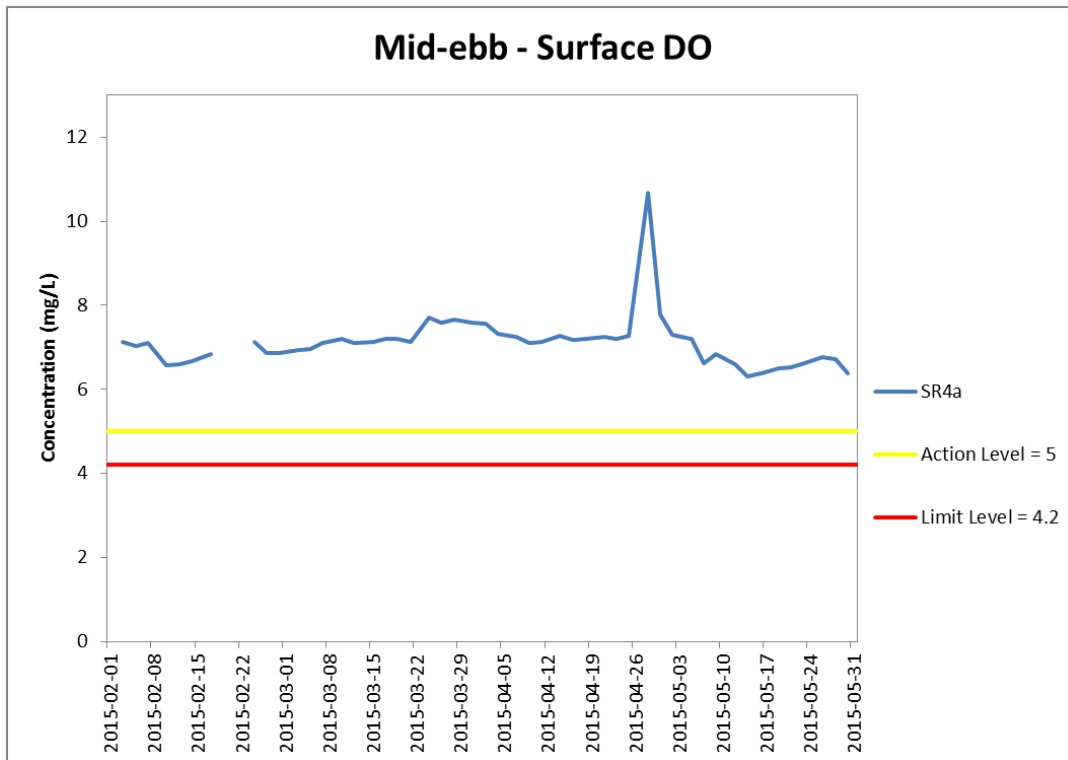
Figure H4 Impact Monitoring – Mean Level of Dissolved Oxygen (mg/L) in surface waters during mid-ebb tide between 1 February and 31 May 2015 at SR4a.

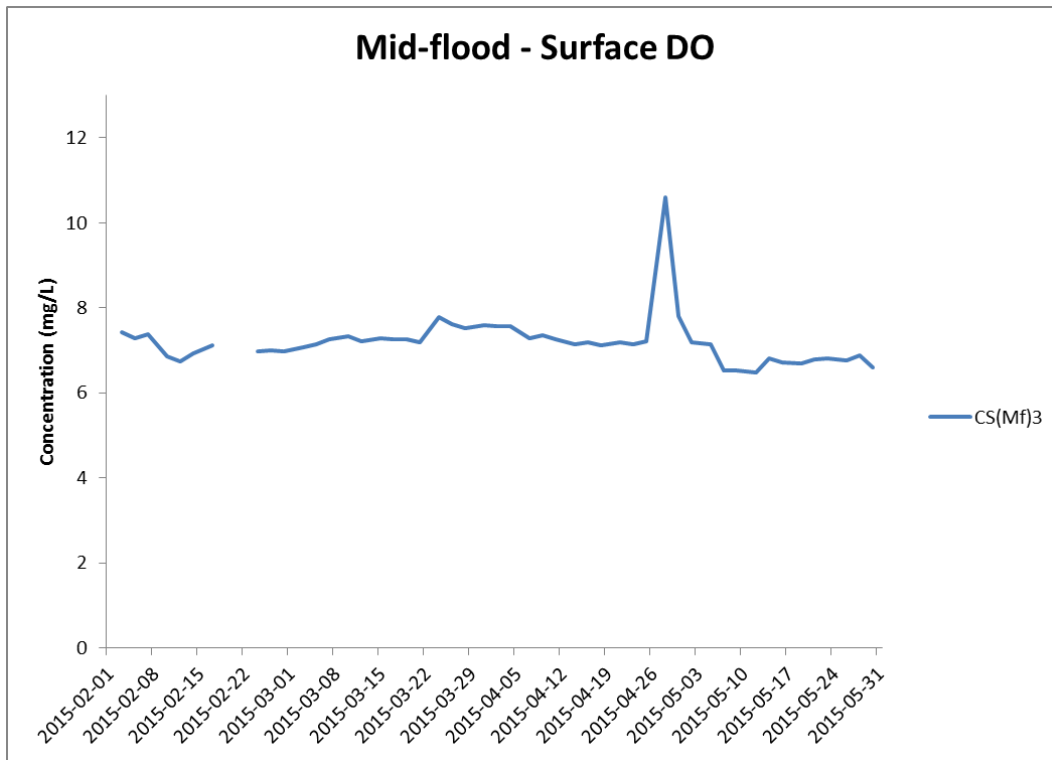
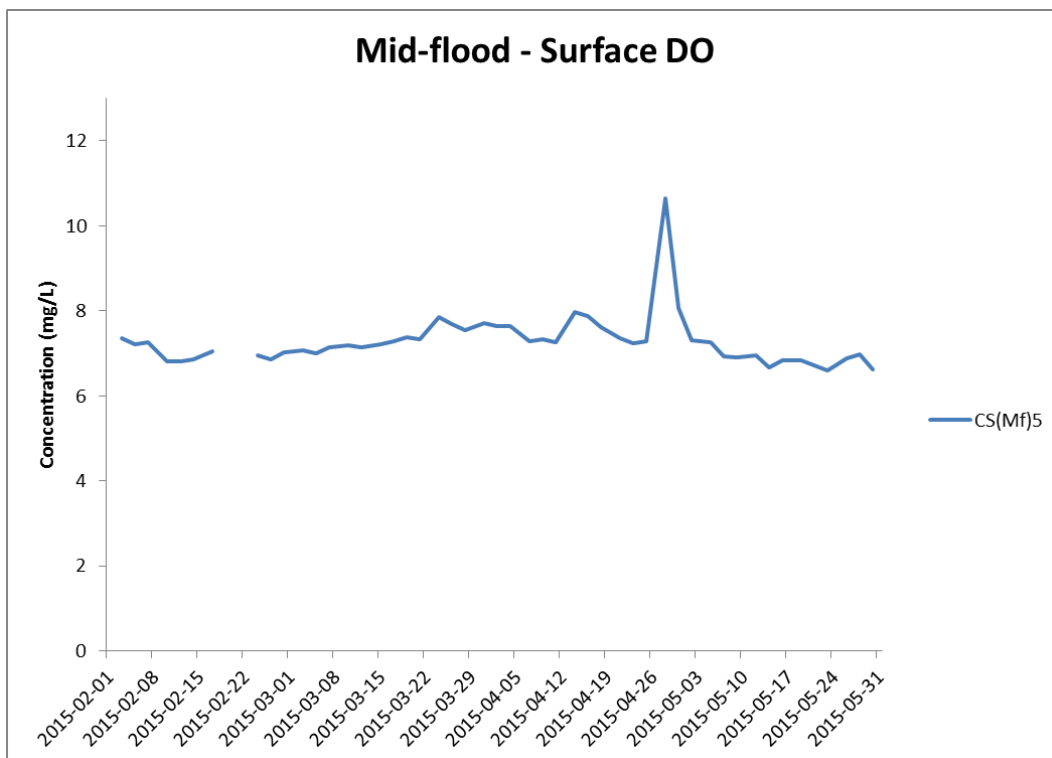
Figure H5 Impact Monitoring - Mean Level of Dissolved Oxygen (mg/L) in surface waters during mid-flood tide between 1 February and 31 May 2015 at CS(Mf)3 and CS(Mf)5.

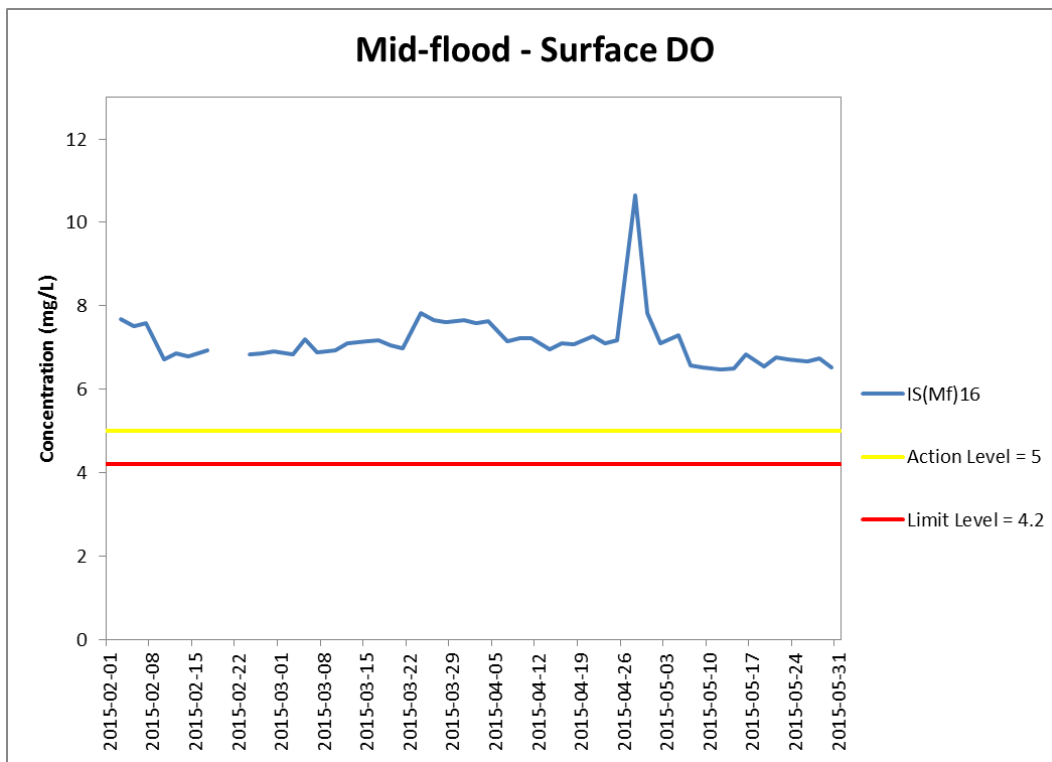
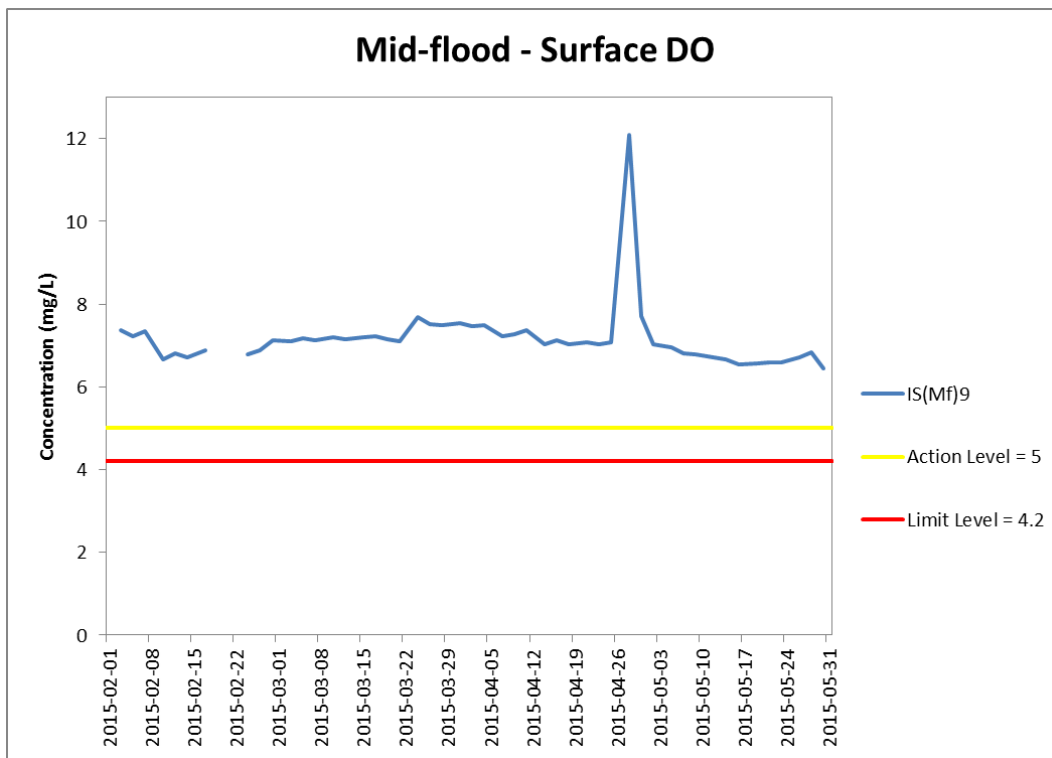
Figure H6 Impact Monitoring – Mean Level of Dissolved Oxygen (mg/L) in surface waters during mid-flood tide between 1 February and 31 May 2015 at IS(Mf)16 and IS(Mf)9.

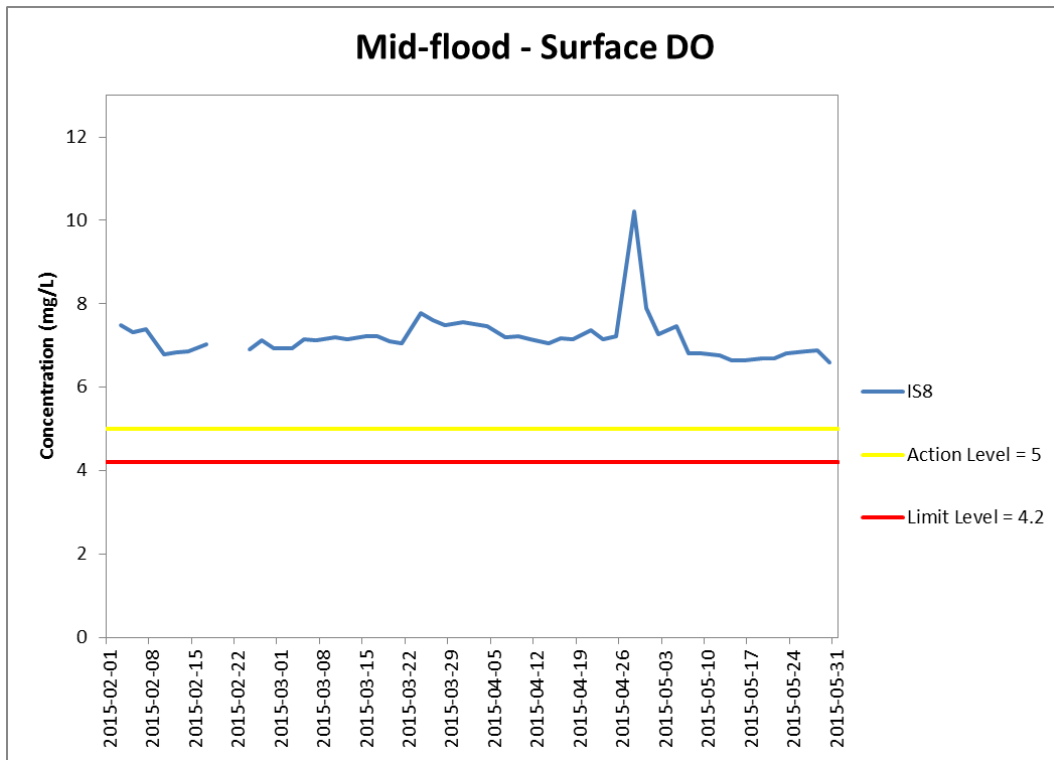
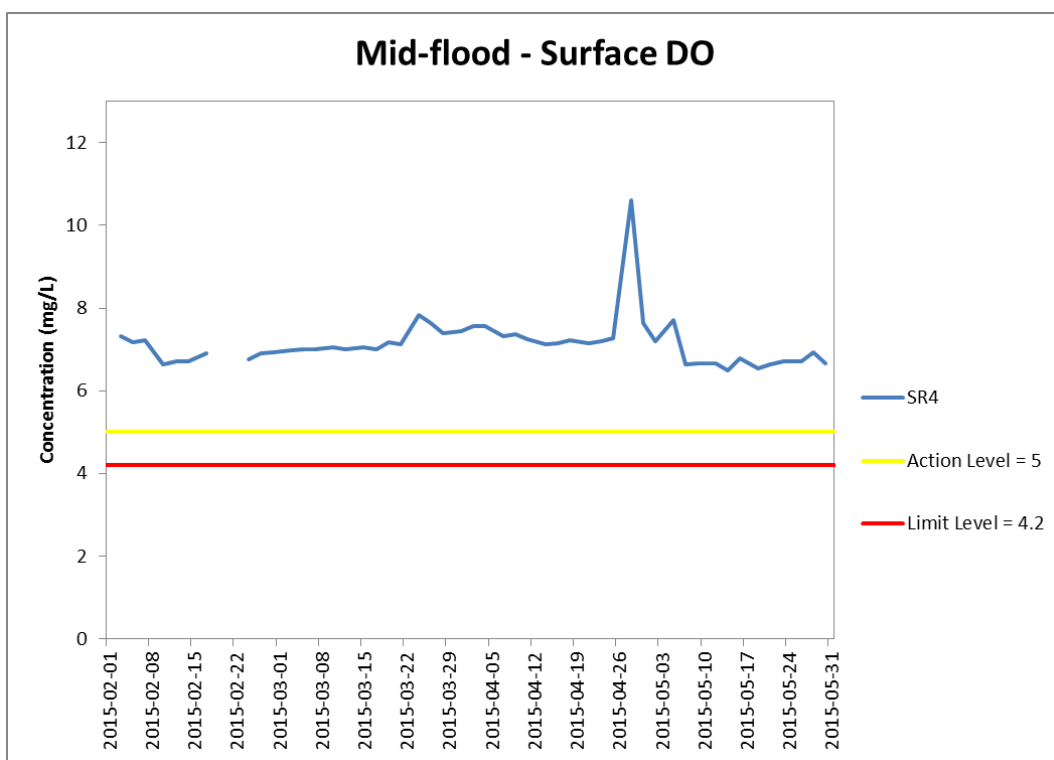
Figure H7 Impact Monitoring - Mean Level of Dissolved Oxygen (mg/L) in surface waters during mid-flood tide between 1 February and 31 May 2015 at IS8 and SR4.

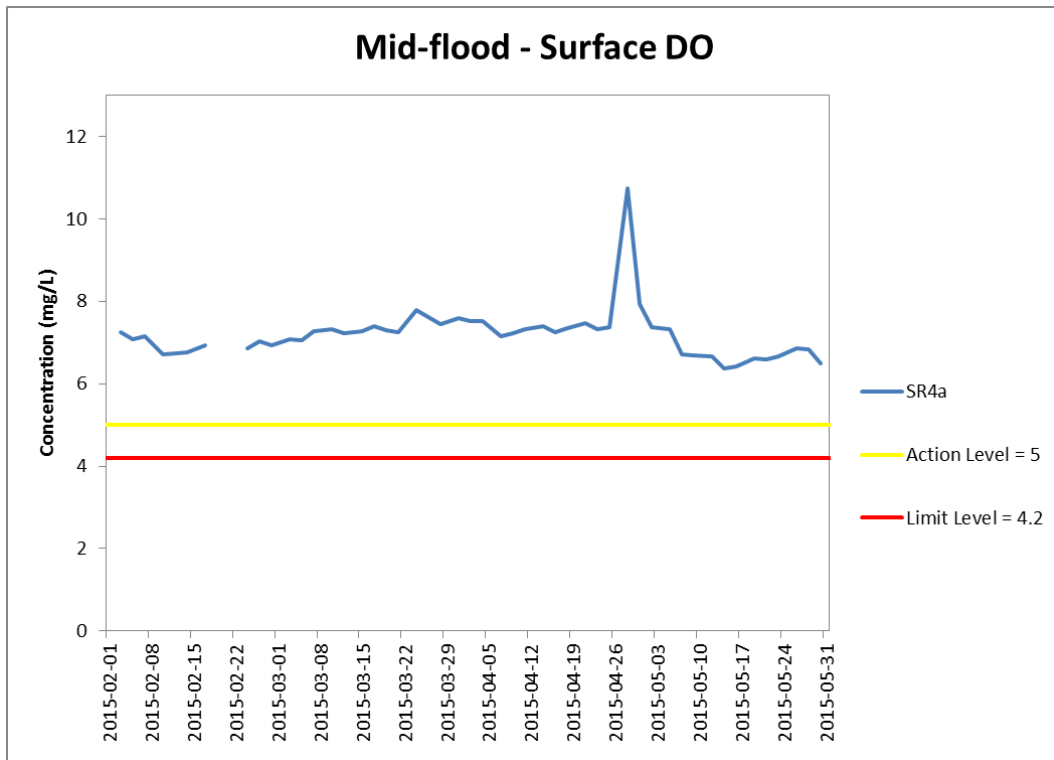
Figure H8 Impact Monitoring – Mean Level of Dissolved Oxygen (mg/L) in surface waters during mid-flood tide between 1 February and 31 May 2015 at SR4a.

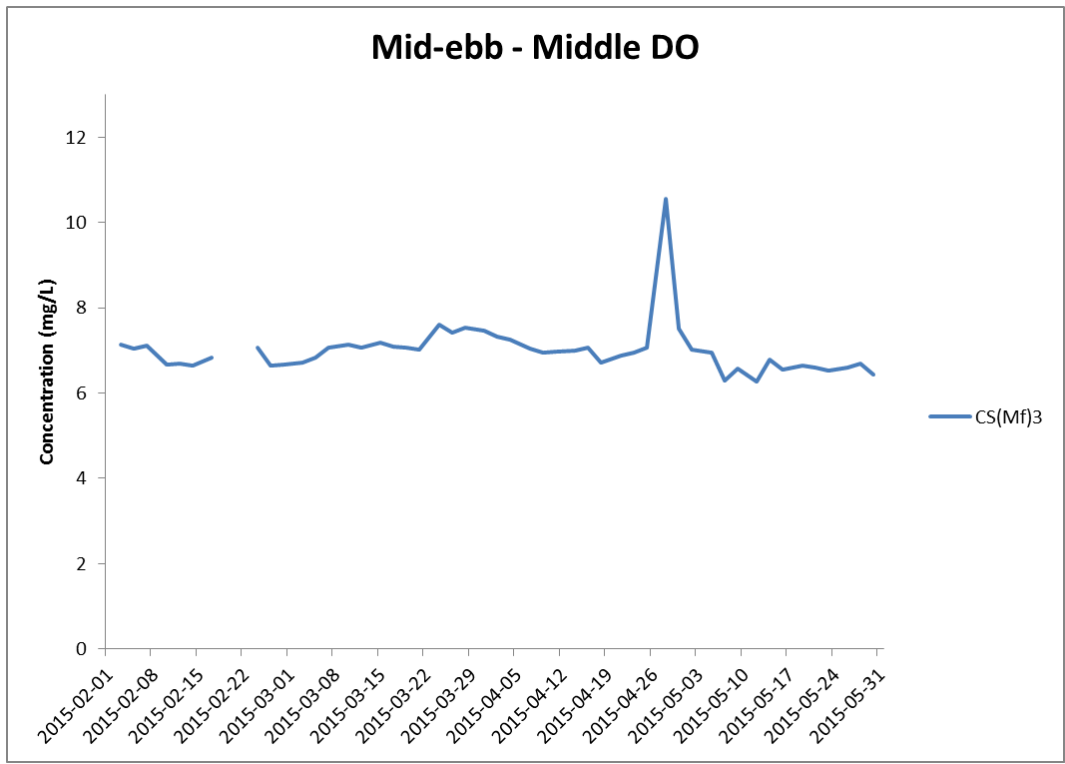
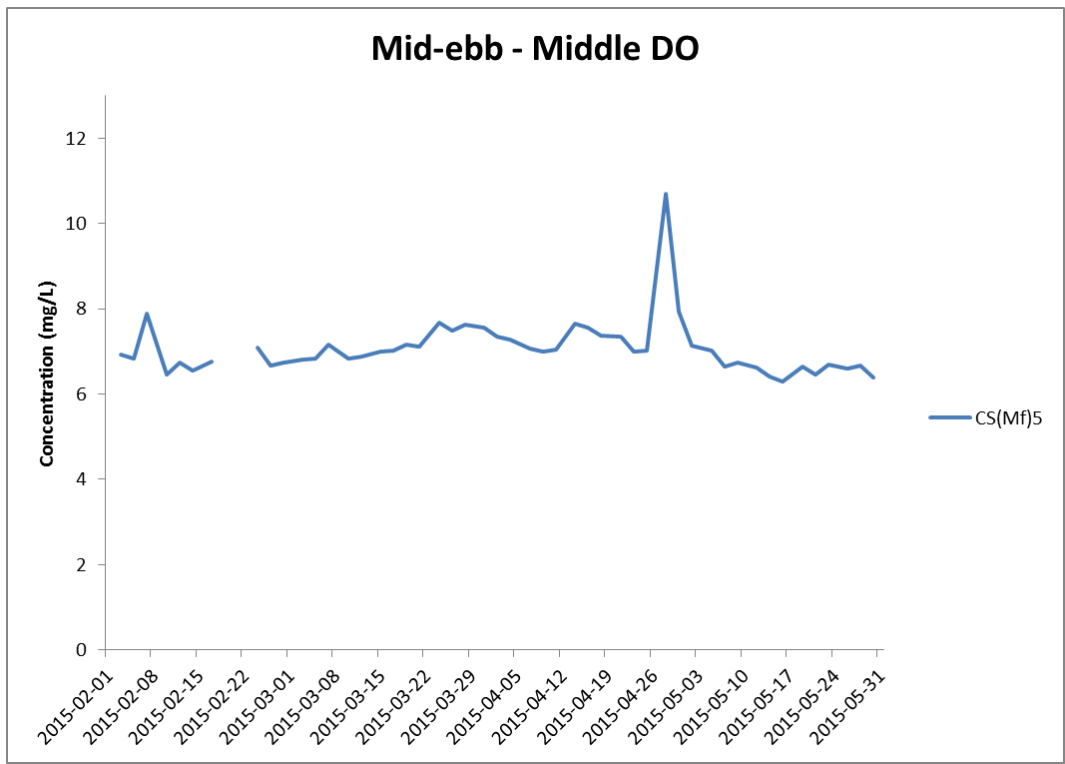
Figure H9 Impact Monitoring - Mean Level of Dissolved Oxygen (mg/L) in mid-depth waters during mid-ebb tide between 1 February and 31 May 2015 at CS(Mf)3 and CS(Mf)5.

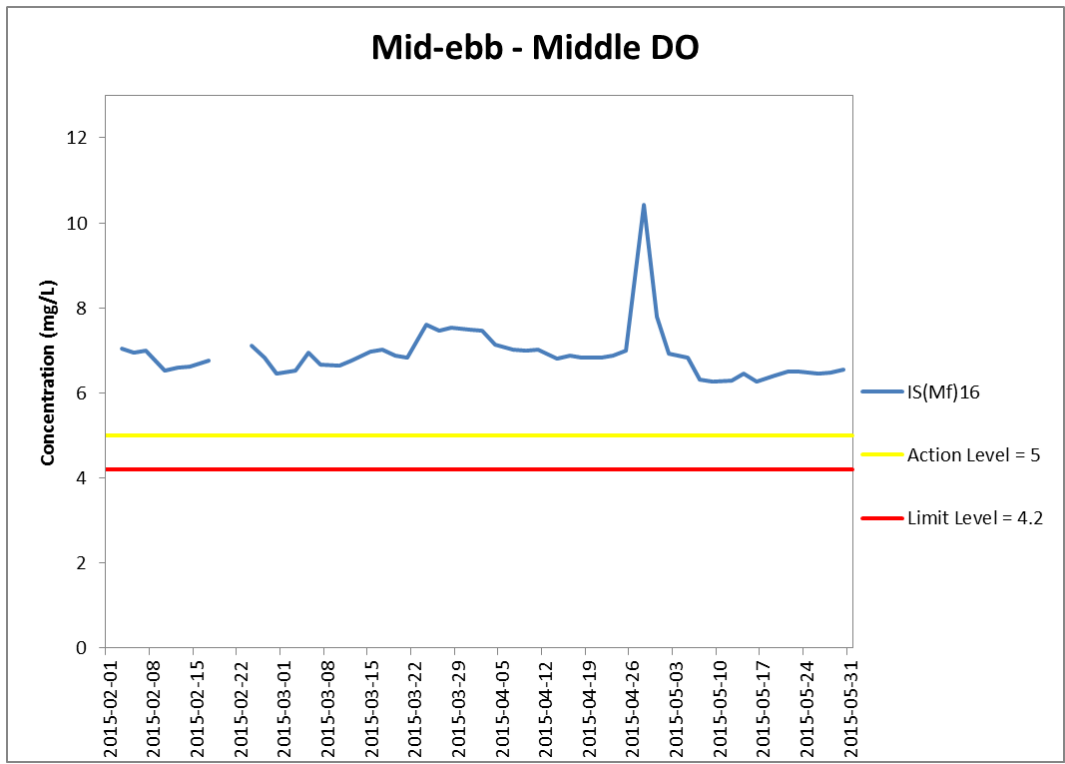
Figure H10 Impact Monitoring – Mean Level of Dissolved Oxygen (mg/L) in mid-depth waters during mid-ebb tide between 1 February and 31 May 2015 at IS(Mf)16.

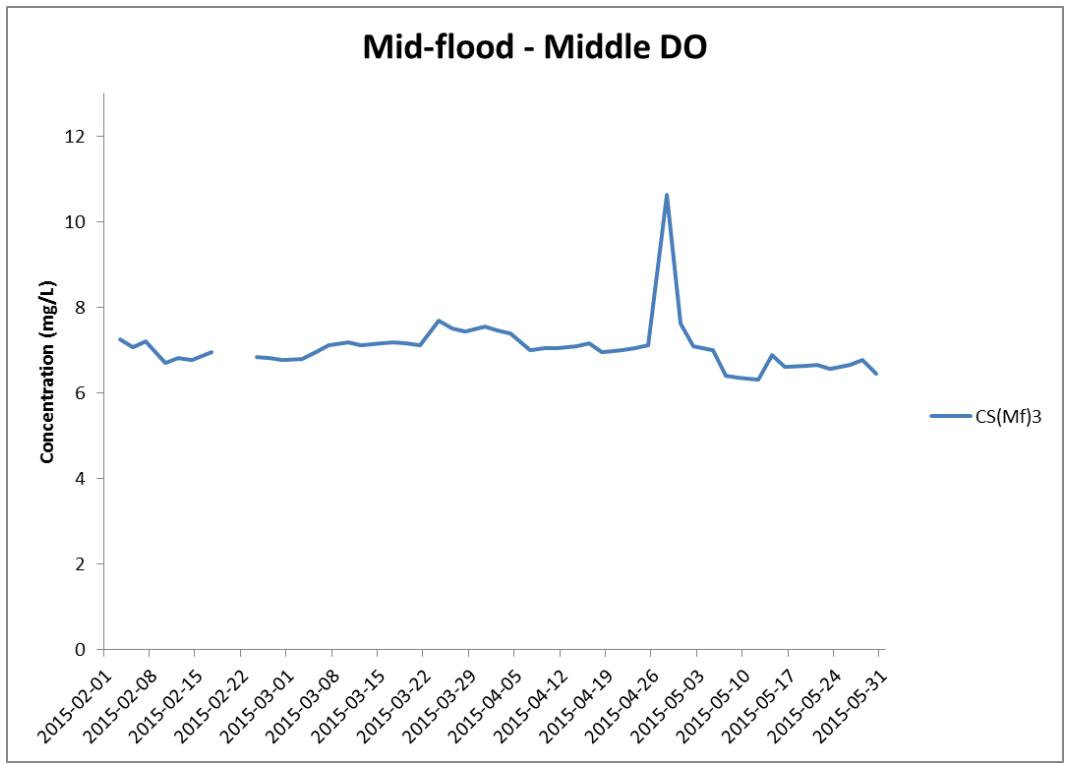
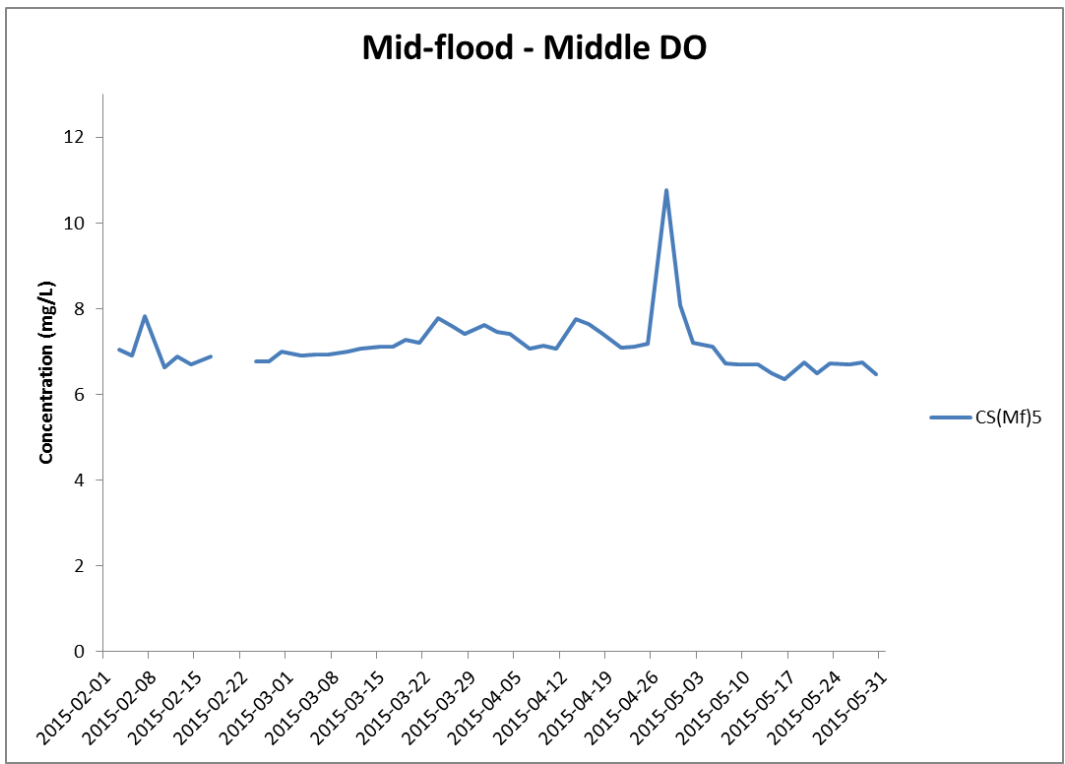
Figure H11 Impact Monitoring - Mean Level of Dissolved Oxygen (mg/L) in mid-depth waters during mid-flood tide between 1 February and 31 May 2015 at CS(Mf)3 and CS(Mf)5.

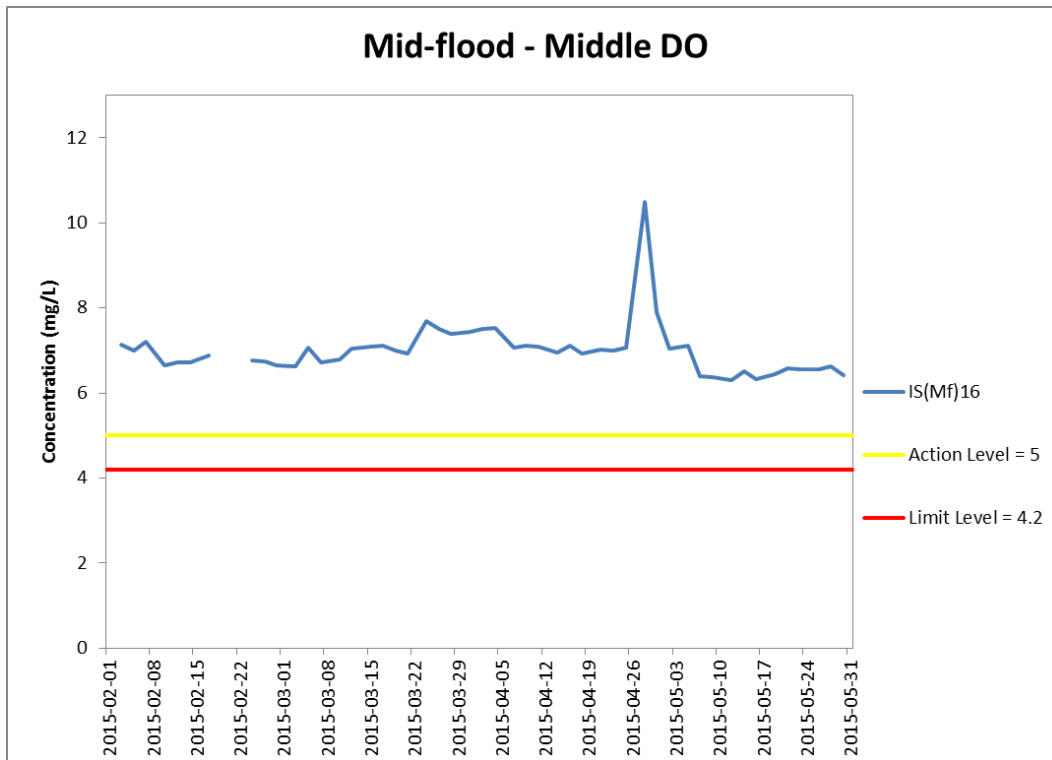
Figure H12 Impact Monitoring - Mean Level of Dissolved Oxygen (mg/L) in mid-depth waters during mid-flood tide between 1 February and 31 May 2015 at IS(Mf)16.

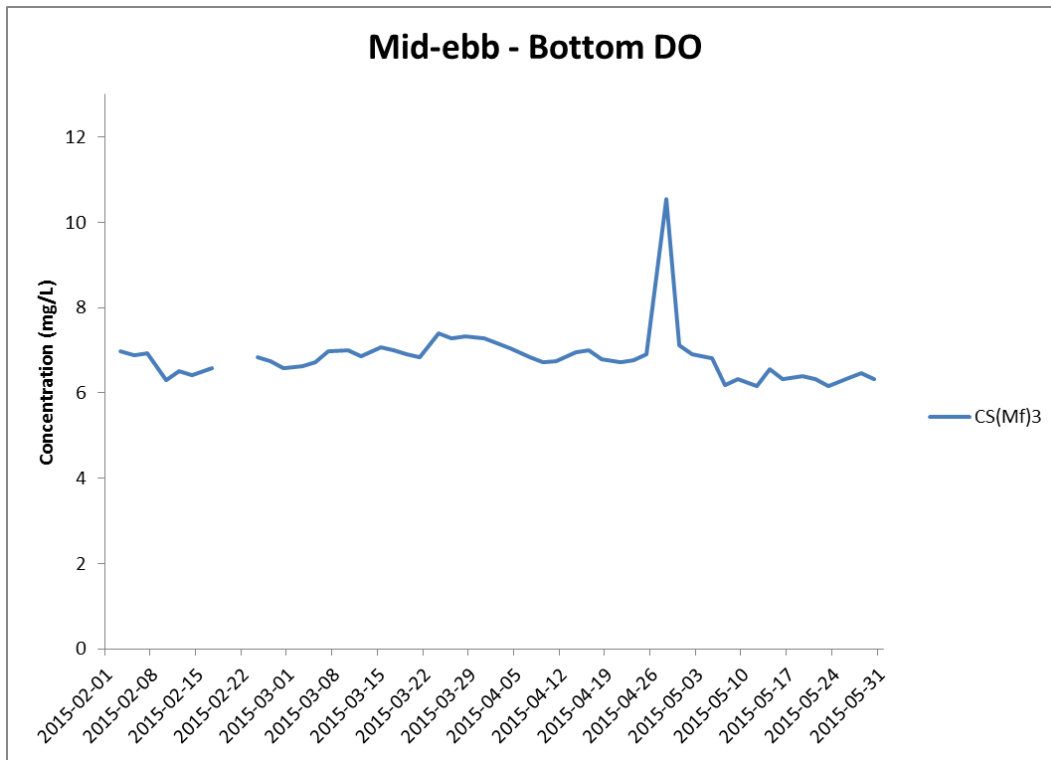
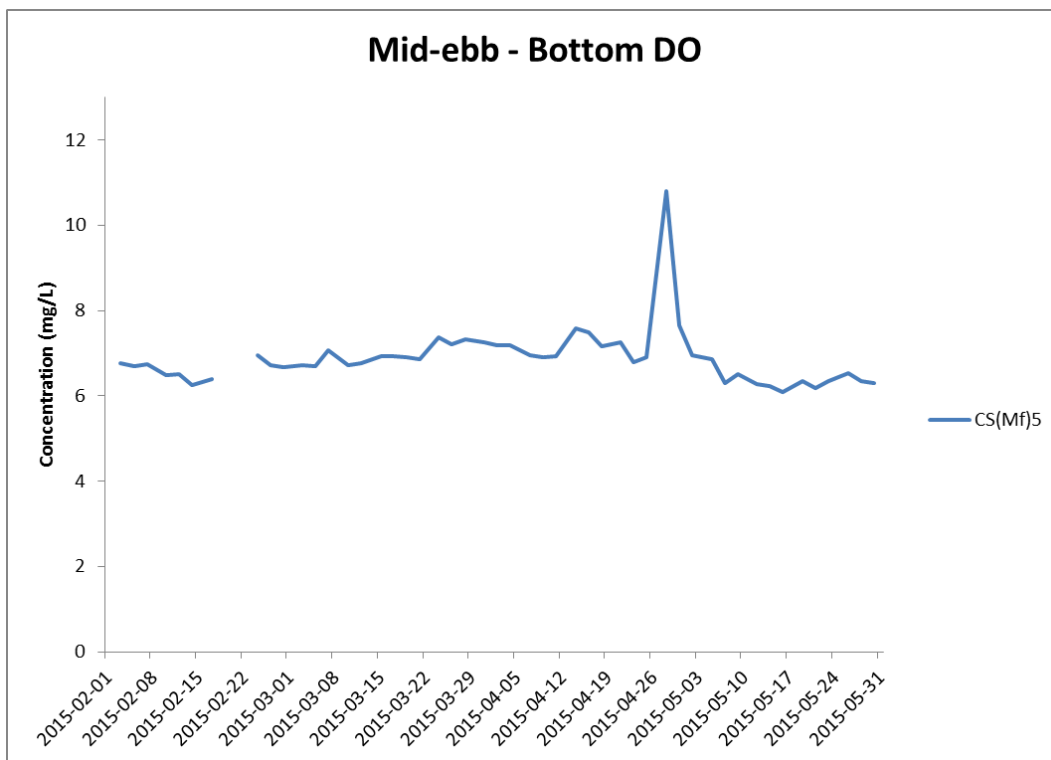
Figure H13 Impact Monitoring - Mean Level of Dissolved Oxygen (mg/L) in bottom waters during mid-ebb tide between 1 February and 31 May 2015 at CS(Mf)3 and CS(Mf)5.

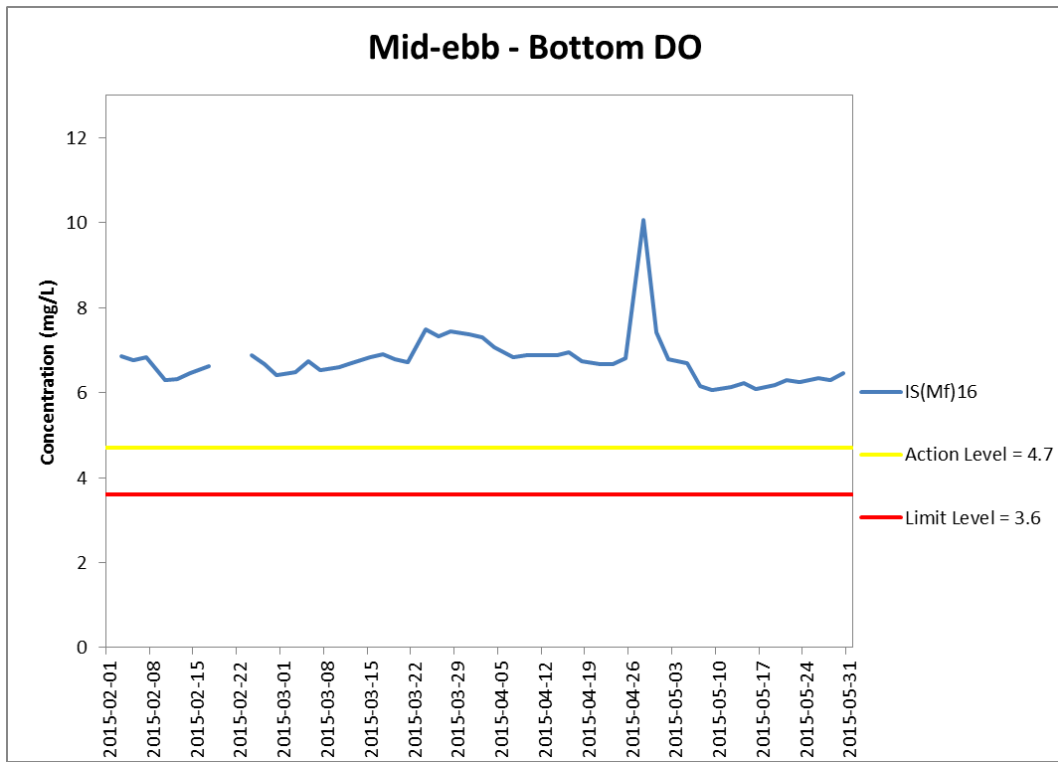
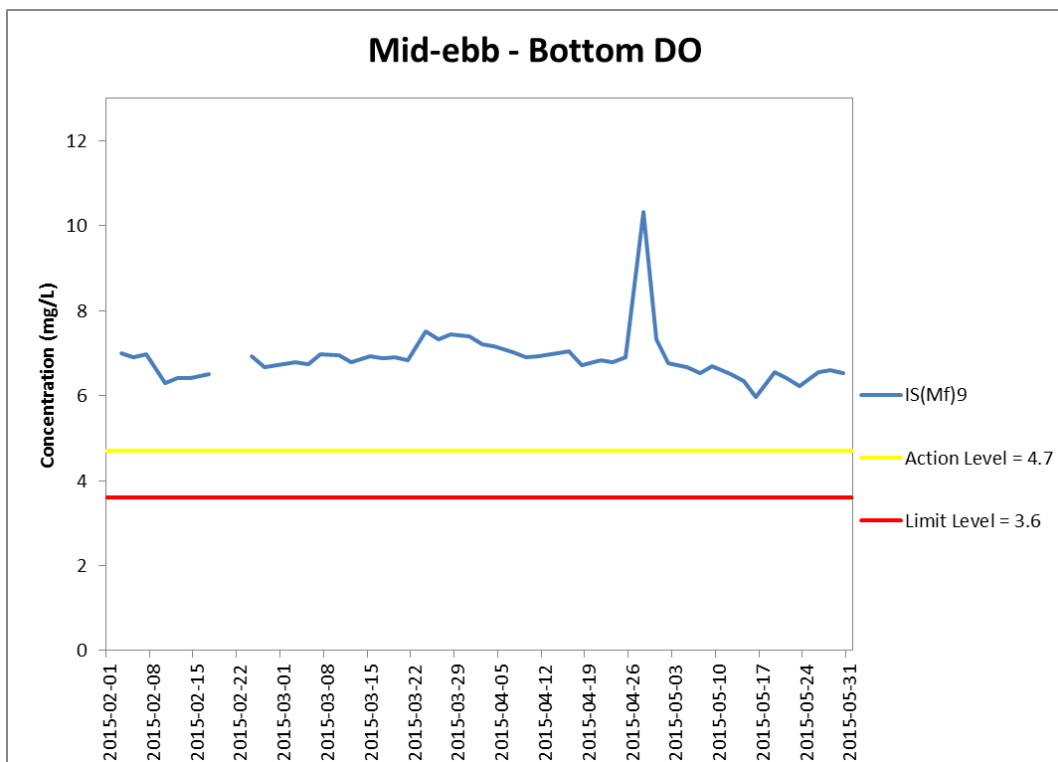
Figure H14 Impact Monitoring - Mean Level of Dissolved Oxygen (mg/L) in bottom waters during mid-ebb tide between 1 February and 31 May 2015 at IS(Mf)16 and IS(Mf)9.

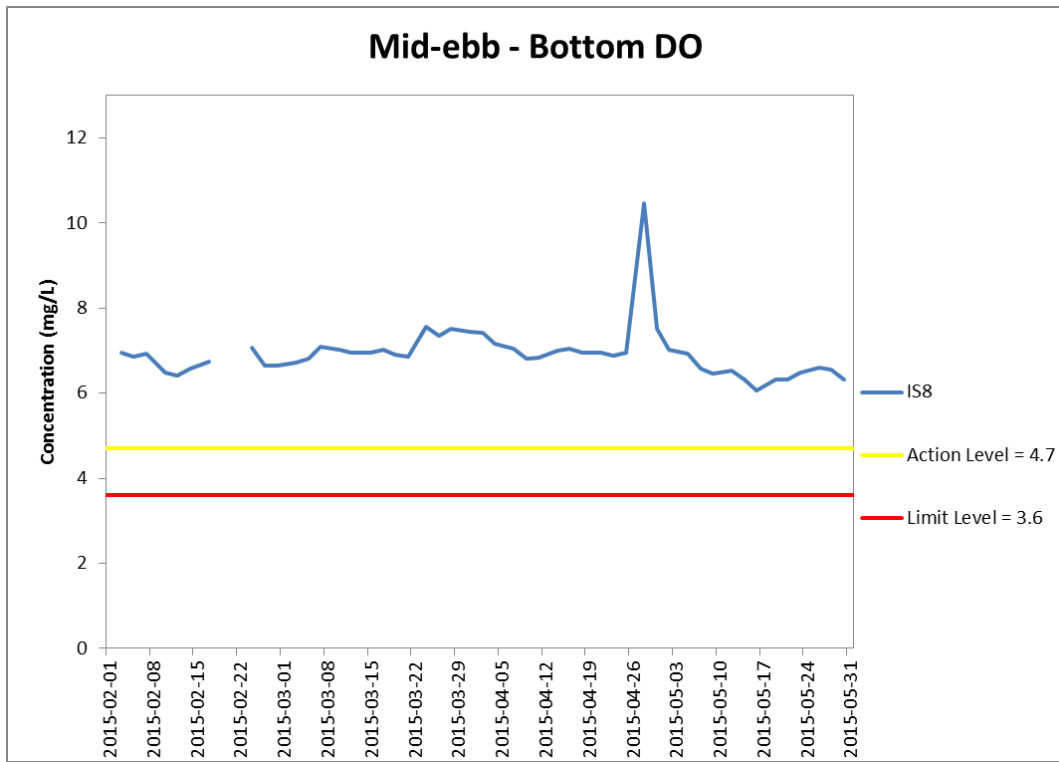
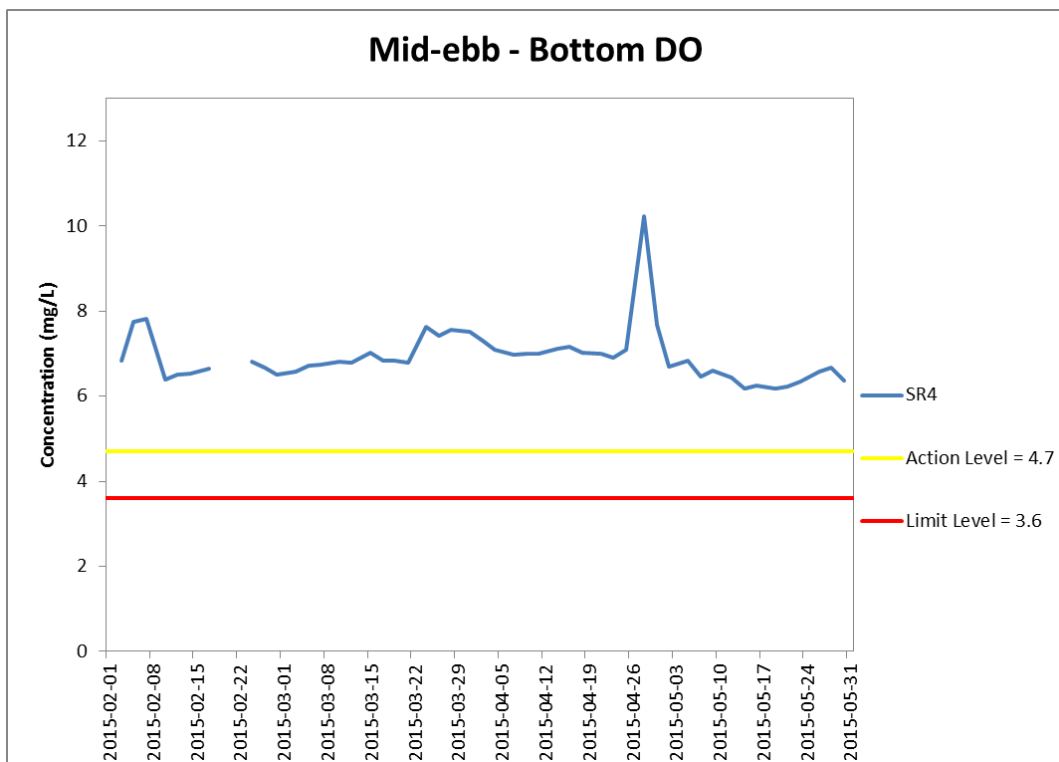
Figure H15 Impact Monitoring - Mean Level of Dissolved Oxygen (mg/L) in bottom waters during mid-ebb tide between 1 February and 31 May 2015 at IS8 and SR4.

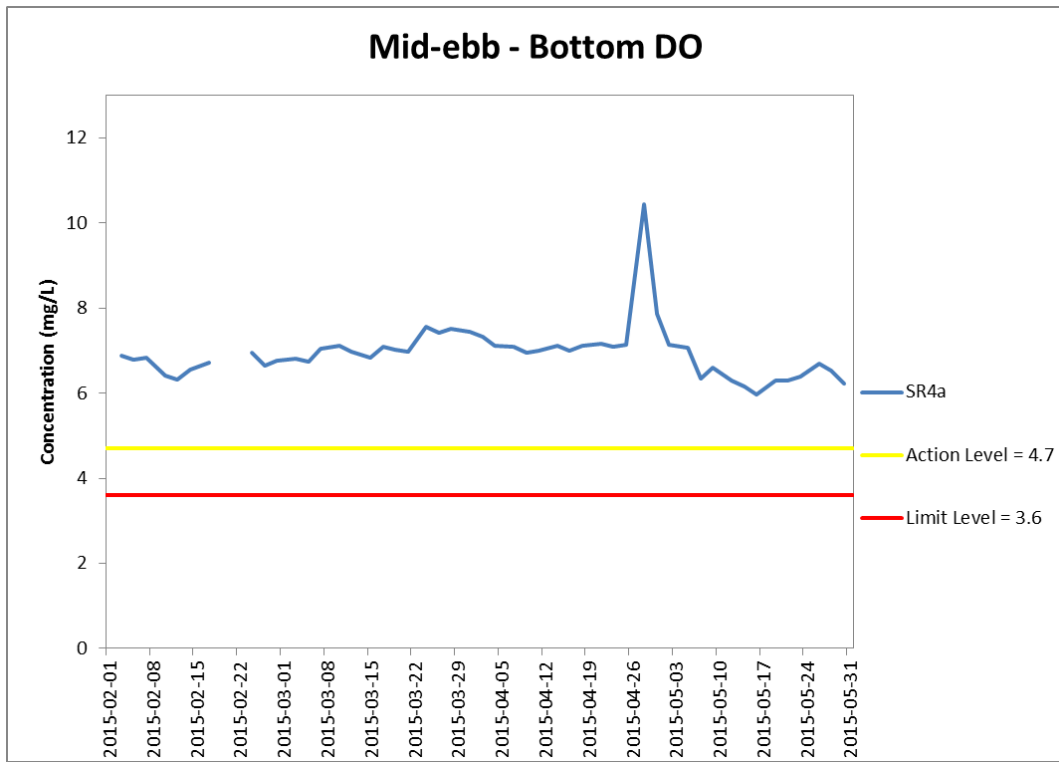
Figure H16 Impact Monitoring – Mean Level of Dissolved Oxygen (mg/L) in bottom waters during mid-ebb tide between 1 February and 31 May 2015 at SR4a.
