**Contract No. HY/2012/07
Tuen Mun – Chek Lap Kok Link –
Southern Connection Viaduct Section**

***Sixth Quarterly Environmental Monitoring &
Audit (EM&A) Report***

19 October 2015

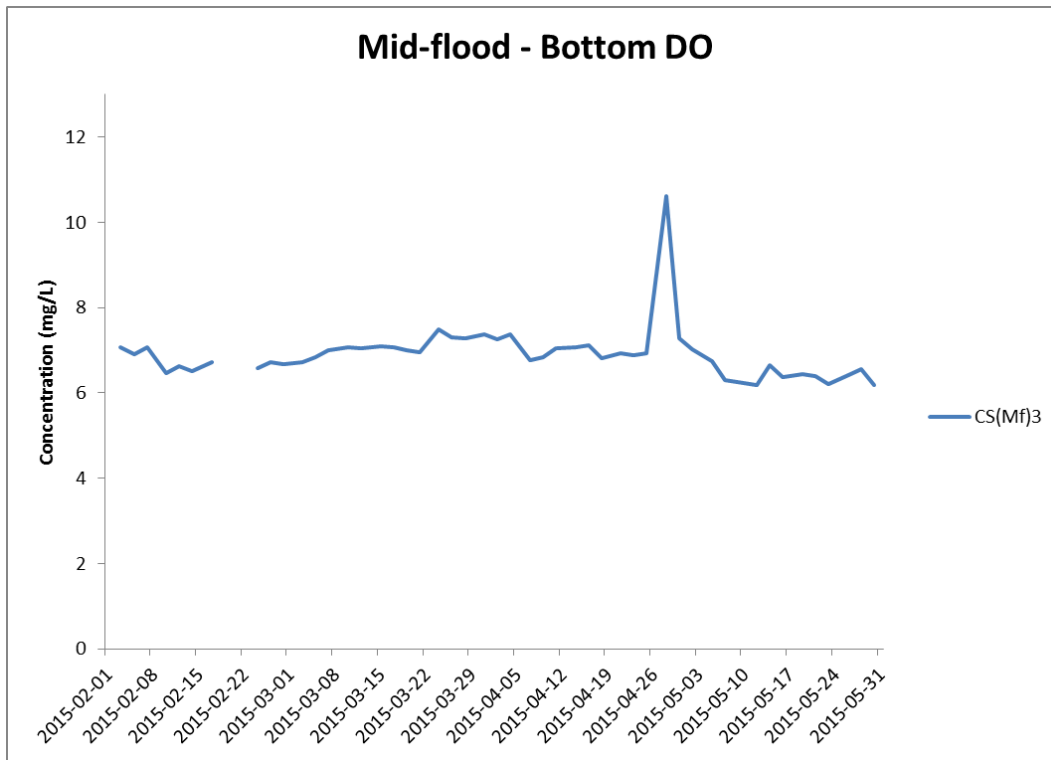
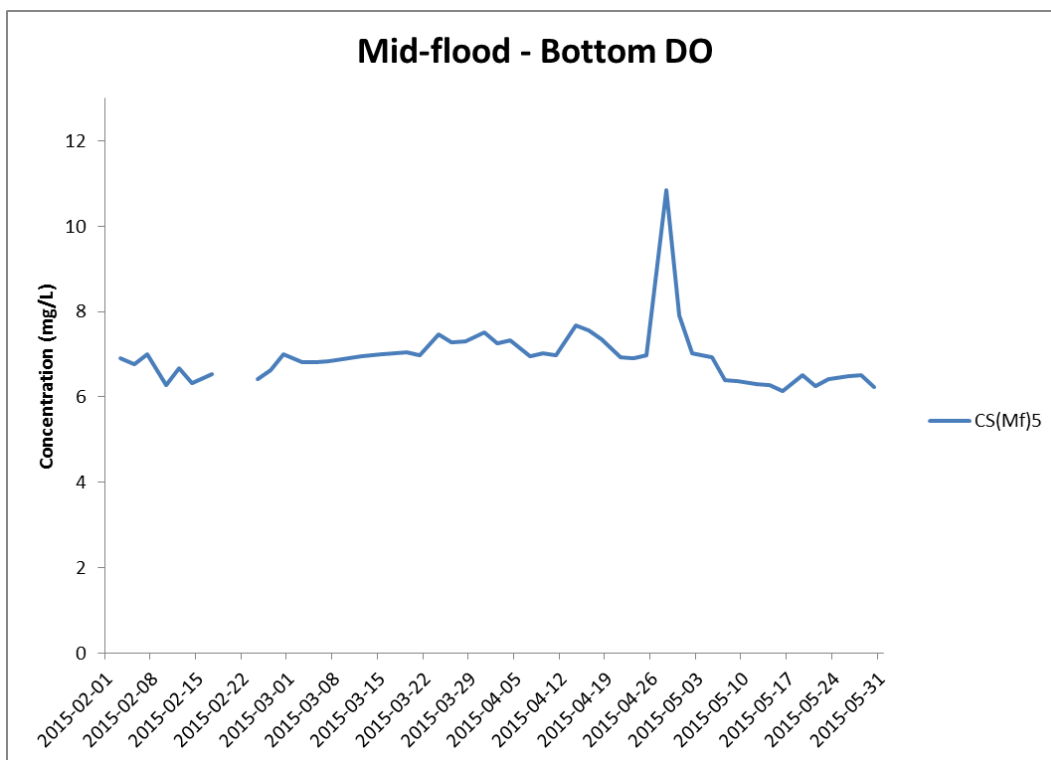
Figure H17 Impact Monitoring – Mean Level of Dissolved Oxygen (mg/L) in bottom waters during mid-flood tide between 1 February and 31 May 2015 at CS(Mf)3 and CS(Mf)5.

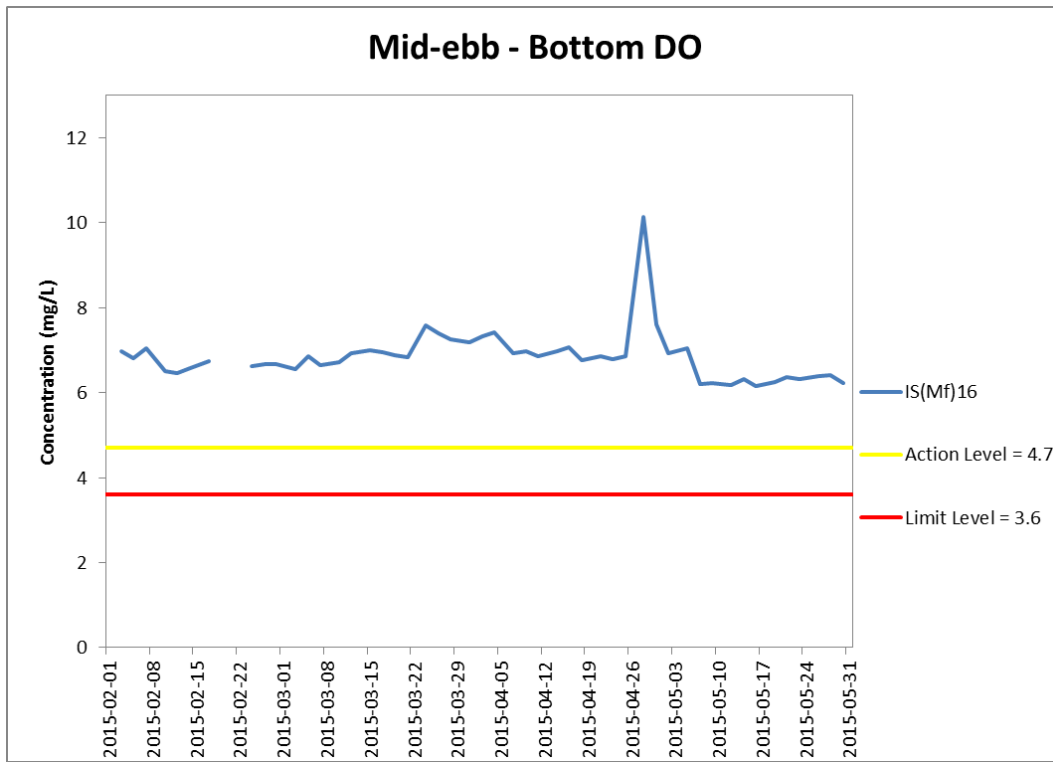
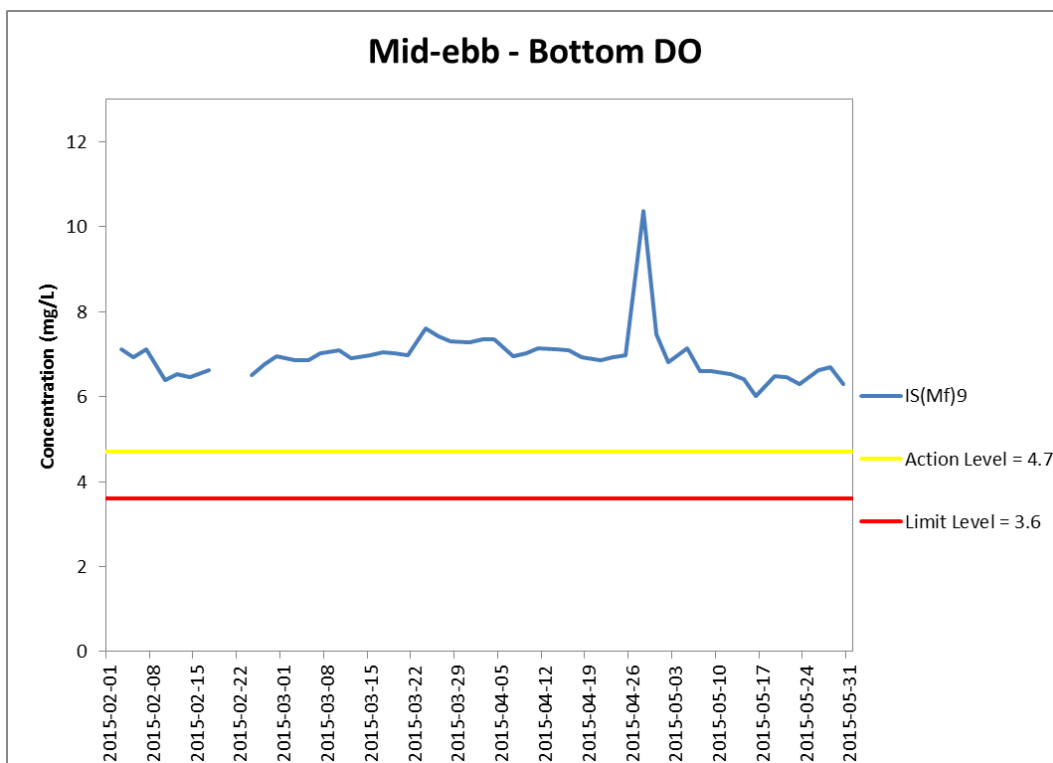
Figure H18 Impact Monitoring – Mean Level of Dissolved Oxygen (mg/L) in bottom waters during mid-flood tide between 1 February and 31 May 2015 at IS(Mf)16 and IS(Mf)9.

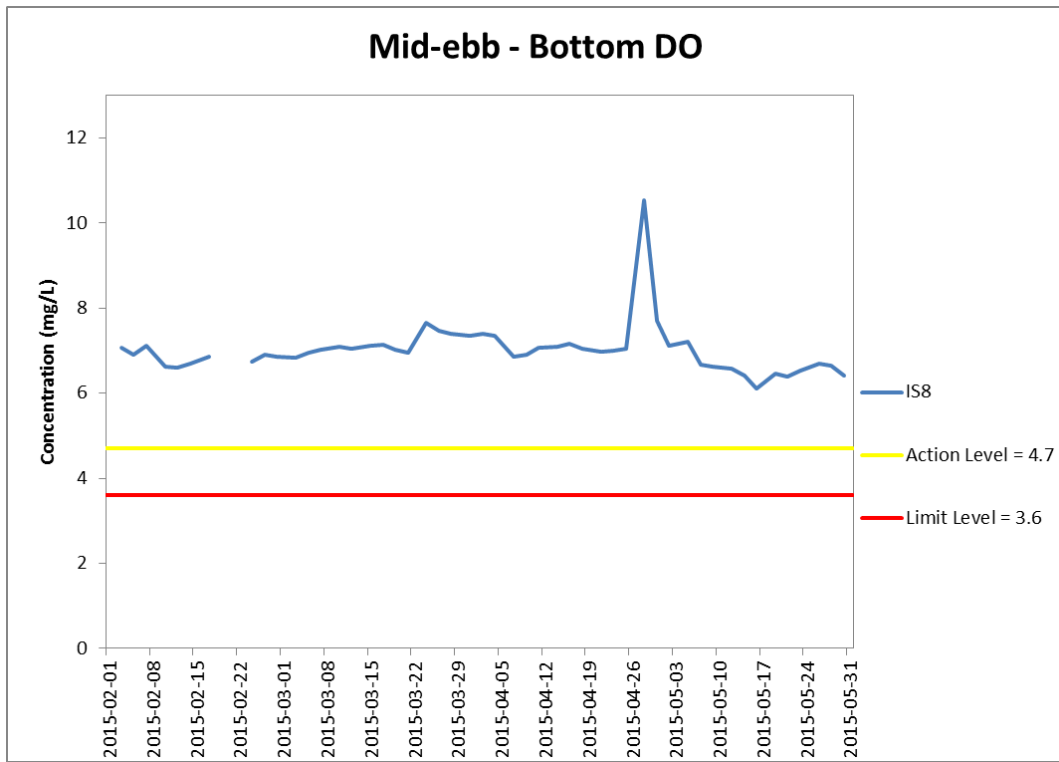
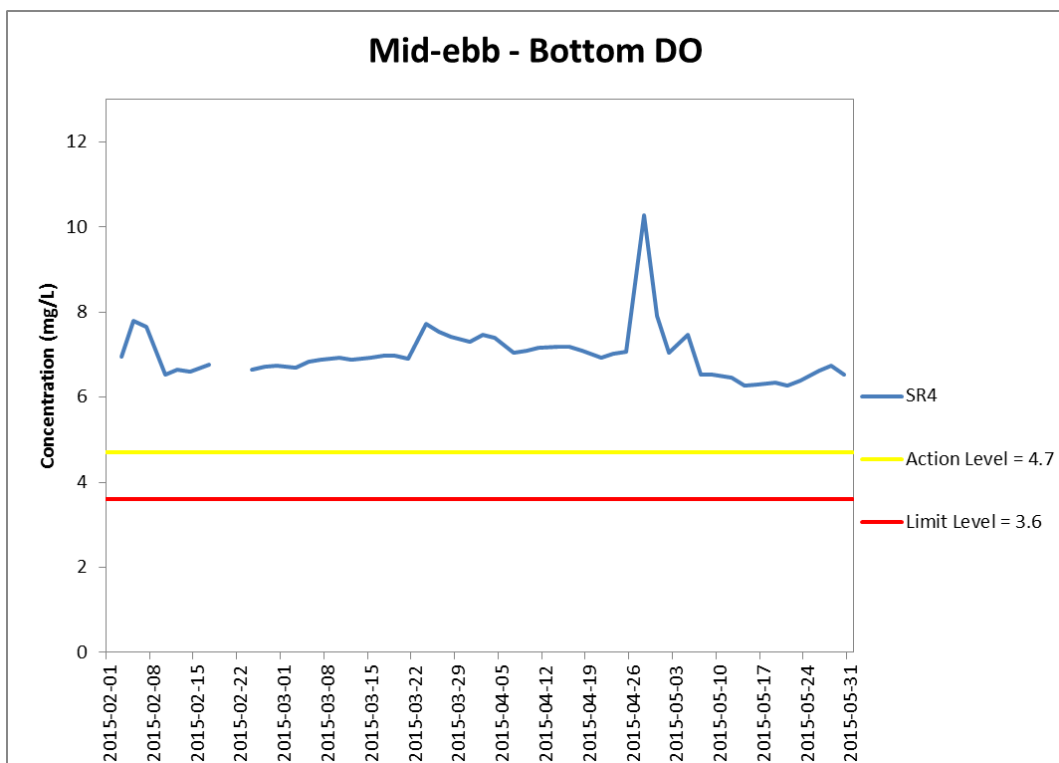
Figure H19 Impact Monitoring – Mean Level of Dissolved Oxygen (mg/L) in bottom waters during mid-flood tide between 1 February and 31 May 2015 at IS8 and SR4.

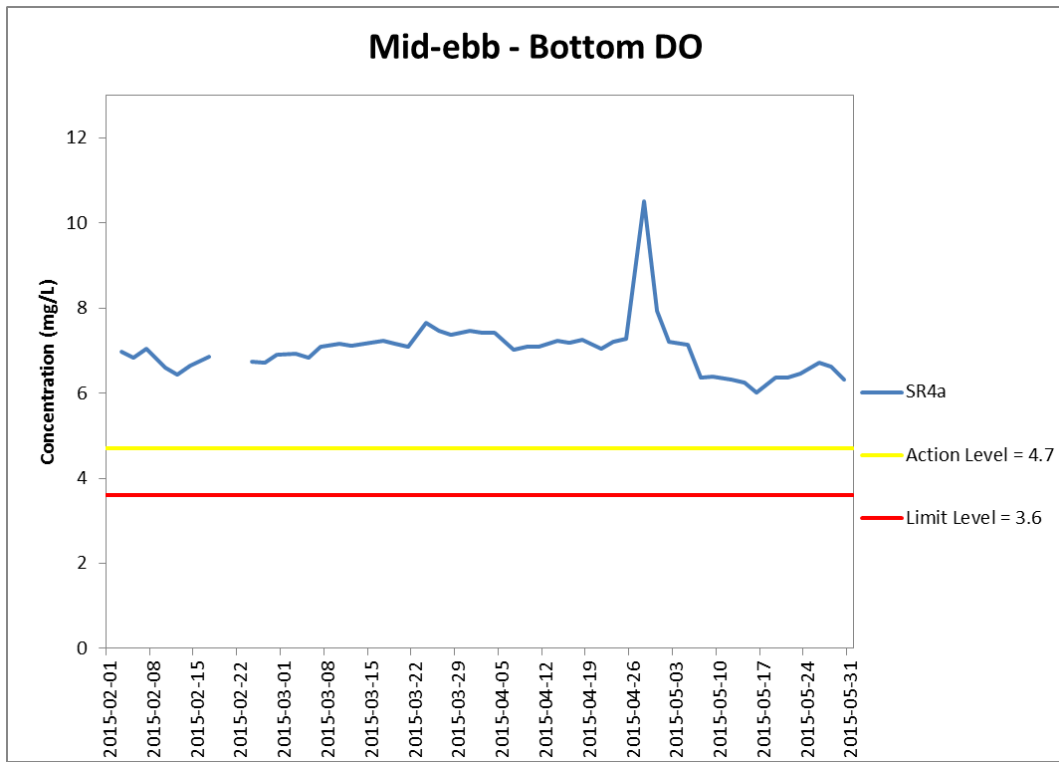
Figure H20 Impact Monitoring – Mean Level of Dissolved Oxygen (mg/L) in bottom waters during mid-flood tide between 1 February and 31 May 2015 at SR4a.

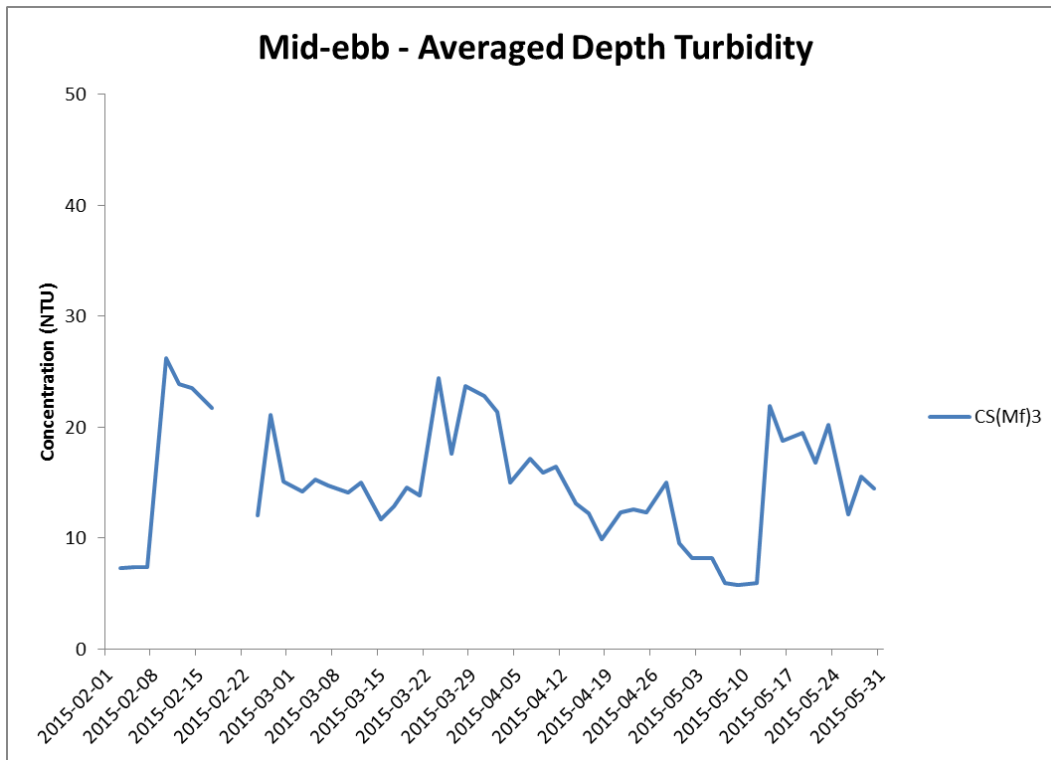
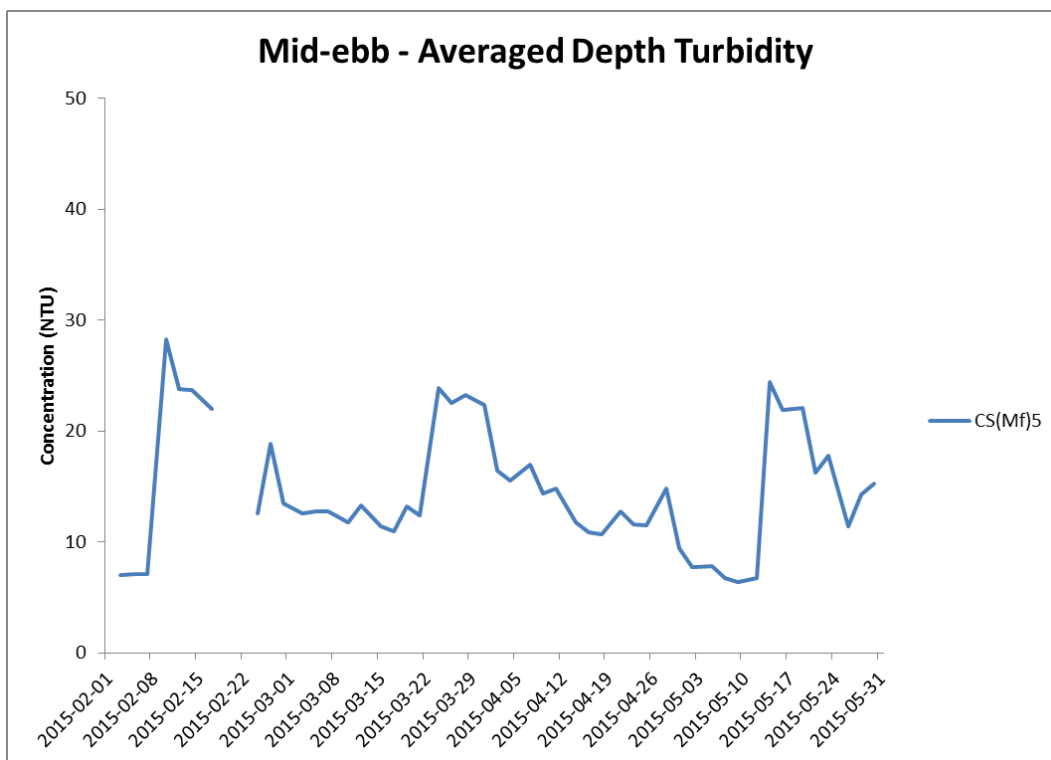
Figure H21 Impact Monitoring – Mean Level of depth-averaged Turbidity (NTU) during mid-ebb tide between 1 February and 31 May 2015 at CS(Mf)3 and CS(Mf)5.

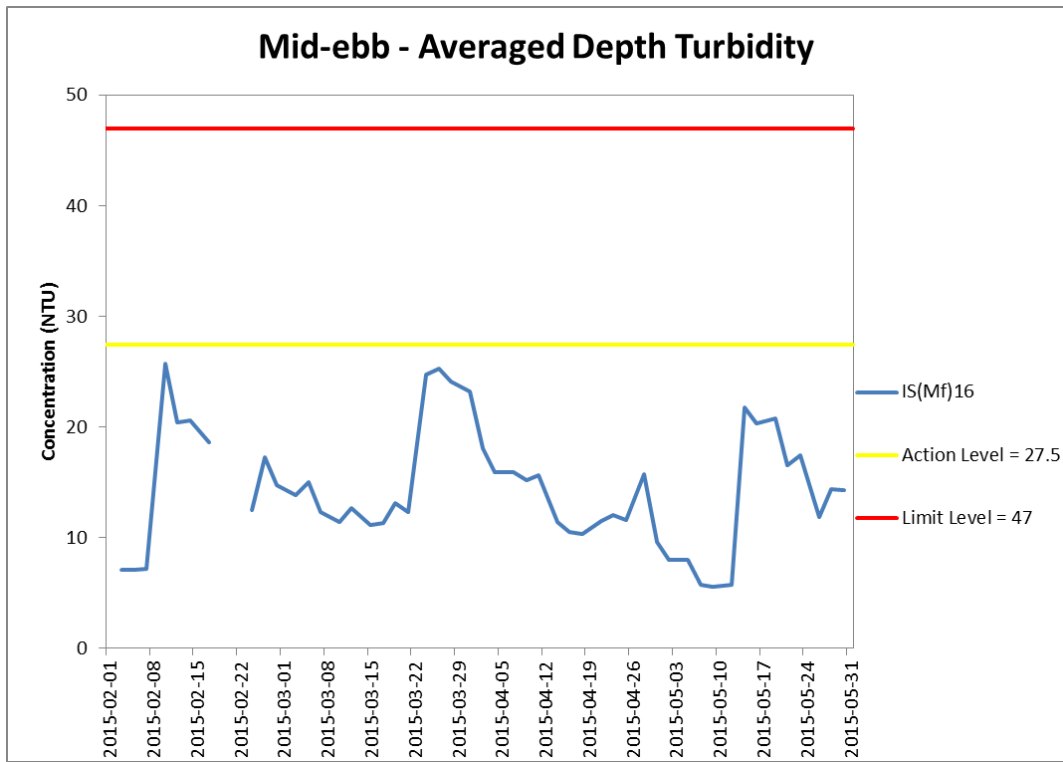
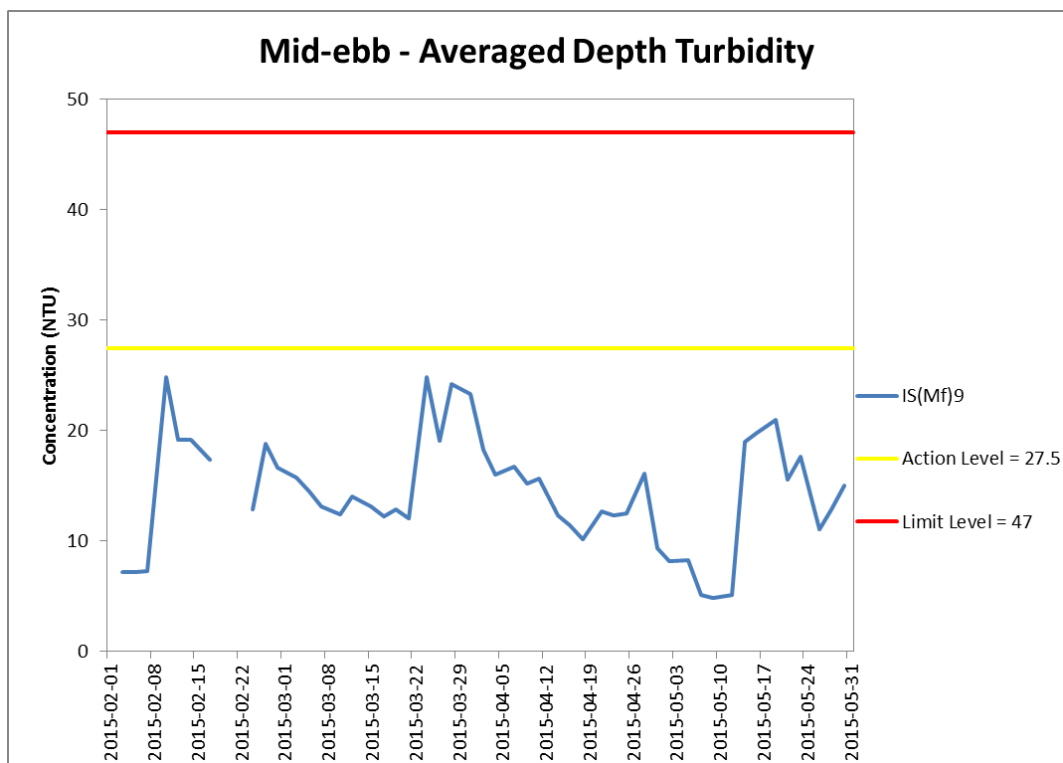
Figure H22 Impact Monitoring – Mean Level of depth-averaged Turbidity (NTU) during mid-ebb tide between 1 February and 31 May 2015 at IS(Mf)16 and IS(Mf)9.

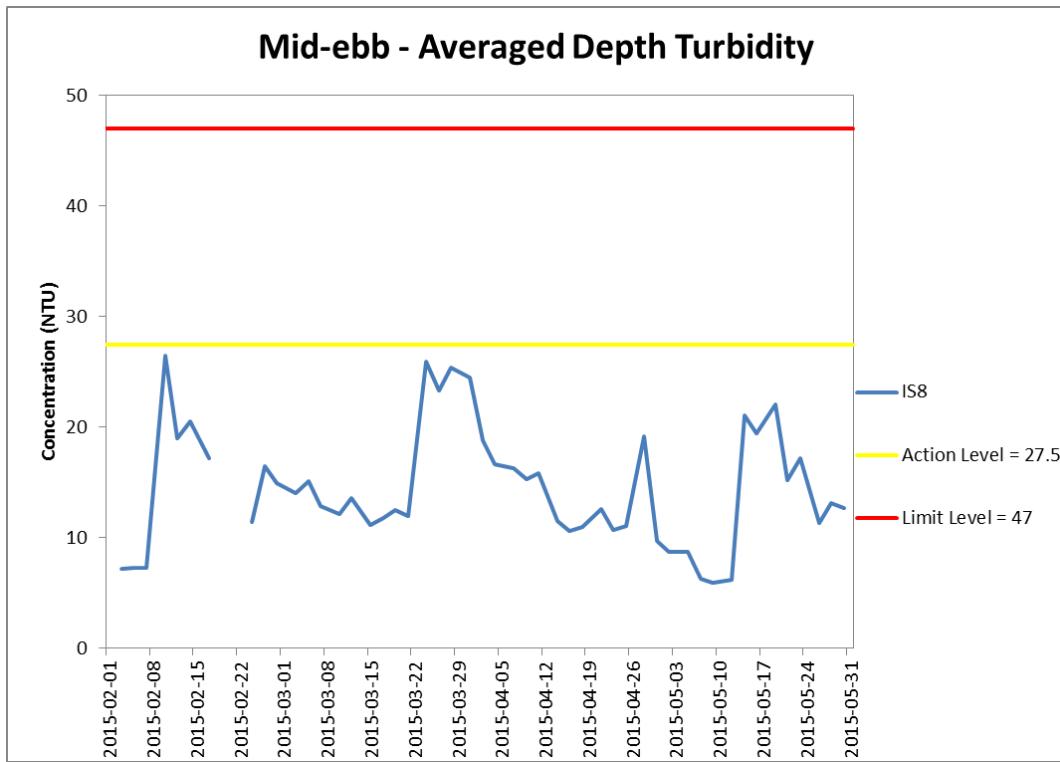
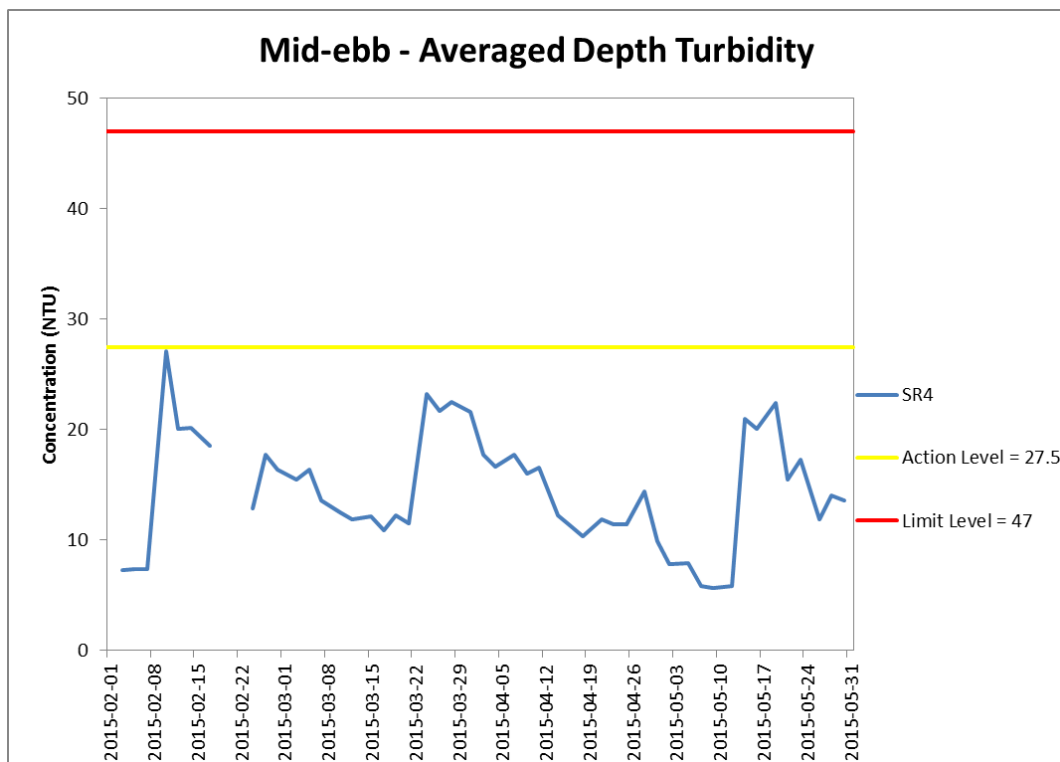
Figure H23 Impact Monitoring – Mean Level of depth-averaged Turbidity (NTU) during mid-ebb tide between 1 February and 31 May 2015 at IS8 and SR4.

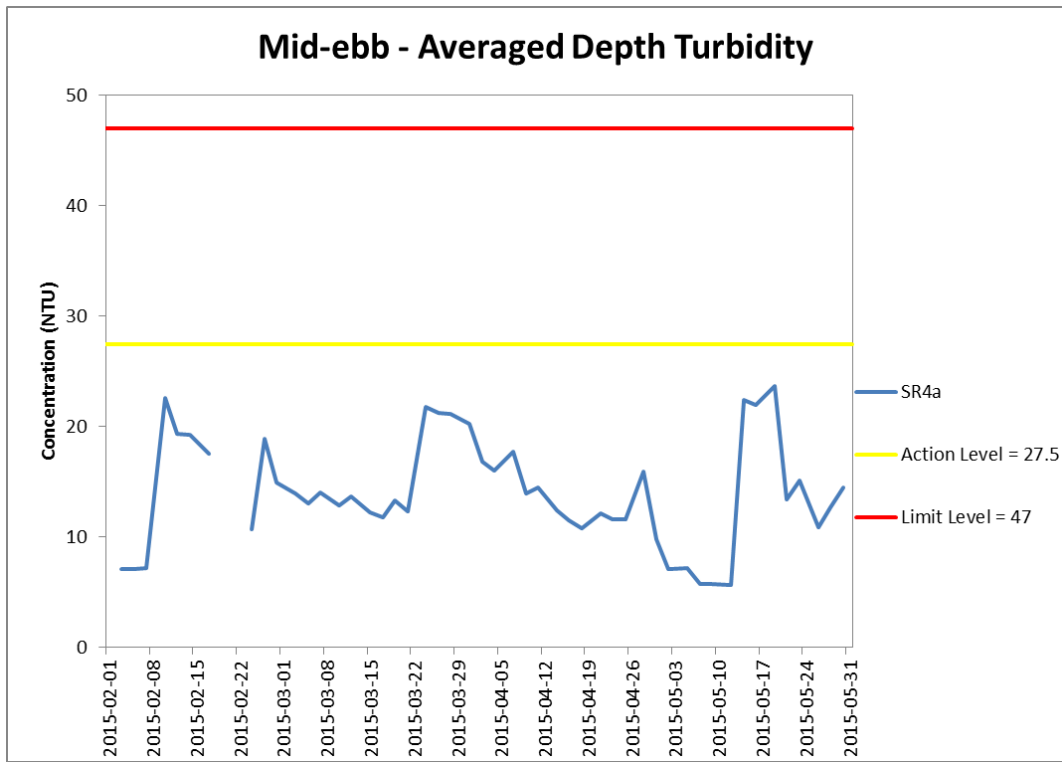
Figure H24 Impact Monitoring – Mean Level of depth-averaged Turbidity (NTU) during mid-ebb tide between 1 February and 31 May 2015 at SR4a.

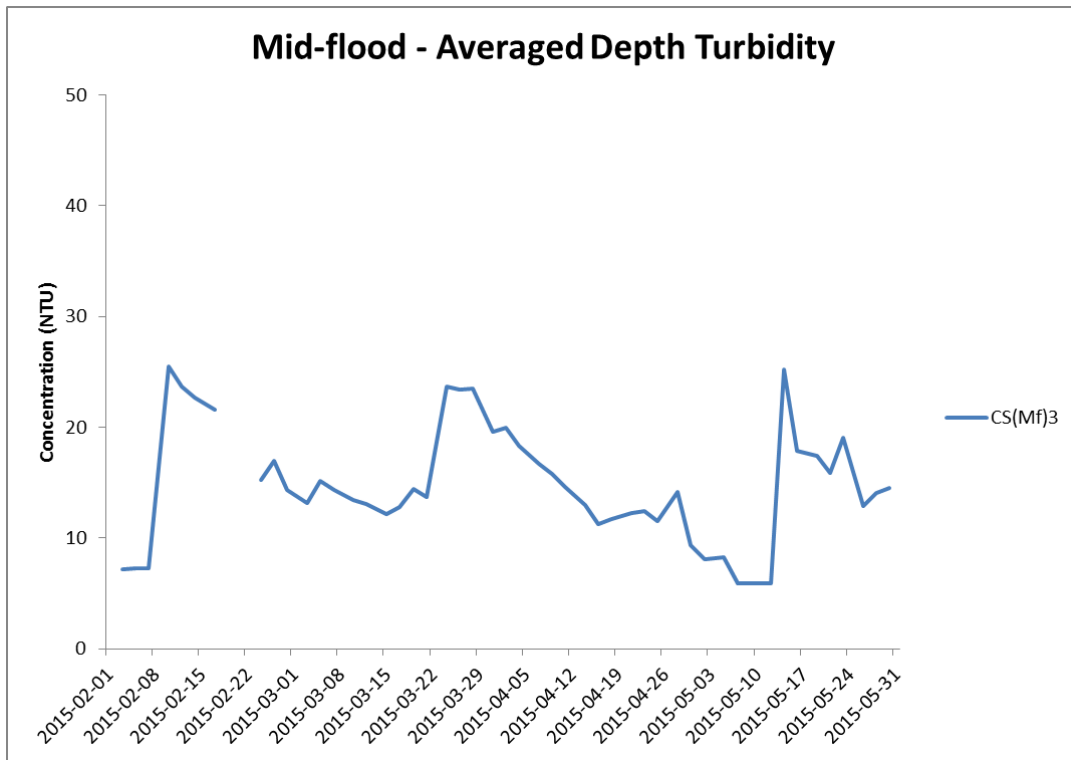
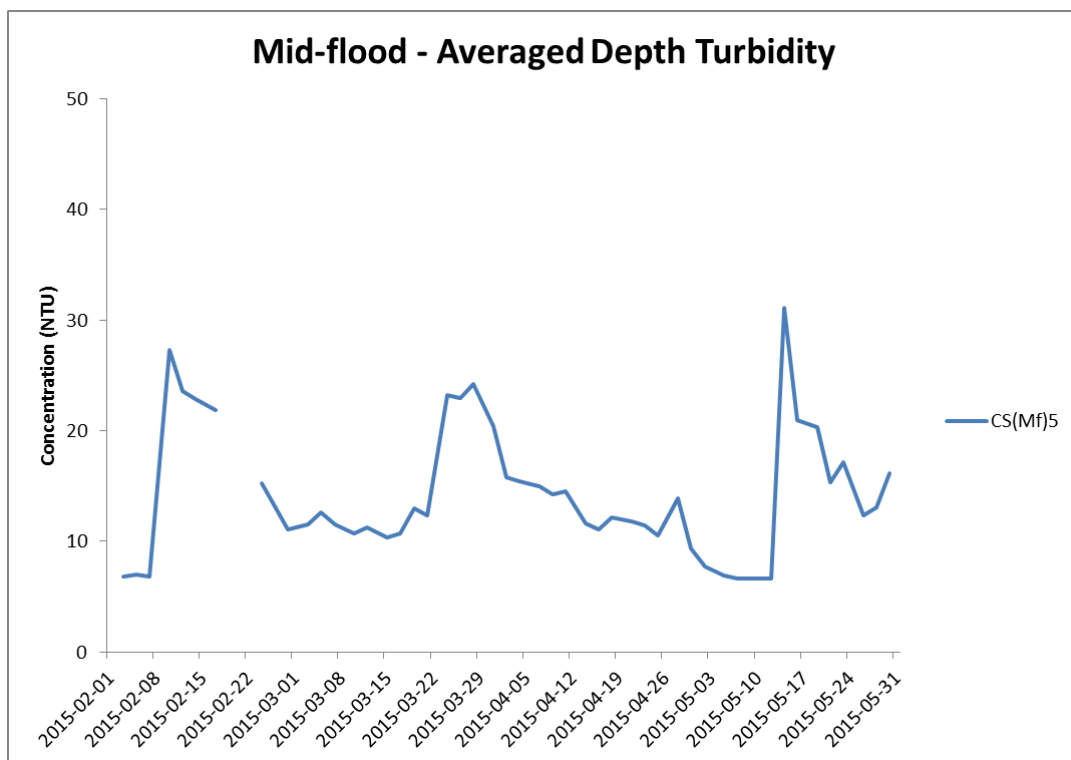
Figure H25 Impact Monitoring – Mean Level of depth-averaged Turbidity (NTU) during mid-flood tide between 1 February and 31 May 2015 at CS(Mf)3 and CS(MF)5.

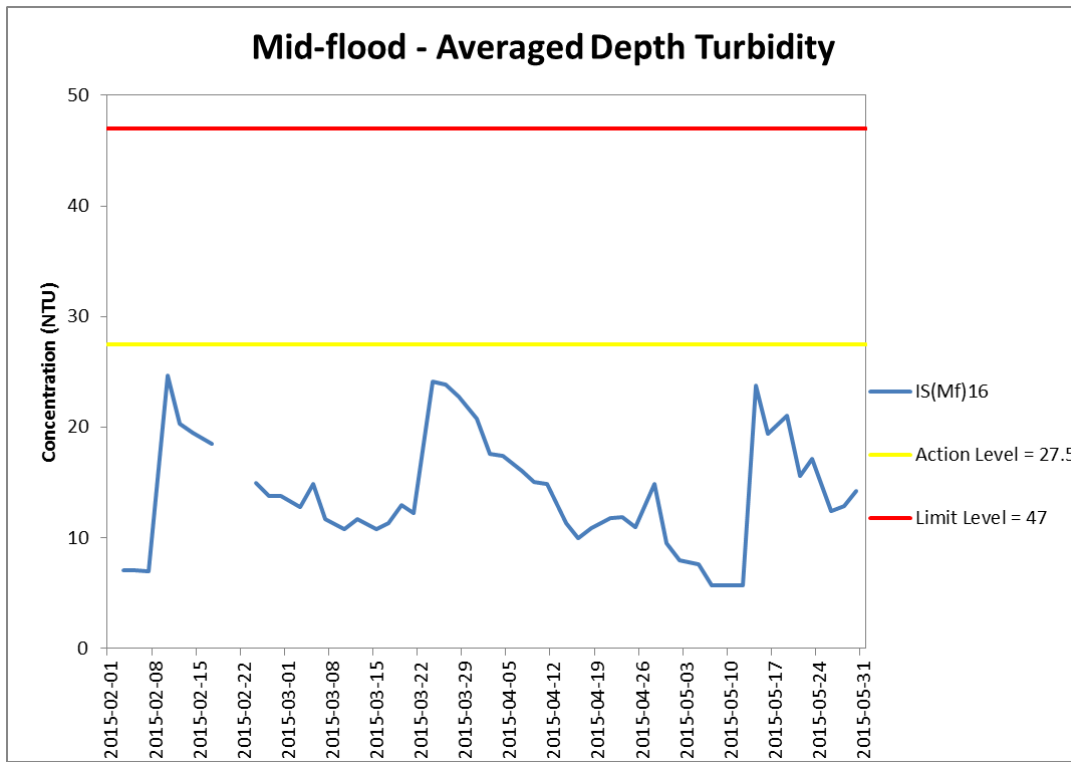
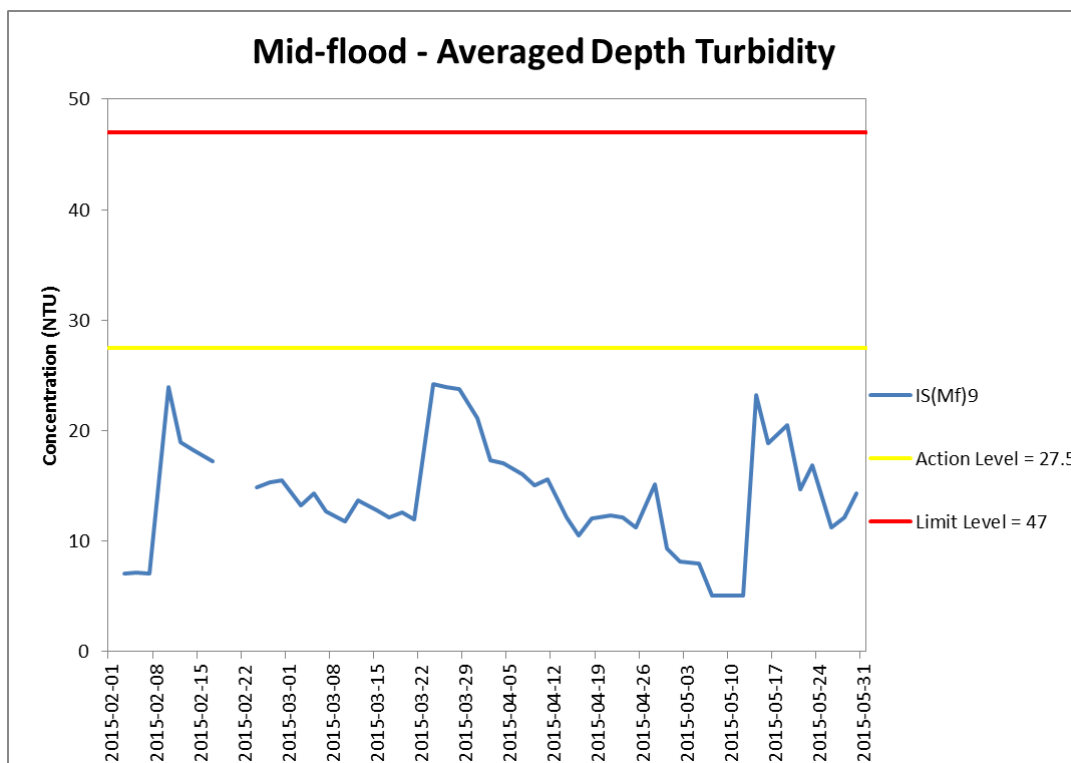
Figure H26 Impact Monitoring - Mean Level of depth-averaged Turbidity (NTU) during mid-flood tide between 1 February and 31 May 2015 at IS(Mf)16 and IS(Mf)9.

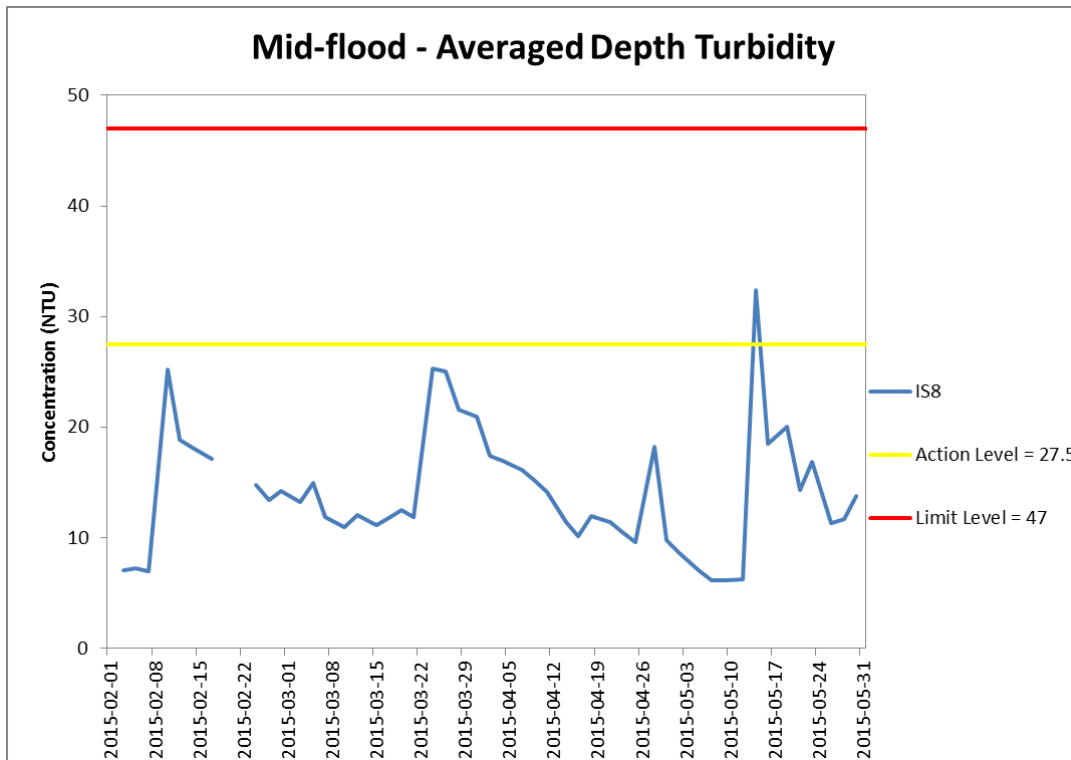
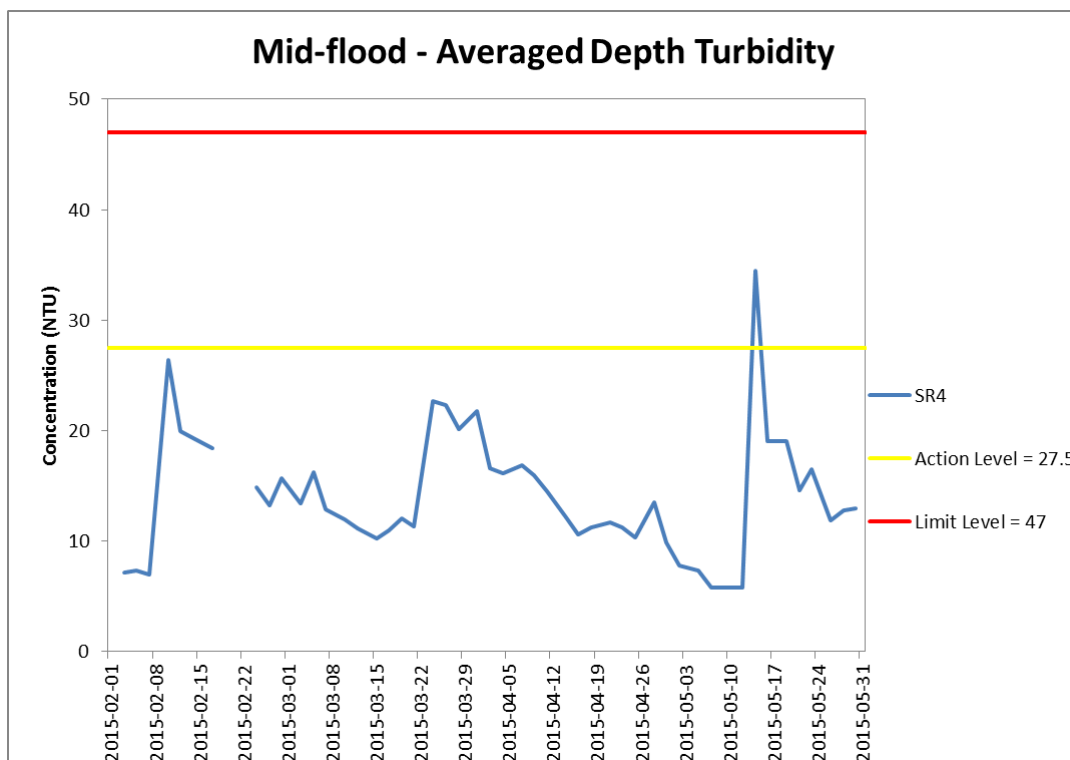
Figure H27 Impact Monitoring - Mean Level of depth-averaged Turbidity (NTU) during mid-flood tide between 1 February and 31 May 2015 at IS8 and SR4.

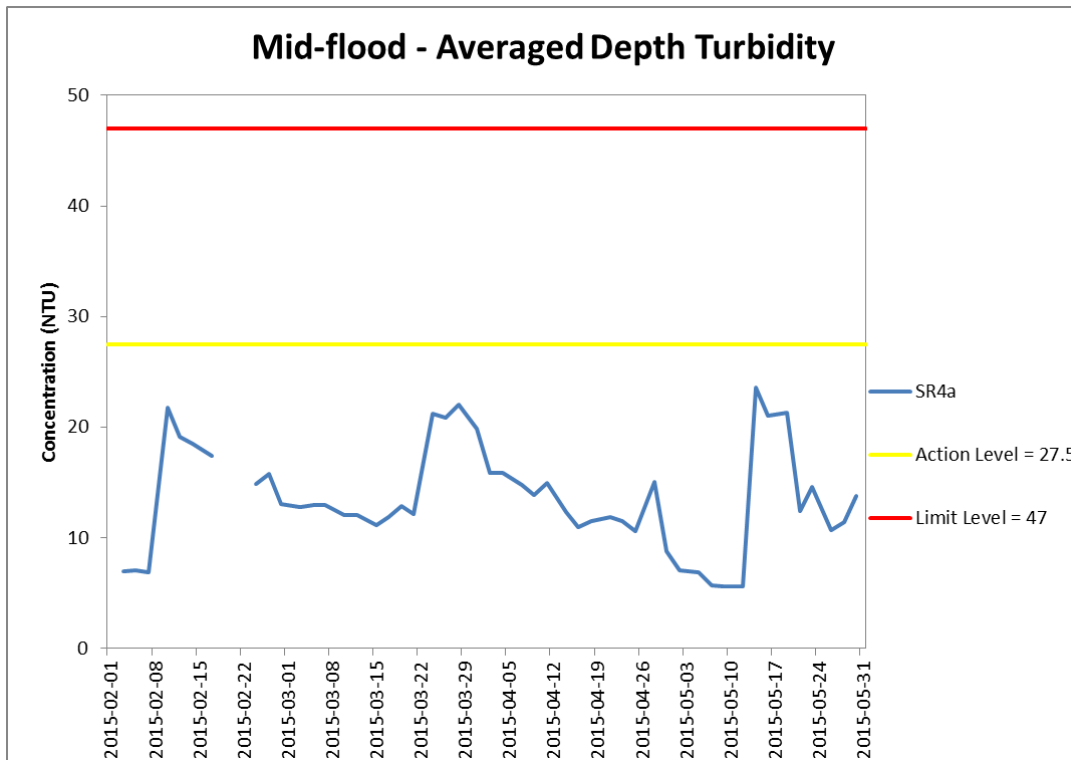
Figure H28 Impact Monitoring - Mean Level of depth-averaged Turbidity (NTU) during mid-flood tide between 1 February and 31 May 2015 at SR4a.

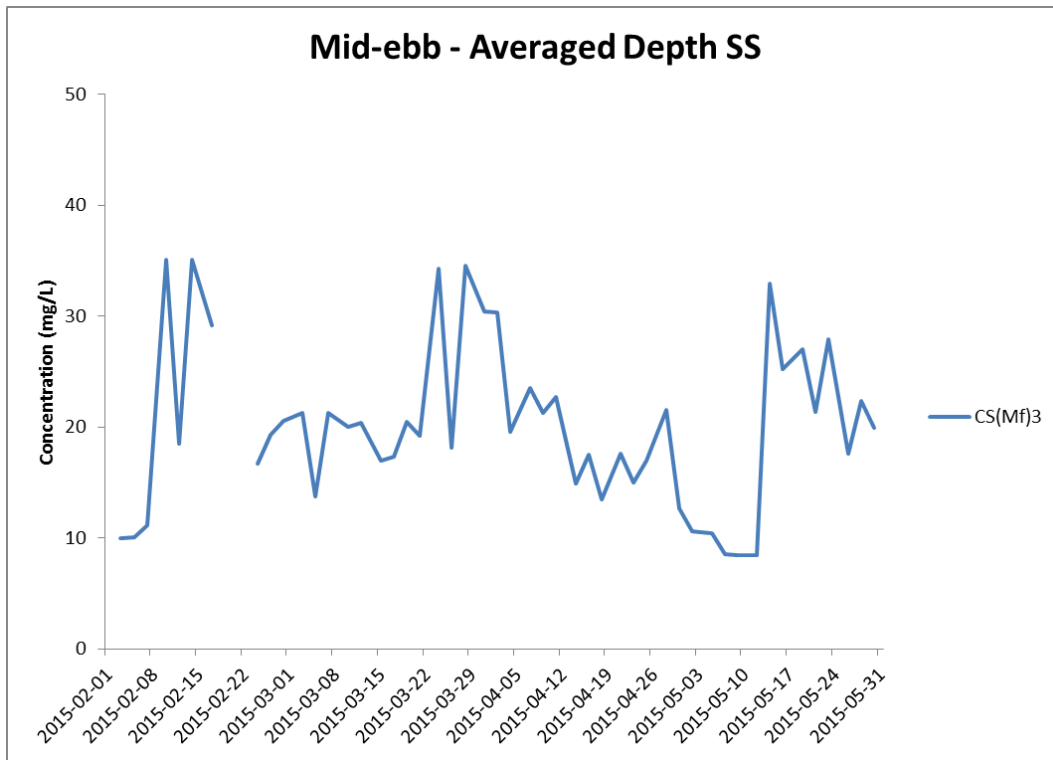
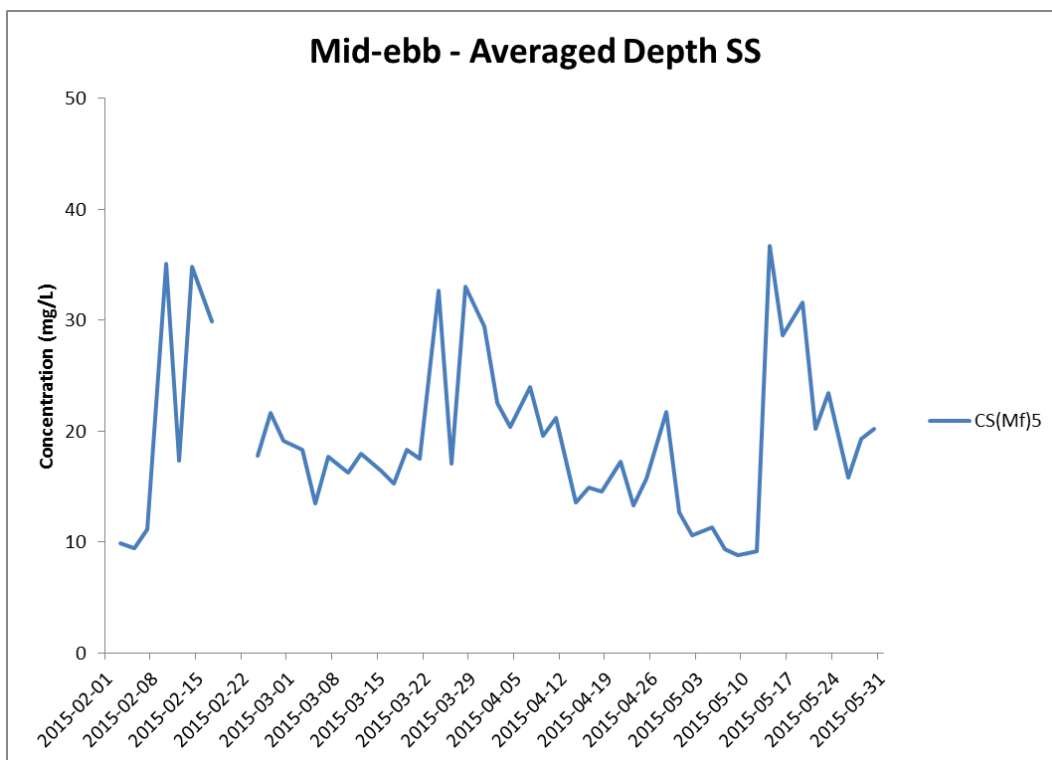
Figure H29 Impact Monitoring – Mean depth-averaged level of Suspended Solids (mg/L) during mid-ebb tide between 1 February and 31 May 2015 at CS(Mf)3 and CS(Mf)5.

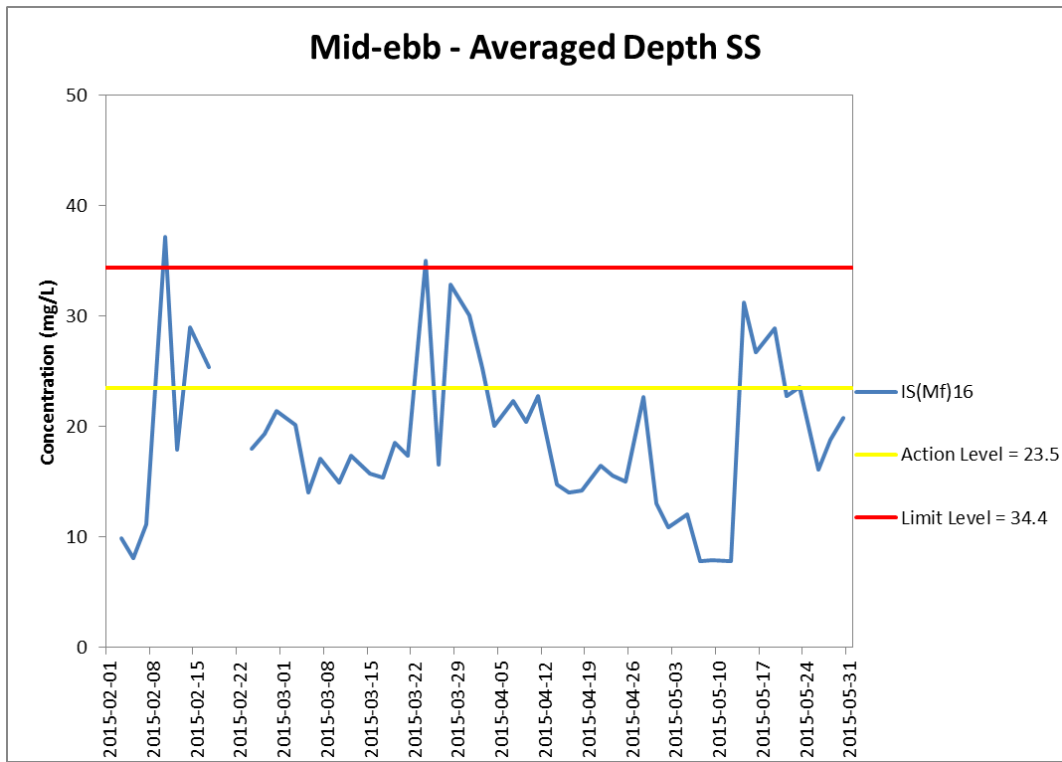
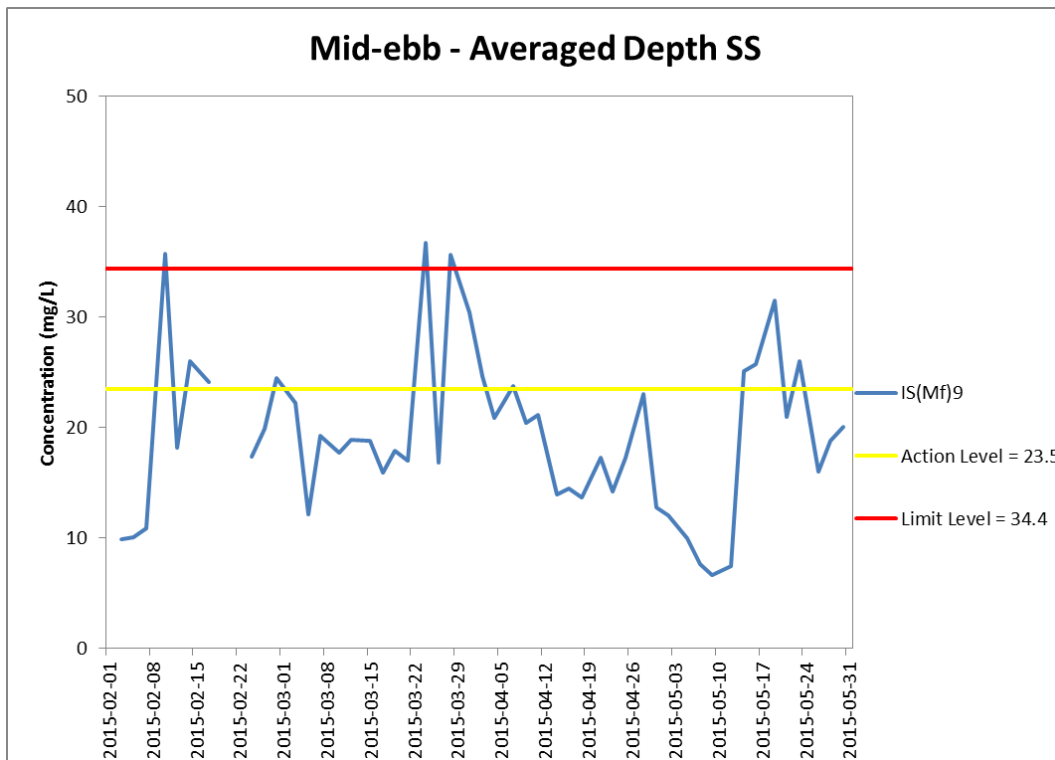
Figure H30 Impact Monitoring - Mean depth-averaged level of Suspended Solids (mg/L) during mid-ebb tide between 1 February and 31 May 2015 at IS(Mf)16 and IS(Mf)9.

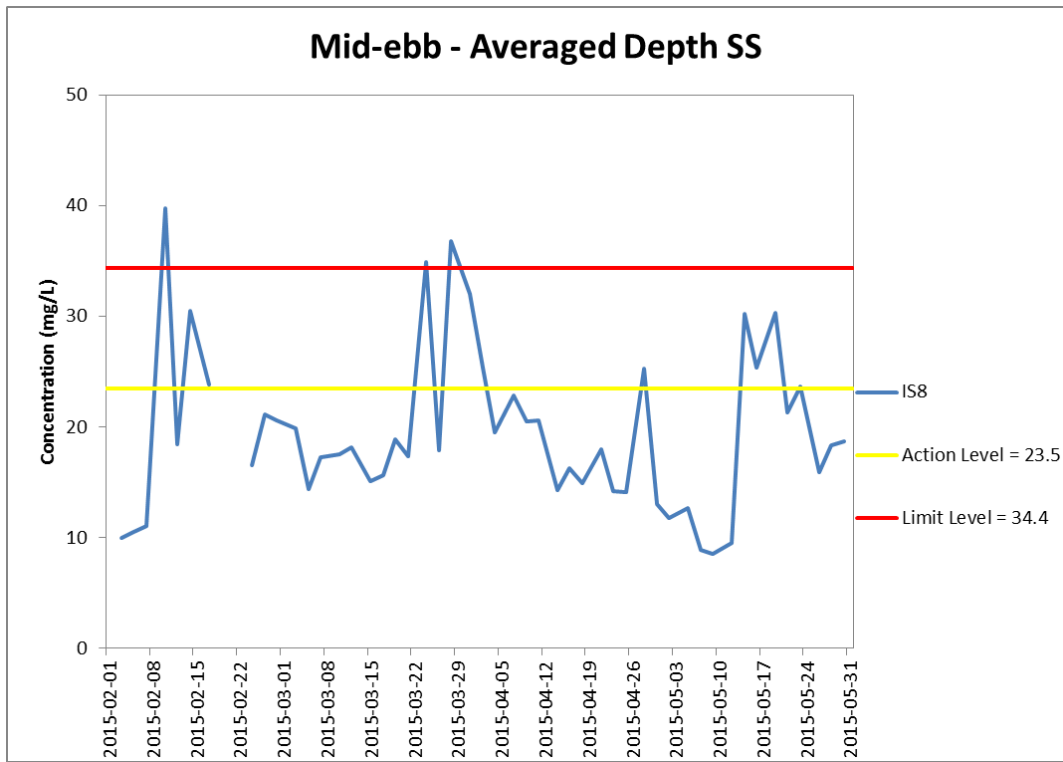
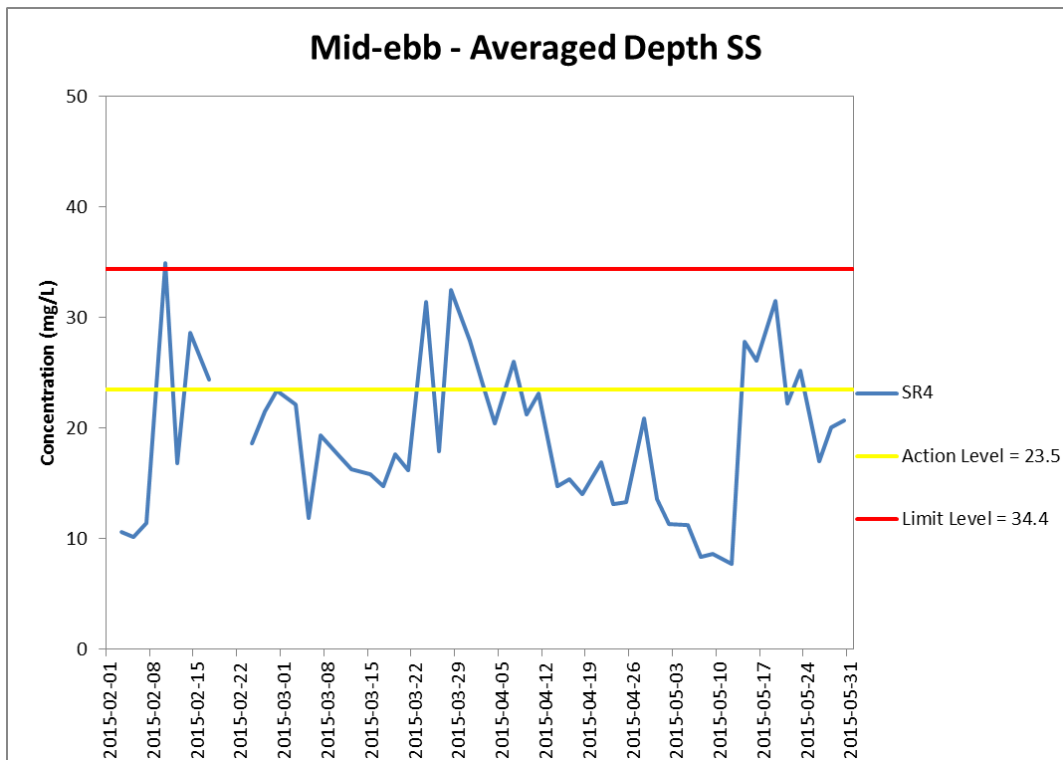
Figure H31 Impact Monitoring - Mean depth-averaged level of Suspended Solids (mg/L) during mid-ebb tide between 1 February and 31 May 2015 at IS8 and SR4.

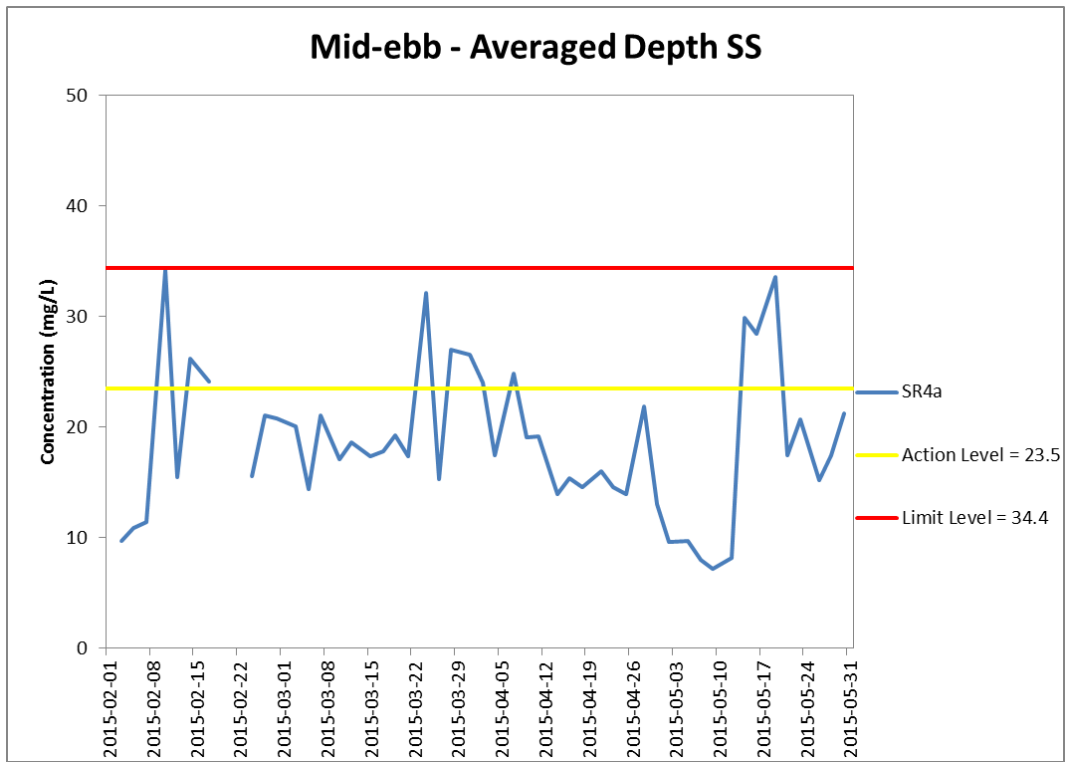
Figure H32 Impact Monitoring - Mean depth-averaged level of Suspended Solids (mg/L) during mid-ebb tide between 1 February and 31 May 2015 at SR4a.
