**Contract No. HY/2012/07
Tuen Mun – Chek Lap Kok Link –
Southern Connection Viaduct Section**

***Sixth Quarterly Environmental Monitoring &
Audit (EM&A) Report***

19 October 2015

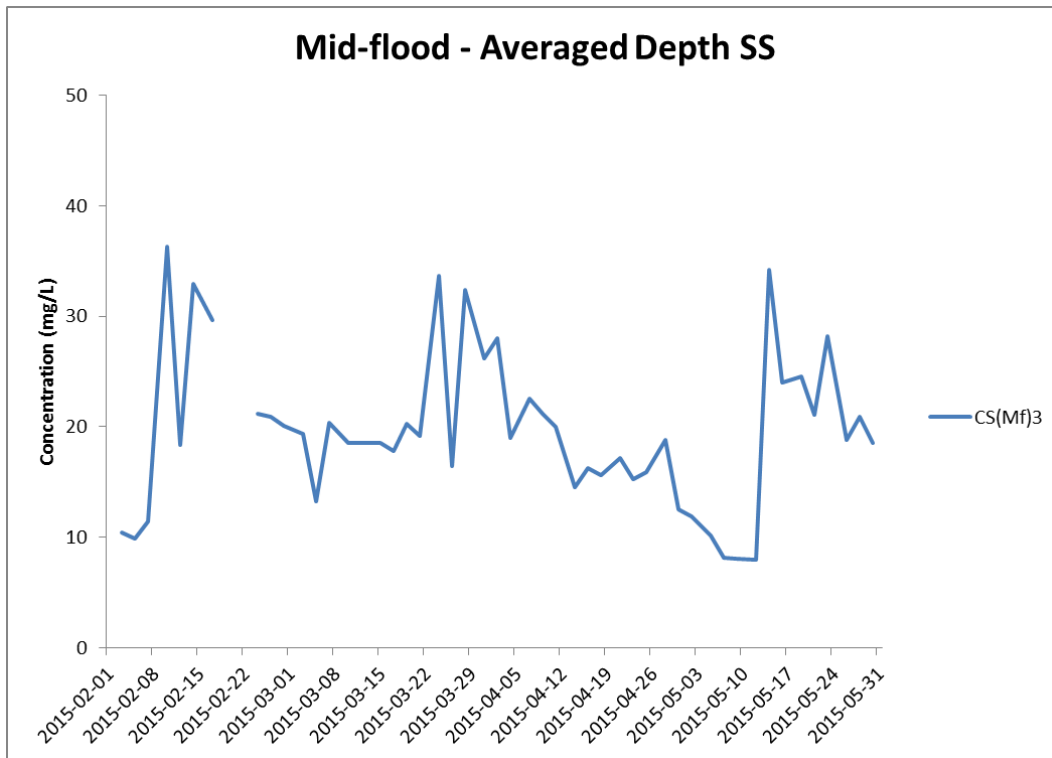
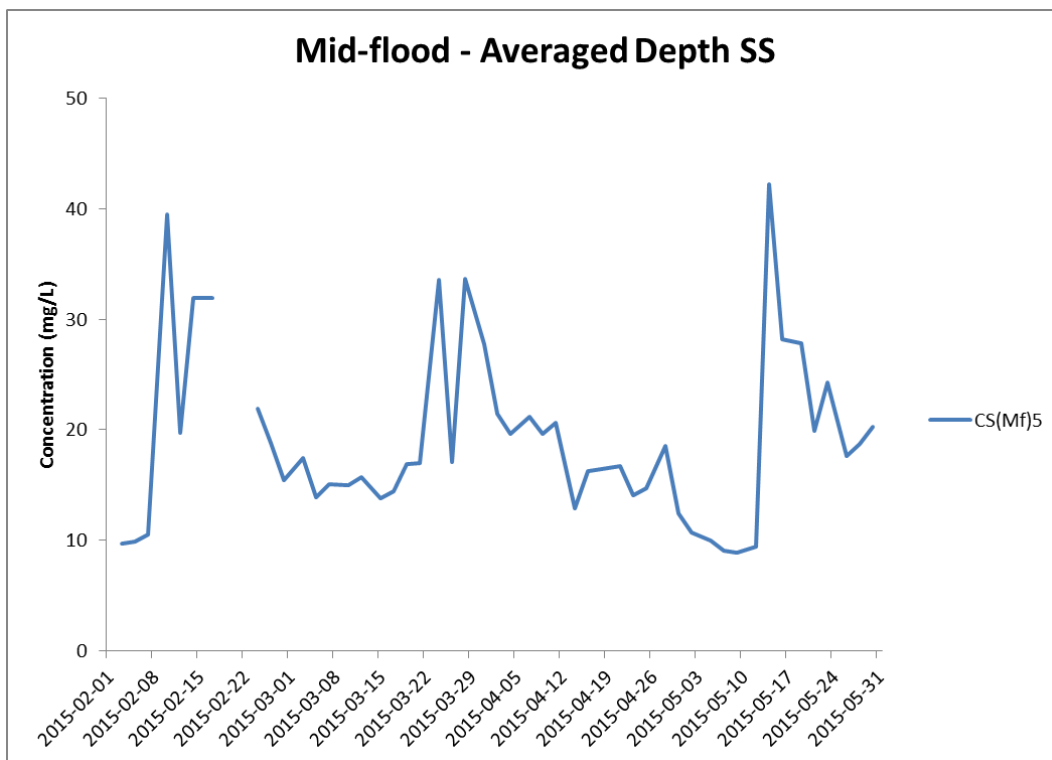
Figure H33 Impact Monitoring – Mean depth-averaged level of Suspended Solids (mg/L) during mid-flood tide between 1 February and 31 May 2015 at CS(Mf)3 and CS(Mf)5.

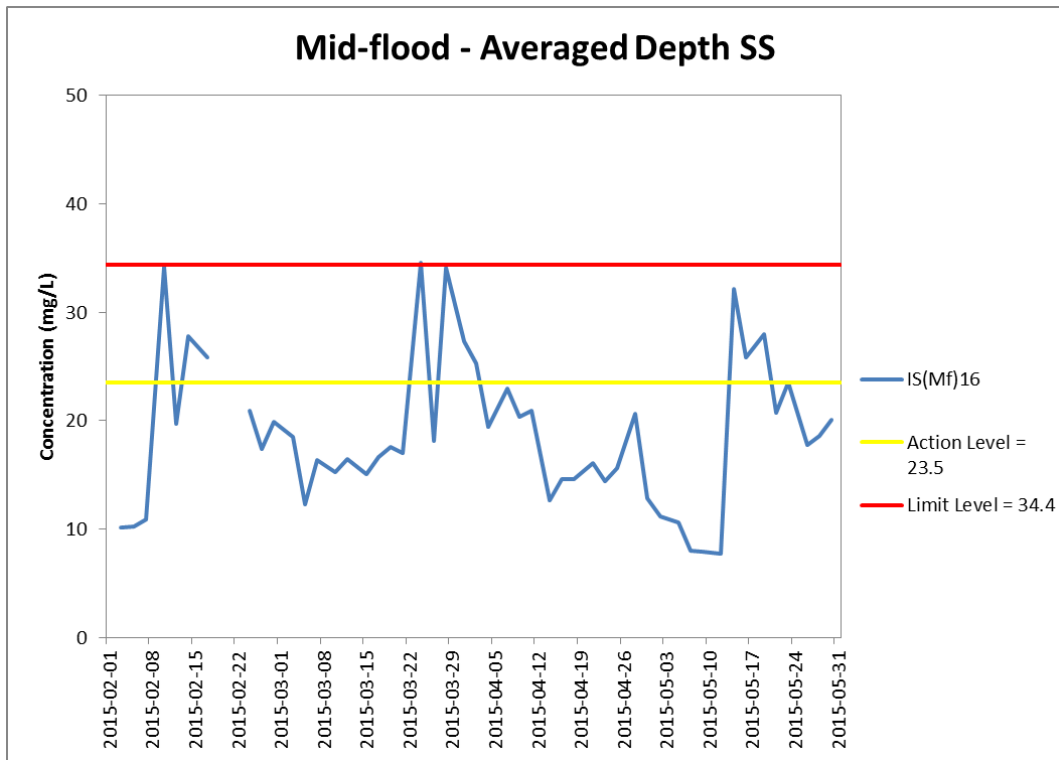
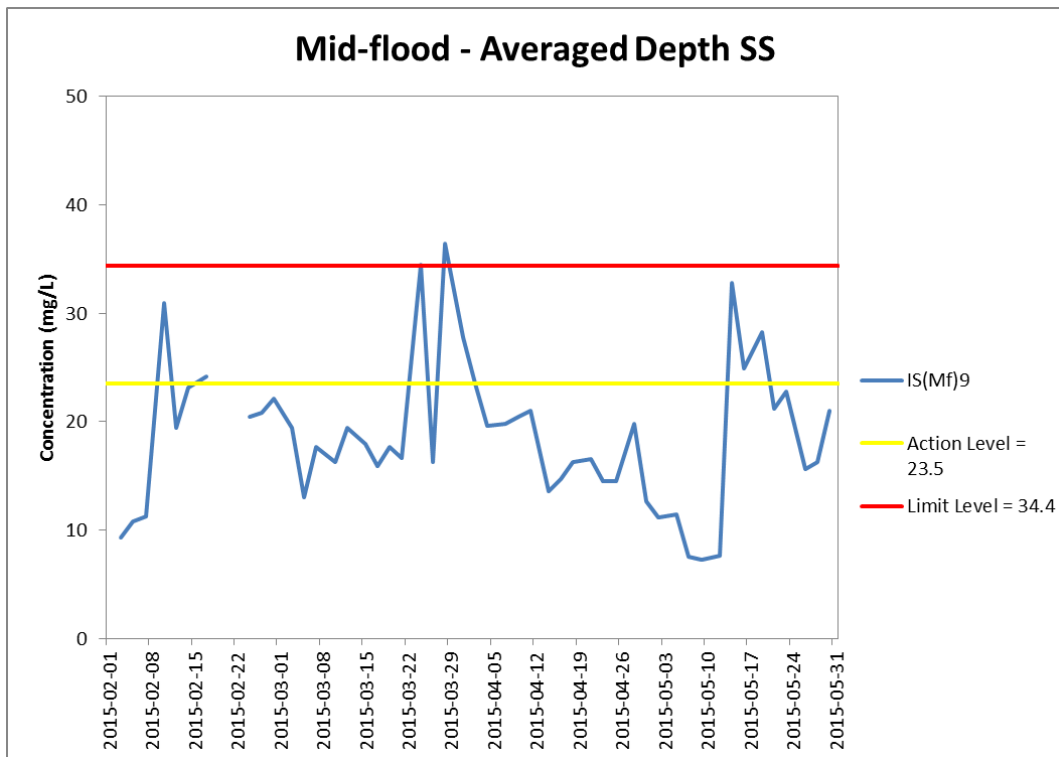
Figure H34 Impact Monitoring - Mean depth-averaged level of Suspended Solids (mg/L) during mid-flood tide between 1 February and 31 May 2015 at IS(Mf)16 and IS(Mf)9.

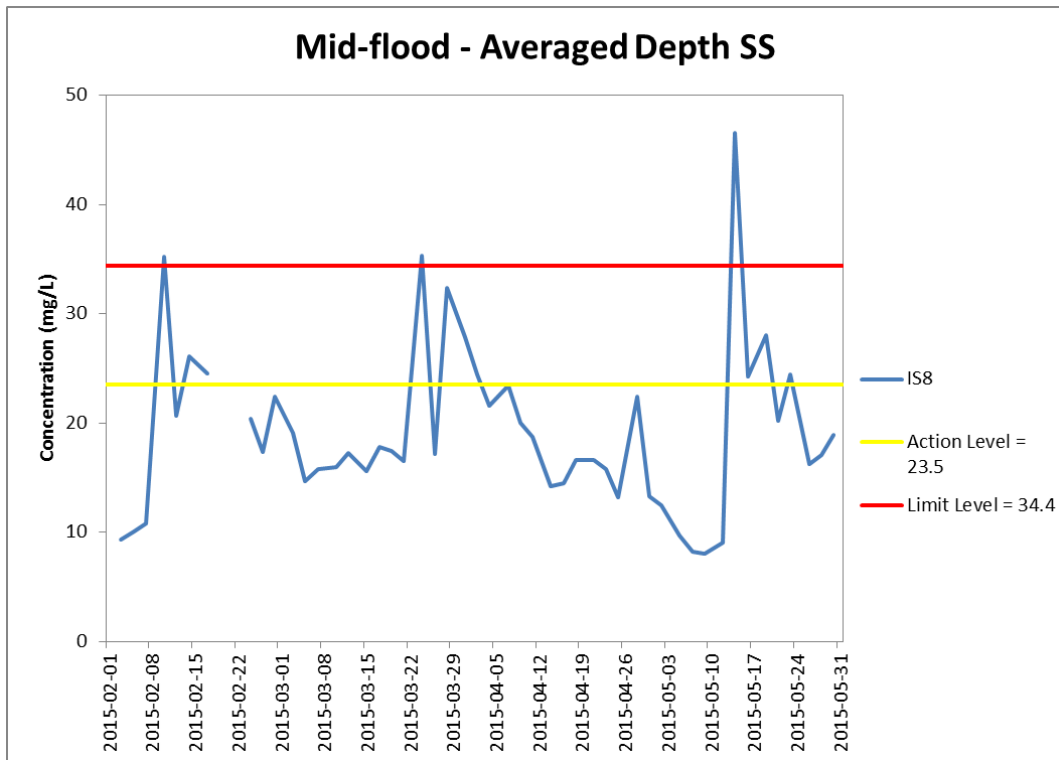
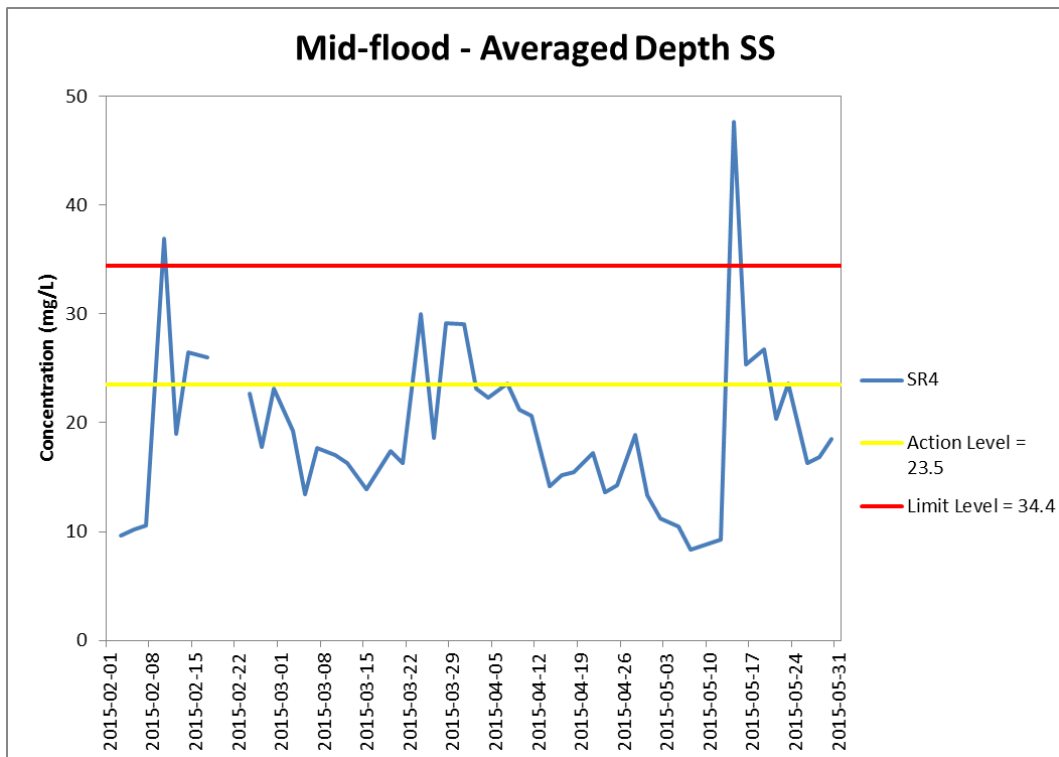
Figure H35 Impact Monitoring - Mean depth-averaged level of Suspended Solids (mg/L) during mid-flood tide between 1 February and 31 May 2015 at IS8 and SR4.

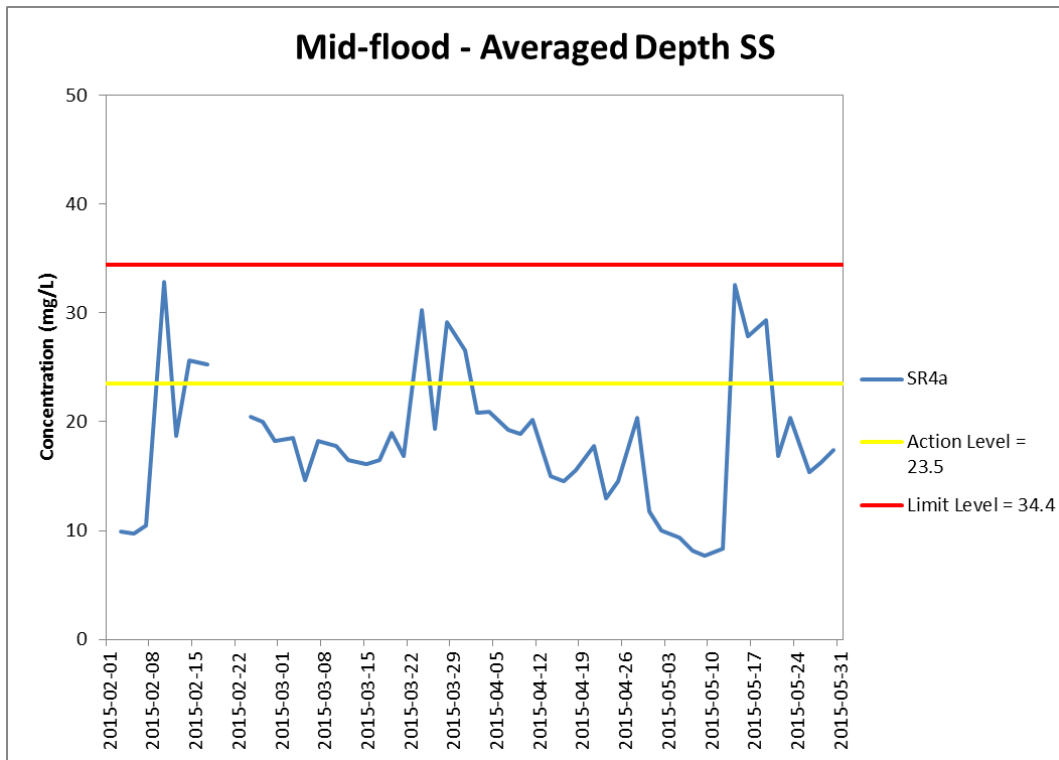
Figure H36 Impact Monitoring – Mean depth-averaged level of Suspended Solids (mg/L) during mid-flood tide between 1 February and 31 May 2015 at SR4a.

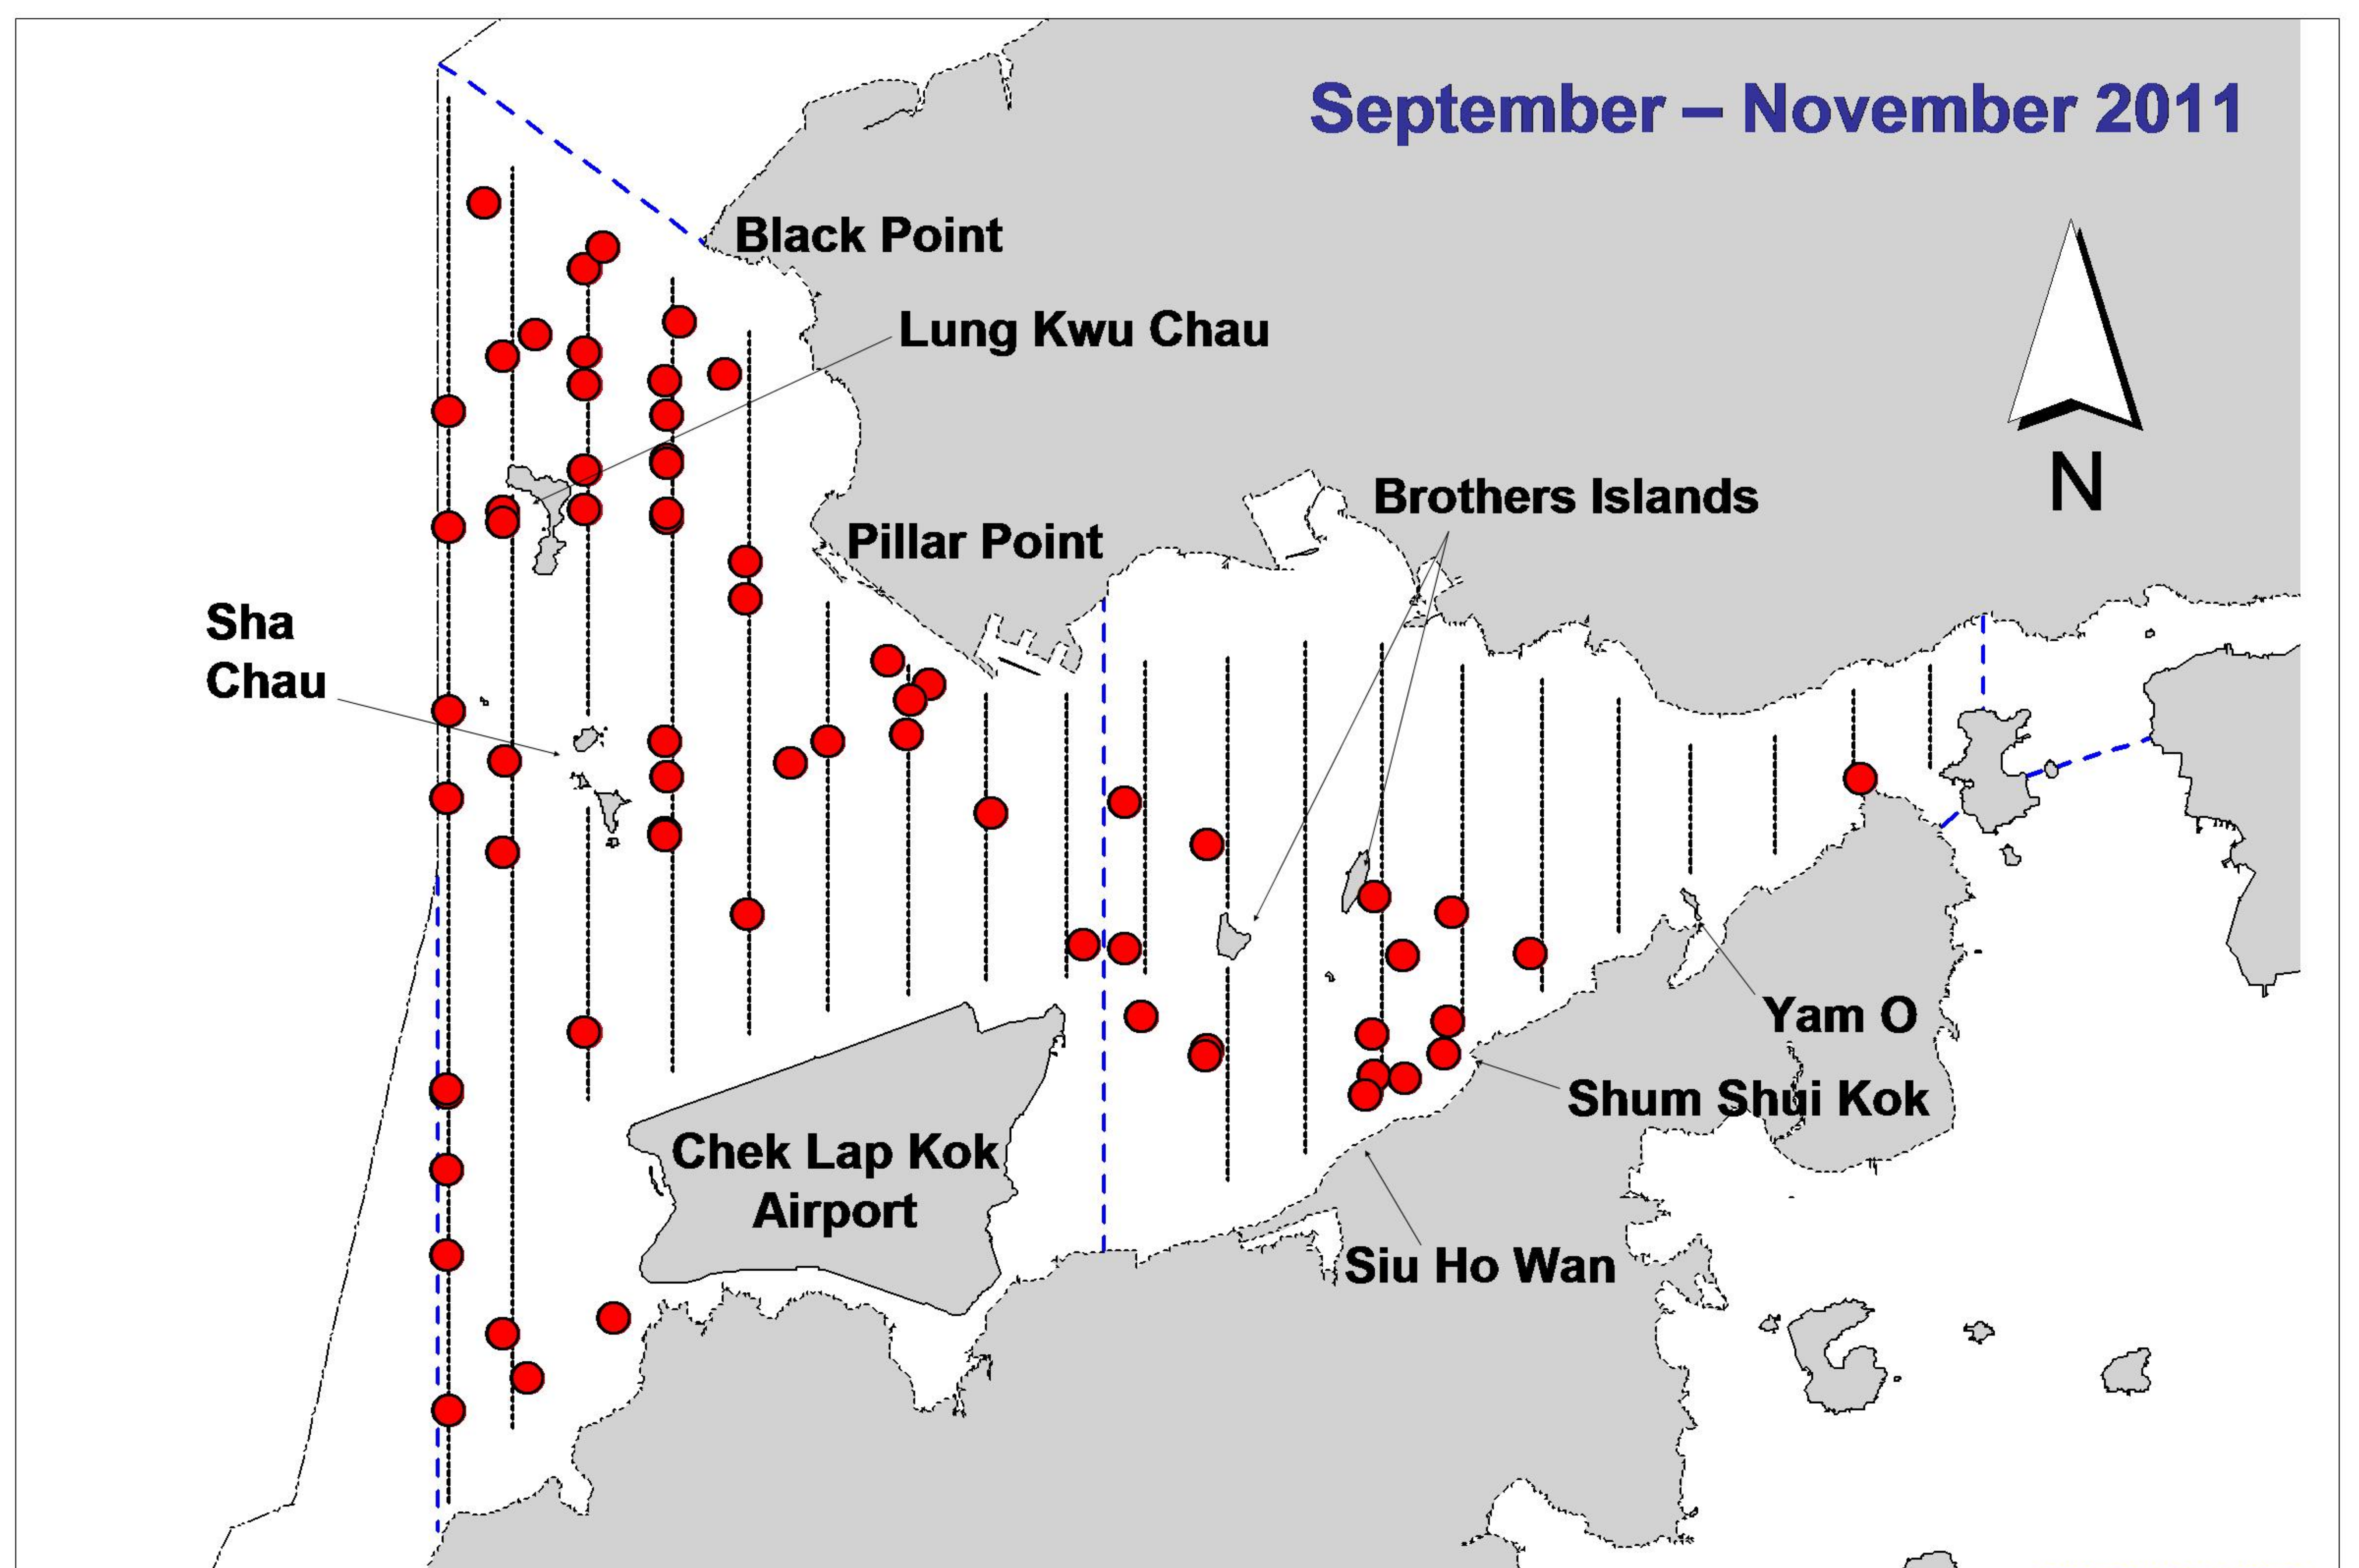
Figure 1. Distribution of Chinese white dolphin sighting in Northwest and Northeast Lantau during HKLR03 impact phase (top) and baseline monitoring surveys (bottom)
