Contract No. HY/2012/08
Tuen Mun – Chek Lap Kok Link –
Northern Connection Sub-sea Tunnel
Section

Sixth Quarterly Environmental Monitoring & Audit (EM&A) Report

30 October 2015

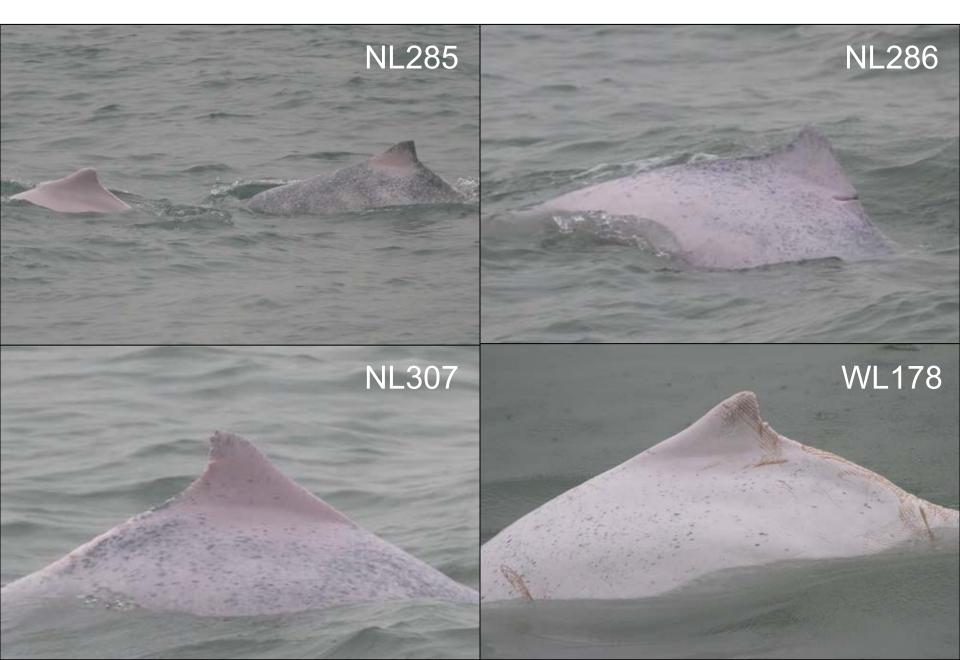
Appendix V. Ranging patterns (95% kernel ranges) of 16 individual dolphins that were sighted during HKLR03 impact phase monitoring period (note: yellow dots indicates sightings made in March-May 2015)
