TUEN MUN - CHEK LAP KOK LINK
CONTRACT NO. HY/2013/12 –
NORTHERN CONNECTION TOLL PLAZA AND
ASSOCIATED WORKS

4th QUARTERLY ENVIRONMENTAL MONITORING &
AUDIT SUMMARY REPORT –
(August to October 2015)

CRBC AND KADEN JOINT VENTURE

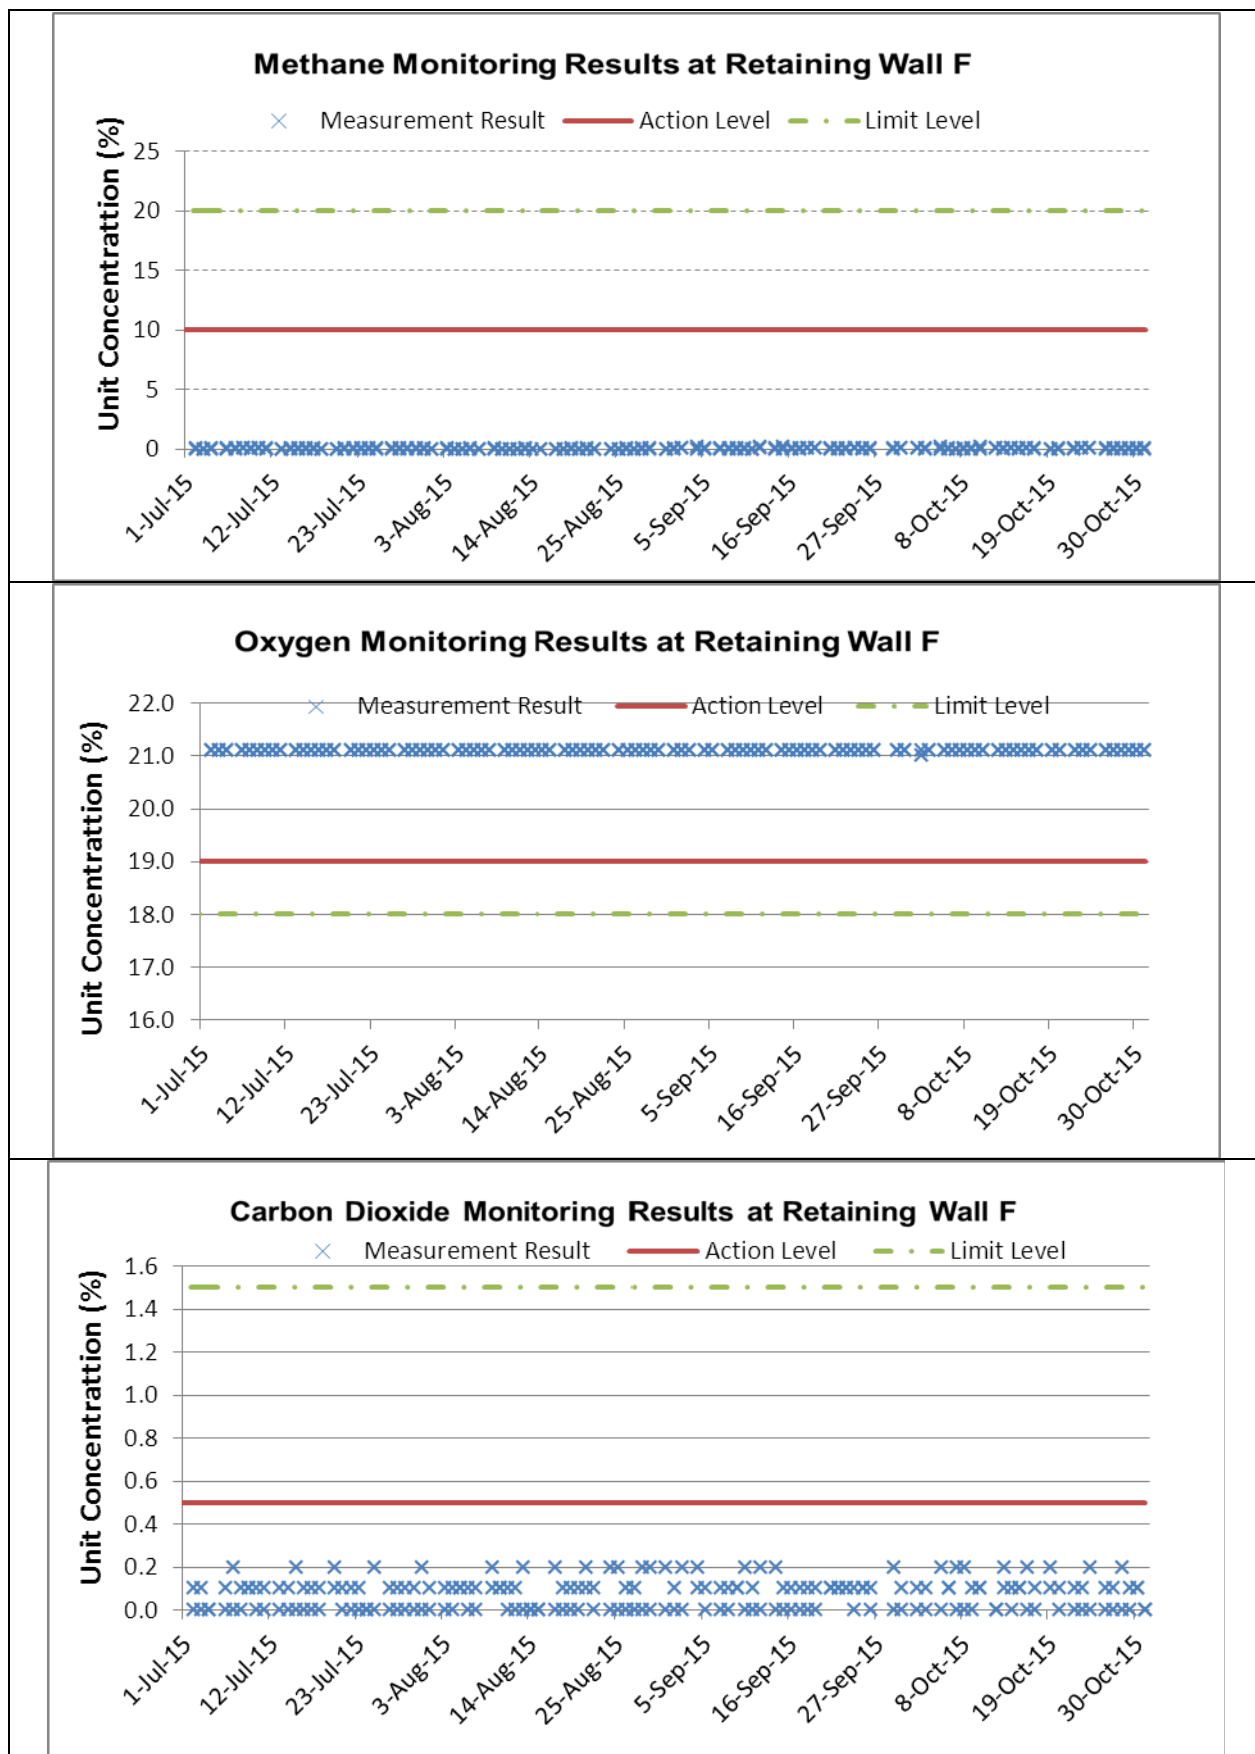
During 1 July to 31 October 2015, major construction activity was construction of retaining wall F and the specified works included excavation, rock breaking, blinding, formworking, steel-fixing and concreting. The weather condition varied from sunny to rainy. The monitoring data was provided by the Contractor followed to their QA/QC control.

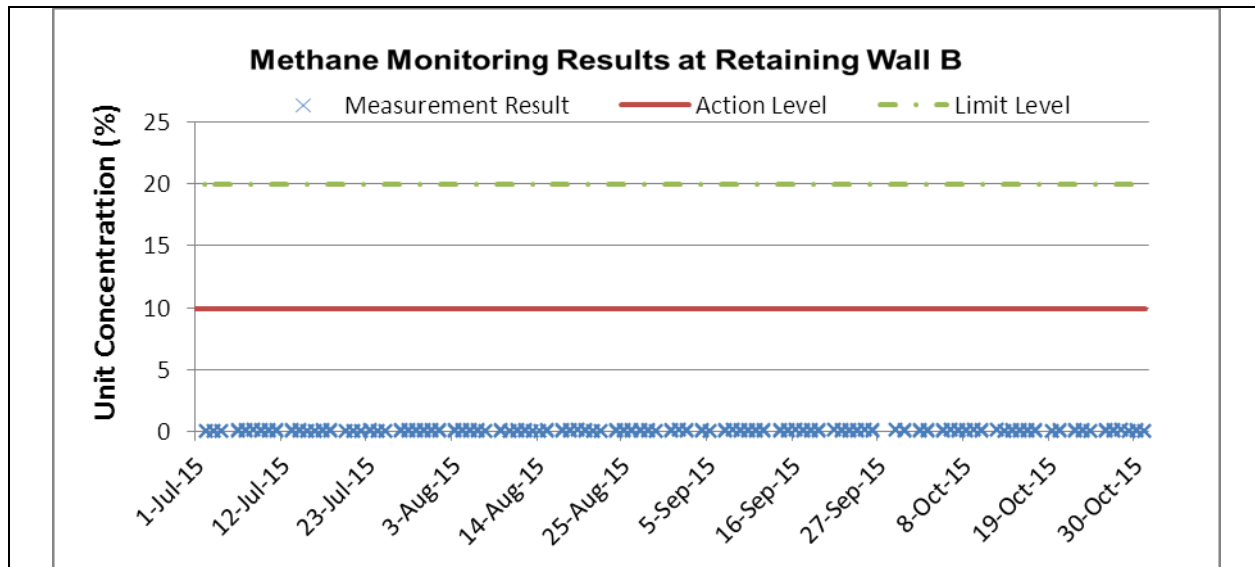
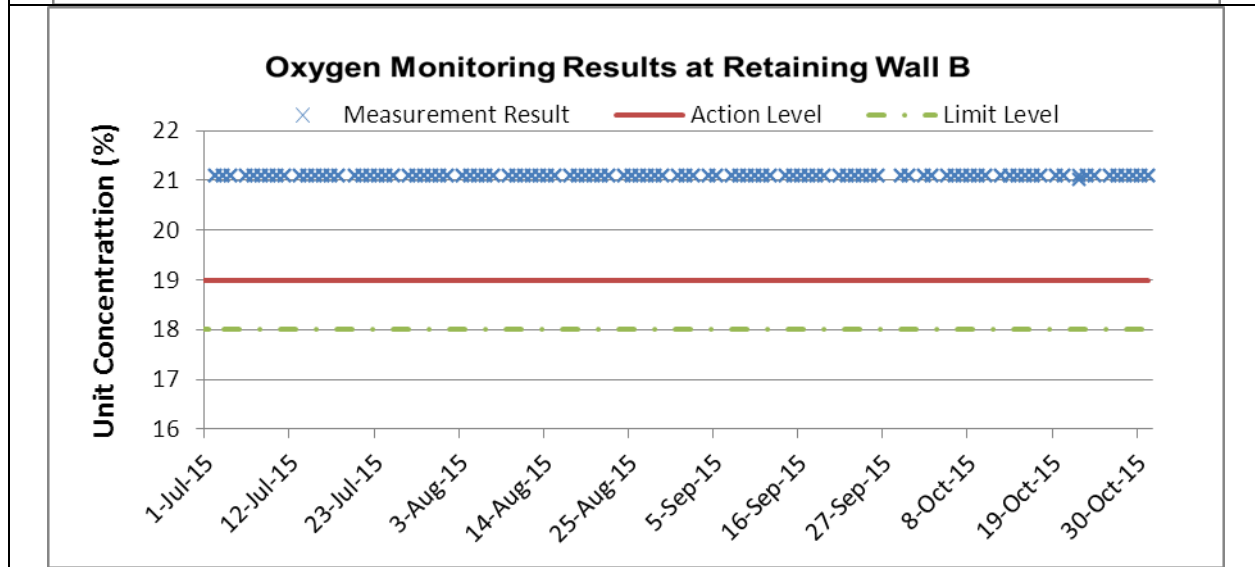
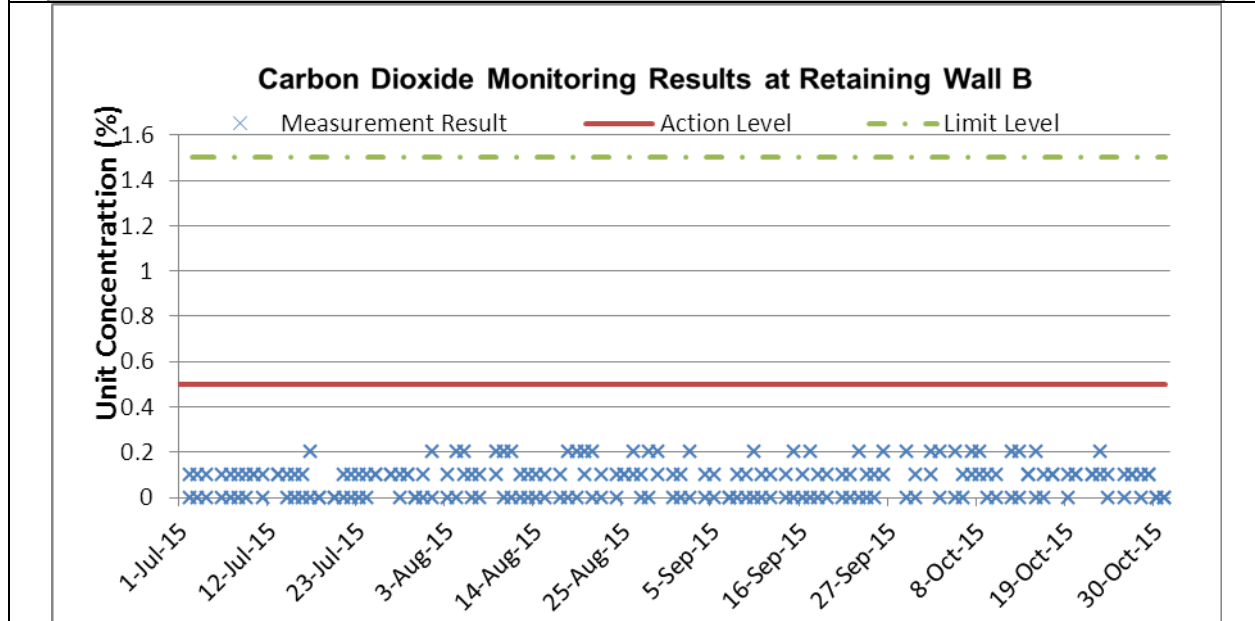
During 1 July to 31 October 2015, major construction activity was construction of retaining wall B and the specified works included excavation, rock breaking, blinding, formworking, steel-fixing and concreting. The weather condition varied from sunny to rainy. The monitoring data was provided by the Contractor followed to their QA/QC control.
