**Contract No. HY/2012/08
Tuen Mun – Chek Lap Kok Link –
Northern Connection Sub-sea Tunnel
Section**

*Eleventh Quarterly Environmental Monitoring &
Audit (EM&A) Report*

27 February 2017

**Contract No. HY/2012/08 TM-CLKL Northern Connection Sub-sea
Tunnel Section
Eleventh Quarterly EM&A Report (June 2016 – August 2016)**

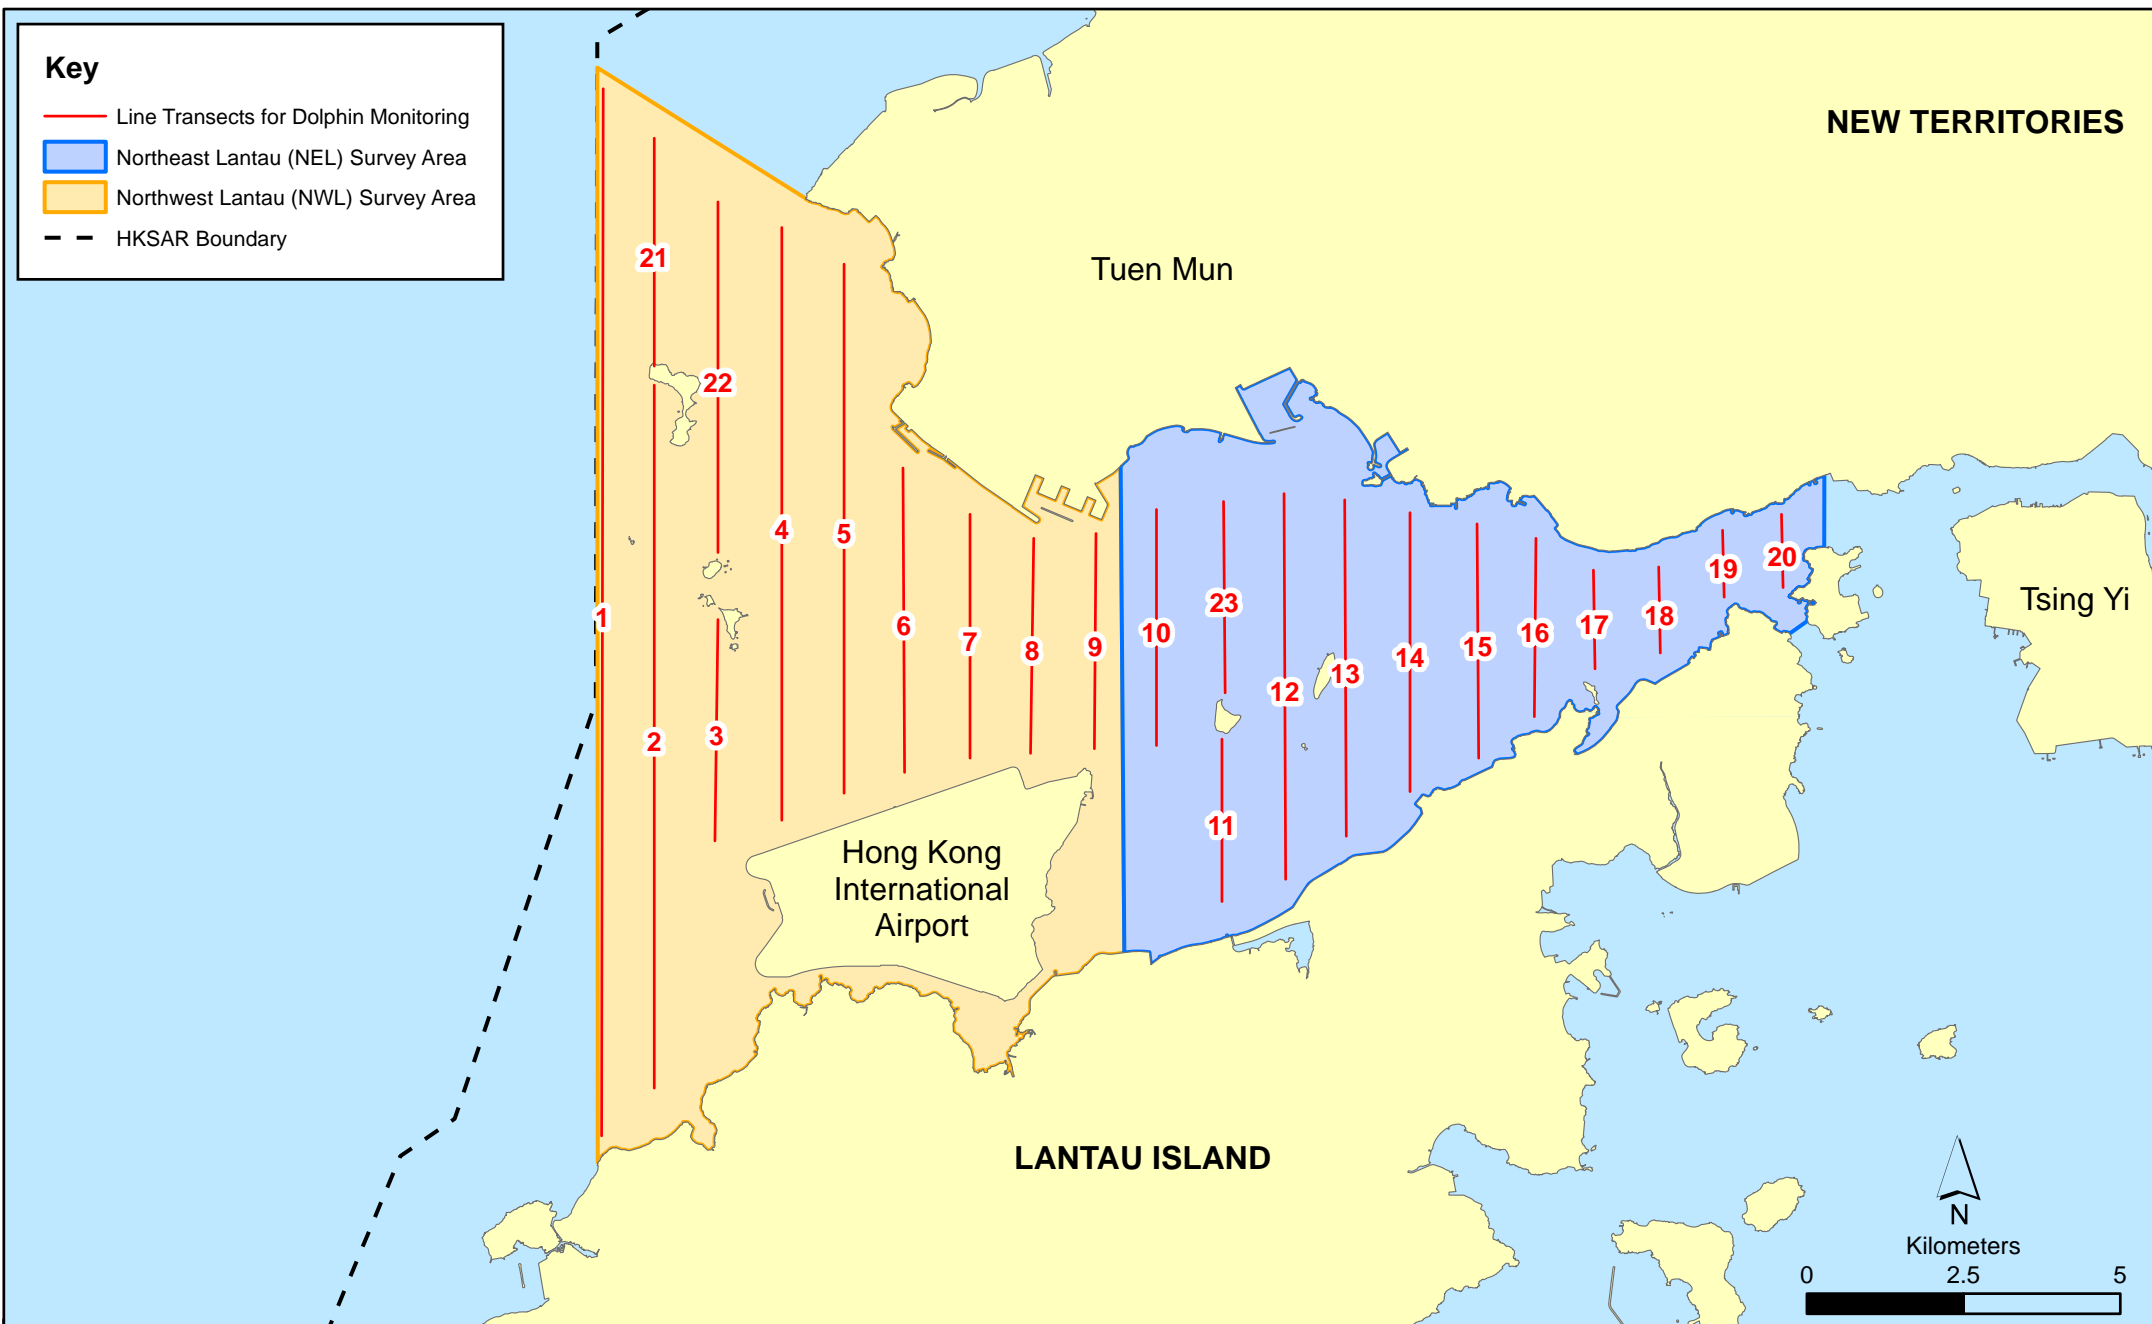
Figure 2.2

The impact dolphin monitoring was carried out in the NEL and NWL along the line transect as depicted in *Figure 2.2*. The co-ordinates of all transect lines are shown in *Table 2.6* below.

Layout of Transect Lines of Dolphin Monitoring in Northwest and Northeast Lantau Areas

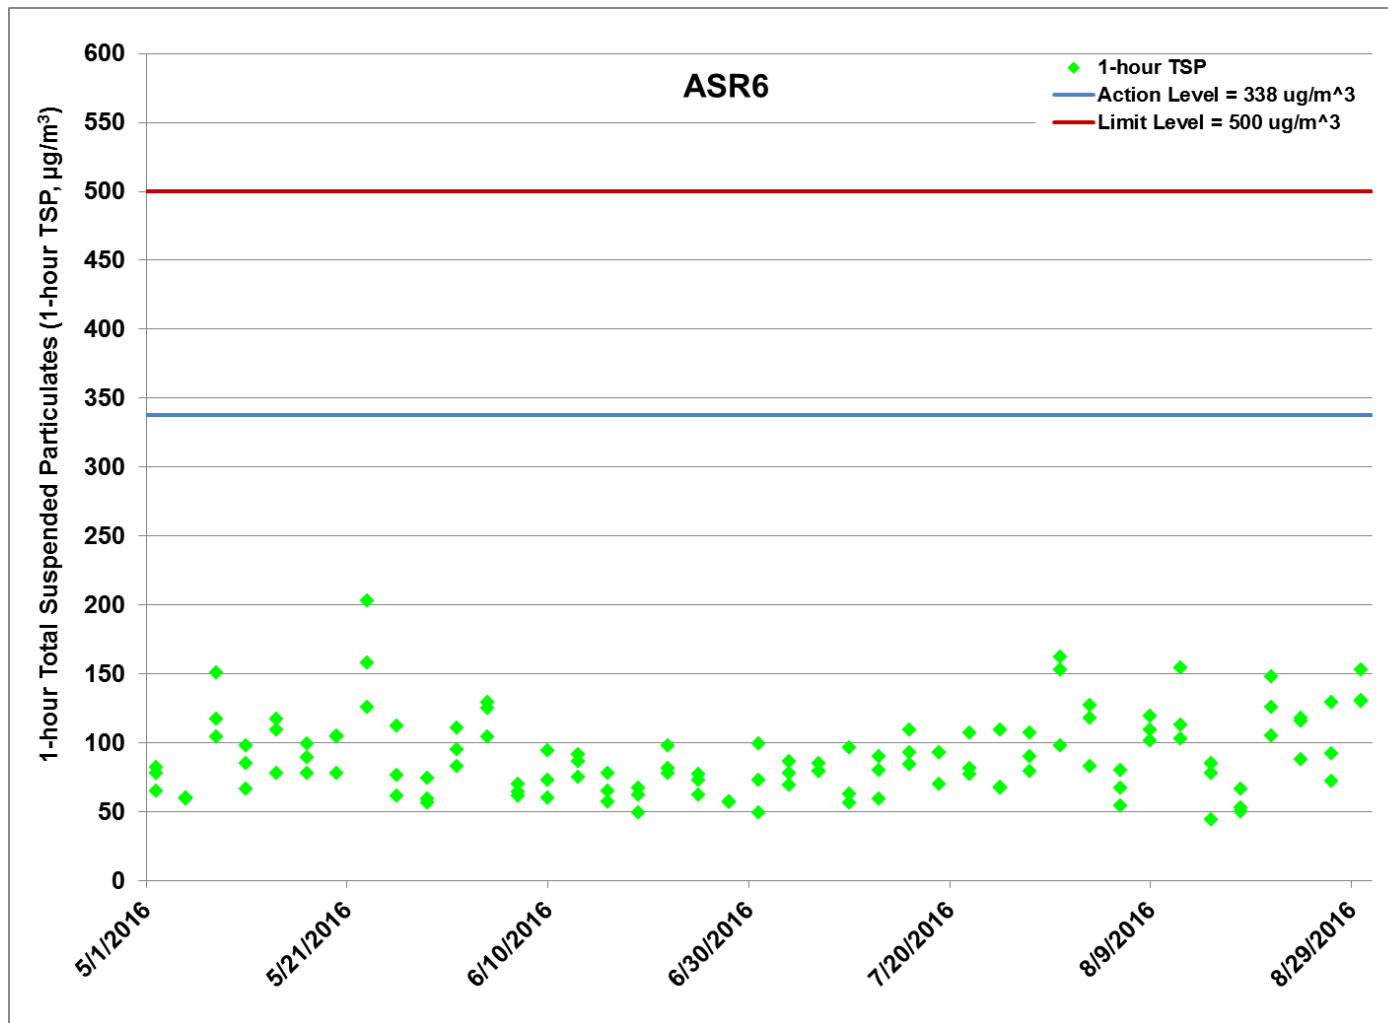
Figure F.2 Impact Monitoring - 1-hour Total Suspended Particulates ($\mu\text{g}/\text{m}^3$) at ASR6 between 1 May 2016 and 31 August 2016 during impact monitoring period. The weather conditions during the monitoring period varied from sunny to cloudy. Major land-based construction activities included: CSM Ground Treatment and Diaphragm Wall Construction (1/5/2016 - 31/8/2016) and Box Culvert Extension (1/5/2016 - 31/8/2016). Ref: 0212330_Impact AQM graphs_ August 2016_REV a.xlsx

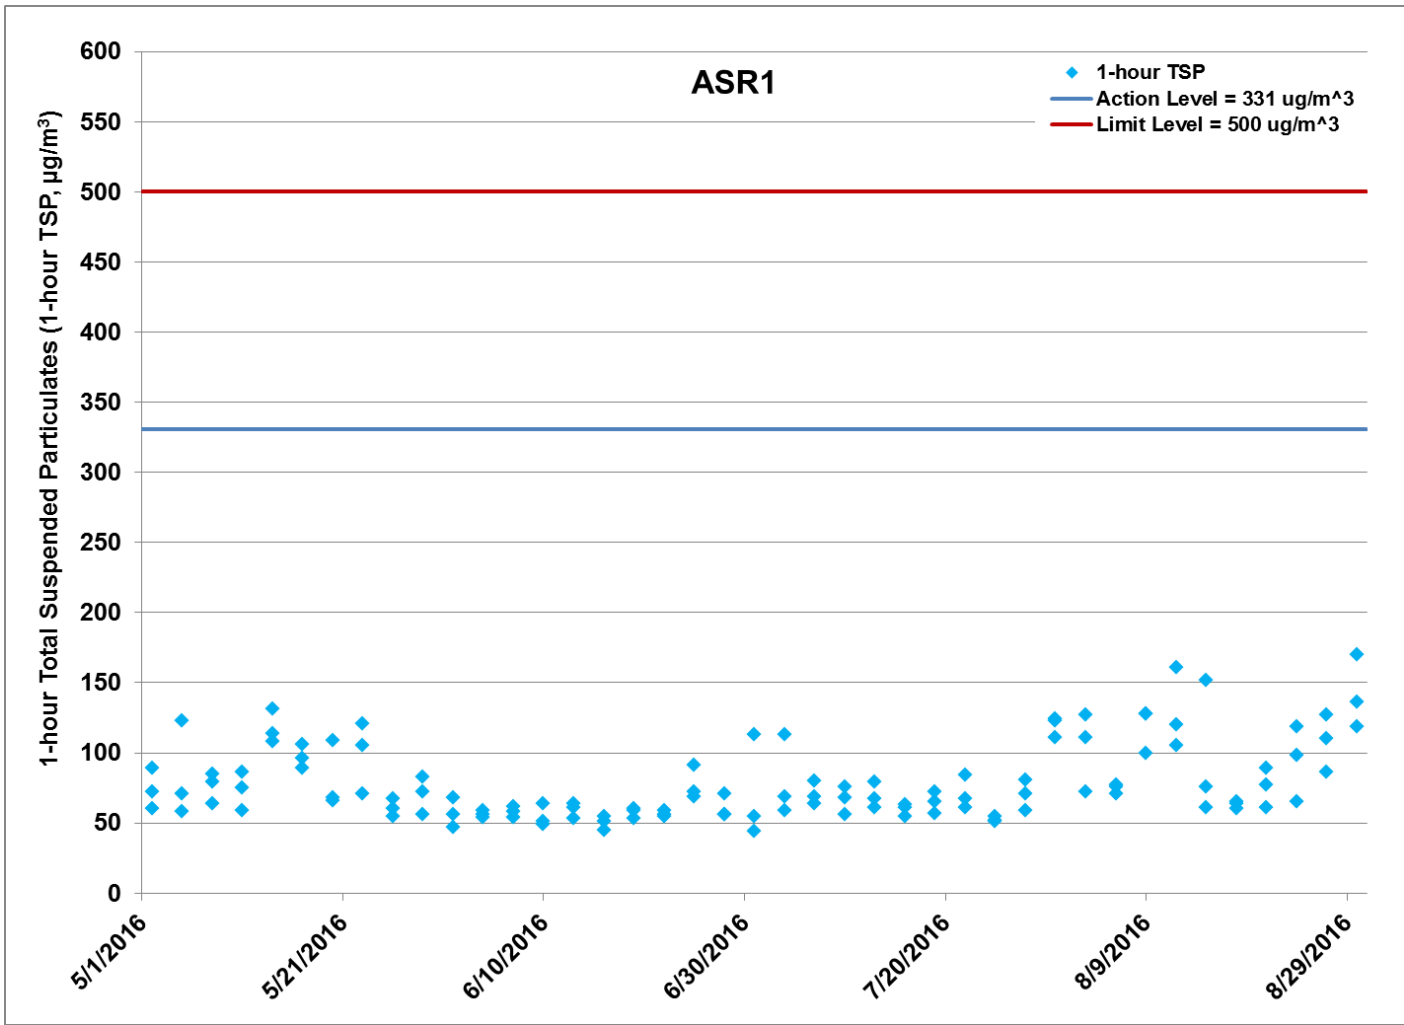
Figure F.3 Impact Monitoring - 1-hour Total Suspended Particulates ($\mu\text{g}/\text{m}^3$) at ASR1 between 1 May 2016 and 31 August 2016 during impact monitoring period. The weather conditions during the monitoring period varied from sunny to cloudy. Major land-based construction activities included: CSM Ground Treatment and Diaphragm Wall Construction (1/5/2016 - 31/8/2016) and Box Culvert Extension (1/5/2016 - 31/8/2016). Ref: 0212330_Impact AQM graphs_ August 2016_REV a.xlsx

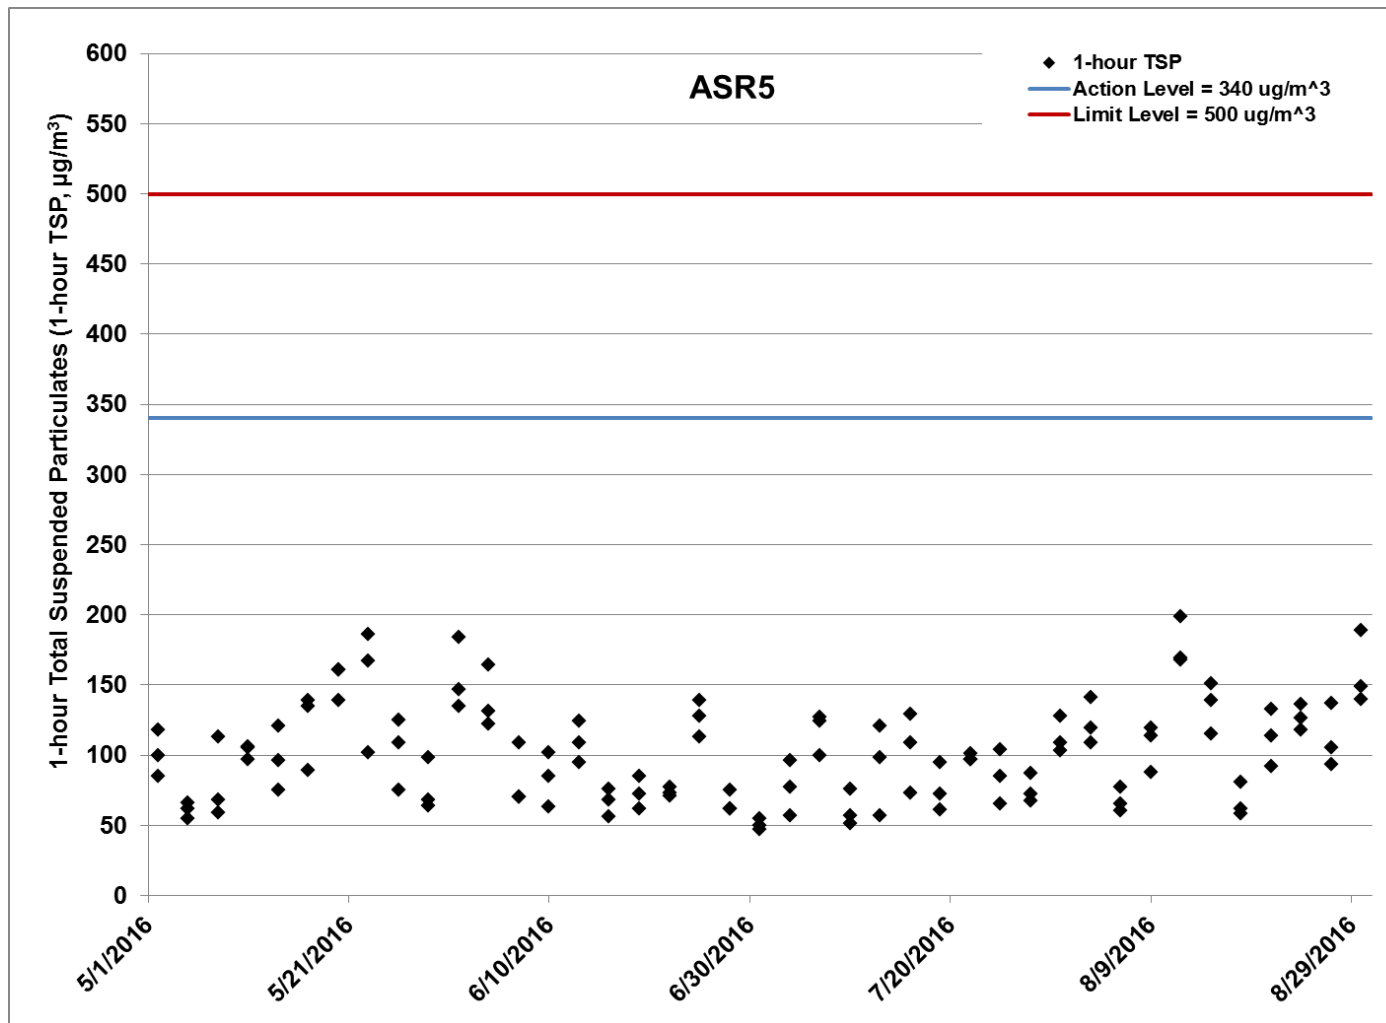
Figure F.4 Impact Monitoring - 1-hour Total Suspended Particulates ($\mu\text{g}/\text{m}^3$) at ASR5 between 1 May 2016 and 31 August 2016 during impact monitoring period. The weather conditions during the monitoring period varied from sunny to cloudy. Major land-based construction activities included: CSM Ground Treatment and Diaphragm Wall Construction (1/5/2016 - 31/8/2016) and Box Culvert Extension (1/5/2016 - 31/8/2016). Ref: 0212330_Impact AQM graphs_ August 2016_REV a.xlsx

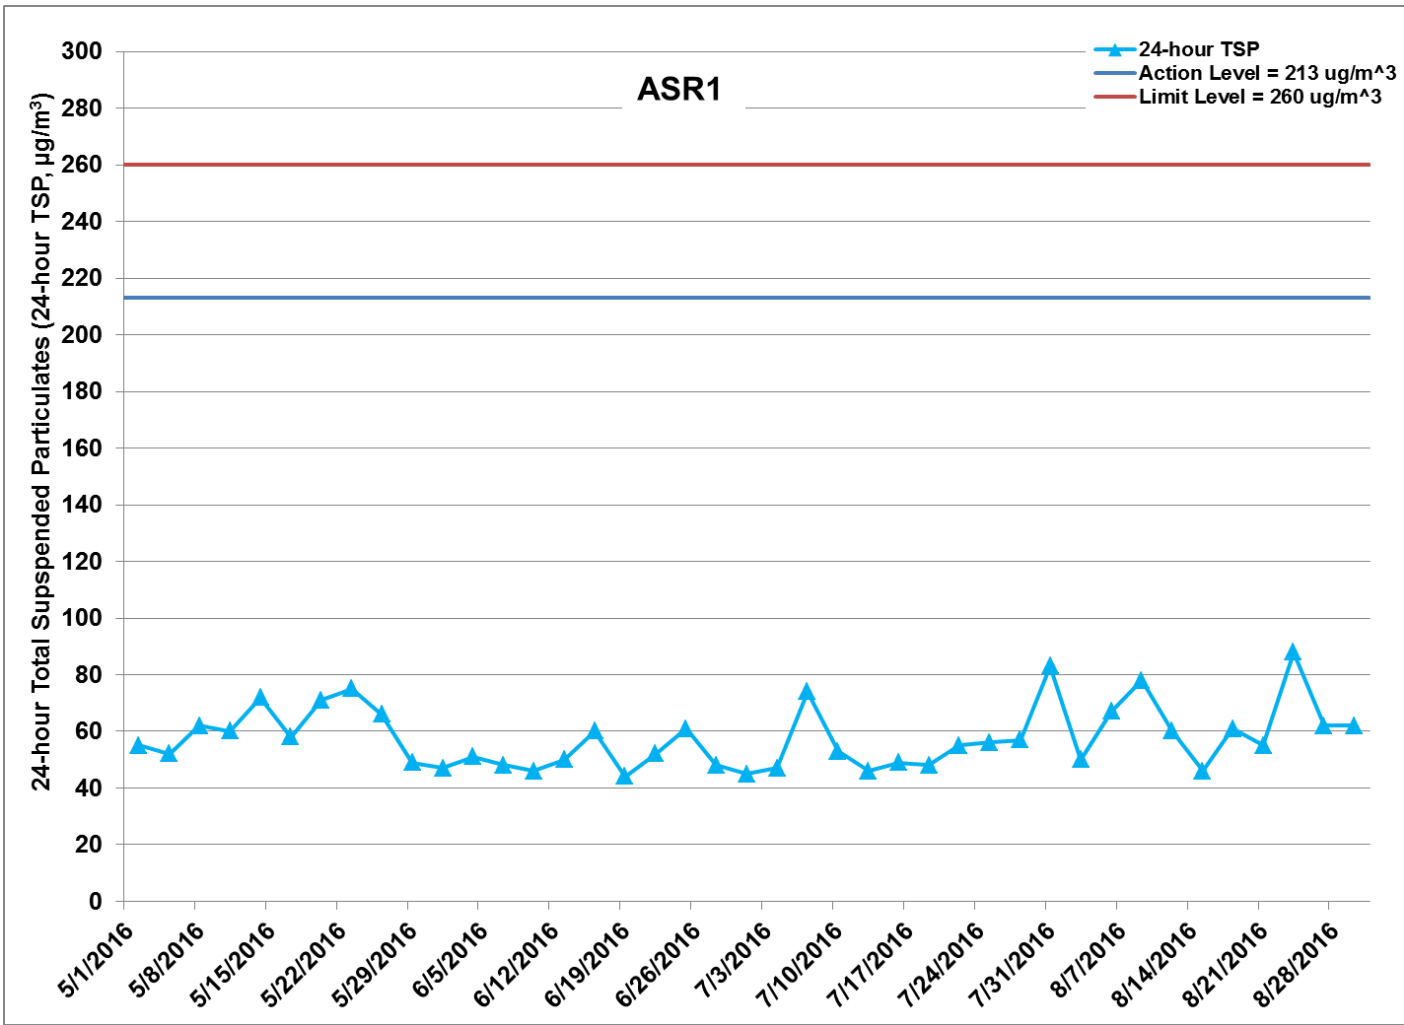
Figure F.6 Impact Monitoring - 24-hour Total Suspended Particulates ($\mu\text{g}/\text{m}^3$) at ASR1 between 1 May 2016 and 31 August 2016 during impact monitoring period. The weather conditions during the monitoring period varied from sunny to cloudy. Major land-based construction activities included: CSM Ground Treatment and Diaphragm Wall Construction (1/5/2016 - 31/8/2016) and Box Culvert Extension (1/5/2016 - 31/8/2016). Ref: 0212330_Impact AQM graphs_ August 2016_REV a.xlsx

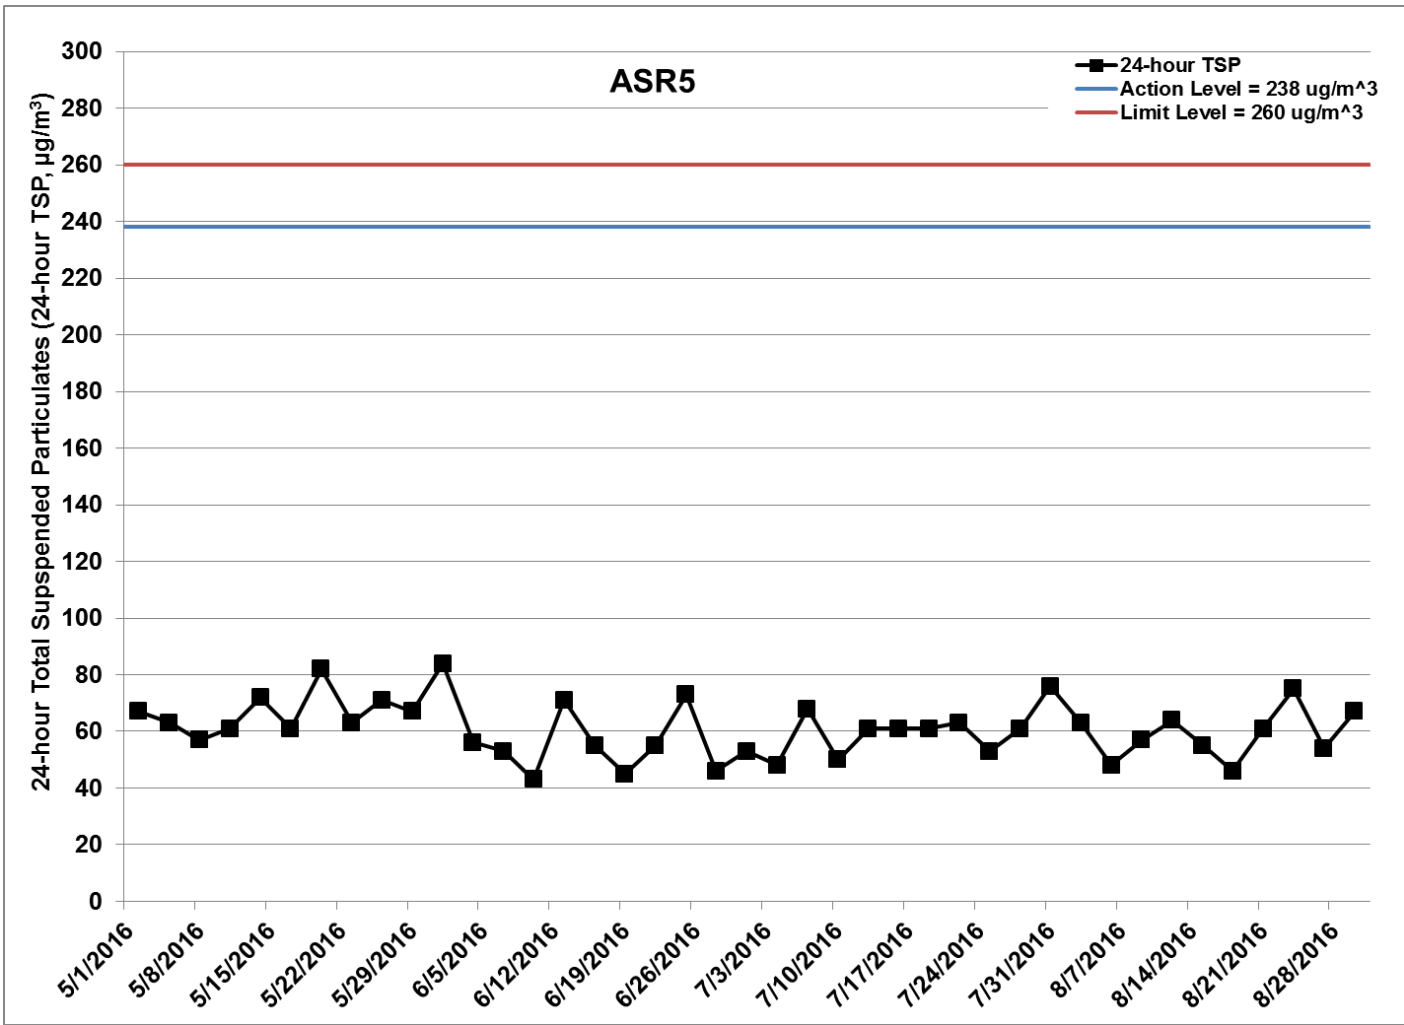
Figure F.7 Impact Monitoring - 24-hour Total Suspended Particulates ($\mu\text{g}/\text{m}^3$) at ASR5 between 1 May 2016 and 31 August 2016 during impact monitoring period. The weather conditions during the monitoring period varied from sunny to cloudy. Major land-based construction activities included: CSM Ground Treatment and Diaphragm Wall Construction (1/5/2016 - 31/8/2016) and Box Culvert Extension (1/5/2016 - 31/8/2016). Ref: 0212330_Impact AQM graphs_ August 2016_REV a.xlsx

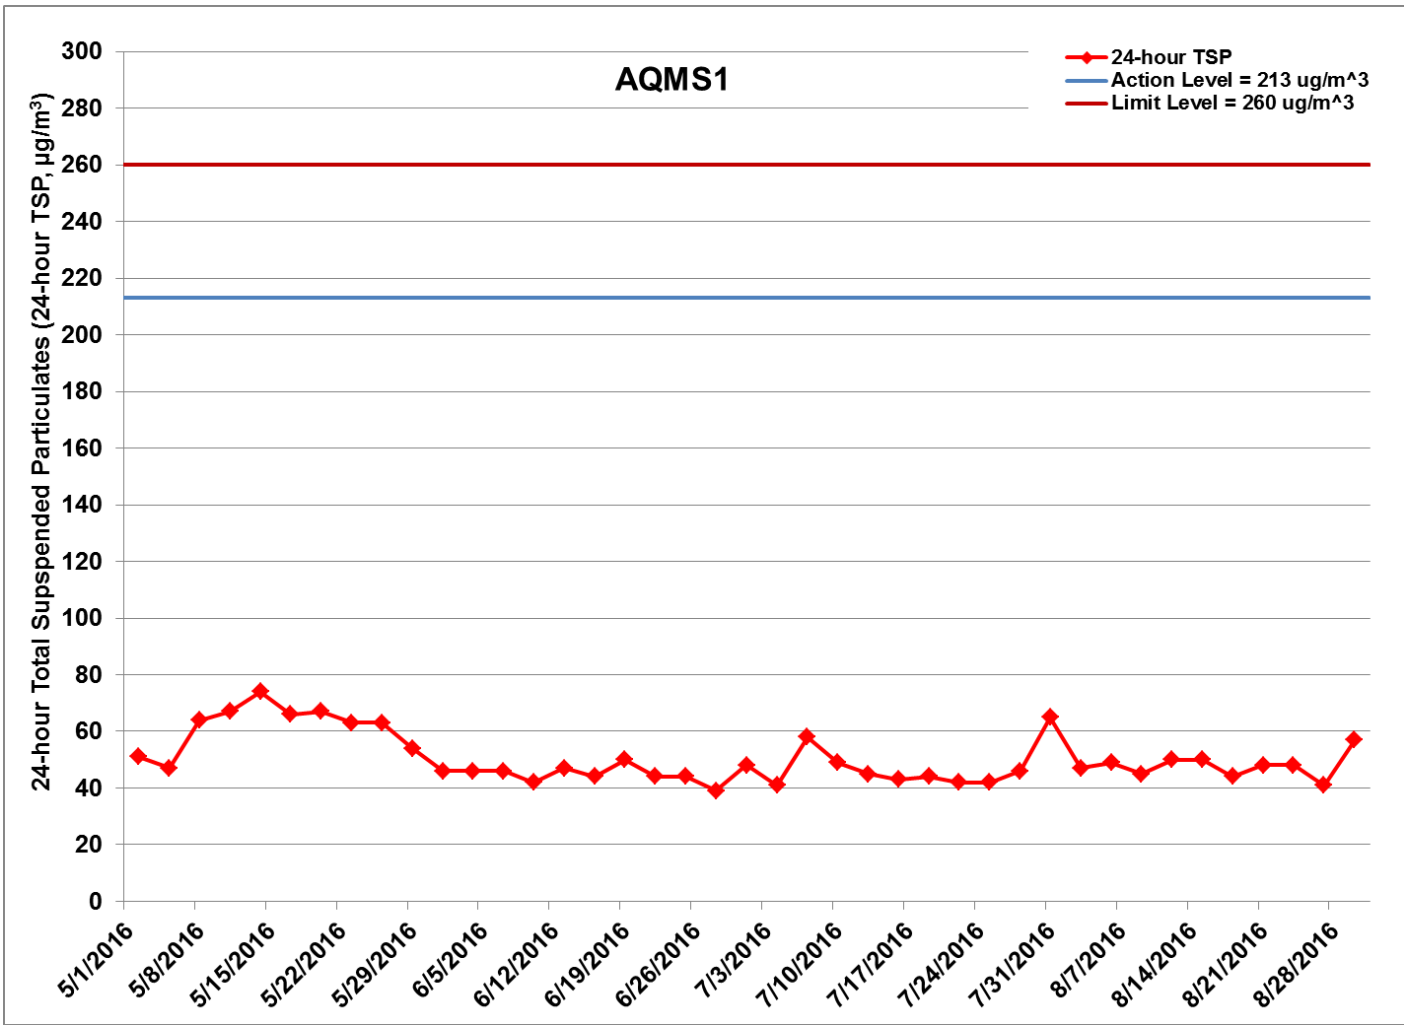
Figure F.8 Impact Monitoring - 24-hour Total Suspended Particulates ($\mu\text{g}/\text{m}^3$) at AQMS1 between 1 May 2016 and 31 August 2016 during impact monitoring period. The weather conditions during the monitoring period varied from sunny to cloudy. Major land-based construction activities included: CSM Ground Treatment and Diaphragm Wall Construction (1/5/2016 - 31/8/2016) and Box Culvert Extension (1/5/2016 - 31/8/2016). Ref: 0212330_Impact AQM graphs_ August 2016_REV a.xlsx

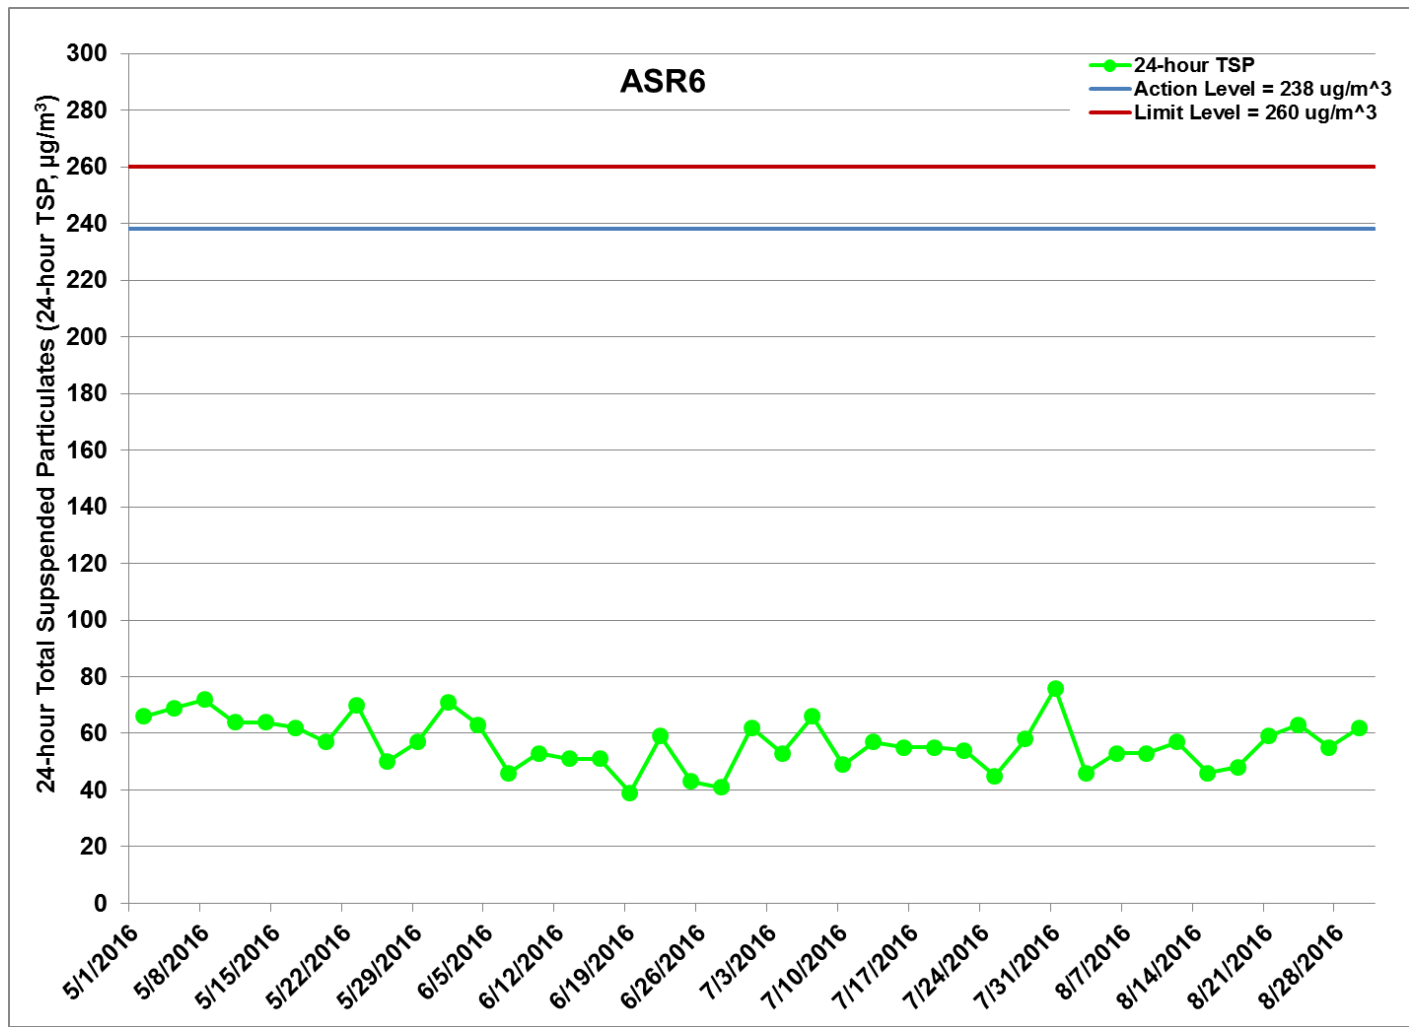
Figure F.9 Impact Monitoring - 24-hour Total Suspended Particulates ($\mu\text{g}/\text{m}^3$) at ASR6 between 1 May 2016 and 31 August 2016 during impact monitoring period. The weather conditions during the monitoring period varied from sunny to cloudy. Major land-based construction activities included: CSM Ground Treatment and Diaphragm Wall Construction (1/5/2016 - 31/8/2016) and Box Culvert Extension (1/5/2016 - 31/8/2016). Ref: 0212330_Impact AQM graphs_ August 2016_REV a.xlsx

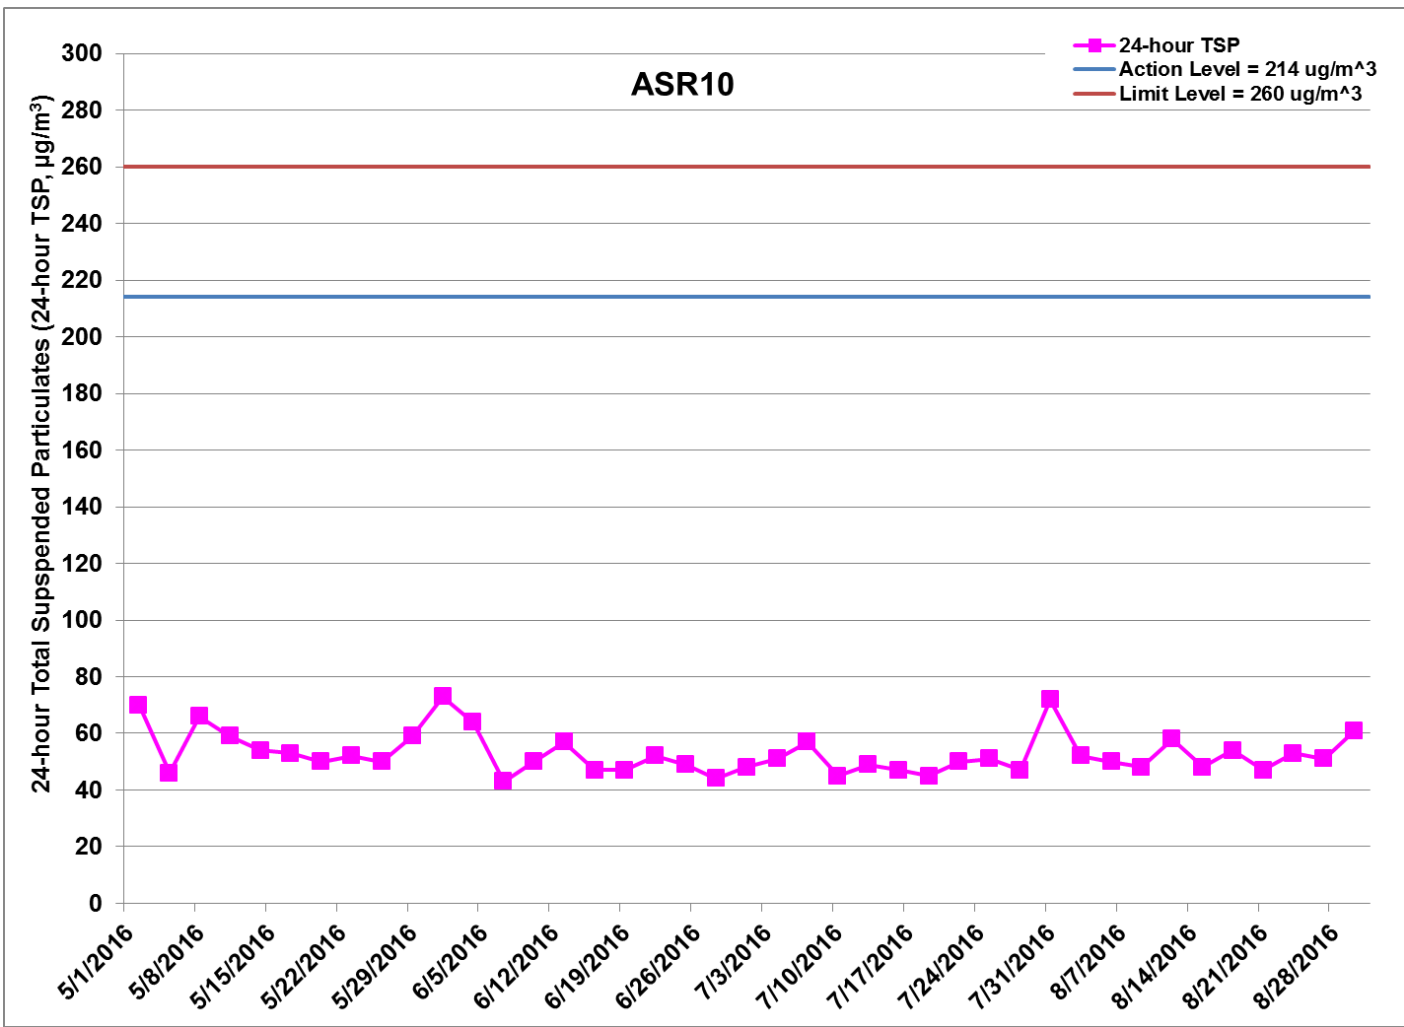
Figure F.10 Impact Monitoring - 24-hour Total Suspended Particulates ($\mu\text{g}/\text{m}^3$) at ASR10 between 1 May 2016 and 31 August 2016 during impact monitoring period. The weather conditions during the monitoring period varied from sunny to cloudy. Major land-based construction activities included: CSM Ground Treatment and Diaphragm Wall Construction (1/5/2016 - 31/8/2016) and Box Culvert Extension (1/5/2016 - 31/8/2016). Ref: 0212330_Impact AQM graphs_ August 2016_REV a.xlsx

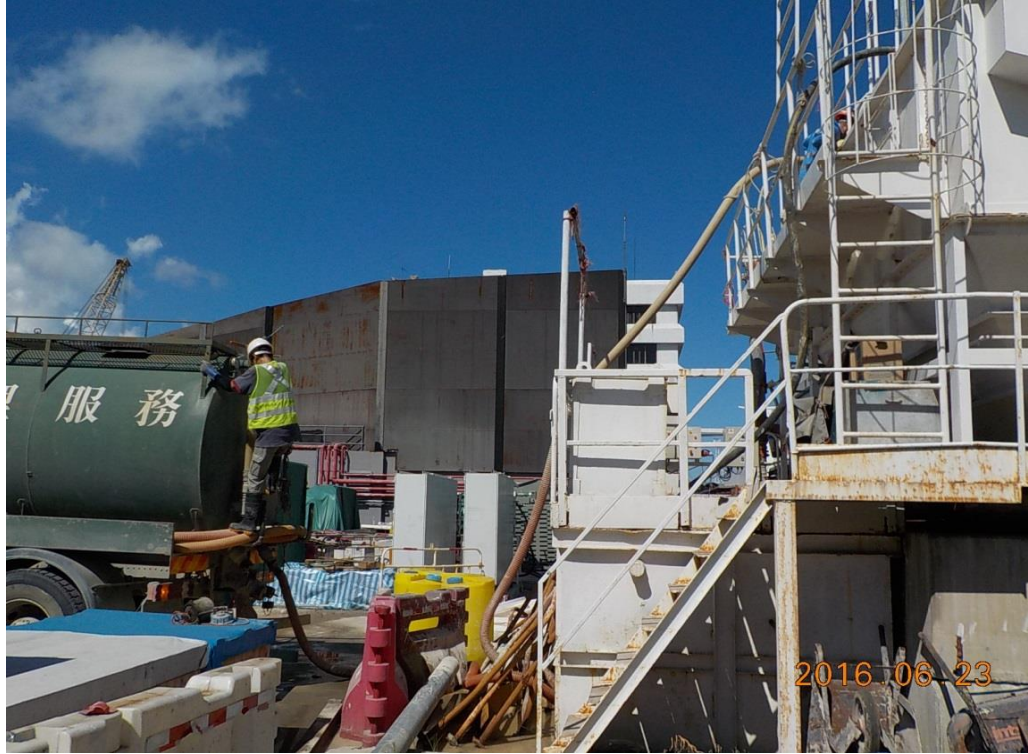
Built-up sludge was removed regularly (81-91 Ho Yeung Street area)

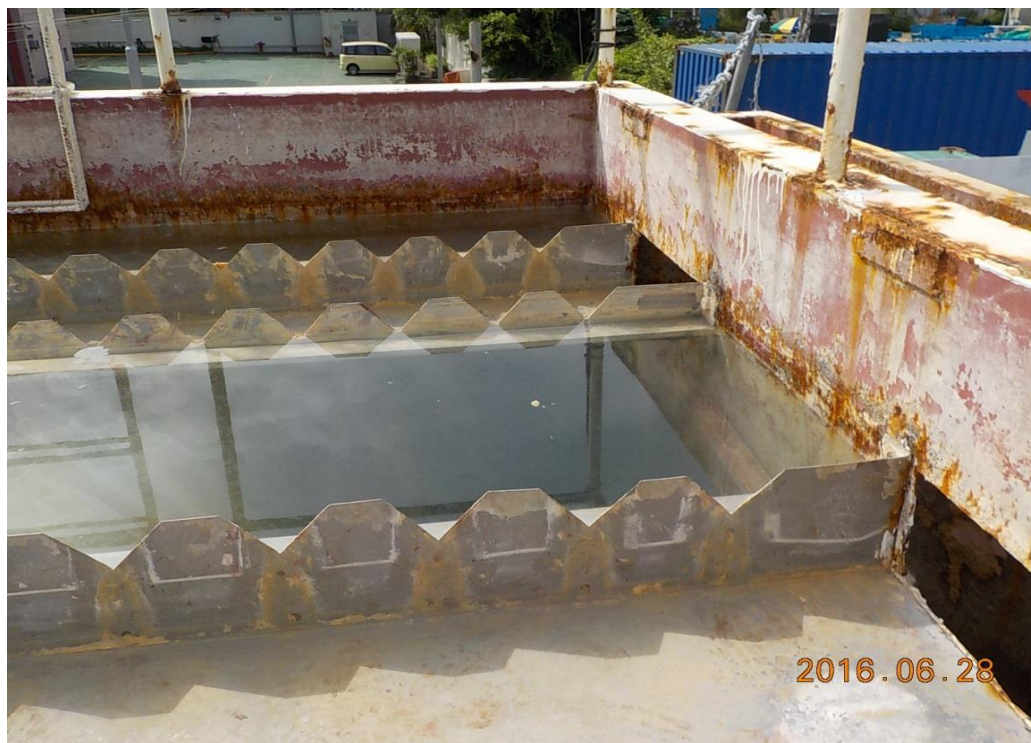
No muddy water discharge was discovered at the discharge point. (81-91 Ho Yeung Street area)
