**Contract No. HY/2012/07
Tuen Mun – Chek Lap Kok Link –
Southern Connection Viaduct Section**

*Twelfth Quarterly Environmental Monitoring &
Audit (EM&A) Report*

27 April 2017

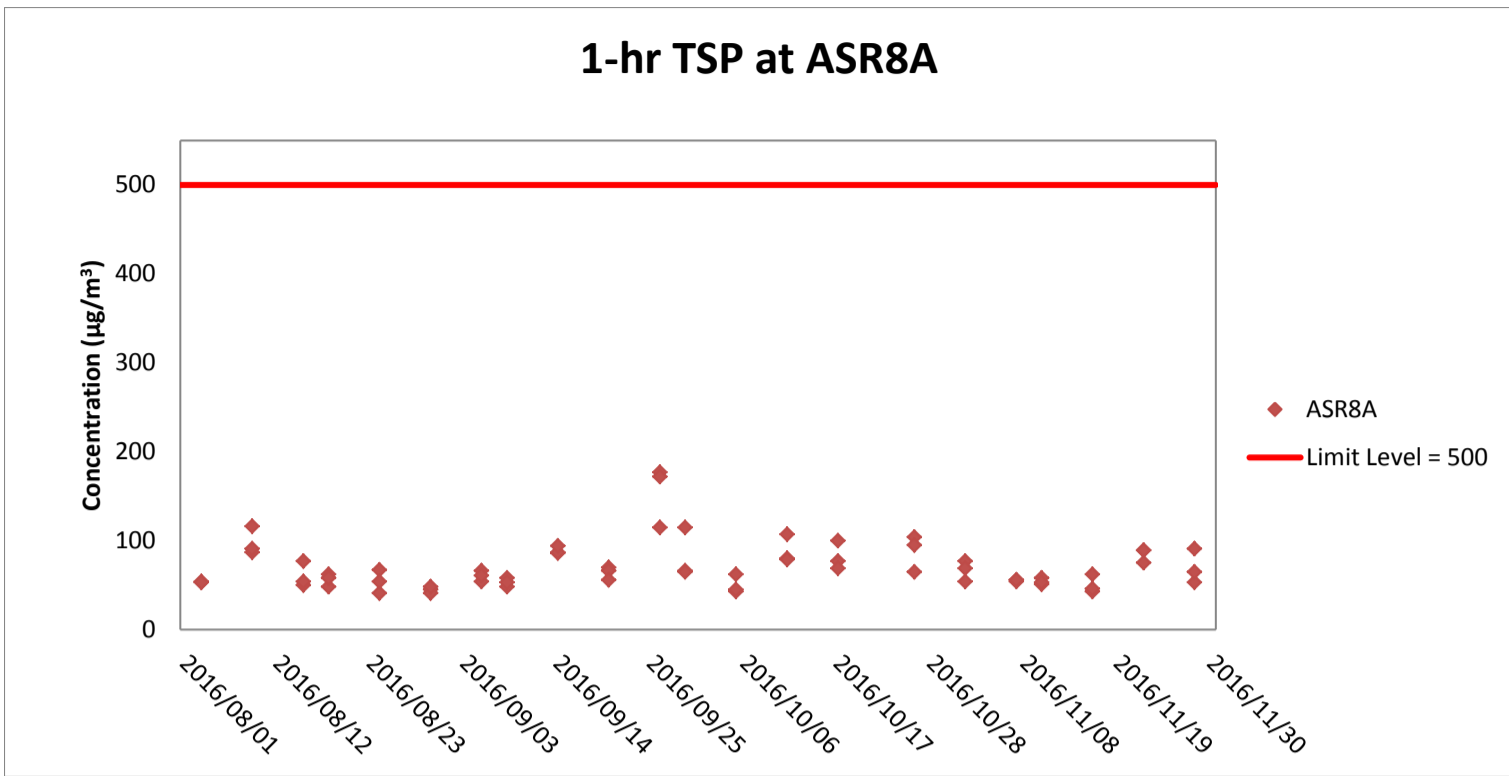
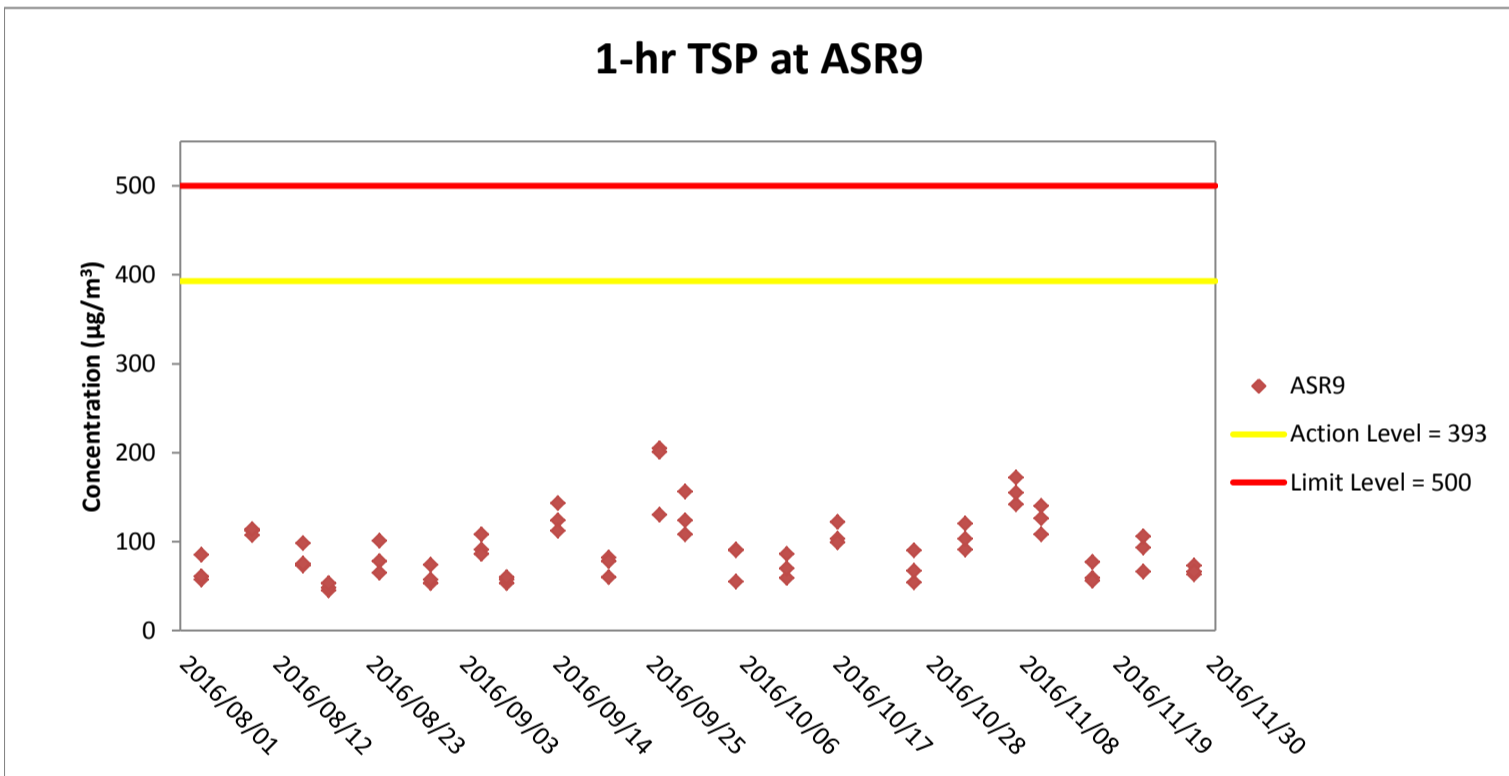
Impact Air Quality
Monitoring Graphical
Presentation

Weather condition within the reporting period varied between sunny to rainy.

Major construction works undertaken within the reporting period include Pier construction; Re-alignment of Cheung Tung Road; Road works along North Lantau Highway;; Installation of pier head and deck segments; and Slope work of Viaducts A, B & C.

AQM on 20 October 2016 was postponed to 26 October 2016 due to adverse weather conditions.

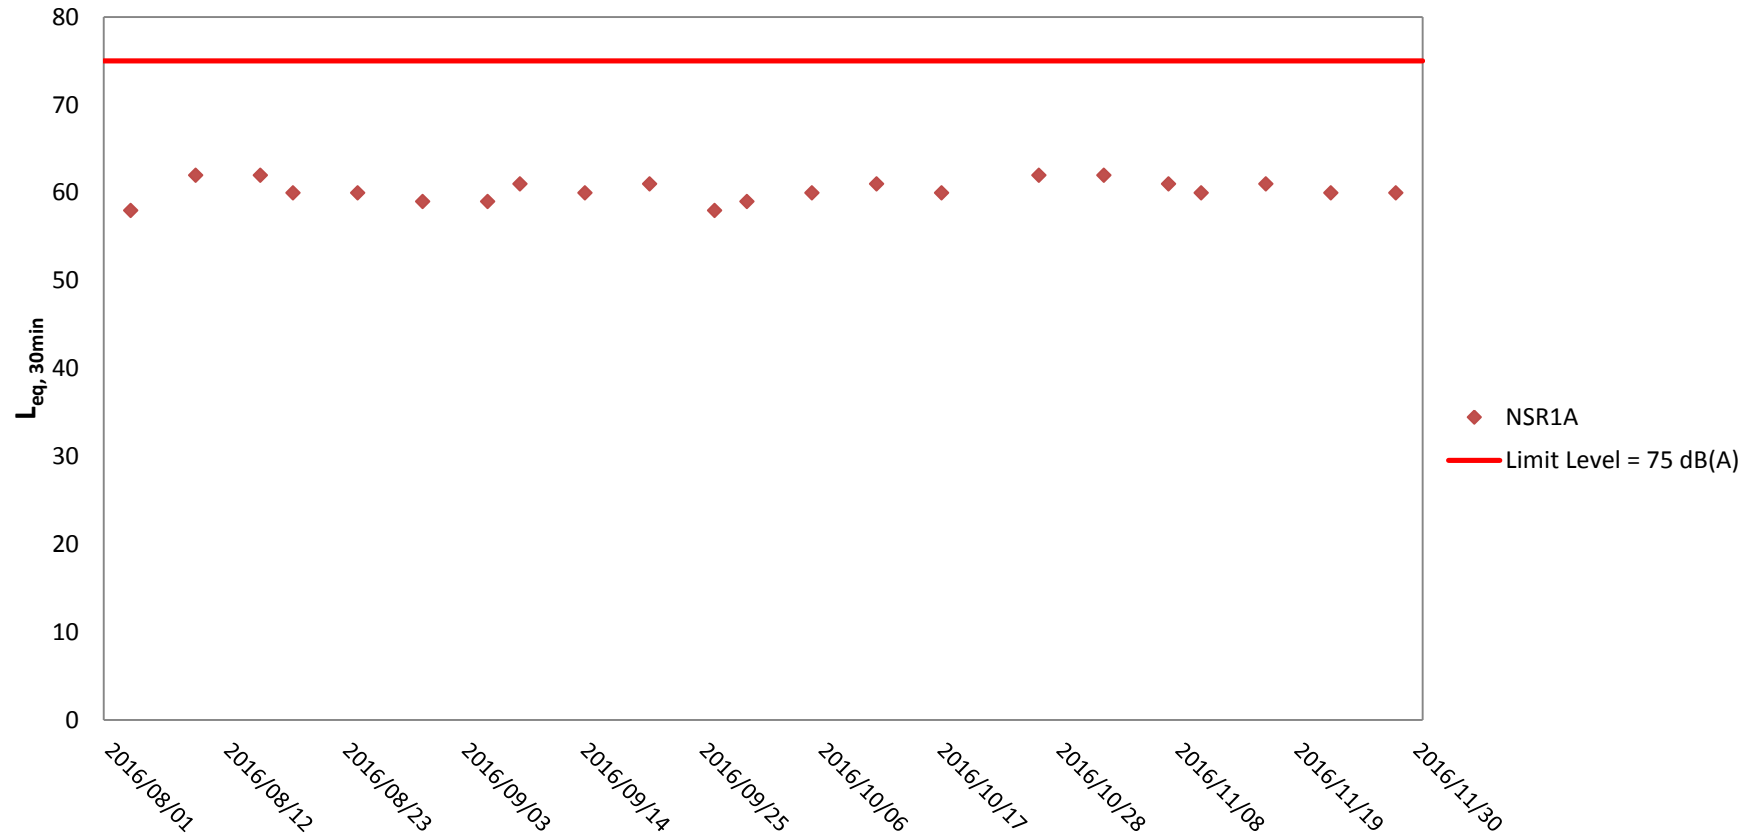
Noise Monitoring Results at NSR 1A ($L_{eq, 30min}$)

Weather condition within the reporting period varied between sunny to rainy.

Major construction works undertaken within the reporting period include Pier construction; Re-alignment of Cheung Tung Road; Road works along North Lantau Highway; Installation of pier head and deck segments; and Slope work of Viaducts A, B & C.

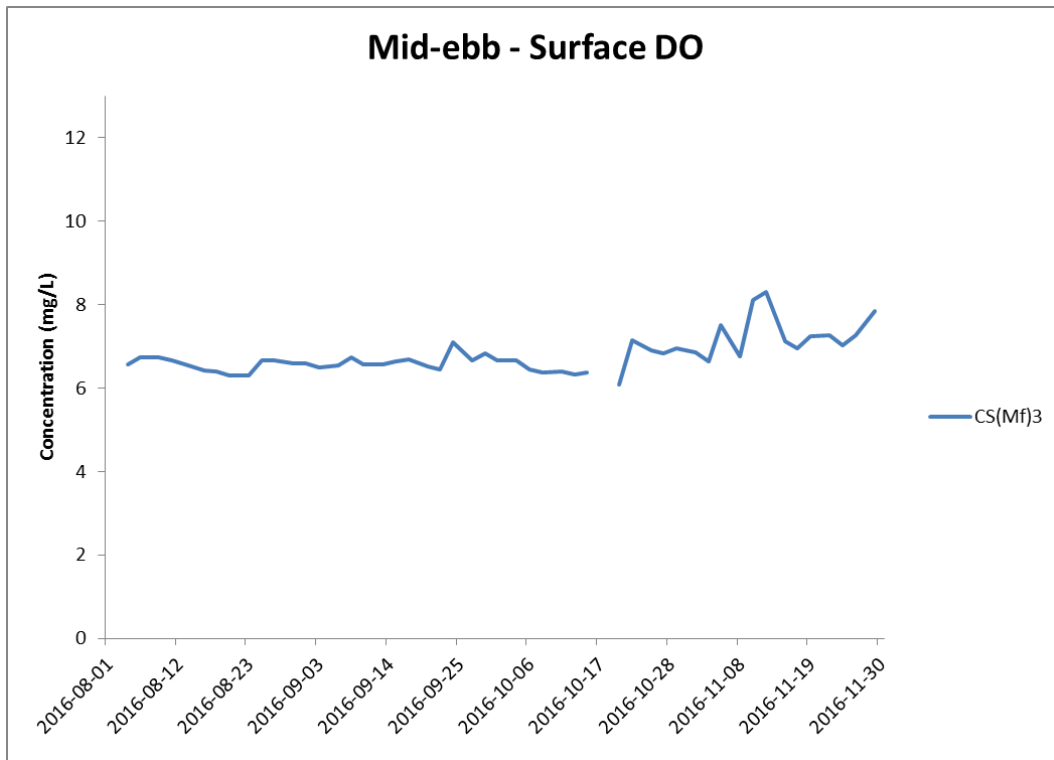
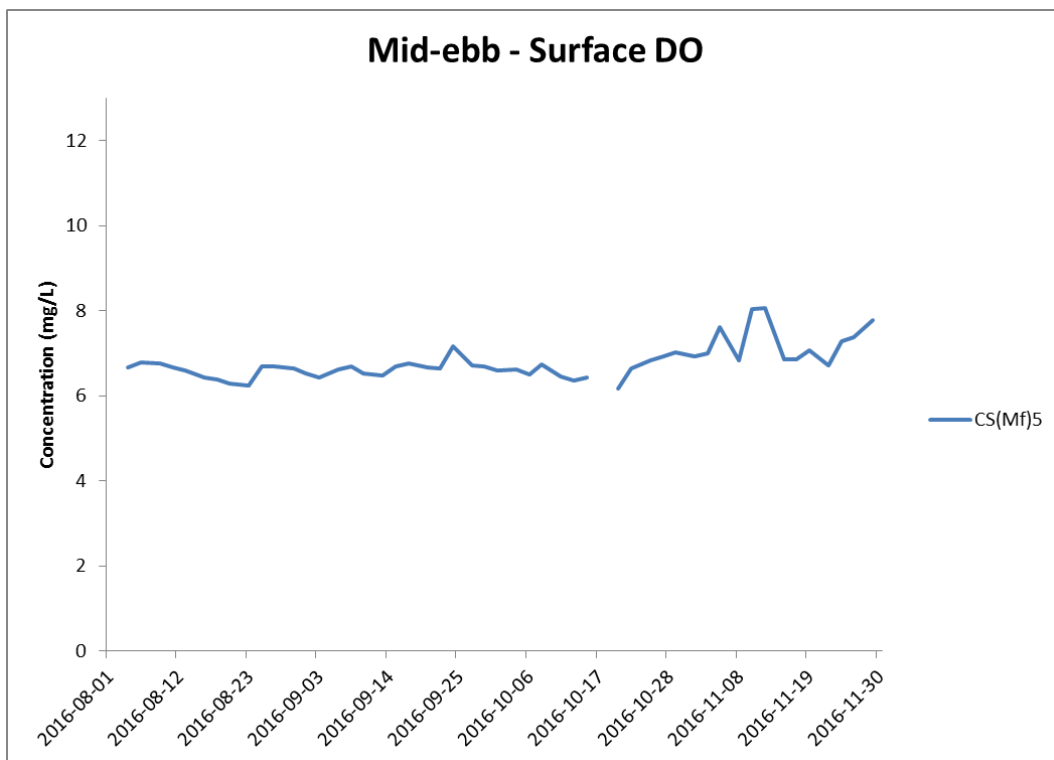
Figure H1 Impact Monitoring - Mean Level of Dissolved Oxygen (mg/L) in surface waters during mid-ebb tide between 1 August and 30 November 2016 at CS(Mf)3 and CS(Mf)5.

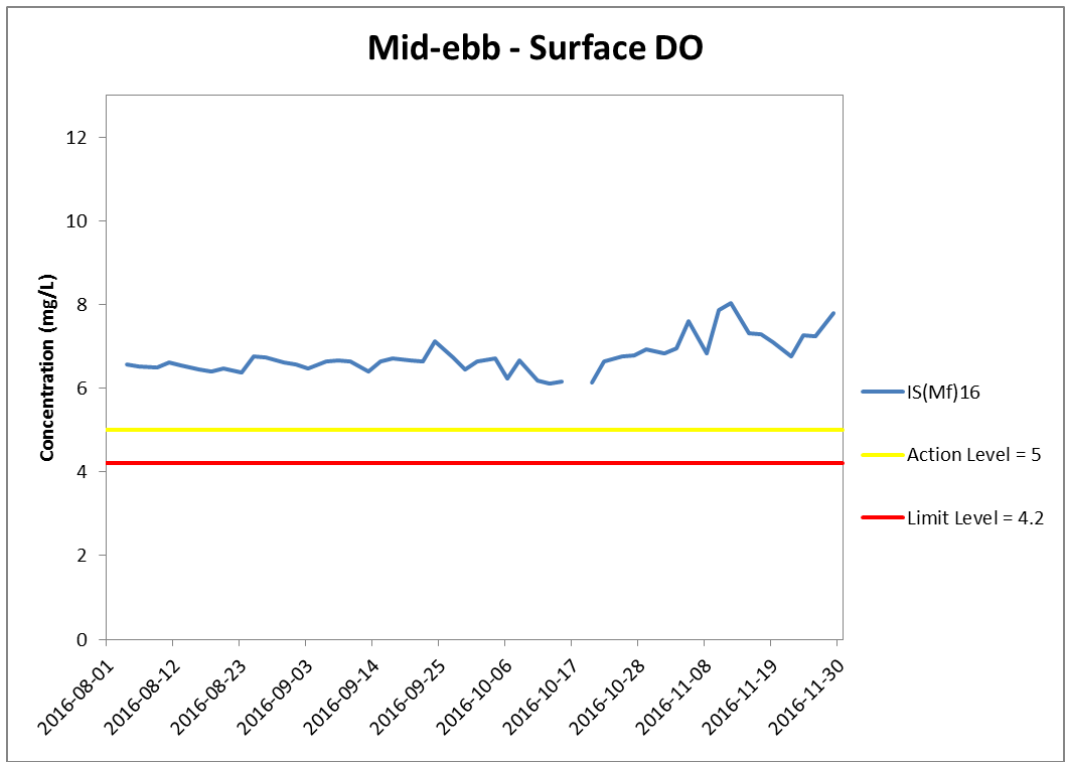
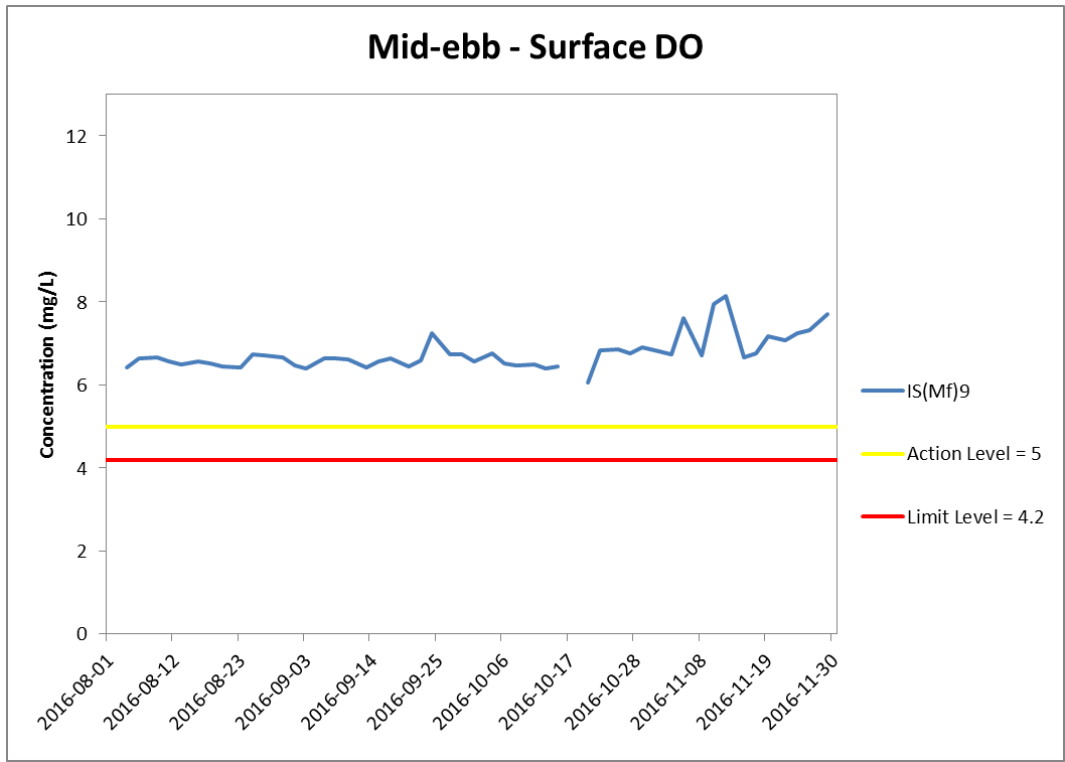
Figure H2 Impact Monitoring - Mean Level of Dissolved Oxygen (mg/L) in surface waters during mid-ebb tide between 1 August and 30 November 2016 at IS(Mf)16 and IS(Mf)9.

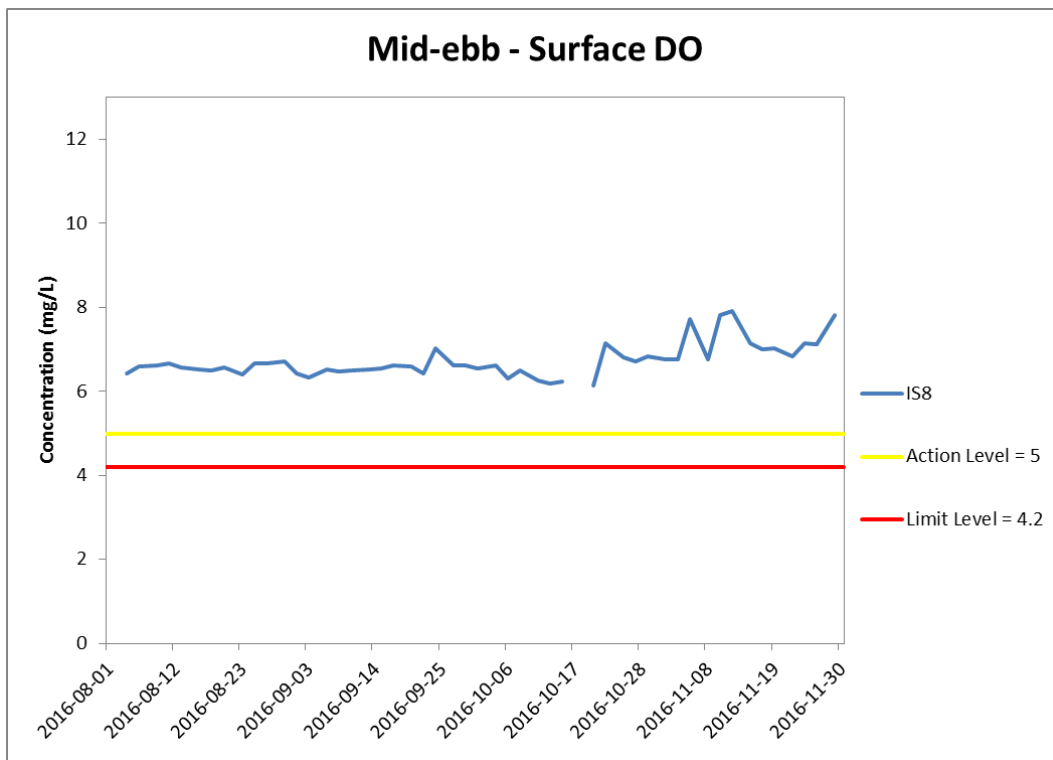
Figure H3 Impact Monitoring - Mean Level of Dissolved Oxygen (mg/L) in surface waters during mid-ebb tide between 1 August and 30 November 2016 at IS8 and SR4.

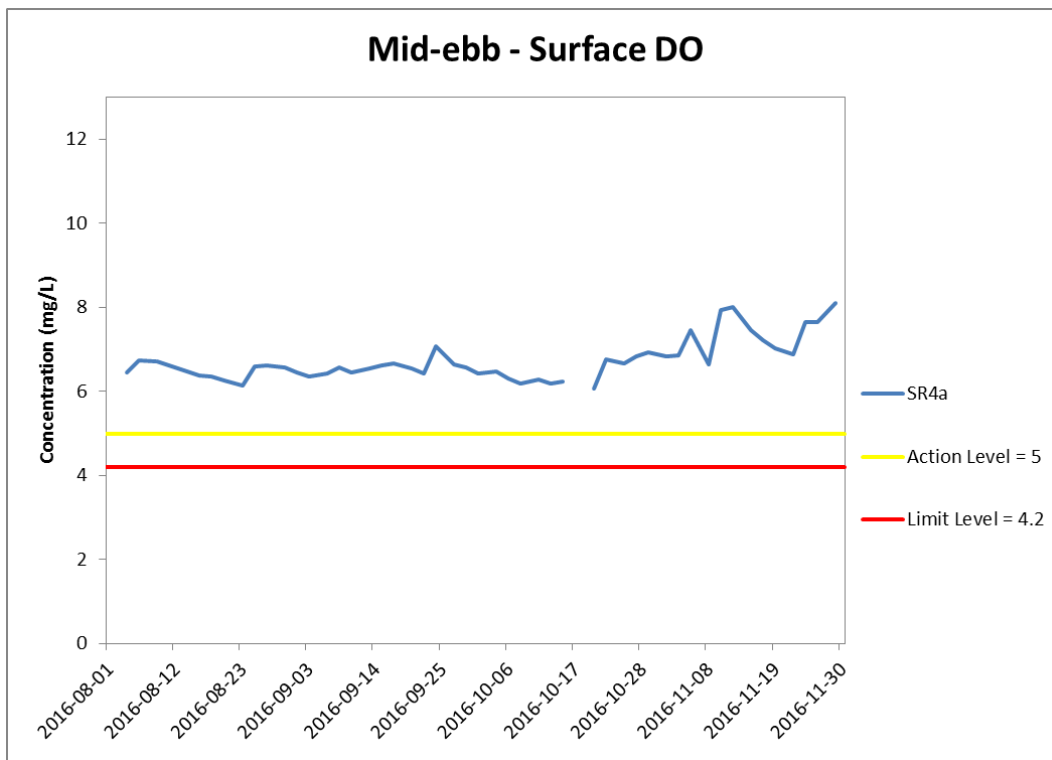
Figure H4 Impact Monitoring - Mean Level of Dissolved Oxygen (mg/L) in surface waters during mid-ebb tide between 1 August and 30 November 2016 at SR4a.

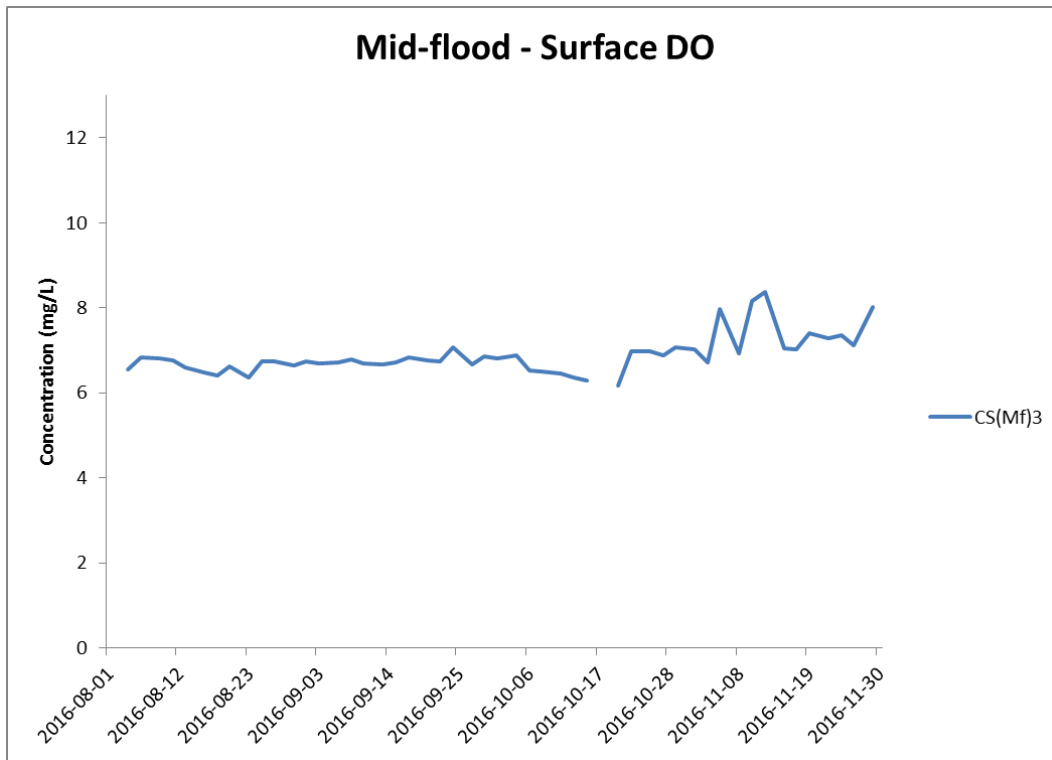
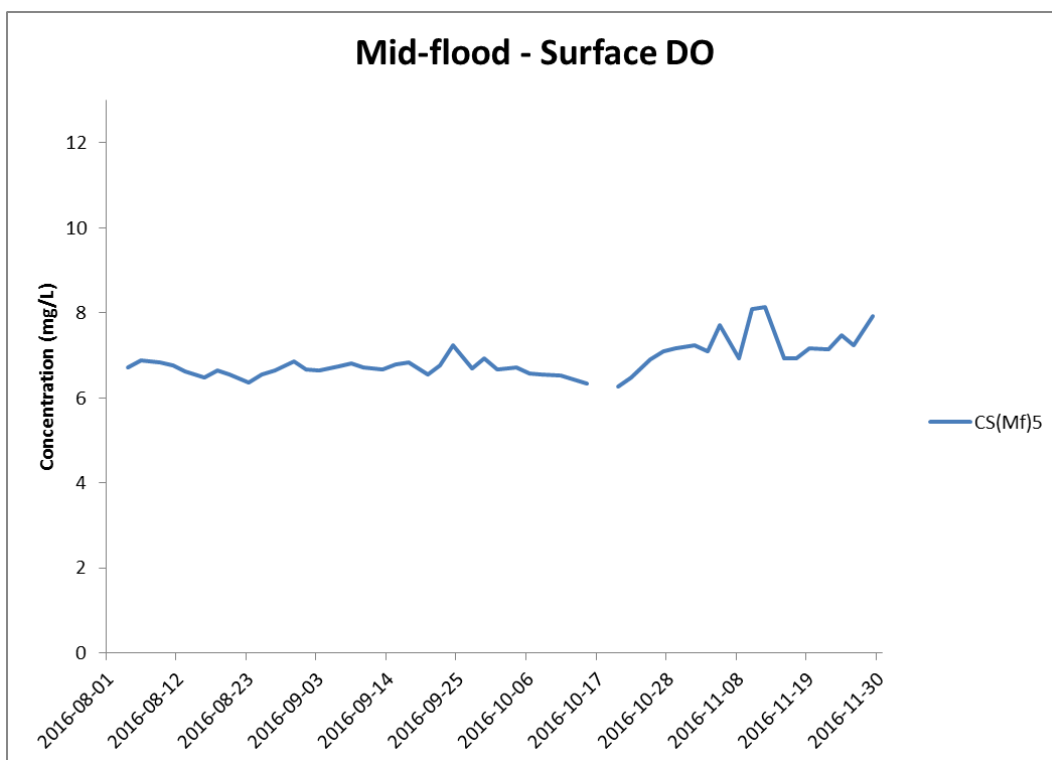
Figure H5 Impact Monitoring - Mean Level of Dissolved Oxygen (mg/L) in surface waters during mid-flood tide between 1 August and 30 November 2016 at CS(Mf)3 and CS(Mf)5.

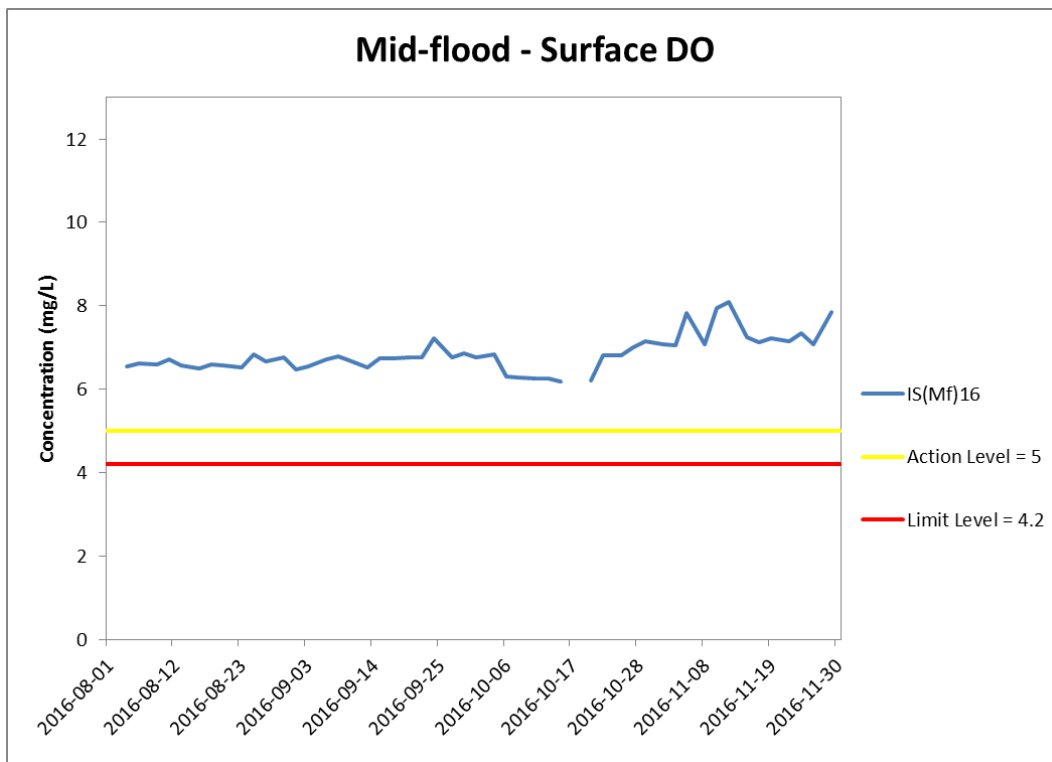
Figure H6 Impact Monitoring - Mean Level of Dissolved Oxygen (mg/L) in surface waters during mid-flood tide between 1 August and 30 November 2016 at IS(Mf)16 and IS(Mf)9.

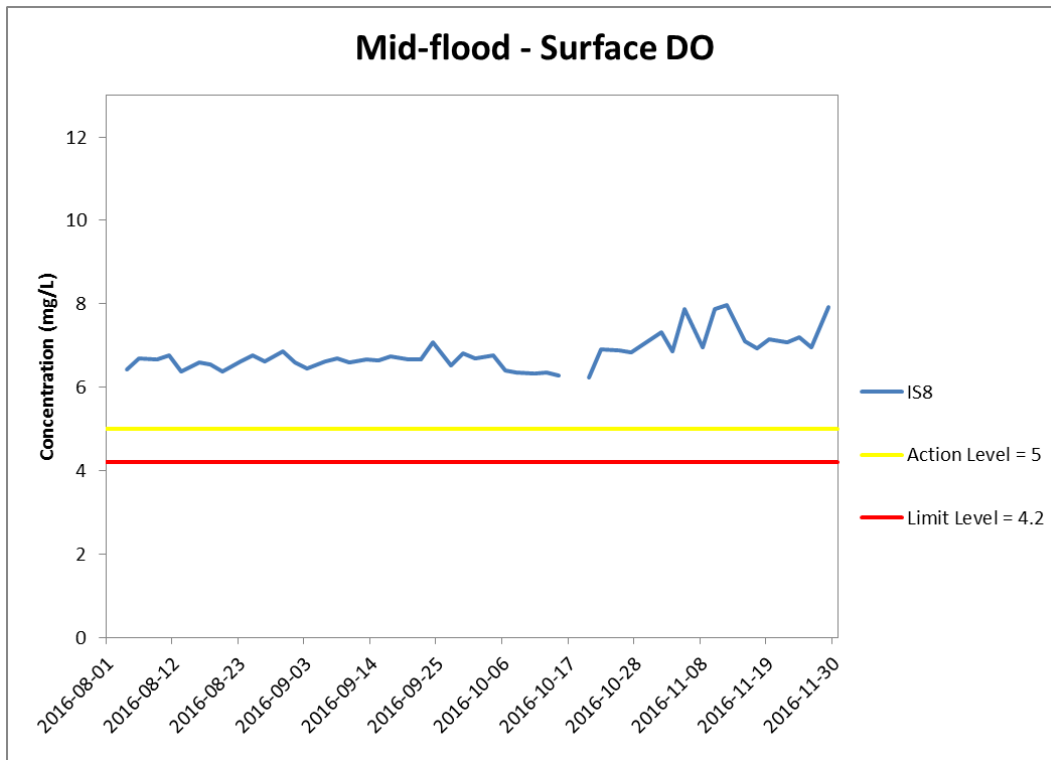
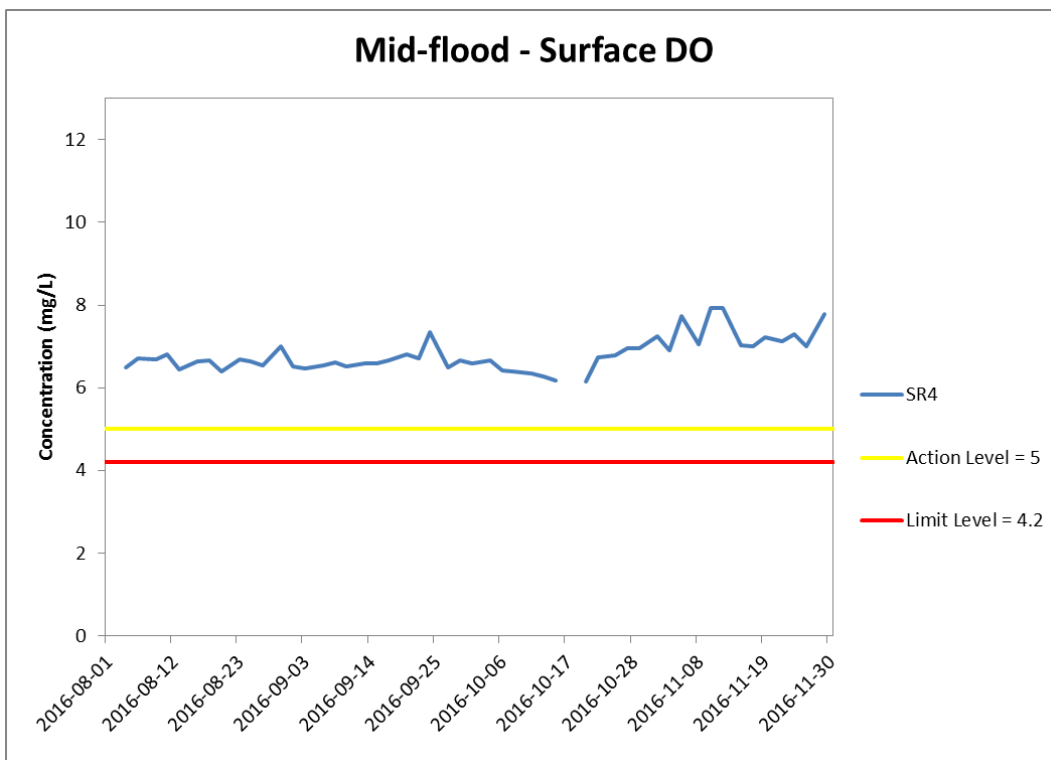
Figure H7 Impact Monitoring – Mean Level of Dissolved Oxygen (mg/L) in surface waters during mid-flood tide between 1 August and 30 November 2016 at IS8 and SR4.

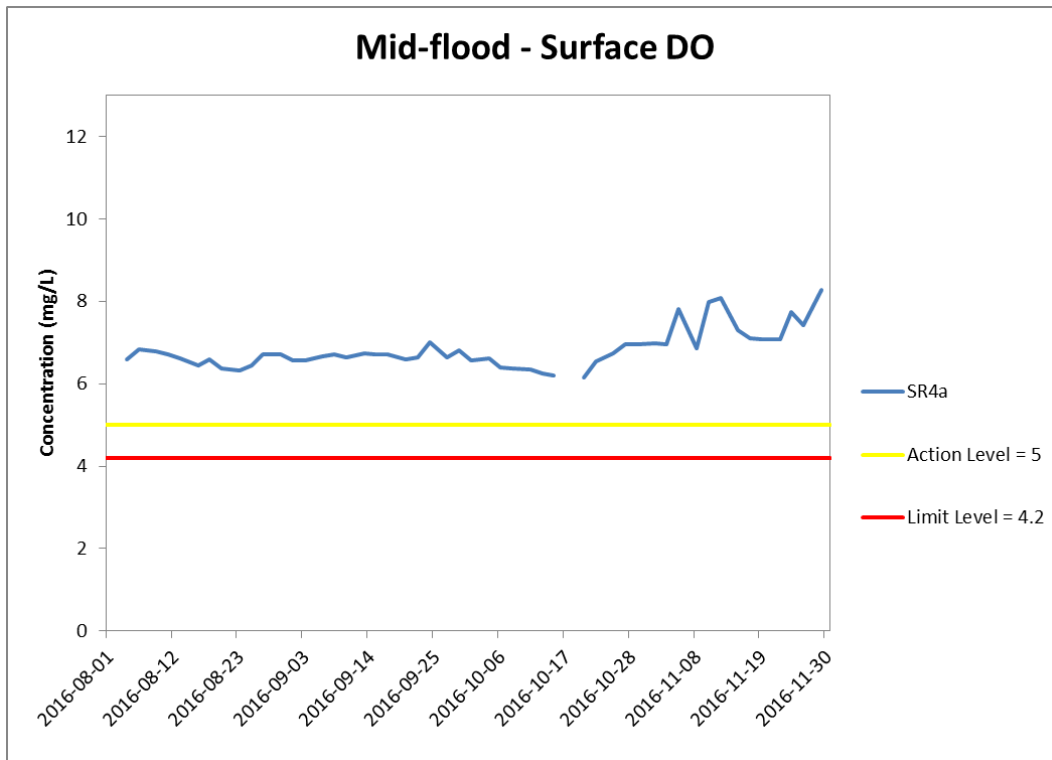
Figure H8 Impact Monitoring - Mean Level of Dissolved Oxygen (mg/L) in surface waters during mid-flood tide between 1 August and 30 November 2016 at SR4a.

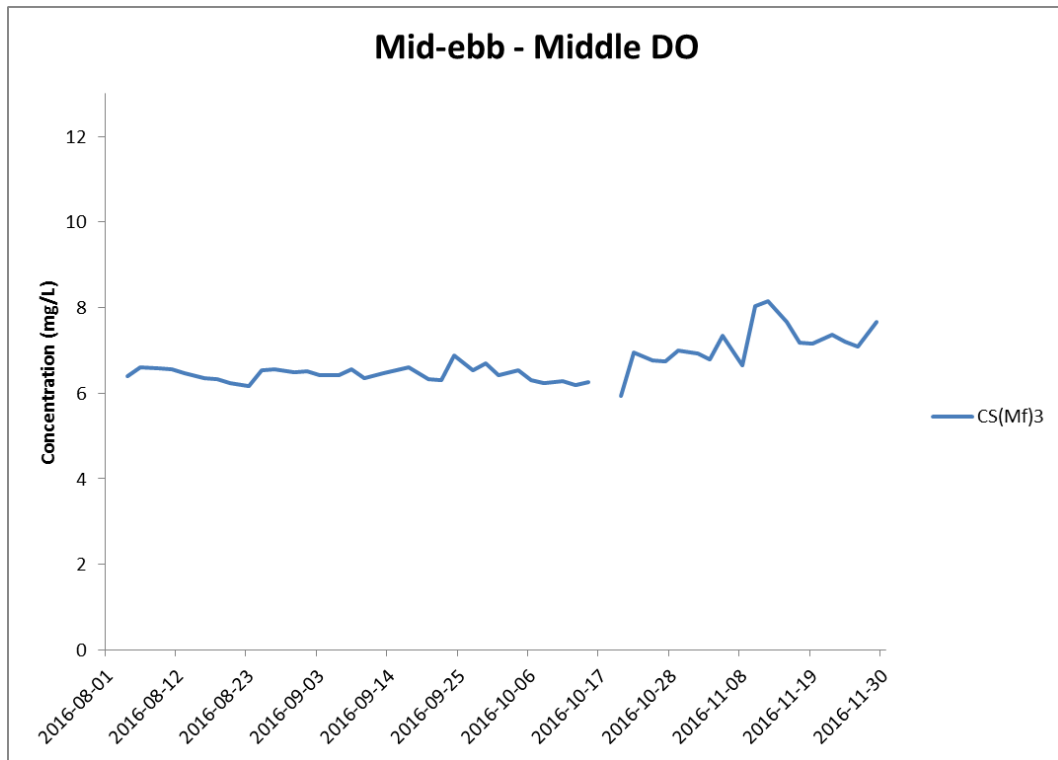
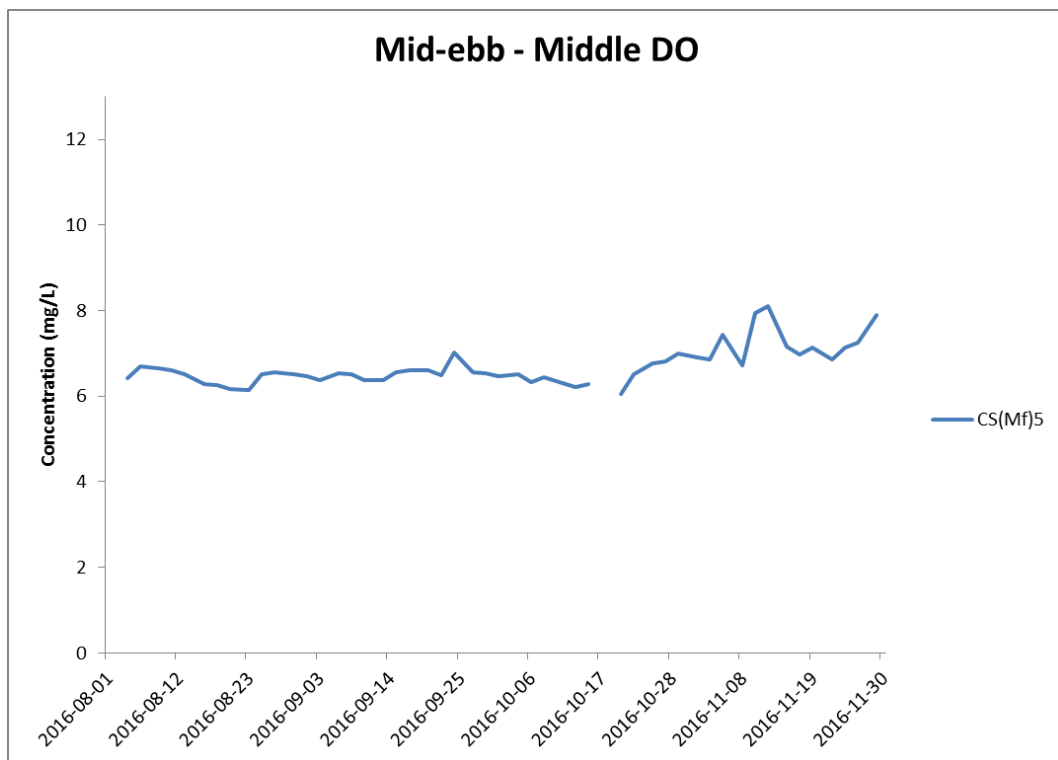
Figure H9 Impact Monitoring - Mean Level of Dissolved Oxygen (mg/L) in mid-depth waters during mid-ebb tide between 1 August and 30 November 2016 at CS(Mf)3 and CS(Mf)5.

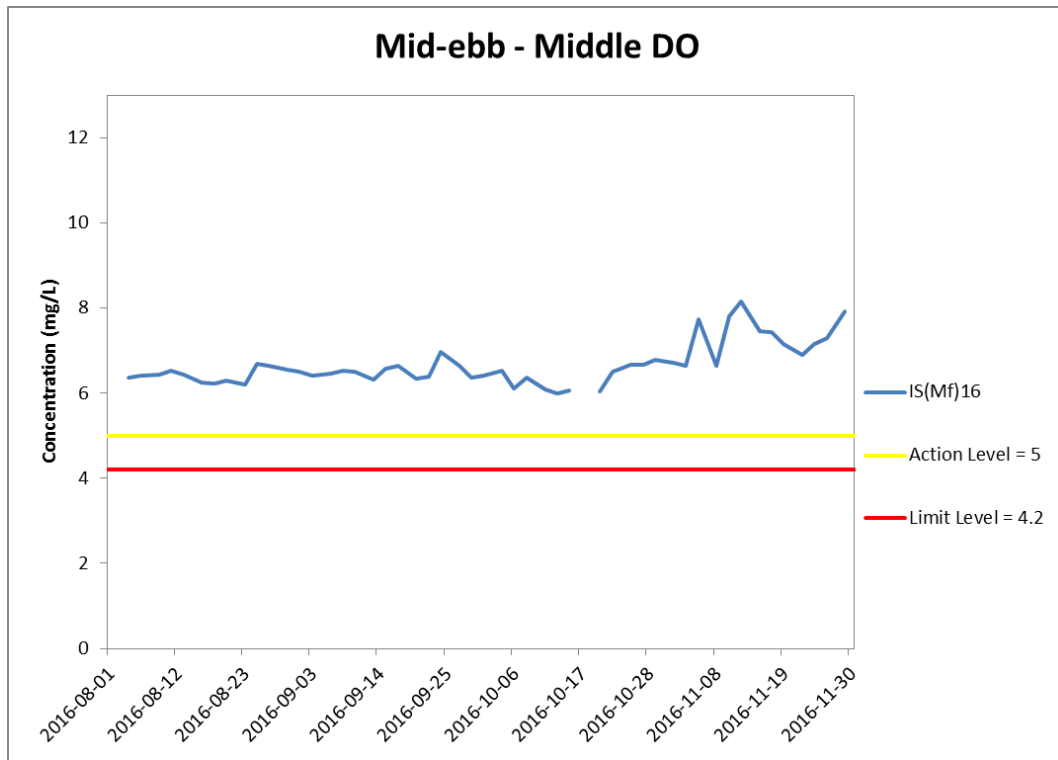
Figure H10 Impact Monitoring - Mean Level of Dissolved Oxygen (mg/L) in mid-depth waters during mid-ebb tide between 1 August and 30 November 2016 at IS(Mf)16.

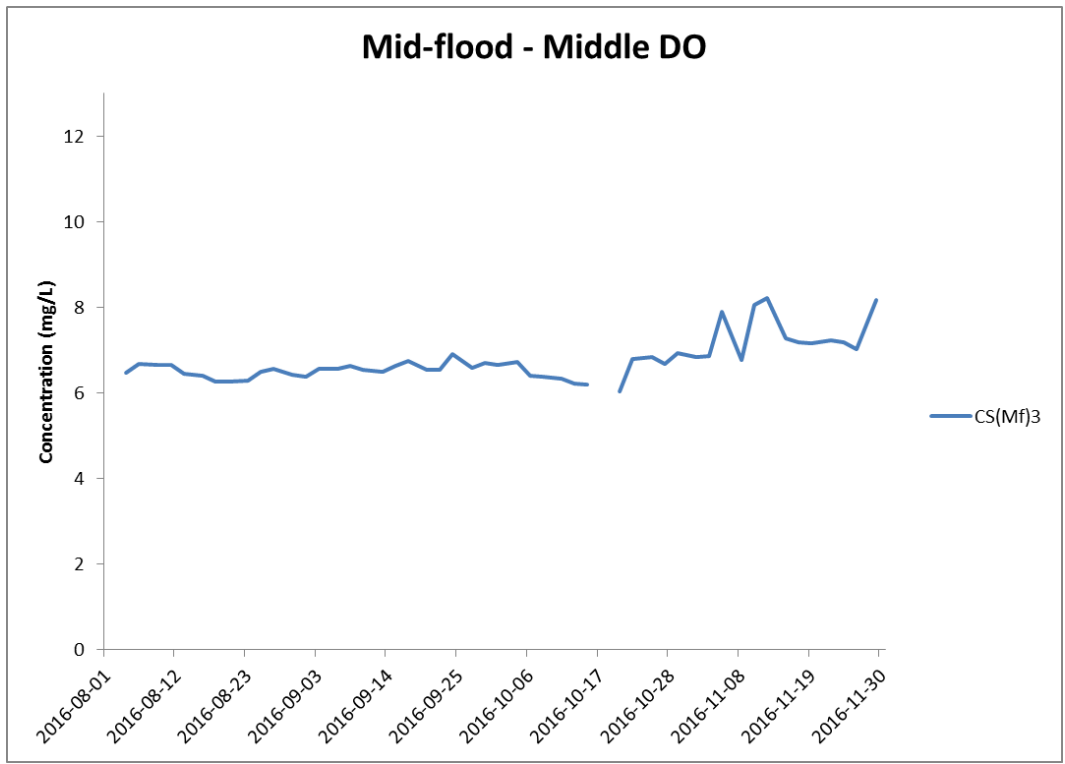
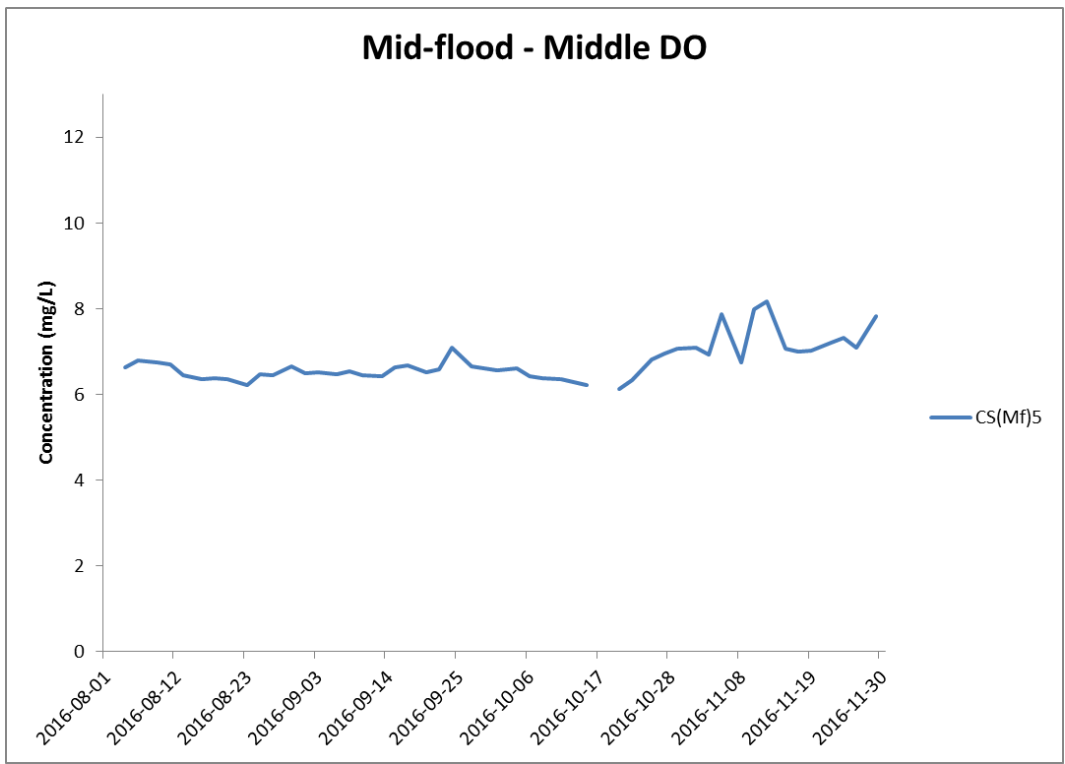
Figure H11 Impact Monitoring – Mean Level of Dissolved Oxygen (mg/L) in mid-depth waters during mid-flood tide between 1 August and 30 November 2016 at CS(Mf)3 and CS(Mf)5.

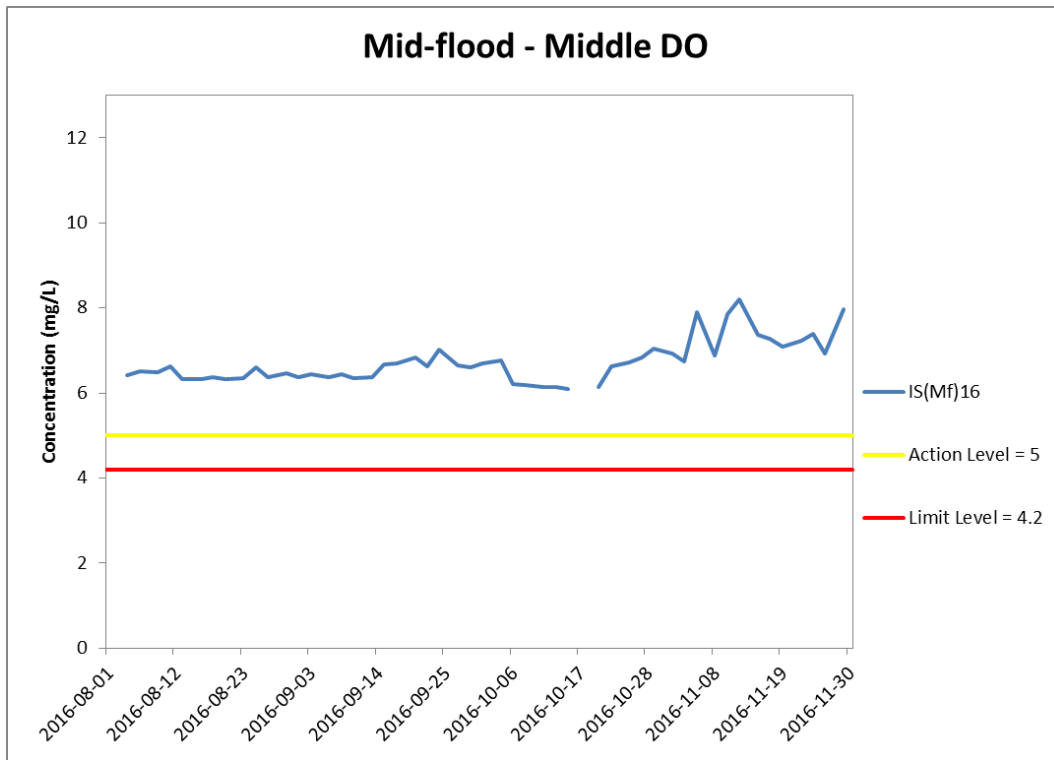
Figure H12 Impact Monitoring - Mean Level of Dissolved Oxygen (mg/L) in mid-depth waters during mid-flood tide between 1 August and 30 November 2016 at IS(Mf)16.

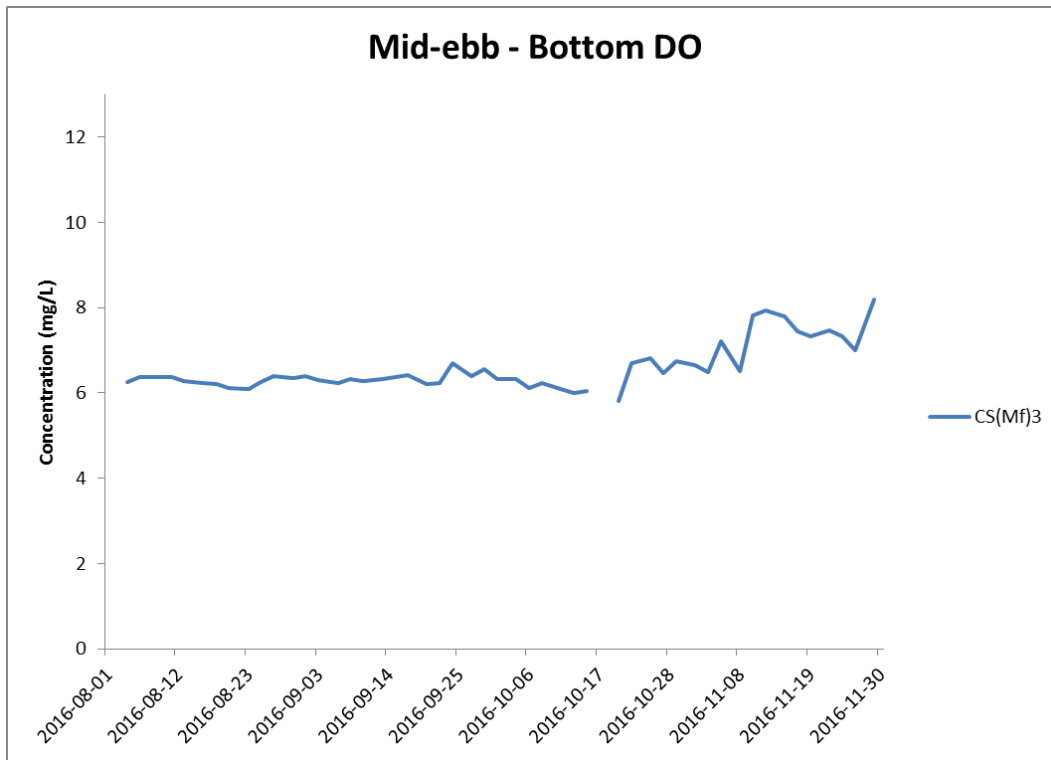
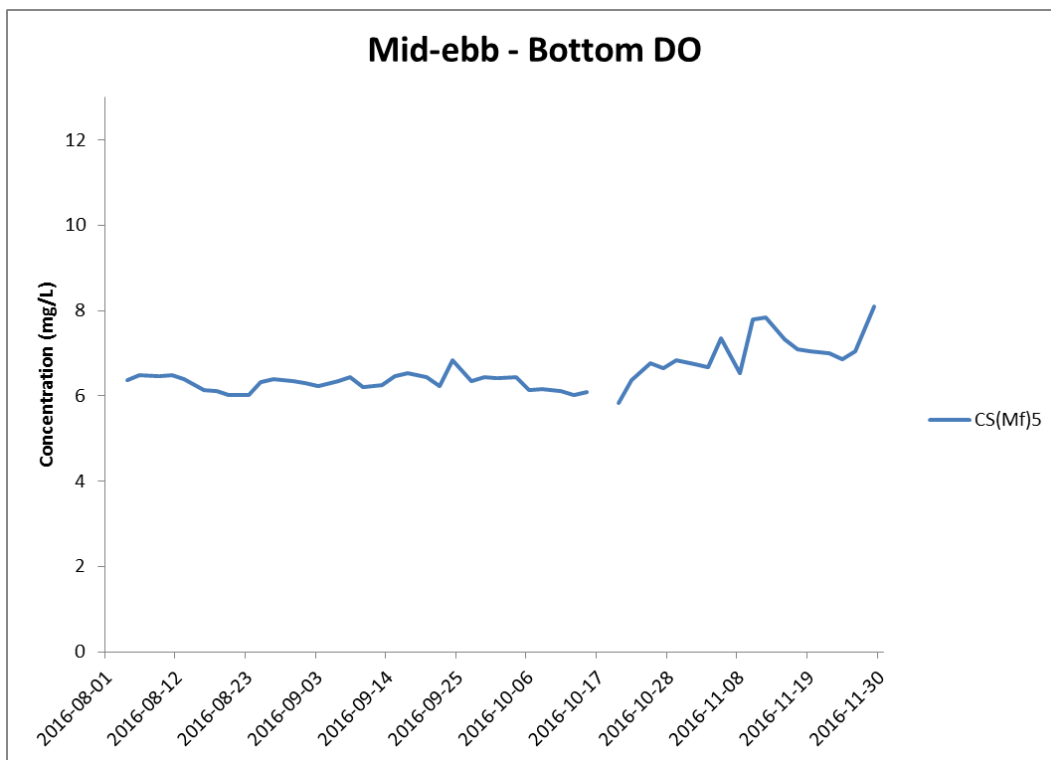
Figure H13 Impact Monitoring - Mean Level of Dissolved Oxygen (mg/L) in bottom waters during mid-ebb tide between 1 August and 30 November 2016 at CS(Mf)3 and CS(Mf)5.

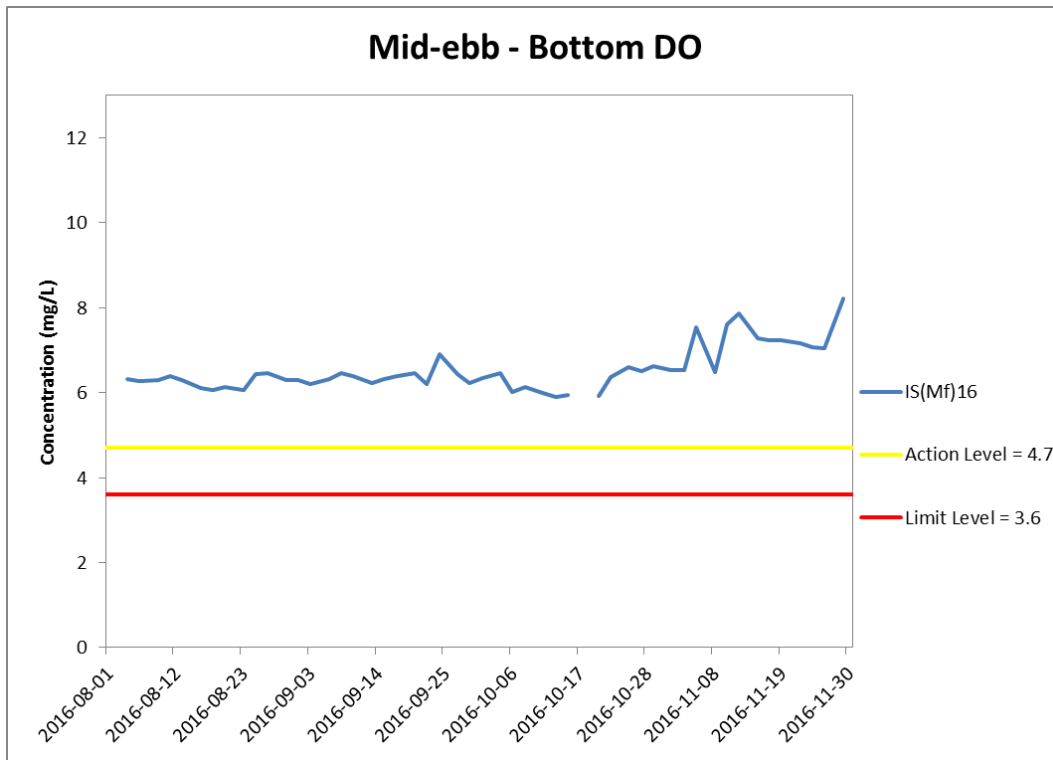
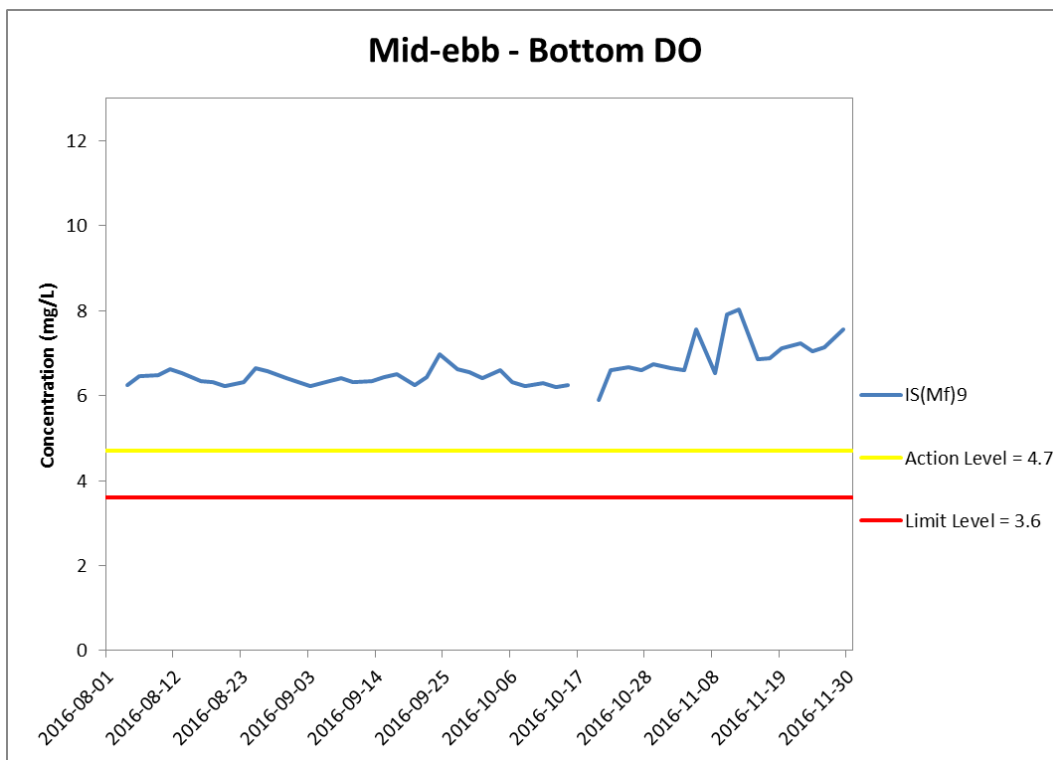
Figure H14 Impact Monitoring - Mean Level of Dissolved Oxygen (mg/L) in bottom waters during mid-ebb tide between 1 August and 30 November 2016 at IS(Mf)16 and IS(Mf)9.
