**Contract No. HY/2012/07
Tuen Mun – Chek Lap Kok Link –
Southern Connection Viaduct Section**

*Twelfth Quarterly Environmental Monitoring &
Audit (EM&A) Report*

27 April 2017

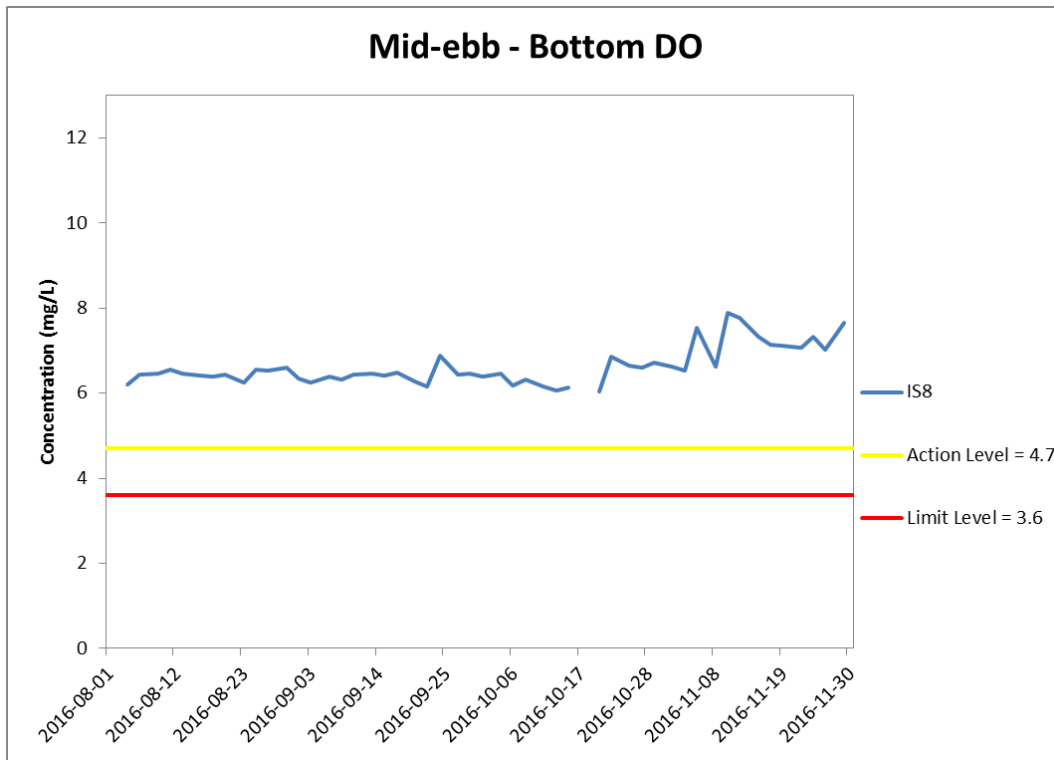
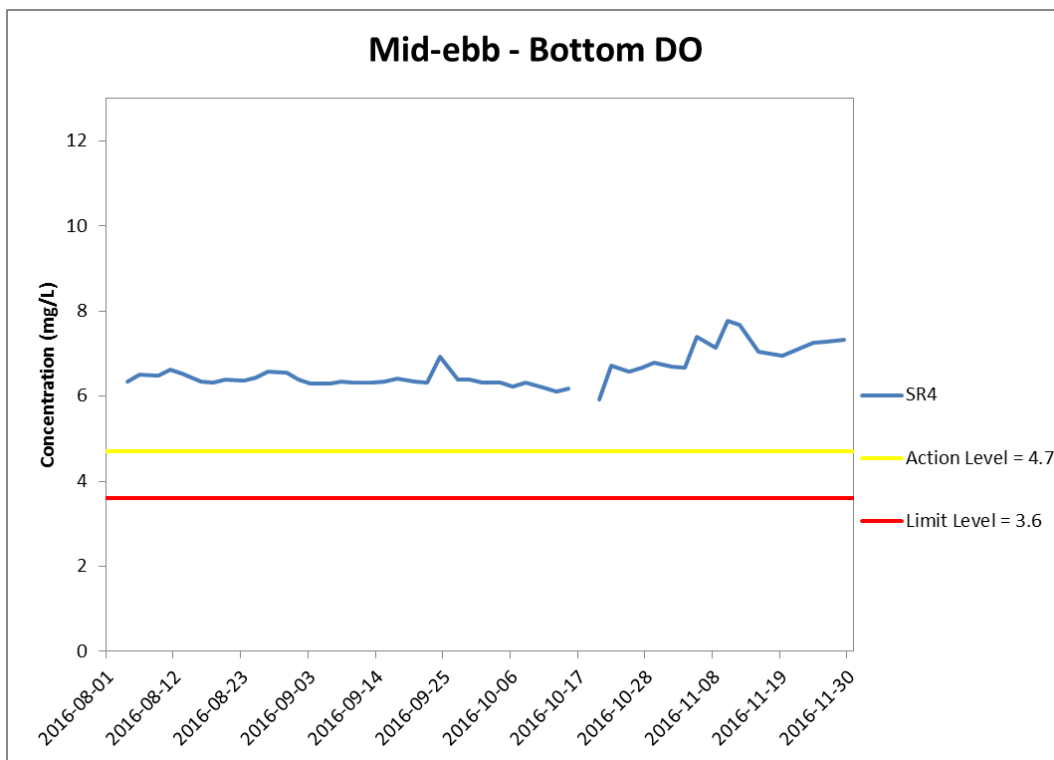
Figure H15 Impact Monitoring - Mean Level of Dissolved Oxygen (mg/L) in bottom waters during mid-ebb tide between 1 August and 30 November 2016 at IS8 and SR4.

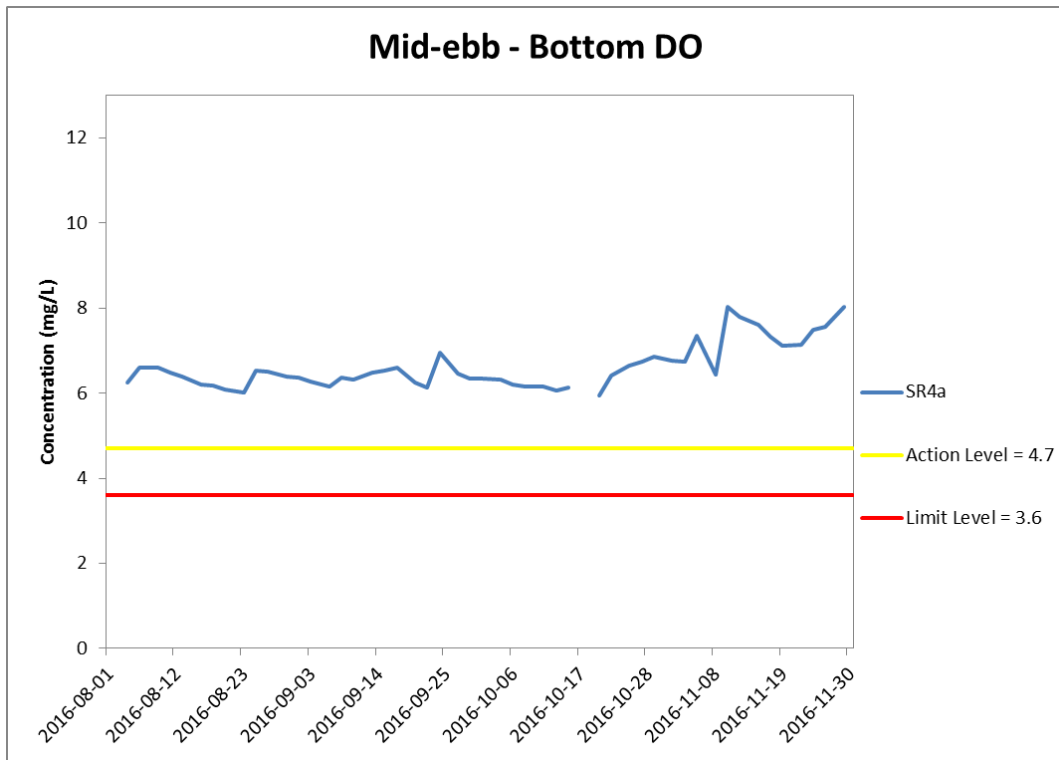
Figure H16 Impact Monitoring - Mean Level of Dissolved Oxygen (mg/L) in bottom waters during mid-ebb tide between 1 August and 30 November 2016 at SR4a.

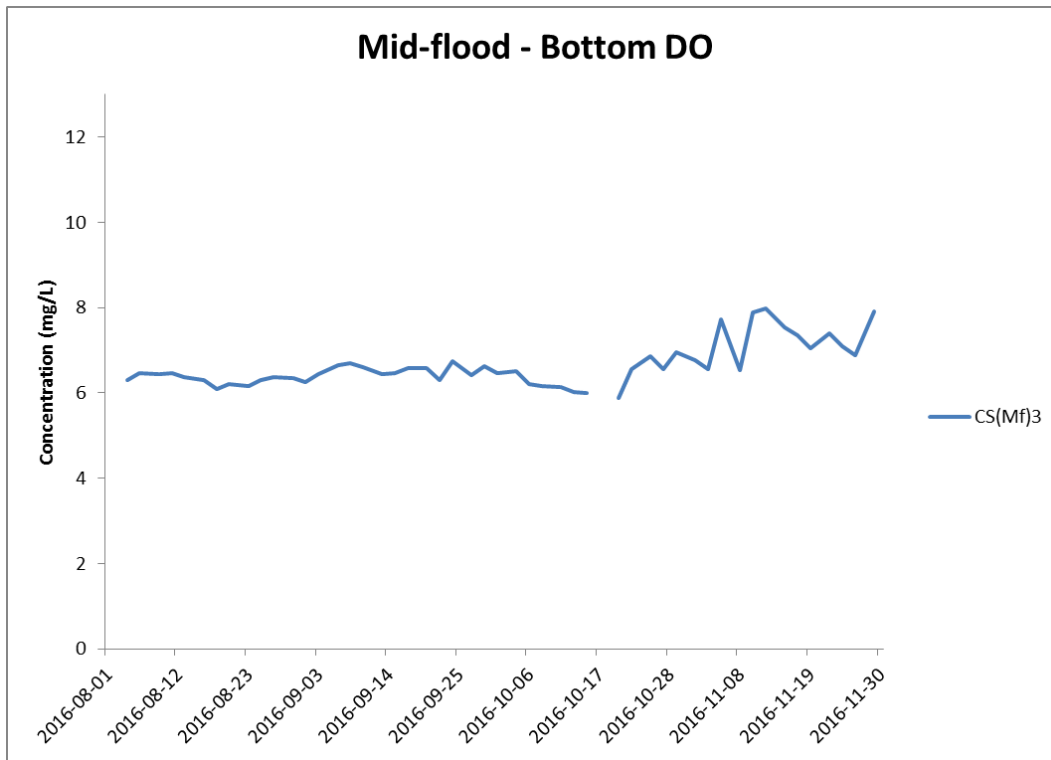
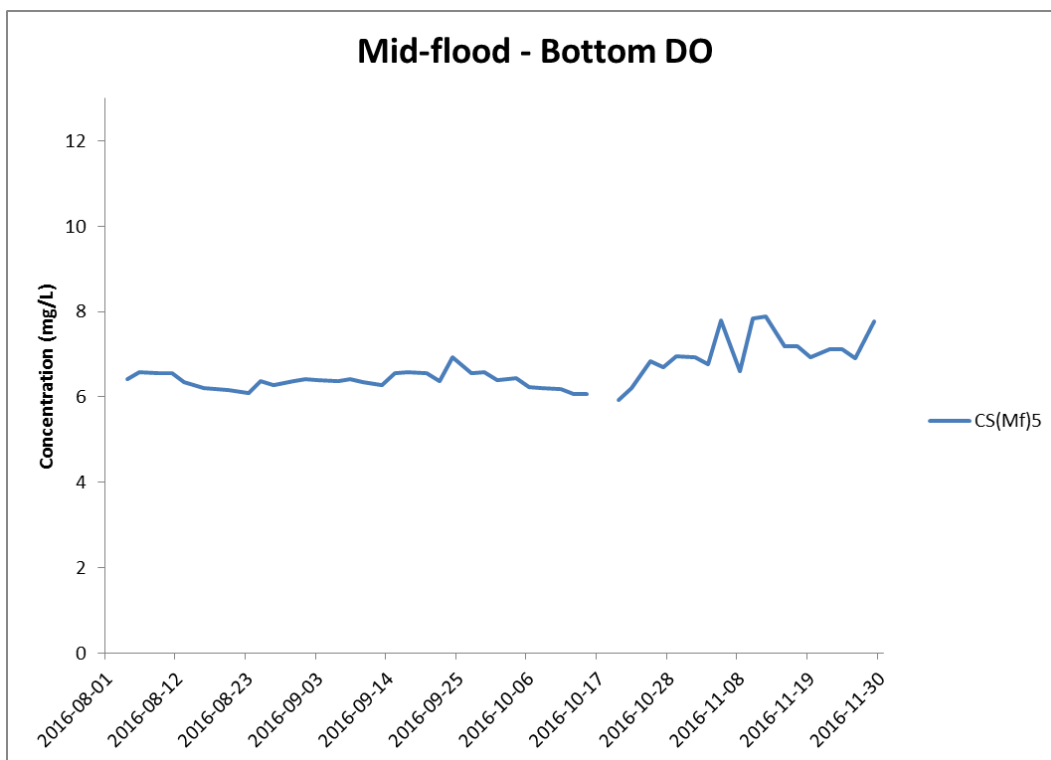
Figure H17 Impact Monitoring – Mean Level of Dissolved Oxygen (mg/L) in bottom waters during mid-flood tide between 1 August and 30 November 2016 at CS(Mf)3 and CS(Mf)5.

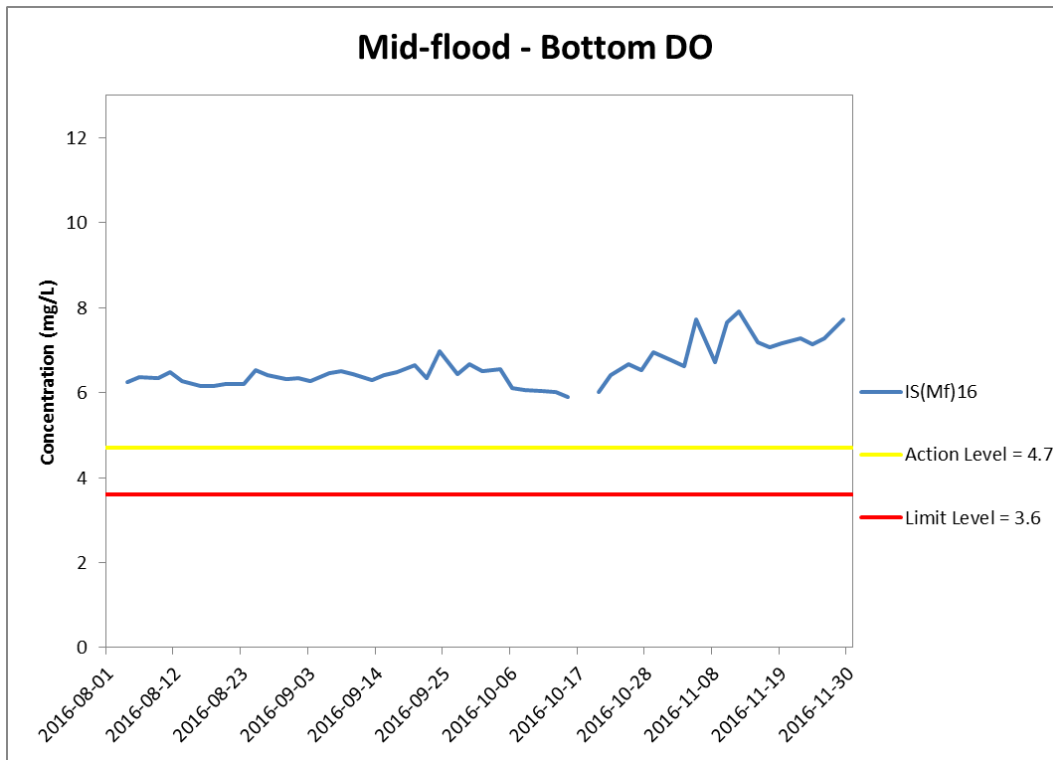
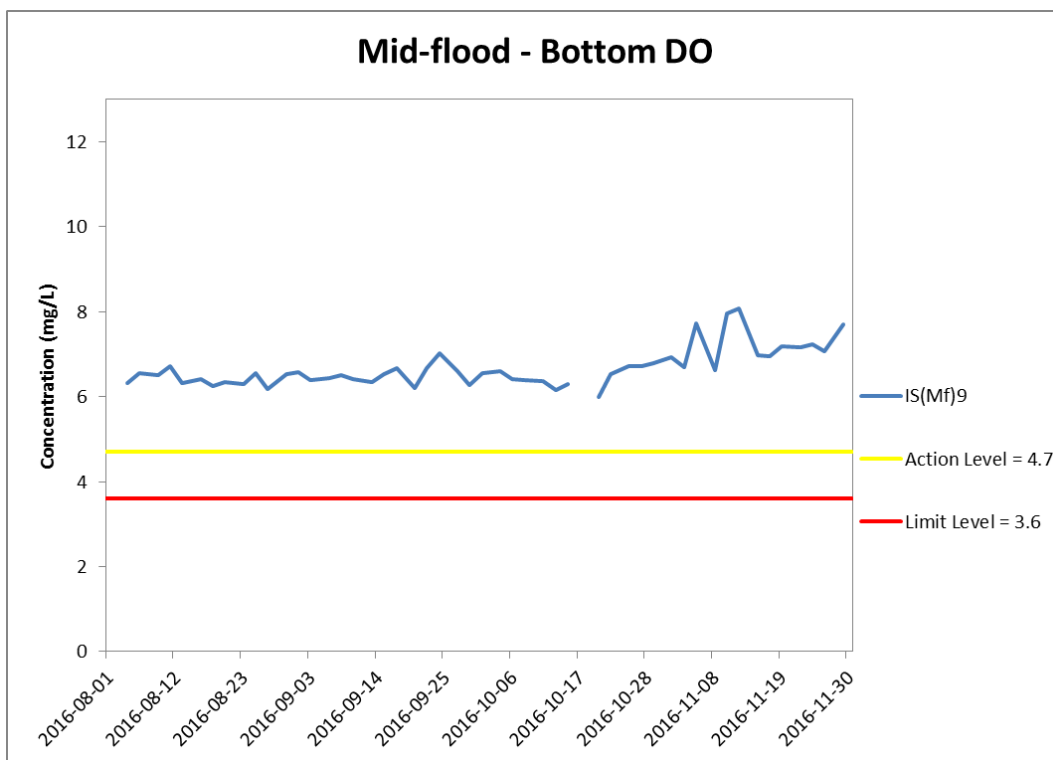
Figure H18 Impact Monitoring – Mean Level of Dissolved Oxygen (mg/L) in bottom waters during mid-flood tide between 1 August and 30 November 2016 at IS(Mf)16 and IS(Mf)9.

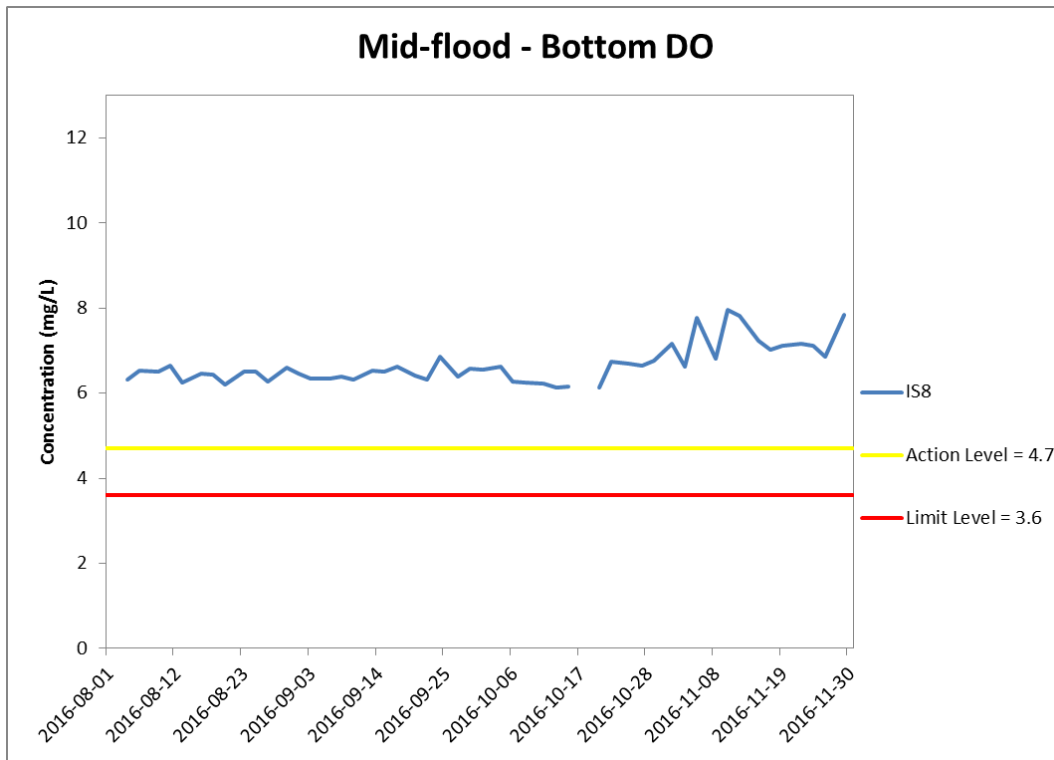
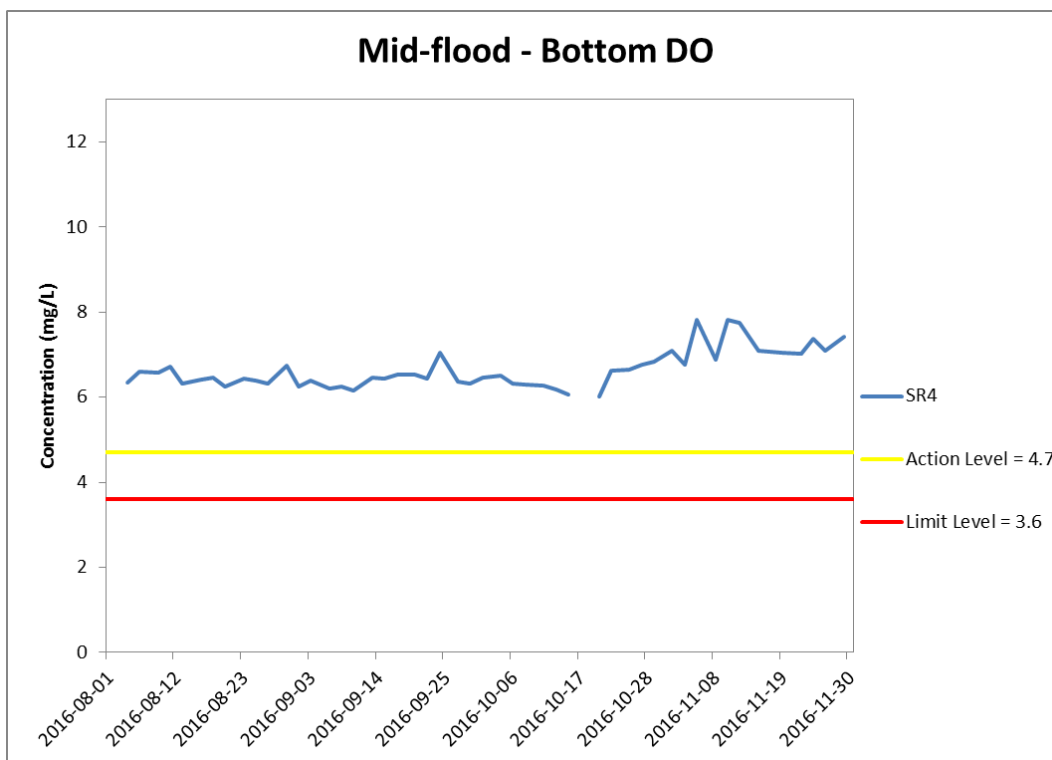
Figure H19 Impact Monitoring – Mean Level of Dissolved Oxygen (mg/L) in bottom waters during mid-flood tide between 1 August and 30 November 2016 at IS8 and SR4.

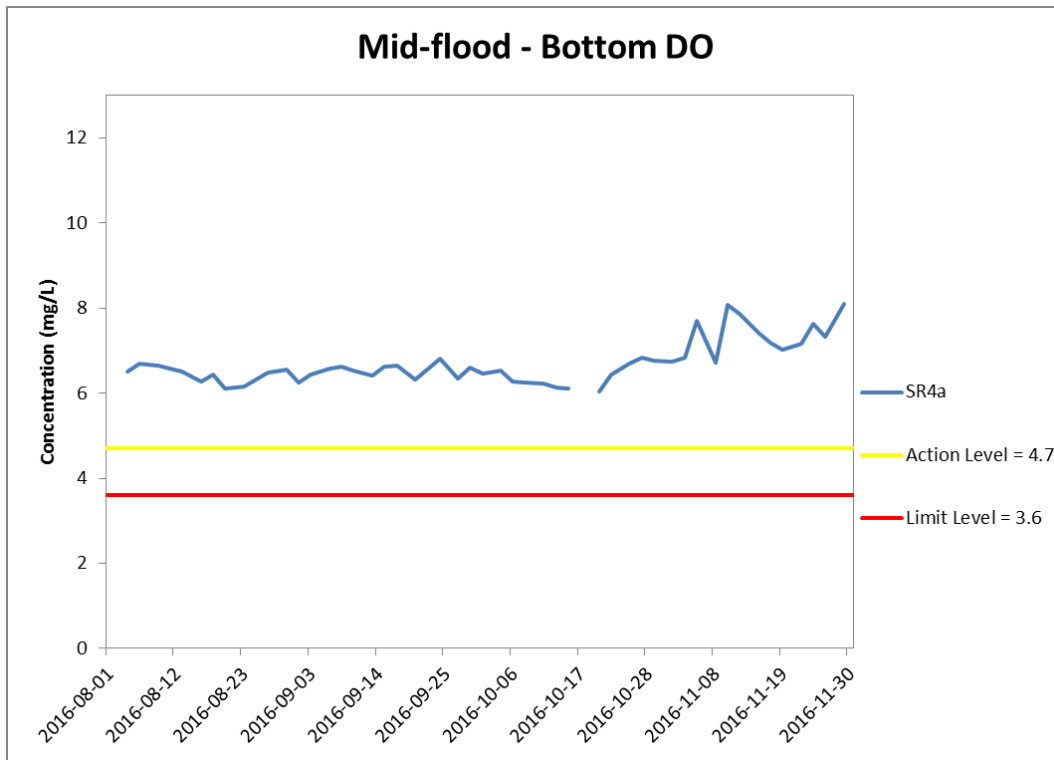
Figure H20 Impact Monitoring - Mean Level of Dissolved Oxygen (mg/L) in bottom waters during mid-flood tide between 1 August and 30 November 2016 at SR4a.

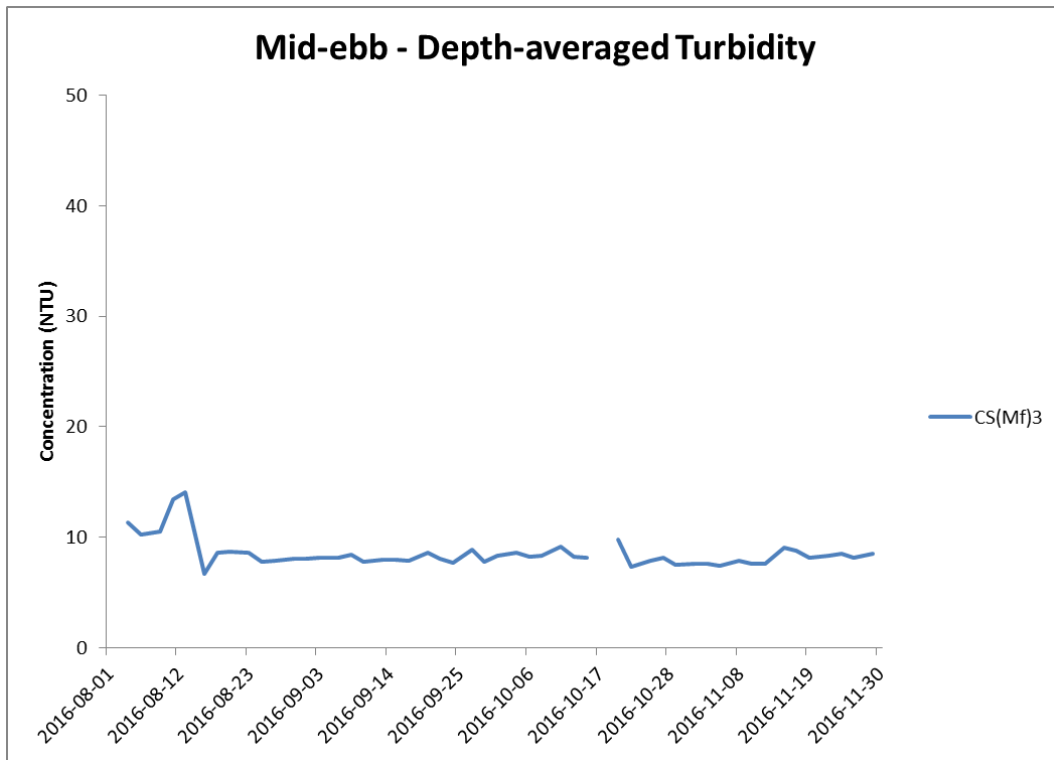
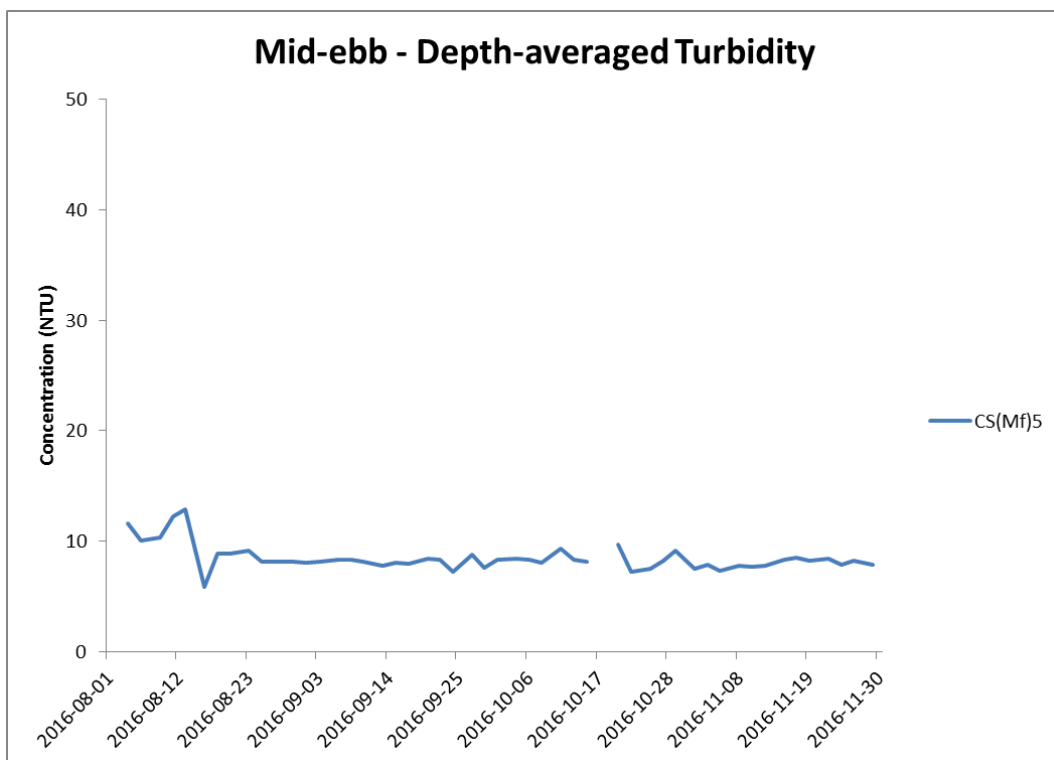
Figure H21 Impact Monitoring – Mean Level of depth-averaged Turbidity (NTU) during mid-ebb tide between 1 August and 30 November 2016 at CS(Mf)3 and CS(Mf)5.

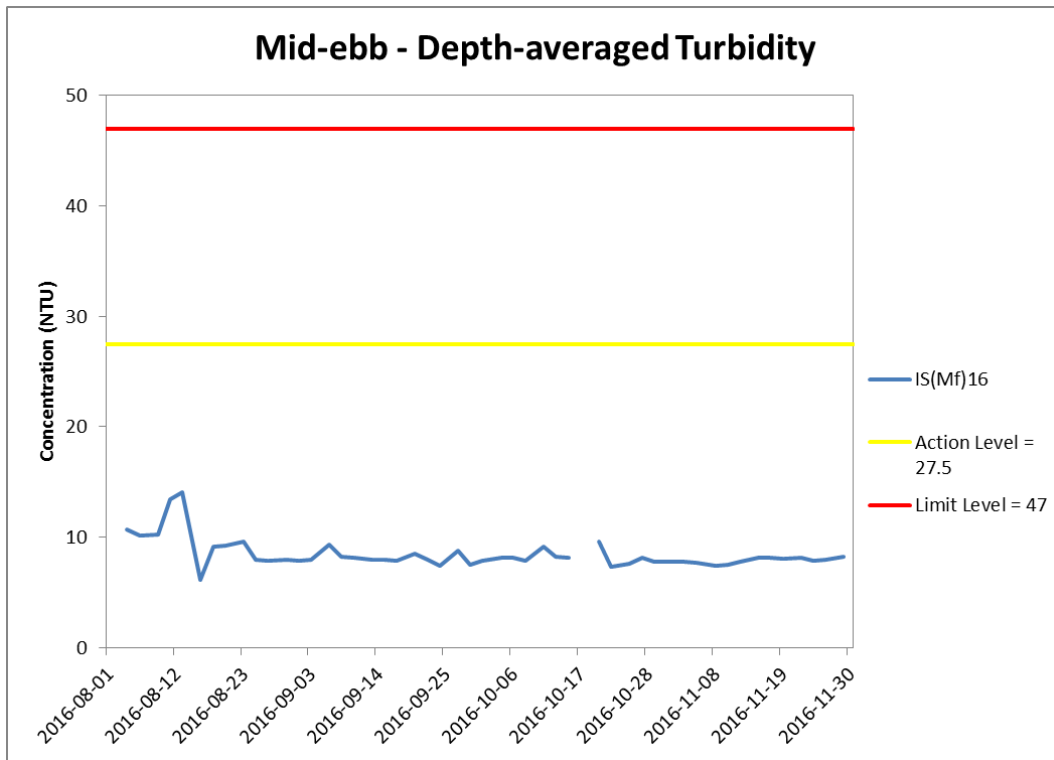
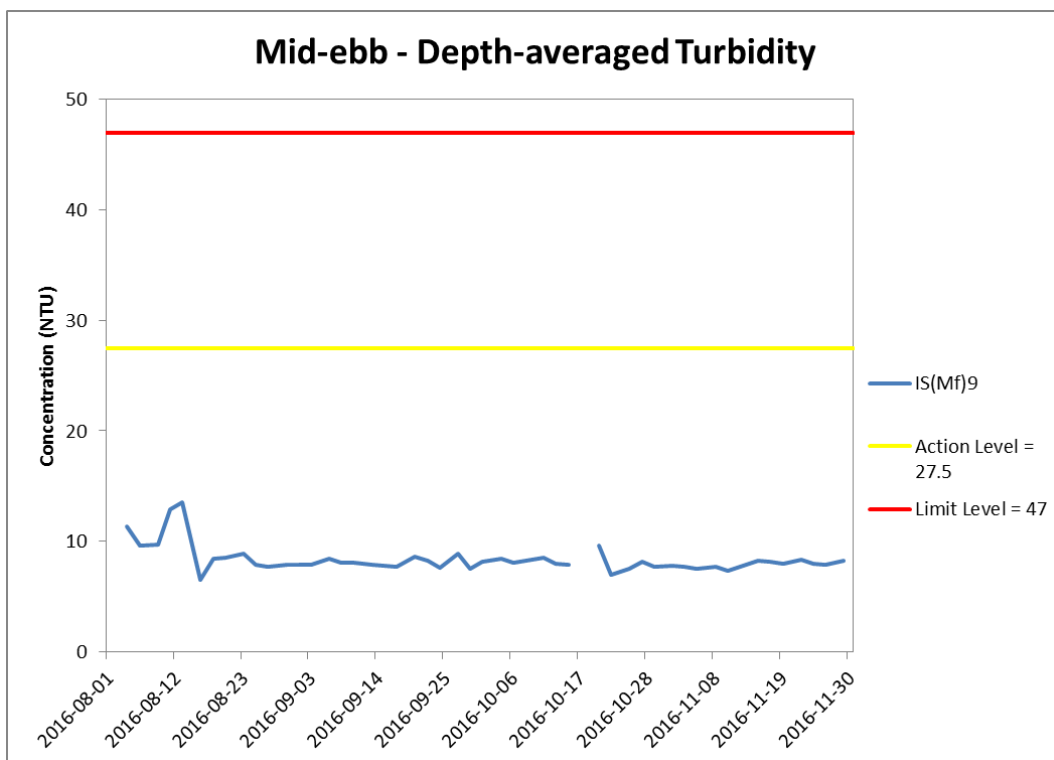
Figure H22 Impact Monitoring – Mean Level of depth-averaged Turbidity (NTU) during mid-ebb tide between 1 August and 30 November 2016 at IS(Mf)16 and IS(Mf)9.

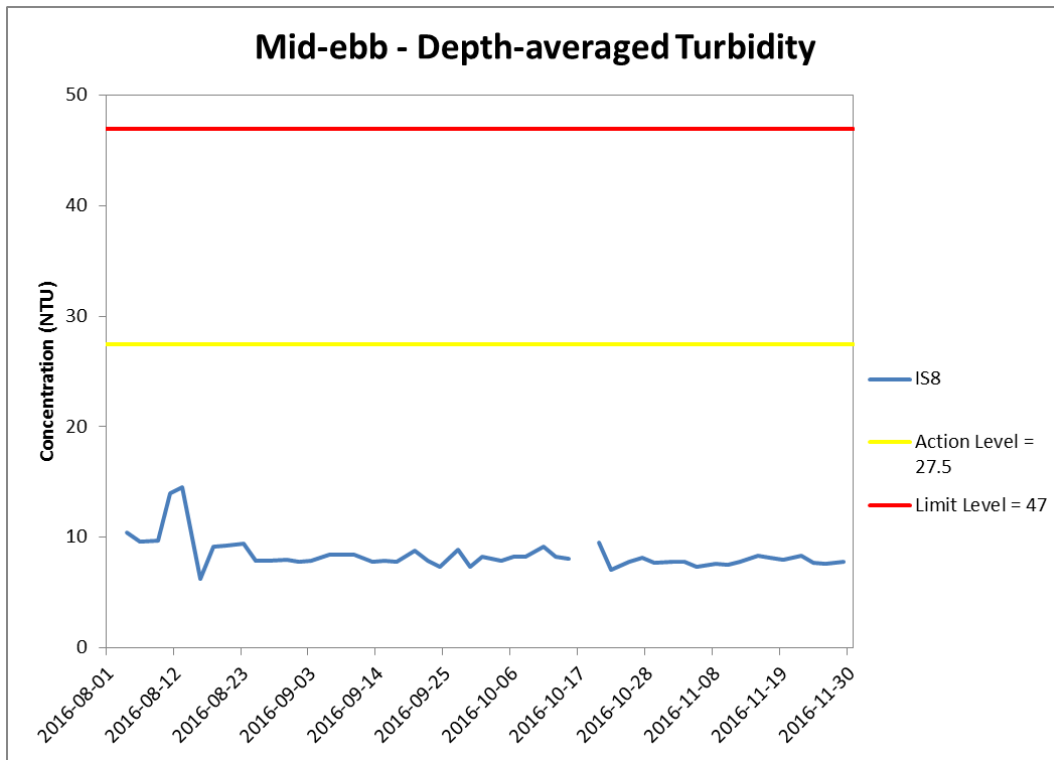
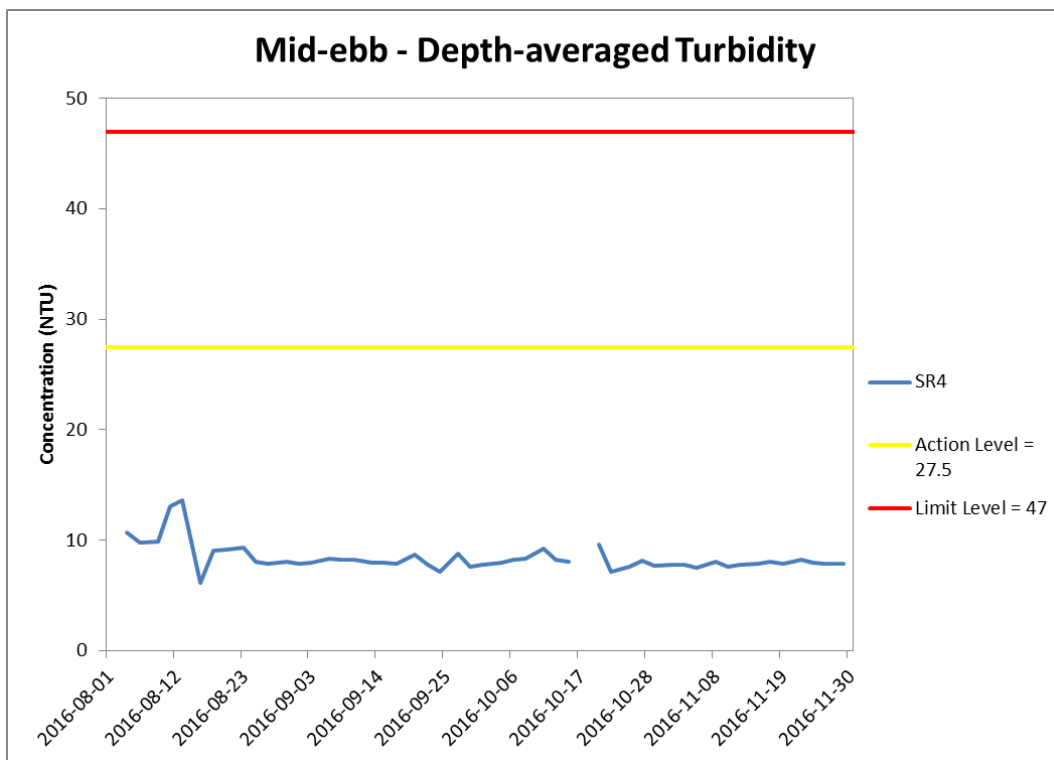
Figure H23 Impact Monitoring – Mean Level of depth-averaged Turbidity (NTU) during mid-ebb tide between 1 August and 30 November 2016 at IS8 and SR4.

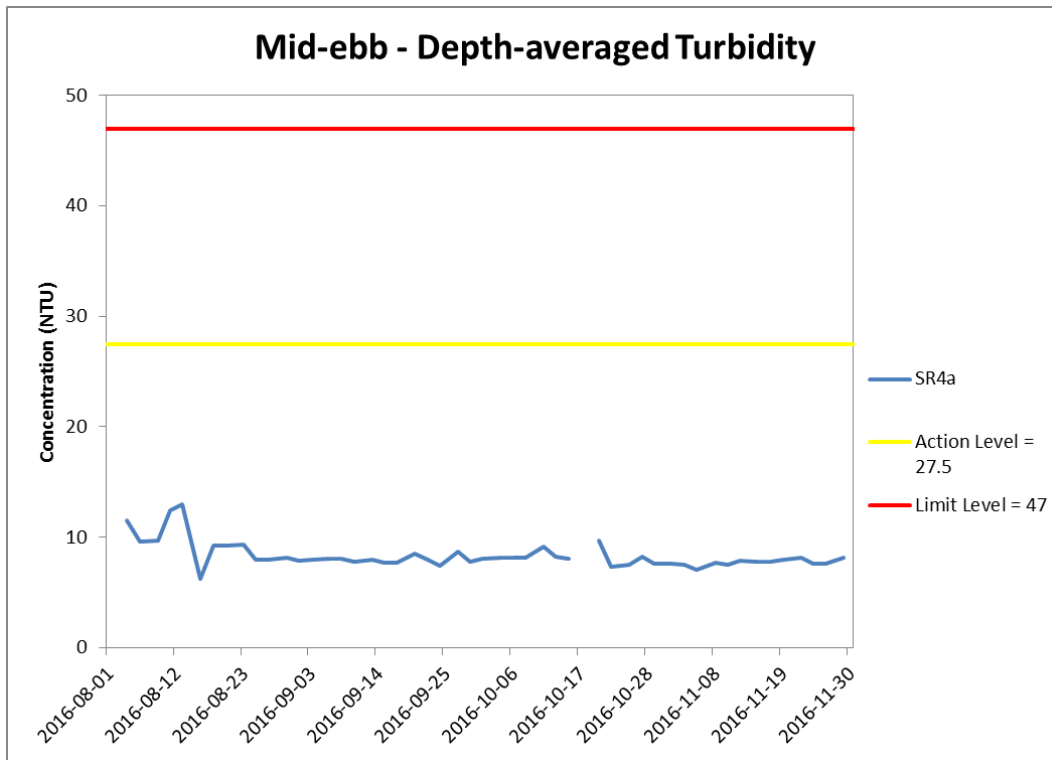
Figure H24 Impact Monitoring – Mean Level of depth-averaged Turbidity (NTU) during mid-ebb tide between 1 August and 30 November 2016 at SR4a.

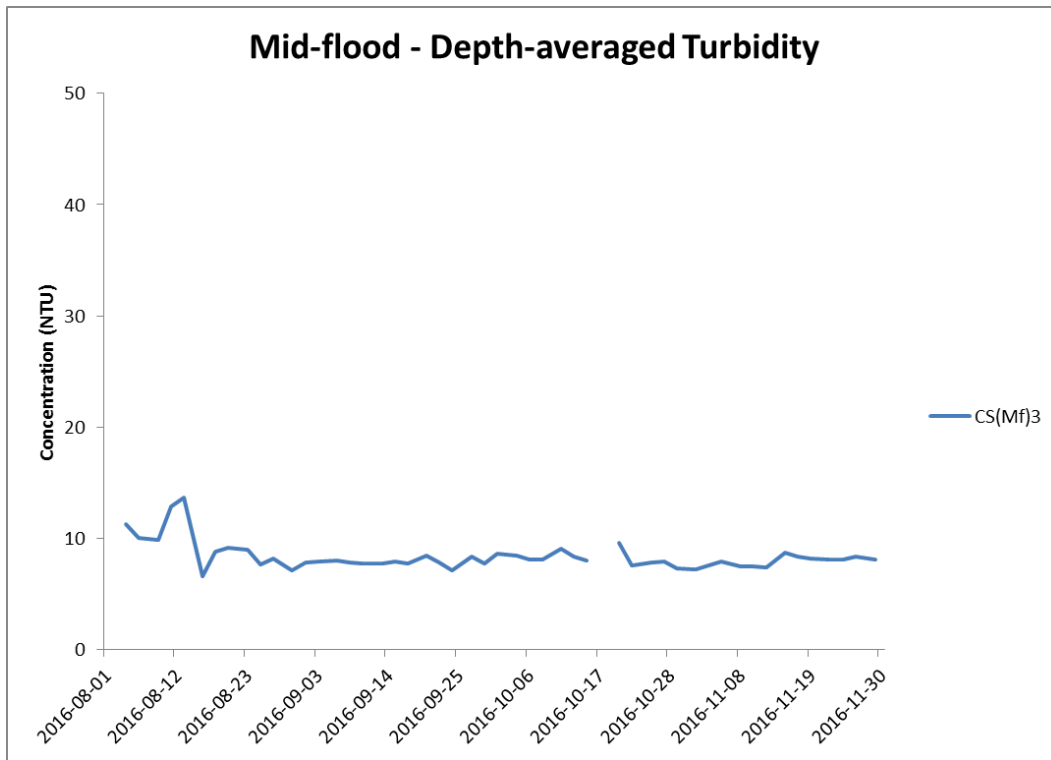
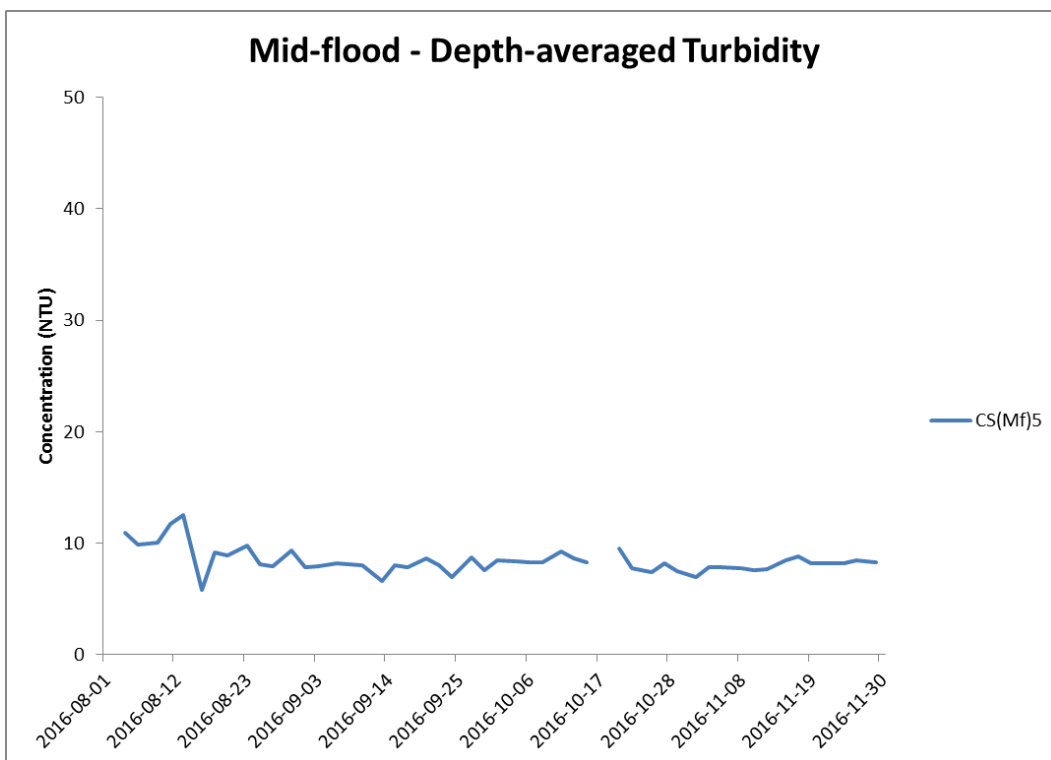
Figure H25 Impact Monitoring – Mean Level of depth-averaged Turbidity (NTU) during mid-flood tide between 1 August and 30 November 2016 at CS(Mf)3 and CS(MF)5.

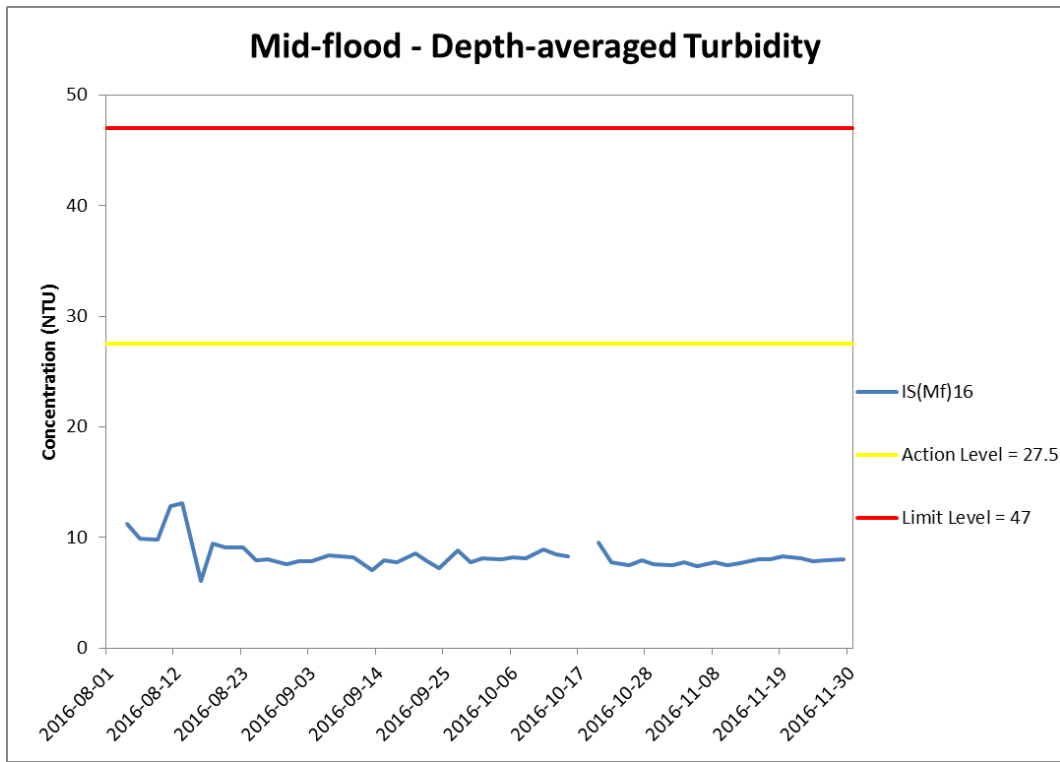
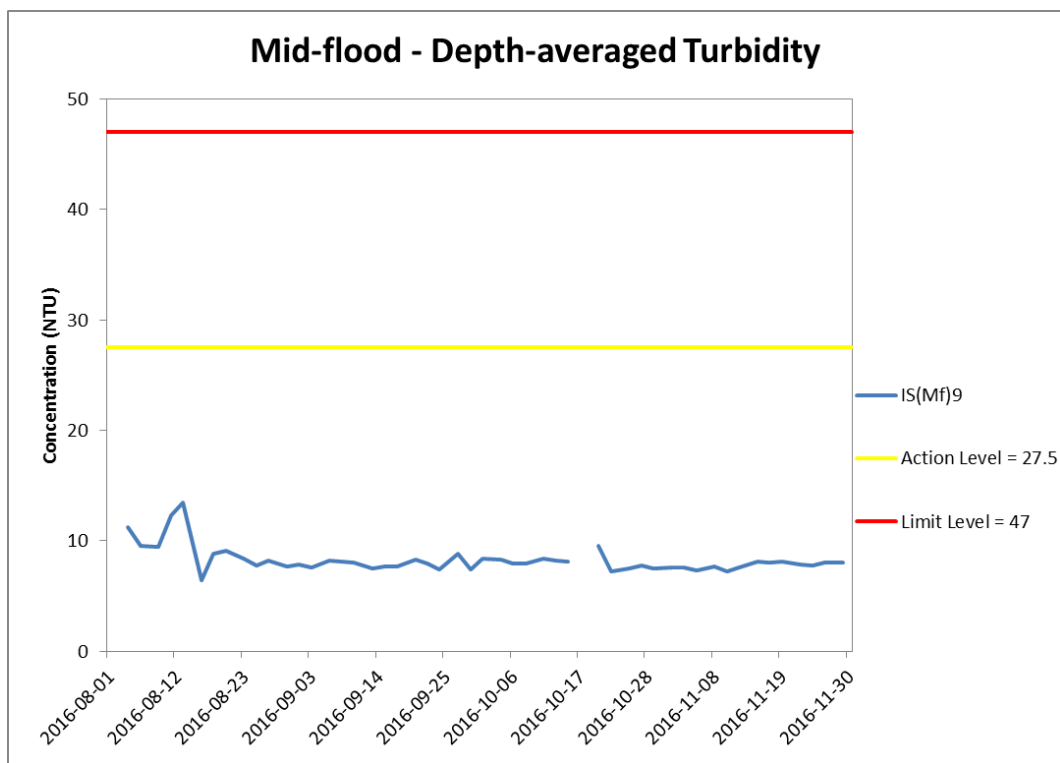
Figure H26 Impact Monitoring - Mean Level of depth-averaged Turbidity (NTU) during mid-flood tide between 1 August and 30 November 2016 at IS(Mf)16 and IS(Mf)9.

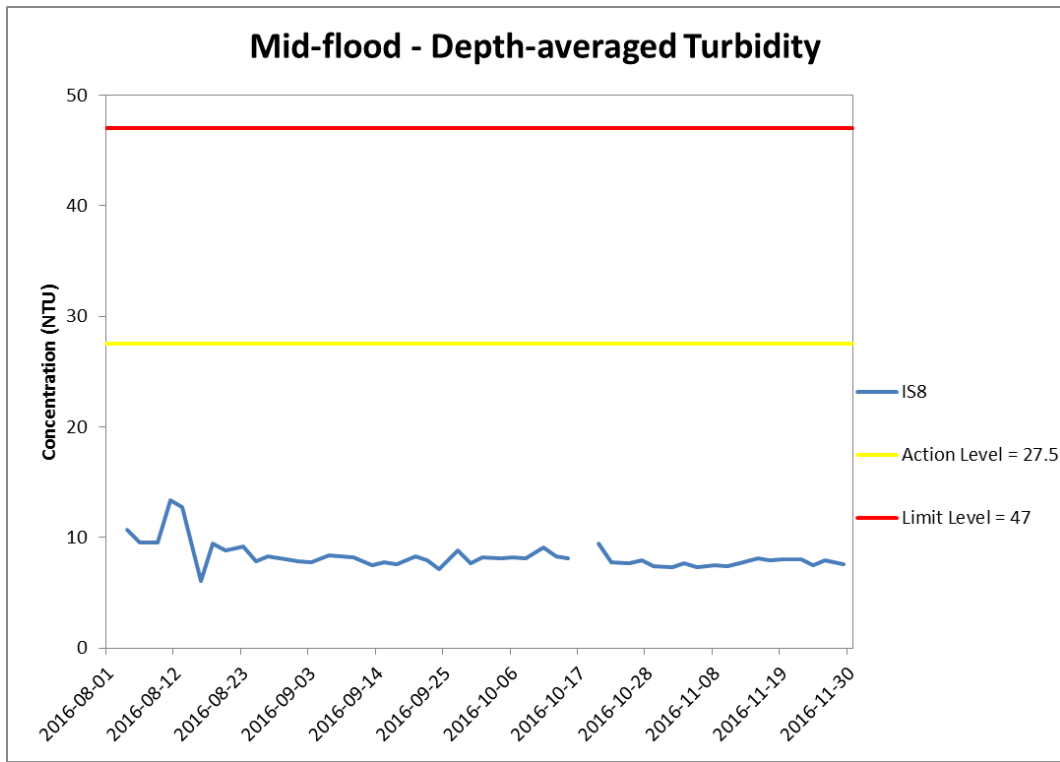
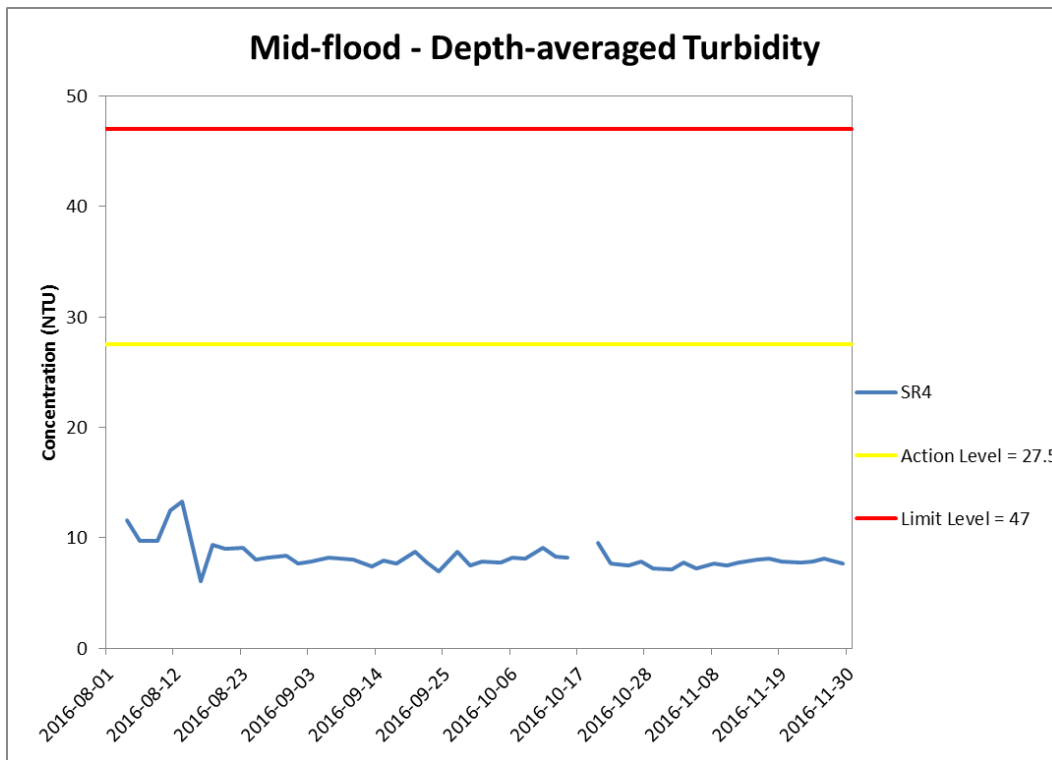
Figure H27 Impact Monitoring – Mean Level of depth-averaged Turbidity (NTU) during mid-flood tide between 1 August and 30 November 2016 at IS8 and SR4.

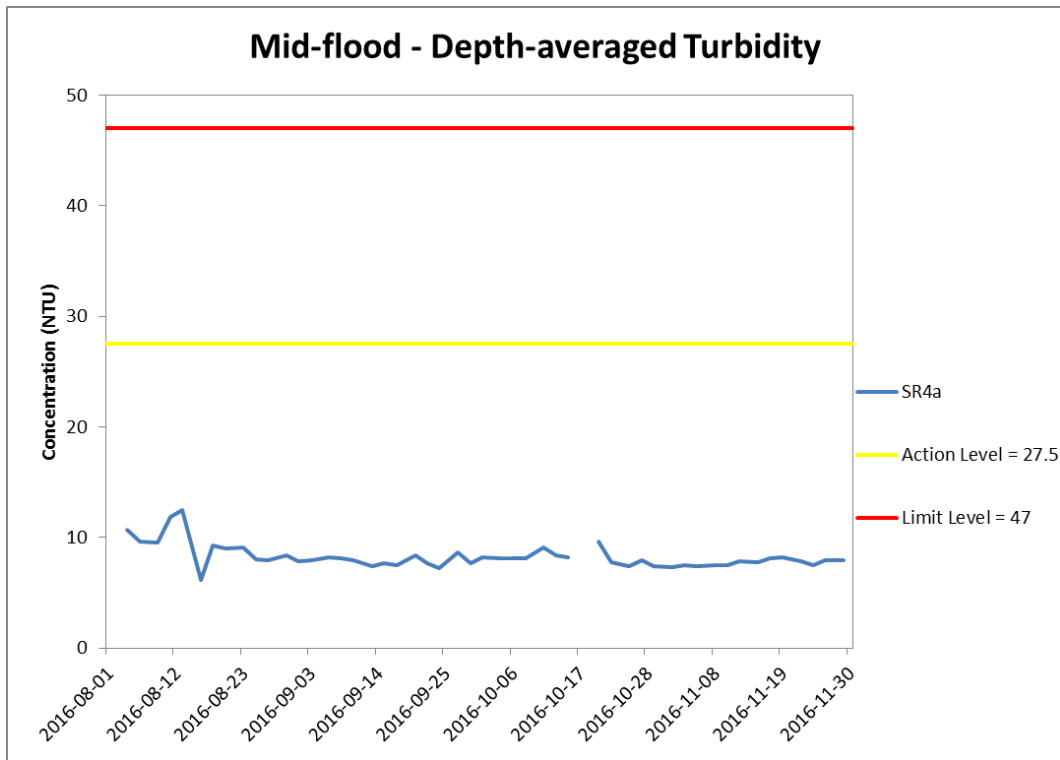
Figure H28 Impact Monitoring - Mean Level of depth-averaged Turbidity (NTU) during mid-flood tide between 1 August and 30 November 2016 at SR4a.

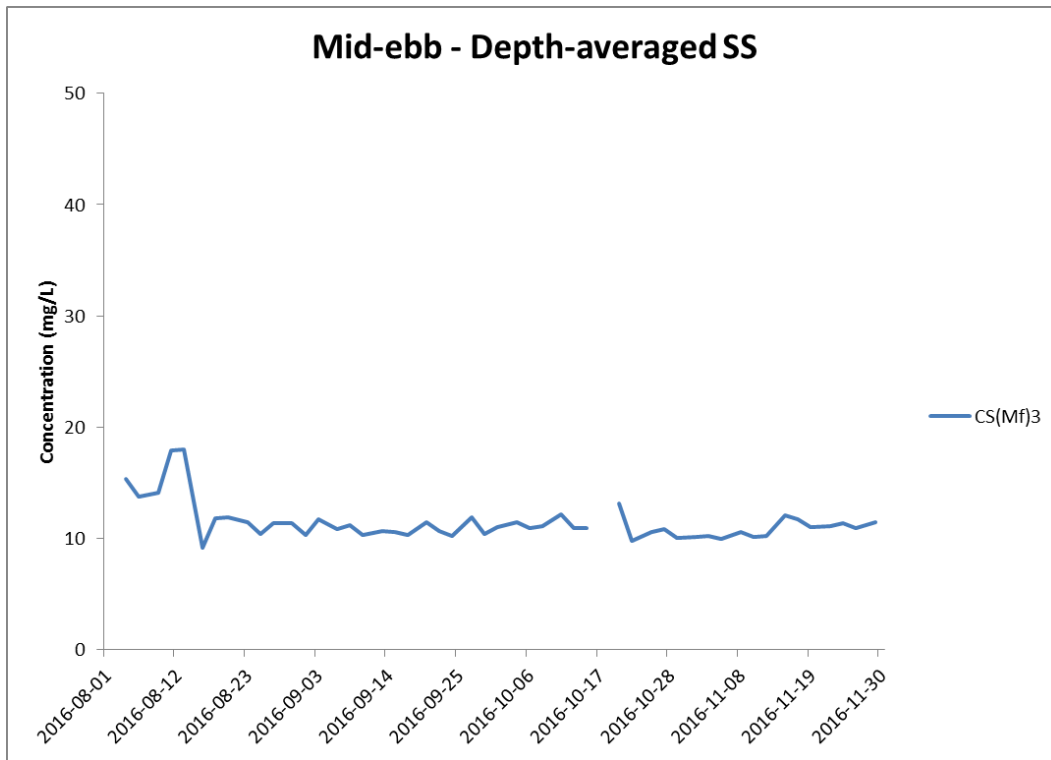
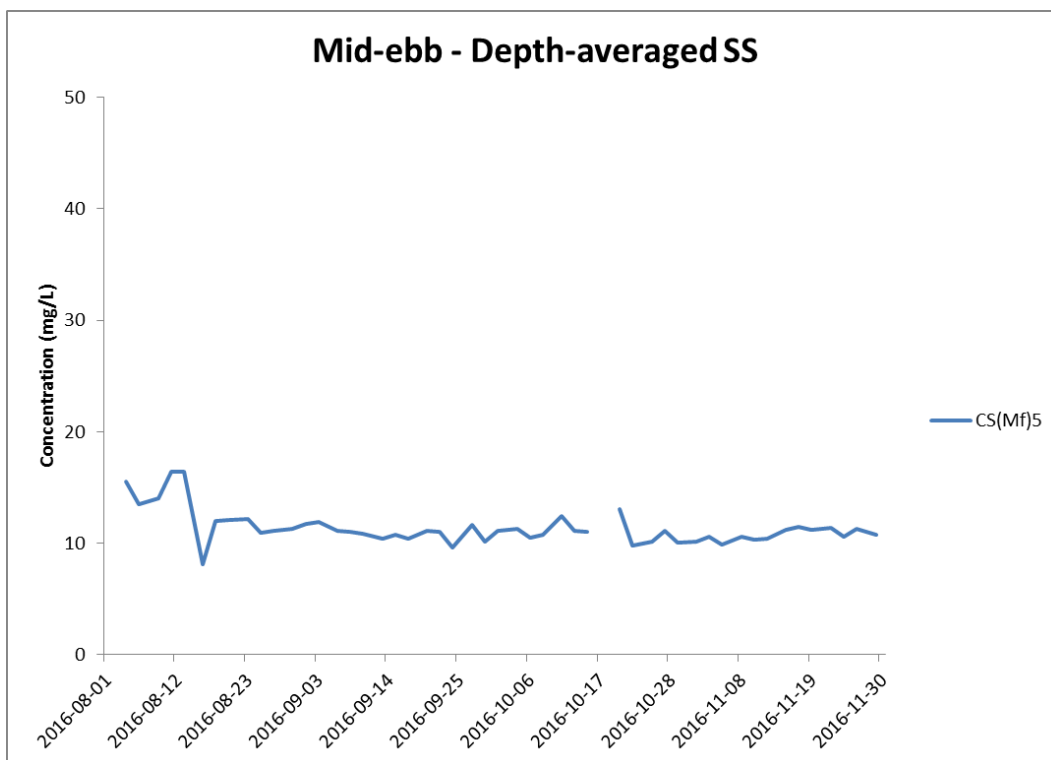
Figure H29 Impact Monitoring – Mean depth-averaged level of Suspended Solids (mg/L) during mid-ebb tide between 1 August and 30 November 2016 at CS(Mf)3 and CS(Mf)5.

The construction impact on depth-averaged SS was assessed by comparing the quarterly mean values of depth-averaged SS with the relevant ambient mean values (*Table 2.18*). The monitoring results showed that the quarterly means of depth-averaged SS at all sampling stations during both mid-ebb and mid-flood tides were well below the corresponding ambient means. The depth-averaged SS results suggest that the Project did not cause unacceptable impact on water quality in the reporting period.

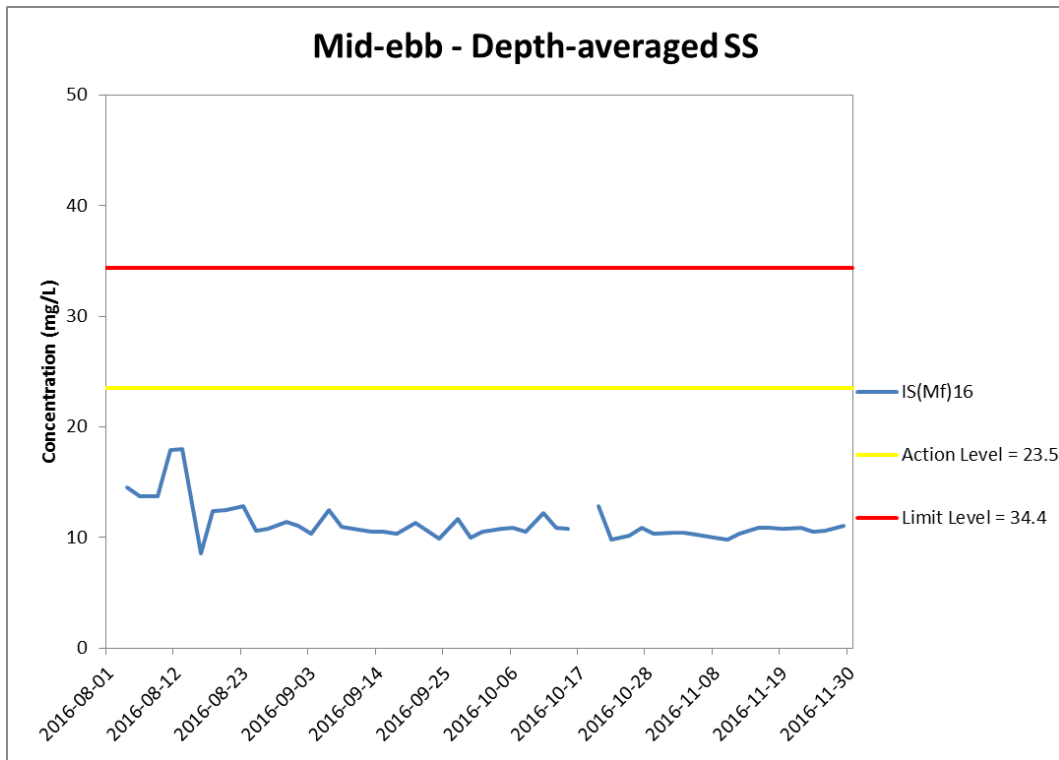
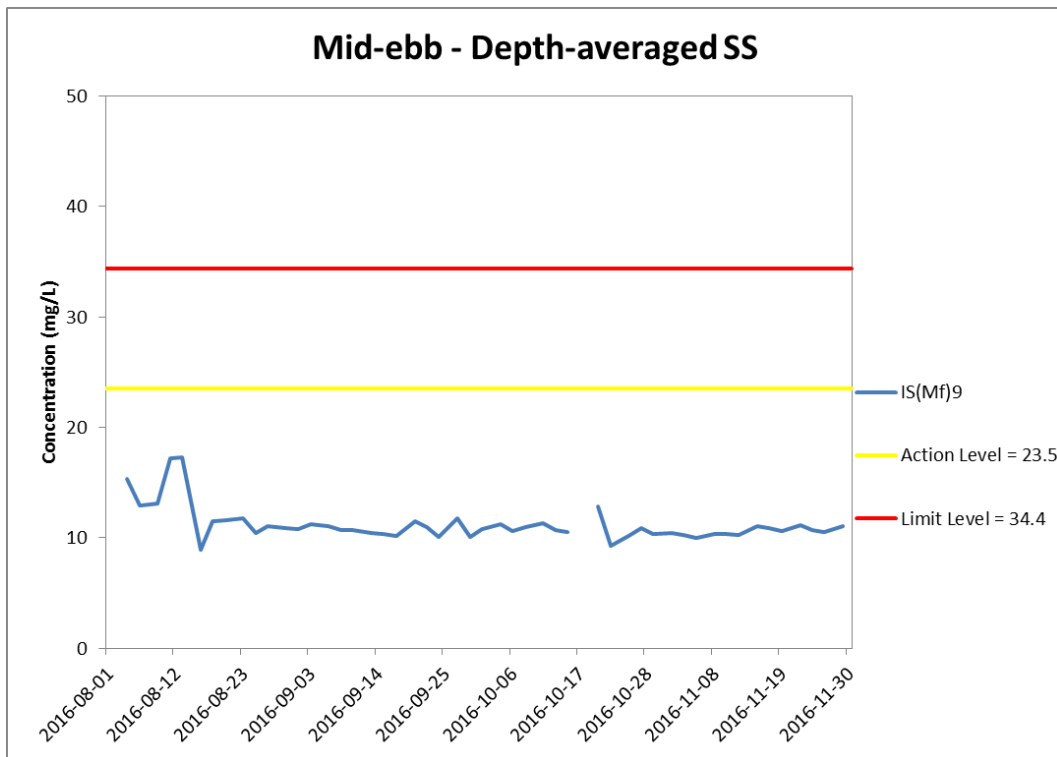
Figure H30 Impact Monitoring - Mean depth-averaged level of Suspended Solids (mg/L) during mid-ebb tide between 1 August and 30 November 2016 at IS(Mf)16 and IS(Mf)9.
