**Contract No. HY/2012/07
Tuen Mun – Chek Lap Kok Link –
Southern Connection Viaduct Section**

*Twelfth Quarterly Environmental Monitoring &
Audit (EM&A) Report*

27 April 2017

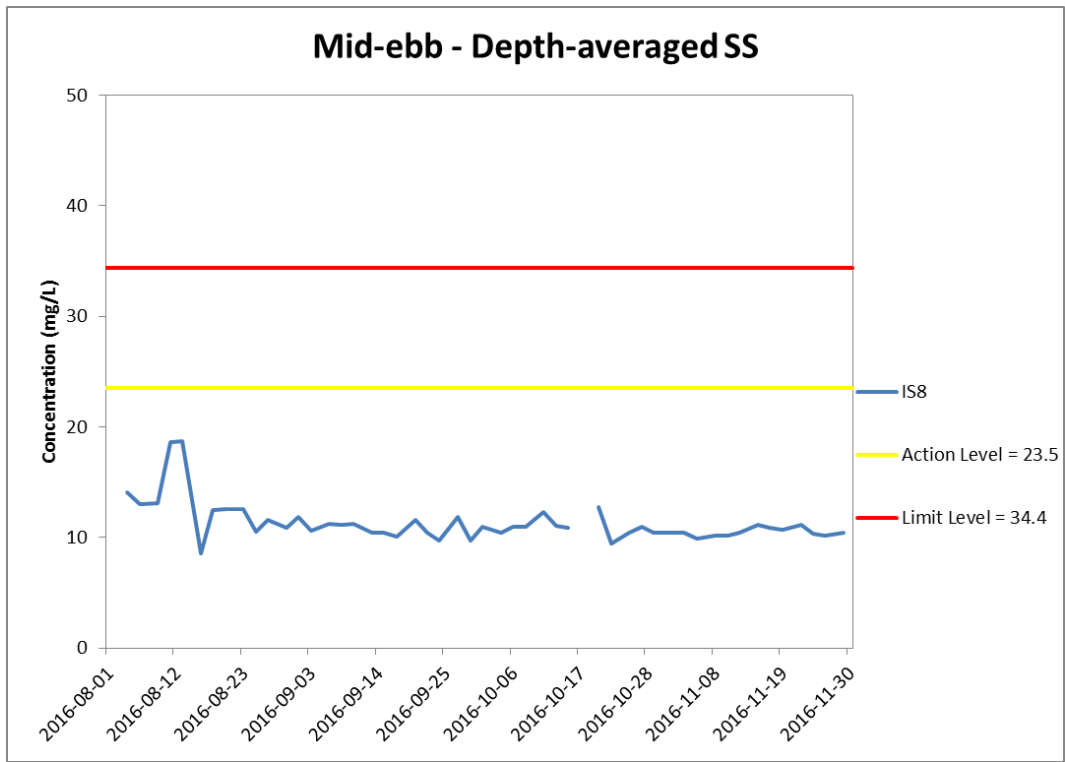
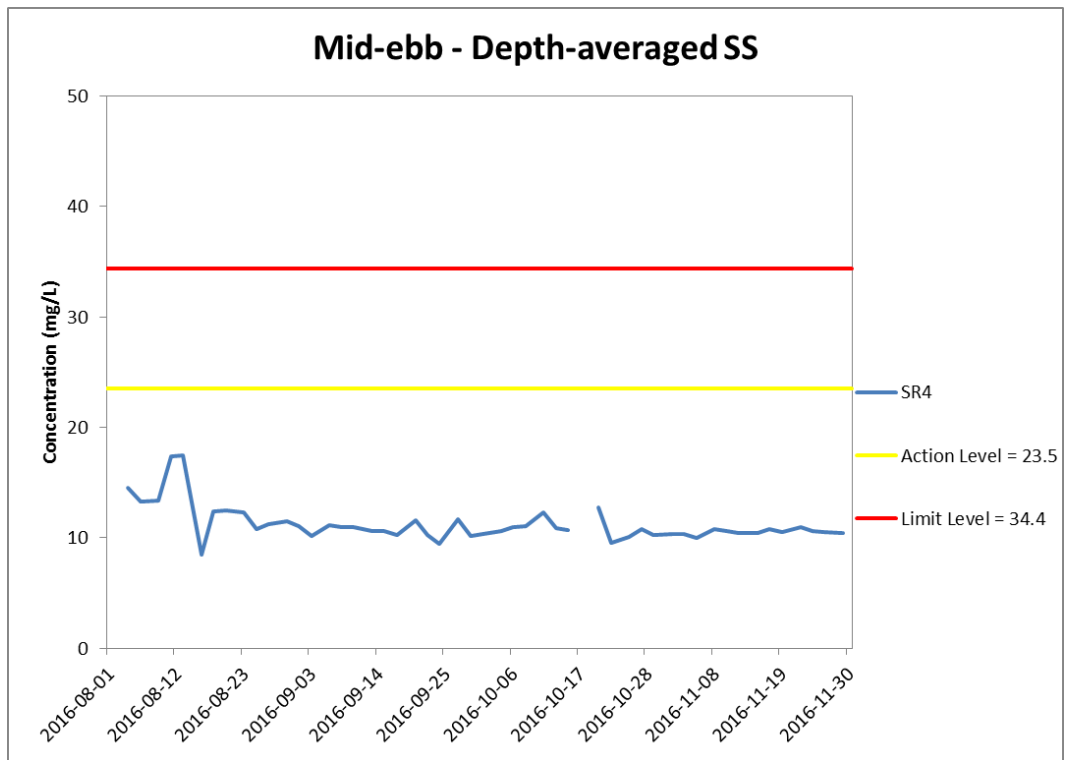
Figure H31 Impact Monitoring - Mean depth-averaged level of Suspended Solids (mg/L) during mid-ebb tide between 1 August and 30 November 2016 at IS8 and SR4.

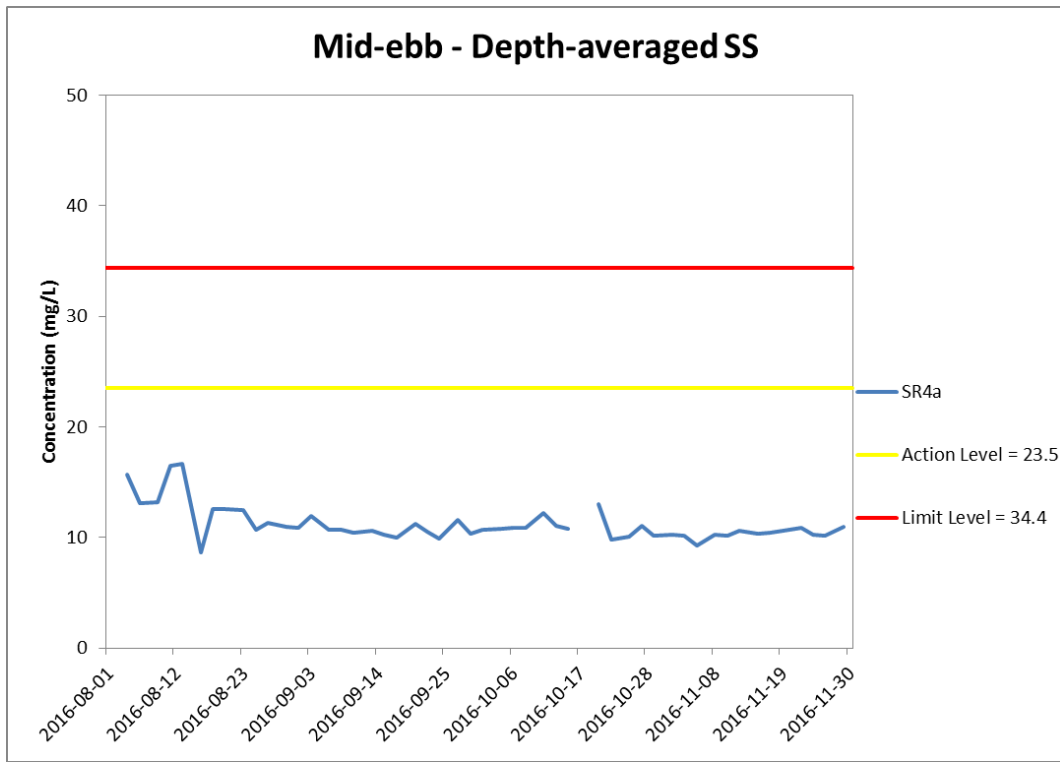
Figure H32 Impact Monitoring - Mean depth-averaged level of Suspended Solids (mg/L) during mid-ebb tide between 1 August and 30 November 2016 at SR4a.

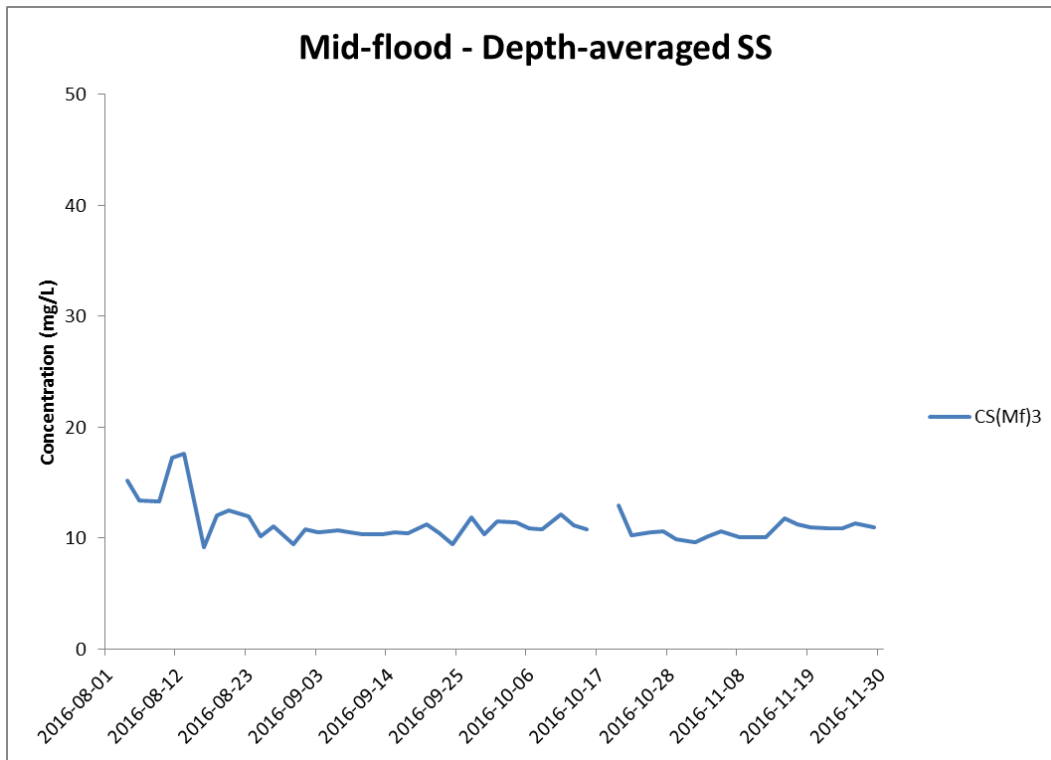
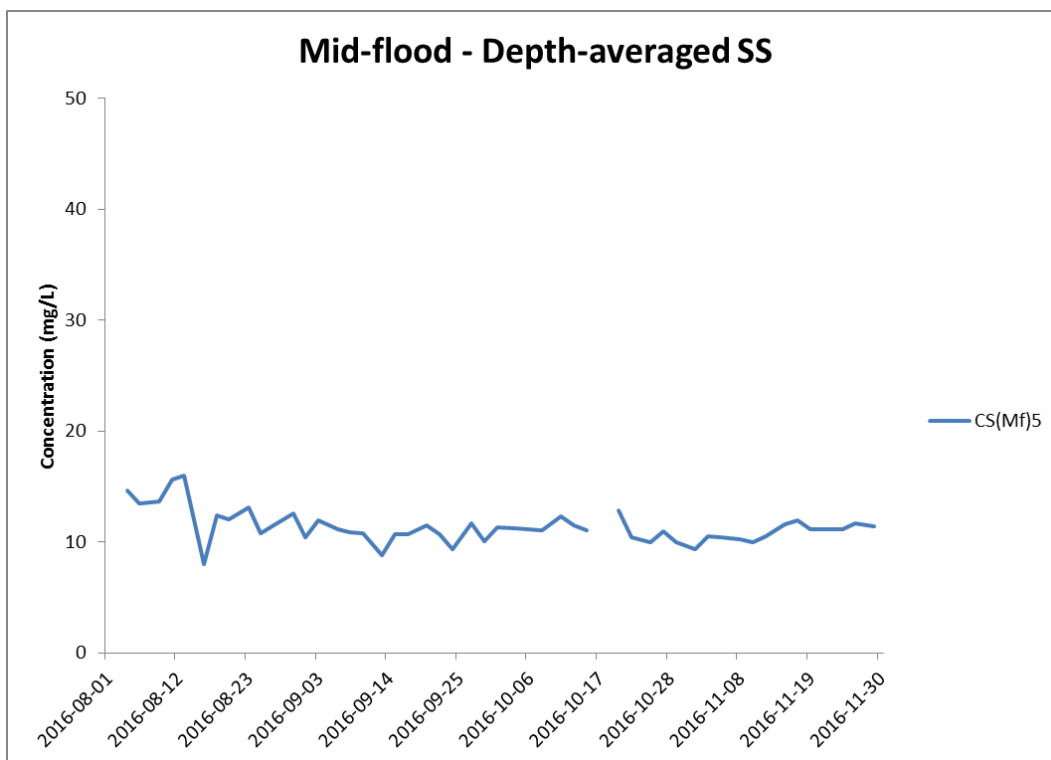
Figure H33 Impact Monitoring – Mean depth-averaged level of Suspended Solids (mg/L) during mid-flood tide between 1 August and 30 November 2016 at CS(Mf)3 and CS(Mf)5.

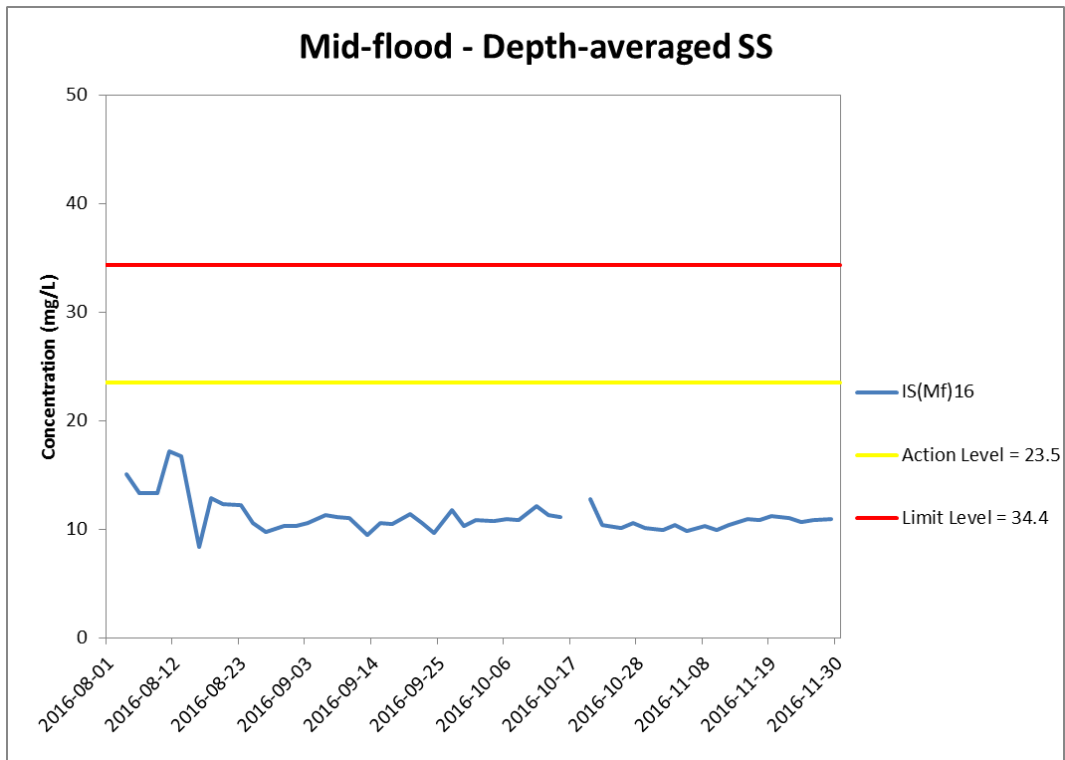
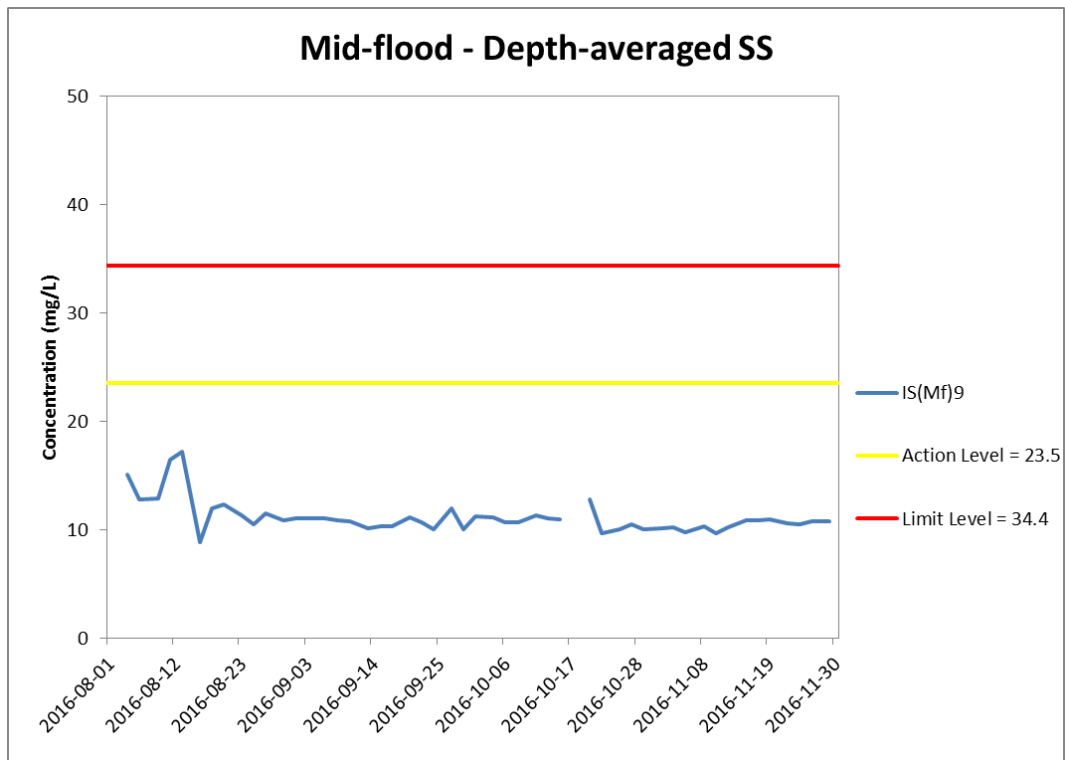
Figure H34 Impact Monitoring – Mean depth-averaged level of Suspended Solids (mg/L) during mid-flood tide between 1 August and 30 November 2016 at IS(Mf)16 and IS(Mf)9.

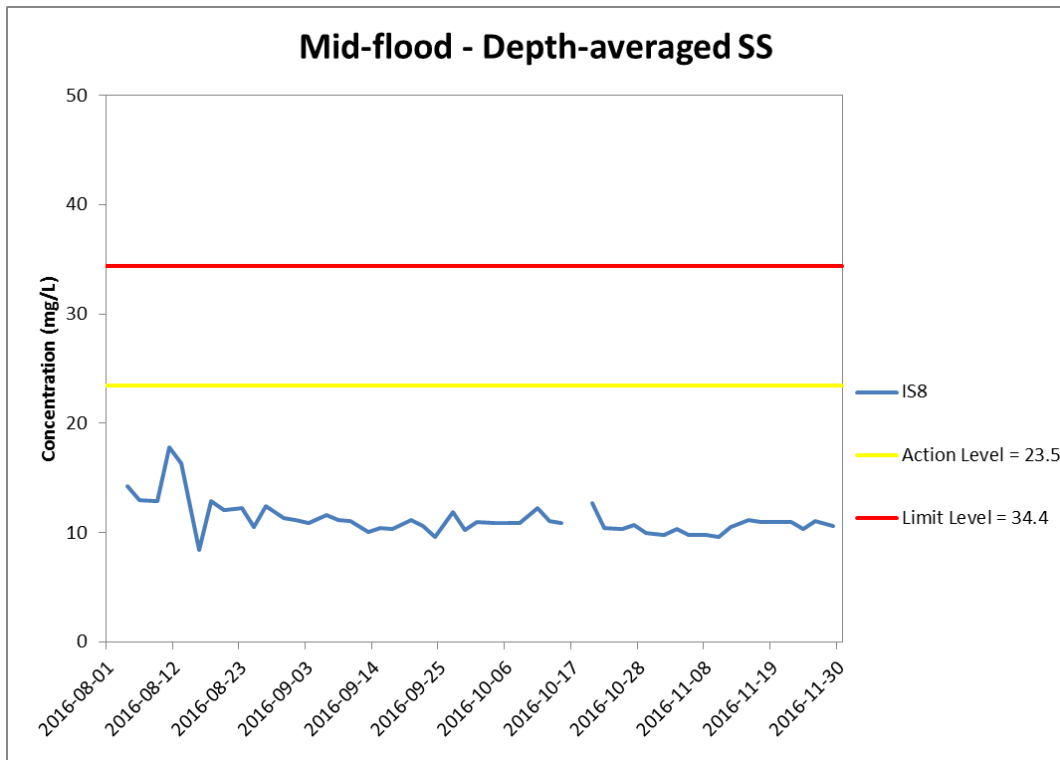
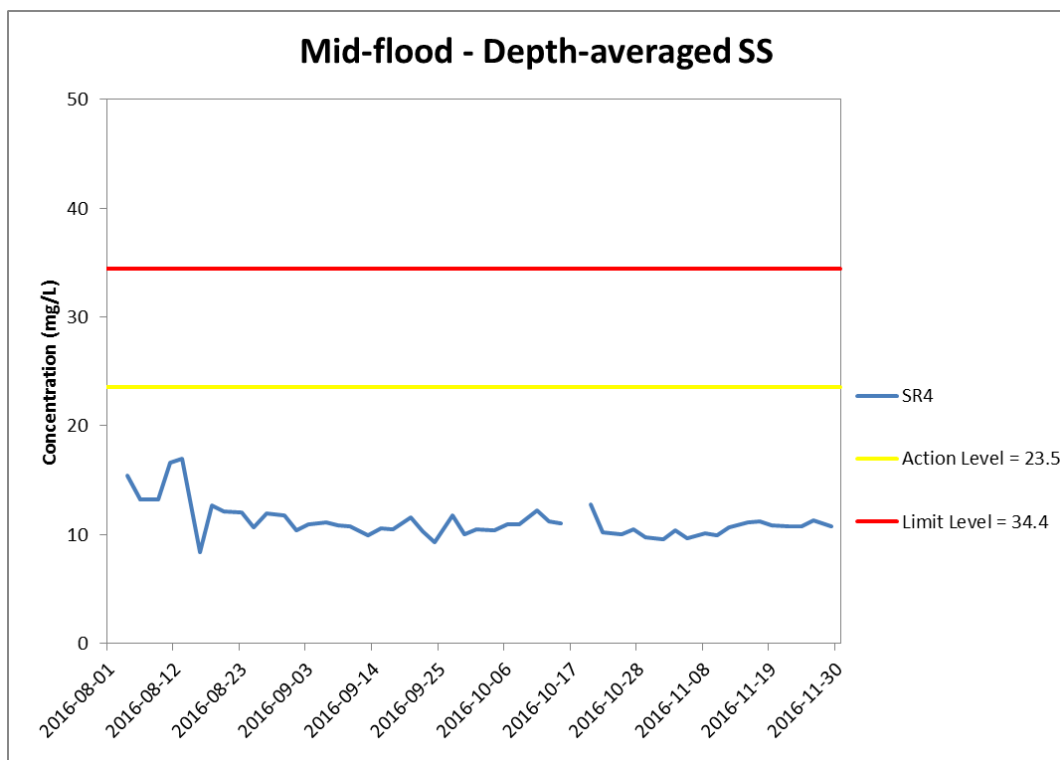
Figure H35 Impact Monitoring – Mean depth-averaged level of Suspended Solids (mg/L) during mid-flood tide between 1 August and 30 November 2016 at IS8 and SR4.

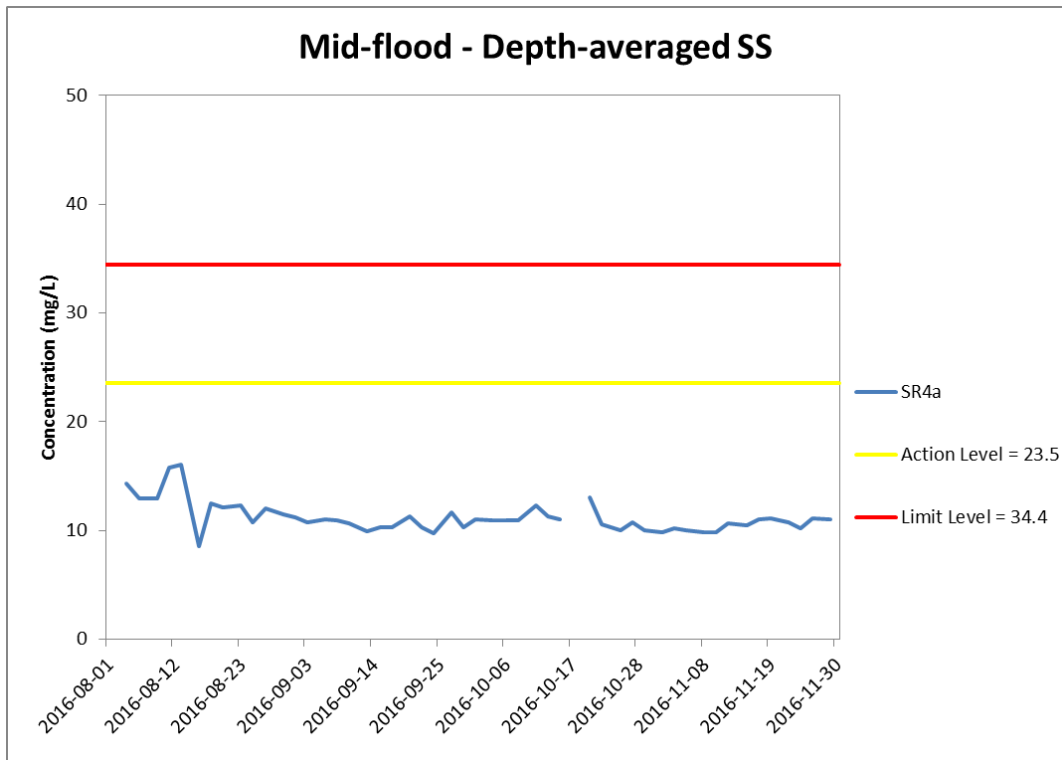
Figure H36 Impact Monitoring - Mean depth-averaged level of Suspended Solids (mg/L) during mid-flood tide between 1 August and 30 November 2016 at SR4a.

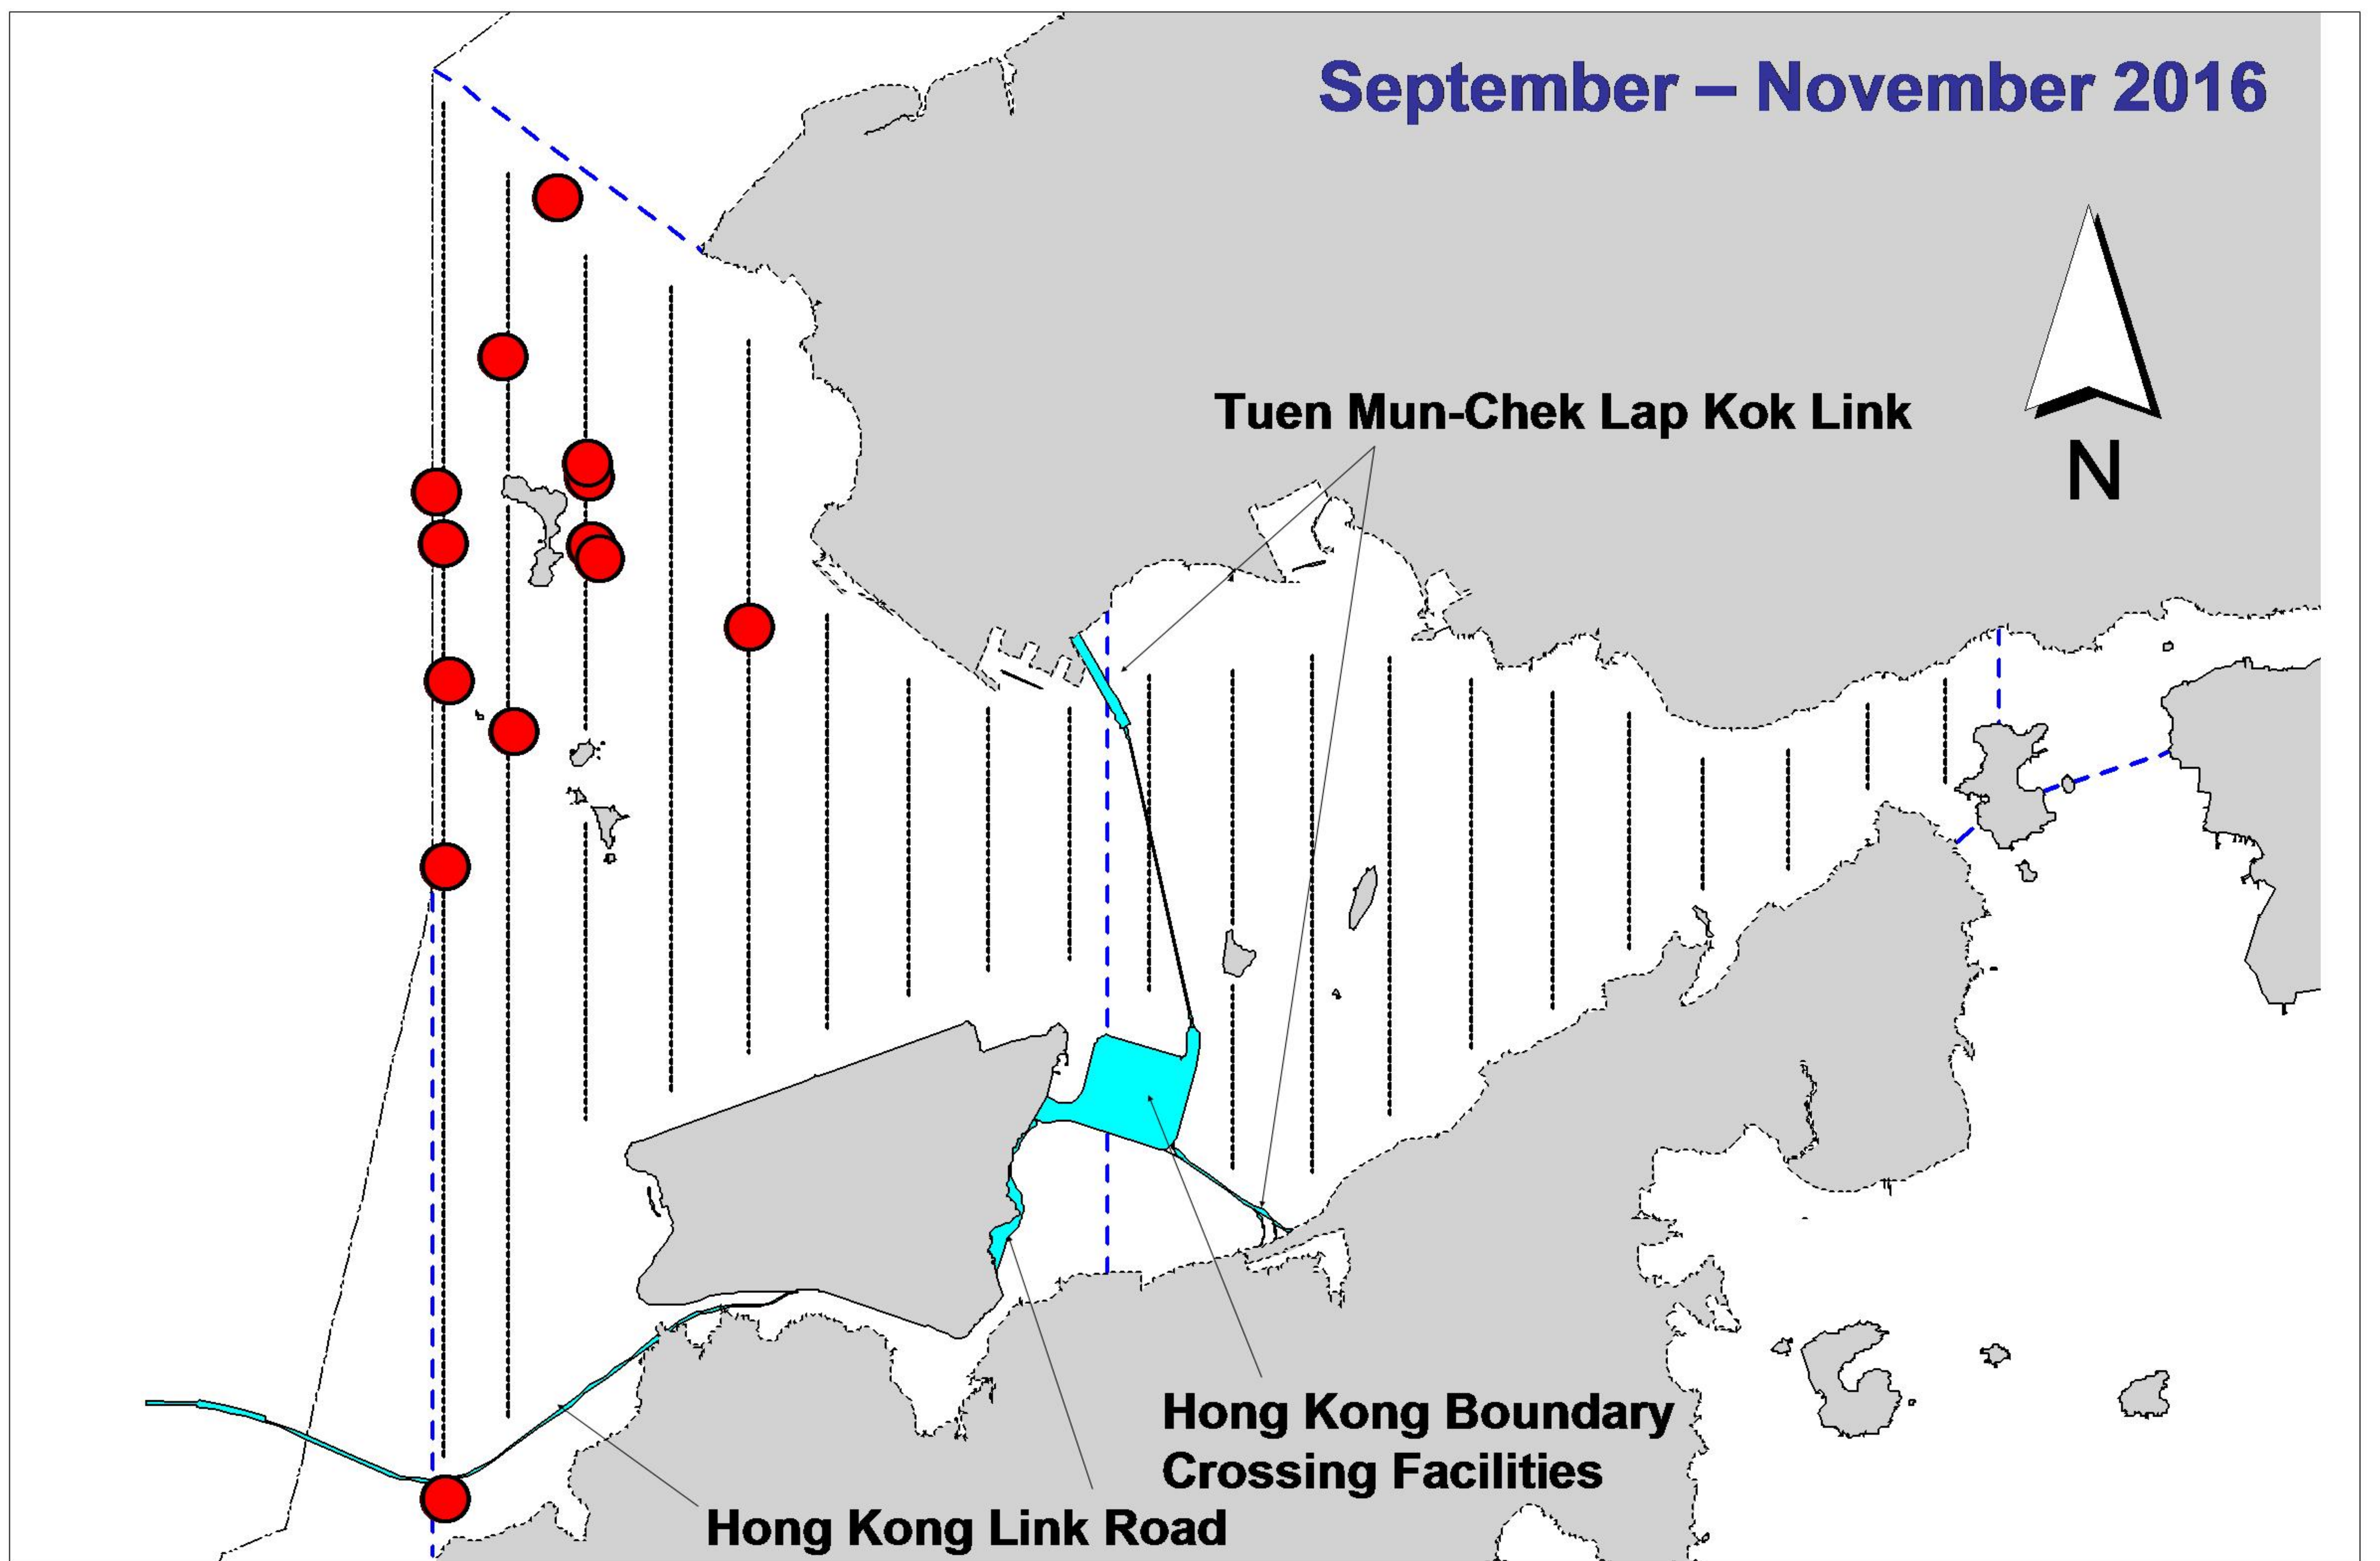
Figure 1. Distribution of Chinese white dolphin sighting in Northwest and Northeast Lantau during HKLR03 impact phase (top) and baseline monitoring surveys (bottom)
