**Contract No. HY/2012/07  
Tuen Mun – Chek Lap Kok Link –  
Southern Connection Viaduct Section**

***Thirteenth Quarterly Environmental Monitoring  
& Audit (EM&A) Report***

26 October 2017

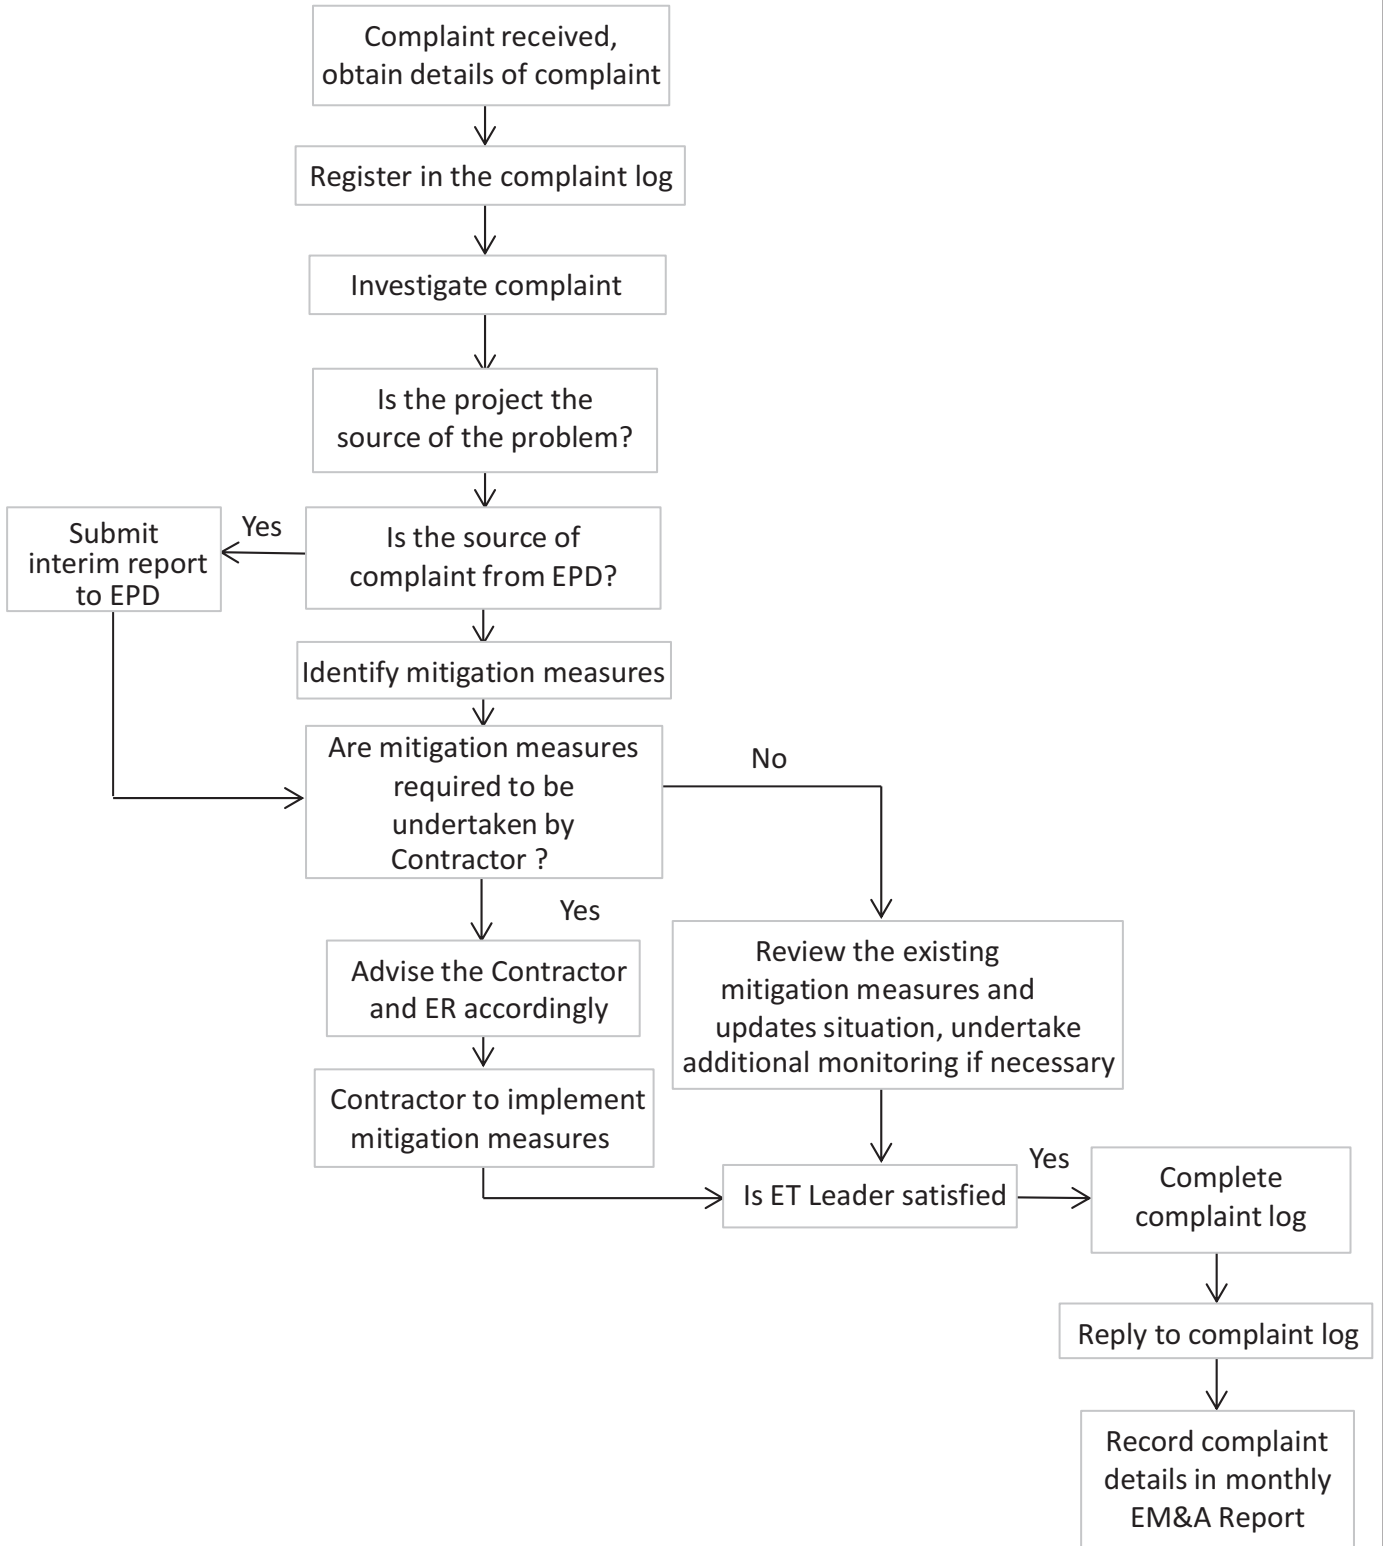
Figure 2.5

Environmental Complaint Handling Procedure

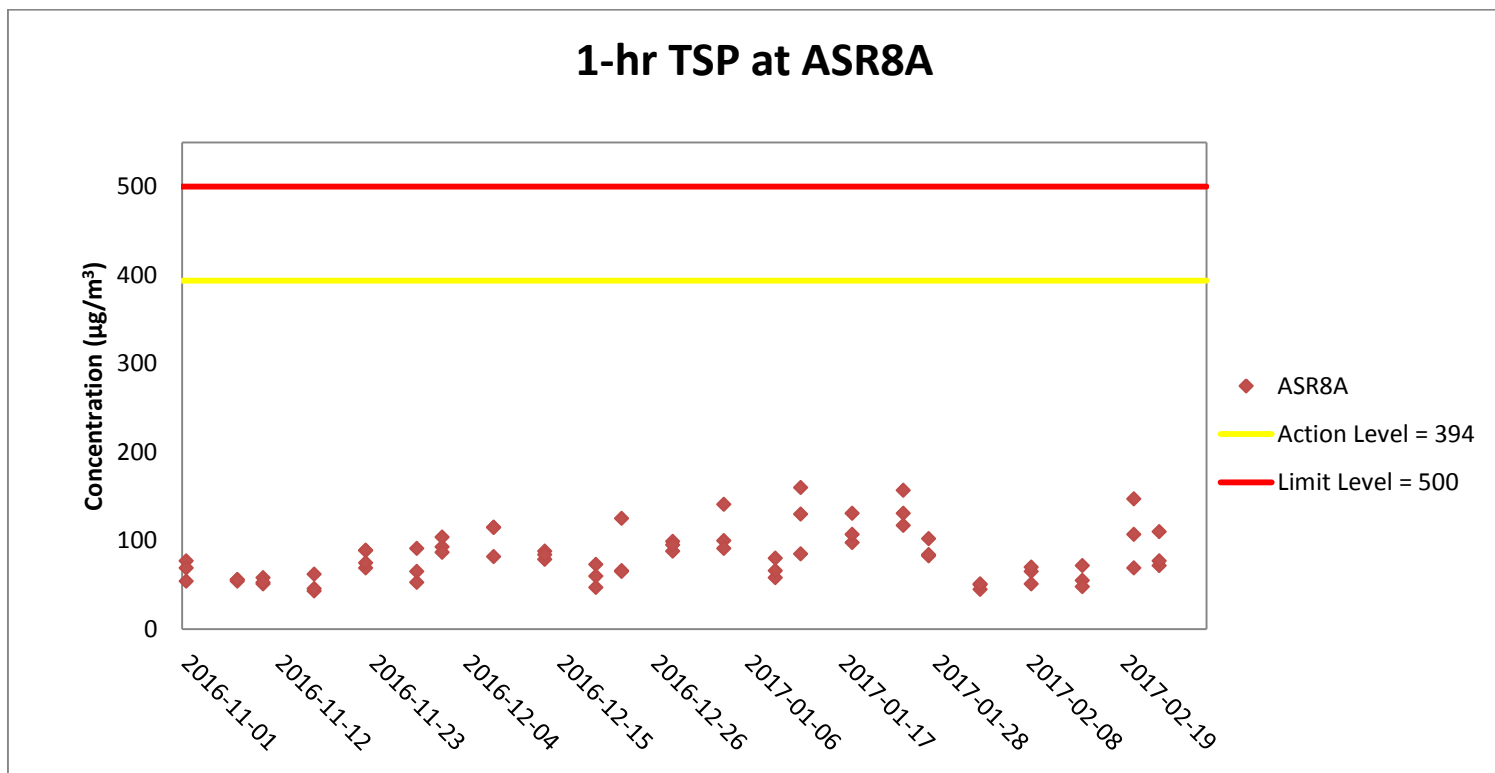
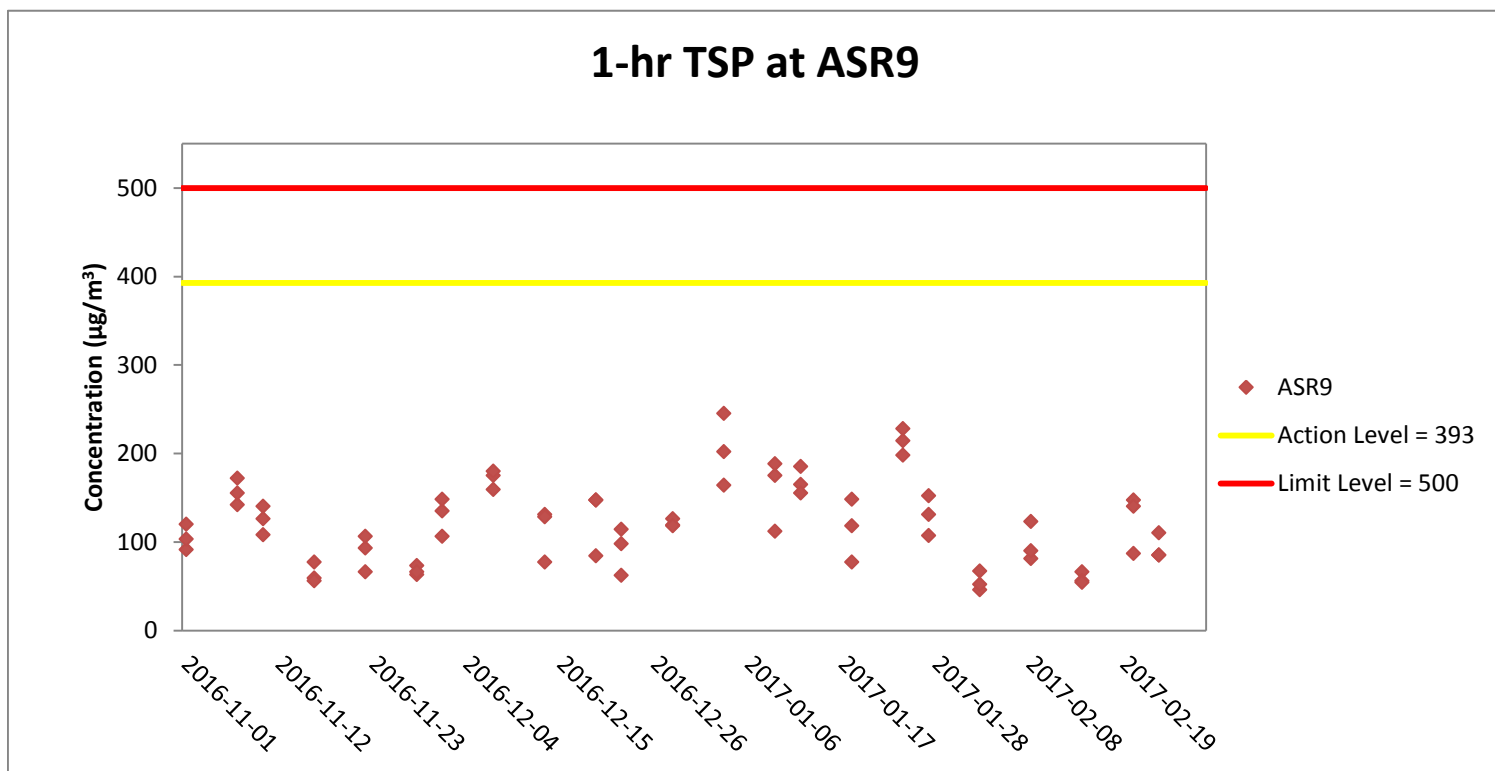
Impact Air Quality  
Monitoring Graphical  
Presentation

Weather condition within the reporting period varied between sunny to rainy.

Major construction works undertaken within the reporting period include Pier construction; Re-alignment of Cheung Tung Road; Road works along North Lantau Highway; Installation of pier head and deck segments; and Slope work of Viaducts A, B & C.

Marine works within the reporting period include Construction and installation of pile caps; Uninstallation of marine piling platform; Pier construction; Launching gantry operation; and Installation of deck segment and pier head segment.

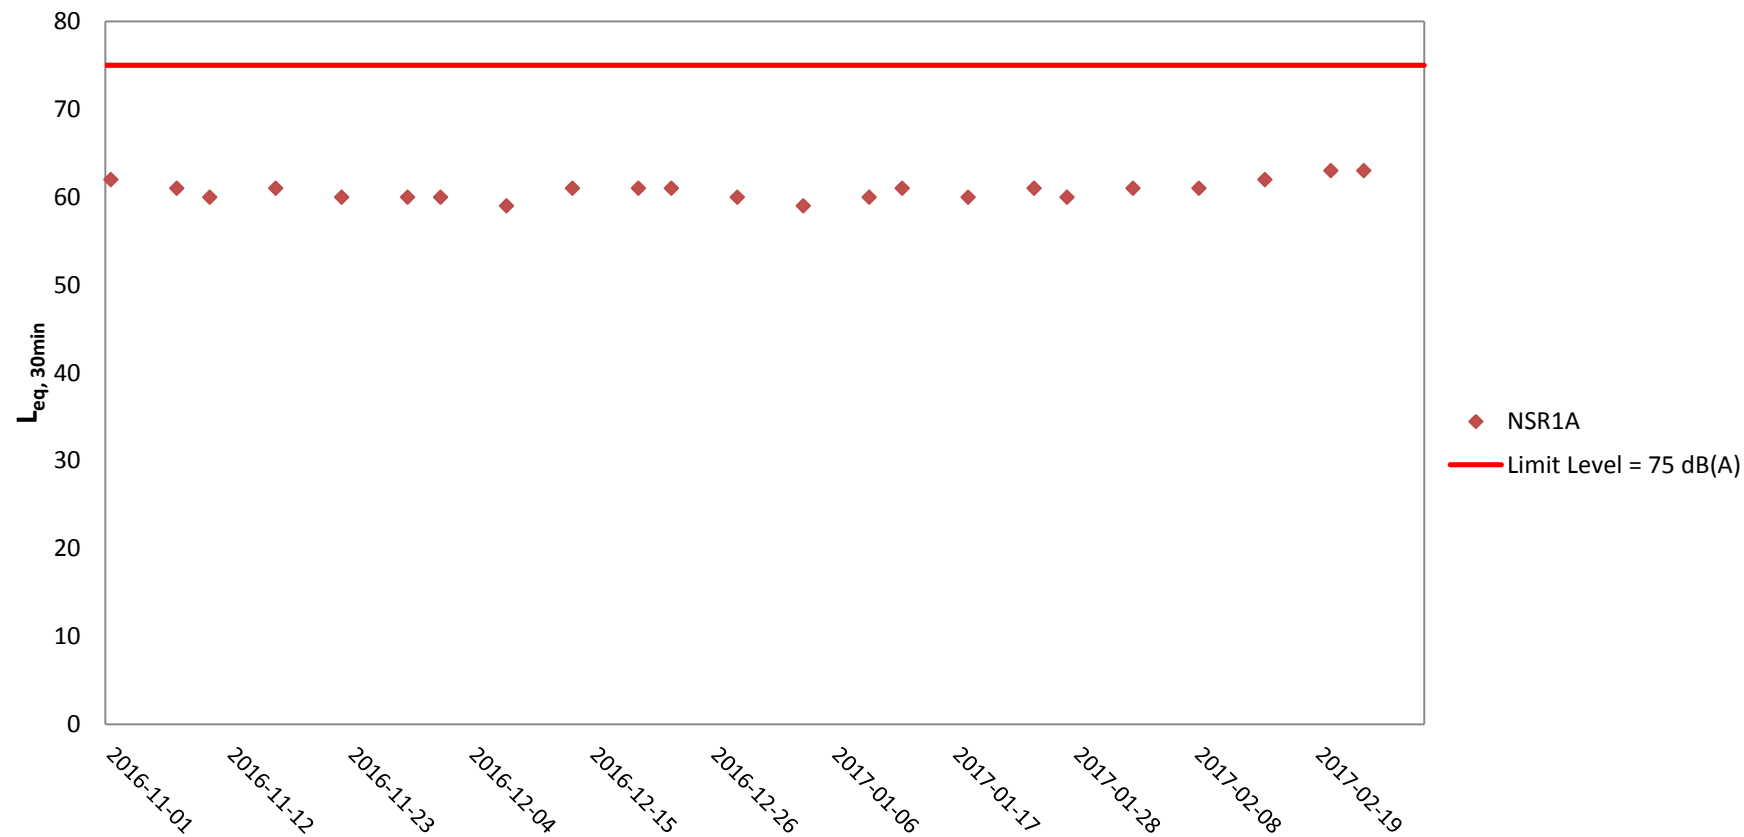
### Noise Monitoring Results at NSR 1A ( $L_{eq, 30min}$ )

Weather condition within the reporting period varied between sunny to rainy.

Major construction works undertaken within the reporting period include Pier construction; Re-alignment of Cheung Tung Road; Road works along North Lantau Highway; Installation of pier head and deck segments; and Slope work of Viaducts A, B & C.

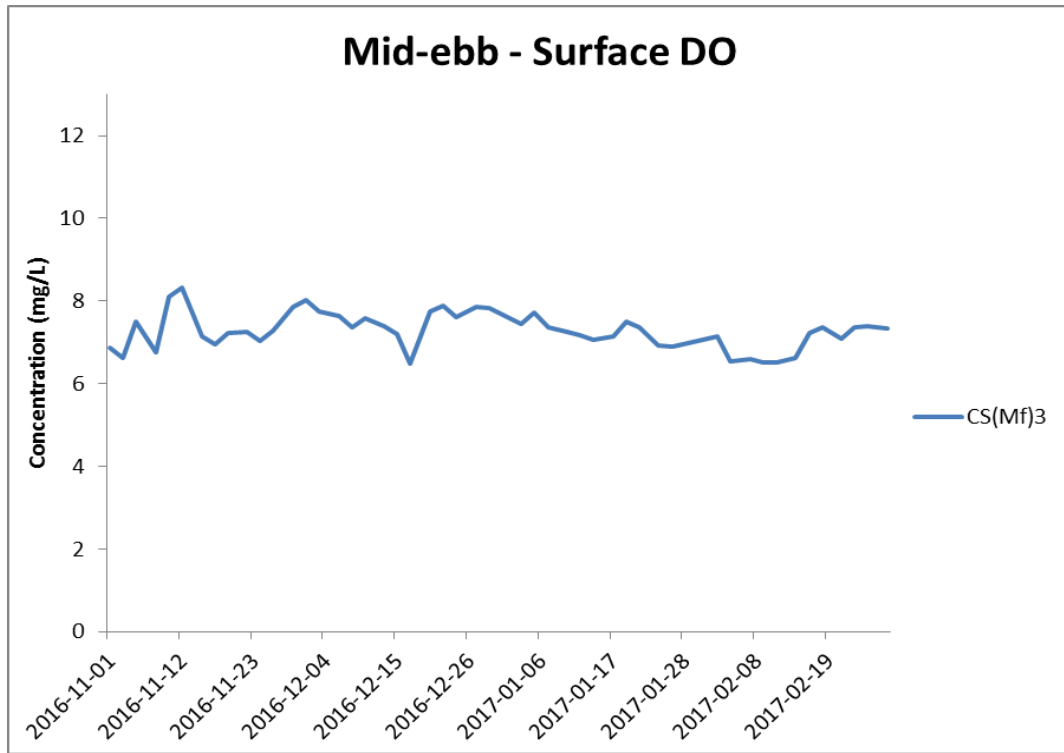
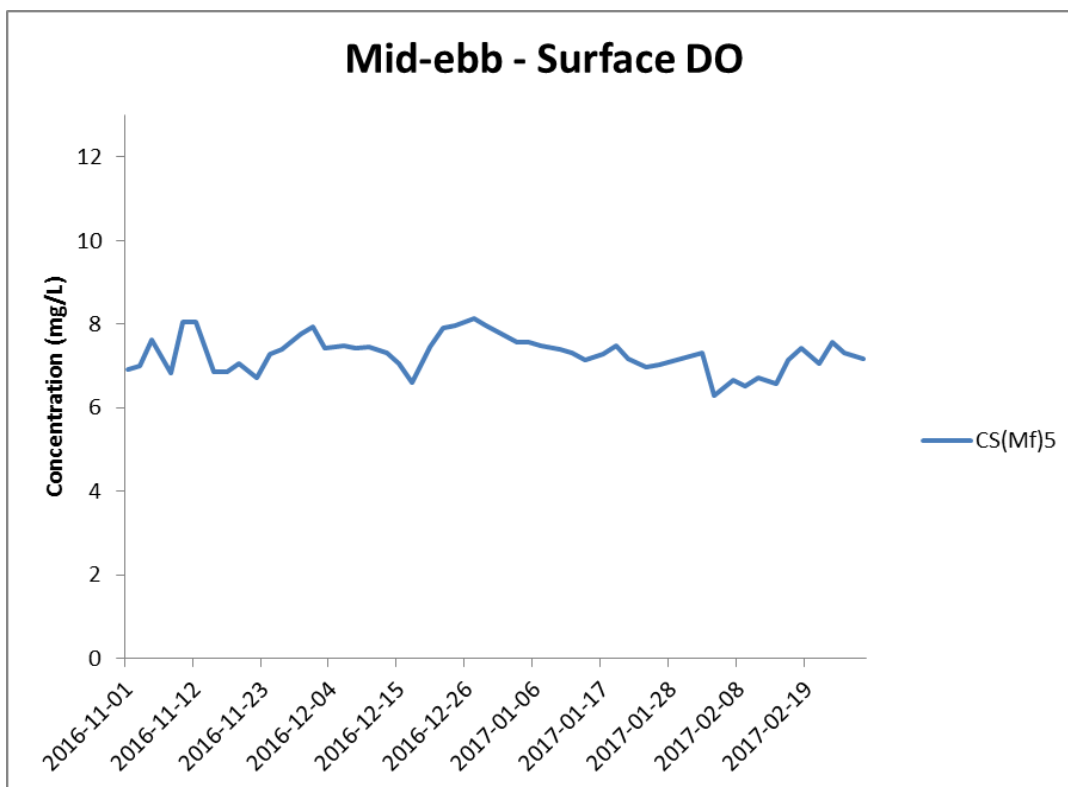
**Figure H1 Impact Monitoring - Mean Level of Dissolved Oxygen (mg/L) in surface waters during mid-ebb tide between 1 November 2016 and 28 February 2017 at CS(Mf)3 and CS(Mf)5.**

*(Weather condition varied between sunny to rainy within the reporting period.)  
 WQM on 28 and 31 January 2017 were cancelled due to suspension of marine works during holiday. Marine works within the reporting period include Uninstallation of marine piling platform; Pier construction; Launching gantry operation; and Installation of deck segment and pier head segment.*

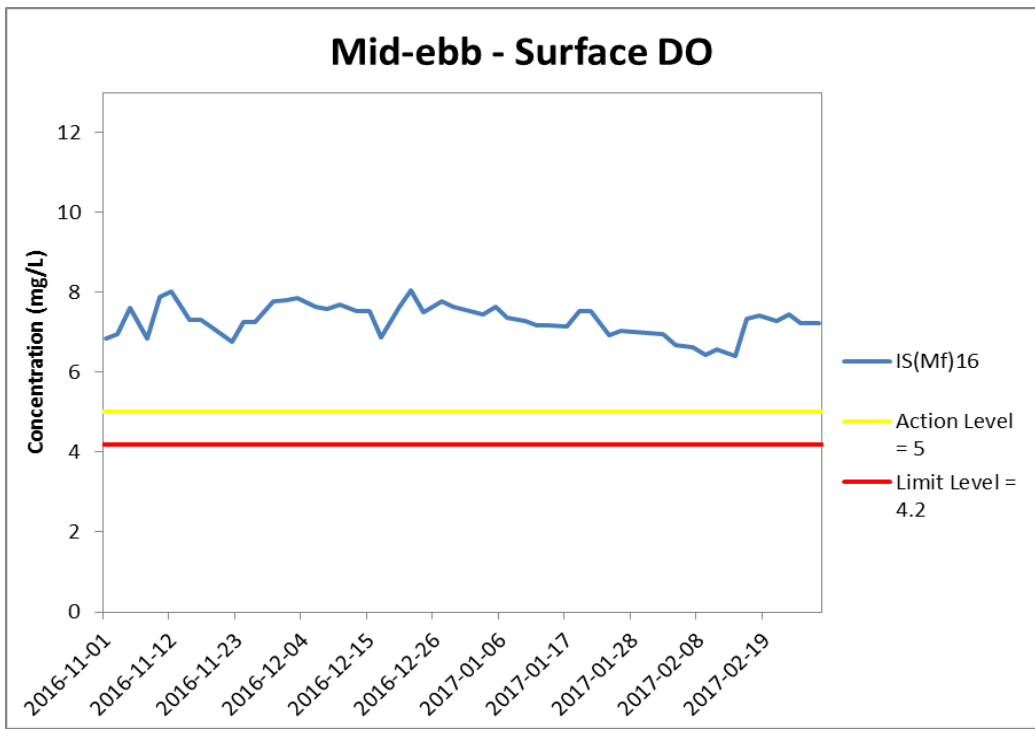
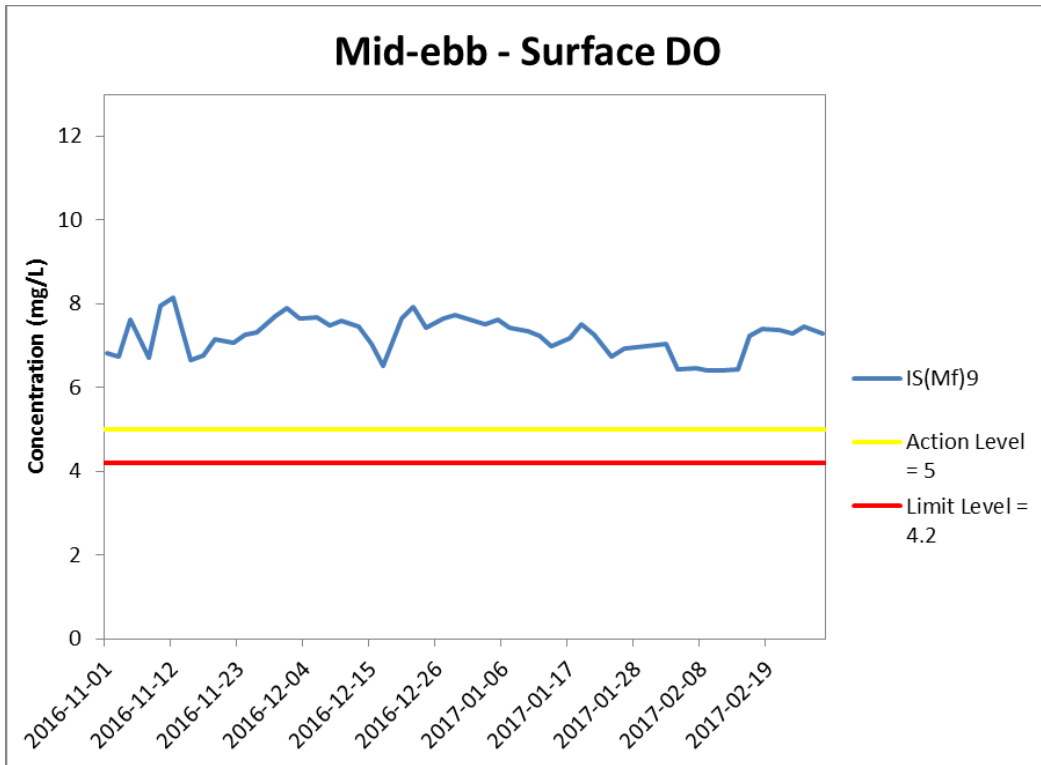
**Figure H2 Impact Monitoring - Mean Level of Dissolved Oxygen (mg/L) in surface waters during mid-ebb tide between 1 November 2016 and 28 February 2017 at IS(Mf)16 and IS(Mf)9.**

*(Weather condition varied between sunny to rainy within the reporting period.)  
 WQM on 28 and 31 January 2017 were cancelled due to suspension of marine works during holiday. Marine works within the reporting period include Uninstallation of marine piling platform; Pier construction; Launching gantry operation; and Installation of deck segment and pier head segment.*

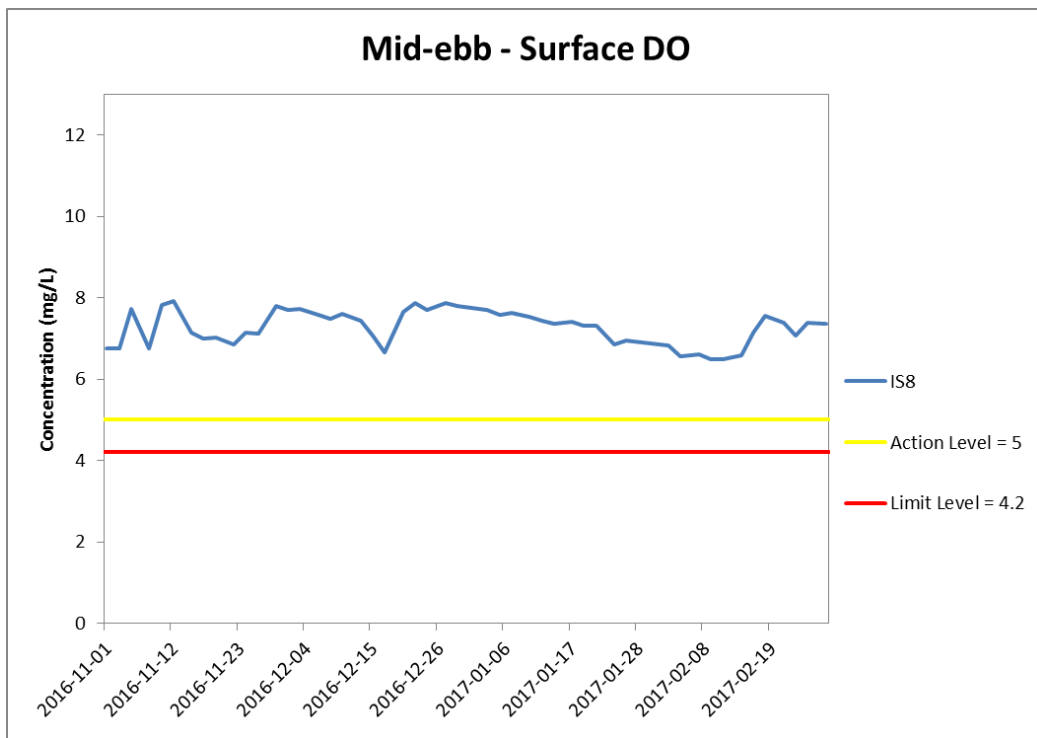
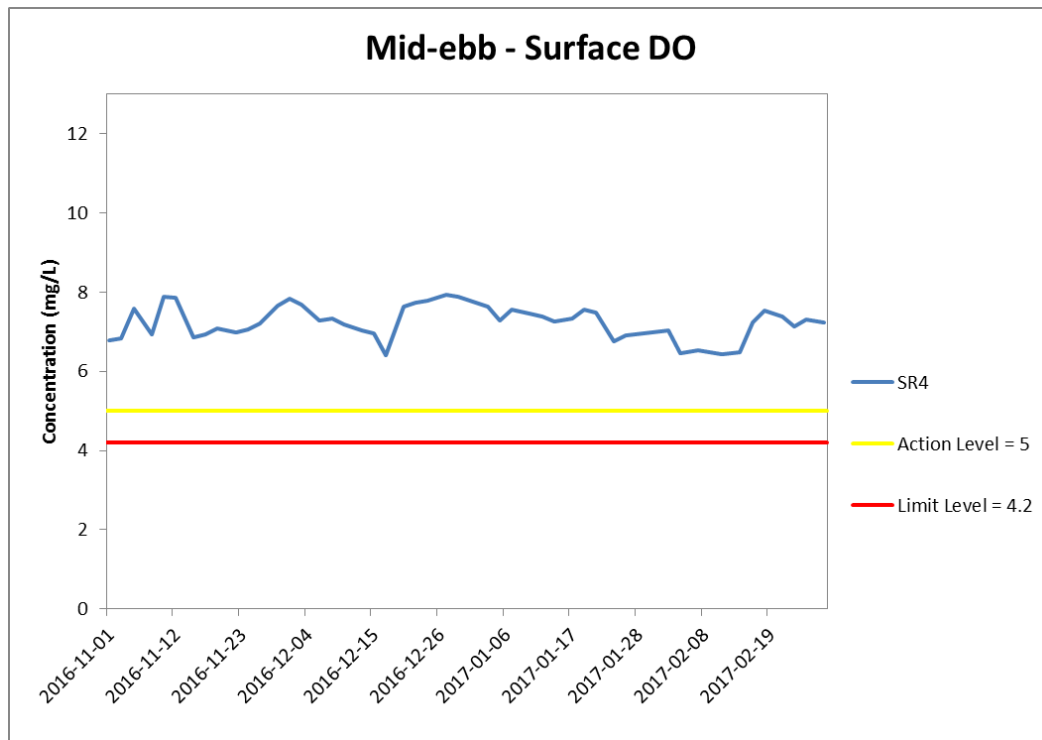
**Figure H3 Impact Monitoring - Mean Level of Dissolved Oxygen (mg/L) in surface waters during mid-ebb tide between 1 November 2016 and 28 February 2017 at IS8 and SR4.**

*(Weather condition varied between sunny to rainy within the reporting period.) WQM on 28 and 31 January 2017 were cancelled due to suspension of marine works during holiday. Marine works within the reporting period include Uninstallation of marine piling platform; Pier construction; Launching gantry operation; and Installation of deck segment and pier head segment.*

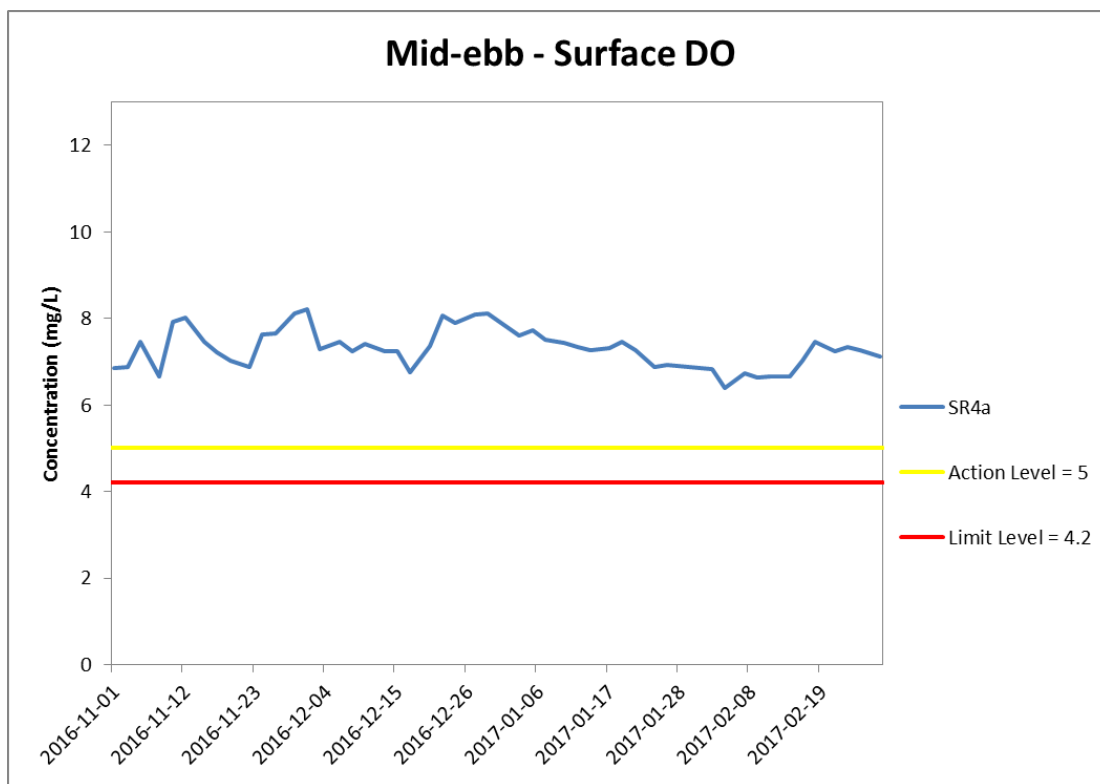
**Figure H4 Impact Monitoring - Mean Level of Dissolved Oxygen (mg/L) in surface waters during mid-ebb tide between 1 November 2016 and 28 February 2017 at SR4a.**

*(Weather condition varied between sunny to rainy within the reporting period.) WQM on 28 and 31 January 2017 were cancelled due to suspension of marine works during holiday. Marine works within the reporting period include Uninstallation of marine piling platform; Pier construction; Launching gantry operation; and Installation of deck segment and pier head segment.*

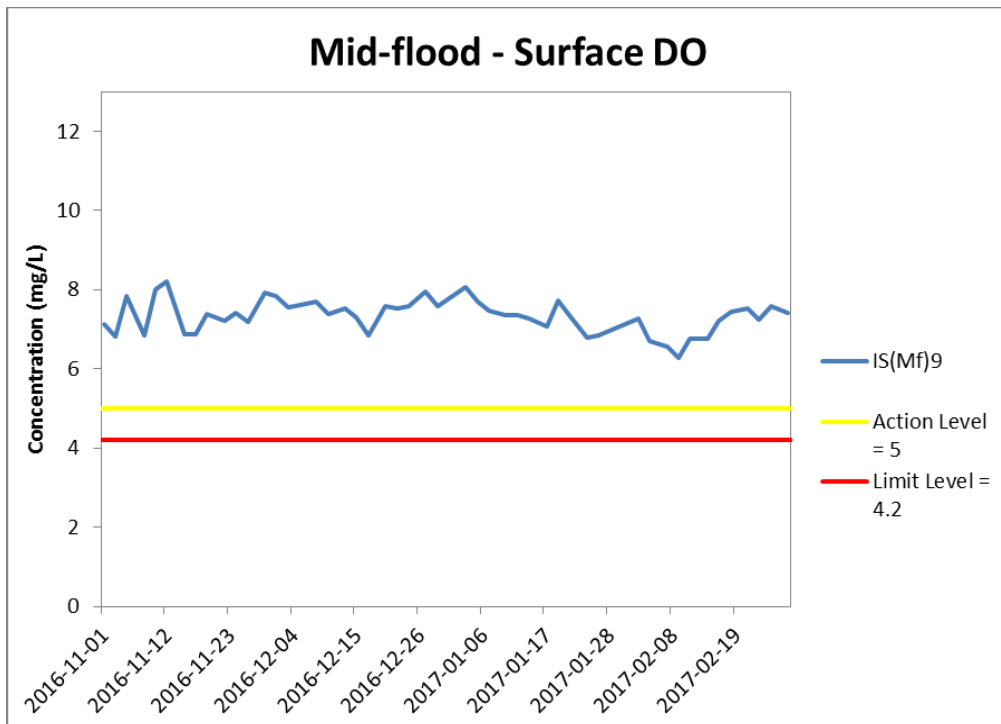
**Figure H6 Impact Monitoring – Mean Level of Dissolved Oxygen (mg/L) in surface waters during mid-flood tide between 1 November 2016 and 28 February 2017 at IS(Mf)16 and IS(Mf)9.**

*(Weather condition varied between sunny to rainy within the reporting period.) WQM on 28 and 31 January 2017 were cancelled due to suspension of marine works during holiday. Marine works within the reporting period include Uninstallation of marine piling platform; Pier construction; Launching gantry operation; and Installation of deck segment and pier head segment.*

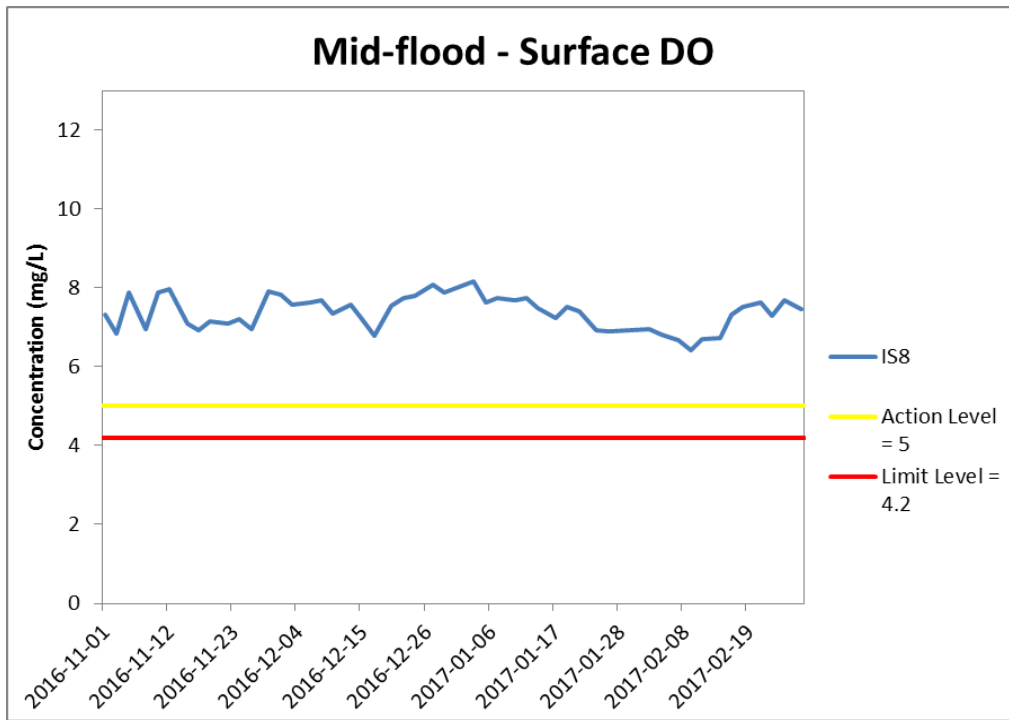
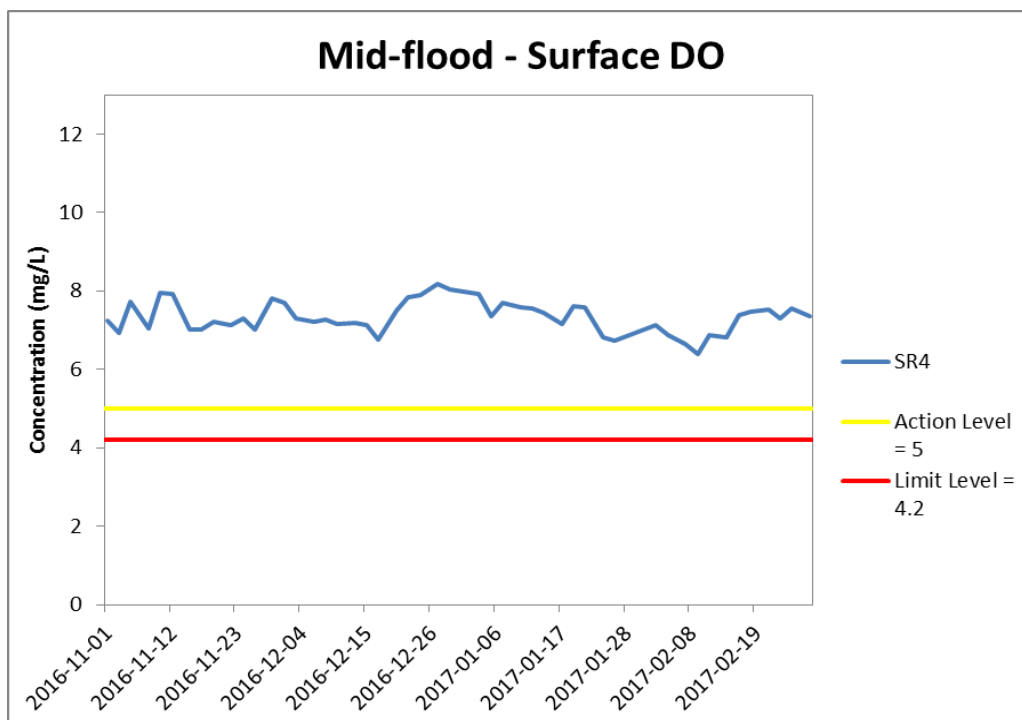
**Figure H7 Impact Monitoring – Mean Level of Dissolved Oxygen (mg/L) in surface waters during mid-flood tide between 1 November 2016 and 28 February 2017 at IS8 and SR4.**

*(Weather condition varied between sunny to rainy within the reporting period.)  
WQM on 28 and 31 January 2017 were cancelled due to suspension of marine works during holiday. Marine works within the reporting period include Uninstallation of marine piling platform; Pier construction; Launching gantry operation; and Installation of deck segment and pier head segment.*

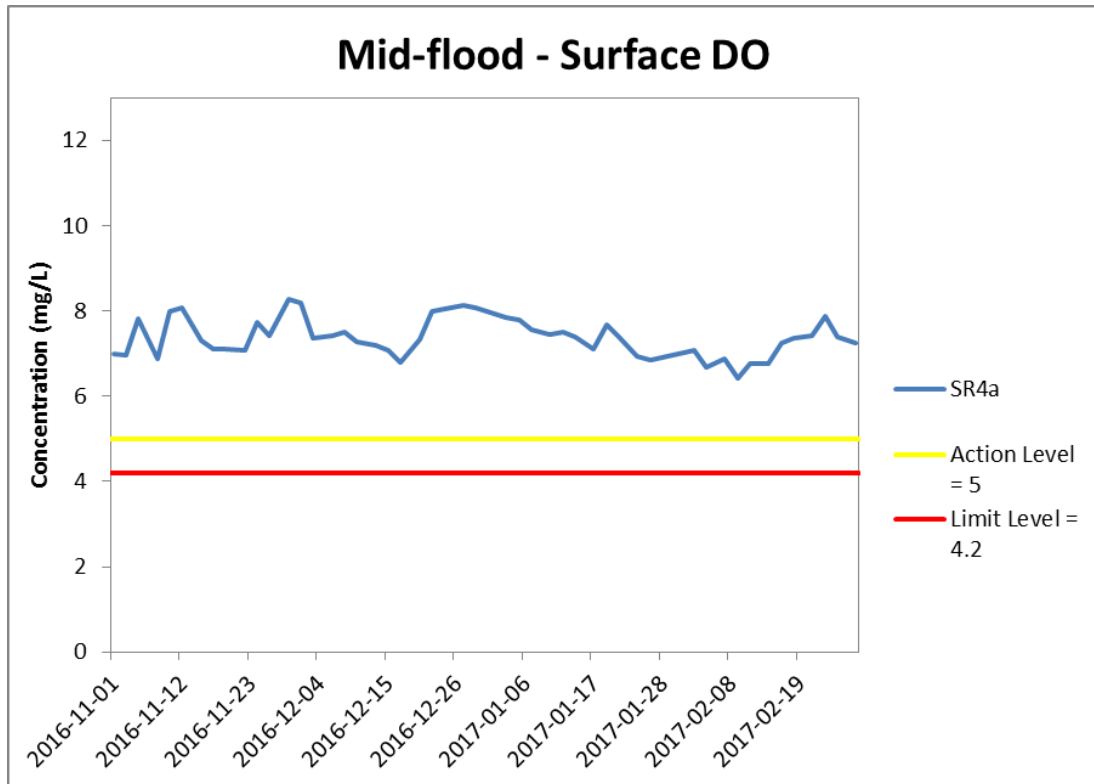
**Figure H8 Impact Monitoring – Mean Level of Dissolved Oxygen (mg/L) in surface waters during mid-flood tide between 1 November 2016 and 28 February 2017 at SR4a.**

*(Weather condition varied between sunny to rainy within the reporting period.)  
 WQM on 28 and 31 January 2017 were cancelled due to suspension of marine works during holiday. Marine works within the reporting period include Uninstallation of marine piling platform; Pier construction; Launching gantry operation; and Installation of deck segment and pier head segment.*

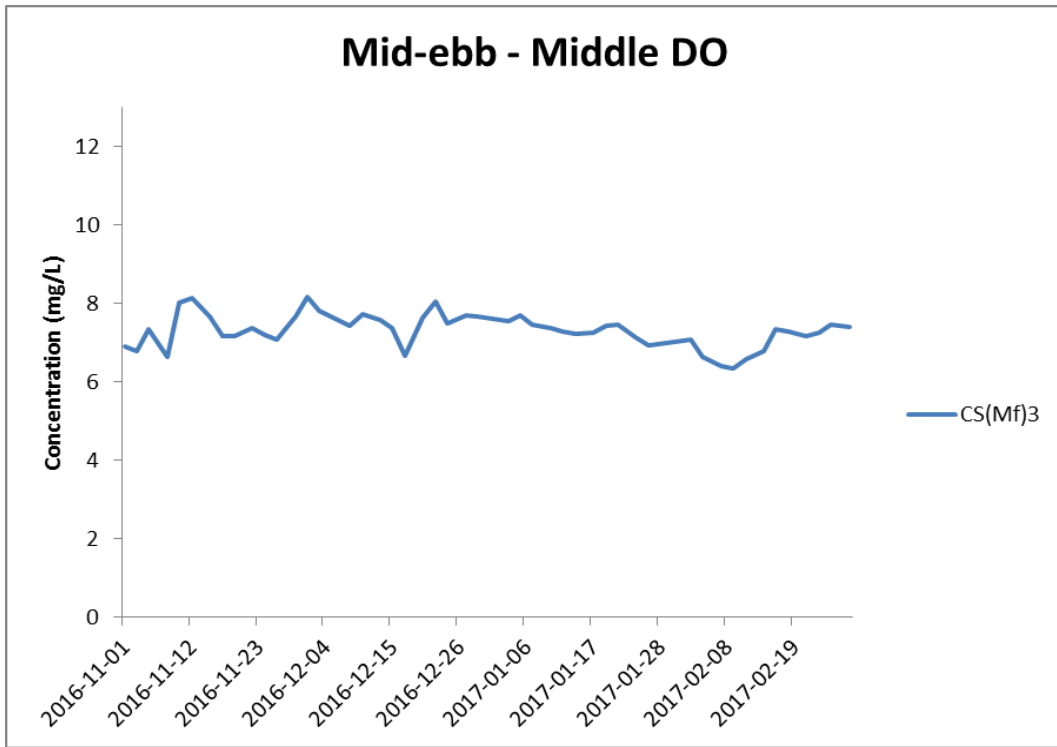
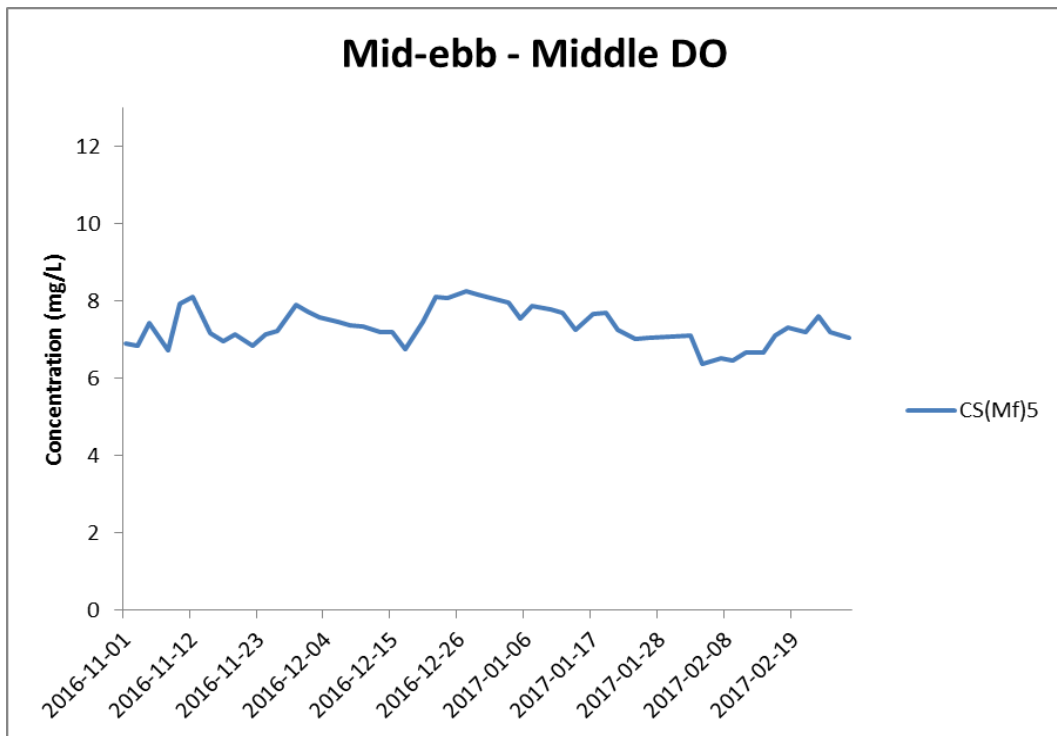
**Figure H9 Impact Monitoring - Mean Level of Dissolved Oxygen (mg/L) in mid-depth waters during mid-ebb tide between 1 November 2016 and 28 February 2017 at CS(Mf)3 and CS(Mf)5.**

*(Weather condition varied between sunny to rainy within the reporting period.)  
 WQM on 28 and 31 January 2017 were cancelled due to suspension of marine works during holiday. Marine works within the reporting period include Uninstallation of marine piling platform; Pier construction; Launching gantry operation; and Installation of deck segment and pier head segment.*

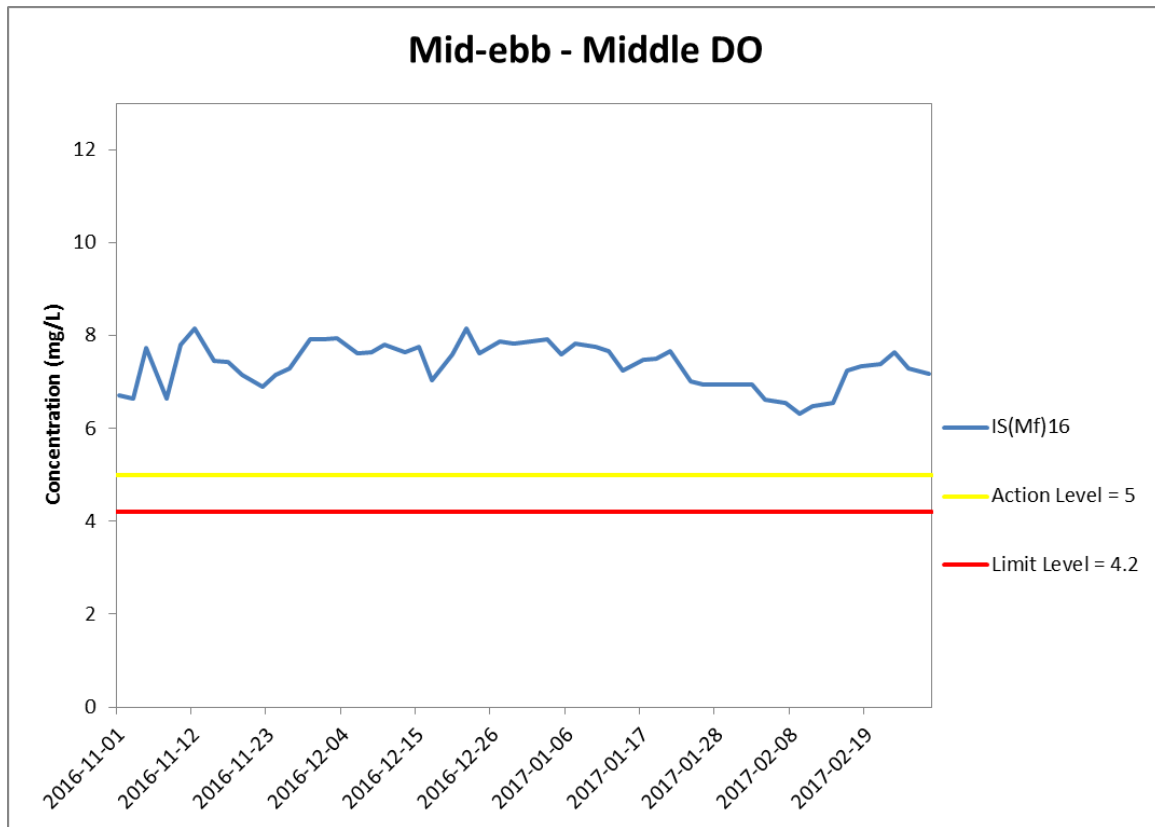
**Figure H10 Impact Monitoring – Mean Level of Dissolved Oxygen (mg/L) in mid-depth waters during mid-ebb tide between 1 November 2016 and 28 February 2017 at IS(Mf)16.**

*(Weather condition varied between sunny to rainy within the reporting period.)  
 WQM on 28 and 31 January 2017 were cancelled due to suspension of marine works during holiday. Marine works within the reporting period include Uninstallation of marine piling platform; Pier construction; Launching gantry operation; and Installation of deck segment and pier head segment.*

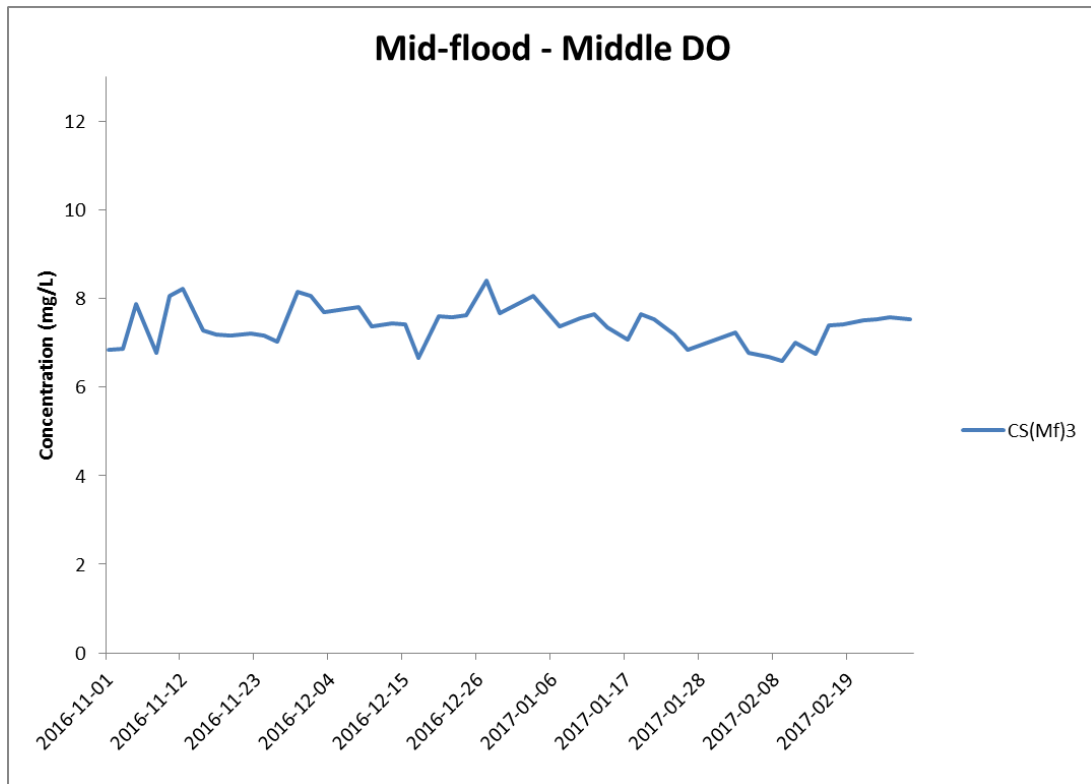
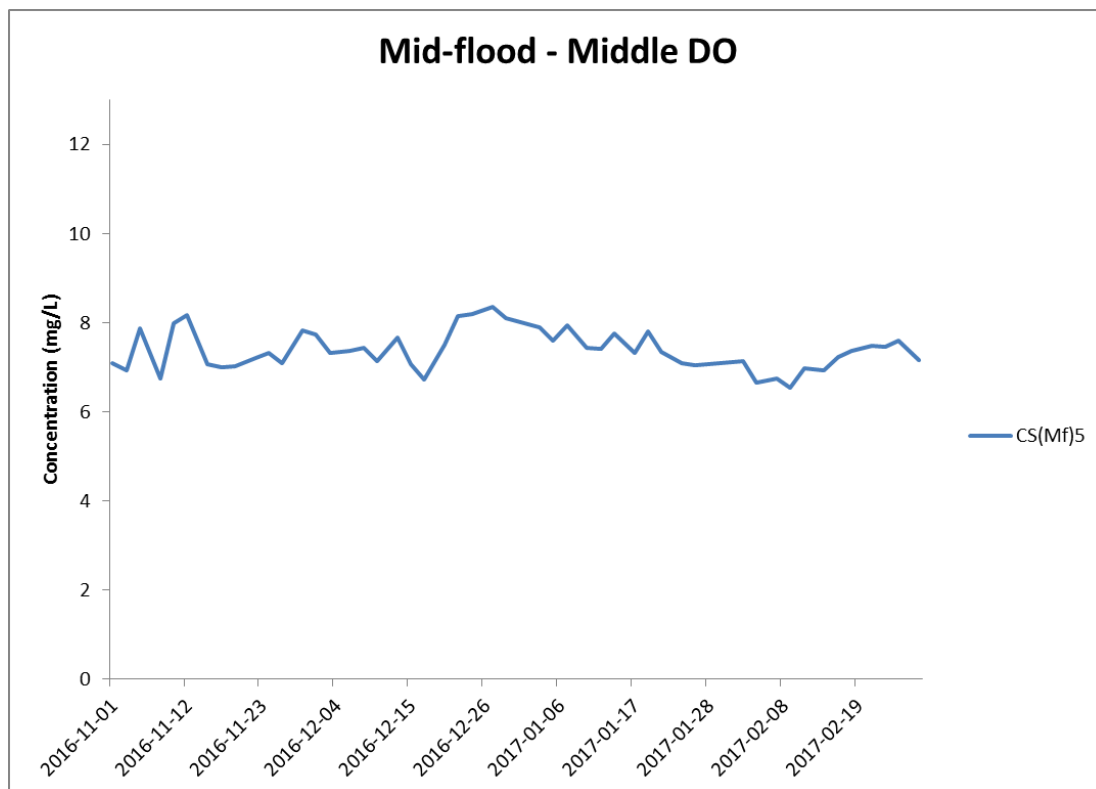
**Figure H11 Impact Monitoring - Mean Level of Dissolved Oxygen (mg/L) in mid-depth waters during mid-flood tide between 1 November 2016 and 28 February 2017 at CS(Mf)3 and CS(Mf)5.**

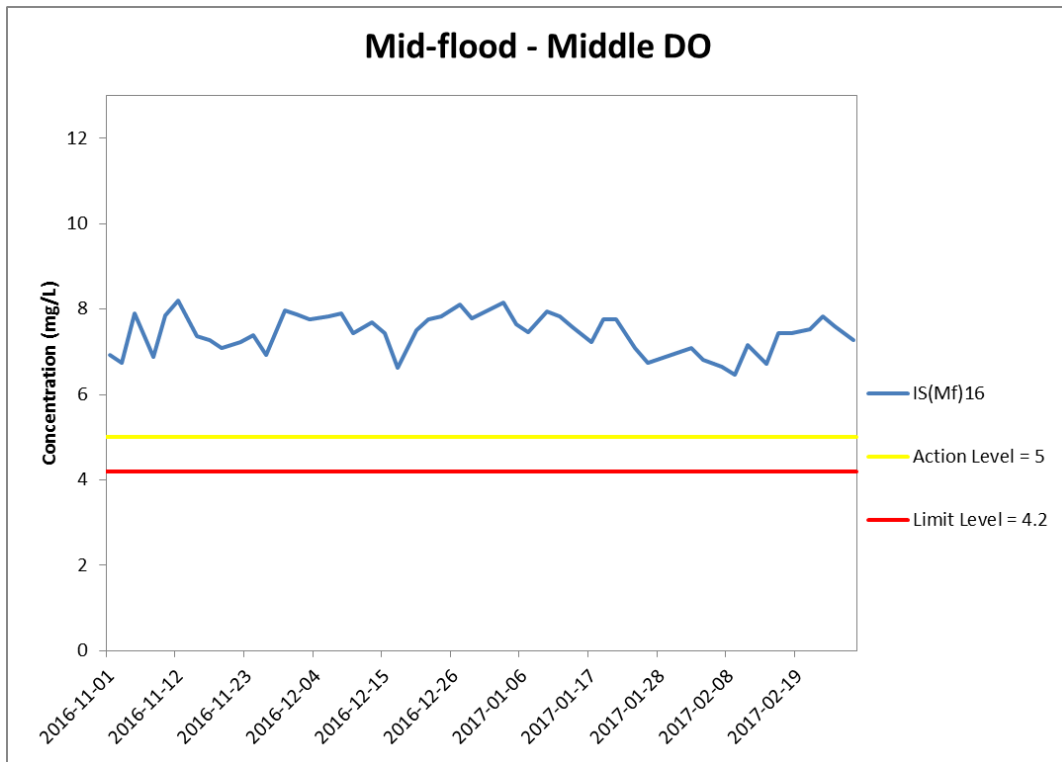
**Figure H12 Impact Monitoring – Mean Level of Dissolved Oxygen (mg/L) in mid-depth waters during mid-flood tide between 1 November 2016 and 28 February 2017 at IS(Mf)16.**

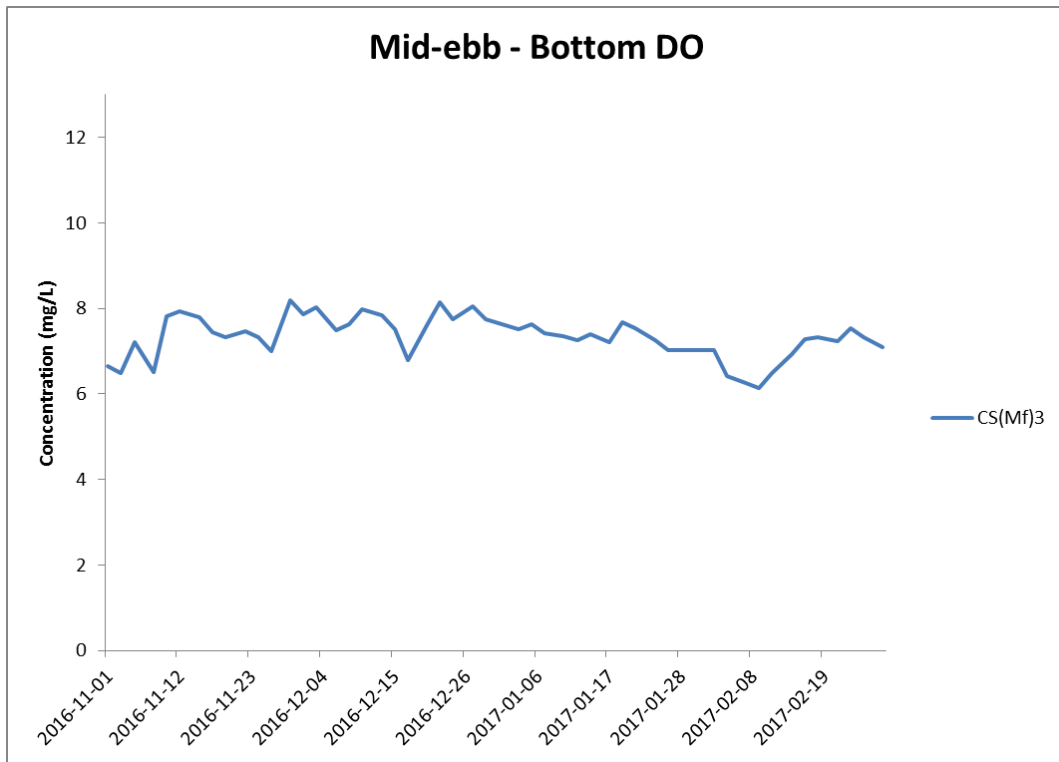
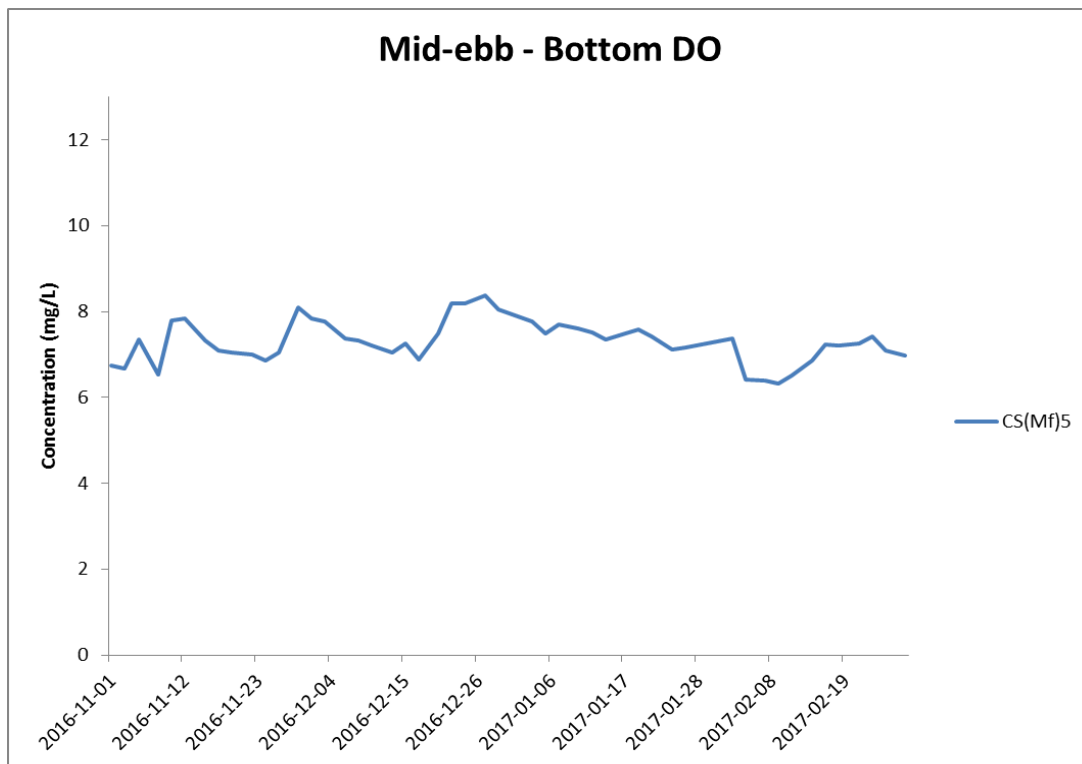
**Figure H13 Impact Monitoring – Mean Level of Dissolved Oxygen (mg/L) in bottom waters during mid-ebb tide between 1 November 2016 and 28 February 2017 at CS(Mf)3 and CS(Mf)5.**
