**Contract No. HY/2012/07  
Tuen Mun – Chek Lap Kok Link –  
Southern Connection Viaduct Section**

***Thirteenth Quarterly Environmental Monitoring  
& Audit (EM&A) Report***

26 October 2017

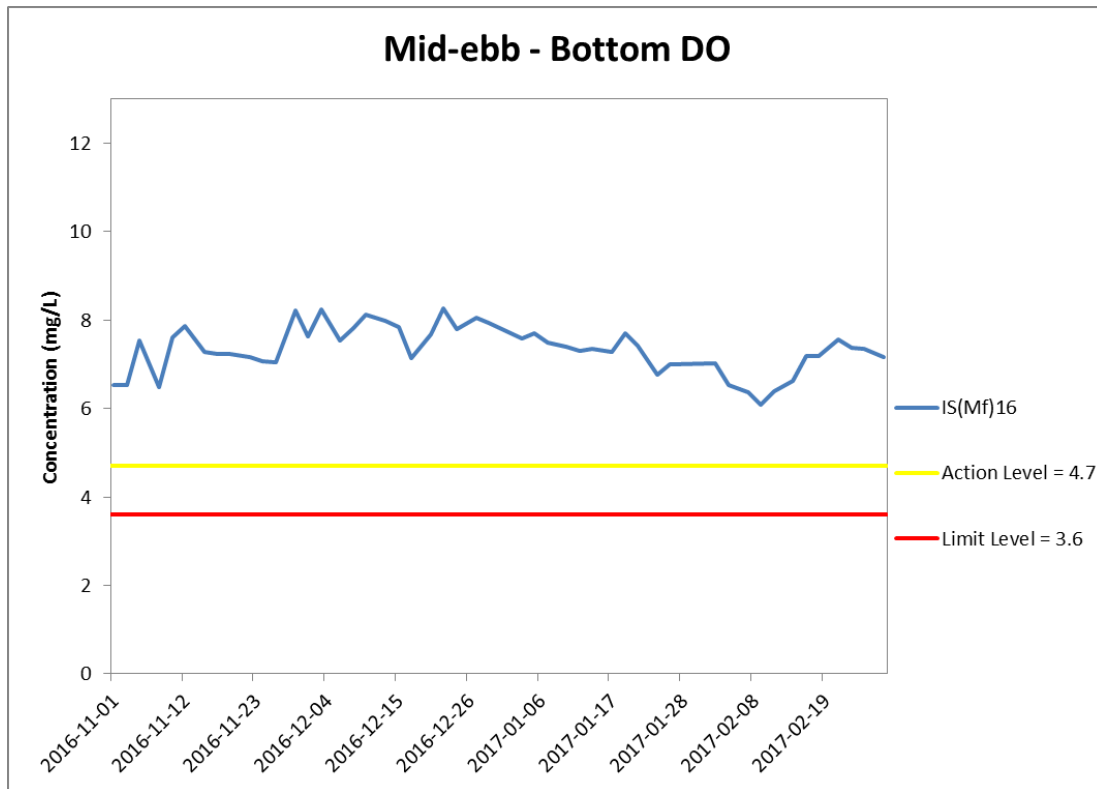
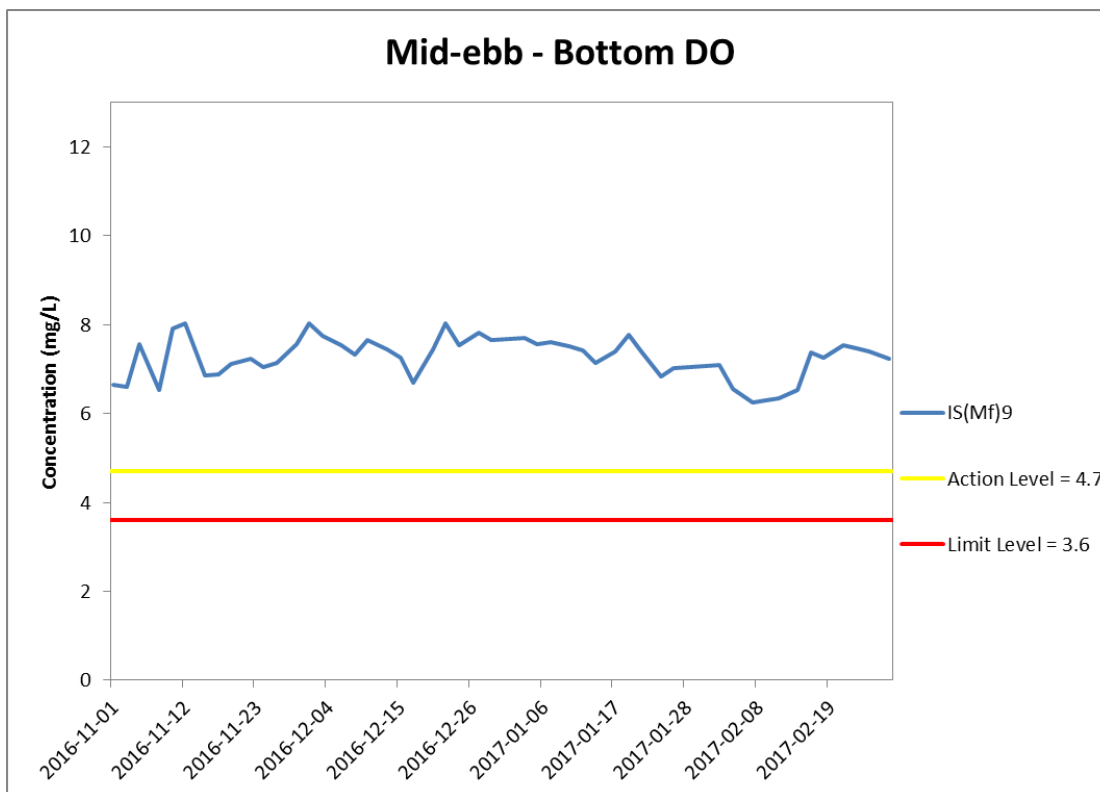
**Figure H14 Impact Monitoring - Mean Level of Dissolved Oxygen (mg/L) in bottom waters during mid-ebb tide between 1 November 2016 and 28 February 2017 at IS(Mf)16 and IS(Mf)9.**

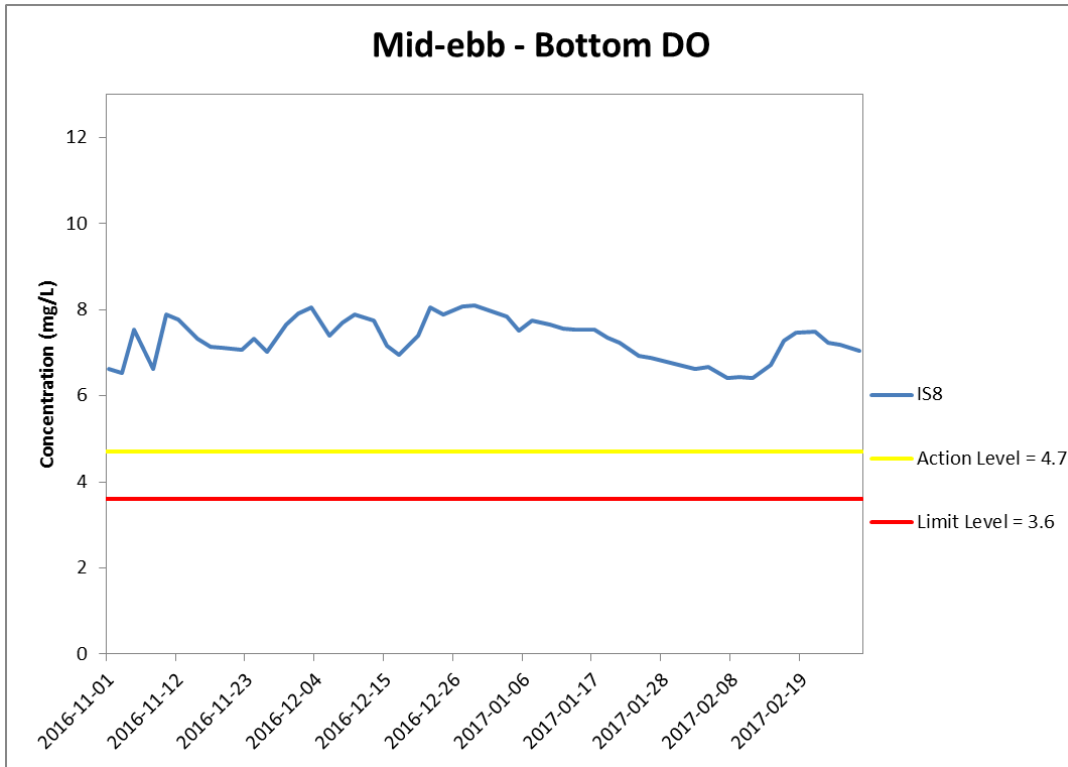
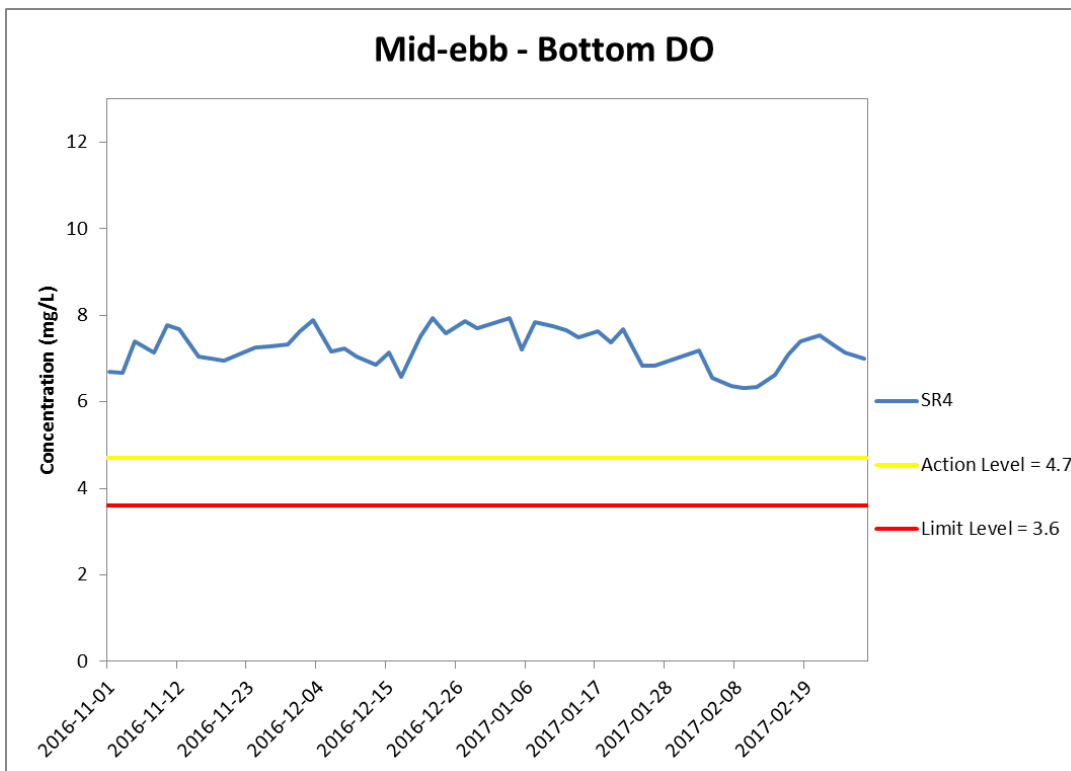
**Figure H15 Impact Monitoring – Mean Level of Dissolved Oxygen (mg/L) in bottom waters during mid-ebb tide between 1 November 2016 and 28 February 2017 at IS8 and SR4.**

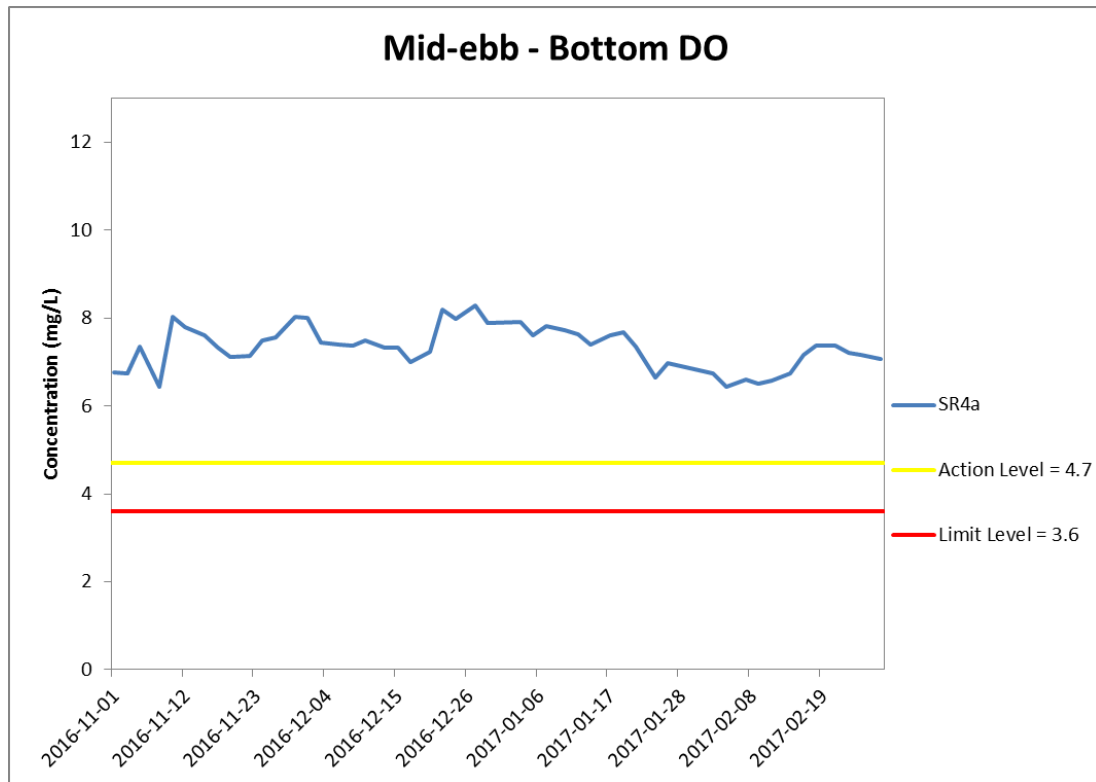
**Figure H16 Impact Monitoring – Mean Level of Dissolved Oxygen (mg/L) in bottom waters during mid-ebb tide between 1 November 2016 and 28 February 2017 at SR4a.**

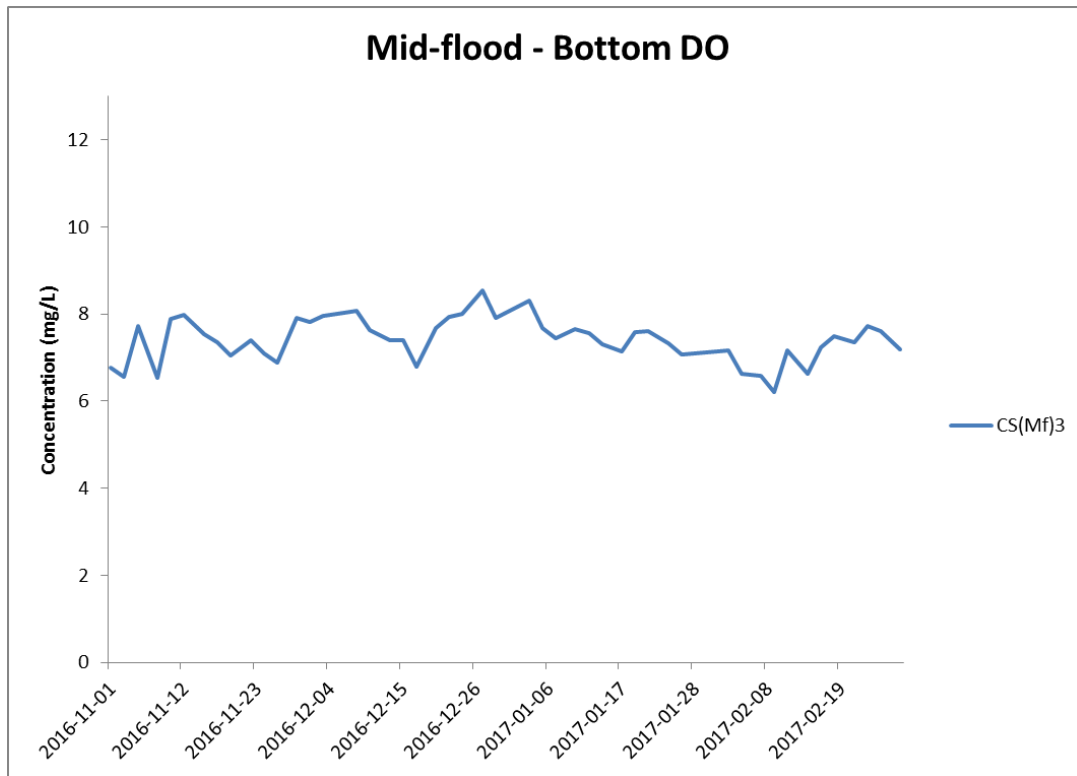
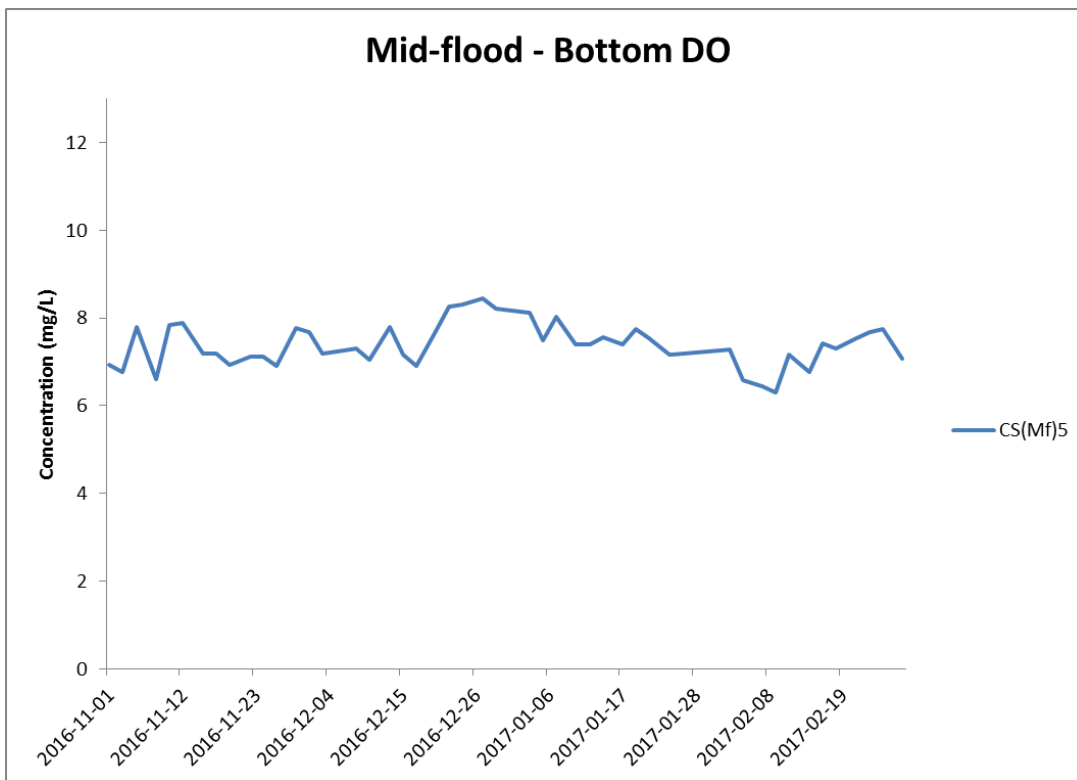
**Figure H17 Impact Monitoring – Mean Level of Dissolved Oxygen (mg/L) in bottom waters during mid-flood tide between 1 November 2016 and 28 February 2017 at CS(Mf)3 and CS(Mf)5.**

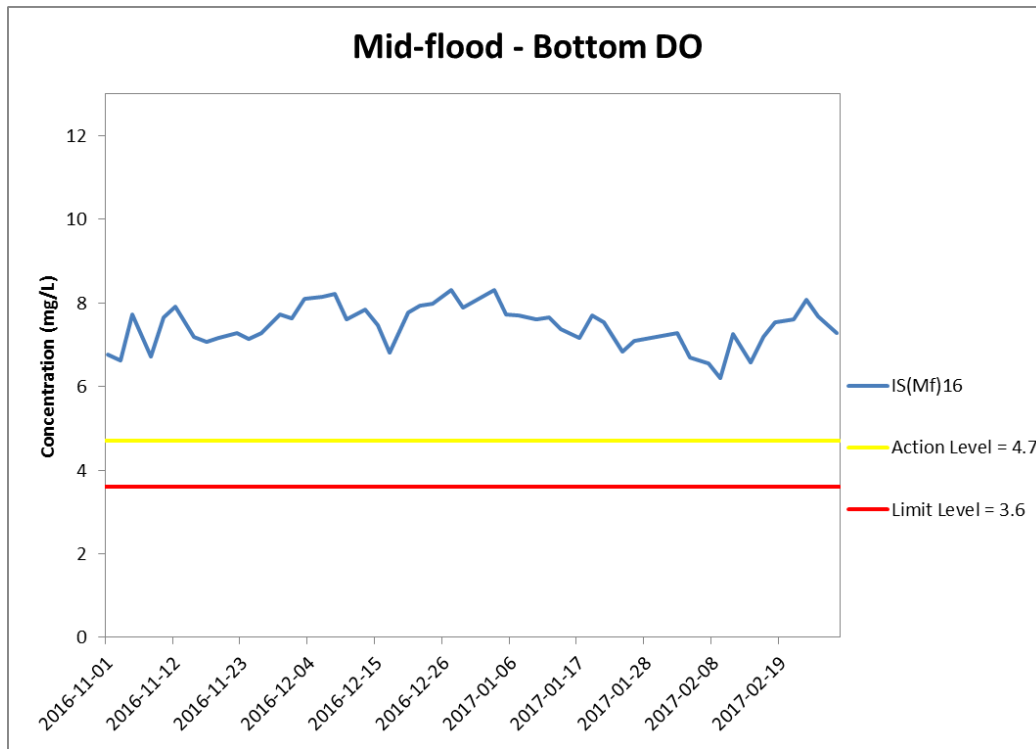
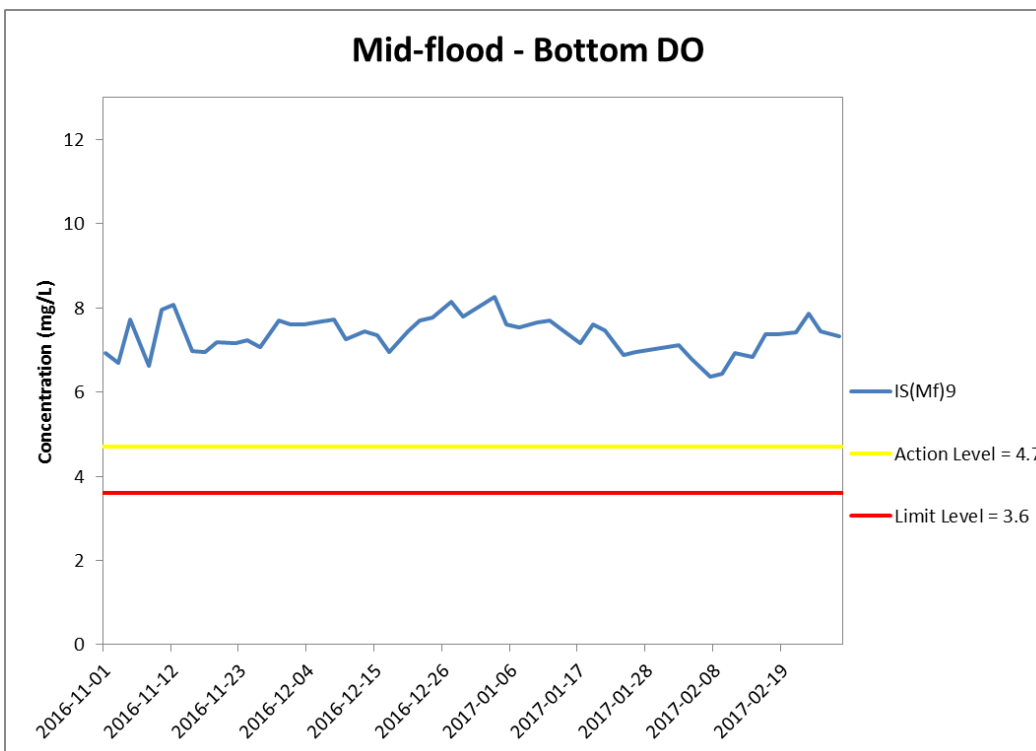
**Figure H18 Impact Monitoring - Mean Level of Dissolved Oxygen (mg/L) in bottom waters during mid-flood tide between 1 November 2016 and 28 February 2017 at IS(Mf)16 and IS(Mf)9.**

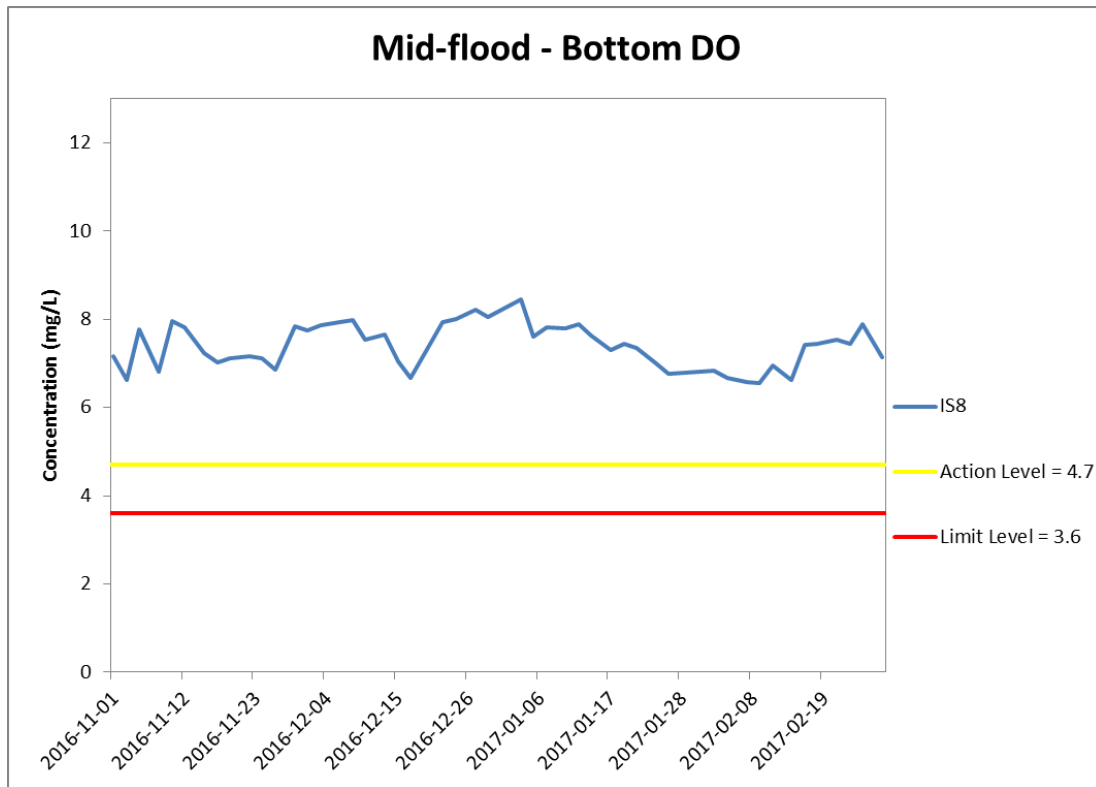
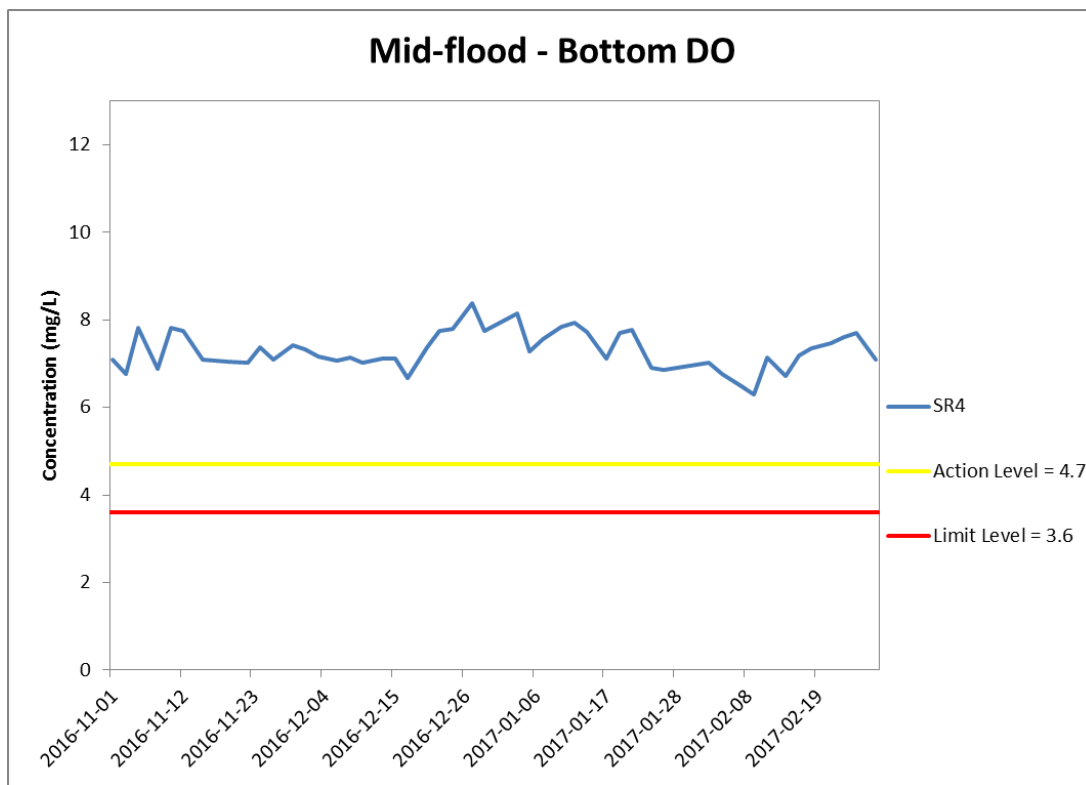
**Figure H19 Impact Monitoring - Mean Level of Dissolved Oxygen (mg/L) in bottom waters during mid-flood tide between 1 November 2016 and 28 February 2017 at IS8 and SR4.**

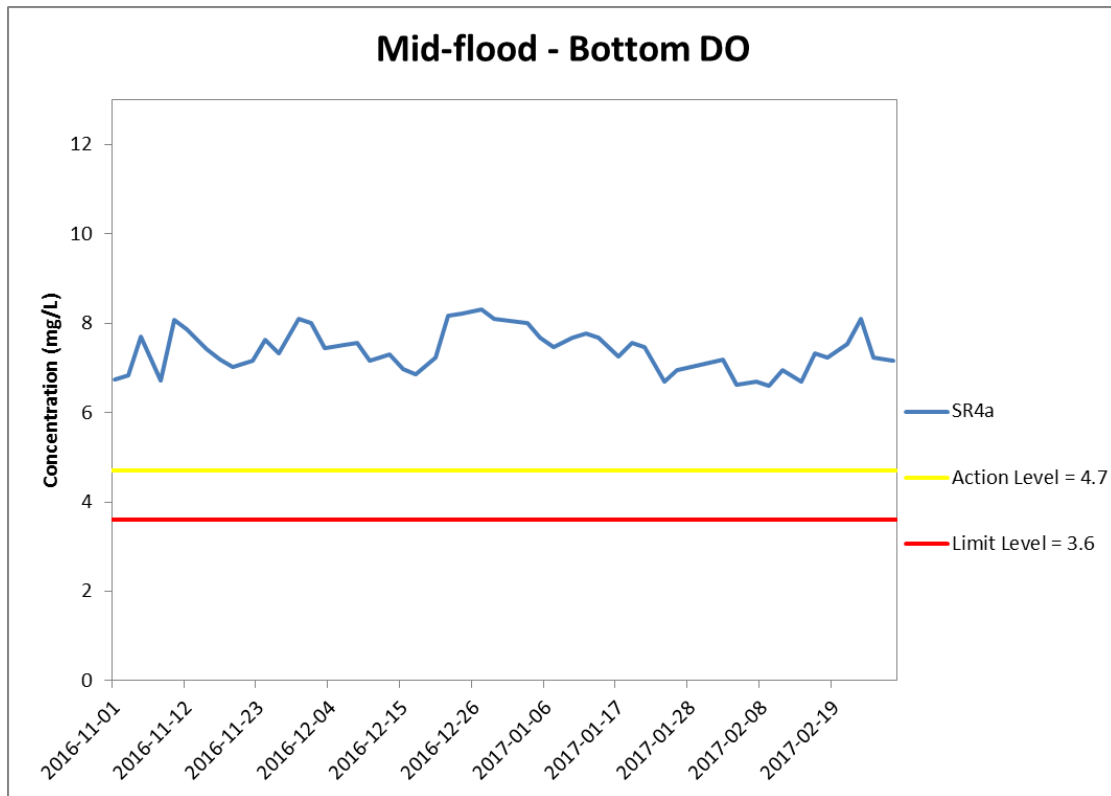
**Figure H20 Impact Monitoring – Mean Level of Dissolved Oxygen (mg/L) in bottom waters during mid-flood tide between 1 November 2016 and 28 February 2017 at SR4a.**

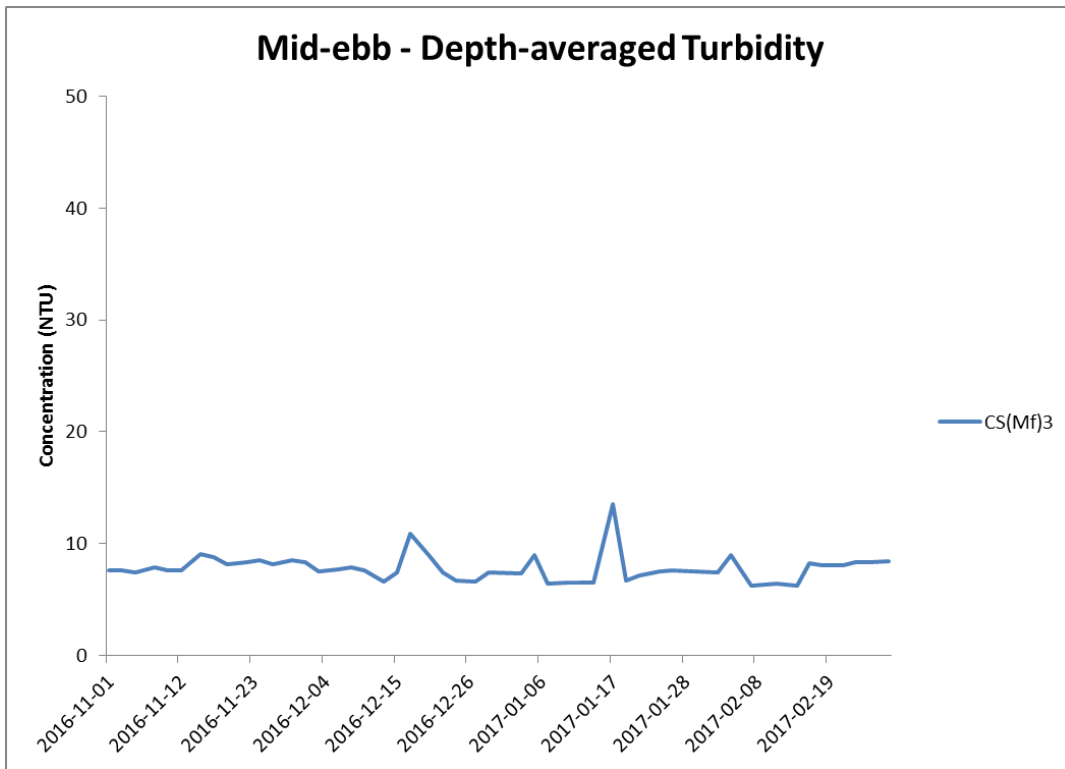
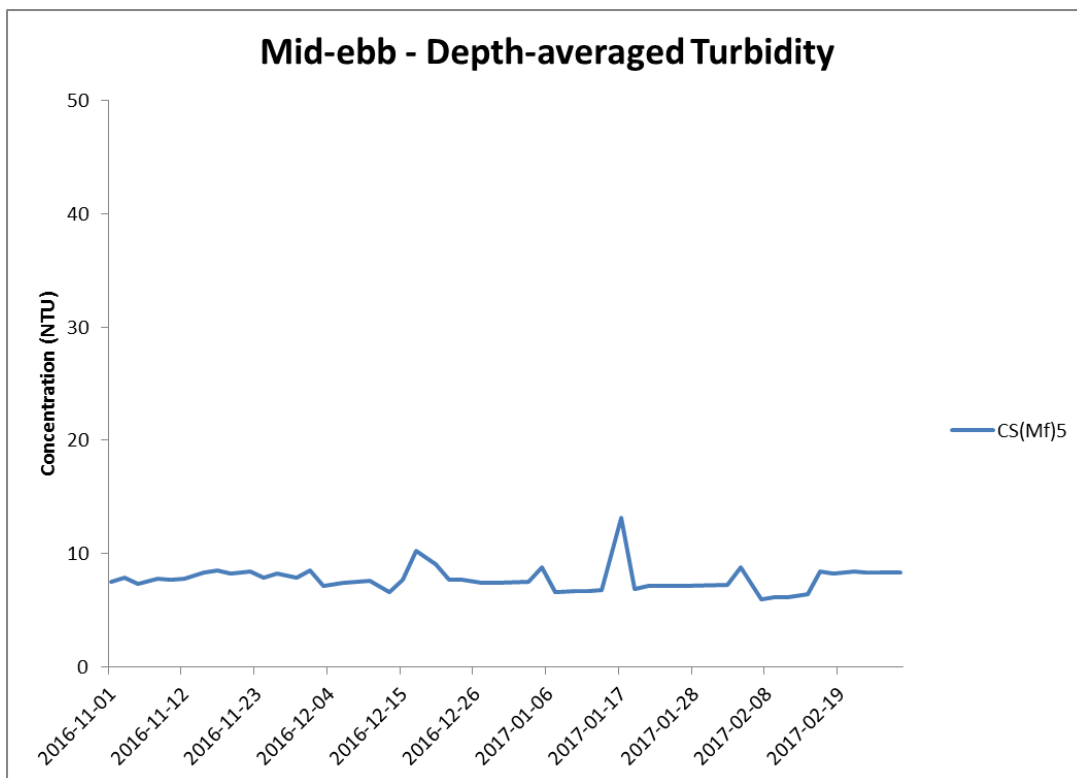
**Figure H21 Impact Monitoring - Mean Level of depth-averaged Turbidity (NTU) during mid-ebb tide between 1 November 2016 and 28 February 2017 at CS(Mf)3 and CS(Mf)5.**

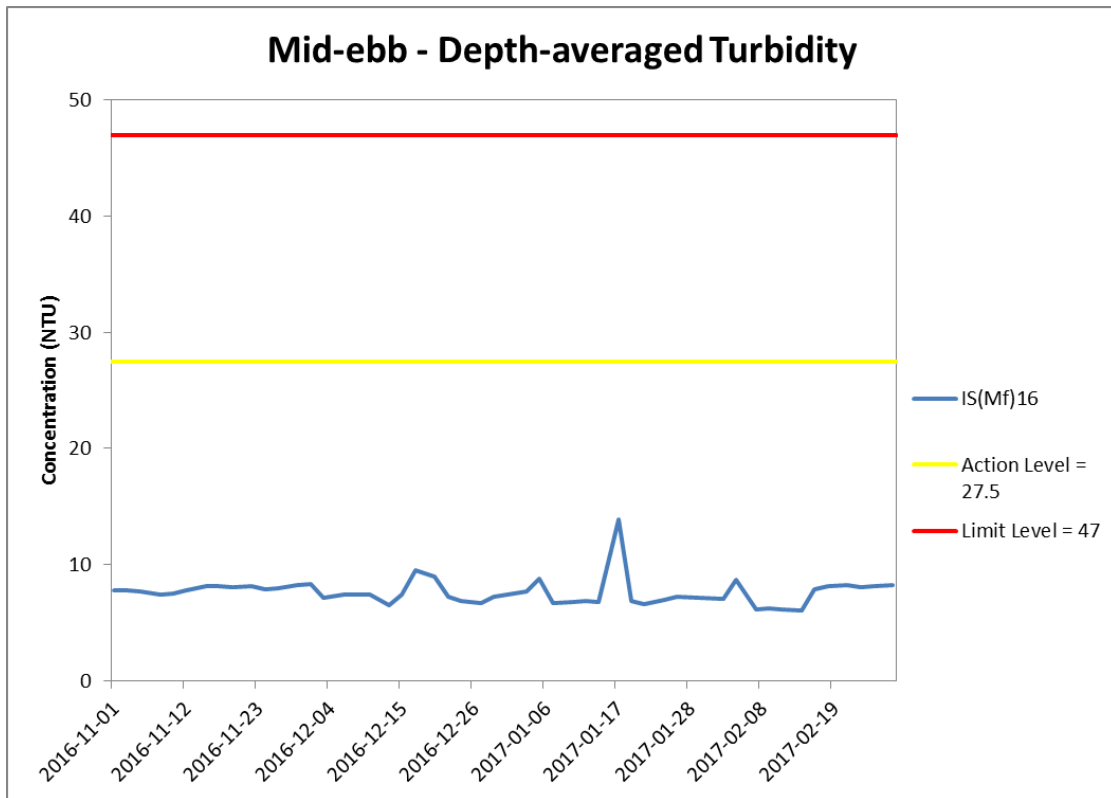
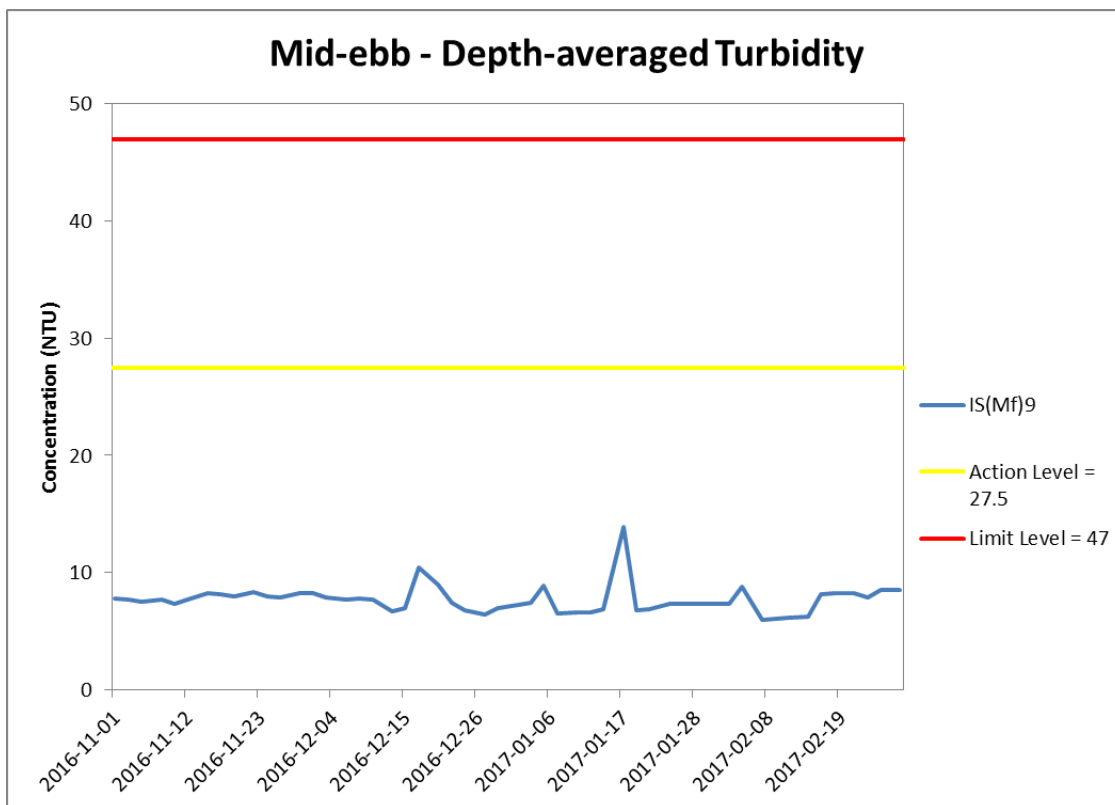
**Figure H22 Impact Monitoring – Mean Level of depth-averaged Turbidity (NTU) during mid-ebb tide between 1 November 2016 and 28 February 2017 at IS(Mf)16 and IS(Mf)9.**

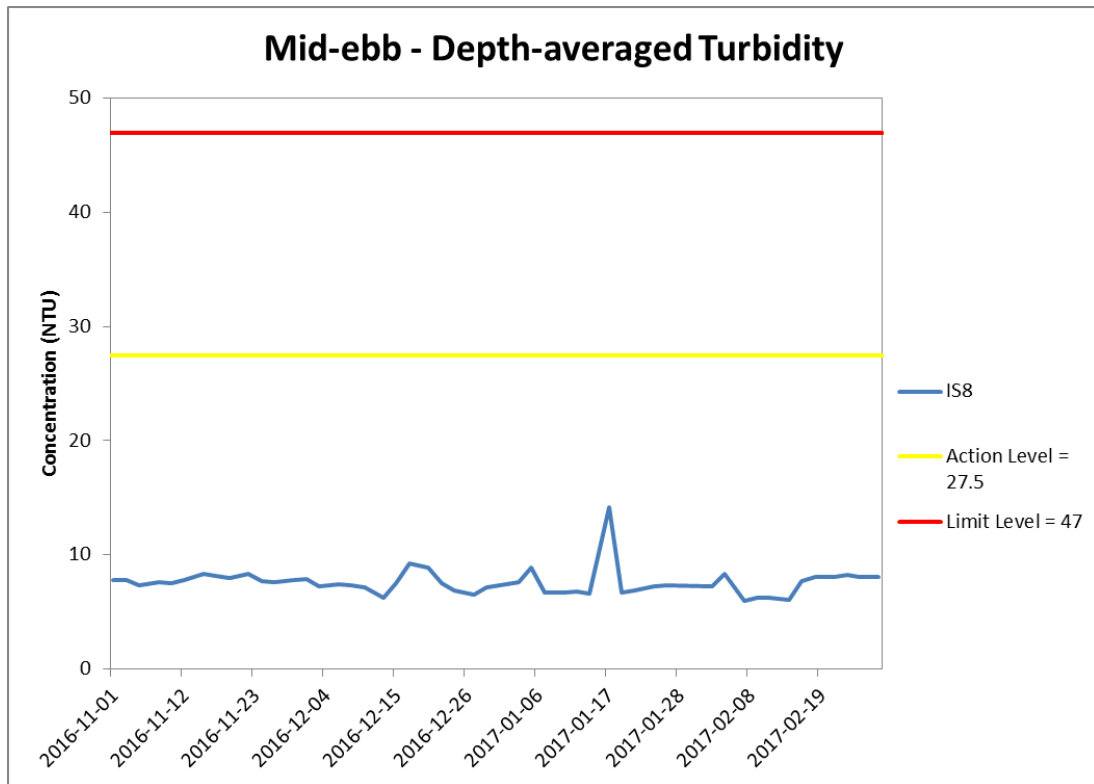
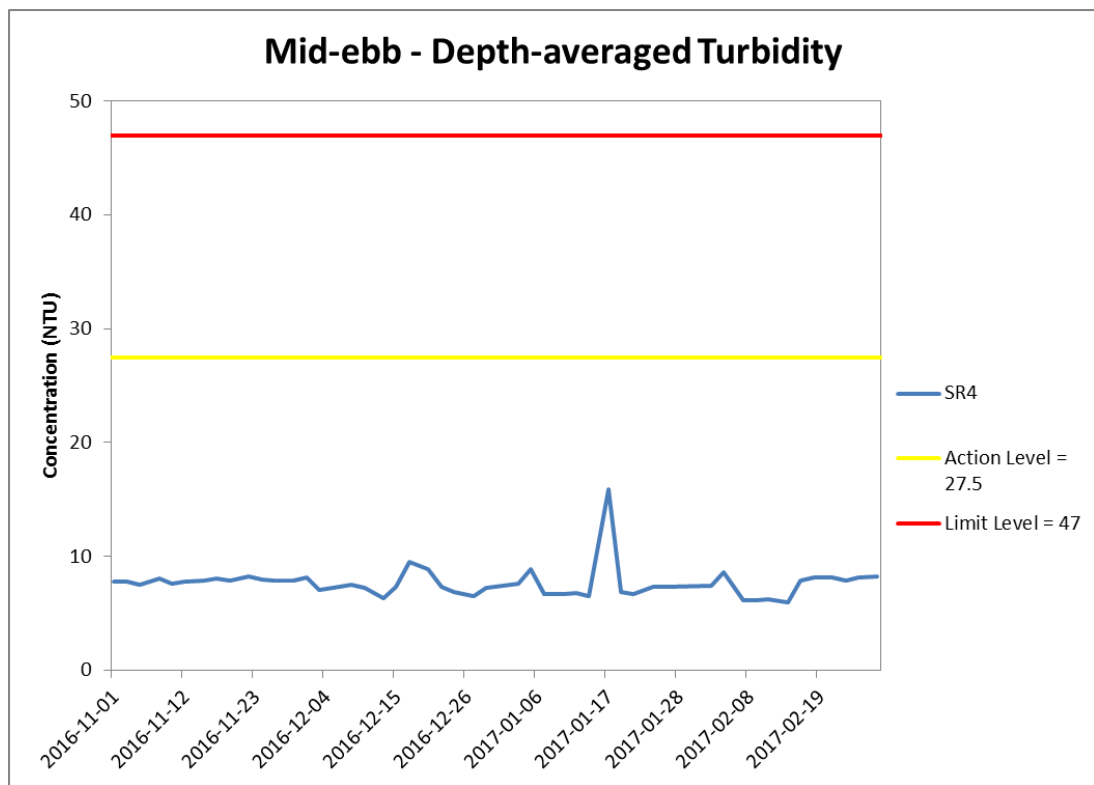
**Figure H23 Impact Monitoring - Mean Level of depth-averaged Turbidity (NTU) during mid-ebb tide between 1 November 2016 and 28 February 2017 at IS8 and SR4.**

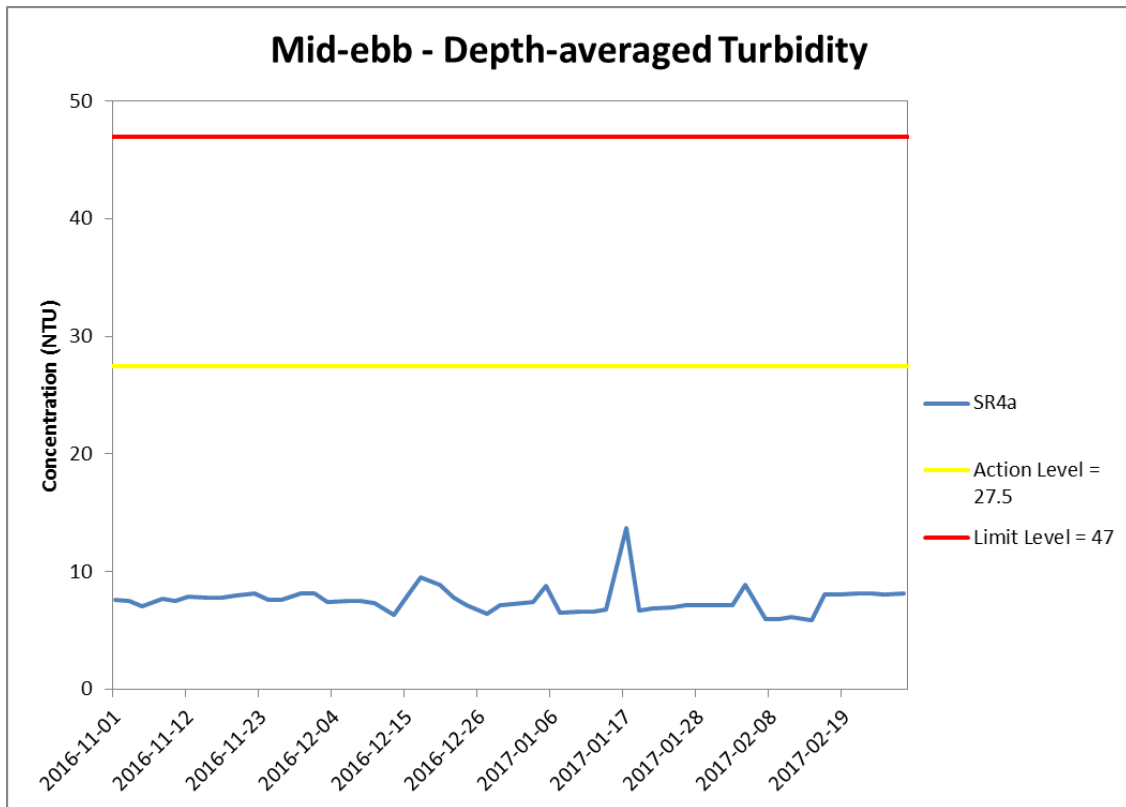
**Figure H24 Impact Monitoring - Mean Level of depth-averaged Turbidity (NTU) during mid-ebb tide between 1 November 2016 and 28 February 2017 at SR4a.**

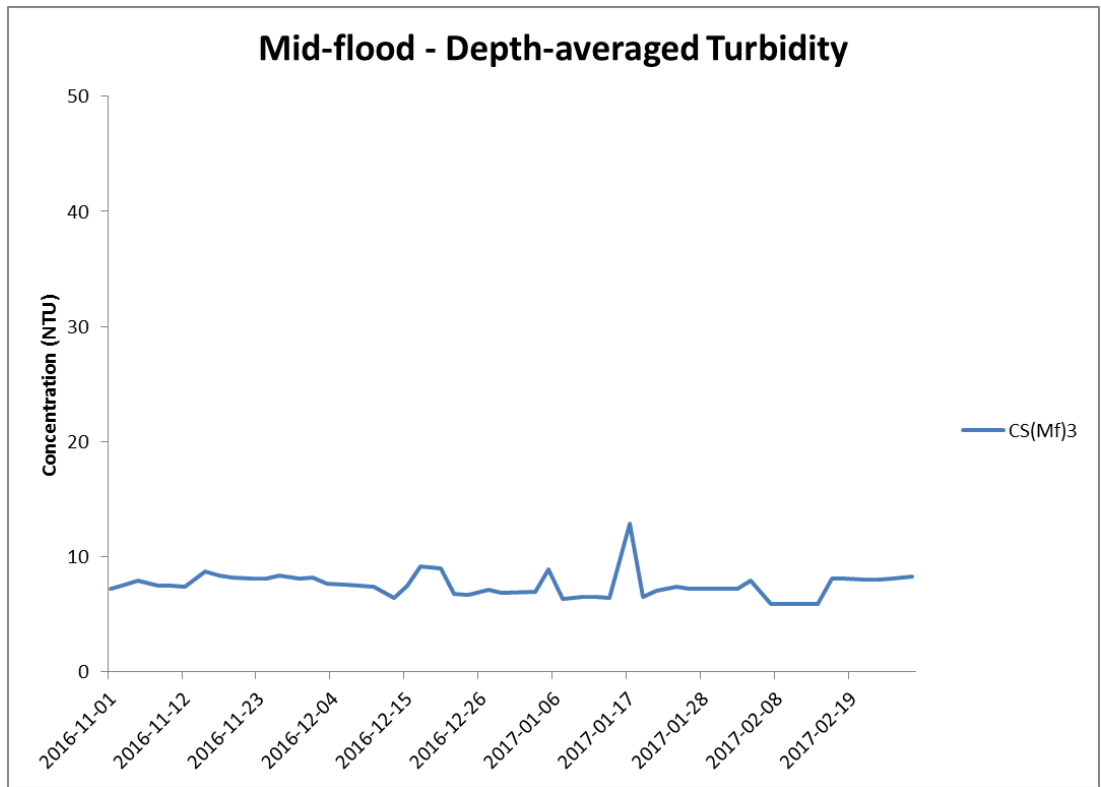
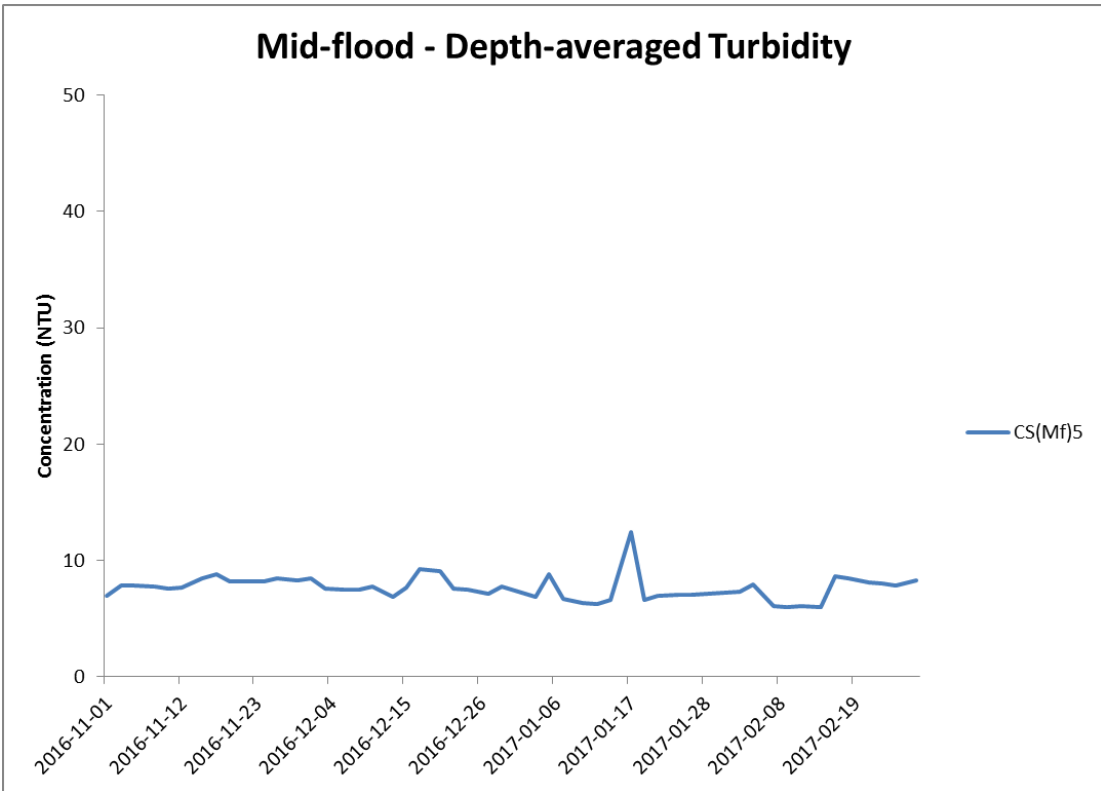
**Figure H25 Impact Monitoring - Mean Level of depth-averaged Turbidity (NTU) during mid-flood tide between 1 November 2016 and 28 February 2017 at CS(Mf)3 and CS(MF)5.**

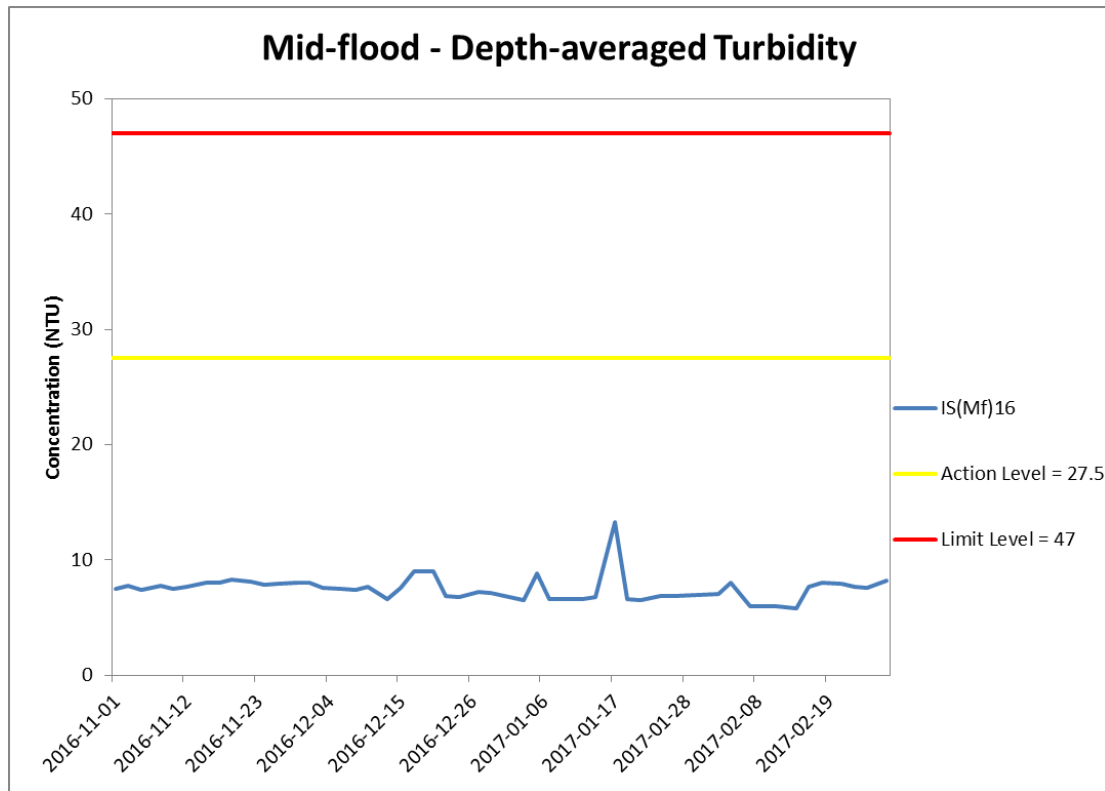
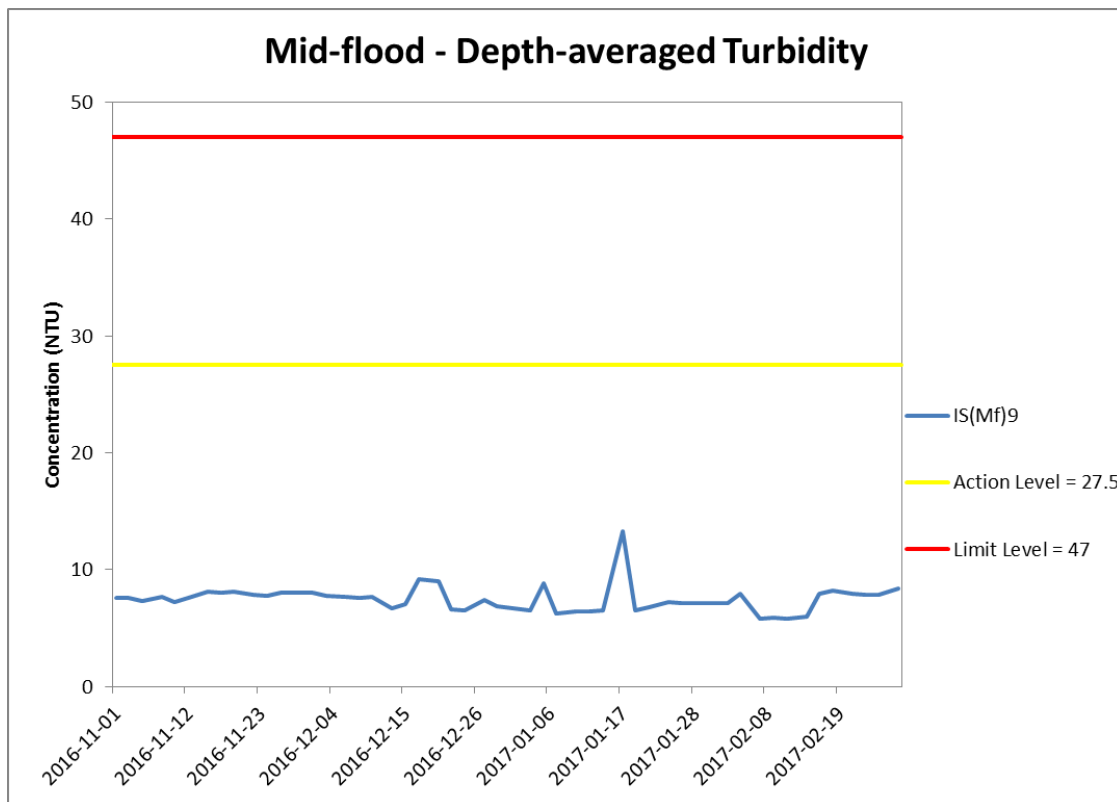
**Figure H26 Impact Monitoring – Mean Level of depth-averaged Turbidity (NTU) during mid-flood tide between 1 November 2016 and 28 February 2017 at IS(Mf)16 and IS(Mf)9.**

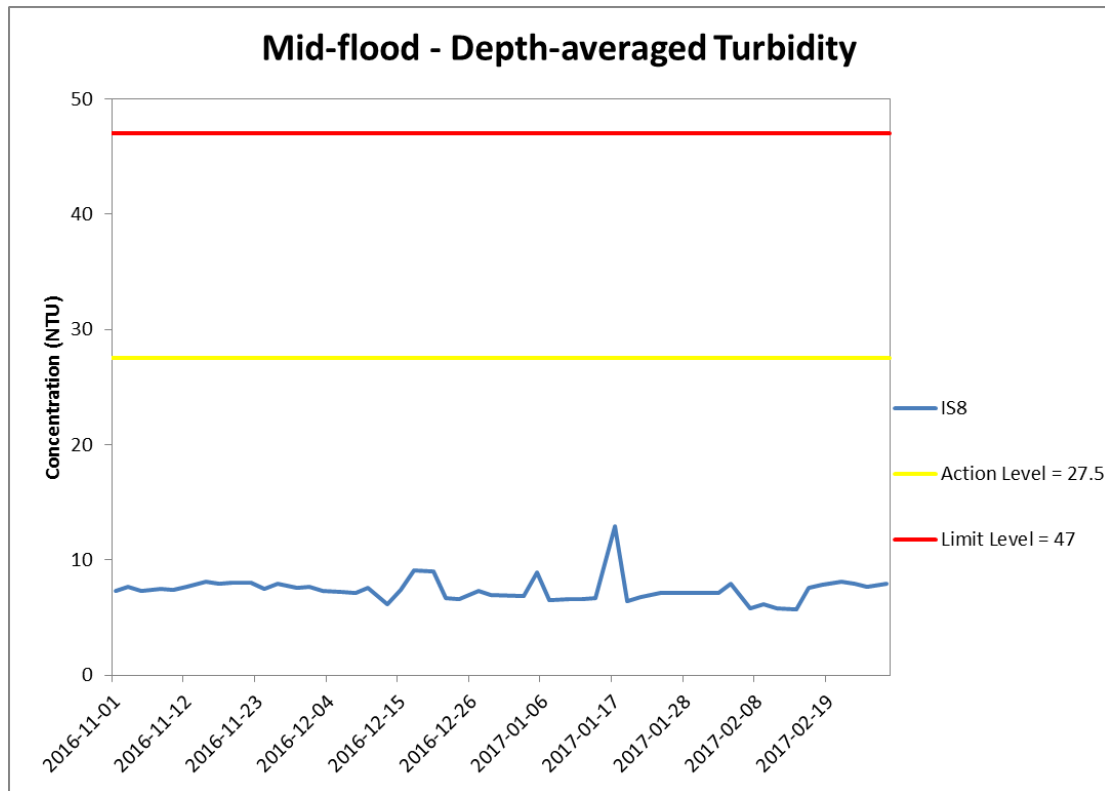
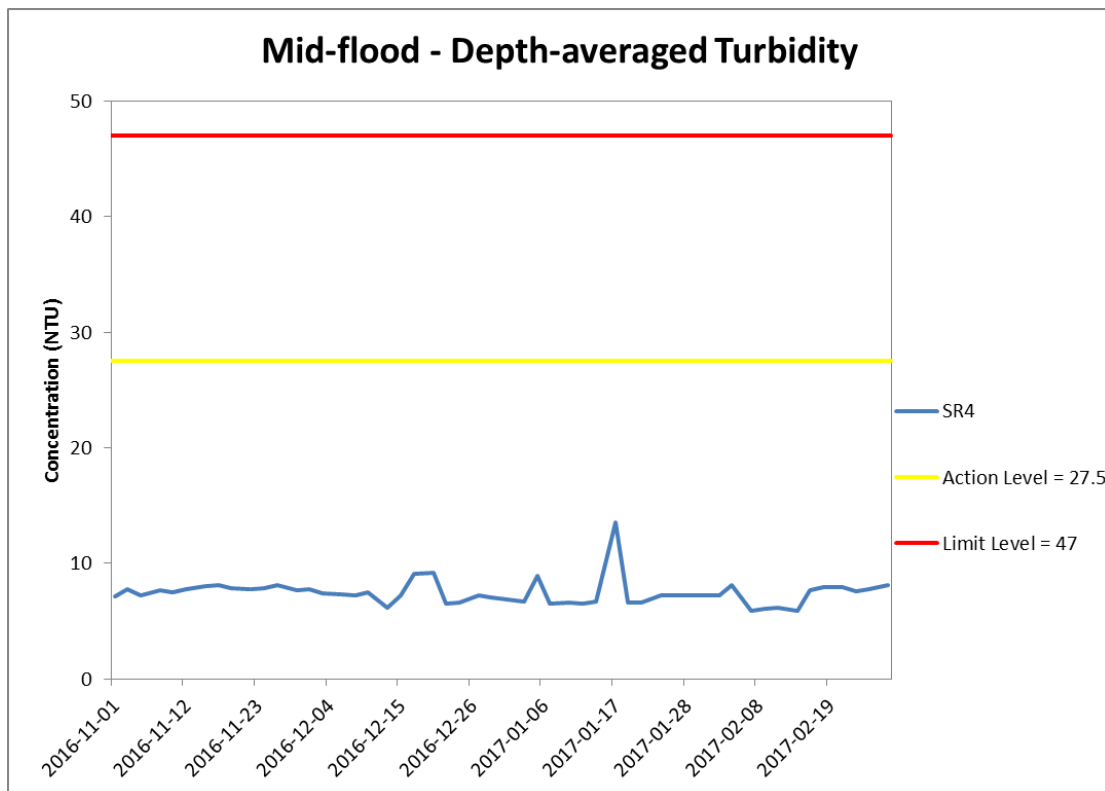
**Figure H27 Impact Monitoring - Mean Level of depth-averaged Turbidity (NTU) during mid-flood tide between 1 November 2016 and 28 February 2017 at IS8 and SR4.**

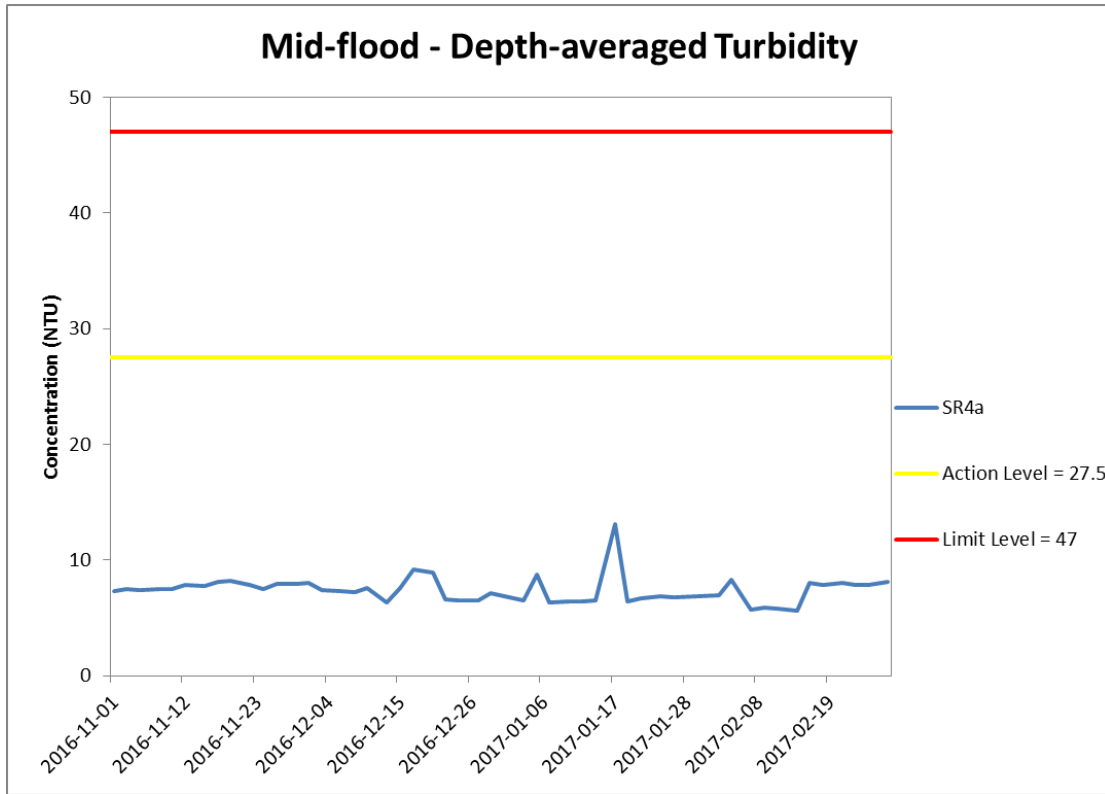
**Figure H28 Impact Monitoring – Mean Level of depth-averaged Turbidity (NTU) during mid-flood tide between 1 November 2016 and 28 February 2017 at SR4a.**
