**Contract No. HY/2012/07  
Tuen Mun – Chek Lap Kok Link –  
Southern Connection Viaduct Section**

***Thirteenth Quarterly Environmental Monitoring  
& Audit (EM&A) Report***

26 October 2017

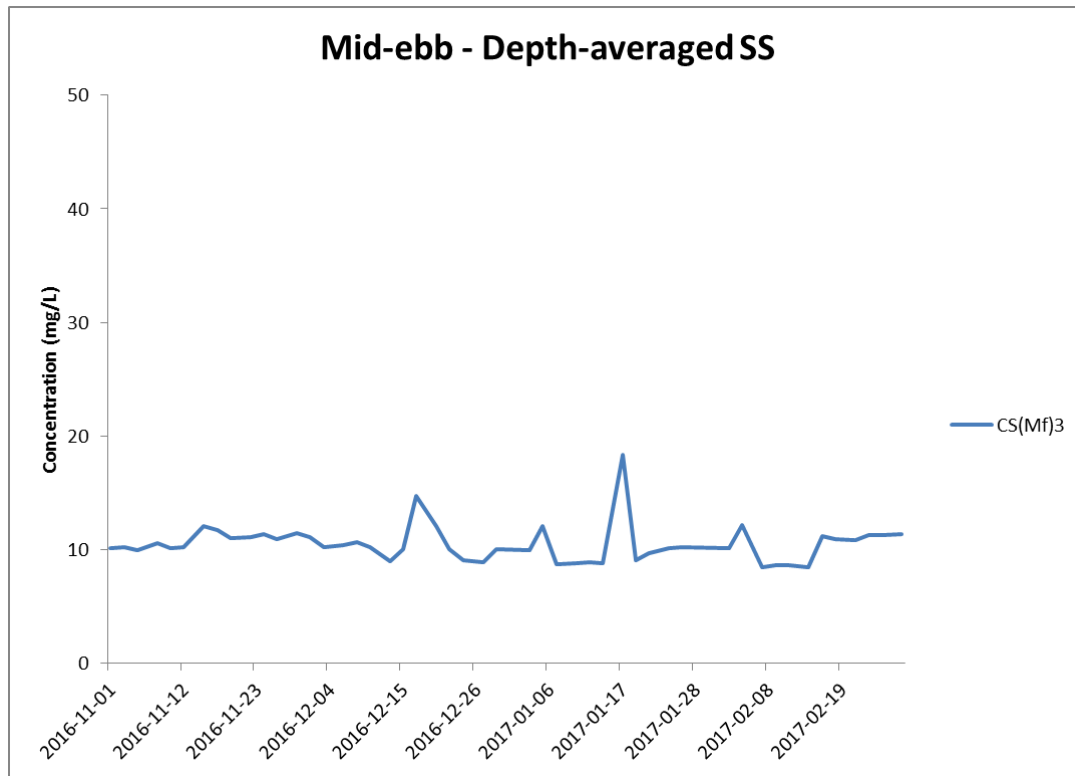
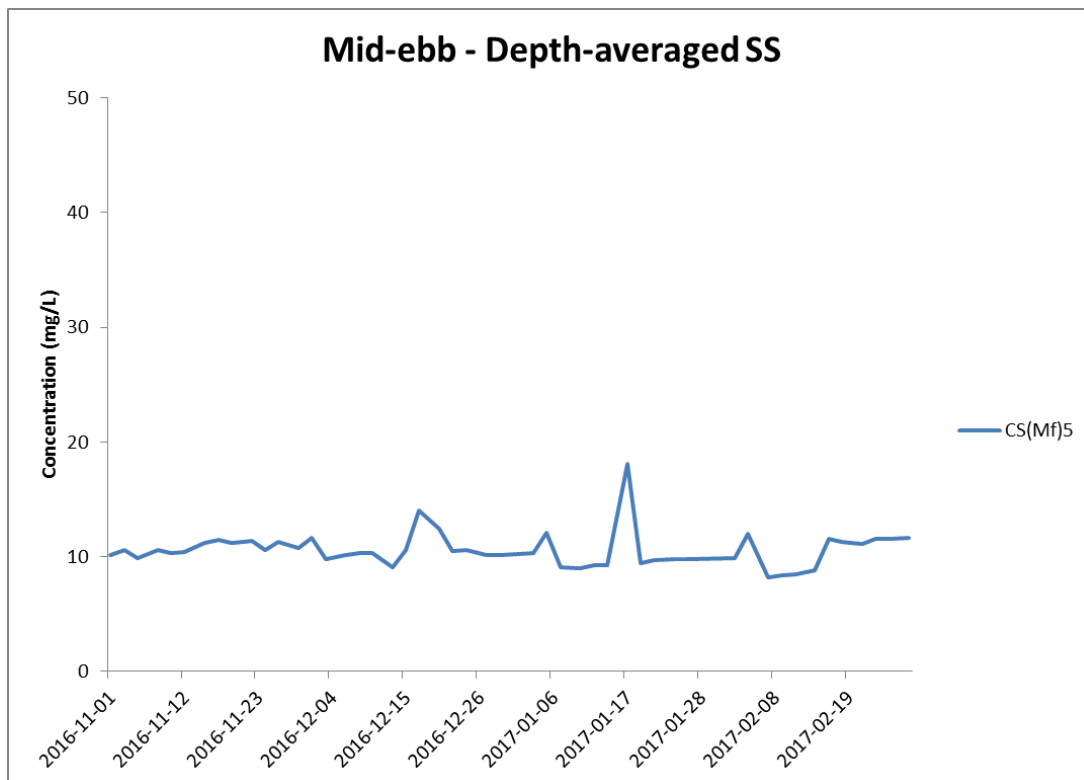
**Figure H29 Impact Monitoring – Mean depth-averaged level of Suspended Solids (mg/L) during mid-ebb tide between 1 November 2016 and 28 February 2017 at CS(Mf)3 and CS(Mf)5.**

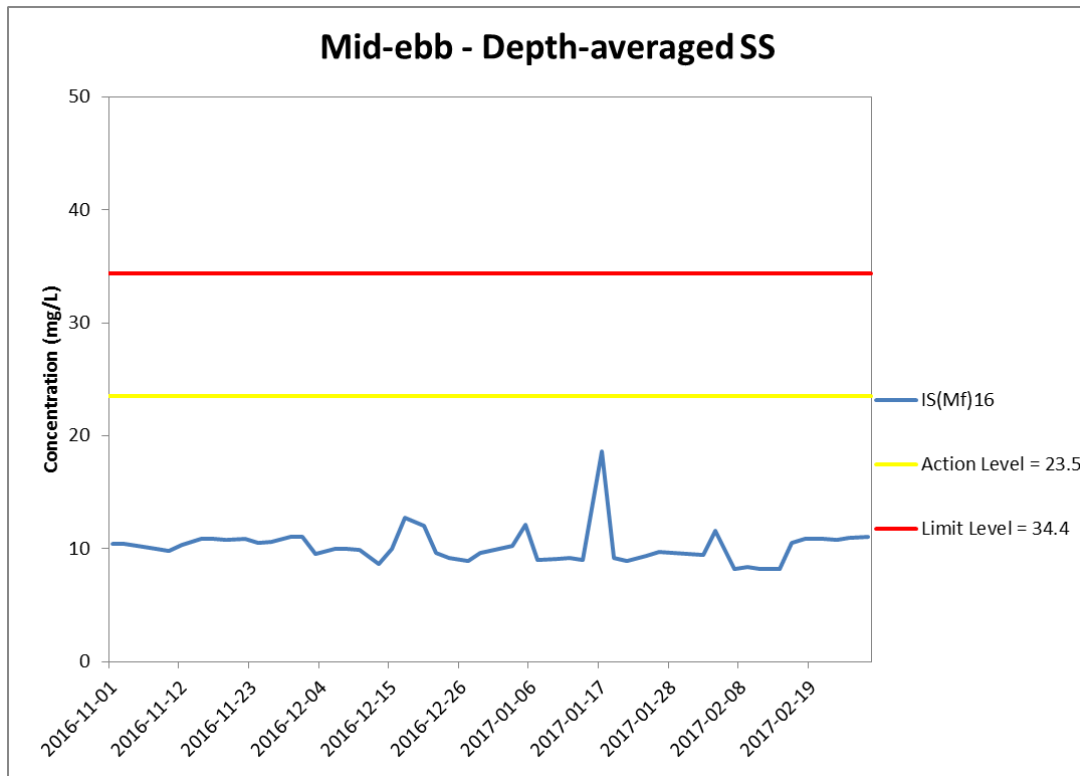
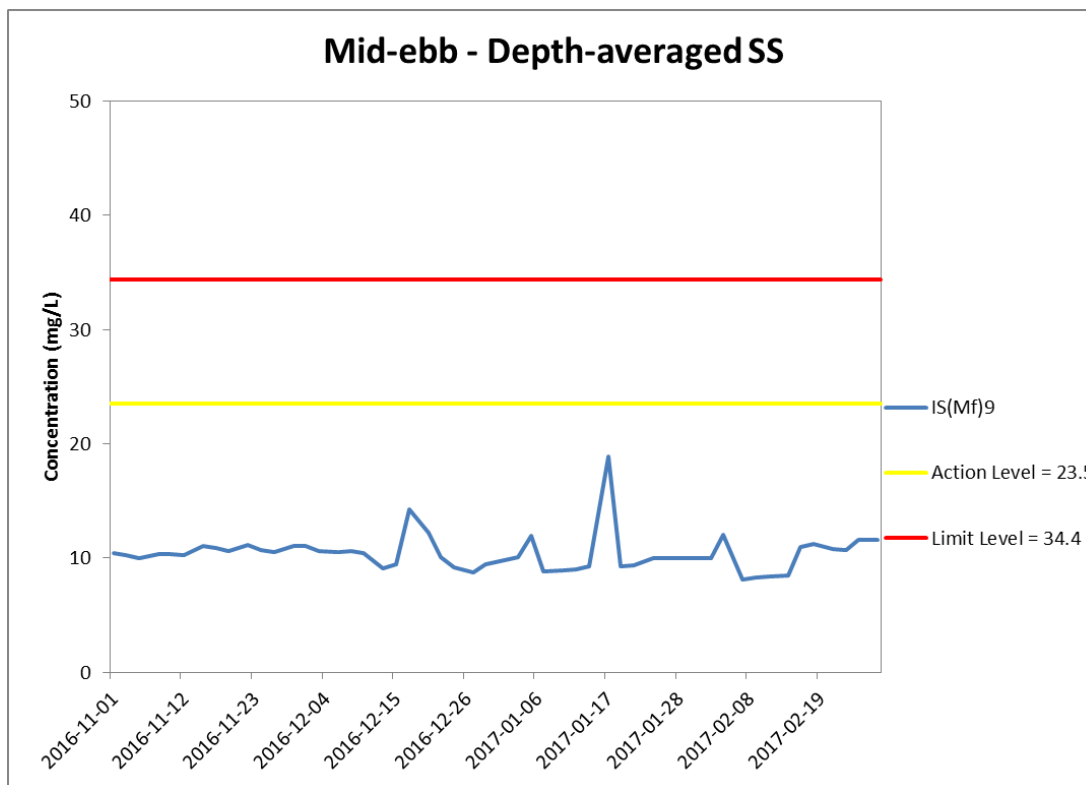
**Figure H30 Impact Monitoring – Mean depth-averaged level of Suspended Solids (mg/L) during mid-ebb tide between 1 November 2016 and 28 February 2017 at IS(Mf)16 and IS(Mf)9.**

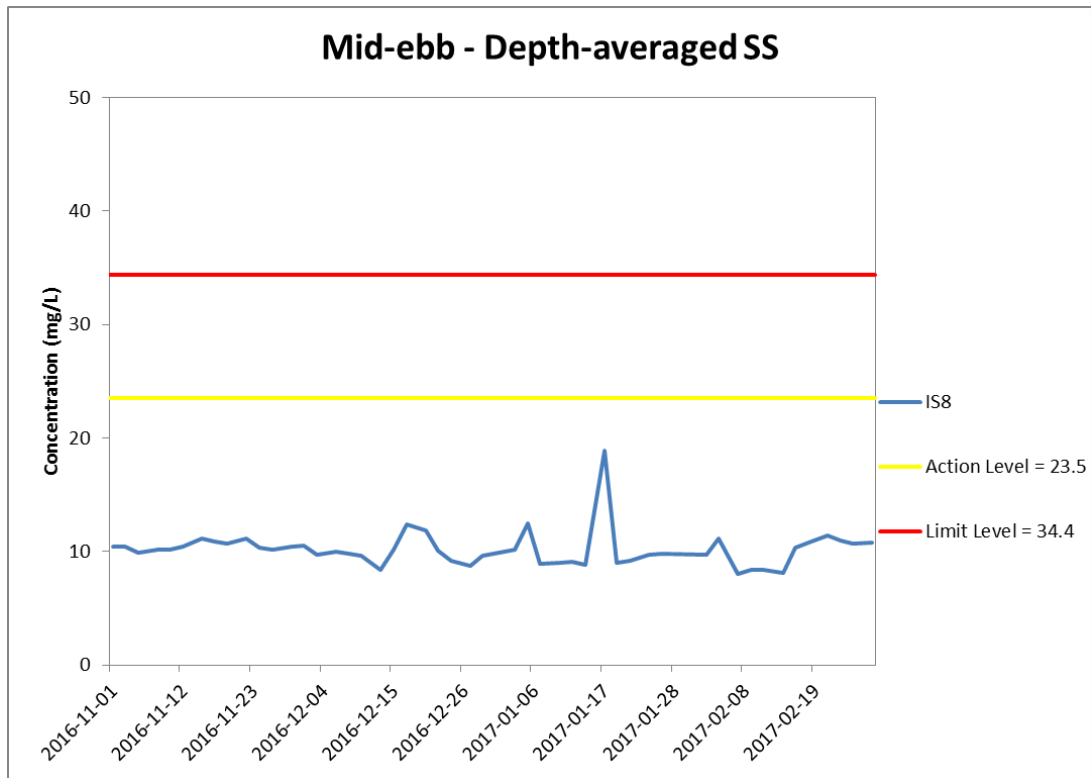
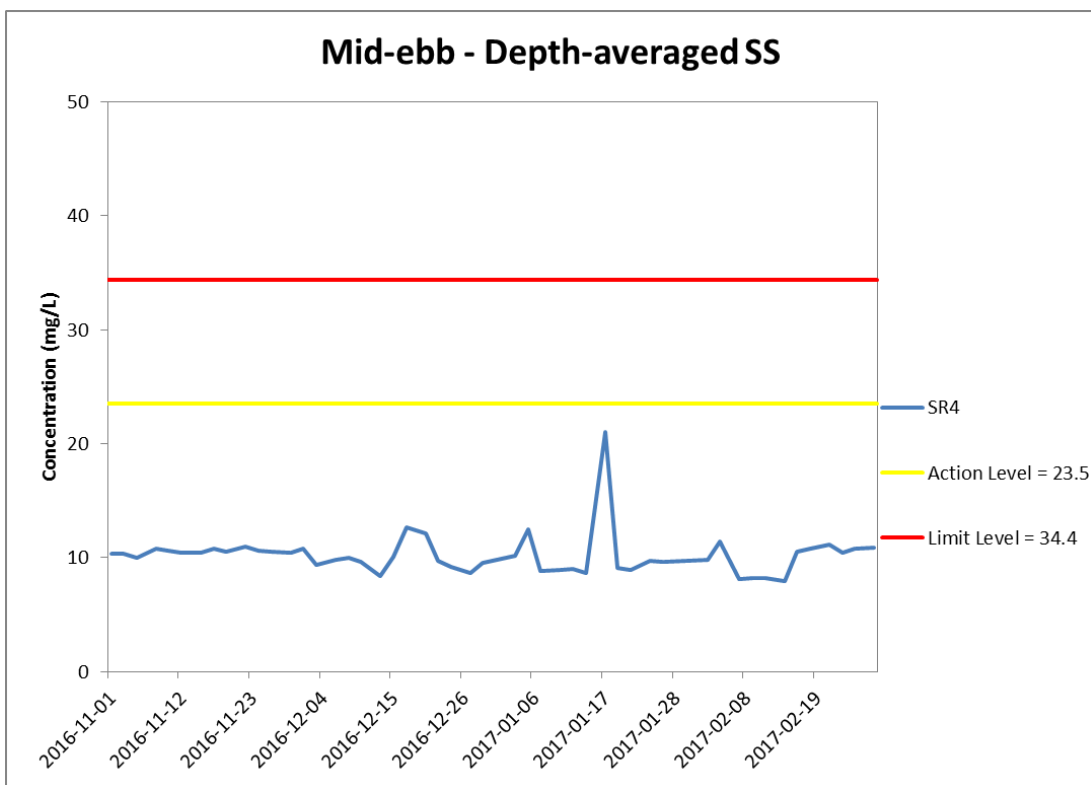
**Figure H31 Impact Monitoring – Mean depth-averaged level of Suspended Solids (mg/L) during mid-ebb tide between 1 November 2016 and 28 February 2017 at IS8 and SR4.**

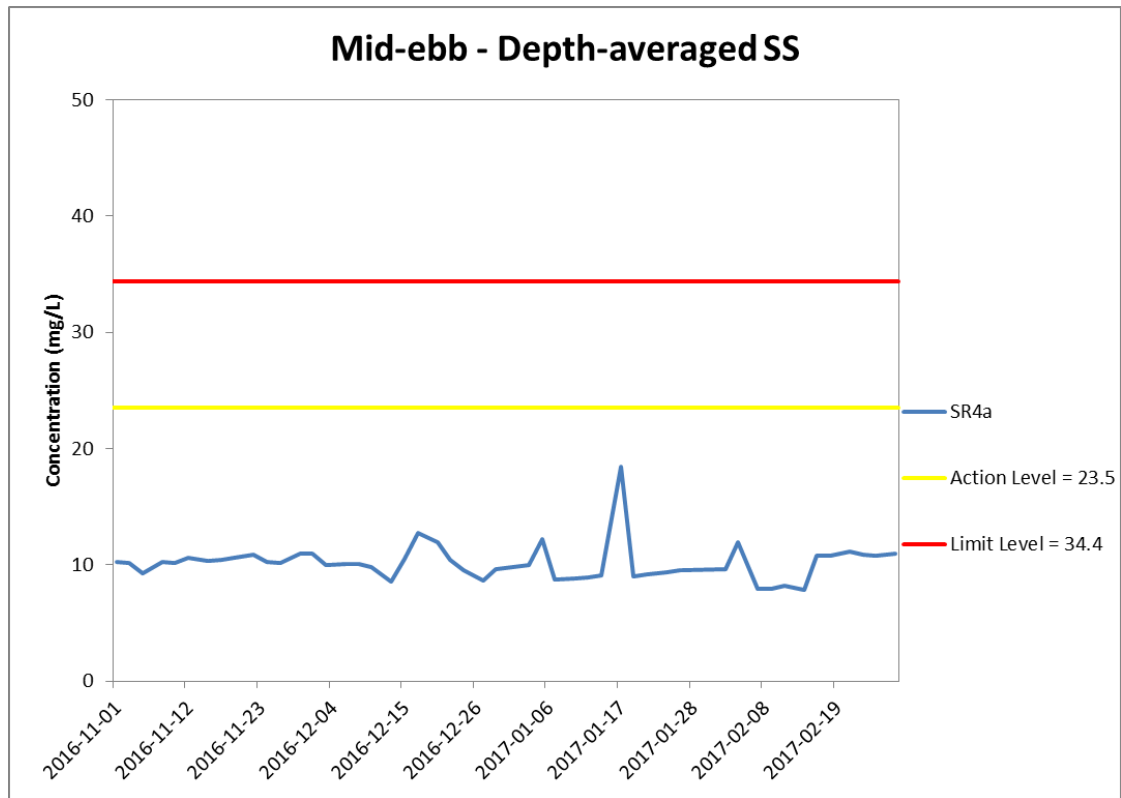
**Figure H32 Impact Monitoring - Mean depth-averaged level of Suspended Solids (mg/L) during mid-ebb tide between 1 November 2016 and 28 February 2017 at SR4a.**

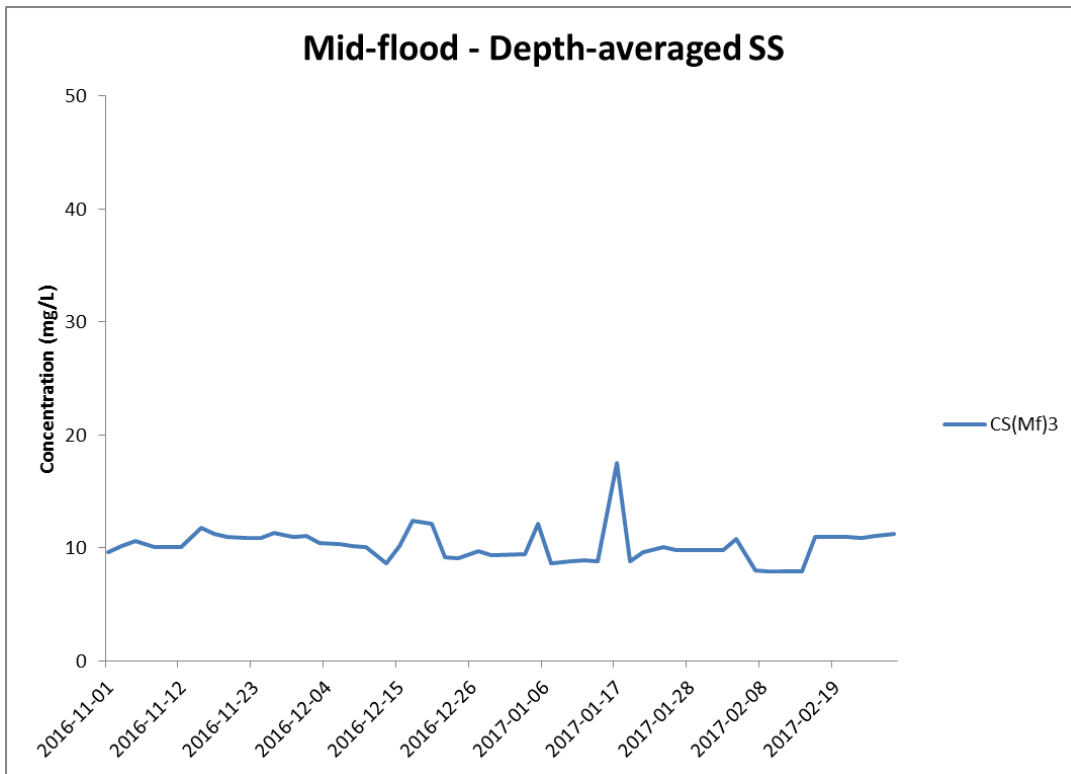
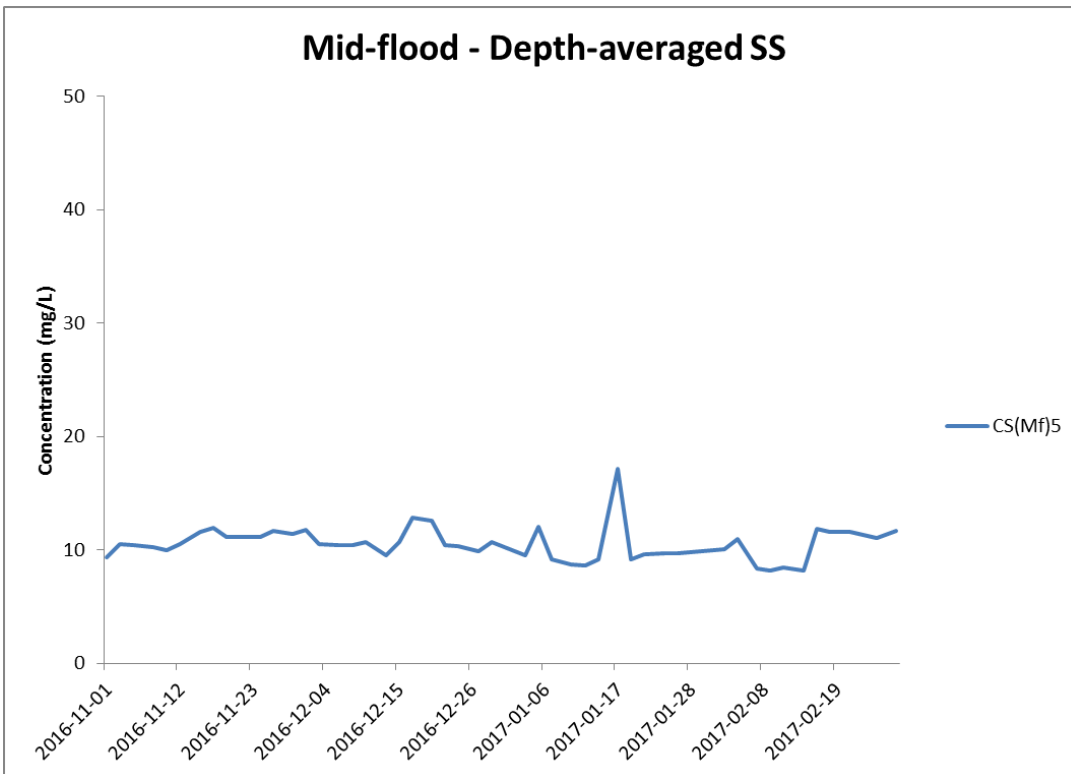
**Figure H33 Impact Monitoring – Mean depth-averaged level of Suspended Solids (mg/L) during mid-flood tide between 1 November 2016 and 28 February 2017 at CS(Mf)3 and CS(Mf)5.**

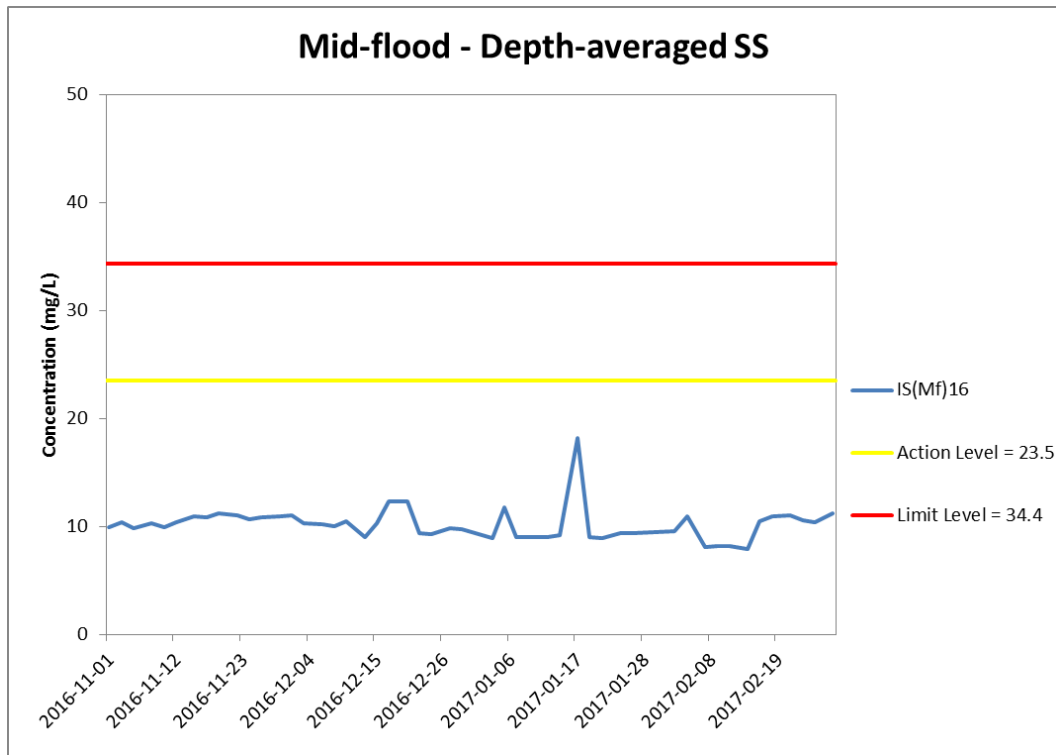
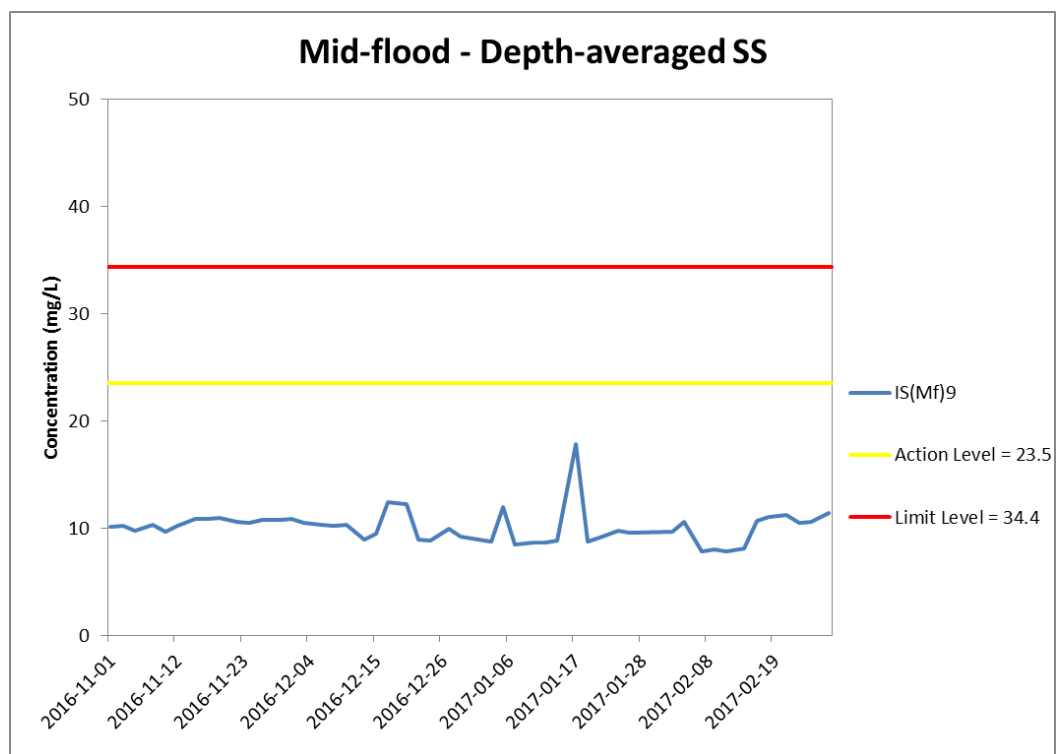
**Figure H34 Impact Monitoring – Mean depth-averaged level of Suspended Solids (mg/L) during mid-flood tide between 1 November 2016 and 28 February 2017 at IS(Mf)16 and IS(Mf)9.**

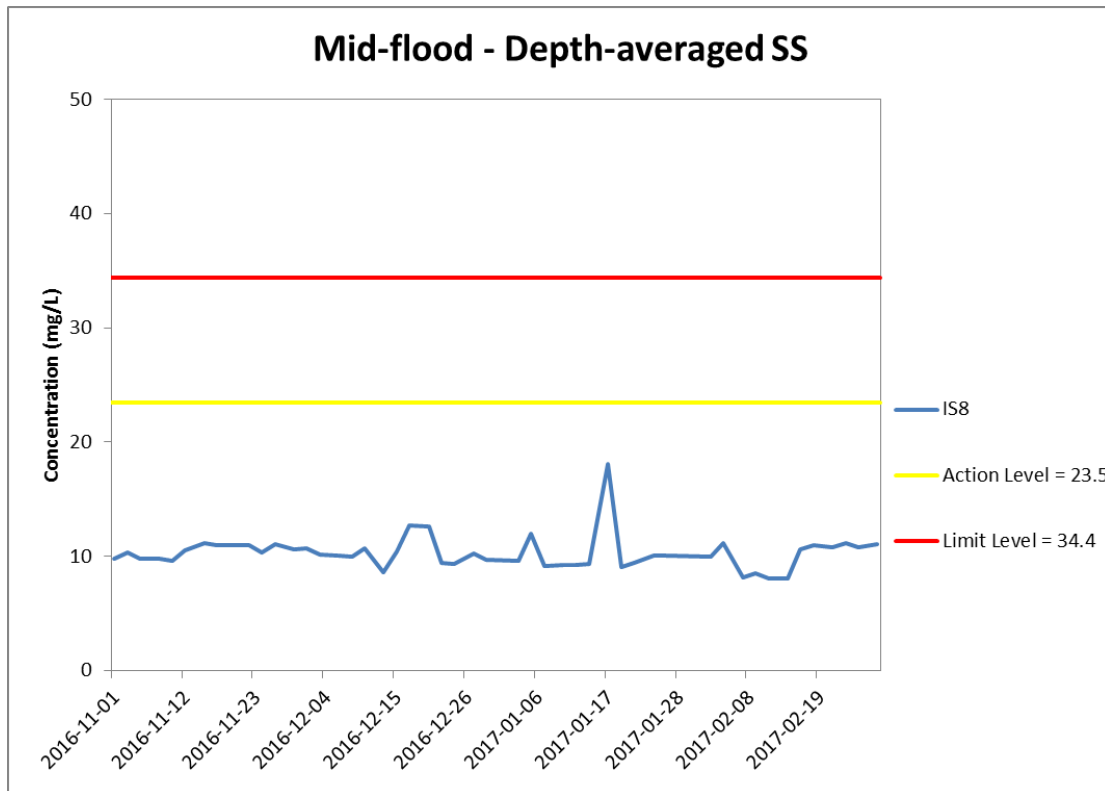
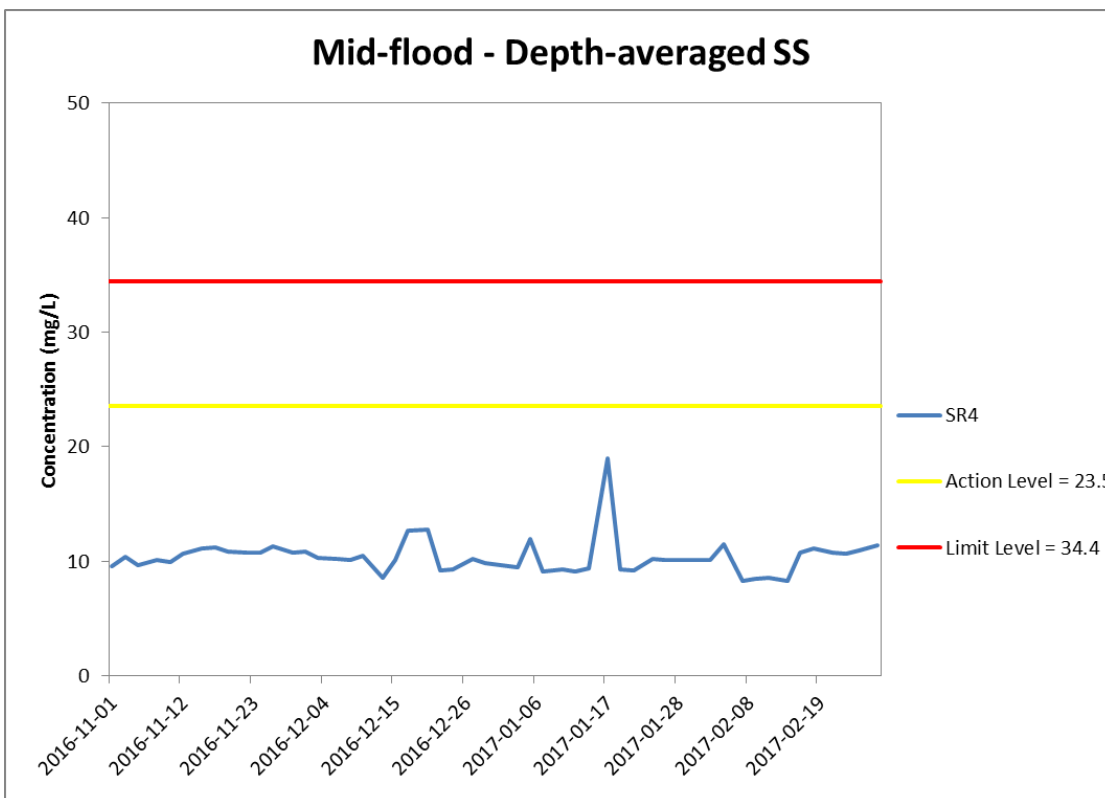
**Figure H35 Impact Monitoring – Mean depth-averaged level of Suspended Solids (mg/L) during mid-flood tide between 1 November 2016 and 28 February 2017 at IS8 and SR4.**

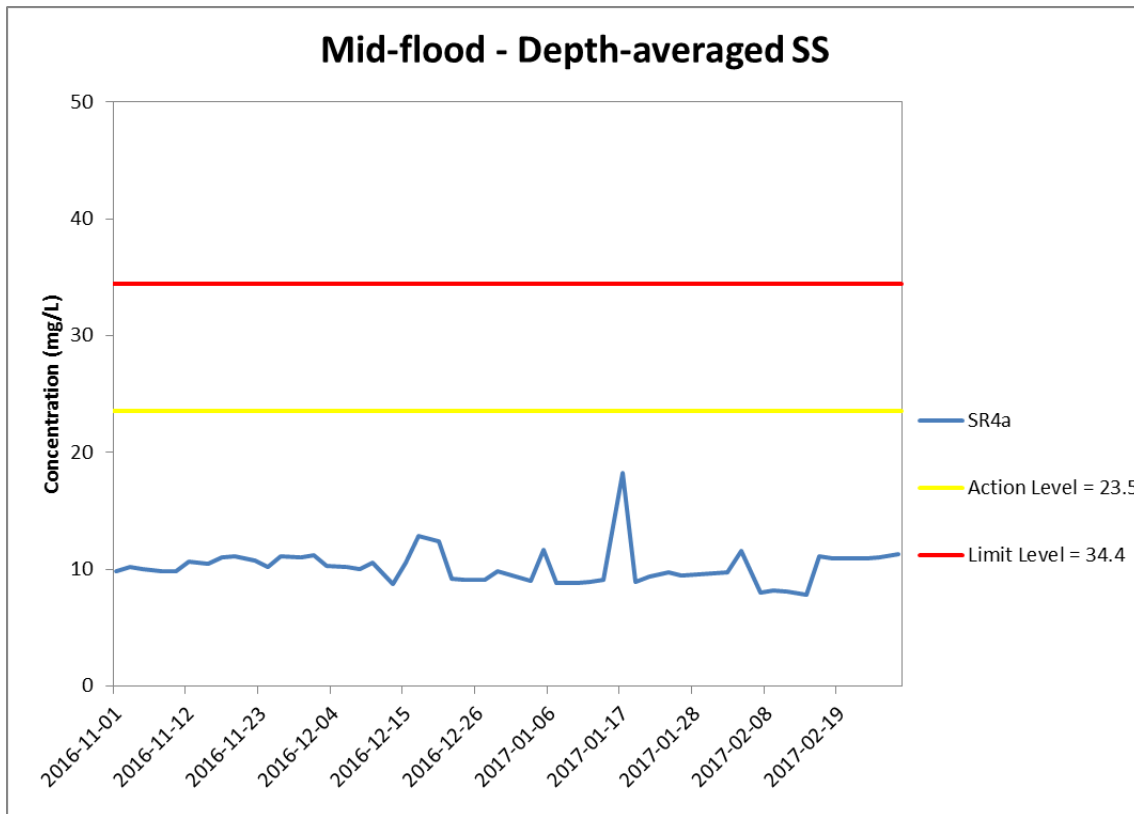
**Figure H36 Impact Monitoring - Mean depth-averaged level of Suspended Solids (mg/L) during mid-flood tide between 1 November 2016 and 28 February 2017 at SR4a.**

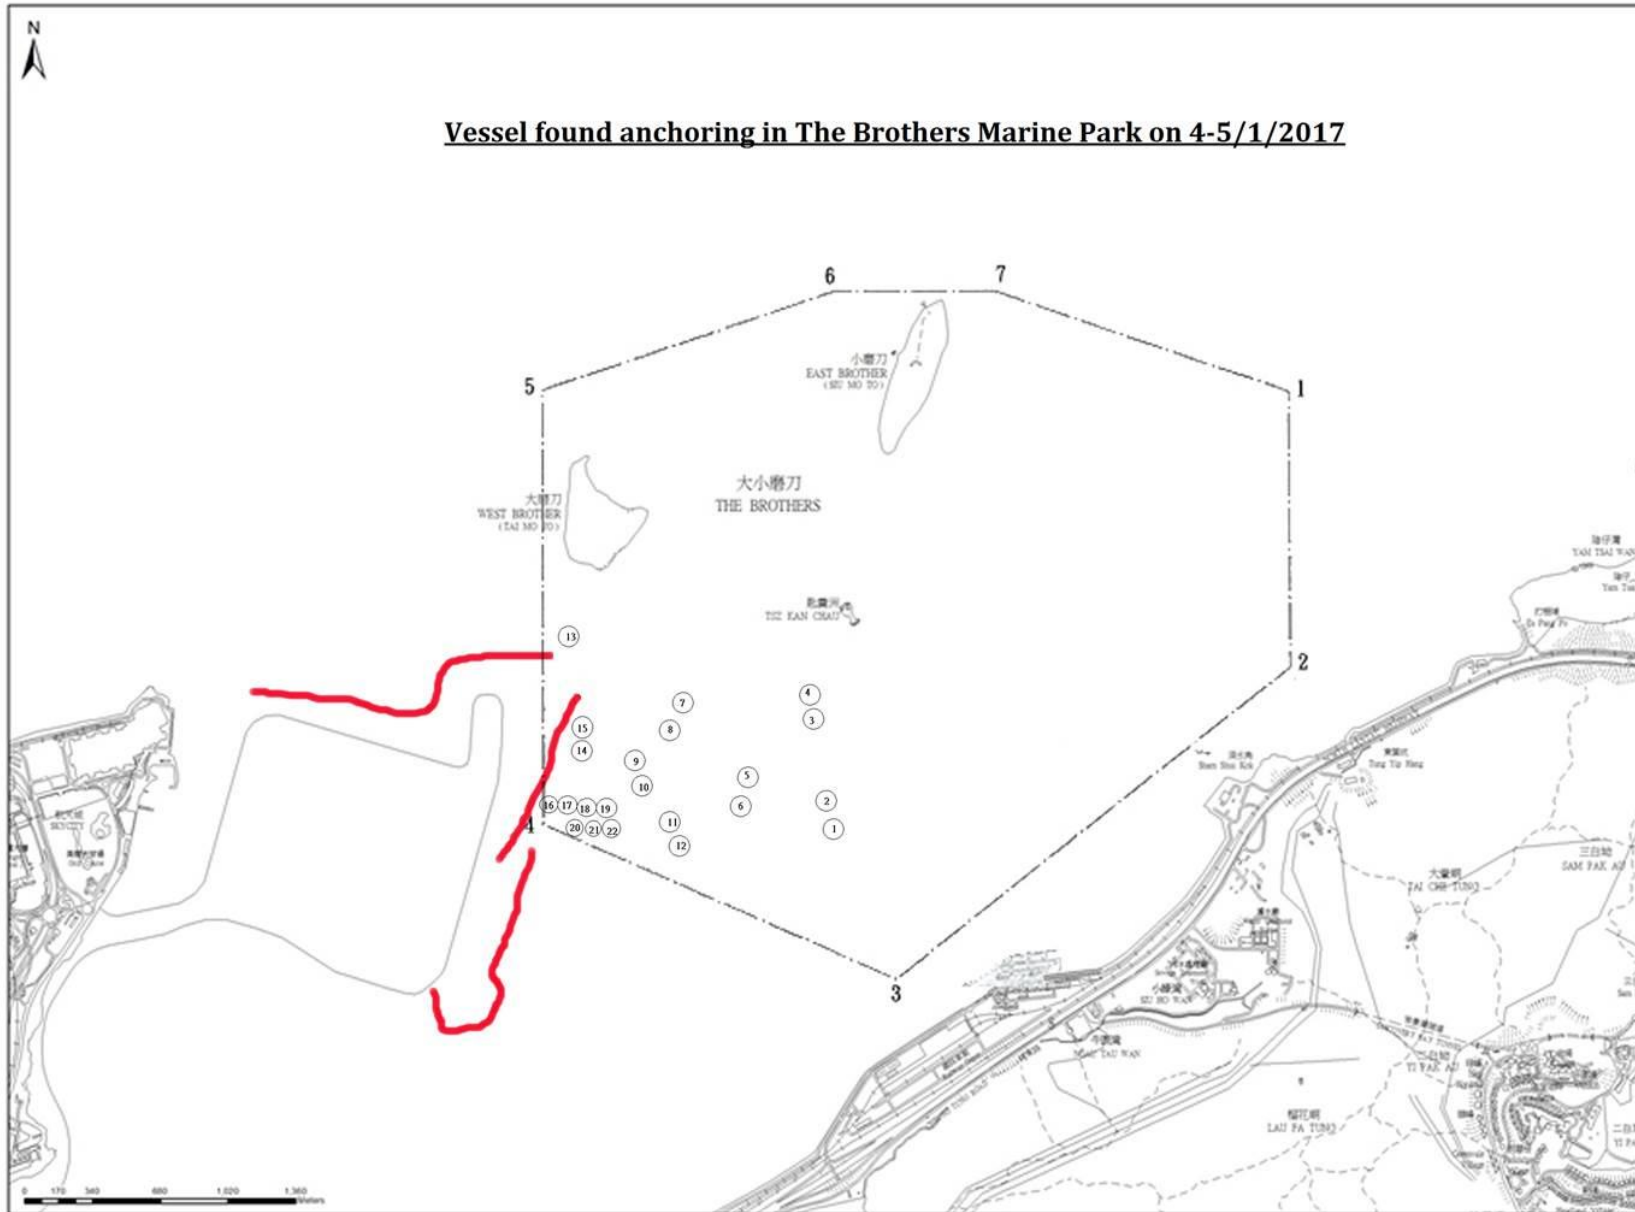
Figure 1 – Observed barges/tug boats inside Brothers Marine Park on 4-5/1/2017

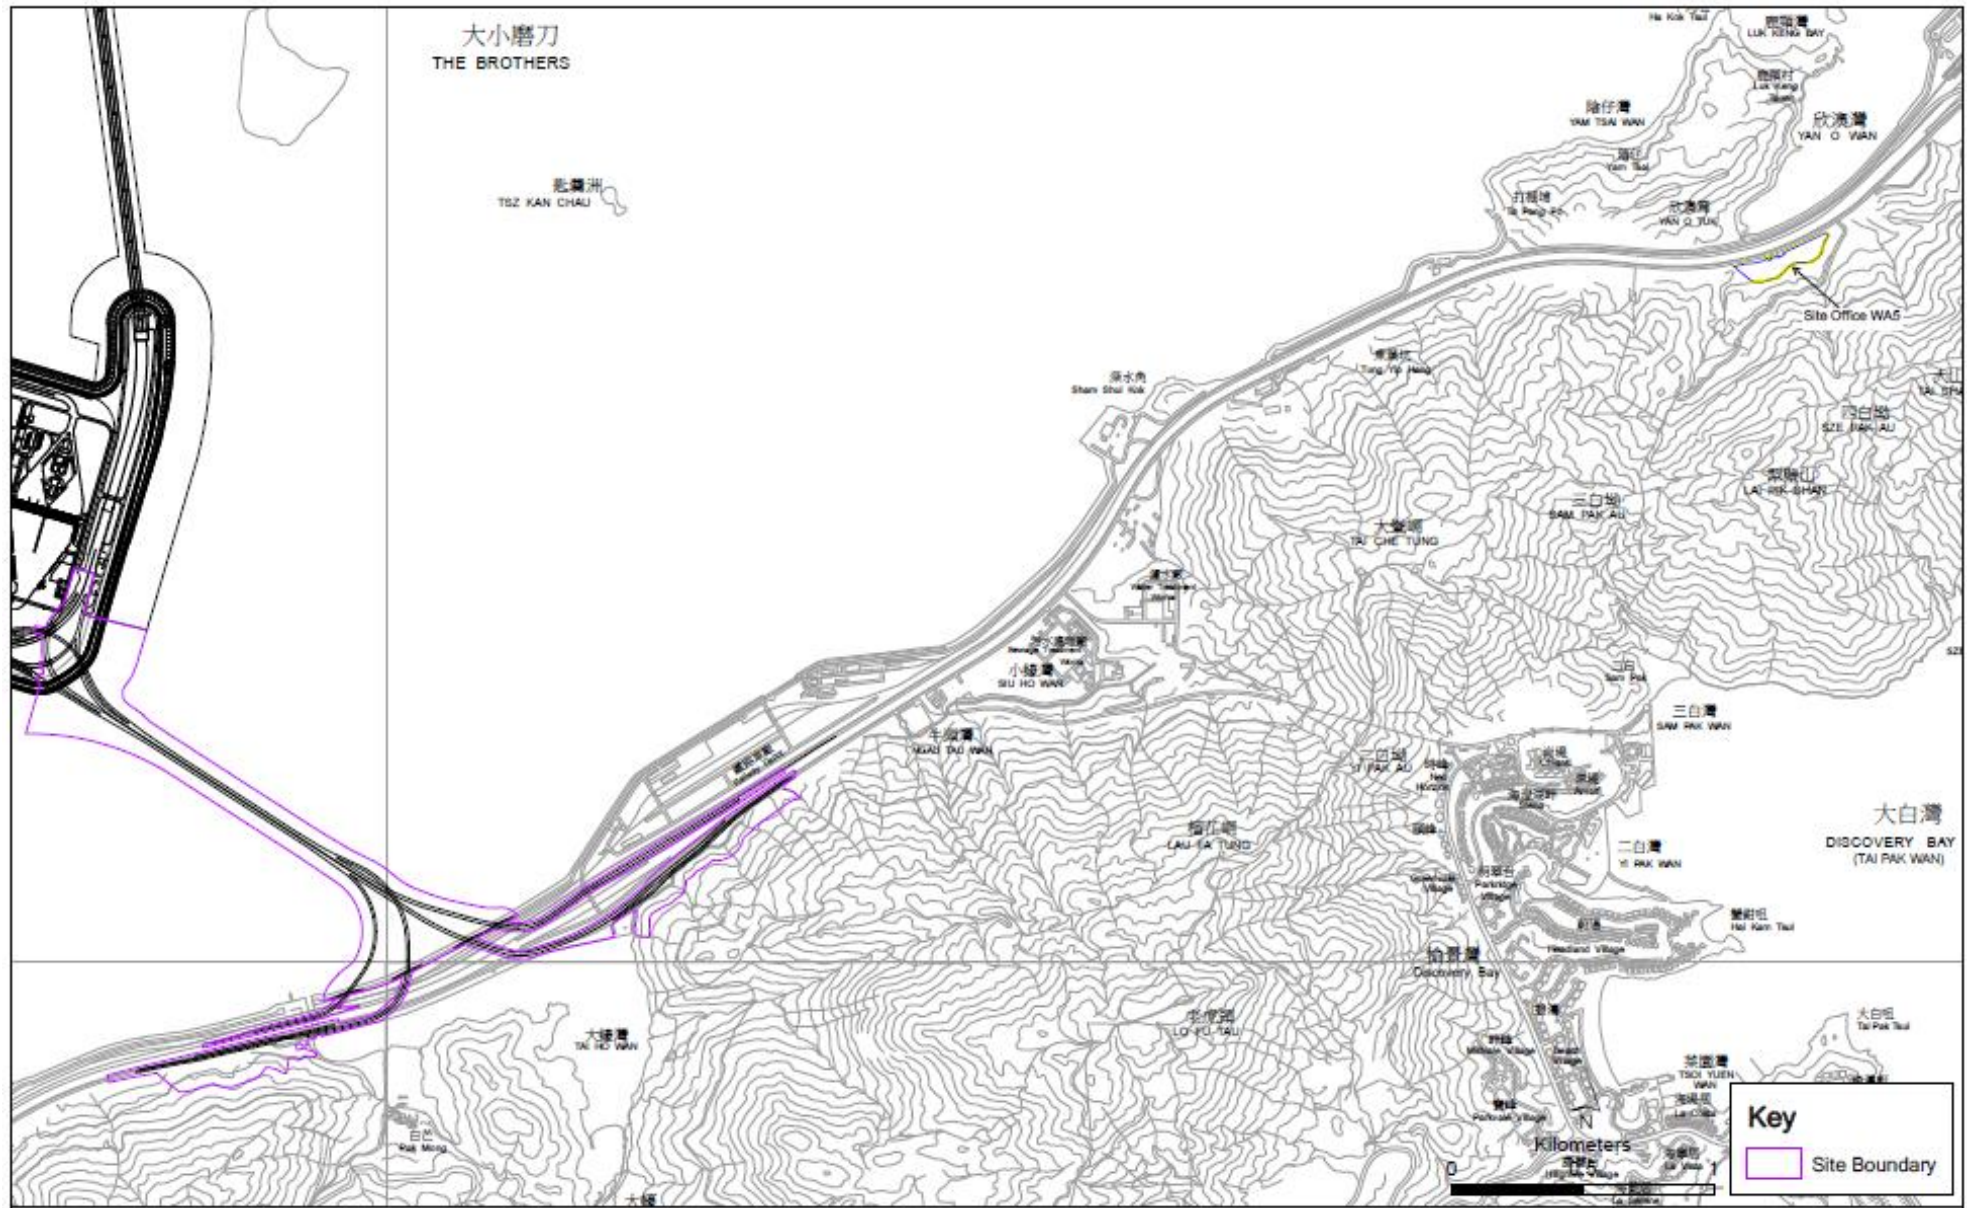
Figure 2 – Project site boundary under this Contract
