**Contract No. HY/2012/08  
Tuen Mun – Chek Lap Kok Link –  
Northern Connection Sub-sea Tunnel  
Section**

*Fourteenth Quarterly Environmental Monitoring  
& Audit (EM&A) Report*

**Contract No. HY/2012/08 TM-CLKL Northern Connection Sub-sea  
Tunnel Section  
Fourteenth Quarterly EM&A Report (March 2017 – May 2017)**

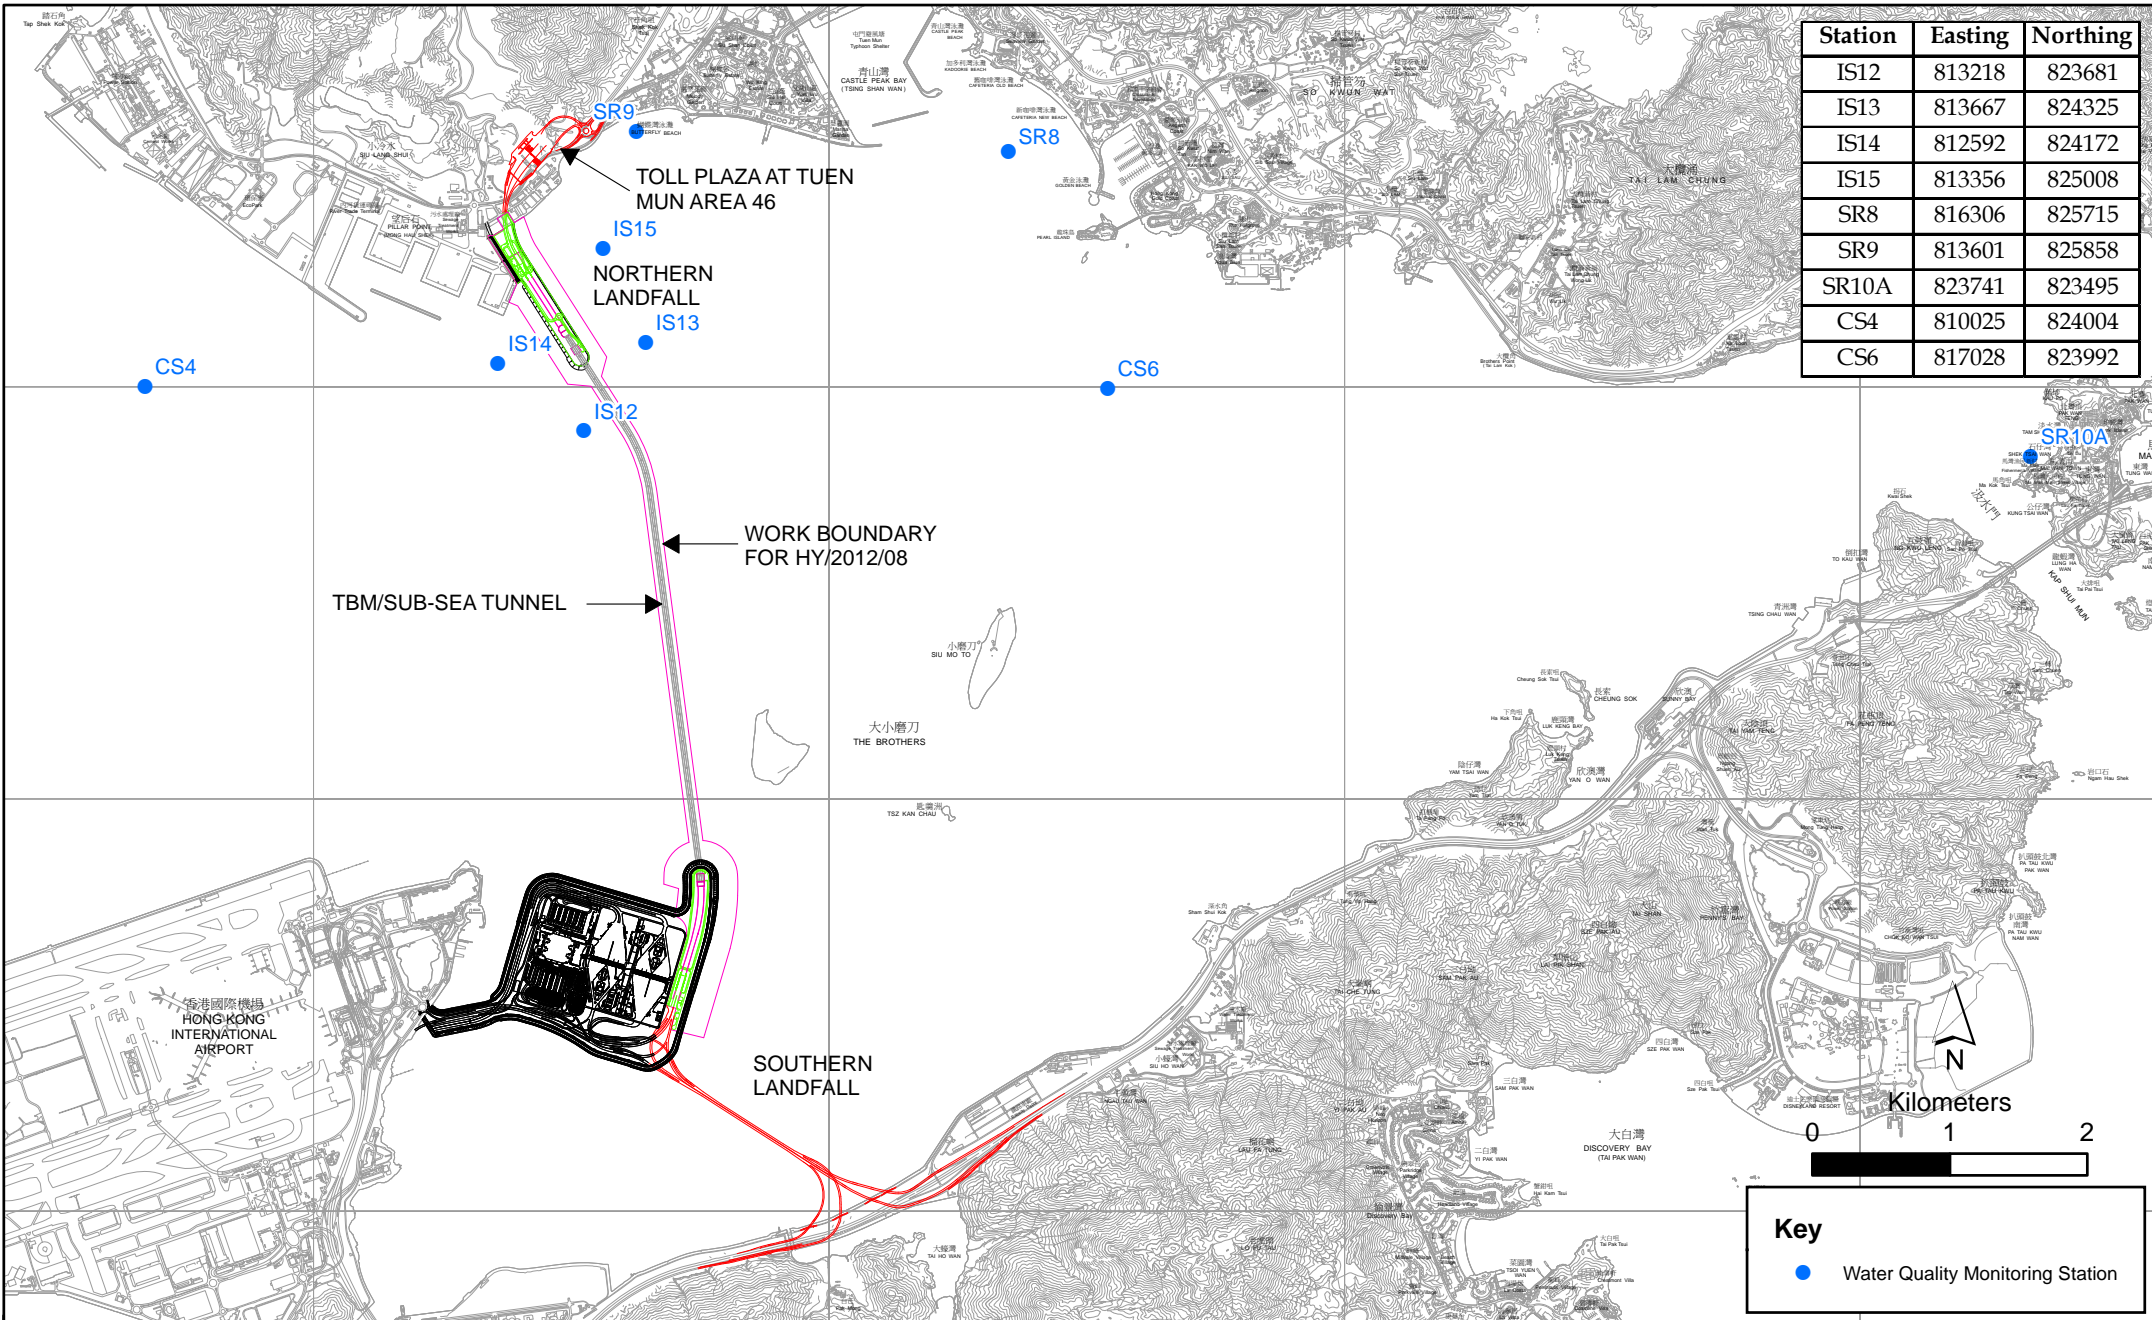
Figure 2.2

Water Quality Monitoring Station

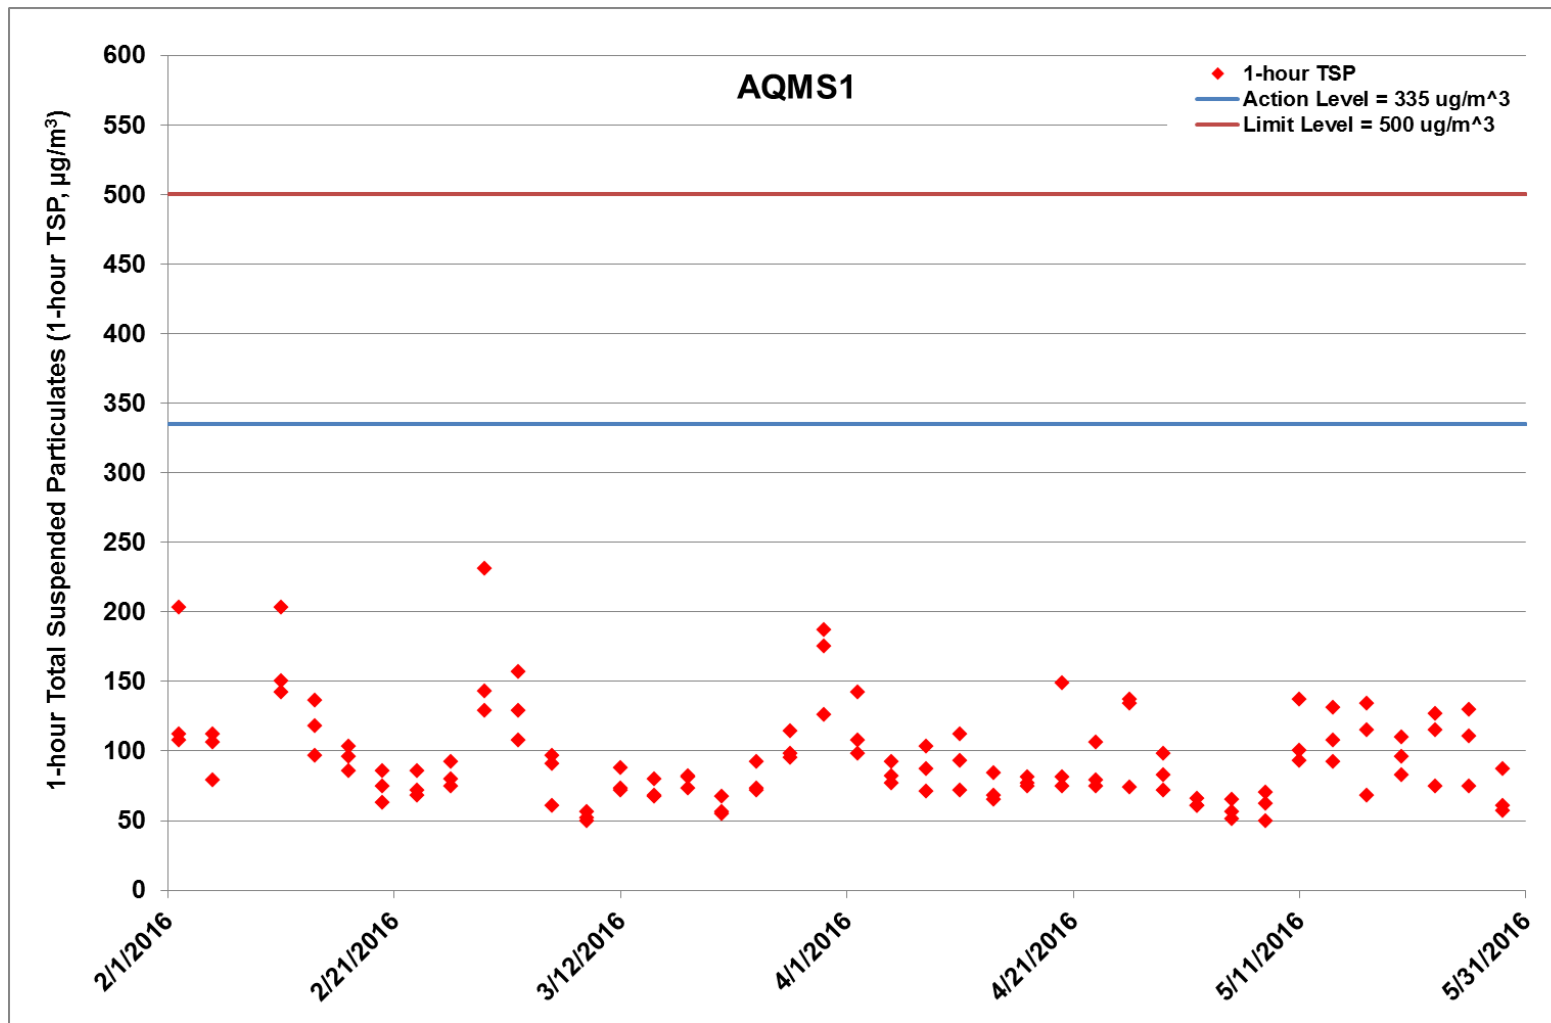
Figure F.1 Impact Monitoring - 1-hour Total Suspended Particulates ( $\mu\text{g}/\text{m}^3$ ) at AQMS1 between 1 February 2016 and 31 May 2016 during impact monitoring period. The weather conditions during the monitoring period varied from sunny to cloudy. Major land-based construction activities included: CSM Ground Treatment and Diaphragm Wall Construction (1/4/2016 - 31/5/2016) and Box Culvert Extension (1/2/2016 - 31/5/2016). Ref: 0212330\_Impact AQM graphs\_ May 2016\_REV a.xlsx

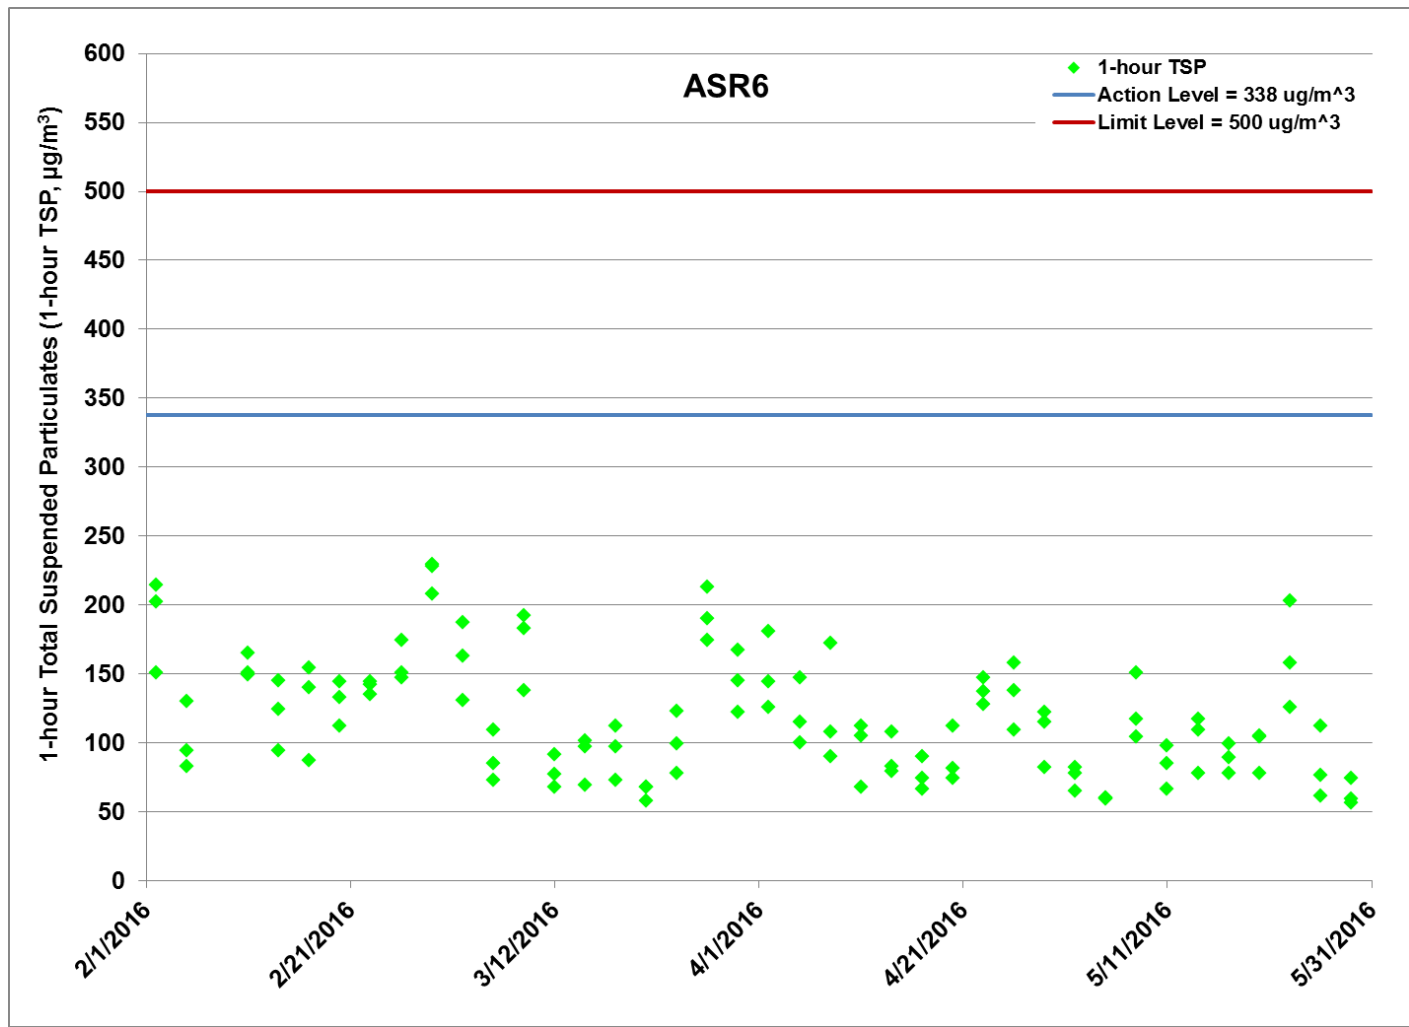
Figure F.2 Impact Monitoring - 1-hour Total Suspended Particulates ( $\mu\text{g}/\text{m}^3$ ) at ASR6 between 1 February 2016 and 31 May 2016 during impact monitoring period. The weather conditions during the monitoring period varied from sunny to cloudy. Major land-based construction activities included: CSM Ground Treatment and Diaphragm Wall Construction (1/4/2016 - 31/5/2016) and Box Culvert Extension (1/2/2016 - 31/5/2016). Ref: 0212330\_Impact AQM graphs\_ May 2016\_REV a.xlsx

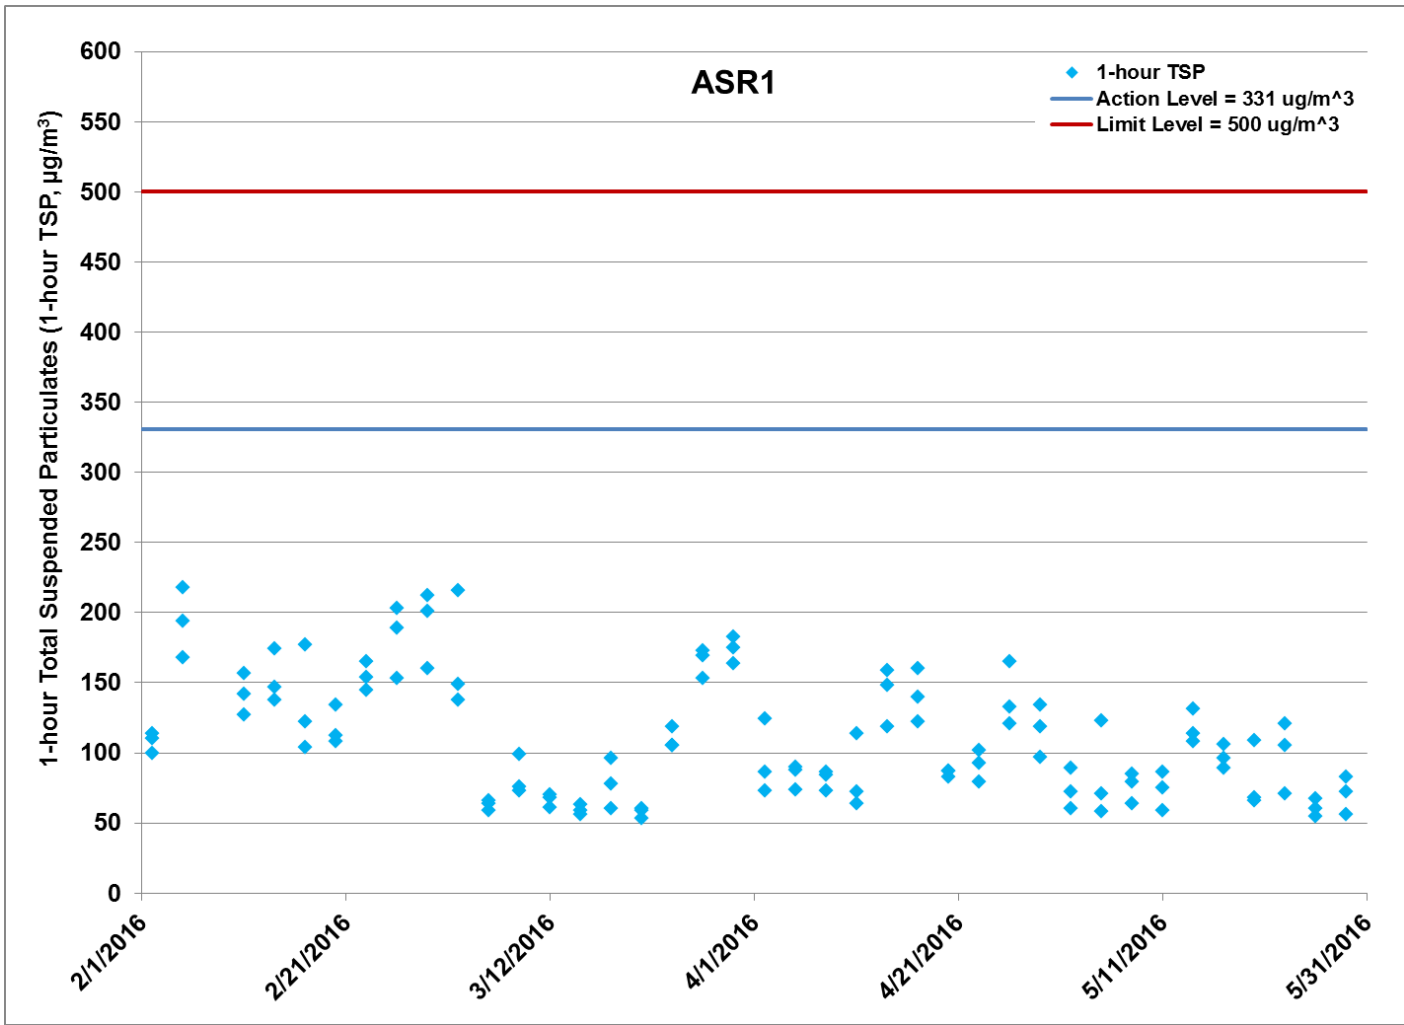
Figure F.3 Impact Monitoring - 1-hour Total Suspended Particulates ( $\mu\text{g}/\text{m}^3$ ) at ASR1 between 1 February 2016 and 31 May 2016 during impact monitoring period. The weather conditions during the monitoring period varied from sunny to cloudy. Major land-based construction activities included: CSM Ground Treatment and Diaphragm Wall Construction (1/4/2016 - 31/5/2016) and Box Culvert Extension (1/2/2016 - 31/5/2016). Ref: 0212330\_Impact AQM graphs\_May 2016\_REV a.xlsx

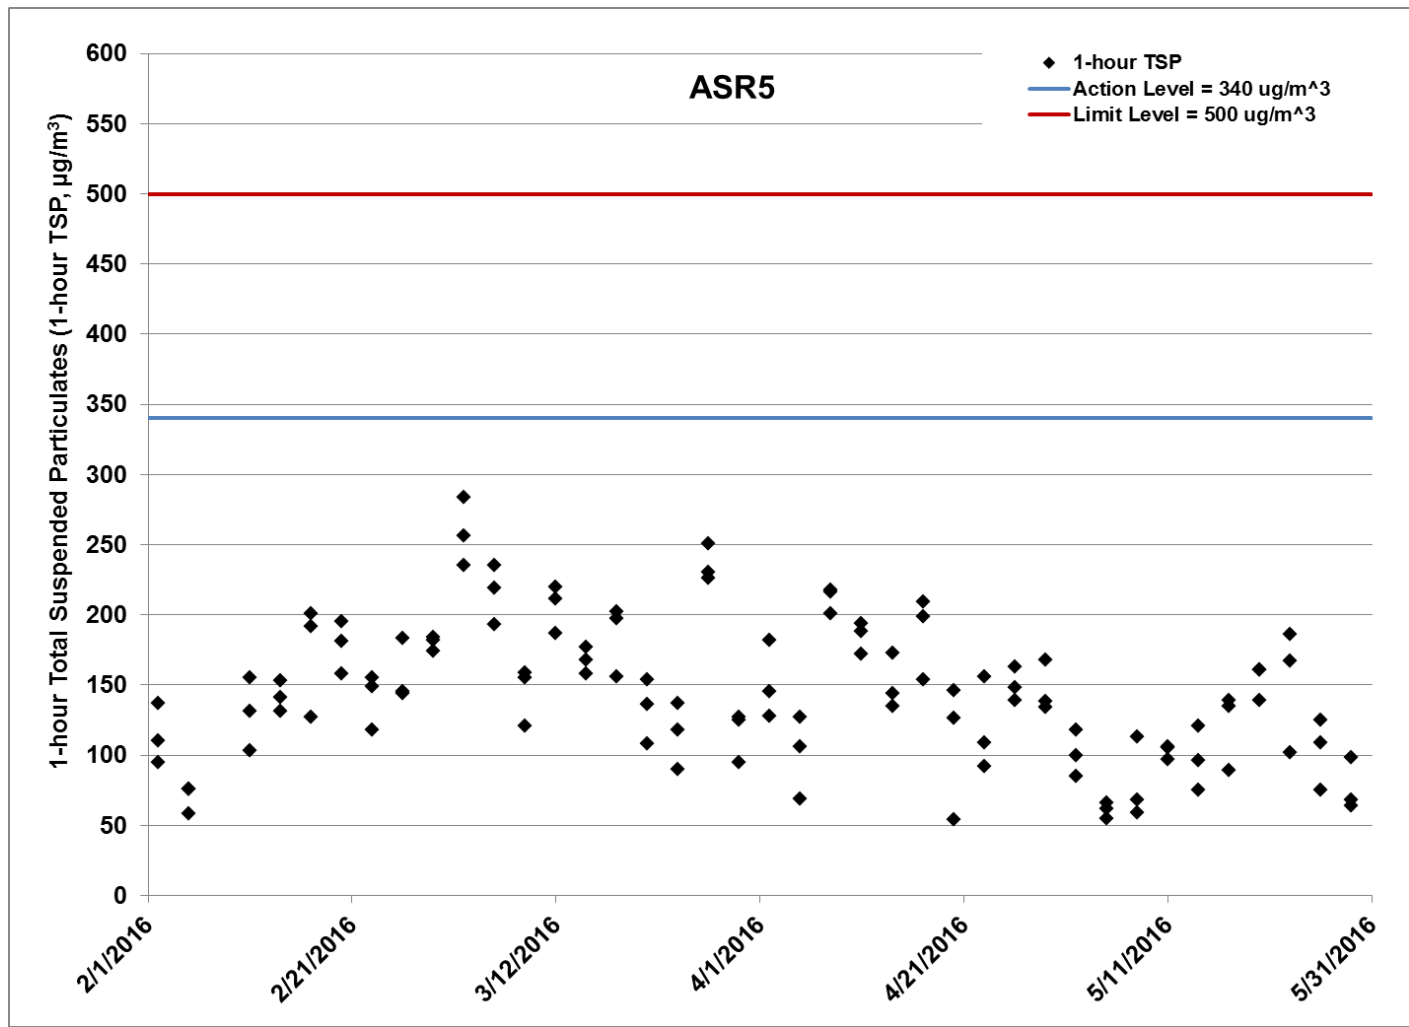
Figure F.4 Impact Monitoring - 1-hour Total Suspended Particulates ( $\mu\text{g}/\text{m}^3$ ) at ASR5 between 1 February 2016 and 31 May 2016 during impact monitoring period. The weather conditions during the monitoring period varied from sunny to cloudy. Major land-based construction activities included: CSM Ground Treatment and Diaphragm Wall Construction (1/4/2016 - 31/5/2016) and Box Culvert Extension (1/2/2016 - 31/5/2016). Ref: 0212330\_Impact AQM graphs\_ May 2016\_REV a.xlsx

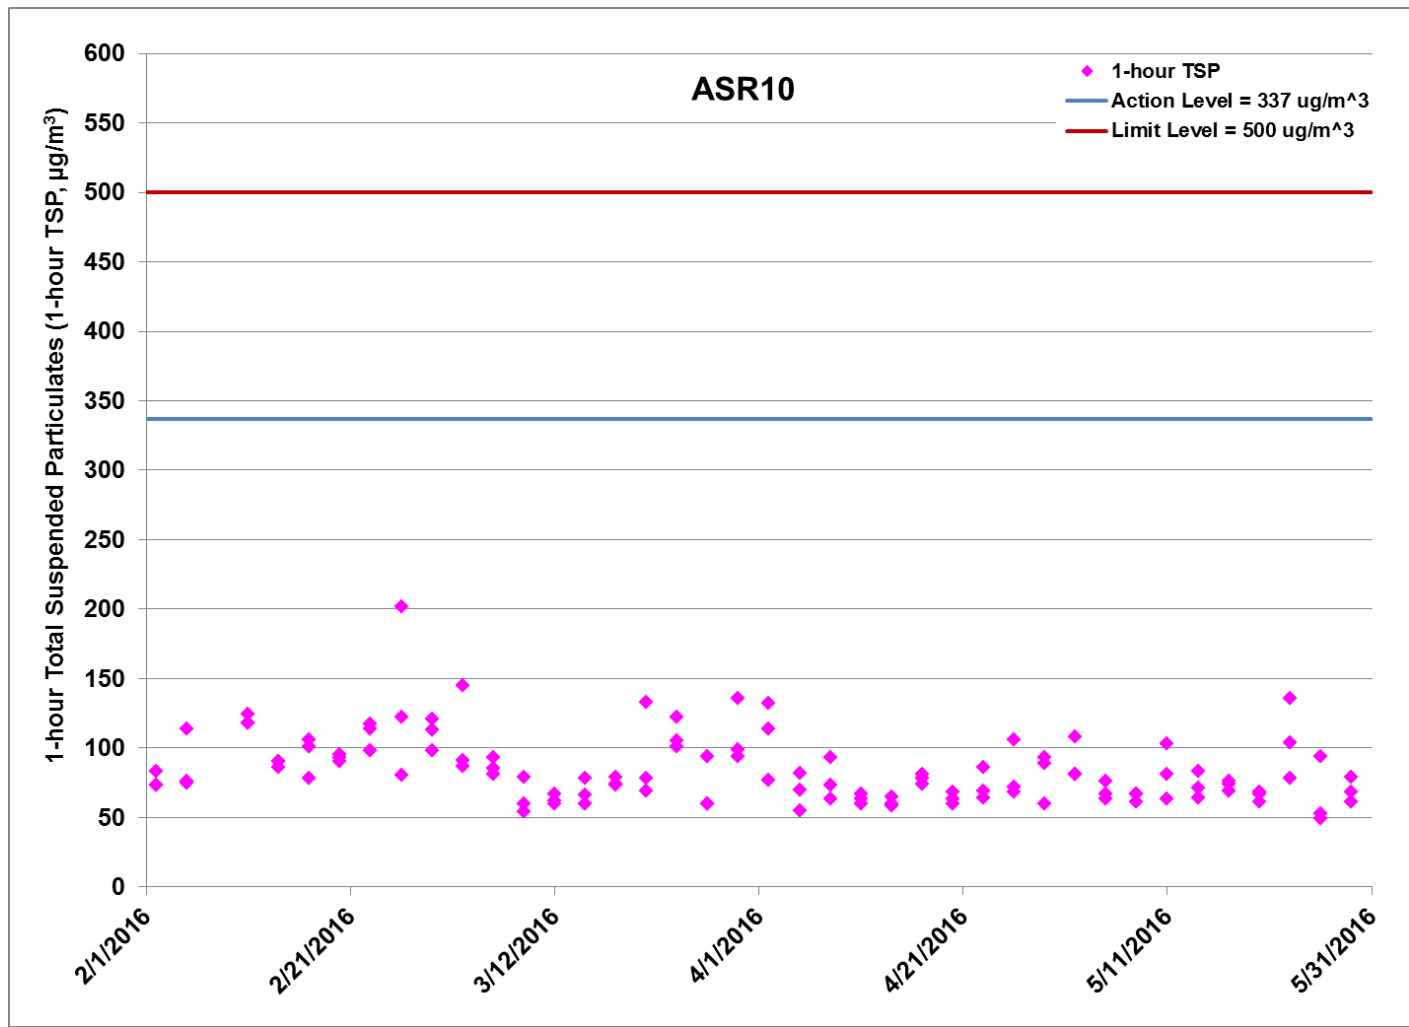
Figure F.5 Impact Monitoring - 1-hour Total Suspended Particulates ( $\mu\text{g}/\text{m}^3$ ) at ASR10 between 1 February 2016 and 31 May 2016 during impact monitoring period. The weather conditions during the monitoring period varied from sunny to cloudy. Major land-based construction activities included: CSM Ground Treatment and Diaphragm Wall Construction (1/4/2016 - 31/5/2016) and Box Culvert Extension (1/2/2016 - 31/5/2016). Ref: 0212330\_Impact AQM graphs\_ May 2016\_REV a.xlsx

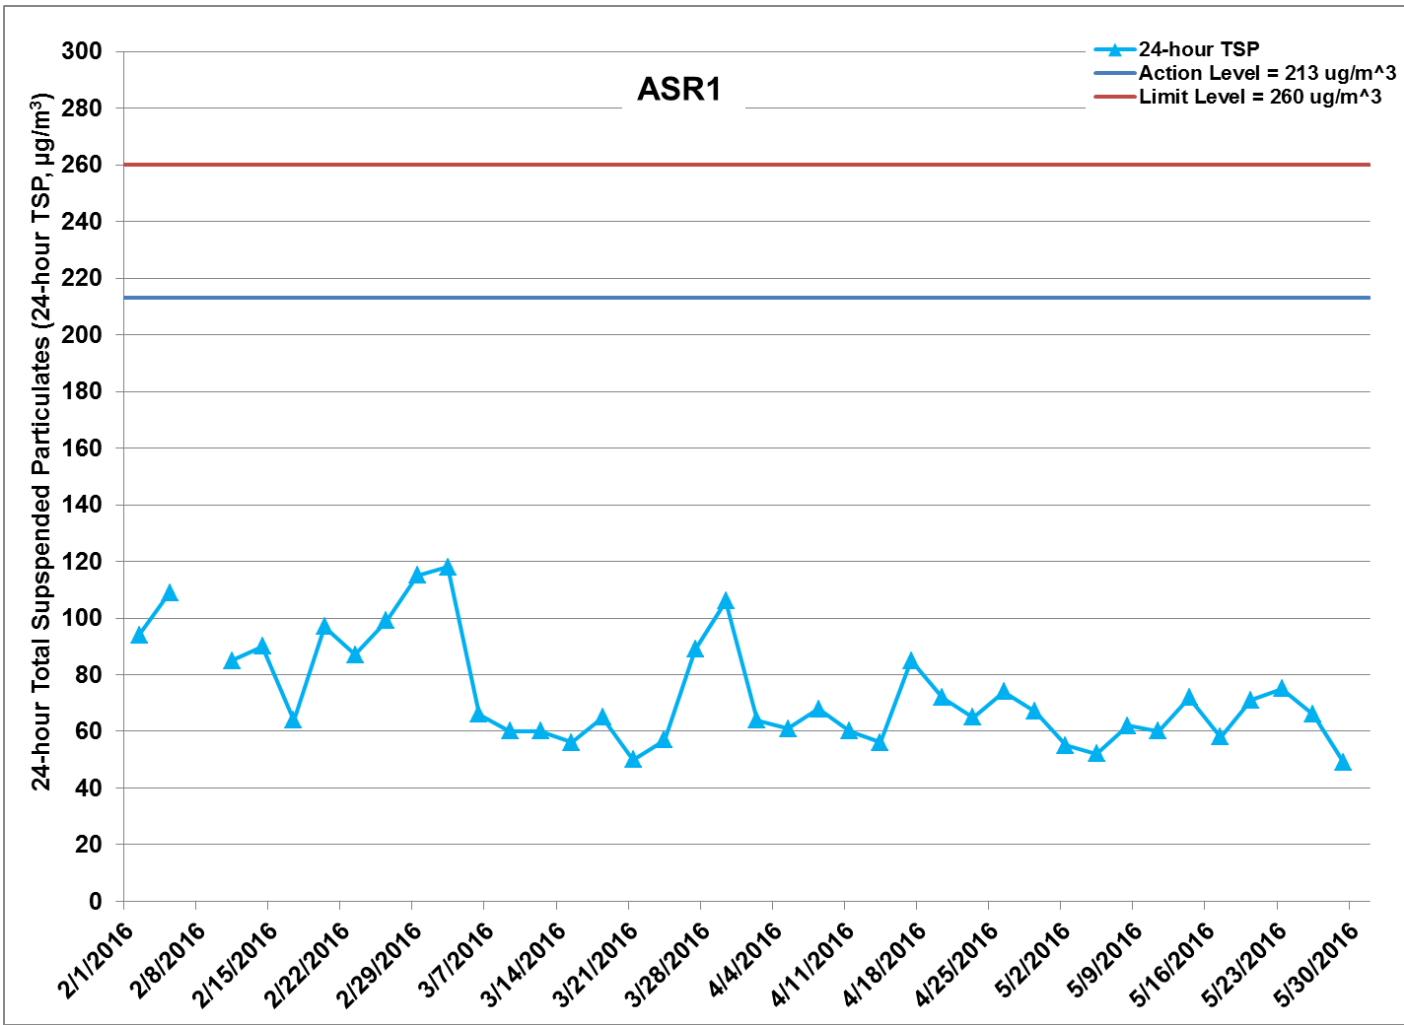
Figure F.6 Impact Monitoring - 24-hour Total Suspended Particulates ( $\mu\text{g}/\text{m}^3$ ) at ASR1 between 1 February 2016 and 31 May 2016 during impact monitoring period. The weather conditions during the monitoring period varied from sunny to cloudy. Major land-based construction activities included: CSM Ground Treatment and Diaphragm Wall Construction (1/4/2016 - 31/5/2016) and Box Culvert Extension (1/2/2016 - 31/5/2016). Ref: 0212330\_Impact AQM graphs\_ May 2016\_REV a.xlsx

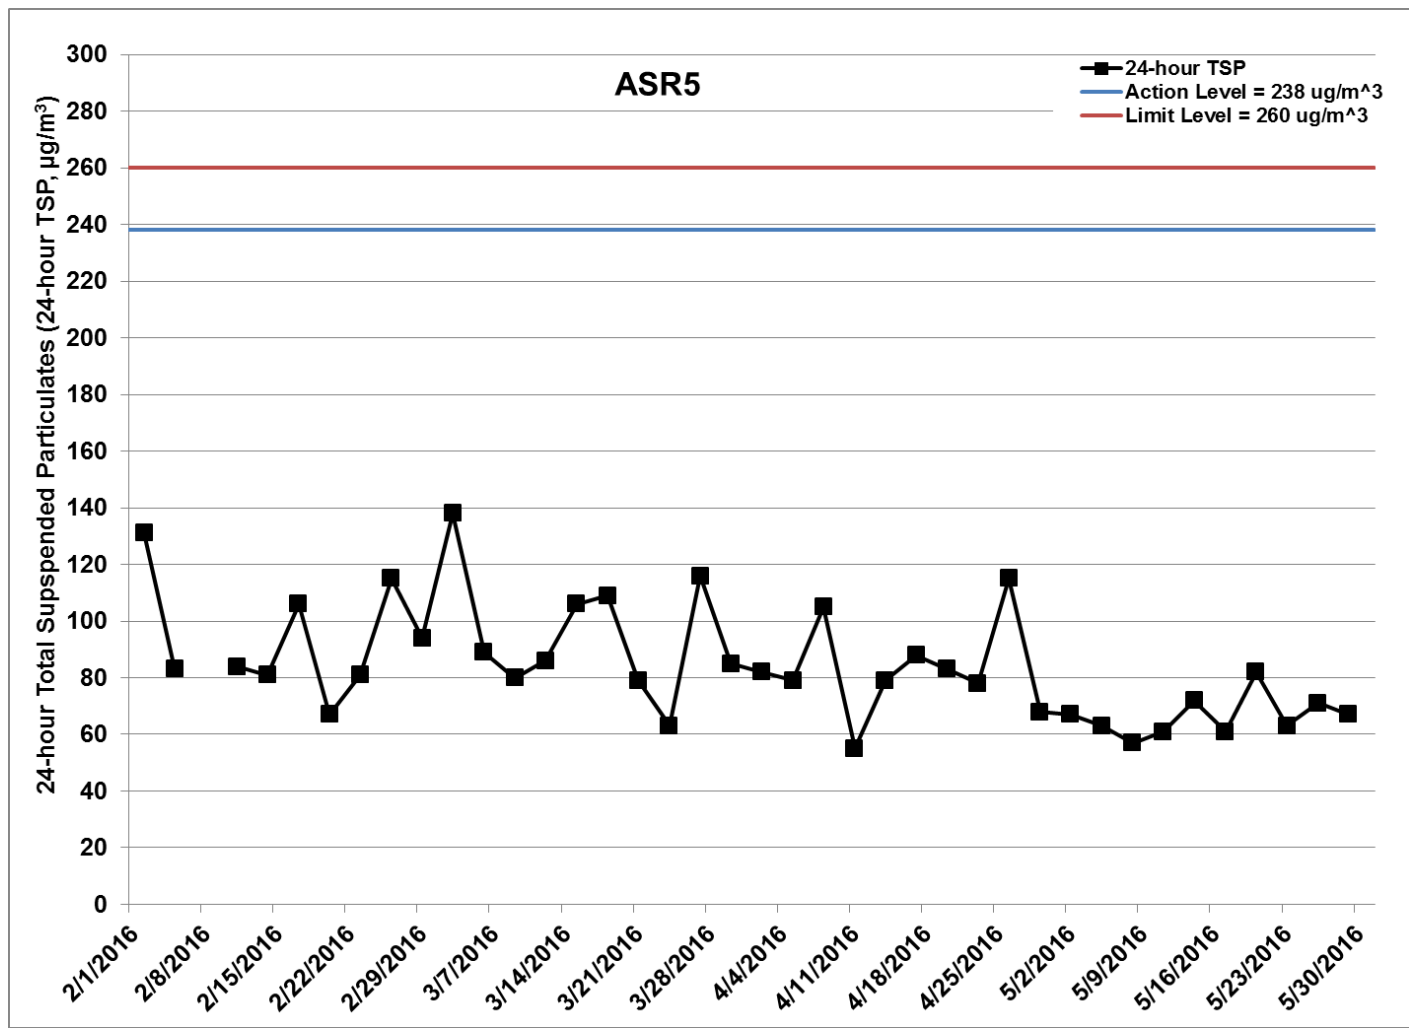
Figure F.7 Impact Monitoring - 24-hour Total Suspended Particulates ( $\mu\text{g}/\text{m}^3$ ) at ASR5 between 1 February 2016 and 31 May 2016 during impact monitoring period. The weather conditions during the monitoring period varied from sunny to cloudy. Major land-based construction activities included: CSM Ground Treatment and Diaphragm Wall Construction (1/4/2016 - 31/5/2016) and Box Culvert Extension (1/2/2016 - 31/5/2016). Ref: 0212330\_Impact AQM graphs\_ May 2016\_REV a.xlsx

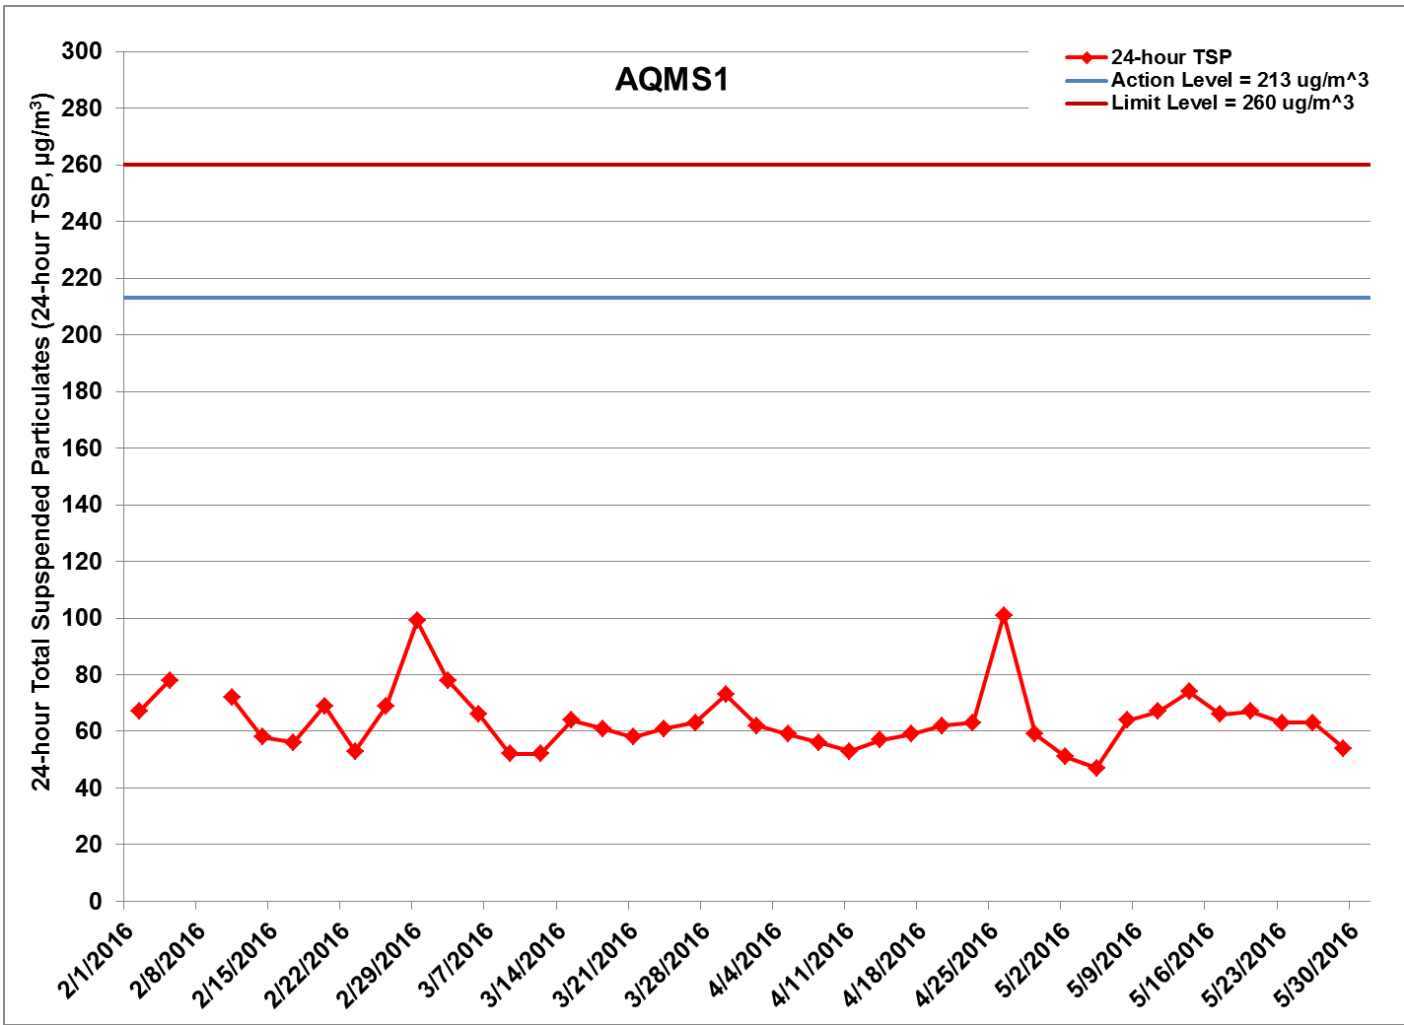
Figure F.8 Impact Monitoring - 24-hour Total Suspended Particulates ( $\mu\text{g}/\text{m}^3$ ) at AQMS1 between 1 February 2016 and 31 May 2016 during impact monitoring period. The weather conditions during the monitoring period varied from sunny to cloudy. Major land-based construction activities included: CSM Ground Treatment and Diaphragm Wall Construction (1/4/2016 - 31/5/2016) and Box Culvert Extension (1/2/2016 - 31/5/2016). Ref: 0212330\_Impact AQM graphs\_ May 2016\_REV a.xlsx

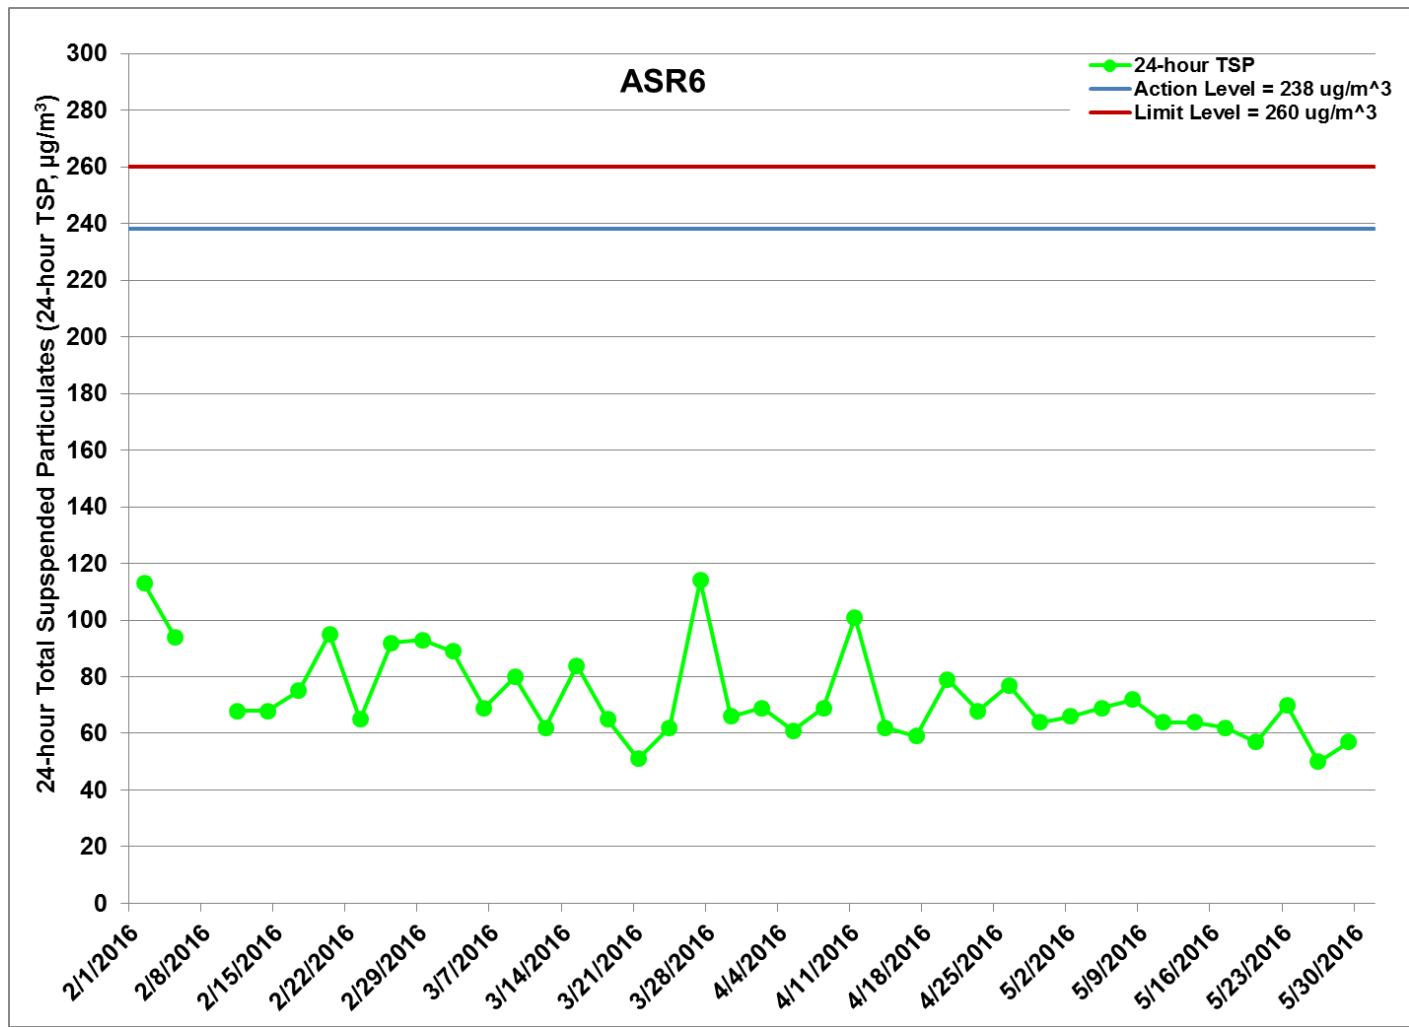
Figure F.9 Impact Monitoring - 24-hour Total Suspended Particulates ( $\mu\text{g}/\text{m}^3$ ) at ASR6 between 1 February 2016 and 31 May 2016 during impact monitoring period. The weather conditions during the monitoring period varied from sunny to cloudy. Major land-based construction activities included: CSM Ground Treatment and Diaphragm Wall Construction (1/4/2016 - 31/5/2016) and Box Culvert Extension (1/2/2016 - 31/5/2016). Ref: 0212330\_Impact AQM graphs\_ May 2016\_REV a.xlsx

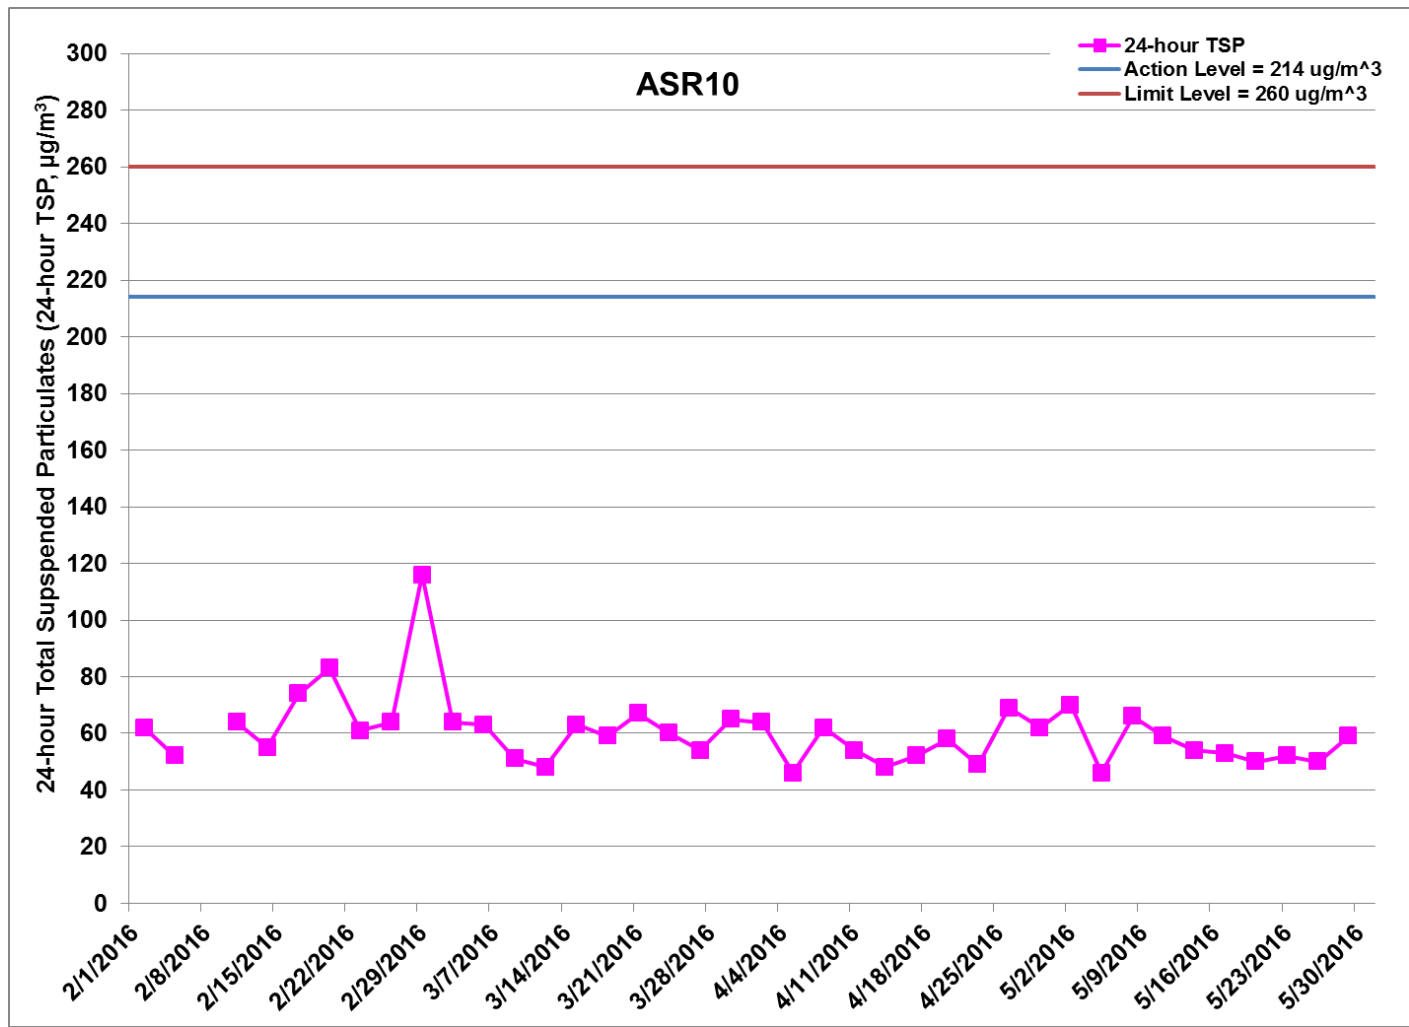
Figure F.10 Impact Monitoring - 24-hour Total Suspended Particulates ( $\mu\text{g}/\text{m}^3$ ) at ASR10 between 1 February 2016 and 31 May 2016 during impact monitoring period. The weather conditions during the monitoring period varied from sunny to cloudy. Major land-based construction activities included: CSM Ground Treatment and Diaphragm Wall Construction (1/4/2016 - 31/5/2016) and Box Culvert Extension (1/2/2016 - 31/5/2016). Ref: 0212330\_Impact AQM graphs\_ May 2016\_REV a.xlsx

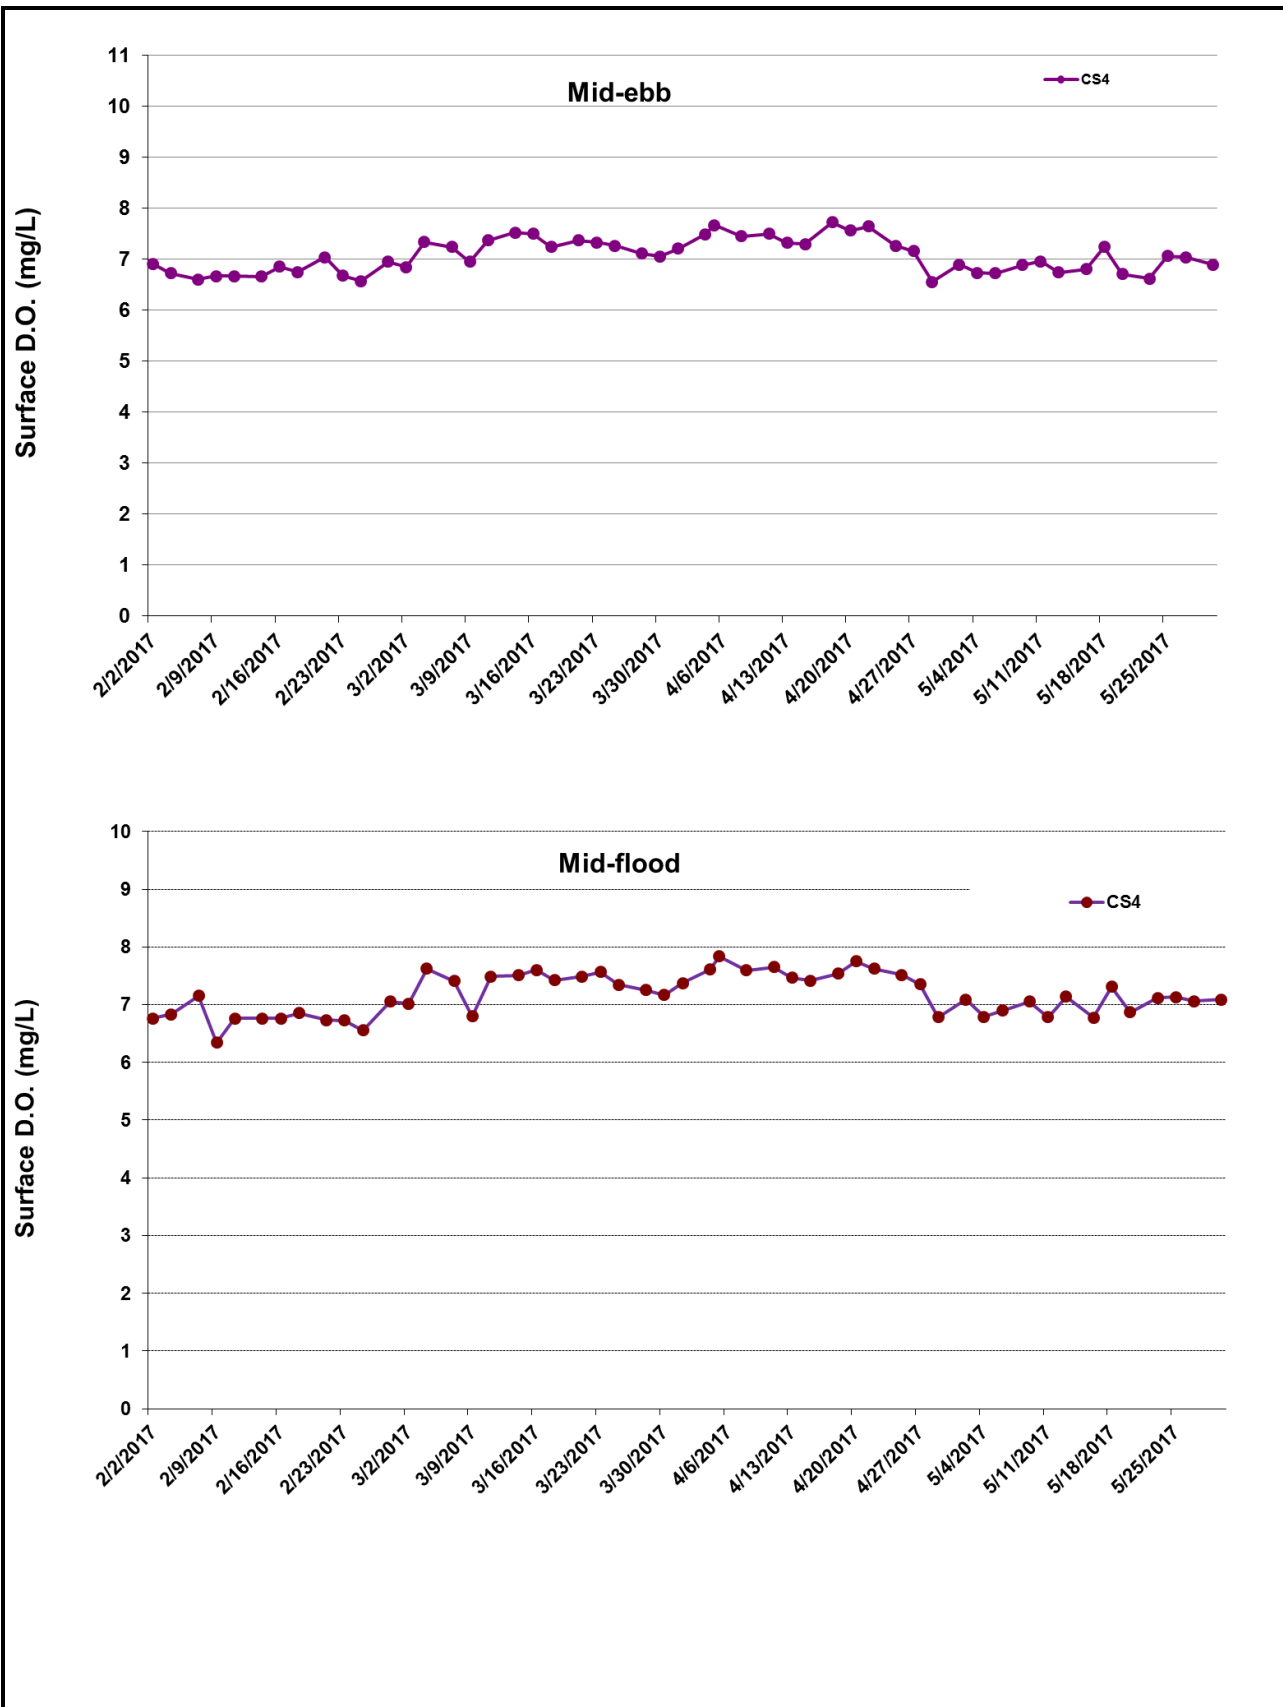
Figure G1 Impact Monitoring - Mean Level of Dissolved Oxygen (mg/L) in surface waters between 1 February 2017 and 31 May 2017 at CS4. The weather conditions during the monitoring period varied mostly from sunny to cloudy. Major marine works included: Filling works at Portion N-A (1/3/2017 - 20/5/2017).
