**Contract No. HY/2012/08  
Tuen Mun – Chek Lap Kok Link –  
Northern Connection Sub-sea Tunnel  
Section**

*Fourteenth Quarterly Environmental Monitoring  
& Audit (EM&A) Report*

**Contract No. HY/2012/08 TM-CLKL Northern Connection Sub-sea  
Tunnel Section  
Fourteenth Quarterly EM&A Report (March 2017 – May 2017)**

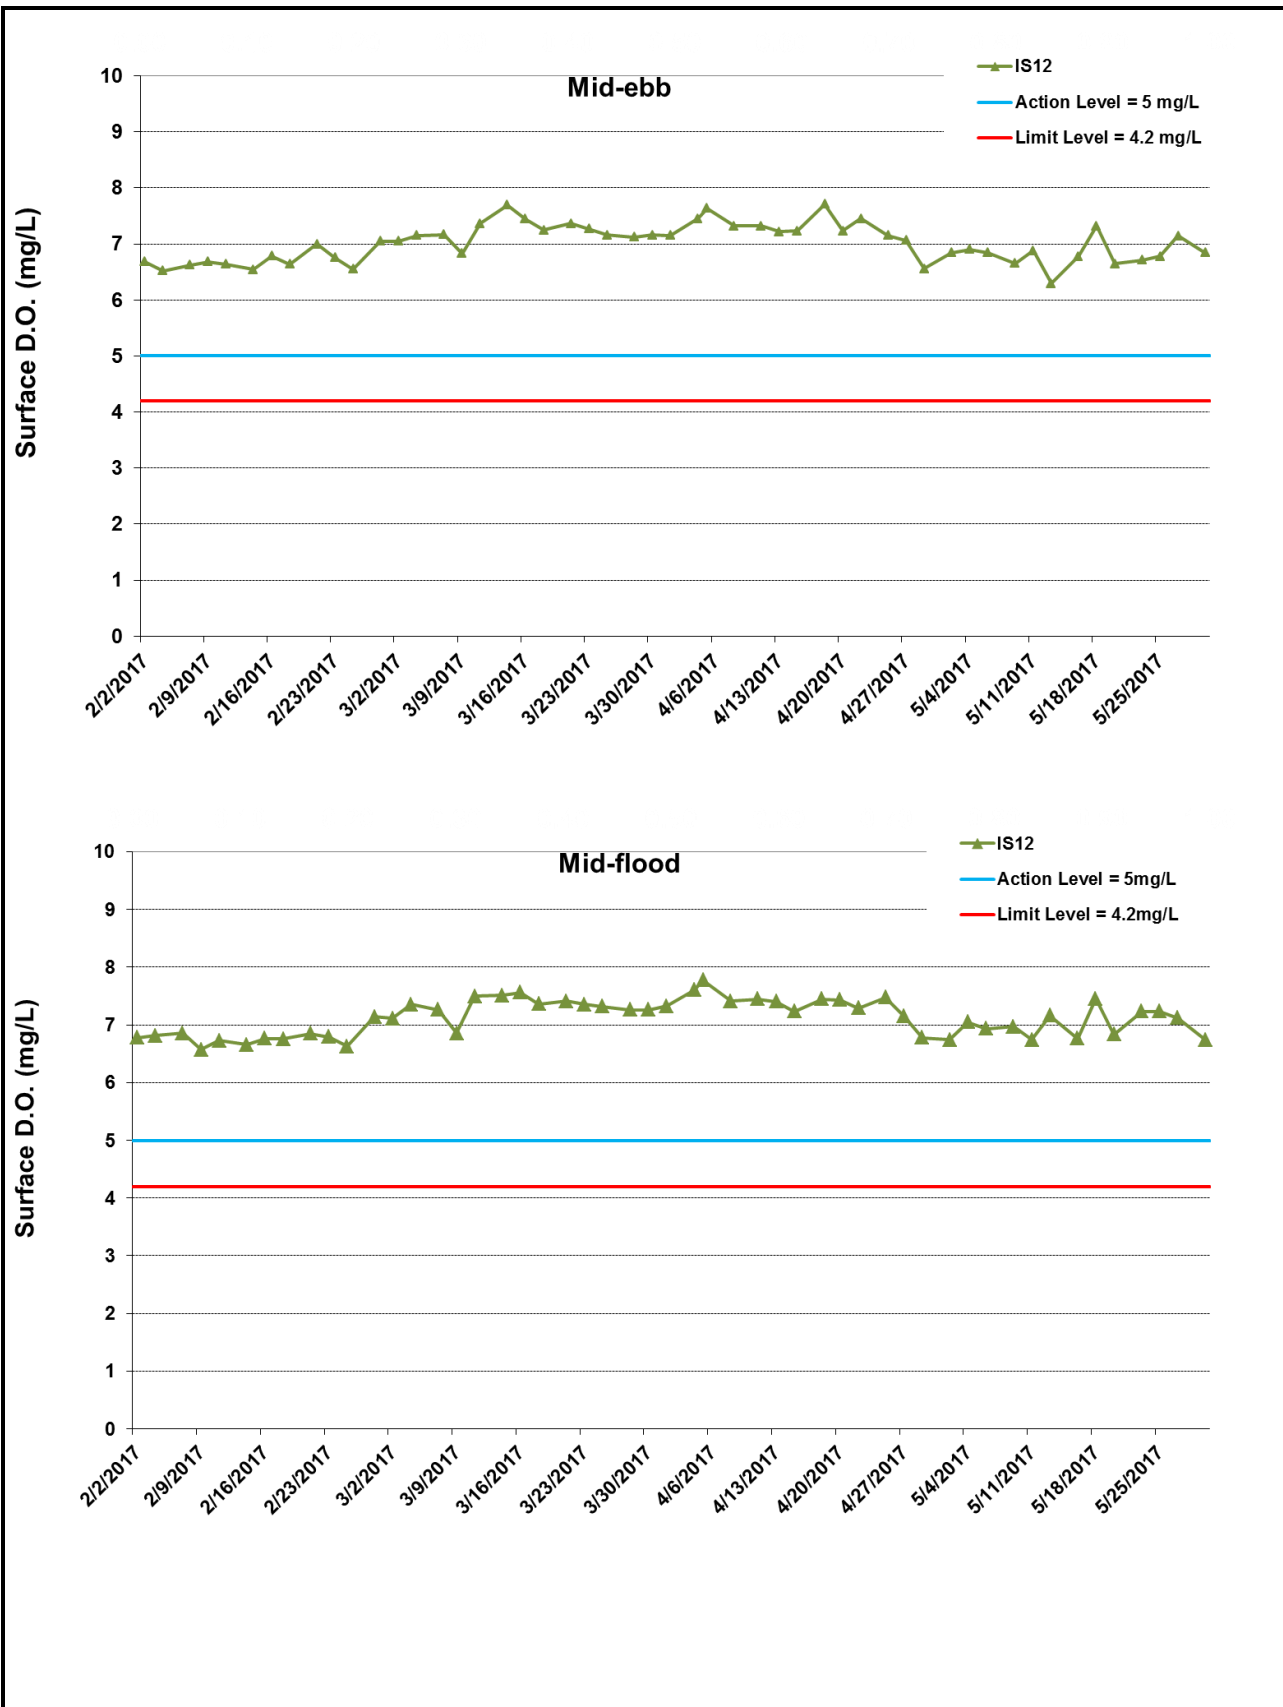
Figure G3 Impact Monitoring - Mean Level of Dissolved Oxygen (mg/L) in surface waters between 1 February 2017 and 31 May 2017 at IS12. The weather conditions during the monitoring period varied mostly from sunny to cloudy. Major marine works included: Filling works at Portion N-A (1/3/2017 - 20/5/2017).

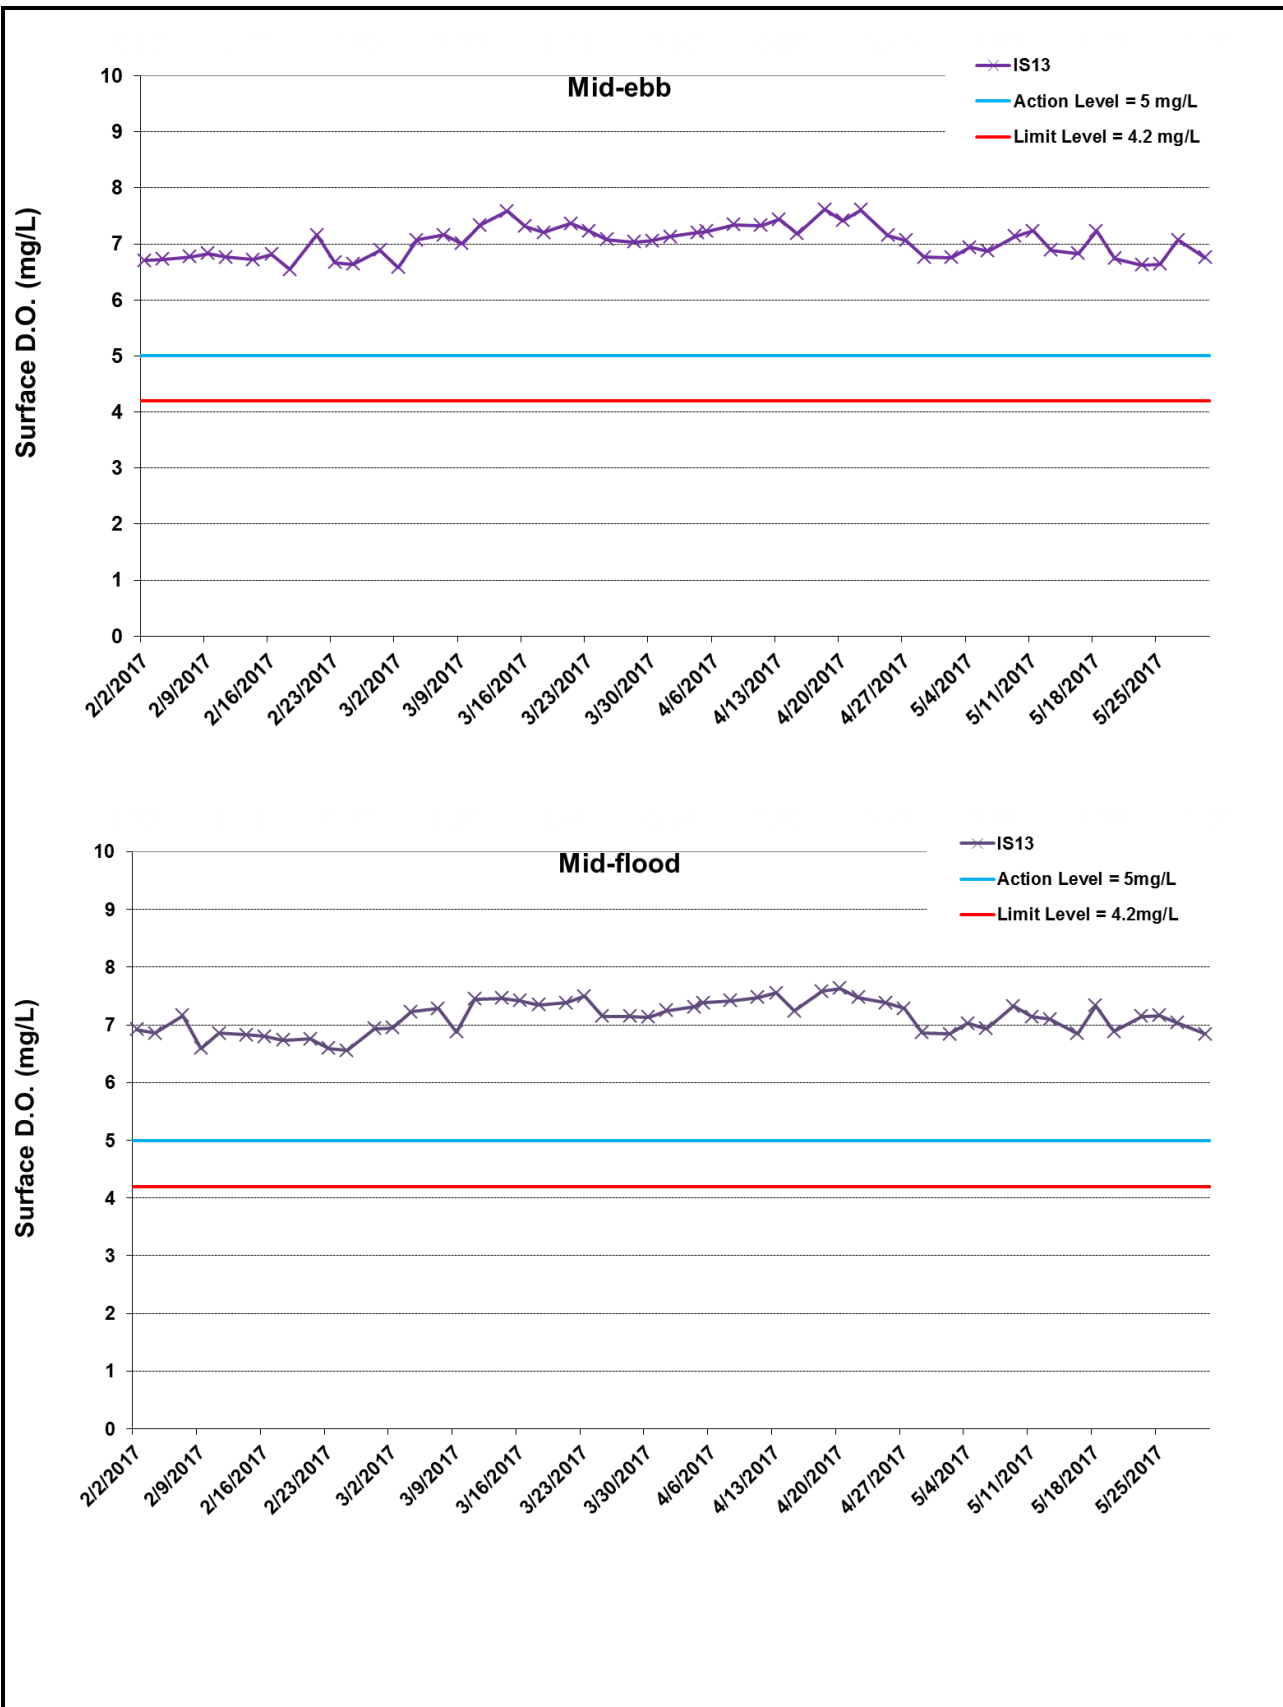
Figure G4 Impact Monitoring - Mean Level of Dissolved Oxygen (mg/L) in surface waters between 1 February 2017 and 31 May 2017 at IS13. The weather conditions during the monitoring period varied mostly from sunny to cloudy. Major marine works included: Filling works at Portion N-A (1/3/2017 - 20/5/2017).

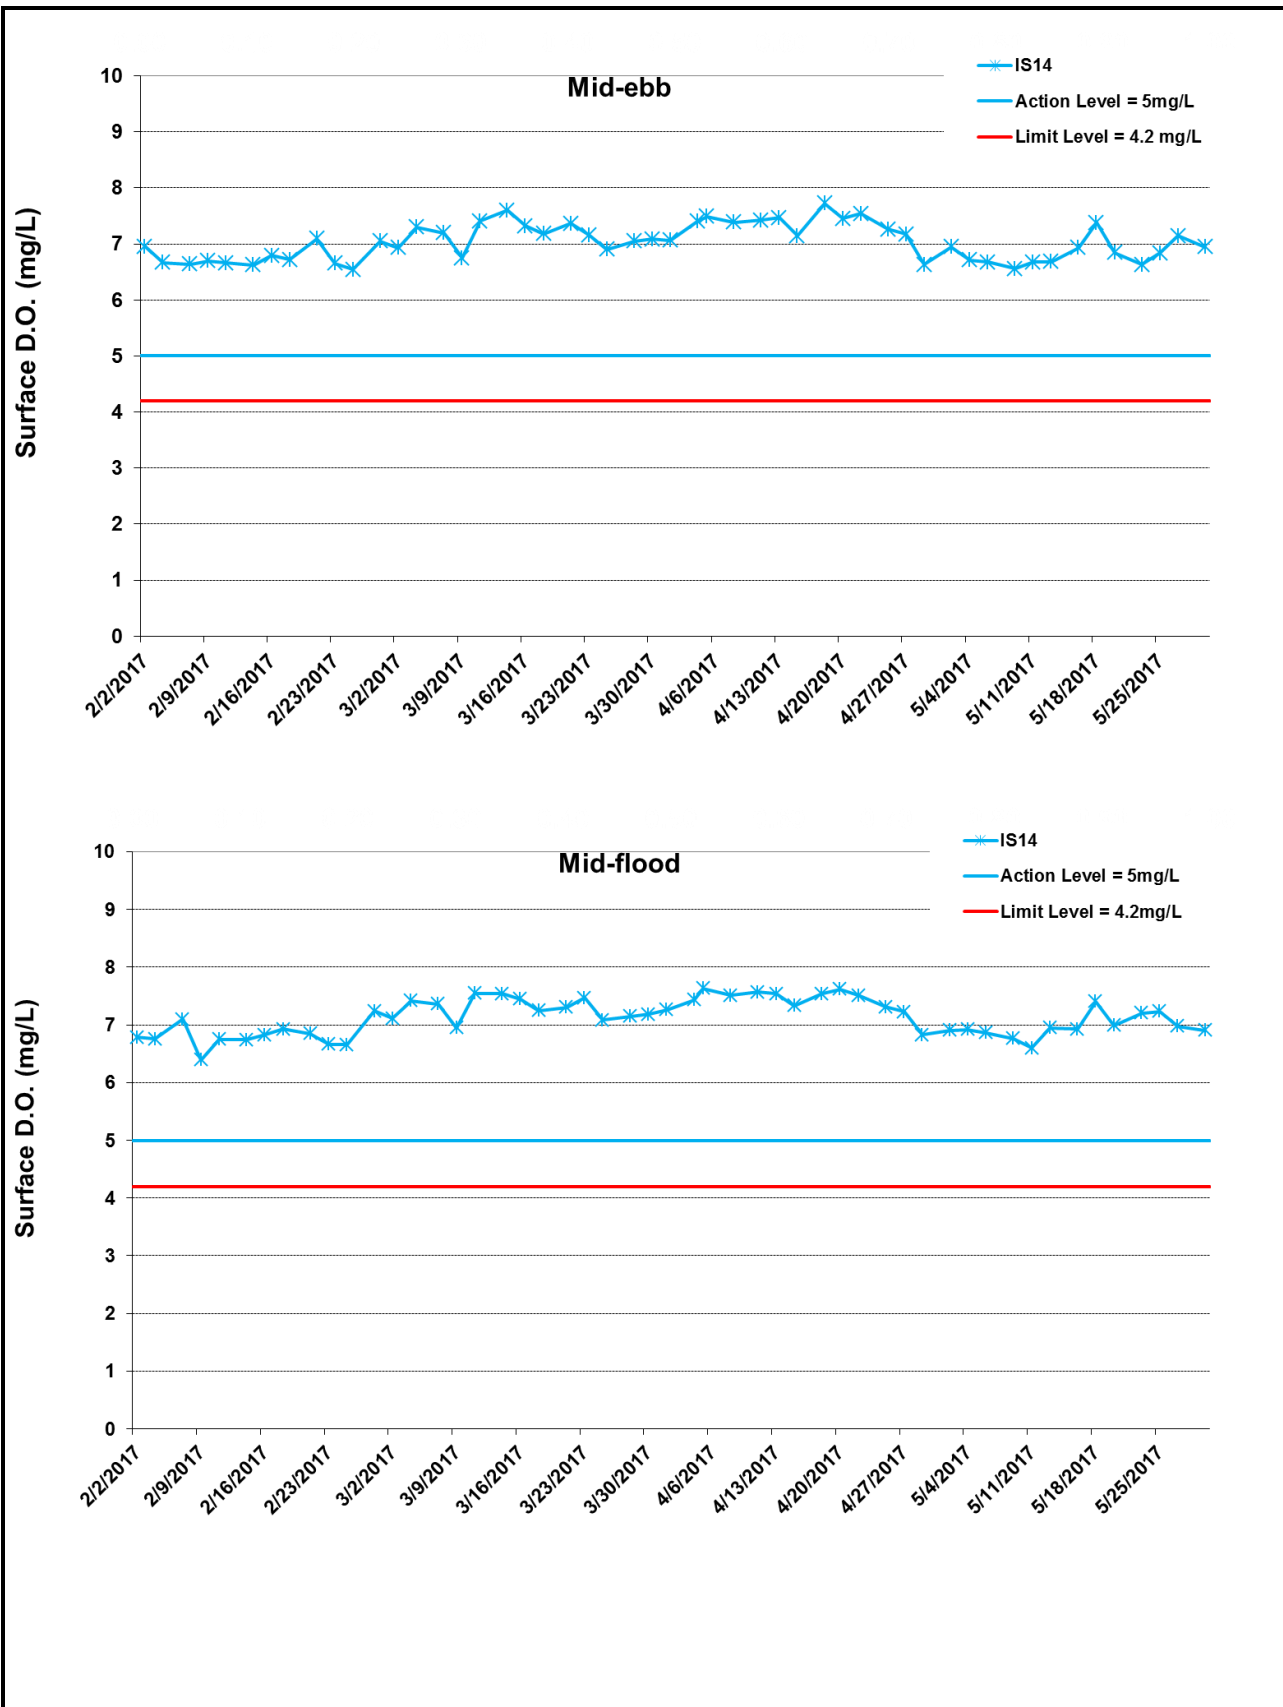
Figure G5 Impact Monitoring - Mean Level of Dissolved Oxygen (mg/L) in surface waters between 1 February 2017 and 31 May 2017 at IS14. The weather conditions during the monitoring period varied mostly from sunny to cloudy. Major marine works included: Filling works at Portion N-A (1/3/2017 - 20/5/2017).

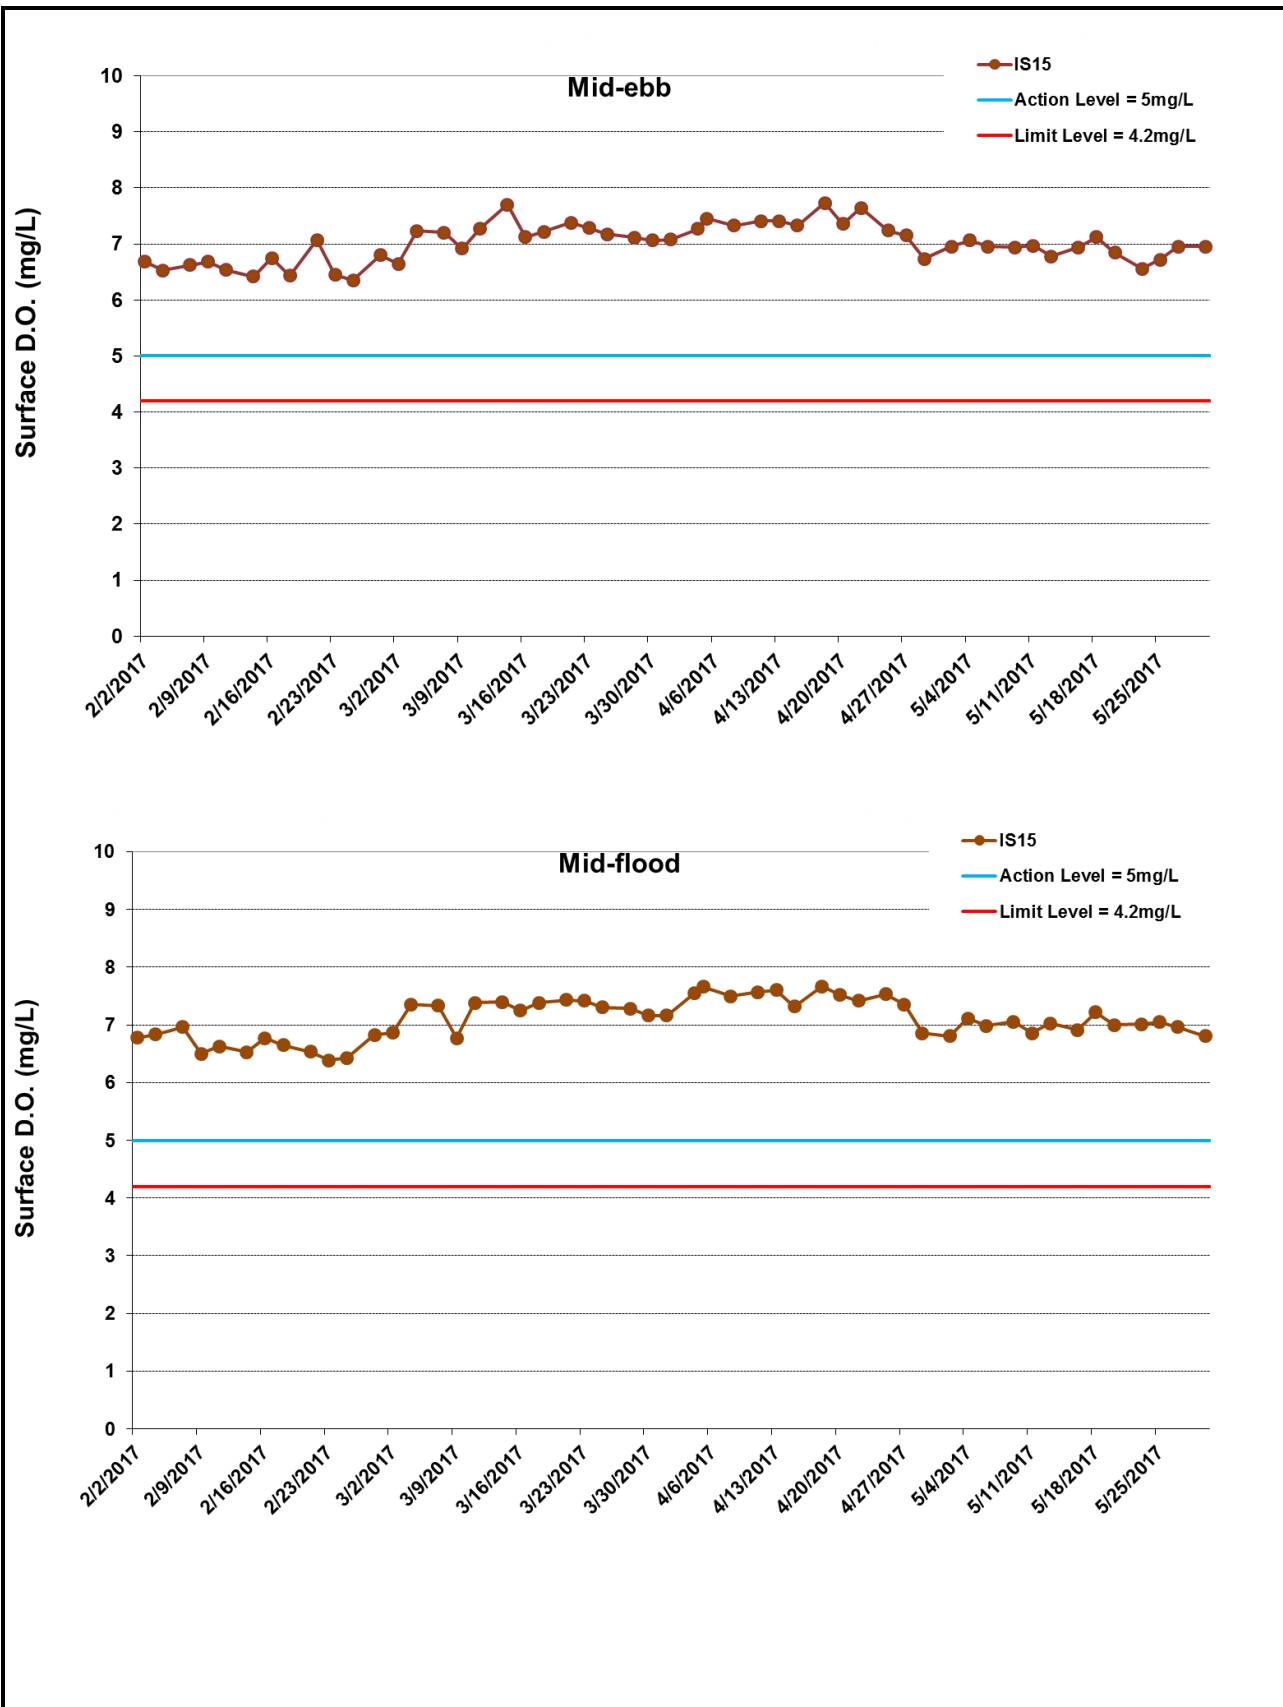
Figure G6 Impact Monitoring - Mean Level of Dissolved Oxygen (mg/L) in surface waters between 1 February 2017 and 31 May 2017 at IS15. The weather conditions during the monitoring period varied mostly from sunny to cloudy. Major marine works included: Filling works at Portion N-A (1/3/2017 - 20/5/2017).

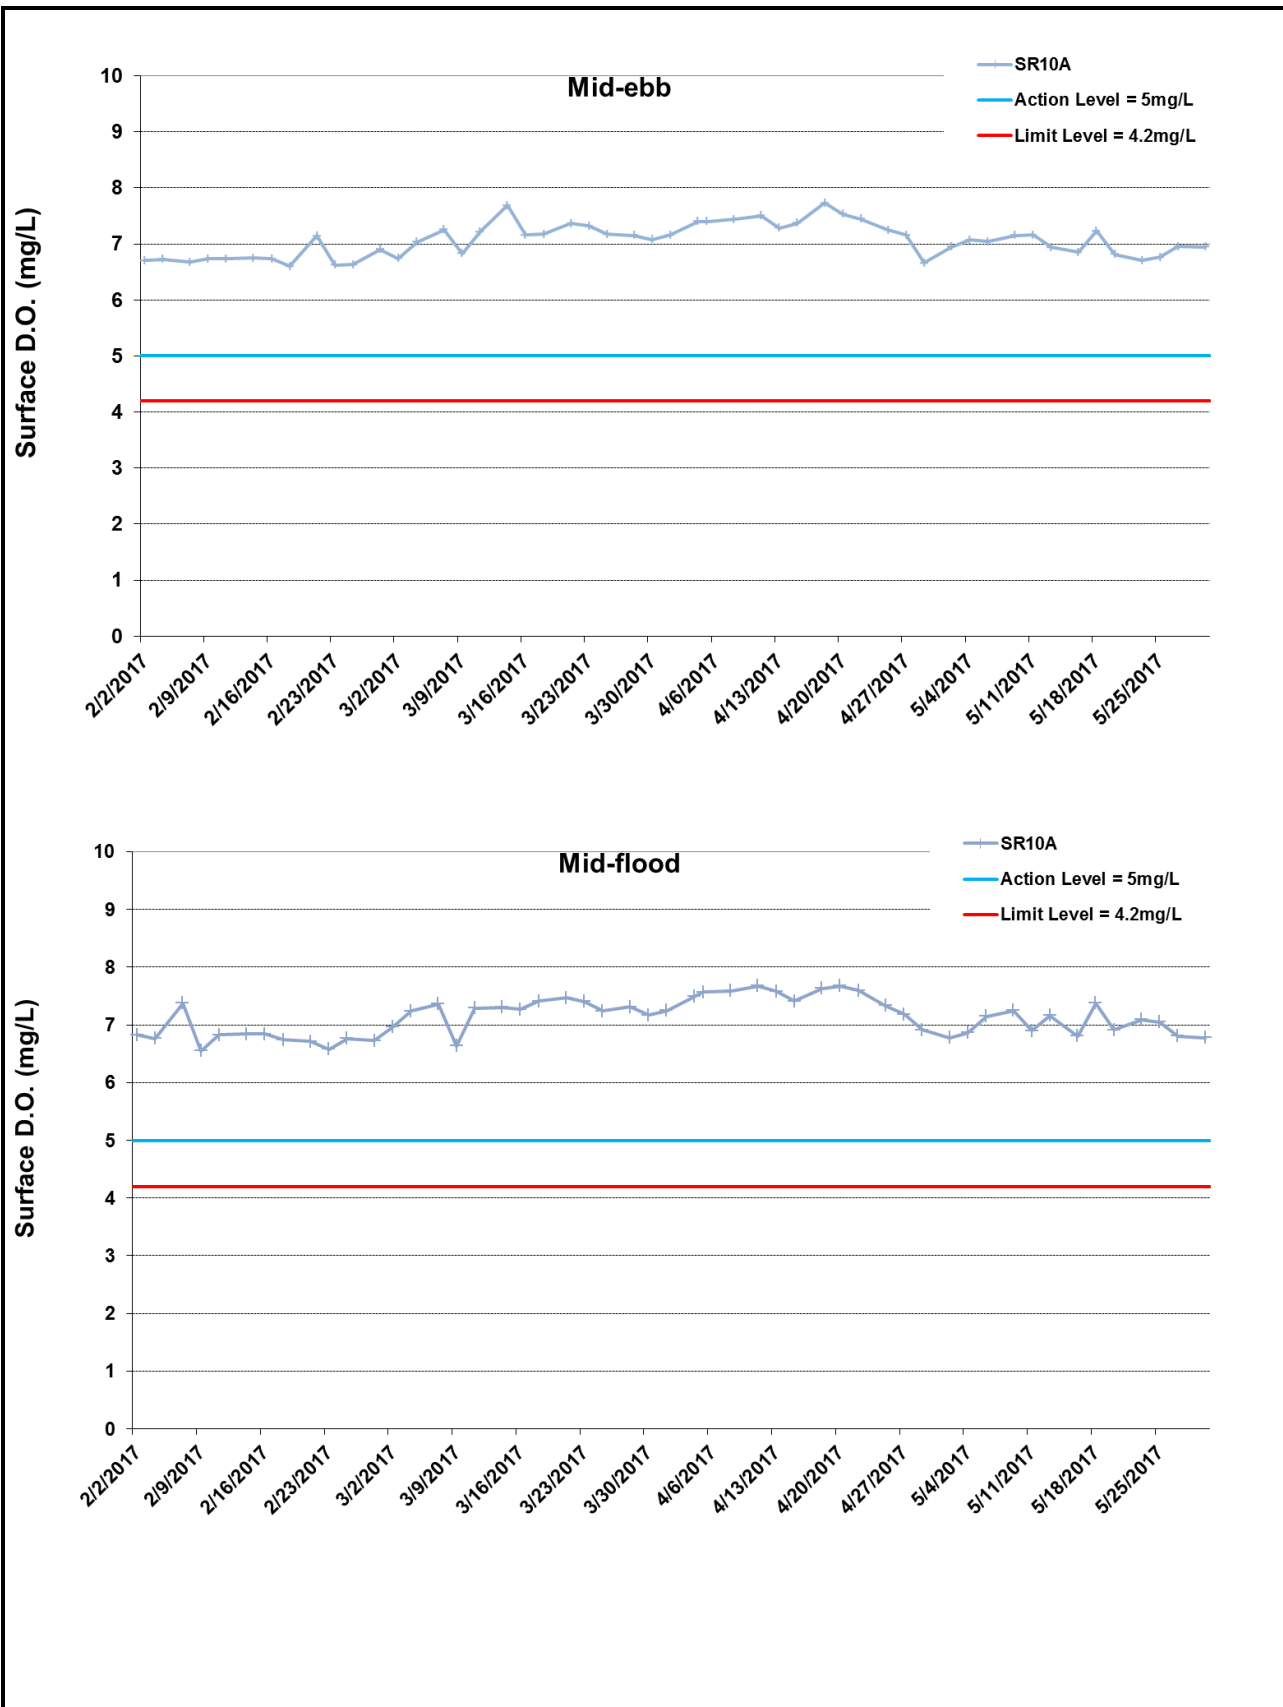
Figure G7 Impact Monitoring - Mean Level of Dissolved Oxygen (mg/L) in surface waters between 1 February 2017 and 31 May 2017 at SR10A. The weather conditions during the monitoring period varied mostly from sunny to cloudy. Major marine works included: Filling works at Portion N-A (1/3/2017 - 20/5/2017).

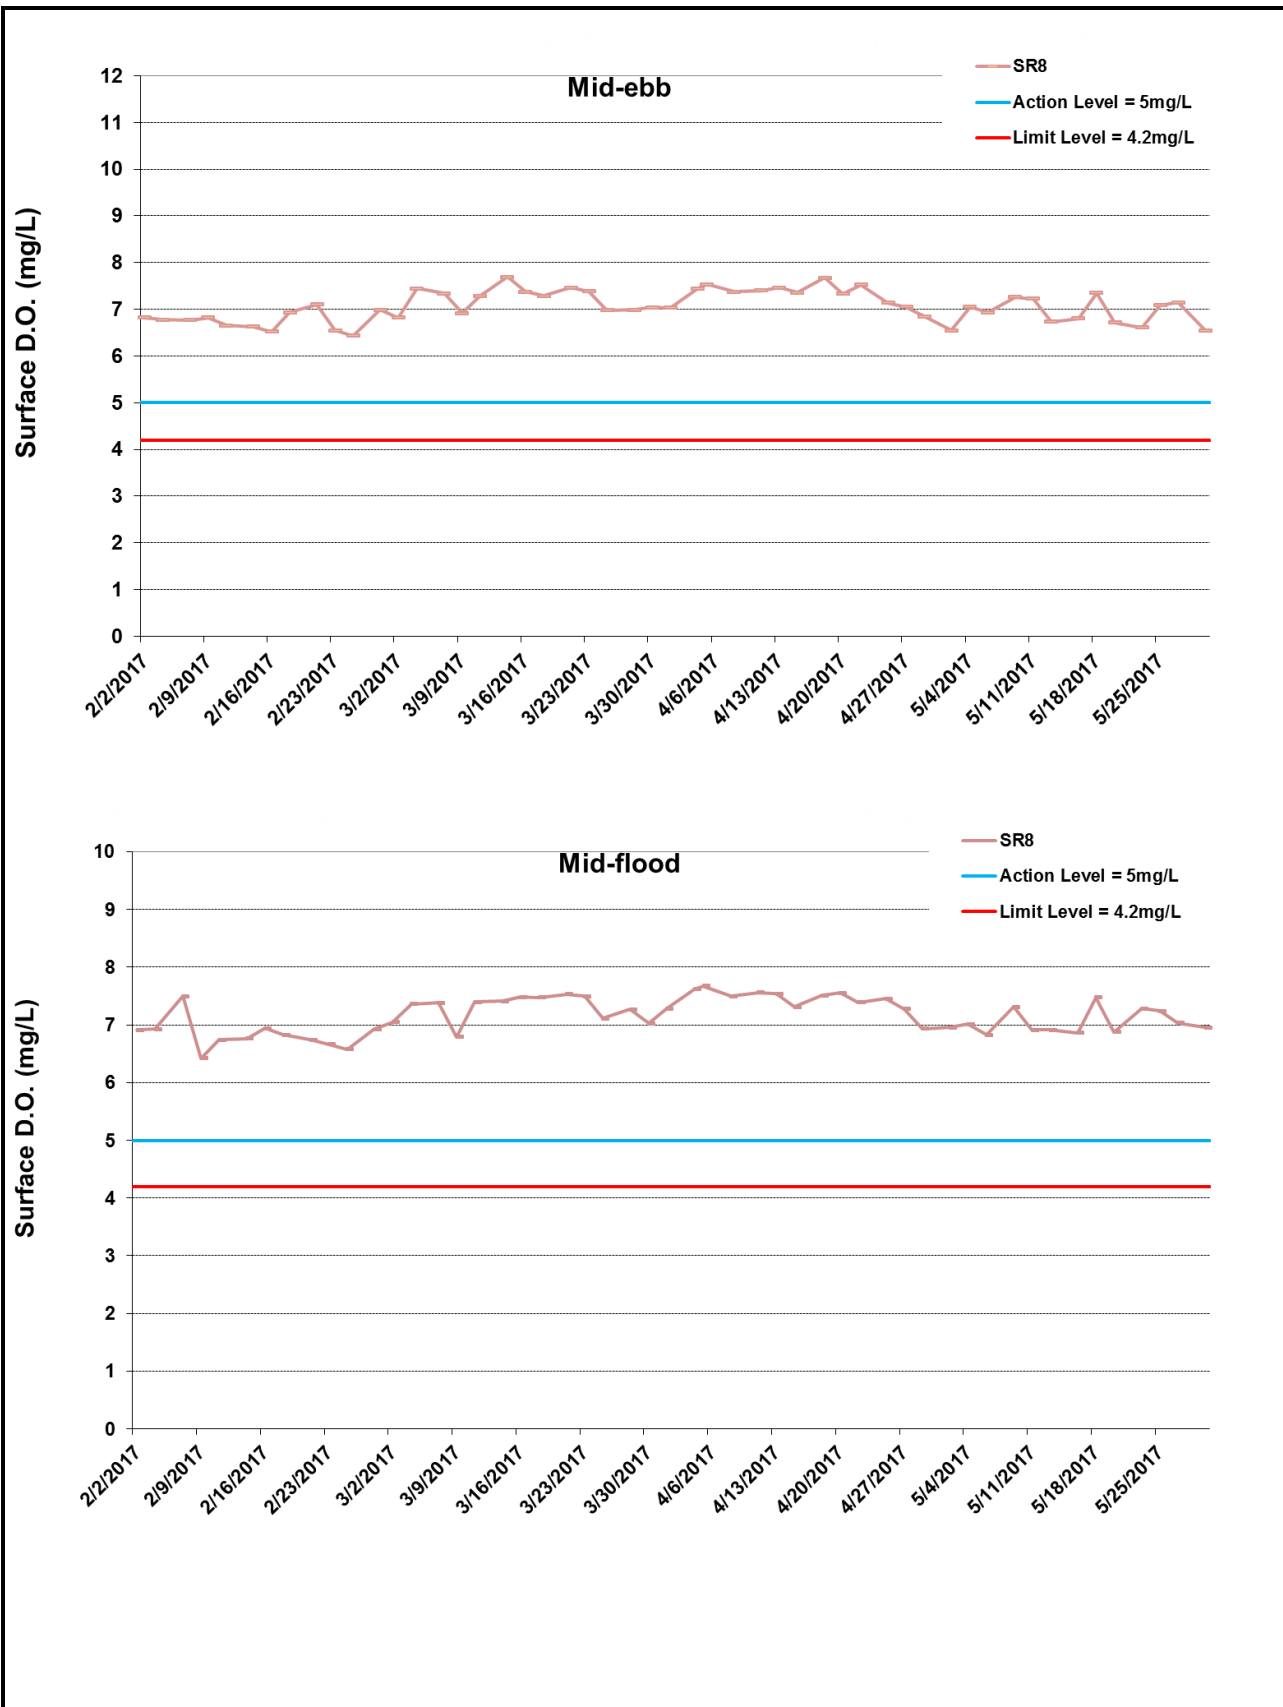
Figure G8 Impact Monitoring - Mean Level of Dissolved Oxygen (mg/L) in surface waters between 1 February 2017 and 31 May 2017 at SR8. The weather conditions during the monitoring period varied mostly from sunny to cloudy. Major marine works included: Filling works at Portion N-A (1/3/2017 - 20/5/2017).

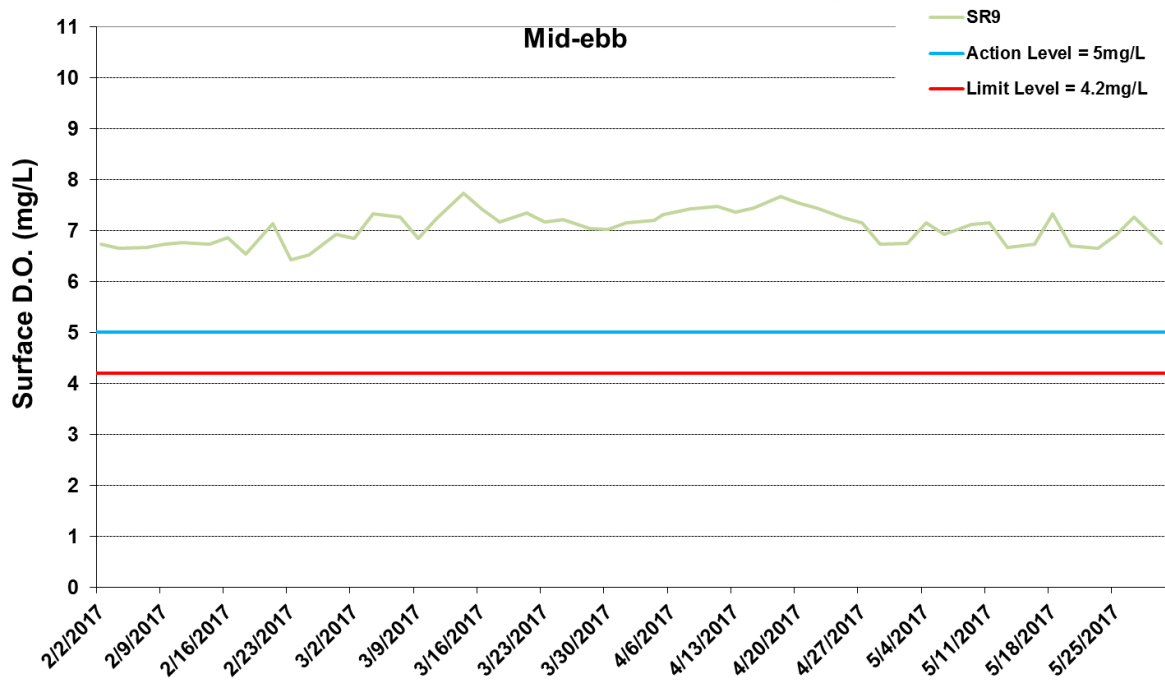
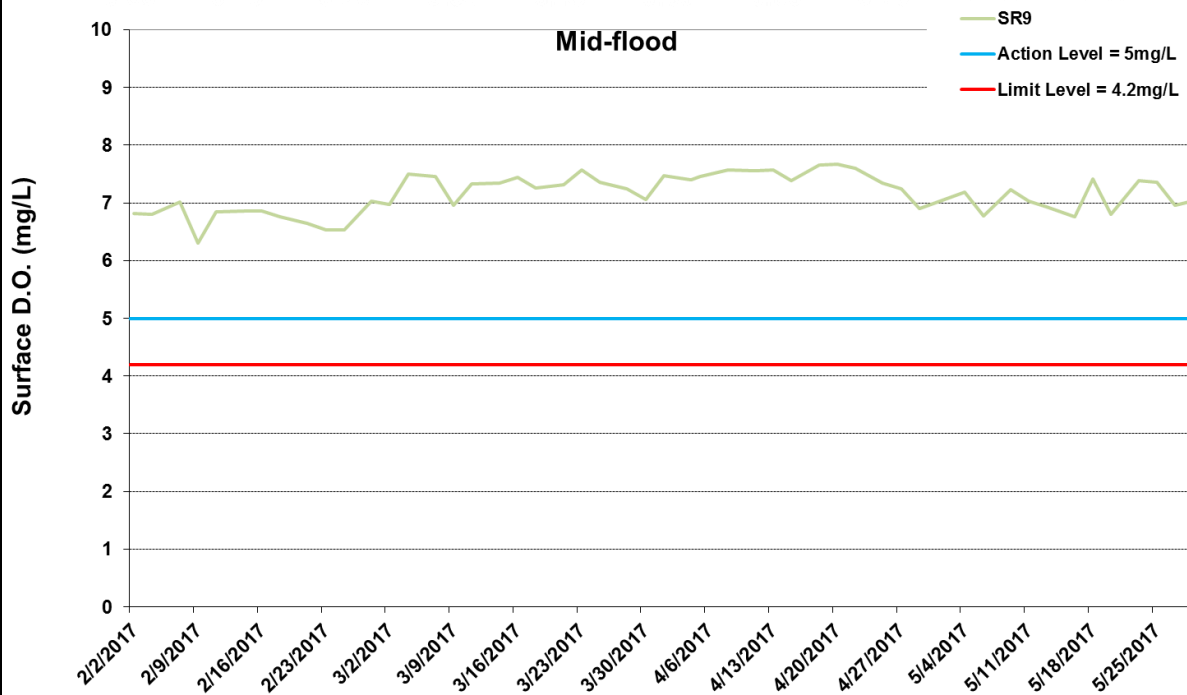
Figure G9 Impact Monitoring - Mean Level of Dissolved Oxygen (mg/L) in surface waters between 1 February 2017 and 31 May 2017 at SR9. The weather conditions during the monitoring period varied mostly from sunny to cloudy. Major marine works included: Filling works at Portion N-A (1/3/2017 - 20/5/2017).

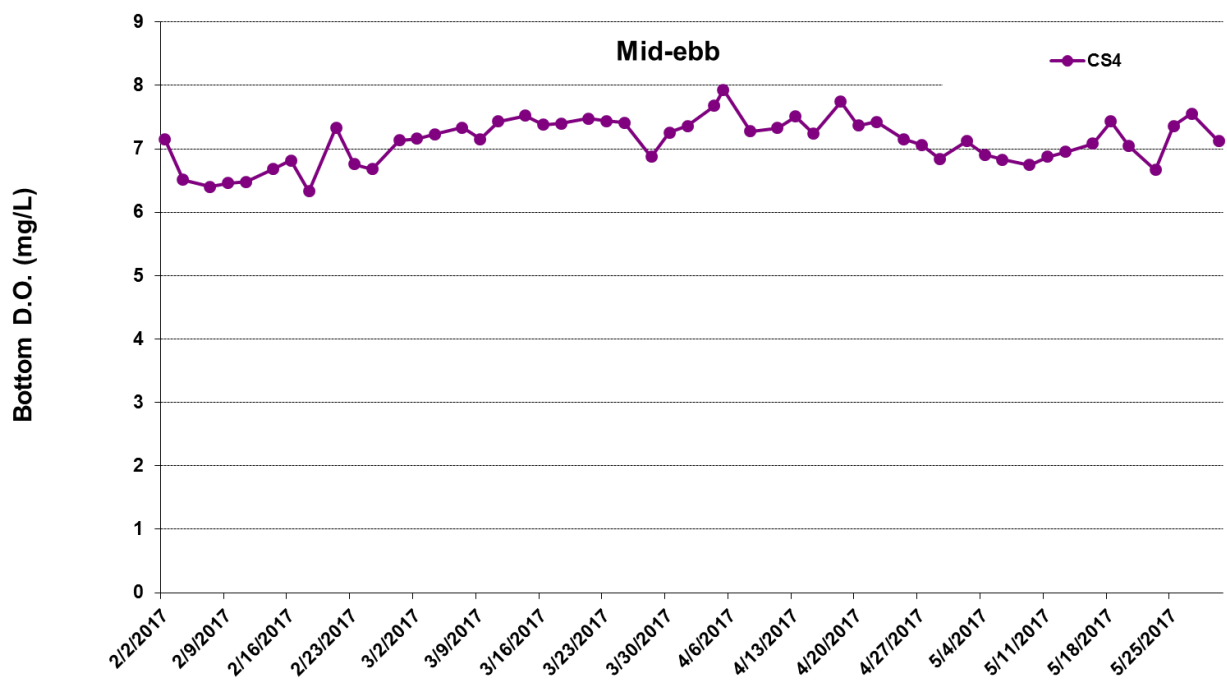
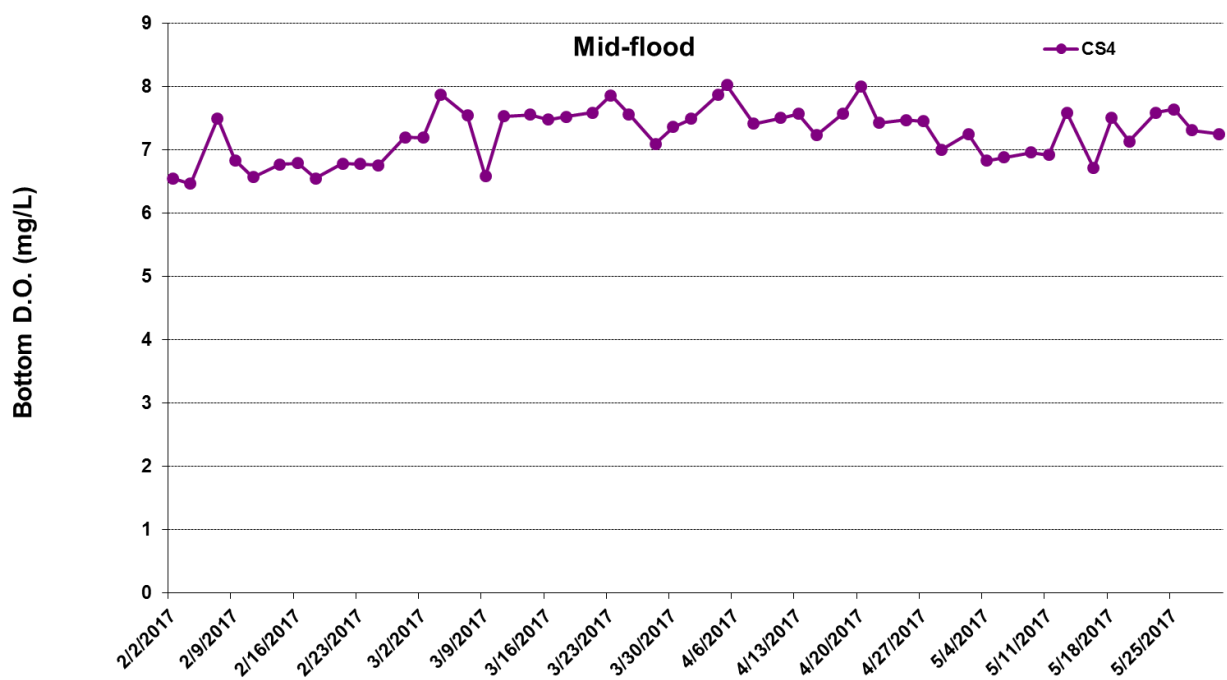
Figure G17 Impact Monitoring - Mean Level of Dissolved Oxygen (mg/L) in bottom water between 1 February 2017 and 31 May 2017 at CS4. The weather conditions during the monitoring period varied mostly from sunny to cloudy. Major marine works included: Filling works at Portion N-A (1/3/2017 - 20/5/2017).

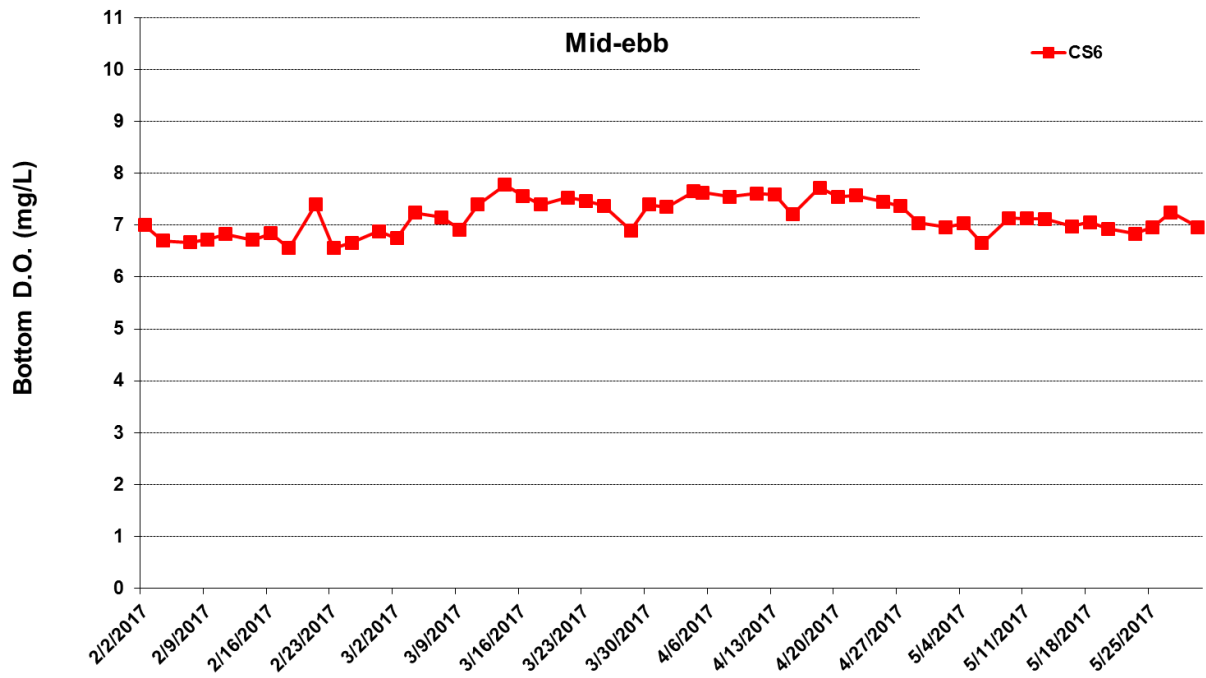
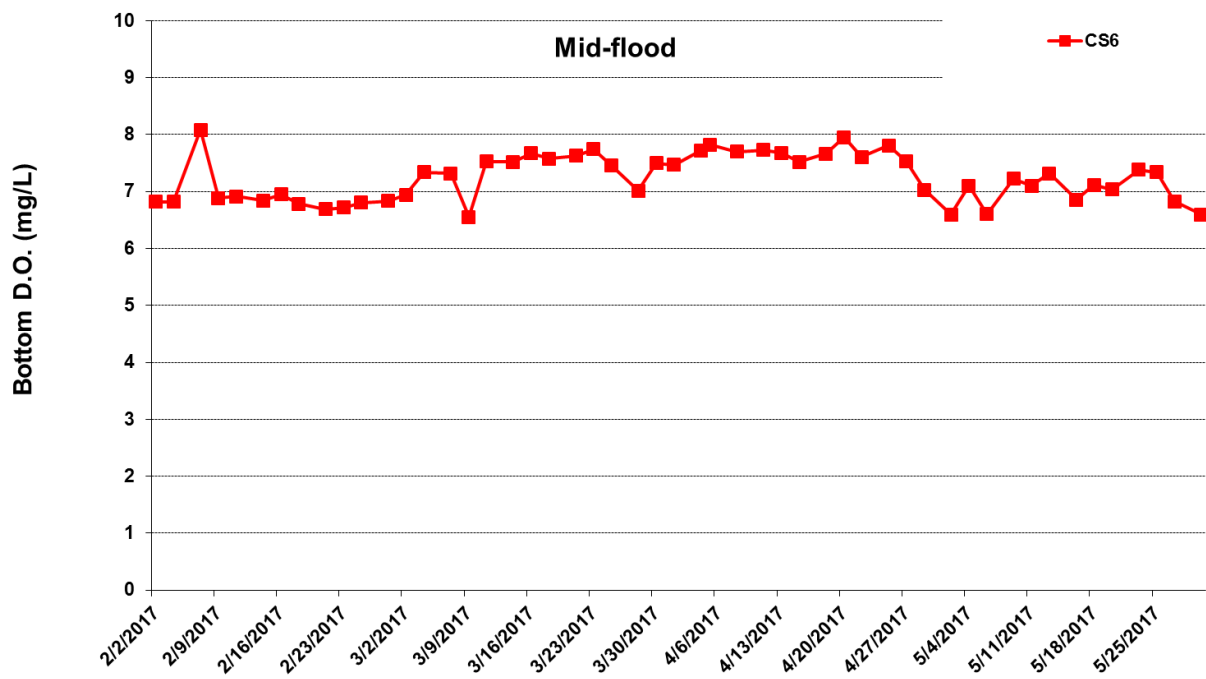
Figure G18 Impact Monitoring - Mean Level of Dissolved Oxygen (mg/L) in bottom water between 1 February 2017 and 31 May 2017 at CS6. The weather conditions during the monitoring period varied mostly from sunny to cloudy. Major marine works included: Filling works at Portion N-A (1/3/2017 - 20/5/2017).

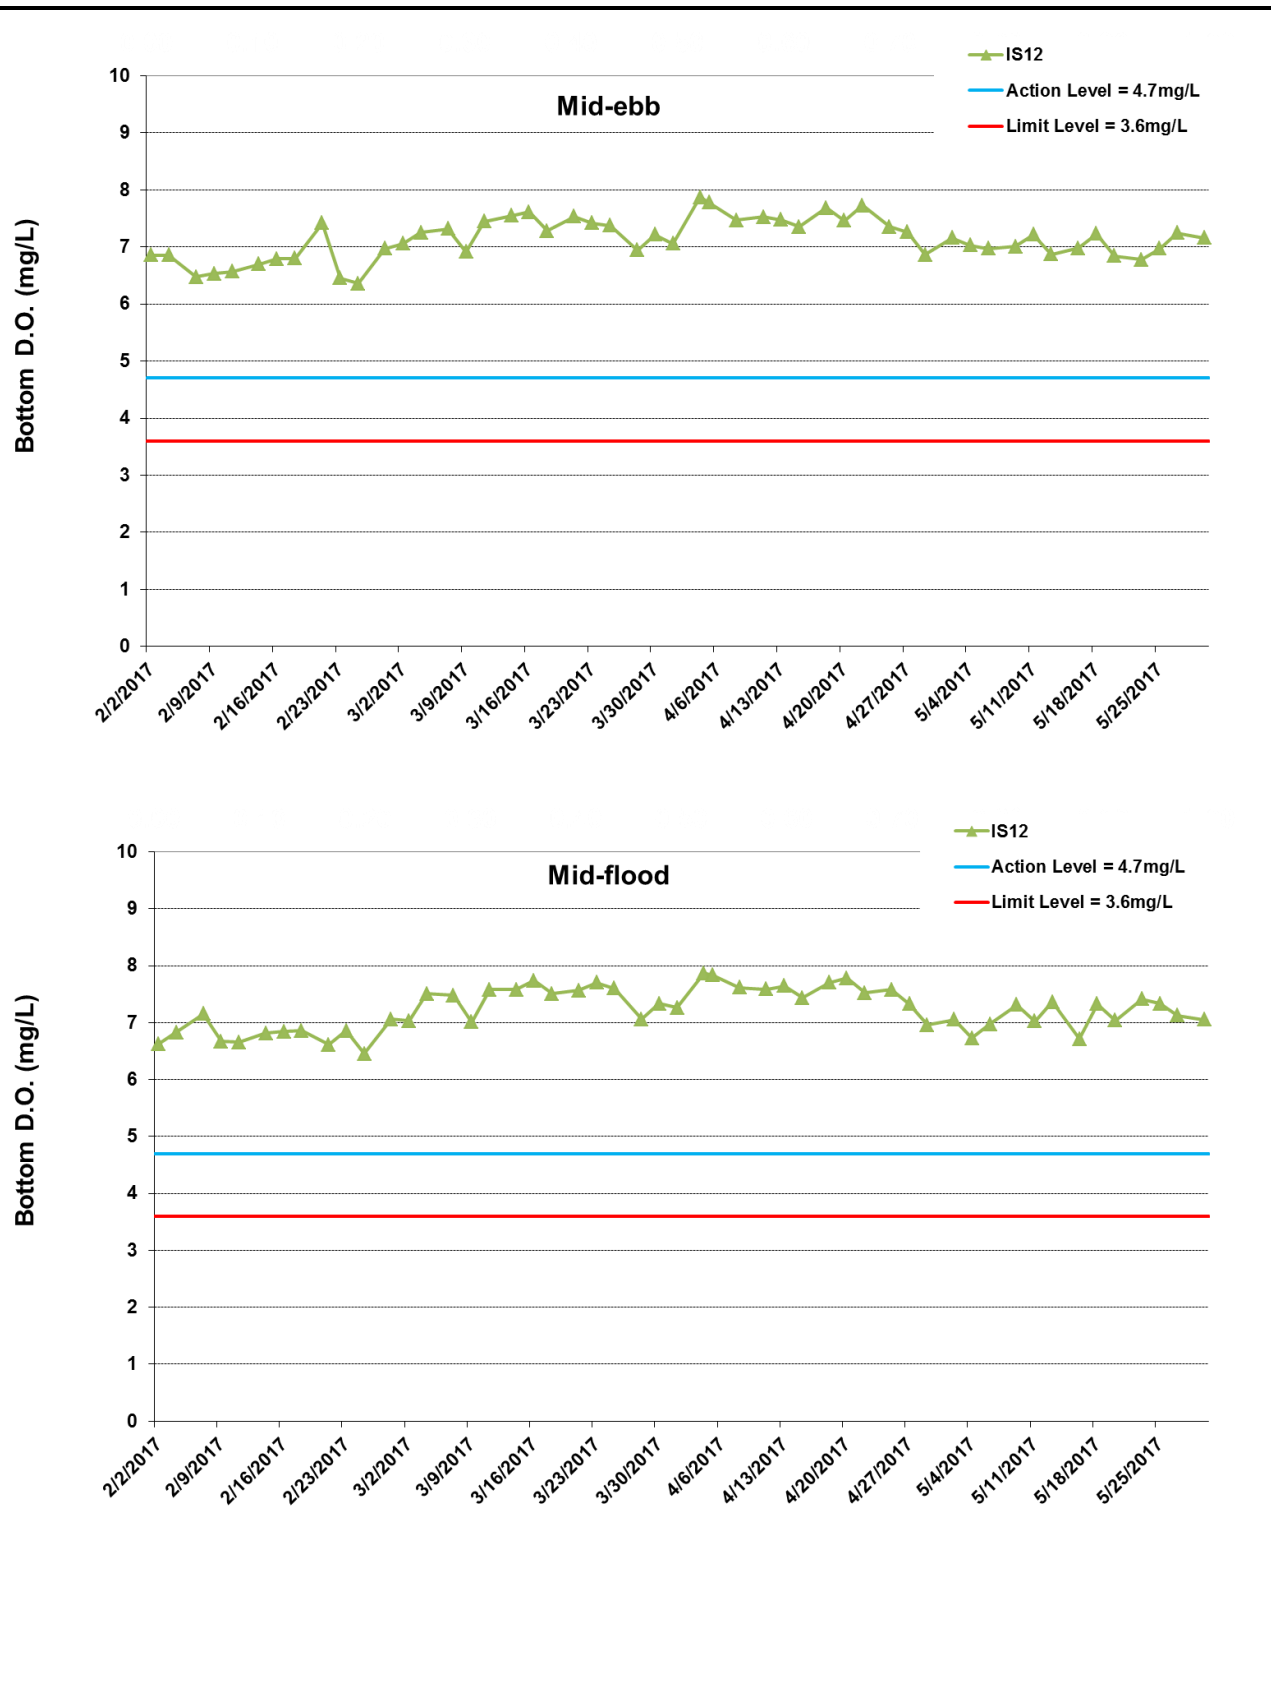
Figure G19 Impact Monitoring - Mean Level of Dissolved Oxygen (mg/L) in bottom water between 1 February 2017 and 31 May 2017 at IS12. The weather conditions during the monitoring period varied mostly from sunny to cloudy. Major marine works included: Filling works at Portion N-A (1/3/2017 - 20/5/2017).

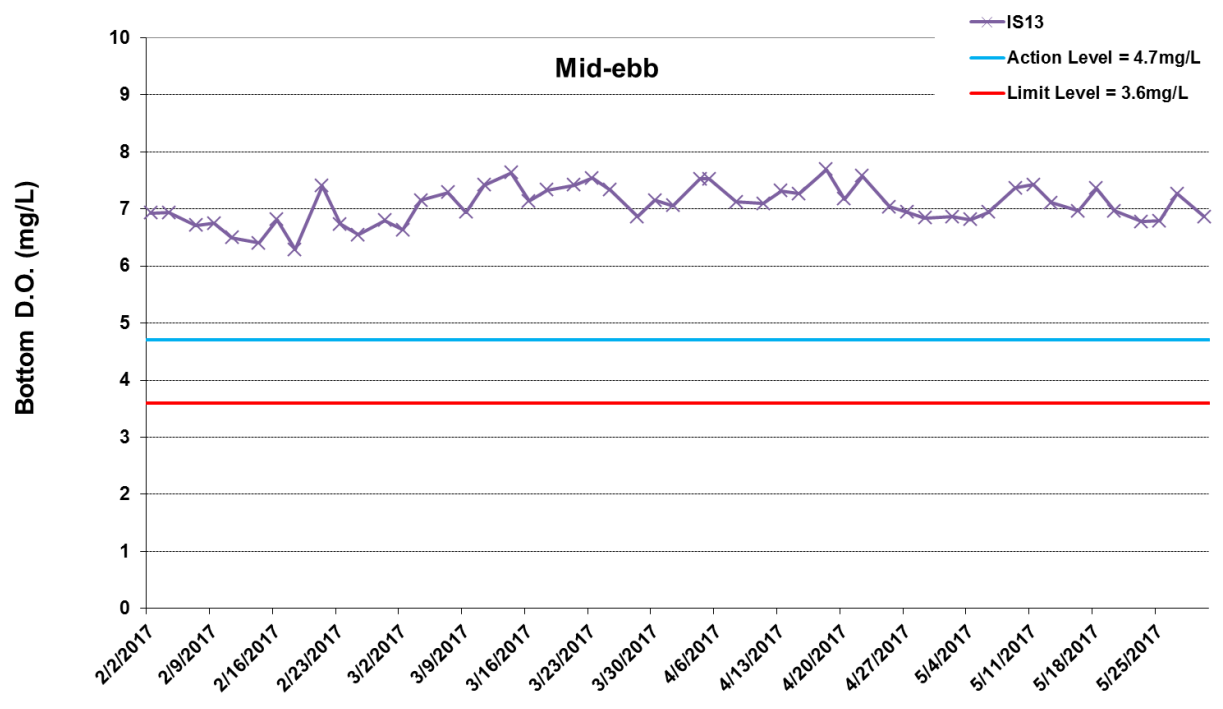
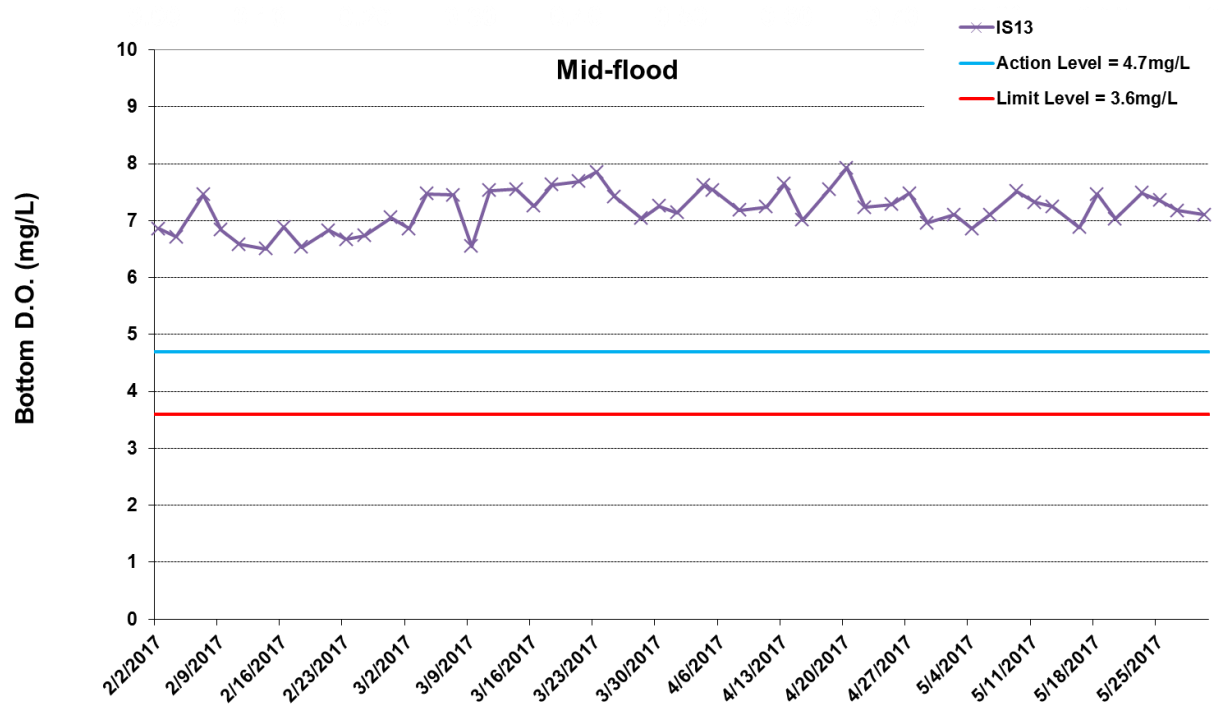
Figure G20 Impact Monitoring - Mean Level of Dissolved Oxygen (mg/L) in bottom water between 1 February 2017 and 31 May 2017 at IS13. The weather conditions during the monitoring period varied mostly from sunny to cloudy. Major marine works included: Filling works at Portion N-A (1/3/2017 - 20/5/2017).
