**Contract No. HY/2012/08  
Tuen Mun – Chek Lap Kok Link –  
Northern Connection Sub-sea Tunnel  
Section**

*Fourteenth Quarterly Environmental Monitoring  
& Audit (EM&A) Report*

**Contract No. HY/2012/08 TM-CLKL Northern Connection Sub-sea  
Tunnel Section  
Fourteenth Quarterly EM&A Report (March 2017 – May 2017)**

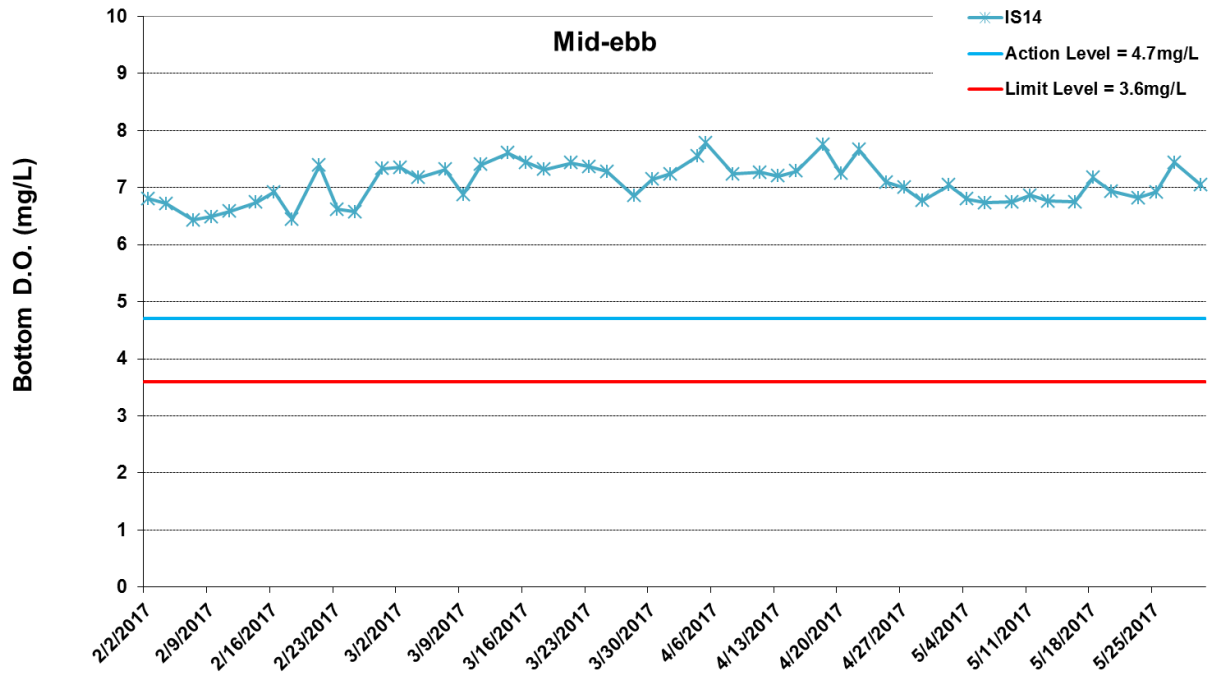
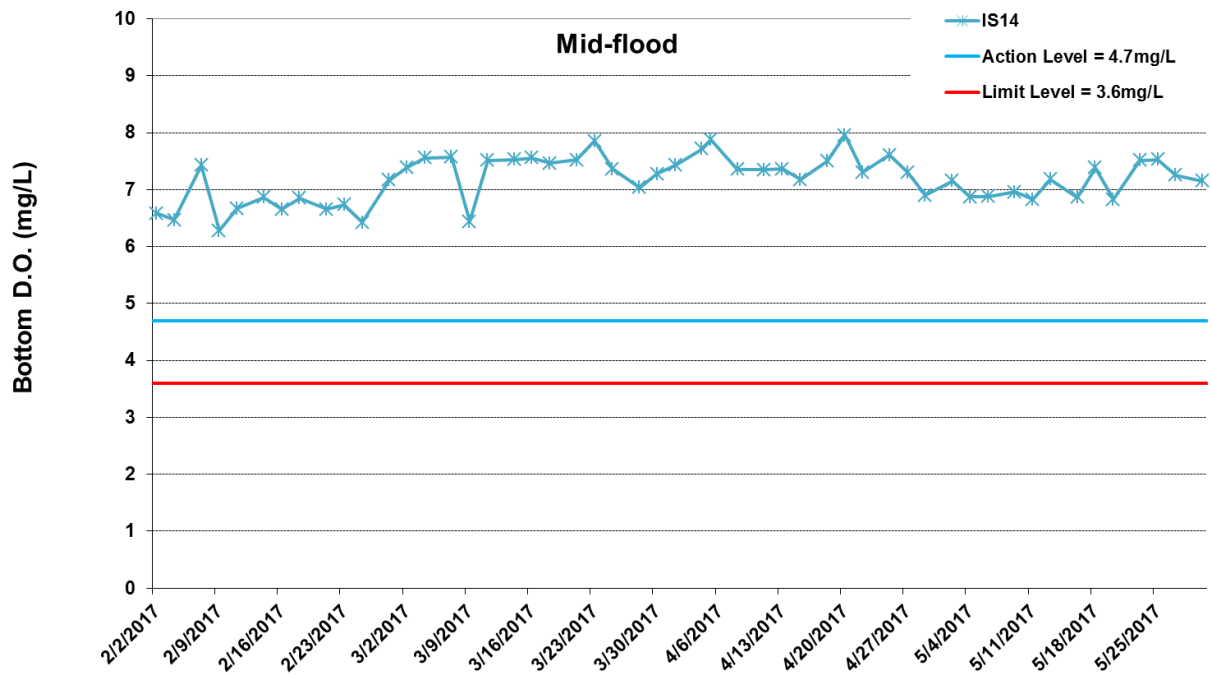
Figure G21 Impact Monitoring - Mean Level of Dissolved Oxygen (mg/L) in bottom water between 1 February 2017 and 31 May 2017 at IS14. The weather conditions during the monitoring period varied mostly from sunny to cloudy. Major marine works included: Filling works at Portion N-A (1/3/2017 - 20/5/2017).

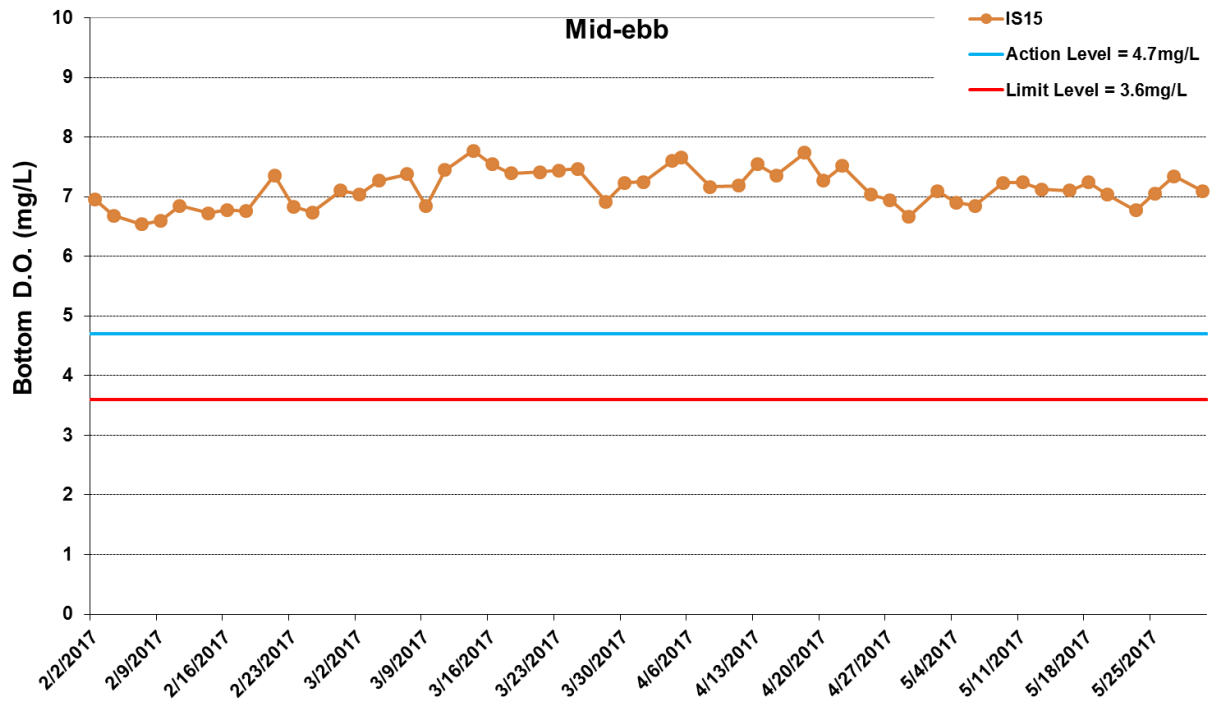
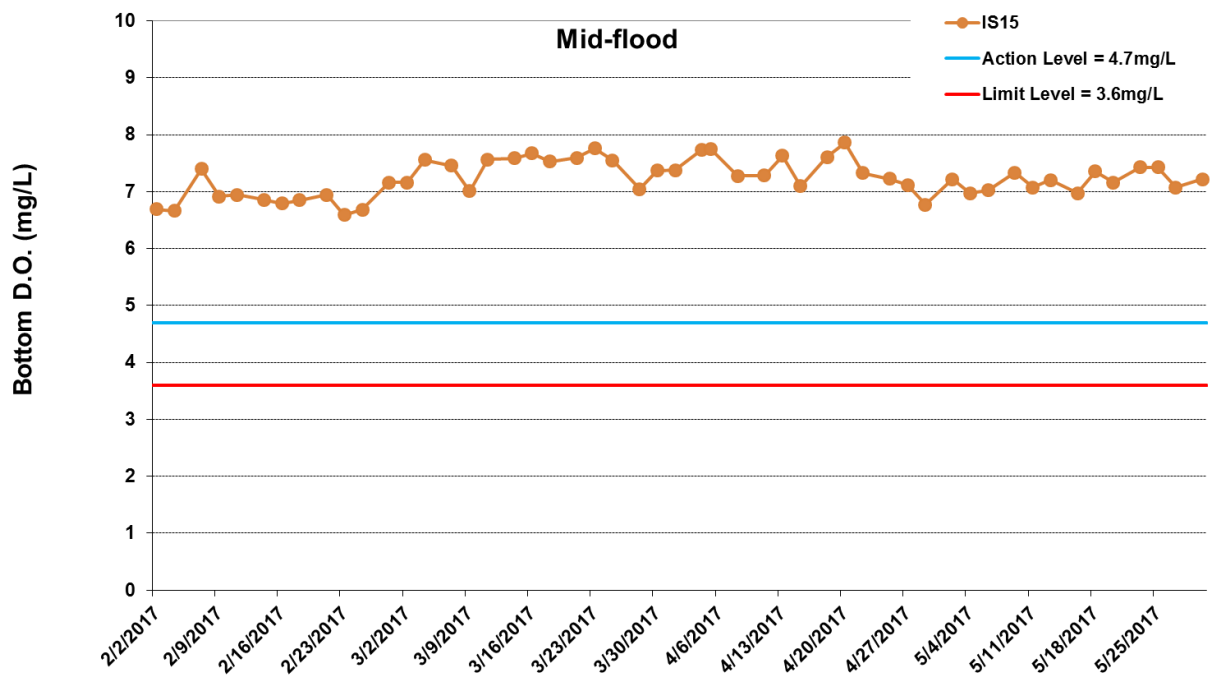
Figure G22 Impact Monitoring - Mean Level of Dissolved Oxygen (mg/L) in bottom water between 1 February 2017 and 31 May 2017 at IS15. The weather conditions during the monitoring period varied mostly from sunny to cloudy. Major marine works included: Filling works at Portion N-A (1/3/2017 - 20/5/2017).

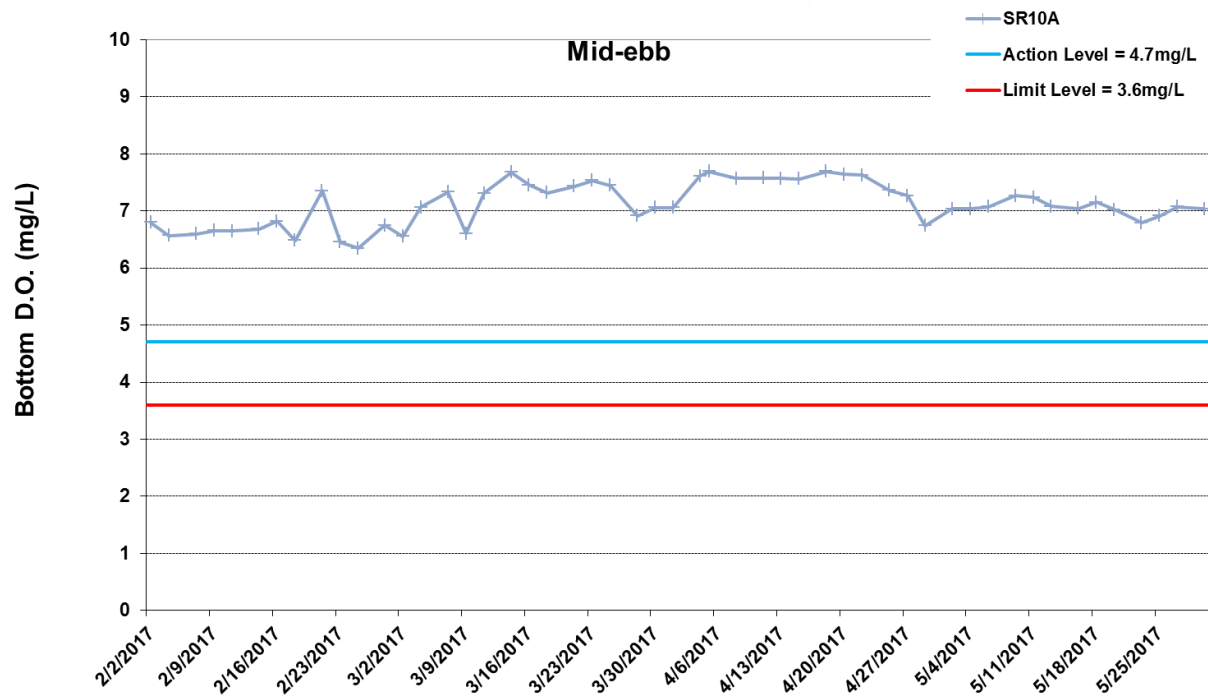
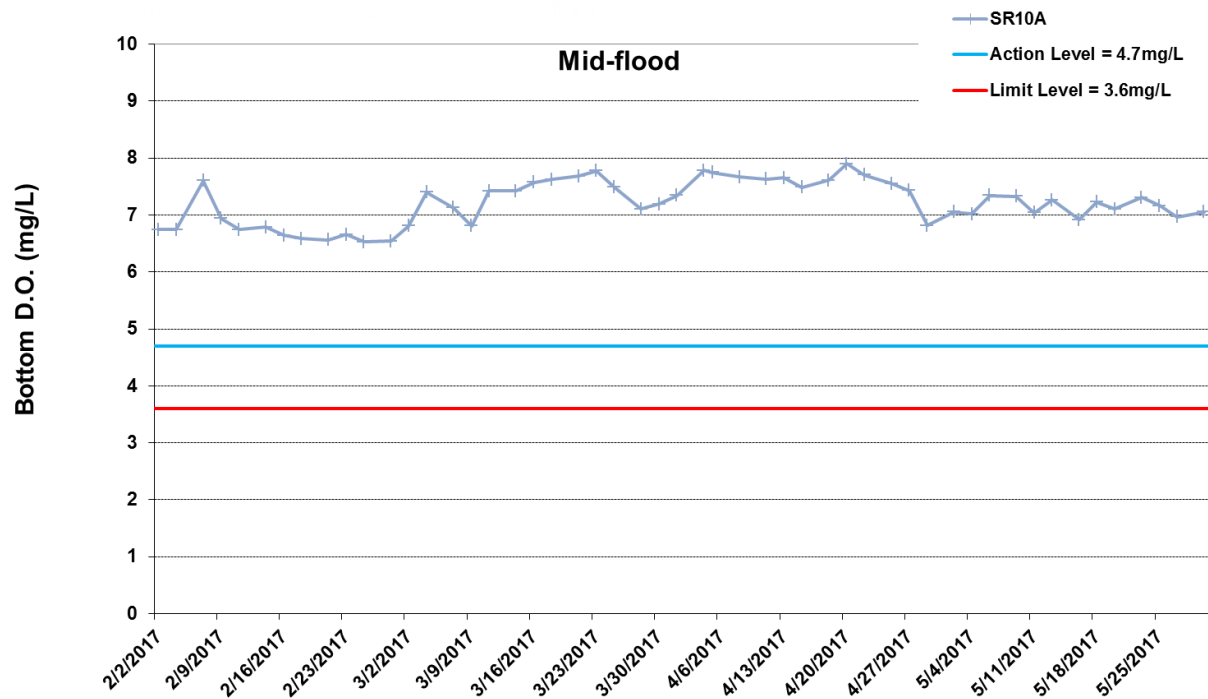
Figure G23 Impact Monitoring - Mean Level of Dissolved Oxygen (mg/L) in bottom water between 1 February 2017 and 31 May 2017 at SR10A. The weather conditions during the monitoring period varied mostly from sunny to cloudy. Major marine works included: Filling works at Portion N-A (1/3/2017 - 20/5/2017).

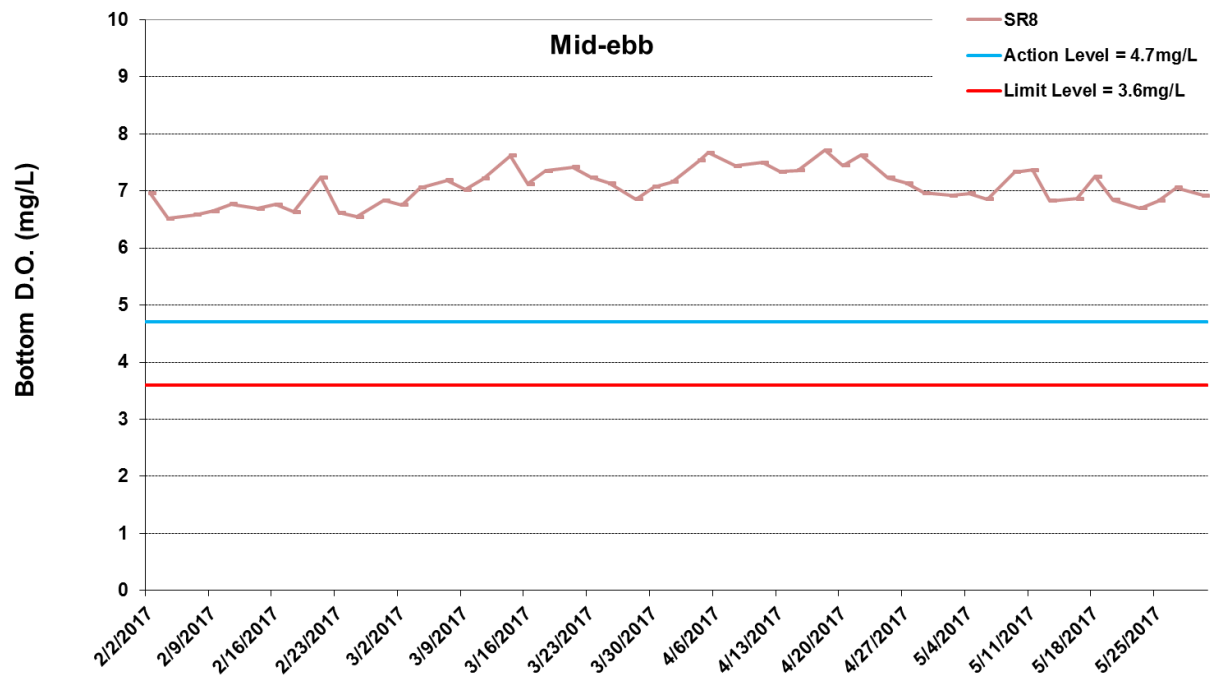
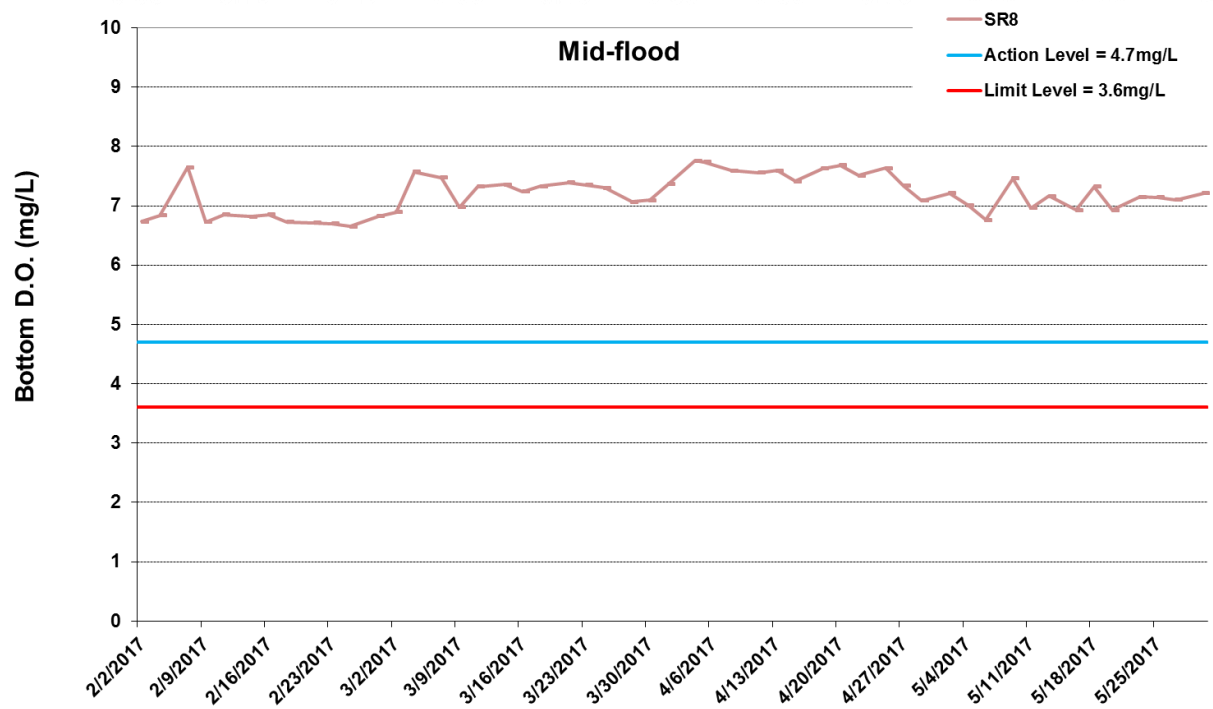
Figure G24 Impact Monitoring - Mean Level of Dissolved Oxygen (mg/L) in bottom water between 1 February 2017 and 31 May 2017 at SR8. The weather conditions during the monitoring period varied mostly from sunny to cloudy. Major marine works included: Filling works at Portion N-A (1/3/2017 - 20/5/2017).

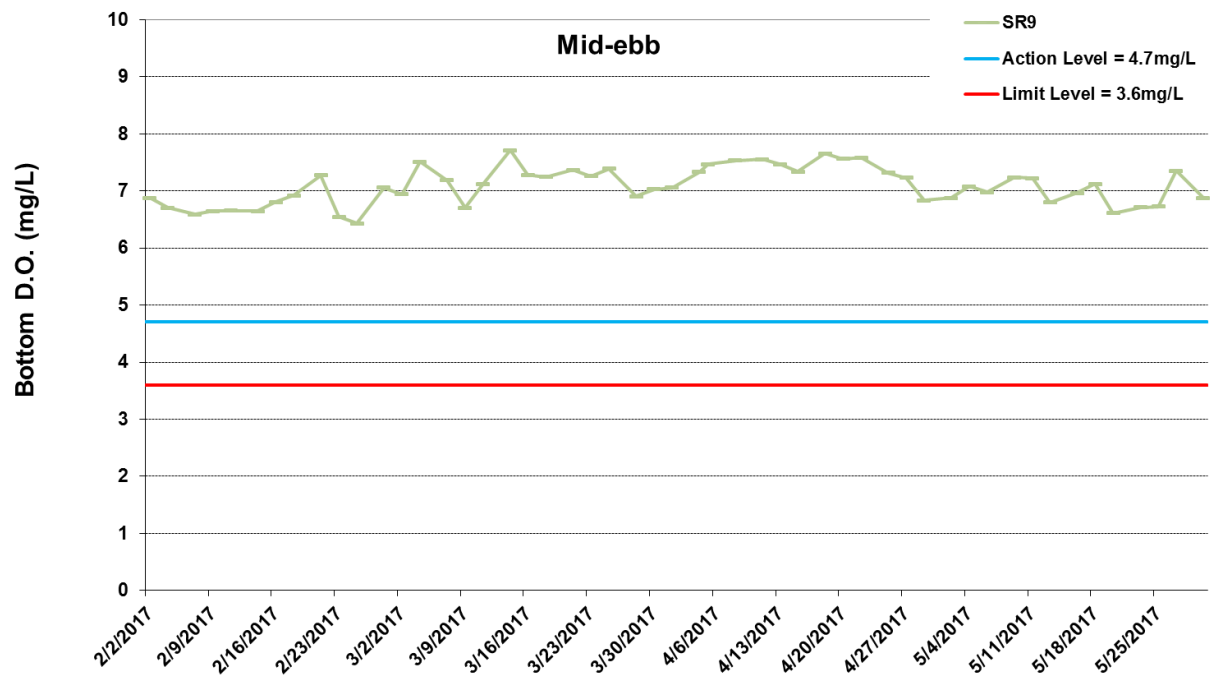
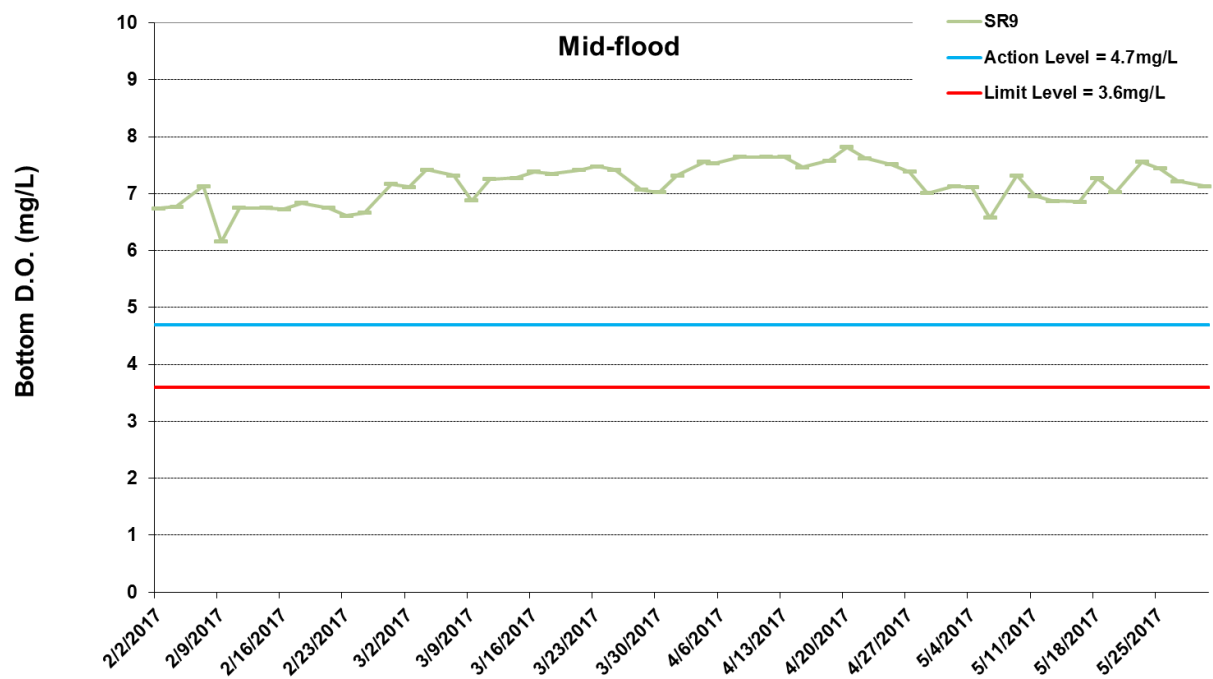
Figure G25 Impact Monitoring - Mean Level of Dissolved Oxygen (mg/L) in bottom water between 1 February 2017 and 31 May 2017 at SR9. The weather conditions during the monitoring period varied mostly from sunny to cloudy. Major marine works included: Filling works at Portion N-A (1/3/2017 - 20/5/2017).

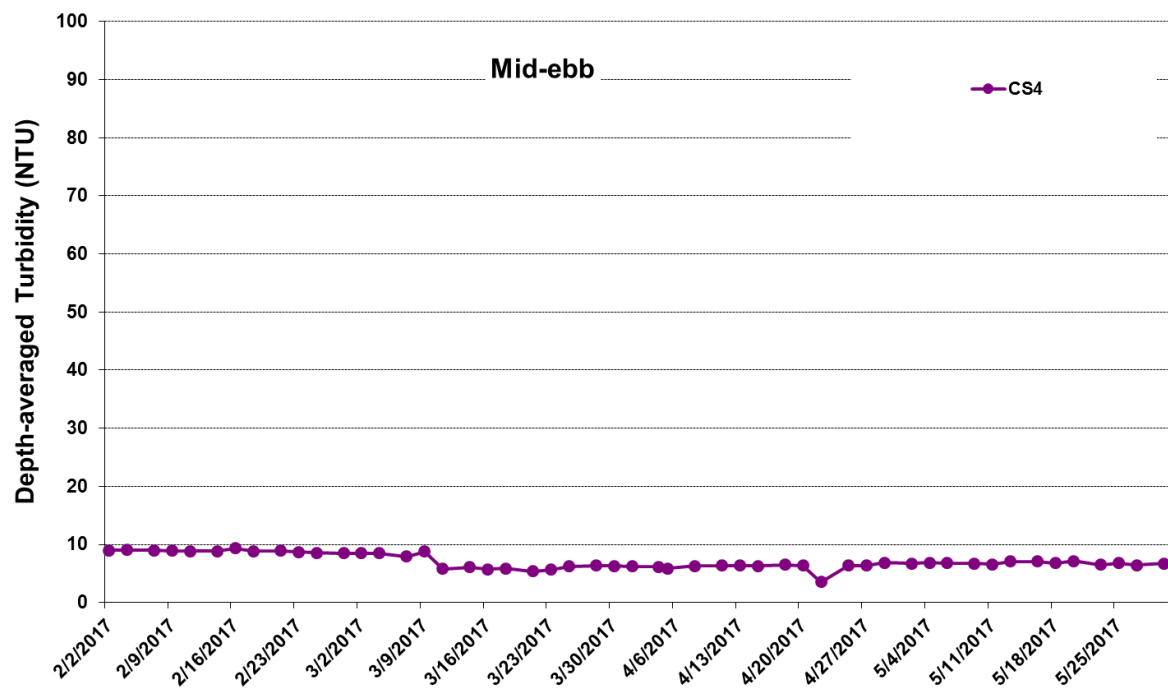
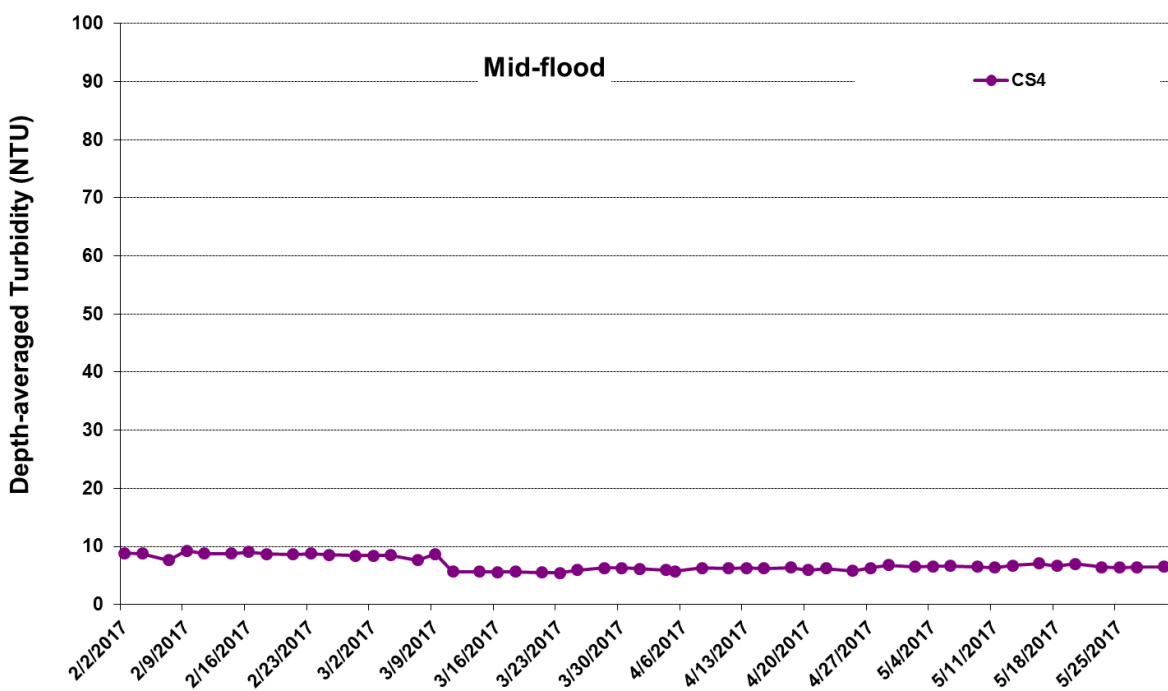
**Figure G26 Impact Monitoring - Mean Depth-averaged Level of Turbidity (NTU) between 1 February 2017 and 31 May 2017 at CS4. The weather conditions during the monitoring period varied mostly from sunny to cloudy. Major marine works included: Filling works at Portion N-A (1/3/2017 - 20/5/2017).**

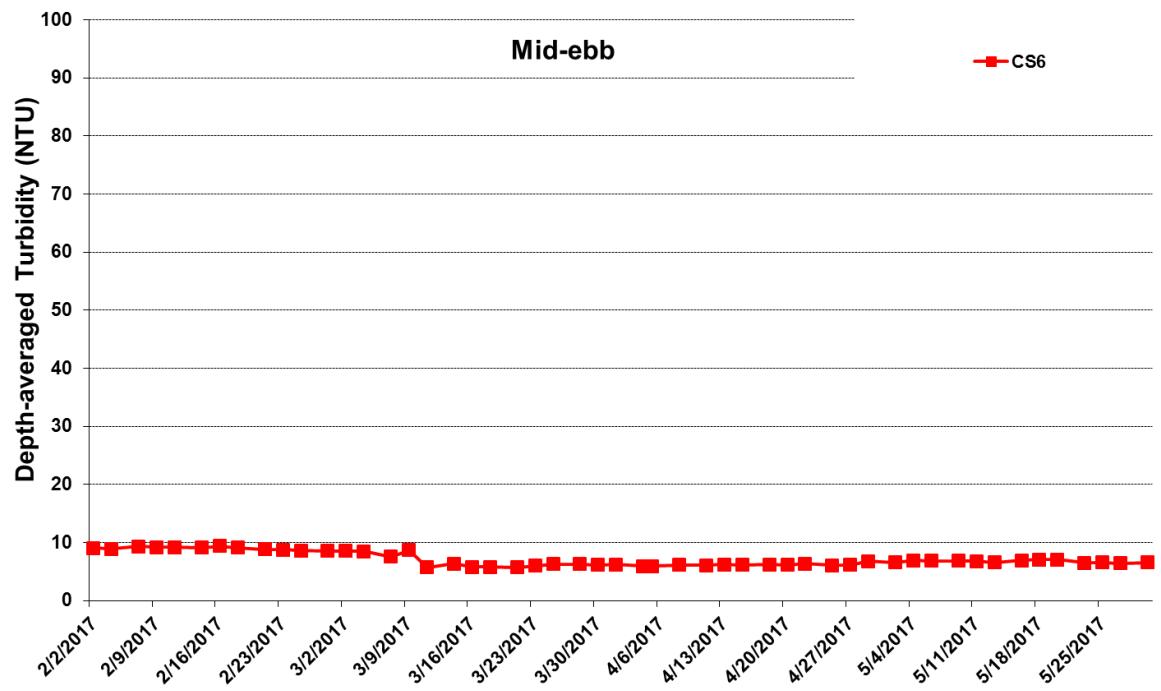
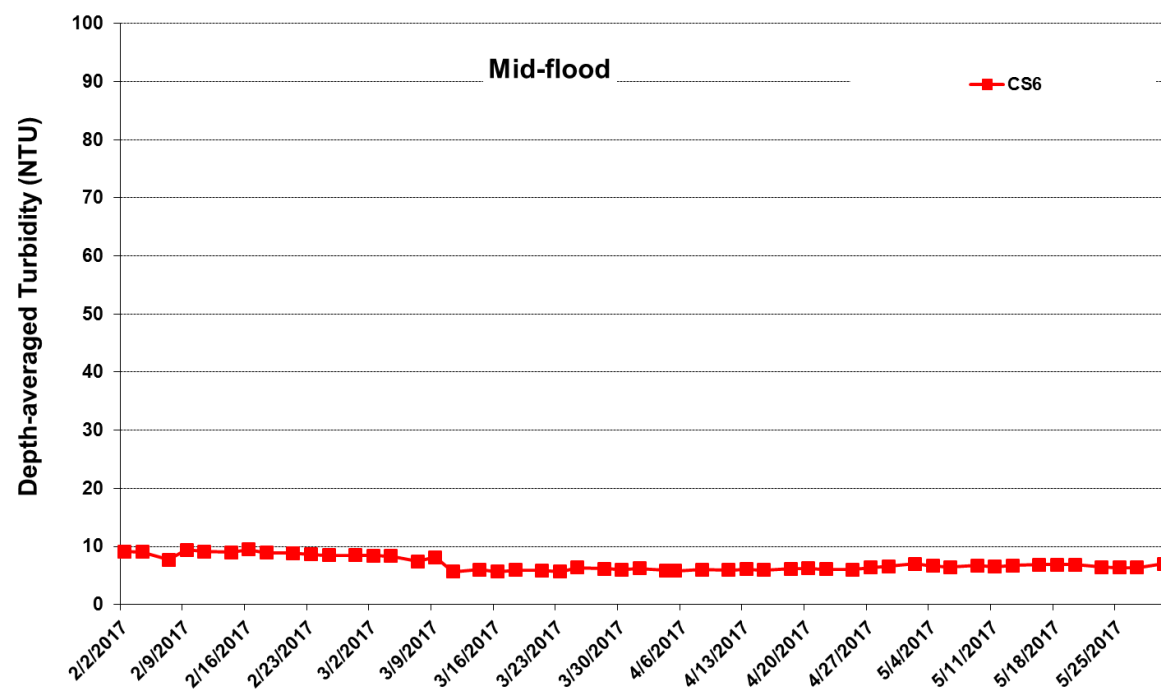
Figure G27 Impact Monitoring - Mean Depth-averaged Level of Turbidity (NTU) between 1 February 2017 and 31 May 2017 at CS6. The weather conditions during the monitoring period varied mostly from sunny to cloudy. Major marine works included: Filling works at Portion N-A (1/3/2017 - 20/5/2017).

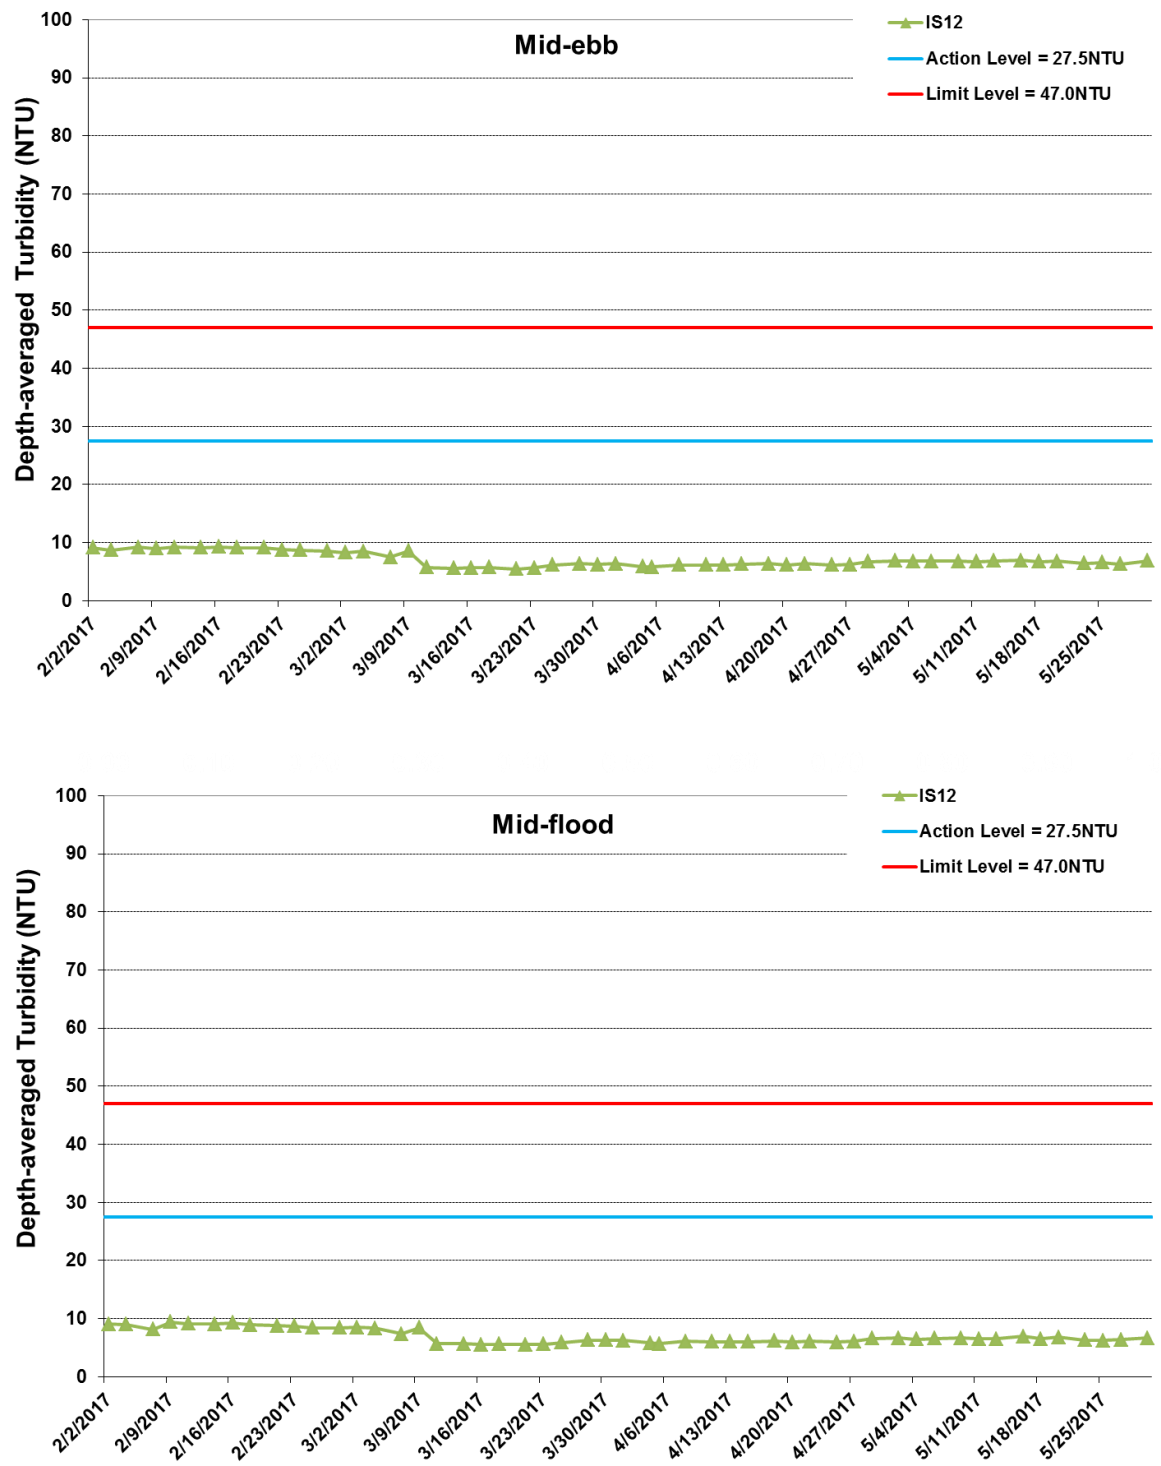
Figure G28 Impact Monitoring - Mean Depth-averaged Level of Turbidity (NTU) between 1 February 2017 and 31 May 2017 at IS12. The weather conditions during the monitoring period varied mostly from sunny to cloudy. Major marine works included: Filling works at Portion N-A (1/3/2017 - 20/5/2017).

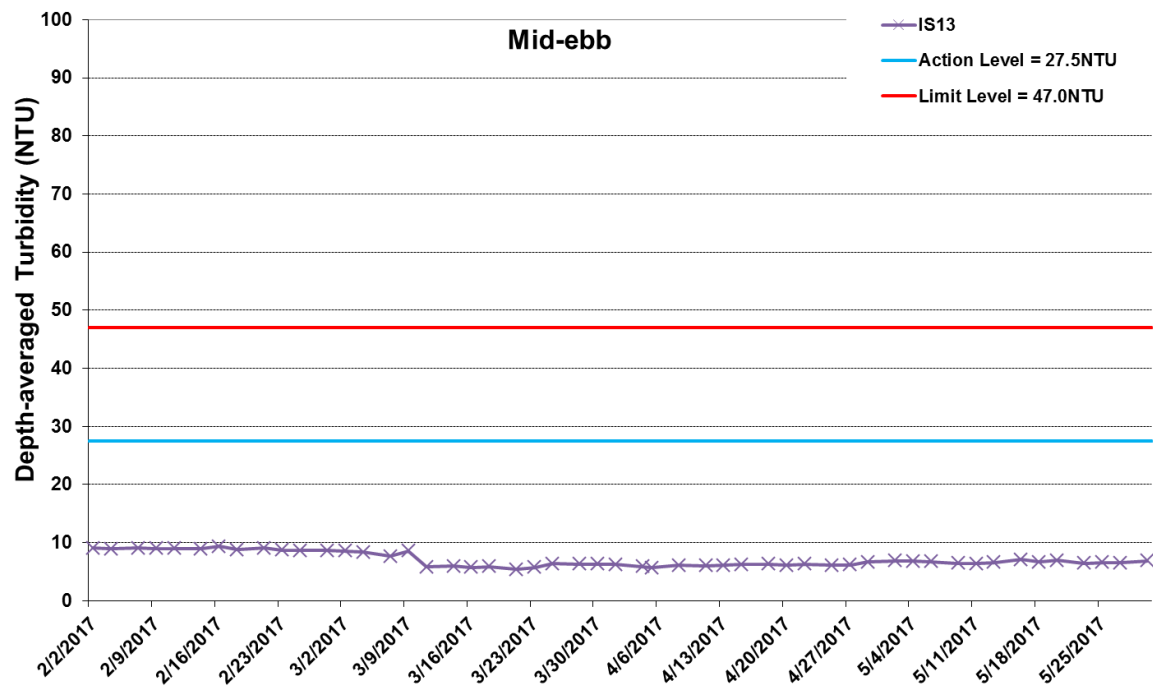
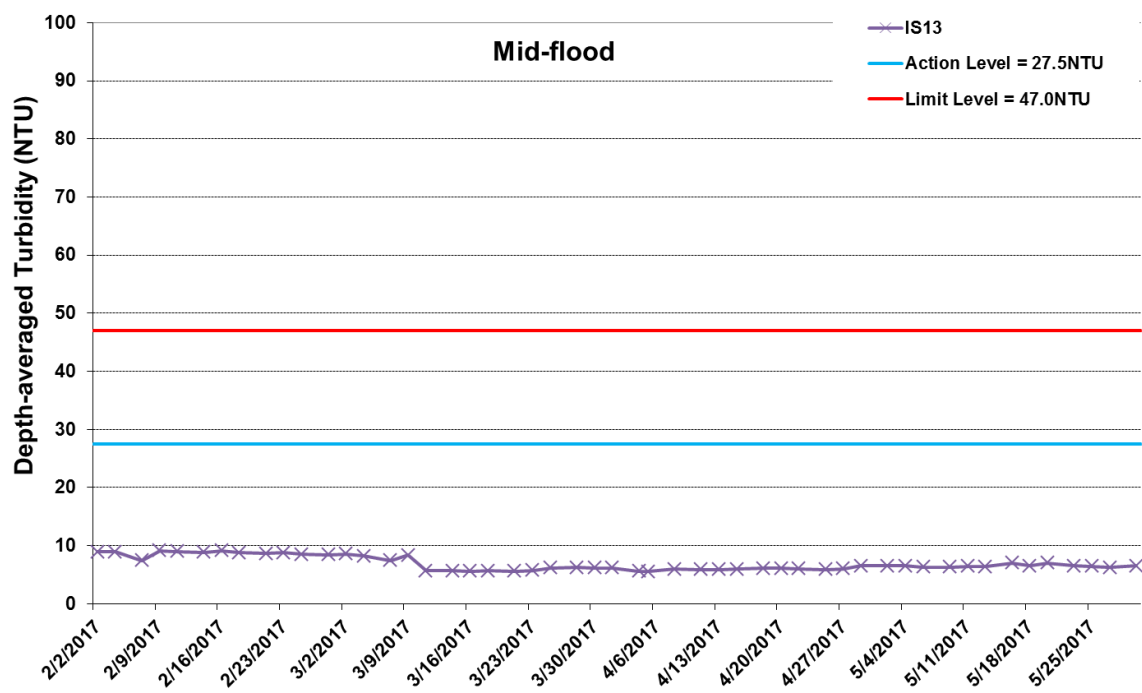
Figure G29 Impact Monitoring - Mean Depth-averaged Level of Turbidity (NTU) between 1 February 2017 and 31 May 2017 at IS13. The weather conditions during the monitoring period varied mostly from sunny to cloudy. Major marine works included: Filling works at Portion N-A (1/3/2017 - 20/5/2017).

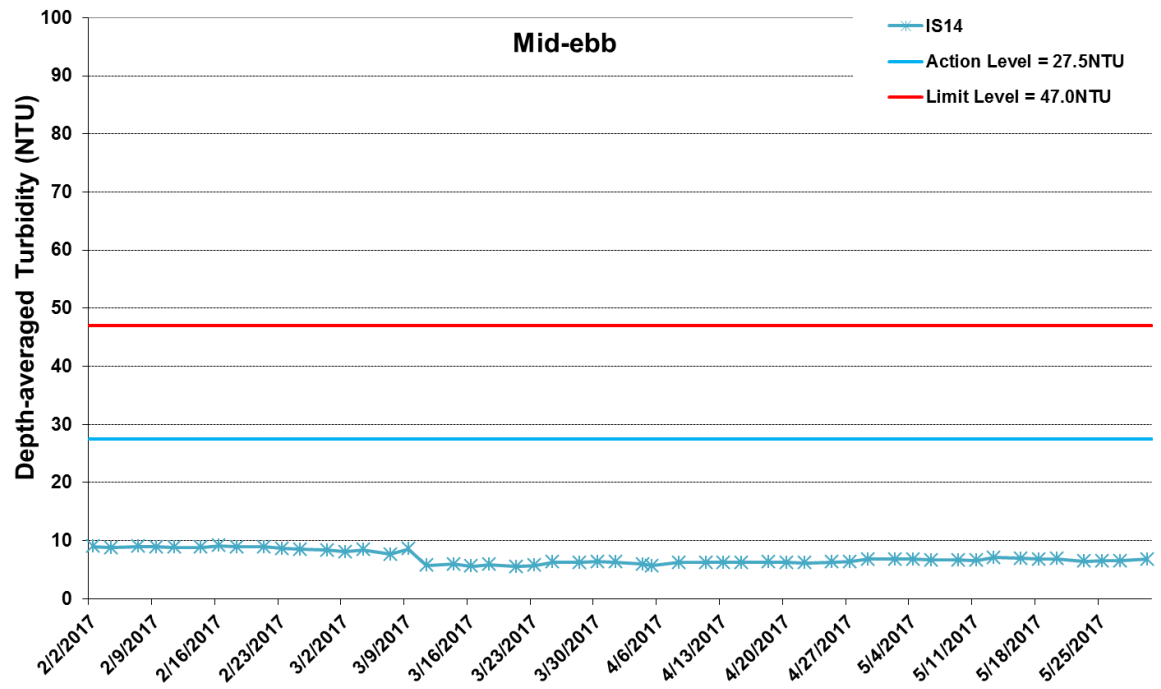
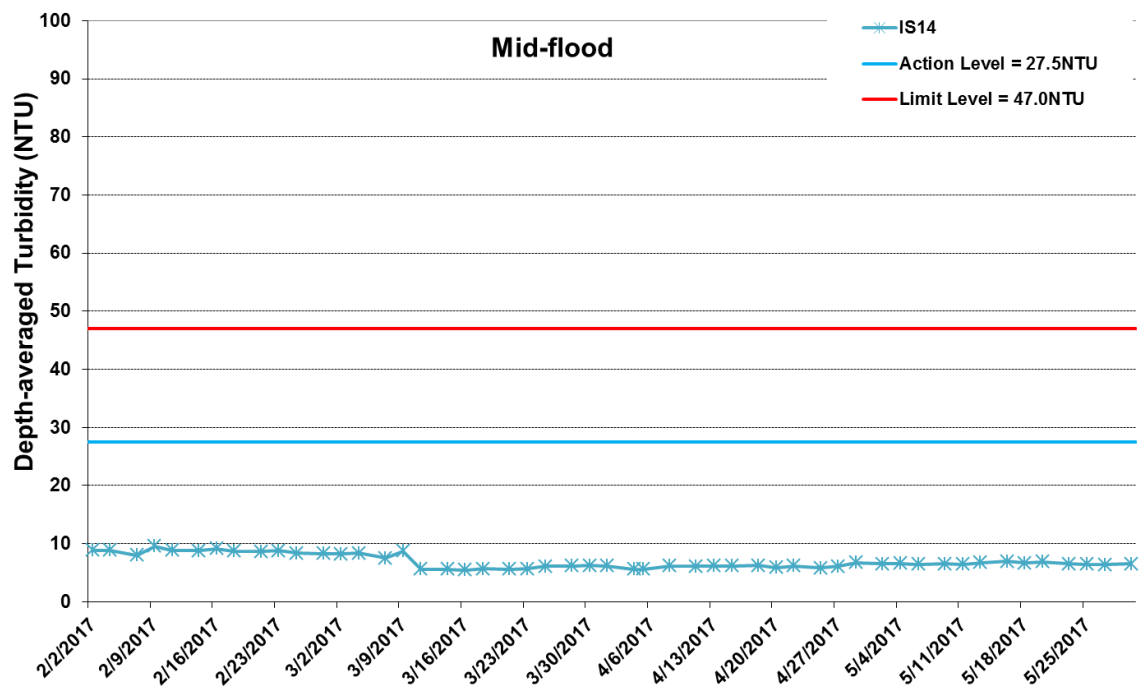
Figure G30 Impact Monitoring - Mean Depth-averaged Level of Turbidity (NTU) between 1 February 2017 and 31 May 2017 at IS14. The weather conditions during the monitoring period varied mostly from sunny to cloudy. Major marine works included: Filling works at Portion N-A (1/3/2017 - 20/5/2017).

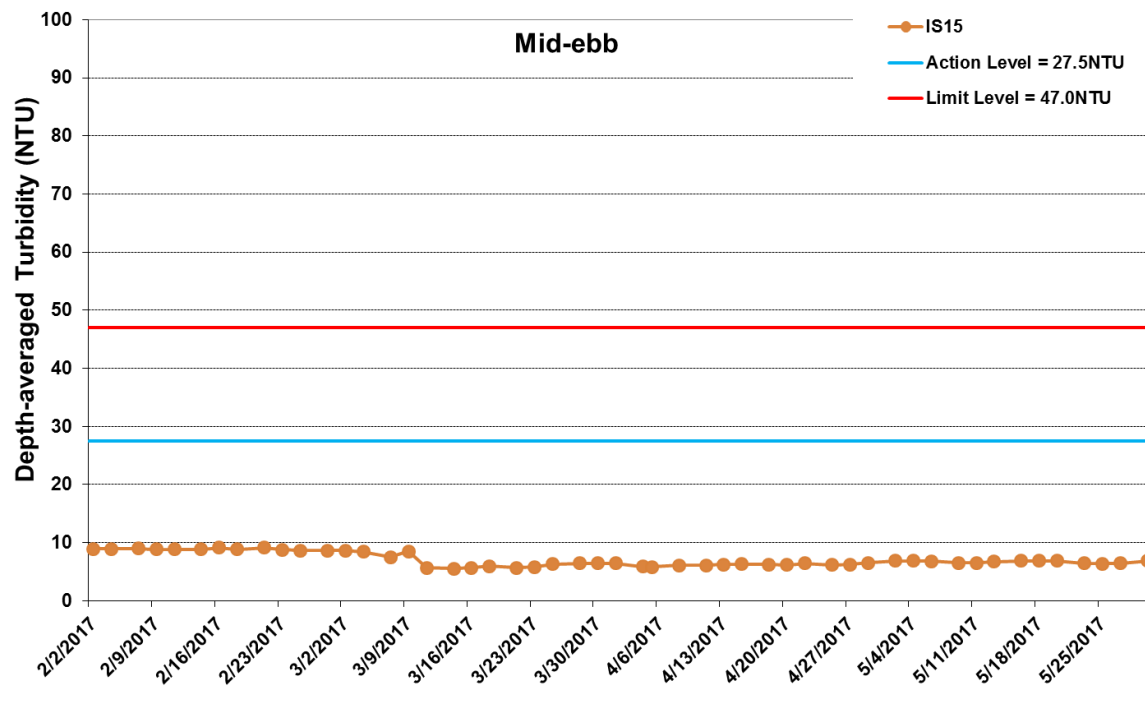
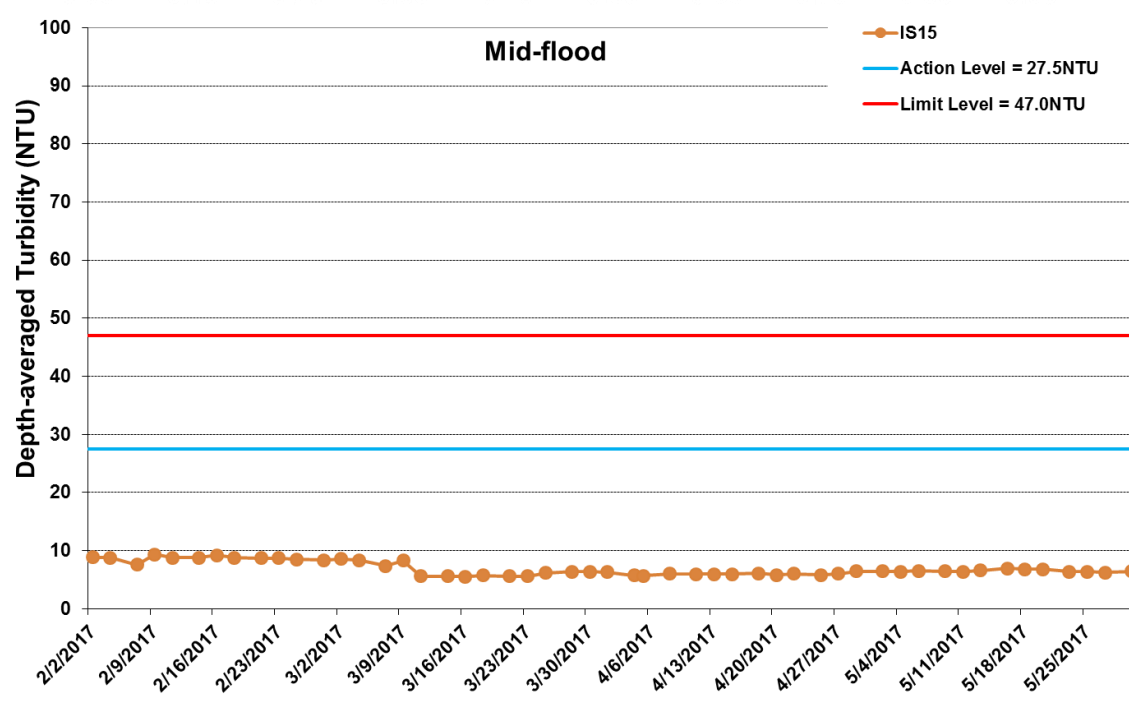
Figure G31 Impact Monitoring - Mean Depth-averaged Level of Turbidity (NTU) between 1 February 2017 and 31 May 2017 at IS15. The weather conditions during the monitoring period varied mostly from sunny to cloudy. Major marine works included: Filling works at Portion N-A (1/3/2017 - 20/5/2017).

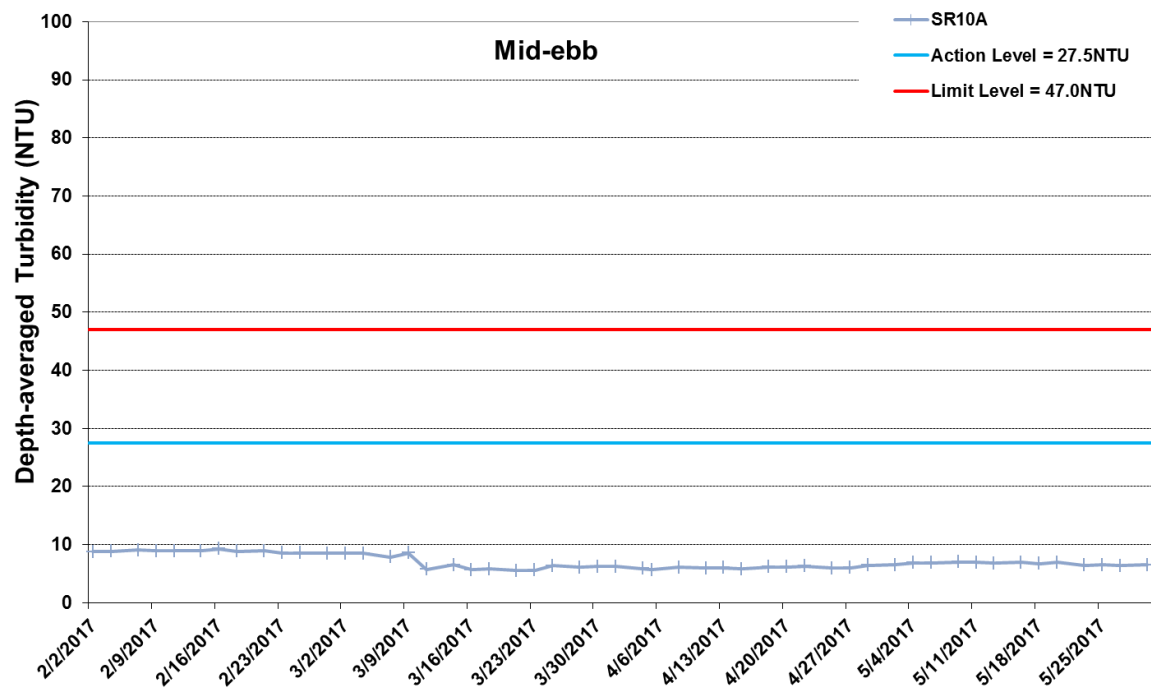
Figure G32 Impact Monitoring - Mean Depth-averaged Level of Turbidity (NTU) between 1 February 2017 and 31 May 2017 at SR10A. The weather conditions during the monitoring period varied mostly from sunny to cloudy. Major marine works included: Filling works at Portion N-A (1/3/2017 - 20/5/2017).

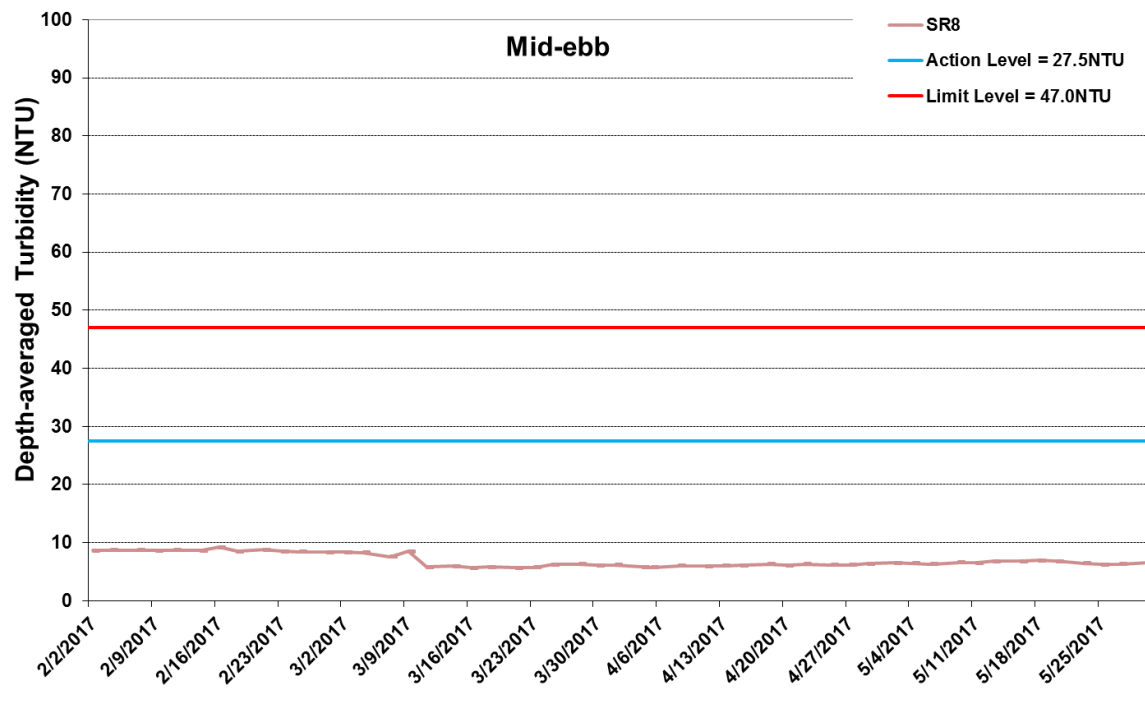
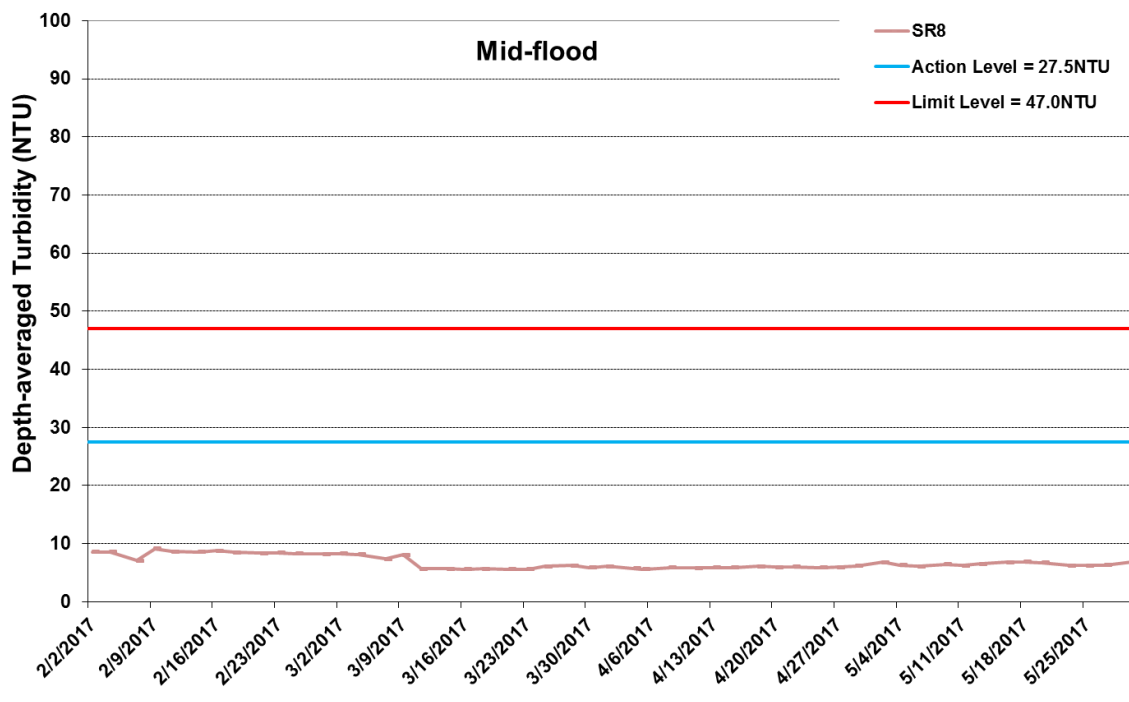
Figure G33 Impact Monitoring - Mean Depth-averaged Level of Turbidity (NTU) between 1 February 2017 and 31 May 2017 at SR8. The weather conditions during the monitoring period varied mostly from sunny to cloudy. Major marine works included: Filling works at Portion N-A (1/3/2017 - 20/5/2017).

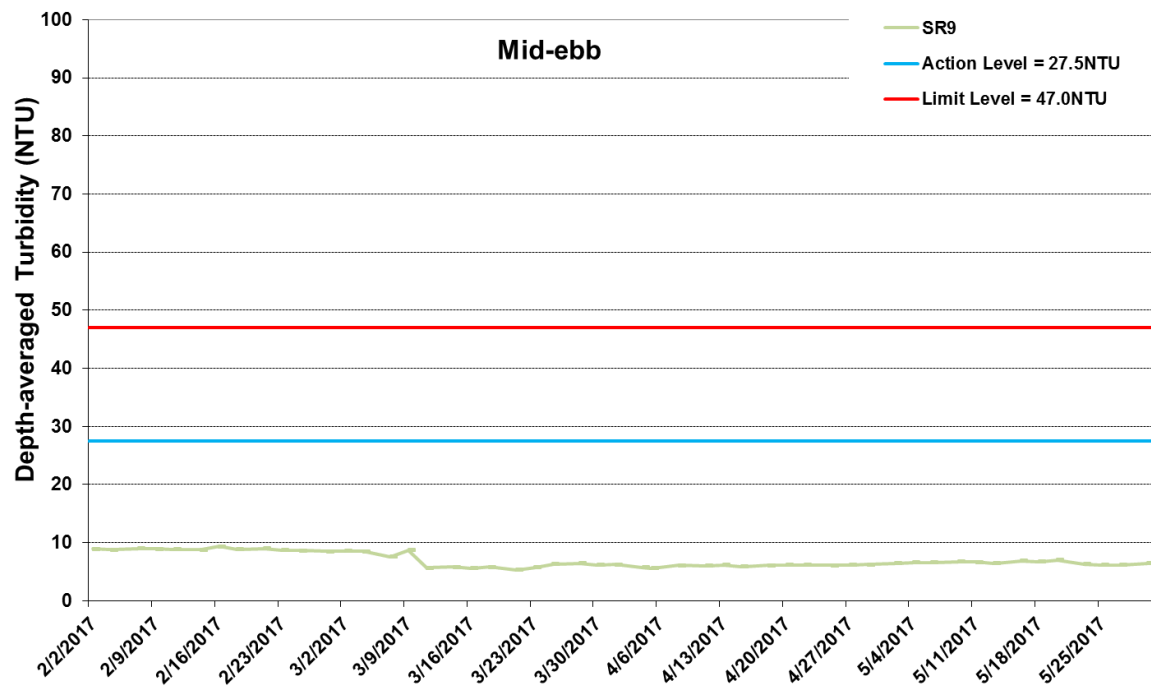
Figure G34 Impact Monitoring - Mean Depth-averaged Level of Turbidity (NTU) between 1 February 2017 and 31 May 2017 at SR9. The weather conditions during the monitoring period varied mostly from sunny to cloudy. Major marine works included: Filling works at Portion N-A (1/3/2017 - 20/5/2017).
