**Contract No. HY/2012/08  
Tuen Mun – Chek Lap Kok Link –  
Northern Connection Sub-sea Tunnel  
Section**

*Fourteenth Quarterly Environmental Monitoring  
& Audit (EM&A) Report*

**Contract No. HY/2012/08 TM-CLKL Northern Connection Sub-sea  
Tunnel Section  
Fourteenth Quarterly EM&A Report (March 2017 – May 2017)**

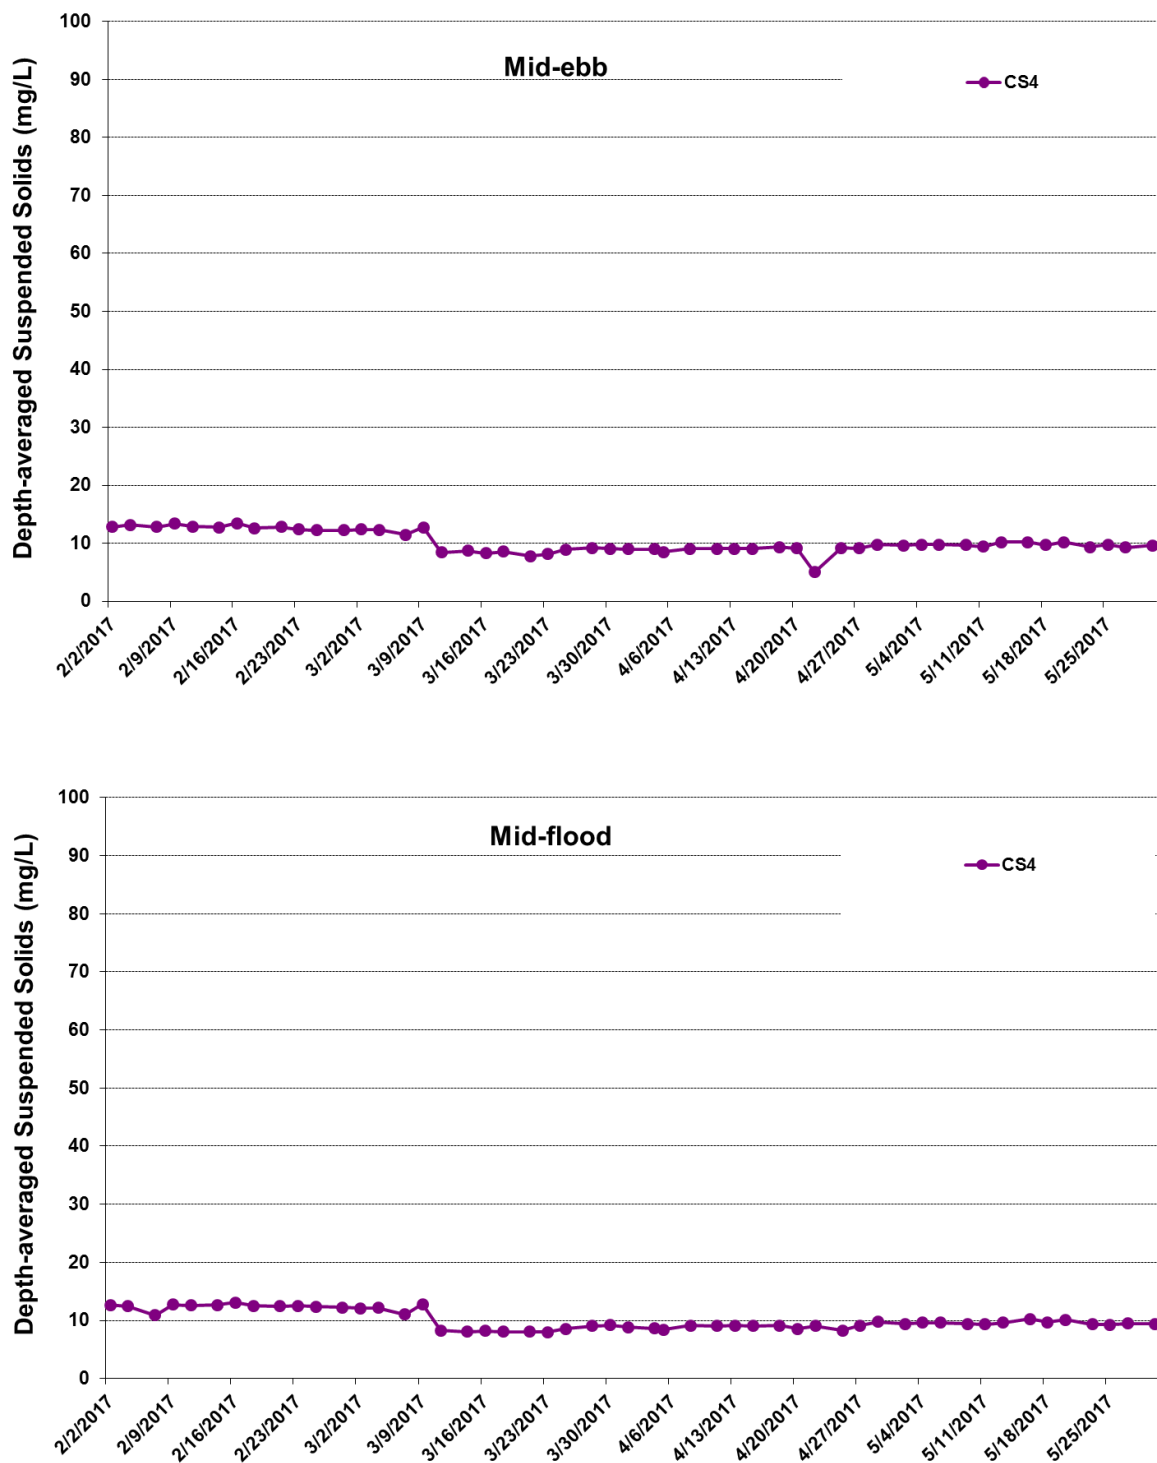
Figure G35 Impact Monitoring - Mean Depth-averaged Level of Suspended Solids (mg/L) between 1 February 2017 and 31 May 2017 at CS4. The weather conditions during the monitoring period varied mostly from sunny to cloudy. Major marine works included: Filling works at Portion N-A (1/3/2017 - 20/5/2017).

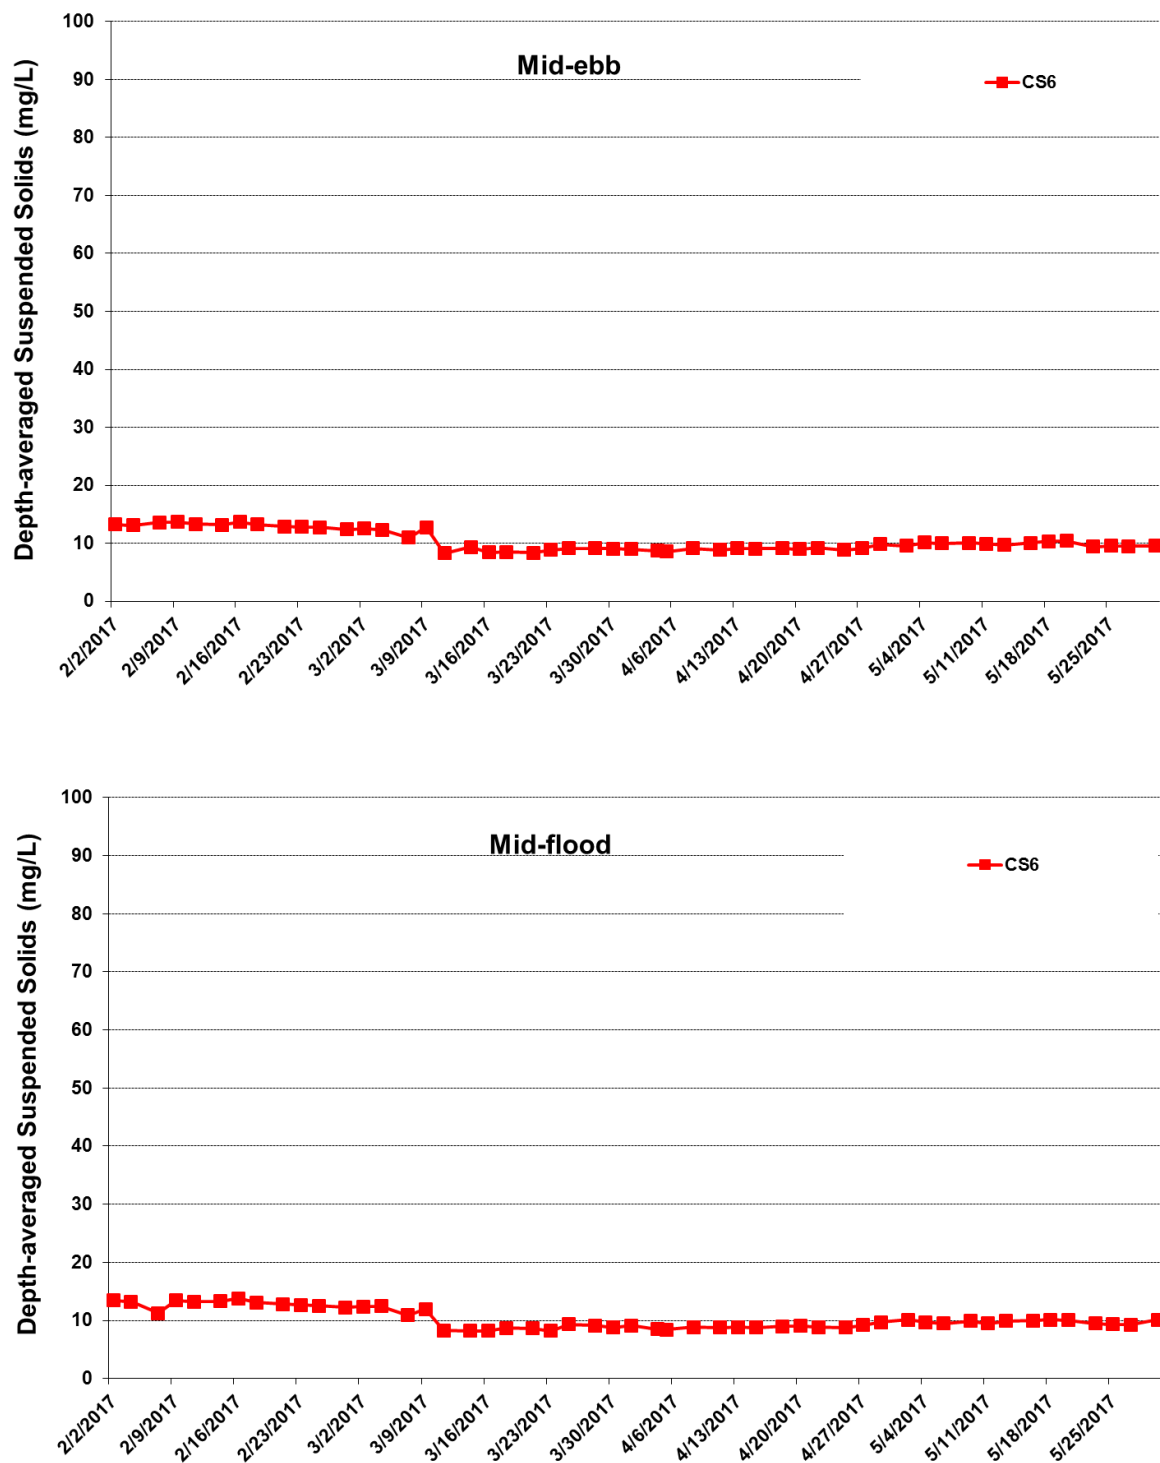
Figure G36 Impact Monitoring - Mean Depth-averaged Level of Suspended Solids (mg/L) between 1 February 2017 and 31 May 2017 at CS6. The weather conditions during the monitoring period varied mostly from sunny to cloudy. Major marine works included: Filling works at Portion N-A (1/3/2017 - 20/5/2017).
