**AUES JOB No.: TCS00715/14**

**TUEN MUN - CHEK LAP KOK LINK  
CONTRACT NO. HY/2013/12 –  
NORTHERN CONNECTION TOLL PLAZA AND  
ASSOCIATED WORKS**

**37<sup>TH</sup> MONTHLY ENVIRONMENTAL MONITORING AND  
AUDIT (EM&A) REPORT – NOVEMBER 2017**

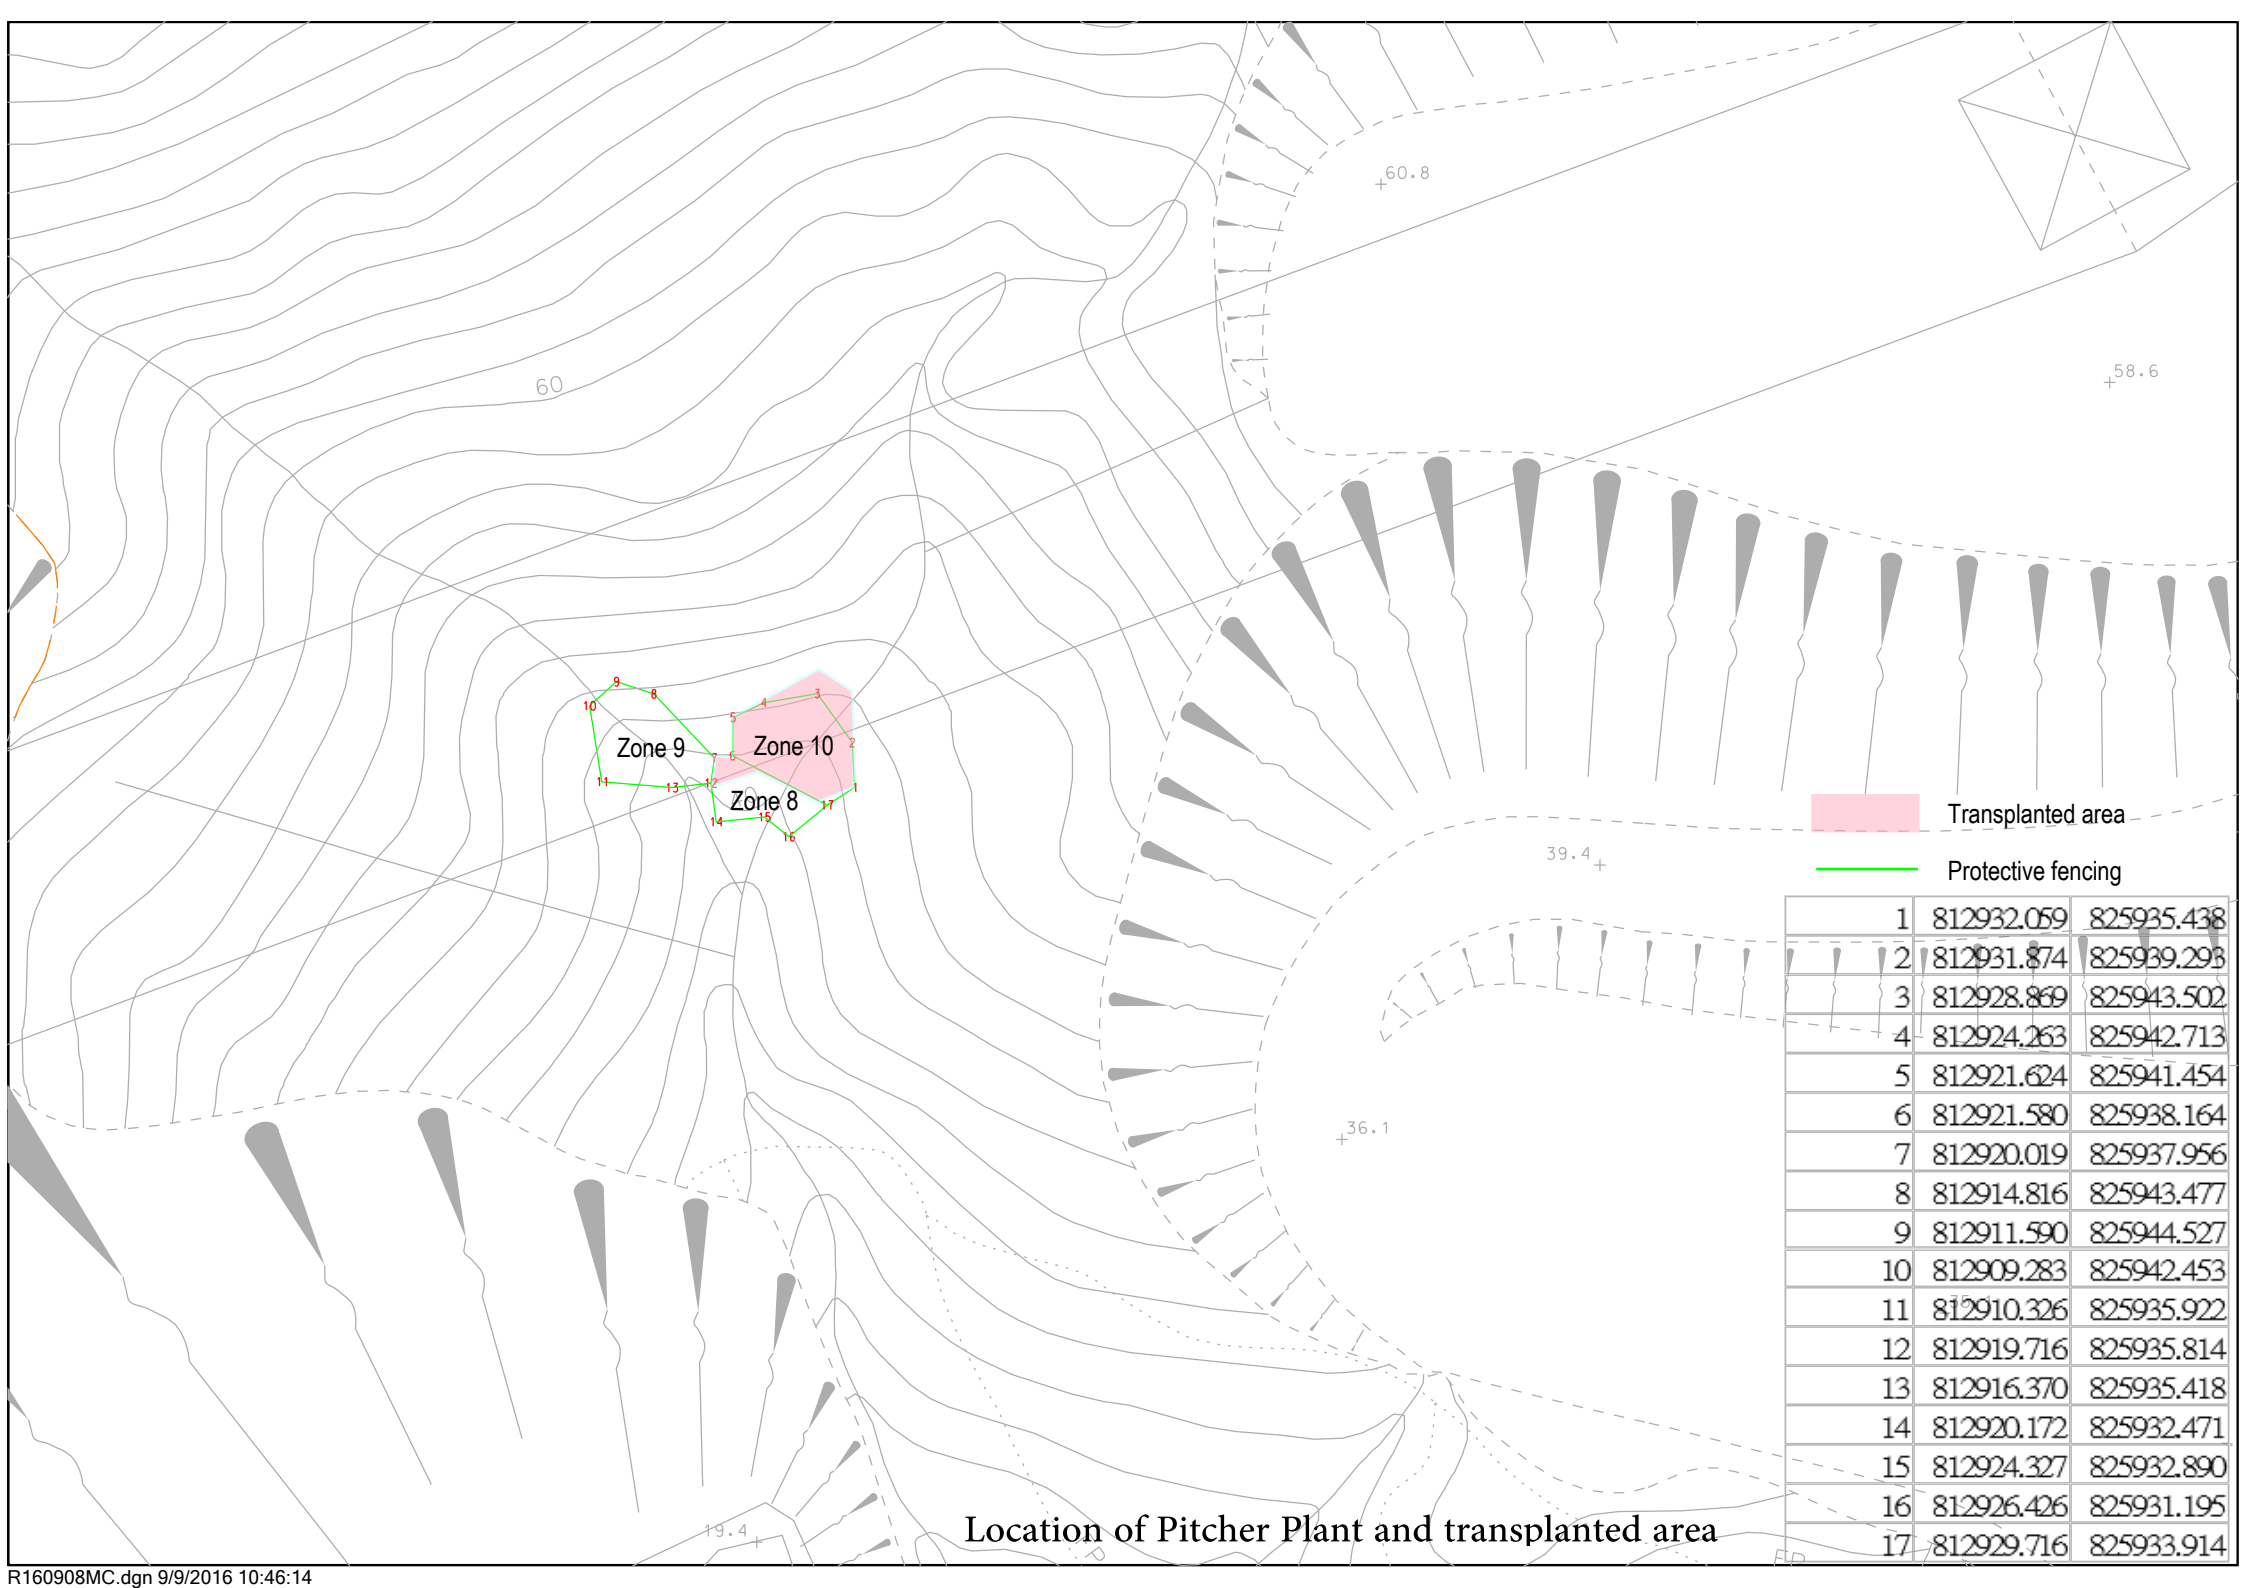
Transplanted area  
 Protective fencing

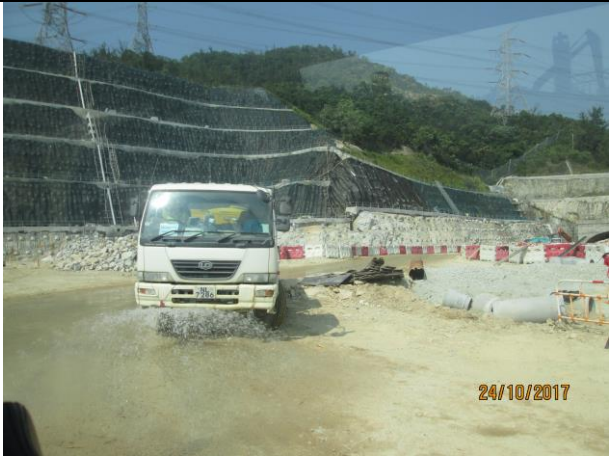
**Photo 7** Watering of haul road by water truck to keep road surface wet was observed during the site inspection on 24 October 2017

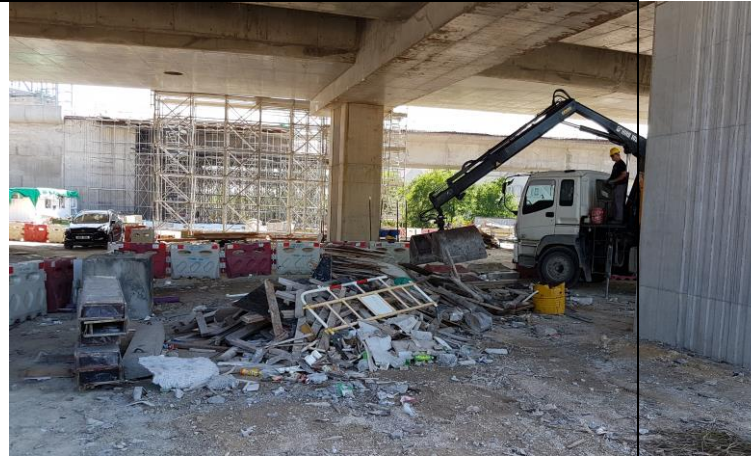
**Photo 8** Housekeeping works at Retaining Wall B.

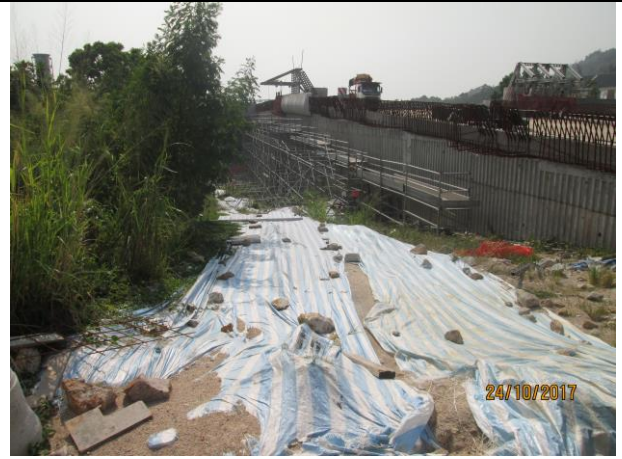
**Photo 8** Covered part of the exposed slopes and stockpile by tarpaulin sheet was observed in the site inspection on 24 October 2017

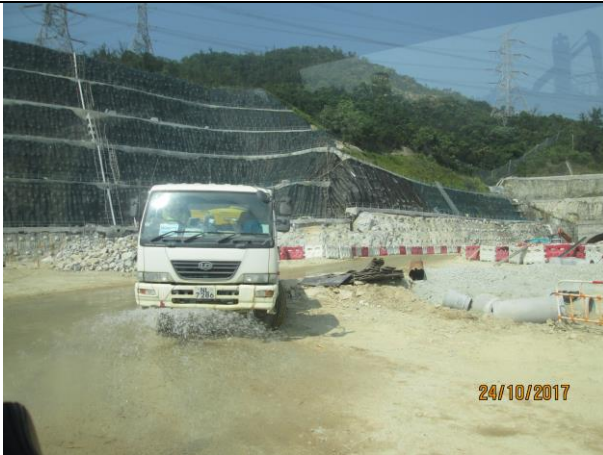
**Photo 9** Watering of haul road by water truck to keep road surface wet was observed during the site inspection on 24 October 2017

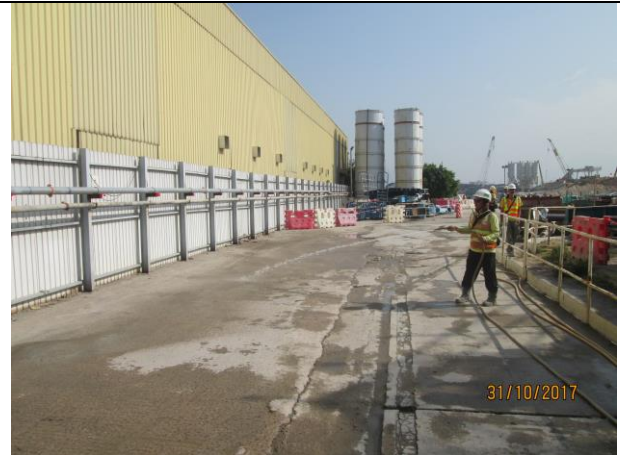
**Photo 10** Watering of haul road to keep road surface wet was observed at Portion F during the site inspection on 31 October 2017

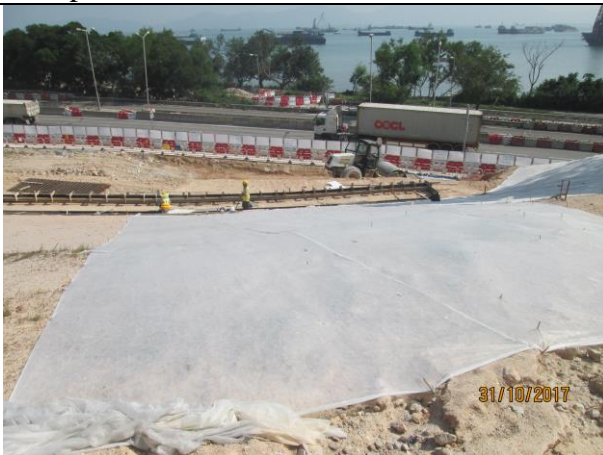
**Photo 11** Photo taken of hydro seeding for the exposed sloop at slop 170 during the site inspection on 31 October 2017

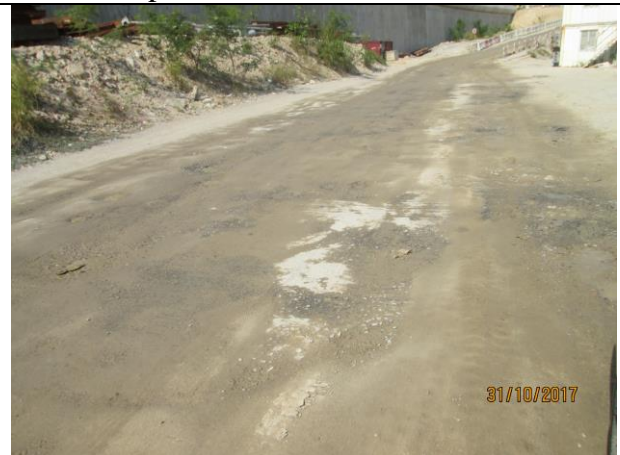
**Photo 12** Watering of haul road by water truck to keep road surface wet was observed during the site inspection on 31 October 2017

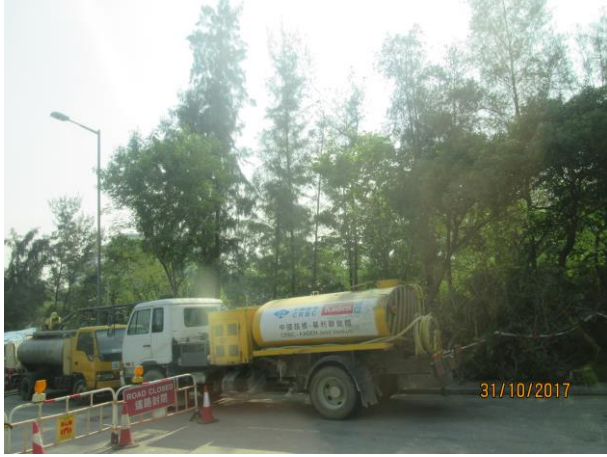
**Photo 13** Two water truck were in operation during the site inspection on 31 October 2017

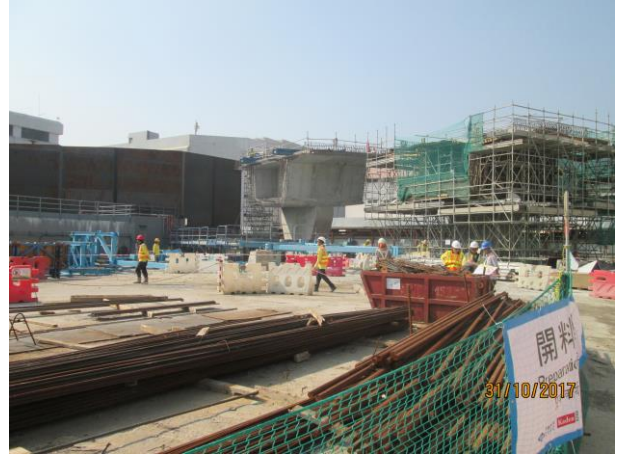
**Photo 14** No dust emitted for the Portion F was observed during the site inspection on 31 October 2017 and the works area was clean and tidy

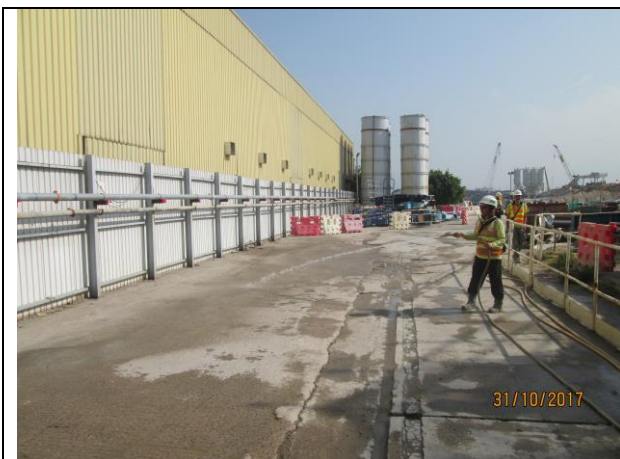
**Photo 7** Watering of haul road to keep road surface wet was observed at Portion F during the site inspection on 31 October 2017

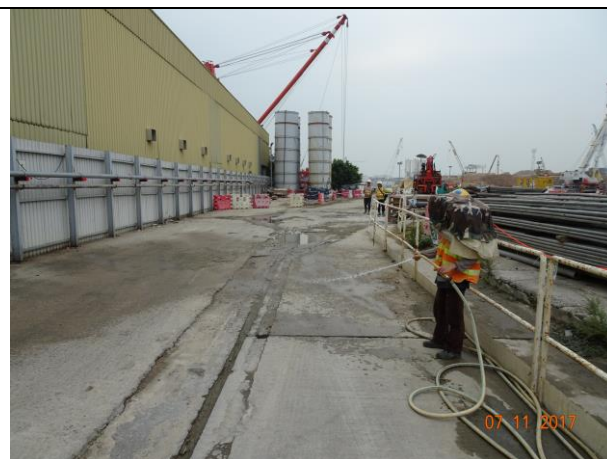
**Photo 8** Watering of haul road to keep road surface wet was observed at Portion F during the site inspection on 7 November 2017

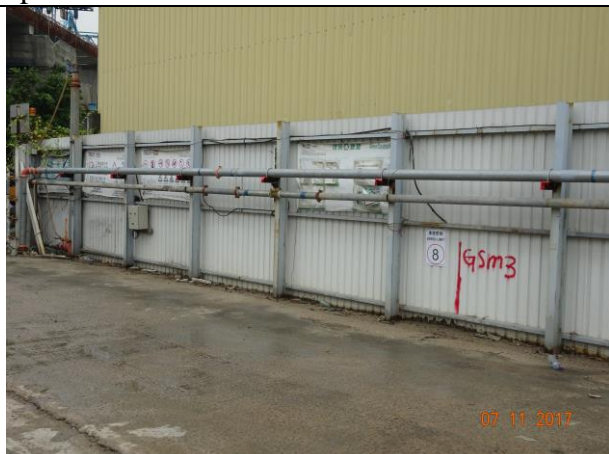
**Photo 9** Set speed control at ~8km/hr for all vehicles using the haul road at Portion F

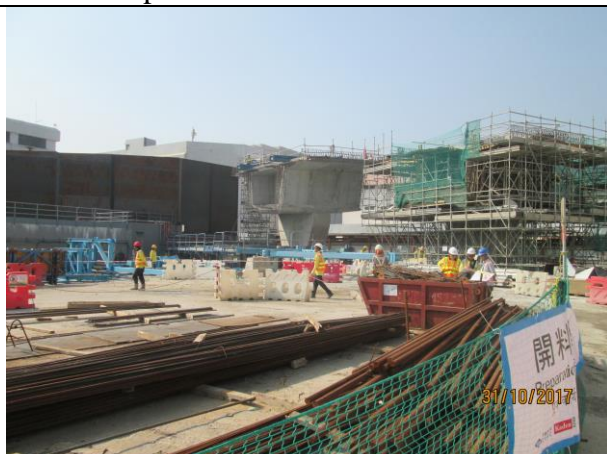
**Photo 10** No dust emitted for the Portion F was observed during the site inspection on 31 October 2017 and the works area was clean and tidy

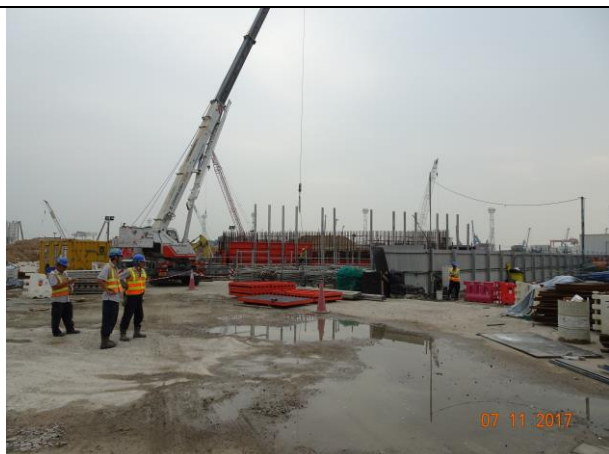
**Photo 11** No dust emitted for the Portion F was observed during the site inspection on 7 November 2017 and the works area was clean and tidy

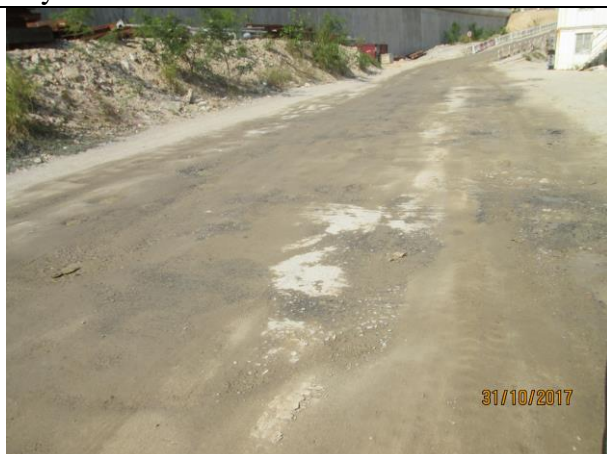
**Photo 12** Watering of haul road by water truck to keep road surface wet was observed during the site inspection on 31 October 2017

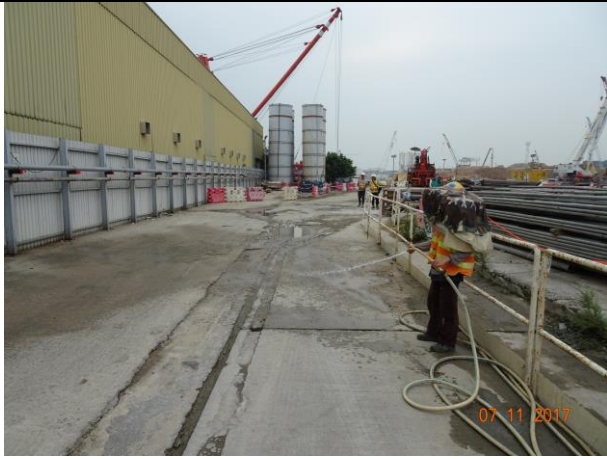
**Photo 7** Watering of haul road to keep road surface wet was observed at Portion F during the site inspection on 7 November 2017

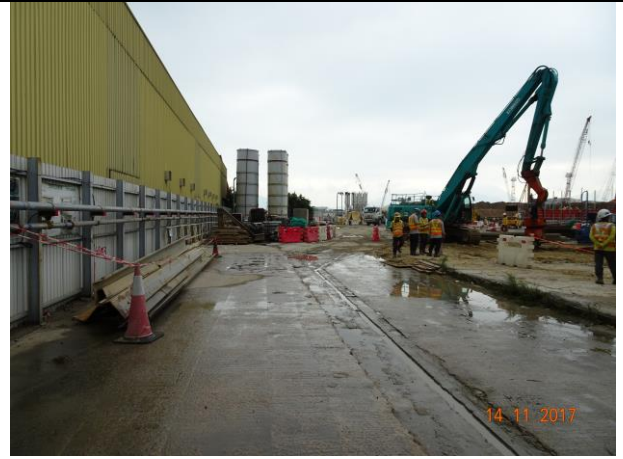
**Photo 8** Watering of haul road to keep road surface wet was observed at Portion F during the site inspection on 14 November 2017

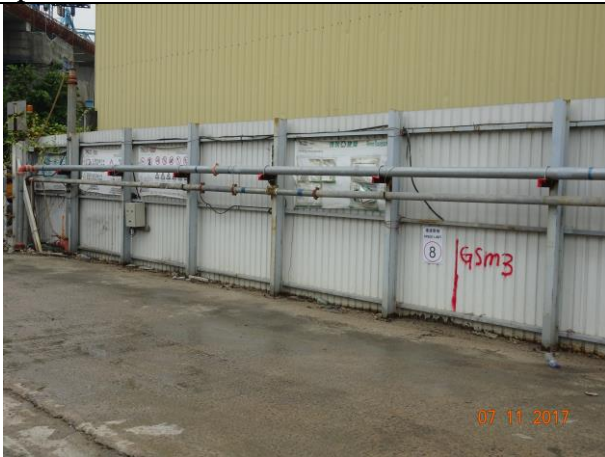
**Photo 9** Set speed control at ~8km/hr for all vehicles using the haul road at Portion F

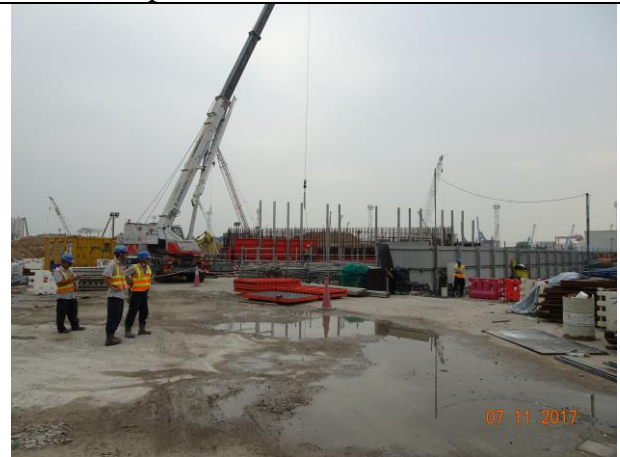
**Photo 10** No dust emitted for the Portion F was observed during the site inspection on 7 November 2017 and the works area was clean and tidy

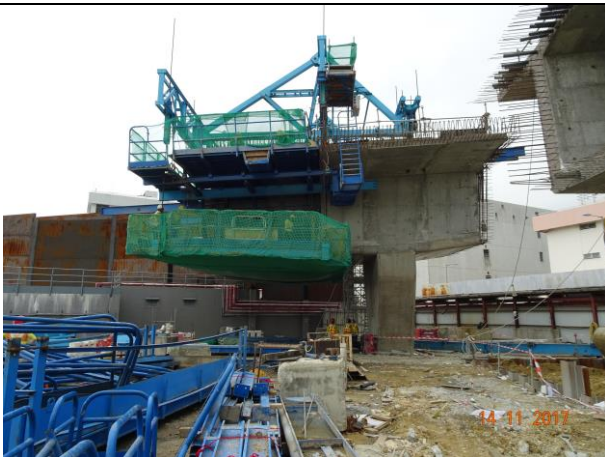
**Photo 11** No dust emitted for the Portion F was observed during the site inspection on 14 November 2017 and the works area was clean and tidy

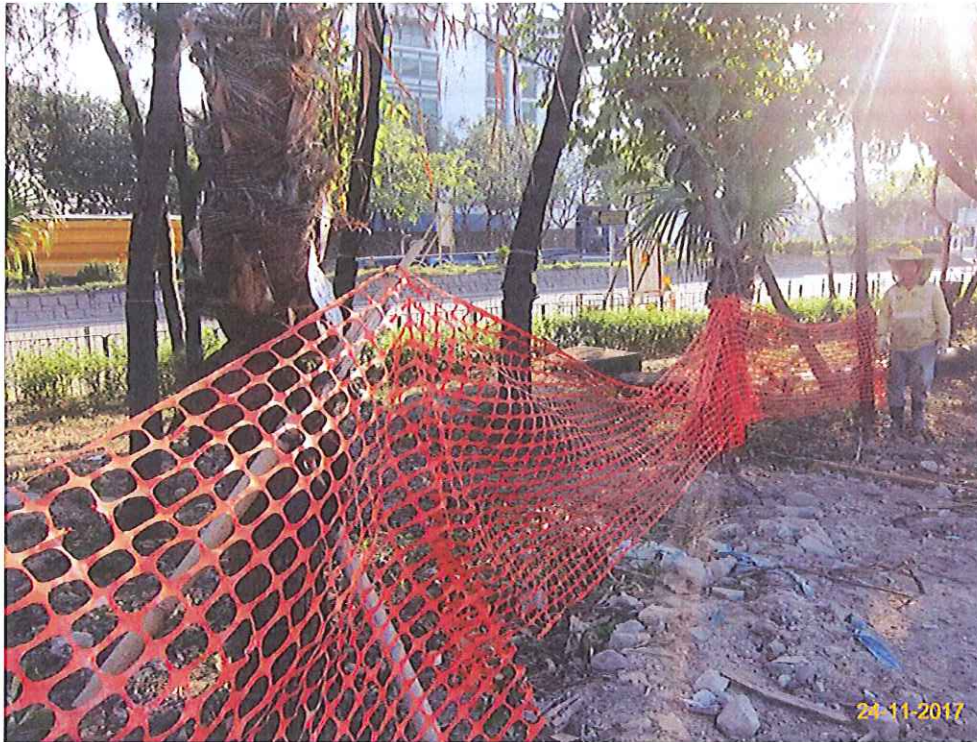
Item 1. Existing trees on boundary of the Project Area should be protected carefully during construction.

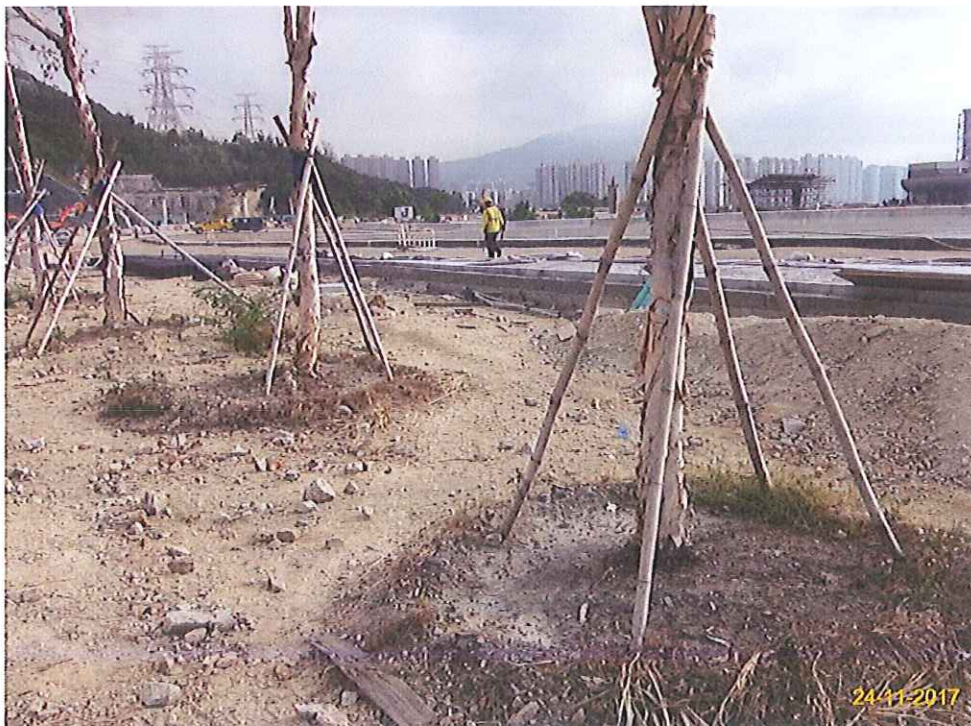
Item 2. Tree Transplanting works was conducted on 22-May-17.

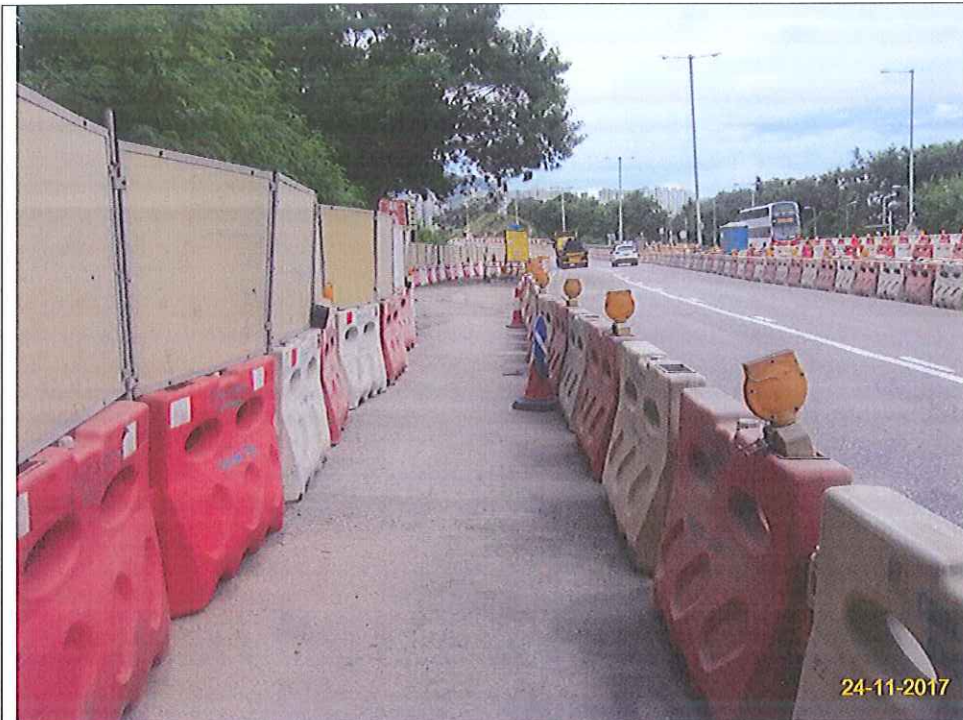
Item 5. Hoarding with panel around works area & Item 6. Temporary traffic management lighting.

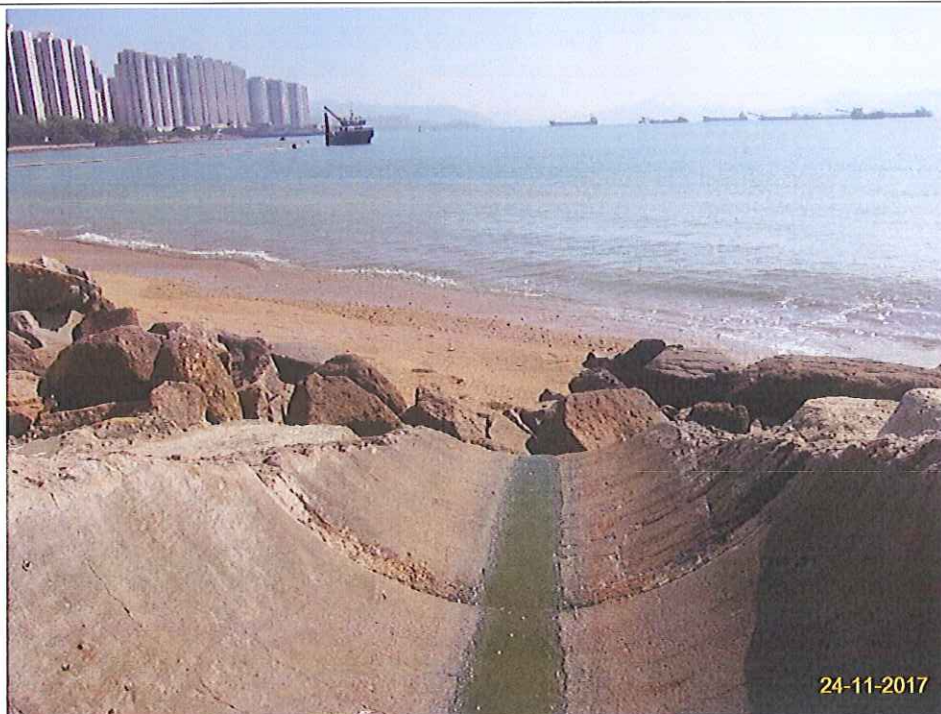
Item 7. Ensure no run-off into water body.

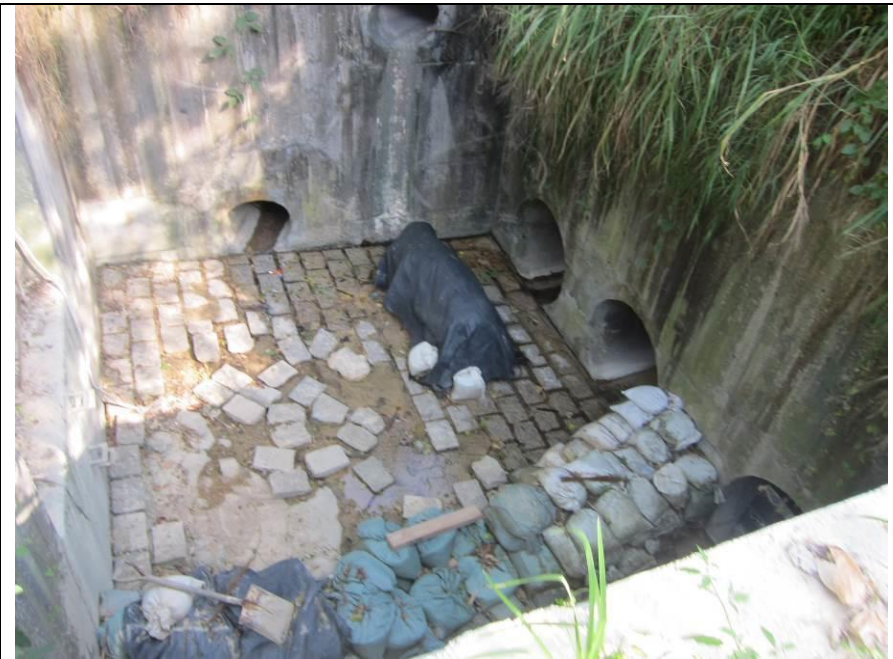
Stream B Outfall: No water is discharging.

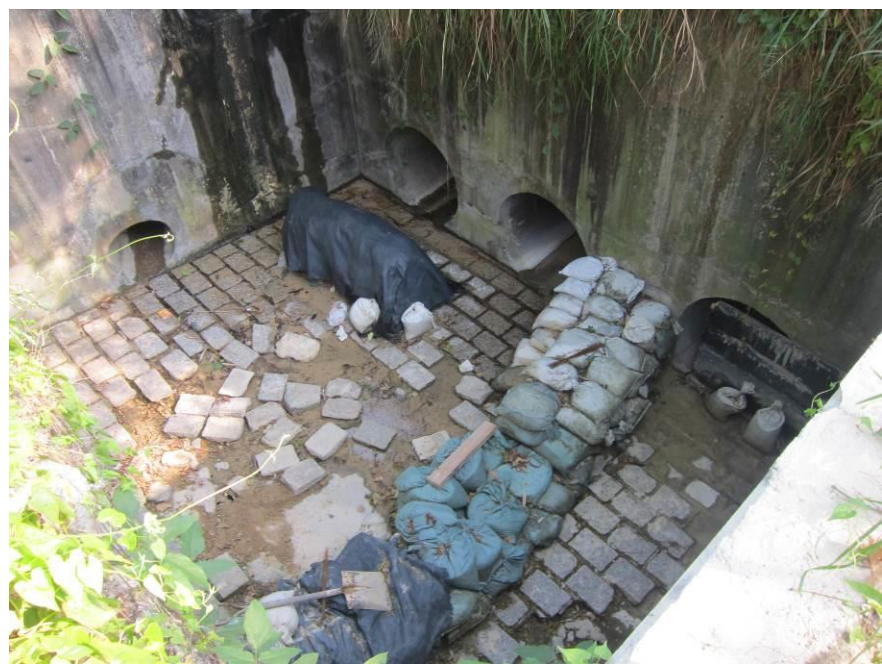
Stream B Outfall: No water is discharging.

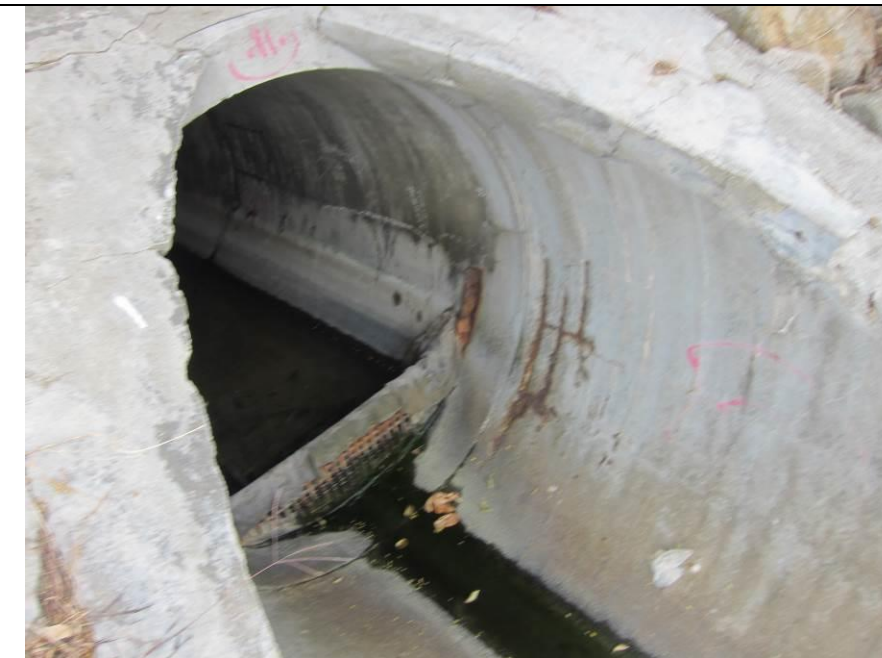
Outfall 1: No water is discharging.

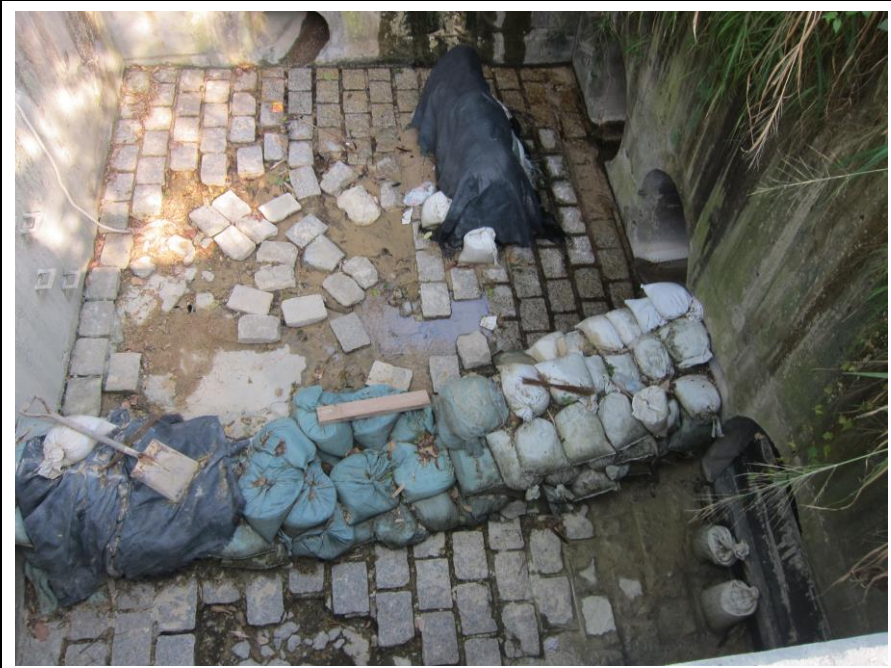
Stream B Outfall: No water is discharging.

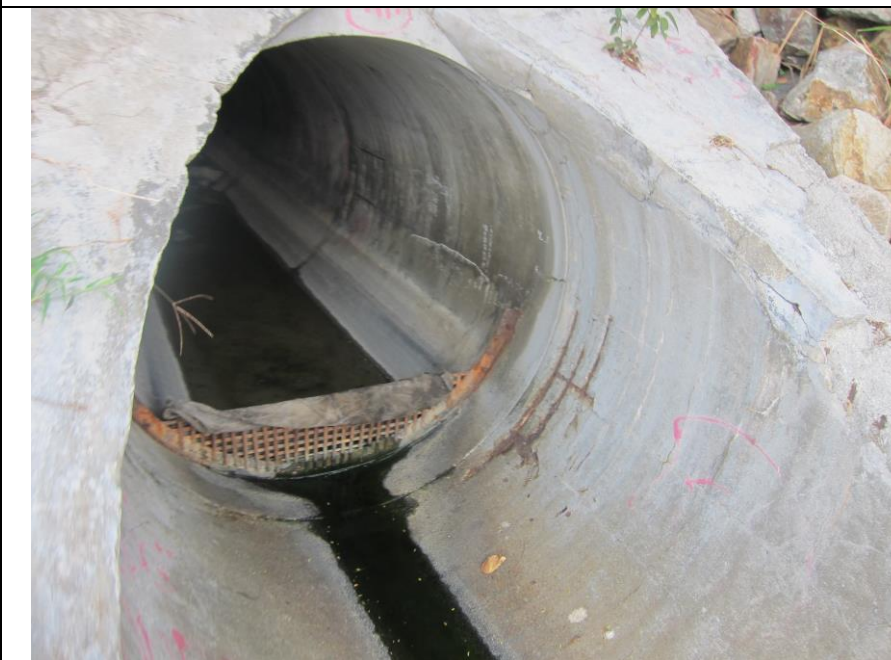
Outfall 1: No water is discharging.
