**TUEN MUN - CHEK LAP KOK LINK
CONTRACT NO. HY/2013/12 –
NORTHERN CONNECTION TOLL PLAZA AND
ASSOCIATED WORKS**

**13th QUARTERLY ENVIRONMENTAL MONITORING &
AUDIT SUMMARY REPORT –
(November 2017 to January 2018)**

**Contract No. HY/2013/12 TM-CLKL Northern Connection Toll Plaza and
Associated Works
13th Quarterly EM&A Summary Report (November 2017 to January
2018)**

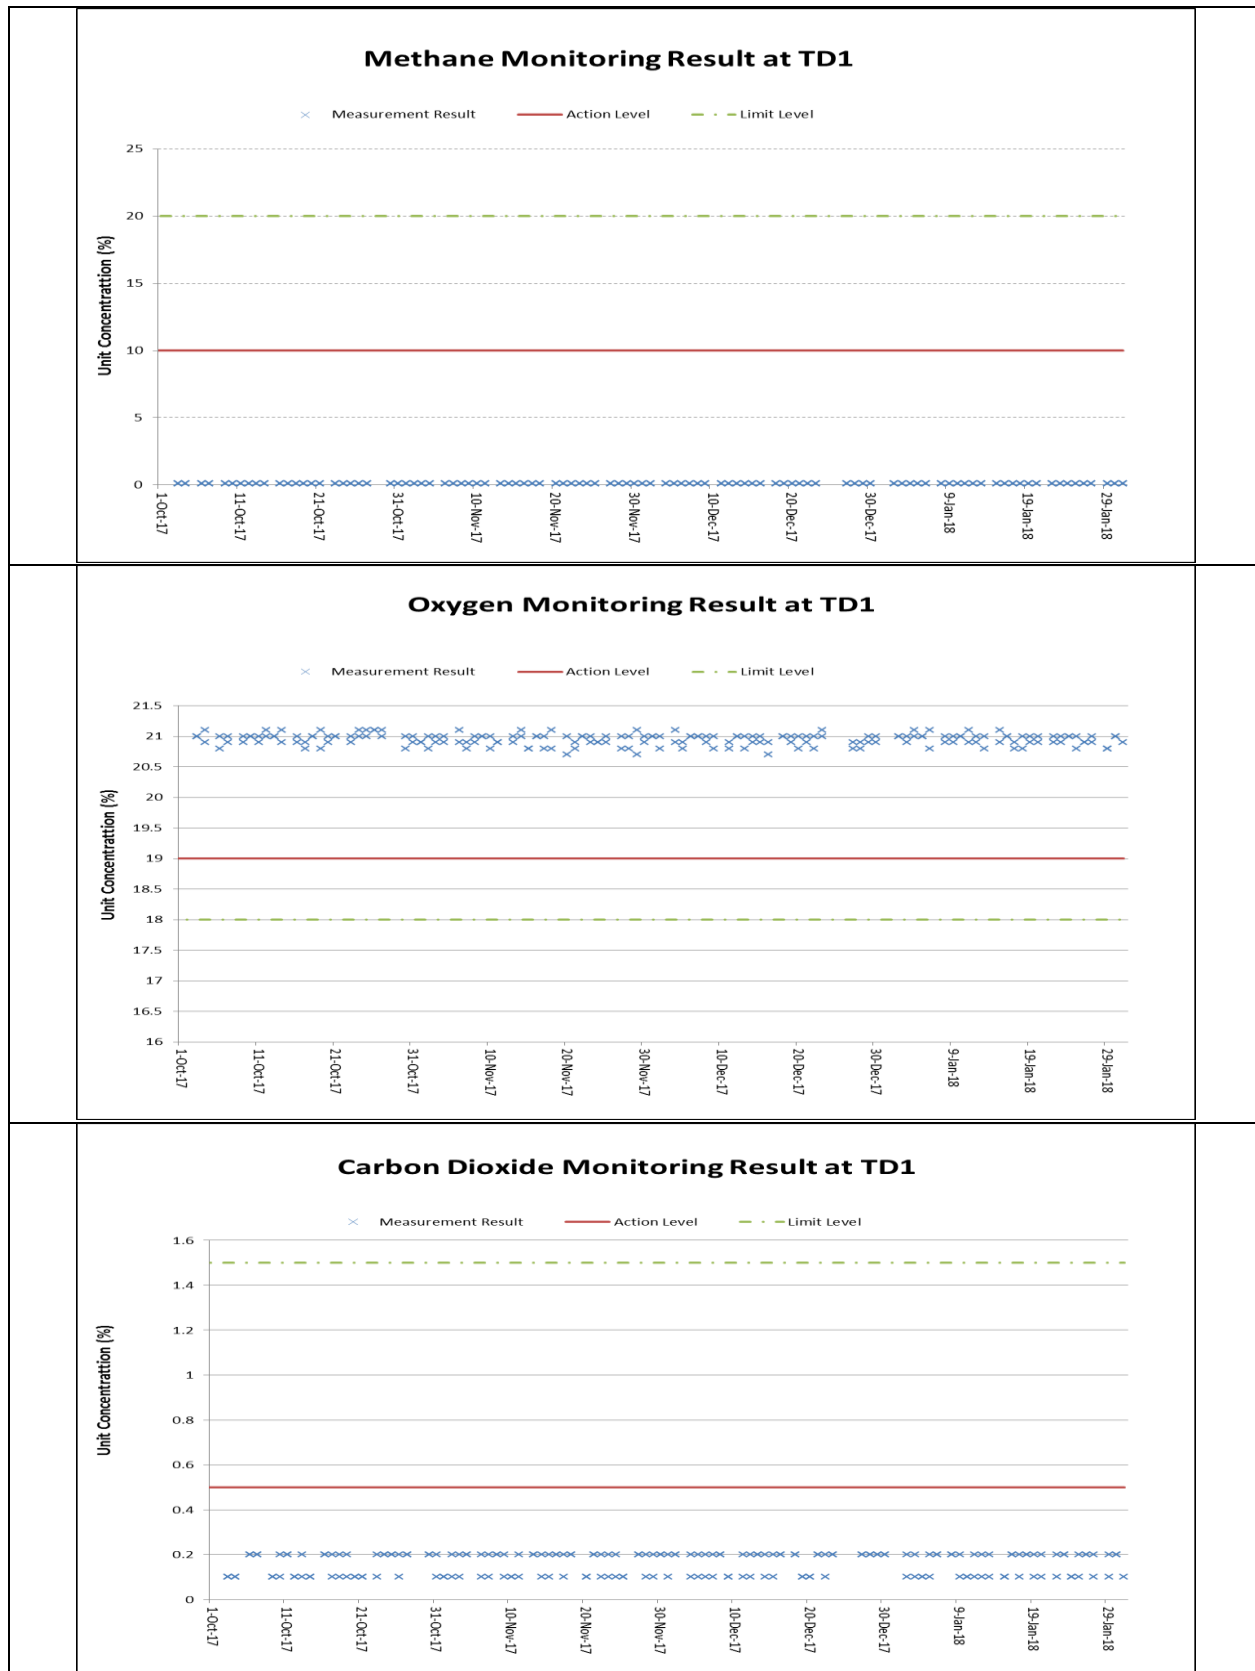
Landfill Gas Monitoring Graphical Plots

During this reporting period, major construction activity at TD1 and the specified works included excavation, stitching, blinding, formworking, steel-fixing and concreting. The weather condition varied from sunny to rainy. The monitoring data was provided by the Contractor followed to their QA/QC control.
