**Contract No. HY/2012/08
Tuen Mun - Chek Lap Kok Link -
Northern Connection Sub-sea Tunnel
Section**

*Seventeenth Quarterly Environmental Monitoring
& Audit (EM&A) Report*

**Contract No. HY/2012/08 TM-CLKL Northern Connection Sub-sea
Tunnel Section
Seventeenth Quarterly EM&A Report (December 2017 – February 2018)**

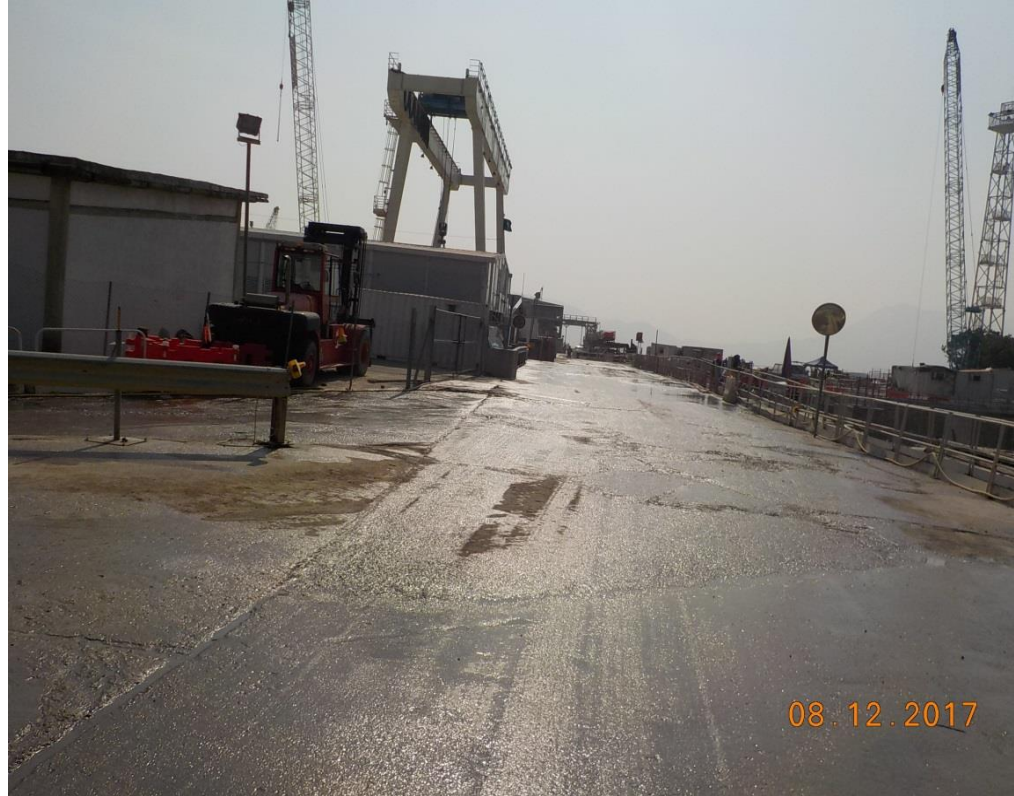
Water spraying was applied frequently during dry conditions. (Works Area Portion N-A)

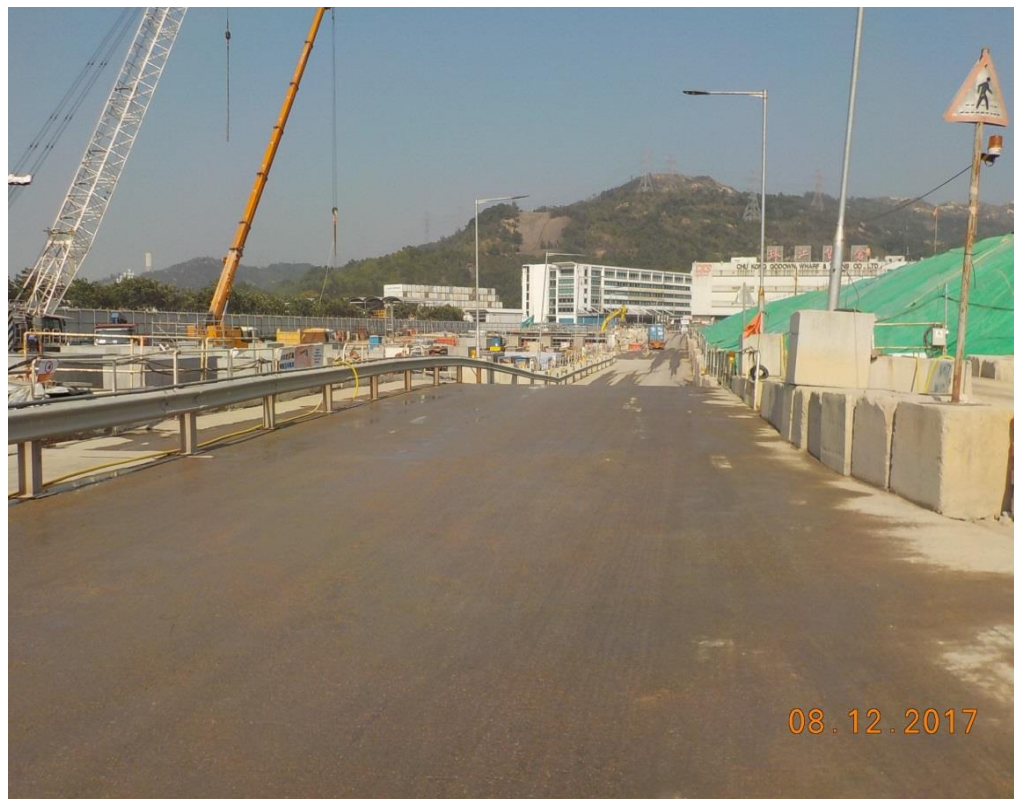
Exposed soil at Portion N-A was also covered by tarpaulin sheets. (Works Area Portion N-A)

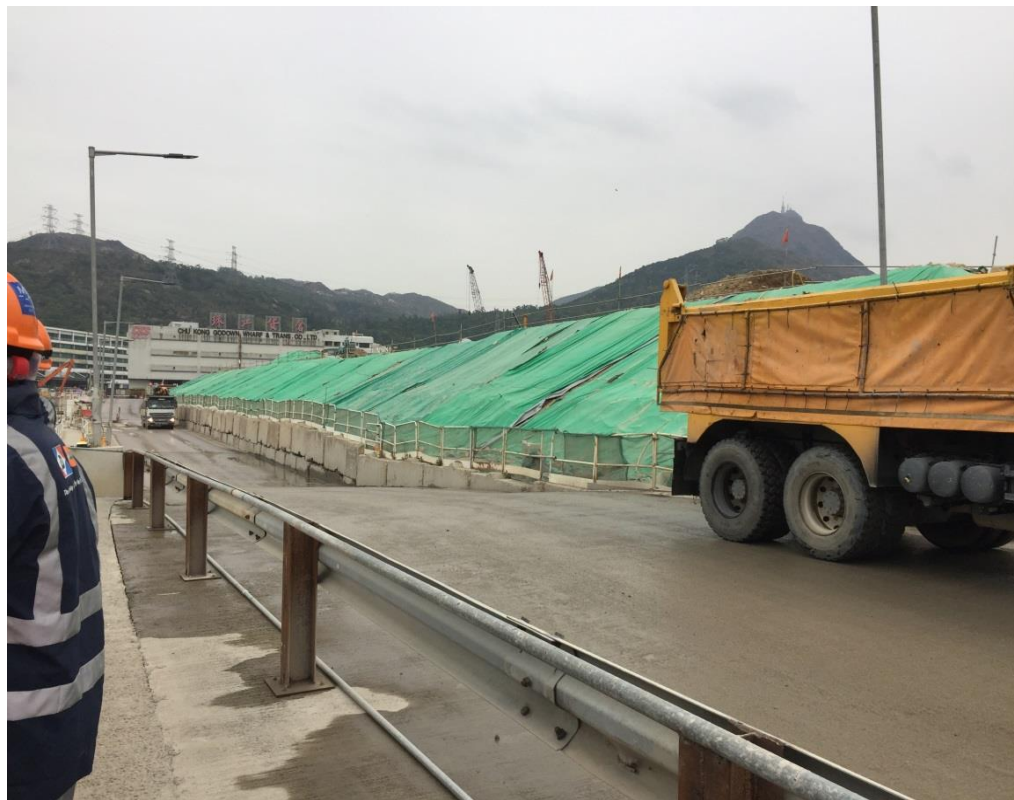
Exposed soil at Portion N-A was also covered by tarpaulin sheets. (Works Area Portion N-A)

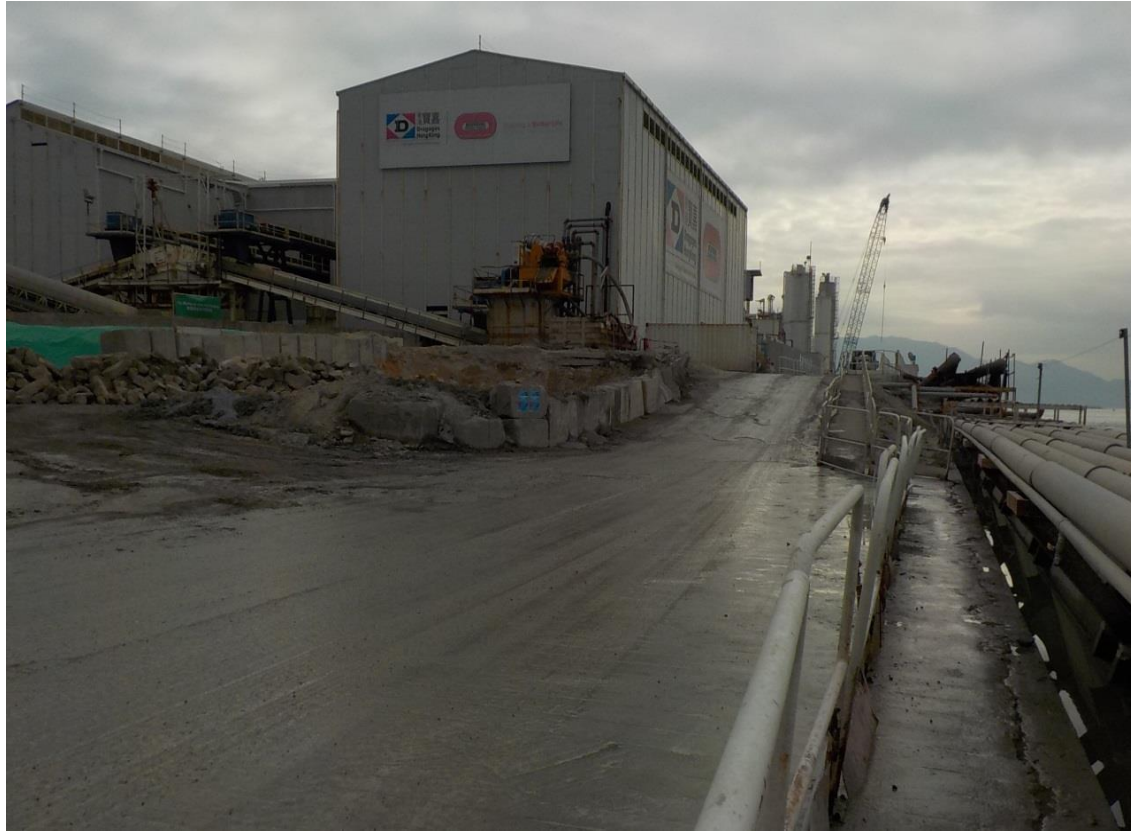
Water spraying was applied frequently during dry conditions. (Works Area Portion N-C)

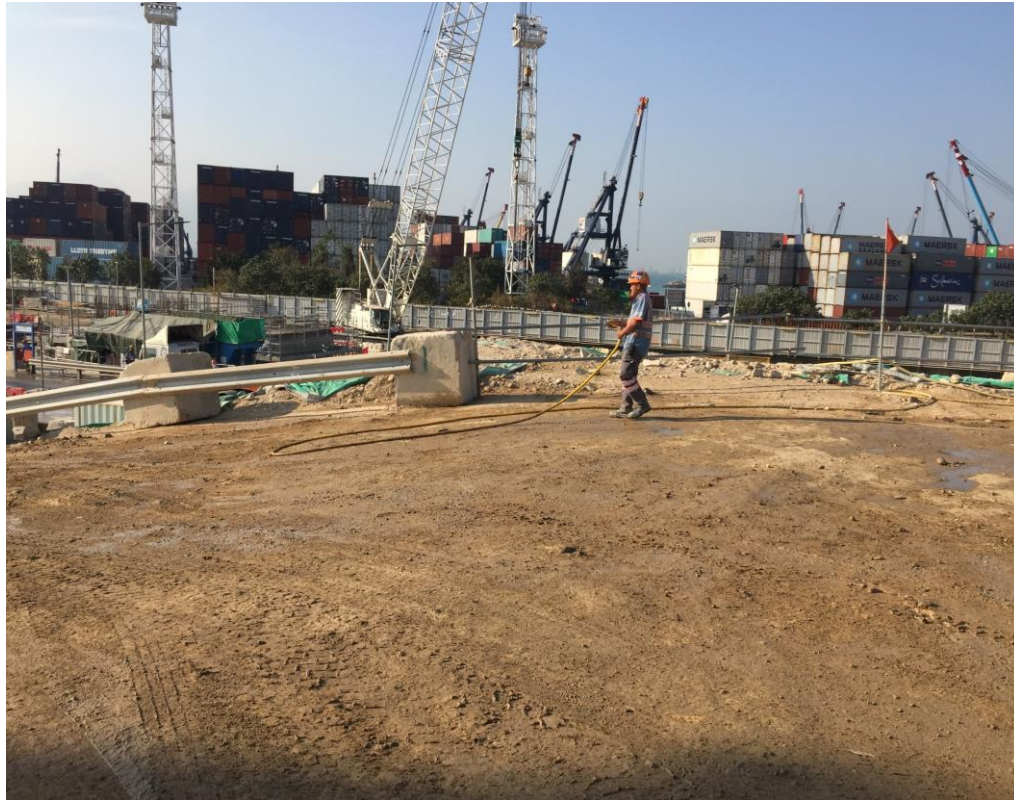
Water spraying was applied frequently during dry conditions.(Works Area Portion N-A)

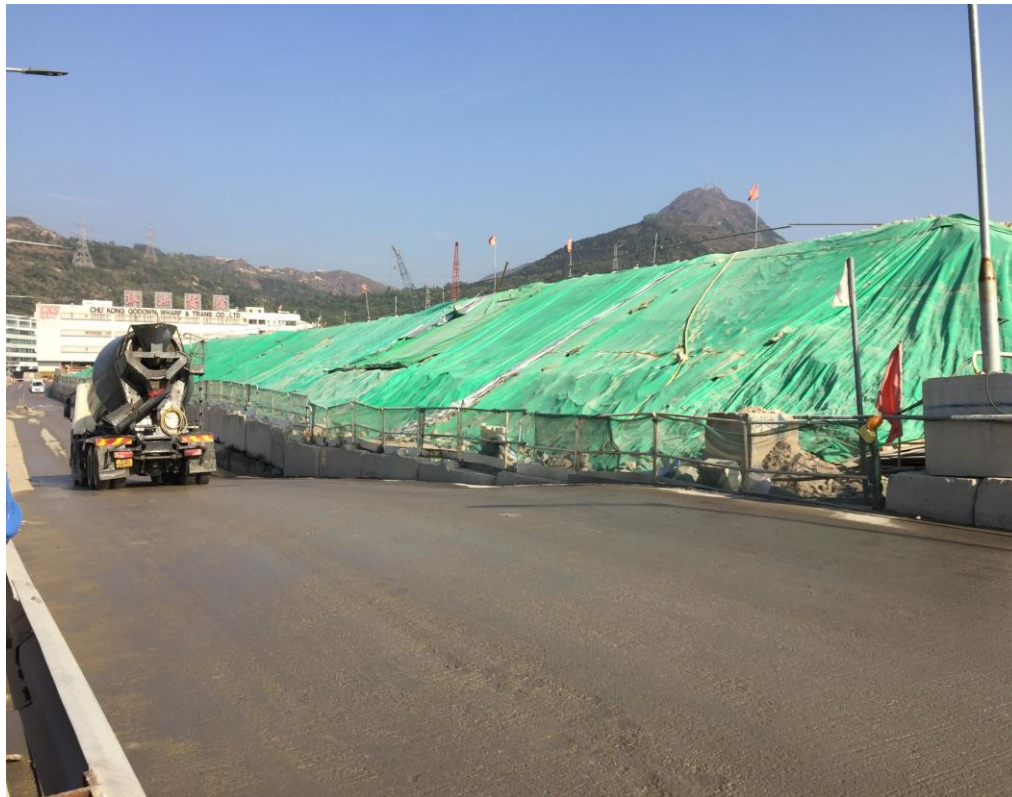
Exposed soil at Portion N-A was also covered by tarpaulin sheets. (Works Area Portion N-A)

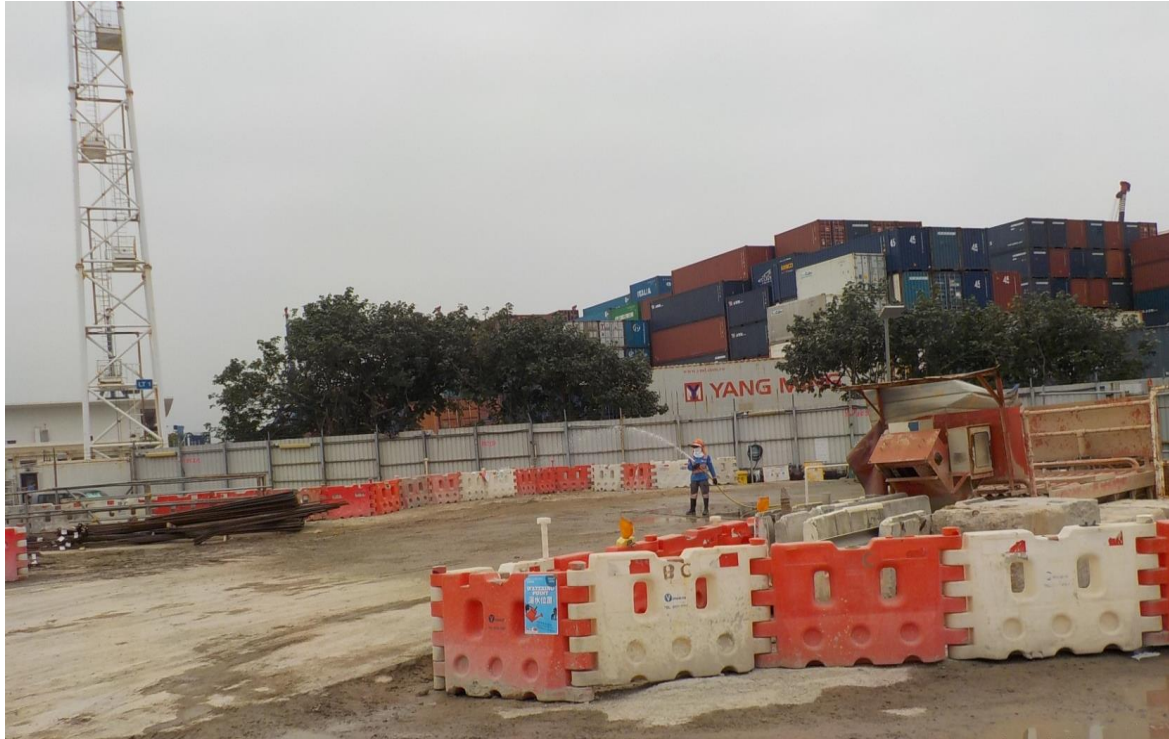
Water spraying was applied frequently during dry conditions.(Works Area Portion N-A)

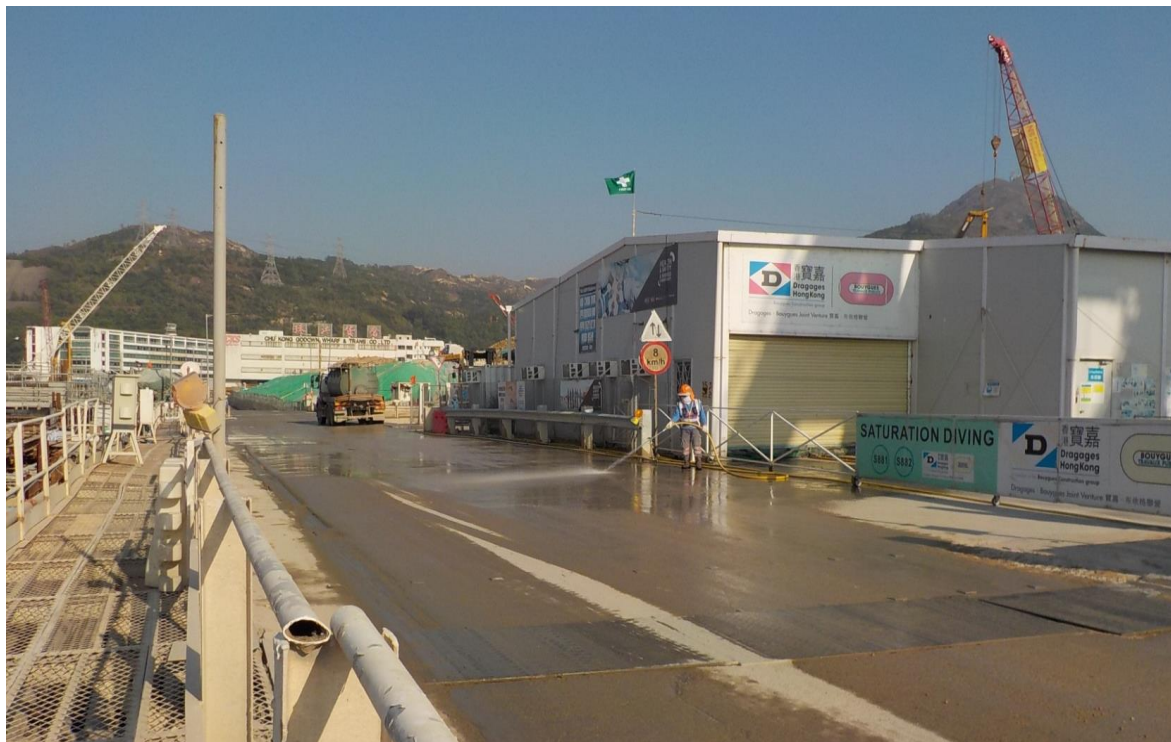
Exposed soil at Portion N-A was covered by tarpaulin sheets. (Works Area Portion N-A)

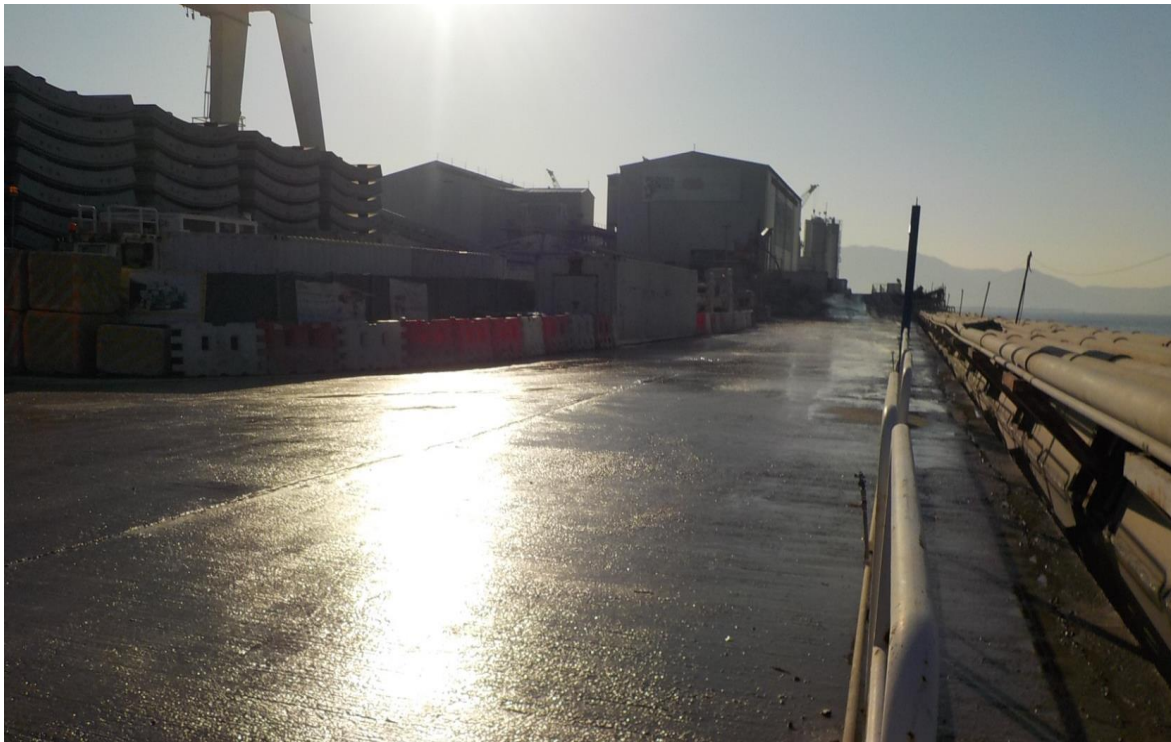
Water spraying was applied frequently during dry conditions.(Works Area Portion N-B)

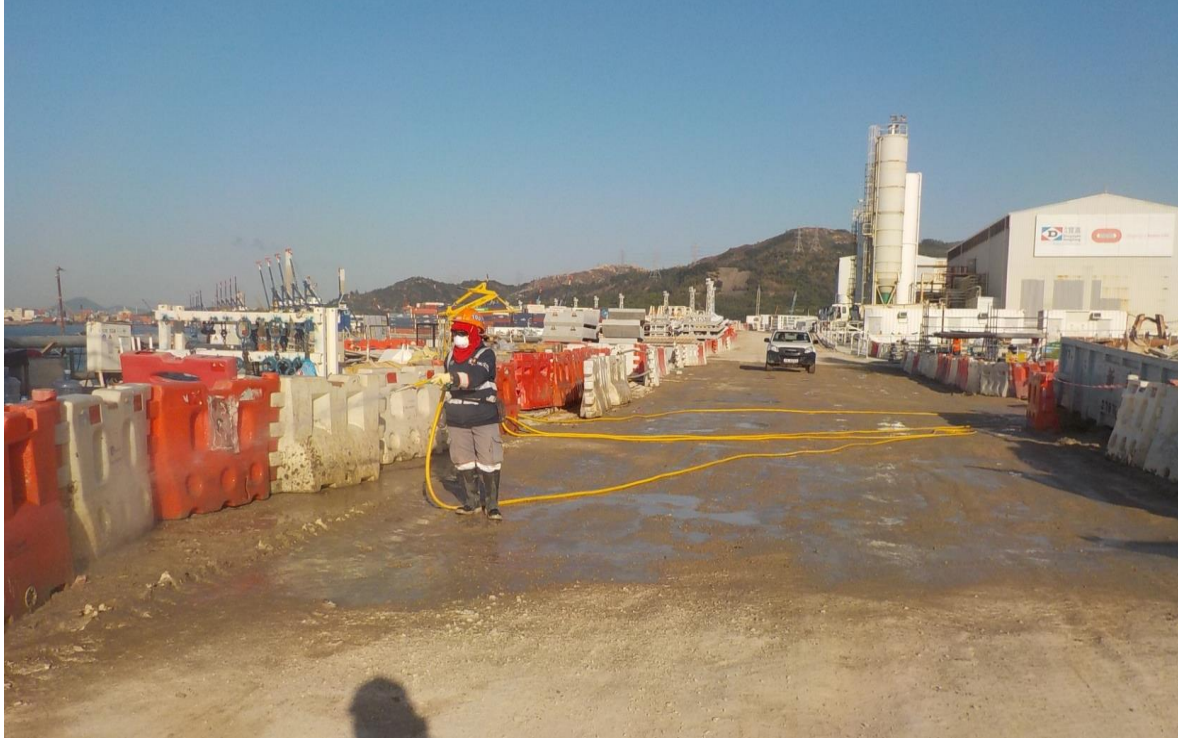
Water spraying was applied frequently during dry conditions.(Works Area Portion N-C)

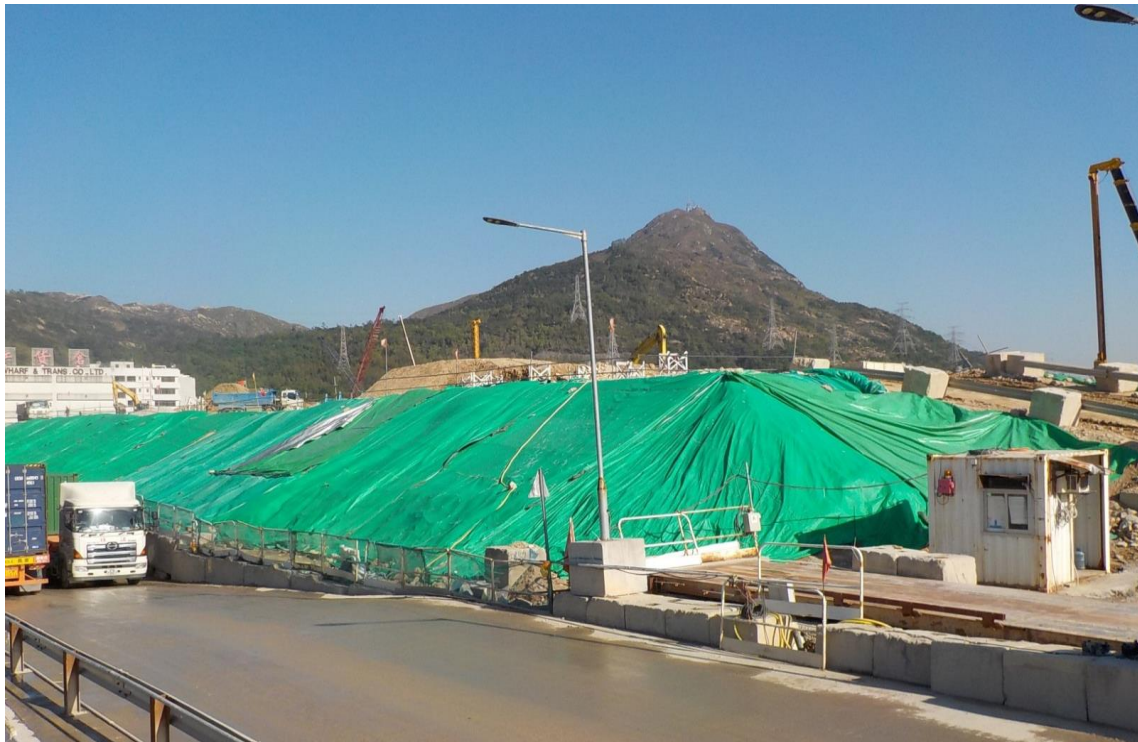
Exposed soil at Portion N-A was covered by tarpaulin sheets. (Works Area Portion N-A)

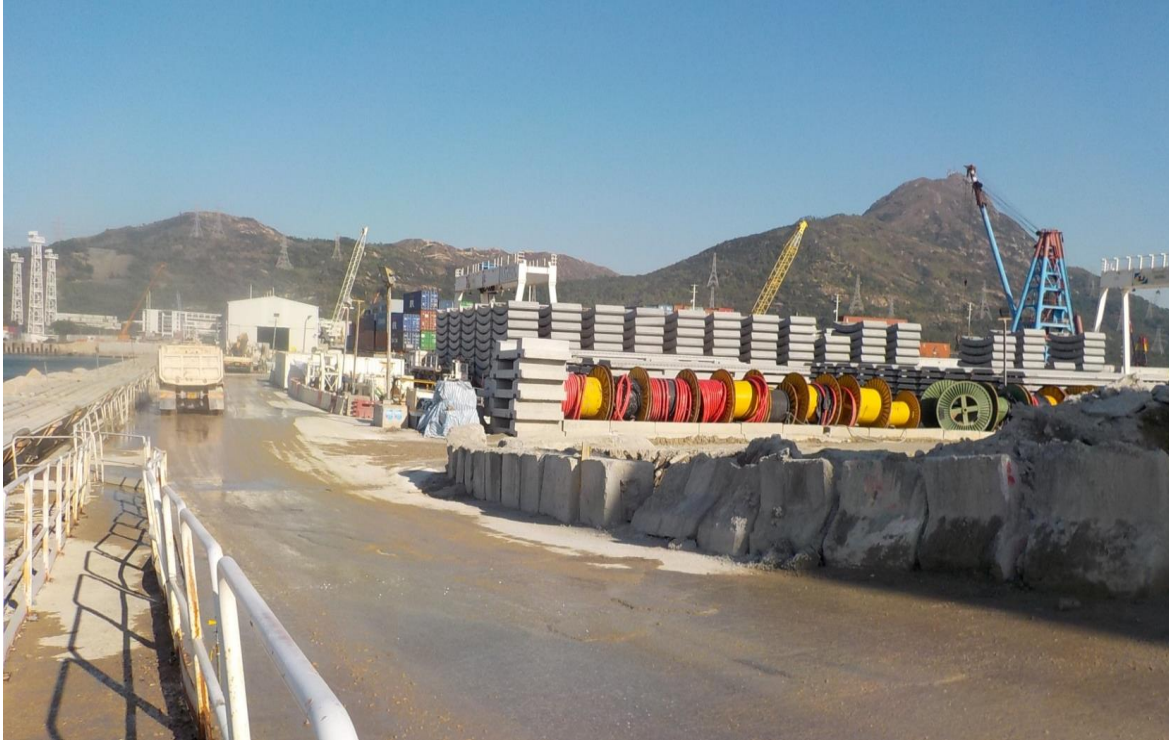
Water spraying was applied frequently during dry conditions.(Works Area Portion N-C)

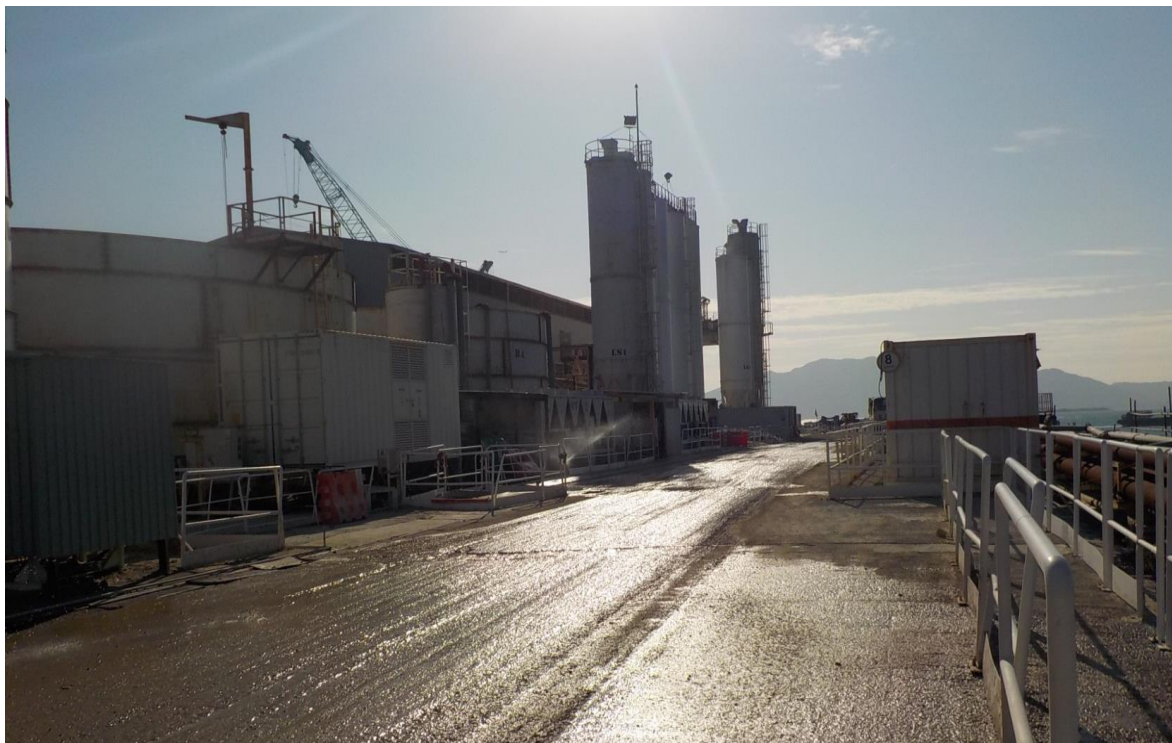
Water spraying was applied frequently during dry conditions.(Works Area Portion N-B)

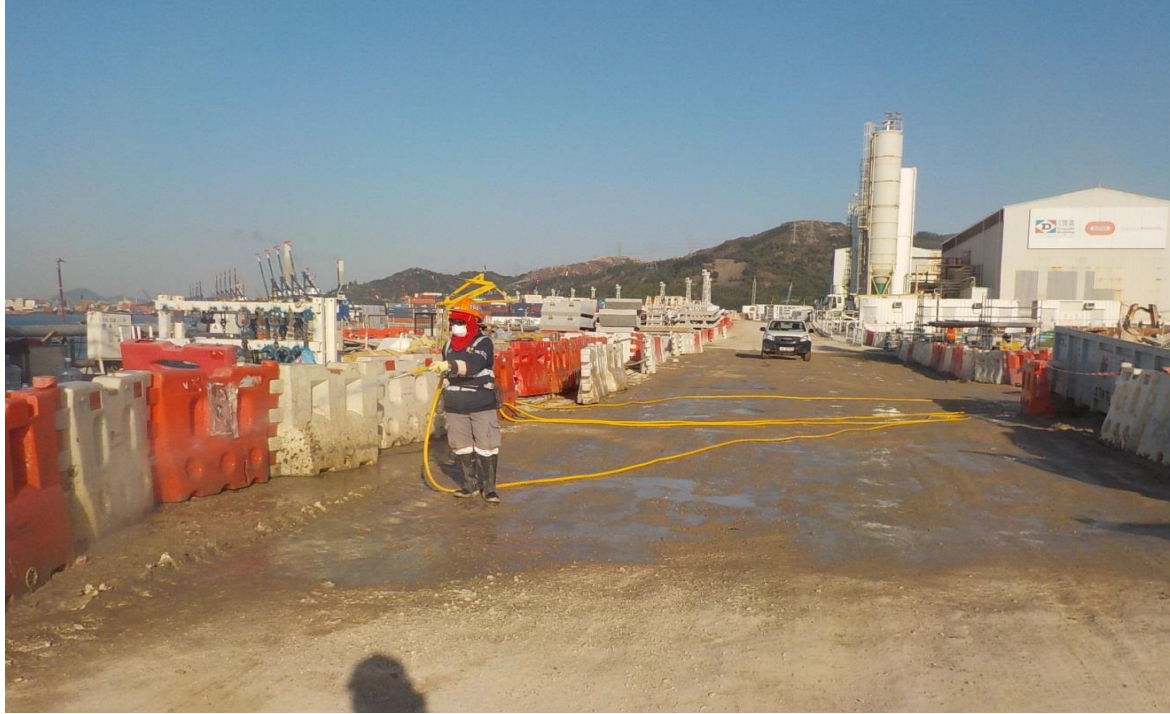
Water spraying was applied frequently during dry conditions.(Works Area Portion N-C)

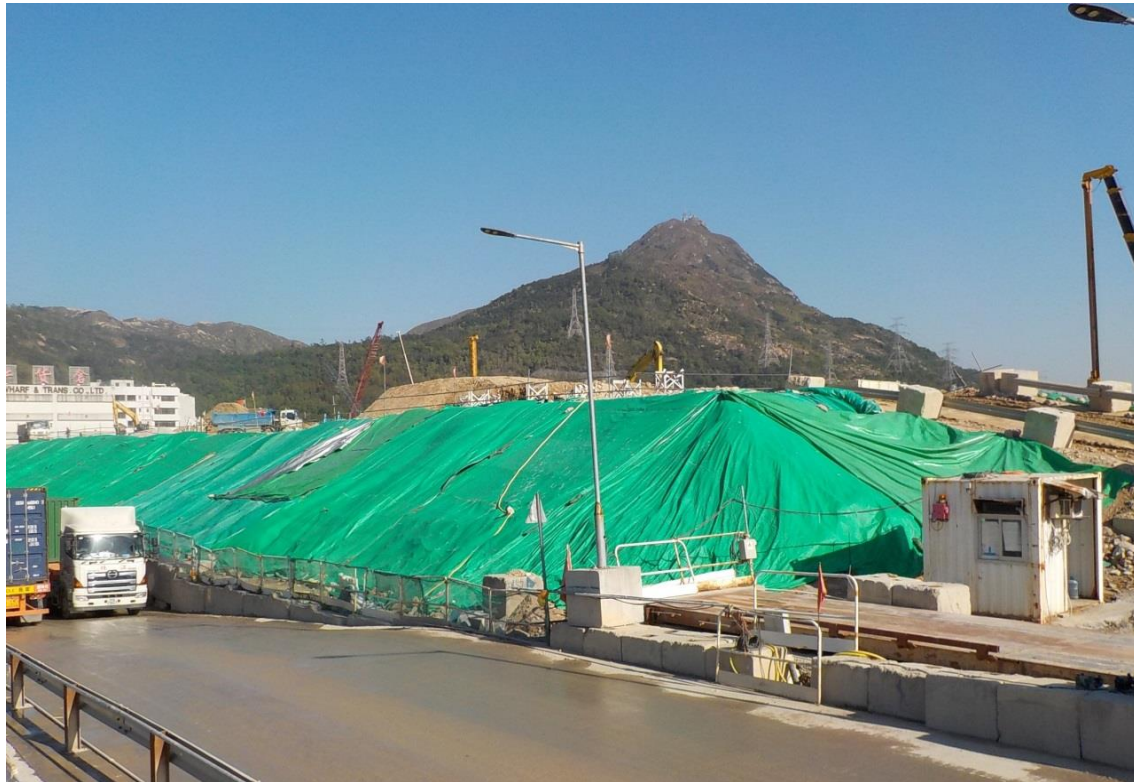
Exposed soil at Portion N-A was covered by tarpaulin sheets. (Works Area Portion N-A)

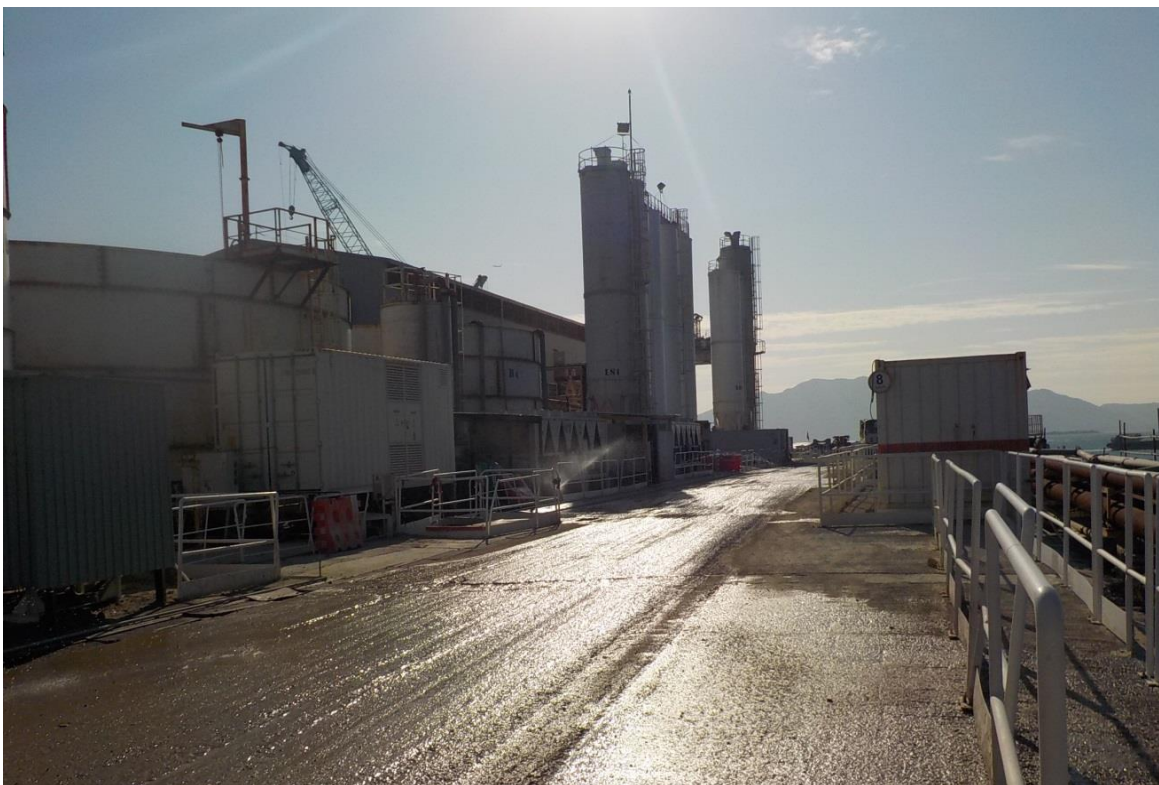
Water spraying was applied frequently during dry conditions.(Works Area Portion N-B)

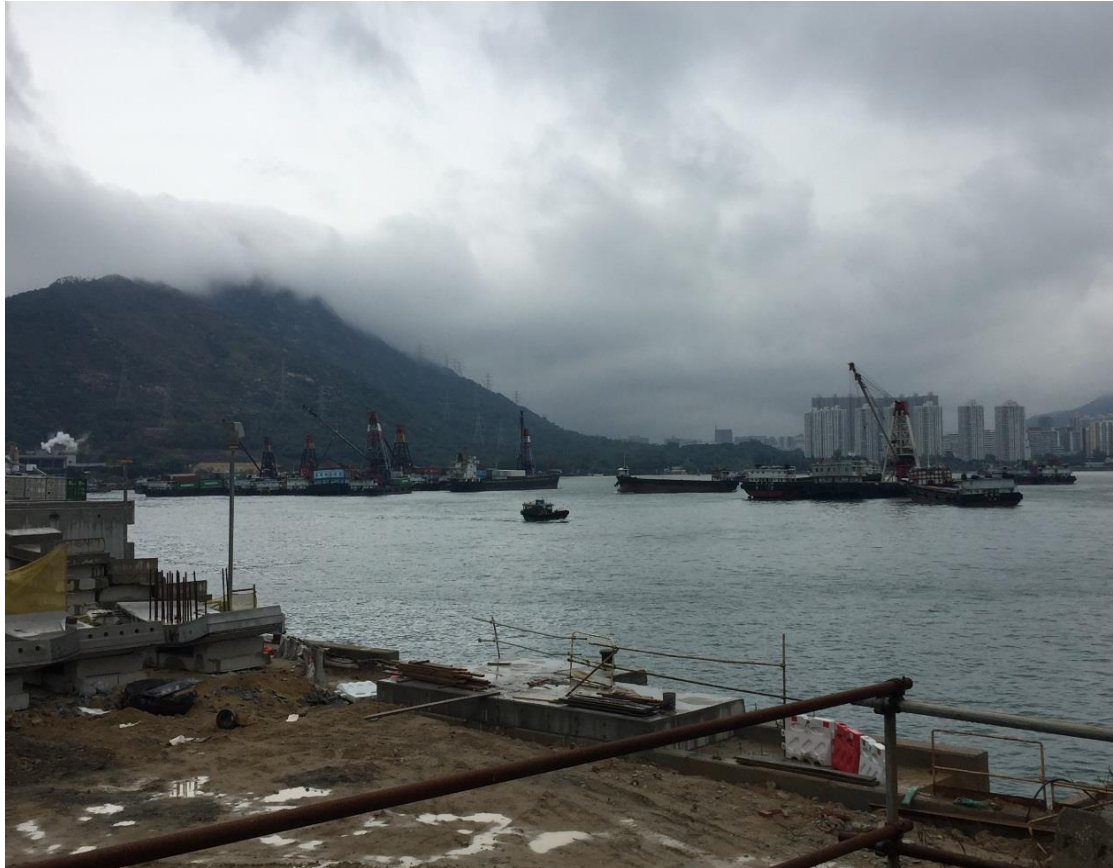
Barges not under this Contract are observed near the site

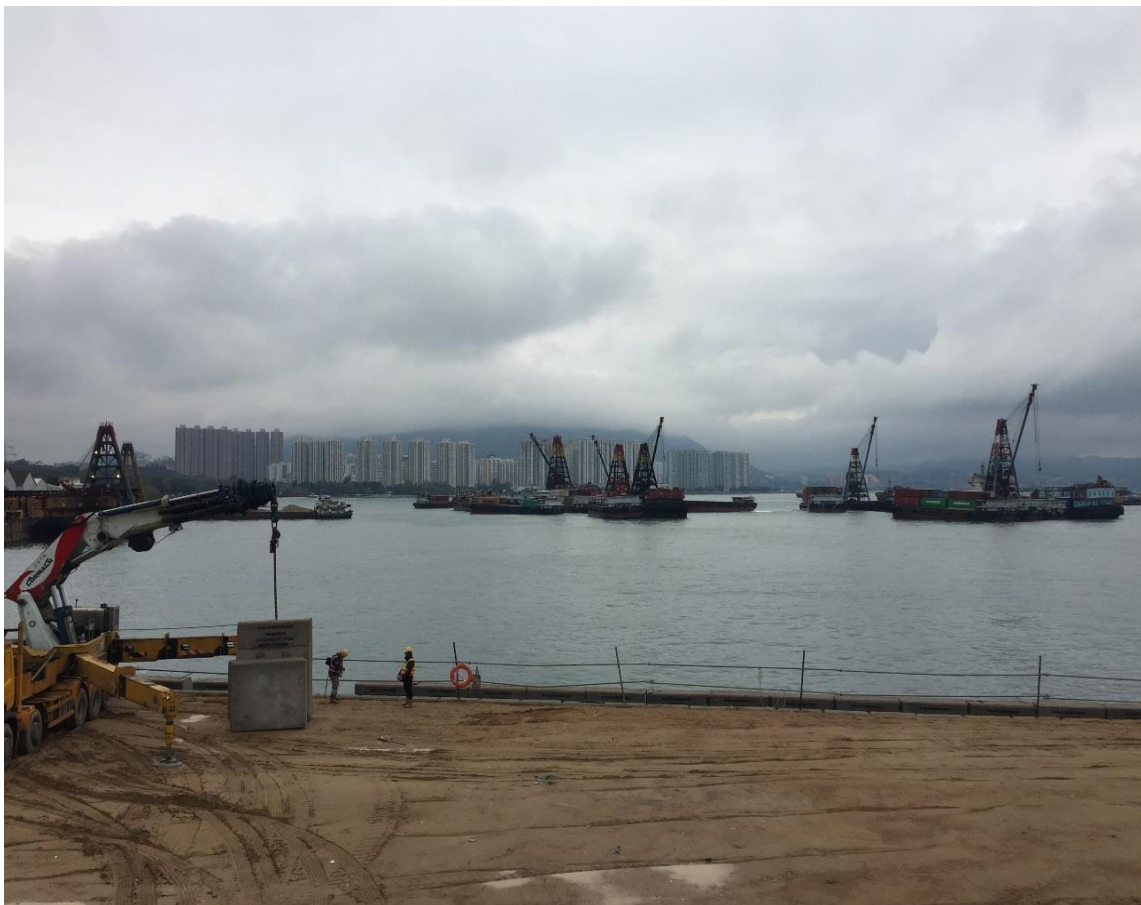
Barges not under this Contract are observed near the site
