**Contract No. HY/2012/08
Tuen Mun - Chek Lap Kok Link -
Northern Connection Sub-sea Tunnel
Section**

*Fifty-second Monthly Environmental Monitoring
& Audit (EM&A) Report*

13 March 2018

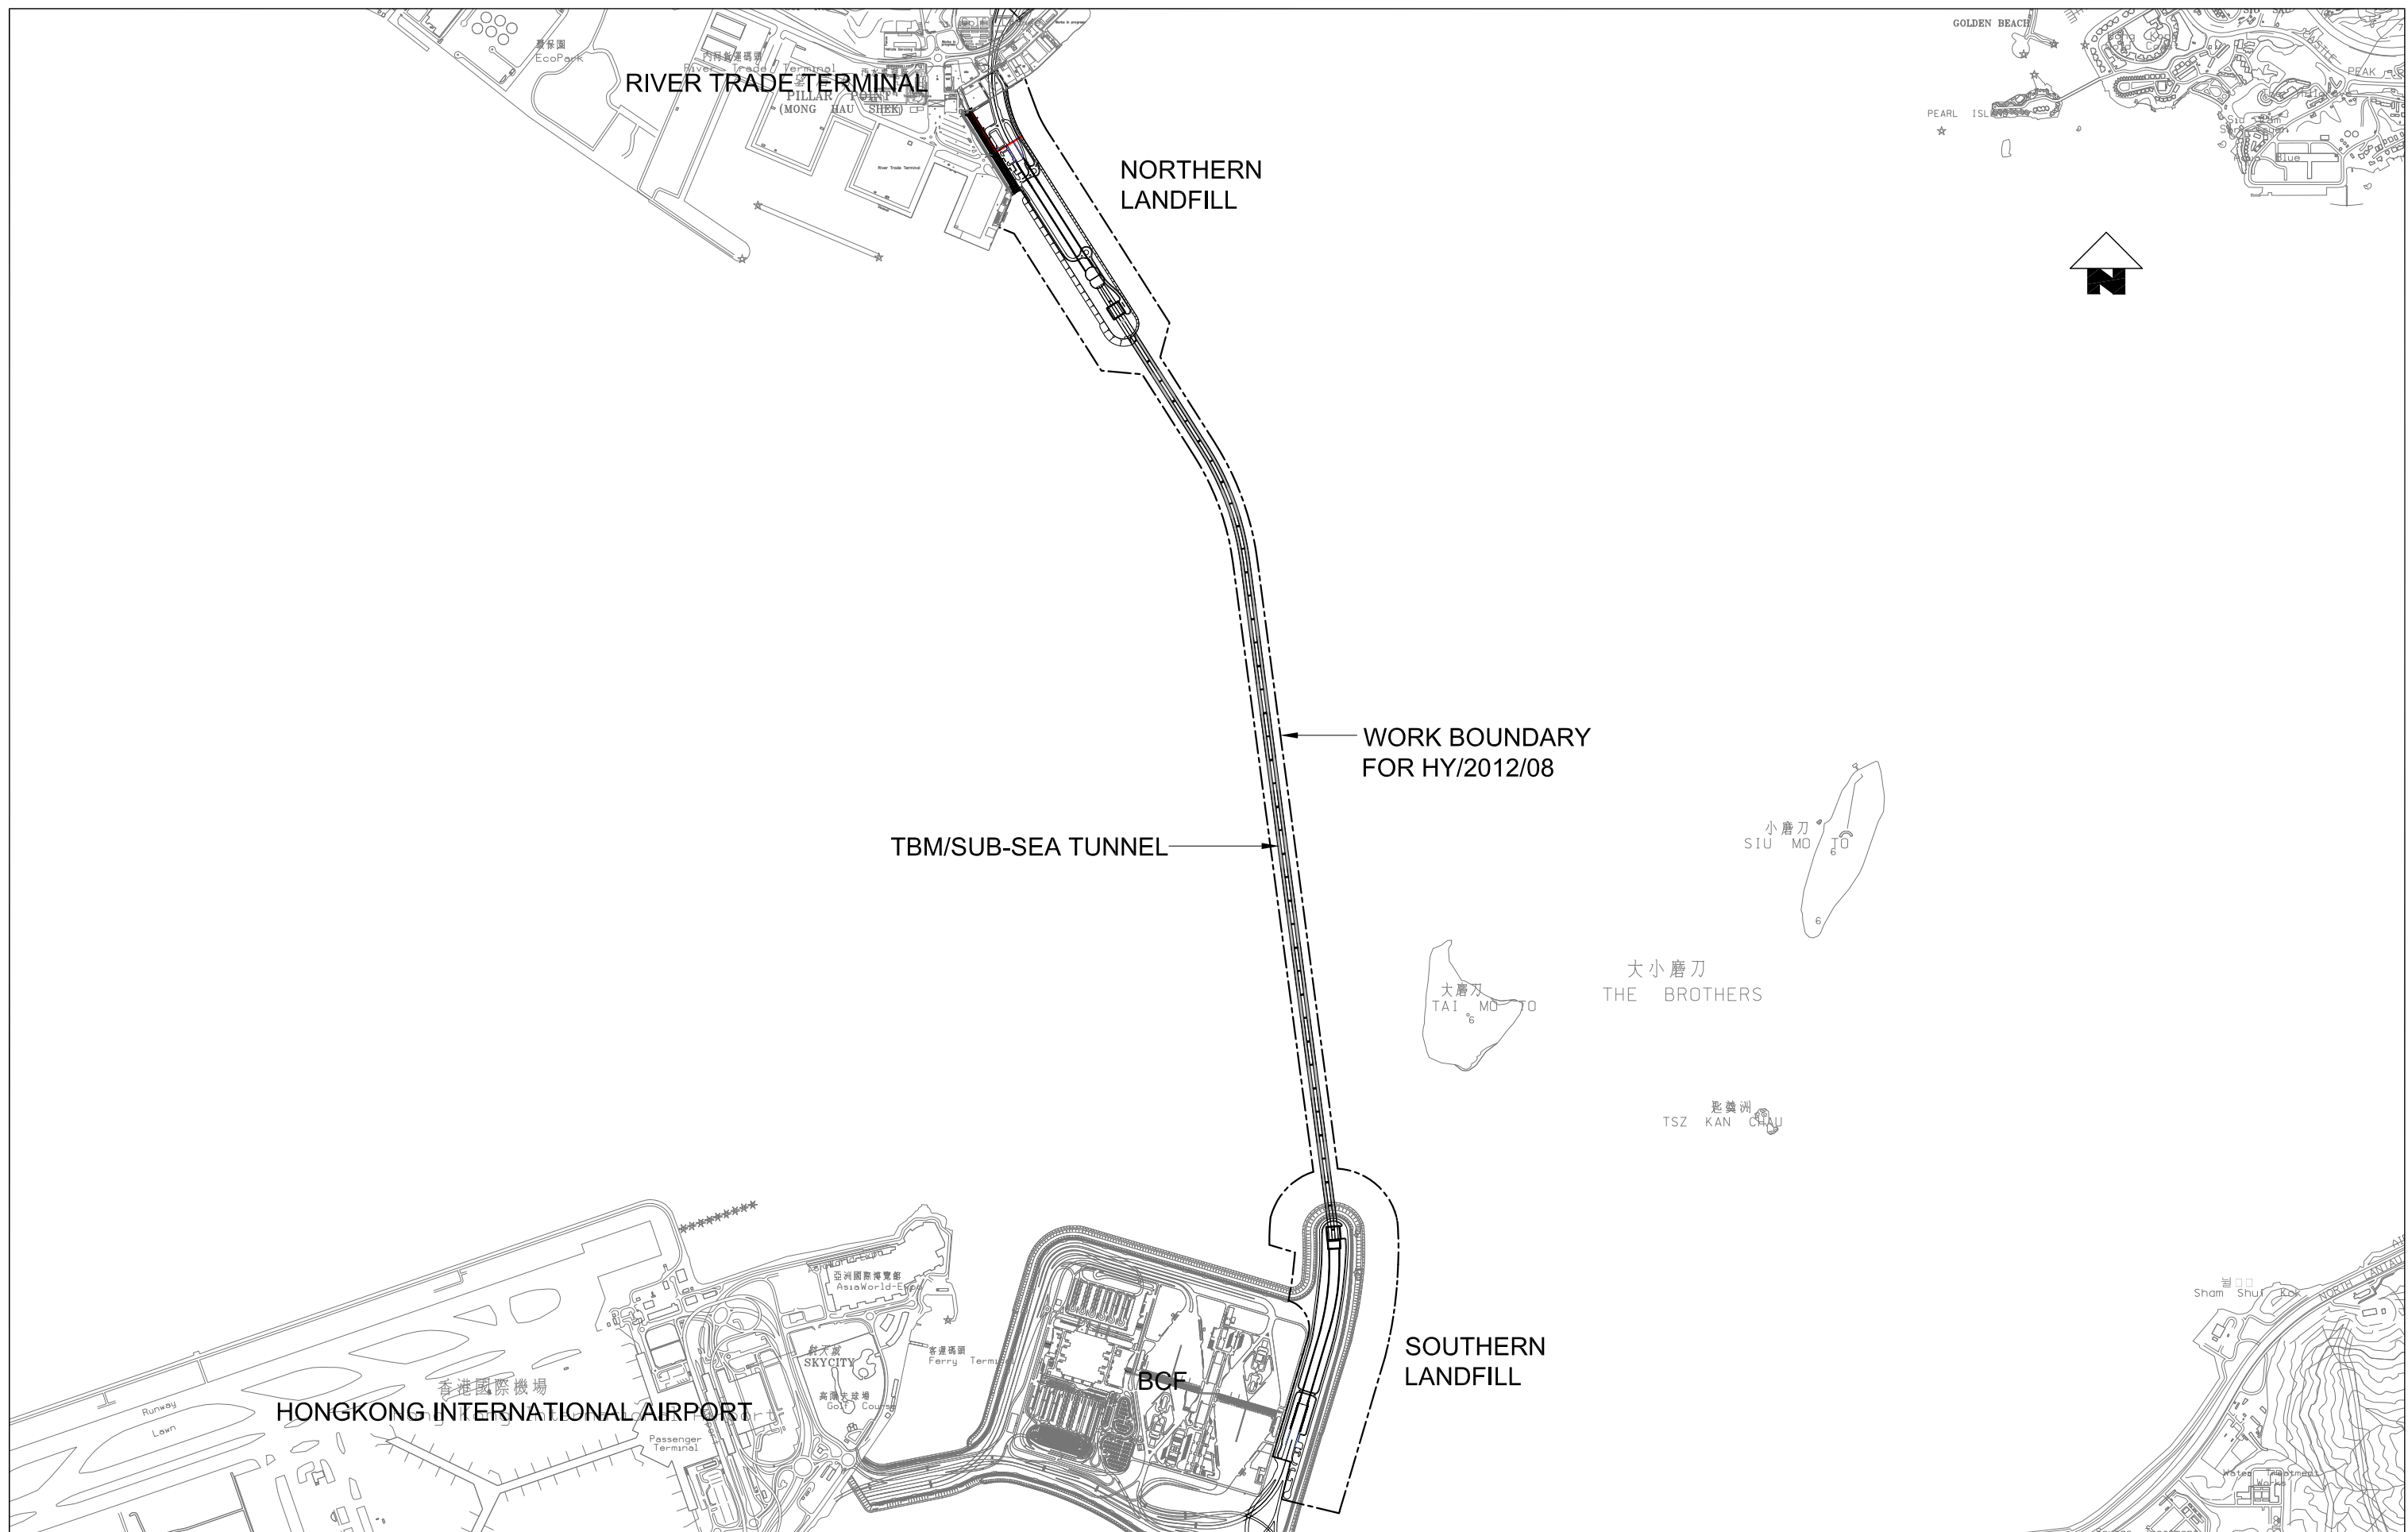
Layout of the Contract components is presented in *Figure 1.1*.

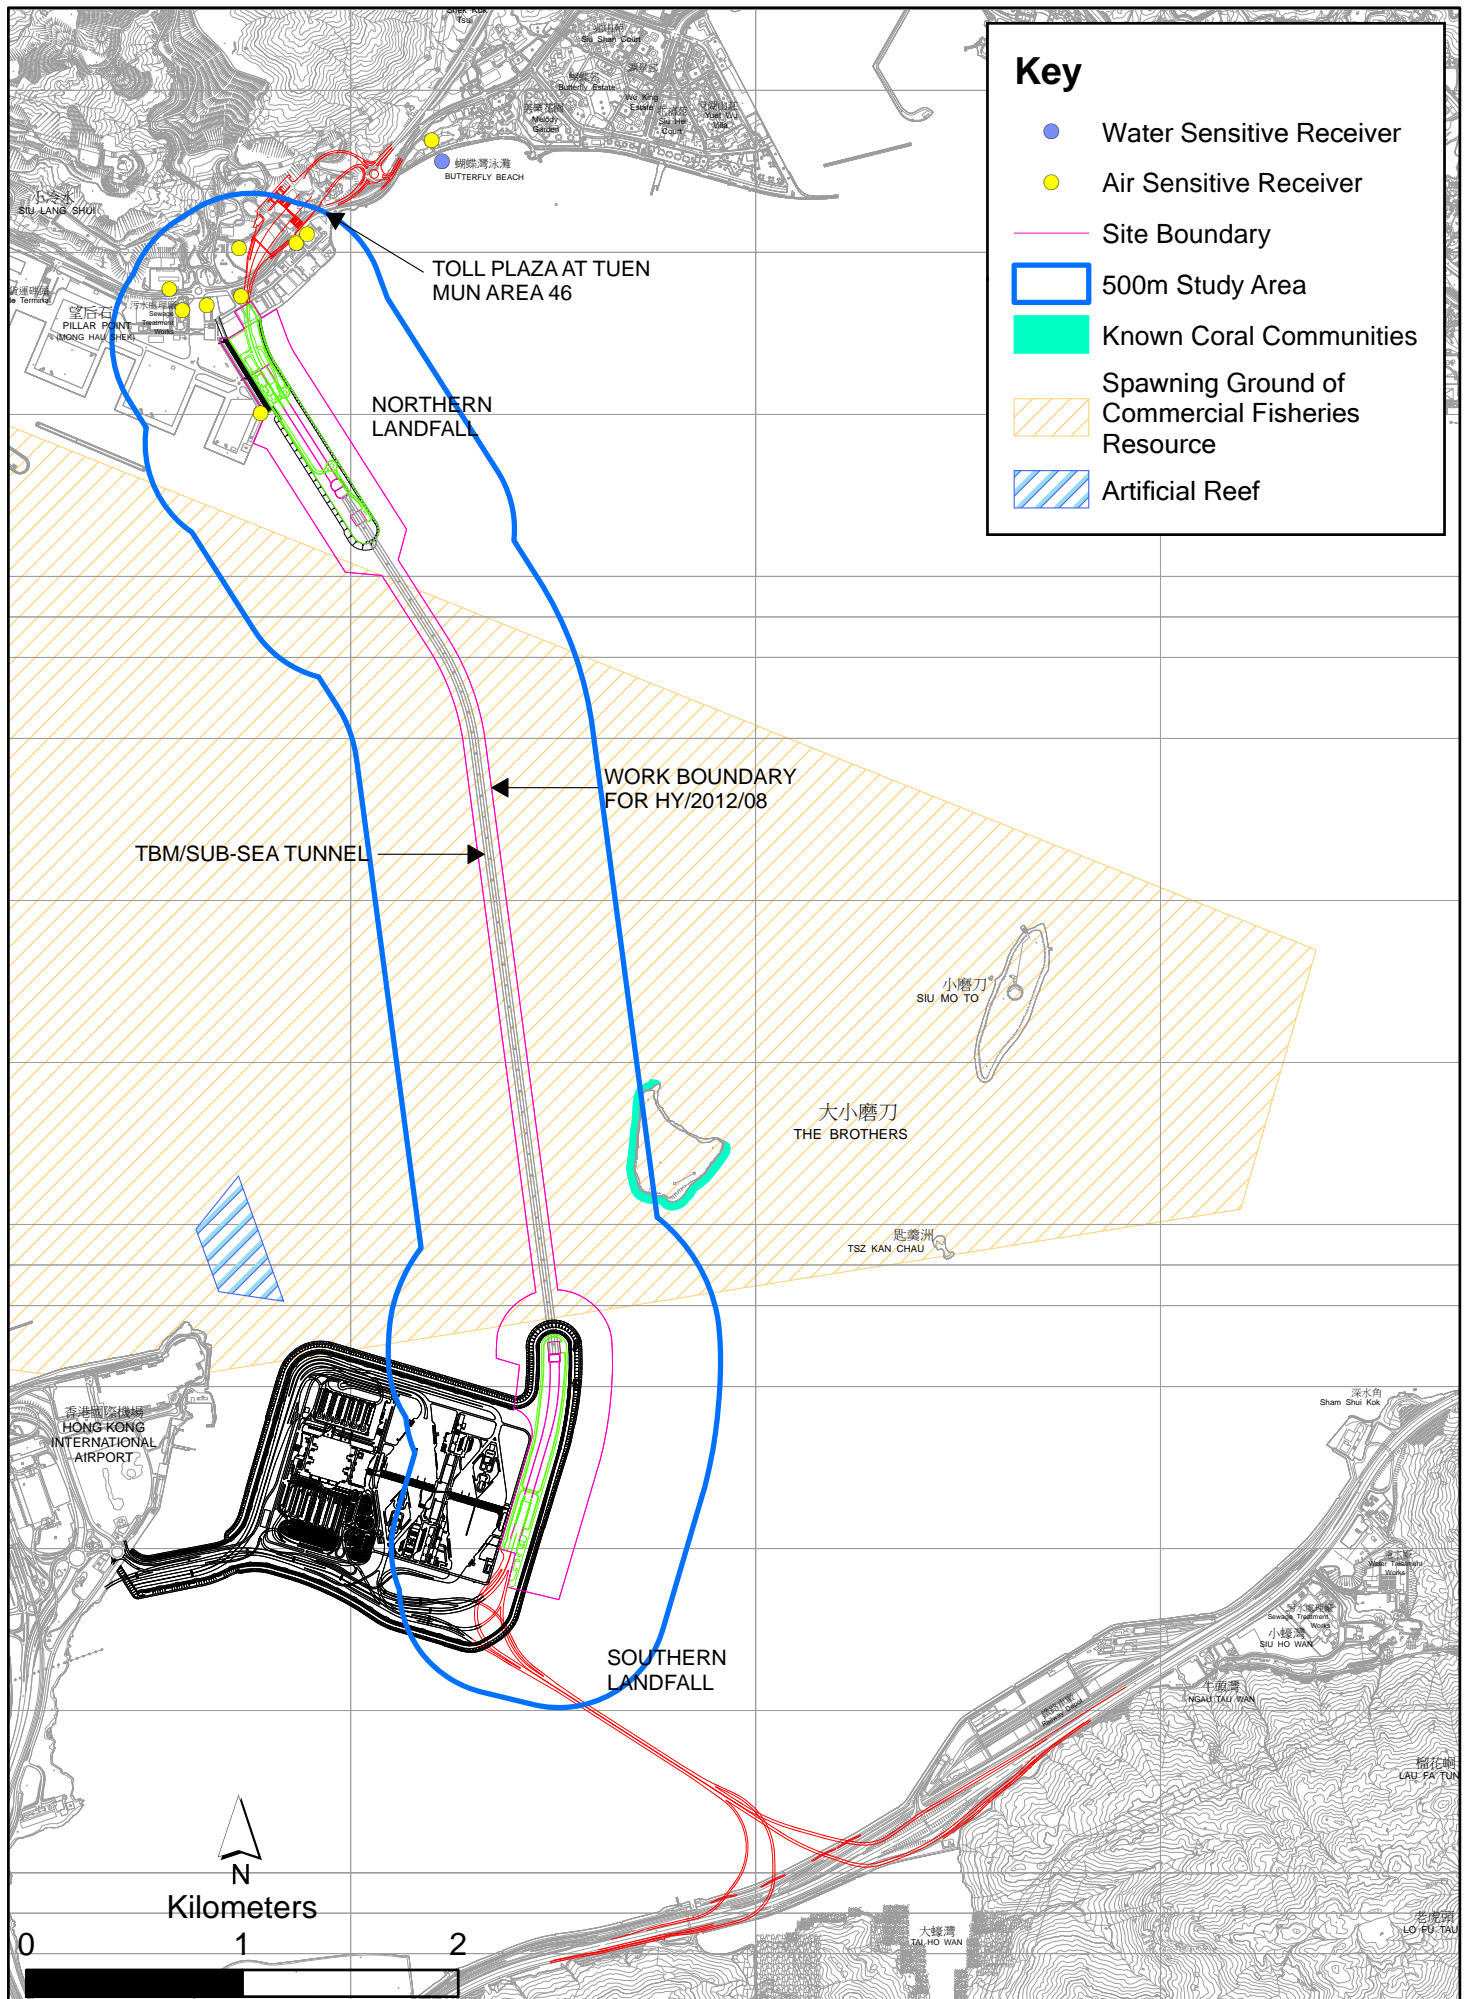
Figure 1.3 Environmental Sensitive Receivers in the vicinity of Contract No. HY/2012/08 Tuen Mun - Chek Lap Kok Link - Northern Connection Sub-Sea Tunnel Section

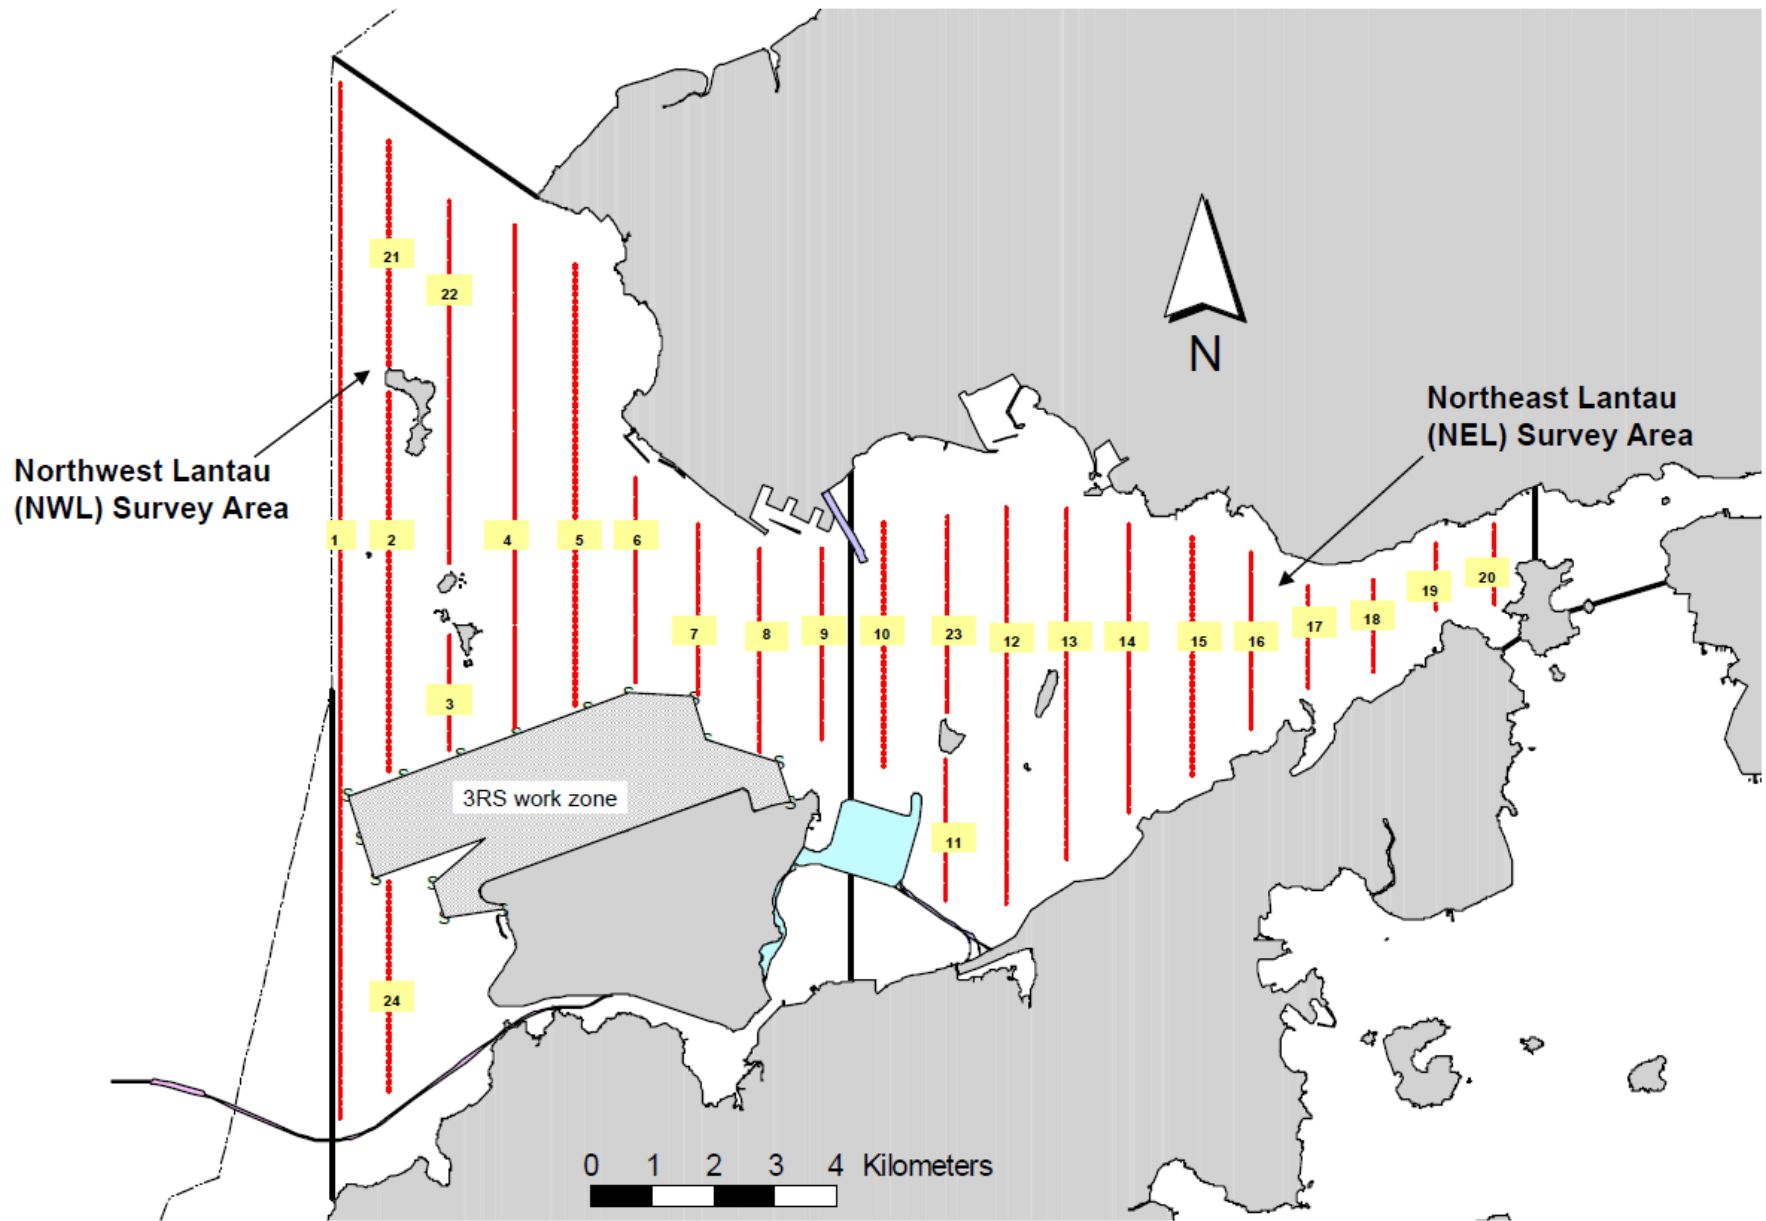
Figure 2.2

The impact dolphin monitoring was carried out in the NEL and NWL along the line transect as depicted in *Figure 2.2*. The co-ordinates of all transect lines are shown in *Table 2.6* below.

Layout of Transect Lines of Dolphin Monitoring in Northwest and Northeast Lantau Areas

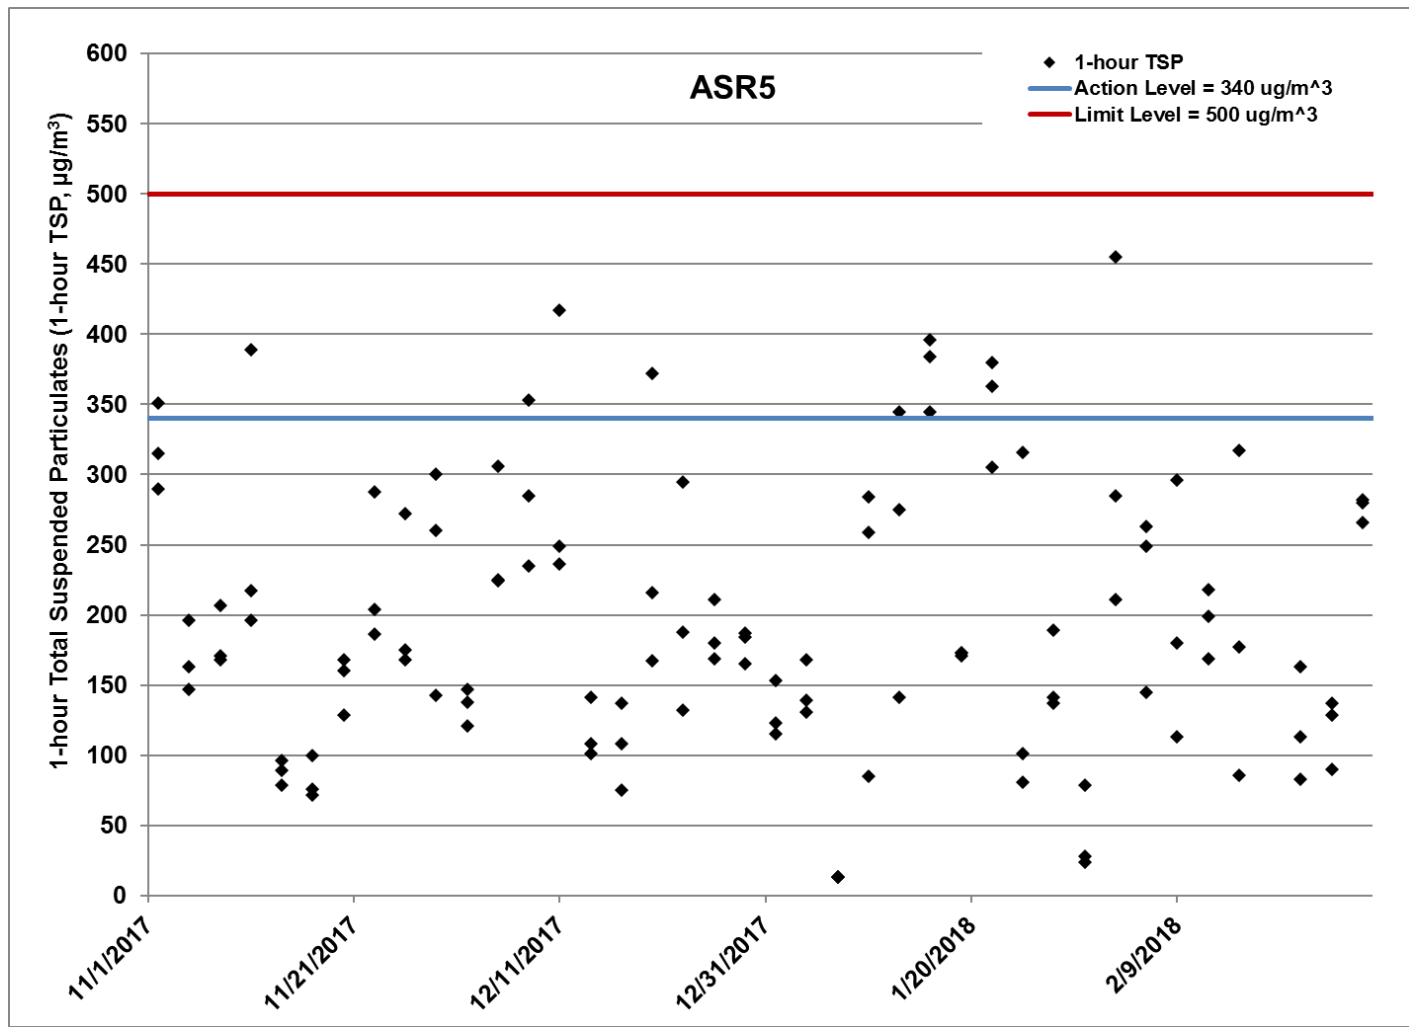
Figure G.4 Impact Monitoring - 1-hour Total Suspended Particulates ($\mu\text{g}/\text{m}^3$) at ASR5 between 1 November 2017 and 28 February 2018 during impact monitoring period. The weather conditions during the monitoring period varied from sunny to cloudy. Major land-based construction activities included: Box Culvert Extension, Construction of North Ventilation Building (1/11/2017 - 28/2/2018)

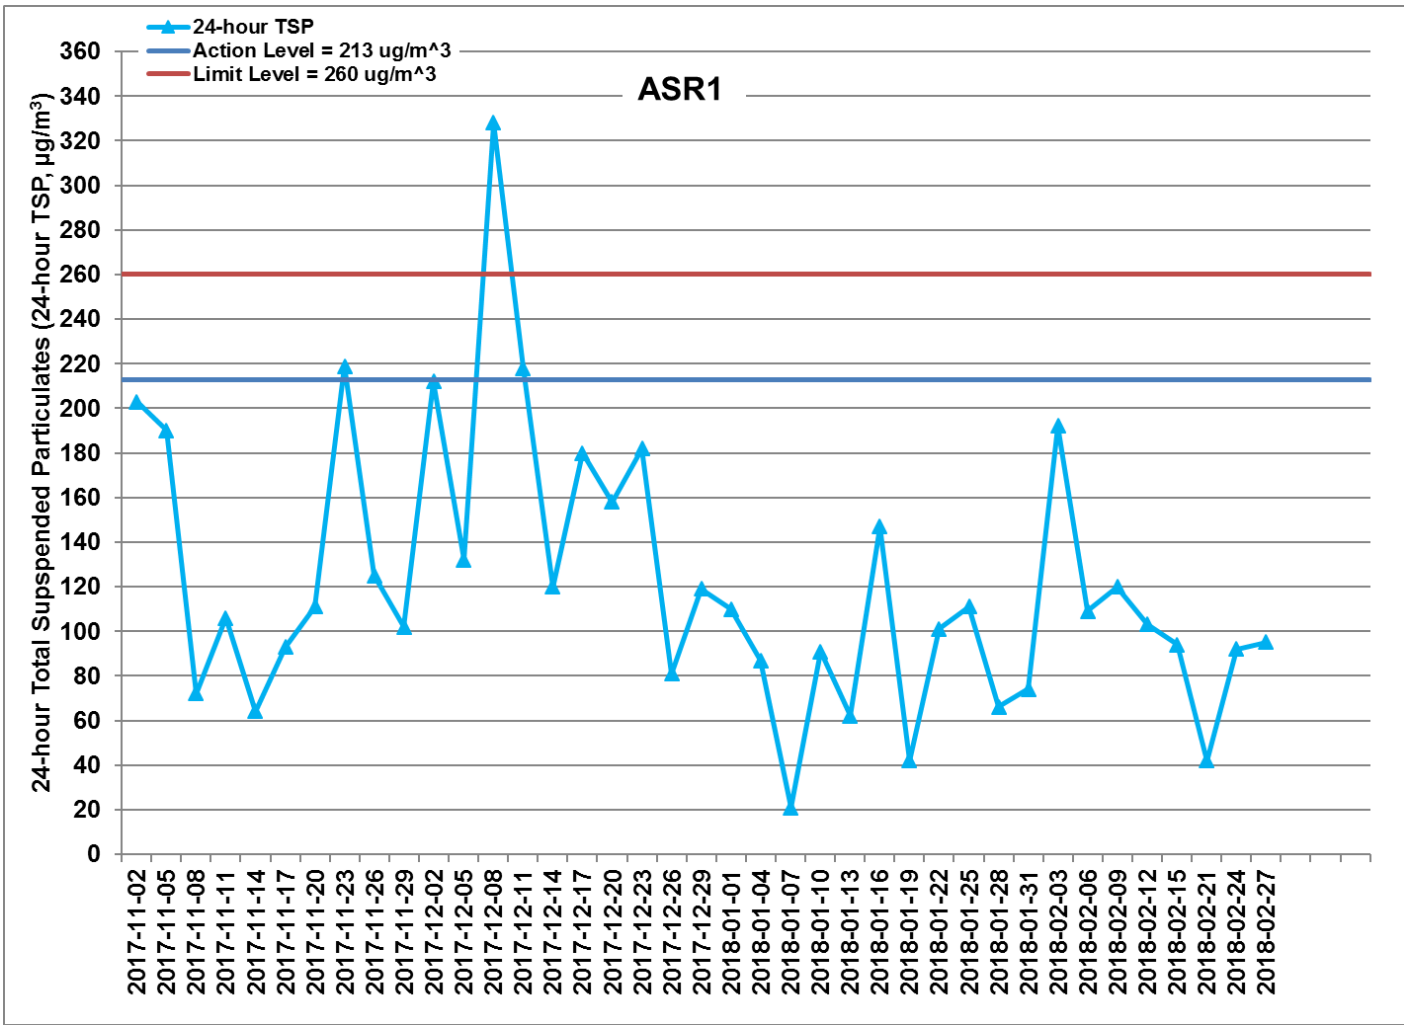
Figure G.6 Impact Monitoring - 24-hour Total Suspended Particulates ($\mu\text{g}/\text{m}^3$) at ASR1 between 1 November 2017 and 28 February 2018 during impact monitoring period. The weather conditions during the monitoring period varied from sunny to cloudy. Major land-based construction activities included: Box Culvert Extension, Construction of North Ventilation Building (1/11/2017 - 28/2/2018)

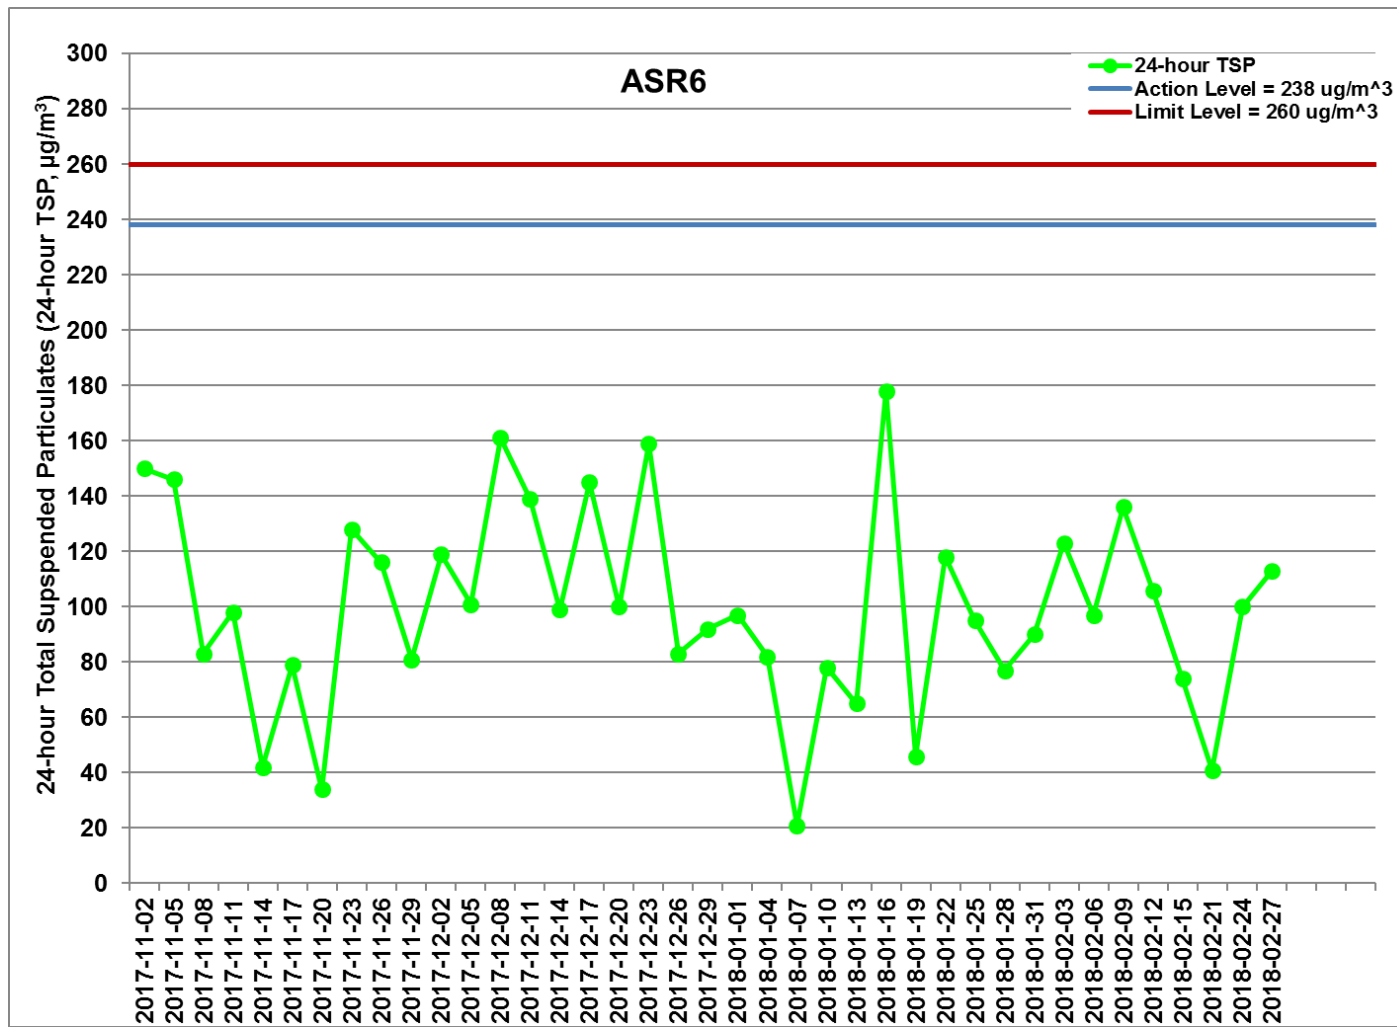
Figure G.9 Impact Monitoring - 24-hour Total Suspended Particulates ($\mu\text{g}/\text{m}^3$) at ASR6 between 1 November 2017 and 28 February 2018 during impact monitoring period. The weather conditions during the monitoring period varied from sunny to cloudy. Major land-based construction activities included: Box Culvert Extension, Construction of North Ventilation Building (1/11/2017 - 28/2/2018)

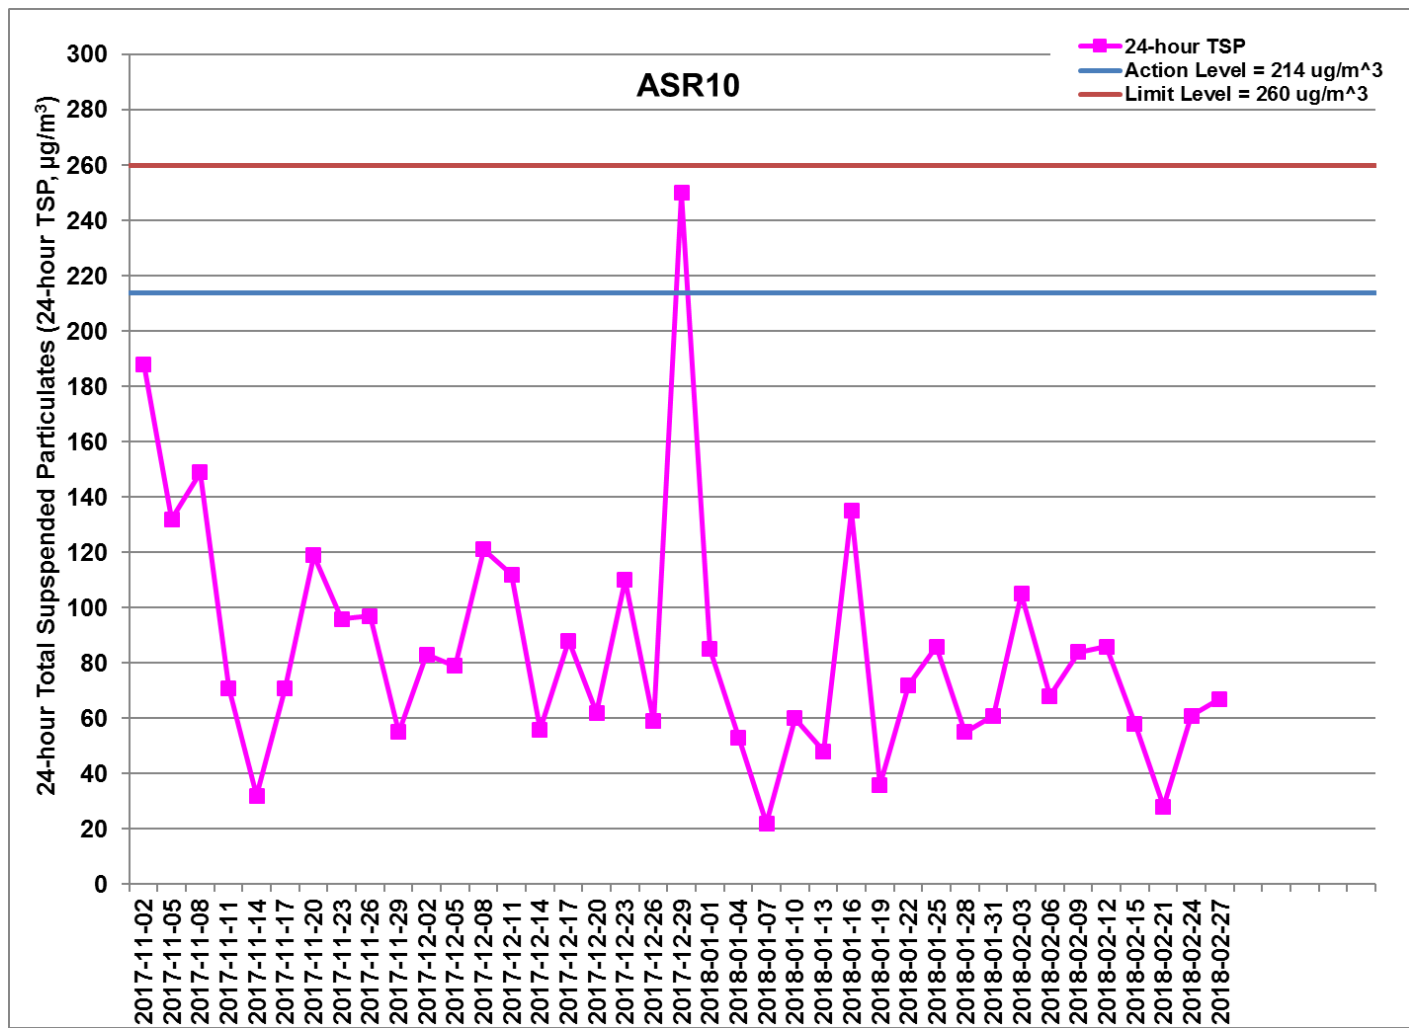
Figure G.10 Impact Monitoring - 24-hour Total Suspended Particulates (µg/m³) at ASR10 between 1 November 2017 and 28 February 2018 during impact monitoring period. The weather conditions during the monitoring period varied from sunny to cloudy. Major land-based construction activities included: Box Culvert Extension, Construction of North Ventilation Building (1/11/2017 - 28/2/2018)
