**Contract No. HY/2012/07
Tuen Mun – Chek Lap Kok Link –
Southern Connection Viaduct Section**

*Nineteenth Quarterly Environmental Monitoring
& Audit (EM&A) Report*

31 January 2019

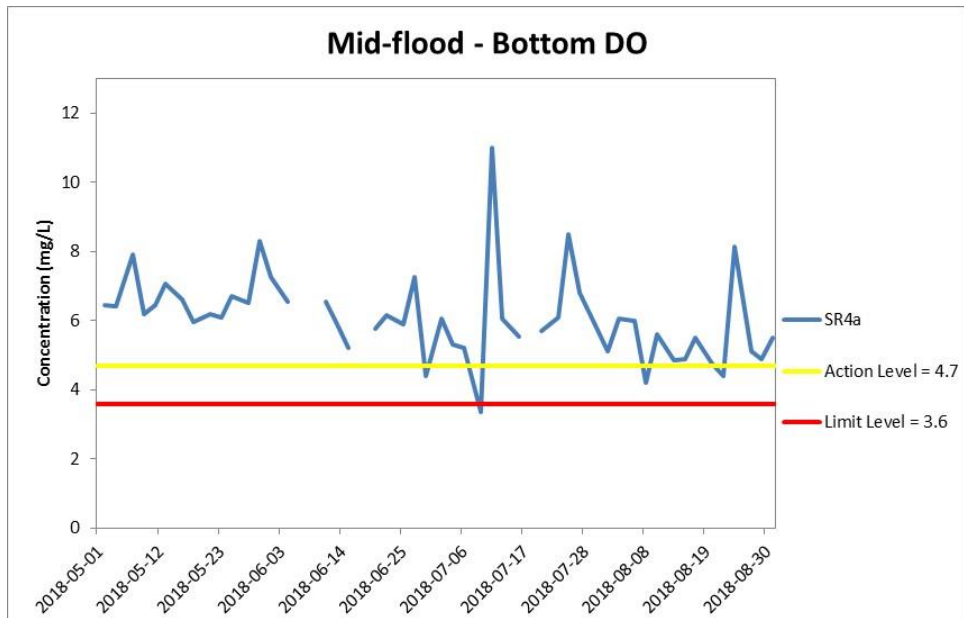
Figure H20 Impact Monitoring - Mean Level of Dissolved Oxygen (mg/L) in bottom waters during mid-flood tide between 1 May and 31 August 2018 at SR4a.
